# LAND OFF 1292 ASHTON OLD ROAD, MANCHESTER

## PHASE 1: PRELIMINARY RISK ASSESSMENT

**Job Number:** LKC 22 1066  
**Date:** 16<sup>th</sup> May 2022  
**Client:** Sterling Investment Projects Ltd

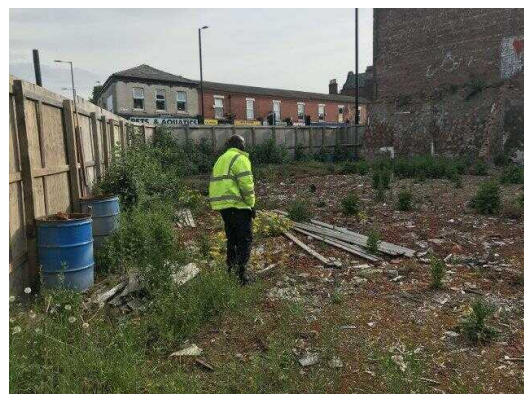
**Photograph 1:** View of N section of site, looking NE. Metal drums present.

- The only visual contamination noted were several empty metal drums of fuel additive, identified along the site boundary in the northwest of the site.

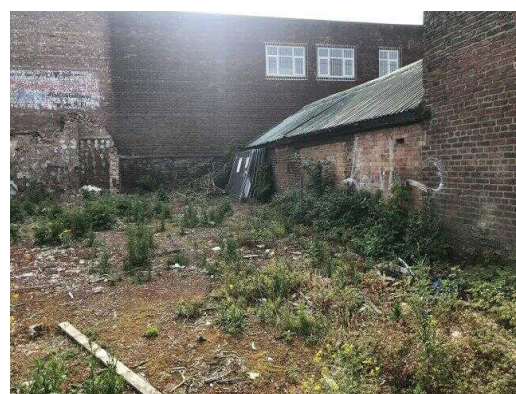
**Photograph 2:** View of N section of site, looking E.

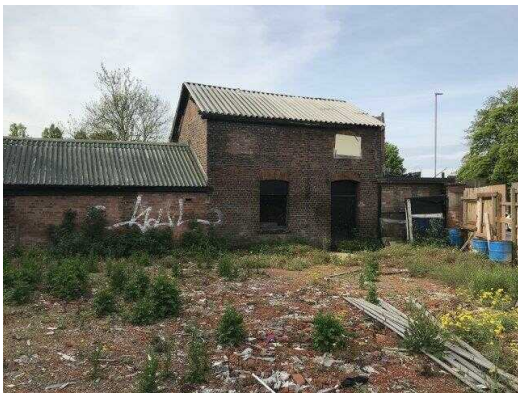
| <p><b>Photograph 3:</b> View of N of site and central building, from N, looking S.</p> | <p><b>Photograph 4:</b> Inside central building.</p> |

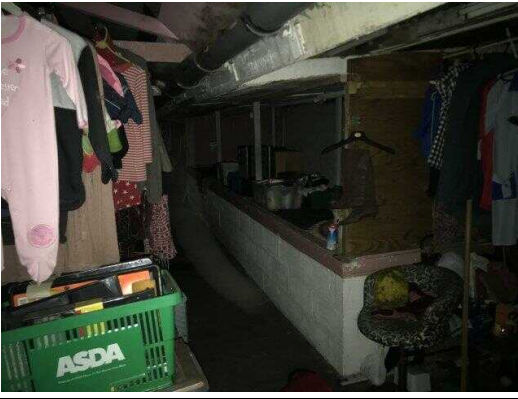
| <p><b>Photograph 5:</b> Inside disused market area in S area of site.</p> | <p><b>Photograph 6:</b> Inside entranceway into disused market area in S area of site.</p> |

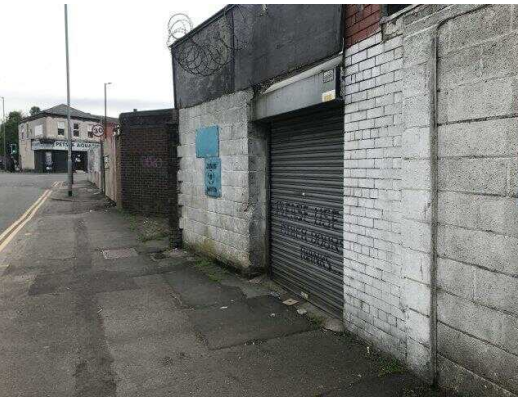
| <p><b>Photograph 7:</b> Access into disused market area in S area of site, on the W of the site.</p> | <p><b>Photograph 8:</b> Access into disused market area in S area of site, on the S of the site.</p> |

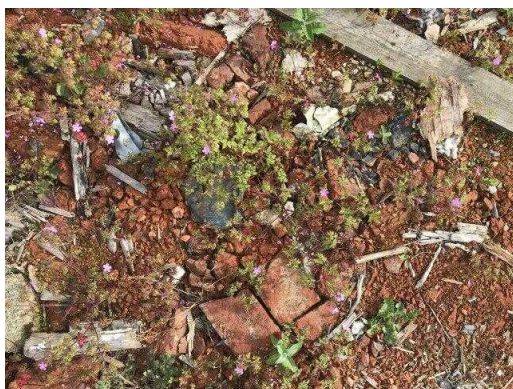
- The north of the site was open with groundcover consisting of demolition rubble (brick, concrete, ceramic tiles, plastic). No asbestos was noted in the made ground, however it is possible that some could be present.

**Photograph 9:** Groundcover in N of site.

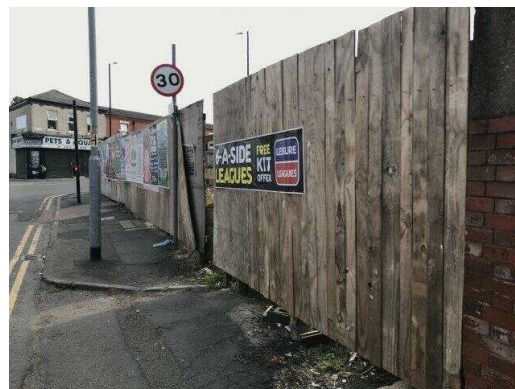
**Photograph 10:** Access to the N of the site through the fence on the W boundary.

- Access with a JCB or drilling rig would be possible in the north of the site if one of the fencing panels is removed. Access to the buildings may be possible with a drilling rig in some areas where space allows and with the removal of some of the debris and materials within the buildings.

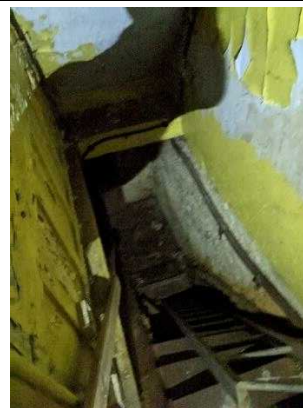
**Photograph 12:** Entrance to cellar area in SW of site.

| Potential Source | Contaminants |
|---|---|
| Cellar | <ul style="list-style-type: none"> <li>- Cellar is not infilled and therefore doesn't provide a significant source of contamination.</li> </ul> |

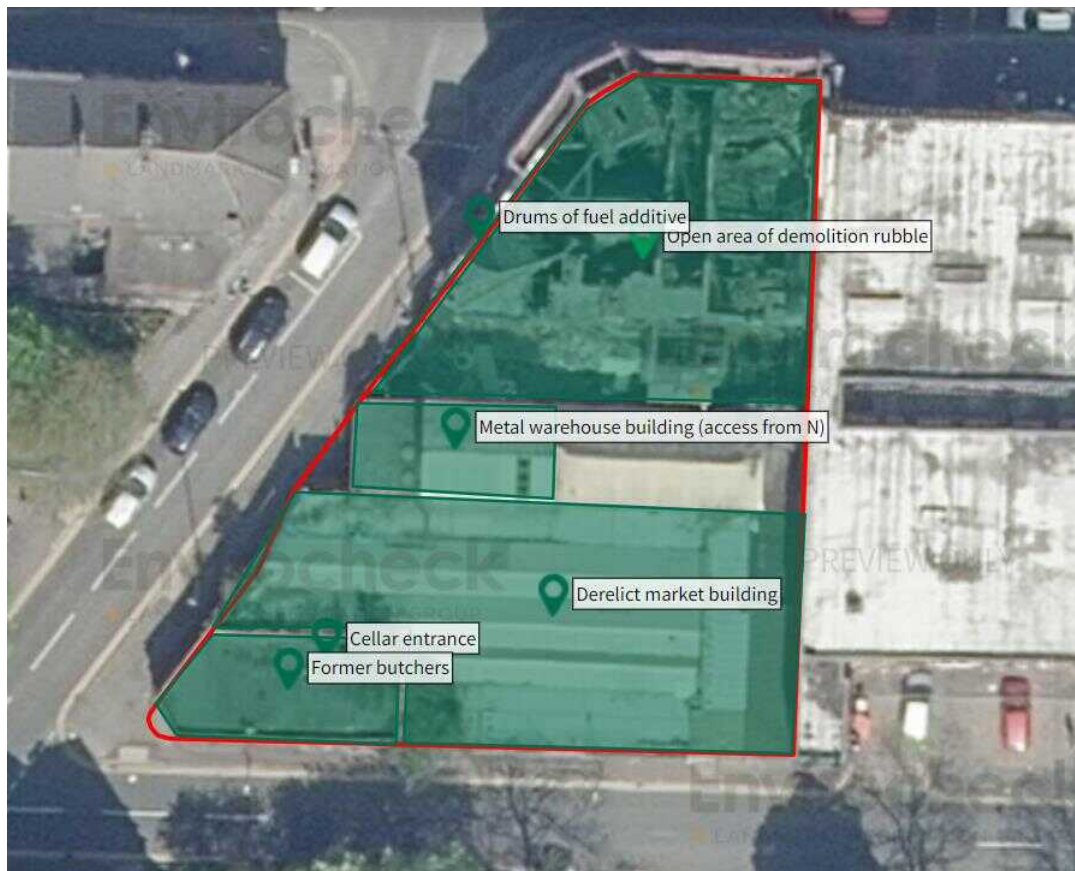
Plate 4-2: Plan showing relevant site walkover features.

Relevant features are also shown on Plate 4-2.
