THOMAS STREET, MANCHESTER

## No. 7 KELVIN STREET STRUCTURAL WORKS

Project No 1601-09  
March 2021  
Rev: P03  
TST-REN-00-XX-RP-S-00001

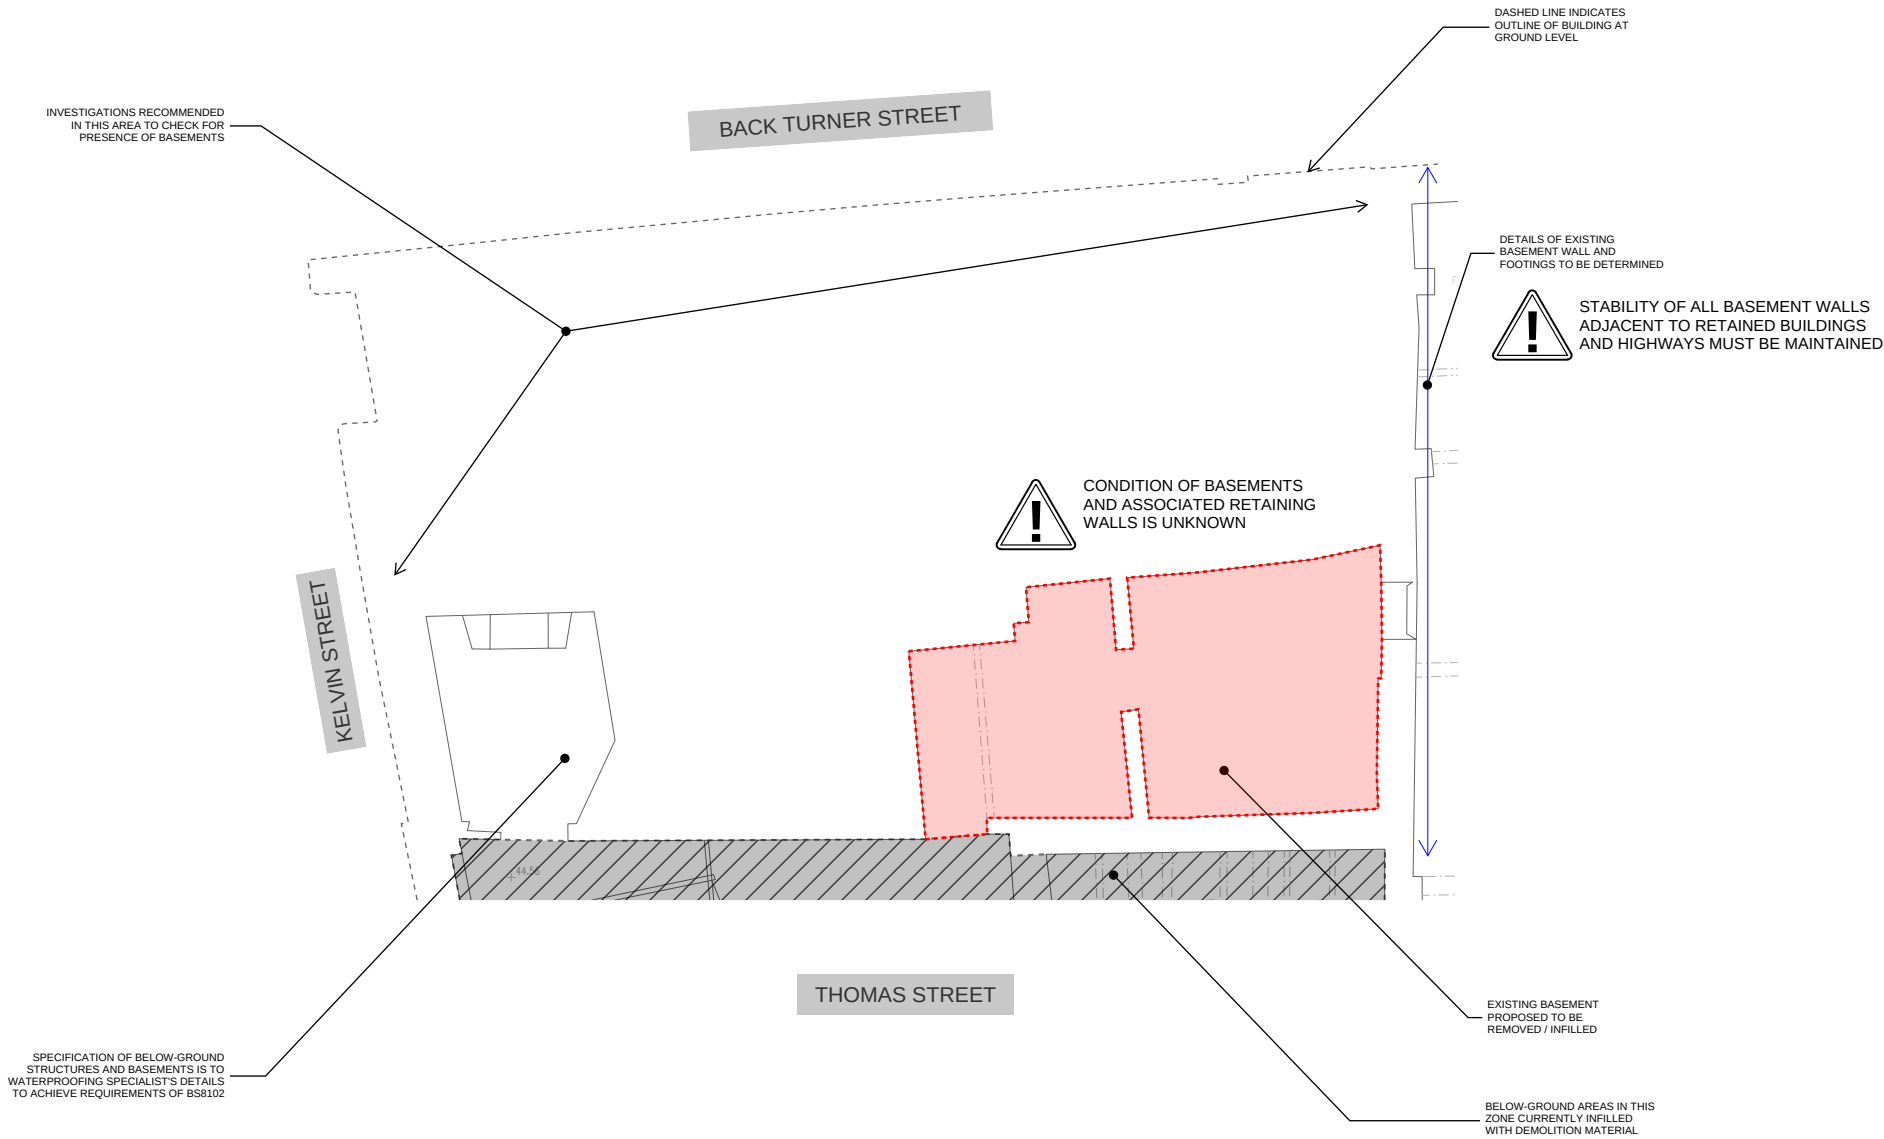
**BASEMENT**

- TB** DENOTES NEW TIMBER BEAMS, SIZE TBC.
- WB** DENOTES STEEL WALING BEAM, SIZE TBC. ALLOW FOR 260x90 PFC
- TIE** DENOTES STEEL TIE MEMBER, SIZE TBC. ALLOW FOR 150x90 PFC

The demolition rubble which has been used as backfill to part of the basement of 48-50 Thomas Street may be surcharging the basement walls and it is recommended that this be partially removed. Removal will also be necessary to allow inspection of, and works to the basement areas below No. 7 Kelvin Street.

No basement is thought to be present below No. 7 Kelvin Street however it is strongly recommended that this be checked by opening up some small holes in the ground floor. The base / footing details of the existing columns (which have apparently been introduced to enhance the load-carrying capacity of the floor, or to rectify deficiency from decay or damage) should be investigated also.

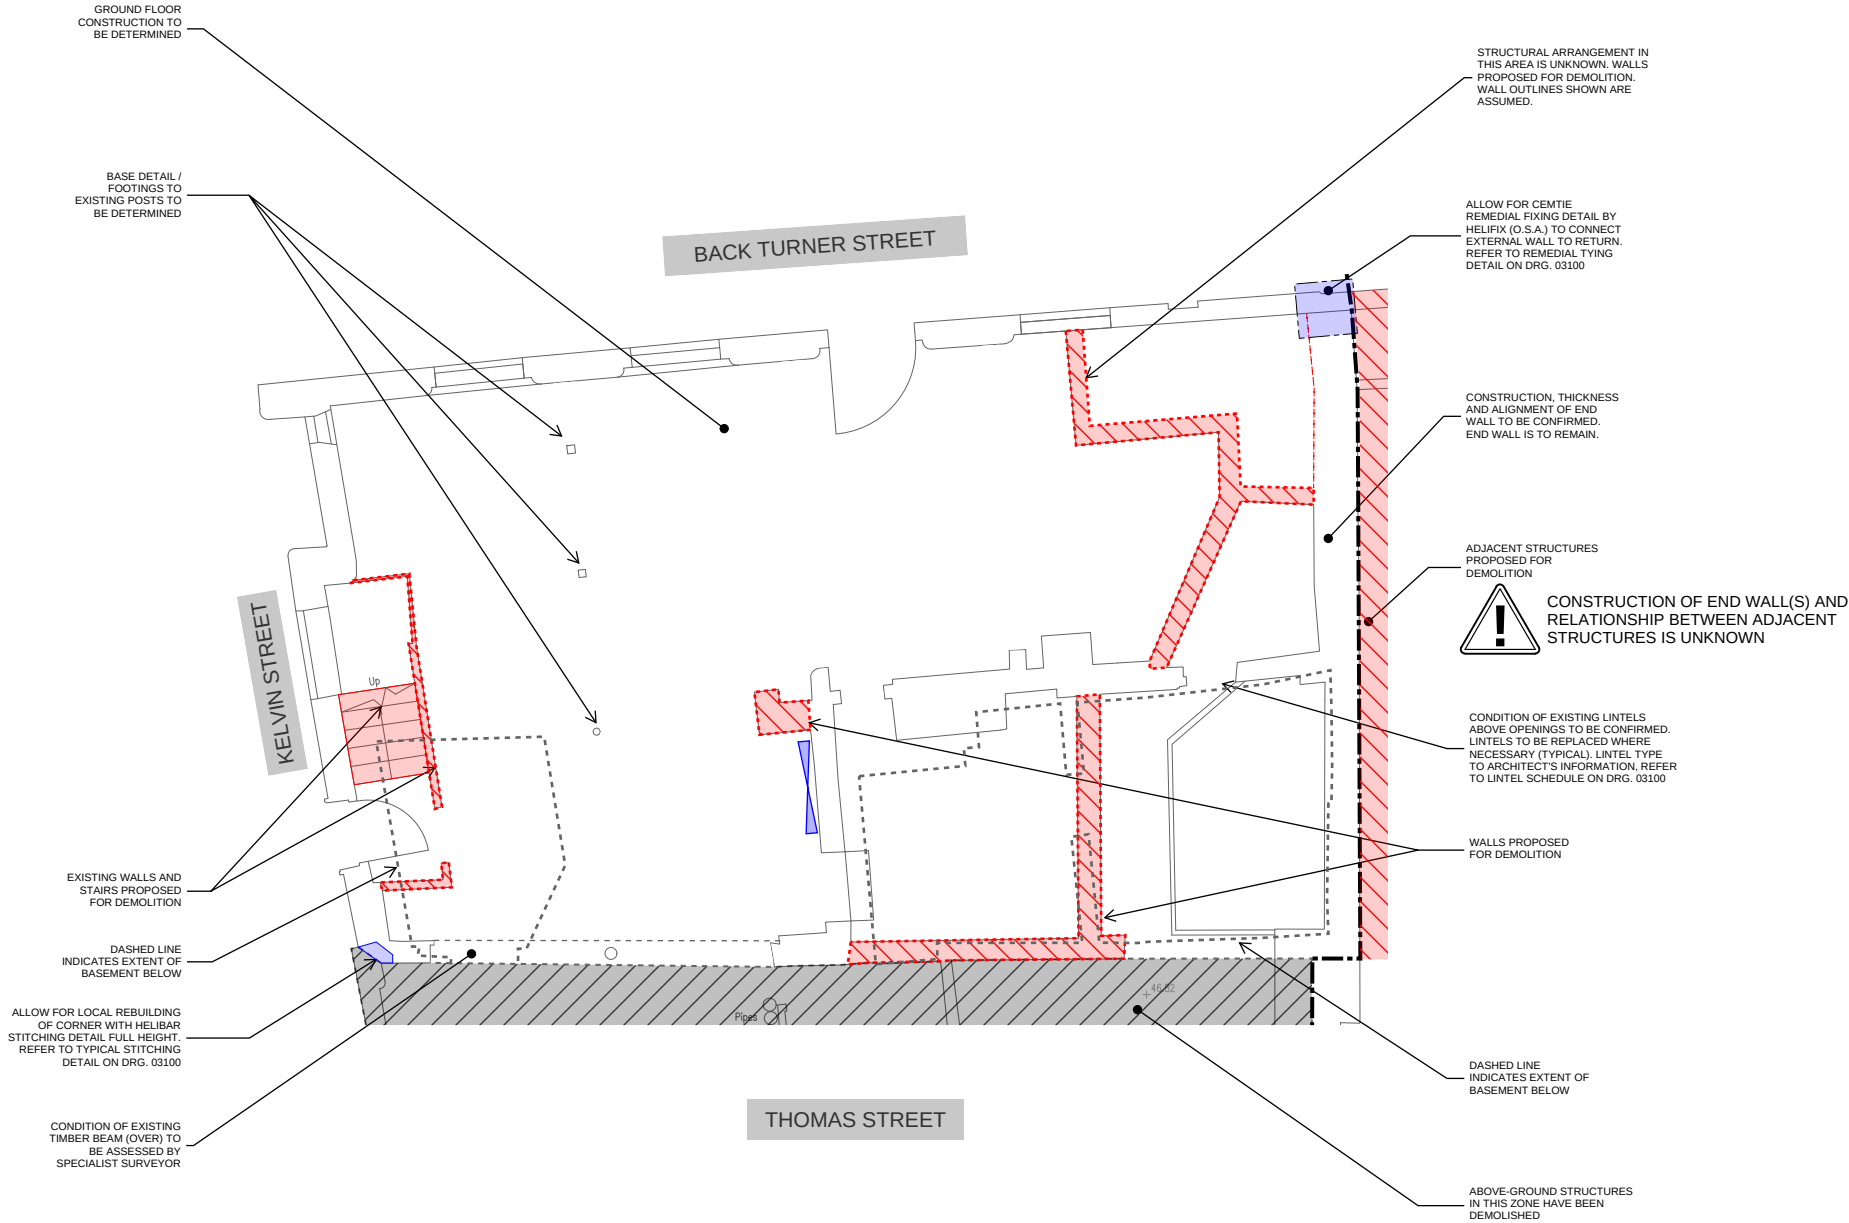
| Drawing Title:<br><b>No. 7 KELVIN STREET GROUND FLOOR G.A.</b> | | | | |

- TB** DENOTES NEW TIMBER BEAMS, SIZE TBC.
- WB** DENOTES STEEL WALING BEAM, SIZE TBC. ALLOW FOR 260x90 PFC
- TIE** DENOTES STEEL TIE MEMBER, SIZE TBC. ALLOW FOR 150x90 PFC

The existing staircase linking Ground and First floors is to be removed; second floor is currently only accessible via a ladder and access hatch. A new staircase is to be constructed linking all floors requiring portions of the existing floor to be removed.

Some areas of ground floor are not covered by the measured survey that is available, seemingly due to these areas being inaccessible at the time of survey. These areas should be opened up and surveyed to allow the structural works in these areas to be confirmed.

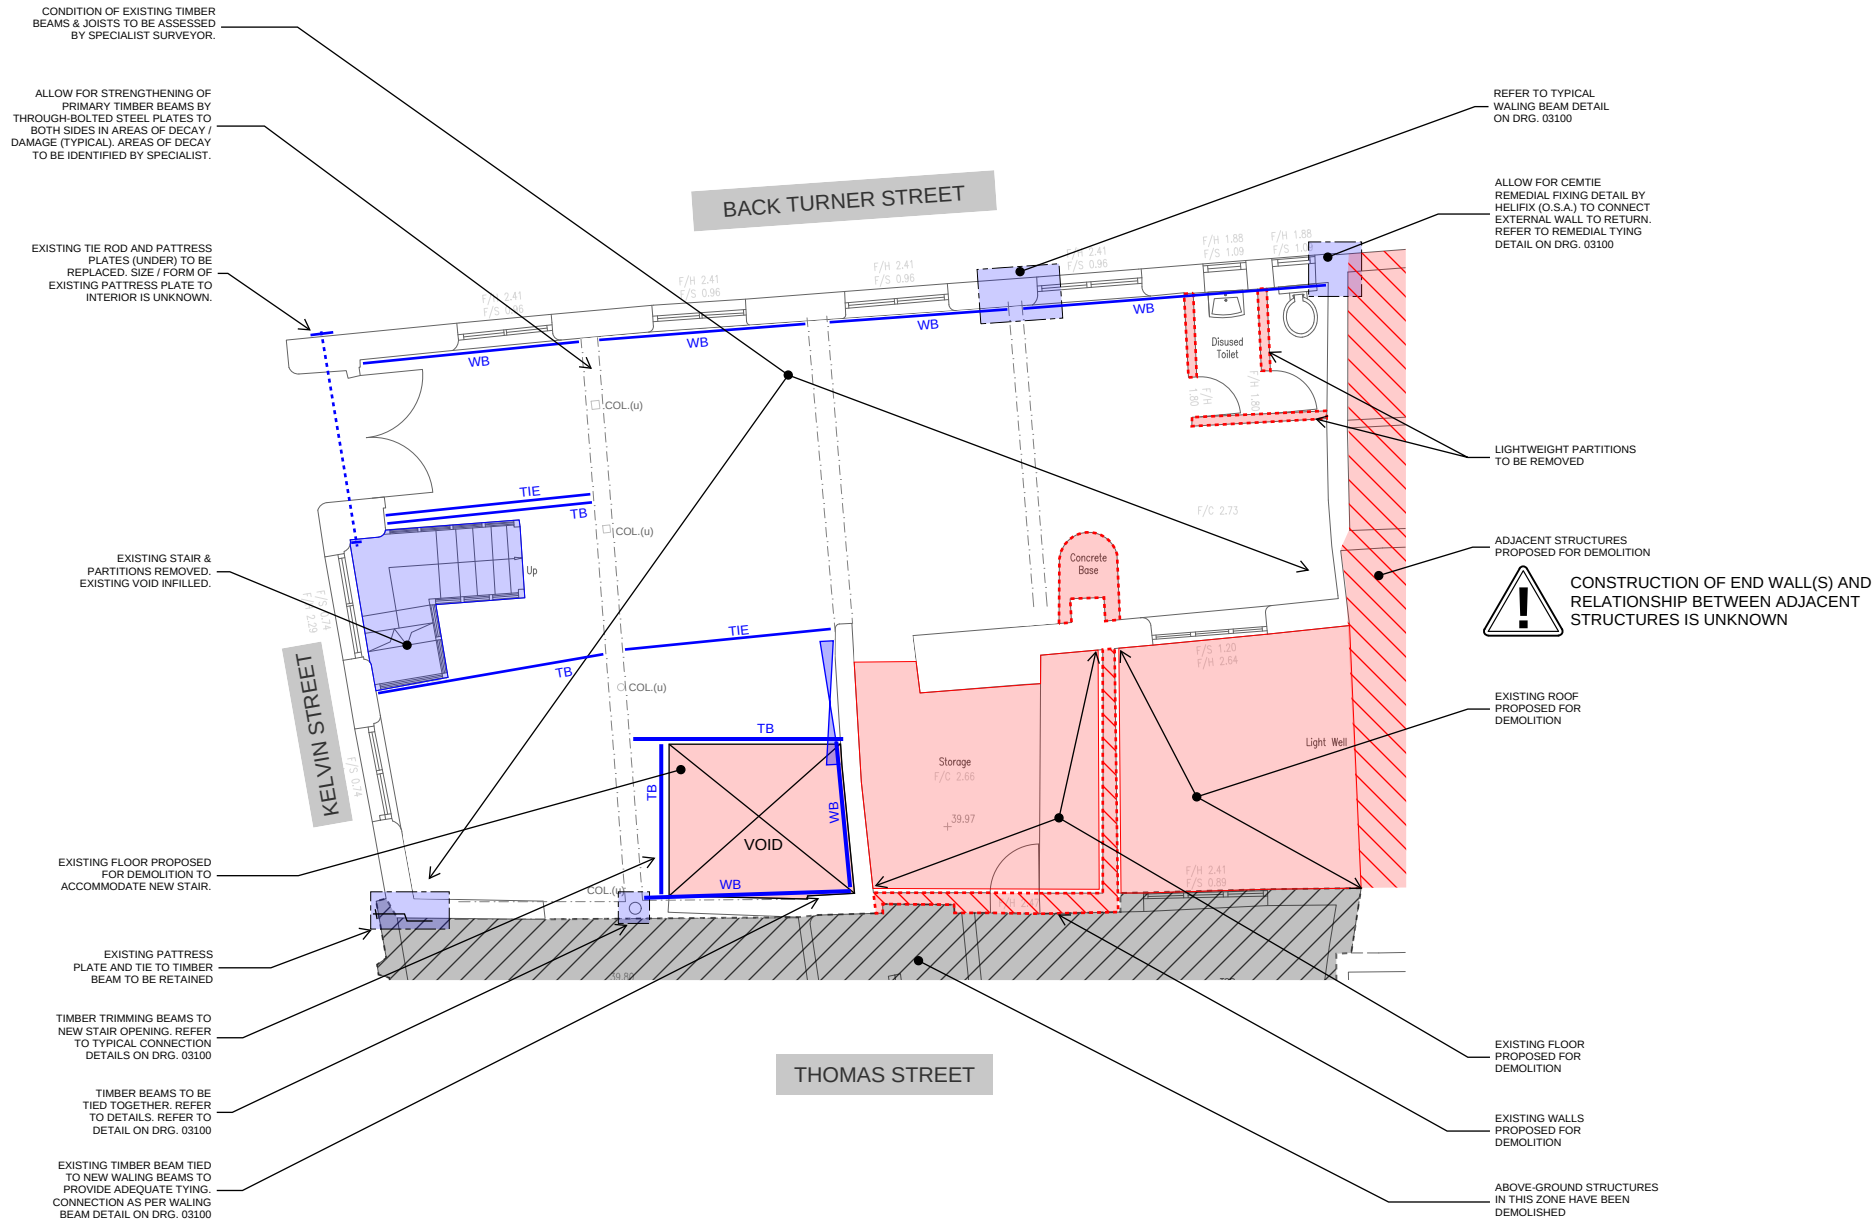
| Drawing Title:<br><b>No. 7 KELVIN STREET<br/>FIRST FLOOR G.A.</b> | | | | |

- TB** DENOTES NEW TIMBER BEAMS, SIZE TBC.
- WB** DENOTES STEEL WALING BEAM, SIZE TBC. ALLOW FOR 260x90 PFC
- TIE** DENOTES STEEL TIE MEMBER, SIZE TBC. ALLOW FOR 150x90 PFC

Number 7 Kelvin Street is proposed to become residential apartments following modification and removal of some internal walls; this may also necessitate the removal and replacement of some portions of floor currently supported by the removed elements.

This tying will be provided by tying joists across supporting beams, providing connection between joists and supporting walls and providing ties between beam ends. The beam end ties will be provided by means of steel elements to the internal face of the adjacent walls; these members will in many cases also be used as waling beams to restrain the walls which show signs of historic movement.

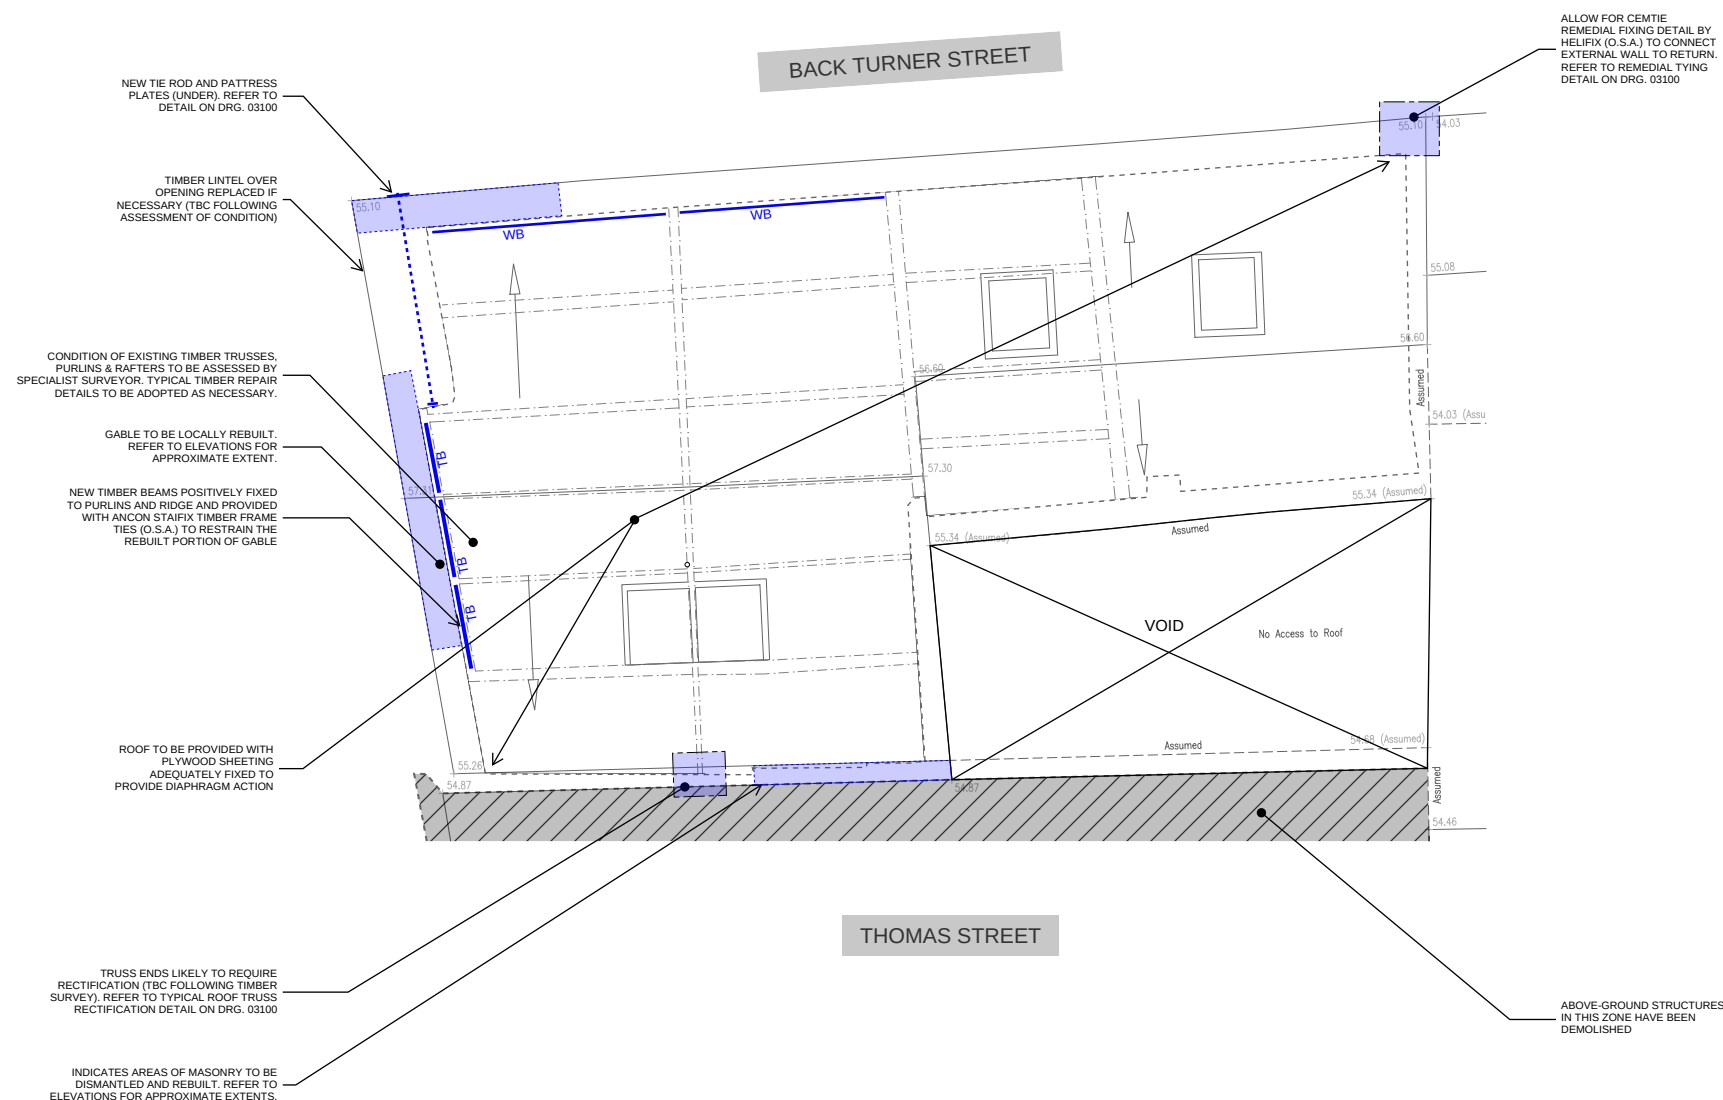
DENOTES HELIBAR CRACK STITCHING DETAIL TO WALLS.  
EXTENT TBC ON SITE, ASSUME FULL HEIGHT  
(FLOOR-CEILING) U.N.O.  
REFER TO TYPICAL STITCHING DETAIL ON DRG. 03100

**TB** DENOTES NEW TIMBER BEAMS, SIZE TBC.

**WB** DENOTES STEEL WALING BEAM, SIZE TBC  
ALLOW FOR 260x90 PFC

**TIE** DENOTES STEEL TIE MEMBER, SIZE TBC.  
ALLOW FOR 150x90 PFC

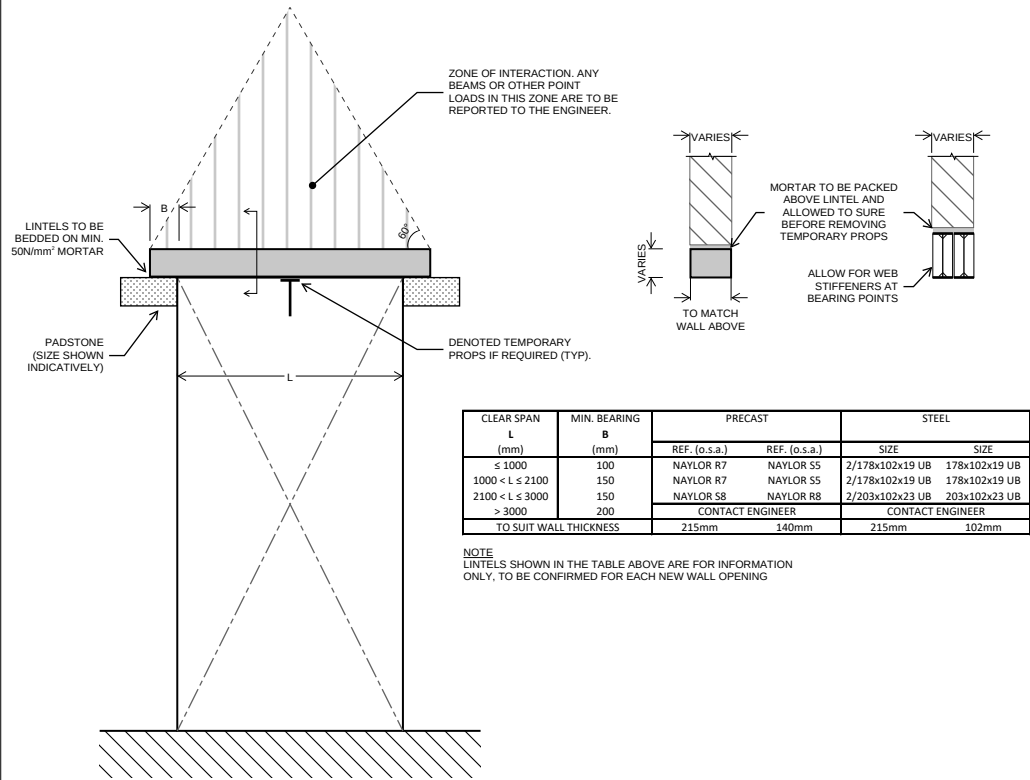
Typical Lintel Details

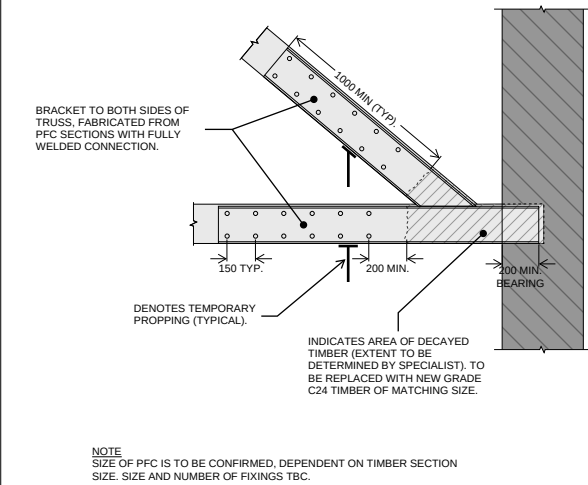
Typical Roof Truss Rectification Detail

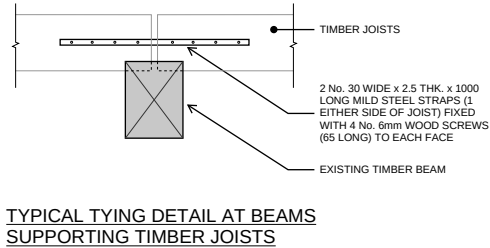
Typical Tying Detail at Beams Supporting Timber Joists

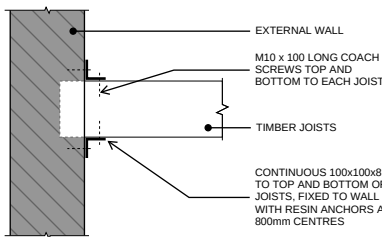
Typical Joist Tying Detail at External Walls

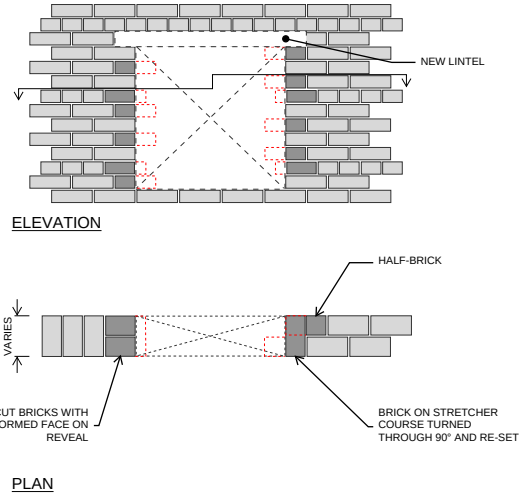
Typical Wall Opening Detail

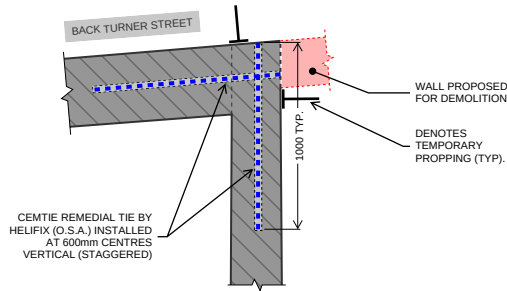
Remedial Tying Detail Between Return Walls

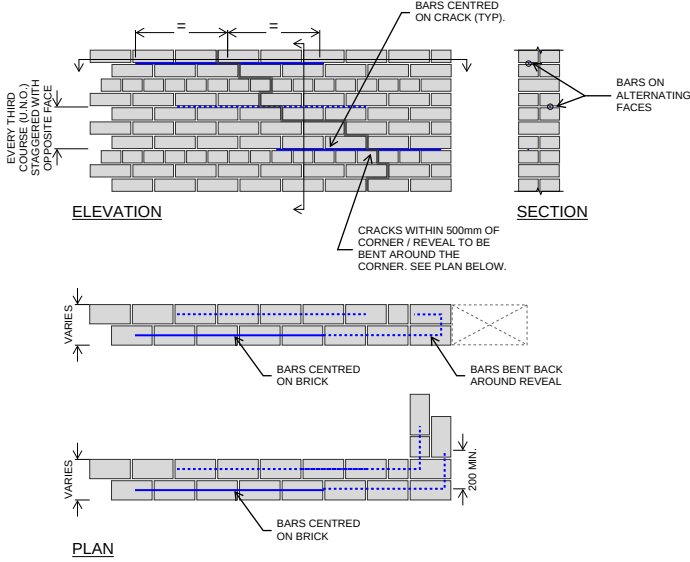
Typical Crack Stitching Detail

In various places the existing walls exhibit cracking. In these locations a brick stitching detail will be employed to tie together the wall to either side of the crack(s). To further enhance the robustness of the building, particularly the area of the Back Turner Street elevation to Kelvin Street, the primary floor and roof elements will be tied to the external walls.

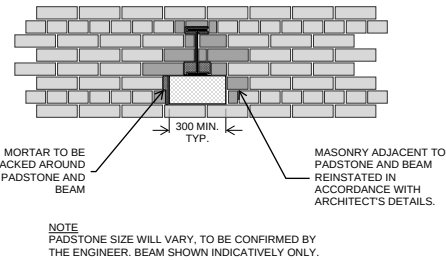
Typical Padstone Detail

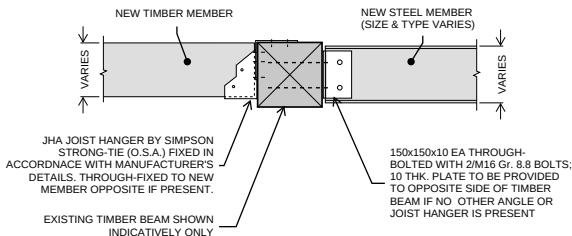
Typical Connection Details to Existing Timber Beams

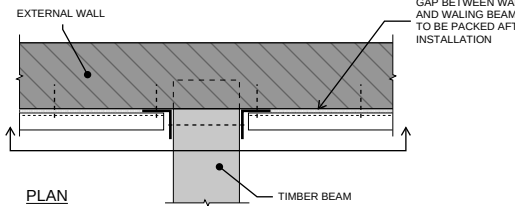
Typical Walling Beam Details

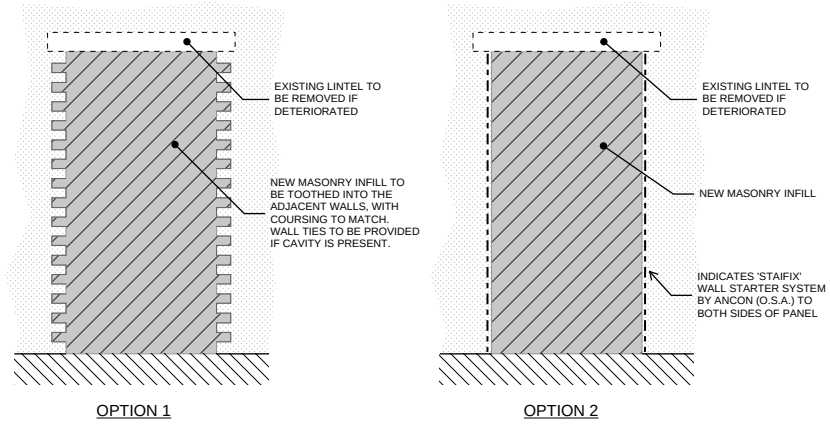
Typical Wall Infill Details

Where demolition of 48-50 Thomas Street has taken place, the now-exposed wall will require local dismantling and rebuilding in various areas with the existing wall openings to be infilled, further enhancing the robustness of the building as a whole. On the Kelvin Street corner of this elevation a brick stitching detail will be employed over the full height.

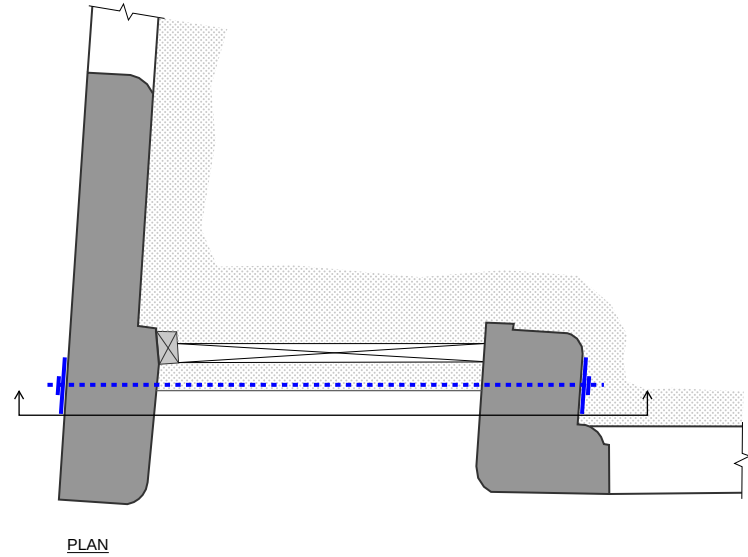
Tie Rod / Pattress Plate Detail

The elevation to Kelvin Street is proposed to be left unchanged, with repointing of brickwork as necessary. Tie rods (held by pattress plates on the Back Turner Street elevation and internally) are proposed to be introduced to help restrain the left side of the loading bay (i.e. the Kelvin Street / Back Turner Street corner). A tie rod and pattress plate are already present at the underside of first floor in this position. A portion of the existing brickwork near the top of the gable on Kelvin Street is proposed to be dismantled and rebuilt as it is considerably out-of-plumb.

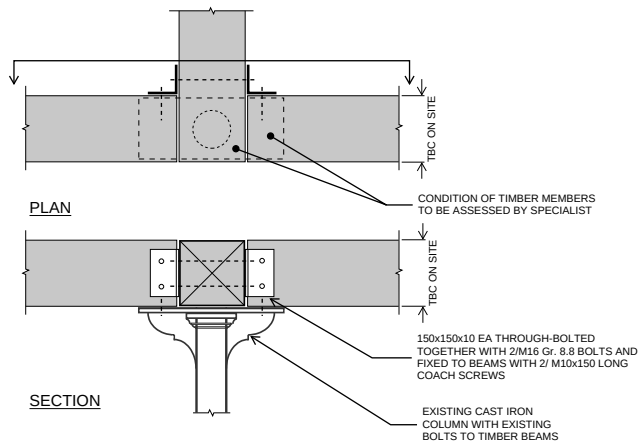
Tying Detail for Existing Timber Beams (Thomas Street Elevation)
