# TV/FM & DAB RECEPTION SURVEY REPORT

**THIS PRE-CONSTRUCTION TV/FM & DAB RECEPTION SURVEY WAS CONDUCTED BY:**

**DATE OF SURVEY:** 12<sup>th</sup> May 2022  
**REF NO:** TBAER063

Rodney Street,  
Land to the west of Rodney Street,  
Manchester  
M4 6JJ

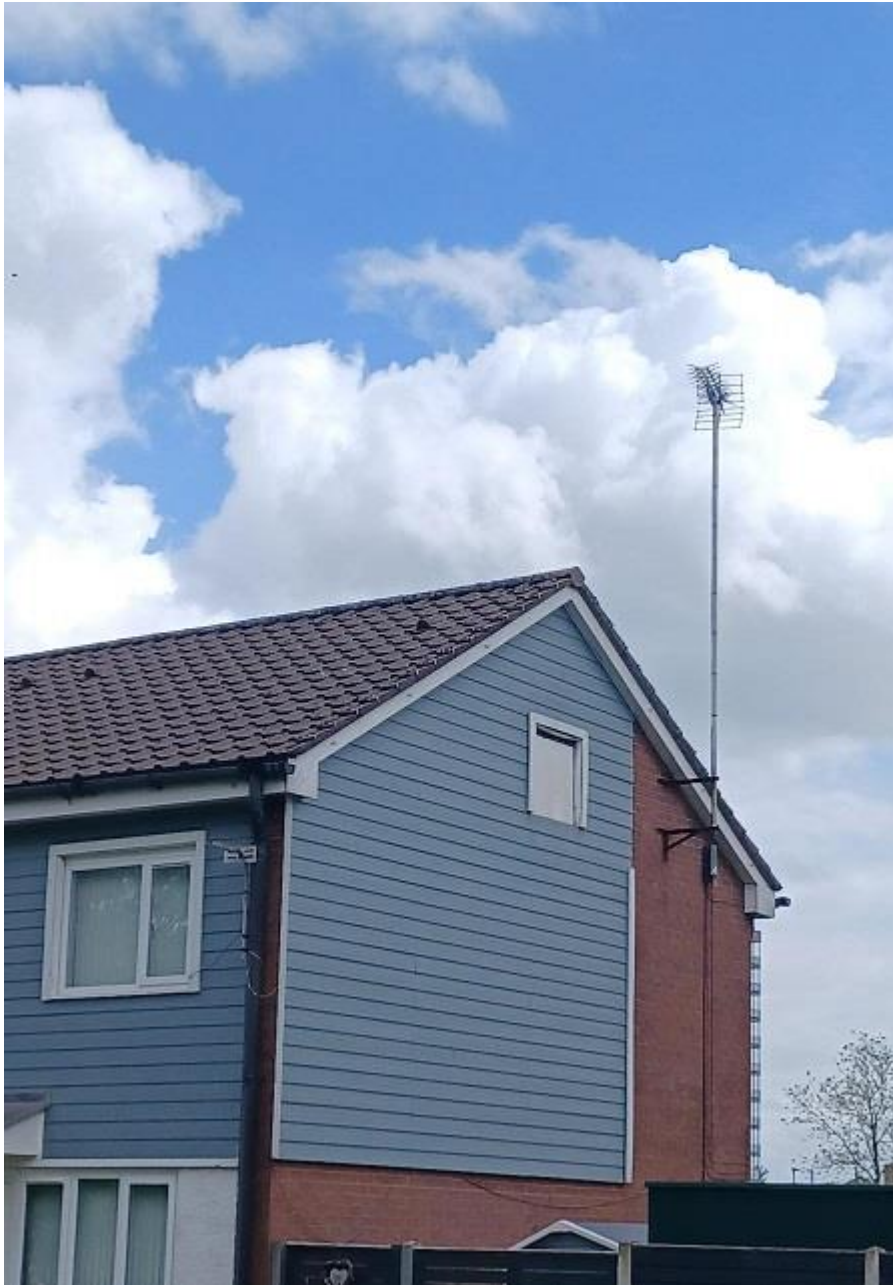
## VISIBLE TV AERIAL LOCATED IN THE AREA OF TEST POINT 1

Visible Existing Aerial Arrays: 52 element aerals on 4m mast, wall mounted and directed towards the Winter Hill Transmitter.

Visible Existing Obstructions: Various multistorey buildings in the general direction of the Winter Hill Transmitter

Television reception is of an acceptable quality and strength

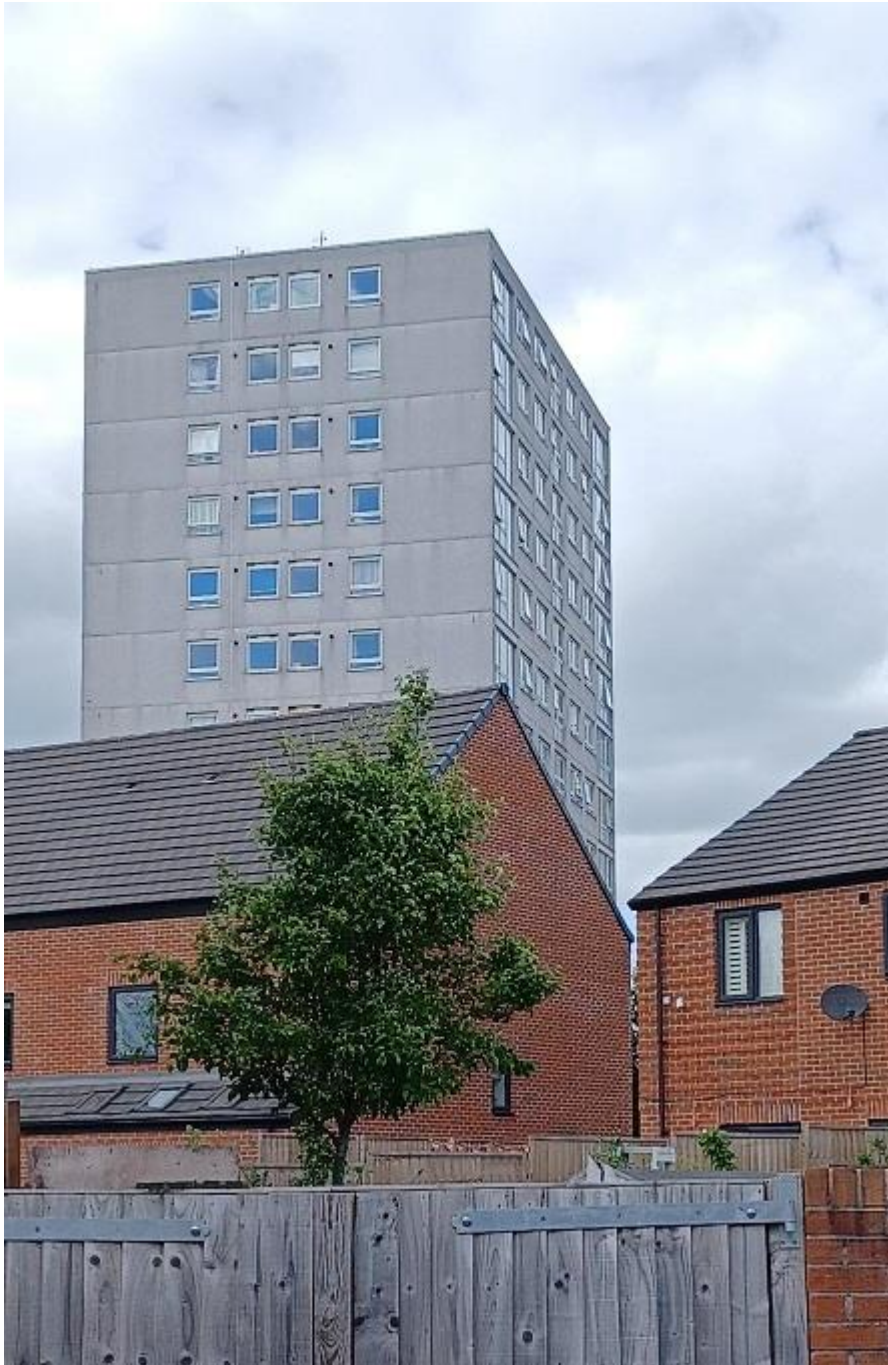
## VISIBLE TV AERIAL LOCATED IN THE AREA OF TEST POINT 2

**Visible Existing Aerial Arrays:** only satellite dishes visible.

**Visible Existing Obstructions:** Various buildings in the general direction of the Winter Hill Transmitter

Television reception is of an acceptable quality and strength

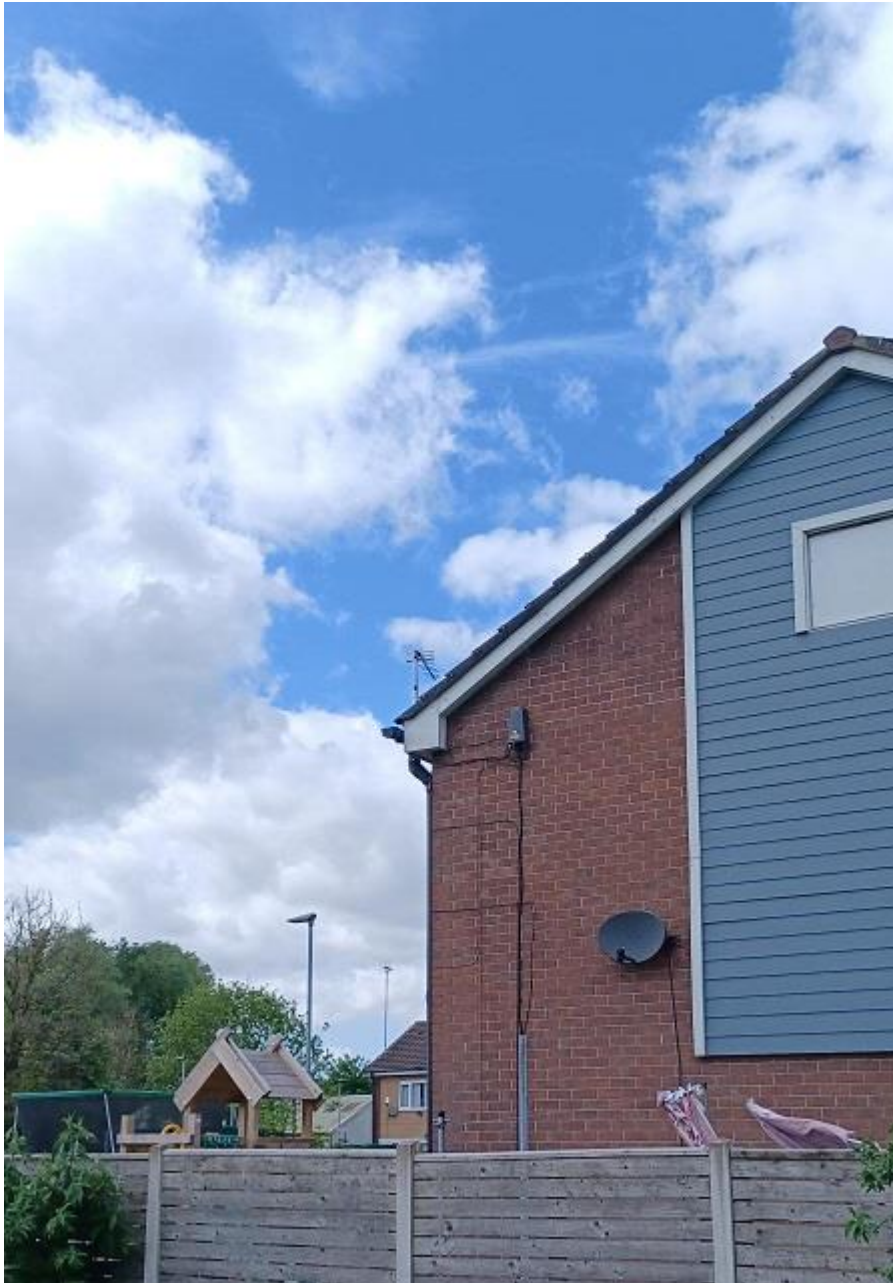
## VISIBLE TV AERIAL LOCATED IN THE AREA OF TEST POINT 3

**Visible Existing Aerial Arrays:** Satellite.

**Visible Existing Obstructions:** Various buildings in the general direction of the Winter Hill Transmitter

Television reception is of a good quality and strength
