# Television and Radio Baseline Survey and Report

No.3 Circle Square

June 2022

Pager Power has been commissioned to investigate the potential impact of the proposed No.3 Circle Square building development upon terrestrial television and radio reception in the surrounding area. The proposed development is located on Brancaster Road in central Manchester.

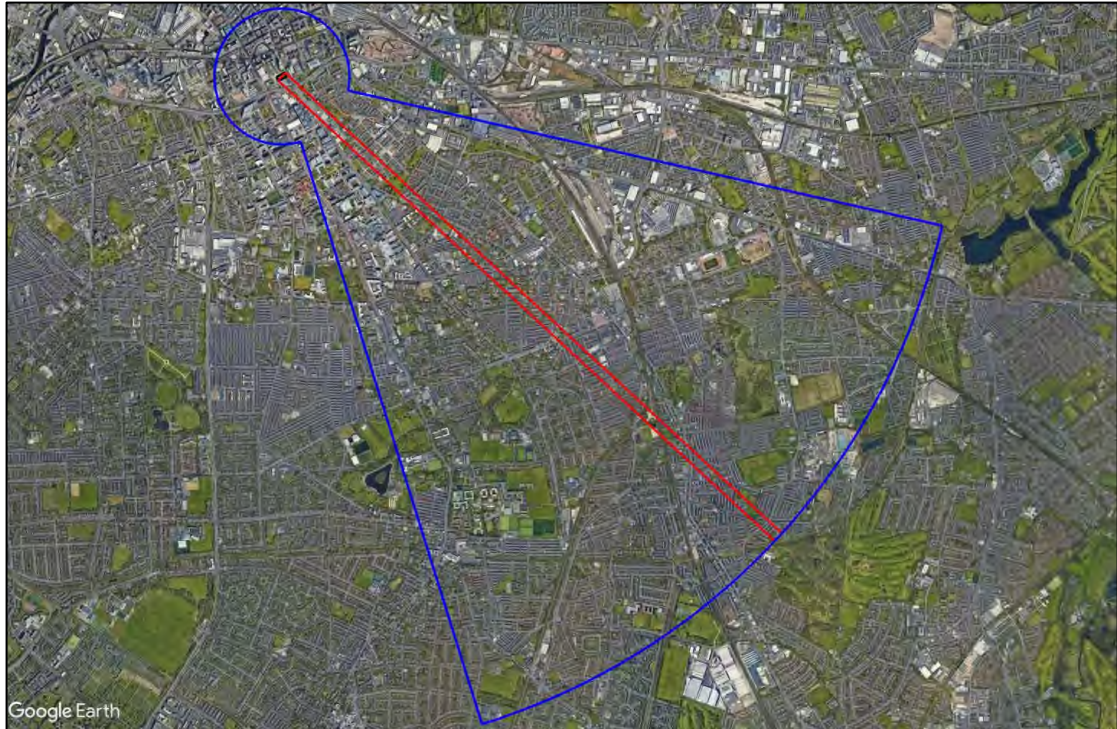
Figure 5 Interference zones map

Figure 5 below shows the interference zones overlaid onto an aerial image of the area.

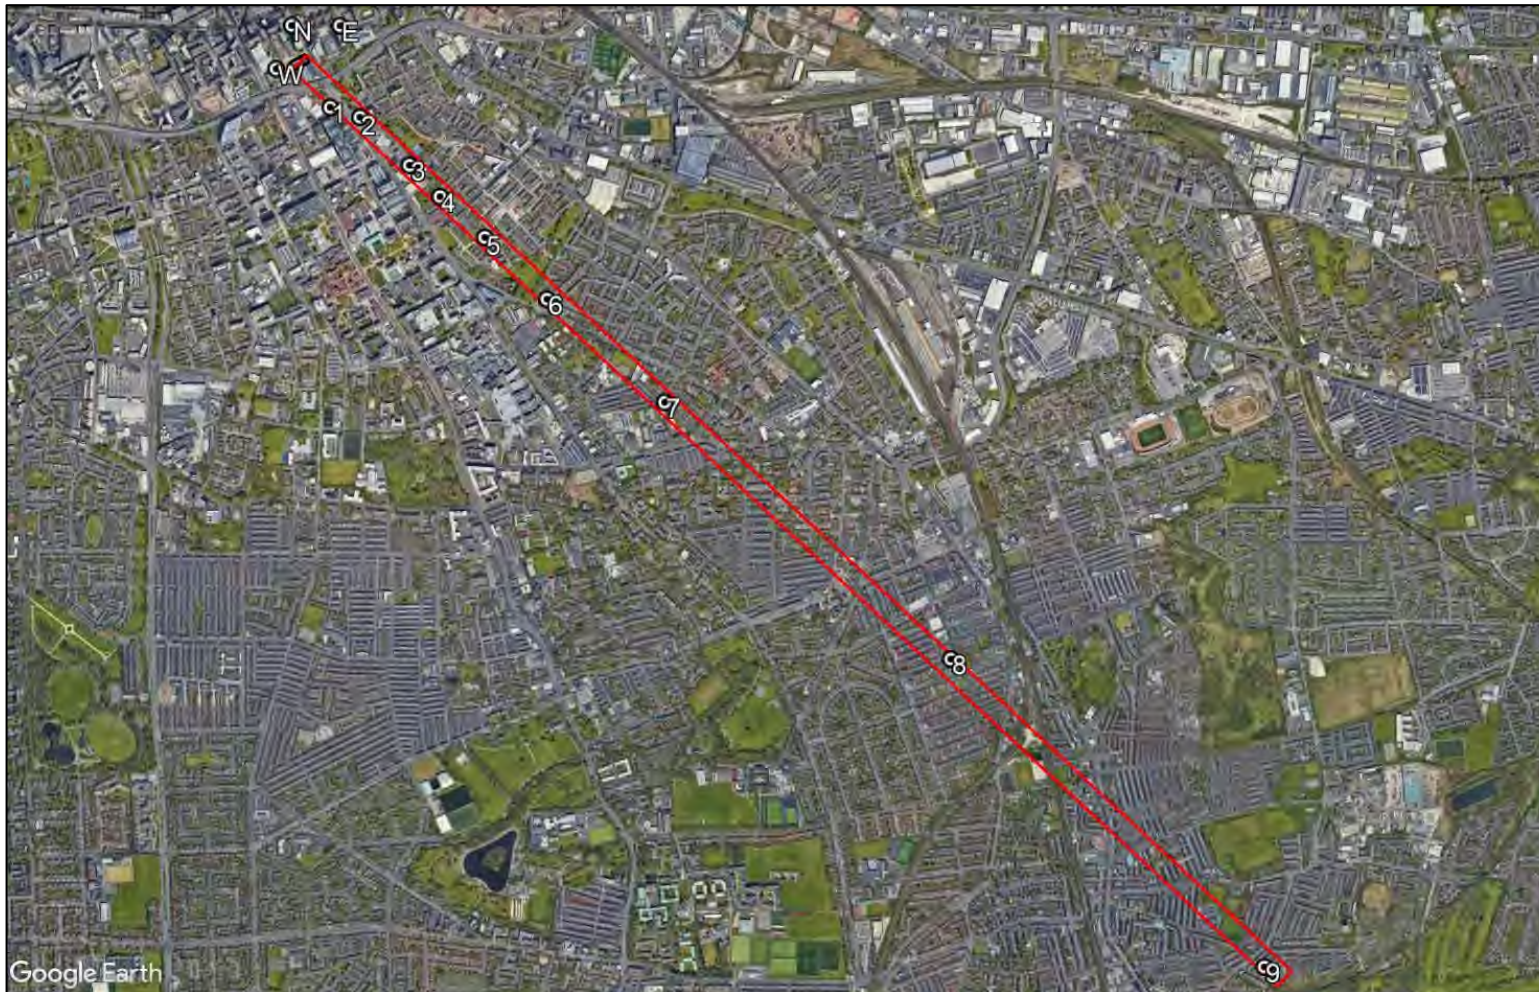
Figure 6 Survey locations

Figures 7 and 8 on the following pages shows the survey locations overlaid onto aerial photography. The proposed development location and the shadow zone are also shown. Survey locations were chosen pre-survey (within the shadow zone); however, safe and available access influenced the specific position on the day. The locations below show the actual survey locations. More readings were carried out closer to the proposed building. This is because interference is generally more likely the closer the location is to the obstruction. Television measurements were taken at survey locations 1 to 9. Radio measurements were taken at survey locations 1, north (N), east (E), and west (W).

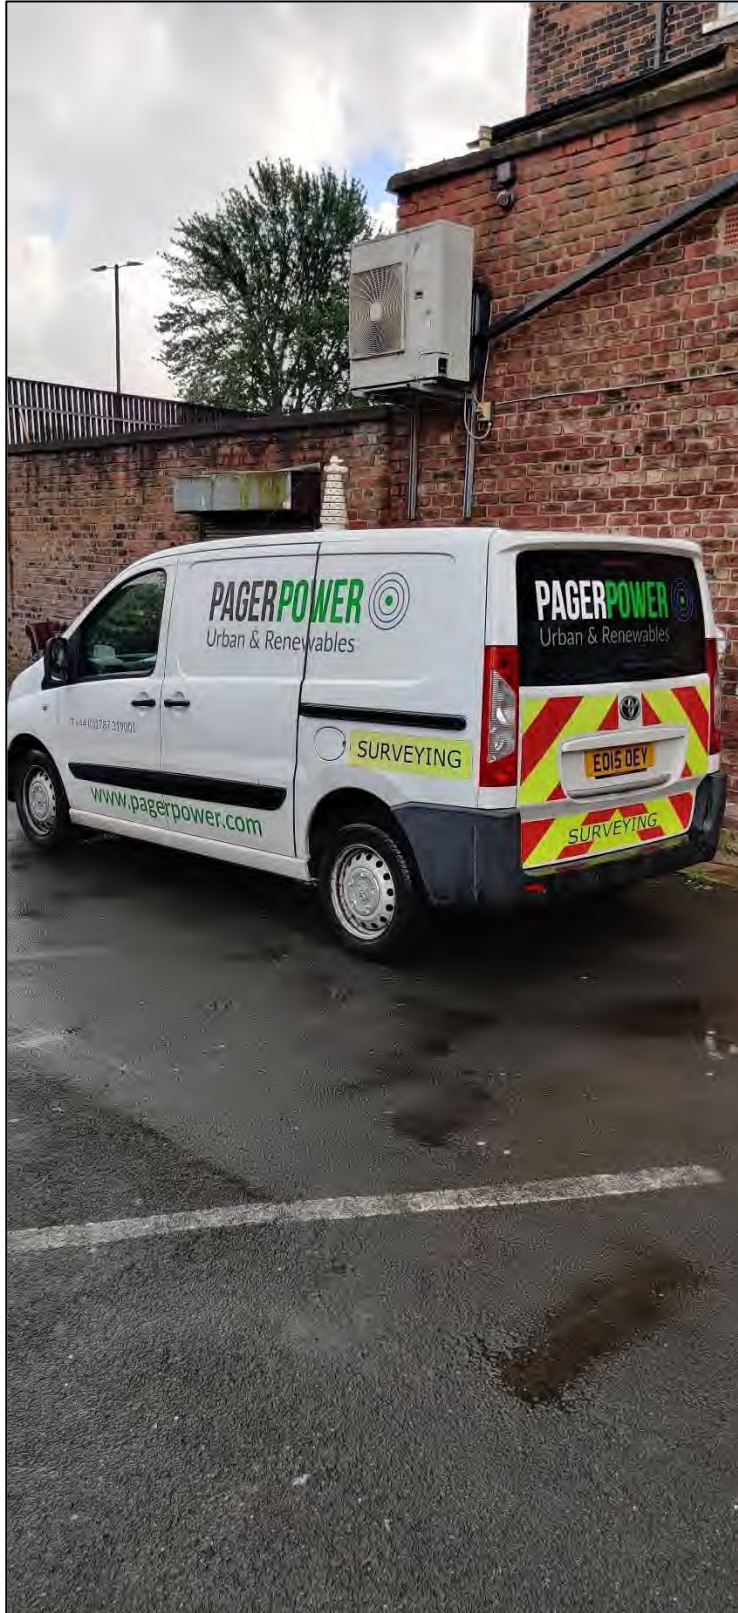
## Location 1

Notes: No aerials observed on survey; however, a review of the available imagery indicates that there is a HP UHF aerial directed towards the Winter Hill transmitter and multiple satellite dishes located on the three-storey building adjacent to location 1.

| Location | Average Measured Signal Strength (dB) | Remarks | High Level Conclusion |
|---|---|---|---|
| 1 | <p>Average:<br/>39.6 (Moderate)</p> <p>Main TV MUX: 42.7 (Moderate)</p> <p>Local TV MUX: 33.6 (Low)</p> | <p>No aerials were observed on the survey; however, a review of the available imagery indicates that there is an HP<sup>6</sup> UHF<sup>7</sup> aerial directed towards the Winter Hill transmitter and multiple satellite dishes located on the three-storey building adjacent to location 1.</p> <p>All main multiplexes displayed fine<sup>8</sup> picture and audio quality, an average of moderate signal strength and signal fluctuations of less than or equal to 0.5dB.</p> <p>One local multiplex displayed fine picture and audio quality. Two local multiplexes did not decode. An average of low signal strength and signal fluctuations of less than or equal to 0.2dB.</p> | <p>This location is approximately 183 metres from the proposed development.</p> <p>A three-storey building is located adjacent to this location.</p> <p>A reduction in signal strength is possible based on the proximity to the proposed development. Based on the current signal quality and height of identified aerial relative to the proposed development, interference is possible.</p> |

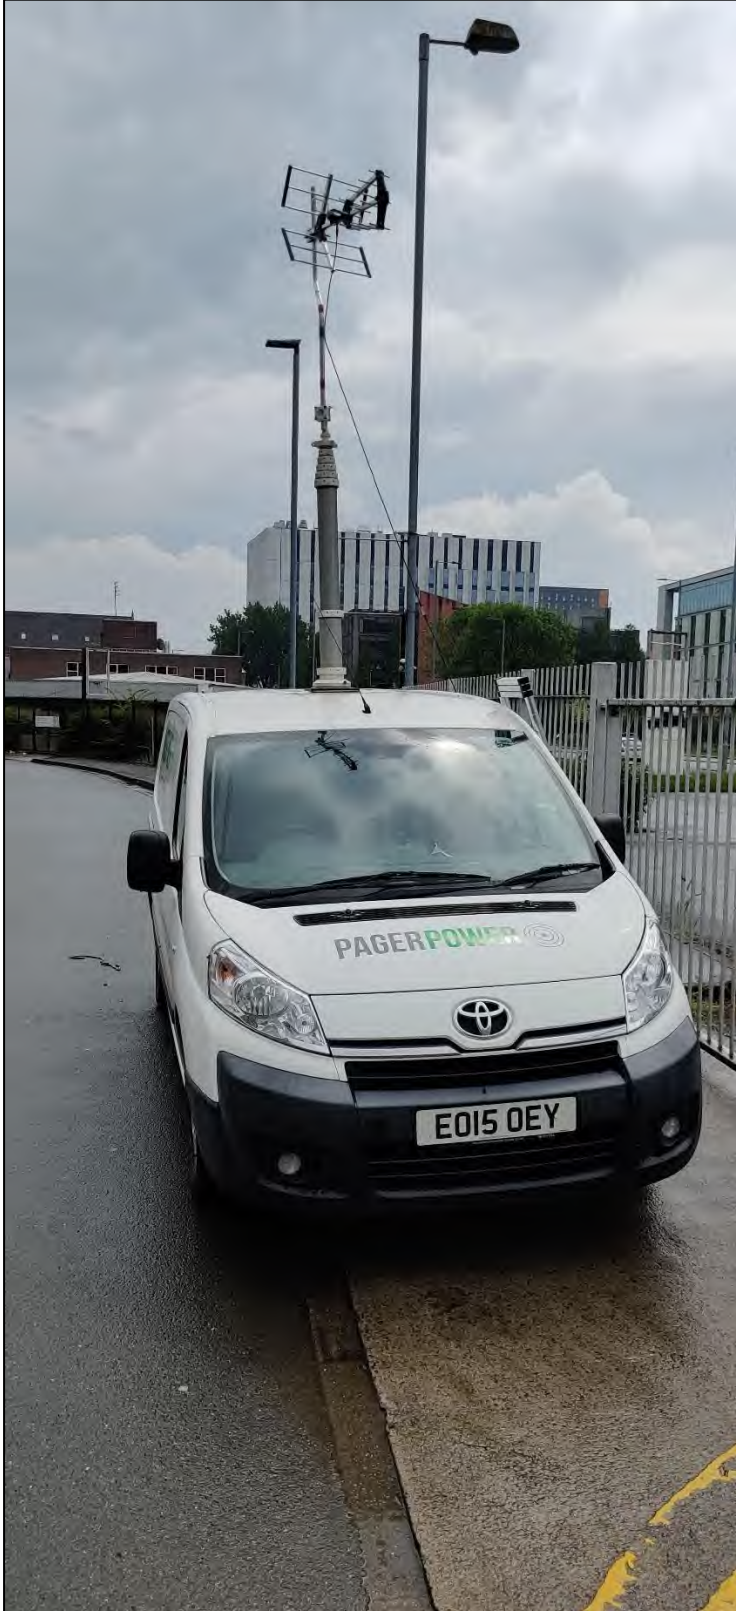
Location 2

Notes: Multiple HP UHF aerial directed towards the Winter Hill transmitter was observed.  
Multiple satellite dishes were observed.

| Location | Average Measured Signal Strength (dB) | Remarks | High Level Conclusion |
|---|---|---|---|
| 2 | <p>Average: 40.3 (Moderate)</p> <p>Main TV MUX: 43.4 (Moderate)</p> <p>Local TV MUX: 34.0 (Low)</p> | <p>Multiple HP UHF aerial directed towards the Winter Hill transmitter was observed. Multiple satellite dishes were observed.</p> <p>All main multiplexes displayed fine picture and audio quality, an average of moderate signal strength and signal fluctuations of less than or equal to 0.4dB.</p> <p>One local multiplex displayed fine picture and audio quality. Two local multiplexes did not decode. An average of low signal strength and signal fluctuations of less than or equal to 0.1dB.</p> | <p>This location is approximately 277 metres from the proposed development.</p> <p>A small number of two-storey dwellings are located adjacent to this location.</p> <p>A reduction in signal strength is possible based on the proximity to the proposed development. Based on the current signal quality and height of identified aerials relative to the proposed development, interference is possible.</p> |

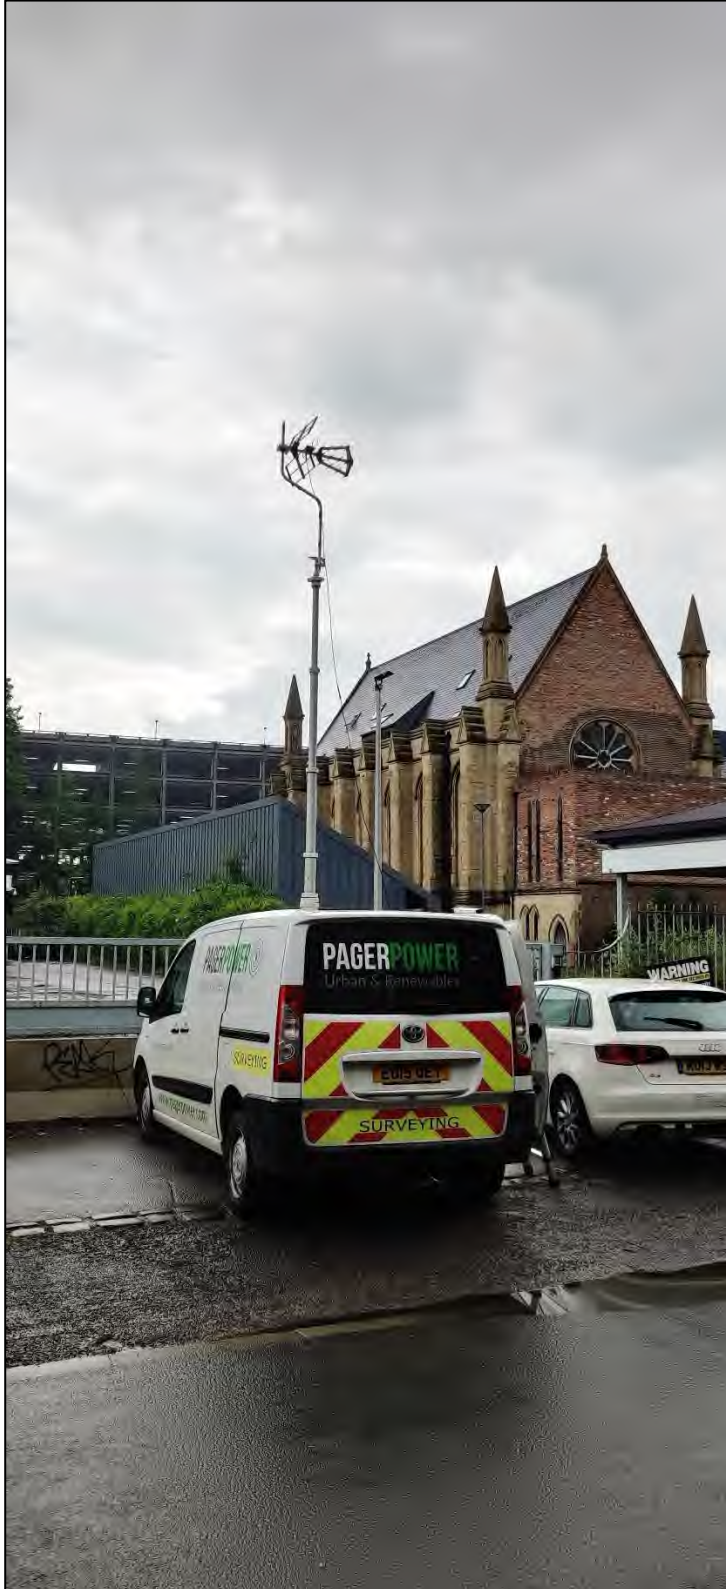
Location 3

Notes: No UHF aerial or satellite dishes were observed.

| Location | Average Measured Signal Strength (dB) | Remarks | High Level Conclusion |
|---|---|---|---|
| 3 | <p>Average: 43.8 (Moderate)</p> <p>Main TV MUX: 47.9 (Good)</p> <p>Local TV MUX: 35.5 (Moderate)</p> | <p>No UHF aerial or satellite dishes were observed.</p> <p>All main multiplexes displayed fine picture and audio quality, an average of good signal strength and signal fluctuations of less than or equal to 0.2dB.</p> <p>Two local multiplexes displayed fine picture and audio quality. One local multiplex did not decode. An average of moderate signal strength and signal fluctuations of less than or equal to 0.1dB.</p> | <p>This location is approximately 535 metres from the proposed development.</p> <p>Multi-storey flats and commercial property are located adjacent to this location.</p> <p>A reduction in signal strength is possible based on the proximity to the proposed development. Significant effects are not predicted due to the height or presence of any aerials in the area.</p> |

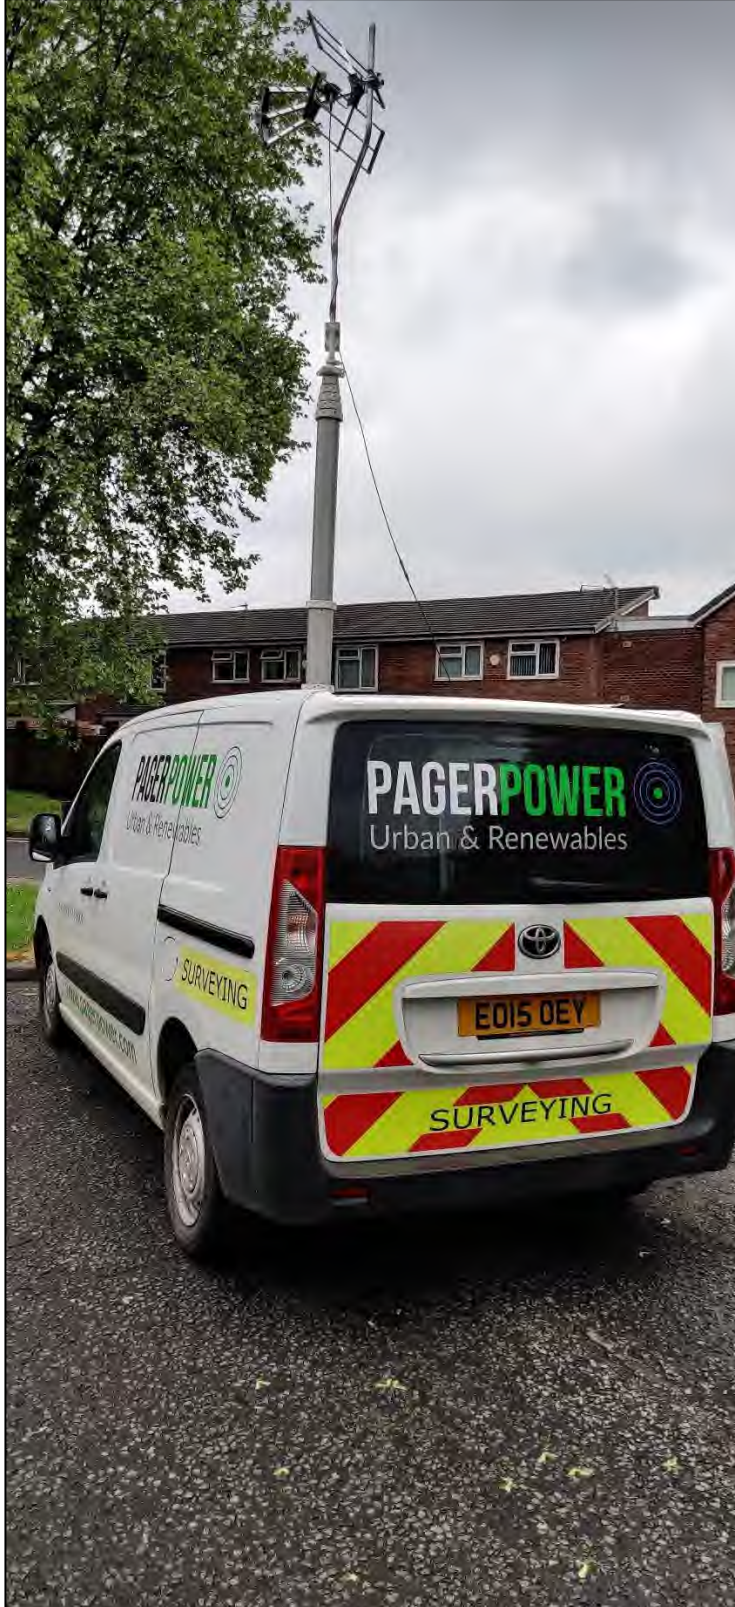
Location 4

Notes: Multiple HP UHF aerial directed towards the Winter Hill transmitter was observed.  
Multiple satellite dishes were observed.

| Location | Average Measured Signal Strength (dB) | Remarks | High Level Conclusion |
|---|---|---|---|
| 4 | <p>Average: 45.7 (Good)</p> <p>Main TV MUX: 50.1 (Good)</p> <p>Local TV MUX: 36.9 (Moderate)</p> | <p>Multiple HP UHF aerial directed towards the Winter Hill transmitter was observed. Multiple satellite dishes were observed.</p> <p>All main multiplexes displayed fine picture and audio quality, an average of good signal strength and signal fluctuations of less than or equal to 0.3dB.</p> <p>All local multiplexes displayed fine picture and audio quality, an average of moderate signal strength and signal fluctuations of less than or equal to 0.2dB.</p> | <p>This location is approximately 700 metres from the proposed development.</p> <p>Predominately two-storey dwellings are located adjacent to this location.</p> <p>A reduction in signal strength is possible based on the proximity to the proposed development. This could depend on the relative height of the building development and any receiving aerials. Based on the current signal quality, significant effects are not predicted.</p> |

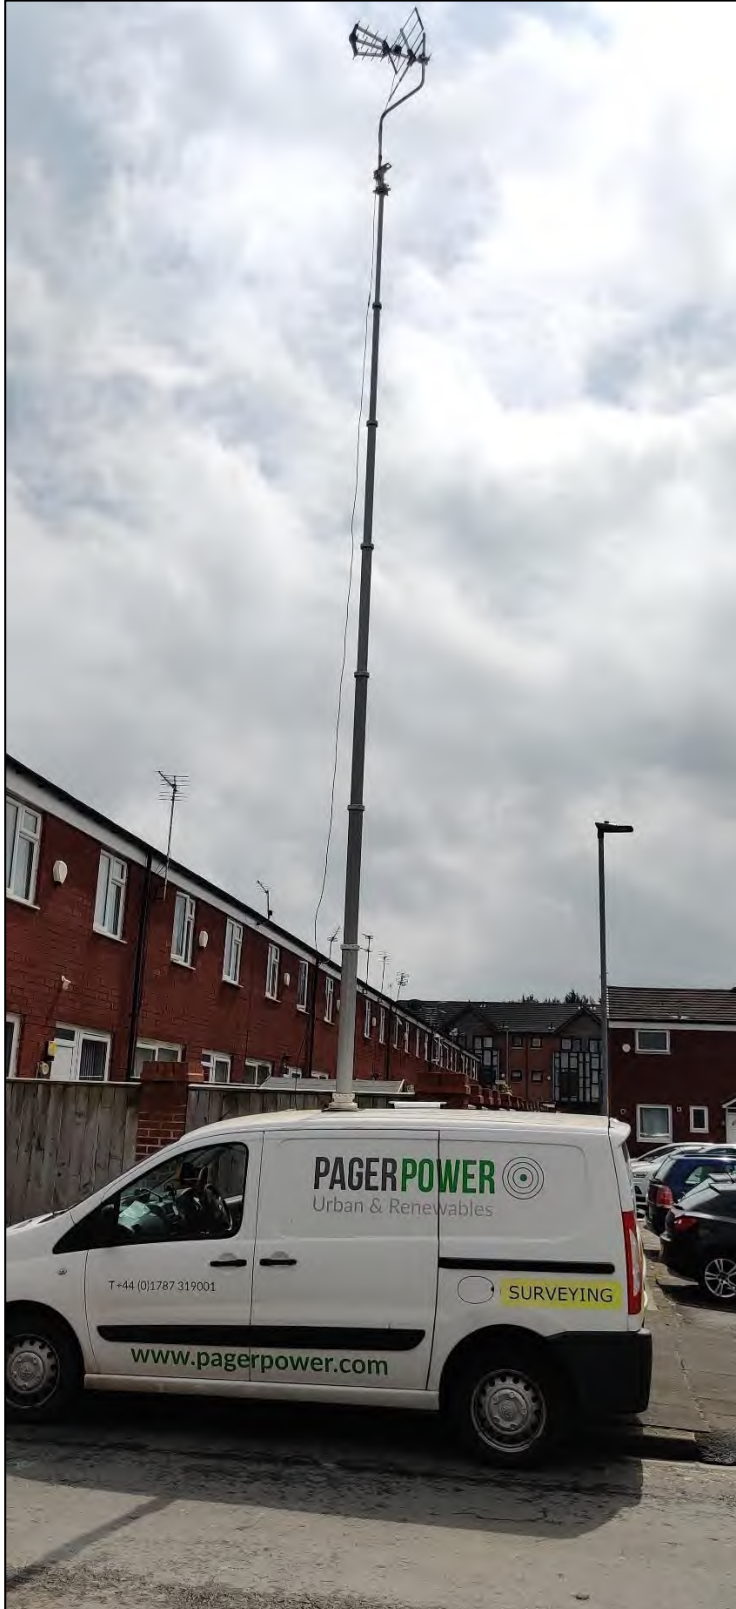
Location 5

Notes: Multiple HP UHF aerial directed towards the Winter Hill transmitter was observed.  
Multiple satellite dishes were observed.

| Location | Average Measured Signal Strength (dB) | Remarks | High Level Conclusion |
|---|---|---|---|
| 5 | <p>Average: 50.7 (Good)</p> <p>Main TV MUX: 55.9 (Very good)</p> <p>Local TV MUX: 40.3 (Moderate)</p> | <p>Multiple HP UHF aerial directed towards the Winter Hill transmitter was observed. Multiple satellite dishes were observed.</p> <p>All main multiplexes displayed fine picture and audio quality, an average of very good signal strength and signal fluctuations of less than or equal to 0.2dB.</p> <p>All local multiplexes displayed fine picture and audio quality, an average of moderate signal strength and signal fluctuations of less than or equal to 0.2dB.</p> | <p>This location is approximately 930 metres from the proposed development.</p> <p>Predominately two-storey dwellings are located adjacent to this location.</p> <p>A reduction in signal strength is possible based on the proximity to the proposed development. This could depend on the relative height of the building development and any receiving aerials. Based on the current signal quality, significant effects are not predicted.</p> |

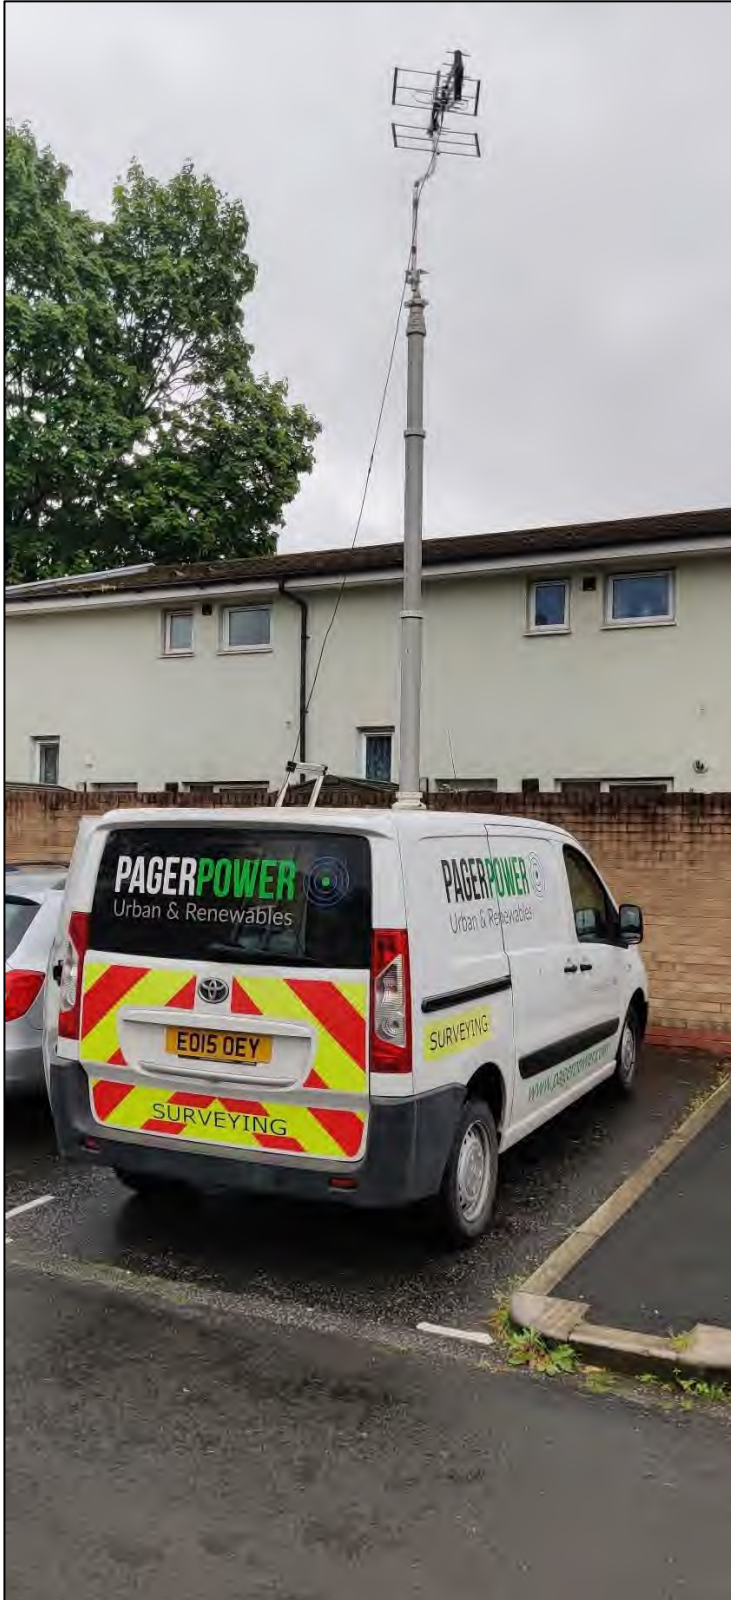
Location 6

Notes: Multiple HP UHF aerial directed towards the Winter Hill transmitter was observed.  
Multiple satellite dishes were observed.

| Location | Average Measured Signal Strength (dB) | Remarks | High Level Conclusion |
|---|---|---|---|
| 6 | <p>Average: 49.9 (Good)</p> <p>Main TV MUX: 54.7 (Good)</p> <p>Local TV MUX: 40.3 (Moderate)</p> | <p>Multiple HP UHF aerial directed towards the Winter Hill transmitter was observed. Multiple satellite dishes were observed.</p> <p>All main multiplexes displayed fine picture and audio quality, an average of good signal strength and signal fluctuations of less than or equal to 0.2dB.</p> <p>Two local multiplexes displayed fine picture and audio quality. One local multiplex did not decode. An average of moderate signal strength and signal fluctuations of less than or equal to 0.2dB.</p> | <p>This location is approximately 1.26km from the proposed development. Effects at this range are likely to be relatively small based on previous experience. Based on the current signal quality, effects are unlikely to be noticeable.</p> <p>Interference is unlikely.</p> |

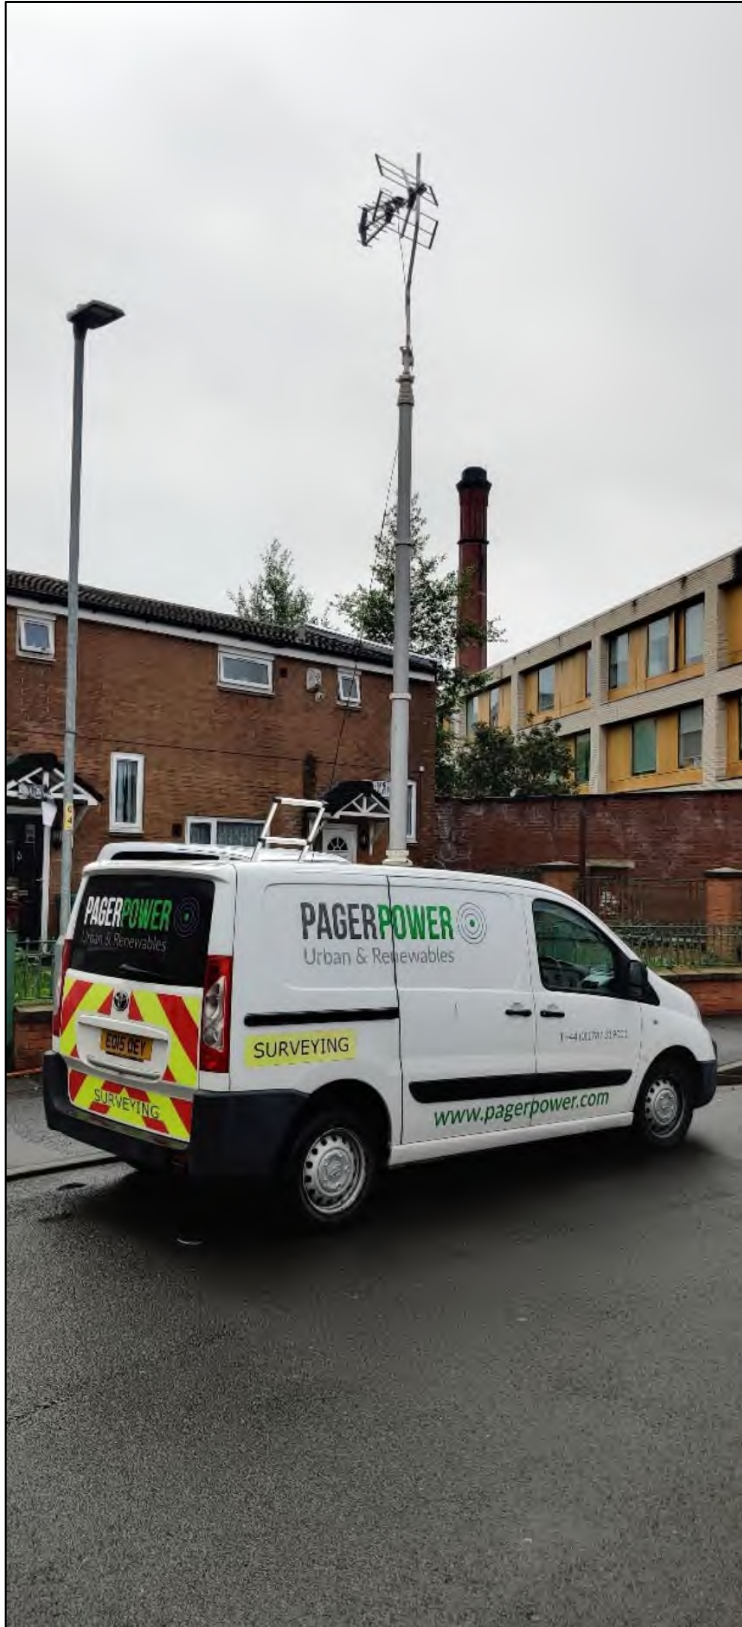
Location 7

Notes: Multiple HP UHF aerial directed towards the Winter Hill transmitter was observed.  
Multiple satellite dishes were observed.

| Location | Average Measured Signal Strength (dB) | Remarks | High Level Conclusion |
|---|---|---|---|
| 7 | <p>Average: 57.3 (Very good)</p> <p>Main TV MUX: 63.3 (Very good)</p> <p>Local TV MUX: 45.5 (Good)</p> | <p>Multiple HP UHF aerial directed towards the Winter Hill transmitter was observed. Multiple satellite dishes were observed.</p> <p>All main multiplexes displayed fine picture and audio quality, an average of very good signal strength and signal fluctuations of less than or equal to 0.1dB.</p> <p>All local multiplexes displayed fine picture and audio quality, an average of good signal strength and signal fluctuations of less than or equal to 0.1dB.</p> | <p>This location is approximately 1.84km from the proposed development. Effects at this range are likely to be relatively small based on previous experience. Based on the current signal quality, effects are unlikely to be noticeable.</p> <p>Interference is unlikely.</p> |

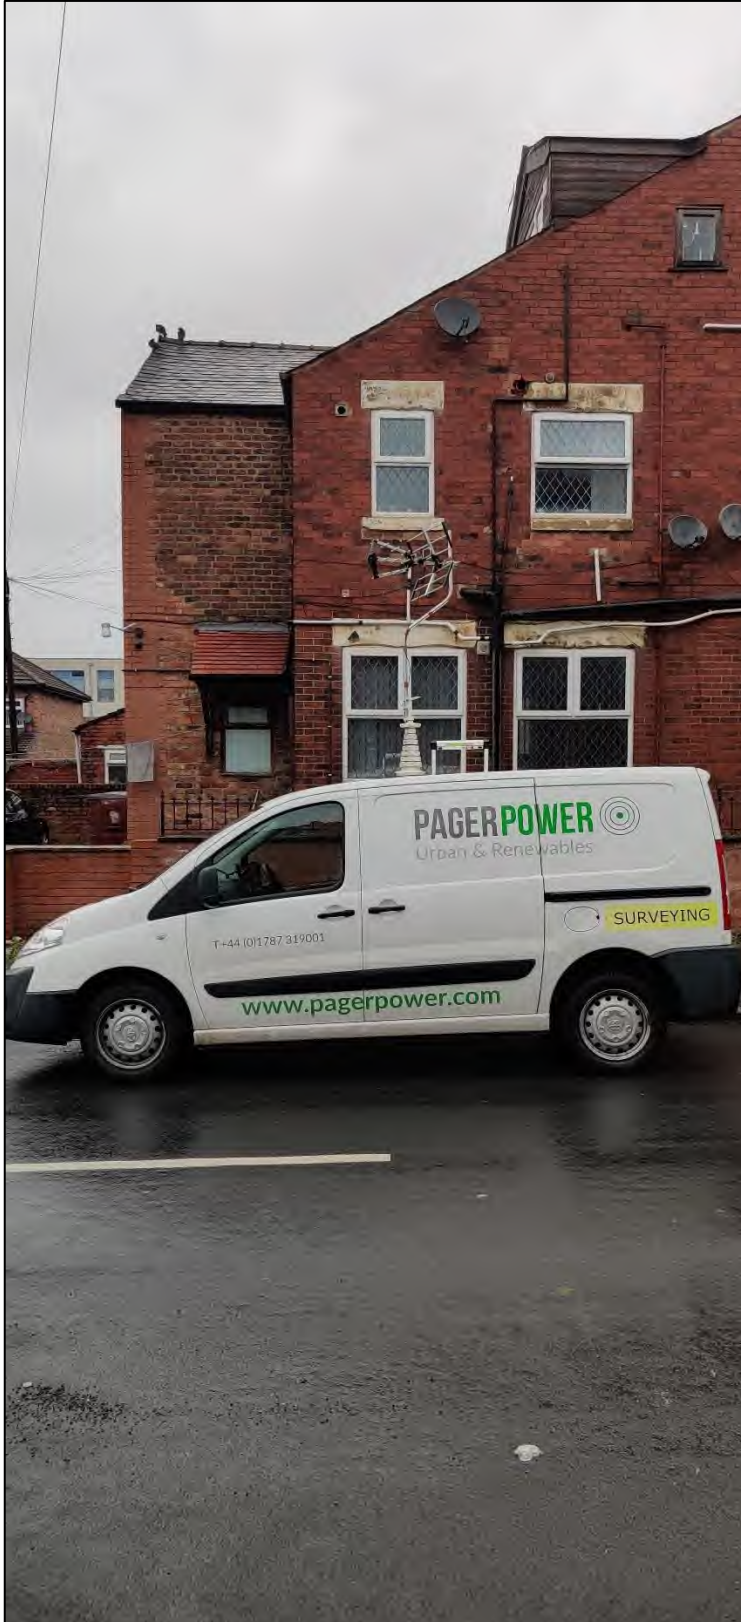
Location 8

Notes: Multiple HP UHF aerial directed towards the Winter Hill transmitter was observed.  
Multiple satellite dishes were observed.

| Location | Average Measured Signal Strength (dB) | Remarks | High Level Conclusion |
|---|---|---|---|
| 8 | <p>Average: 65.2 (Very good)</p> <p>Main TV MUX: 71.0 (Very good)</p> <p>Local TV MUX: 53.6 (Good)</p> | <p>Multiple HP UHF aerial directed towards the Winter Hill transmitter was observed. Multiple satellite dishes were observed.</p> <p>All main multiplexes displayed fine picture and audio quality, an average of very good signal strength and signal fluctuations of less than or equal to 0.2dB.</p> <p>All local multiplexes displayed fine picture and audio quality, an average of good signal strength and signal fluctuations of less than or equal to 0.1dB.</p> | <p>This location is approximately 3.27km from the proposed development. Effects at this range are likely to be relatively small based on previous experience. Based on the current signal quality, effects are unlikely to be noticeable.</p> <p>Interference is unlikely.</p> |

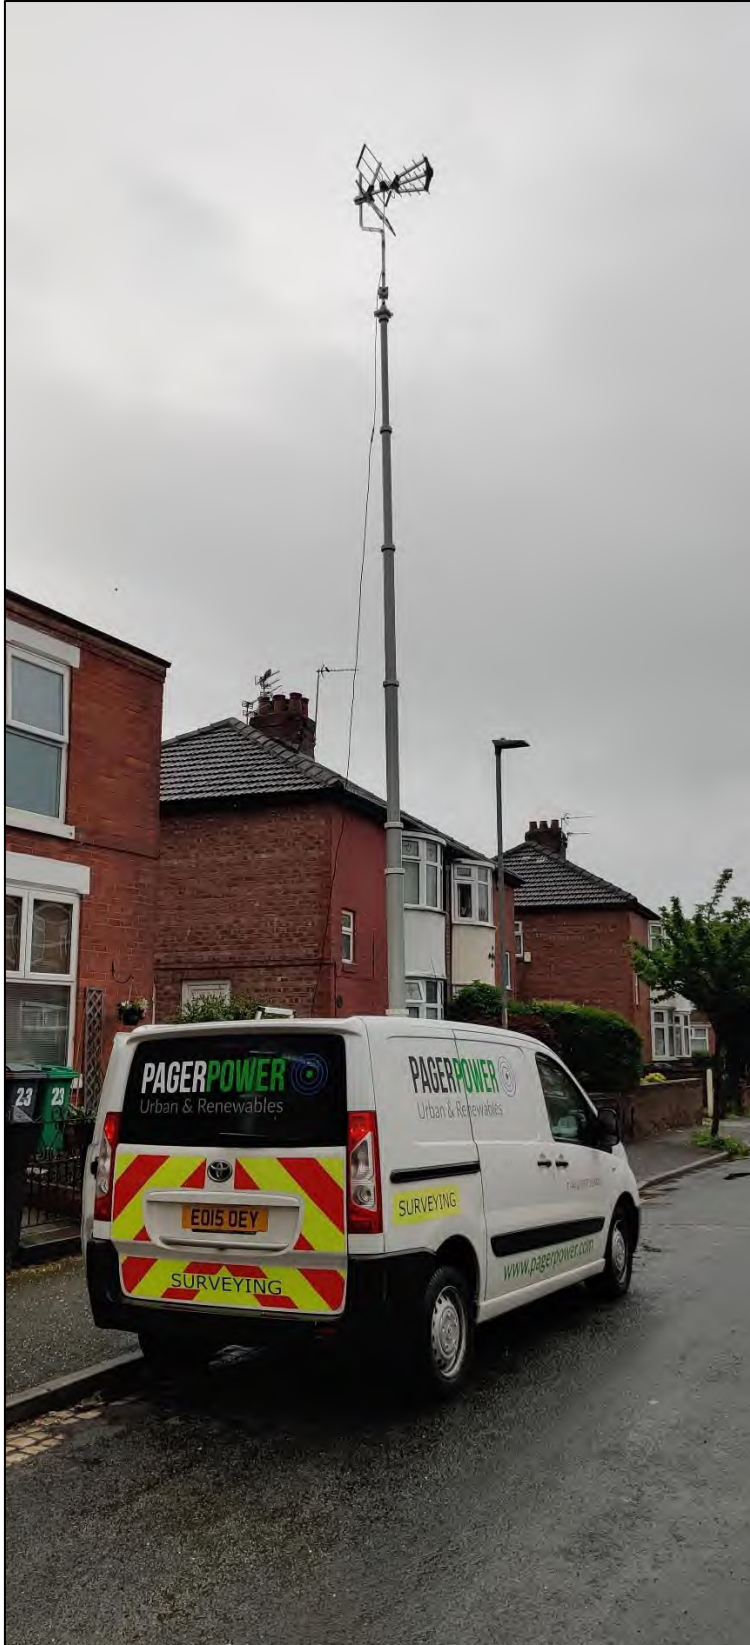
Location 9

Notes: Multiple HP UHF aerial directed towards the Winter Hill transmitter was observed.  
Multiple satellite dishes were observed.

| Location | Average Measured Signal Strength (dB) | Remarks | High Level Conclusion |
|---|---|---|---|
| 9 | <p>Average: 60.3 (Very good)</p> <p>Main TV MUX: 66.2 (Very good)</p> <p>Local TV MUX: 48.5 (Good)</p> | <p>Multiple HP UHF aerial directed towards the Winter Hill transmitter was observed. Multiple satellite dishes were observed.</p> <p>All main multiplexes displayed fine picture and audio quality, an average of very good signal strength and signal fluctuations of less than or equal to 0.1dB.</p> <p>All local multiplexes displayed fine picture and audio quality, an average of good signal strength and signal fluctuations of less than or equal to 0.2dB.</p> | <p>This location is approximately 4.9km from the proposed development. Effects at this range are likely to be relatively small based on previous experience. Based on the current signal quality, effects are unlikely to be noticeable.</p> <p>Interference is unlikely.</p> |
