Back Turner Street, Manchester

Verification Report

MS/C3967/10941

# VOC Hotspot Removal Excavation

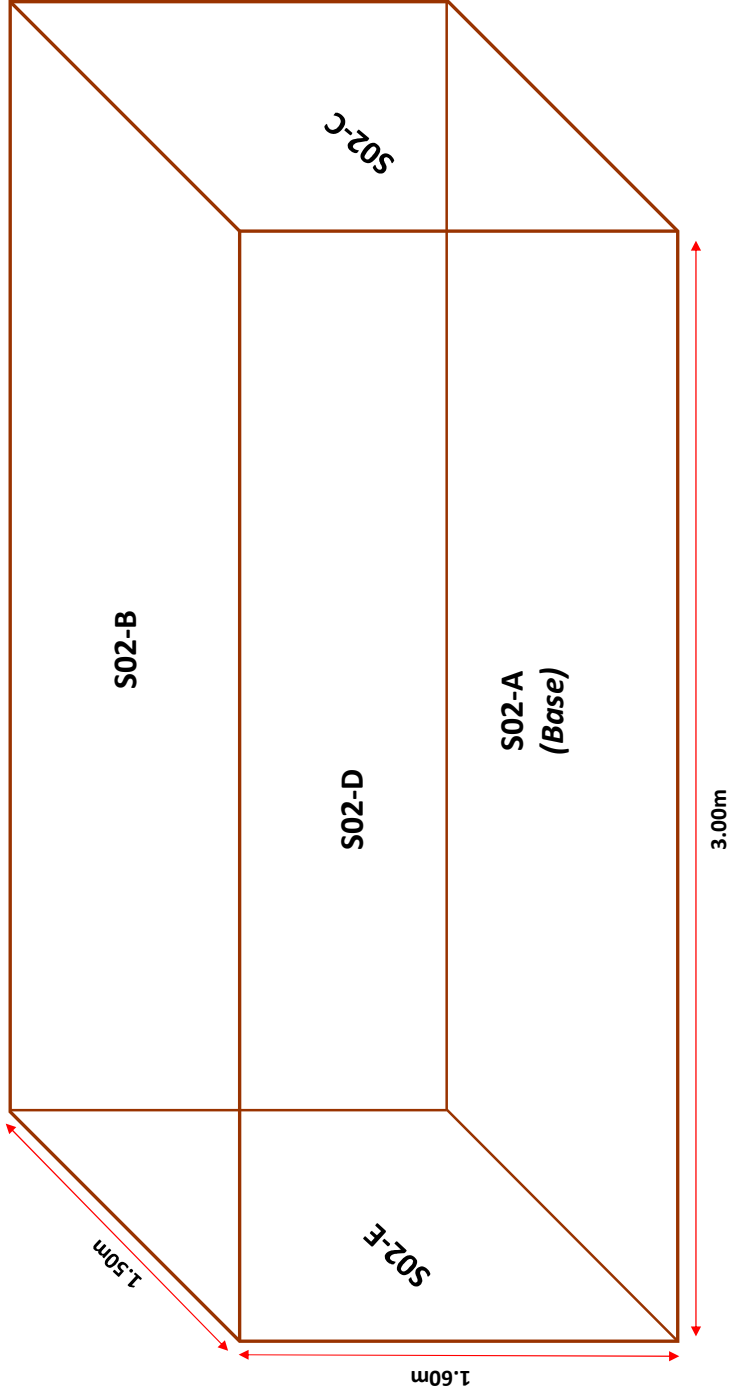
The soils encountered during the hotspot removal were stiff and very stiff slightly sandy clay with occasional black staining at shallow depths. An aromatic odour was within the area of the hotspot. The final excavations had dimensions of approximately 3.00m x 1.50m x 1.60m (length x width x depth) a total volume of VOC impacted soils of circa 7.2m<sup>3</sup>. Waste transfer notes are presented in Appendix E.

Although elevated PID readings were still recorded in the base and sides of the excavation the concentrations recorded were considered to be sufficiently low, as detailed above. Additionally, a gas protection score of 1.5 points will be achieved with the installation of a cast in situ monolithic reinforced ground bearing raft slab which will offer some inherent protection against VOC vapour ingress. Additionally, it was noted that the excavation was infilled with concrete creating an even greater barrier for VOC vapours.

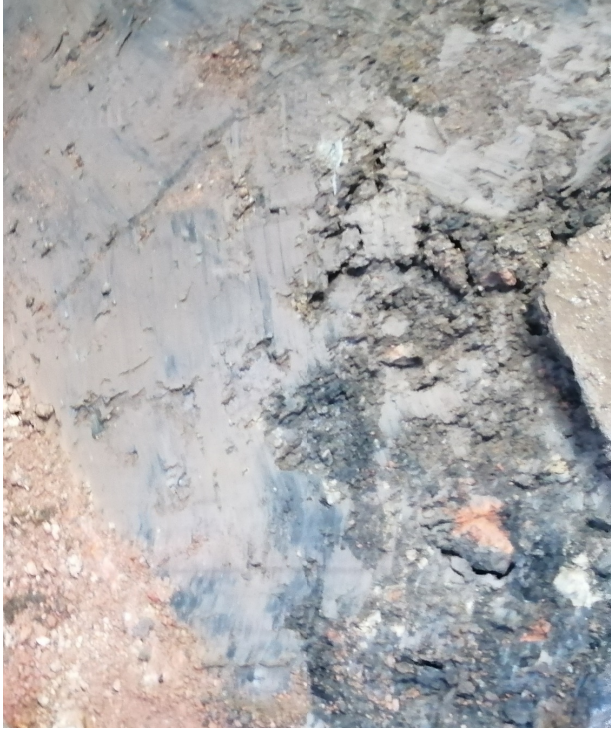
PHOTO 1

| Photo Descriptions | | | |
|---|---|---|---|
| 1 | Black Staining around S02 | | |
