## Museum of Science & Industry

### Fire Door Survey Report

### Ancillary Building

## Ancillary Buildings - Goods Office, VE Block, Toilet Block, Workshop, Stores and Photographic Studio

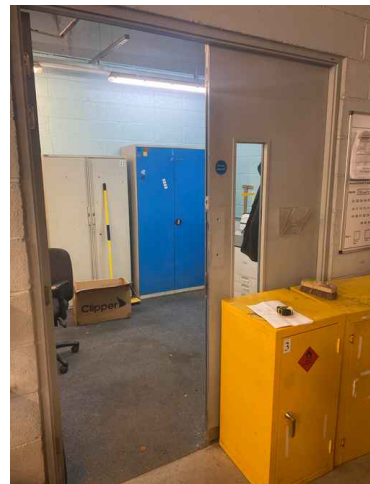
Door details  
1 of 2

| Door details | |
|---|---|
| Door is rotten, covered in punctures and far beyond economical repair. | |
| Replacement required. | |

| Door details | |
|---|---|
| <b>Recommended actions:</b> | Doorset is not compliant and cannot be repaired or upgraded to meet a satisfactory standard - Replacement Required Double Doorset |

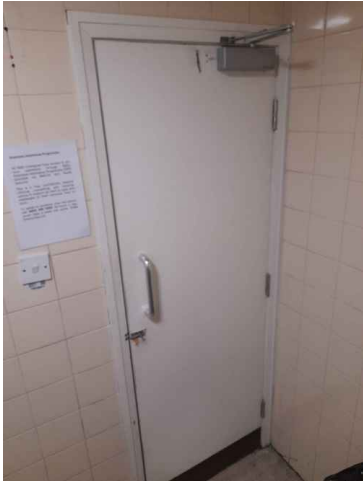
Door details  
1 of 2

| <b>Is the door leaf free from damage affecting its fire integrity?:</b> | No |

| <b>Action required - Door Leaf:</b> | Arrange for minor realignment without affecting the compliance of the door leaf, Door leaf to be re-lipped to close gaps to within tolerance, Install a new dropdown seal, Arrange for fire door repairs |

| Recommended actions: | Doorset can be upgraded to a notional standard Service Pack B - Single doorset |

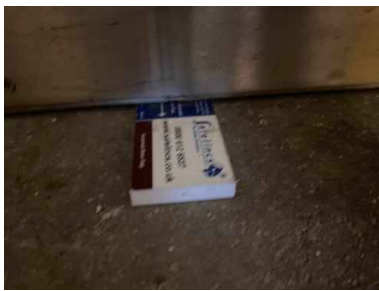
Seals  
1 of 1

| Door details | |
|---|---|
| Are the seals free from damage?: | No |

| Door details | |
|---|---|
| Action required - Seals: | Arrange for replacement intumescent seals/smoke seals FD30 10mm |

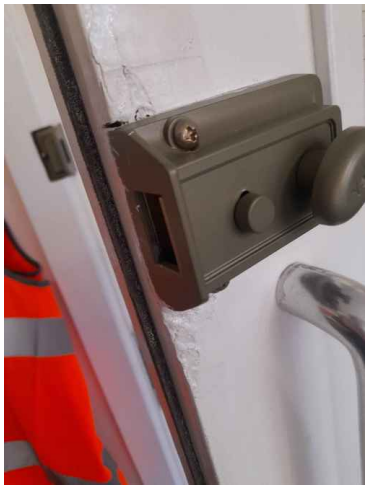
Door leaf  
2 of 4

| <b>Is the door leaf free from damage affecting its fire integrity?:</b> | No |
| Damage around ironmongery | |

| <b>Action required - Door Leaf:</b> | Door leaf to be re-lipped to close gaps to within tolerance, Arrange for refitting or additional compliant door stop to be retro fitted, Install a new dropdown seal, Arrange for fire door repairs |

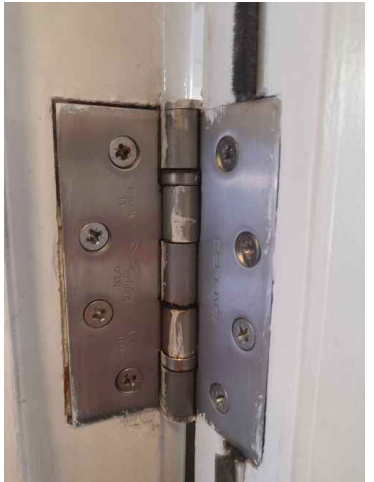
Ironmongery  
1 of 2

| Are the hinges free of metal fragment and oil leakage, which shows signs of wear?: | No |

| Action required - Ironmongery: | Arrange for hinge repairs or replacement due to wear & tear |

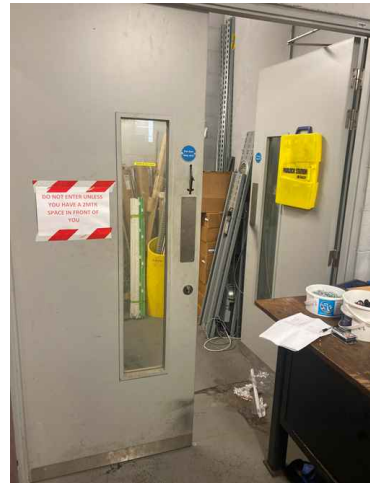
Door details  
1 of 2

| Door details | |
|---|---|
| Replacement required. | |

| Door details | |
|---|---|
| Recommended actions: | Doorset is not compliant and cannot be repaired or upgraded to meet a satisfactory standard - Replacement Required Double Doorset |

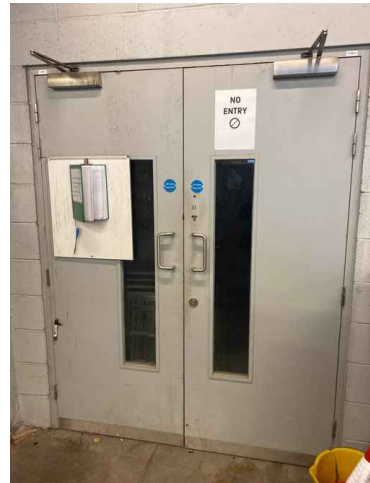
Door details  
1 of 1

| Door details | |
|---|---|
| Door could not be accessed however it is clear from an external view that the door is in need of replacement. | |
| Replacement required. | |

| Door details | |
|---|---|
| Recommended actions: | Doorset is not compliant and cannot be repaired or upgraded to meet a satisfactory standard - Replacement Required Double Doorset |

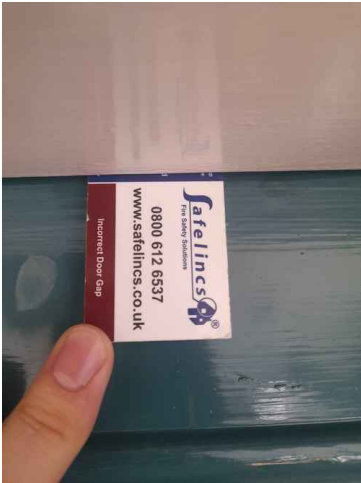
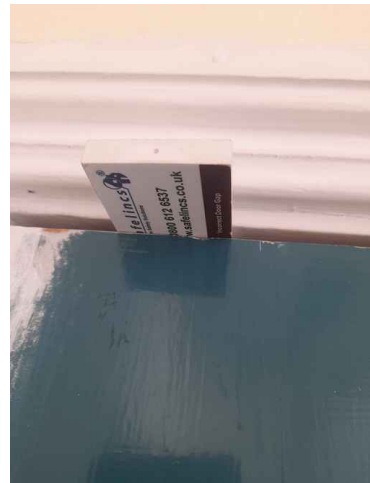
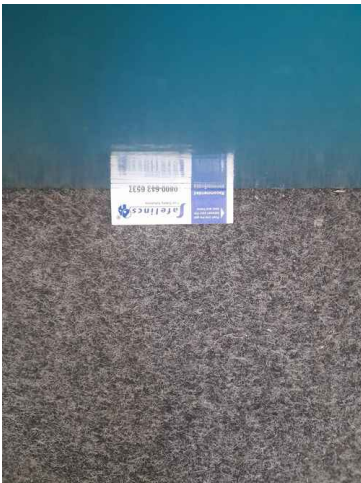
Door leaf  
1 of 4

| <b>Is the door leaf free from damage affecting its fire integrity?:</b> | No |

| <b>Action required - Door Leaf:</b> | Arrange for fire door repairs, Door leaf to be re-lipped to close gaps to within tolerance, Arrange for minor realignment without affecting the compliance of the door leaf, Install a new dropdown seal |

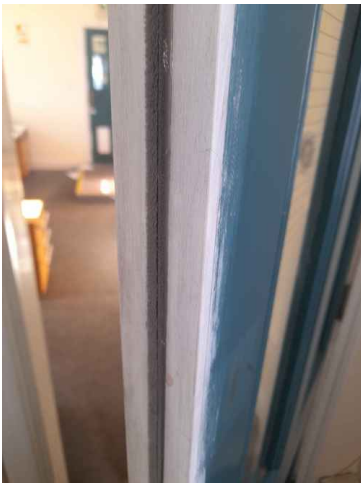
Seals  
1 of 1

| <b>Are the seals free from damage?:</b> | Yes |

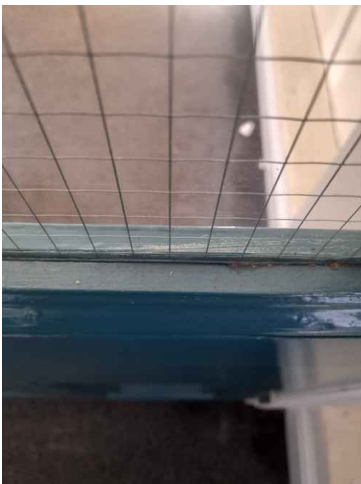
Glazing and Glass  
1 of 1

| Is the glass free from damage and cracking?: | Yes |

| Action required - Glazing And Glass: | Install/repair continuous intumescent seal between the glass and bead |

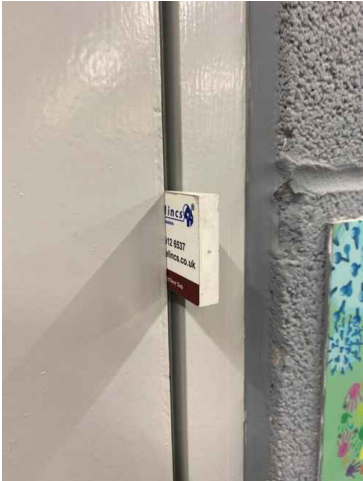
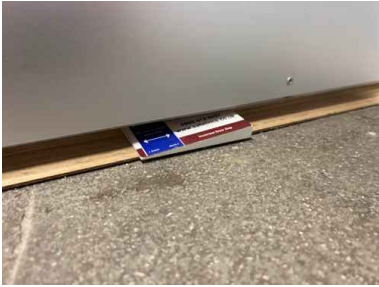
Door leaf  
1 of 2

| <b>Is the door leaf free from damage affecting its fire integrity?:</b> | No |

| <b>Action required - Door Leaf:</b> | Arrange for replacement compliant full door set |

| Recommended actions: | Doorset is not compliant and cannot be repaired or upgraded to meet a satisfactory standard - Replacement Required Single Doorset |

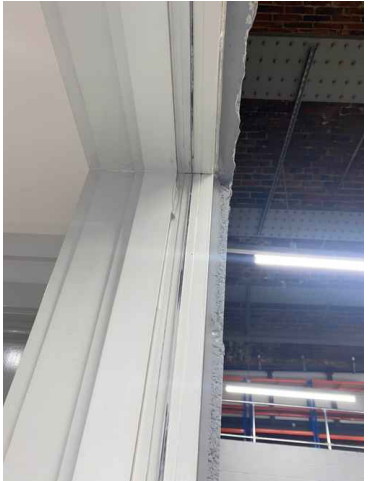
Seals  
1 of 1

| <b>Are the seals free from damage?:</b> | No |

| Action required - Seals: | Arrange for replacement intumescent seals/smoke seals FD30 10mm |

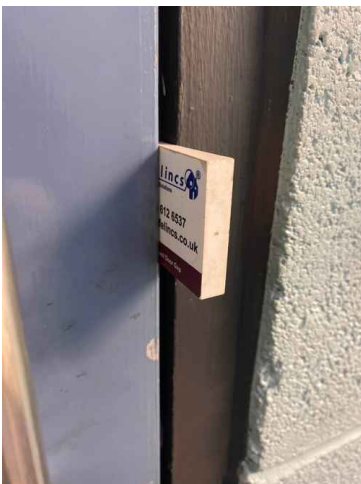
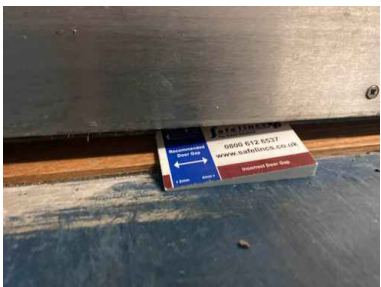
Door leaf  
1 of 2

| Door details | |
|---|---|
| Is the door leaf free from damage affecting its fire integrity?: | Yes |

| Recommended actions: | Doorset is not compliant and cannot be repaired or upgraded to meet a satisfactory standard - Replacement Required Single Doorset |

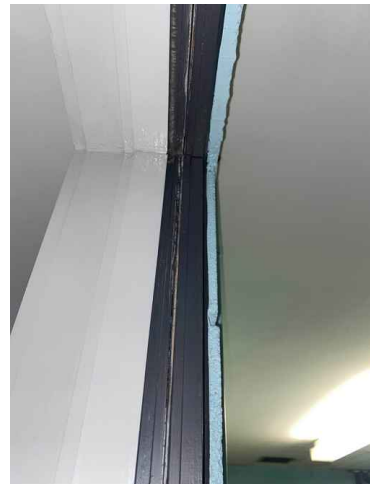
Seals  
1 of 1

| Door details | |
|---|---|
| Are the seals free from damage?: | No |

| Action required - Seals: | Arrange for replacement intumescent seals/smoke seals FD30 10mm |

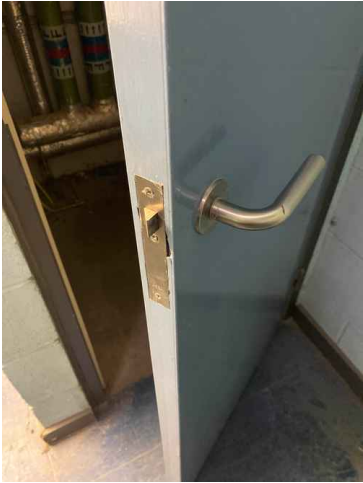
Ironmongery  
2 of 2

| <b>Are the hinges free of metal fragment and oil leakage, which shows signs of wear?:</b> | No |
| <b>Is all ironmongery free from damage and correctly operating?:</b> | Yes |

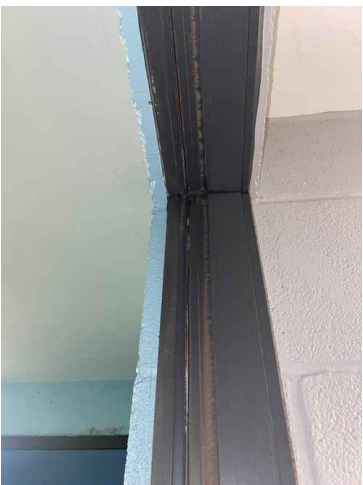
Seals  
1 of 1

| <b>Are the seals free from damage?:</b> | No |

| <b>Action required - Seals:</b> | Arrange for replacement intumescent seals/smoke seals FD30 10mm |

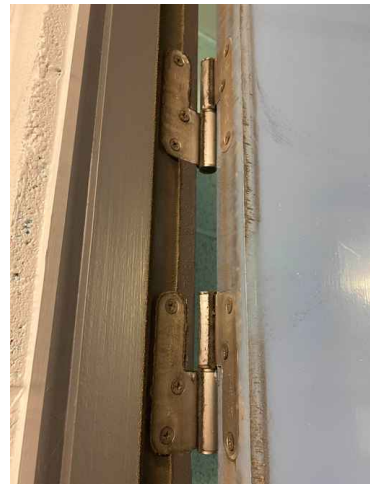
Ironmongery  
1 of 1

| <b>Are the hinges free of metal fragment and oil leakage, which shows signs of wear?:</b> | No |
| <b>Is all ironmongery free from damage and correctly operating?:</b> | Yes |

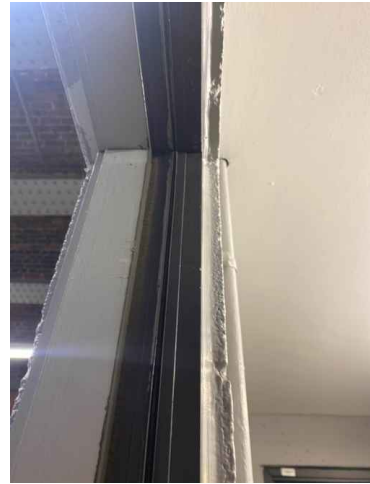
Seals  
1 of 1

| <b>Are the seals free from damage?:</b> | Yes |

| <b>Action required - Seals:</b> | Arrange for replacement intumescent seals/smoke seals FD30 10mm |

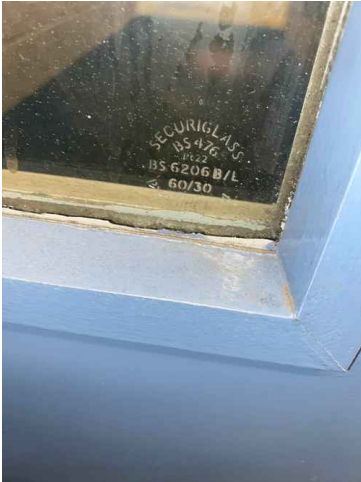
Glazing and Glass  
2 of 2

| <b>Are the glazing beads correctly attached to the frame from both sides and free from damage?:</b> | Yes |
| <b>Is the glass free from damage and cracking?:</b> | Yes |

| <b>Action required - Glazing And Glass:</b> | Install/repair continuous intumescent seal between the glass and bead |

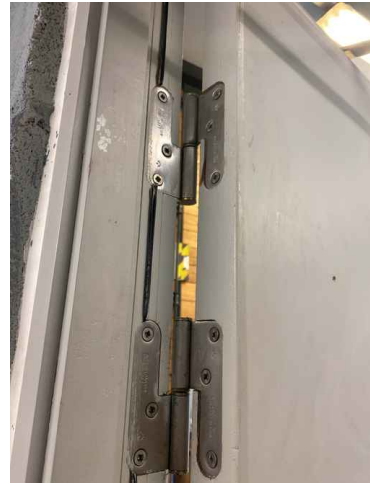
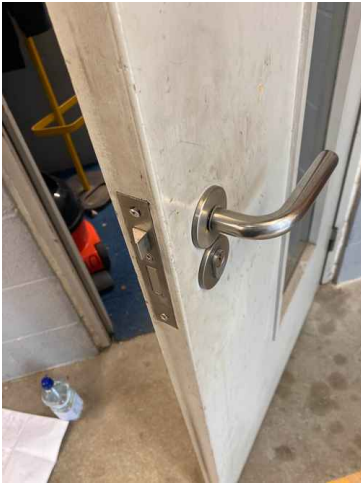
Ironmongery  
1 of 2

| Are the hinges free of metal fragment and oil leakage, which shows signs of wear?: | No |
| Is all ironmongery free from damage and correctly operating?: | Yes |

| Action required - Ironmongery: | Arrange for hinge repairs or replacement due to wear & tear |

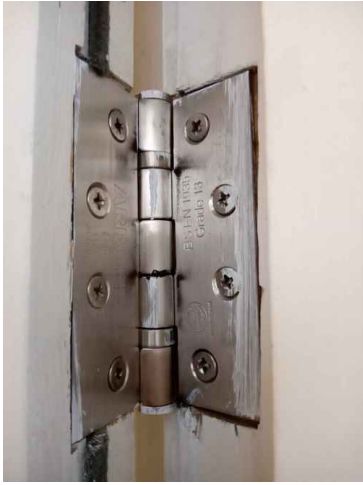
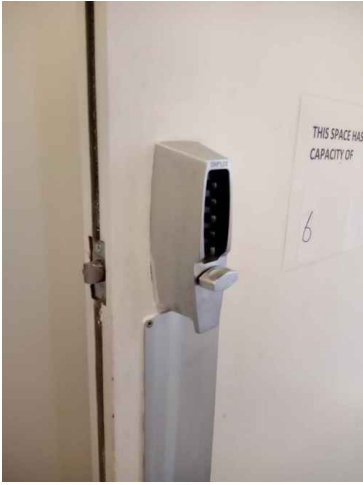
Ironmongery  
1 of 2

| Are the hinges free of metal fragment and oil leakage, which shows signs of wear?: | No |
| Is all ironmongery free from damage and correctly operating?: | Yes |

| Action required - Ironmongery: | Arrange for hinge repairs or replacement due to wear & tear |

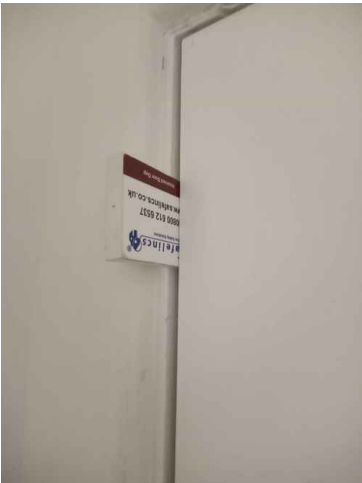
Door leaf  
1 of 2

| <b>Is the door leaf free from damage affecting its fire integrity?:</b> | Yes |

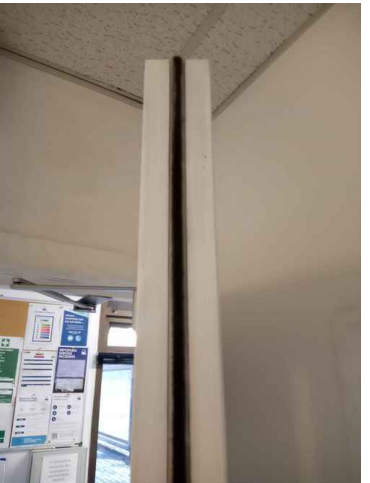
Seals  
1 of 1

| <b>Are the seals free from damage?:</b> | Yes |

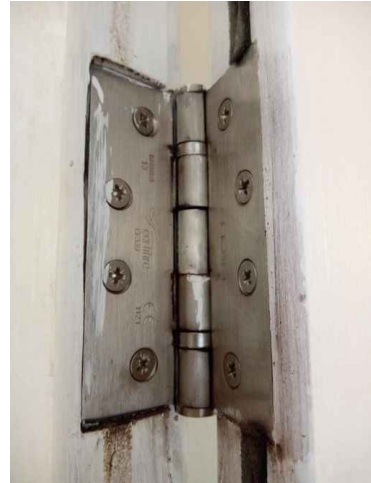
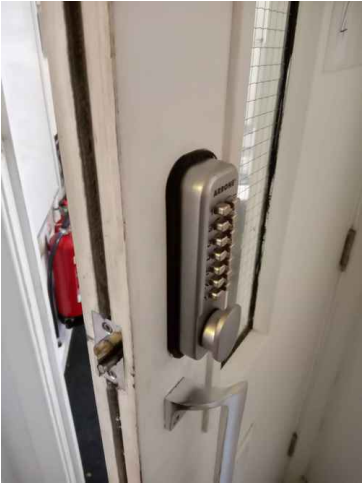
| Are the hinges free of metal fragment and oil leakage, which shows signs of wear?: | No |
| Is all ironmongery free from damage and correctly operating?: | Yes |

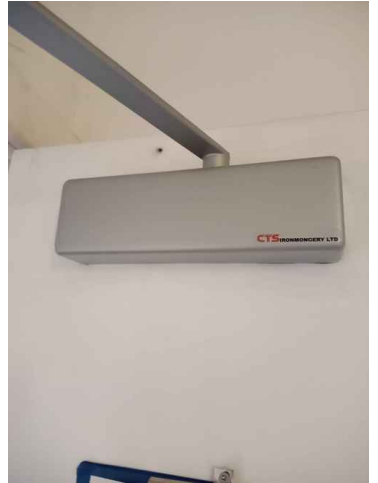
Door closers  
1 of 1

| Is the closer free from damage and not leaking?: | Yes |

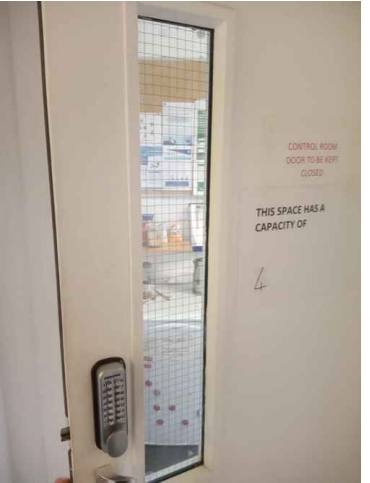
Glazing and Glass  
1 of 1

| Are the glazing beads correctly attached to the frame from both sides and free from damage?: | Yes |
| Is the glass free from damage and cracking?: | Yes |

| Action required - Glazing And Glass: | Install/repair continuous intumescent seal between the glass and bead |

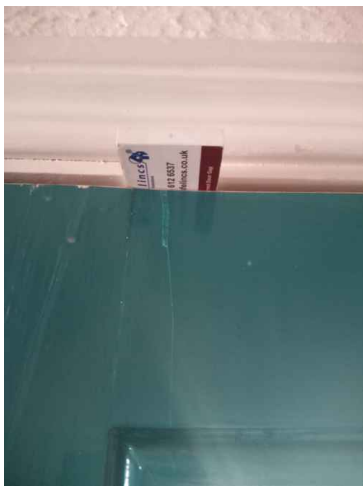
Door leaf  
1 of 2

| Door details | |
|---|---|
| Door is warped. Replacement required. | |
| Is the door leaf free from damage affecting its fire integrity?: | Yes |

| Additional work | |
|---|---|
| Recommended actions: | Doorset is not compliant and cannot be repaired or upgraded to meet a satisfactory standard - Replacement Required Single Doorset |

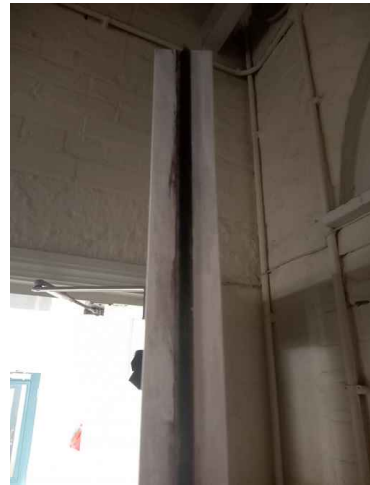
Seals  
1 of 1

| Door details | |
|---|---|
| Are the seals free from damage?: | Yes |

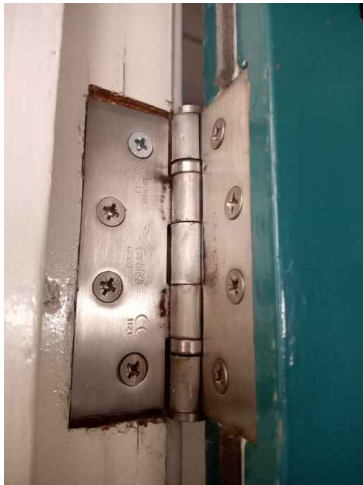
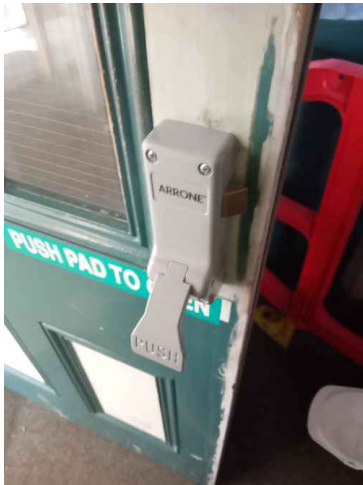
| Are the hinges free of metal fragment and oil leakage, which shows signs of wear?: | No |
| Is all ironmongery free from damage and correctly operating?: | Yes |

| Action required - Ironmongery: | Arrange for hinge repairs or replacement due to wear & tear |

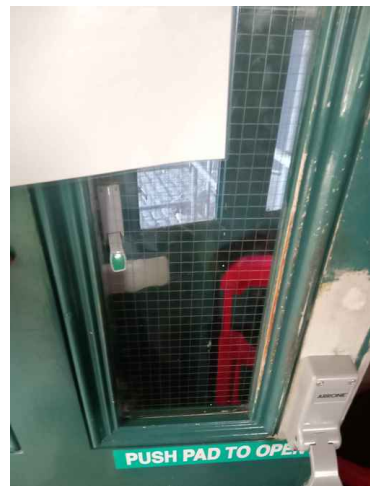
Glazing and Glass  
1 of 1

| Are the glazing beads correctly attached to the frame from both sides and free from damage?: | Yes |
| Is the glass free from damage and cracking?: | Yes |

| Action required - Glazing And Glass: | Install/repair continuous intumescent seal between the glass and bead |
