## Museum of Science & Industry

### Fire Compartmentation Survey Report

Proposed Basement

## **Fire Stopping Report**

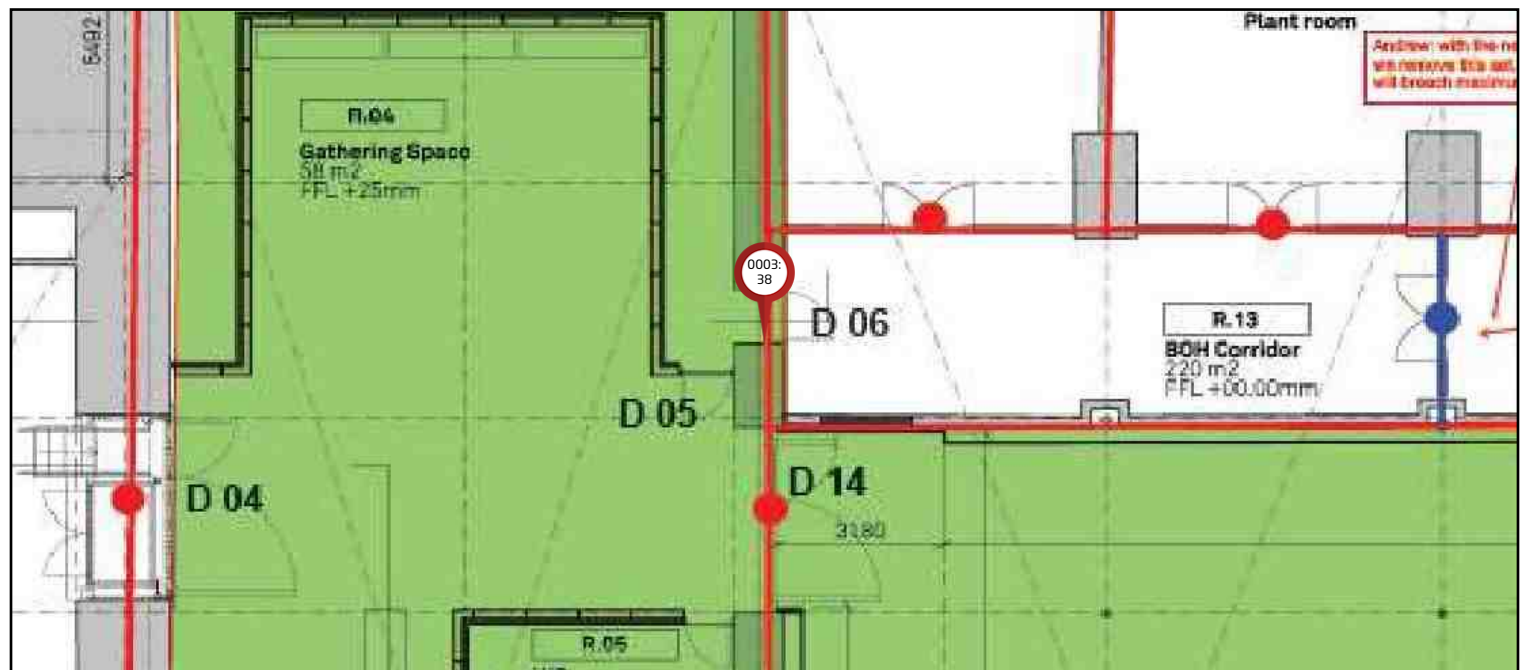
**Pin Number:** 0003:38  
**Company:** Neo Property Solutions  
**Contractor:** Tony Narkevicius - 30

| Survey | |
|---|---|
| Multiple services including trunking through brick wall. | |
| <b>Breach identified:</b> | Multiple Services, Trunking |
| Existing firestop needs removing as dry fitted. | |

| Survey | |
|---|---|
| <b>Installation type:</b> | SD-122-RDW |
| RWA45 is needed inside the trunking. | |

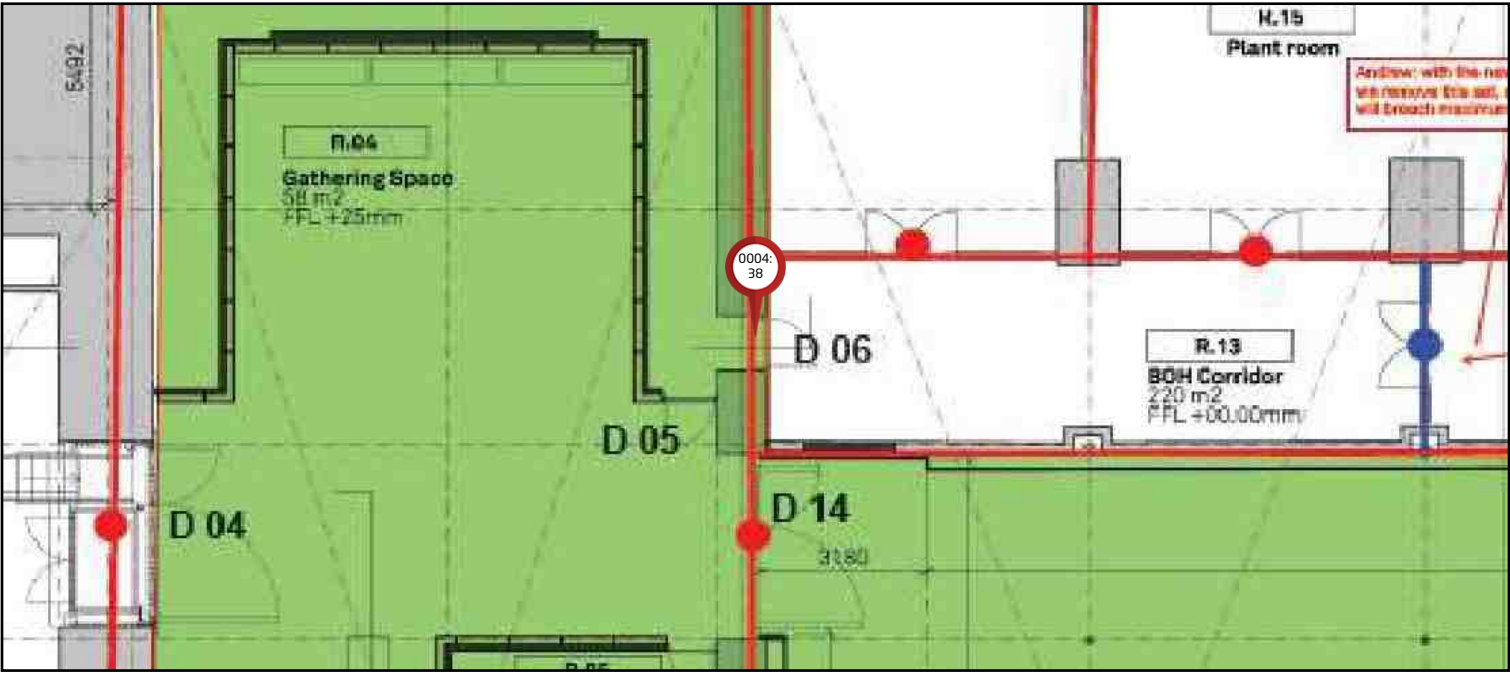
**Pin Number:** 0004:38  
**Company:** Neo Property Solutions  
**Contractor:** Tony Narkevicius - 30

| Survey | |
|---|---|
| 50mm pipe. Existing mastic needs removing | |
| Breach identified: | Pipe |

| Survey | |
|---|---|
| Remove existing mastic. | |
| Installation type: | SD-128-RDW |
