217 Stockport Road,

Ardwick

Daytime Bat & Bird Survey

Report

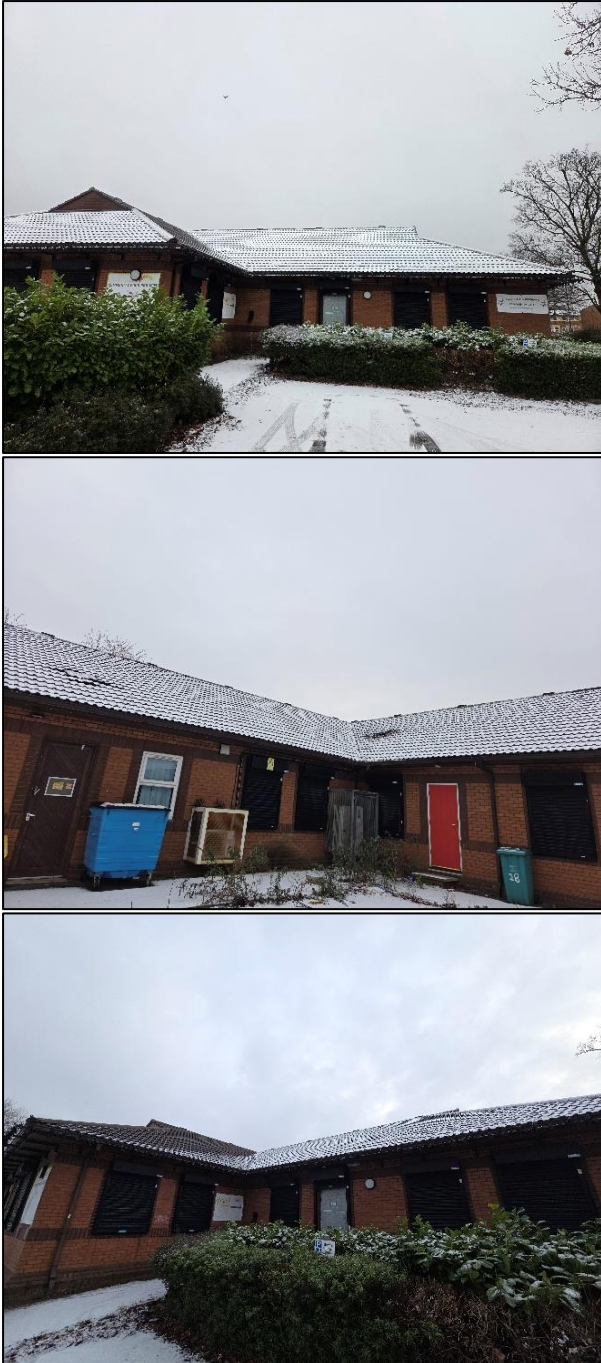
- 3.3.1 The site is a detached single storey building with brick walls and a cross hipped roof covered with interlocking concrete tiles (see Photographs 1 and 2).

*Photographs 1, 2 & 3 showing the exterior of the site*

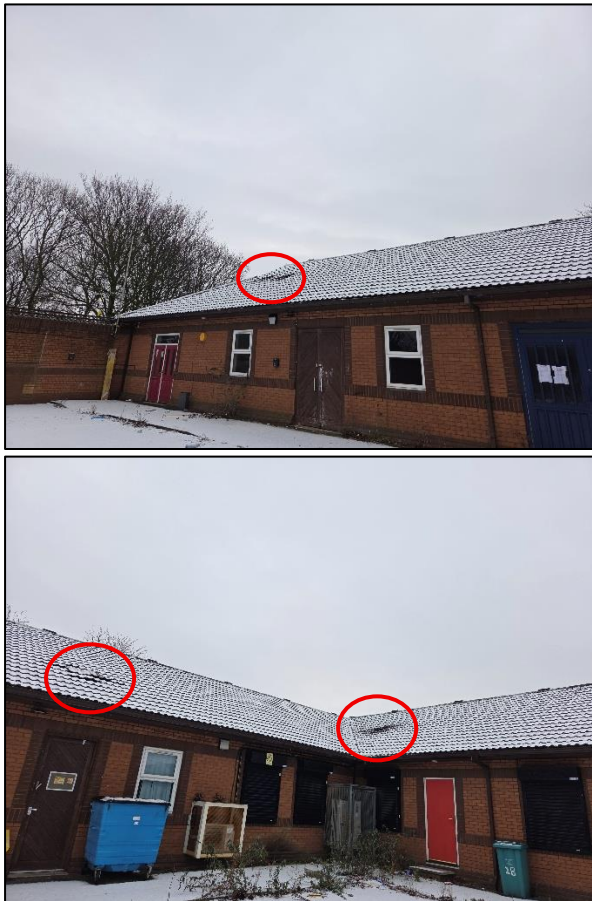
3.3.2 On the longer elevations at the 'L' shaped part of the building, three area of raised roof tiles were noted (see Photographs 6 and 7).

Photographs 6 & 7 showing areas of lifted roof tiles

- 4.1.1 The site is located within poor quality bat foraging habitat. Bats' use of the surrounding area is likely to be limited to small numbers of Common Pipistrelle *Pipistrellus pipistrellus*. No evidence indicating use by bats or birds was recorded.
- 4.1.2 The presence of several raised roof tiles offers potential access and roosting opportunities for individual bats but the site is very unlikely to be used as a maternity roost due to the poor quality of surrounding habitats. The site is unsuitable for void dwelling bats (i.e. Brown Long-eared *Plecotus auritus*).
- 4.1.3 The site is assessed as offering low potential to support roosting bats.

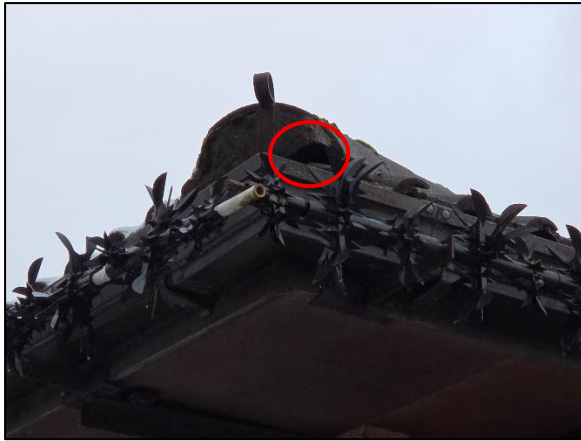
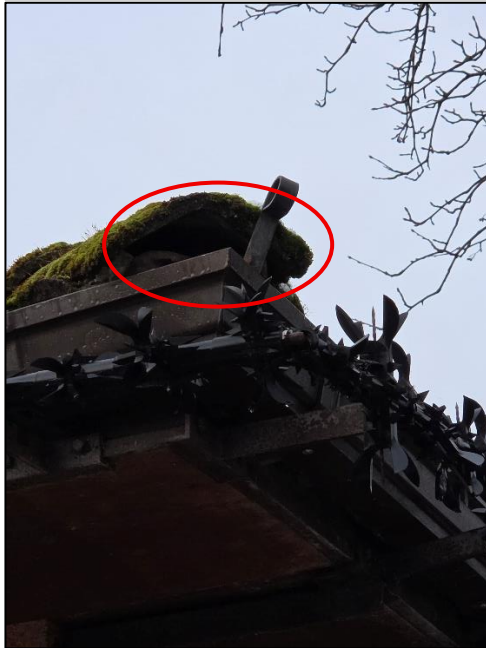
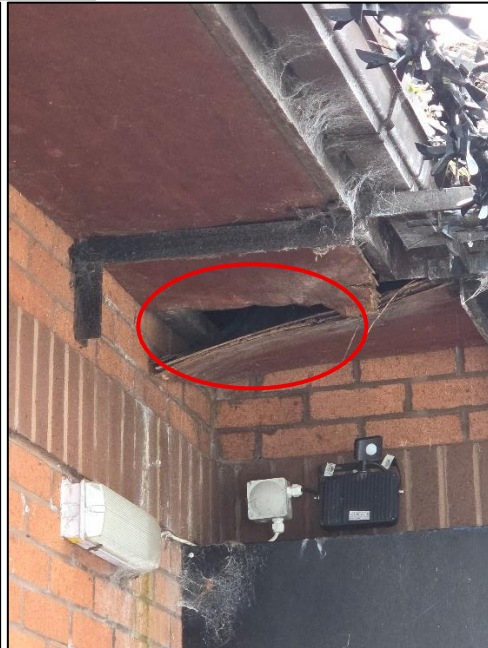
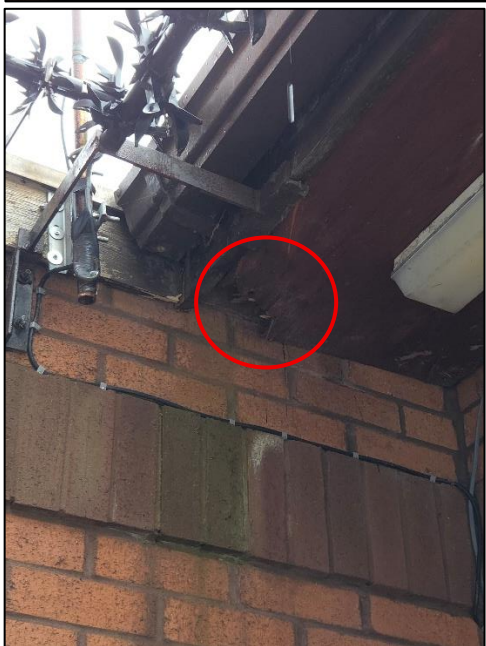
3.3.3 Guttering around the entirety of the building is flush and intact throughout. Potential access points were noted at the end hip tiles. Two areas of damaged soffit boards were also recorded (see Photographs 8-11).

Photographs 8, 9, 10 & 11 showing gaps at end hip tiles and damaged and soffit board

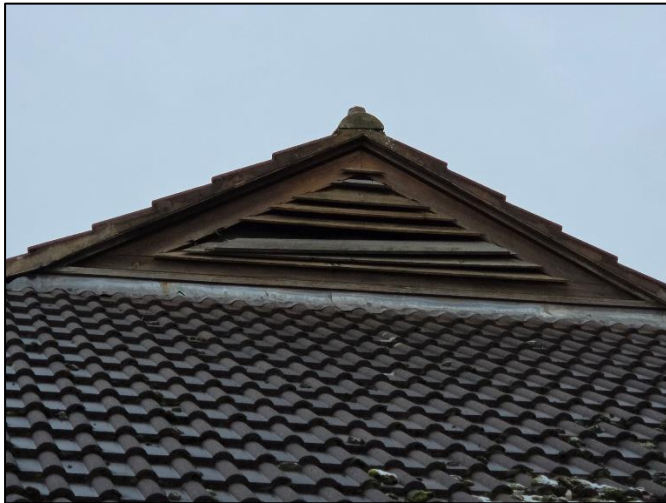
- 3.3.4 Wooden cladding is present on raised gables; this is damaged at the southeast elevation (see Photograph 12).

*Photograph 12 showing deteriorated boards at southeastern elevation*

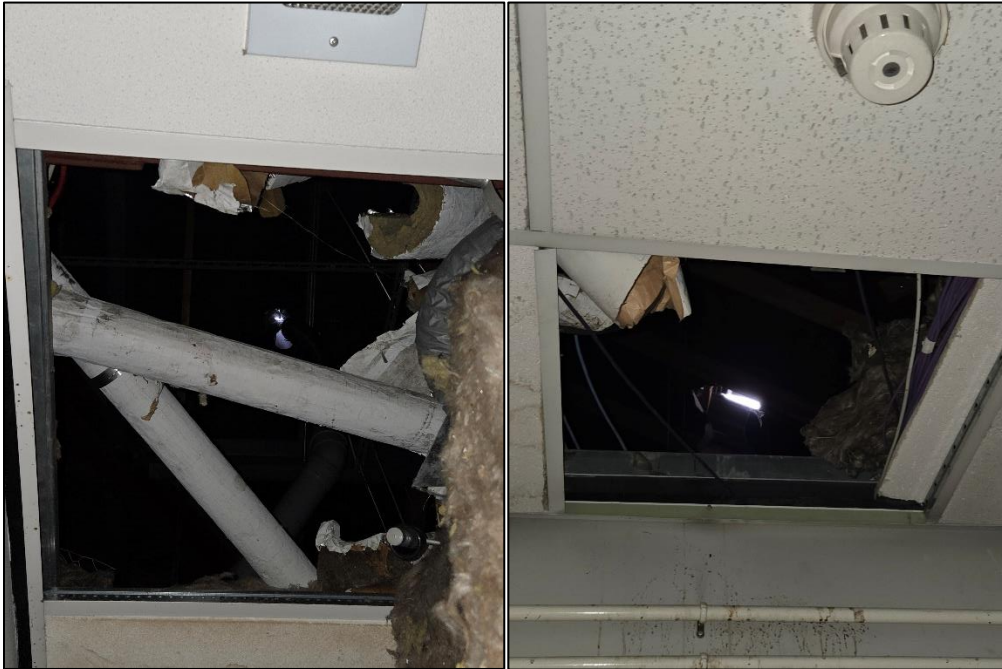
- 3.4.2 Two tears in the lining were recorded during the survey. These were present in rooms 'MCC IT 1' and 'Female Toilets' (see Photographs 14 and 15).

*Photographs 14 &15 showing gaps in roof lining*

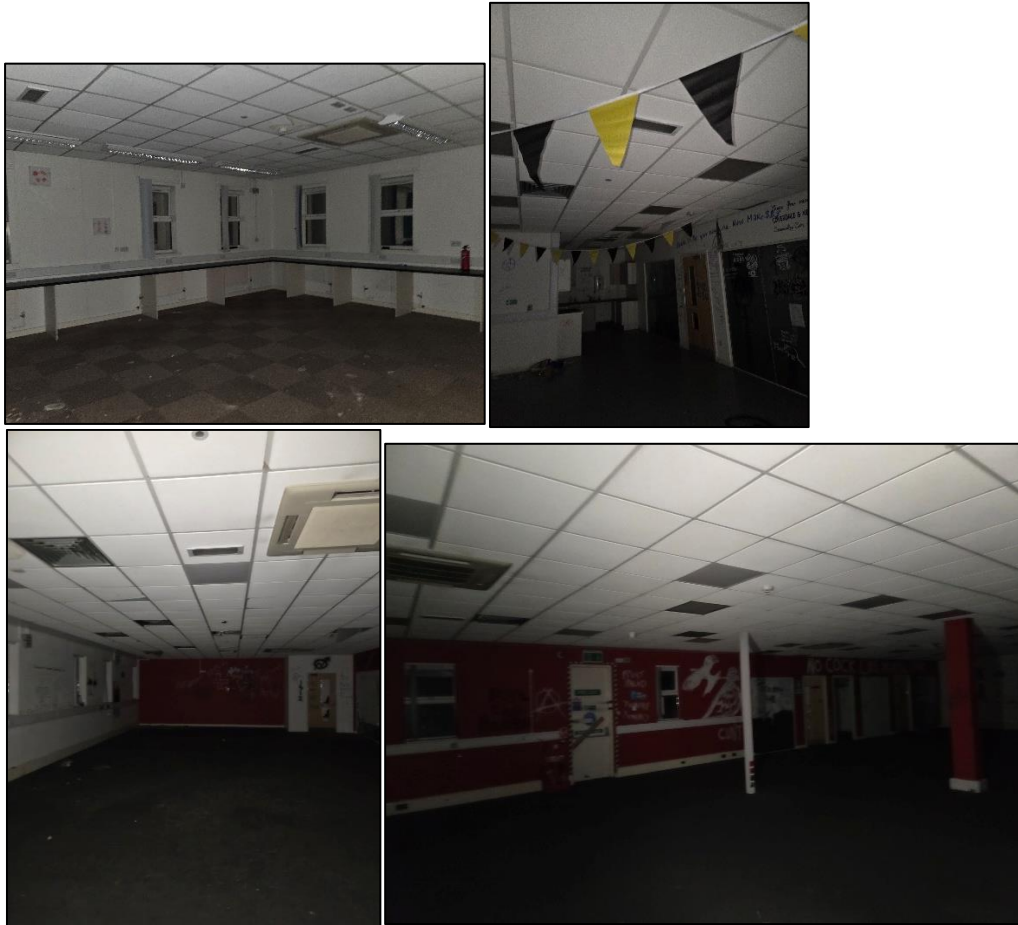
- 3.4.4 Rooms within the building were cold and the overwhelming majority were dark due to metal shutters present on windows (see Photographs 17 to 20).

Photograph 17, 18, 19 & 20 showing the interior

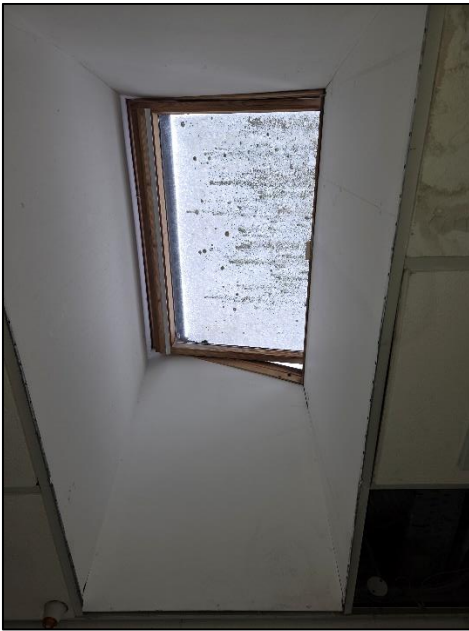
- 3.4.6 One skylight window was partially open (see Photograph 21).

*Photograph 21 showing partially open skylight*

- 5.2.1 It is recommended that access to birds is removed by sealing the open window/vents.
- 5.2.2 Should birds gain access and nest in the site it would be necessary to avoid works within 4m of active nests until nesting activity is finished.

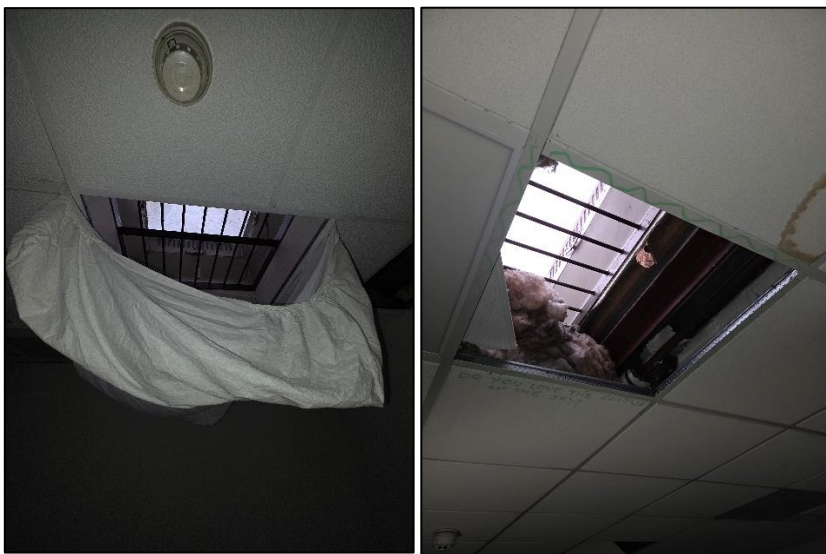
- 3.4.7 One of the vents covers is missing (see Photographs 22 and 23).

*Photographs 22 & 23 showing the two vents present*
