## Archaeological Excavation Report

Mayfield,  
Manchester

**Report No:**  
SA/2021/56

**Project:** Mayfield, Manchester: Archaeological Excavation

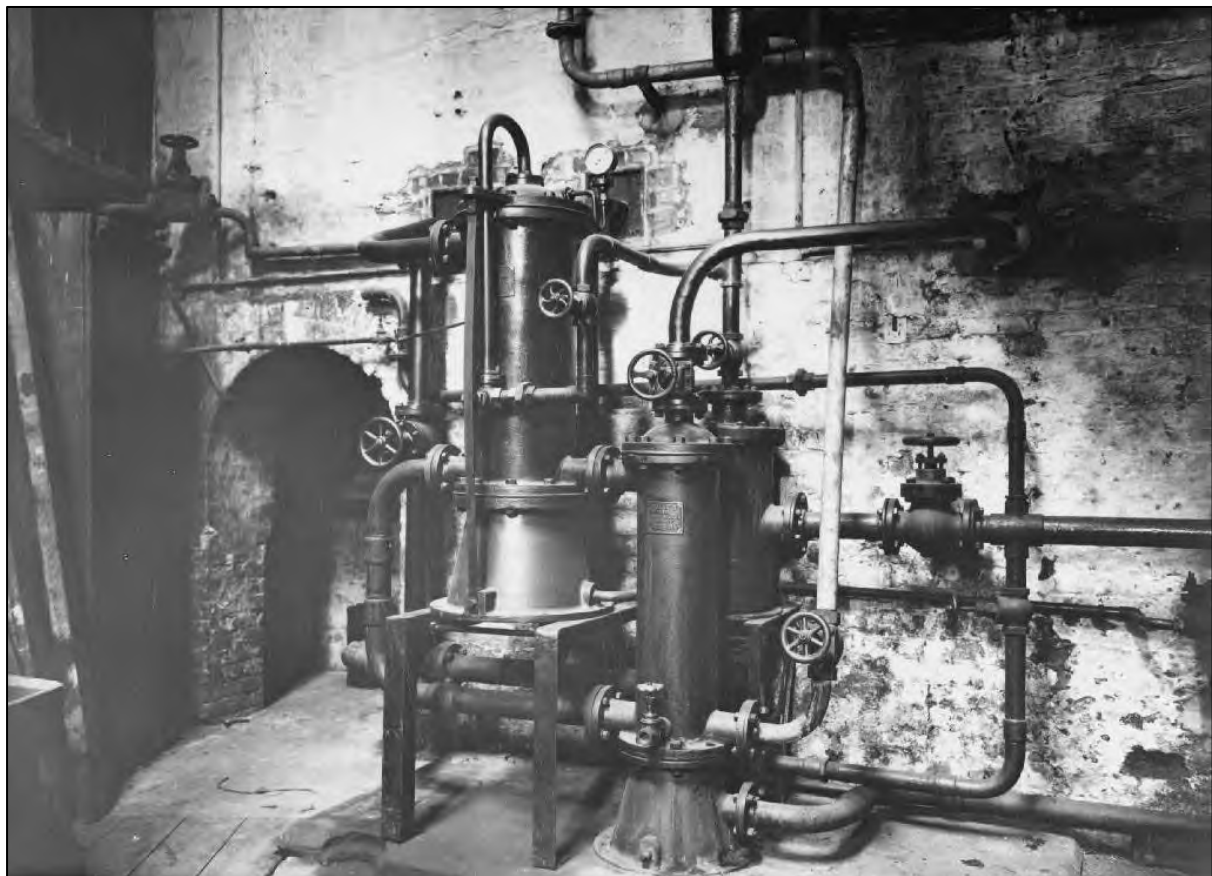
*Plate 14: The Royle Calorifier at Mayfield Baths, 1902.*

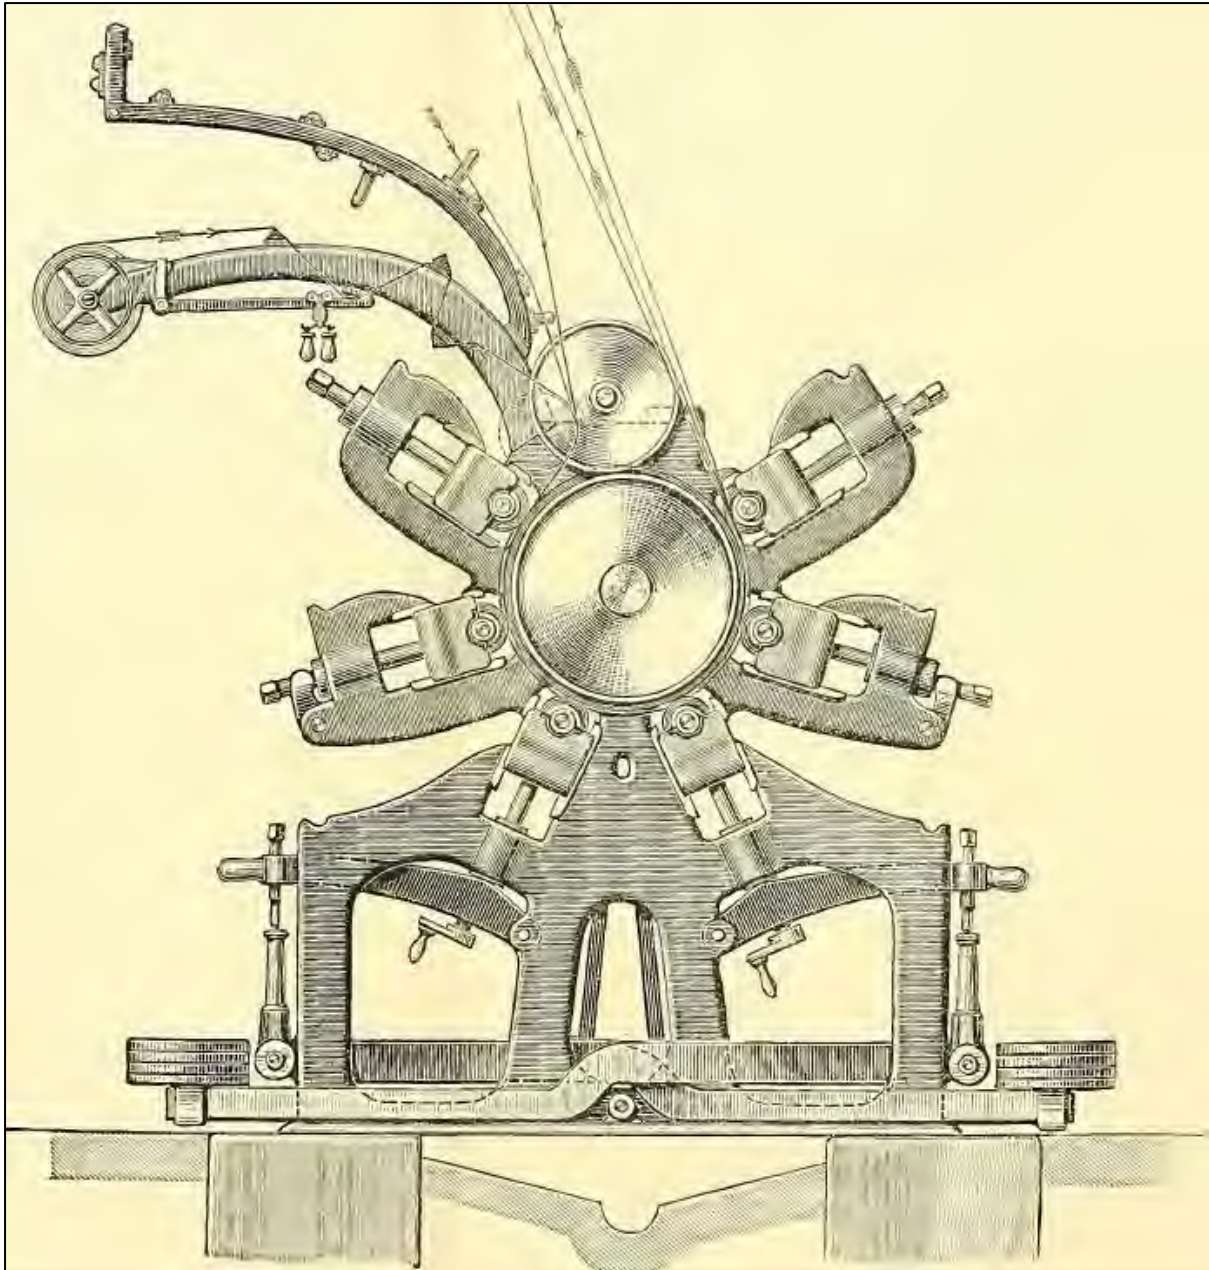
*Plate 17: A six colour printing machine depicted in 'The Printing of Cotton Fabrics' (Sansone 1887) similar to those mentioned in the 1897 auction*

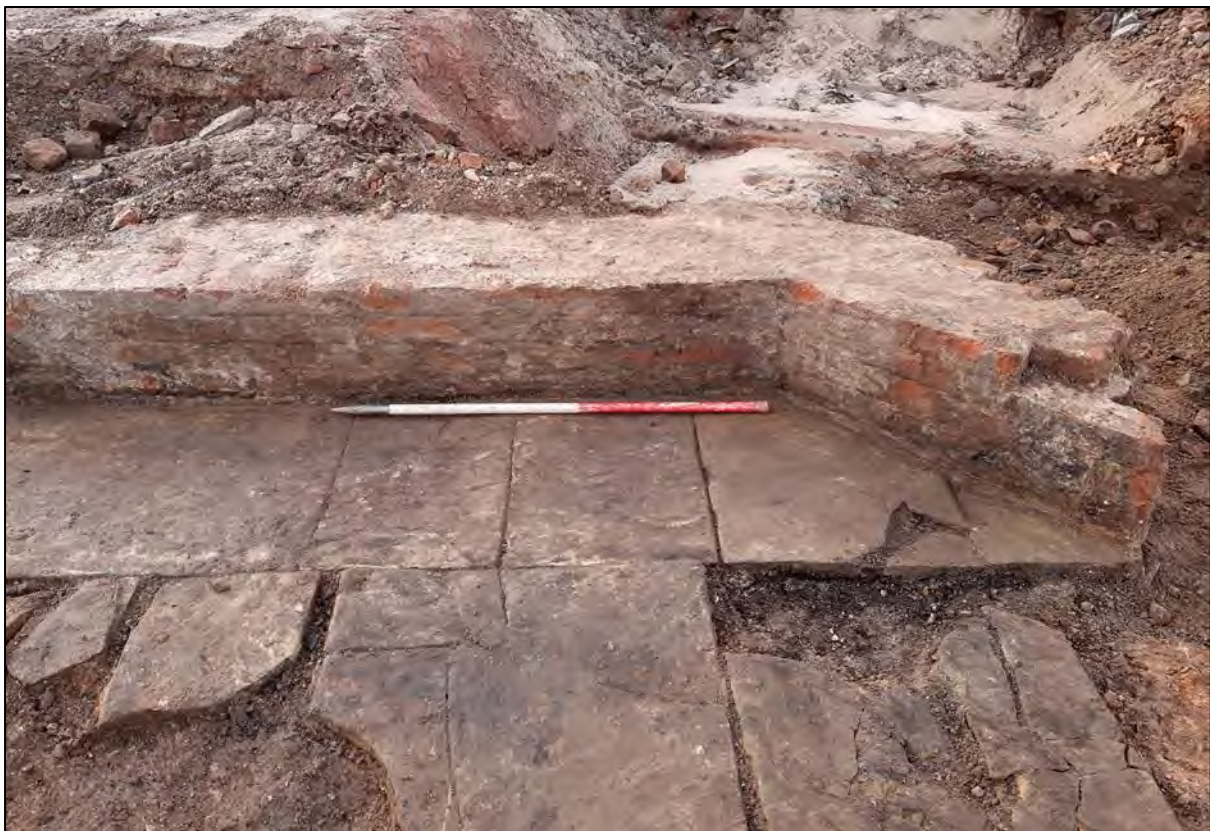
Plate 41: Wall 114, looking south (1m scale)

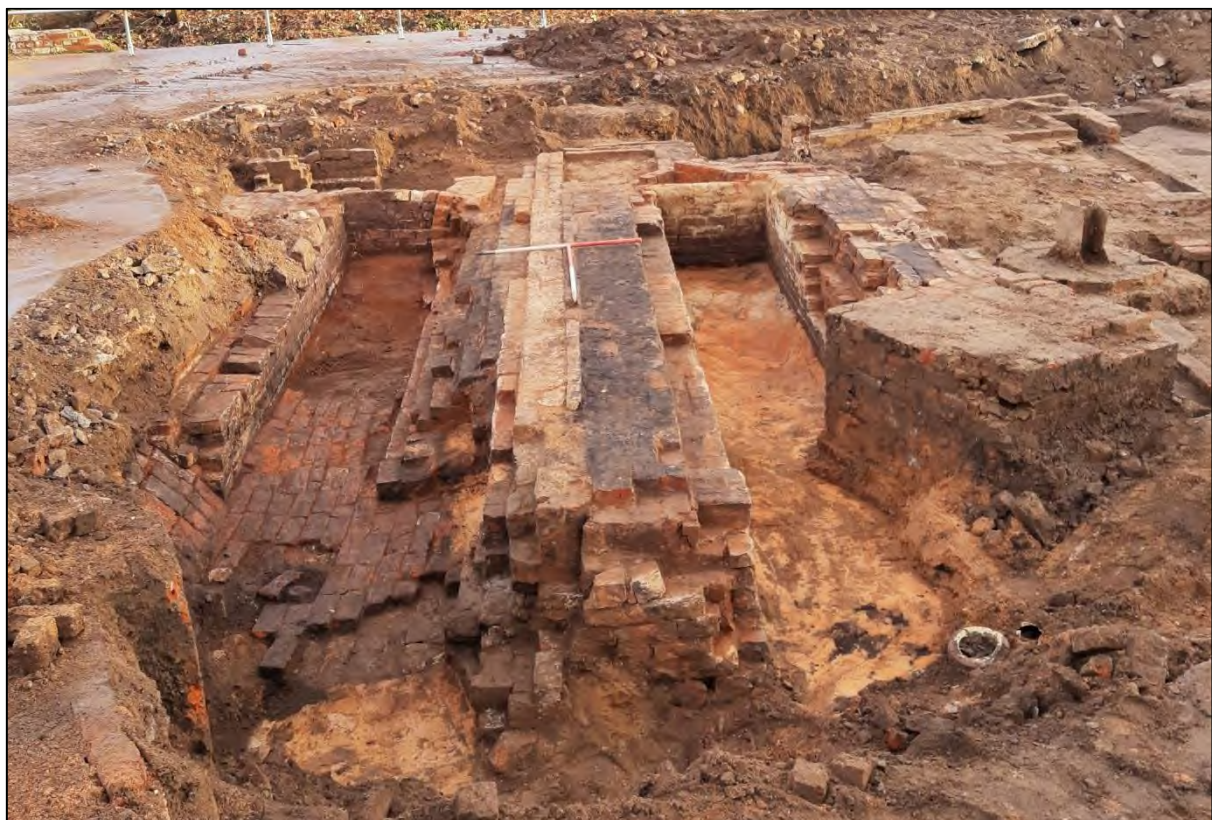
*Plate 43: Boiler beds 111 and 112, looking north (2 x 1m scales)*

The two boiler-beds, **111** and **112** were located to the southwest of the chimney at the west of the excavation area (Plate 43). Both boilers were truncated by later activity. This included a further brick stanchion, **109**, which truncated the southeast of boiler-bed **111** and measured 1.2 x 1.1m.

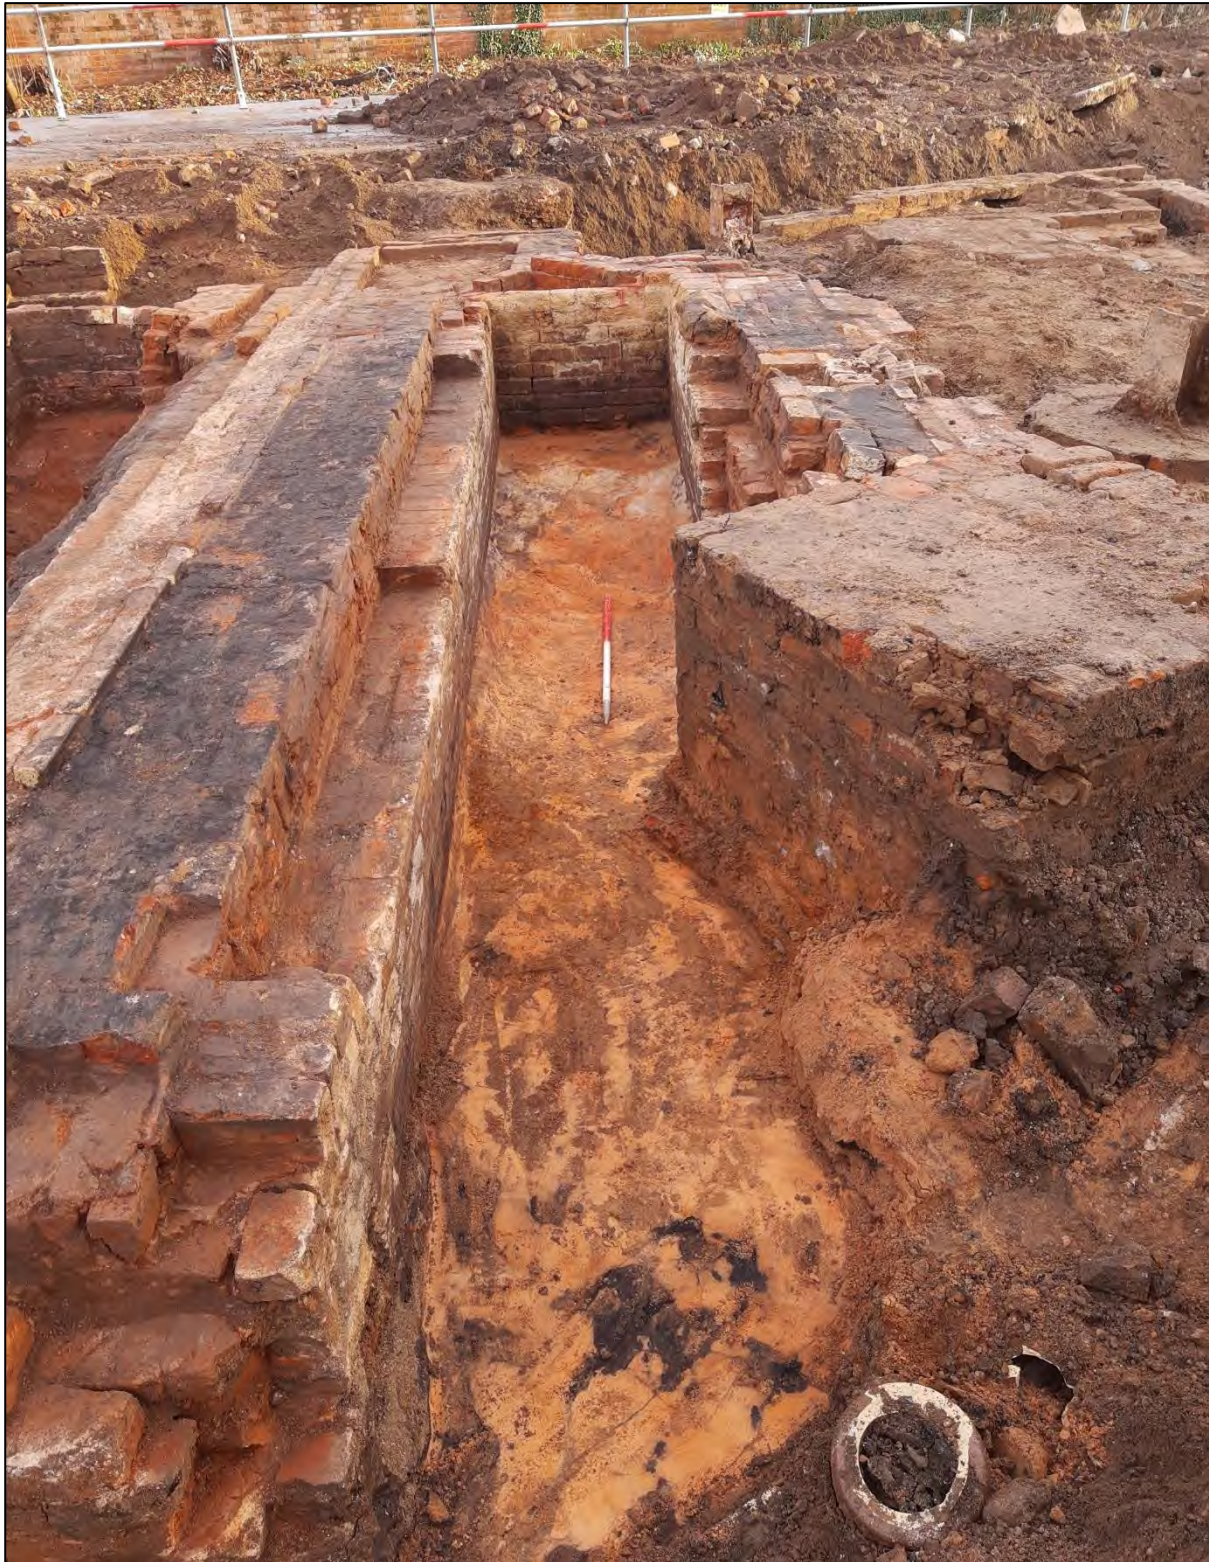
*Plate 44: Boiler 111, looking north (1m scale)*

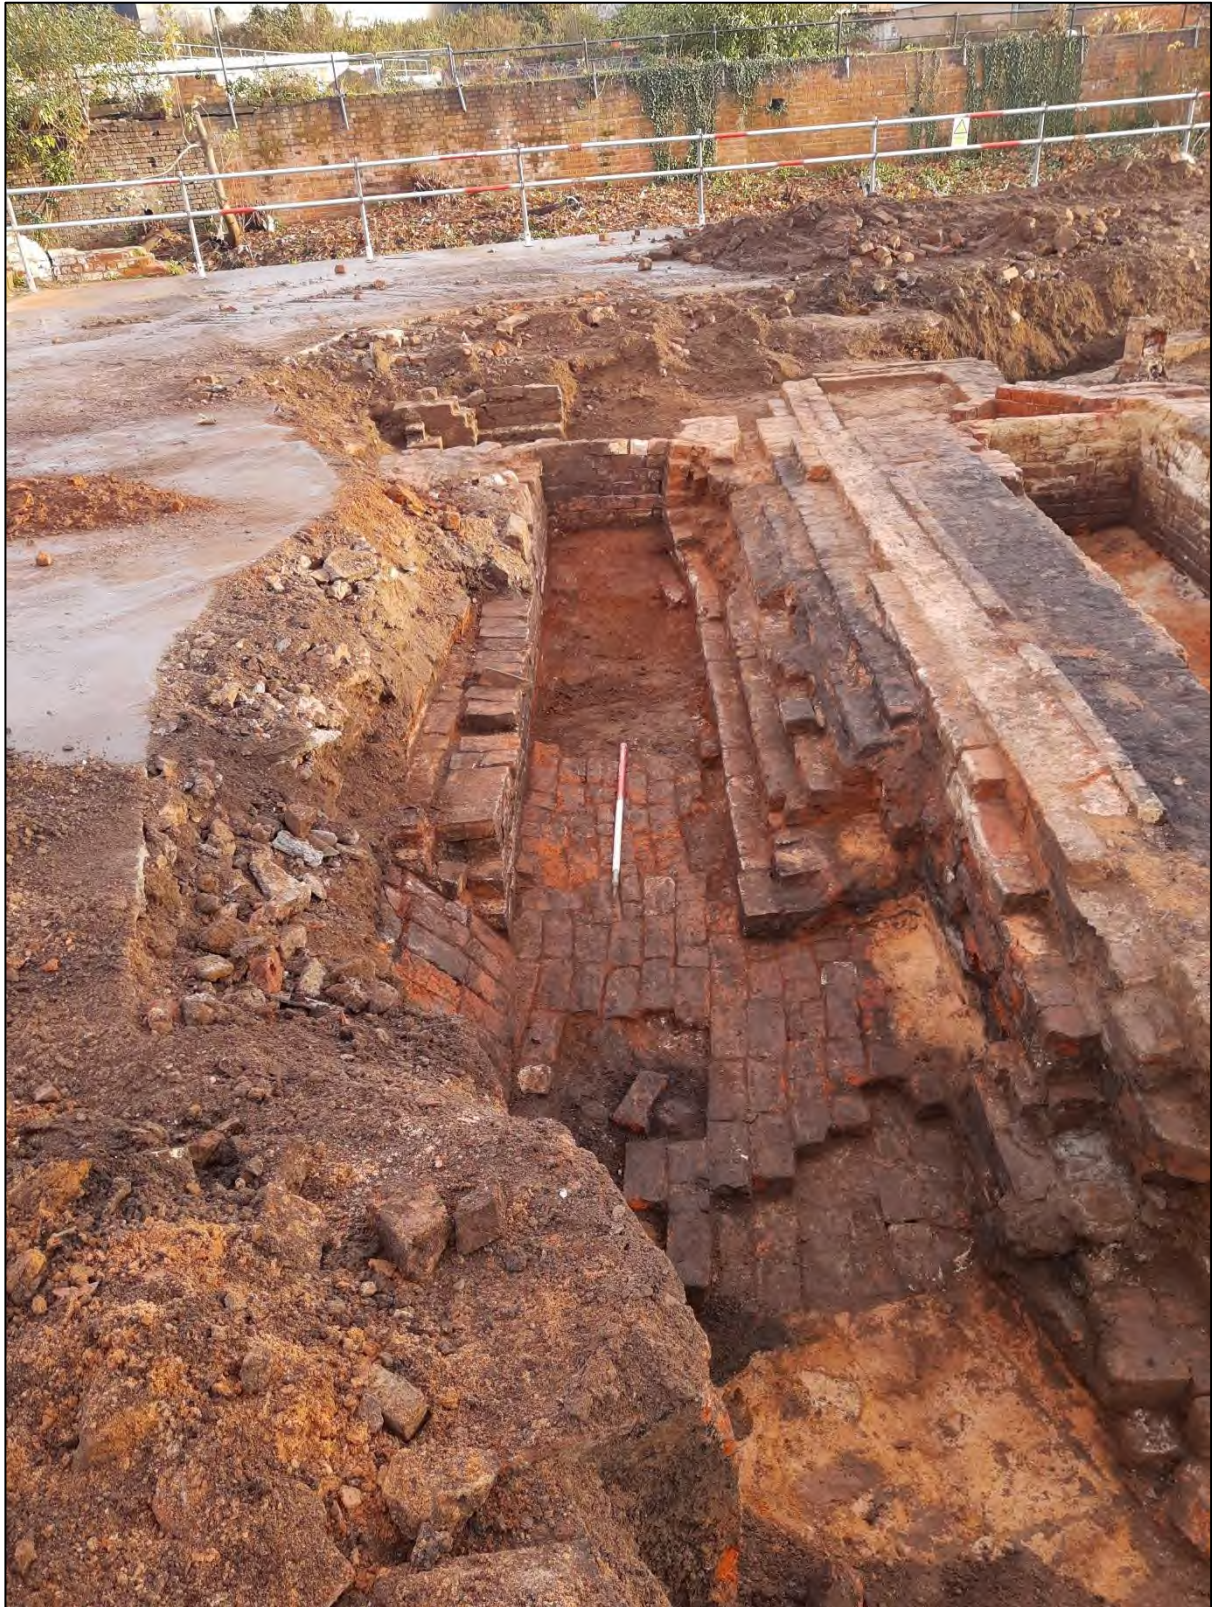
*Plate 45: Boiler 112, looking north (1m scale)*

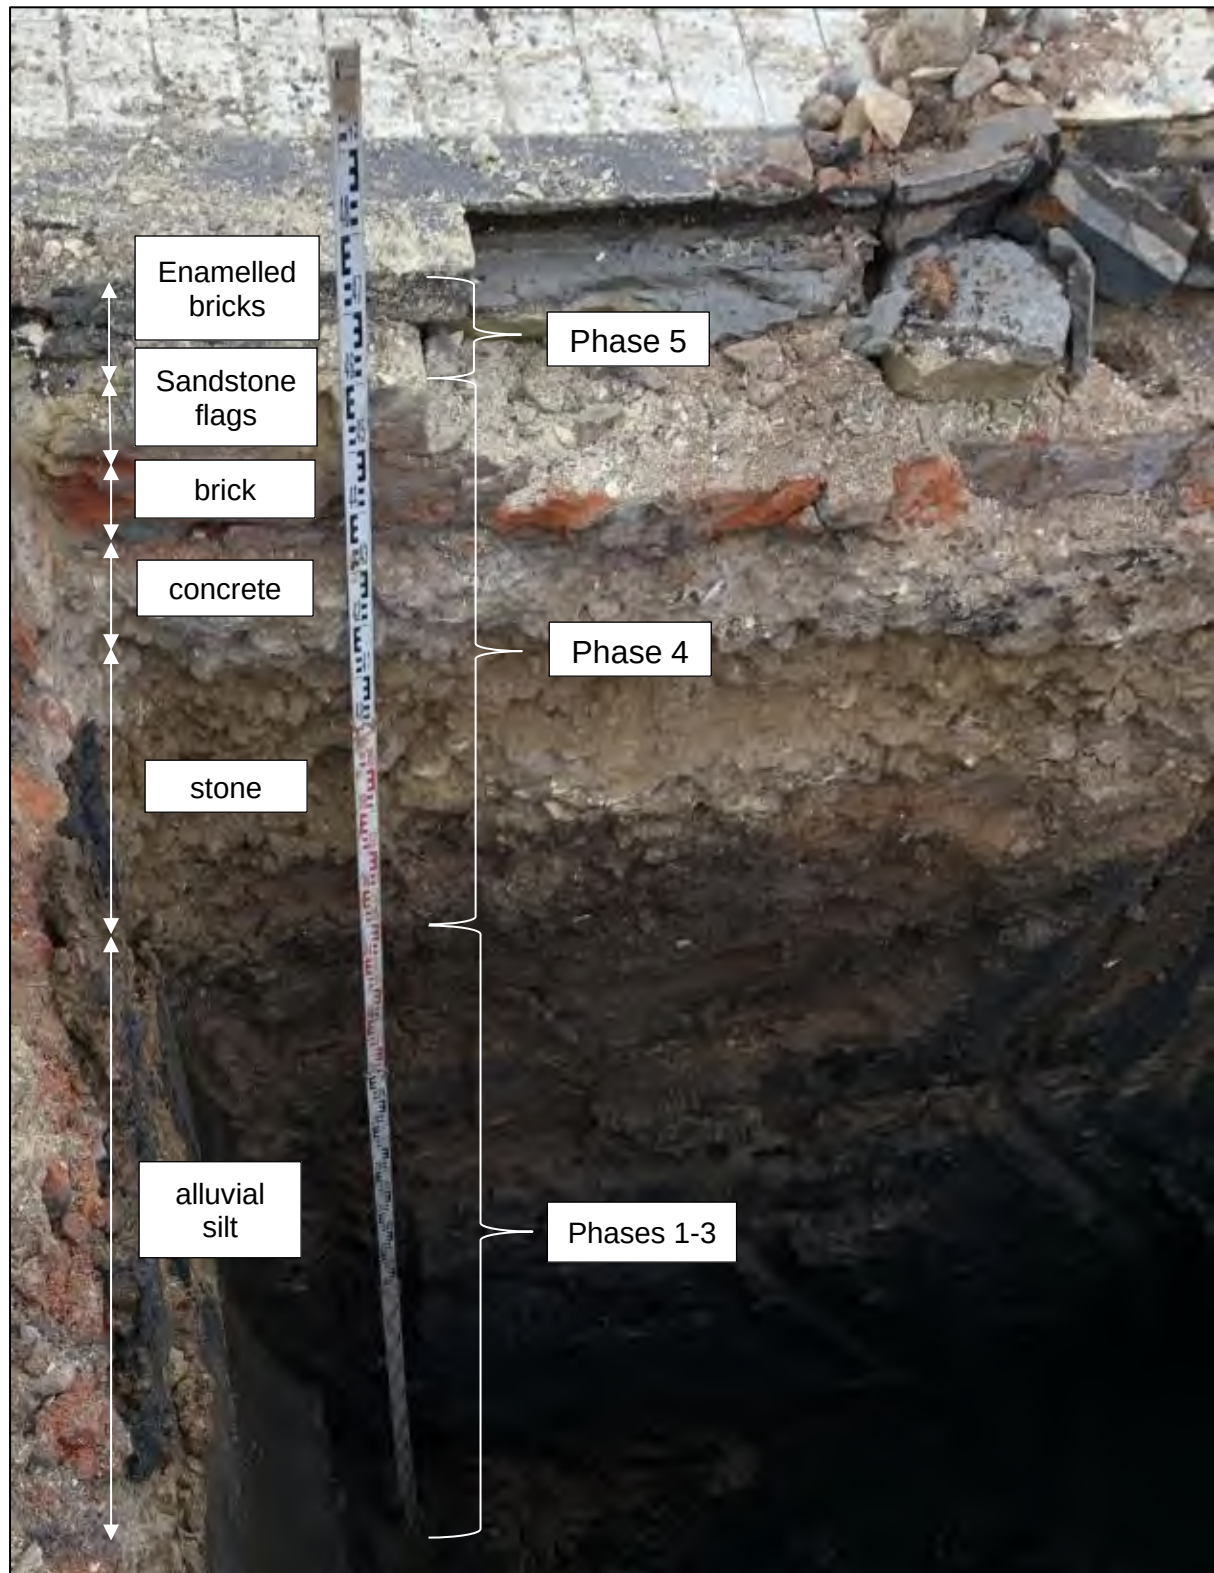
*Plate 49: Sondage through the base of Pool 226 showing the composition of the foundations above earlier layers of alluvial silt*

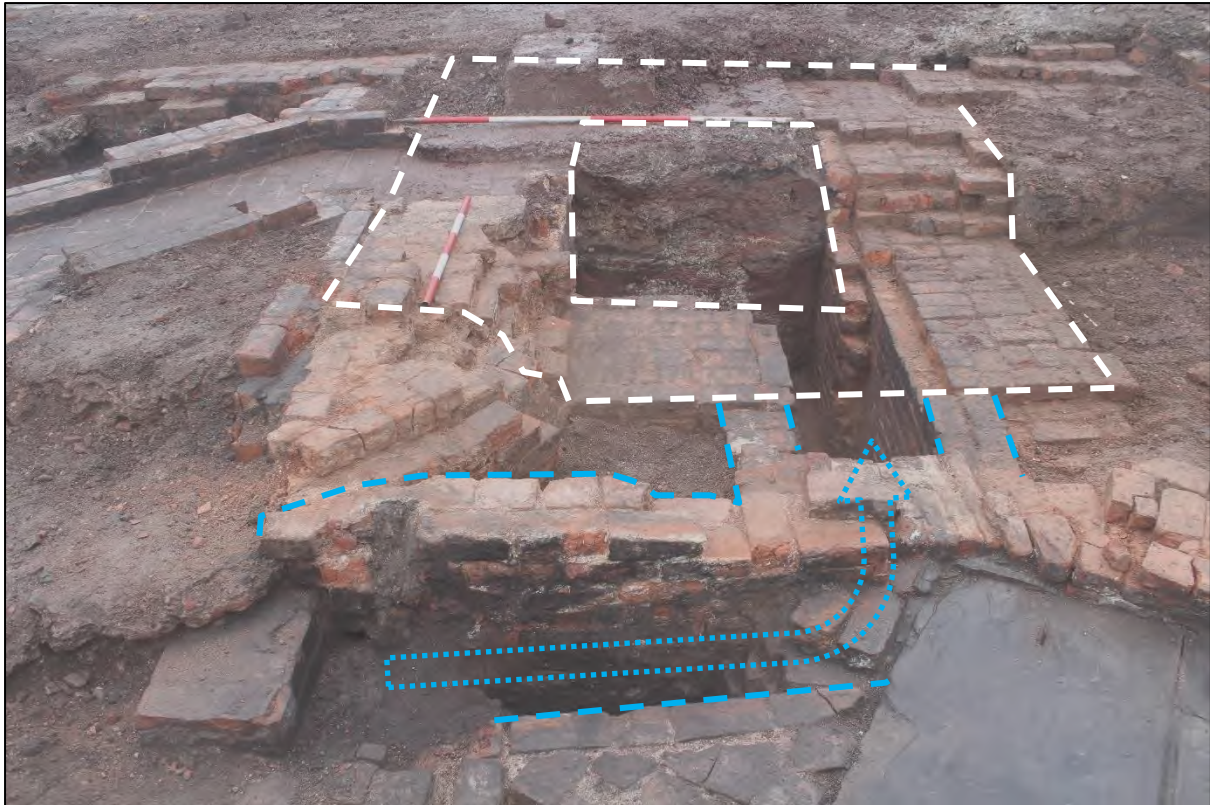
Plate 53: The remains of chimney 219 (white) and flue 218 (blue)

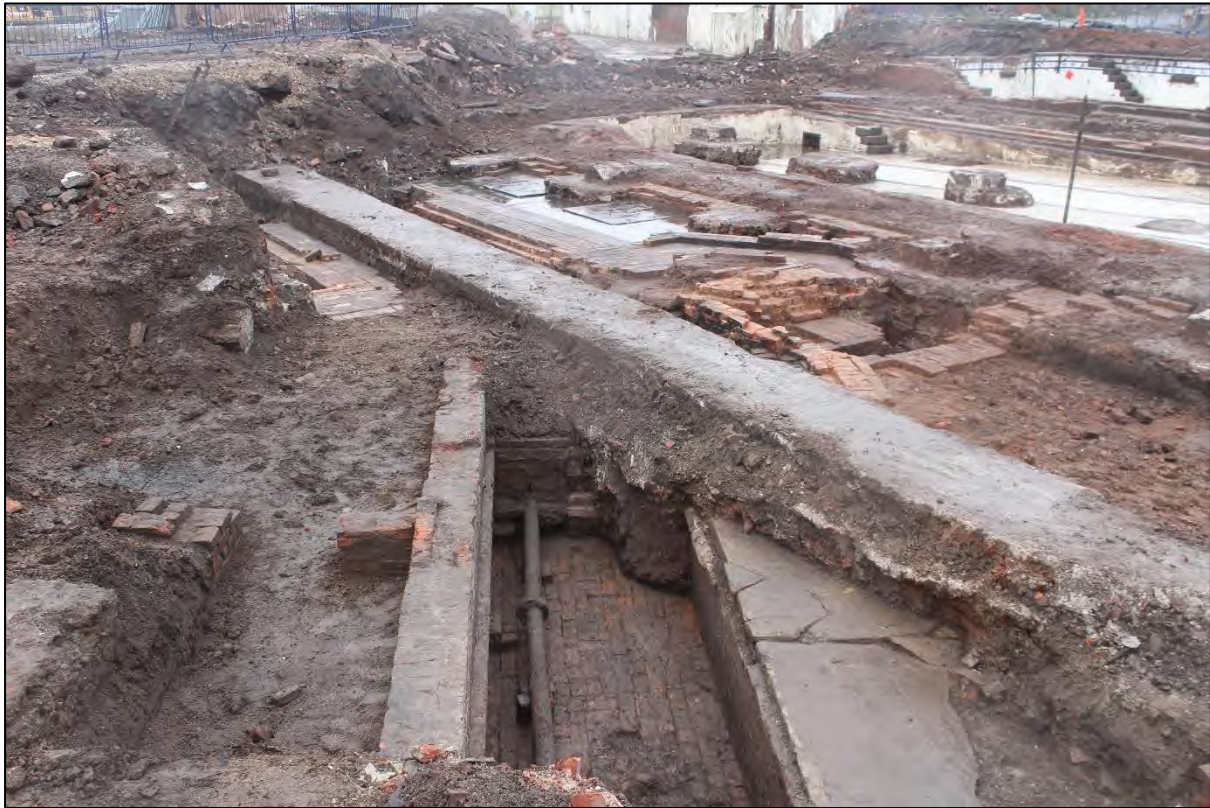
*Plate 55: The brick conduit formed by walls 204, 206 and 205 looking south-east*

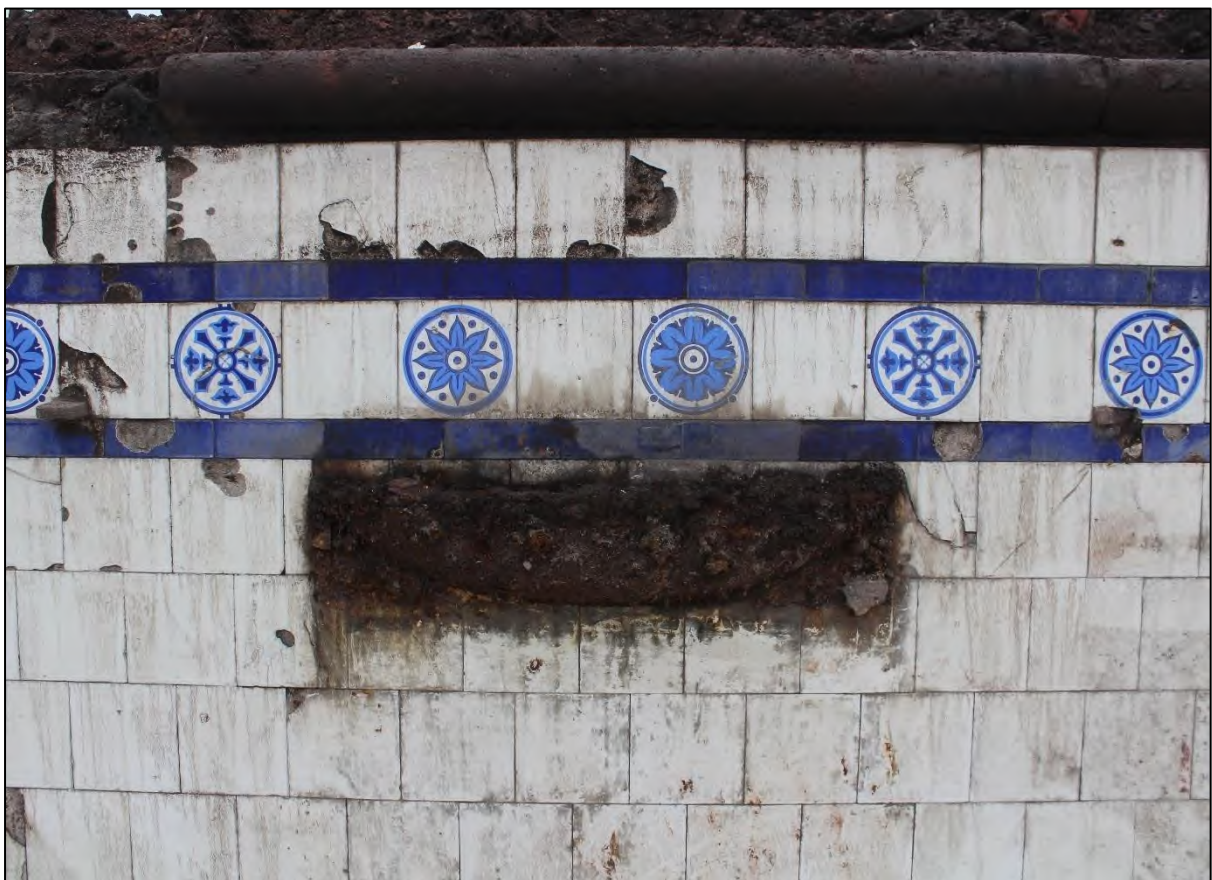
*Plate 60: The poolside of 225, showing the spit trough and floral tiles, looking east.*

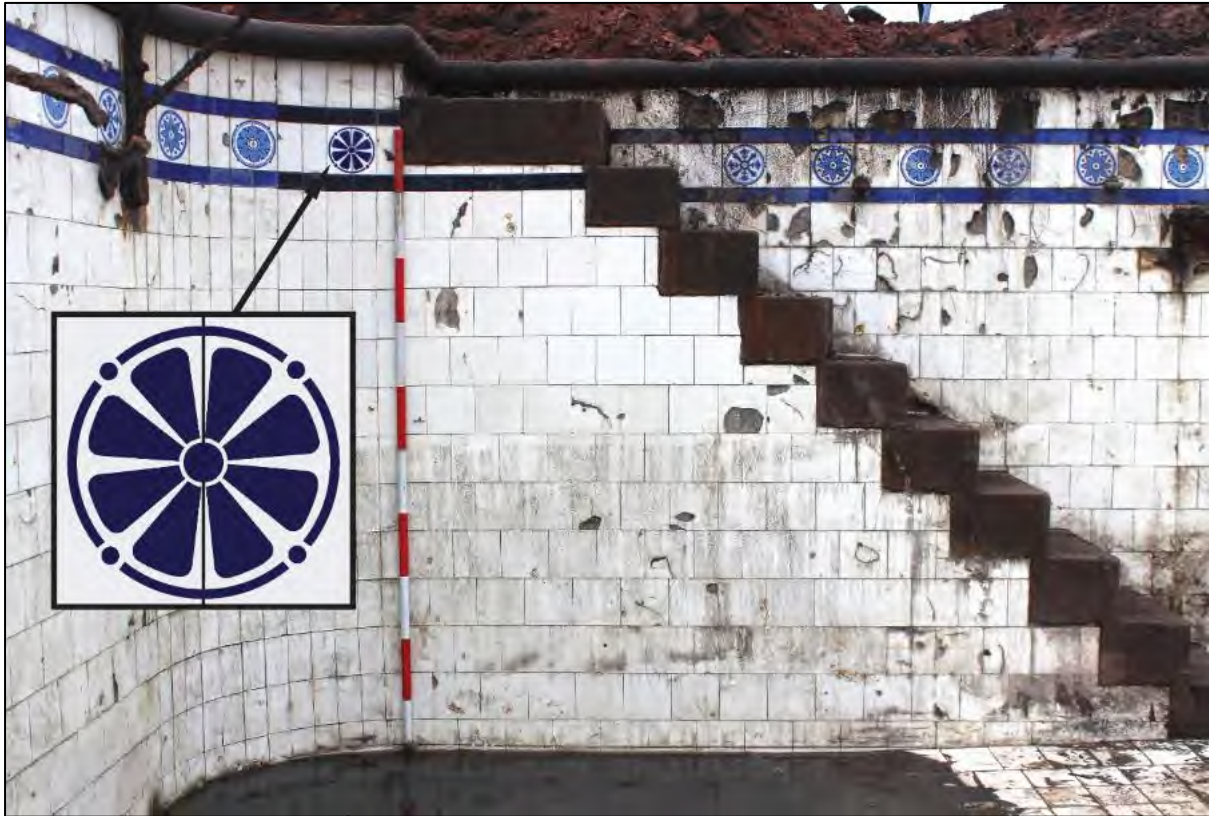
*Plate 61: Pool 225 showing the later steps and replacement tiles (2m scale)*

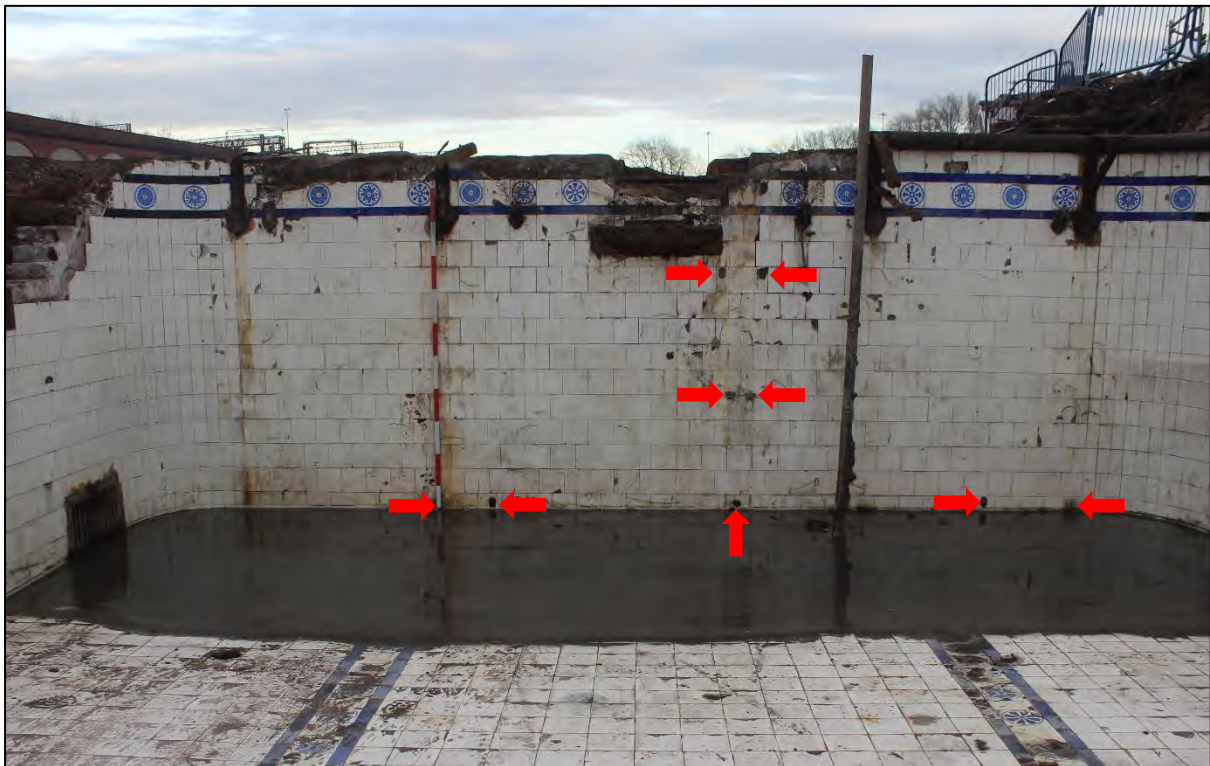
Plate 62: The eastern end of Pool 225 showing the position of the fixings for the steam injection pipe (removed) and L-shaped brackets visible above the waterline (2m scale)

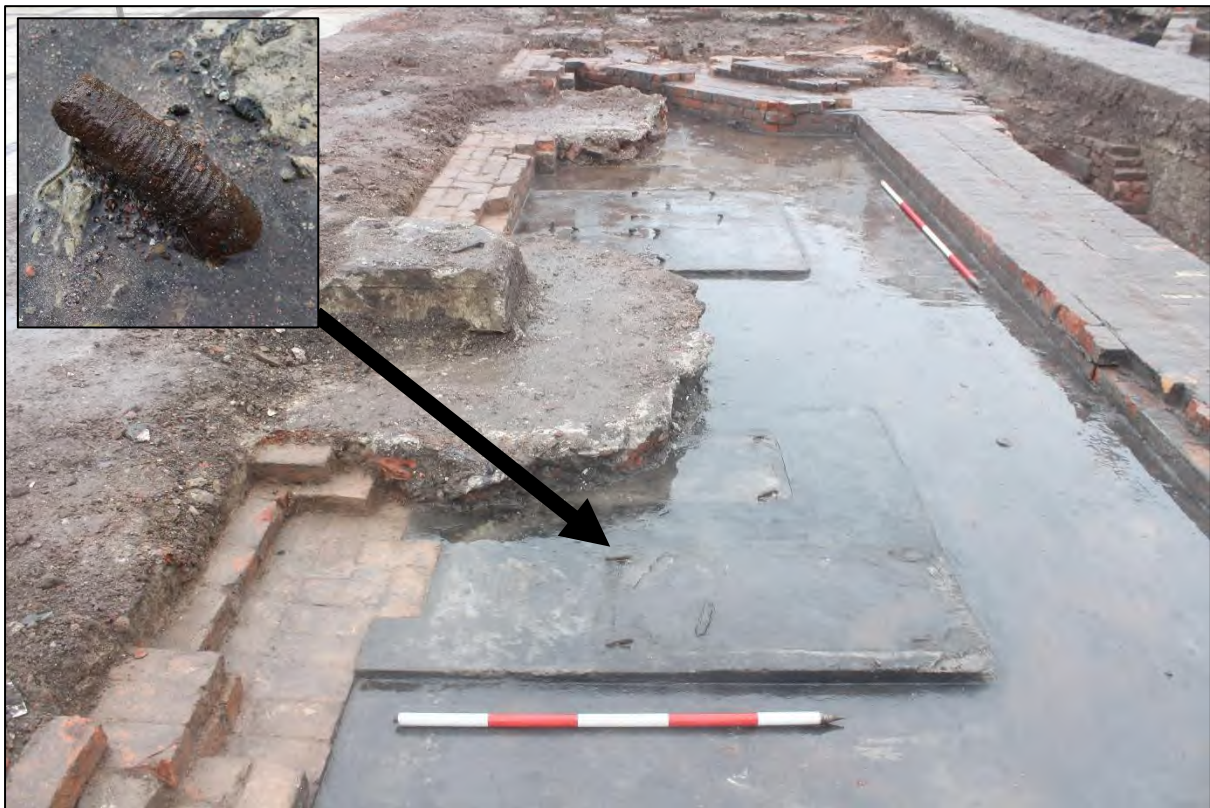
*Plate 66: Anteroom to the boiler showing stone machine beds 216a (foreground) and 216b in the rear of the shot (1m and 2m scales) Inset: showing threaded bolt*

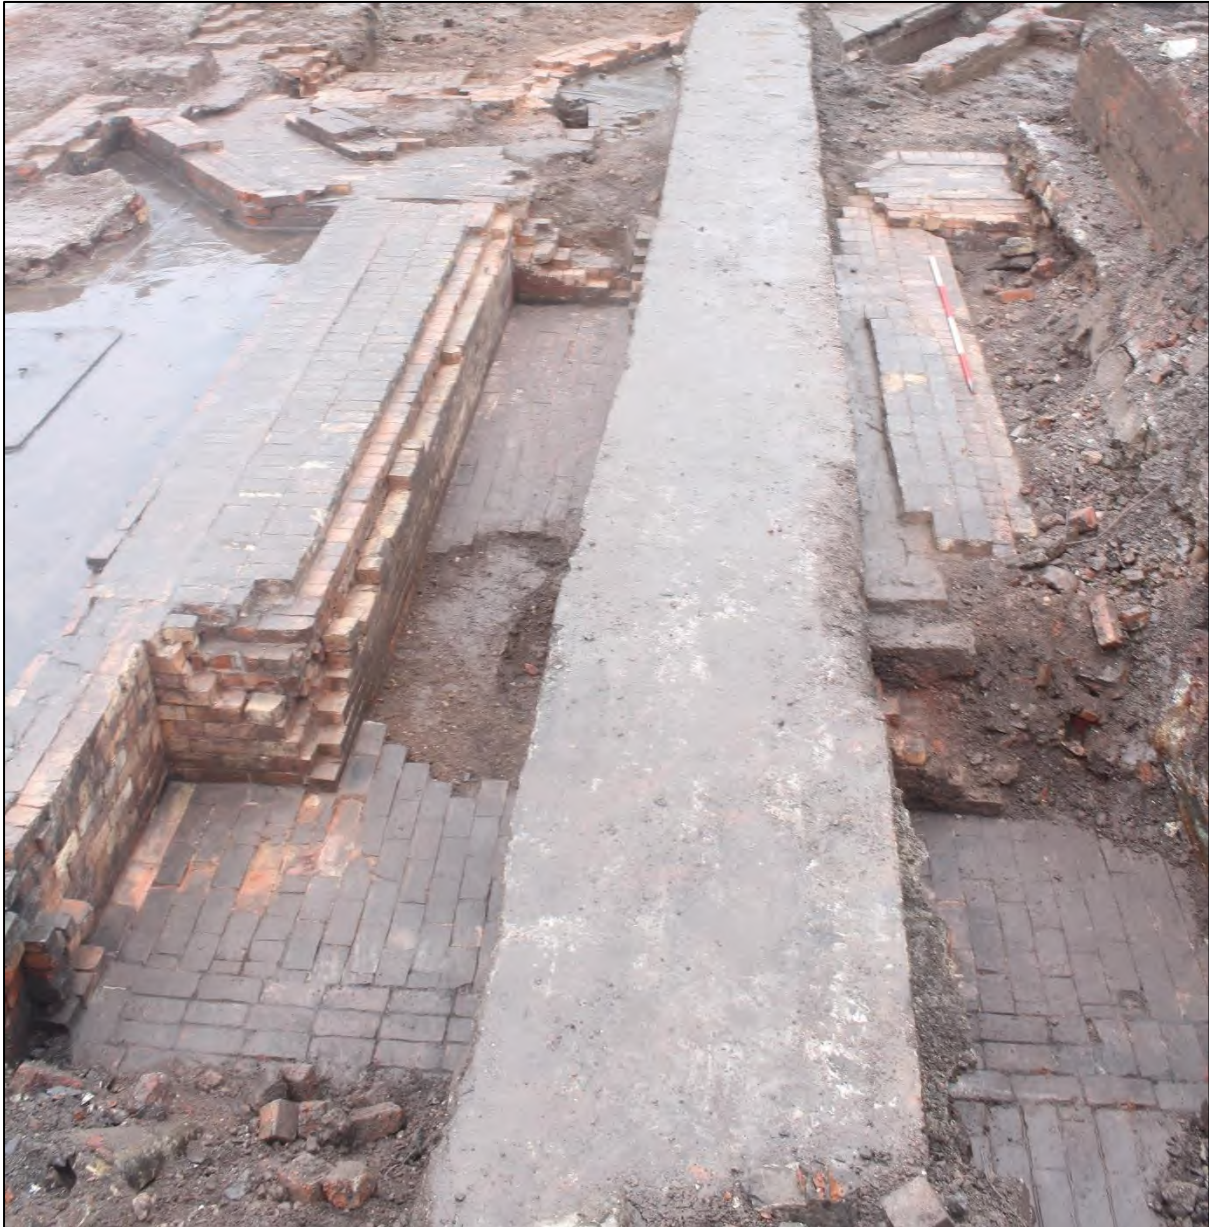
*Plate 69: View of the boilers 221 and 222 and flue 217 looking west (2m scale)*

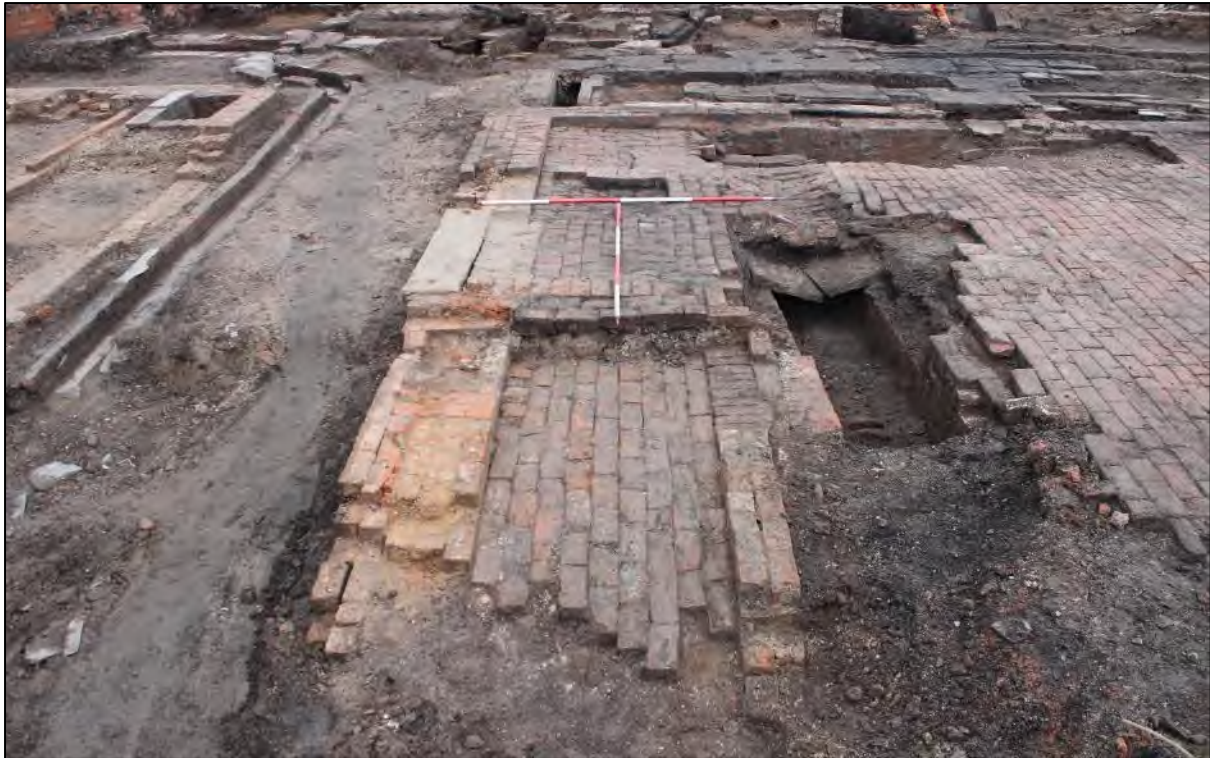
Plate 73: Walls 3011 and 3057 forming the northern wall of Building B. Note the yellowish-brown mortar and handmade brick forming the original one-and-a-half brick wall. Looking north-east (2 x 2m scales)

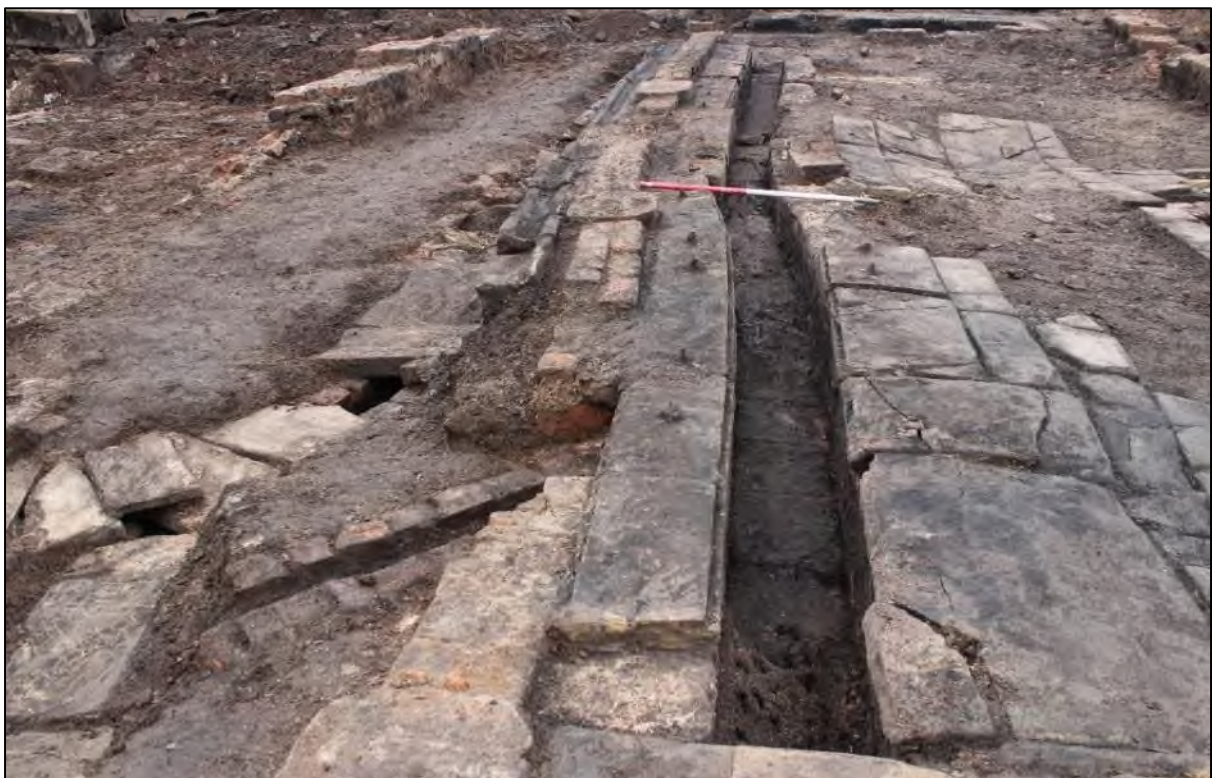
*Plate 78: View of drain 3038 constructed alongside wall 3027 looking south-west (1m scale)*

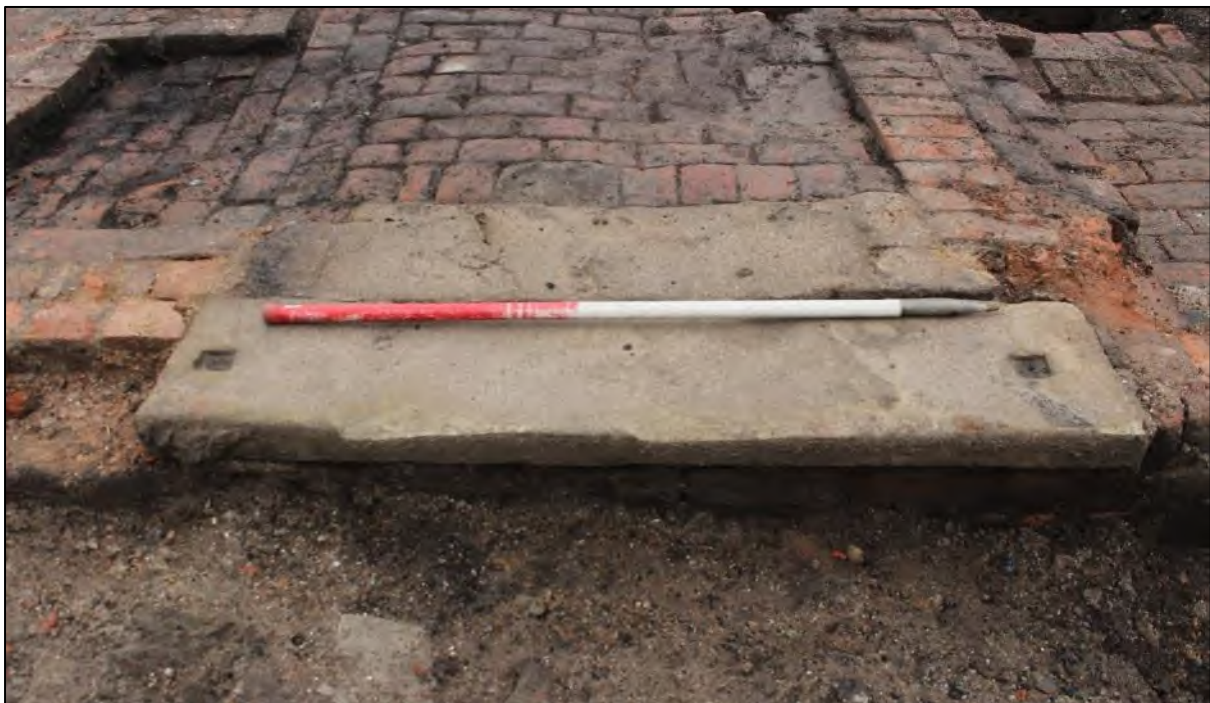
*Plate 83: Wall 3010 featuring a later threshold with rectangular sockets for the door jambs. The earlier wall and threshold are visible to the rear. Both exhibit traces of significant wear. (1m scale)*

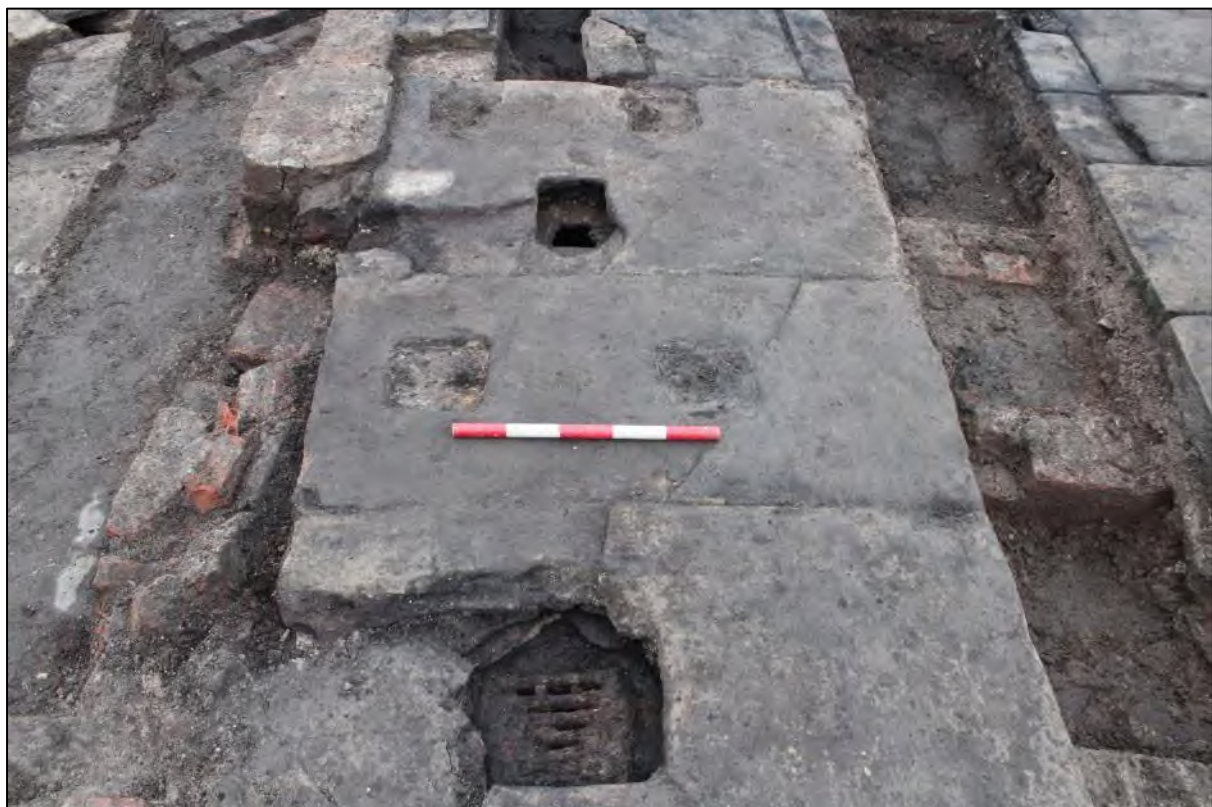
Plate 84: The fittings and drains set into the flags capping the extension of drain 3038 (0.50m scale)

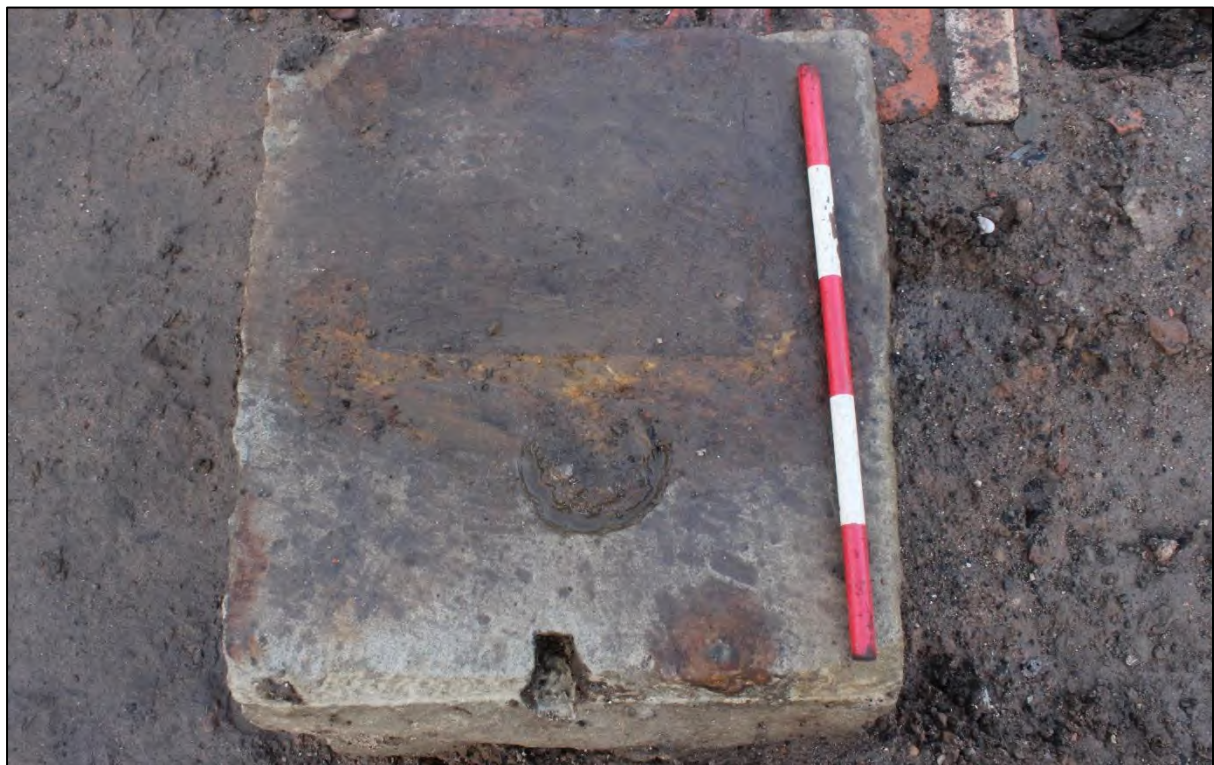
*Plate 115: Column base 3148 looking north. Note the shadow left behind by the cast iron column base as well as holes left by other potential fittings (0.50m scale)*
