## Archaeological Excavation Report

Mayfield,  
Manchester

**Report No:**  
SA/2021/56

**Project:** Mayfield, Manchester: Archaeological Excavation

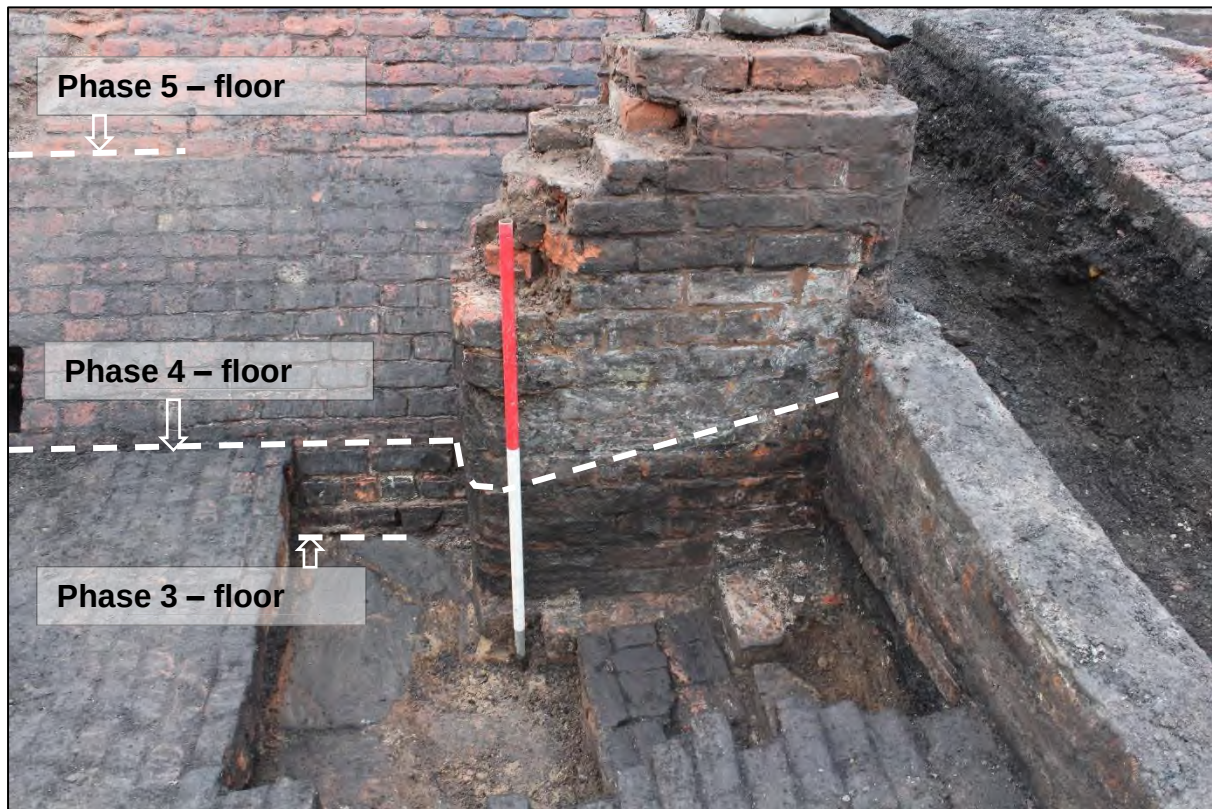
Plate 131: The three successive charging floors revealed within the southern half of the boiler house: 3172 (*Phase 3*); 3065 (*Phase 4*) and 3174 (*Phase 5*). Photographed looking south (1m scale)

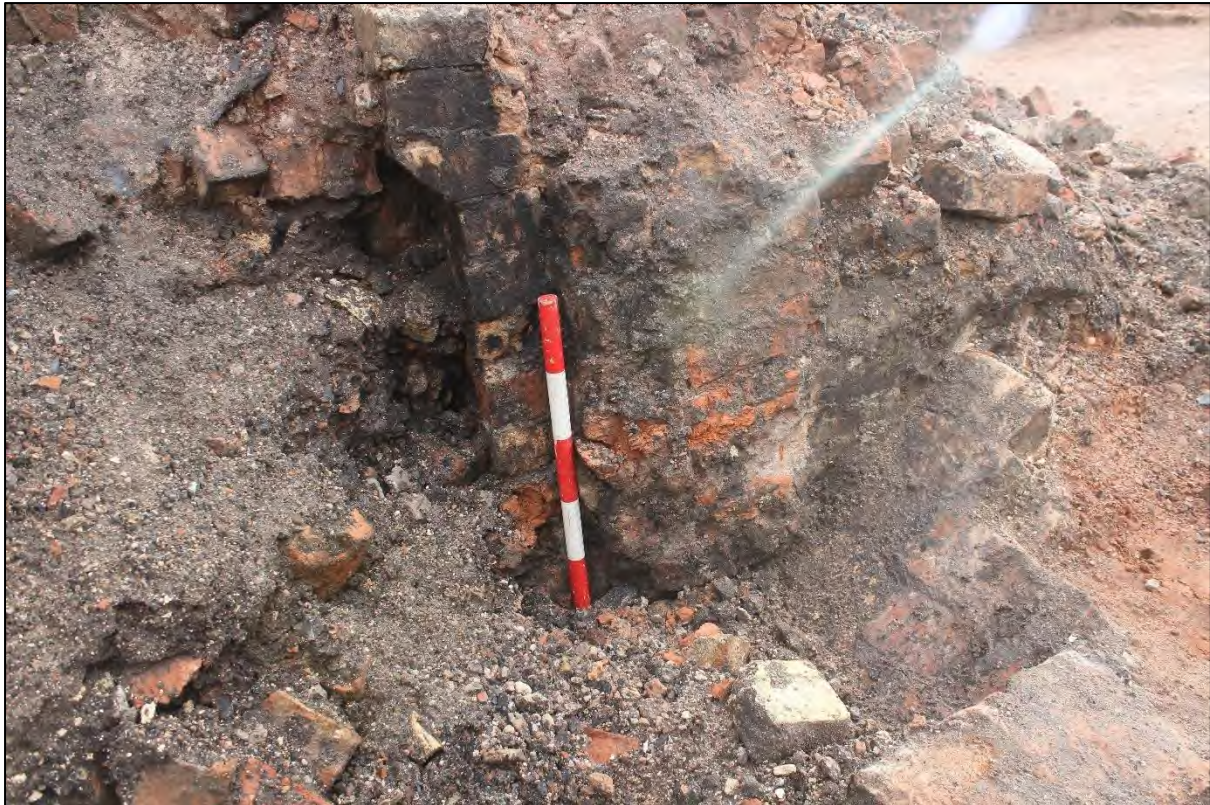
*Plate 132: Remnant of the vaulted flue to the rear of the boilers, looking east. Note the rebated brick wall and adjacent flue sloping down from below the boiler. This would have been the location of a damper to regulate draught (0.50m scale)*

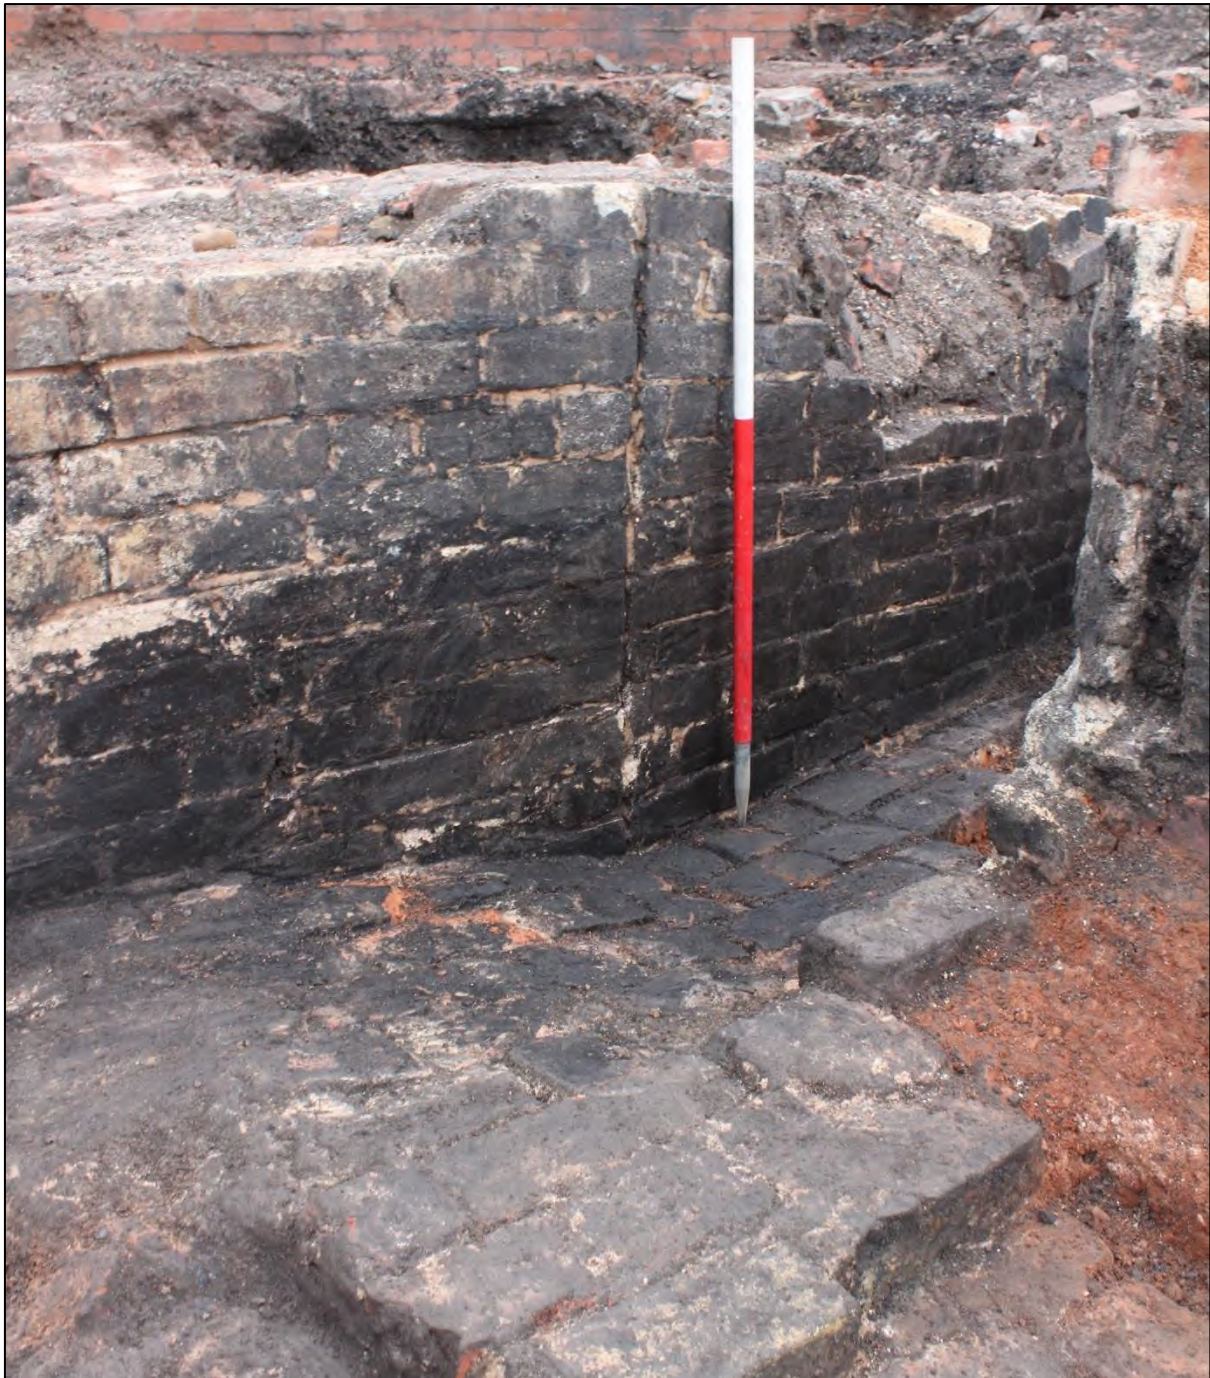
*Plate 144: Vertical phase break within the northern wall of flue 3064/3189 indicating its point of extension (1m scale). Note the upward sloping floor within the flue.*

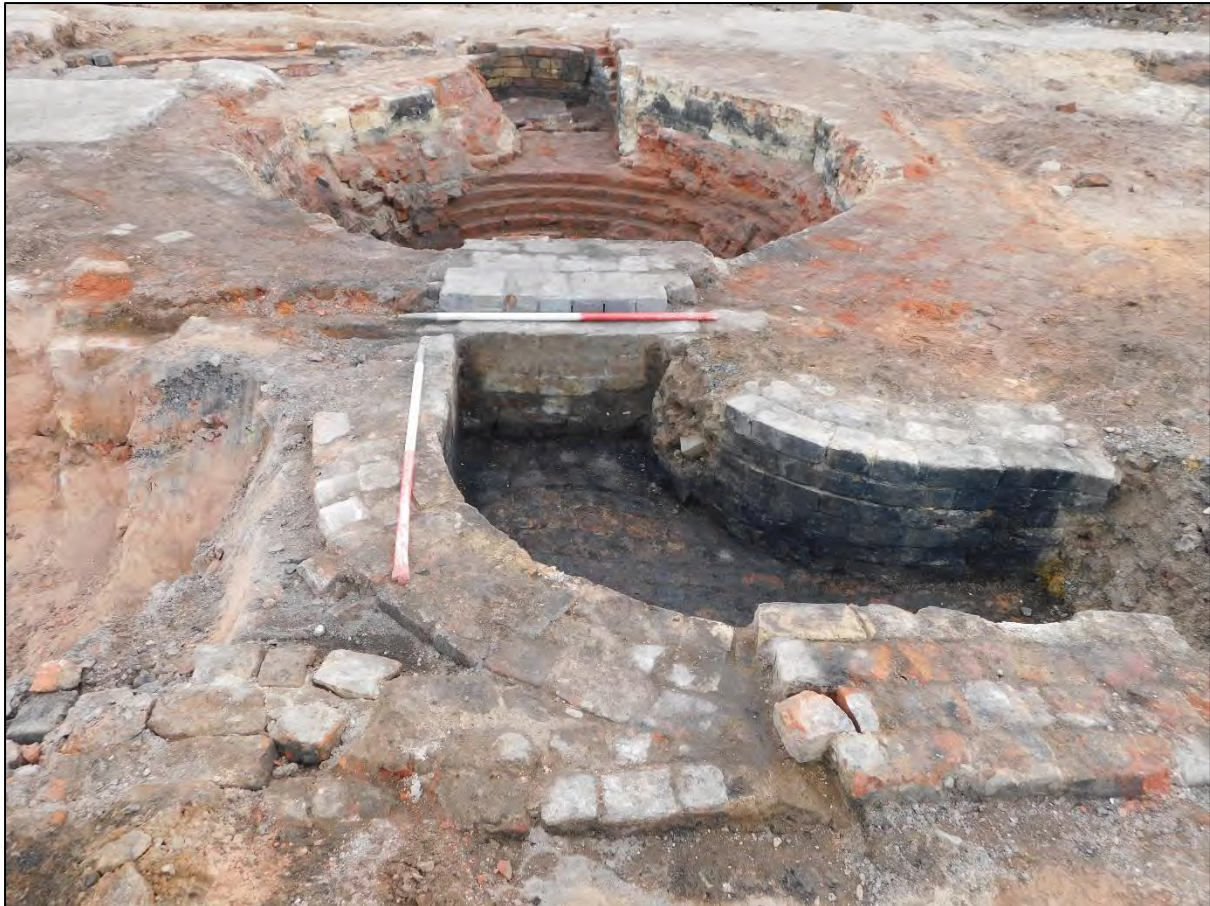
*Plate 163: Flue 422 feeding into chimney 424 blocked by later brick wall 423, facing north (2 x 1m scales)*

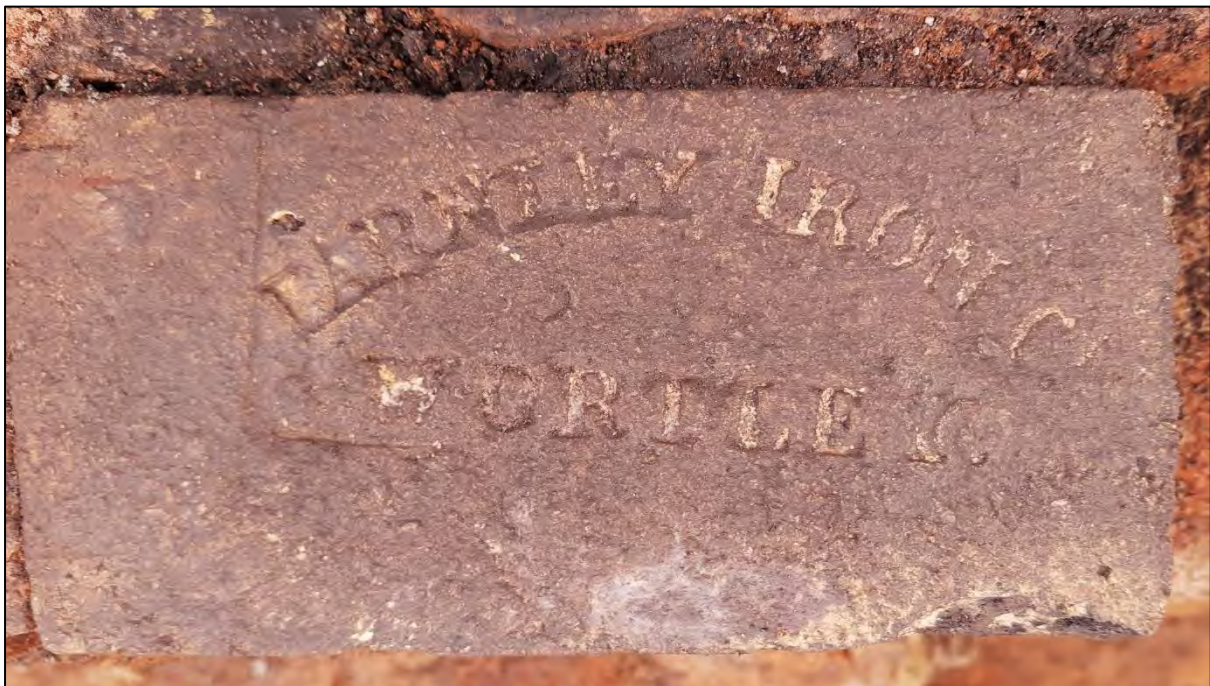
*Plate 179: Firebrick bearing the stamp Farnley Iron Co. Wortley' utilised in Boiler 111*

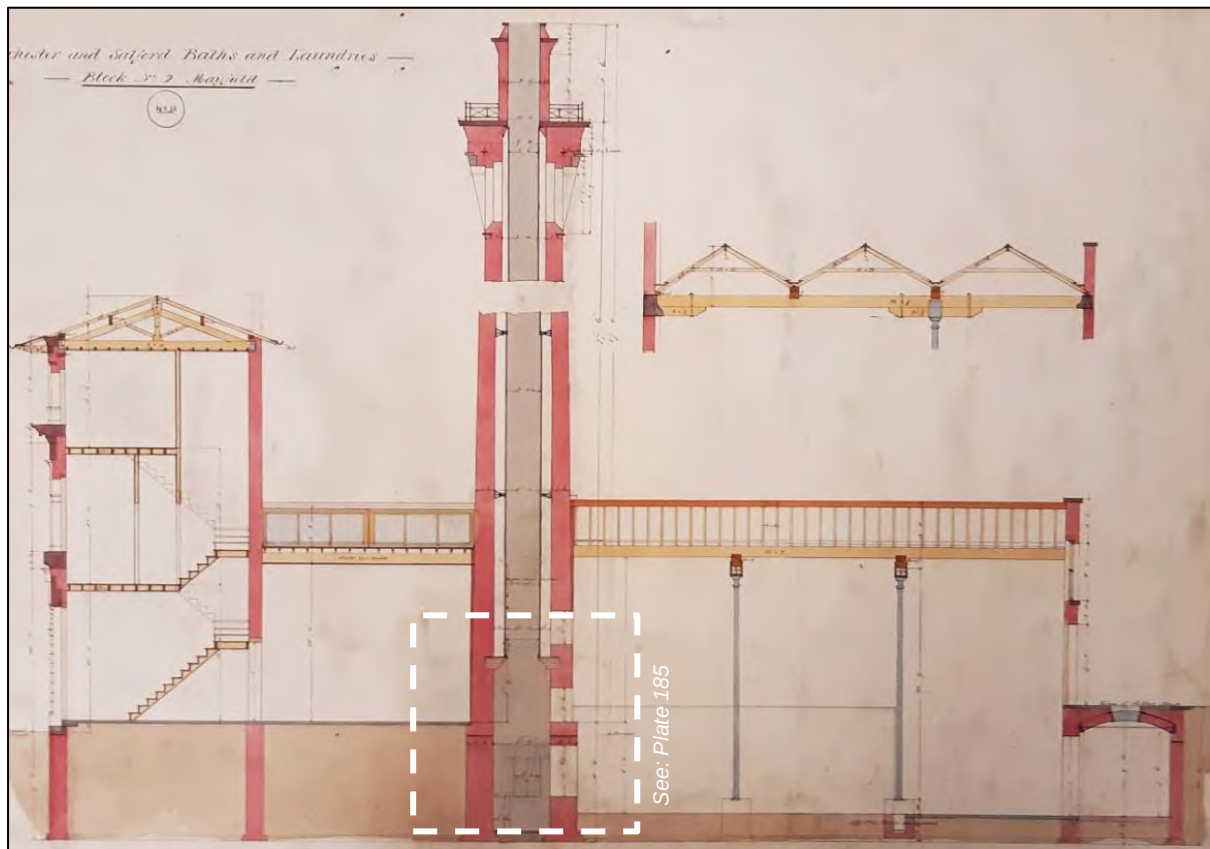
Plate 184: Cross-section through the northern part of Mayfield Baths with detail of chimney foundation

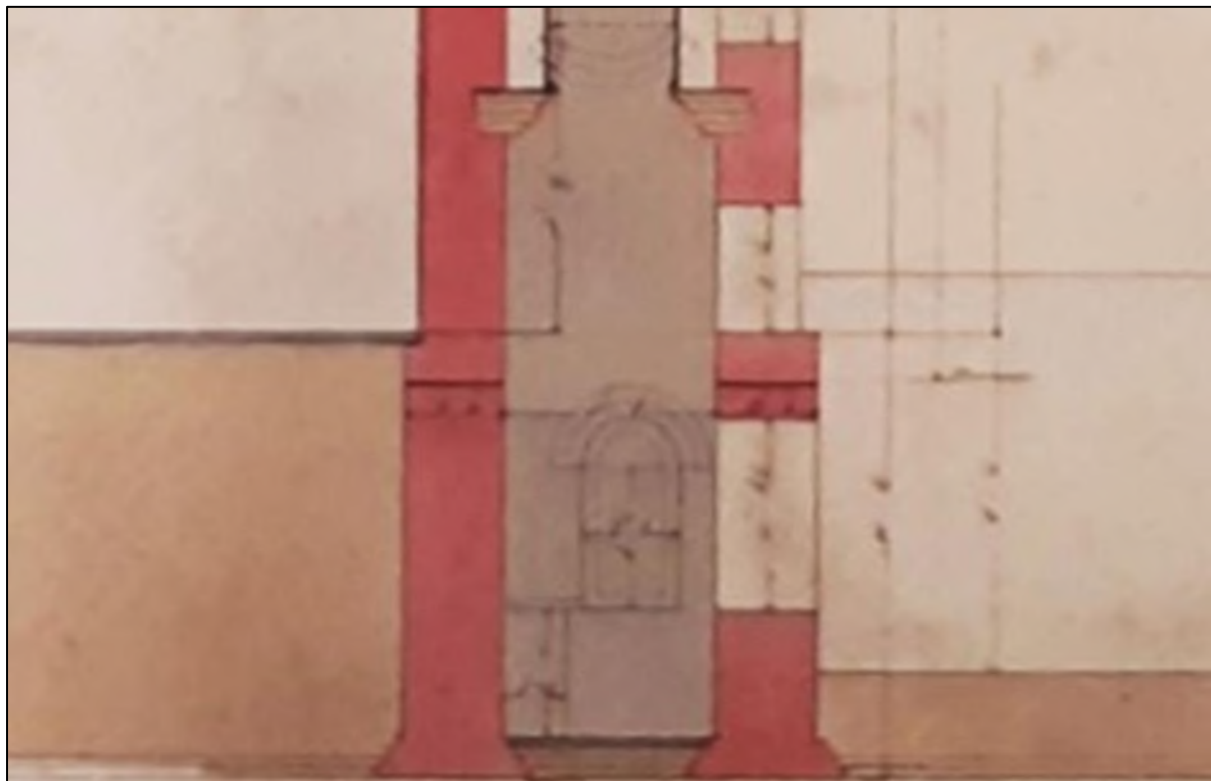
Plate 185: Detail of chimney foundation illustrating the position of the flues

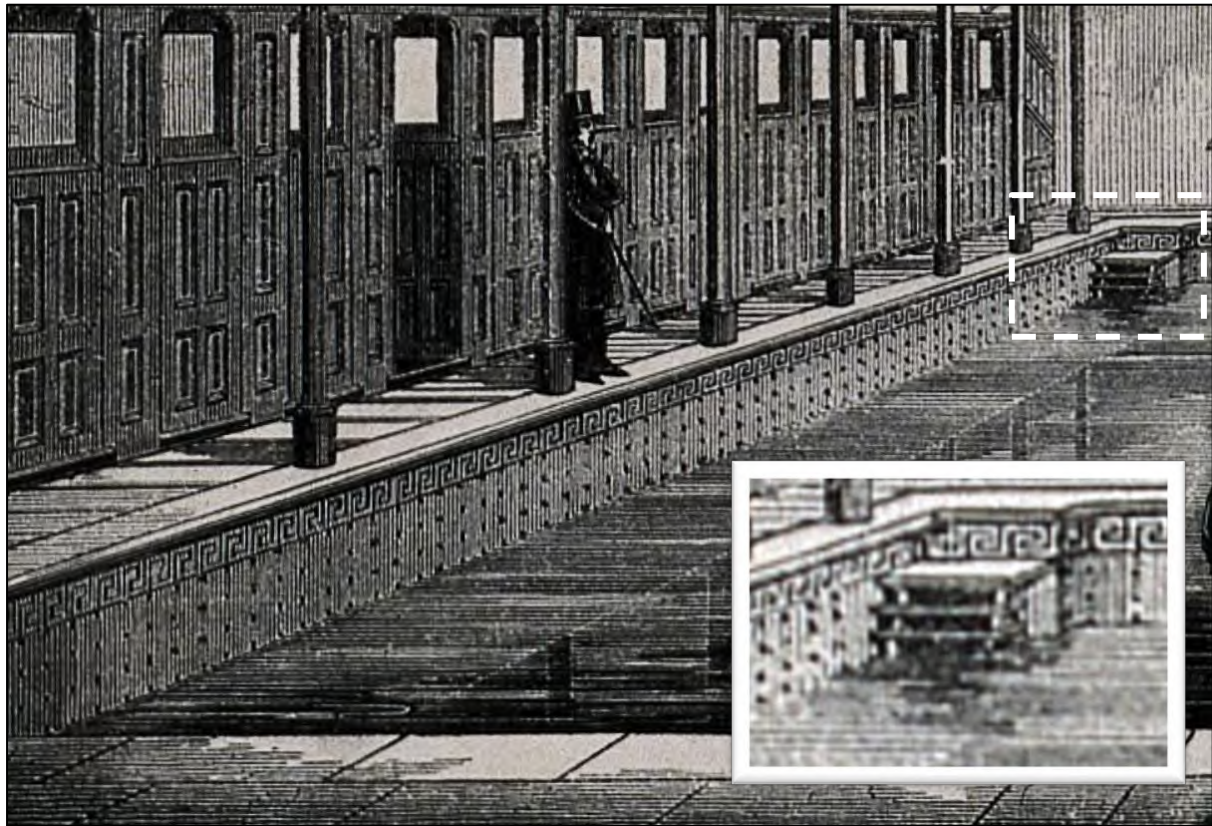
Plate 187: Extract from *The Builder* 1858 showing the original tiles and steps installed in the plunge pool of the first-class men's pool at Mayfield Baths (see inset for close-up)
