Job title  
**Apollo (Club Apollo)  
- Manchester**

Drawing title  
**Test sites and repairs**

| Scale<br><b>1:50.</b> | Drawing No.<br><b>1141 - 01- 04A</b> |

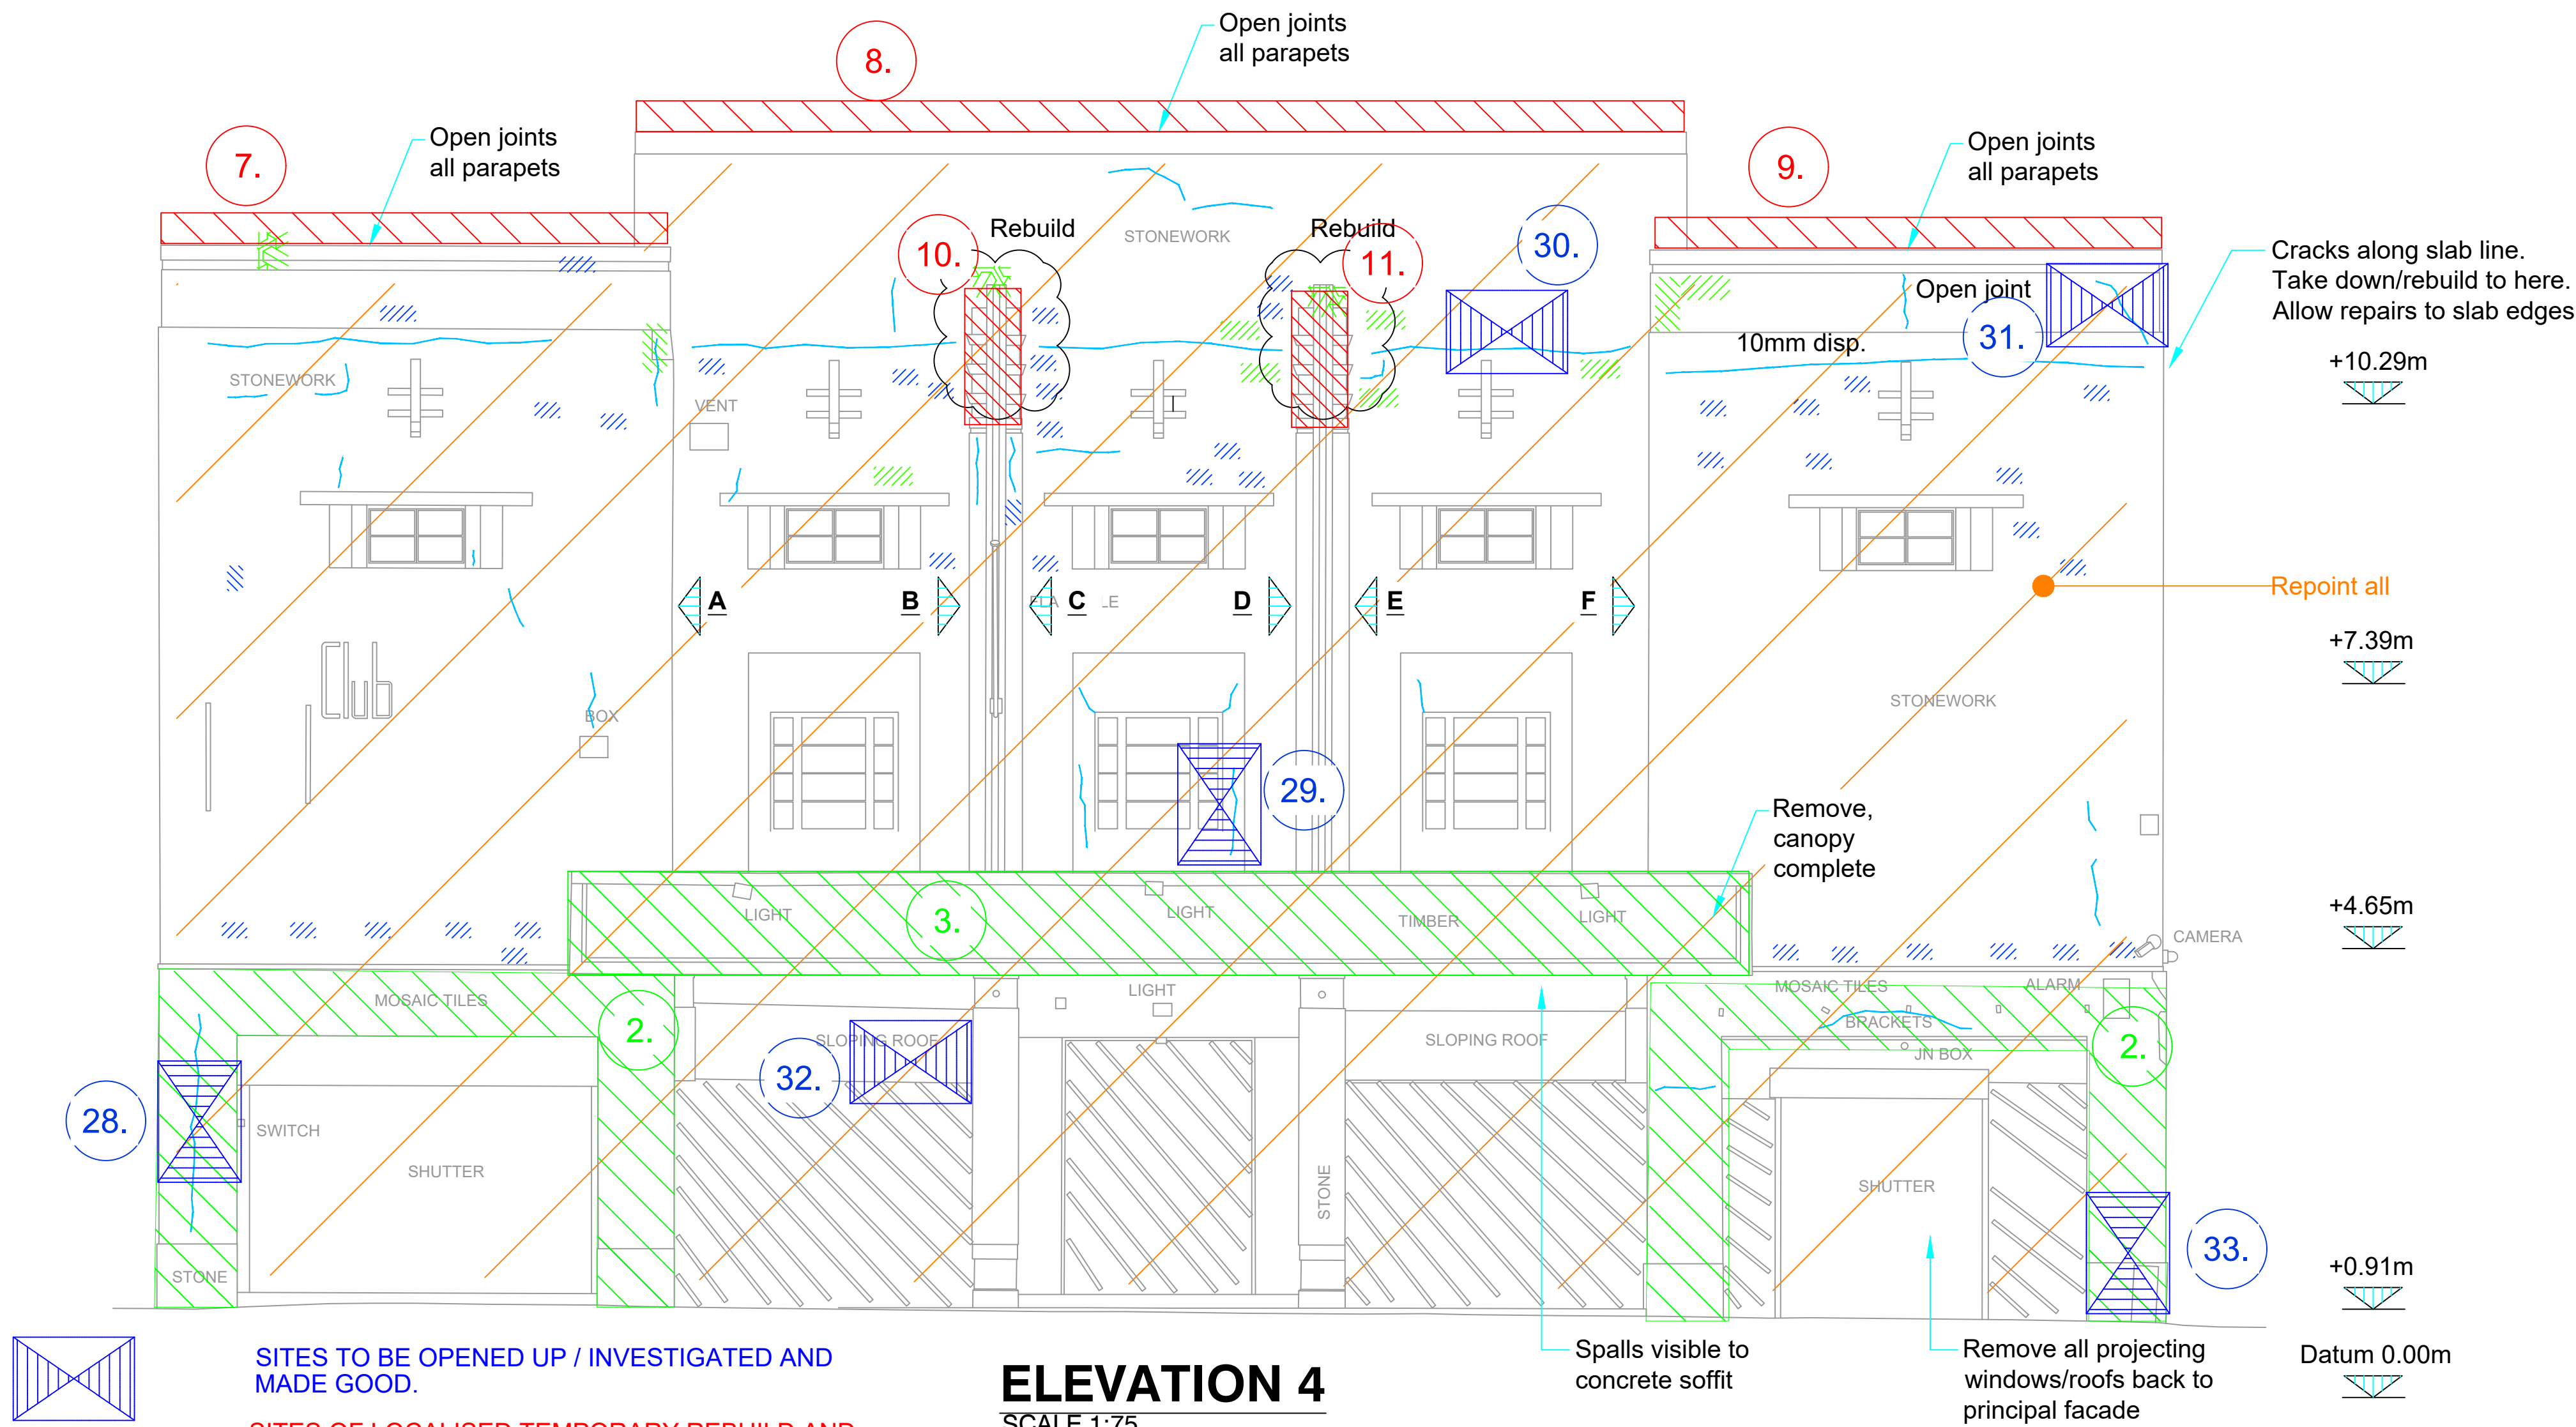
**SITES TO BE OPENED UP / INVESTIGATED AND MADE GOOD.**

**SITES OF LOCALISED TEMPORARY REBUILD AND STABILISATION.**

24 Lm OF FAIENCE COPING REMOVED PREPARED AND REBED.

BRICK + FAIENCE LOADBEARING TRADITIONAL MASONRY FEATURES - TAKE DOWN + REBUILD - QUANTITY AS SHOWN..

**SITES TO BE STRIPPED BACK TO ORIGINAL STRUCTURE.**

SITES TO BE STRIPPED BACK TO ORIGINAL STRUCTURE REMOVE MOSAIC AND STONE CLADDING BACK TO ORIGINAL STRUCTURE.

REMOVE ALL CLADDING TO CANOPY SIGNAGE BACK TO ORIGINAL STRUCTURAL STEELWORK.

SITE 28. ASSUME FAIENCE / BRICK FOR PRICING - CRACK INVESTIGATION 1.0 X 0.6

SITE 29. FAIENCE / BRICKWORK REVEALS AND DETAILS ASSUME 0.9 X 0.6

SITE 30. FAIENCE / BRICKWORK - INC. SLAB EDGE EXPOSURE 1.2 X 0.6

SITE 31. FAIENCE / BRICKWORK - INC. SLAB EDGE EXPOSURE 0.9 X 0.6

SITE 32. OPEN UP TILES ROOF AREAS TO FACILITATE ACCESS AND TO IDENTIFY DETAILS - RE-INSTATE ON COMPLETION.

SITE 33. ASSUME FAIENCE / BRICK FOR PRICING - CRACK INVESTIGATION 1.0 X 0.6
