# whitby wood

## CARMOOR ROAD

### REMIDATION STRATEGY

L074-WTW-11-XX.XX-T-G-000005

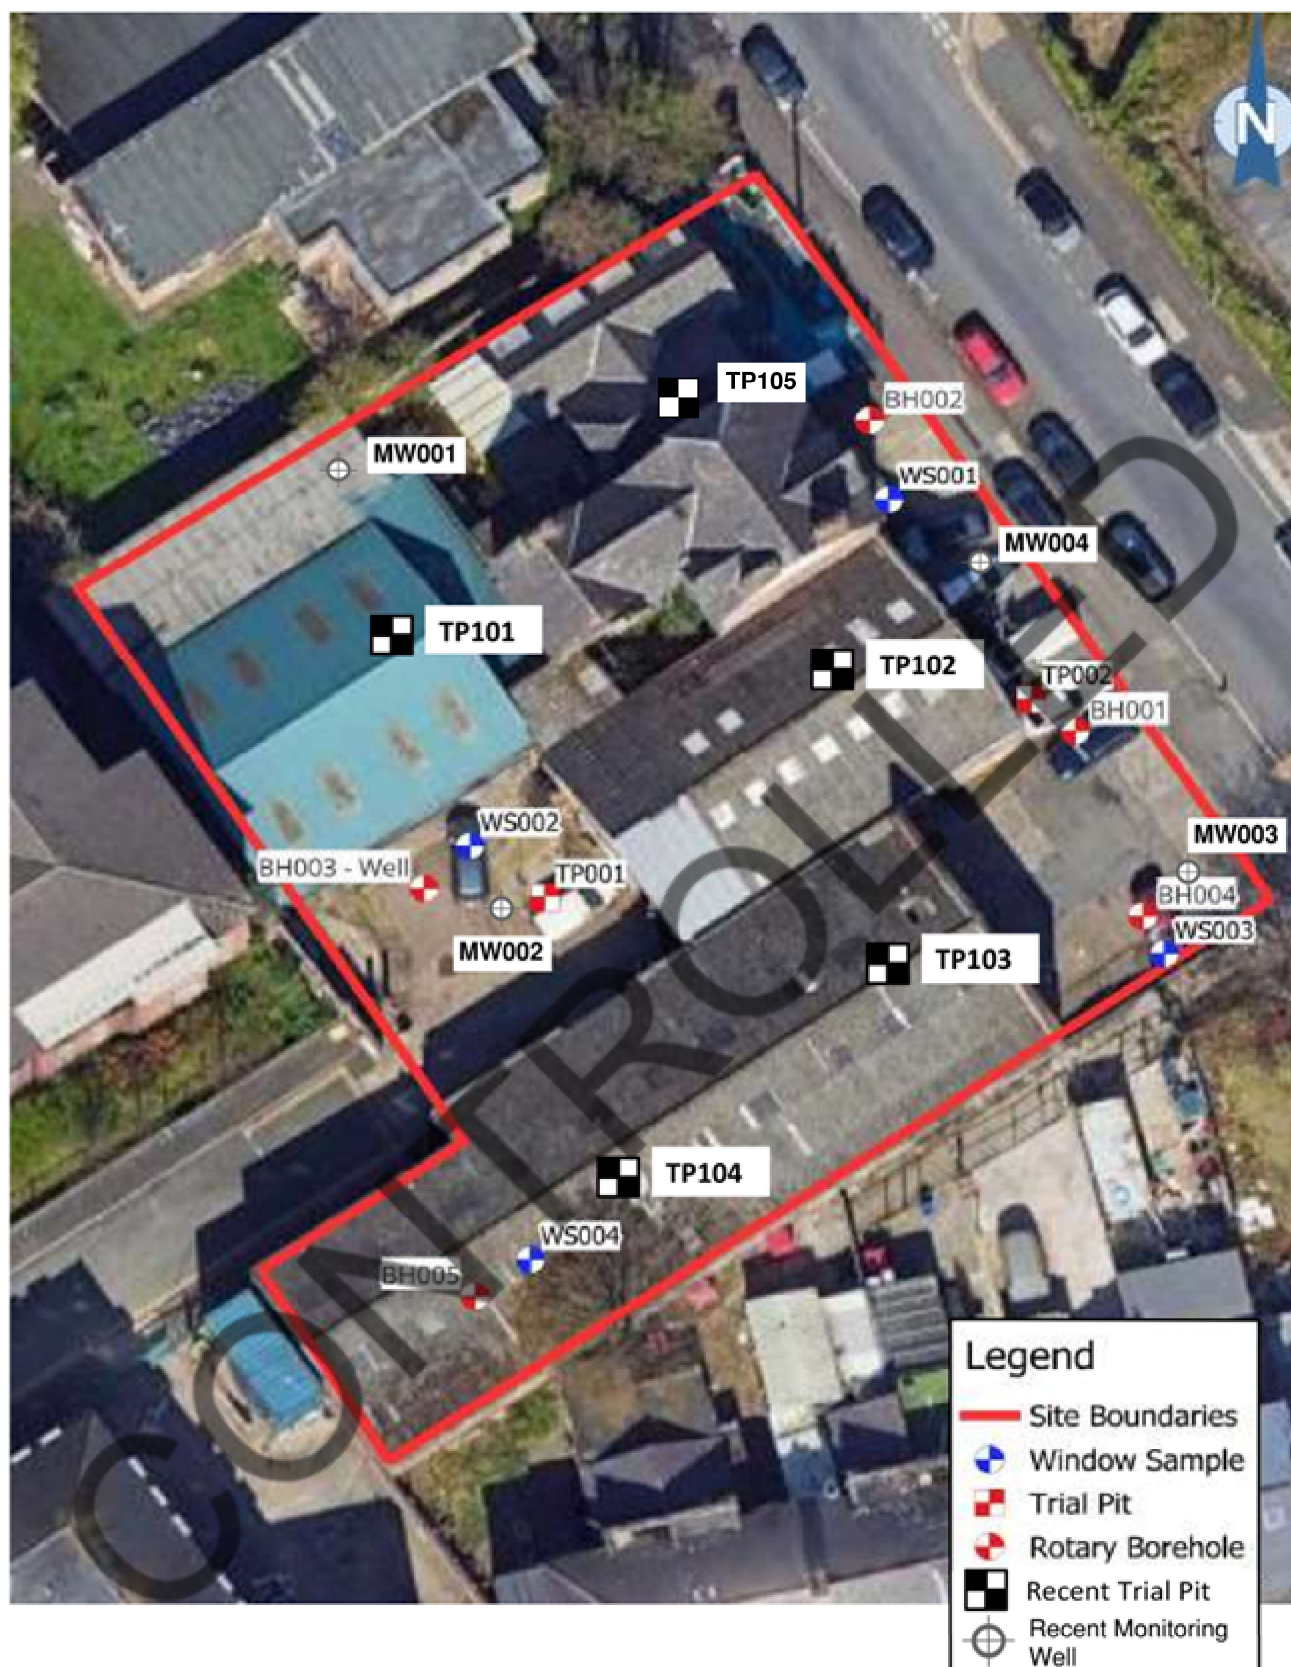
Figure 2: Ground Investigation Layout (Via Land Science Supplementary GI Report) with added approximate Monitoring Well Locations.

Table 1 and Table 2 present the tests carried out on soil samples and Table 3 those for groundwater samples. It should be noted that groundwater was only encountered in one location, hence only one sample was tested as part of this investigation.
