## Archaeological Excavation Report

Mayfield,  
Manchester

**Report No:**  
SA/2021/56

**Project:** Mayfield, Manchester: Archaeological Excavation

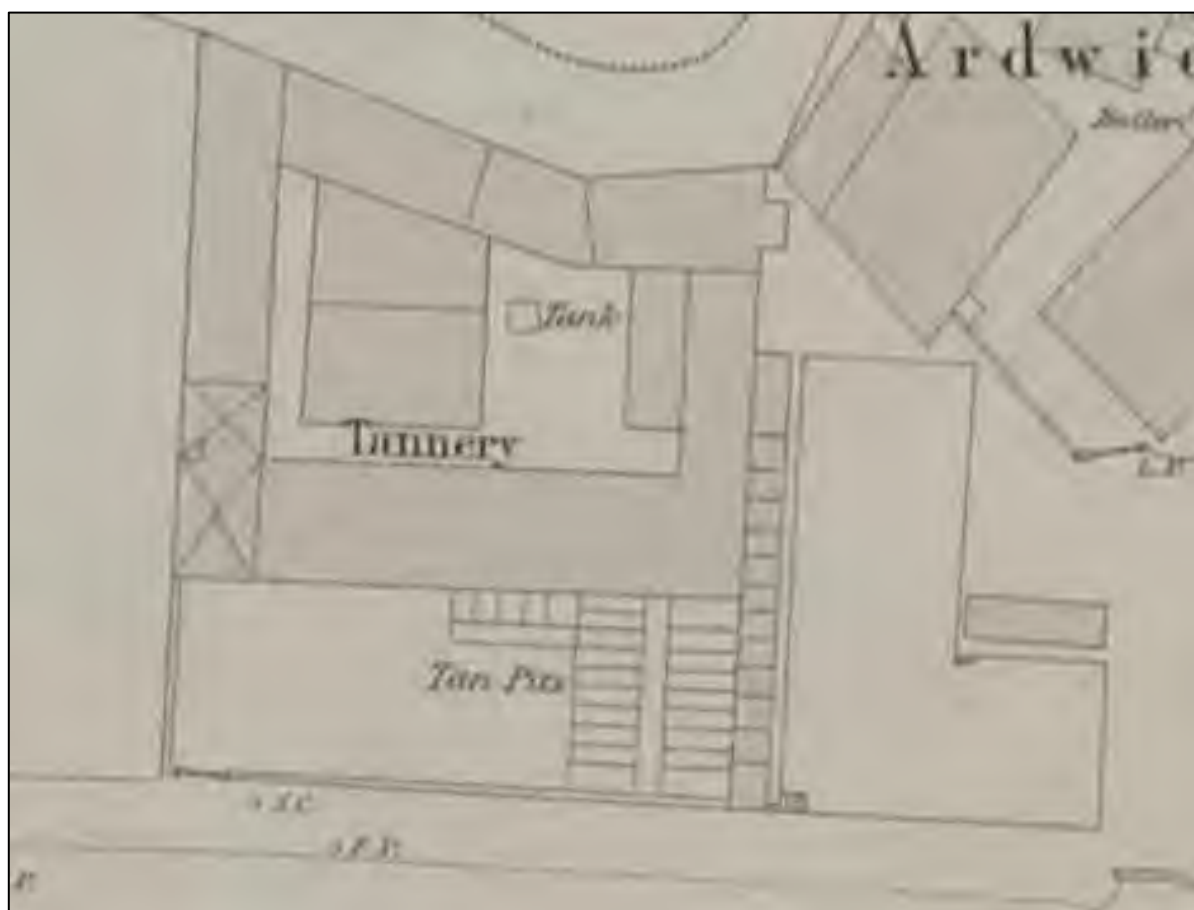
Plate 5: Extract from the 1851 Town Plan map showing the layout of the Ardwick Tannery.

buildings lining the riverside at Mayfield; it was preceded by both the adjacent Chapelfield Works, and the Mayfield dye works across the river. The historic record and cartographic sources indicated that the first tannery buildings were constructed sometime c. 1831-36. The tannery was not surveyed for Banck's map of 1831 but appears on Pigot's 1836 plan, and was expanded prior to the survey of the 1848 plan by Pigot and Slater's directory. On the OS 1851 Town Plan Map, it was labelled simply as 'Tannery' (Plate 5).

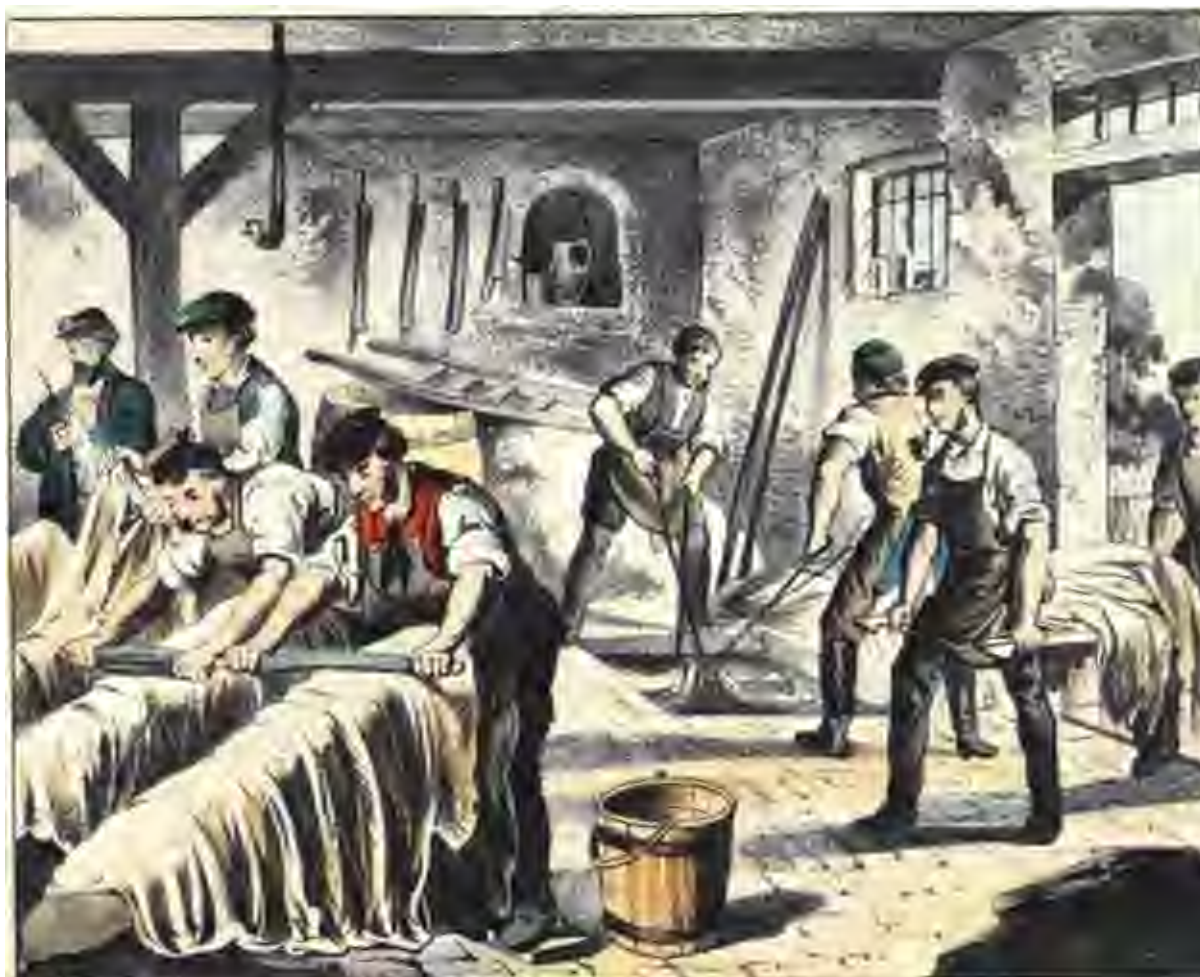
Plate 6: Image illustrating the process of scouring in a late 19<sup>th</sup> century tannery (Courtesy of the Hagen History Centre)

Scouring was one of the first steps in tanning and based upon the historically recorded structures and equipment at the site was one of the processes undertaken at the Ardwick Tannery. This practise most likely took place in the 'tawing and scouring house' listed in the 1892 auction advertisement and was generally undertaken in conjunction with the initial cleaning of skins. Skins would be 'scoured' or scraped to remove and remaining excess fat or tissue which had not been removed during butchery (Plate 6). This process could be undertaken both by hand and machine, as indicated by the presence of 'Jackson's self-contained scouring machines' and 'scouring stone slabs' at the Ardwick site.

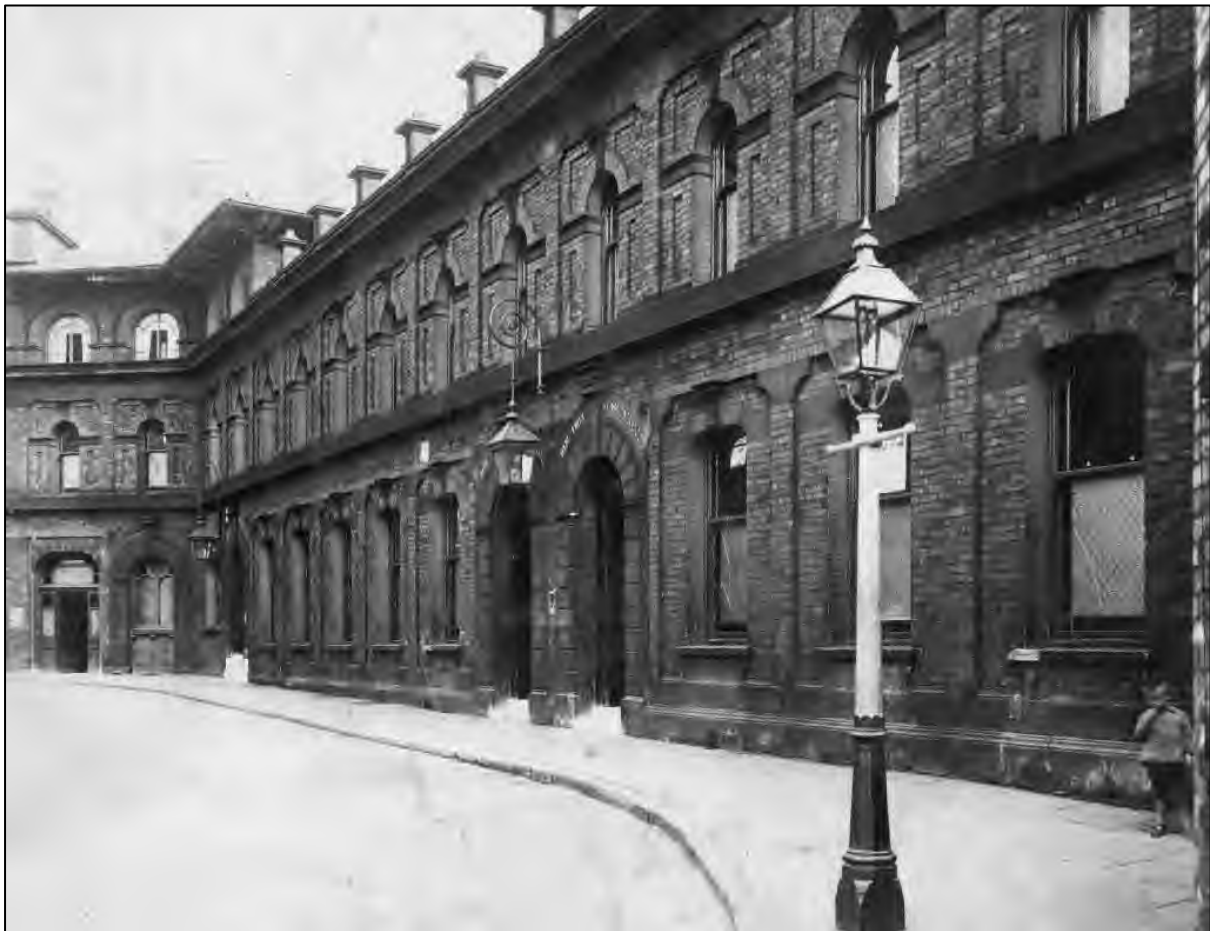
*Plate 7: 1912 photograph of the frontage of the bathhouse along Boardman Street (later Baring Street) with urchin.*

As described in the above articles, the Mayfield Bathhouse was constructed in red brick and stood at three stories in height. Multiple photographs of the façade exist from the early 20<sup>th</sup> century (Plate 7) and it was likely that it underwent minimal changes throughout its period of use. An article in *The Builder*, 18<sup>th</sup> August 1858, described the style of architecture as 'Florentine' while an earlier article of the same publication, 18<sup>th</sup> April 1857, even suggested the design of the chimney had been influenced by the Torre del Mangia, in Sienna (Plate 9). While it might seem ridiculous to compare a mid-19<sup>th</sup> Century smokestack at a swimming pool in Manchester to a medieval Italian belltower, there genuinely were some similarities and influences. Thomas Worthington was strongly associated with Neo-gothic architecture in Britain and used Italian or Venetian-style gothic in other buildings such as the Memorial Hall (1866) which drew influences from the Palazzo Ducal and the Palazzo Santa Sofia. At the

Mayfield baths this style was most visible in the windows and the overhanging cornice (Plate 7).

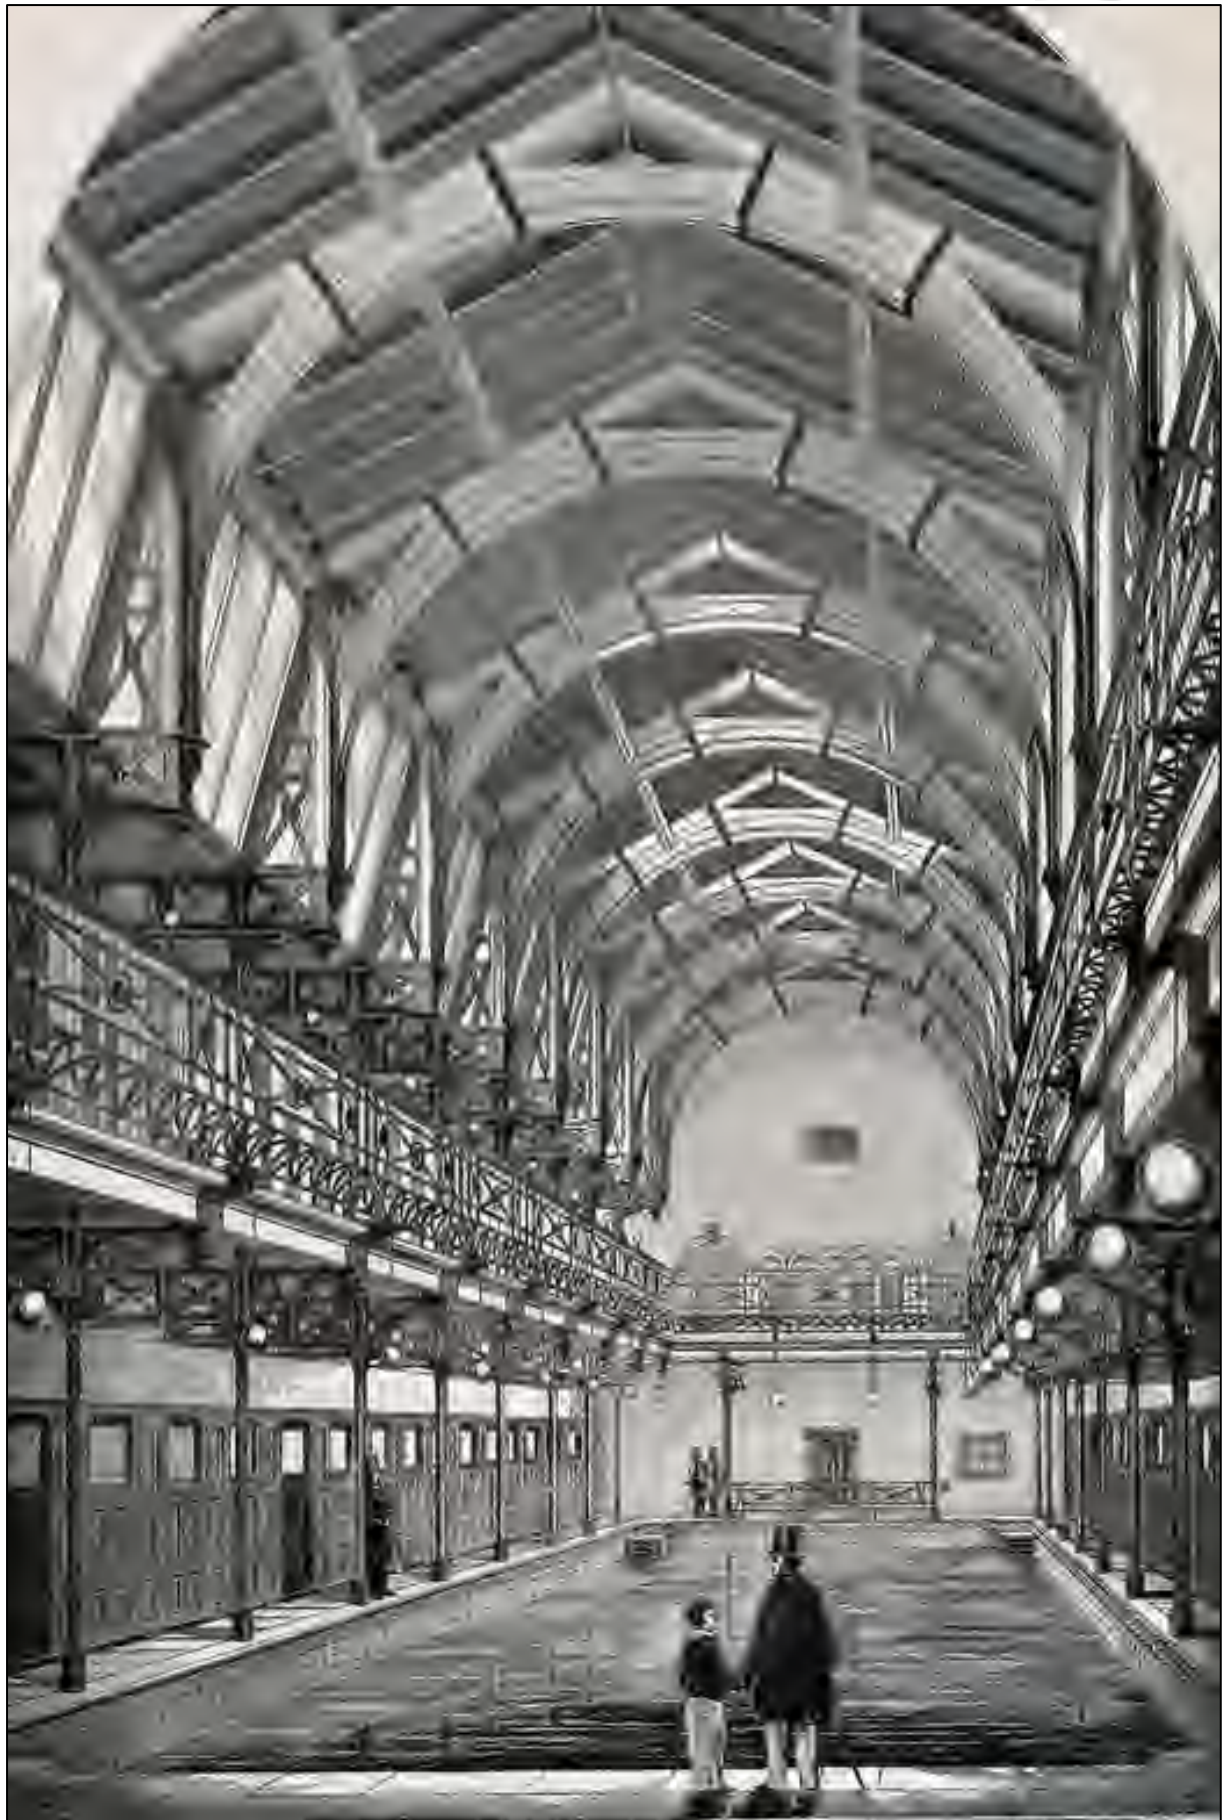
Plate 8: 'Mayfield Baths and Laundries' as print in *The Builder*, 14<sup>th</sup> August 1858.

A comparison between the 1858 engraving (Plate 8) and the various photographs of the early 20<sup>th</sup> century (Plates 11-13) showed that the swimming pools were of a similar design but with some notable differences. The 1858 print and historical records suggests that the first phase of the pools at Mayfield were covered with flagstones and the walls were lined with tile. Noticeably, the tiles were also changed, the pre-1877 tiles appeared to be decorated with geometric designs which were supposedly removed when the pools were relined and retiled. The 20<sup>th</sup> century photography also showed that some of the ironwork had changed, including the addition of 'spit troughs' and a railing around the edge of the pools. Probably the most significant visual difference was the steps. In the 1858 print it appeared that the stairs were probably constructed of wood while the photographs showed that the stairs in the rebuilt pool were constructed of sandstone and tiles. Likely the most important development of the pools had been the relining of the pools in concrete, though this was not visible on any photograph.

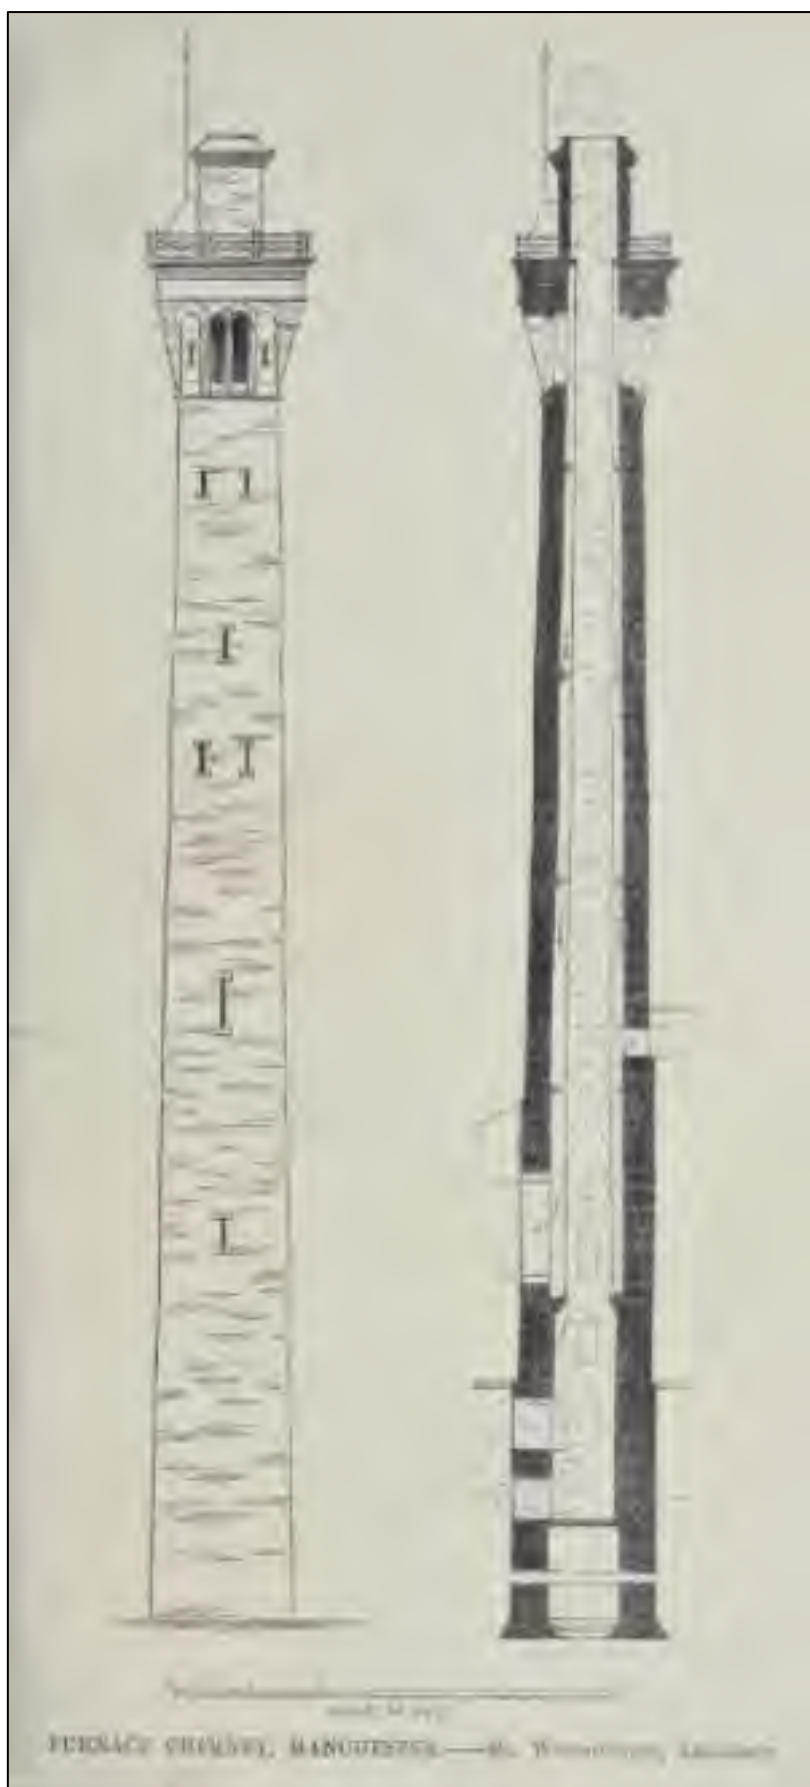
Plate 9: The Mayfield Baths 'Florentine' Chimney, influenced by the Torre del Mangia, Sienna. The Builder, 1858.

The second article in *The Builder*, 18th August 1858, described the chimney in some detail. Notably, the chimney served two purposes; it was used to remove the smoke produced by the boilers – used to heat the baths and power machinery – as well as extracting ‘vapour’ – an important process in such a wet environment which would have helped to reduce the spread of mould. It stated:

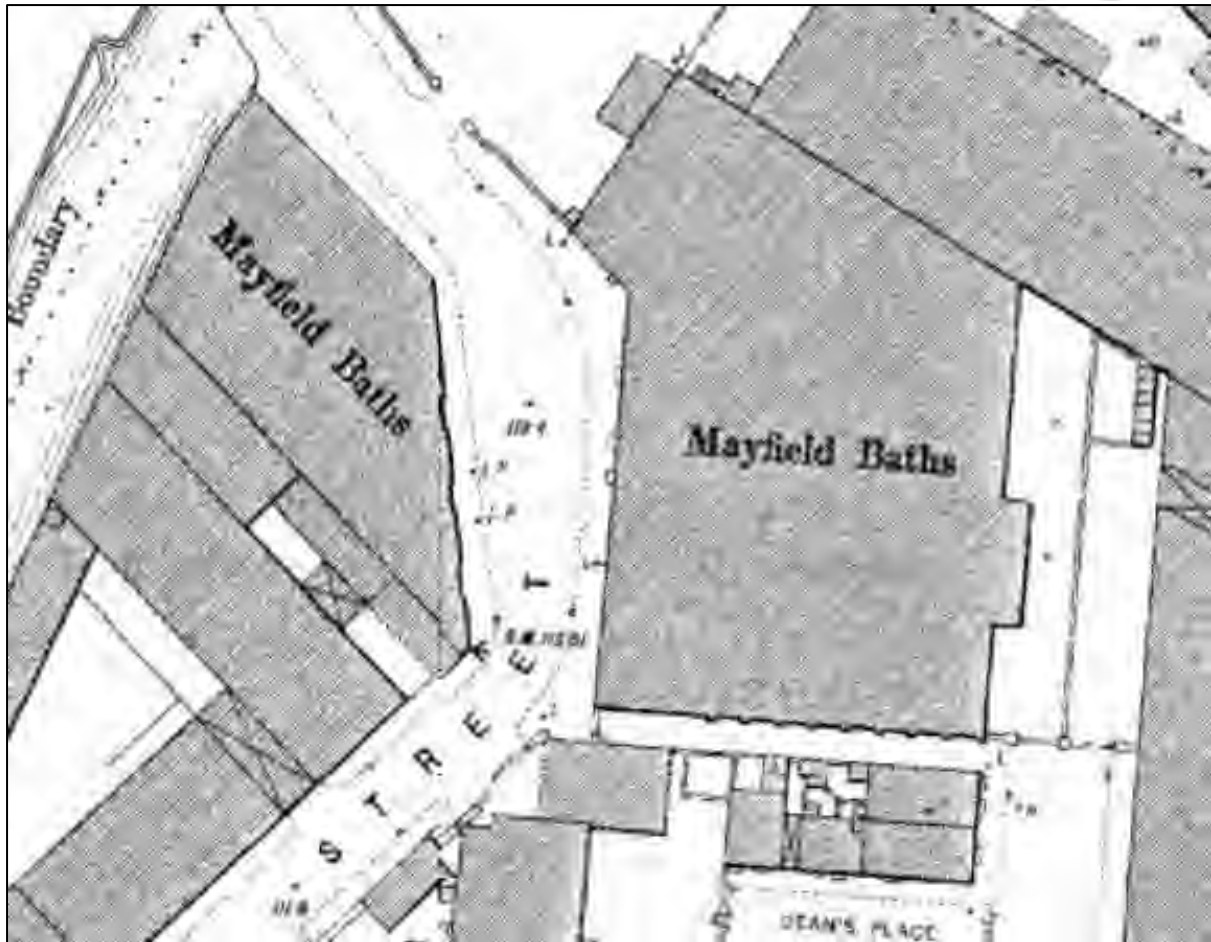
Plate 10: Extract from the 1891 OS Map showing the Mayfield Baths. Note the building to the west which contained the larger 'subscription'-only pool, later used as the female-only pool.

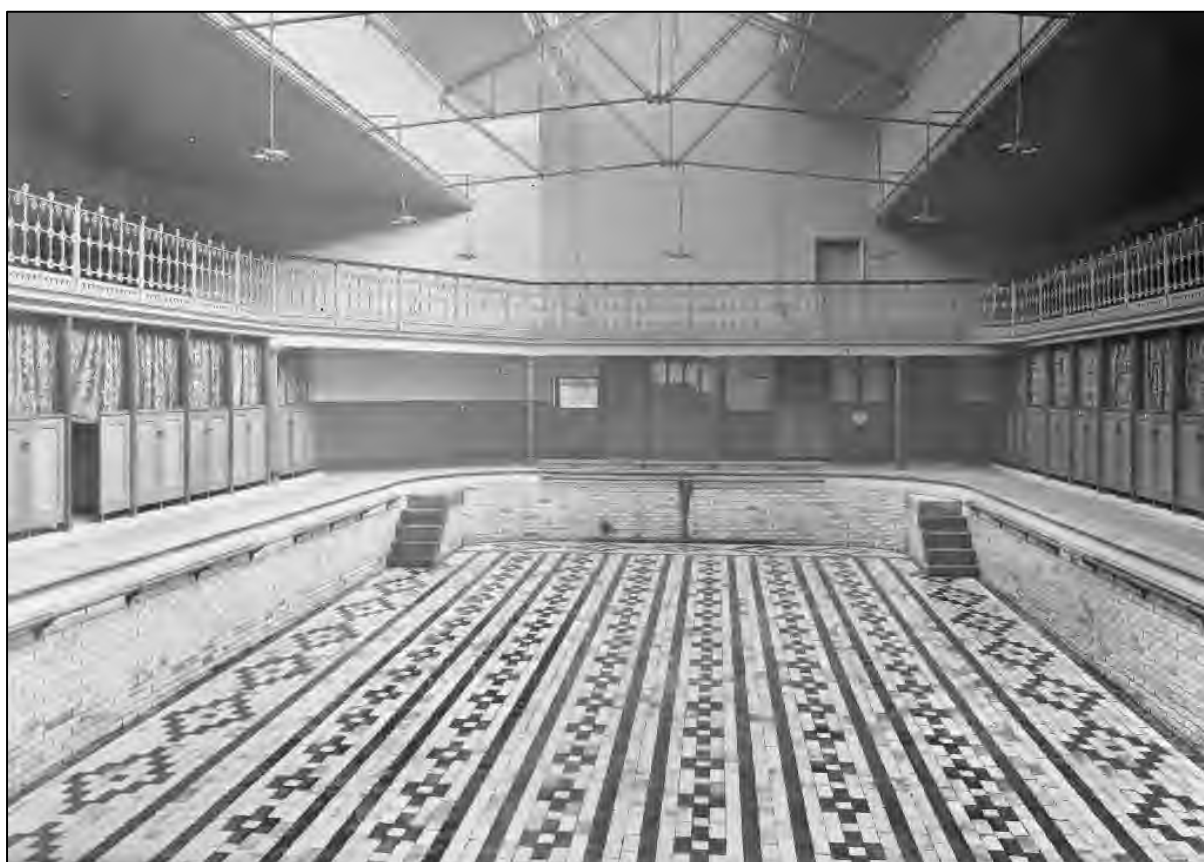
*Plate 11: The female swimming pool at Mayfield 1902. This pool was likely located in the western of the bathhouse buildings, on the western side of Baring Street.*

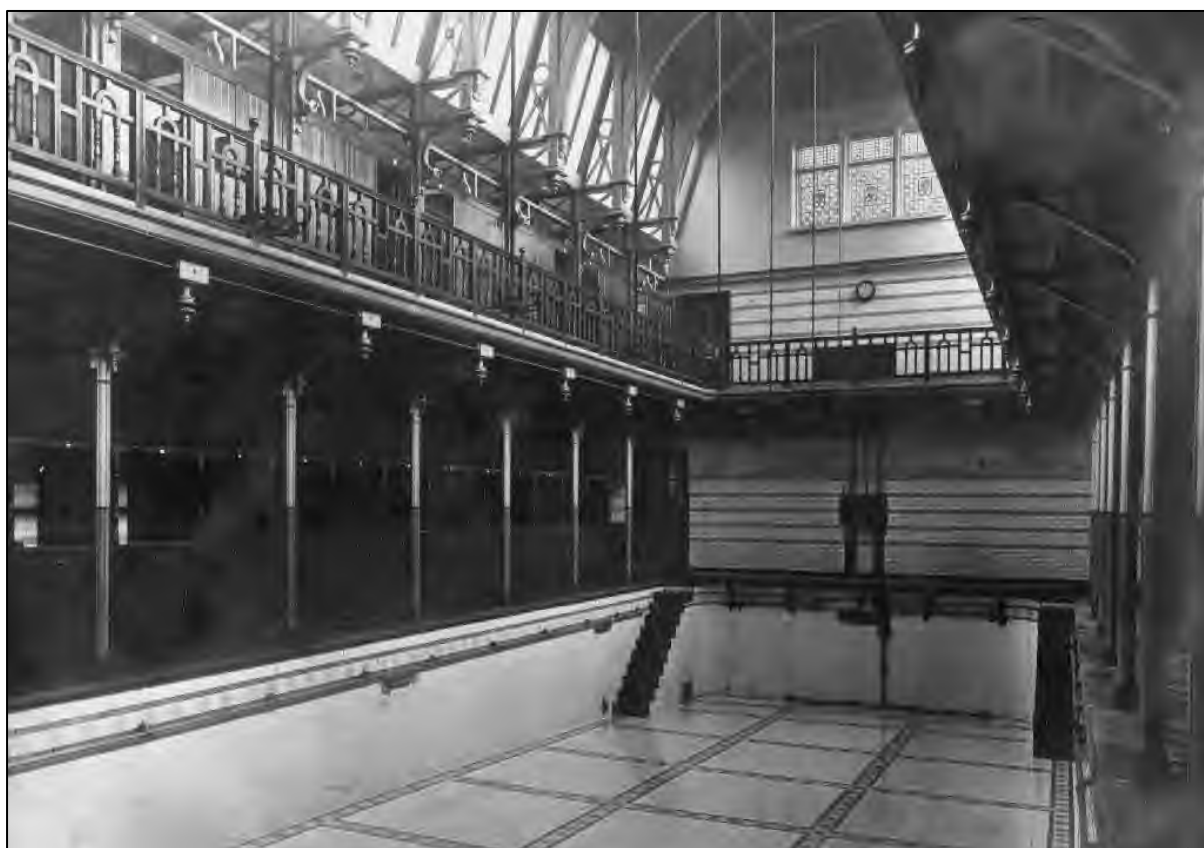
*Plate 12: Men's first-class pool at Mayfield Baths, 1920.*

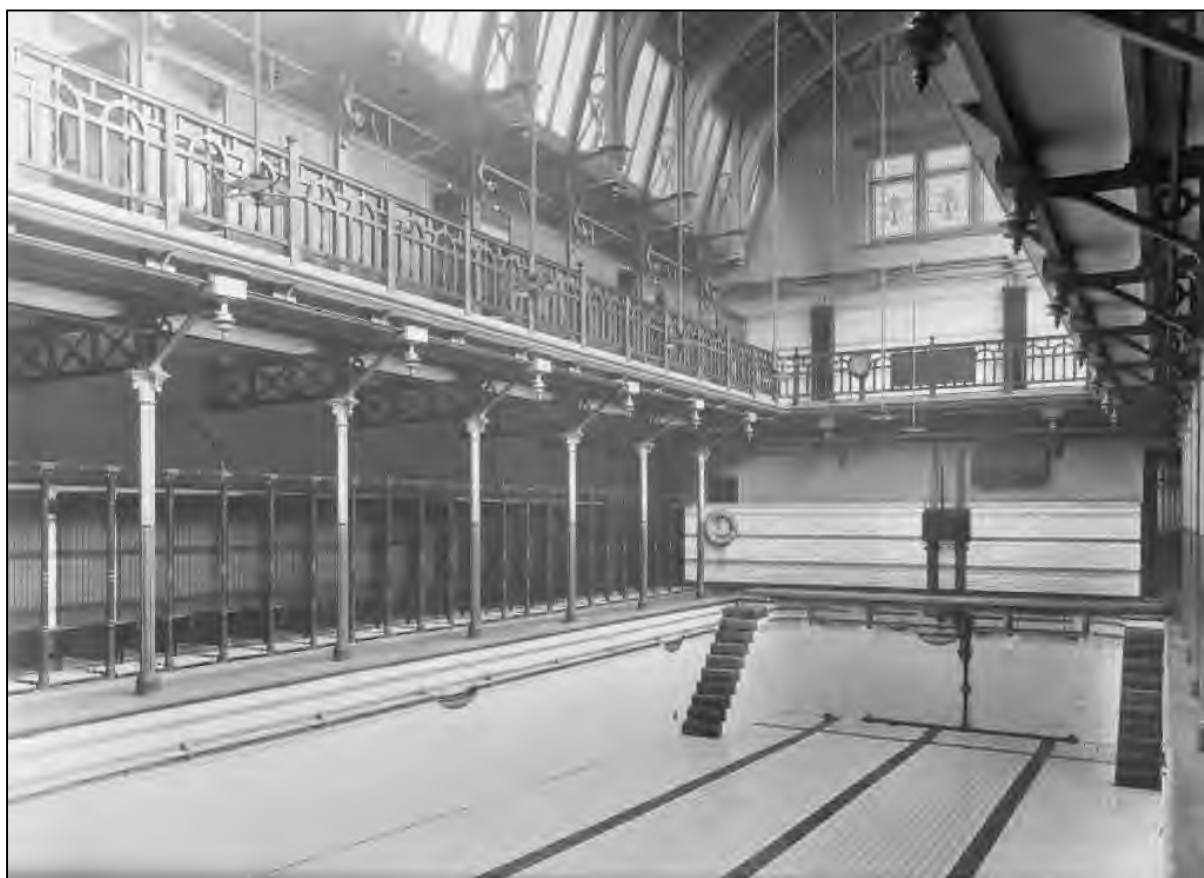
*Plate 13: Men's second-class pool at Mayfield Baths, 1902.*

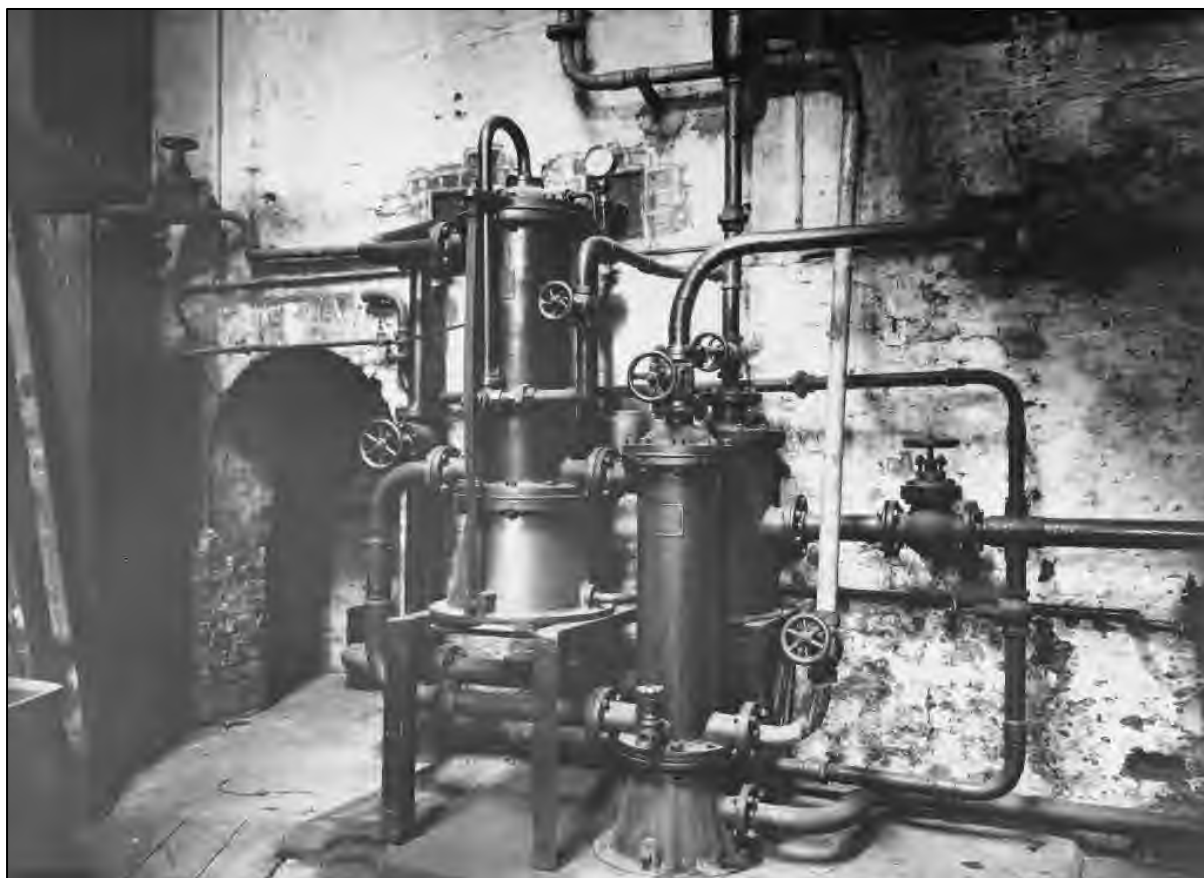
*Plate 14: The Royle Calorifier at Mayfield Baths, 1902.*

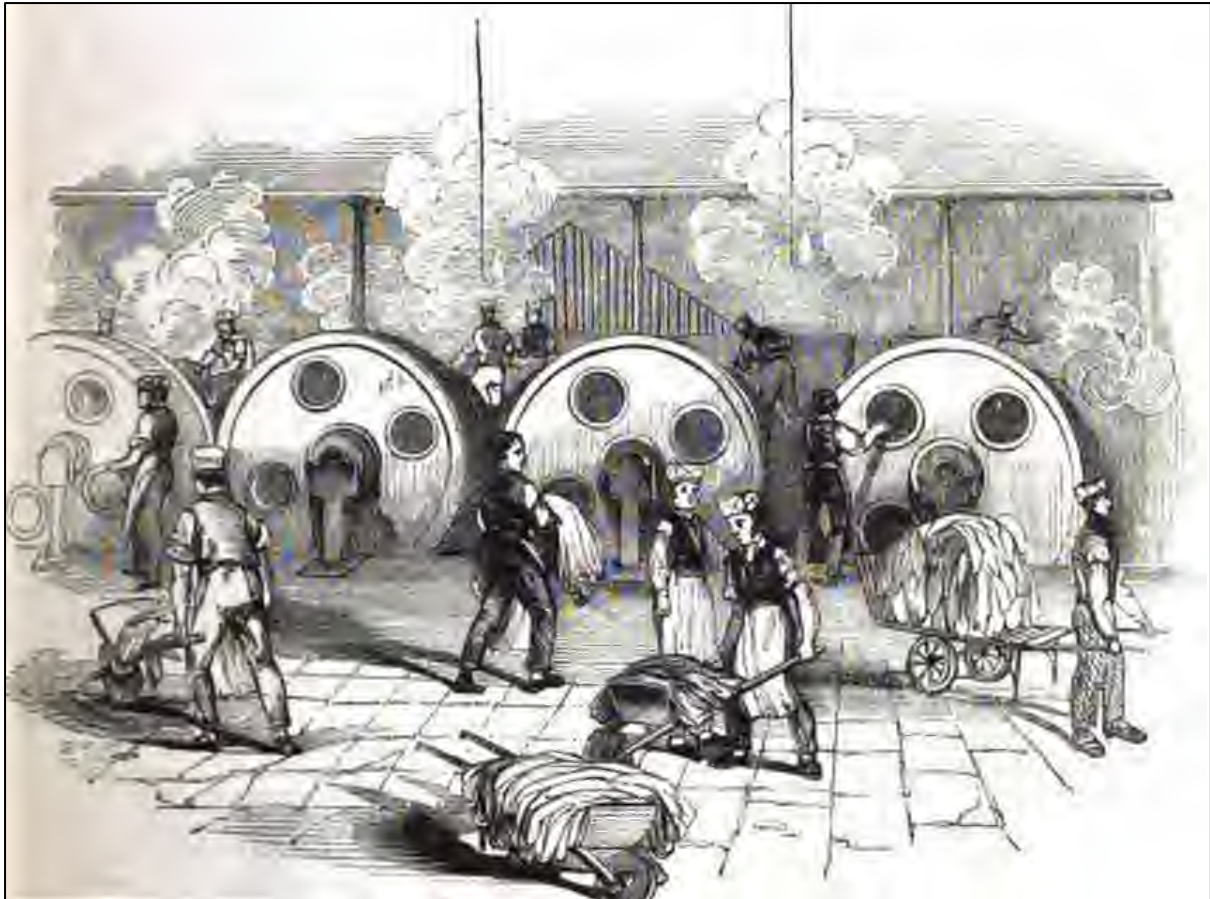
*Plate 15: The dash wheels of the Dukinfield Works, Thomas Hoyle & Sons*

By 1828, the dash wheels, which had been used to wash cloth, were replaced with washing machines invented by David Bentley, which washed lengthy pieces of cloth after the bleaching process. The cotton cloth was brought for bleaching in a grey state and several pieces of cloth were sewn together in preparation for bleaching, each 'piece' of cloth often being around 28 yards long and 40 inches wide (Penny Magazine 1843, 290). After the cloth had been bleached, the pieces were again sewn together with more pieces, creating a single piece of cloth reaching approximately 14,000 yards long (*ibid*). The lengthy cloth would then be placed in a washing machine or 'wash engine', which wound the cloth in a spiral, with the water in the machines being renewed throughout the process. Washing machines were used in various

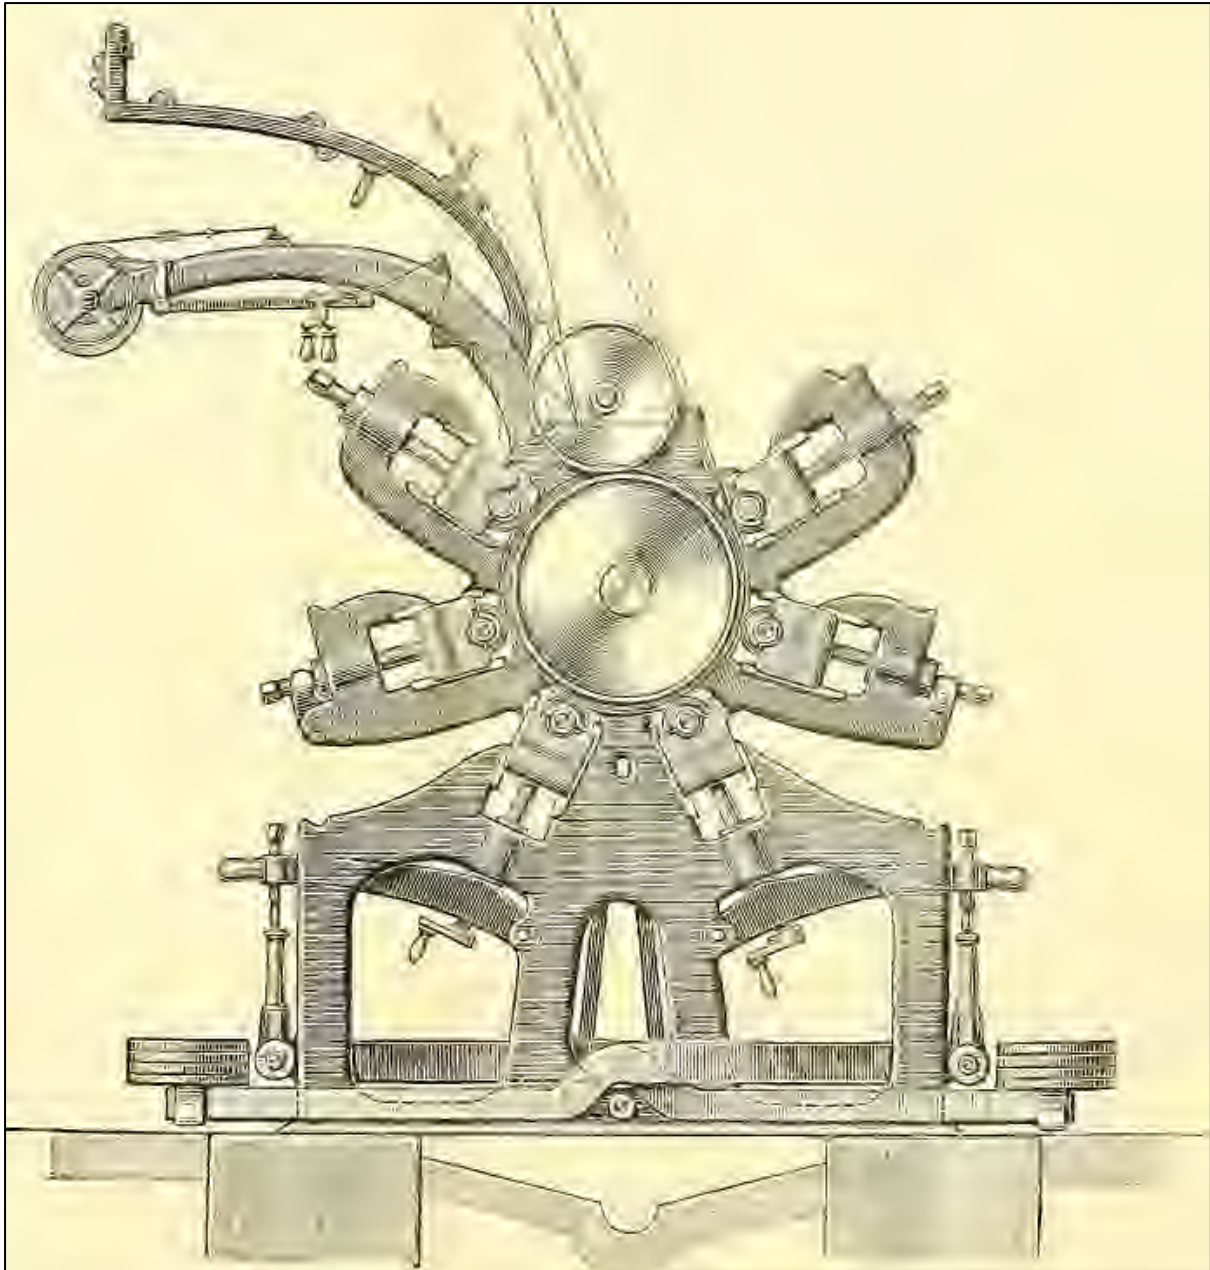
*Plate 17: A six colour printing machine depicted in 'The Printing of Cotton Fabrics' (Sansone 1887) similar to those mentioned in the 1897 auction*

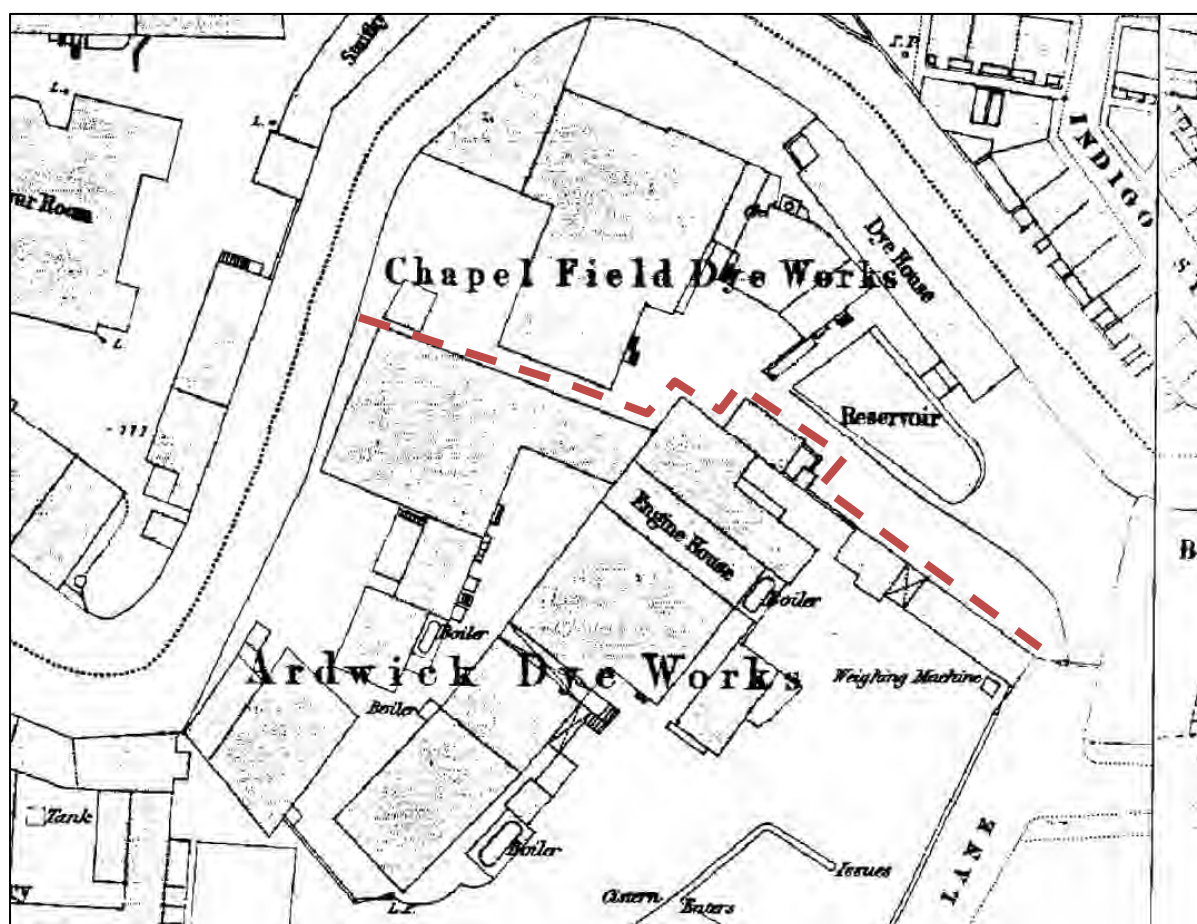
Plate 23: 1851 OS indicating the supposed division between the Chapel Field Dye Works and Ardwick Dye Works

The 1851 OS map provides an indication of the layout of both dyeworks, around the time that Messrs. W Andrew and Co. were in operation (Plate 23). The Ardwick Dyeworks featured an engine, boilers, cistern, weighing machine and a reservoir.

The 1851 OS map (Plate 23) confirms that the Chapelfield Works had been returned to a dyeworks, with the dye house shown on the banks of the river.

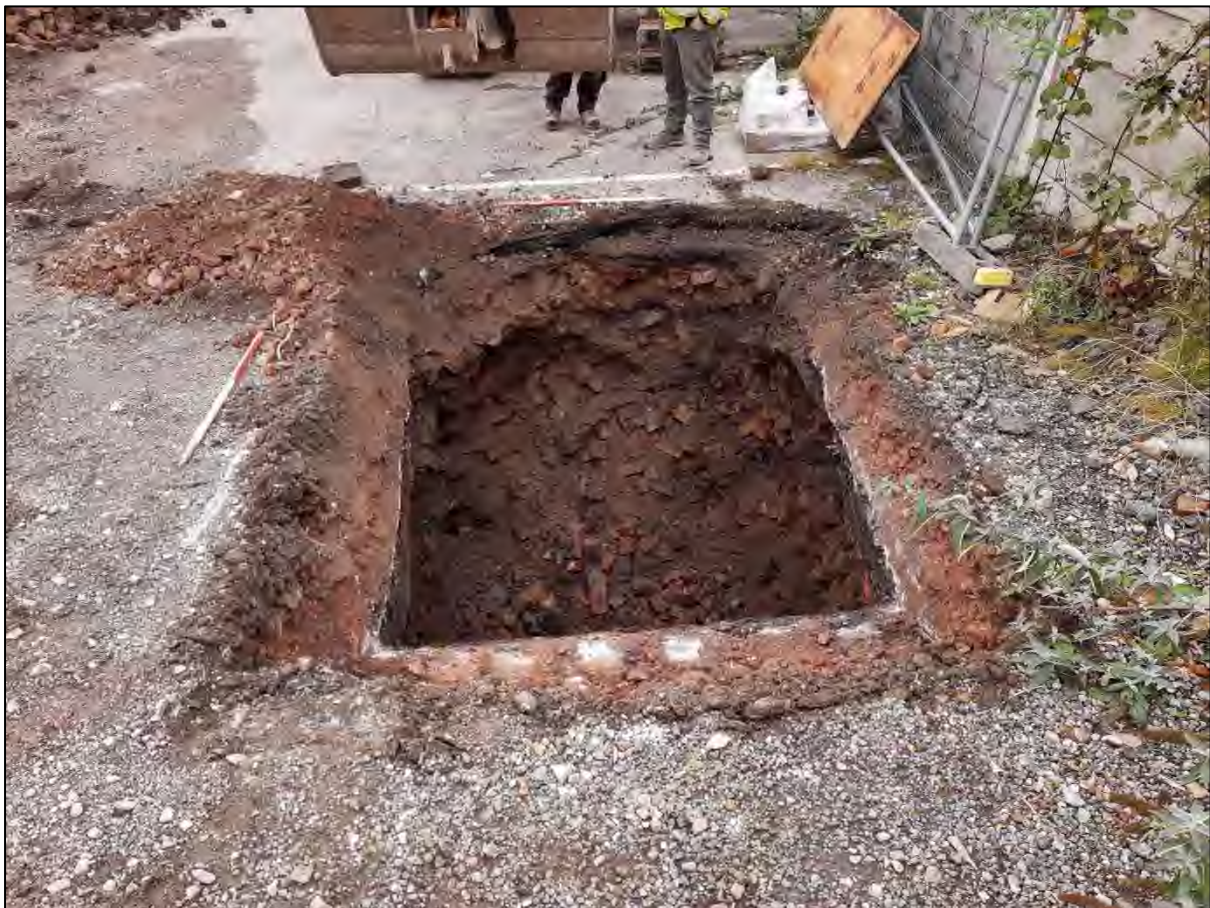
*Plate 24: A post-excavation shot of Trench 1, illustrating the level of remediation that was uncovered. Looking southeast.*

Trench 1 was located at the northwest of the site. The trench was excavated to an extent of 2 x 2m with a maximum excavated depth of approximately 3m. Immediately below the overburden layer, which consisted of 0.4m of tarmac, stone, and concrete, was a loose layer,

**0100**, which was made up of mortar and brick rubble consistent with demolition material (Plate 24). A single small brick feature was located at the base of the trench, **0101**, which appeared to be a vertically laid drain. Due to the depth, location, and fill of the trench, it was not investigated further.

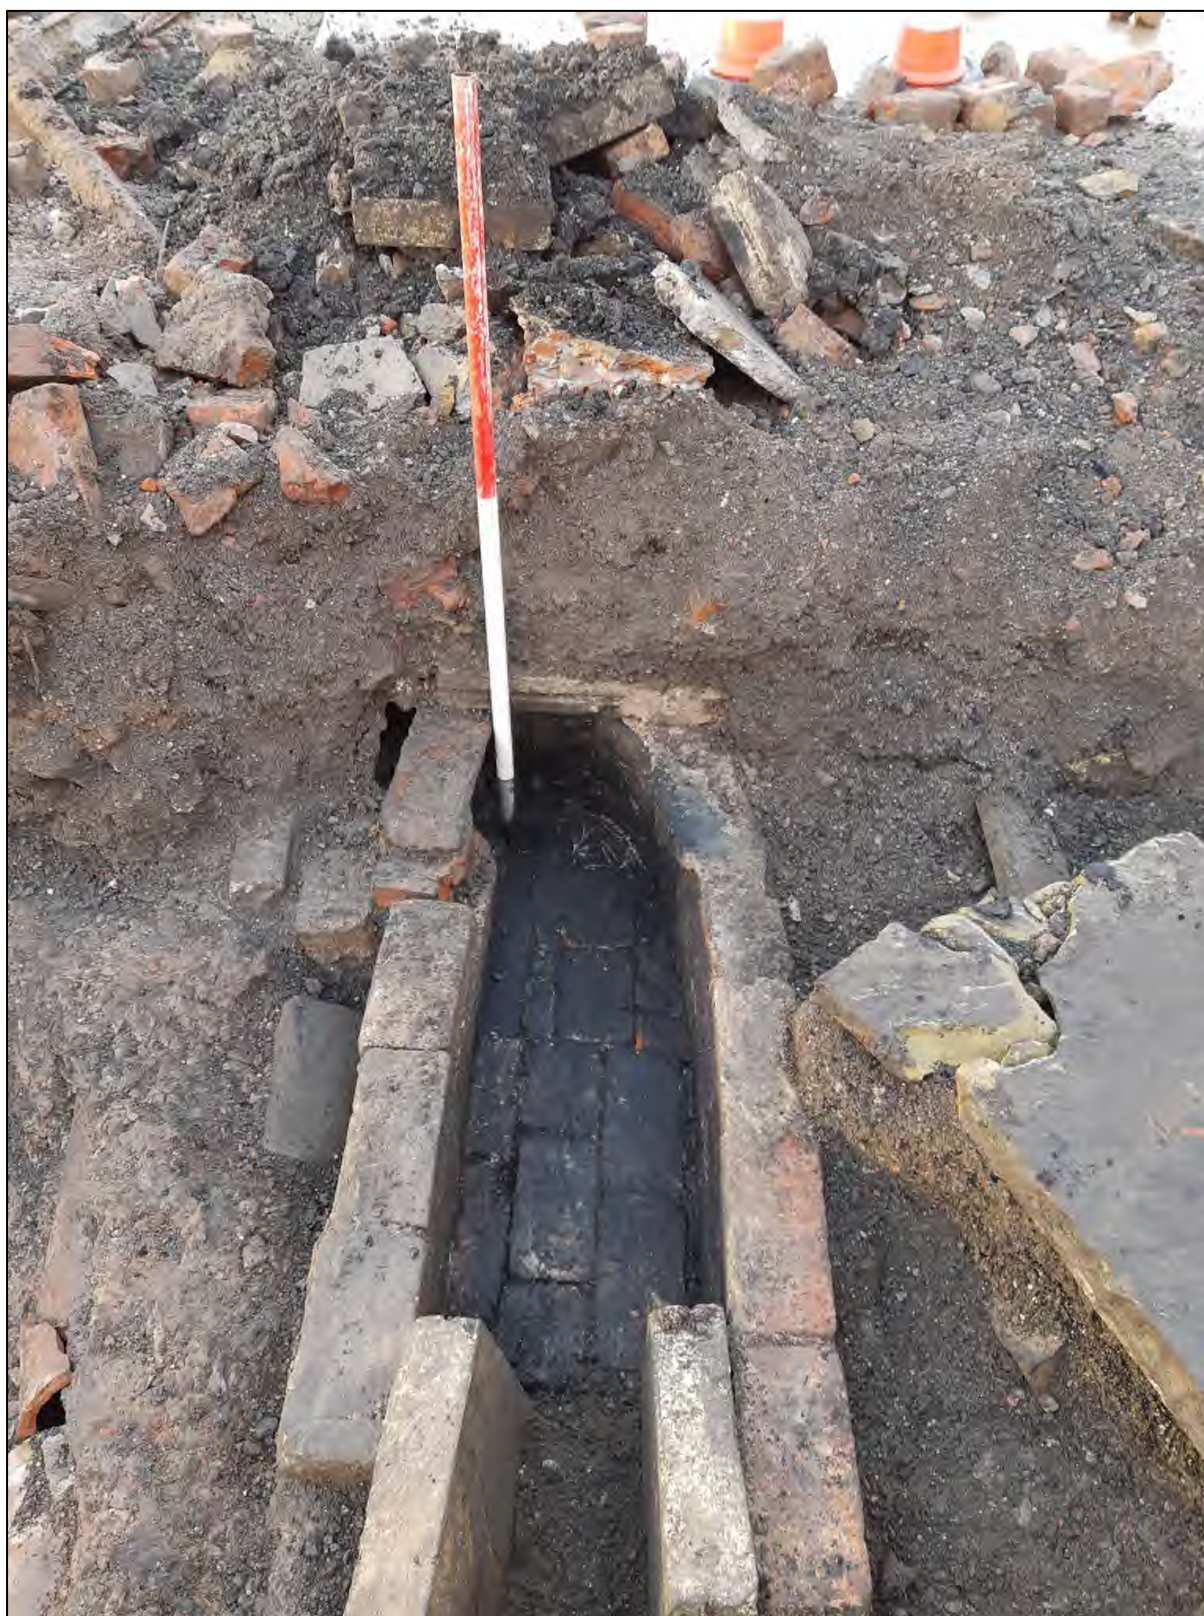
*Plate 26: Structure 0202. Note the brick base to the flue and the sharp eastwards curve into the southern limit of the excavation.*

The archaeology lay beneath a layer of overburden, a concrete surface up to 0.3m thick, and a general demolition material, **0201**, up to 0.7m thick, which comprised of brick mortar and frequent brick rubble consistent with demolition material. To the western end of the trench two linear brick structures were found, **0201** and **0202**. Structure **0201** was constructed of hand-made brick and bonded with a dark-grey lime mortar. It was capped with stone flags measuring 0.5 x 0.5m x 0.1m thick. Structure **0202** had a width of 0.55m and an internal depth of 0.35m. It continued beyond the limit of excavation. It was made solely of firebrick, including the capping which consisted of refractory tiles, stamped 'Ingraham Wortley' and measured 0.32 x 0.4 x 0.07m. Both were aligned northwest-southeast, with the flue positioned furthest to the east curving eastwards into the southern limit of the excavation (Plate 26).
