## Archaeological Excavation Report

Mayfield,  
Manchester

**Report No:**  
SA/2021/56

**Project:** Mayfield, Manchester: Archaeological Excavation

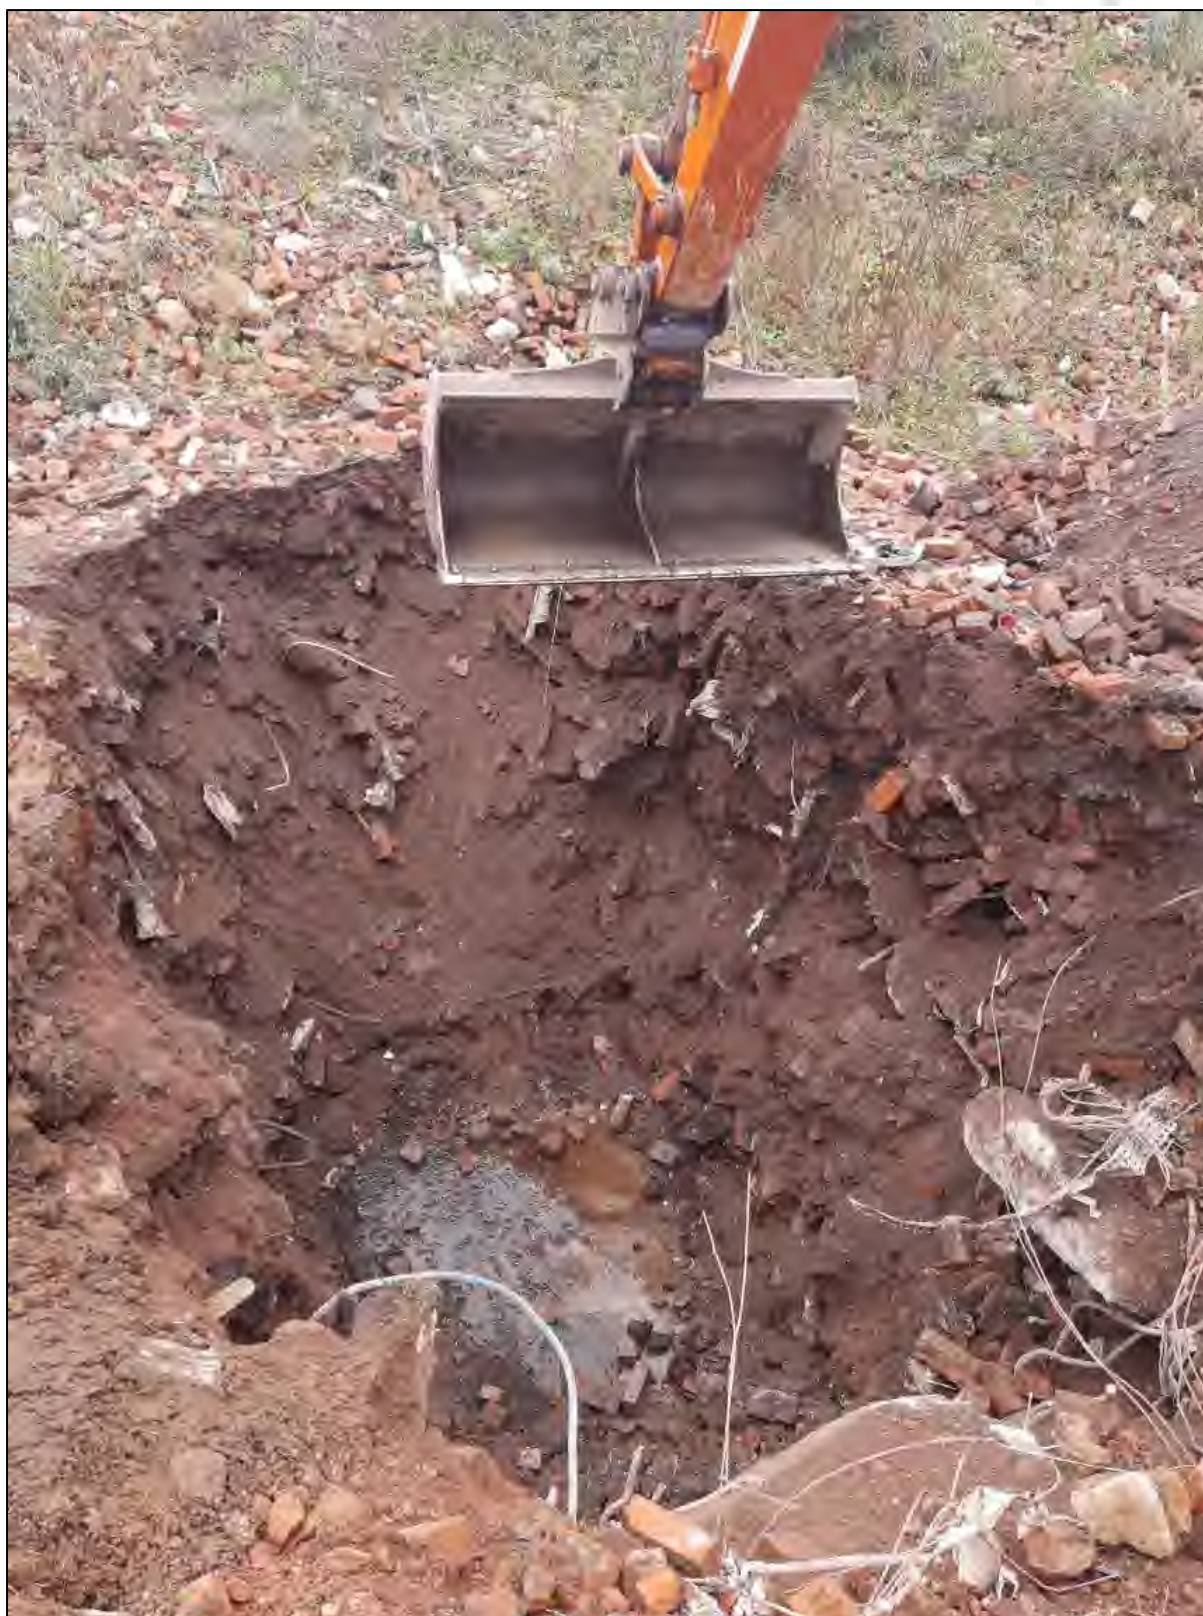
*Plate 33: A mid-excitation shot of Trench 9, illustrating that the entirety of the trench had been heavily remediated. Looking south.*

Trench 9 was located at the southwest of the site. It was targeted over a former ice factory that abutted onto Stove Street (as illustrated on the Ordnance Survey 1:500 Town Plan of 1891). The trench measured 15 x 1.8m and was excavated to a maximum depth of 3.5m. The trench was heavily remediated with material that was primarily formed of mortar and brick rubble consistent with demolition rubble (Plate 33). Such heavy remediation indicated that any surviving articles of archaeological interest had been destroyed during a later use of the site, with no archaeological features or finds of interest being uncovered from Trench 9.

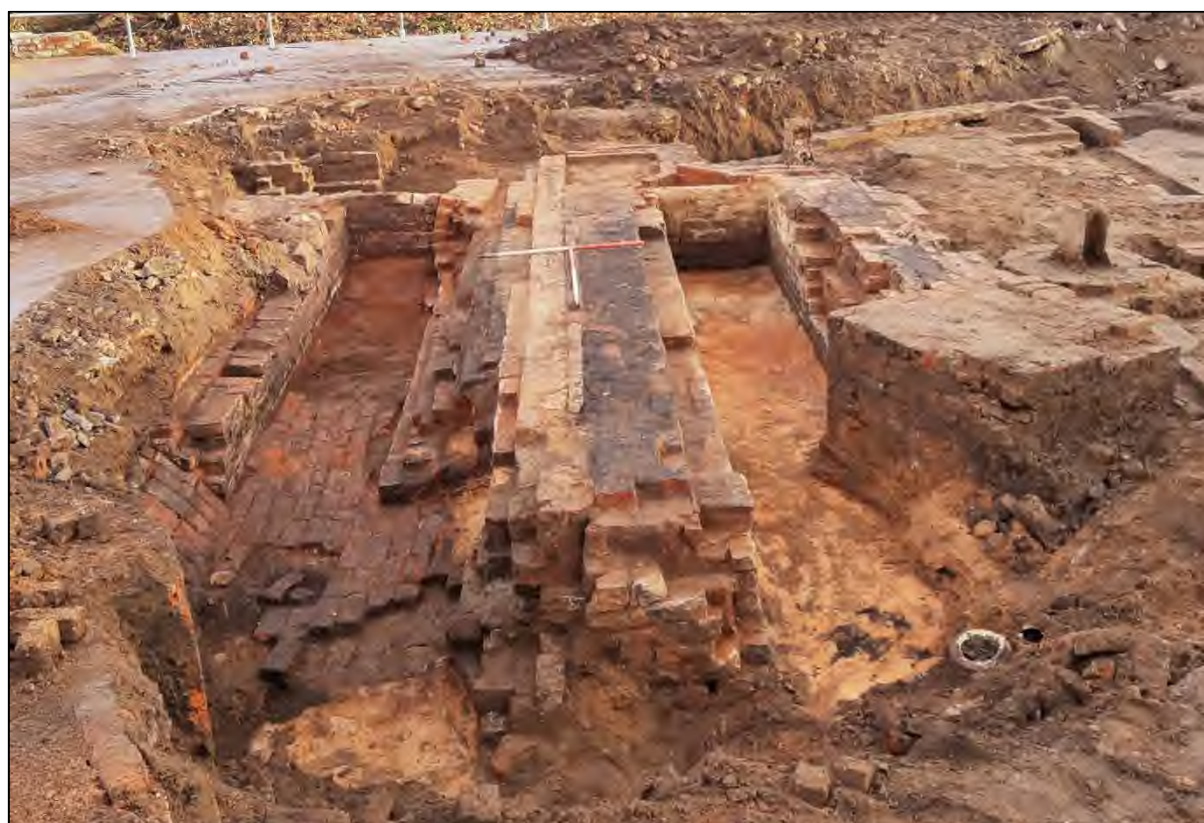
*Plate 43: Boiler beds 111 and 112, looking north (2 x 1m scales)*

The two boiler-beds, **111** and **112** were located to the southwest of the chimney at the west of the excavation area (Plate 43). Both boilers were truncated by later activity. This included a further brick stanchion, **109**, which truncated the southeast of boiler-bed **111** and measured 1.2 x 1.1m.

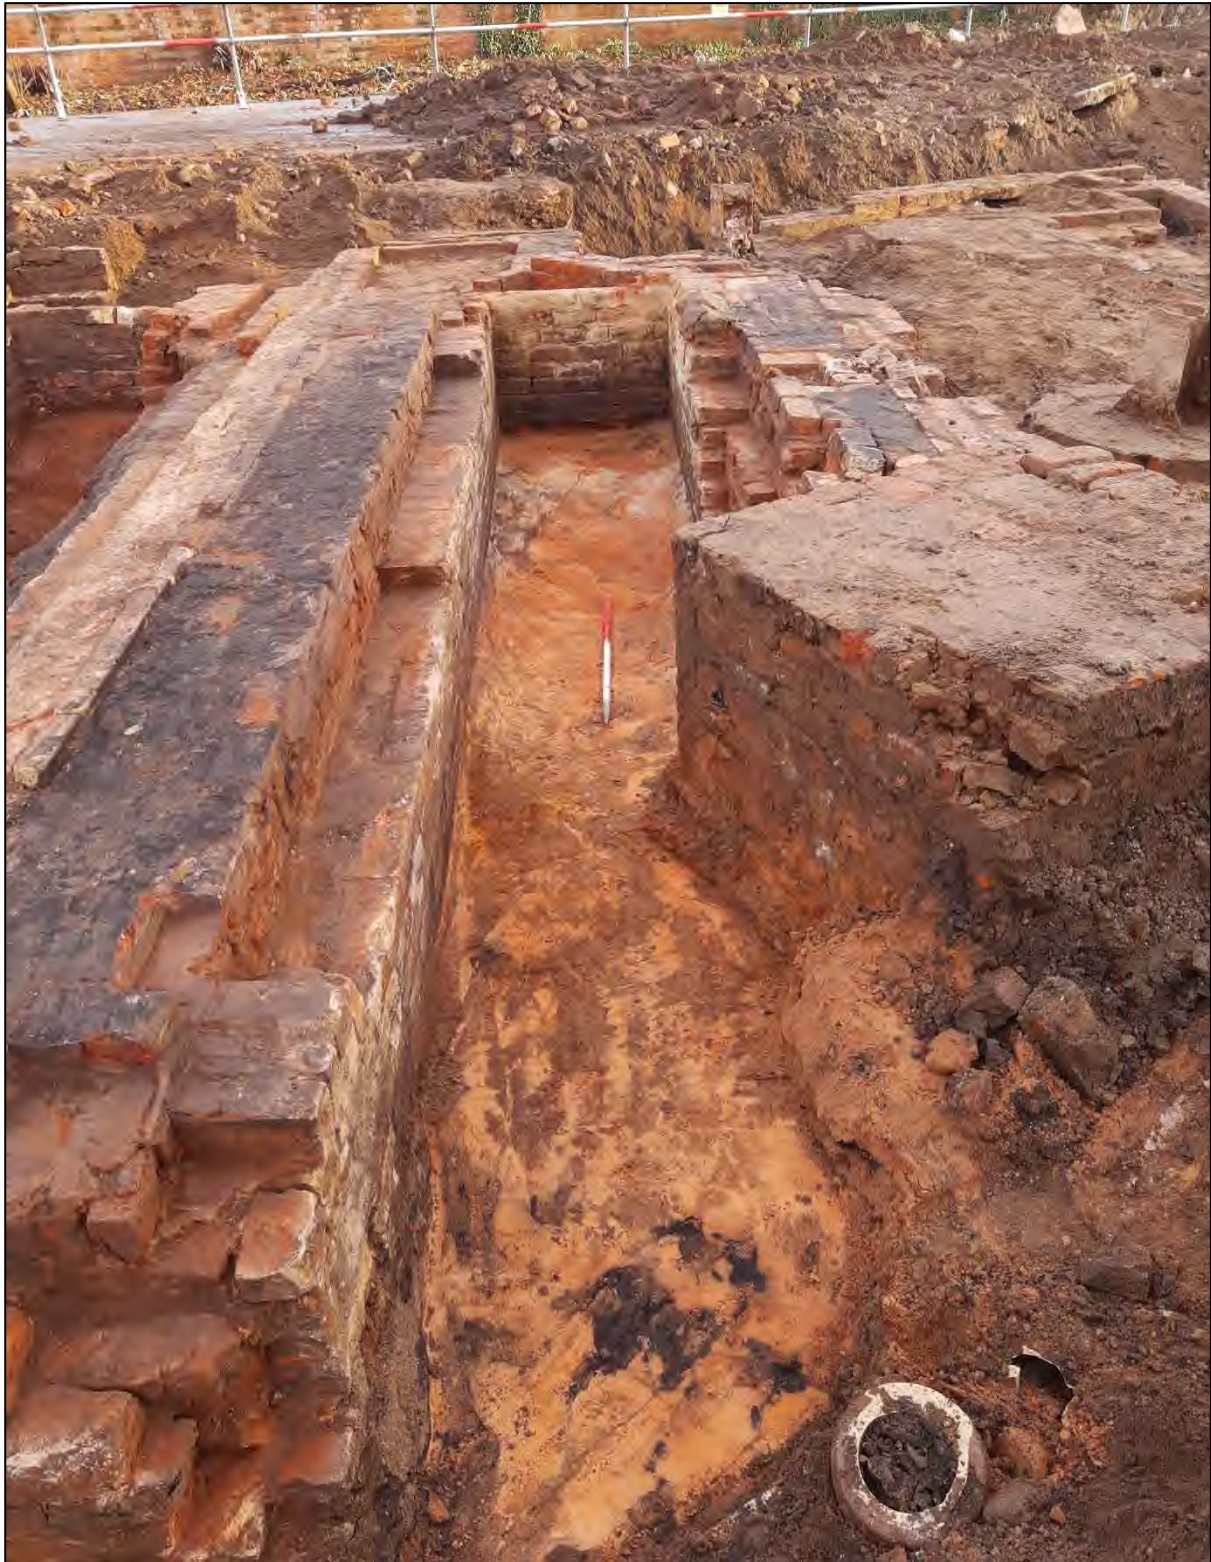
*Plate 44: Boiler 111, looking north (1m scale)*

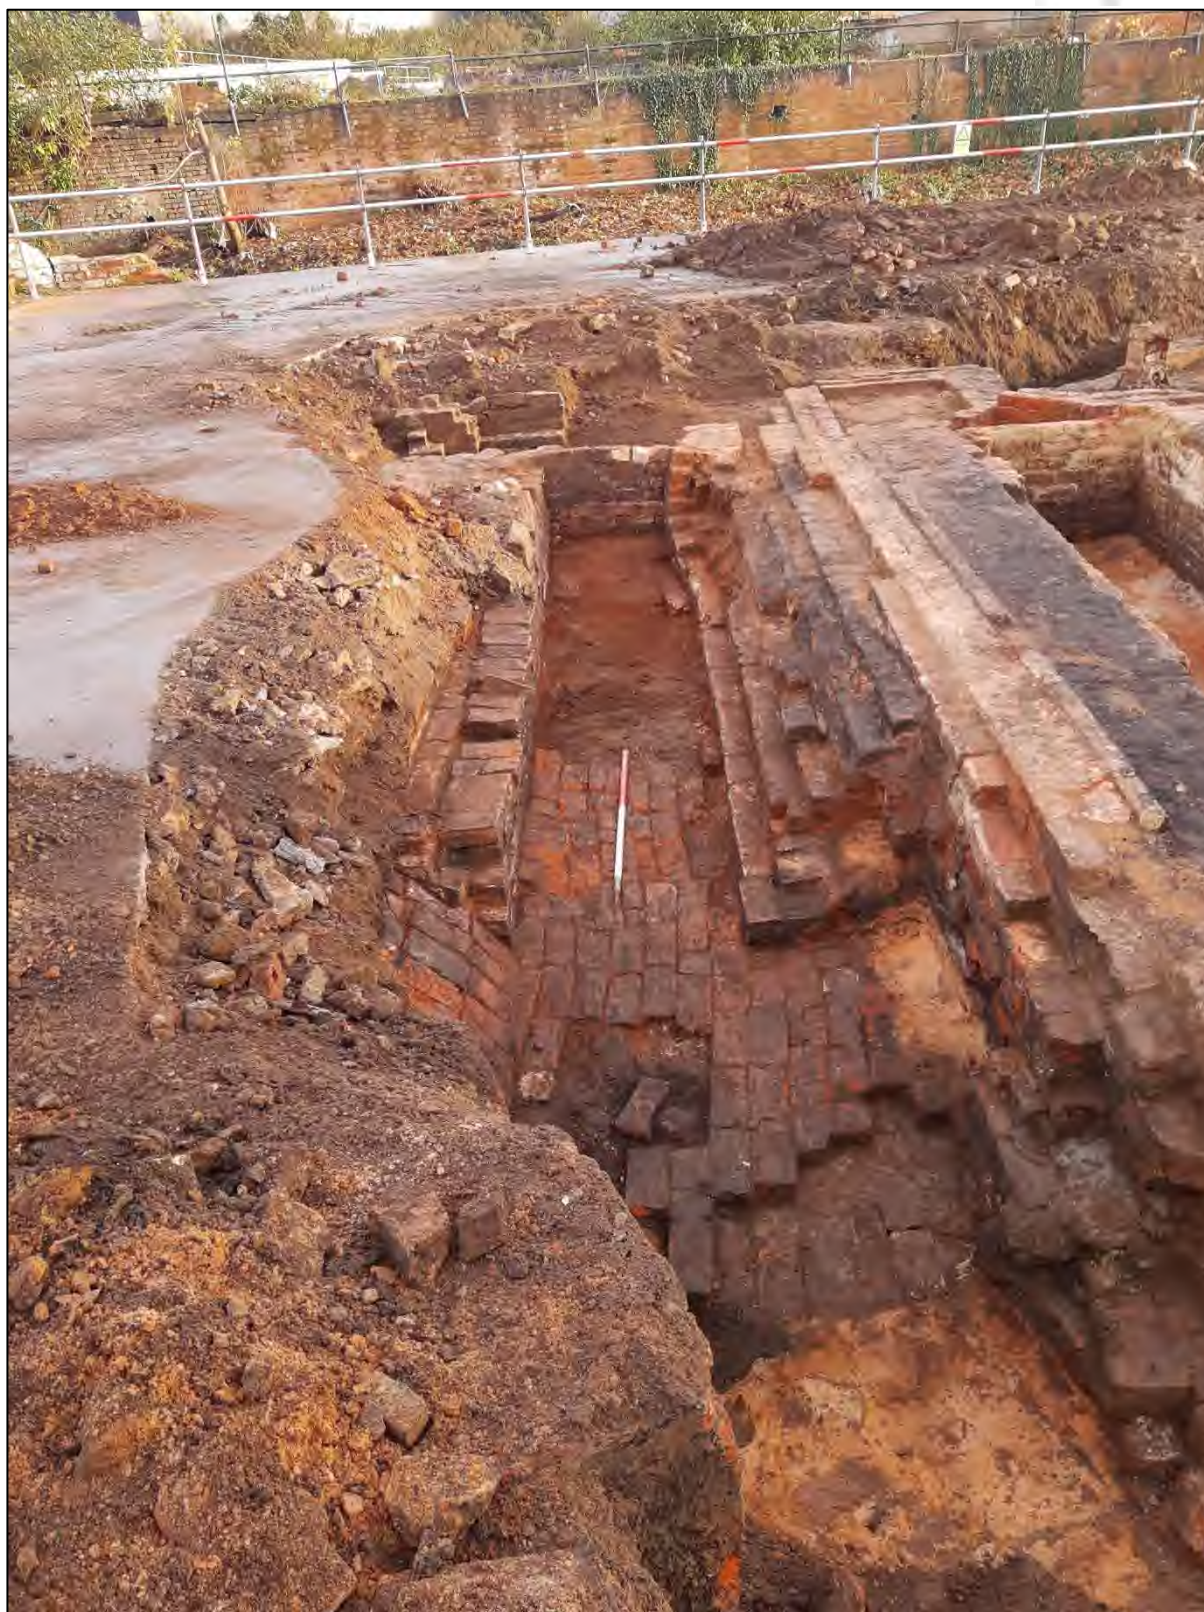
*Plate 45: Boiler 112, looking north (1m scale)*

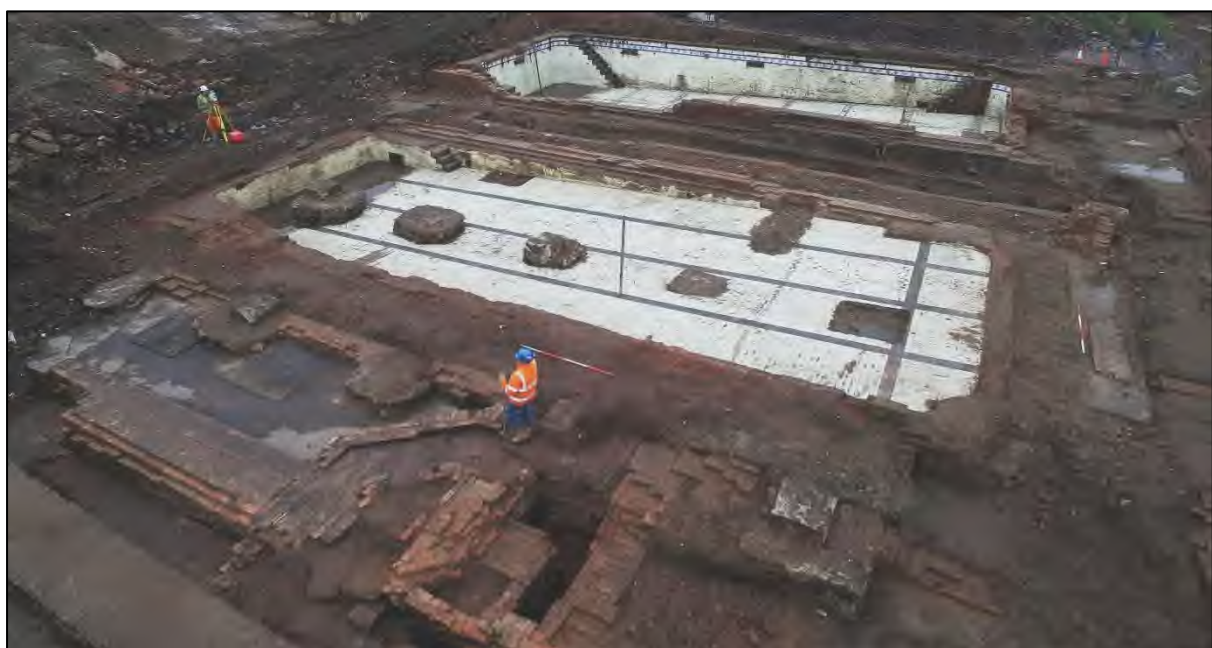
*Plate 46: The excavated remains of Mayfield Baths looking south-east*

The Excavation Area 2 expanded upon the results of the earlier evaluation Trench 8. It uncovered significant remains of the Mayfield Baths, which was in use at the site c. 1857-1941 (Plate 46; Figure 7). It uncovered well-preserved remains of two plunge pools, steam boilers, associated flues, and chimney. The entire Area 2 was covered by a tarmac and MOT layer, reflecting the site's contemporary use as a carpark. Various mid-to-late-20<sup>th</sup> century foundational remains were also found across the site, the most substantial of which consisted of concrete wall foundations and concrete stanchions. In some floored areas of the baths, such as the swimming pools and boilers, material associated with the 1940s demolition of the site was found, which included architectural stone and brick fragments.

The most visually compelling elements exposed during the works were the two plunge pools situated in the eastern half of the excavation (Plates 46 and 47). Pool 225 was located in the southeast corner of the area and was identified as the men's first-class pool. Pool 226 was located to the north and was identified as the men's second-class pool. The pools were divided by an east / west aligned brick wall, 227. The pools measured 19.20m by 7.32m. They had a rectangular shape in plan with rounded corners. The outer walls of the pools ranged in thickness from 0.65 to 0.85m, and comprised handmade red brick bonded with hard, grey cementitious mortar. The bases of the pools were constructed in concrete, brick and stone and sloped from east to west to create the shallow and deep ends of each structure.

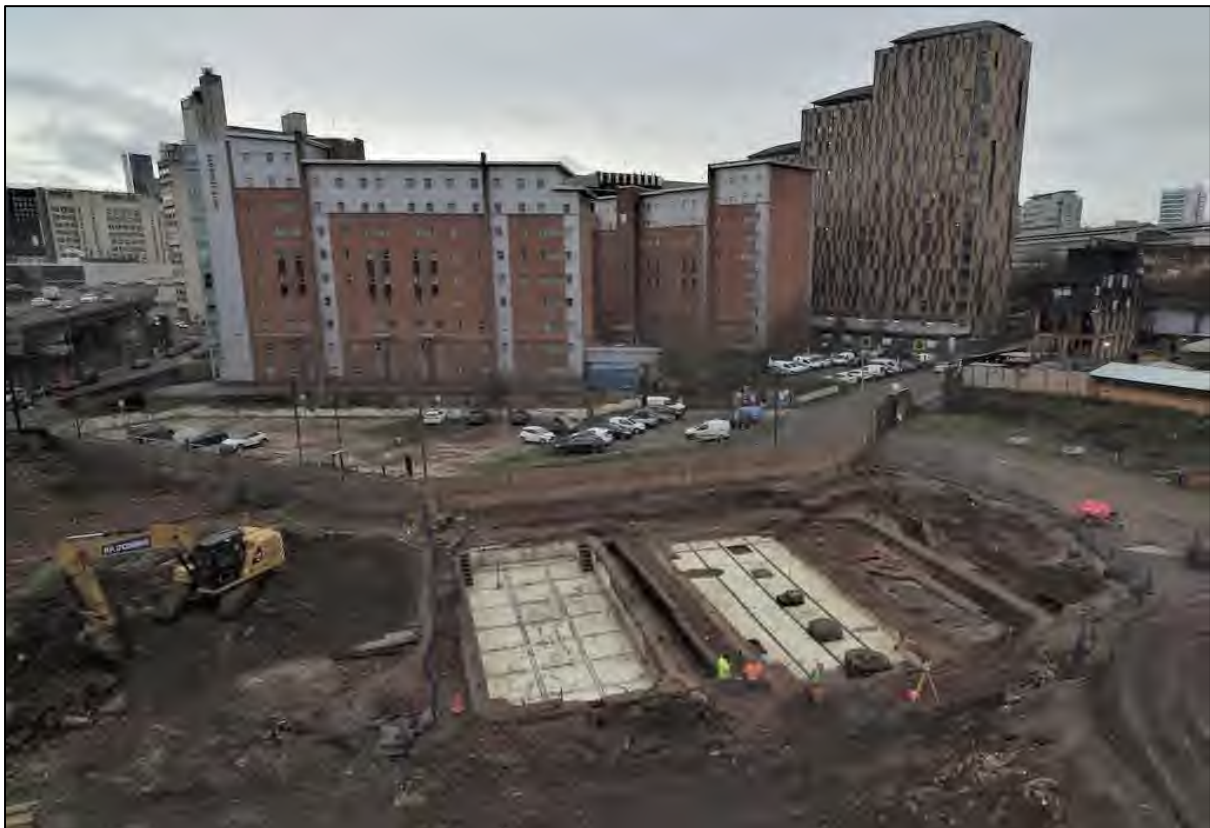
*Plate 47: Aerial view of Mayfield Baths looking north-east*

This phase of construction was represented archaeologically by the remains of two plunge pools, an adjoining boiler house and foundation walls of the rooms, presumably the foyers and offices, which fronted onto Baring Street.

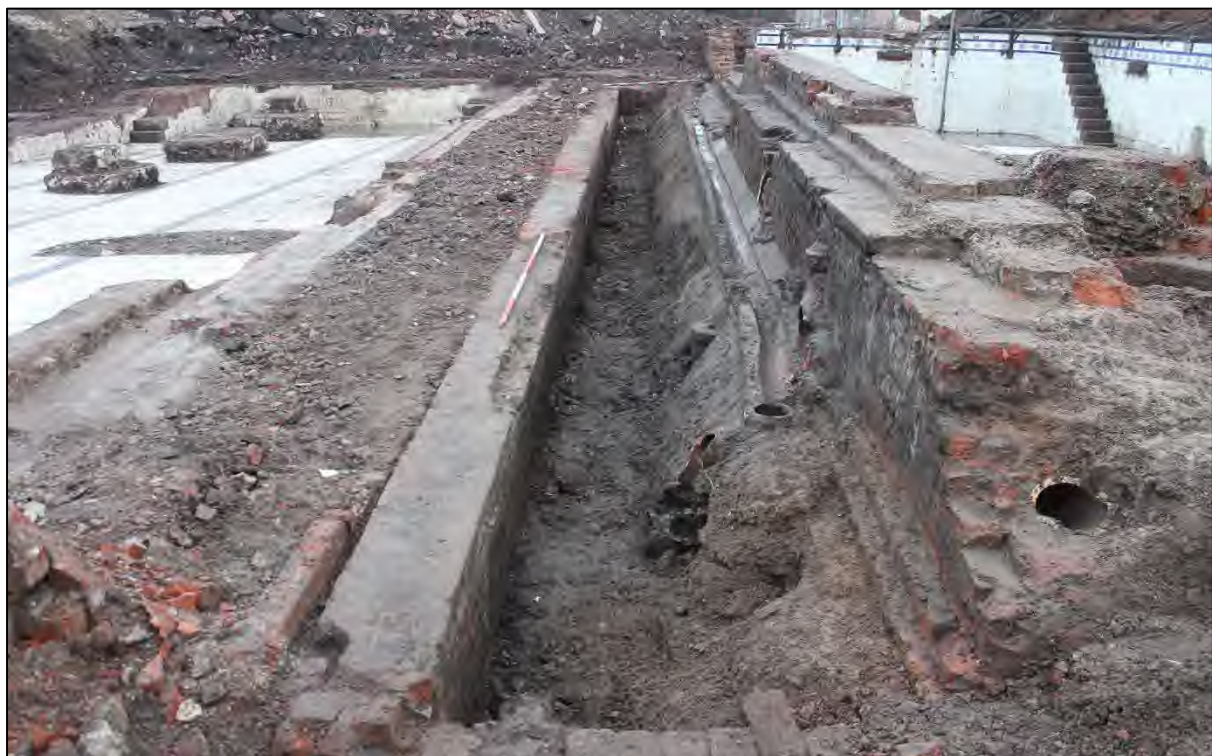
*Plate 48: Wall 227 looking east*

elements of the bathhouse design. The plan shows the water from the pools fed into a chamber situated between the pools (Plate 48) and flowed westwards towards Baring Street, where it emptied into a sewer.

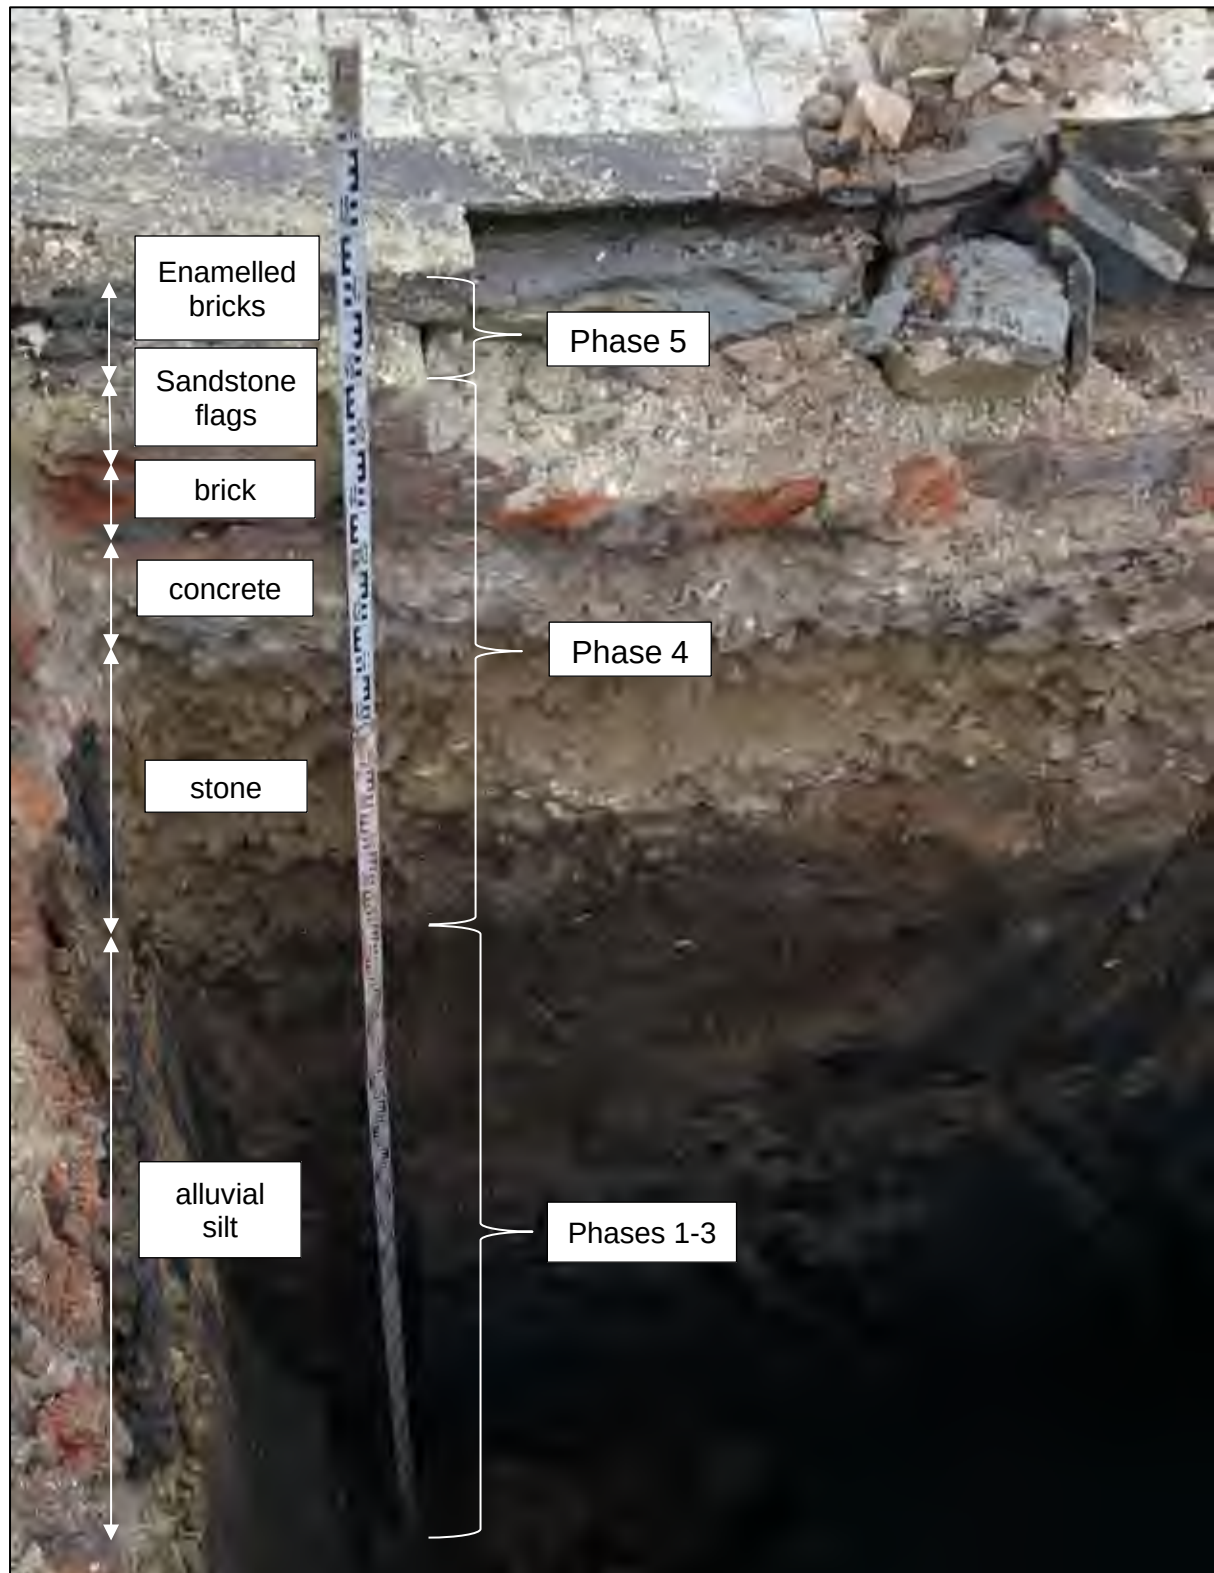
Plate 49: Sondage through the base of Pool 226 showing the composition of the foundations above earlier layers of alluvial silt

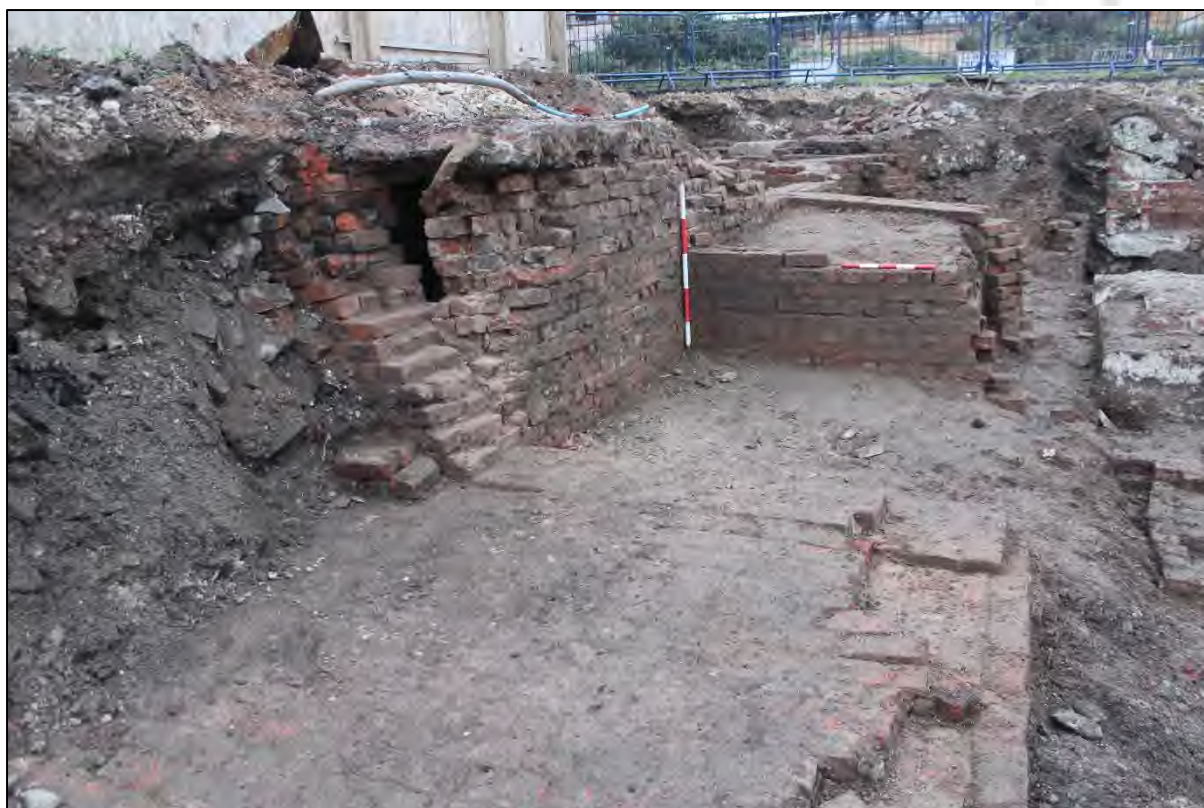
*Plate 51: Walls 207, 200, and 210, forming one of the rooms at the west of the site, looking northwest*

1.84m to the south of wall 207 was wall 210. Wall **210** had a maximum length of 2.1m and a width of 0.36m. Its eastern was disturbed but it likely had connected to wall 203. A brick floor was found between walls 207 and 210 and covered the area of the room, 1.84 x 2.1m.

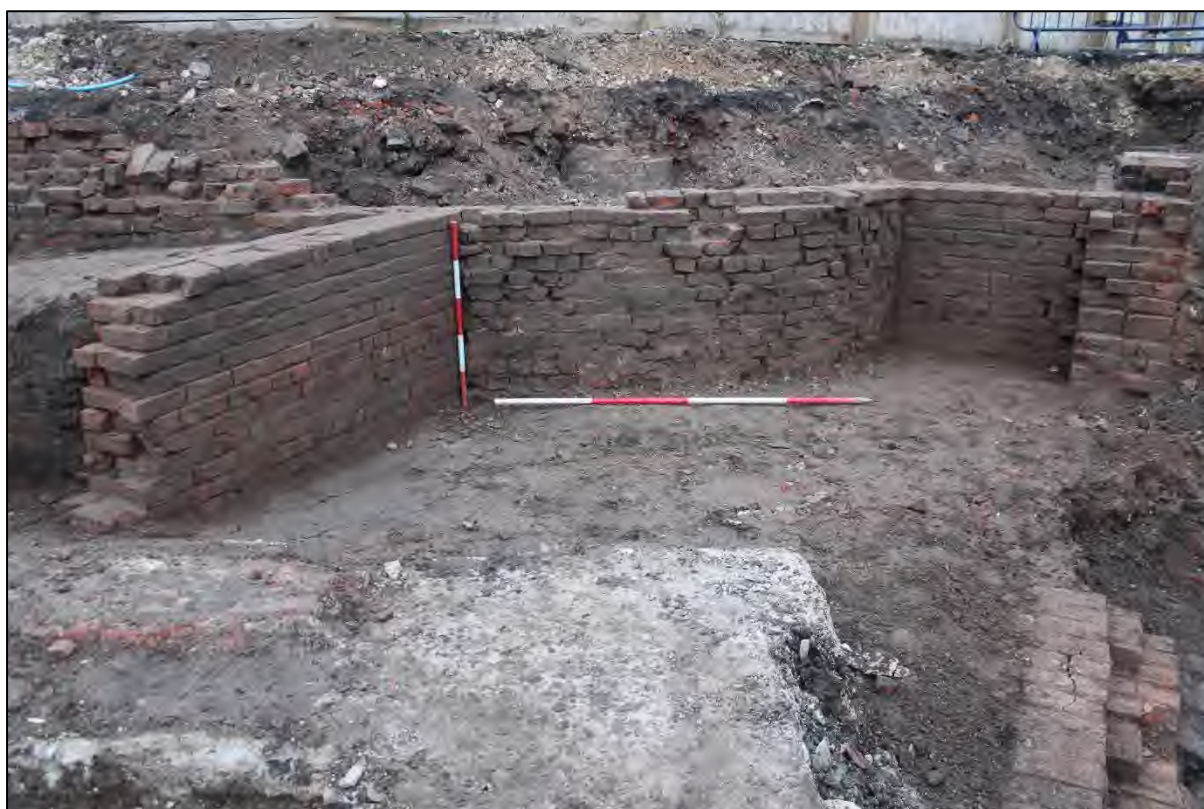
*Plate 52: The curved section of Wall 200*

Parallel to Baring Street, along the western edge of the excavation was brick wall **200**, which was aligned north / south. It had a maximum exposed length of 8.72, a width of 0.35m, and survived to a maximum height of 1.13m. At the northern end, it curved for 1.8m towards the northwest before a second angular dog-led towards the northeast for 1.1m, where it met wall 204 (Plates 50 and 52). Wall 200 formed the eastern edge of a cellar, recognised from the white-washed western face of Wall 200. The cellar continued beyond the limit of excavation towards Baring Street; it was not possible to excavate it further. At its southern end, Wall 200 was abutted by and possibly rebuilt as Wall 223.

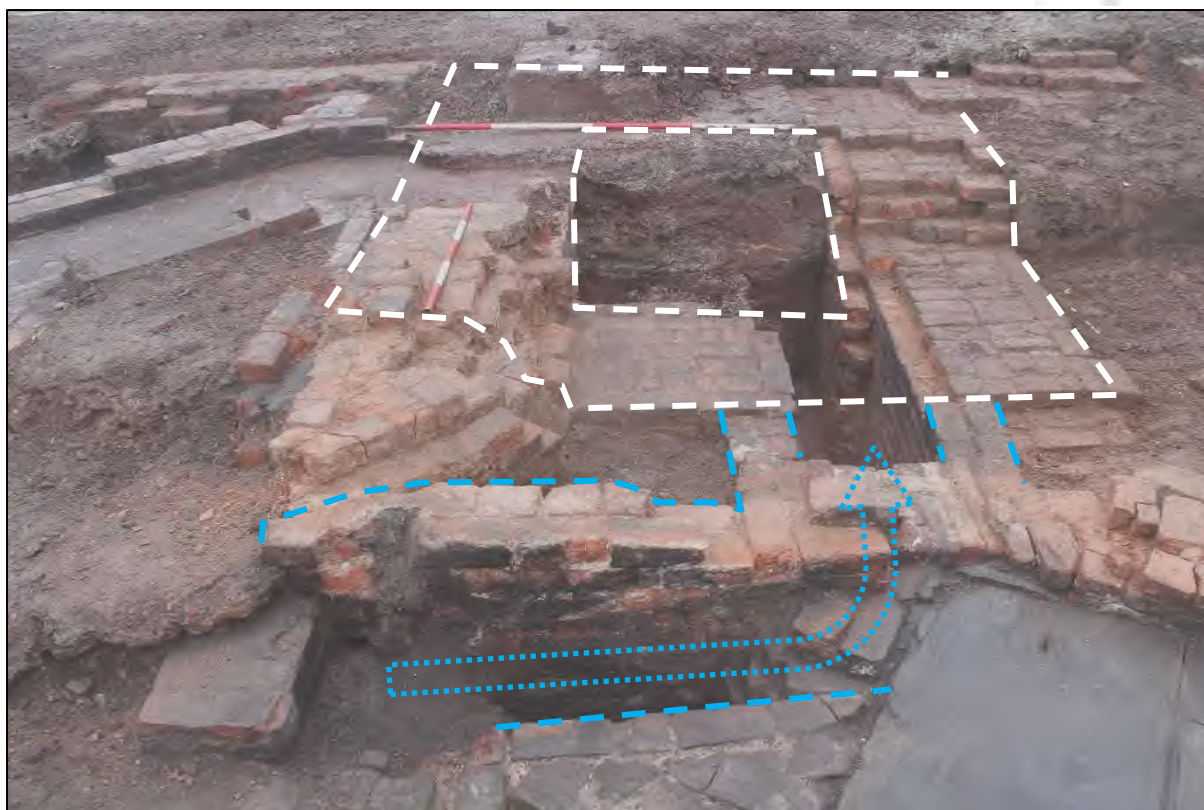
Plate 53: The remains of chimney 219 (white) and flue 218 (blue)

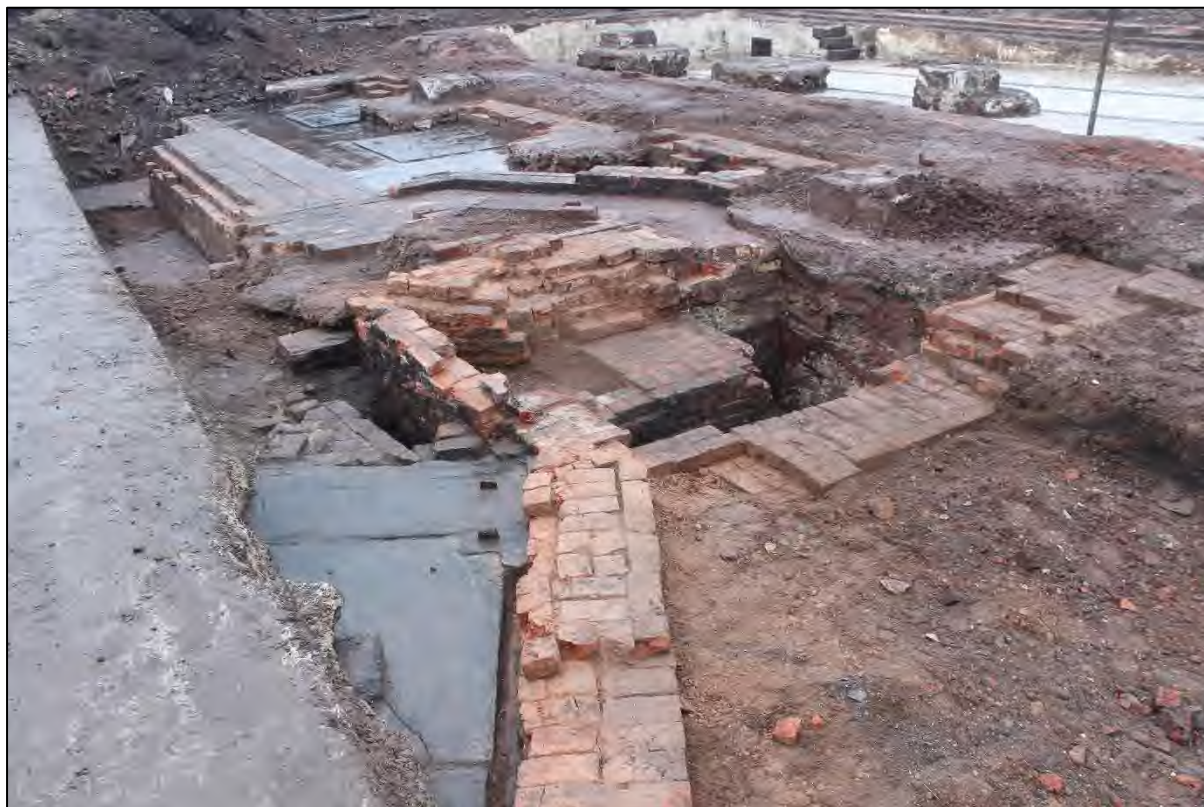
*Plate 54: The brick conduit and remains of the boiler house of the Baths, looking southeast*

Close to the northern edge of the excavation was a large brick conduit, which ran from rear of the boilers and chimney to the northeast edge of the building (Plates 54 and 55). It consisted of three parallel brick walls, **204**, **206**, and **205**. All were aligned northwest / southeast. Wall **204** formed the south-western side of the structure and had a width of 0.47m and a maximum exposed length of 11.5m. The south-eastern extent had been truncated during the construction of 20<sup>th</sup> century concrete foundations. Wall 204 was keyed-in to walls 200 and 209. Running parallel with wall 204 was wall **206**, which acted as a central partition between walls 204 and 205. It was exposed for 4.2m though it continued to the northwest beyond the limit of. Wall 206 had a maximum height of 0.72m below the level of the flagstone floor, 208. The top of both walls were recessed to hold a series of adjoining stone capstones, which survived intact over the south-west side of the conduit. The flagstone capping, **208** ran between walls 204 and 206 and extended from wall 209 to the northwest limit of excavation. It covered an area of 1.3 x 11.5m. The individual flagstones were made of the typical grey York stone and measured 1.44 x 1.3 x 0.08m.

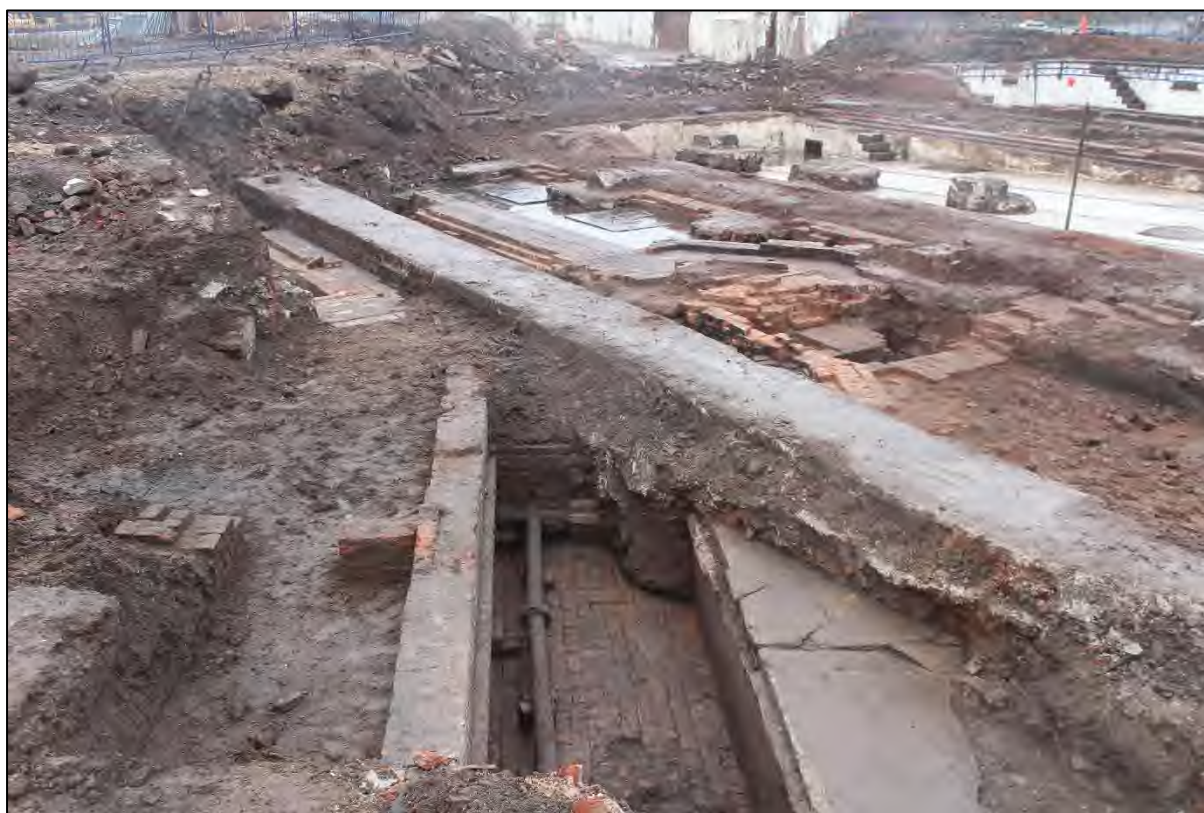
*Plate 55: The brick conduit formed by walls 204, 206 and 205 looking south-east*

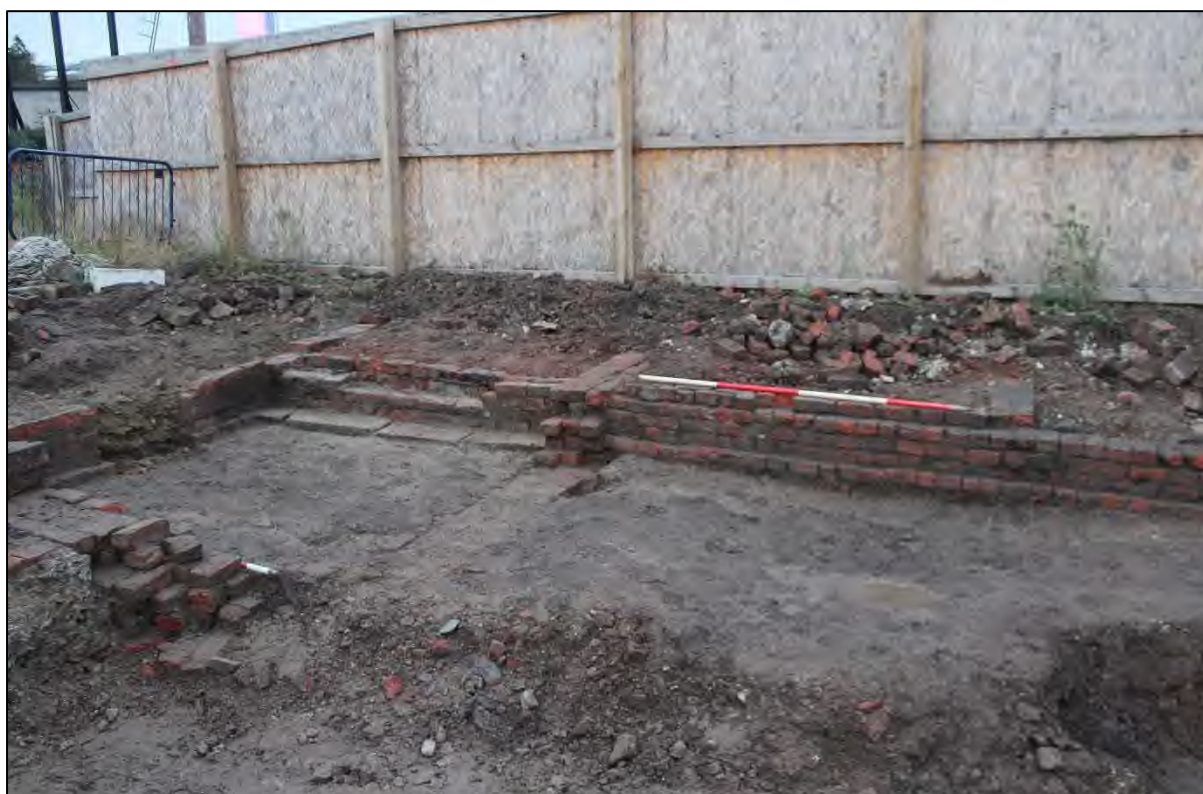
Plate 56: Wall 223 looking west (2m scale)

Wall **223** was located at the southwest of the excavation area (Plate 56). It was aligned north / south and measured 7.1 x 0.36m. It may have been a rebuild or repair of the *Phase 4* wall 200 but in plan it appeared as a continuation. It abutted the junction of the walls 200-212 and the east / west wall, 213. The foundations of the wall were shallower than those of Wall 200. The wall consisted of stepped bricks built upon a flagstone foundation and stood at a maximum height of 0.6m. A wall stub was visible on the western side of wall 223 between walls 212 and 213, indicating that this area had been further divided into small rooms: the southern room had a length of 2.17m and the northern room, a length of 2.2m. Both continued beyond the limit of excavation to the west.

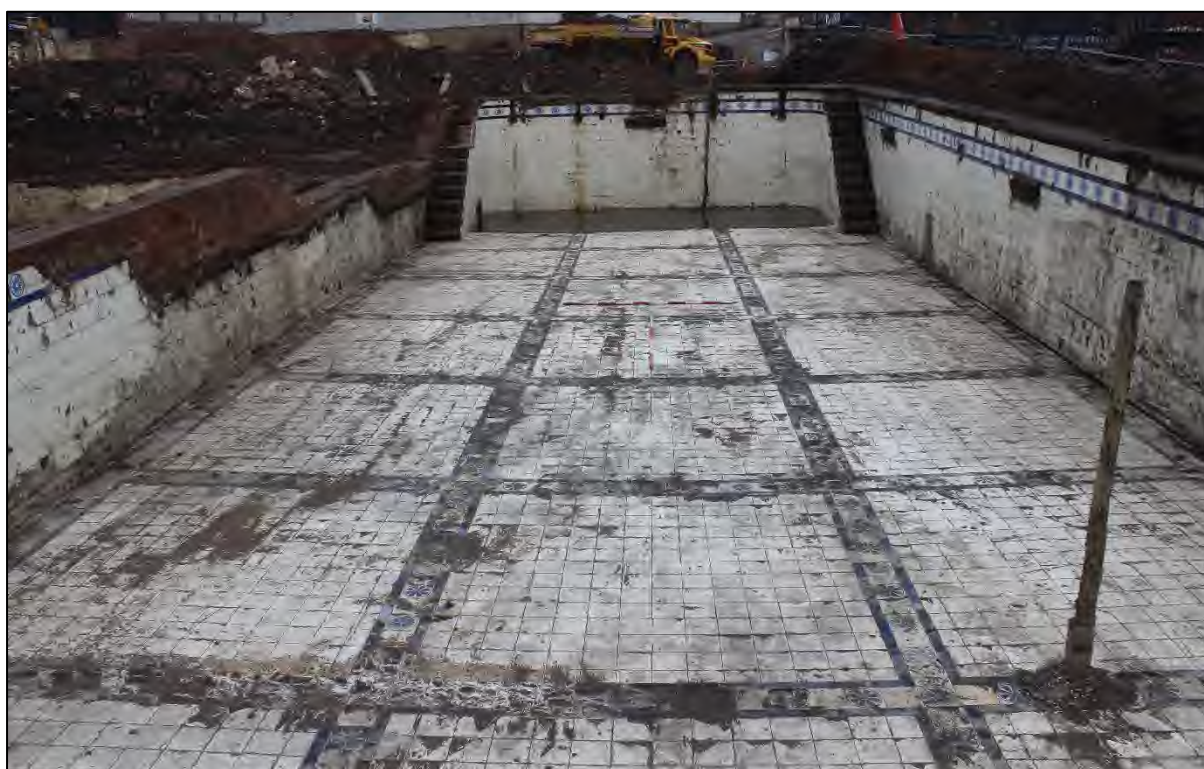
*Plate 57: Pool 225, Men's first-class, looking east (2 x 2m scales)*

##### *Plunge Pools (Plates 57 and 58)*

In the first-class pool, **225** the walls were mainly covered with plain white earthenware tiles affixed with a hard-grey waterproof cement. A repeating pattern of motif tiles – three forms of two-tone, blue radial design – with a solid blue border were used above the waterline (Plate 59). A different blue patterned tile had been used following subsequent alterations; these plainer tiles were arranged in a grid-iron pattern on the base of the pool; they were used in repairs to the damaged areas of the pool walls and had been used to face the later steps, which had obscured the waterline-border around the edge of the pool.

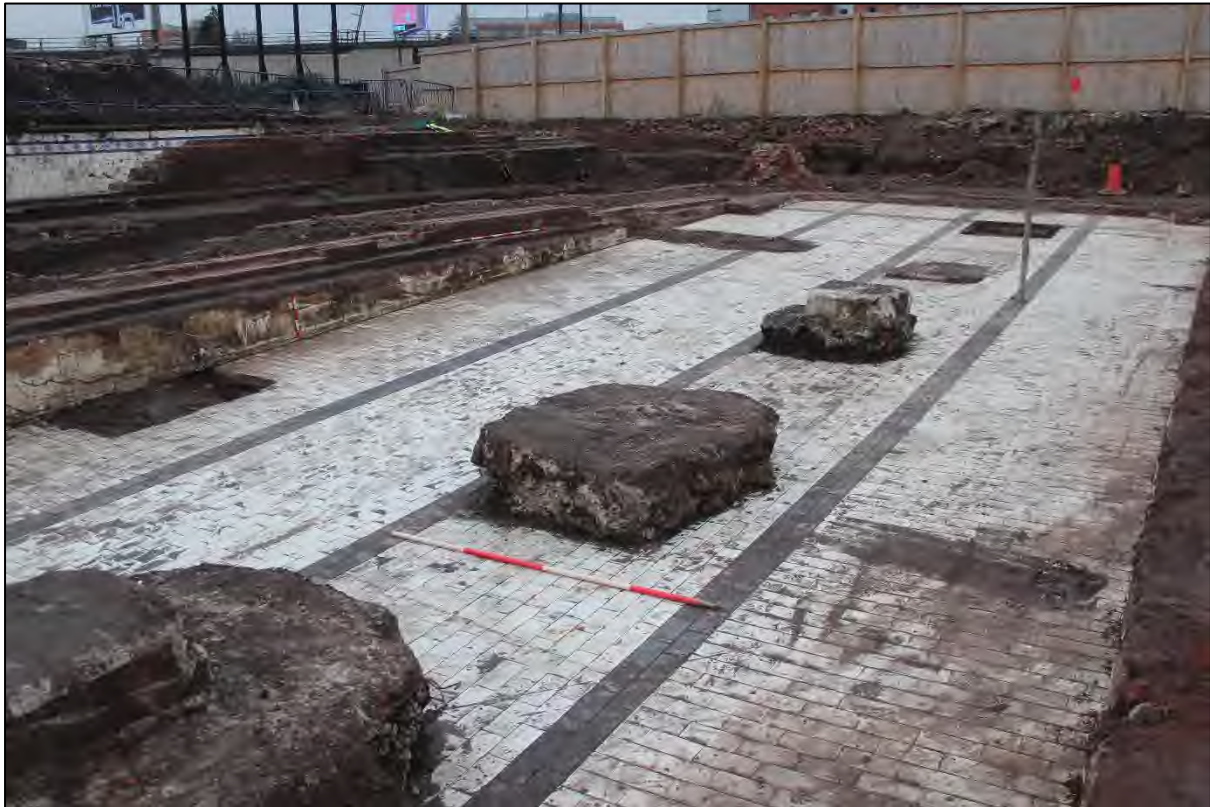
*Plate 58: Pool 226, Men's second-class, looking south-west*

The walls and base of the second-class pool, **226** were finished more simply. In contrast to the ornate tiling in the adjacent pool, the walls were lined entirely in plain 6" (152mm) white earthenware tiles. This was also reflected in the use of black and white enamelled bricks, which were arranged on the base of the pool (Plate 58). Laid above an original flagstone surface, the bricks were bedded on a light greyish-blue cement. Produced by Gilmour & Co of Kilmarnock, Ayrshire, the frogged, fire-clay bricks bearing their maker's mark likely date to the period c.1880-90. The pattern on the base of pool 226 was perhaps more utilitarian. It consisted of three east / west blue stripes along the base of the pool, perhaps used to divide the pool into swimming lanes; two additional stripes running north / south were found at either end of the pool.

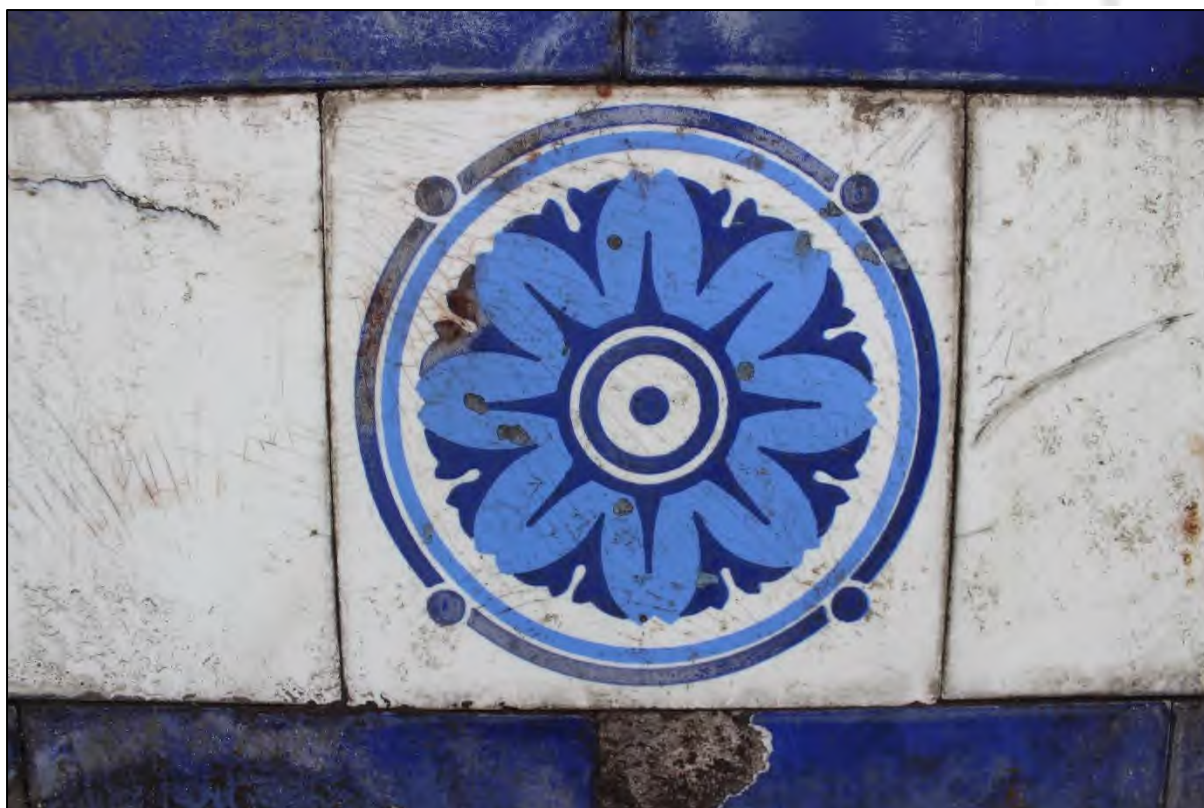
*Plate 59: Example of the Minton Hollins and Co. tile used in the retiling of pool 225*
