## Archaeological Excavation Report

Mayfield,  
Manchester

**Report No:**  
SA/2021/56

**Project:** Mayfield, Manchester: Archaeological Excavation

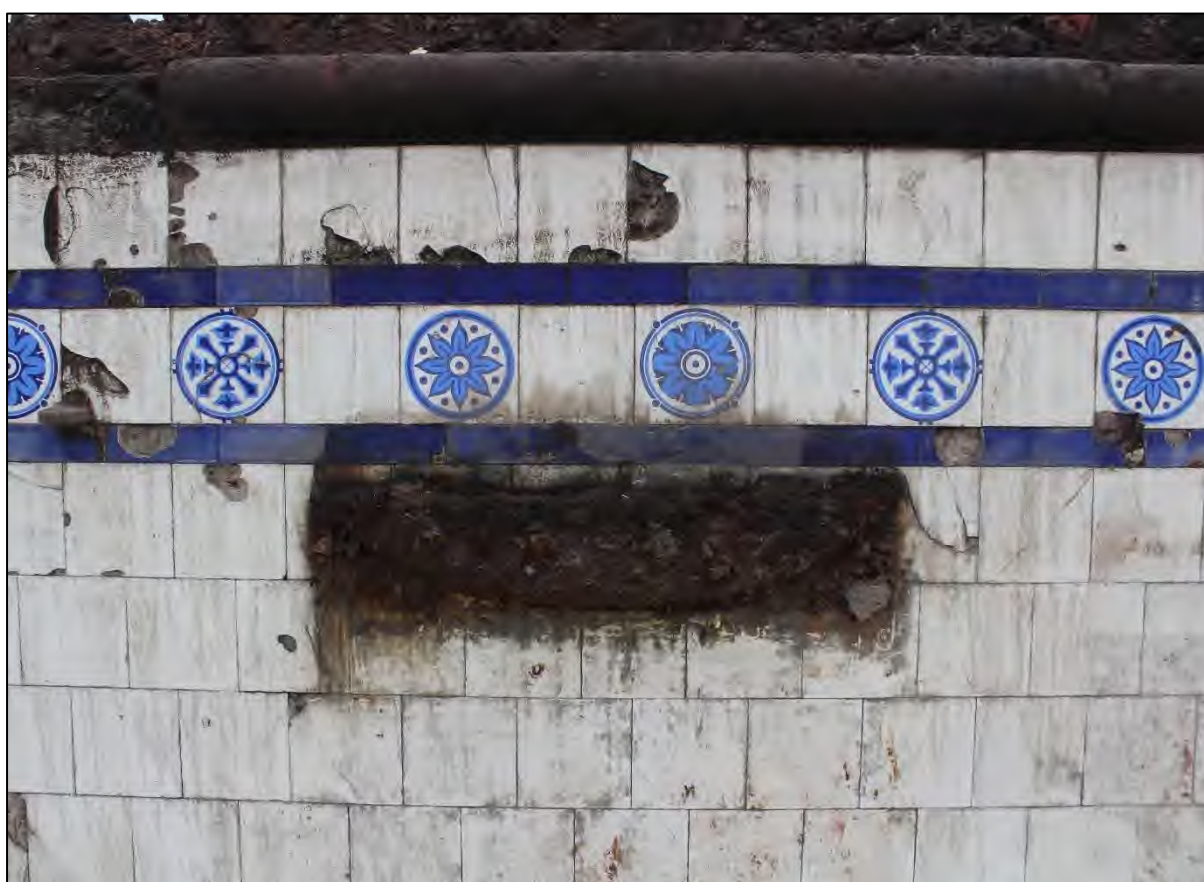
*Plate 60: The poolside of 225, showing the spit trough and floral tiles, looking east.*

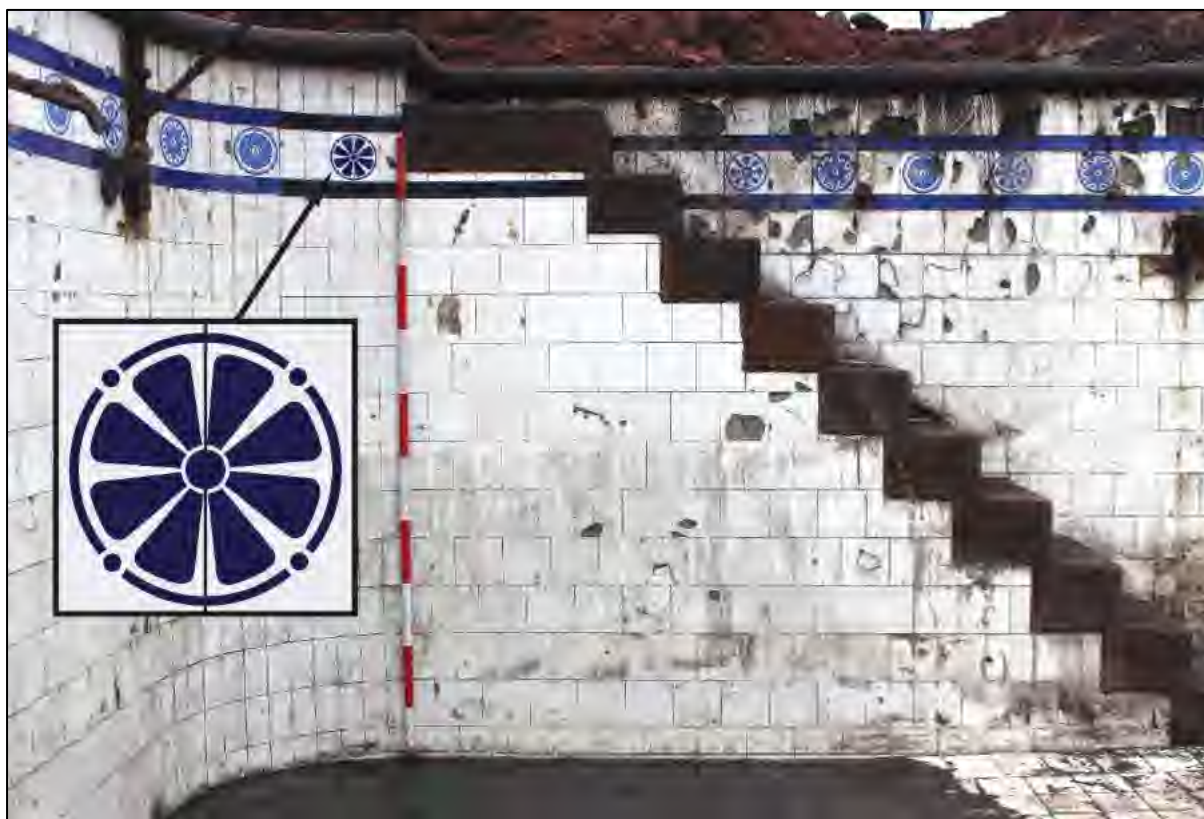
*Plate 61: Pool 225 showing the later steps and replacement tiles (2m scale)*

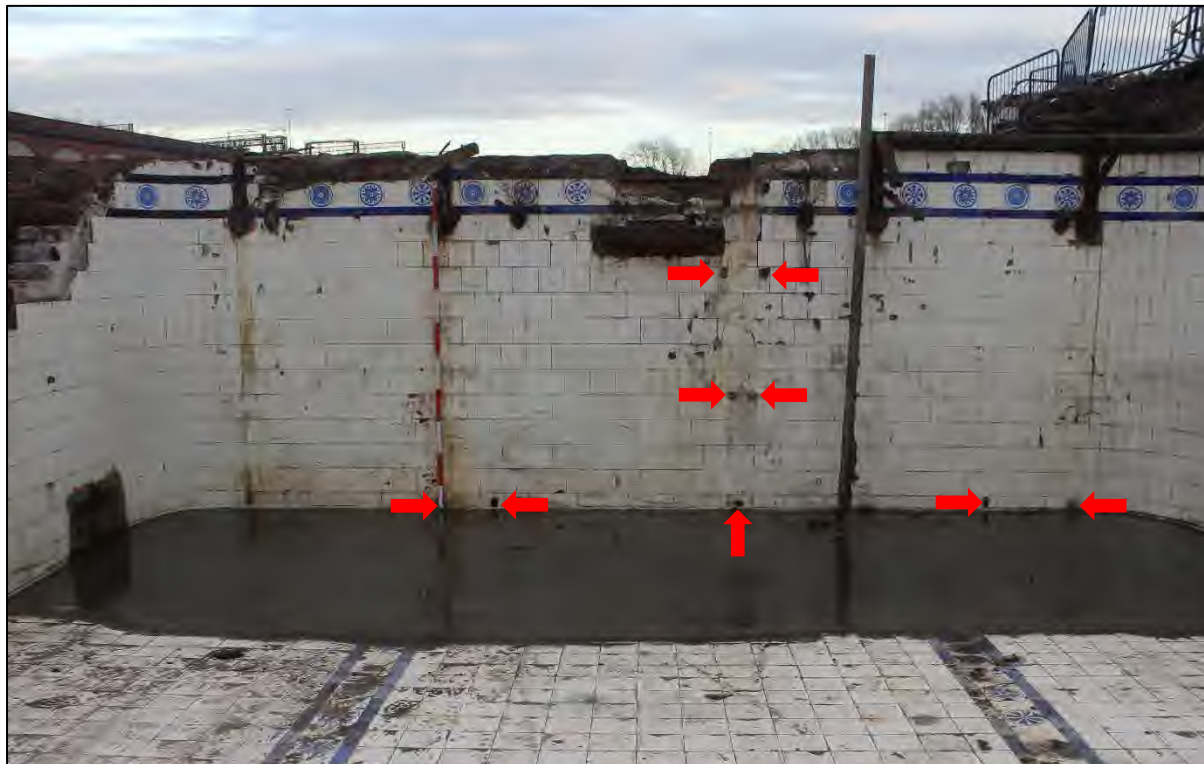
Plate 62: The eastern end of Pool 225 showing the position of the fixings for the steam injection pipe (removed) and L-shaped brackets visible above the waterline (2m scale)

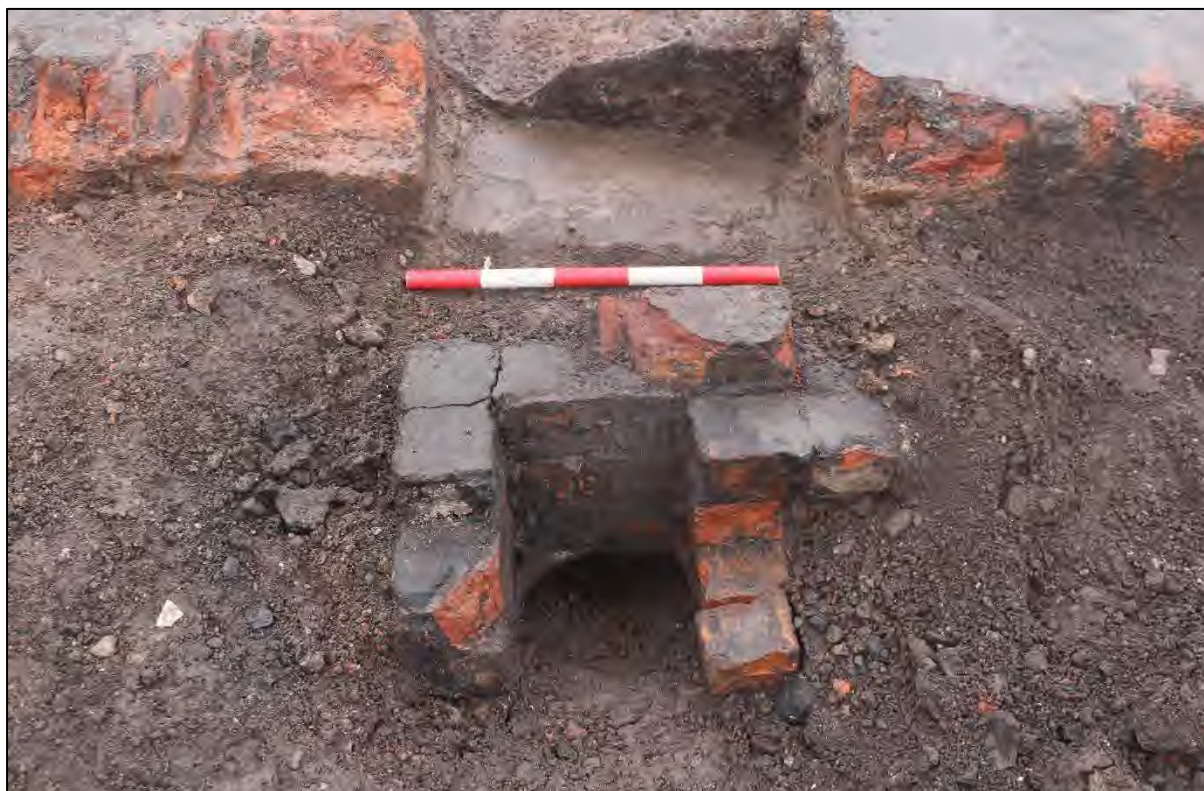
*Plate 63: Phase 5-6 brick structure 228 to the east of pool 225 (0.50m scale)*

A further element of this heating system was found in the upper fabric of the pool wall and to the rear in the form of a small brick-built channel or inlet **228**, possibly housing part of the pipework (Plate 63). This structure was built using wire-cut bricks and bonded with a brittle black ash mortar, consistent with a late 19<sup>th</sup> or early 20<sup>th</sup> century construction date. The structure measured 0.57 x 0.45m.

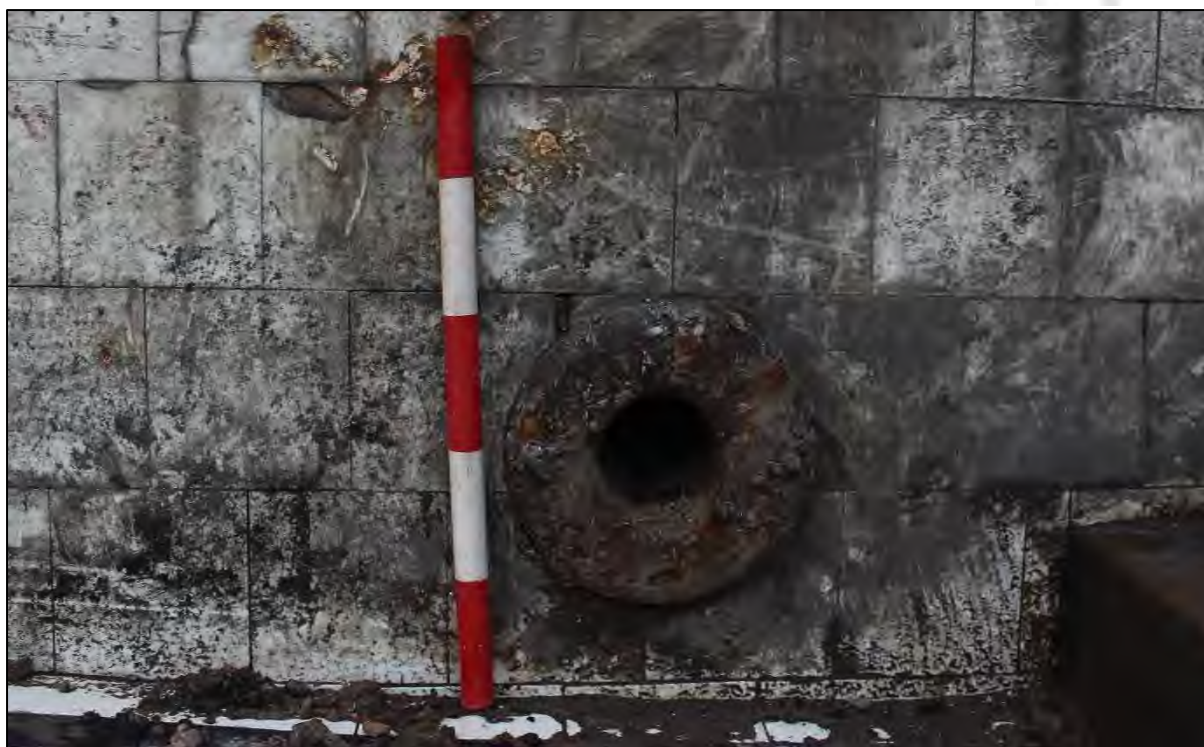
*Plate 64: Cast iron collared pipe in pool 225 (0.50m scale)*

improved at this time. Such a system would have relied on pumping water from the deep end of the pool, aerating it via a large spray before filtering through sand and gravel, reheating and returning to the pool at the shallow end. Based on the evidence provided by early photographs taken in 1902, the collared pipes set at the deep ends of both pools 225 and 226 were already in place (Plate 64).

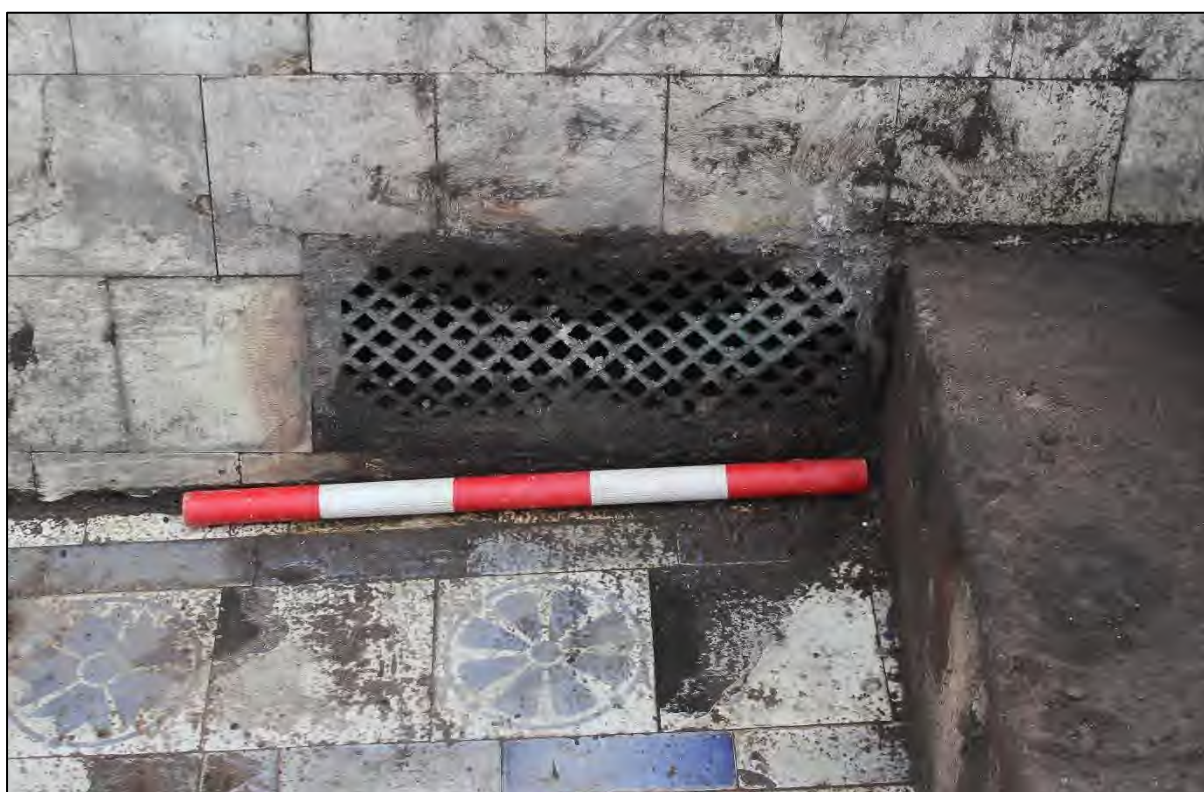
*Plate 65: Brass grate at the south-west corner of Pool 225 (0.50m scale)*

An accompanying inlet for refilling the pool was revealed at the opposing southwest corner of pool 225, adjacent to the steps. This consisted of a rectangular aperture covered by a brass grate, measuring 0.5 x 0.3m (Plate 65). Given the level of truncation to pool 226 no corresponding inlet had survived.

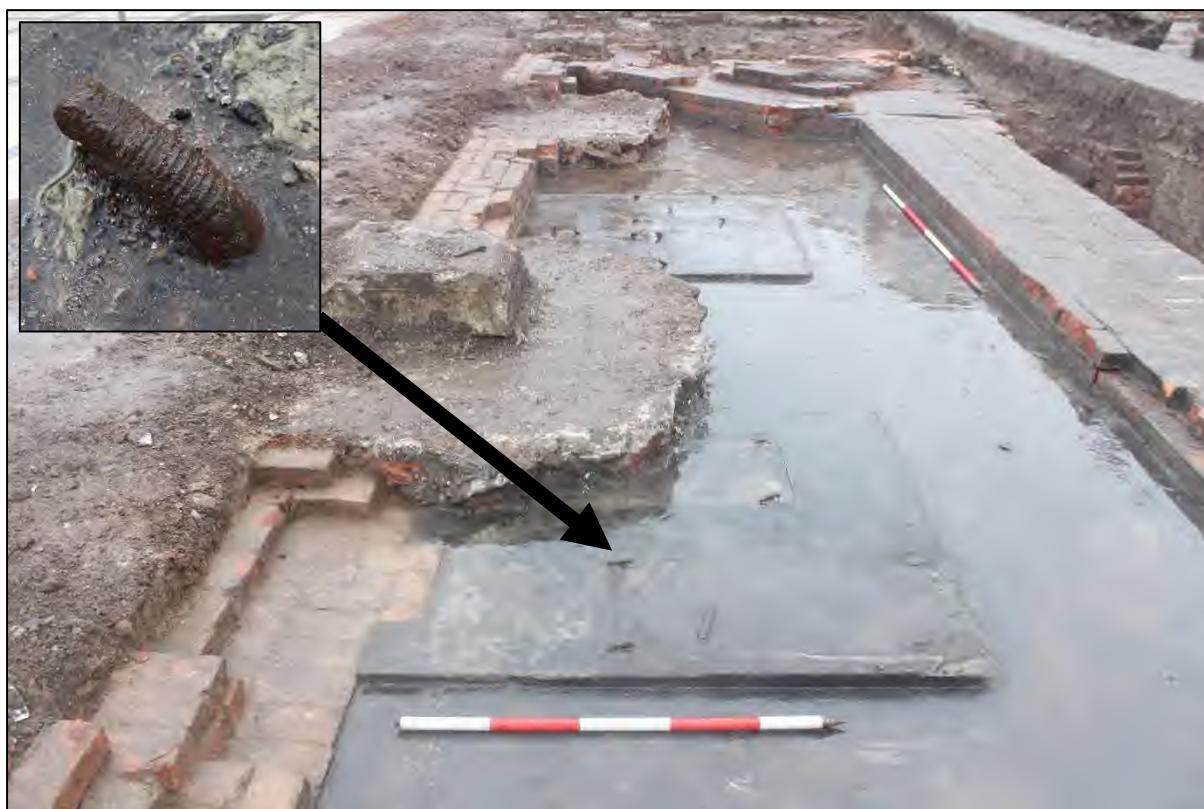
*Plate 66: Anteroom to the boiler showing stone machine beds 216a (foreground) and 216b in the rear of the shot (1m and 2m scales) Inset: showing threaded bolt*

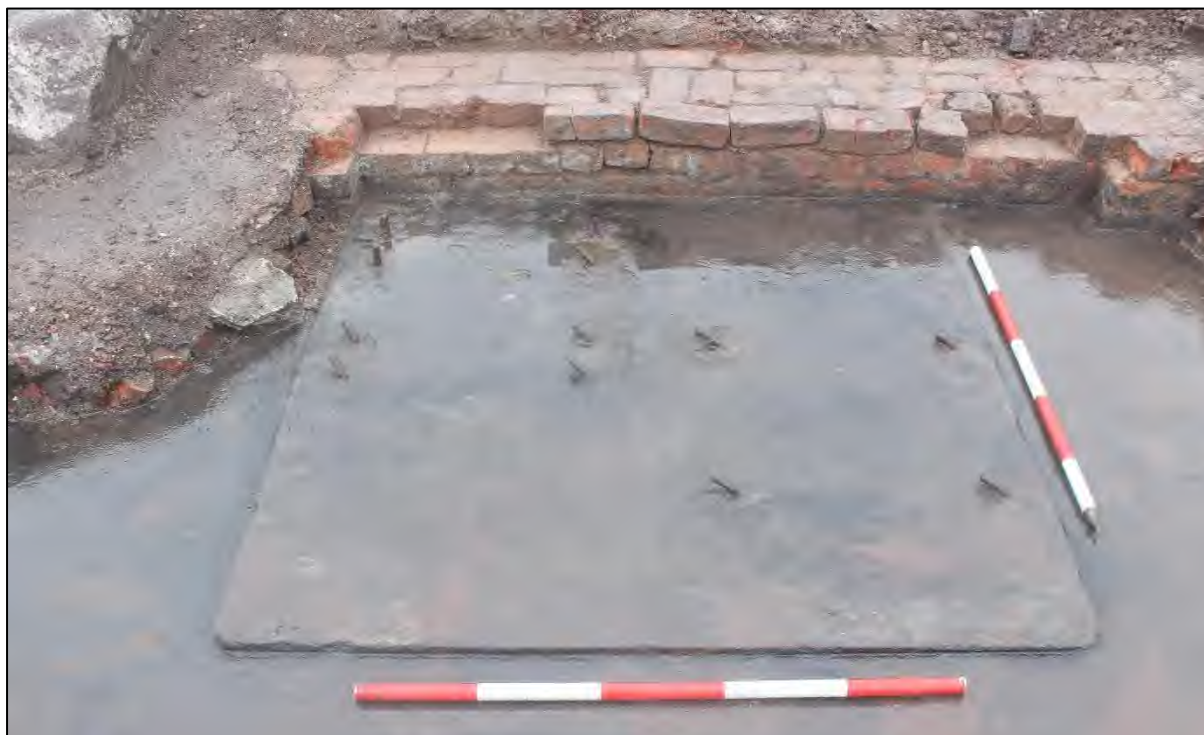
*Plate 67: Example of one of the 216 machine beds (2 x 1m scales)*

Set within the concrete floor, 215, were two machine beds, **216a** and **216b** (Plates 66 and 67). These machine-beds consisted of two hard, mid-grey sandstone slabs which were flush against wall 207. The western of the two slabs 216b measured 1.54 x 1.53m, 1.3m to the east, the eastern slab measured 1.53 x 1.39m. Both slabs contained up to twelve iron or steel fastening points, which were machine threaded.

Further developments to the south of the boiler-house included the insertion of a concrete floor and two rectangular stone beds, **216**, fitted with threaded retraining bars (Plates 66 and 67). The specific machinery that was anchored to these machine beds was likely to have been compact. They may have been associated with the photographed 'calorifier' at the site (Plate 14), which appears to have been installed at some point in first few decades the 20<sup>th</sup> century. The photograph was reputedly taken in 1902, which would make this a very early example, although it seems more likely that the date attributed to the image is incorrect as this plant was developed in subsequent years. Company accounts for 1913-4 record large sums of money – £401 1s 2d in 1913 and £827 5s in 1914 – were expended on filtration plant, suggesting it may have been installed at that date.

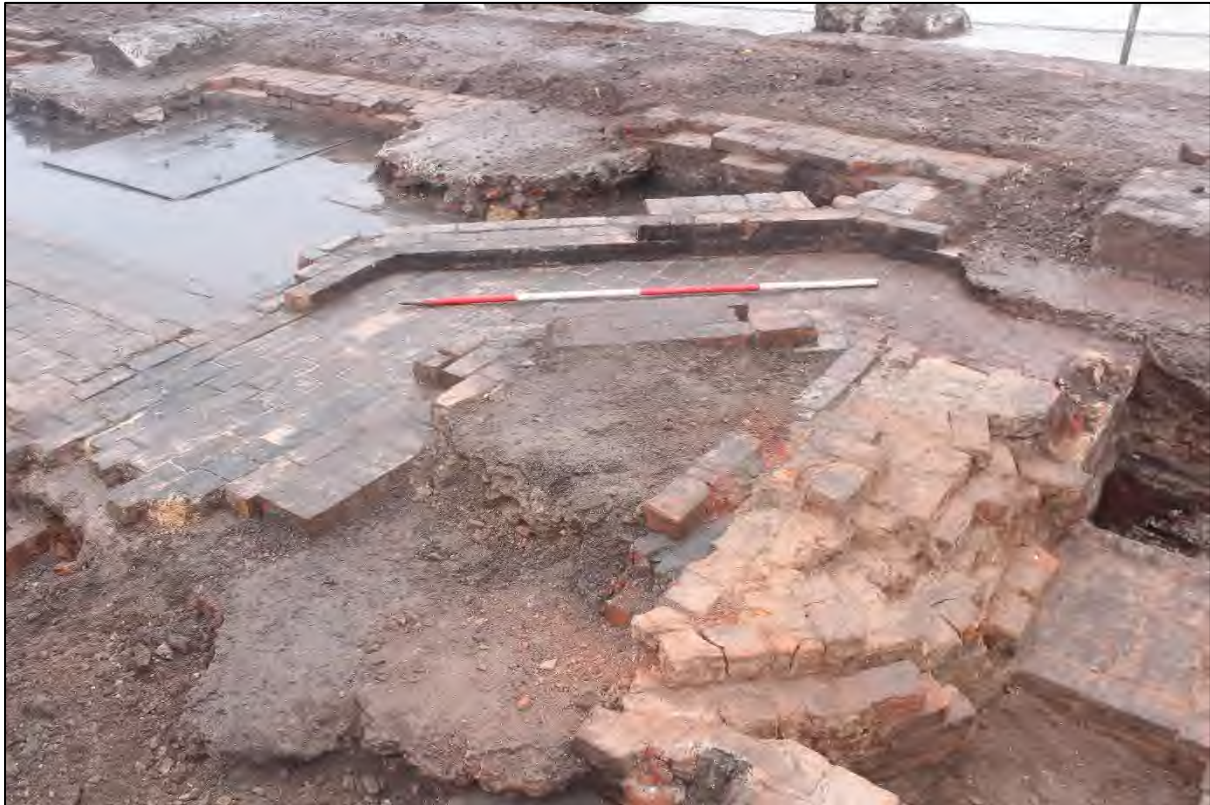
*Plate 68: Flue 217 looking south-east (2m scale)*

The flue **217** was constructed of machine-made bricks and firebricks and ran from north to south along the rear of the boilers, doglegging to the southwest where it entered chimney, 219 (Plate 68). The fabric of the flue was consistent with the adjacent boilers and probably represents a rebuilding of an existing flue occupying the same position. It had an internal width of 0.77m while the walls of the flue had a thickness of 0.35m. It had a total length of 4.2m to the large east / west aligned concrete intrusion which truncated it. A further small section of the flue 217 was found to the north of the concrete intrusion, adjacent to Boiler 222. This section had an internal width of 0.78m and a maximum exposed length of 1.5m. The flue 217 was likely fed by smaller east / west aligned flues which would have been located on the large walls of the boiler-beds. The flue was constructed on a crude foundation of hard, dark-grey concrete, which had been poured up to the remains of flue 218 and chimney 209.

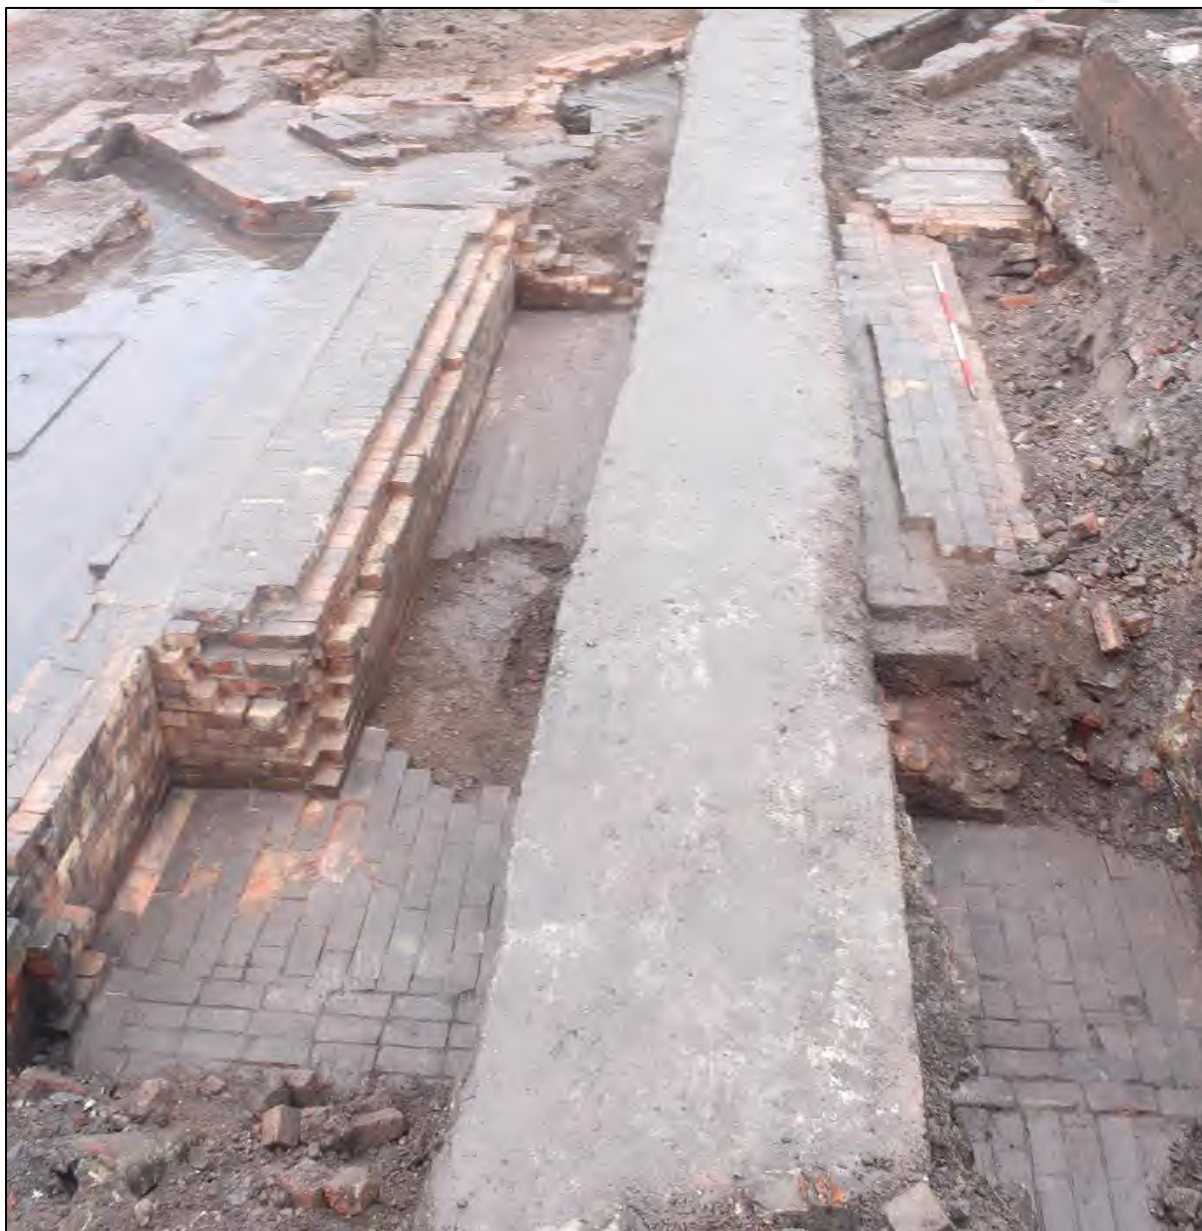
*Plate 69: View of the boilers 221 and 222 and flue 217 looking west (2m scale)*

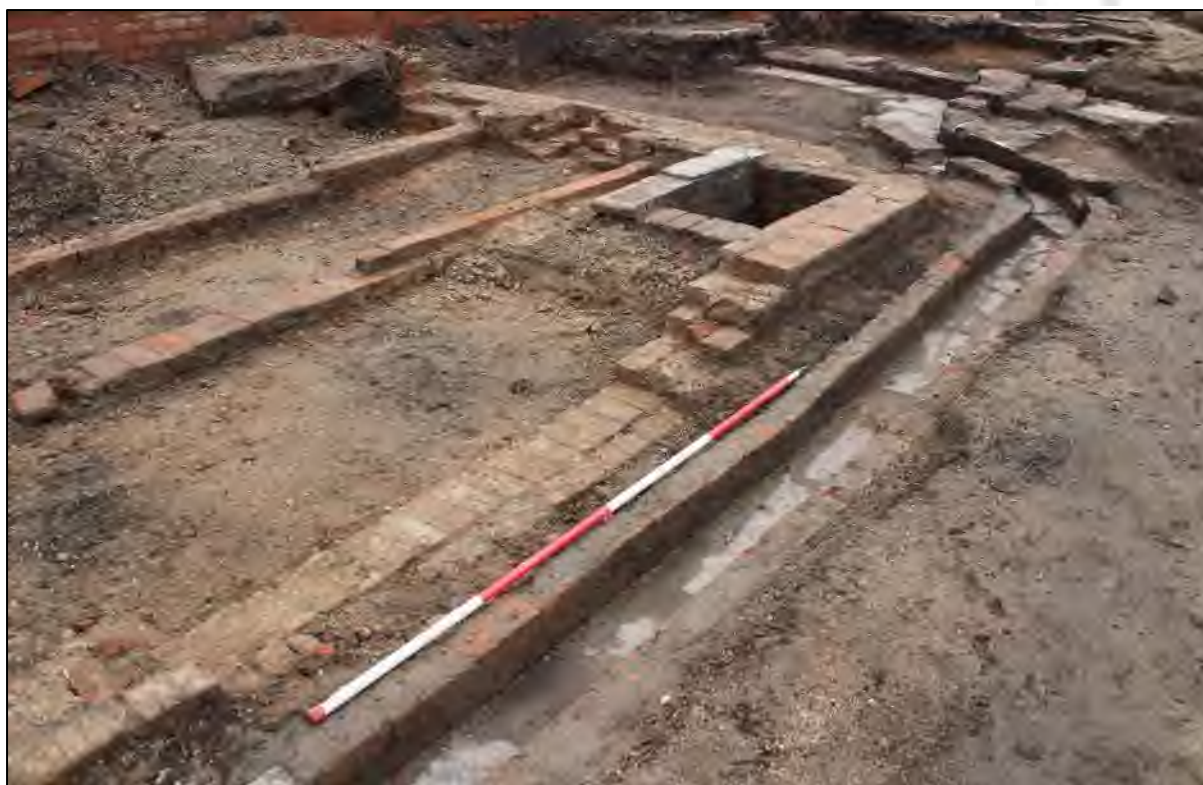
*Plate 70: South-east corner of Building A, showing the external drain 3007 running alongside wall 3002 (2m scale)*

Wall **3002** was aligned east-north-east / west-south-west (Plate 70). The brick wall, measured 0.35m in width and had a total length of 6.12m. It was constructed with handmade brick (brick dimensions: 215 x 105 x 60mm) bonded with a hard, yellowish/greyish white lime-based mortar with moderate charcoal flecks. Wall 3002 was keyed-into wall 3001. It was abutted by a rectilinear brick structure, 3009, probably dating from Phase 5. It was truncated by a later drain, which had been punched through the western extent of the wall, close to the junction with 3006. The drain for the most part respected the alignment of the wall, running alongside the exterior of Building A.

Structure **3007** was a drain feature which ran alongside wall. The western end was aligned northwest-southeast adjacent to Wall **3006**. It cut through Wall **3002** and continued to the east and beyond the limit of excavation towards the north. The total length of the drain was 14m. It had a width of 0.48m and an internal depth of 0.18m. It was somewhat crudely constructed of two single-course brick walls contained a slate-base. Occasional rough flagstone coverings were also present along with occasional reused firebricks. It was bonded with a light-grey ashy mortar.

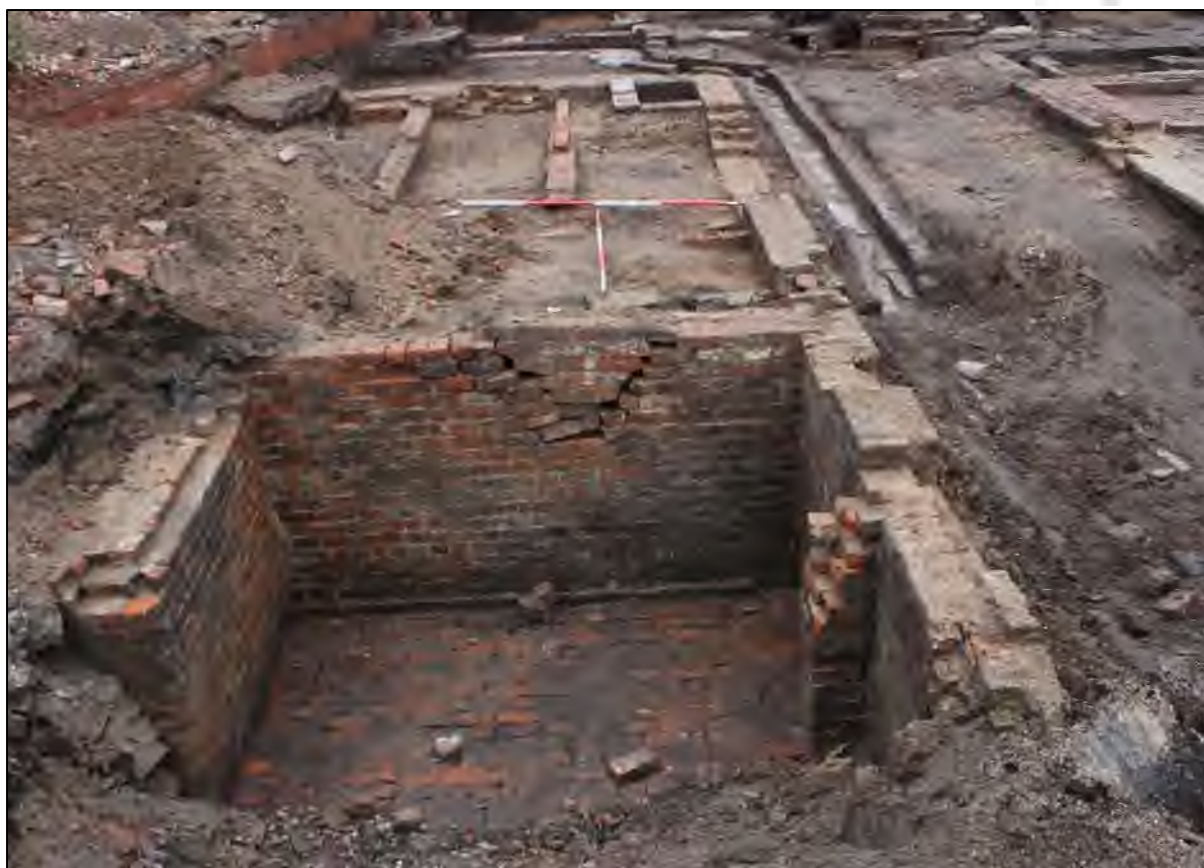
Plate 72: View of Building A, looking east (2 x 2m scales)

Wall **3053** extended westward from Wall **3006** for a length of 1.94 m. It had a width of 0.42m and a height of 1.70m. With walls **3006** and **3005**, it enclosed a small, cellared area (Plate 72) which was covered by the brick floor **3054**. The brick floor, **3054**, abutted the surrounding walls and covered a maximum area of 3.30 x 1.82m, extending westwards beyond the limit of excavation. It was found at a depth of 1.75m from the height of Wall **3006** and abutted the foundation step of that wall.

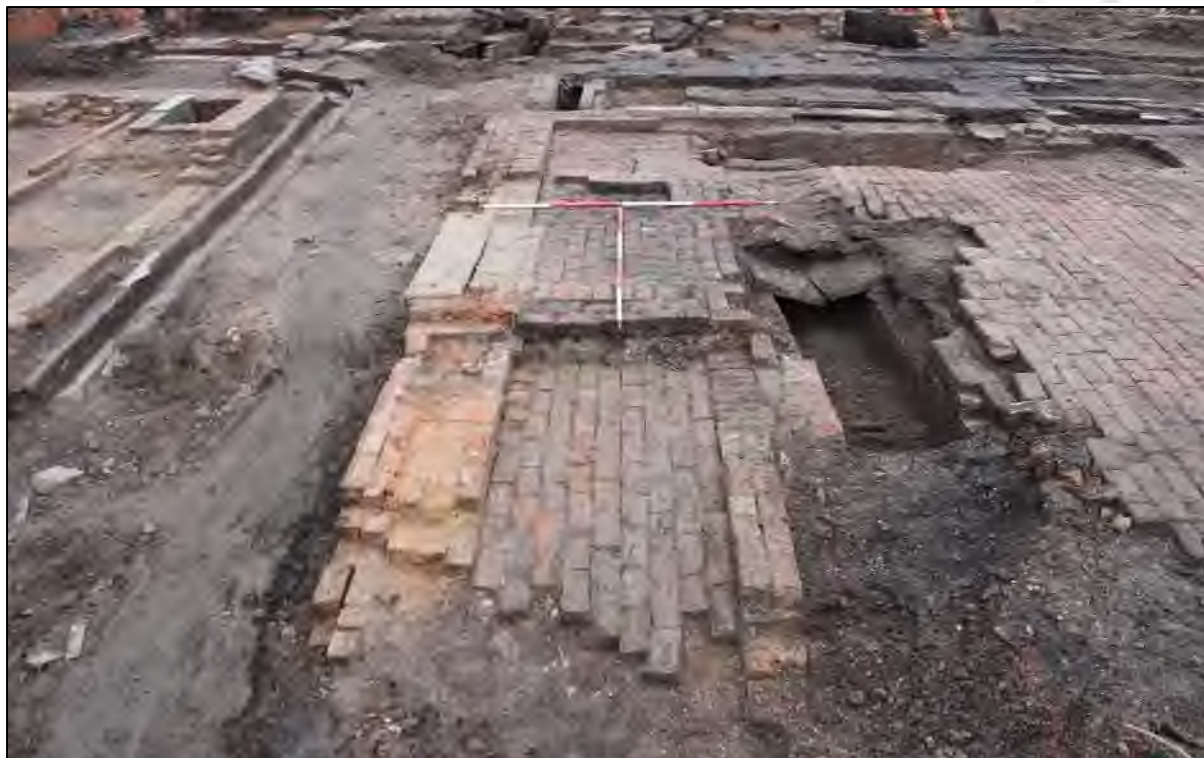
Plate 73: Walls 3011 and 3057 forming the northern wall of Building B. Note the yellowish-brown mortar and handmade brick forming the original one-and-a-half brick wall. Looking north-east (2 x 2m scales)

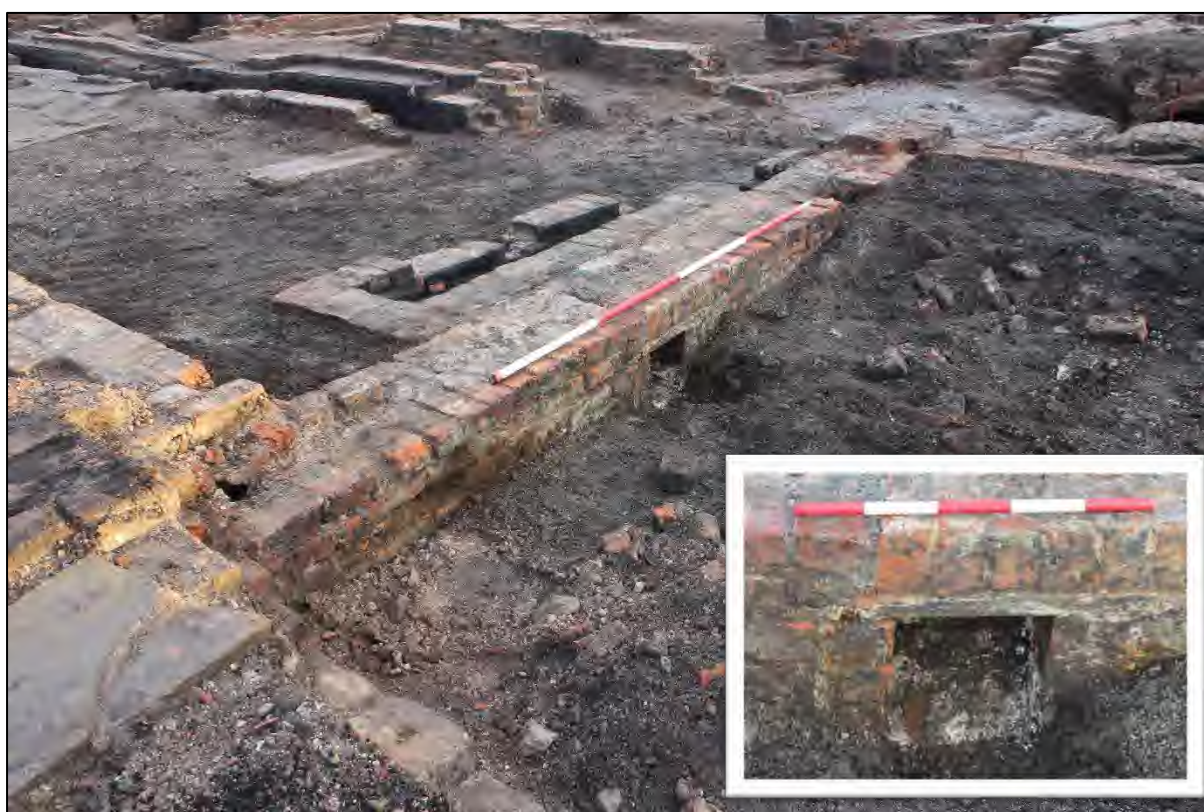
*Plate 75: Wall 3024 looking north-east (2m scale); inset showing rectangular aperture (0.50m scale)*

Wall **3024** was aligned northeast / southwest and formed part of the outer walls of the original *Phase 1* Building B (Plate 75). It had a width of 0.23m and a length of 4.65m. It was keyed-in to Wall 3026 and may have formed part of wall 3040, though this relationship had been disturbed through later insertions. As stated above, wall **3024** was abutted on its northern side by a later wall 3025. Present in the south-eastern face of the wall were two rectangular apertures.

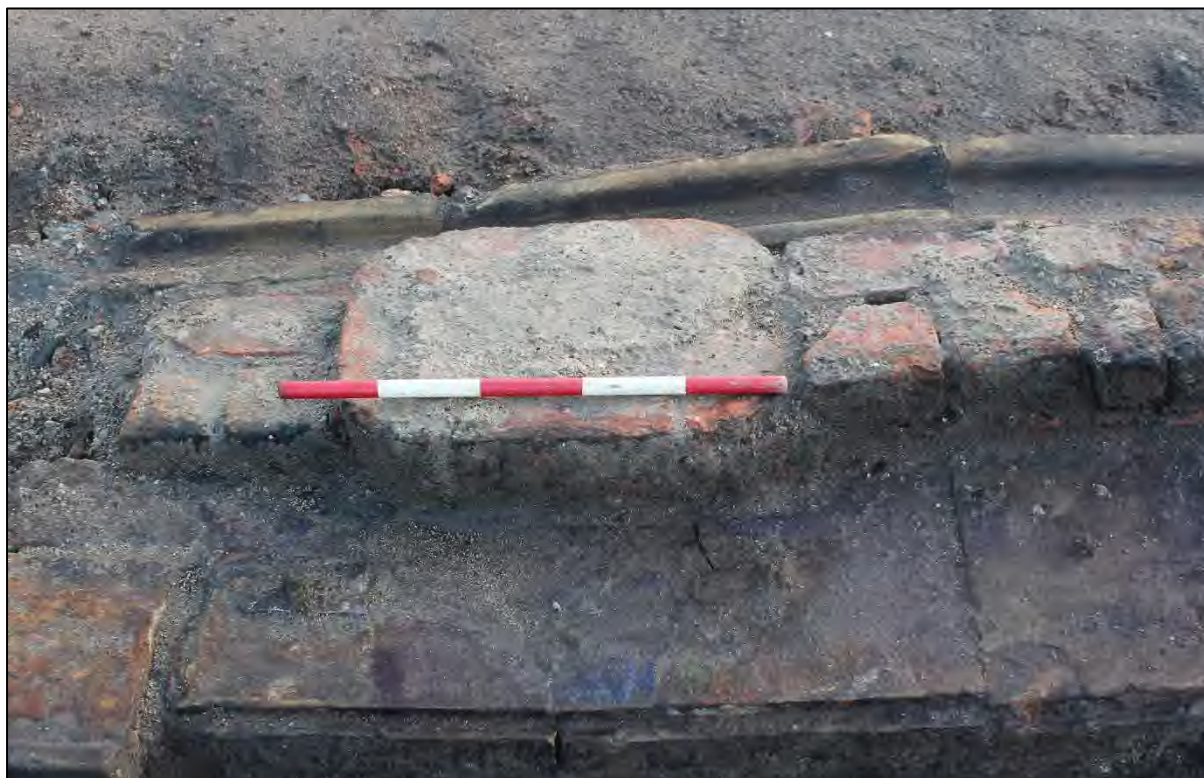
*Plate 76: Detail of brick pier in wall 3027 (0.50m scale)*

Wall **3027** was located at the east of Building B and was aligned north-west/southeast. It formed the eastern limit of the extension to Building B. It had a width of 0.21m and a length of 9.69m. The construction of the wall differed from the original walling techniques; it was narrower and incorporated a series of four brick piers constructed with rounded corners in bullnosed bricks (Plate 76); these measured 0.46 x 0.37m and were spaced 2.55-2.60m apart. The wall had suffered from subsidence, resulting in the movement and bowing-out of a large section of masonry. The southern end of the wall was removed almost in its entirety, perhaps as a result of later intrusive activity. A remnant of wall 3027 was found to abut wall 3026.

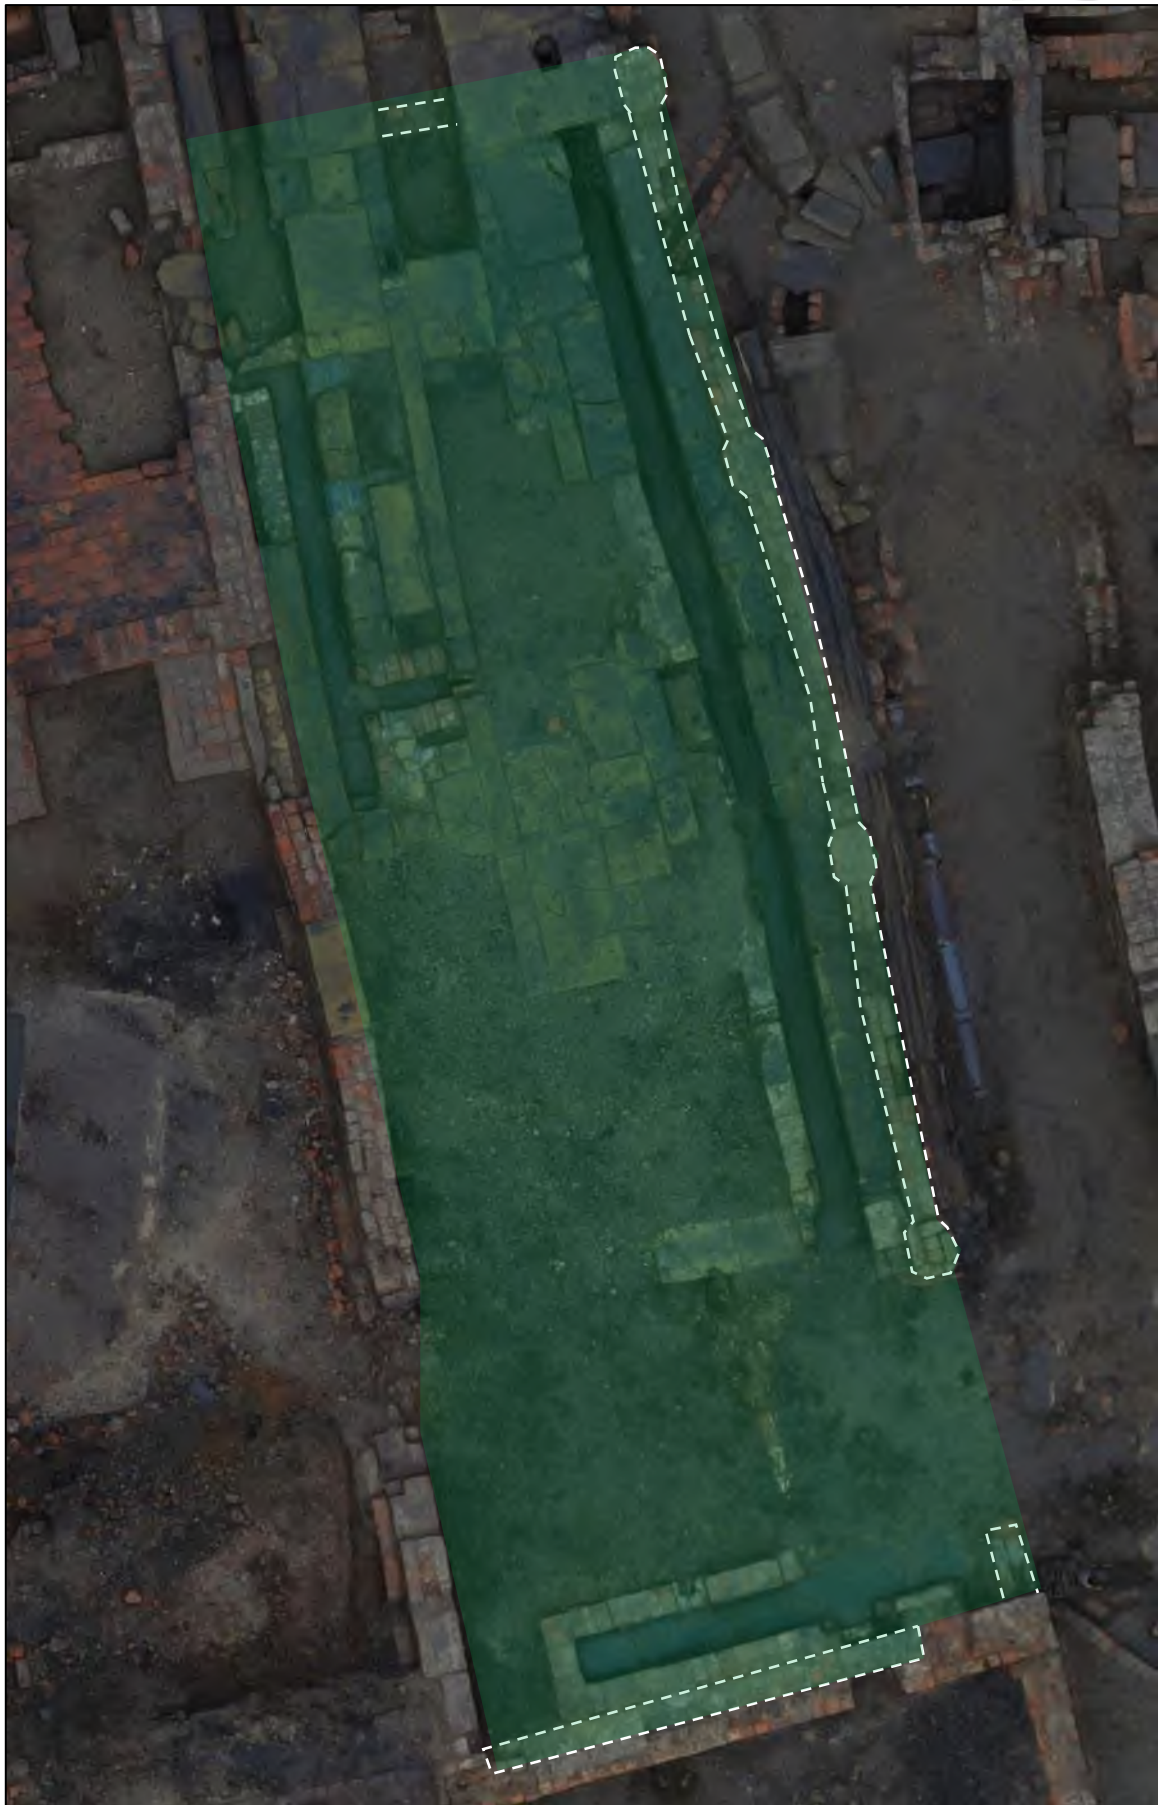
*Plate 77: The early 19<sup>th</sup>-century (Phase 2) extension, formed by walls 3025, 3027 and 3028*

The *Phase 2* rooms were created by the addition of three brick walls, 3025, 3027 and 3028, which were tacked onto the existing structure. Internally, the usable floor space was limited to a narrow corridor of flooring, measuring 2.50m in width, hemmed in on either side by two north-west/south-east aligned drains, which presumably stretched for the length of the building. 3037 and 3038. Stone flag flooring survived together with remnants of the sub-floor drains in the northernmost room, whilst to the south the only surviving structure was a drain positioned against wall 3025.

The southern wall of the extension consisted of an additional wall **3025** built directly against the north-western face of 3024. A phase break was visible running laterally between the two structures was observed. Wall 3025 also abutted the return of wall 3026.

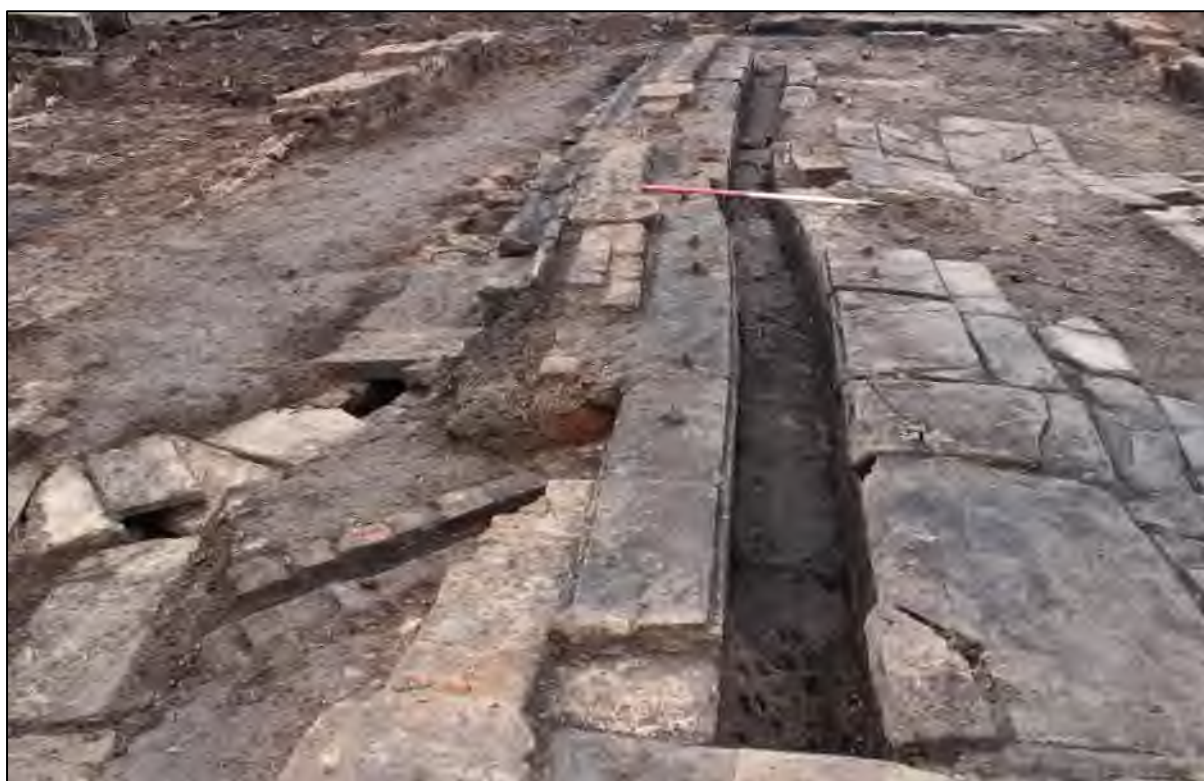
*Plate 78: View of drain 3038 constructed alongside wall 3027 looking south-west (1m scale)*

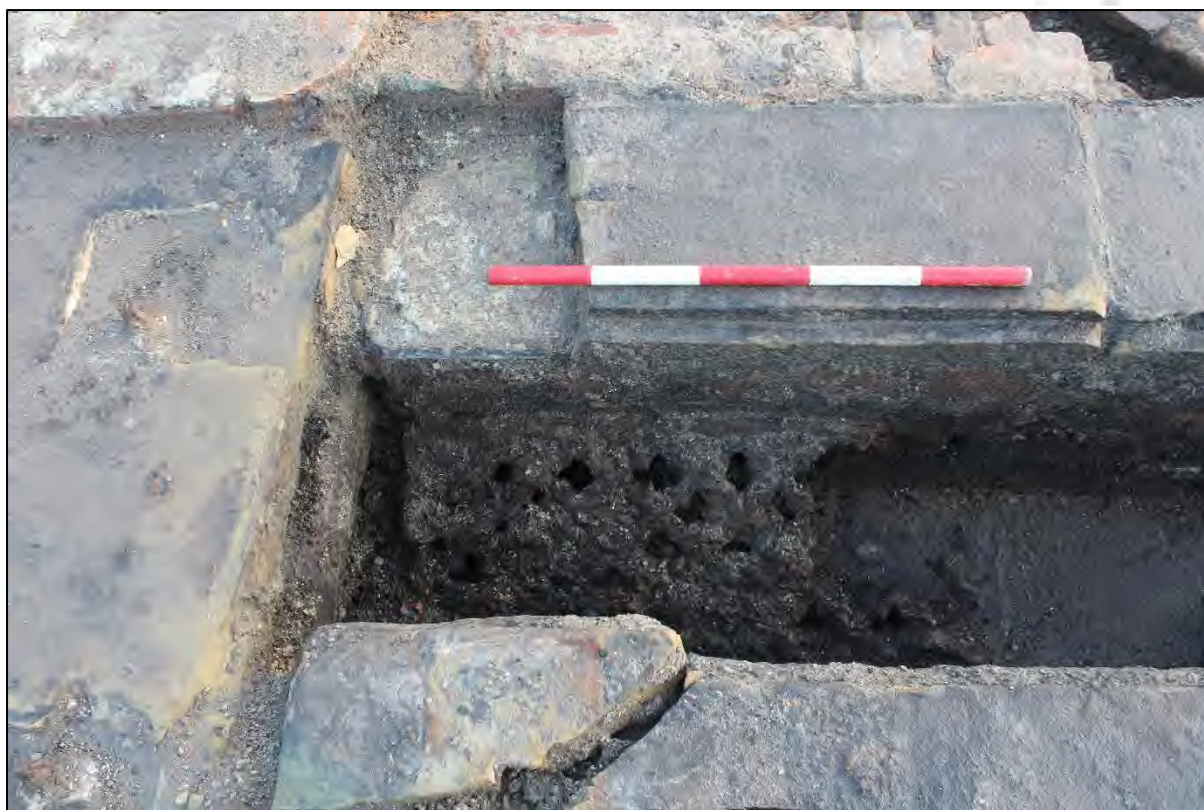
*Plate 79: Detail of the drain interior, rebated stone coping and collapsed cast-iron grate*

The best-preserved example was drain **3038**, which was aligned north-west/southeast along the western side of wall 3027 (Plate 78). This was constructed in brick with a slate base and stone coping. It had a width of 0.45m with an internal width of 0.22m. It had a length of 9.10m but was truncated at its southern end, suggesting it may have continued further to the south. The drain had been extended northwards during the second half of the 19<sup>th</sup>-century (Phase 4). The side walls of the drain were bonded with a yellow-coloured lime-based mortar and had been capped in large fragments of sandstone coping, which sat flush with the adjacent flooring slightly overhanging the interior of the drain. The copingstones were rebated to hold a cast iron grate; fragments of the grate had collapsed into the base of the drain (Plate 79). Upright fittings were also set into the copingstones in regular groupings. Noticeable groups of four (two pairs of opposing bolts) were suggestive of the position of installations, perhaps dyeing stations. The interior of the drain was stained heavily with traces of vivid purple and blue (cobalt) dye, which may represent run-off from the dye making or printing processes.

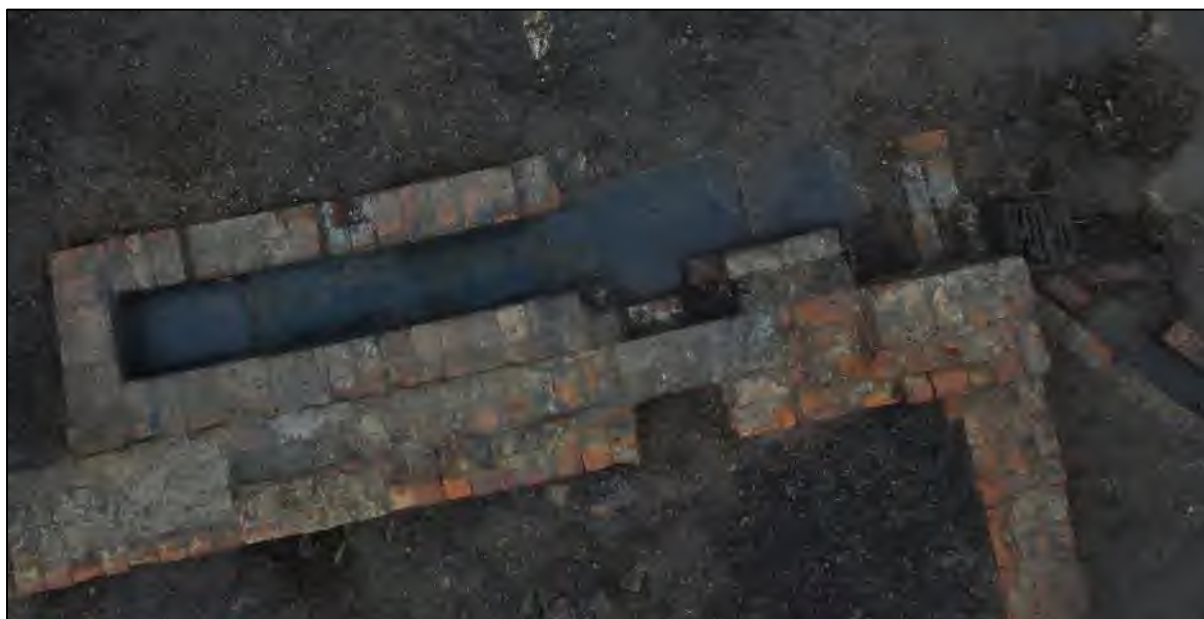
Plate 80: Sub-aerial view of slate-lined drain 3039 with part of drain 3052 visible to the east, looking north

Based upon the building materials and the historic map regression, a few structures associated with Building B have been ascribed to *Phase 3*. These include a further drain, **3039**, which was aligned north-east / south-west and abutted the northern face of wall 3025 (Plates 80 and 81). It was constructed in brick with a slate-covered base, similar in construction to drains 3037 and 3038. It had a width of 0.82m, an internal width of 0.34m, and a length of 2.80m. It was bonded with a mid-grey lime-based mortar, which although similar in colour to wall 3025 contained far less lime content. The mortar used probably contained a mixture of ash and lime, a technique which is indicative of mid-19<sup>th</sup> century construction and began to be adopted in the 1840s (Nevell, 2017, 6). The interior of the drain was stained blue with dye.

Drain **3052** was located at the southeast of Building B and was probably contemporary with 3039. It was aligned north-west / south-east and constructed in brick and slate. It measured 0.45m in width, with an internal width of 0.20m and was 4.50m long. The drain inlet at the north-western end was covered by a cast iron grid; it was also fed by a later ceramic stoneware
