## Archaeological Excavation Report

Mayfield,  
Manchester

**Report No:**  
SA/2021/56

**Project:** Mayfield, Manchester: Archaeological Excavation

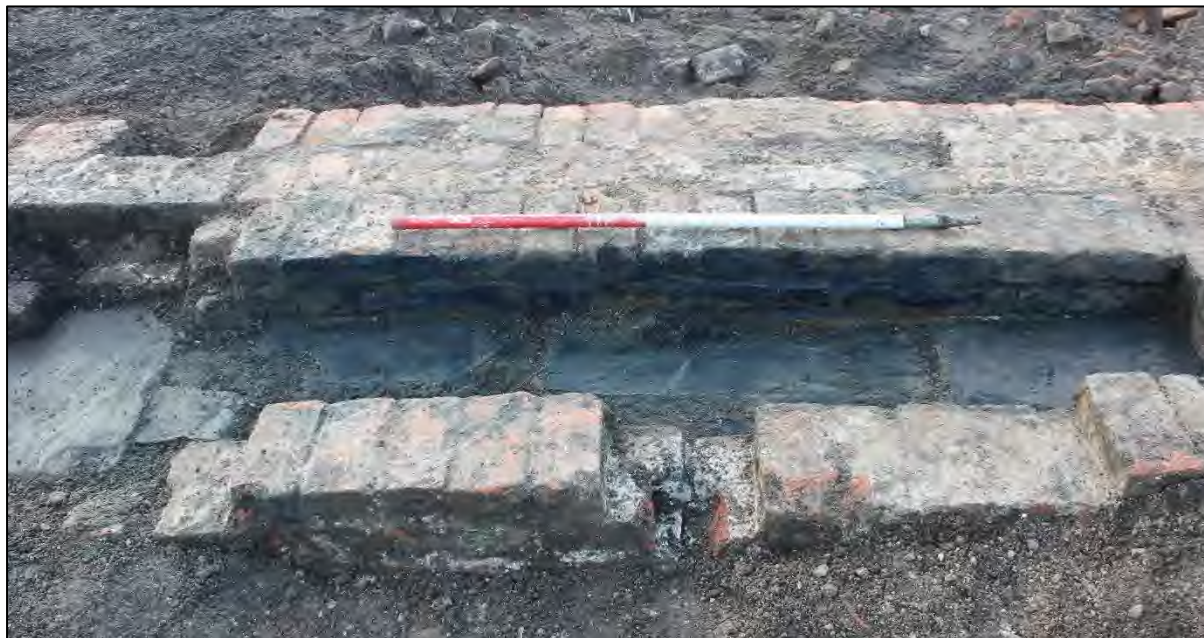
*Plate 81: Slate-lined drain 3039 (1m scale)*

Based upon the building materials and the historic map regression, a few structures associated with Building B have been ascribed to *Phase 3*. These include a further drain, **3039**, which was aligned north-east / south-west and abutted the northern face of wall 3025 (Plates 80 and 81). It was constructed in brick with a slate-covered base, similar in construction to drains 3037 and 3038. It had a width of 0.82m, an internal width of 0.34m, and a length of 2.80m. It was bonded with a mid-grey lime-based mortar, which although similar in colour to wall 3025 contained far less lime content. The mortar used probably contained a mixture of ash and lime, a technique which is indicative of mid-19<sup>th</sup> century construction and began to be adopted in the 1840s (Nevell, 2017, 6). The interior of the drain was stained blue with dye.

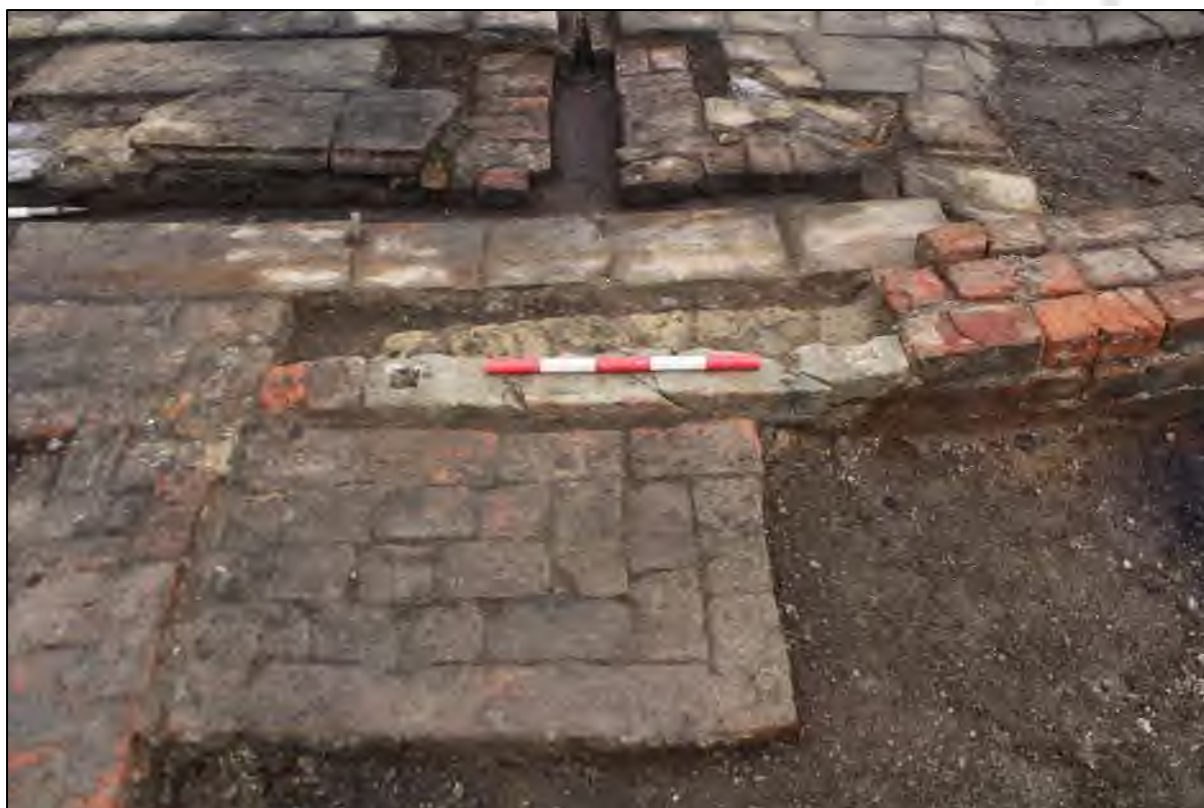
*Plate 82: The Phase 3 Brick Pad 3056 abutting walls 3058 and 3022, obstructing an earlier threshold, to the rear (0.50m scale)*

Other internal changes were made during this period. Two rectangular brick pads **3055/3056** abutting the southern face of wall 3058 and were located within the original part of Building B. Both were constructed in a similar fabric to 3039 utilising an ash-mortar. It was also clear that these were added after a threshold in wall 3022 had fallen out of use. The easternmost brick-pad 3056 measured 0.93 x 0.60m, whilst 3055 to the west measured 0.91 x 0.65m (Plate 82). The function of the structures is unclear.

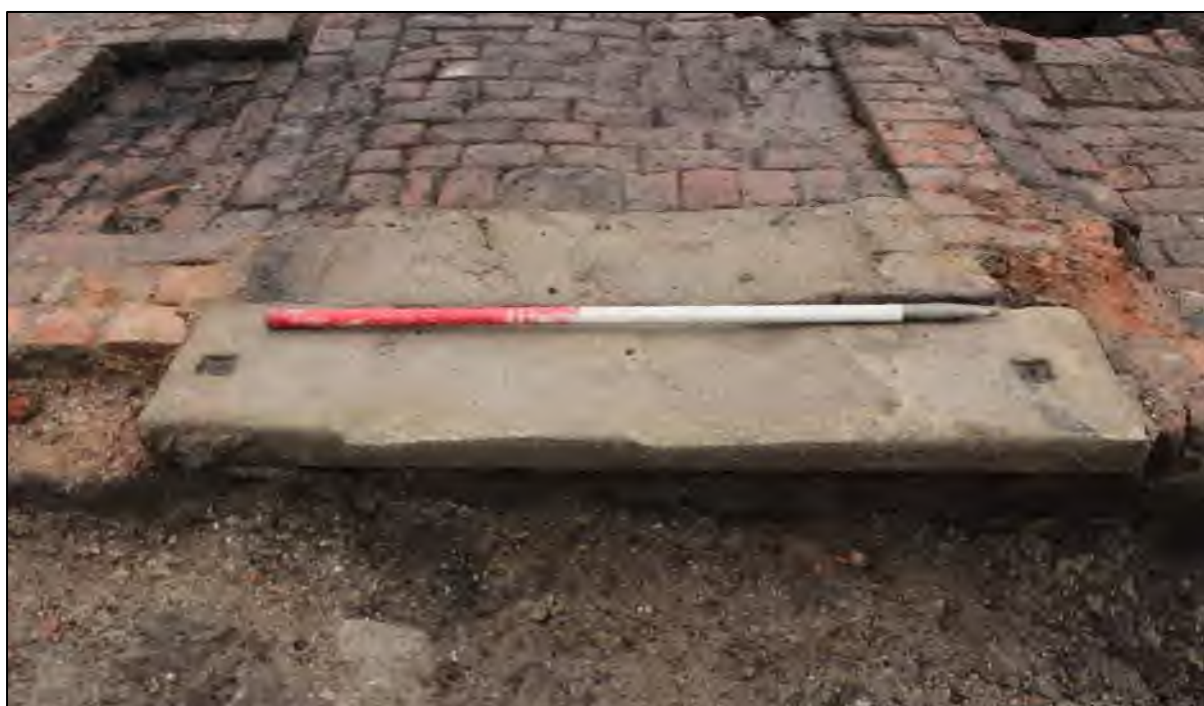
*Plate 83: Wall 3010 featuring a later threshold with rectangular sockets for the door jambs. The earlier wall and threshold are visible to the rear. Both exhibit traces of significant wear. (1m scale)*

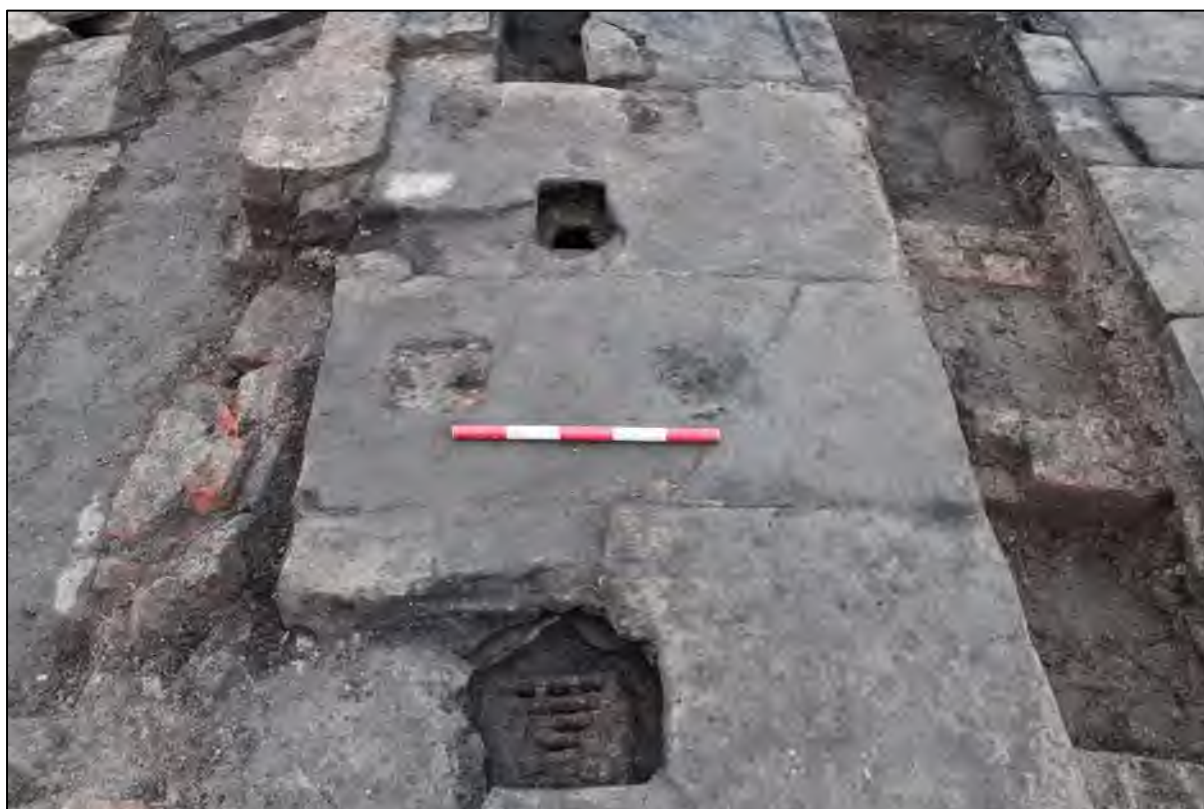
*Plate 84: The fittings and drains set into the flags capping the extension of drain 3038 (0.50m scale)*

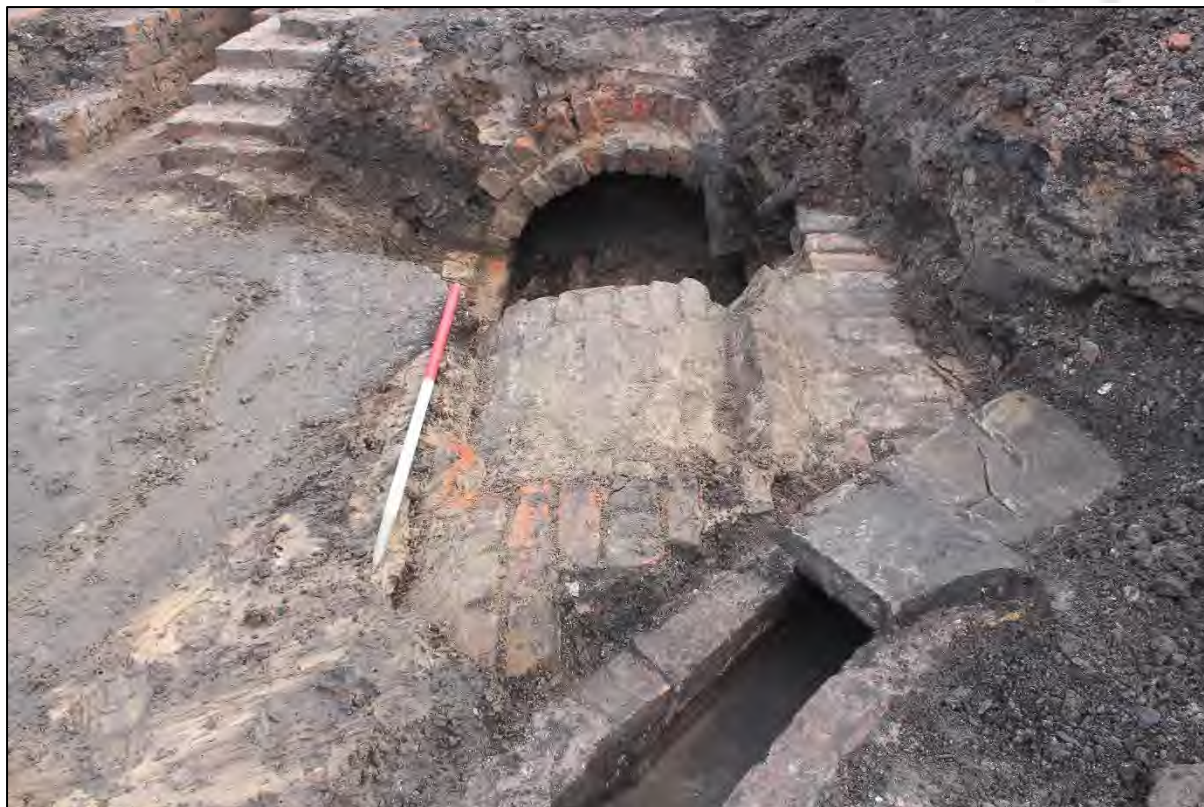
*Plate 85: Vaulted culvert 3079 truncated by drain 3052*

pipe, which had been punched through the side wall of the drain. Remnants of stone capping survived *in-situ* at the exposed south-eastern end of the structure. The walls of the drain abutted wall 3026 and continued beyond the limit of excavation towards the southeast. It was noteworthy that this structure post-dated a brick vaulted culvert 3079 (discussed below), visibly truncating the puddling clay seal and brickwork of the earlier culvert.

A large culvert **3079** was also ascribed to this phase on the basis of its apparent relationships with other structures and its construction (Plate 85). It was situated to the east of Building B, in the south-west of Area 3. **3079** consisted of a brick-built culvert which was aligned northeast/southwest. It had a width of 1.20m and was excavated to a depth of 0.46m, although internally it appeared to be in excess of 1m; the structure was visible in plan over a length of 2.58m. It was bonded with a yellow sandy mortar and utilised handmade bricks. It had a rounded corbelled roof which had been partially disturbed during the excavation. It was truncated at both the eastern and western ends by the drain 3052, and the Wall 3076, respectively. It's temporal relationship to Building B is unclear, although it likely ran beneath the building.

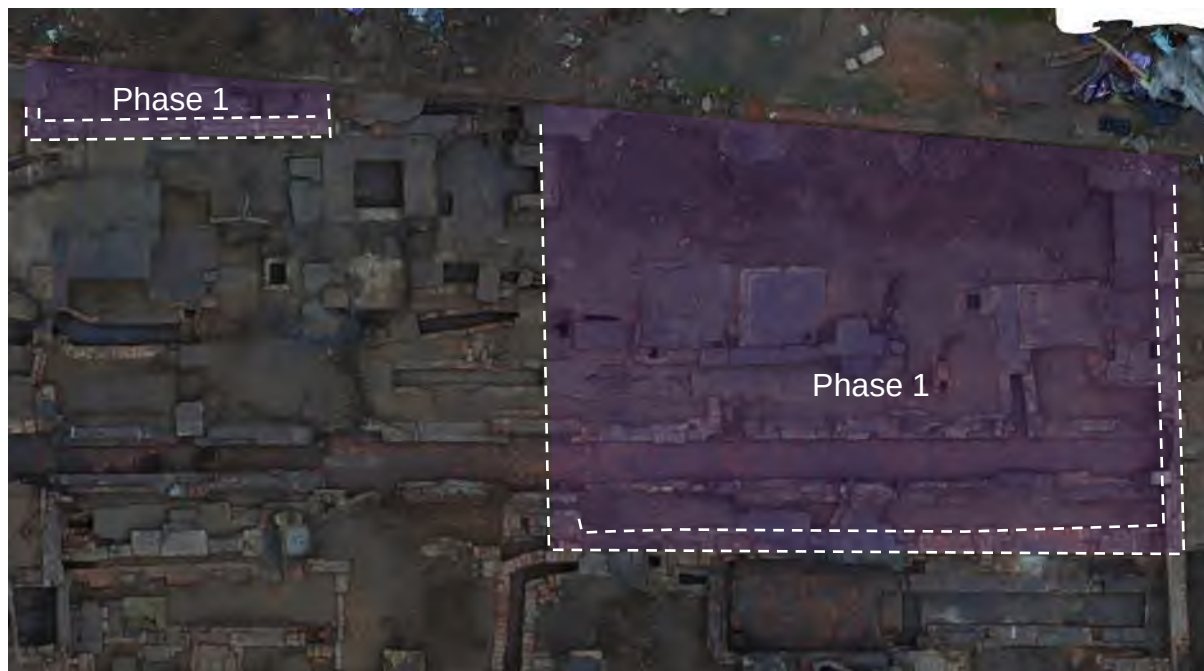
*Plate 86: Phase 1 elements of Building C*

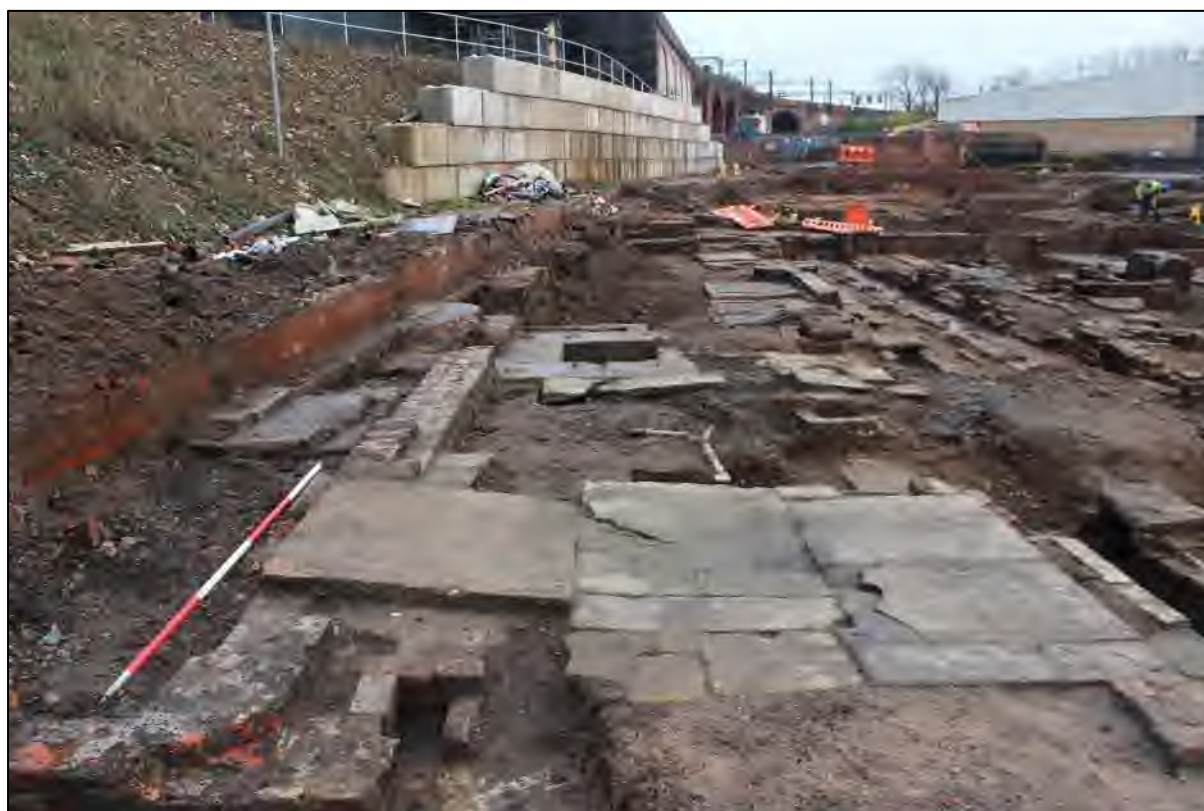
*Plate 87: View east along wall 3078 (2m scale)*

Wall **3078** was aligned east/west at the north of Area 3 (Plate 87). This wall corresponds to the southern side of a building depicted on Green's map of 1794. It had a maximum width of 0.36m and had a total exposed length of 9.10m. It consisted of three courses of handmade bricks which were bonded with a yellow sandy lime-based mortar. It returned to the north, forming part of the western wall of Building C. It was abutted by several other later structures visible within the northern section of the trench. Part of the wall was overlain by a flag surface, indicating the position of a later threshold inserted through the wall.

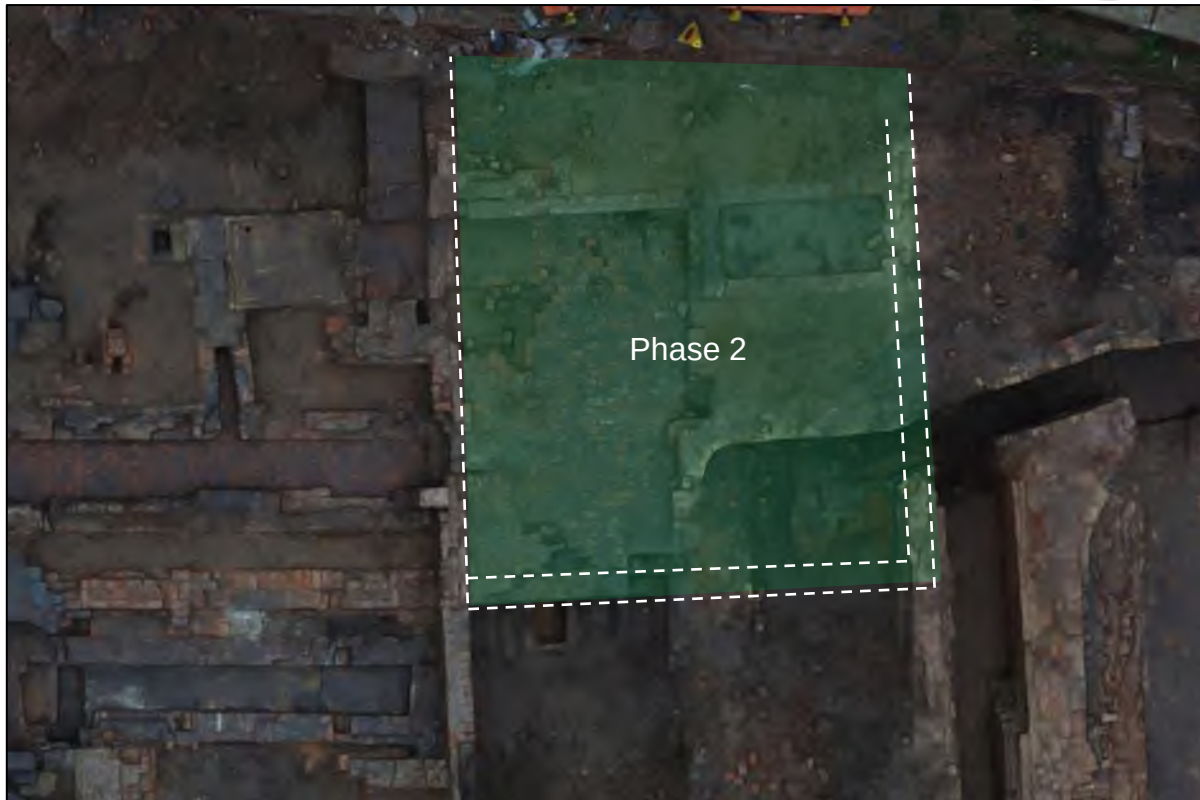
Plate 88: Aerial view indicating the eastern area of expansion within Building C during Phase 2

Two clear elements of *Phase 2* expansion were identified in the northern half of Building C. One of the extensions abutted the eastern side of the *Phase 1* wall 3119 (Plate 88); this portion of the structure was delineated by **3120** to the south and **3106** to the north and walls **3126=3127** to the east. A surviving floor surface **3084** and internal flight of steps **3107** were viewed as broadly contemporary to the walls.

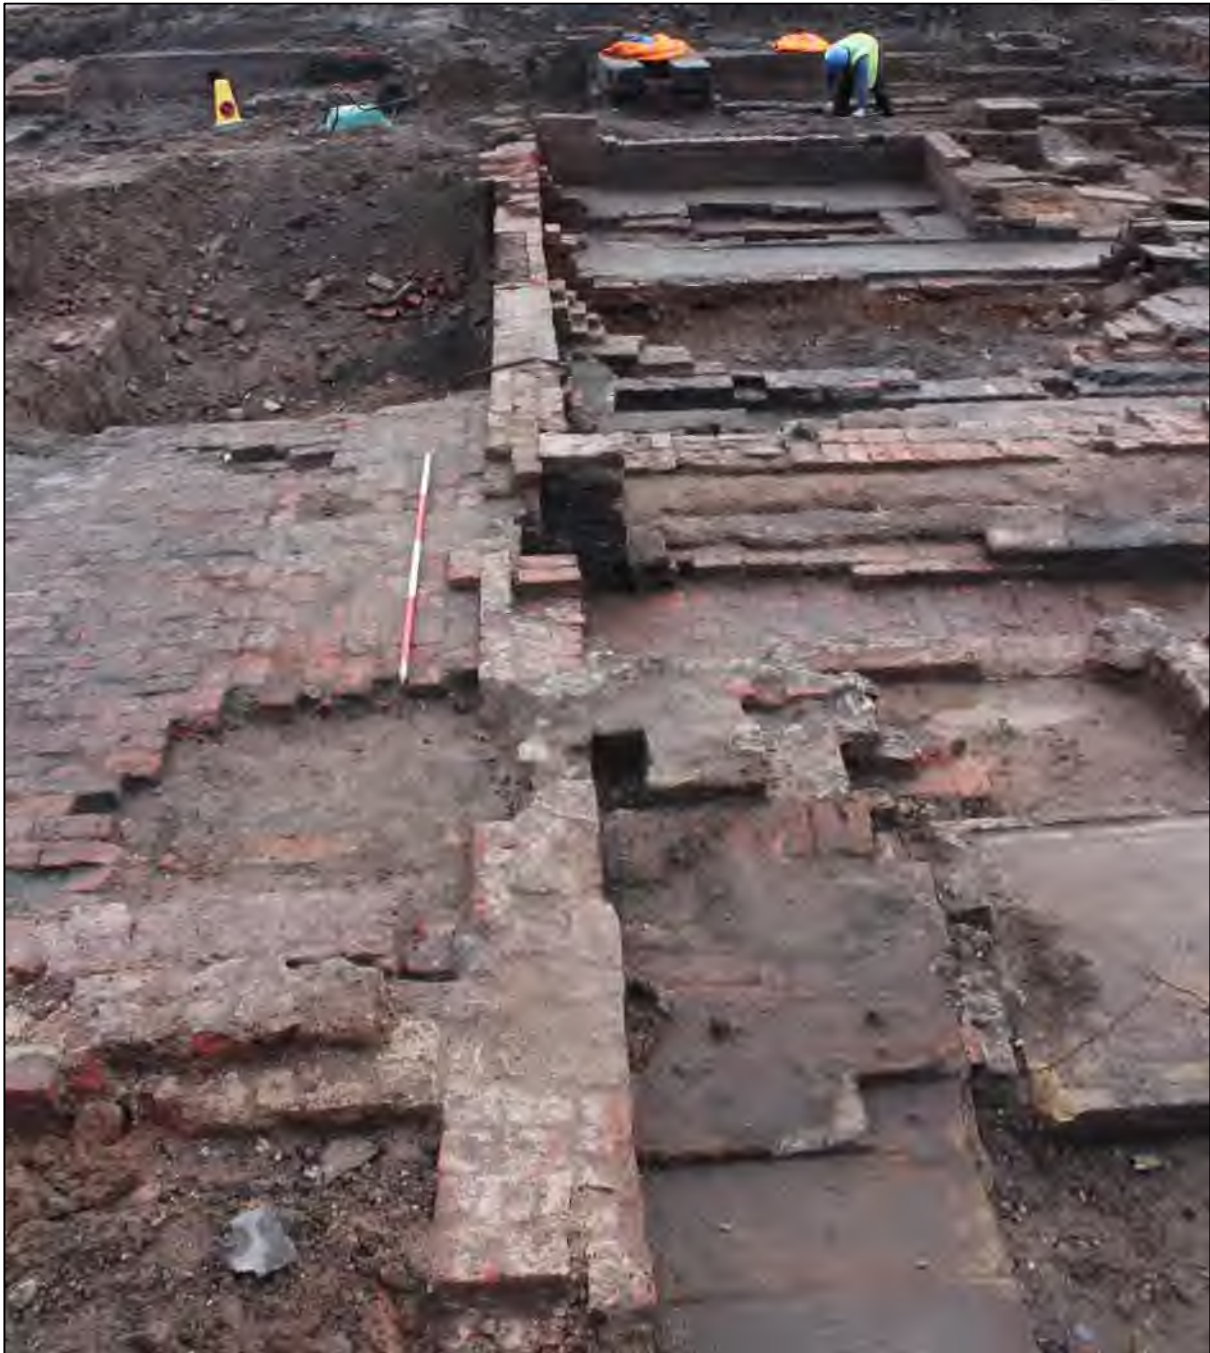
*Plate 89: View looking south along wall 3119 with the Phase 2 structures to the east (left) 2m scale*

Walls **3119** and **3115** were identified as belonging to the first phase of development of the dye works. Wall **3119** was located at the northeast of Area 3 (Plate 89). It was aligned north/south and was bonded with a yellow sandy lime-based mortar. It had a width of 0.36m and a length of 6.52m though it continued beyond the limit of excavation towards the north. It was abutted by multiple features and walls of later phases. At the south it returned towards the west as Wall 3115.

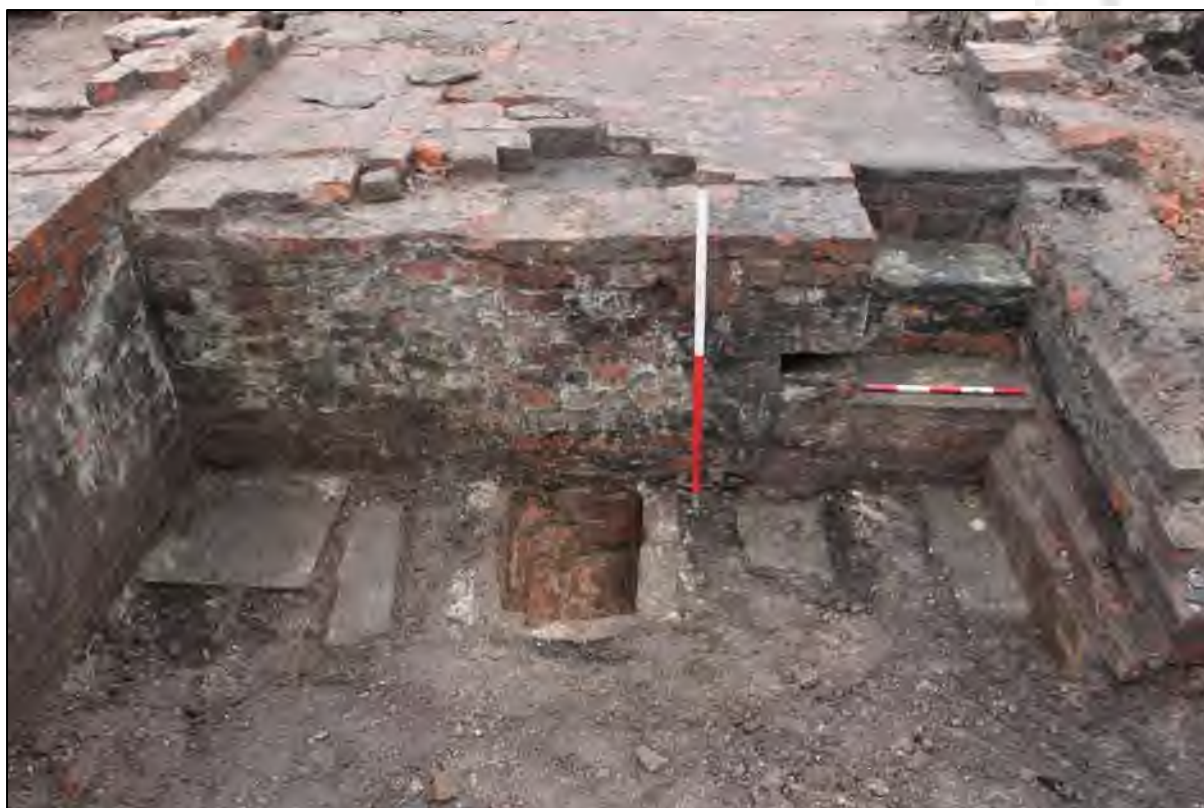
*Plate 90: Surviving extent of Wall 3120 showing the integrated short flight of steps, looking north (1m and 0.50m scales)*

Wall **3120** was laid parallel to 3106 4.55m and positioned to the south (Plate 90). This once formed the southern external wall of this part of Building C, as can be seen on Bancks and Co's map of 1831 (Figure 15). The eastern half of the wall, where it originally was keyed into wall 3126 had been removed during the expansion of the adjacent flue system 3064. The surviving western half of the wall stood to a height of 1.20m, measuring 0.36m in width 2.05m in length. Built into the middle of the wall were a set of steps, which led up to Floor **3084**. Two flagstone treads were uncovered which measured 0.60 x 0.25m with two course brick risers, 0.22m in height.

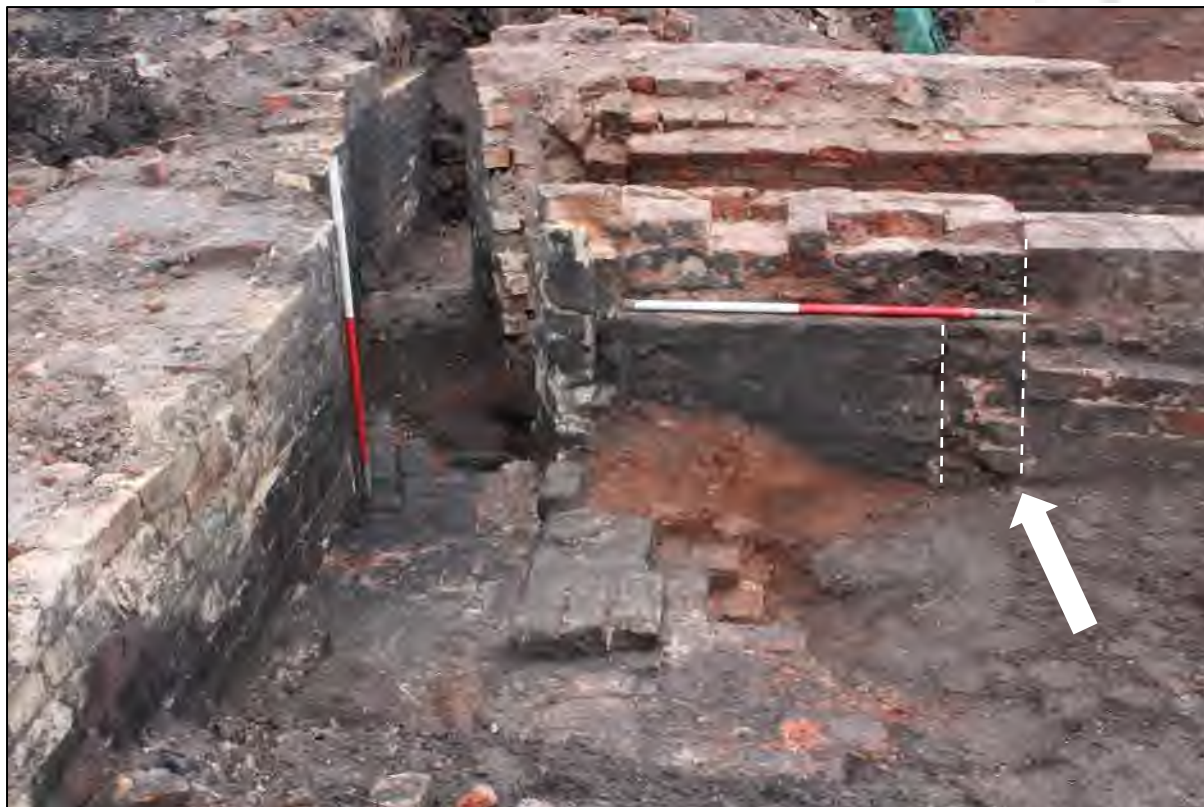
*Plate 91: Remains of wall 3126 with the vertical phase break and truncated return of the wall, incorporated into a later extension of flue 3064, looking east (2 x 1m scales)*

The eastern side of the Phase 2 extension was represented by the fragmentary remains of two walls, thought to be contemporary: **3126=3127**. Both were constructed in handmade brick and were bonded with a greyish-white lime-based mortar. **3126** was aligned north / south and had a surviving length of 1.32m, truncated to the north by flue 3064. The remains of a westerly return, evidently once forming 3120 were visible in the upstanding elevation of the wall (Plate 91). The wall was lined with later walls forming parts of flue 3064 and an associated flue or walkway 3069. Continuing to the north of the flue was another element of the same wall **3127**, visible in plan for 3.48m. This measured 0.46m in width and had been subject to partial repair or modification during the construction of the adjacent flue. The repaired area measured 0.61 x 0.47m and was bonded in a grey ash mortar. The wall was truncated to the north by a modern wall.

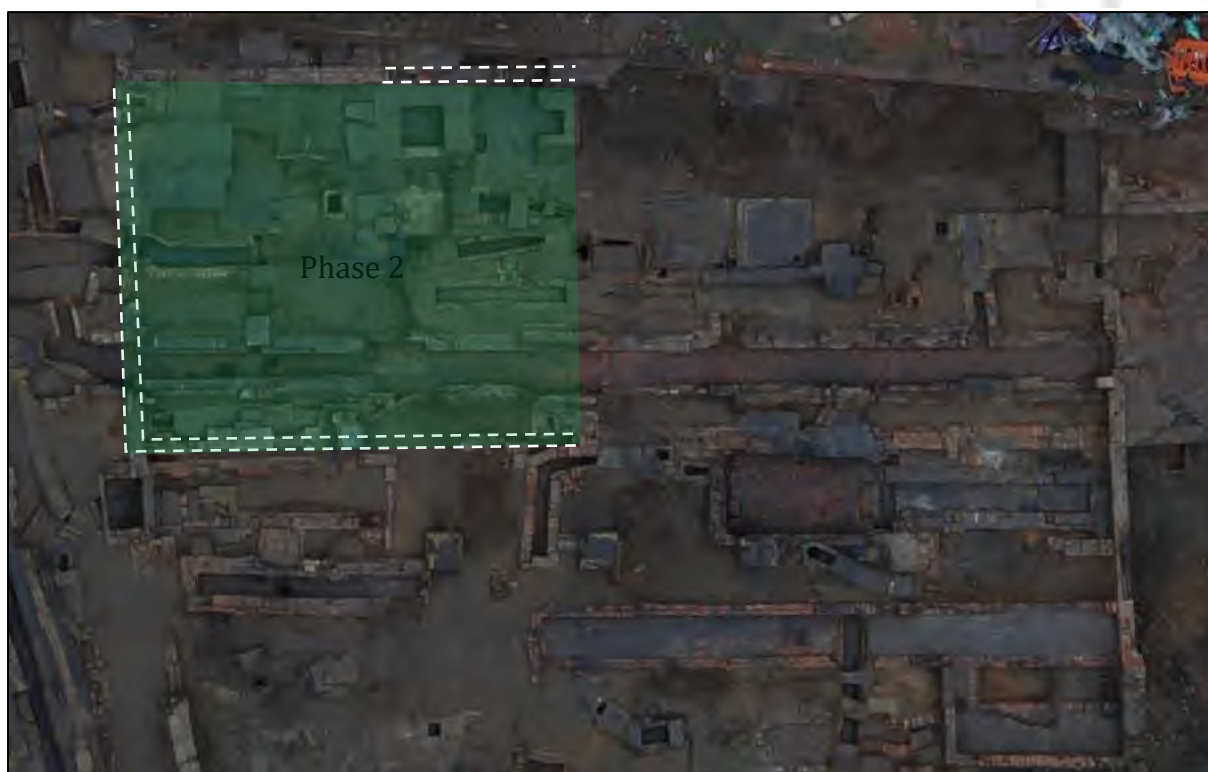
*Plate 92: Aerial view showing the western half of the Building C expanded during Phase 2*

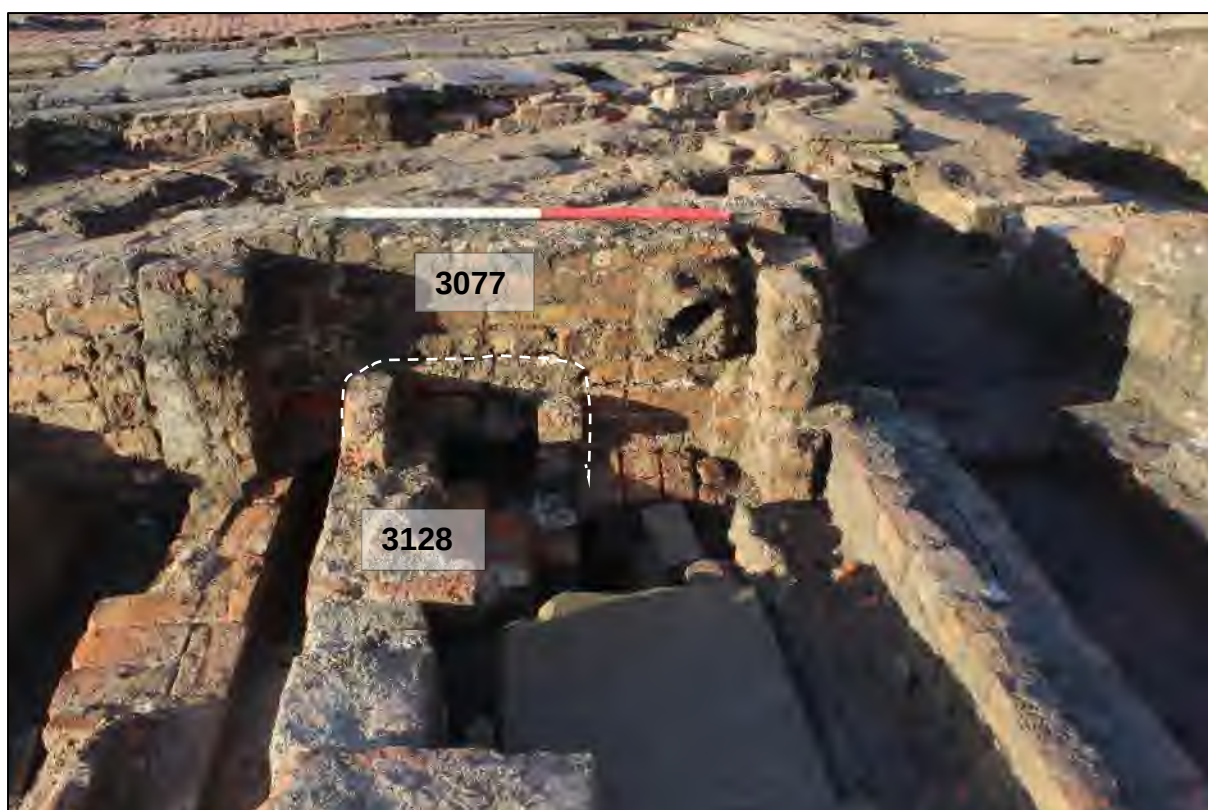
*Plate 93: Phase 2 walls 3103 and 3128 overlain by wall 3077 (1m scale)*

Wall **3103** consisted of the partial remains of a brick wall (Plate 93), which was located at the west of Building C. It was aligned north/south and abutted wall 3078 at its western end. It had a width of 0.35m and a maximum length of 5.35m. It had likely been heavily modified in later phases to accommodate various drains. In plan, it had no clear relationship with Wall 3077, however closer examination of the wall fabric above 3128/3103 revealed a phase break consistent with the southern half of the wall being rebuilt during Phase 3. From historic mapping it was clear 3077 was added in *Phase 3*, during which time the southern wall 3128 was reduced in height.

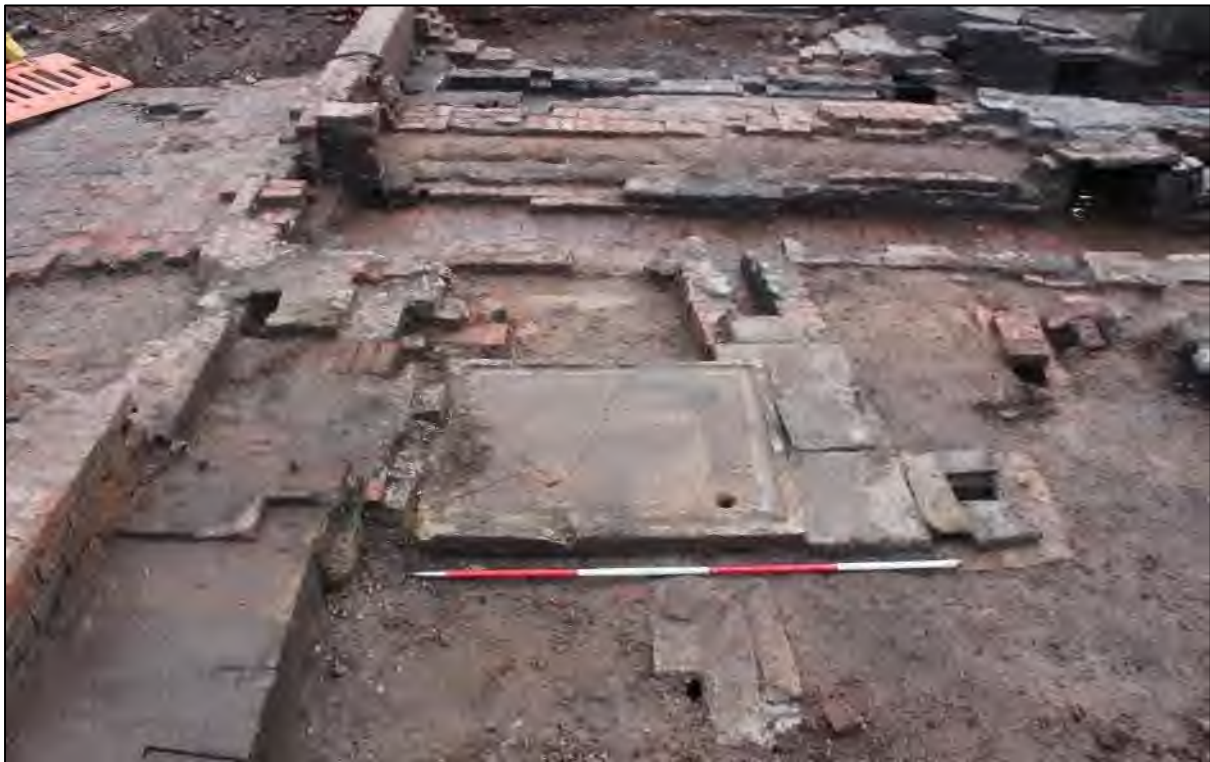
*Plate 94: Vat base 3104*

The earliest example is probably 3104 situated in the *Phase 1* element of Building C and was rectangular in shape measuring 1.49 x 1.16m (Plate 94). This exhibited slight yellowish-green staining, seemingly deriving from its use.

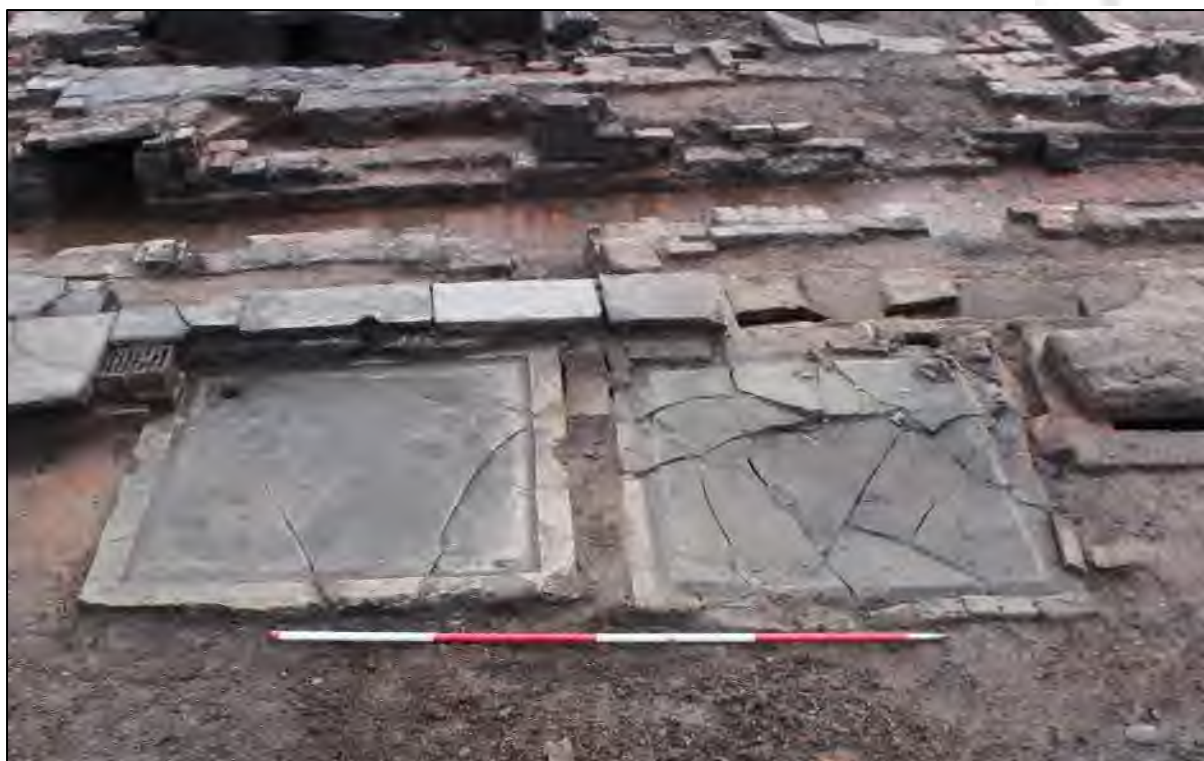
*Plate 95: Vat bases 3098 and 3099 looking south (2m scale)*

Two further vat bases were found to the west 3098 and 3099 (Plate 95). These were close to square in shape, measuring 1.59 x 1.57m. Both 3098 and 3099 were incised with markings, presumably carved by the masons who shaped these stones (Plate 97). A raised flag floor surface 3102 together with a cast iron grate had survived along the southern side of the slabs (Plate 96). Floor **3102** measured 3.80 x 1.02m.

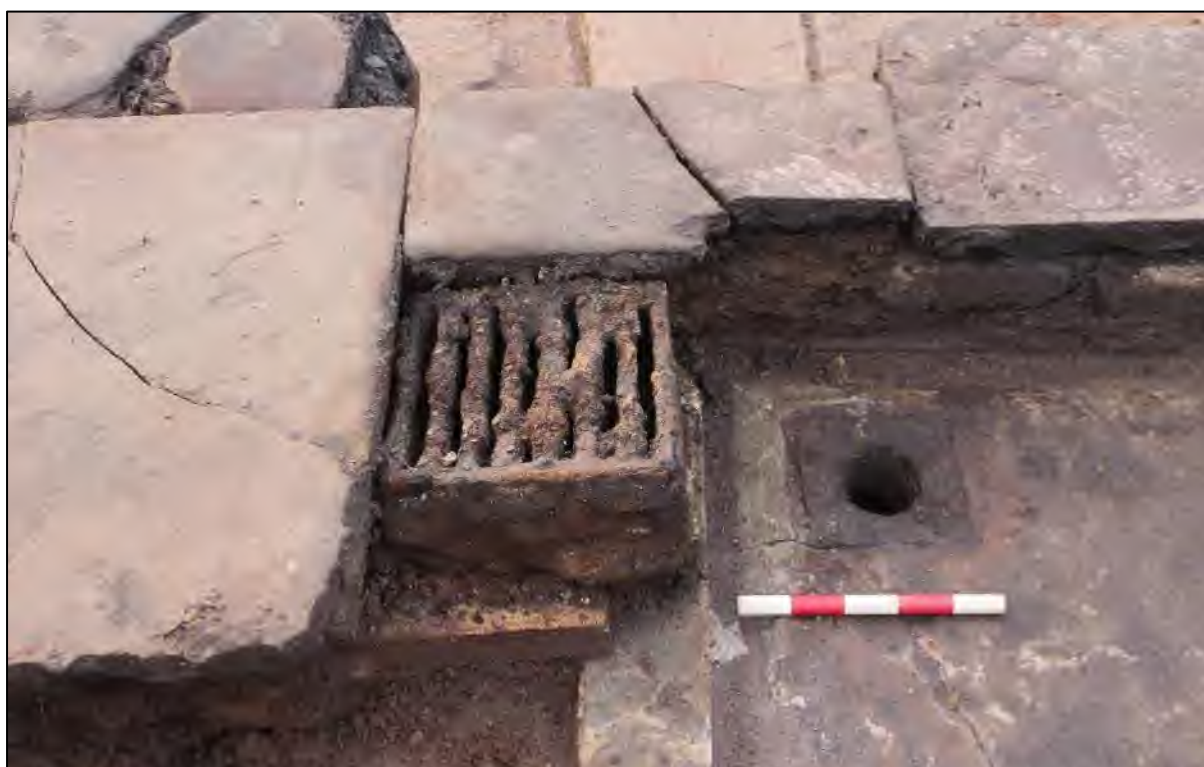
*Plate 96: Detail of the plug hole, adjacent drain and floor surface 3102, raised slightly above the stone slab forming the vat base 3098 (0.25m scale)*

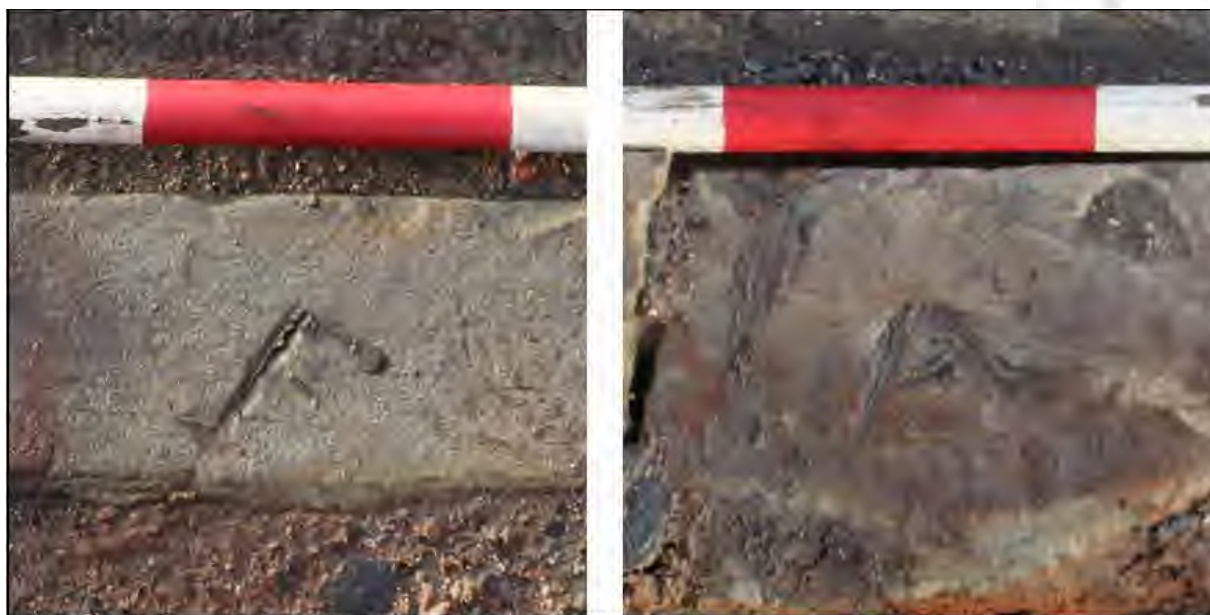
*Plate 97: Detail of the masons' marks on the vat bases 3098 and 3099*

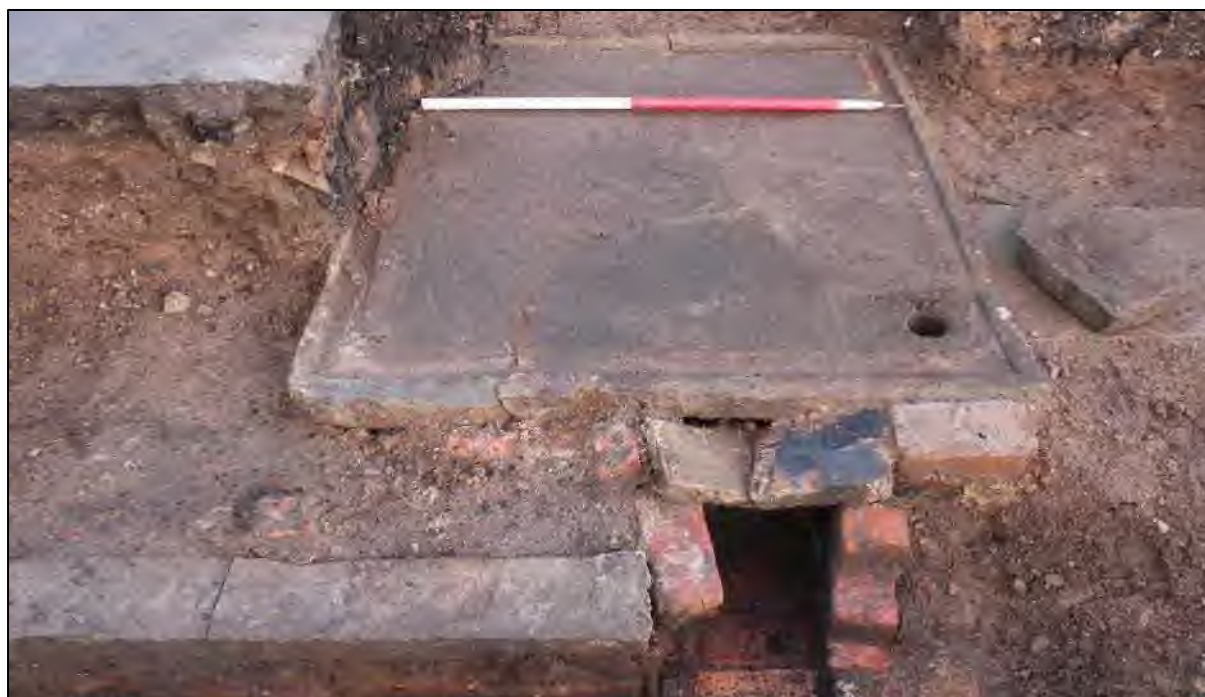
*Plate 98: Vat base 3118 looking north (1m scale)*

The fourth vat base was exposed in the north-western corner of Building C. 3118 was a slightly smaller example than the other three slabs but broadly similar in form (Plate 98). It measured 1.35 x 1.34m and was 80mm thick. Of particular relevance was a buried lead water pipe, seemingly representing a means of feeding the tanks with water. The visible ends of the pipe were deliberately bent over, consistent with this vat becoming obsolete. This was further supported by a later floor surfaces 3138 and 3139, which had been raised 0.32-34m above the vat base (Plate 98).

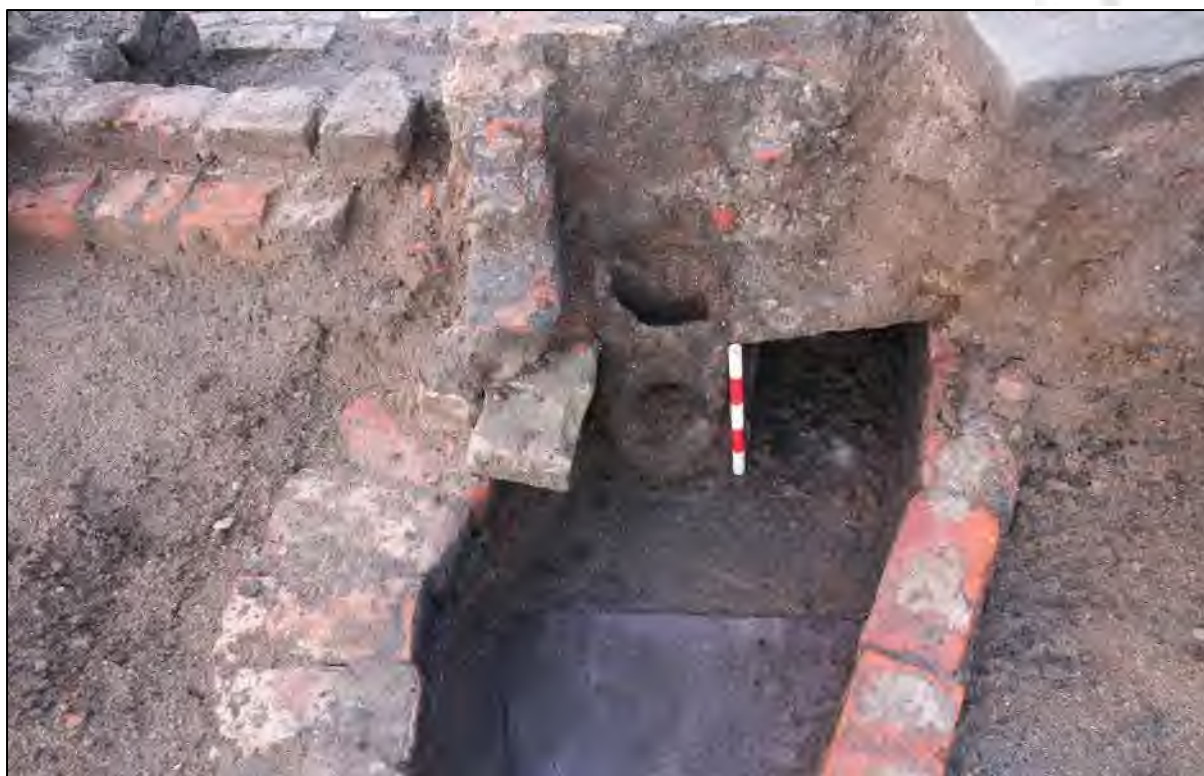
*Plate 99: Drain 3093 with cast iron downpipe and spout (0.25m scale)*

A number of smaller predominantly east / west aligned, covered drains (3093, 3134, 3135, 3117) were identified within the footprint of the Phase 1 / 2 buildings. These represent a different category of sub-floor drain and capped with flags. Linked to several stations (vat bases) where washing or dyeing processes were carried out these evidently allowed for the vats or tubs to be emptied quickly and were fed by plugholes in the stone vat bases. The drains were also connected to an exterior drain 3049, which ran northwards beyond the limit of excavation. Other small rectangular openings were noted in the tops of the drains and also acted as inlets, as well as an additional inlet set into the brick and stone floor 3142 forming part of 3096 adjacent to small masonry machine base 3095, evidently for the run-off of condensed steam or surface water from the engine. The survival of a vertical downpipe and spout attached to wall 3103 and situated above drain 3093 clearly indicates the drains were used to divert rainwater collected from the roof of the building (Plate 99).
