## Archaeological Excavation Report

Mayfield,  
Manchester

**Report No:**  
SA/2021/56

**Project:** Mayfield, Manchester: Archaeological Excavation

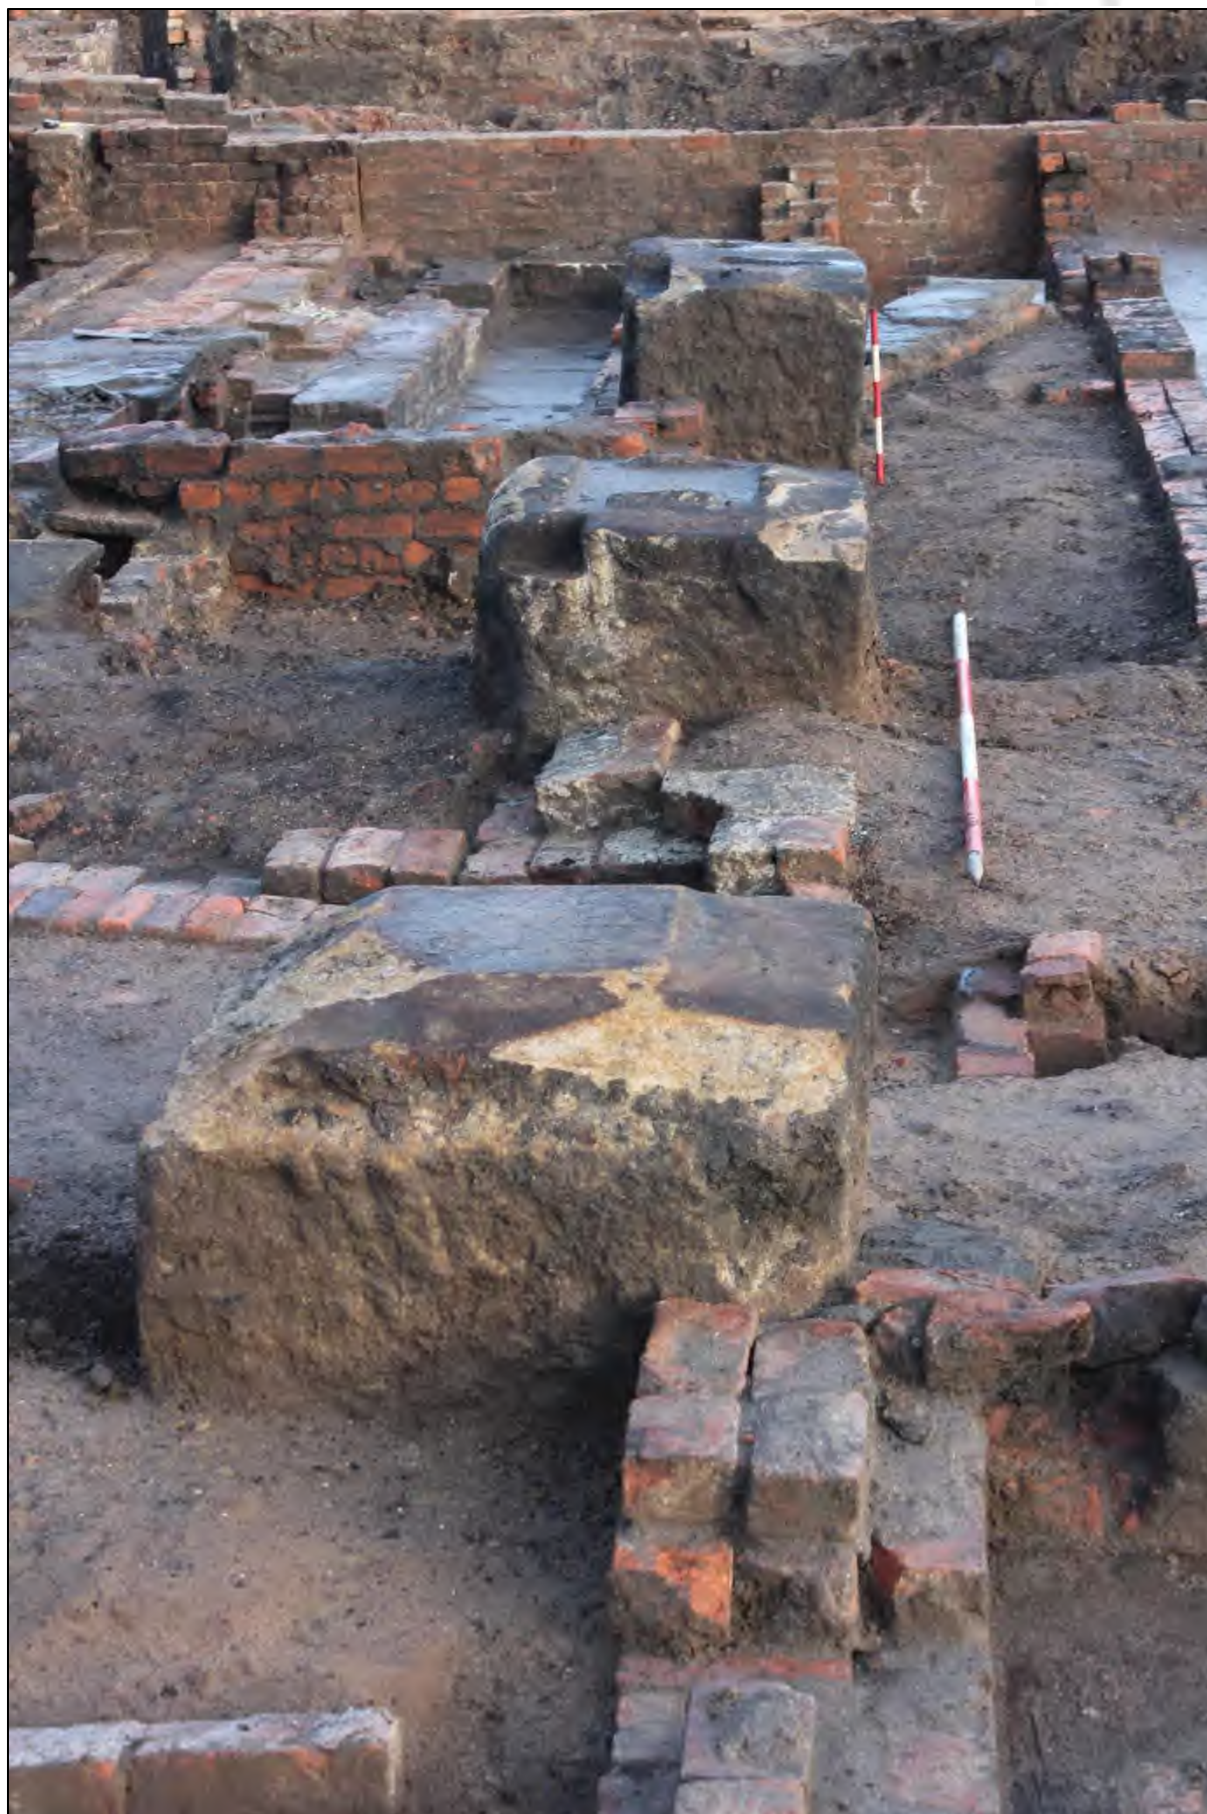
Plate 100: Column bases 3112-3113, looking east (0.50 and 2m scale)

A row of column bases (**3110**, **3111**, **3112**, **3113**, **3114**) were exposed across the middle of Building C, arranged at regular intervals of 2.50m (Plate 100). These were formed of brick bases consisting of regular courses of brickwork, above which were laid stone column bases. The brick pads or bases measured 1.00 x 0.85m, whilst the stone blocks were approximately 0.77 x 0.70m. The stone blocks were not however uniform in their size or shape, suggesting they may have been repurposed from another part of the site. The tops of the surviving masonry were chamfered and in the case of **3111** and **3113** featured a raised rectangular pad (360 x 380mm); the middle of **3112** featured a similar shaped recess. Both the pads and recessed areas would have enabled the plates on underside of the upright cast iron columns to be held in place securely. Although none of the ironwork survived, the column bases give some sense of the internal arrangement within the building and also provide some indication of the floor levels, which for the most part did not survive. Additional column bases were found in the southern half of the building but were ascribed to *Phase 4* on the basis of distribution within the building, which did not correspond this row.

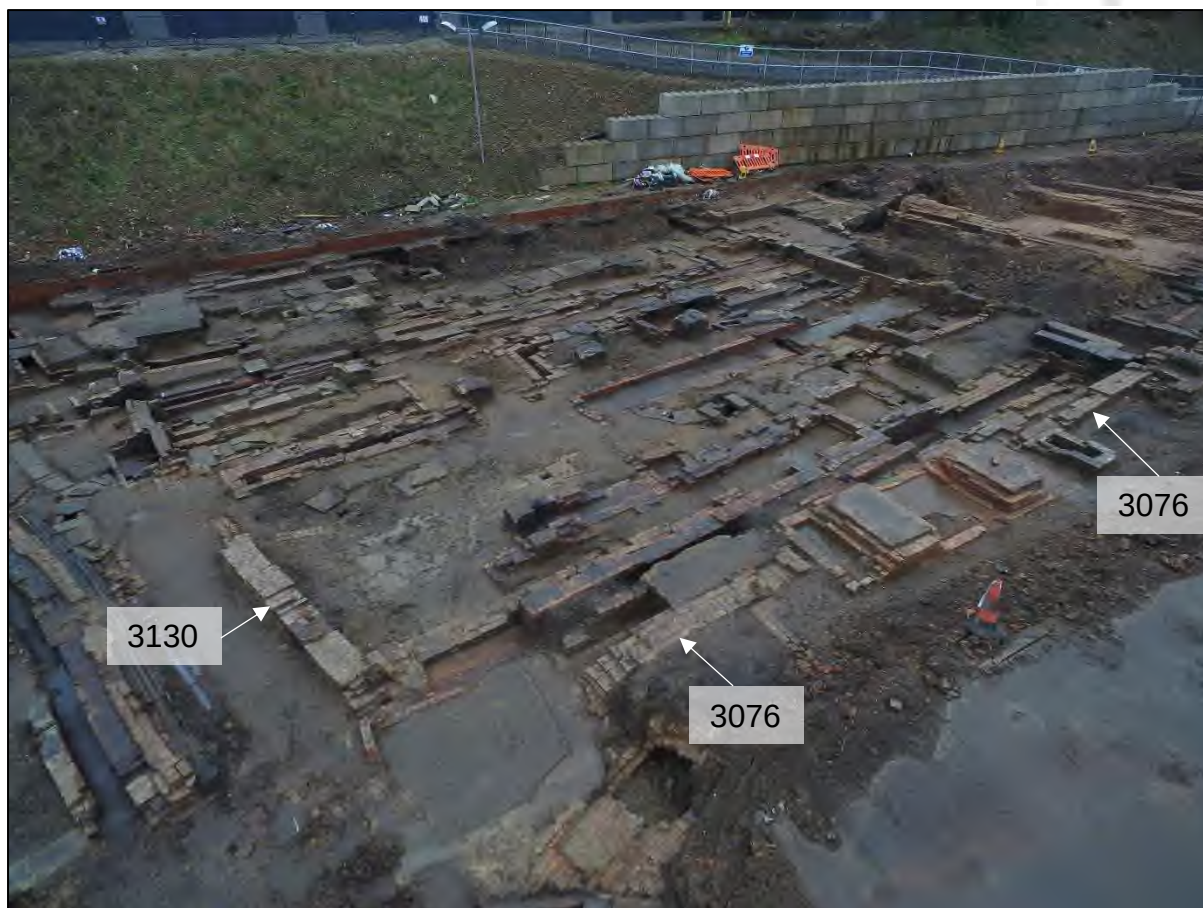
Plate 101: View across the southern half of Building C indicating the Phase 3 walls 3130 and 3076

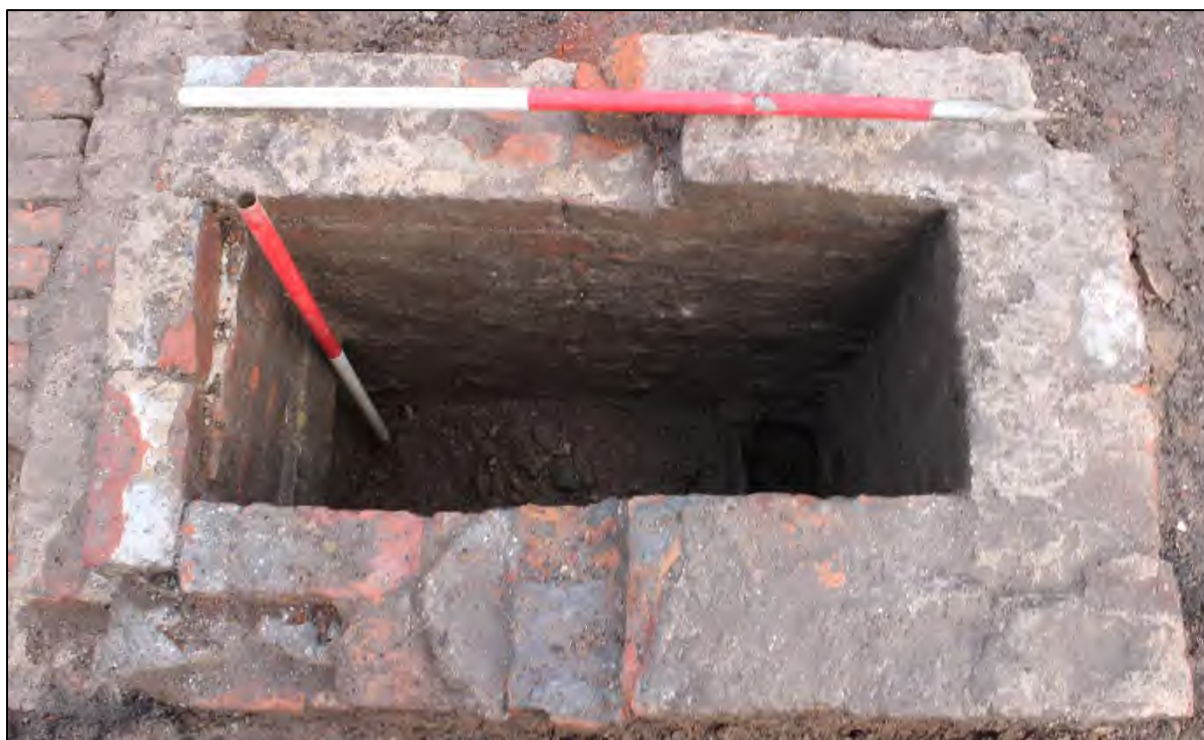
*Plate 102: View of the interior of chamber 3108, note the cast-iron plate on its southern side, looking east (2 x 1m scales)*

**3108** was a rectangular chamber situated above the exposed southern extent of drain **3086** and was built against wall **3076** (Plate 102). It measured 1.26 x 0.84m externally and 0.37 x 0.93m internally and was constructed with handmade brick bonded with a light greyish white lime-based mortar. It abutted the southern face of wall **3076**, suggesting it post-dated its

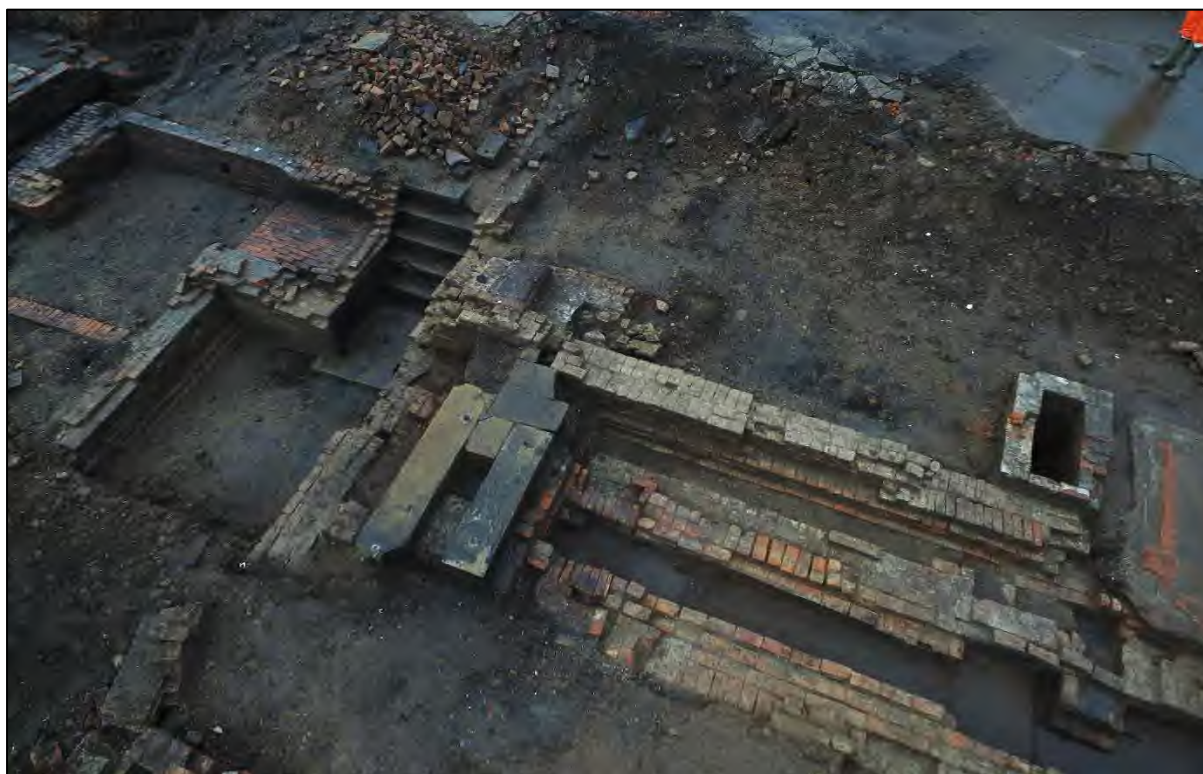
*Plate 103: Aerial view of structural remains along the southern side of Building C, including steps 3068*

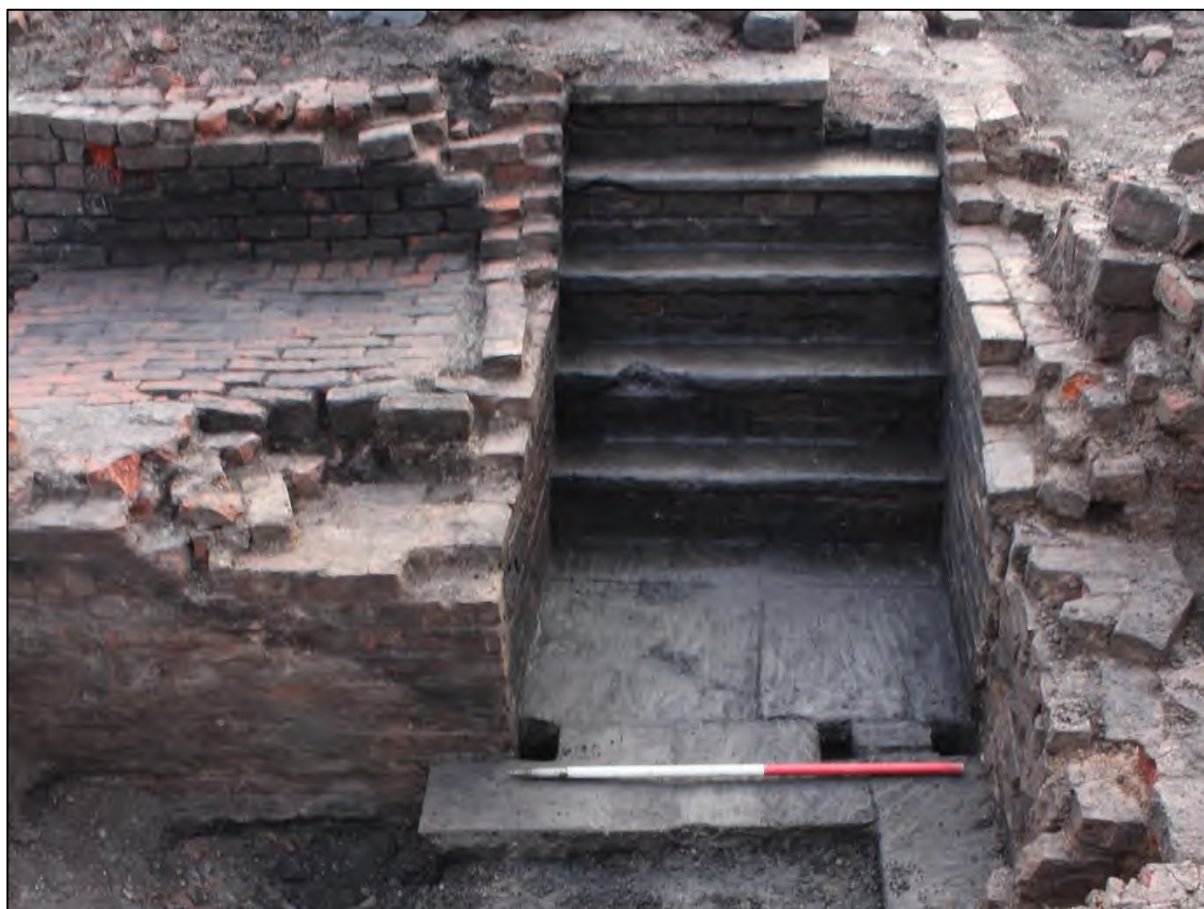
*Plate 104: Steps 3068 looking south (1m scale)*

A flight of steps **3068** leading down into the cellared area were revealed on the northern side of walls 3076 and 3125. It was keyed into 3076 and 3082, as well as 3125 and 3163 (Plates 104 and 105). The steps were formed of two parallel side walls built in the same fabric as 3076/3082. The steps themselves consisted of two-course (0.24m) brick risers with sandstone tread

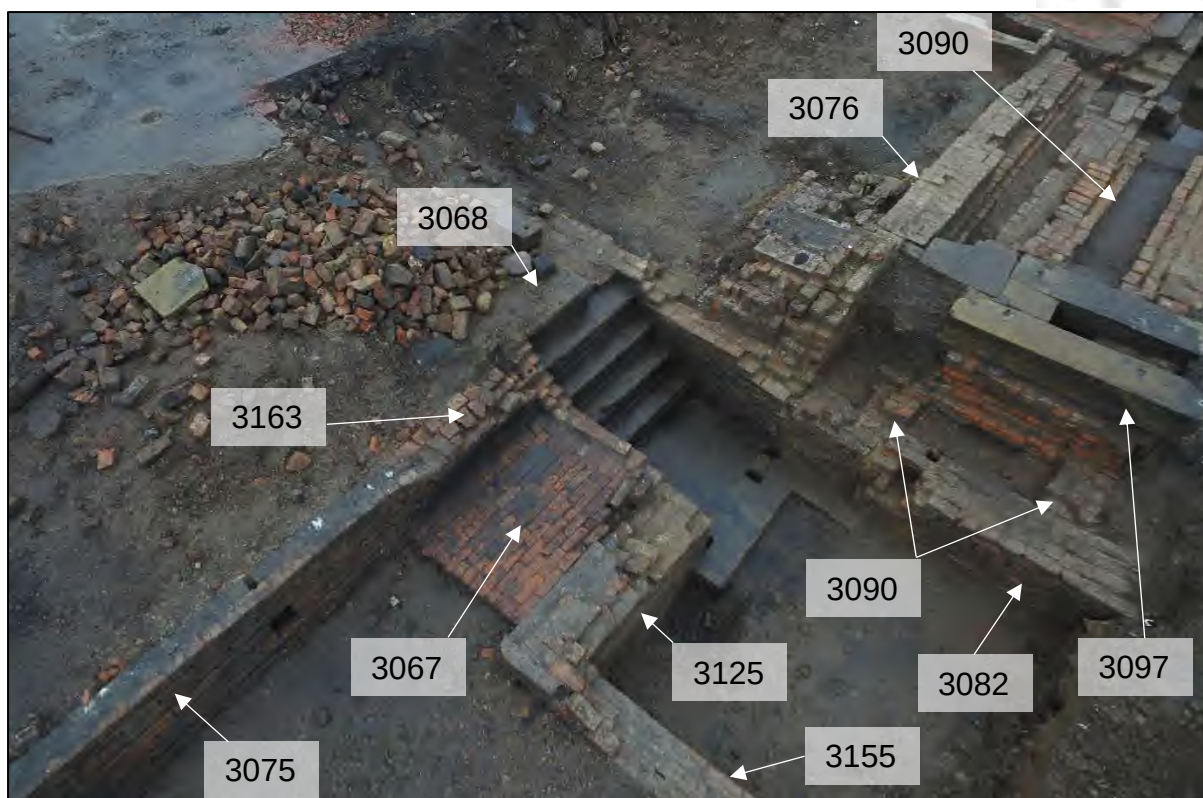
Plate 105: Aerial view showing steps 3068 and associated structures

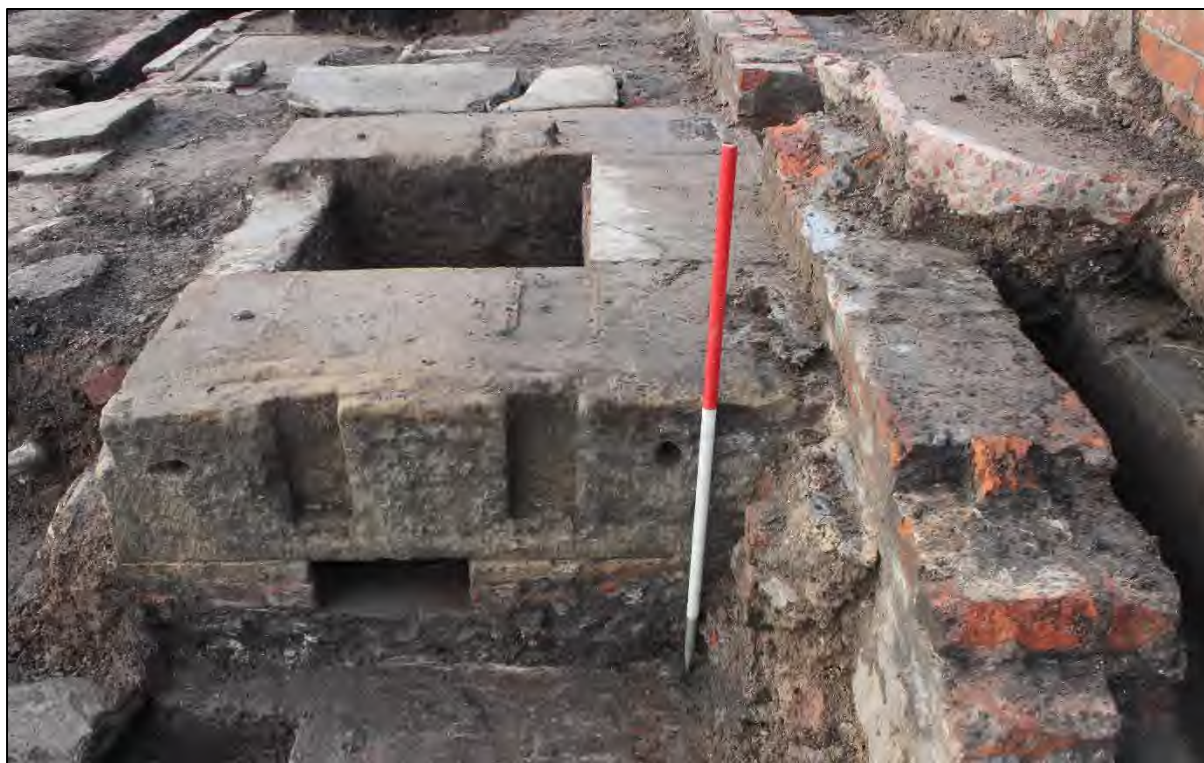
*Plate 106: Masonry engine bed 3095 beside wall 3129 (1m scale)*

Atop the brickwork were two stone blocks set 0.91m apart, both abutting the southern face of wall 3129 (Plate 106). The western block measured 1610 x 570 x 420mm; the eastern block was slightly wider, measuring 620mm wide. Both featured perforations or crow holes in the surface of the stone blocks, and retained iron holding down bolts, which had been secured into the holes with molten lead. The eastern stone block had two further circular perforations and two vertical sockets, presumably for accommodating the fittings of the steam engine (Plates 106 and 107). A stone flag had been laid between the stone blocks, flush with the surface of the stones.

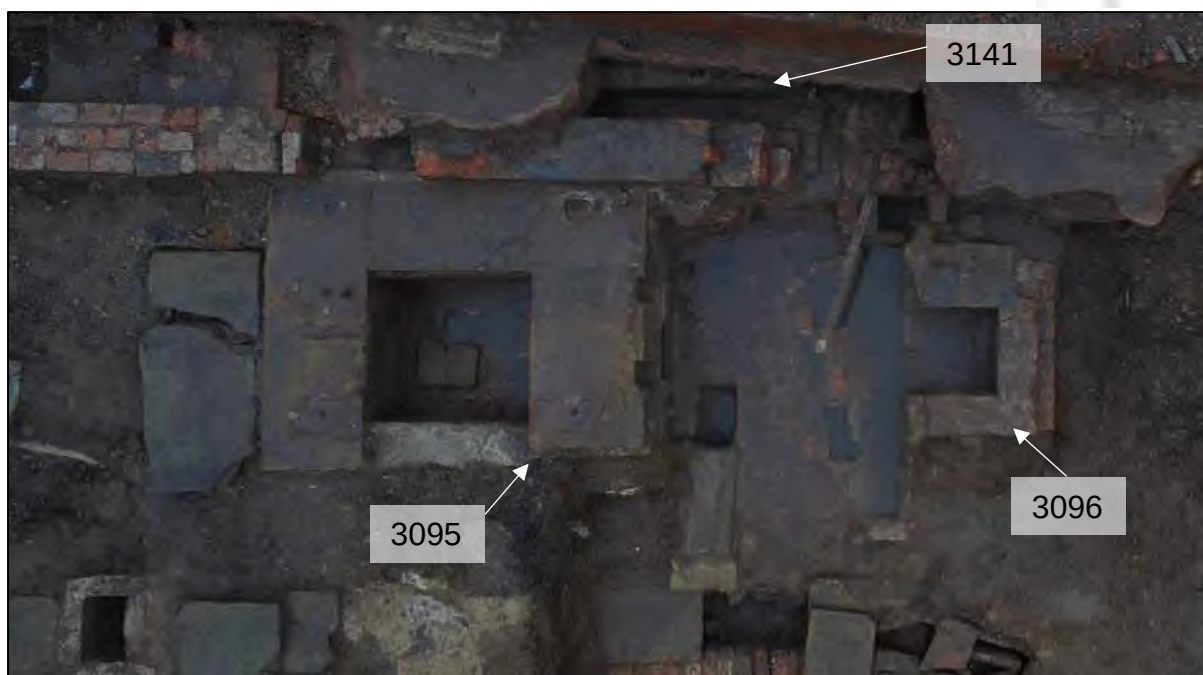
*Plate 107: Aerial view of 3095 and 3096*

To the east of 3095 was structure **3096** consisting of a C-shaped brick construction with a central recess (Plate 107). It sat on a brick and flagstone floor **3142**, which extended up to 3095, measuring 1.92 x 1.44m. **3096** stood to a maximum height of 0.35m with a maximum footprint of 1.11 x 0.89m. The internal recess measured 0.54 x 0.51m. The function of the structure remains unclear but was likely associated with the power systems in this part of the building.

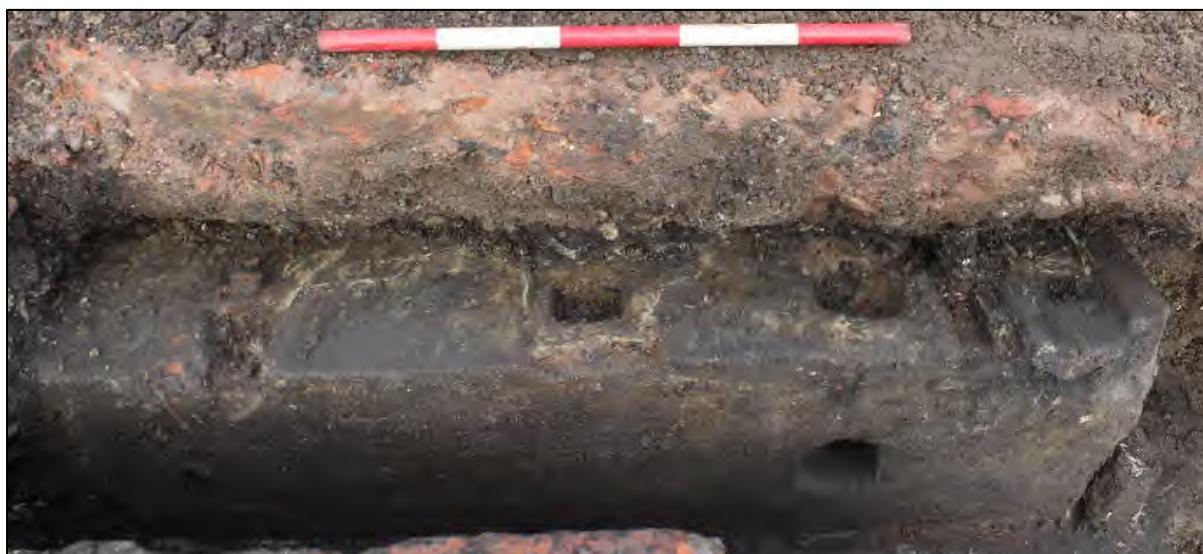
*Plate 108: Detail of the various sockets and crow-holes within stone engine bed 3141 (0.50m scale)*

To the north of wall 3129, revealed in the section of the trench was a further stone engine bed **3141** (Plates 108 and 109). This measured 1.20m in length and was in excess of 0.25m in width and 0.35m in height; it was not fully exposed in plan. From its position it appears the two engines were more or less positioned on opposite sides of the same wall and were perhaps contemporary.

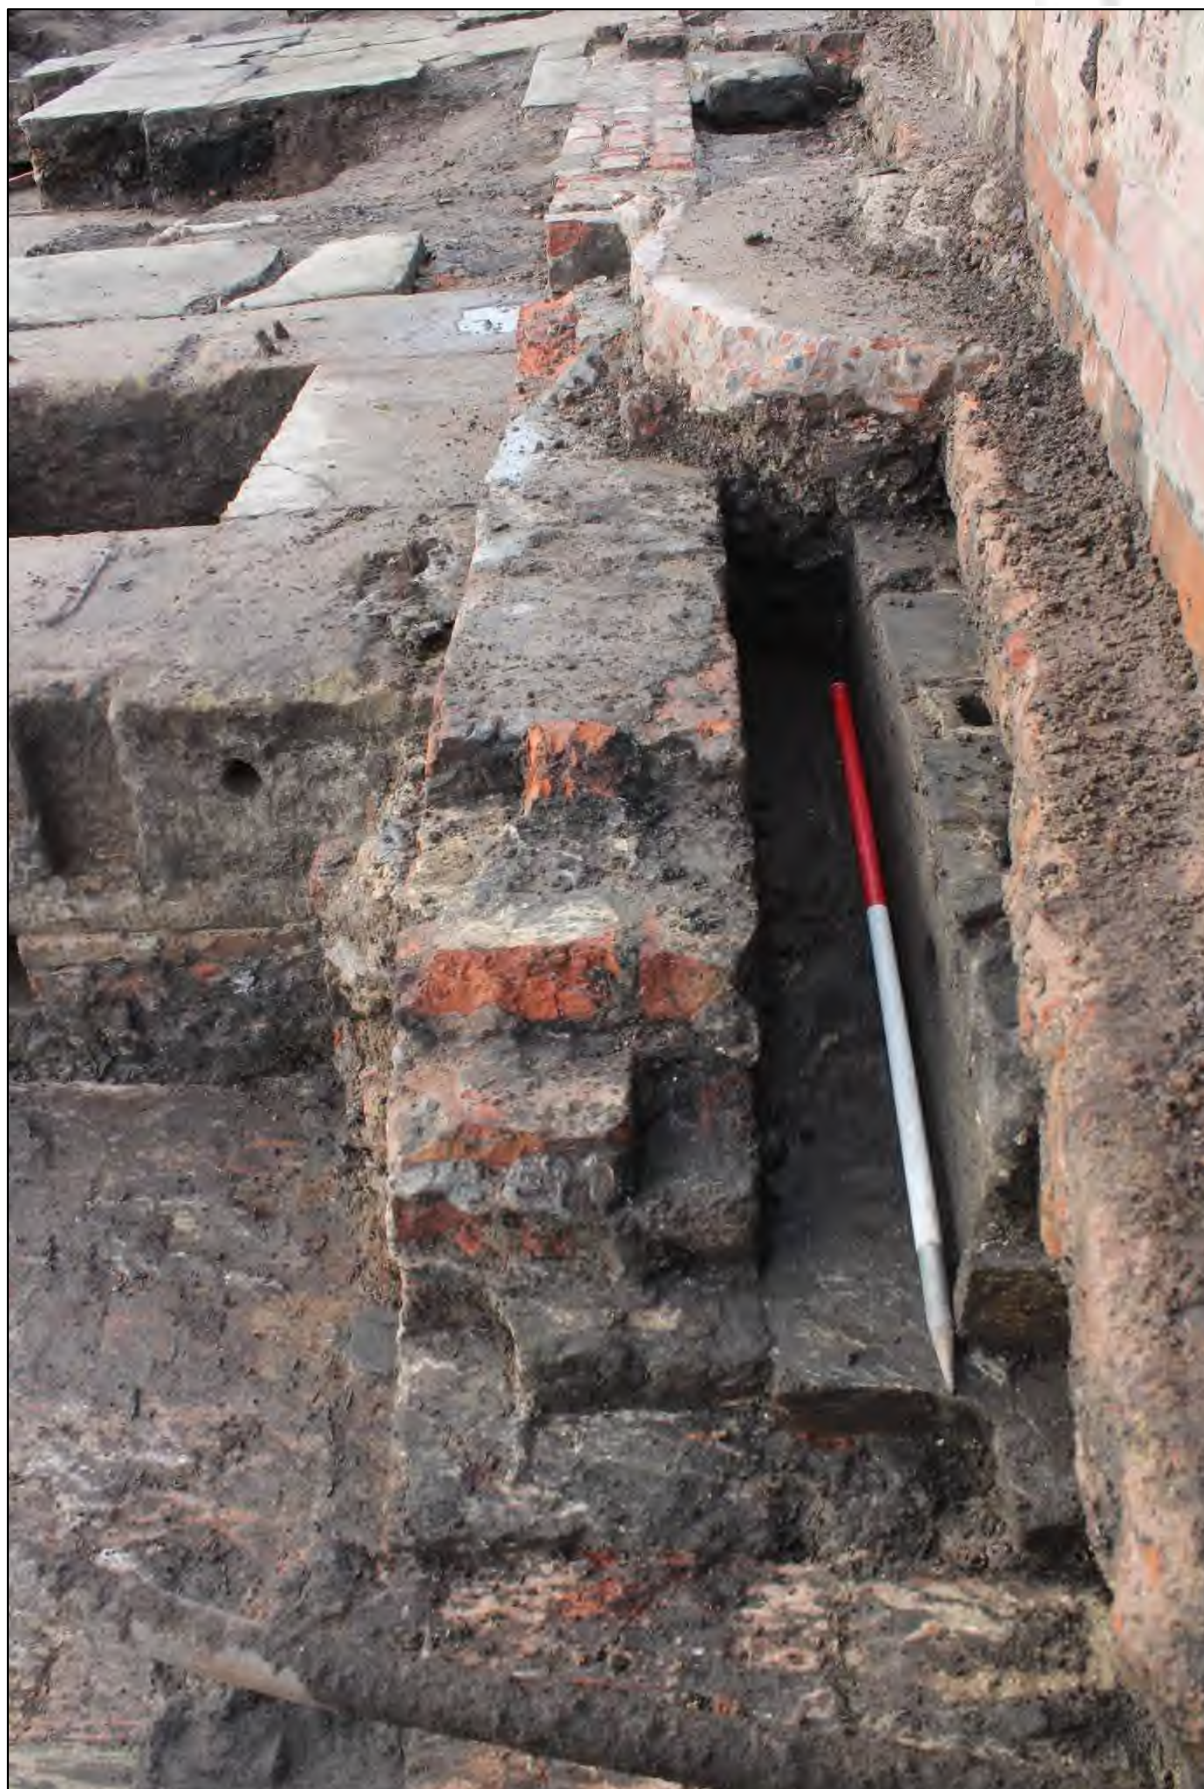
*Plate 109: Stone engine beds 3095 (left) and 3141 (right), positioned either side of wall 3129 (1m scale)*

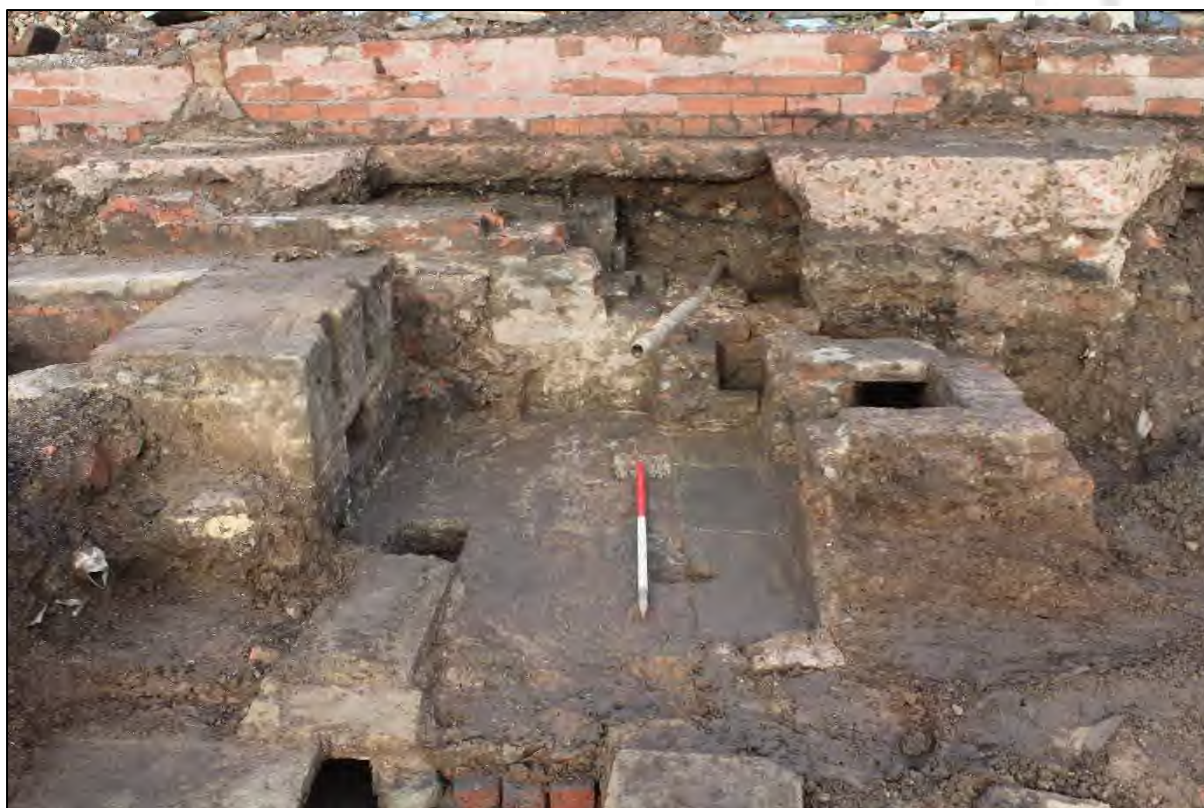
*Plate 110: Stone engine bed 3095 (left) and associated floor 3142 and structure 3096 (right) Note the position and height of stone engine bed 3141 beneath the Phase 7 walls visible in the section. Looking North (1m scale)*

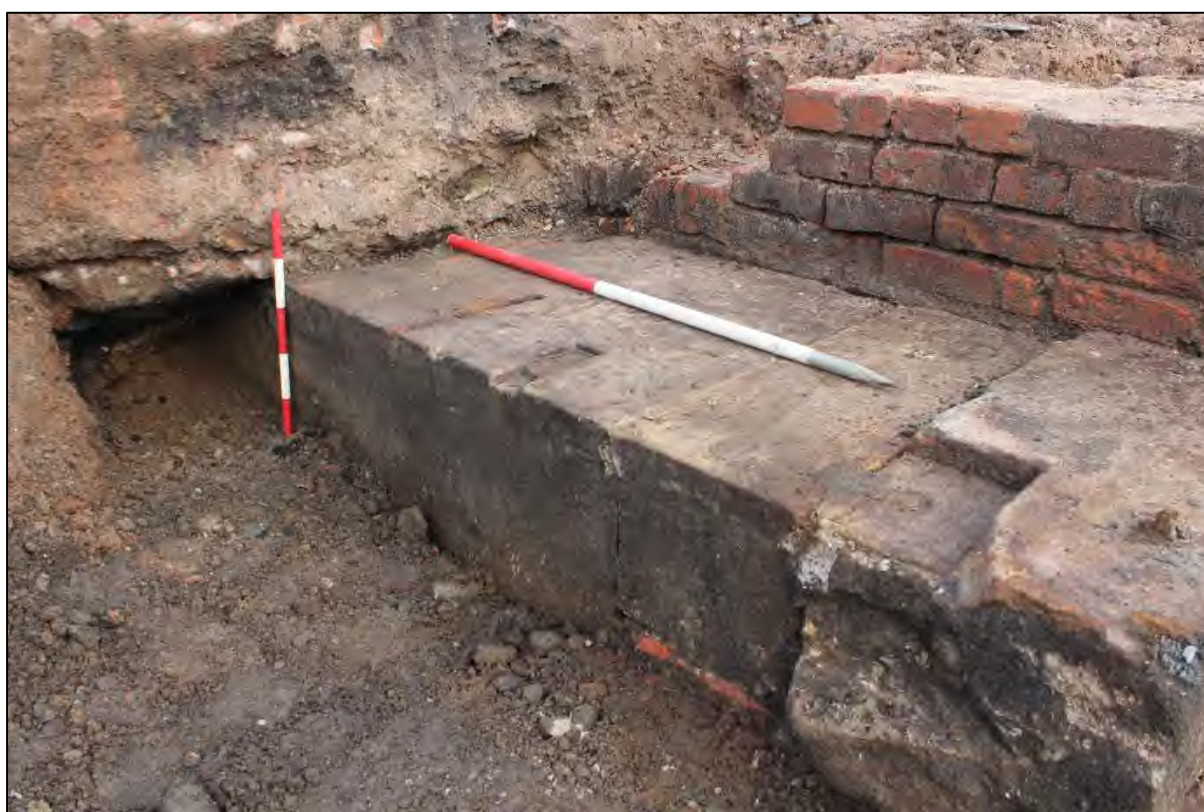
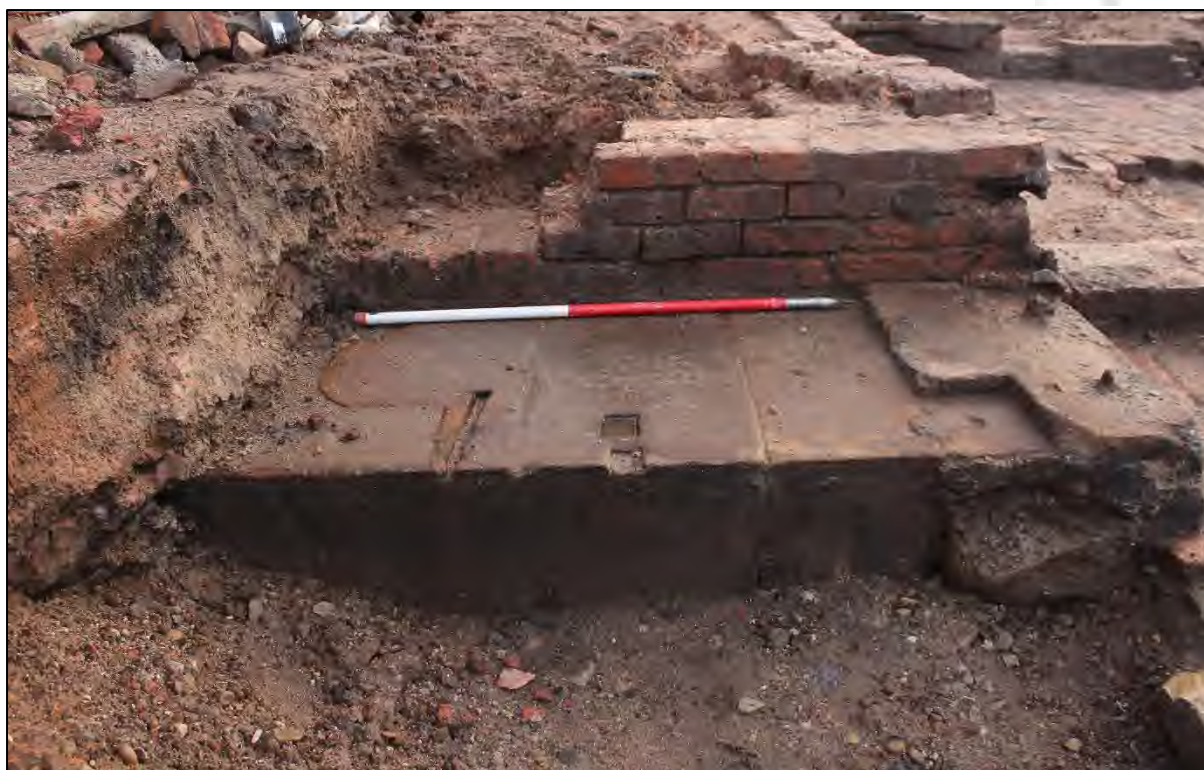
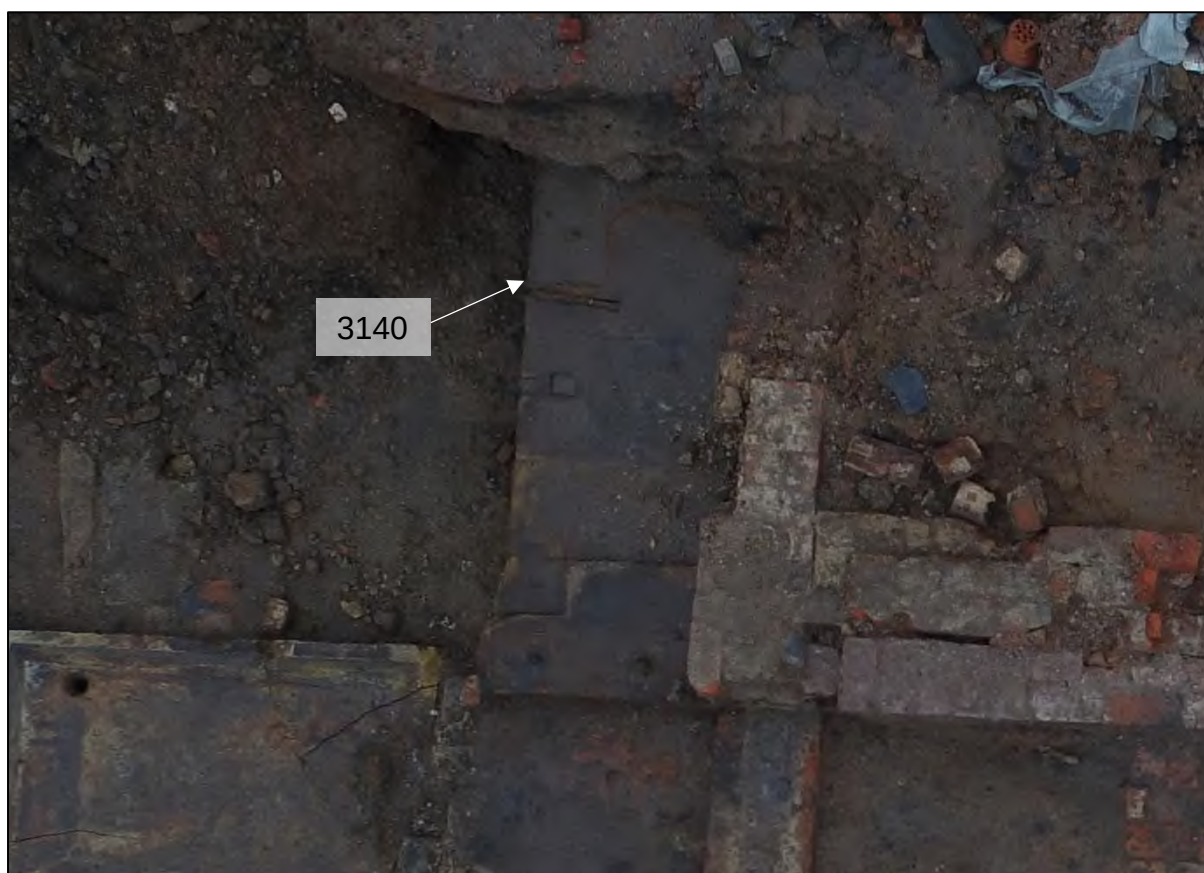
*Plate 111: View of the adjoining blocks making up engine bed 3140 (0.50 and 1m scales)*

*Plate 112: View of the adjoining blocks making up engine bed 3140 (1m scale)*

*Plate 113: Stone bed 3140 positioned against wall 3109*

A further stone engine bed **3140** was revealed alongside wall 3109 (Plates 111-113). This comprised a series of at least three adjoining stone blocks. These had a maximum width of 0.87m and together with a cast iron plate, were incorporated into a rebuilt section of wall 3109. Their combined length exceeded 2.20m, continuing beyond the northern limit of the excavation. The stone blocks rested on a brick plinth, which was bonded with a hard-grey bonding material.

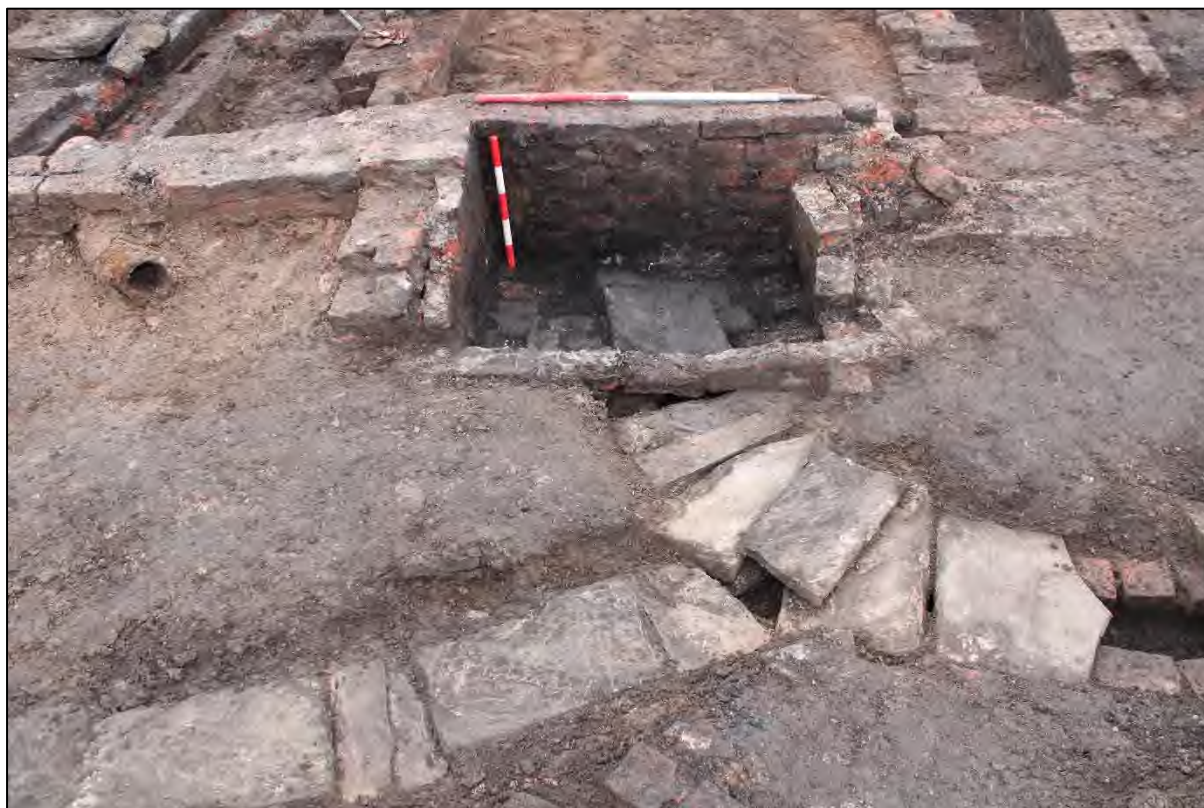
*Plate 114: Structure 3101 looking east (0.50 and 1m scales)*

The 1872 Insurance Plan reveals a flight of steps or external stairwell was added on the western side of Building C. Structure **3101** appears to relate to this addition and therefore was added between 1850 and 1872 (Plate 114). It consisted of a C-shaped section of wall that abutted the western face of 3077 and 3130. The three sides of the structure consisted of single-skin brick walls bonded in a light greyish white ashy lime-based mortar. This had been constructed above an existing drain 3044. An associated crude brick surface had been laid either side of the drain. The structure measured 1.53m north/south and 1.01m east/west and had a surviving height of 0.54m. It post-dated 3077 and 3130 and was itself abutted by 3094.

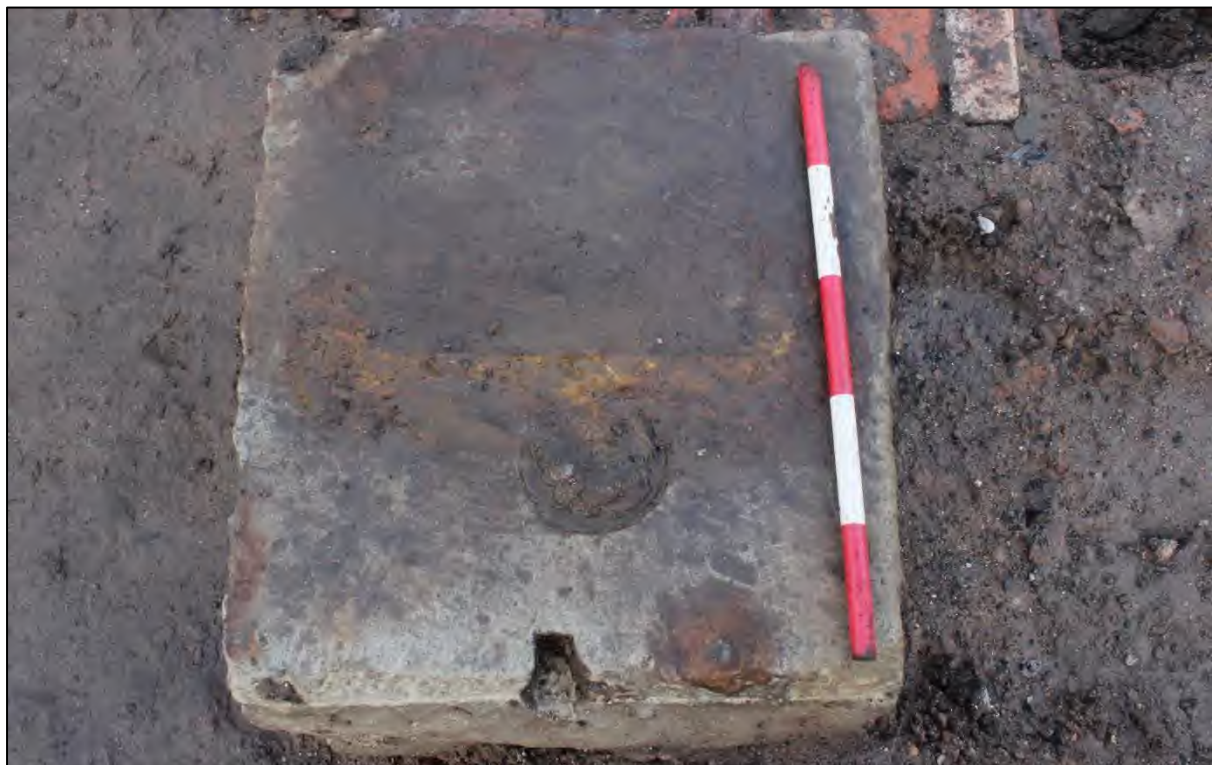
*Plate 115: Column base 3148 looking north. Note the shadow left behind by the cast iron column base as well as holes left by other potential fittings (0.50m scale)*

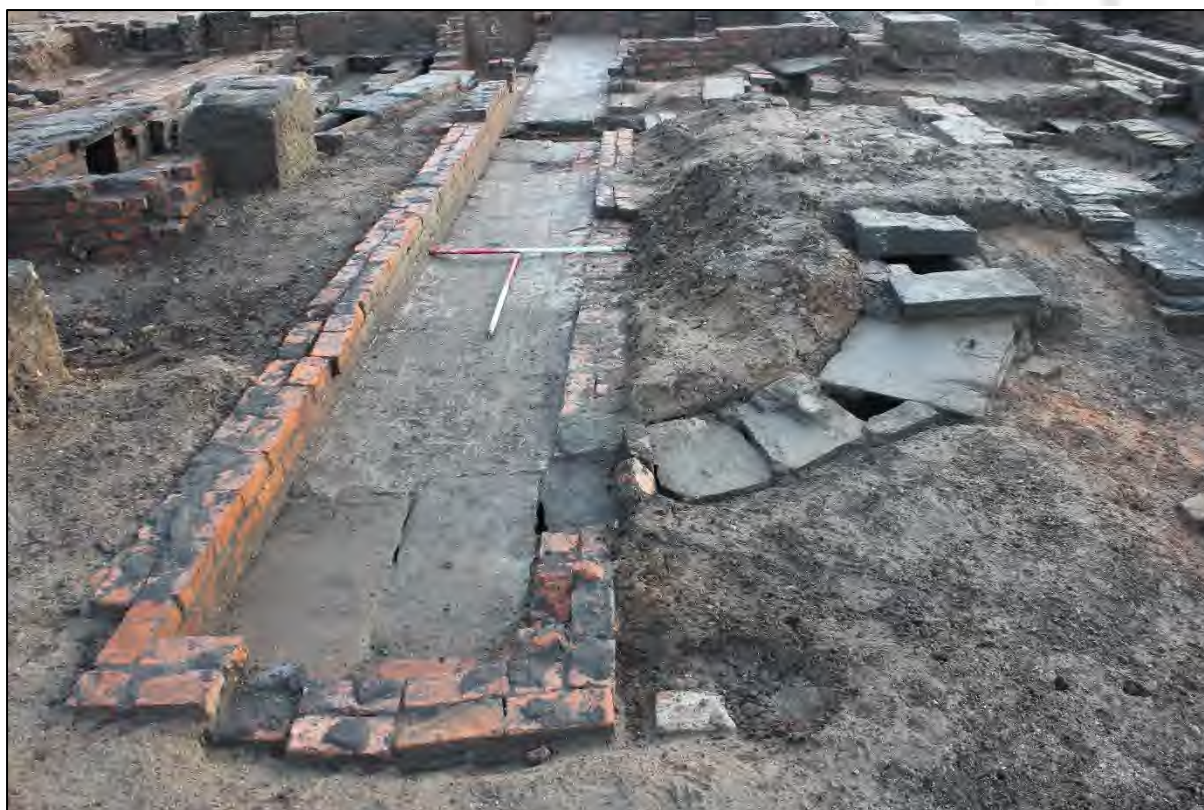
*Plate 116: Phase 6 3080 overlying curvilinear drain 3100 (2 x 1m scales)*

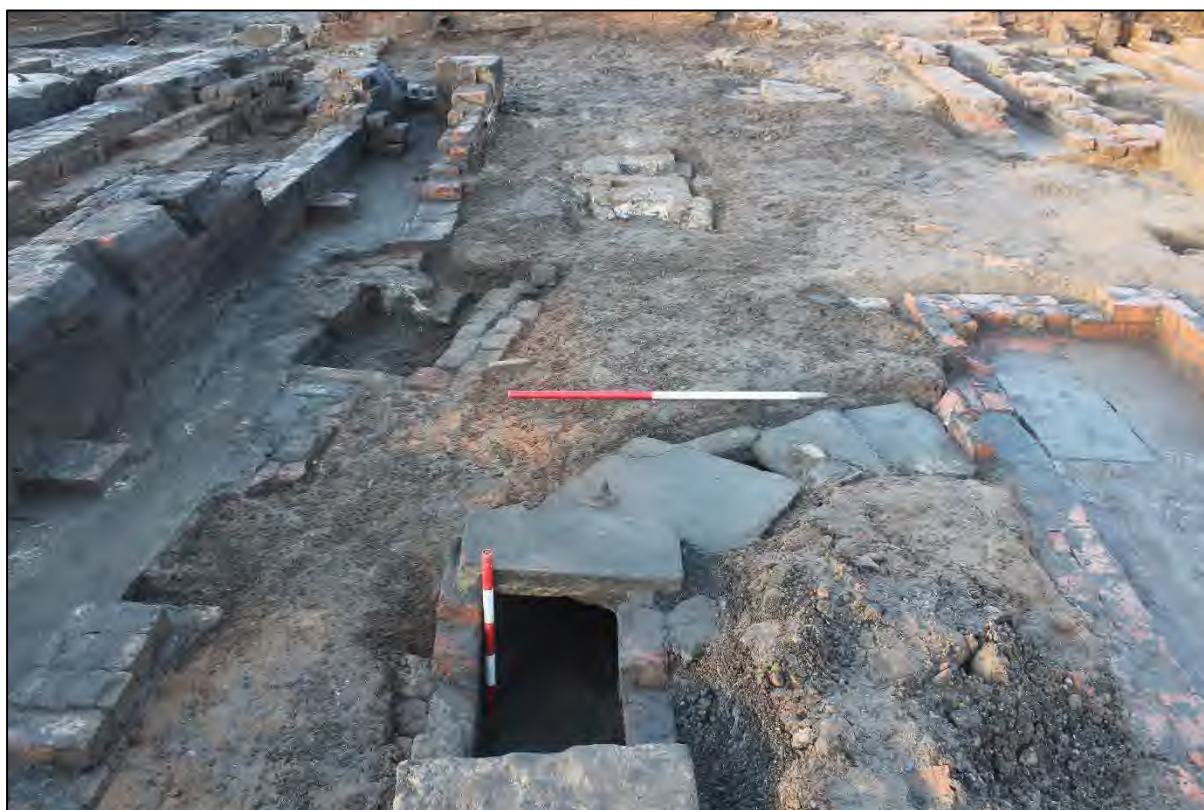
*Plate 117: Alternative view of 3100 looking west (0.50 and 1.00m scales)*
