## Archaeological Excavation Report

Mayfield,  
Manchester

**Report No:**  
SA/2021/56

**Project:** Mayfield, Manchester: Archaeological Excavation

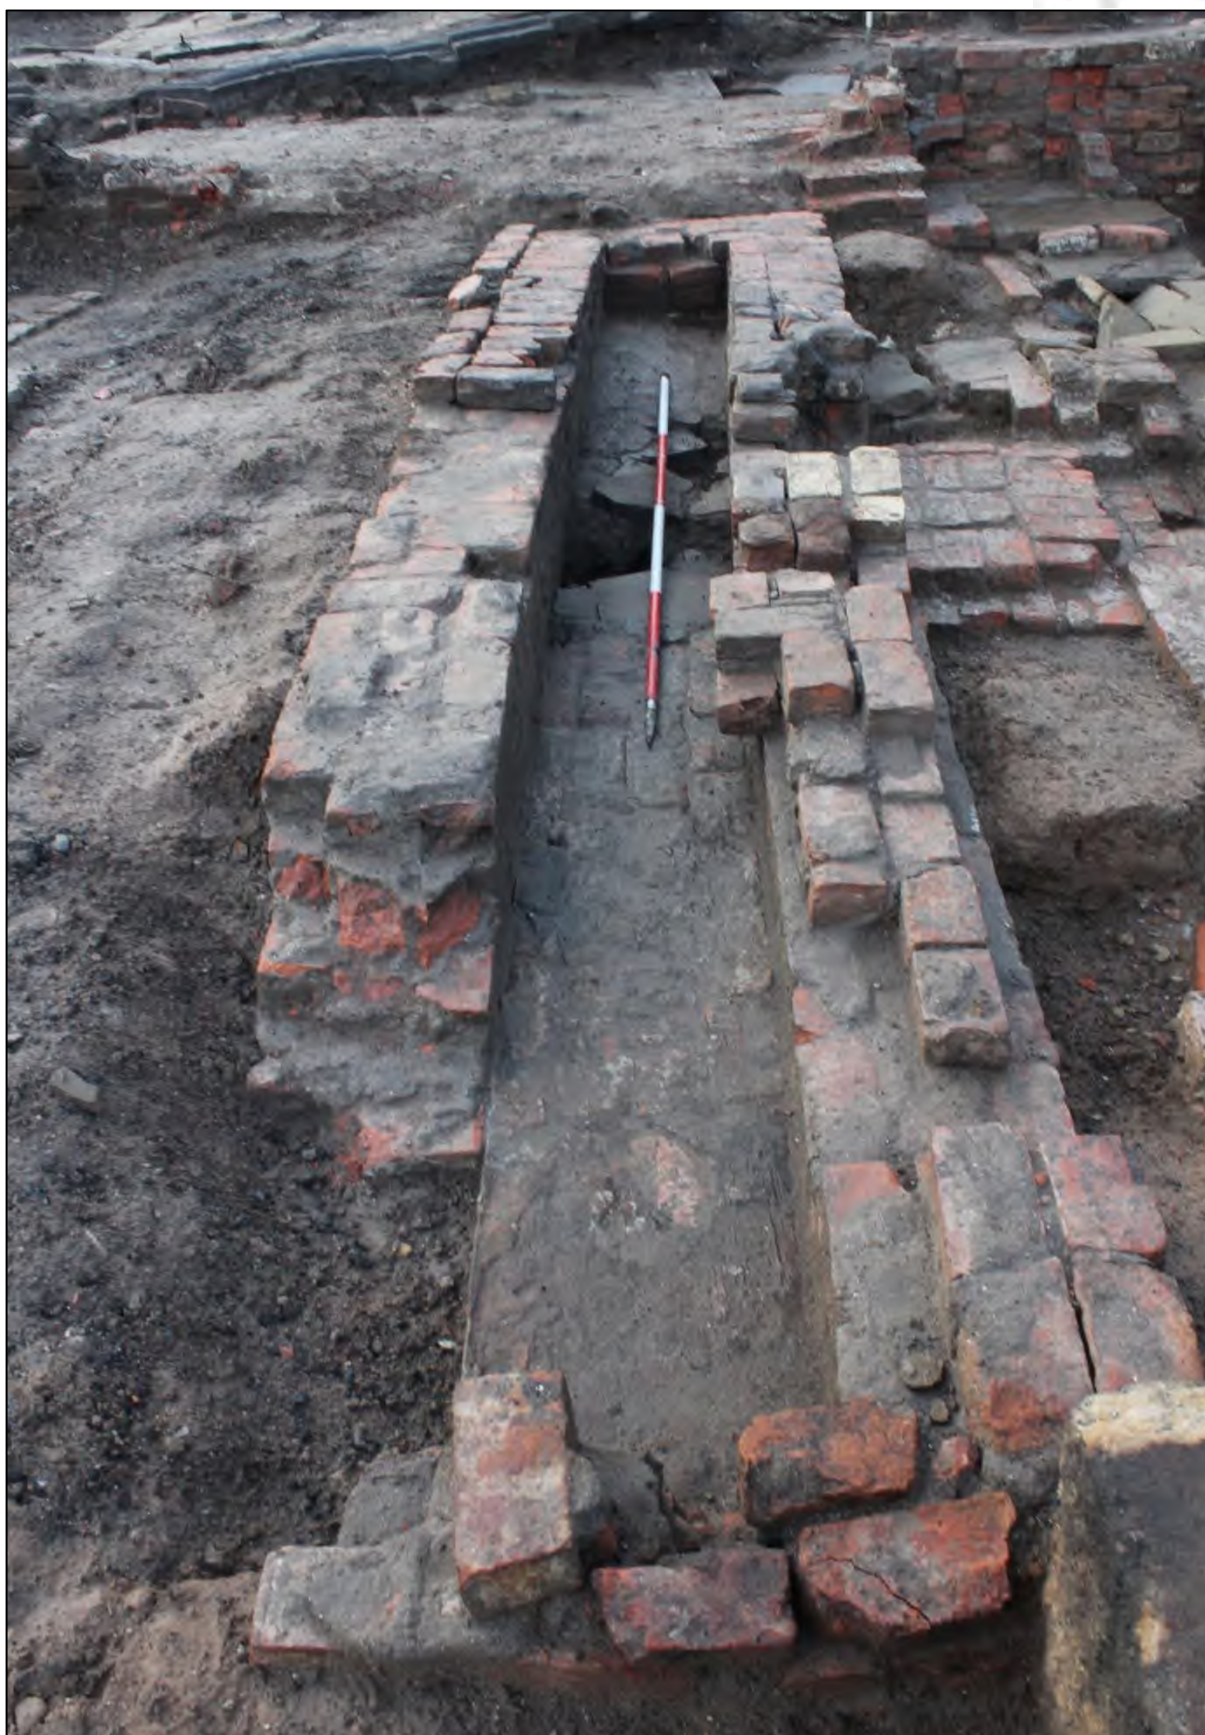
*Plate 118: 3087 looking west (2m scale) Note the use of a light grey, ash mortar, which can be differentiated from the whiter lime-based mortars utilised in Phase 3*

**3087** was situated in the western half of Building C (Plate 118). It measured 5.30 x 1.17m and had an internal width of 0.44m. The walls of the structure were formed largely of handmade bricks, incorporating occasional firebricks, and was bonded with a hard, ashy, light grey mortar the walls were 0.35m wide and survived to a maximum height of 0.40m, although evidently truncated horizontally. The base of the structure was formed of handmade brick bonded with the same grey mortar. The structure was built over an existing drain, 3044, which entered Building C from the east. The middle of 3087 was built around a pre-existing brick column base, 3110; it abutted another, 3111 at its eastern end.

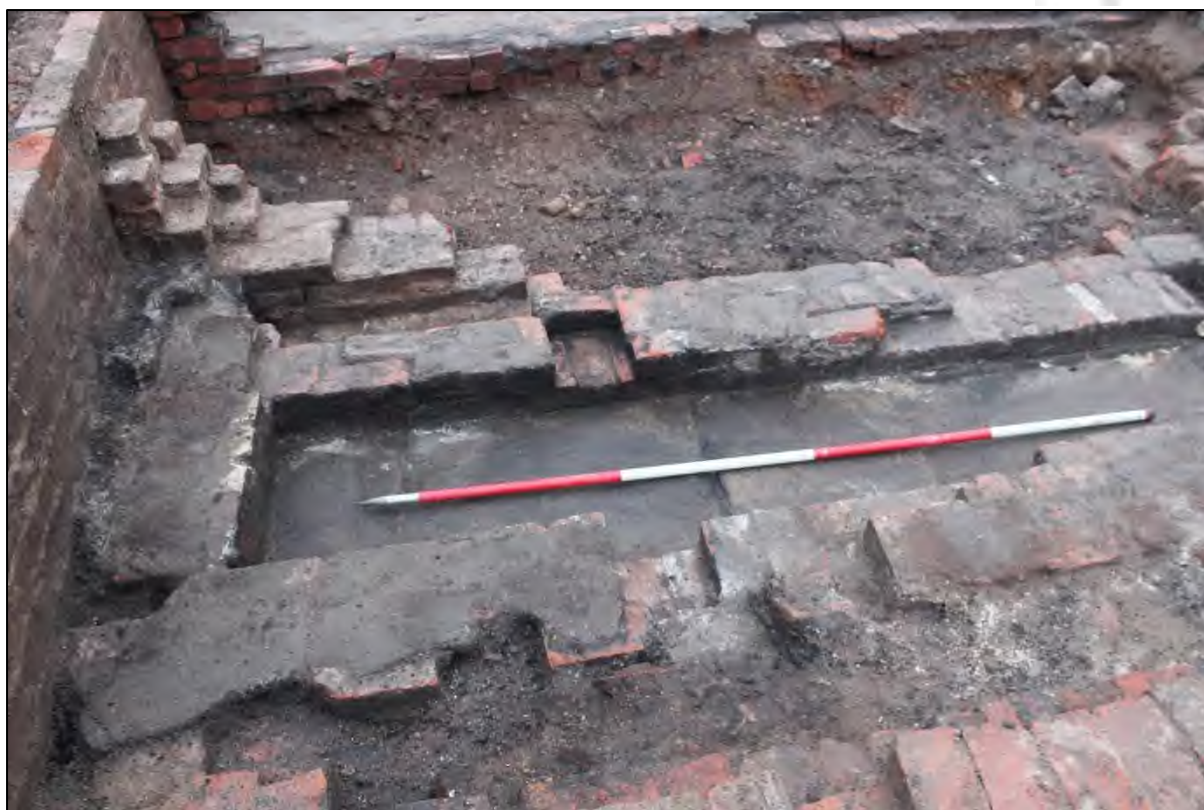
*Plate 119: Part of structure 3085 forming an open channel (2m scale)*

**3085** was situated on the eastern side of the main part of Building C, immediately west of wall 3082 (Plate 119). 3085 had an overall length of 4.74m in length and was 1.31m wide. The outer walls of the structure were 0.36m wide and it had an internal width of 0.63m. A mixture of wire-drawn bricks and firebricks were utilised in the construction of the side walls. The base was formed of sandstone flags. The bricks were bonded with a brittle, grey ash-mortar. Aside from its construction, which was typical of *Phases 5*, its allocation to this phase was evident from its relationship to existing elements of the building. It abutted the western face of wall 3082 and column base 3114 and walls 3149 and 3150 (all ascribed to *Phase 3*). It was also evident that as a result of its construction, the adjacent wall 3149 had been reduced height. A residue had been allowed accumulate above the denuded wall 3149; this was sampled (Sample No. <3>) to ascertain the nature of the processes carried out in this area.

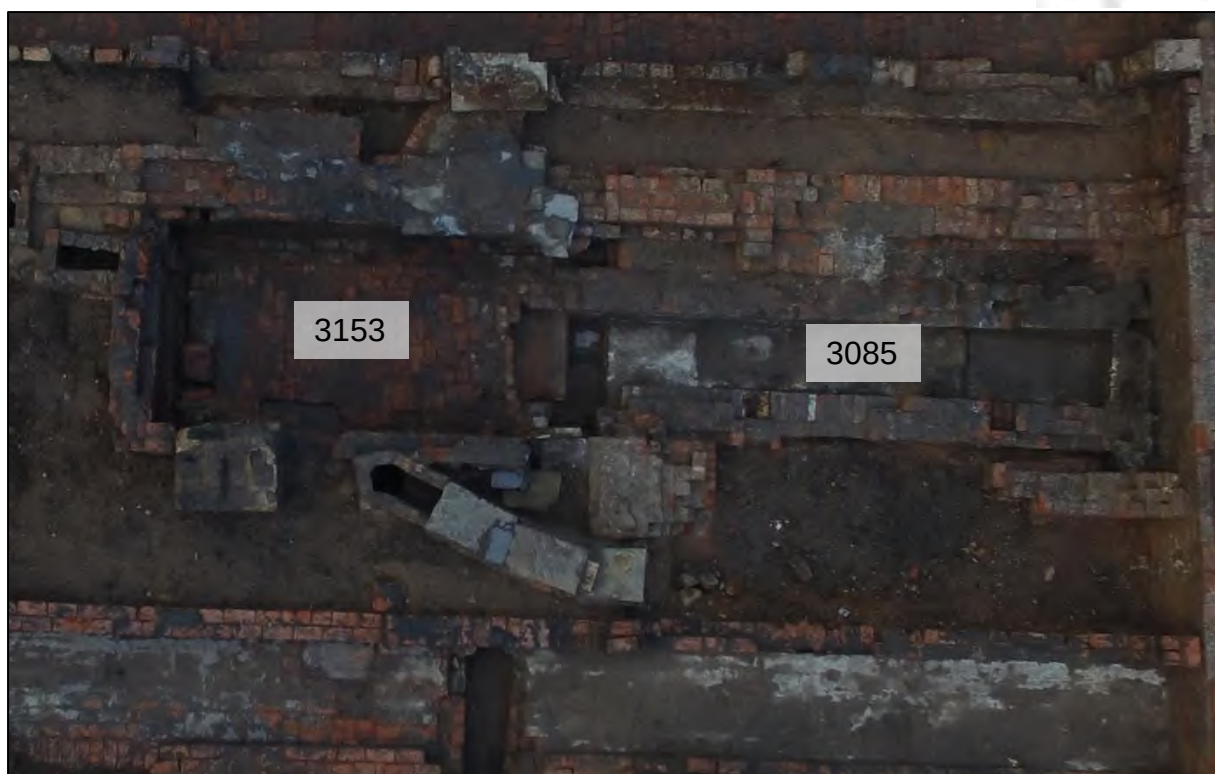
*Plate 120: Aerial view of structures 3153 and 3085*

**3153** represents a subsequent addition to **3085** (Plates 120 and 121). It had an overall footprint of 3.38 x 1.59m. It was situated to the west of the existing structure and was formed largely by the construction three sections of brick wall, tacked onto column bases **3114** and **3113** and wall **3115**. It was fed by a short section of drain connecting **3083** to **3153**; this had been inserted through wall **3115**. An exit through the southern side of structure **3153**, was connected to drain **3086**. From this it would appear this element of the drainage functioned as large tank or chamber, perhaps associated with access and maintenance to the drainage system.

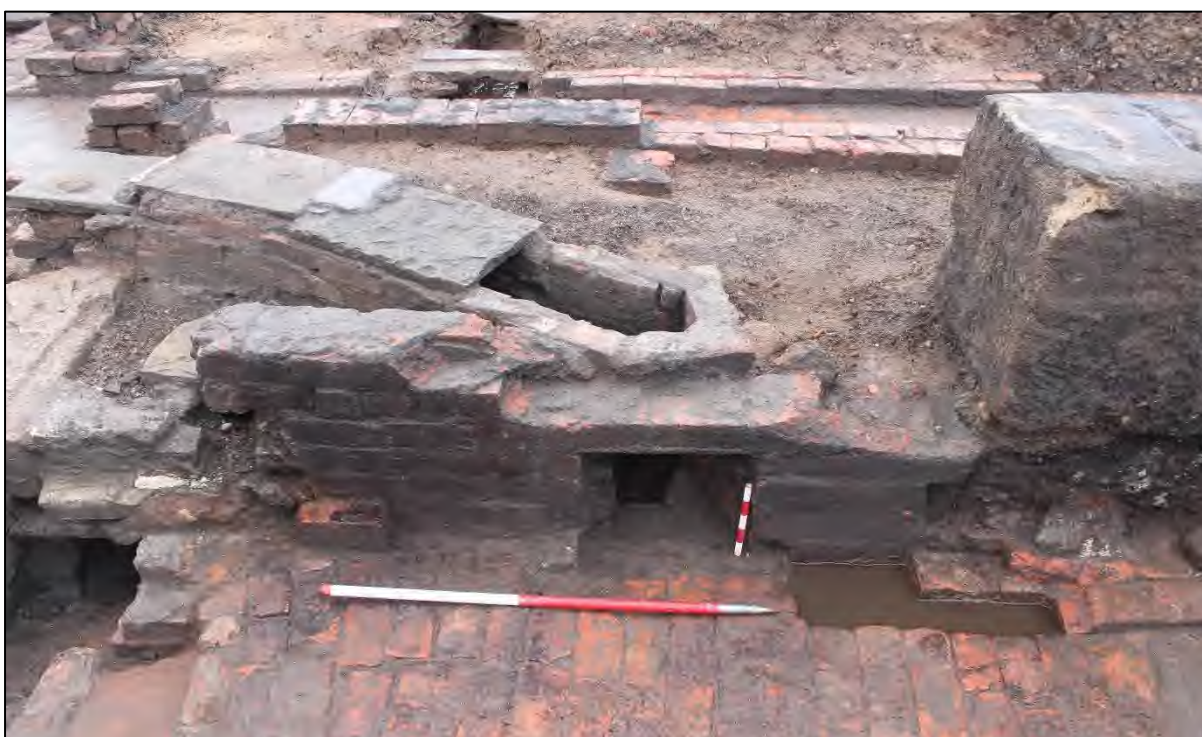
*Plate 122 Southern side of 3153 with 3162 beyond. Note the exit drain (0.25 and 1m scales)*

Another element of the drainage ascribed to Phase 5 was structure **3162** (Plate 122). This short section of truncated drain had a surviving length of 2.49m and was 0.43m wide. It was

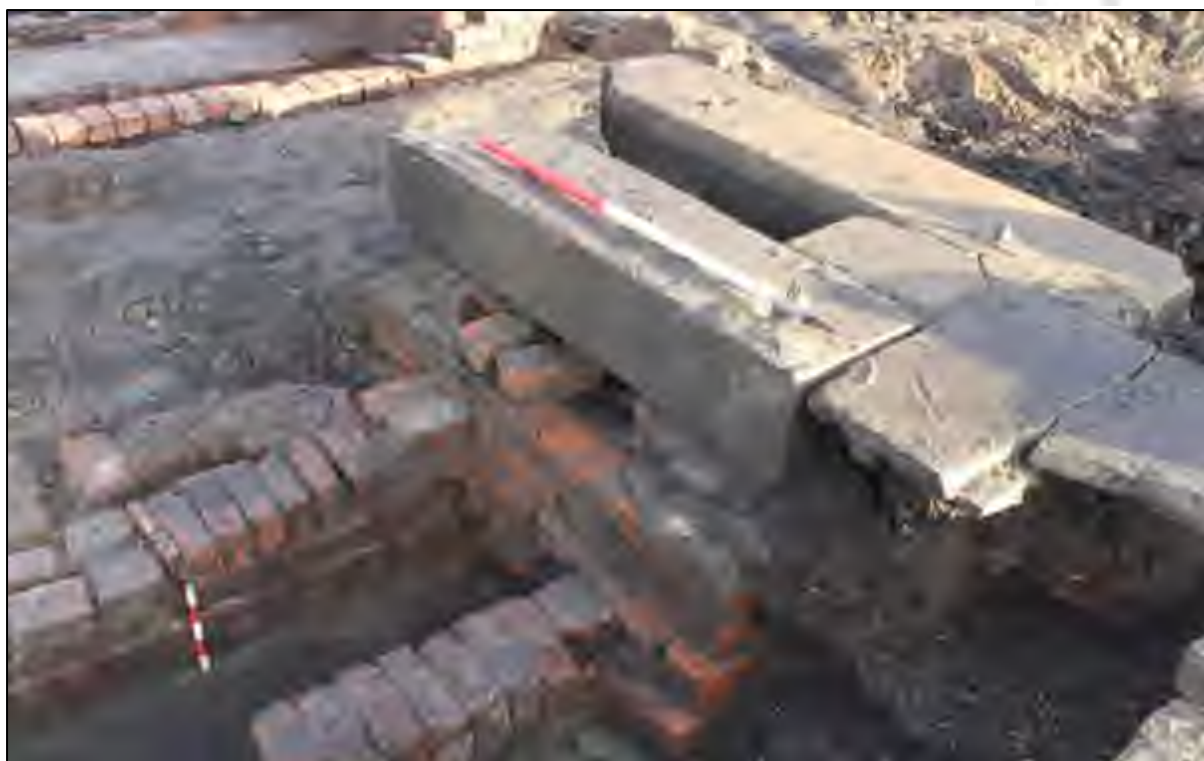
*Plate 123: 3097 constructed above 3090, looking north-west (0.25 and 1m scales)*

**3097** had been built above structure **3090**, close to its eastern end. **3097** was formed two recumbent blocks of sandstone above a rectangular brick base (Plate 123). Constructed of machine-made bricks bonded with a hard-grey ash mortar, comparable to that used in **3087**, the construction is consistent with other elements added during this period. The construction of the base had effectively blocked off part of structure **3090**. The smaller block measured 1409 x 376 x 244mm and the larger 1806 x 373 x 245mm. They were set 0.31m apart, together forming the setting for a small engine or machine bed. Associated with the structure was a contiguous flagstone surface, which had been built above an accumulation of cinders and clinker at the southern end of **3097**.

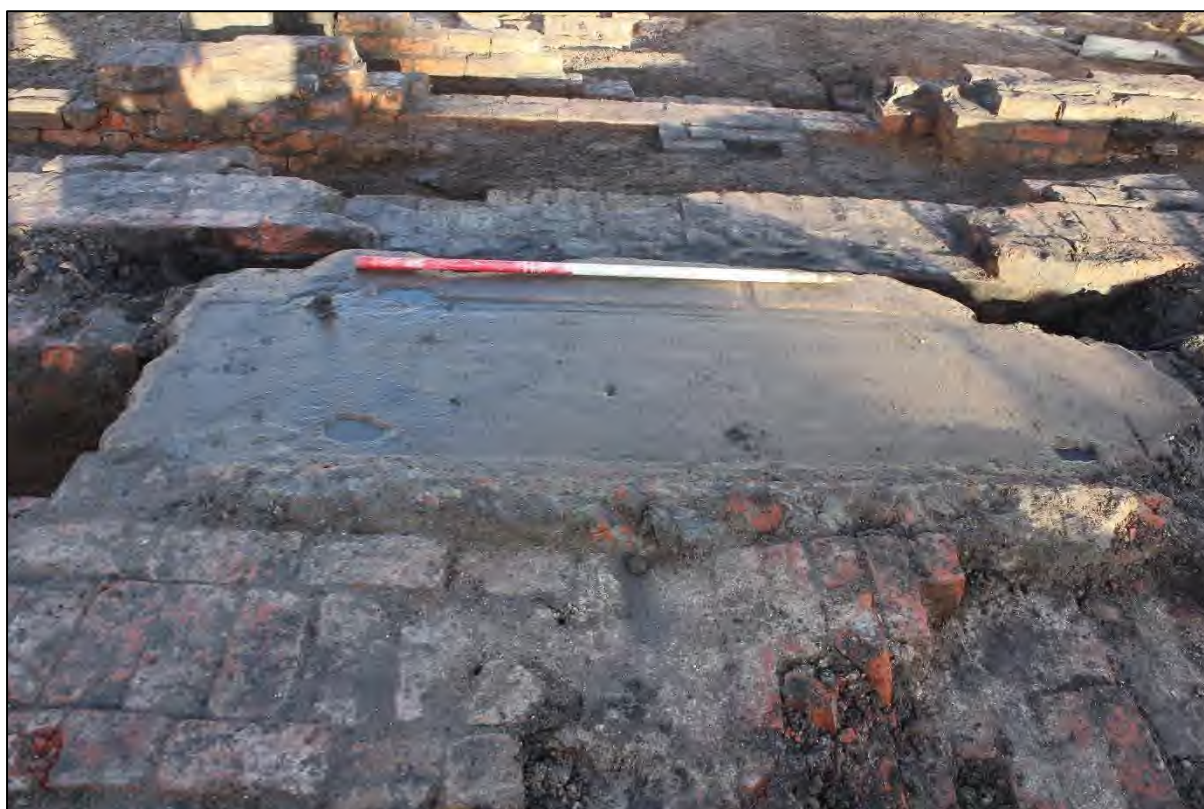
*Plate 124: Stone engine bed 3156 looking north (1m scale)*

**3156** was situated against the southern wall Building C (Plate 124). It consisted of a large sandstone block with a brick base. The brick base extended beneath the masonry element of the structure, consisted of three courses of brickwork, 0.22m high built above the natural sand; this comprised wire-drawn bricks and firebrick and was bonded with a grey ash mortar. A 0.28m wide aperture was built into the brickwork. The overlying sandstone blocks measured 2200 x 800 x 480mm. **3165** was abutted by a series of walls consistent with *Phase 6* and may have become obsolete after the construction of structure **3091**, a large brick structure erected a short distance to the north.

A series of walls were revealed to the south of **3091**. These were found to abut the stone engine bed **3156** and were likely constructed prior to the erection of **3091**. Both were built with machine made brick and bonded with hard Portland cement; wall **3197** abutted the engine bed on the western side and wall **3196** on the eastern side.

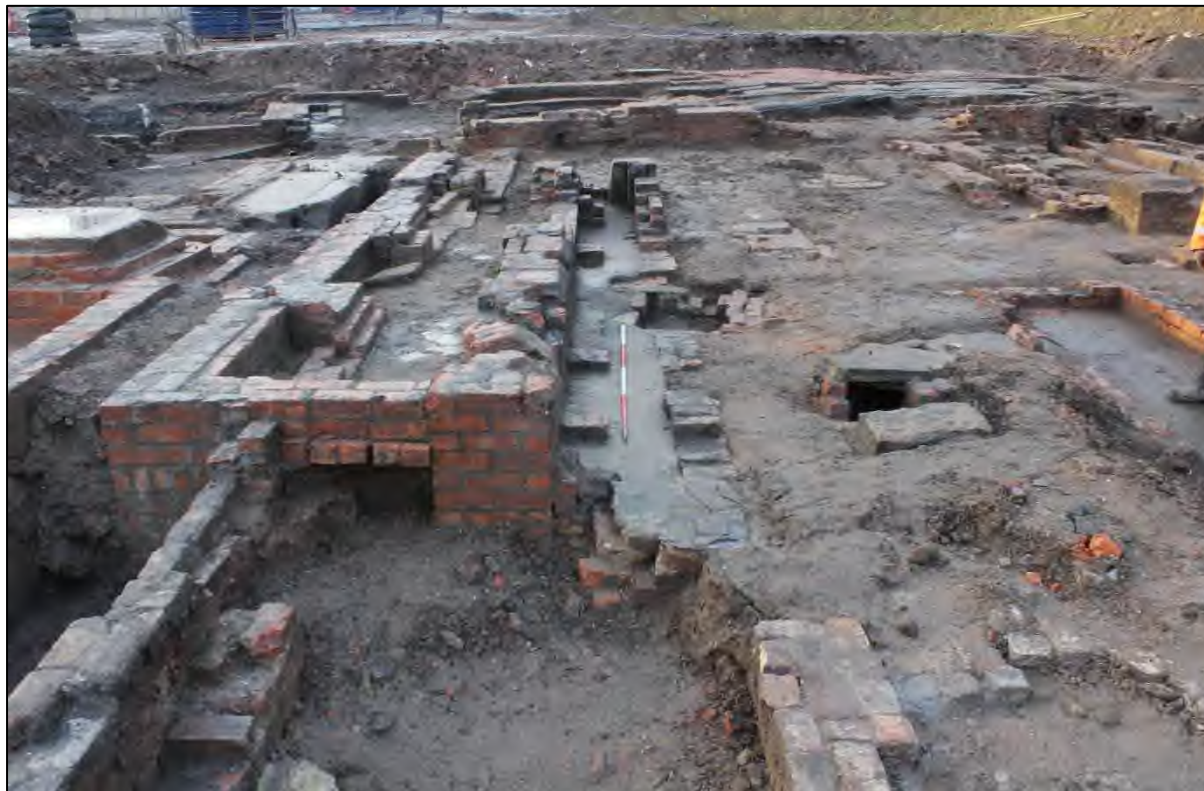
Plate 125: 3091 and 3109 looking west (2m scale)

**3091** was found in the south-west corner of the building and consisted of two parallel brick walls with integrated buttresses (Plate 125); a separate wall had been inserted between the

**3109** was found on the northern side of 3091 (Plate 125). Although broadly contemporary with 3091, it was evident that it abutted its northern face. 3109 comprised three outer walls and an internal brick floor surface, which had been covered over with a concrete screed. The wall fabric was identical to 3091. This had a maximum length of 7.92m and measured 0.82m in width.

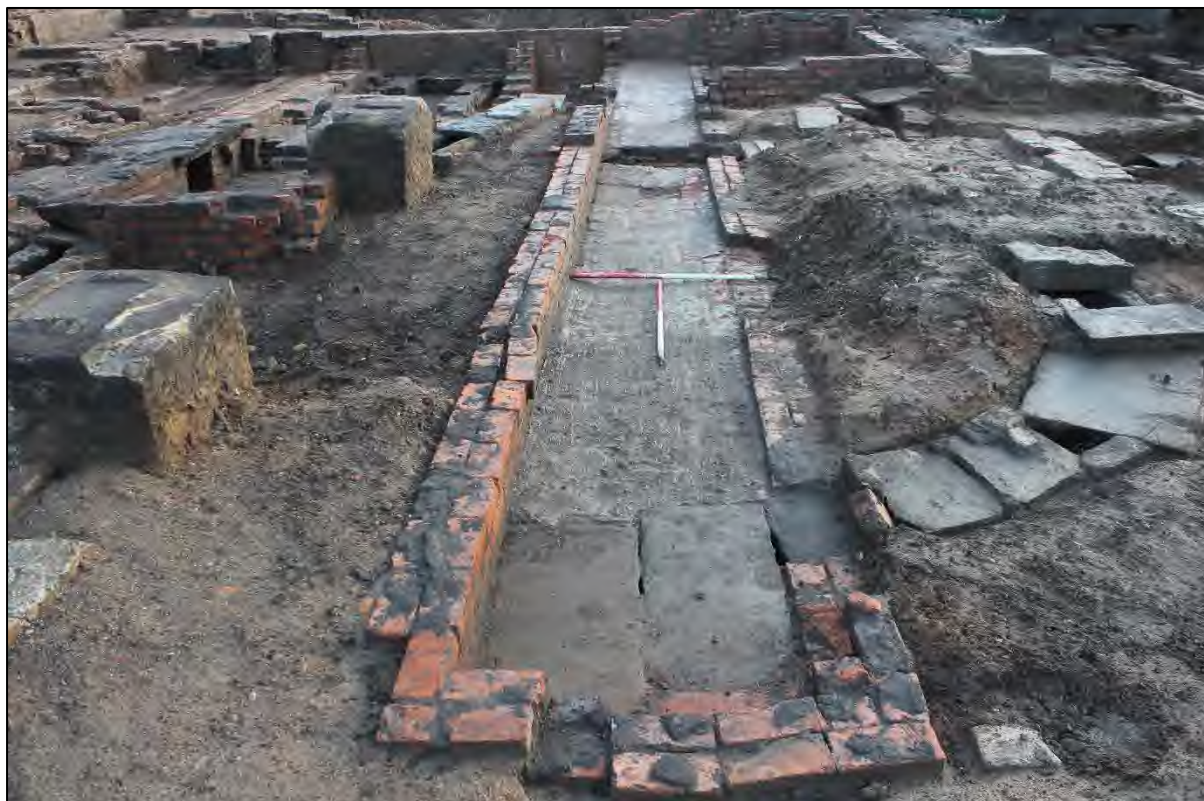
*Plate 126: 3080 looking east*

**3080** was situated to the south of 3085 and 3153 (Plate 126). It probably served a similar function to the long open drains of conduits (such as 3083, 3090=3092, 3085, 3087), which had been built during the previous phases. 3080 measured 12.52m in length and 1.29m in width. It was ascribed to this phase on the basis of its construction and structural / stratigraphic relationships. It abutted wall 3082 to the east and was built over several pre-existing drains: 3086 and 3100.

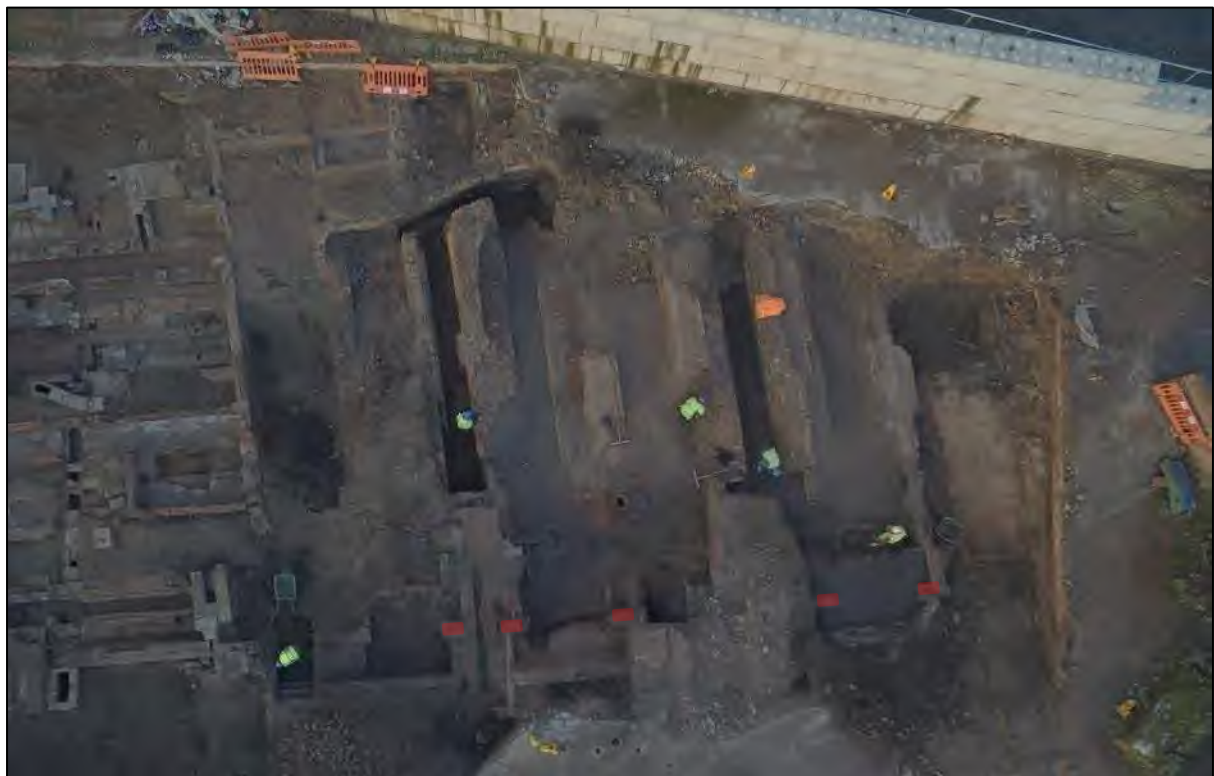
*Plate 127: Aerial view of the boiler House undergoing excavation with the brick piers forming the southern side of the building in Phase 3 highlighted (red)*

The boiler house was also expanded considerably during this period, more than doubling its original footprint. None of the original boiler house was investigated in Area 3, lying beyond the northern limit of excavation. The southern side of the newly extended building was defined by four surviving brick piers, **3121, 3122, 3123, 3124**, which individually measured 0.75 x 0.50m (Plate 127). The piers were bonded with a mid-grey lime-based mortar and were constructed using bull-nosed bricks creating rounded corners (Plate 128). The boiler house had clearly been extended to the south in subsequent phases as indicated by later walls such as 3075. The erection of the piers during the initial phase of construction, rather than a continuation of the brick wall 3076 indicates this side of the structure may have accommodated multiple openings, potentially arched, which would have facilitated the provision of coal into the stoking areas for each boiler. This notion is reinforced by the material choice of bull-nose bricks, frequently used at positions of ingress/egress.

Although the cylindrical boilers themselves had long since been removed, the surviving boiler beds (**3060, 3061, 3062, 3063**) (Plates 127 and 138) together with a number of the cast iron fittings and curved refractory supports recovered from the demolition rubble attest to their presence (Plate 138). Amongst the items salvaged were two cast iron fire-doors, which would have covered the openings to the twin furnaces. Lancashire boilers were patented in 1844 and were commonly used in the second half of the 19<sup>th</sup> century. The internal arrangement within the boiler house closely matches the 1872 insurance plan.

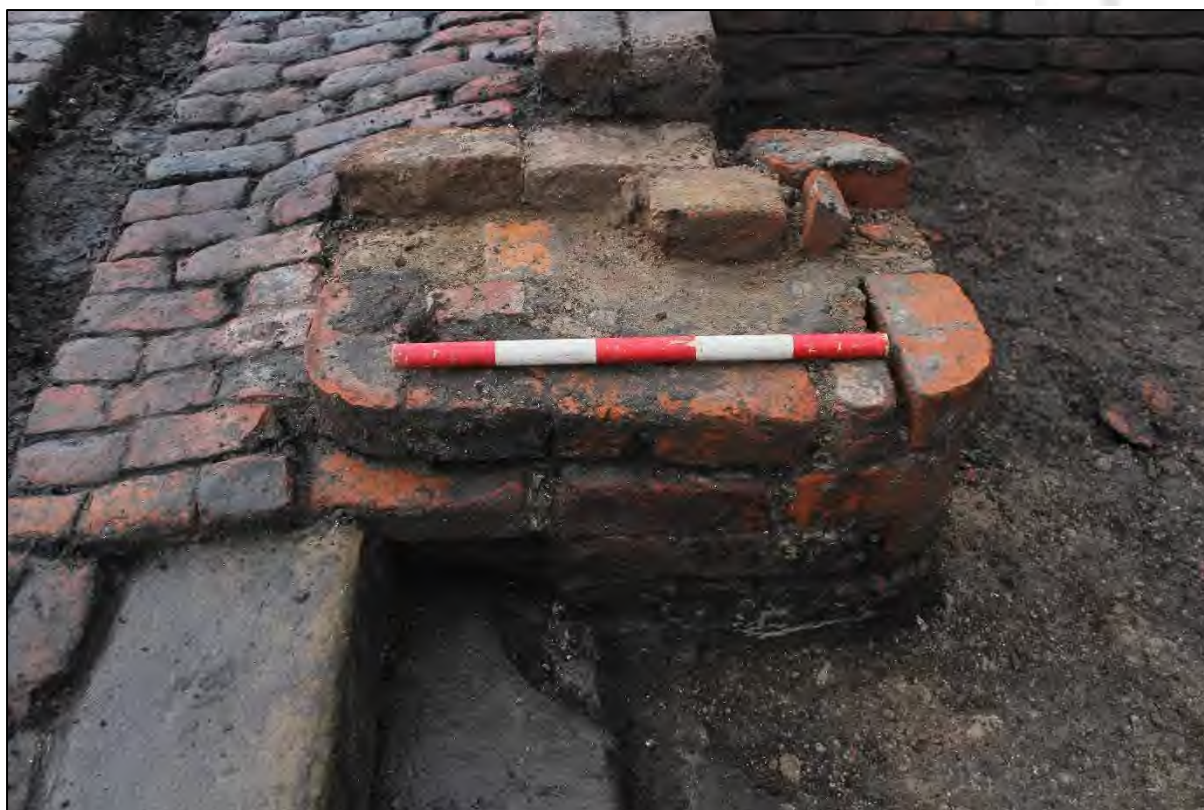
*Plate 128: Detail of brick pier 3124 with adjacent surface 3168, looking south (0.50m scale)*

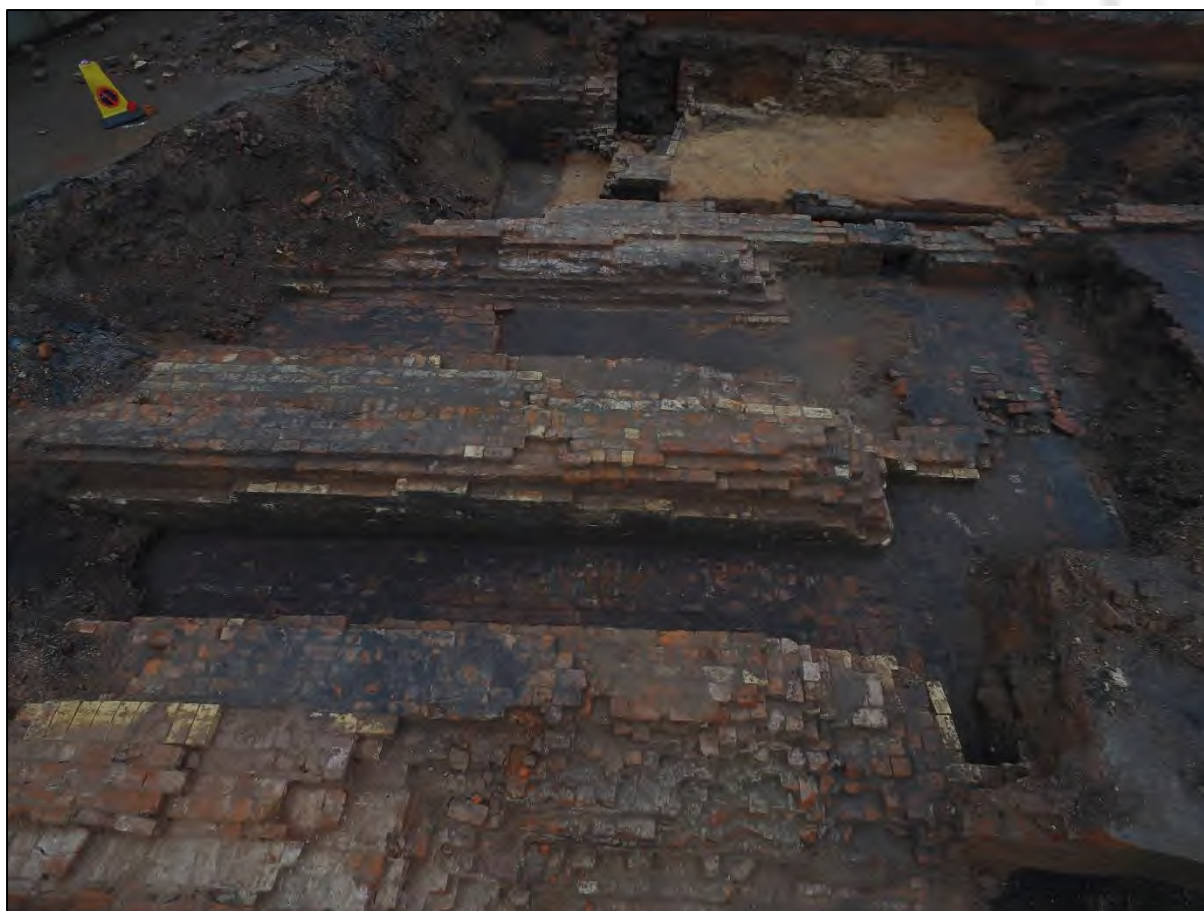
*Plate 129: Aerial view across boiler beds 3061 and 3060, looking east towards the economising house*

Boiler bed **3060** was the easternmost boiler had a lower flue measuring 1.04m in width and was only partially exposed in length (Plate 129). Only the western side flue was visible due to degradation and truncation; this had a surviving width of 0.52m but may have measured 0.79-1.00m in width. The western side of the boiler bed was formed of a 1.10m-wide support wall resting against the outer wall of the boiler house, 3070. The majority of the structure was formed from handmade brick with firebricks visible on the surface of the of western side flue. The fabric of the eastern wall comprised handmade brick bonded with a dark greyish brown lime-based mortar, whilst the surviving upper courses utilised a lighter coloured grey mortar.

Boiler bed **3061** represents the most intact example, with a complete T-shaped plan, featuring both side flues and bottom flue (Plate 129). The interior faces of the flue and base of the side flues had been lined with refractory brick, set in a crumbly sandy brown mortar. The width of the bottom flue was 1.05m wide, whilst the side flues were 0.56m wide. This structure survived to a height of 0.85m. An important observation was the occurrence of a centrally placed longitudinal wall at the base of the bottom flue; this was formed of a 0.11m-wide single skin wall.

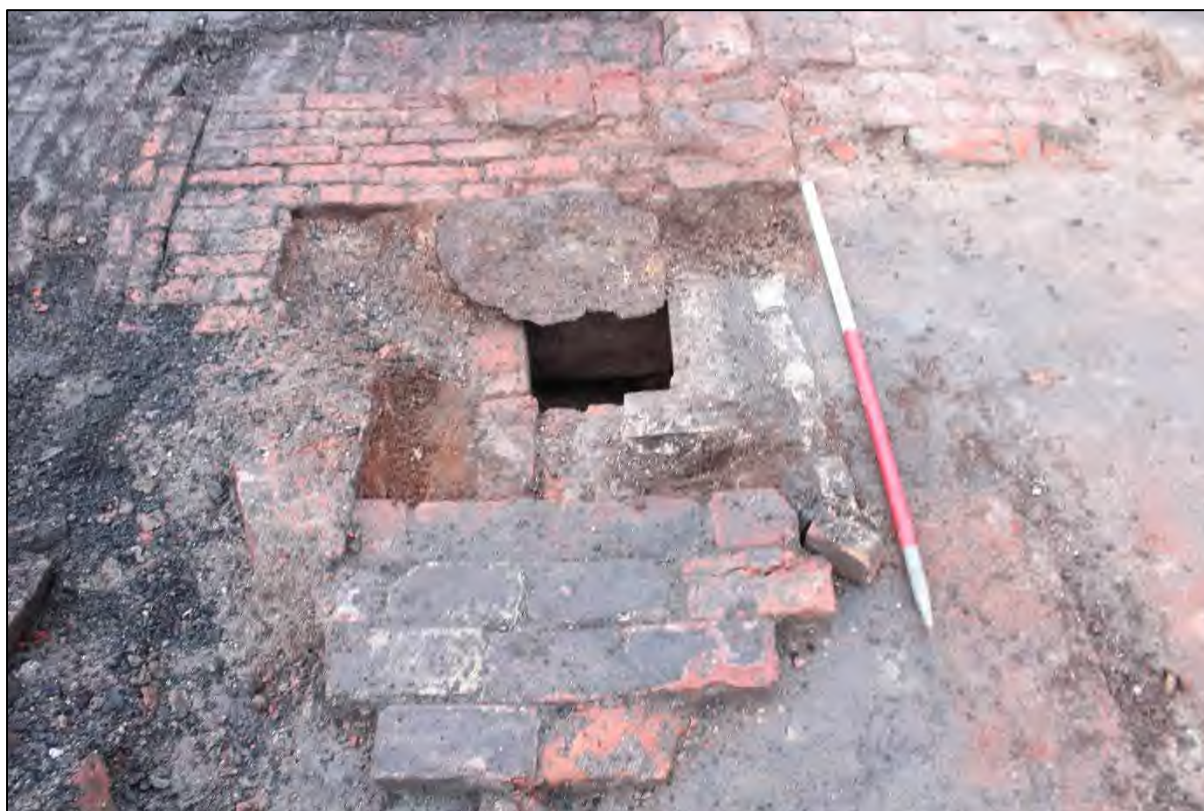
*Plate 130: Brick chamber above the east / west drain at the southern end of the boilers, looking east (1m scale)*

A sub-floor drain was constructed to the south of the boilers. This appeared to run east / west beneath the floor at the southern end of the boilers. A rectangular brick chamber exposed to the south of boiler bed 3062 provided access to the drain (Plate 130); this had an overall size of 0.48 x 0.48m and an internal aperture measuring 0.31 x 0.27m. Another chamber existed to the south of boiler bed 3063; this consisted of a square chamber capped with a sandstone flag. The flag was perforated to accommodate the collar of a cast iron pipe. The drain expose to the south of the boilers is likely to have been associated with the regular maintenance of the boilers, probably serving as a soakaway when the contents of the boilers were 'blown-off'. Lancashire boilers were commonly fitted with a valve, known as a blow-off cock, which was found on the underside of the boiler shell. This was designed to offload, under pressure, any sediment or waste deposited at the bottom of the boiler when the boiler.

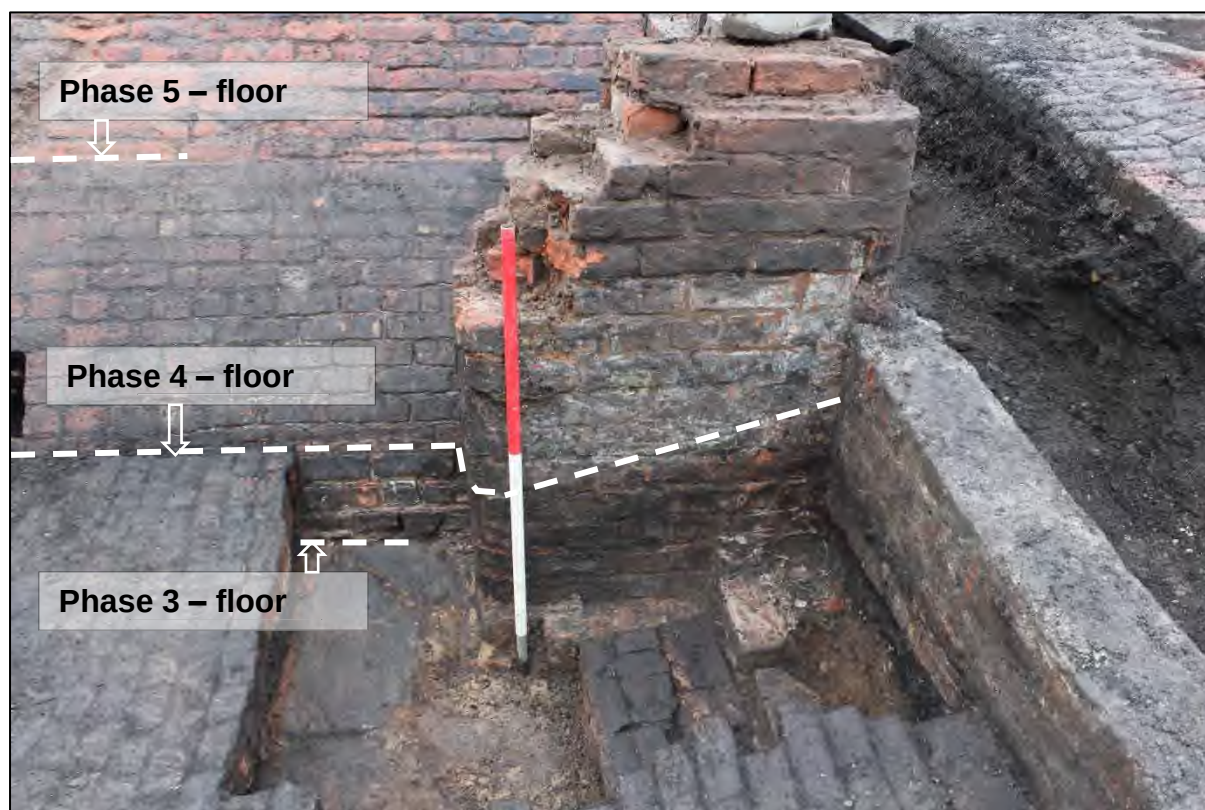
*Plate 131: The three successive charging floors revealed within the southern half of the boiler house: 3172 (Phase 3); 3065 (Phase 4) and 3174 (Phase 5). Photographed looking south (1m scale)*

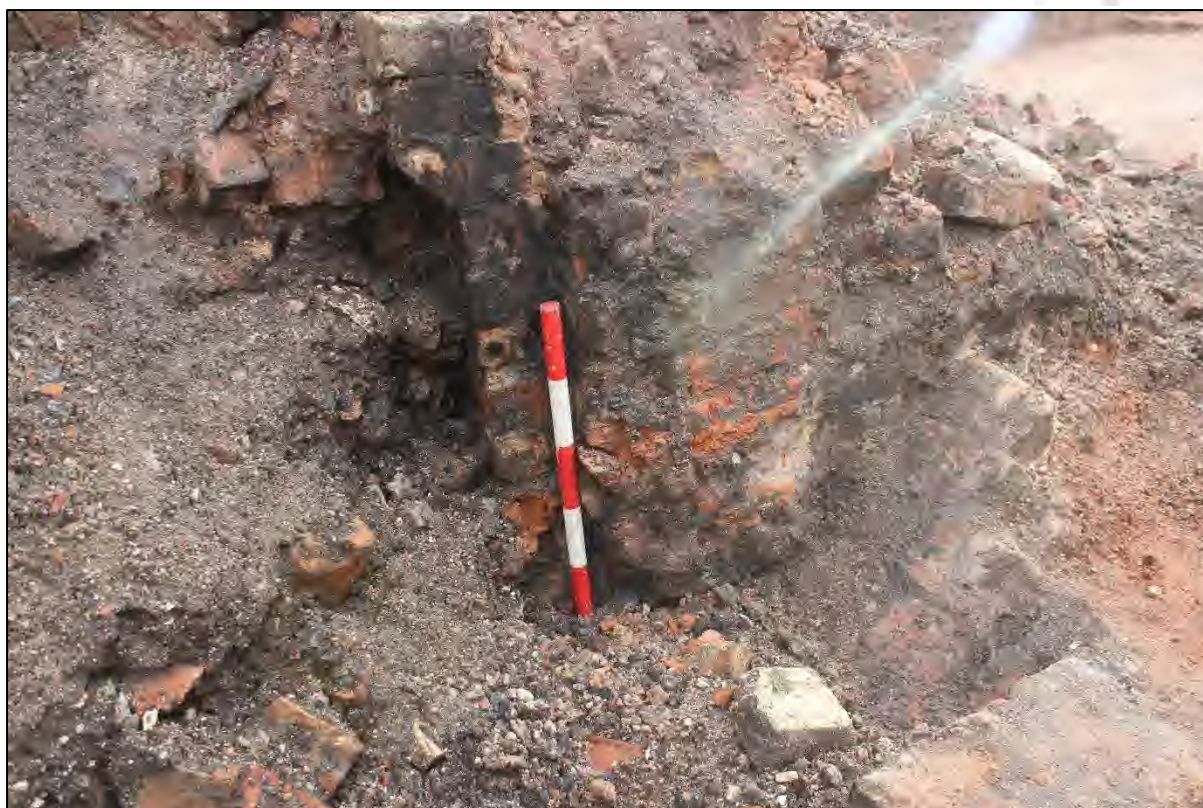
*Plate 132: Remnant of the vaulted flue to the rear of the boilers, looking east. Note the rebated brick wall and adjacent flue sloping down from below the boiler. This would have been the location of a damper to regulate draught (0.50m scale)*

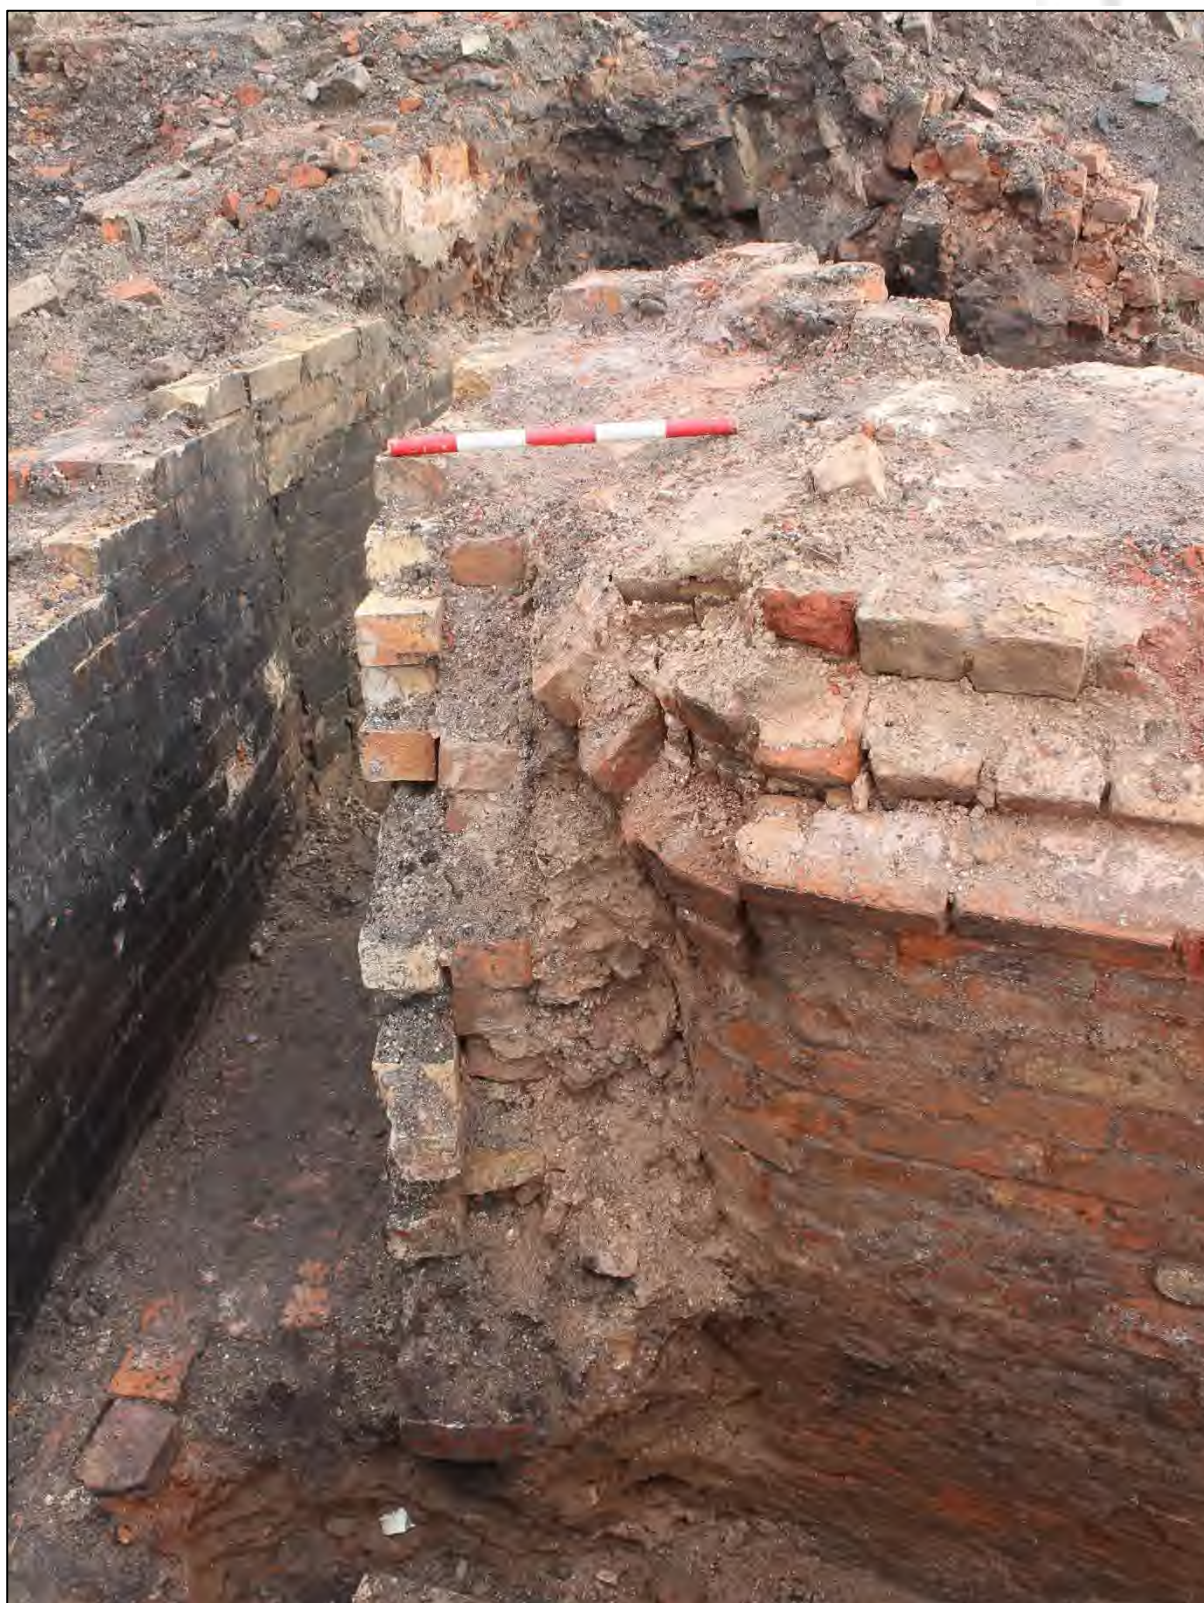
*Plate 133: View of the junction between walkway 3069 and flue 3064, looking north-east (0.50m scale). Note the original handmade brick wall (unscorched) and surviving vaulting. This was altered by the infill of walkway, followed by the raising of the floor surface within flue 3069 and relining. The modified flue cut off access to the walkway.*

Another element of the flue system was vaulted brick structure, **3069** presumably fulfilling the role of a service tunnel or walkway, facilitating access into the main flue system (Plates 133 – 136). This consisted of two parallel one-brick walls, 0.22m wide constructed with handmade brick and bonded with light grey ashy lime-based mortar. The southern end of the structure was formed by a slightly wider, 0.35m wide wall. The structure was floored with handmade brick. The structure was oriented north / south and was situated between boiler bed 3063 and the western wall of the boiler house 3071. Given how neatly this sits within the footprint of the building, it appears to represent a relatively early design choice and was presumably constructed within *Phase 3*. Access into the service tunnel was afforded by a doorway at the south-east corner through the side wall of the boiler bed 3063 and an adjacent brick pier 3176. Whilst the pier was built with ordinary handmade bricks and evidently pre-dated the insertion of the doorway, the corresponding wall to the north had been formed using bullnose bricks. During a subsequent phase of modification, part of the western and southern walls of 3069 were reduced in height to accommodate a southerly extension to wall 3071, 3078. 3078 was built over the denuded stub of the southern wall but was not fully repaired. Access to the walkway via the boiler house was later sealed up and the interior filled with a loose demolition rubble. The modified course of flue 3064, cut off access to the walkway from the north. Later, a drain was inserted above the remains of the infilled walkway, continuing to the south beneath surface 3168.

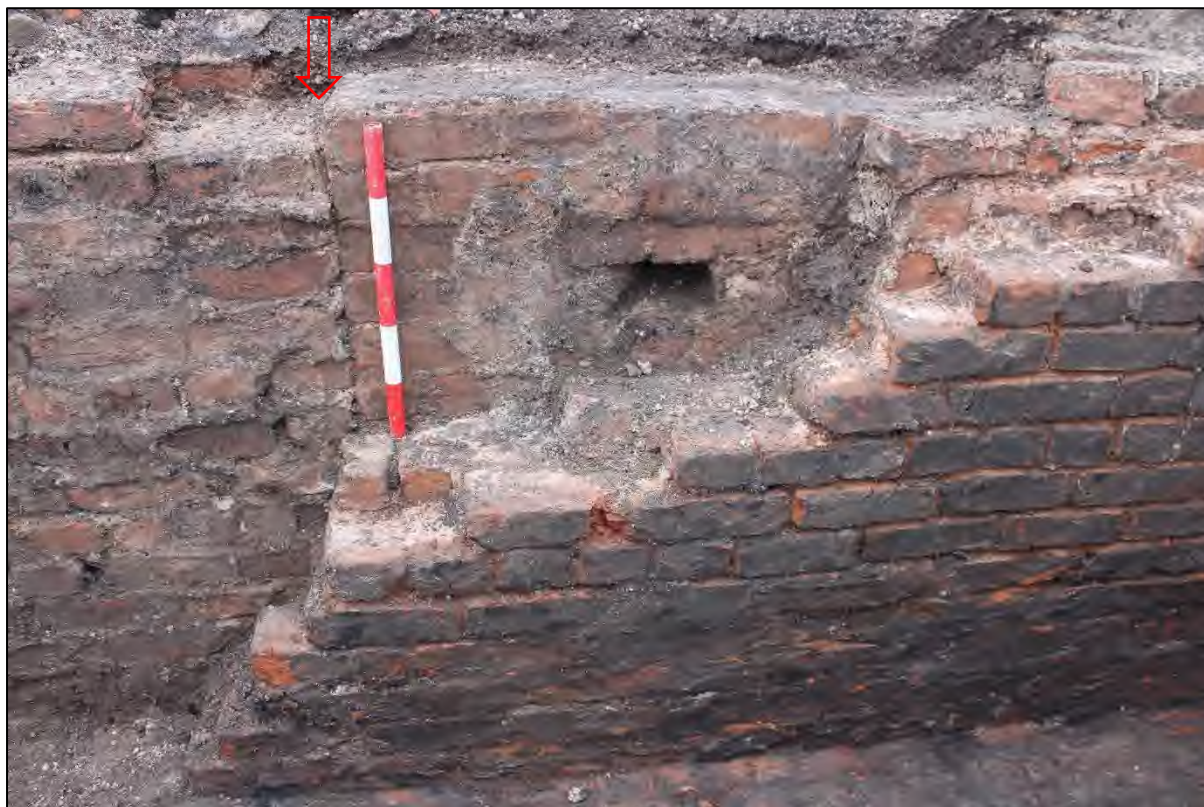
*Plate 134: Phase break between walls 3171 and 3178 with the western wall of walkway 3069 in the foreground, looking west (0.50m scale)*

The obsolescence of walkway 3069 was also suggested by the creation of a new wall 3178 immediately west of the structure (Plate 134). Wall **3178** was constructed to the south of wall 3171, representing a further extension to this wall line. Whilst it largely followed this alignment, it was apparent that southern extent of the wall partly truncated and overlay the southern wall of the walkway (Plate 145). Wall 3178 was built with handmade bricks bonded with a similar mortar to 3177. Constructed within a 0.40m wide construction cut, the wall measured 3.16m

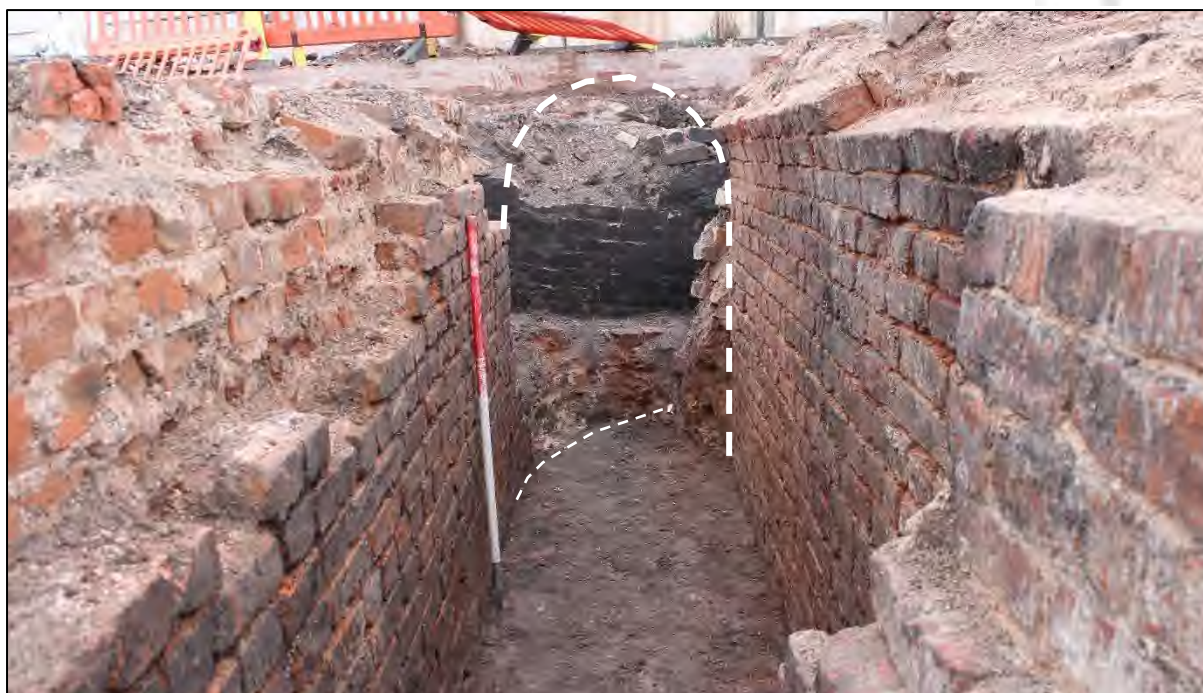
*Plate 135: View of the interior of the vaulted walkway 3069, looking north (1m scale). Note the remains of the curved outer wall preserved beneath a later raised floor surface within flue 3064 to the north, and the surviving vaulting that was an original feature of both 3069 and 3064*

It was probably during this phase of use that the flue system was subject to a complete overhaul. Flue 3064 was relined and extended (Plates 141 and 142). This was primarily achieved by knocking down the curved western wall forming the junction between 3064 and 3069 (Plates 135 and 136). An opening was also made within the adjacent brick wall 3126/3127 – once an external wall – to accommodate the western extension. The floor surface within the flue was subsequently raised and the former walkway 3069 was blocked off. The inner walls and raised floor were relined in firebrick.
