## Archaeological Excavation Report

Mayfield,  
Manchester

**Report No:**  
SA/2021/56

**Project:** Mayfield, Manchester: Archaeological Excavation

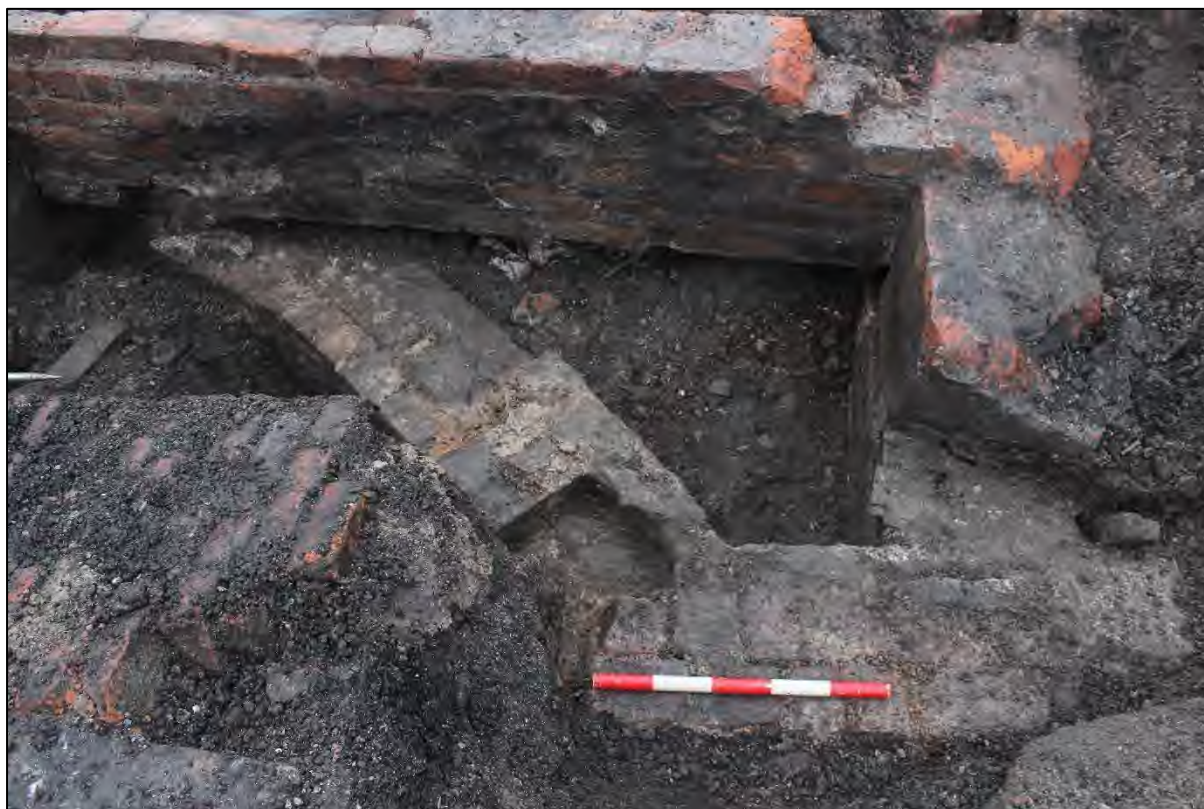
*Plate 137: Apsidal brick wall with southern linear return (3167) looking east (0.50m scale). Note the overlying surface 3168 (part excavated) as well as an overlying brick wall 3169, contemporary with 3173 to the south*

Another element that can be tied to the original construction that lay buried beneath a later raised floor surface (3168) was wall **3167** (Plate 137). Measuring 1.80m in length and 0.36m in width, 3167 had an apsidal shape in plan and was presumably associated with access or egress into or out of the boiler house. The southern extent of the wall had a linear shape in plan, visible for 0.80m and continuing beyond the southern limit of excavation. The wall abutted brick pier 3123. Wall 3167 was eventually reduced in height and buried beneath a later floor surface, which represented a later reconfiguration of access. Reused cast iron boiler plates had been laid above the denuded wall as well as covering a later drain, above which had been laid floor surface 3168; the arched plates may have derived from the original Cornish boilers that were likely replaced in the second half of the 19<sup>th</sup> century. As the apsidal wall is shown on the 1<sup>st</sup> edition 6" to 1-mile Ordnance survey map published 1851 (Figure 16), it is likely to have been a relatively early addition to the building within *Phase 3*; the use of a grey ash mortar places it towards the end of this phase. The structure is absent from the 1872 Insurance Plan suggesting it was demolished in the intervening decades.

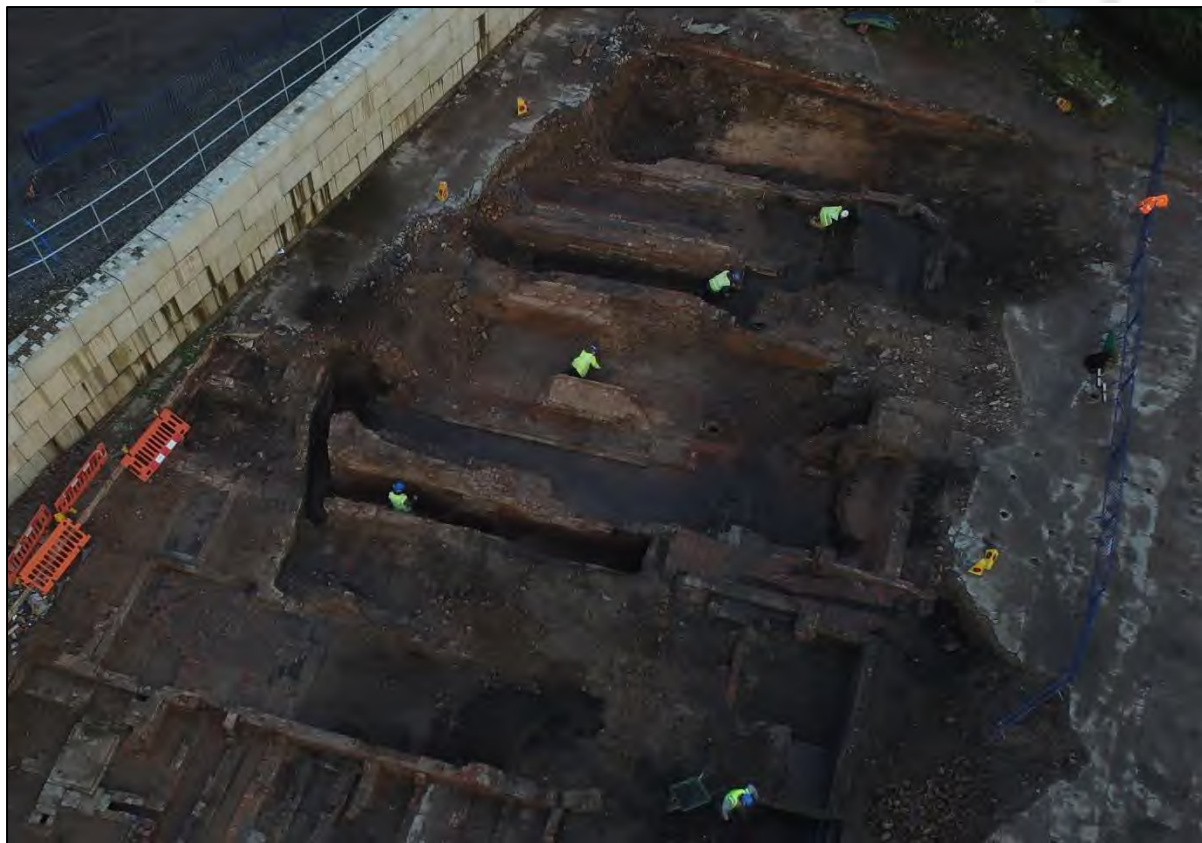
*Plate 138: Oblique aerial view across the boiler house showing the four boiler beds*

Although the cylindrical boilers themselves had long since been removed, the surviving boiler beds (**3060, 3061, 3062, 3063**) (Plates 127 and 138) together with a number of the cast iron fittings and curved refractory supports recovered from the demolition rubble attest to their presence (Plate 138). Amongst the items salvaged were two cast iron fire-doors, which would have covered the openings to the twin furnaces. Lancashire boilers were patented in 1844 and were commonly used in the second half of the 19<sup>th</sup> century. The internal arrangement within the boiler house closely matches the 1872 insurance plan.

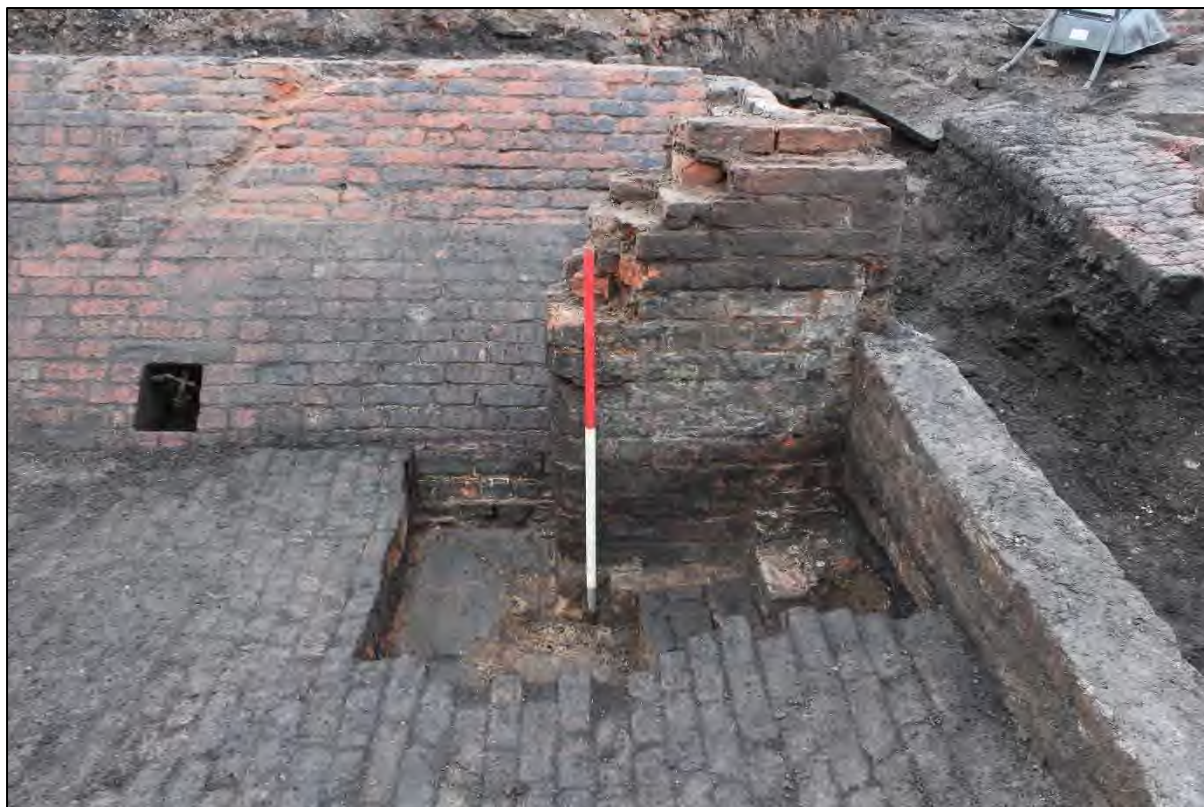
*Plate 139: Wall 3074 and brick pier 3123 looking south (1m scale)*

Two east / west aligned walls 3072=3074 represent a minor southerly extension to the boiler house (Plates 139 and 140). Both sloped inwards, presumably added to facilitate the provision of coal to the charging platforms. Wall 3072 represents the eastern continuation of the sloped wall, surviving to the east of a large concrete machine bed, which truncated the walls and was clearly added in *Phase 7*. The battered internal face of the wall was formed by courses of brickwork laid on a slope. An opening had been built into the interior sloping face of the wall. This measured 0.26 x 0.23m and was 0.35m deep. The top of the opening was capped with a stone lintel, measuring 0.46 x 0.08m. Housed within the aperture, extending upwards into the body of the wall was a threaded iron bolt fitted with two metal plates or anchors, one measured 0.14m in width, the other, 0.20m. These fixtures may have served to strengthen the sloping wall, in a similar fashion to tie rod, securing the sloped courses of brickwork together.

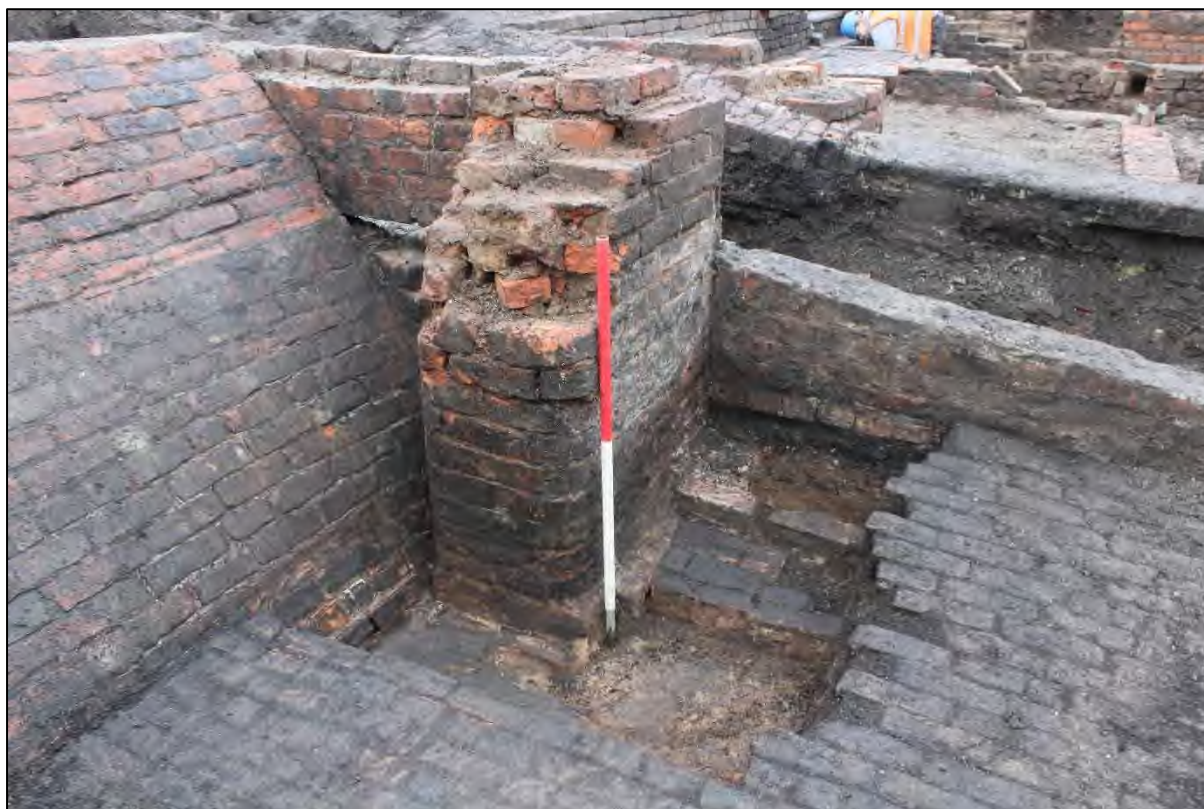
*Plate 140: Wall 3074 and brick pier 3123 looking south-west (1m scale)*

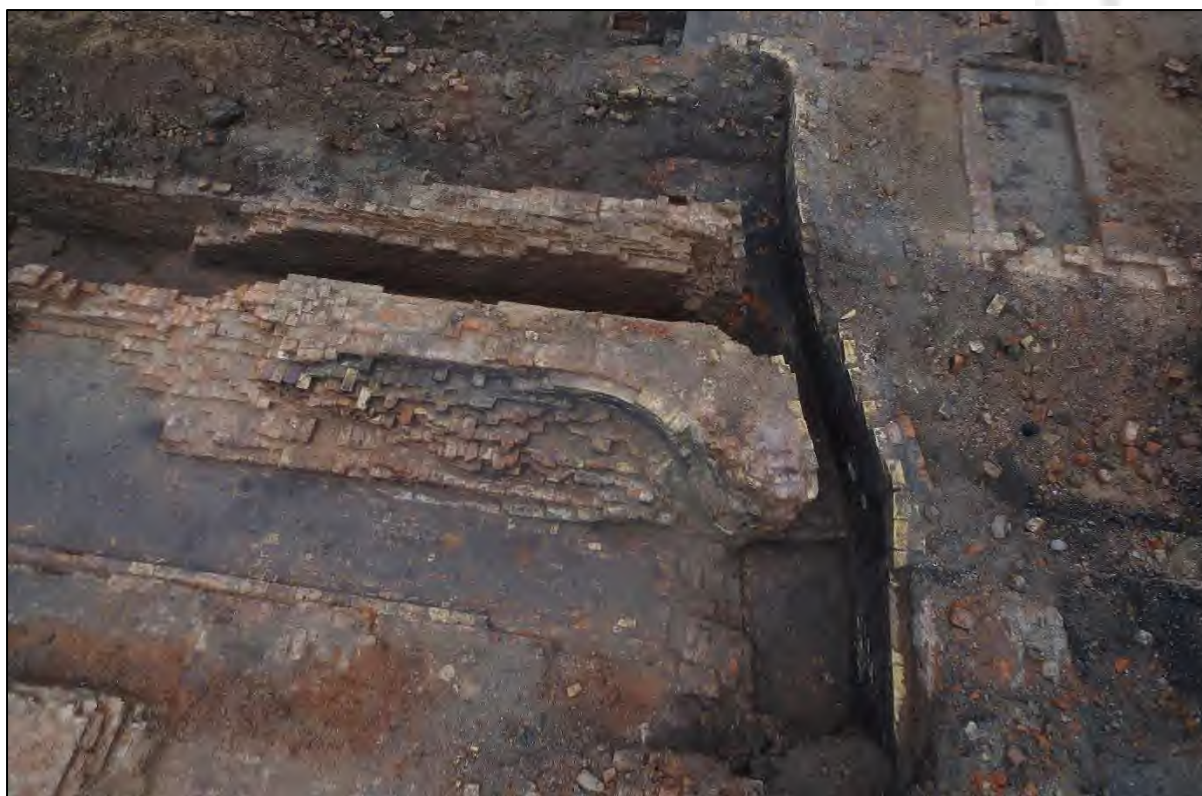
*Plate 141: Aerial view of boiler bed 3063, flue 3064 , its extension 3139 and walkway 3069*

It was probably during this phase of use that the flue system was subject to a complete overhaul. Flue 3064 was relined and extended (Plates 141 and 142). This was primarily achieved by knocking down the curved western wall forming the junction between 3064 and 3069 (Plates 135 and 136). An opening was also made within the adjacent brick wall 3126/3127 – once an external wall – to accommodate the western extension. The floor surface within the flue was subsequently raised and the former walkway 3069 was blocked off. The inner walls and raised floor were relined in firebrick.

The walls of the flue extension **3189** were constructed with an outer course of handmade, regularly moulded brick and an inner lining of refractory brick, bonded with a grey ash mortar. The exposed footprint of the flue covered an area of 2.38 x 1.00m (Plate 141). The extension of the flue to the south necessitated the truncation of another wall, which had previously formed the western return of wall 3126 (Plate 144). A single skin of bricks was then added to the western face of 3126, filling in a slight recess. It was also noteworthy that the extension of the flue, had necessitated partial reconstruction of the northern end of wall 3155. All the internal wall faces of the flue were blackened and scorched, and the refractory bricks were highly degraded, providing clear signs of use. The 1872 Insurance map usefully makes note of the presence of an additional boiler and aniline machine (not revealed archaeologically) within this part of Building C, to the south of flue. The insertion of an additional boiler and associated machinery provide an explanation for the need to extend the flue in this direction.

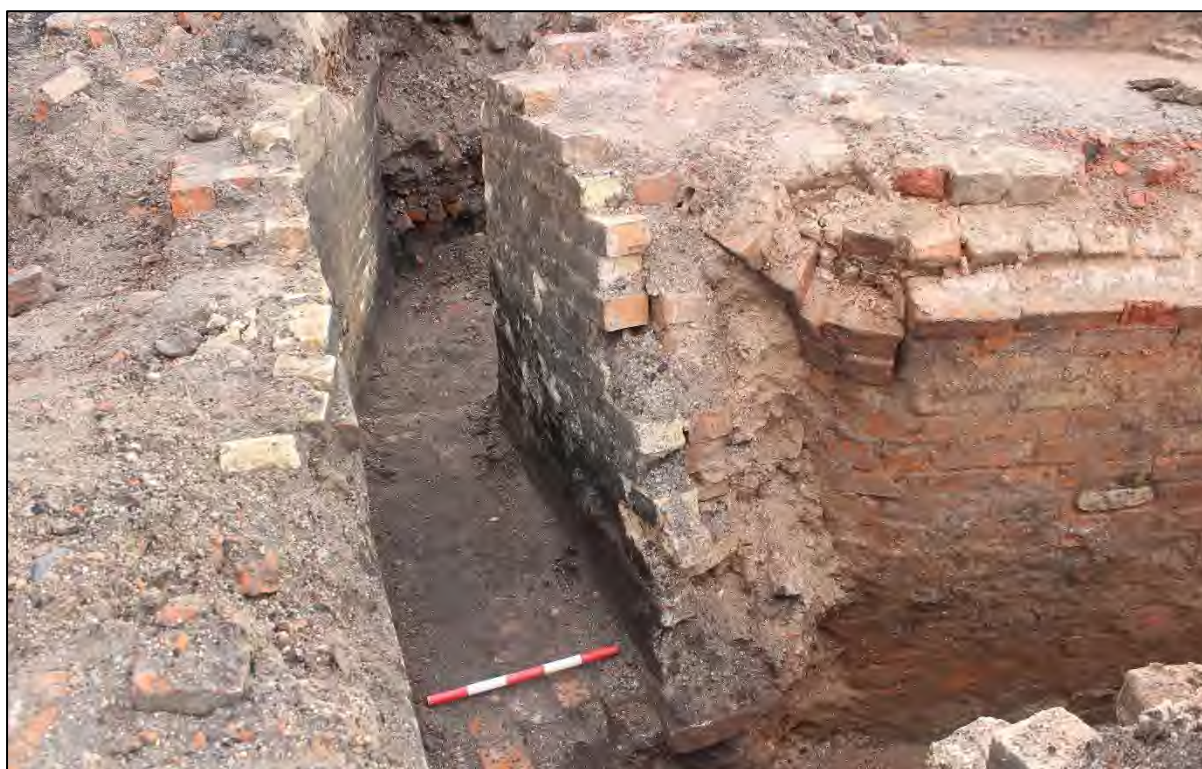
*Plate 142: View of Flue 3064 and walkway 3069, looking east (0.50m scale)*

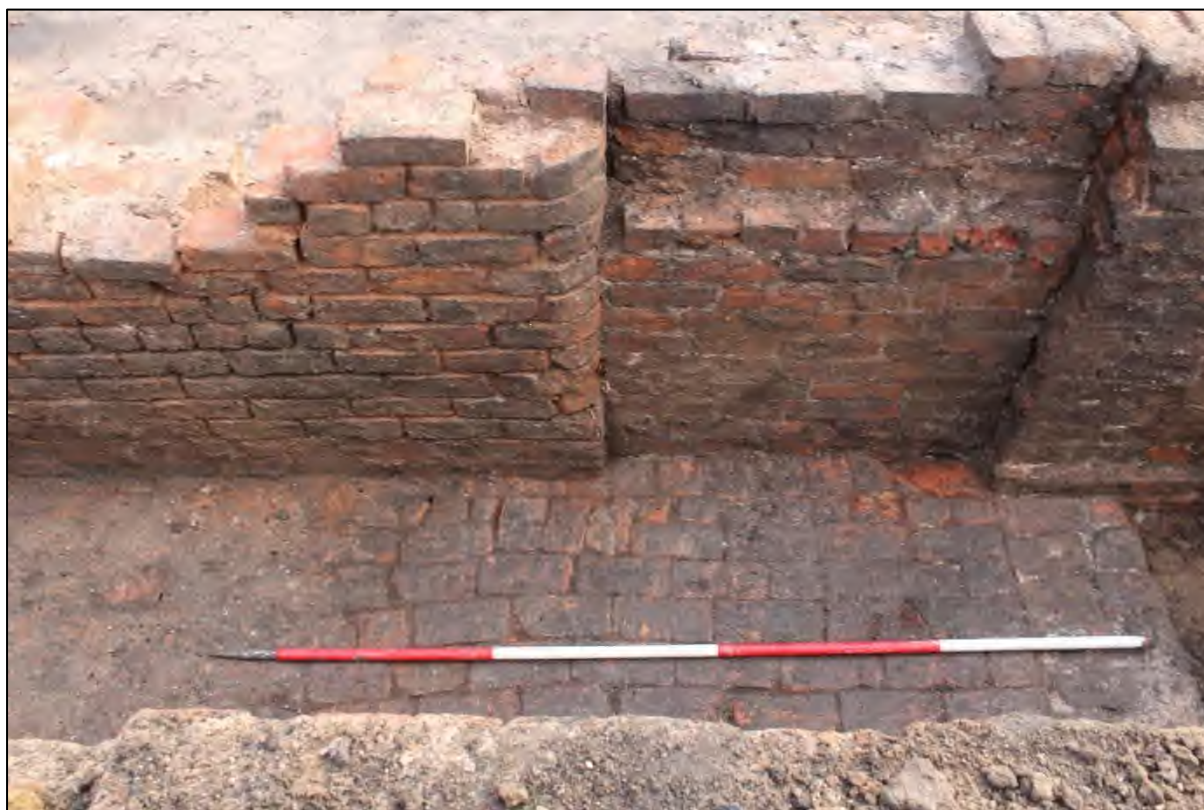
*Plate 143: Southern end of the excavated walkway 3069, showing the blocked doorway 3177 (2m scale)*

As a result of these changes, walkway 3069 became obsolete. This interpretation is corroborated by the insertion of a brick wall into the southern doorway, which formerly provided access into the walkway (Plate 143). The inserted brick wall **3177** measured 0.96m in length and 0.40m wide. It was constructed in handmade brick bonded with a grey ash mortar and was set back from the face of the eastern wall of the flue and brick pier 3176. Walkway 3069 was subsequently infilled with a loose deposit of brick rubble and degraded mortar.. Access into the flue system for clearance and maintenance was therefore probably achieved through the newly extended western end of the flue.

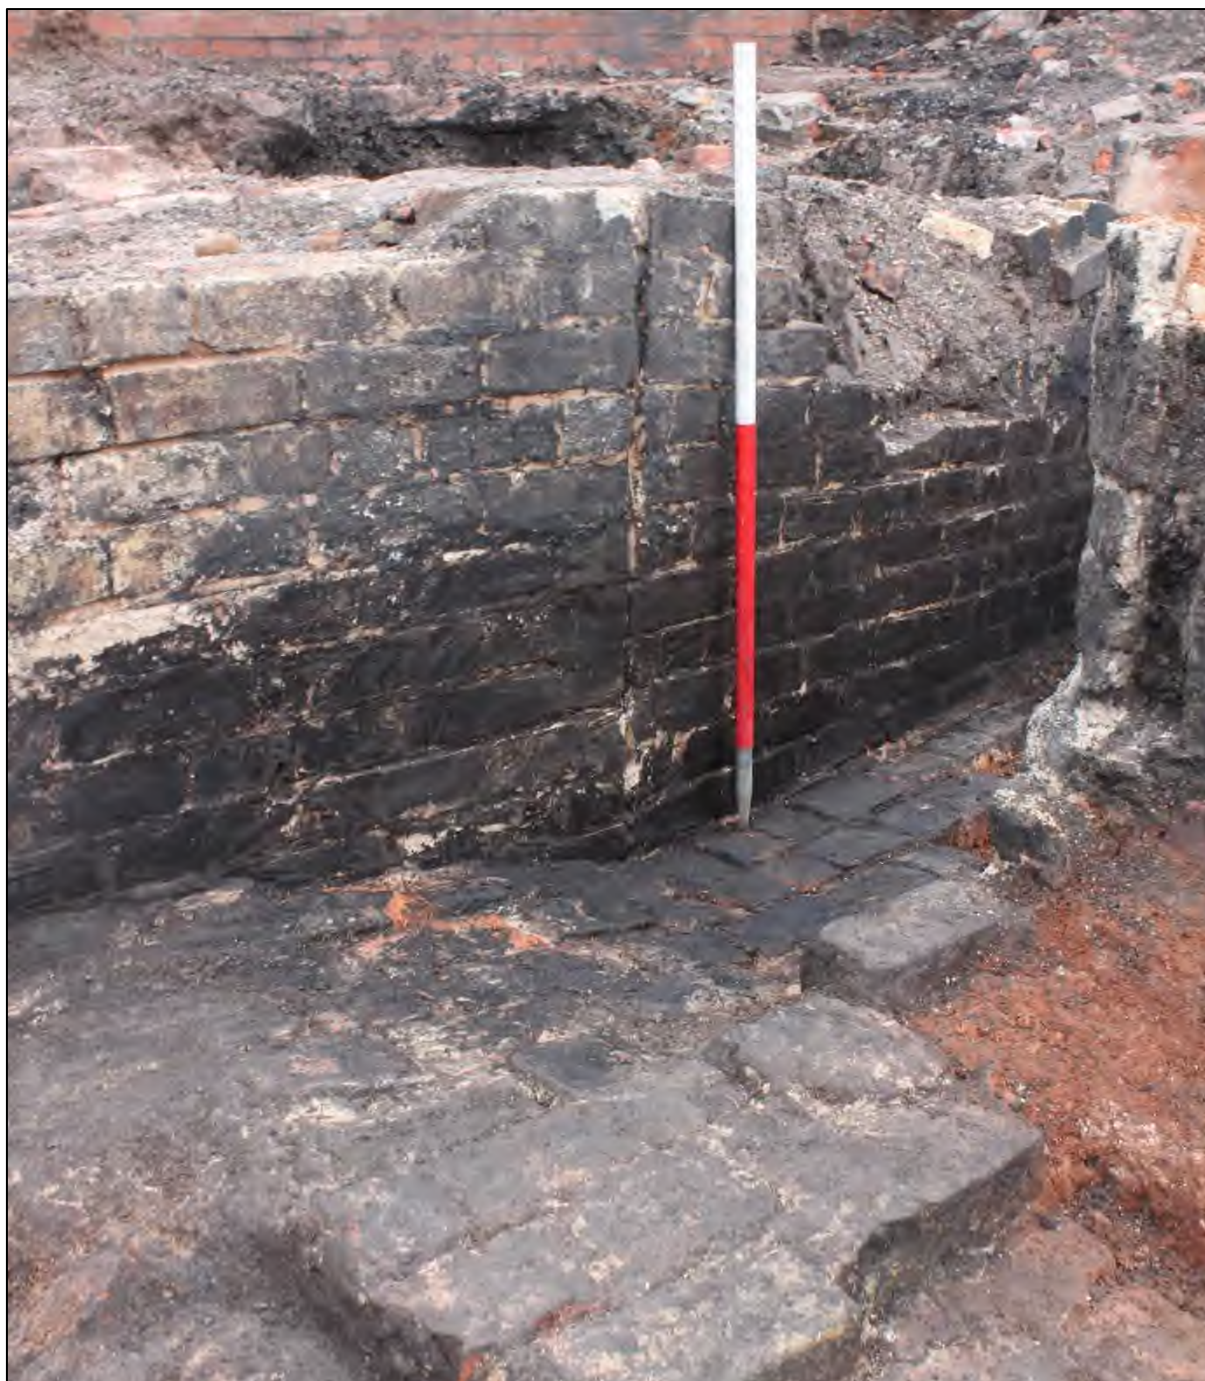
*Plate 144: Vertical phase break within the northern wall of flue 3064/3189 indicating its point of extension (1m scale). Note the upward sloping floor within the flue.*

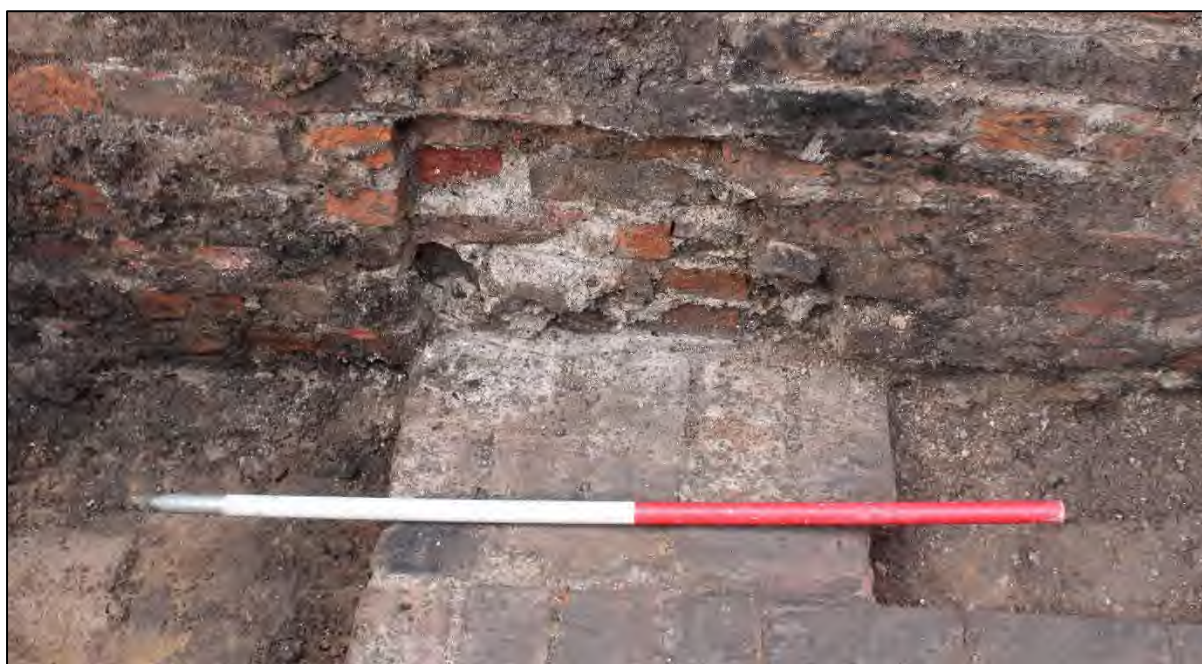
Plate 145: Denuded remains of the southern wall of walkway 3069, built over by wall 3178 (1m scale)

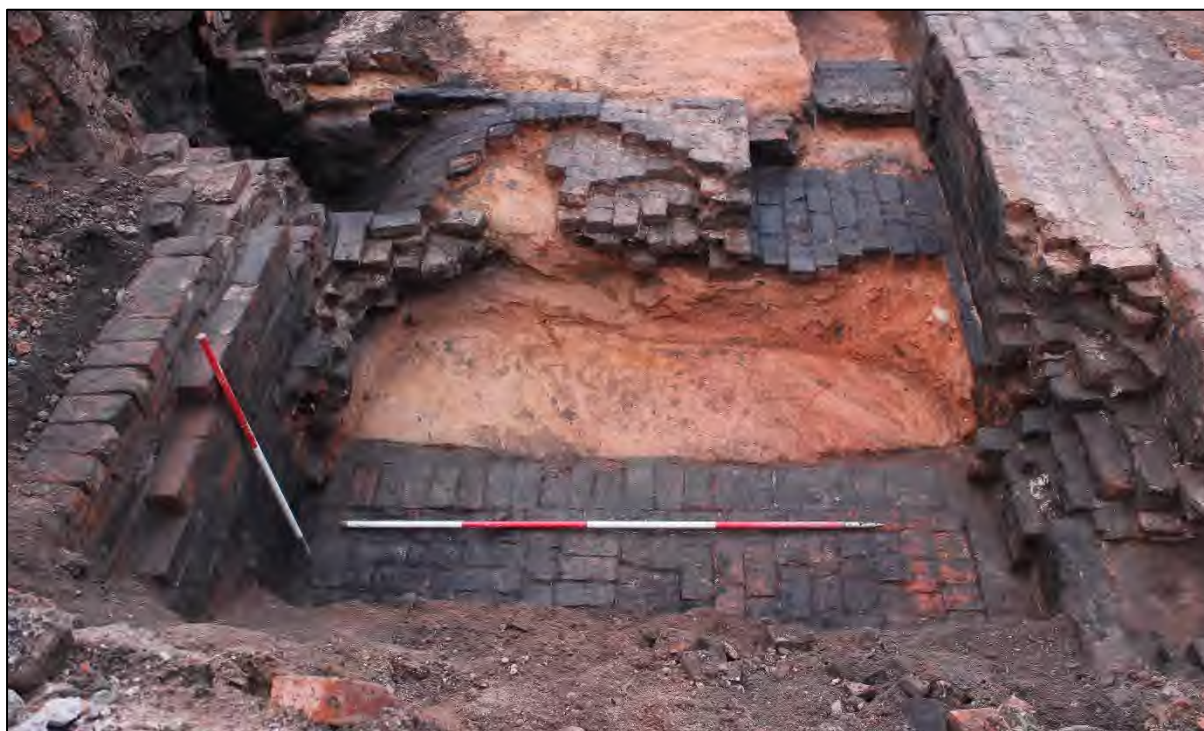
Plate 146: Remains of the economising house looking south (1m and 2m scales)

A major improvement to the steam-raising plant was the addition of the economising house, built on the eastern side of the boiler house (Plate 146). Whilst much of this structure lay beyond the limit of excavation, a suite of structural remains relating to the economiser were revealed. These included a brick-built cellared room, which had a rectangular footprint and had been cut into the natural sandstone (Plate 146). To the south of the main structure was a narrower rock cut channel or passage, aligned north / south alongside the eastern wall of the boiler house; housed within the passage was a large cast iron pipe (Plate 148). An east / west

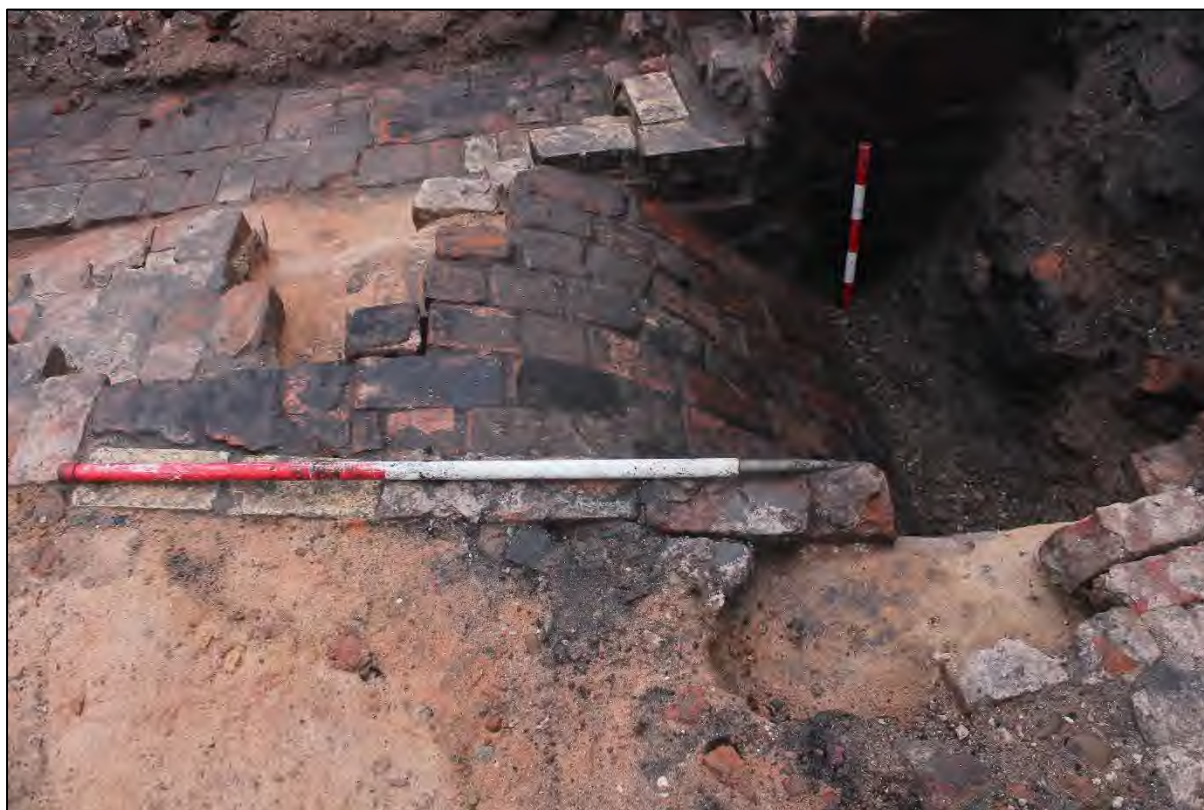
*Plate 147: Flue 3184 looking north (1m and 0.50m scales)*

To the east of surface 3185 were remains that were positively identified as a flue (Plate 147). Flue **3184** was built to the south of wall 3186. Much of the northern wall was truncated but a surviving stub of wall was keyed-into wall 3183 and was clearly contemporaneous; the northern wall was 0.24m wide. The southern wall of the flue was narrower and consisted of a single skin of handmade and refractory brick, 0.11m wide. This was reinforced with a second skin, to the south, which appeared to block-off an earlier flue 3180. The top of the flue was convex and had a gradual break of slope to an east / west sloping base. The structure was built mainly with handmade brick, utilising firebrick in the outer walls, which was found more sporadically in its base; the base of the flue was heavily sooted, in a manner similar to 3185, which suggest both may have formed elements of the same flue system.

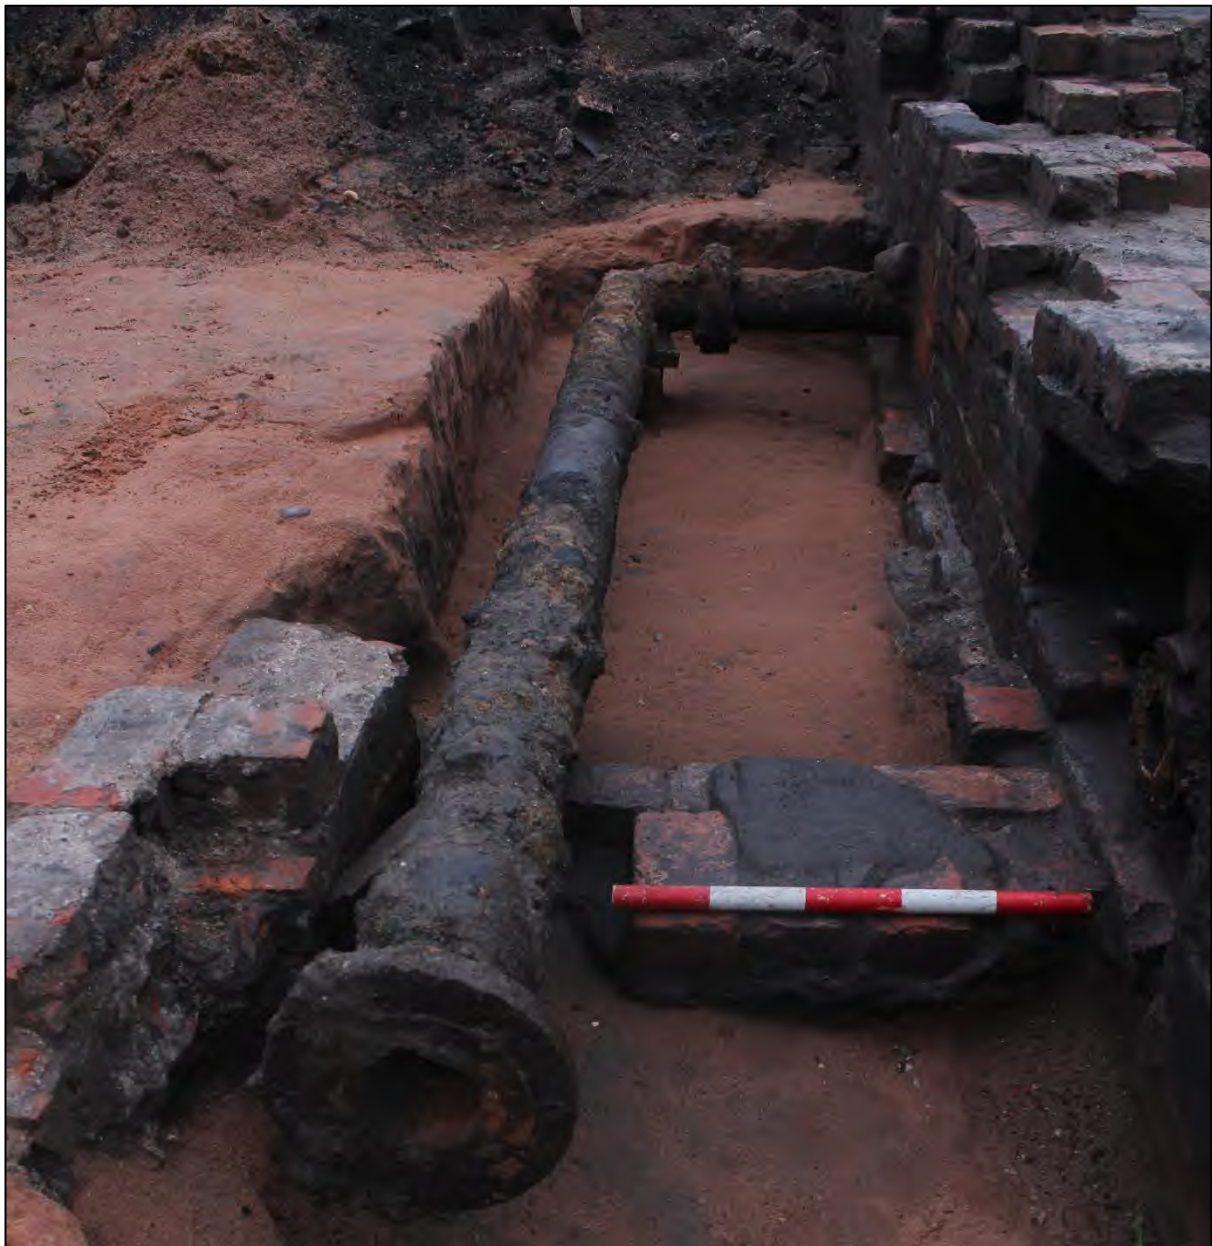
*Plate 148: Rock-cut conduit 3188 together with walls 3187 and 3189, and the large cast-iron steam pipe, looking north*

The function of the rock-cut conduit may be explained by the presence of a large cast-iron steam pipe (140mm diameter, with 260mm collars). This had an L-shape in plan and had been inserted through an opening through wall 3070. The date the pipe was inserted is not clear but it had clearly been surrounded by later brickwork, inserted in *Phase 5 – 6*.

Another element of the boiler house that was spatially and functionally related to the economising house was a narrow rock-cut conduit, **3188**, which ran along the eastern side of the boiler house (Plate 148). The rock-cut feature was 0.85m wide, 4.56m long and survived to a depth of 0.18m. A surviving portion of brick masonry, wall **3187**, was built on a slight shelf in the bedrock on the eastern side of the cut and appeared to be contemporary with the feature. The wall survived over an area of 0.45 x 0.20m. Both structural elements correspond with a small addition that was built against the eastern exterior of the boiler house; this structure is absent on the 1<sup>st</sup> edition 6" to 1-mile Ordnance survey map published 1851 but is clearly depicted on the 1872 Insurance Plan providing clear phasing for its construction. Based on the details of the plan, the structure appears to have been built around an opening or doorway in the eastern wall of the boiler house.

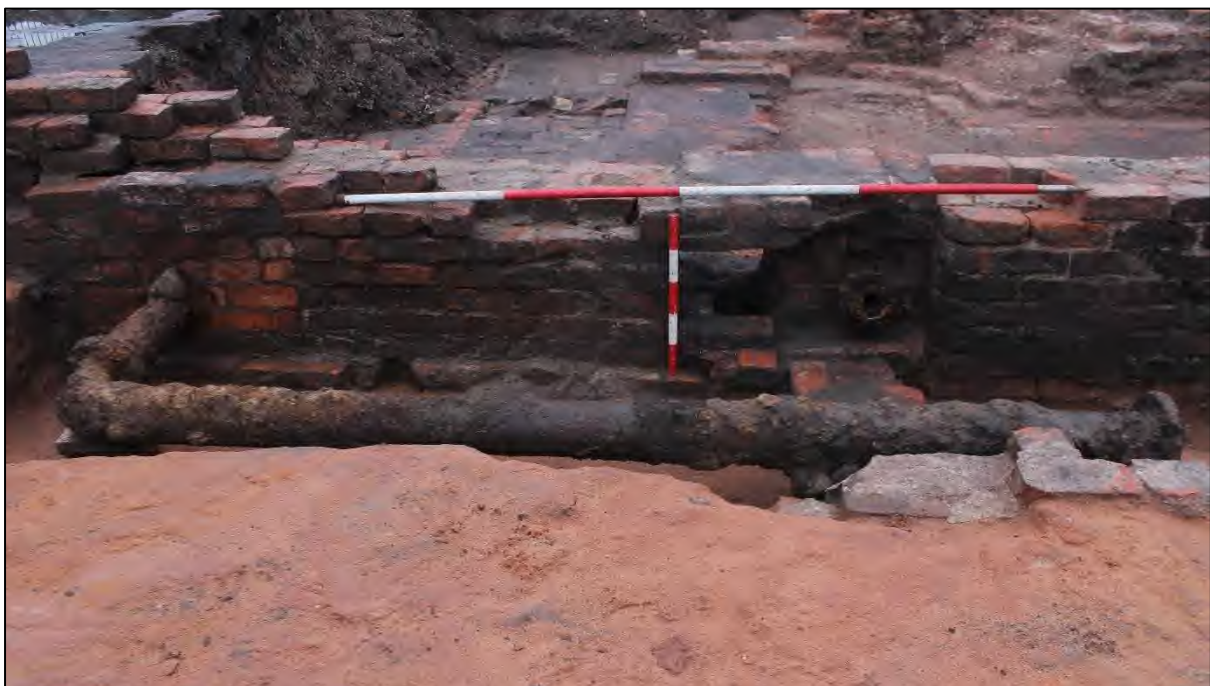
*Plate 149: Eastern elevation of wall 3070 showing the blocked apertures in the wall (2m and 0.50m scales)*

Various details relating to the construction and remodelling of wall 3070, provide evidence of the wider changes made to the boiler house throughout its use. First and foremost, an opening – situated 3.70m from the south-eastern corner of the wall – does not appear to have been original to the build and was perhaps added during *Phase 4*; a vertical phase break visible in the eastern elevation (Plates 149 and 150) marks the position where a section of masonry had been removed and to which bullnose bricks had been inserted. The position of the doorway corresponds to an opening shown on the 1872 Insurance Plan. The alterations to access most likely relate to the general improvements to the steam-raising plant and addition of the economising house. During subsequent alterations of the building, presumably in *Phases 5 or 6*, the opening was partially sealed; this blocking, 3191 utilised a brittle mid to dark grey ash mortar consistent with other *Phase 6* structures in the main part of Building C. The blocking and obvious redundancy of the aperture for through-access appears to signal yet another alteration to the layout of the boiler house during its final phases of use.

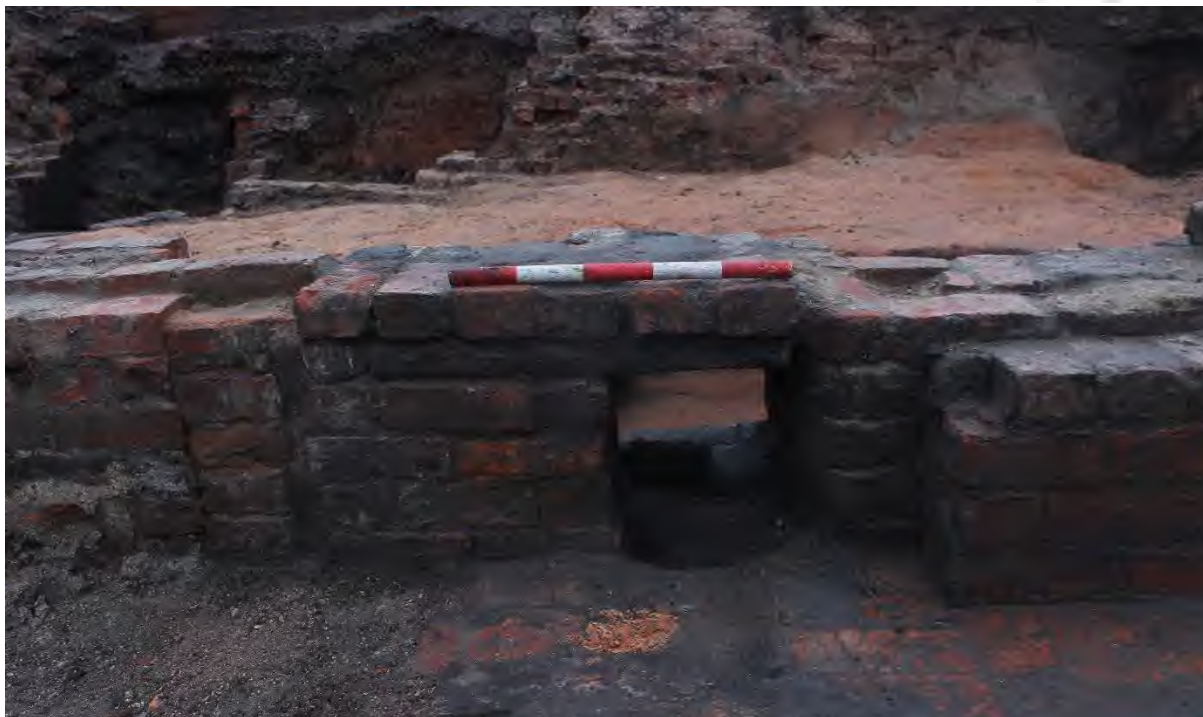
*Plate 150: Western elevation of wall 3070 with blocked doorway 3191 (0.50m scale)*

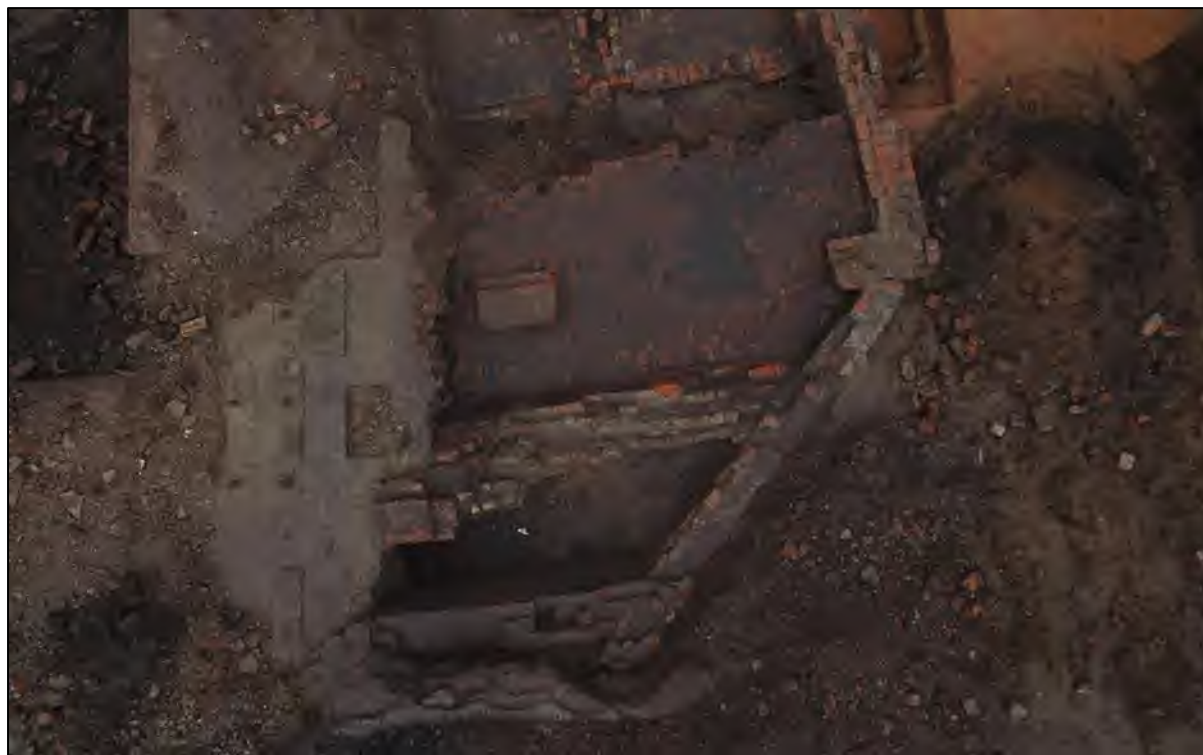
*Plate 151: Part of the Phase 5 extension to the south of the boiler house*

This was most evident in the changes to the southern side of the building, as evidence by an extension built at a 49-degree angle to earlier frontage (Plate 151). Two walls relate to this

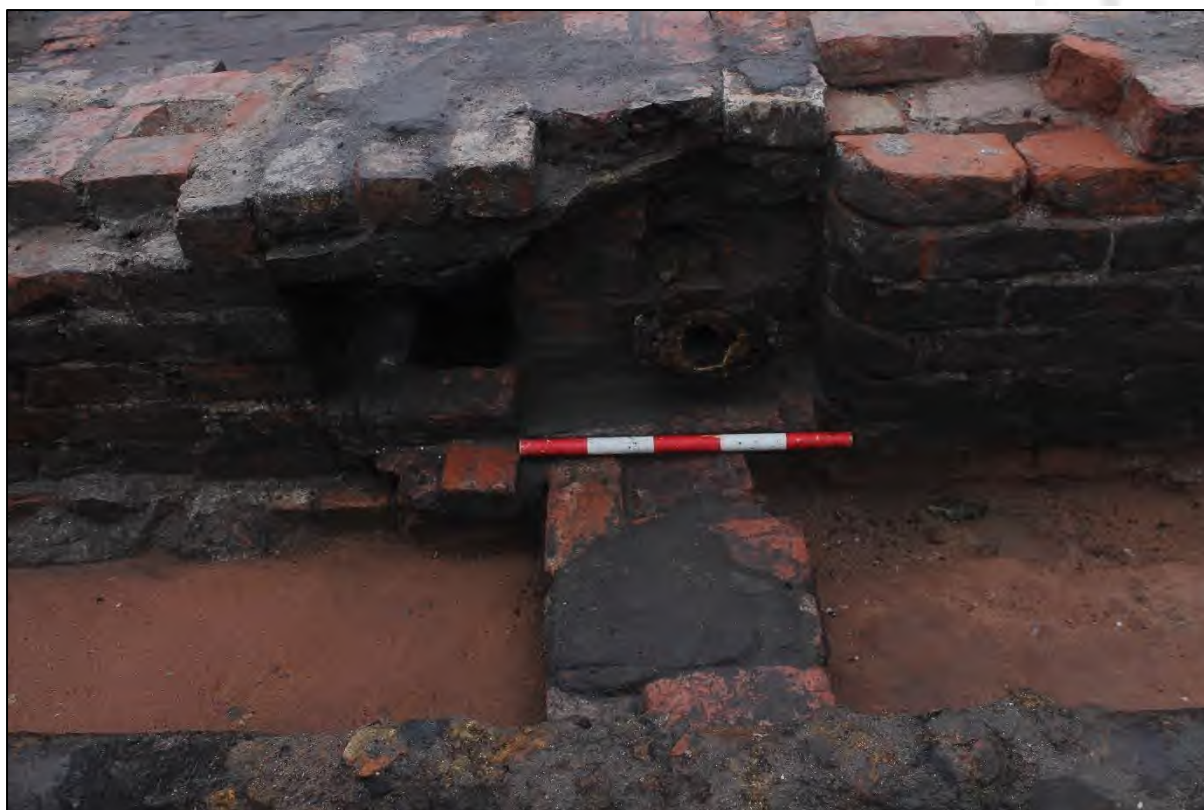
*Plate 152: Wall 3189 and blocking 3191, together with 3070, looking west (0.50m scale)*

Wall **3189** was encountered to the east of wall 3070 and lay within the rock-cut chamber 3188 (Plate 152). Measuring 0.64 x 0.34m. It appeared to be contemporary as blocking 3191,

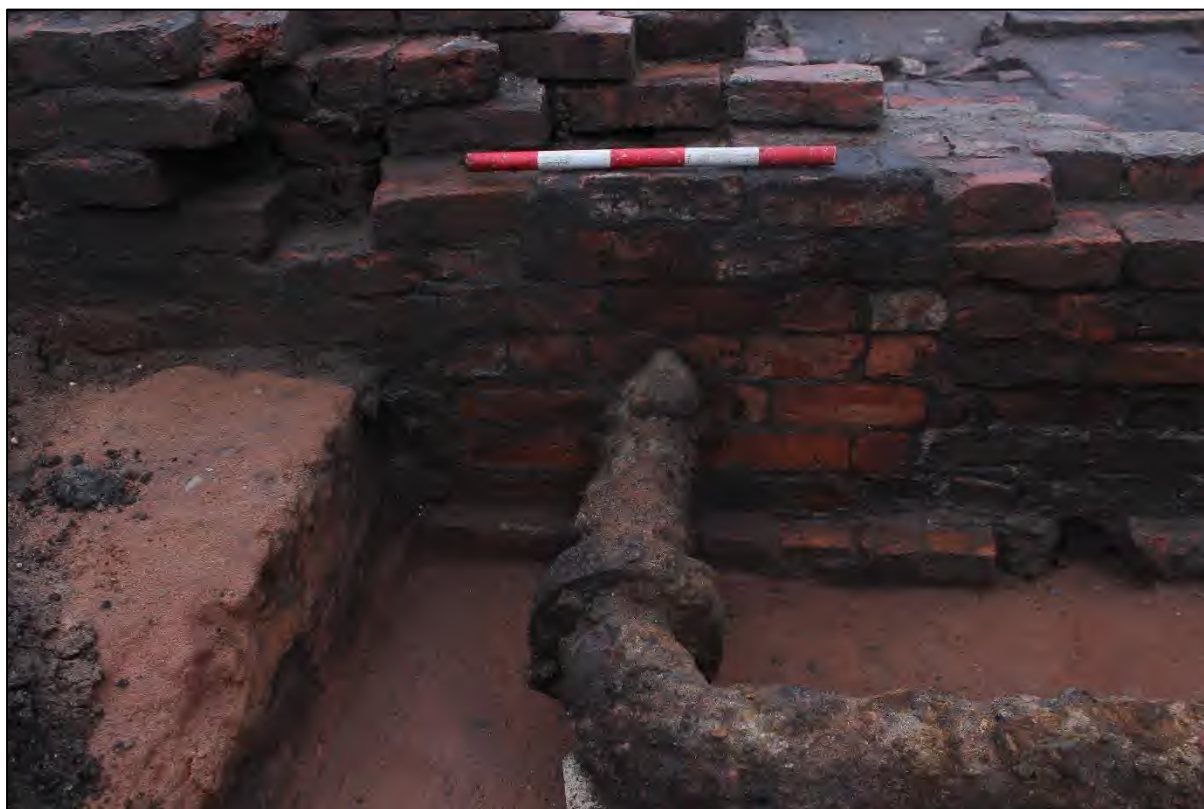
*Plate 153: The cast iron pipe and Phase 5 3195 to the southern extent of wall 3070, note the use of a black mortar*

The final portion of infill, blocking **3195**, visible in the upstanding remains of the eastern wall of the boiler house had been constructed around the steam pipe. This blocking utilised machine-made bricks and a hard, mid to dark black ash mortar (Plate 153).

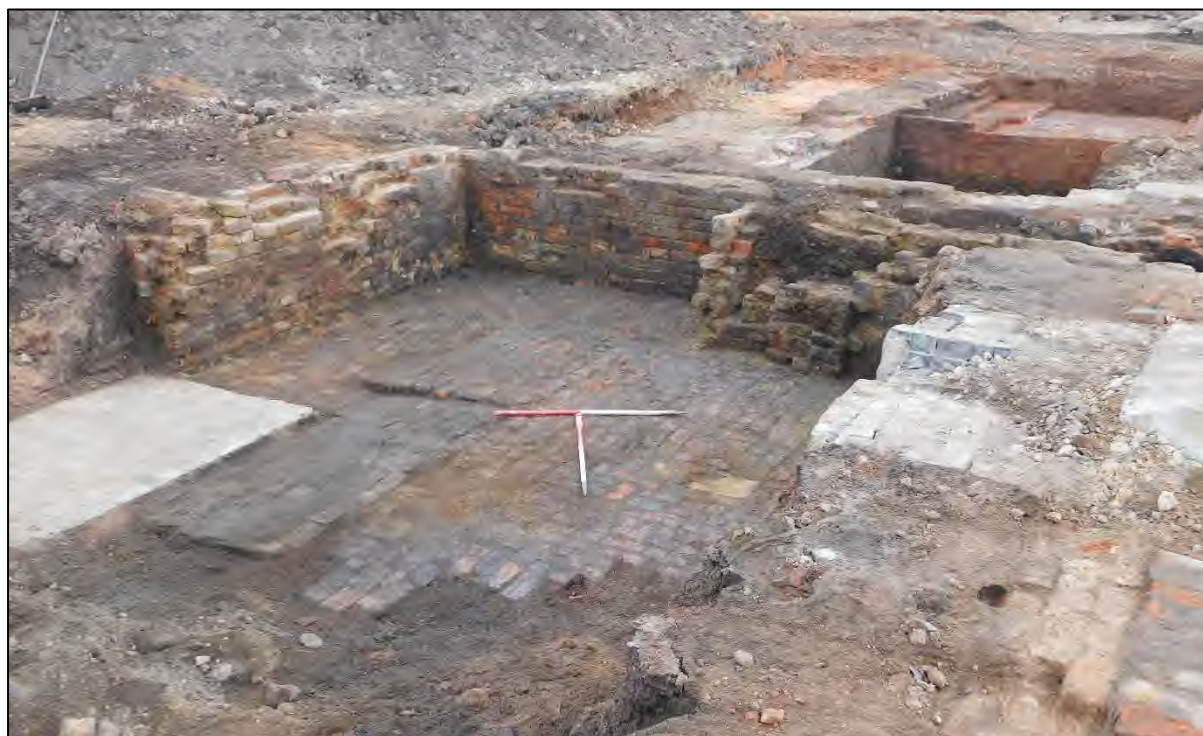
Plate 154: Building A showing walls 402, 403 and surface 404 facing south east (2 x 1m scales)

The earliest phase of the dyeworks was Building A, comprising walls 402, 403 and brick surface 404 (Plates 154 and 155). The survey of these structures was overlaid on the Greens map of 1787-94 and appears to represent the building seen on this map, which was orientated north-east / south-west. With modification and alteration this building and its orientation and remains present throughout *Phases 2 to 5*.

Surface **404** was 12.14m long and 4.13m wide and was constructed from handmade bricks of various sizes. This building was heavily truncated by later 20<sup>th</sup>-century foundation cuts, housing concrete stanchion bases and a cement pad (Plates 154 and 155).

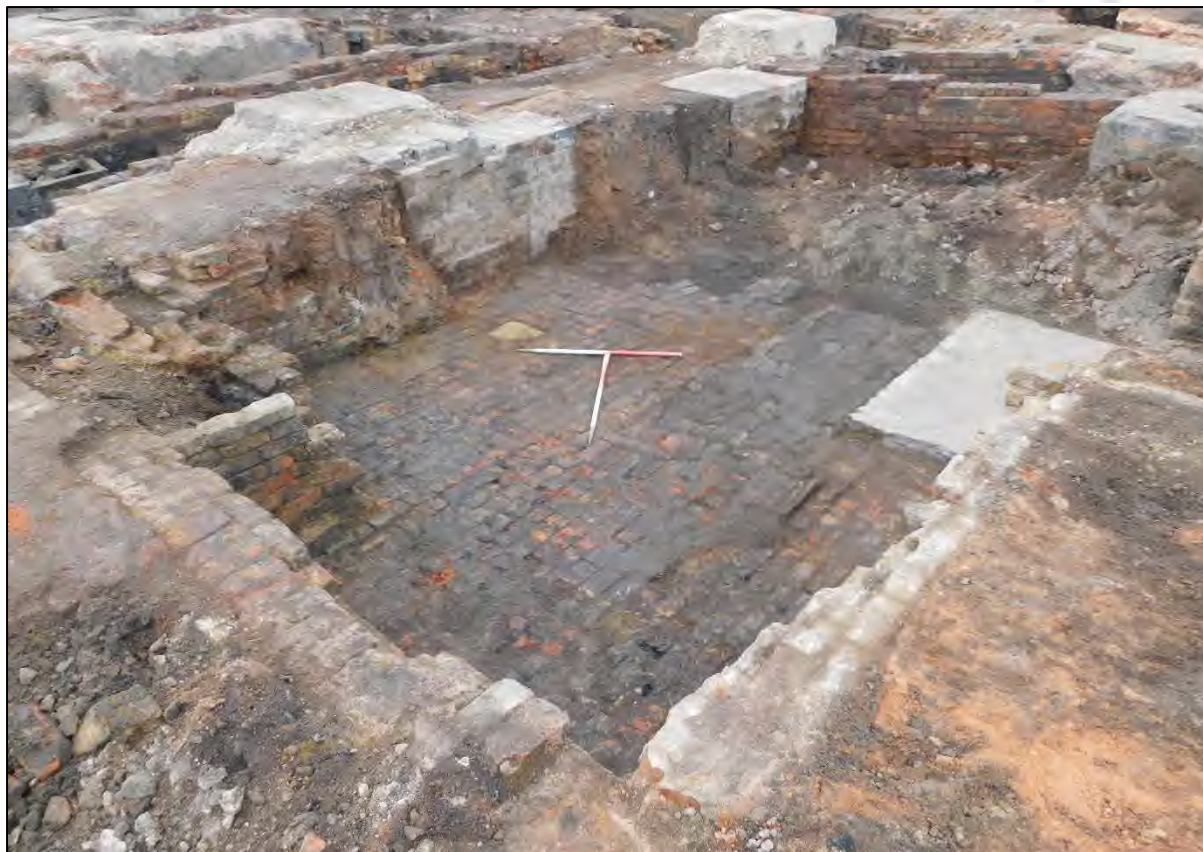
*Plate 155: Building A truncated by station bases and concrete pad, facing north west (2 x 1m scales)*
