## Archaeological Excavation Report

Mayfield,  
Manchester

**Report No:**  
SA/2021/56

**Project:** Mayfield, Manchester: Archaeological Excavation

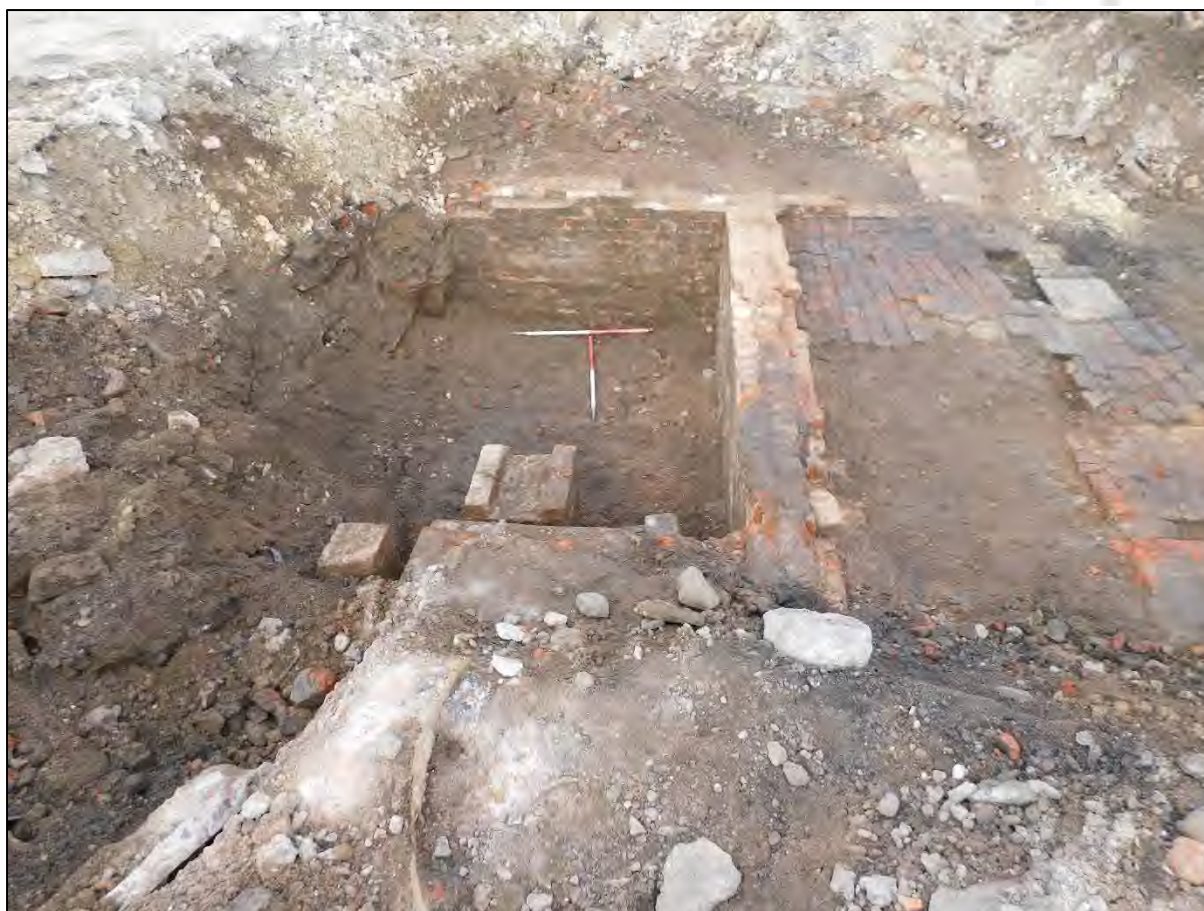
*Plate 156: Building B showing walls 409, 410 and surface 411, facing north west (2 x 1m scales)*

Once the site survey was overlaid onto an 18<sup>th</sup>-century map covering the site, it was clear the outline of a building on Green's map (surveyed 1787-94) closely corresponds with the outer of the walls Building B (Plate 156; Figure 21).

Walls 409 and 410 and surface 411 to the north west corner of site are also part of this building (Plate 156). Wall **409** was an L-shaped external wall measuring 4.34 long by 2.30m with a width of 0.37m and an excavated depth of 1m with no external floor visible. It was bonded by pinkish white lime-based mortar. Wall 409 abutted wall **410**, which was orientated southwest / northeast and measured 1.8 in length and 0.24m in width. Surface **411** had been laid up to both walls 409 and 410 and was 4.10 long and 3.60m wide, incorporating of mixture of sandstone flags, handmade brick and firebrick.

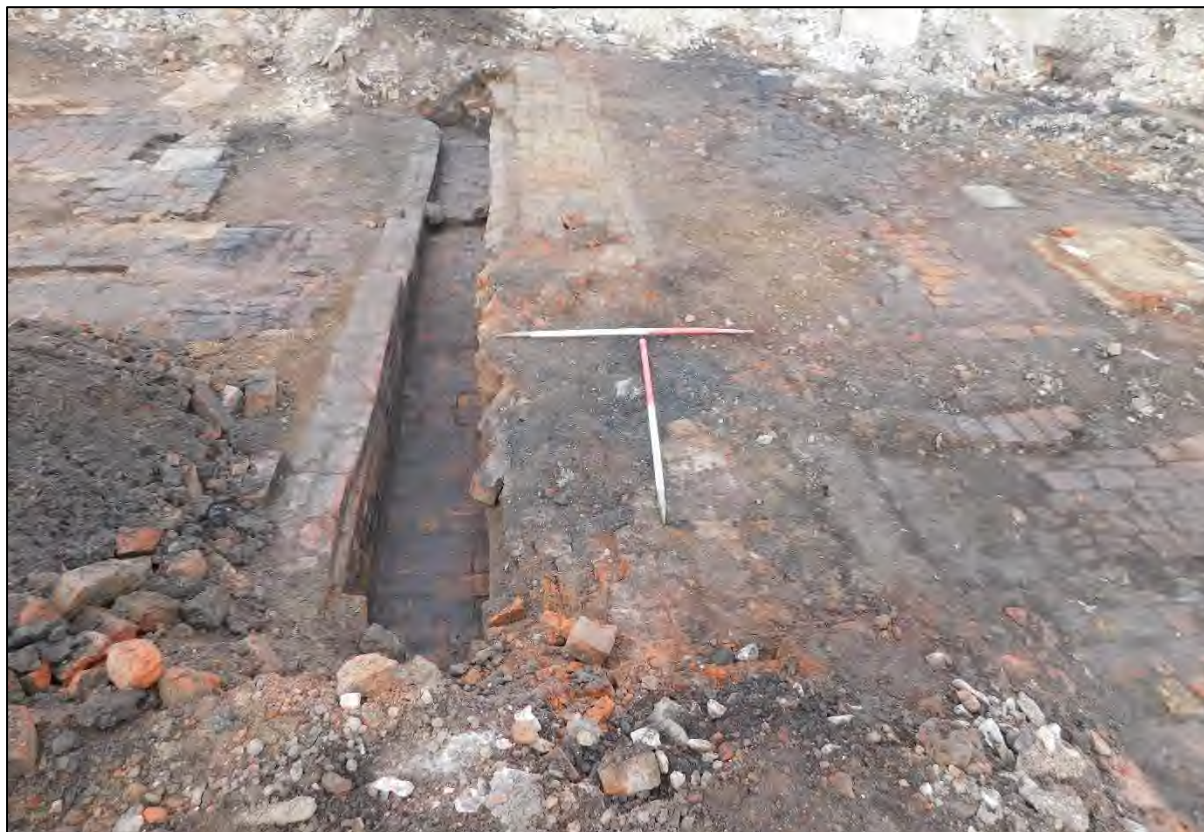
*Plate 157: Building C showing flue 412 abutting wall 413 and surface 414, facing north west (2 x 1m scales)*

An internal surface **414** abutted this and was 6m long and 5m wide constructed of red handmade bricks and sandstone flags (Plate 157). This also abutted internal wall **416** orientated north east to south west and was 5m long and 0.23m wide, constructed of red handmade bricks and was 6.5m long and 5m wide. To the south of this is surface **415** 6m long and 5.30m wide constructed of red handmade bricks and sandstone flags (158). These abutted an opposing external wall **417** orientated north west to south east and was m long and 0.48m wide constructed of red handmade house brick with a grey and sandy mortar bond.

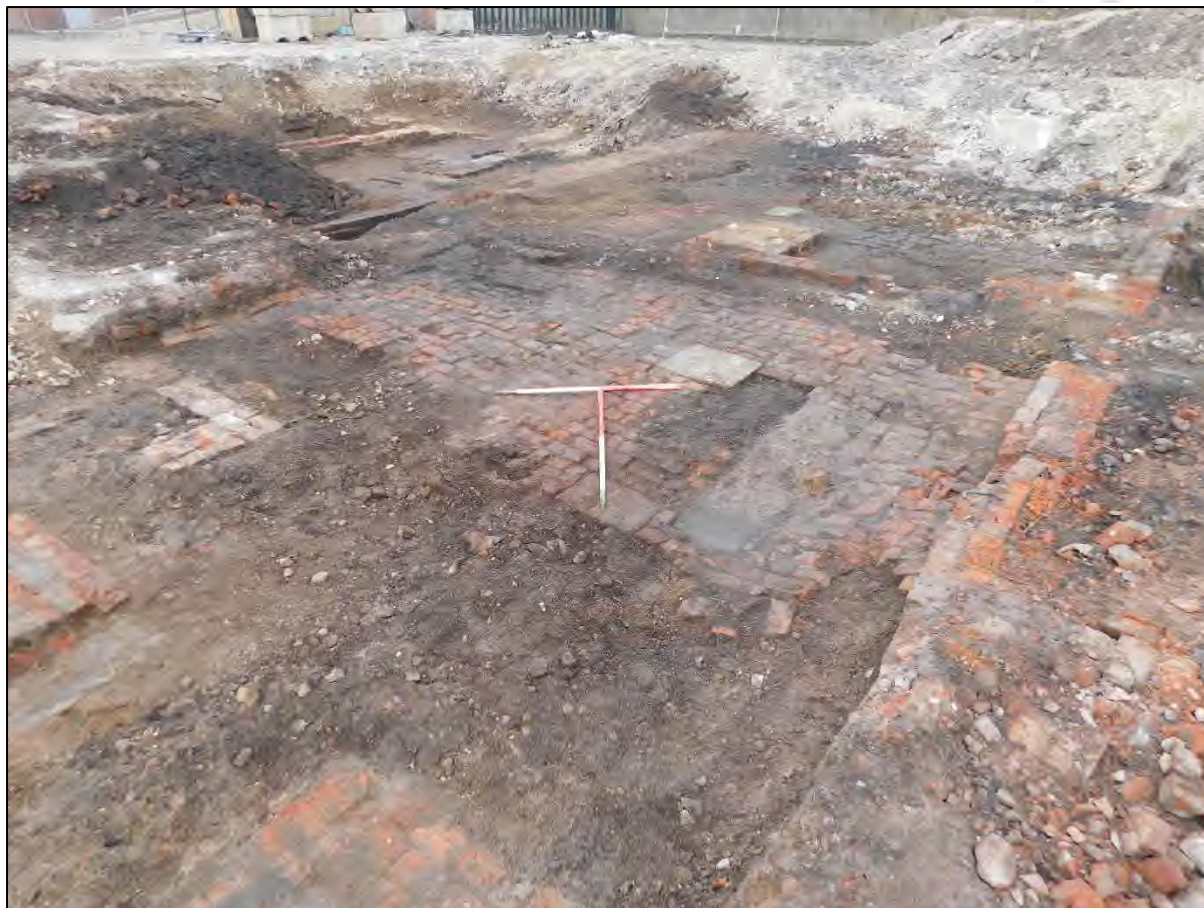
*Plate 158: Surface 415 abutting wall 417, facing west (2 x 1m scales)*

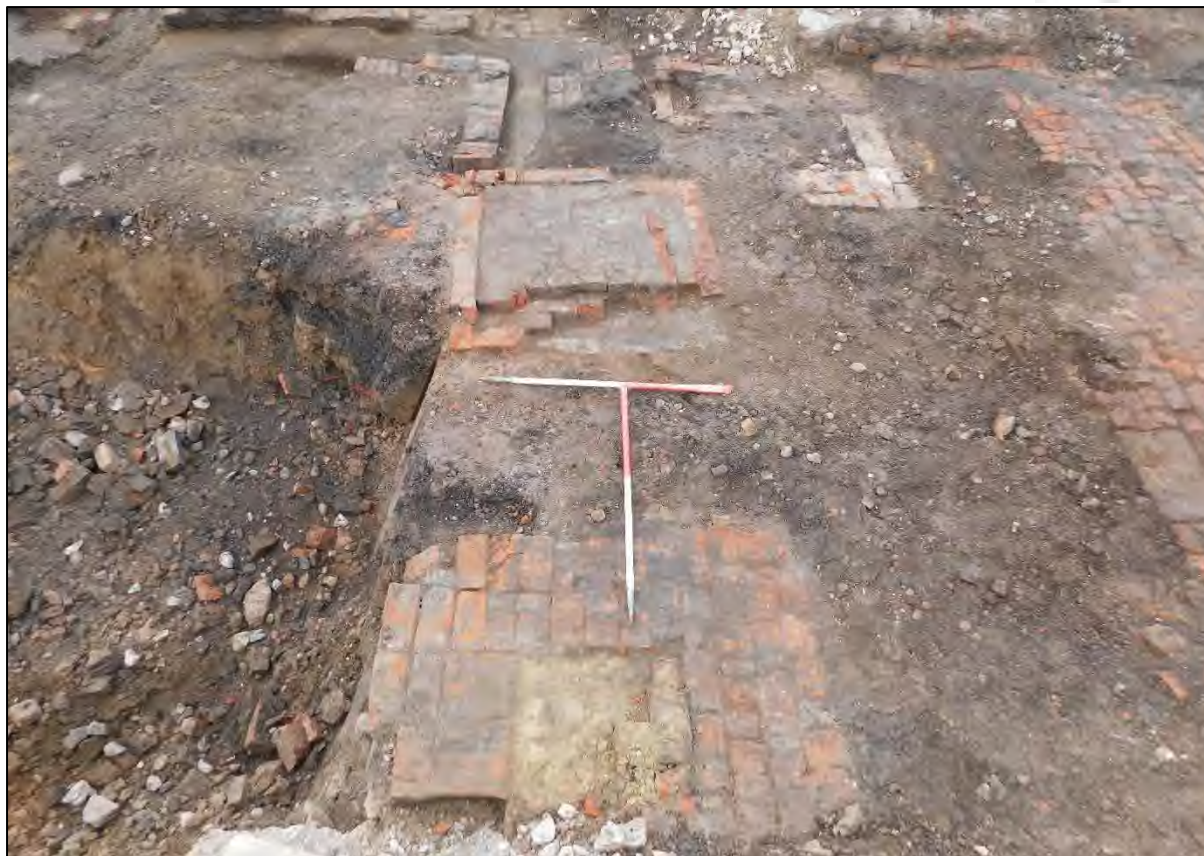
*Plate 159: Column bases 419 and 420 showing later 20<sup>th</sup> century truncation, facing south west (2 x 1m scales)*

There were two internal column bases **419** and **420** to the south of surface **415** (Plate 159). **419** was 1.37m long and 1m wide and constructed from red handmade bricks set in a sandy lime-based mortar. **420** was 1.37m long and 1.36m wide and constructed from the same material. These were heavily truncated by later 20<sup>th</sup>-century foundation cuts, housing concrete stanchion bases.

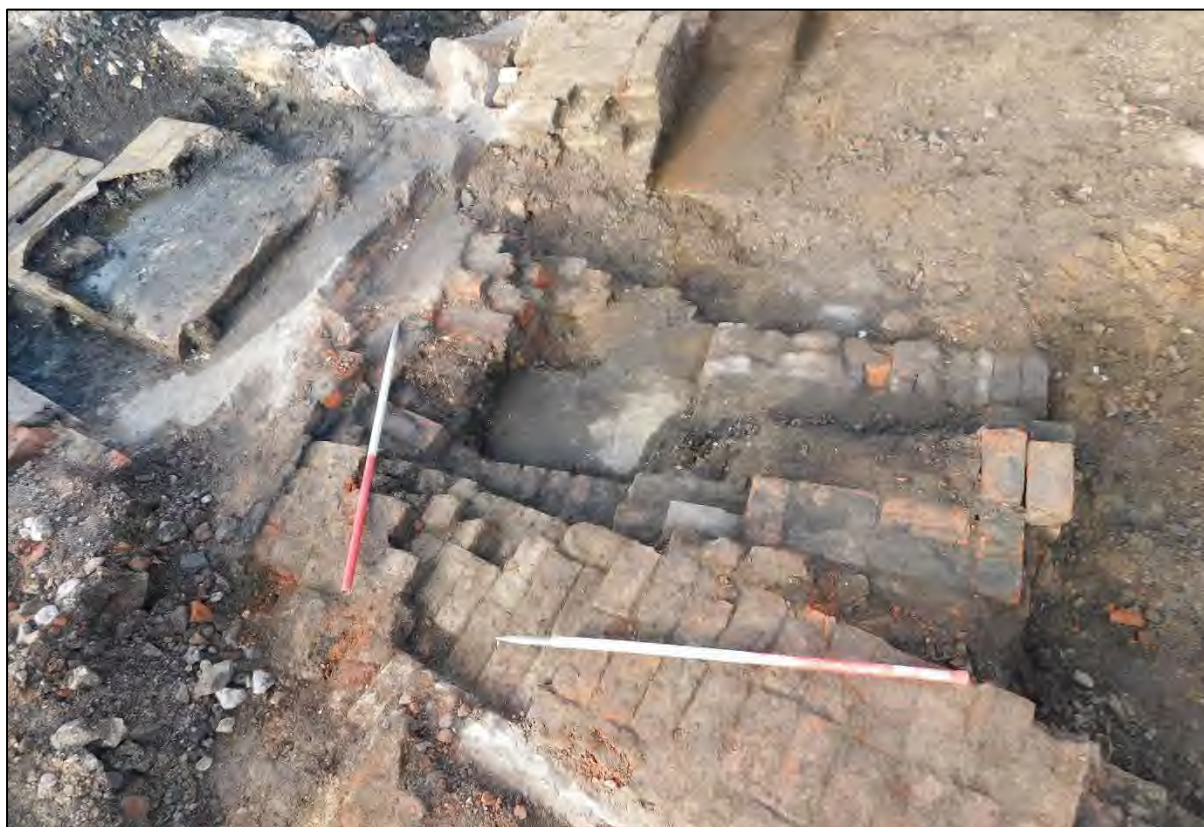
*Plate 160: Wall 413 abutting wall 418, vertical shot (2 x 1m scales)*

Wall **413** abutted wall **418** and was orientated north-east / south-west, measuring 4.08m in length, 1.20m in width and stood to a height of 11 courses (Plate 160). It was constructed of red handmade bricks bonded with a grey sandy mortar. This is the external wall to Building A which has been extended and modified to as seen on Bancks and Co's map from 1831 (Figure 22).

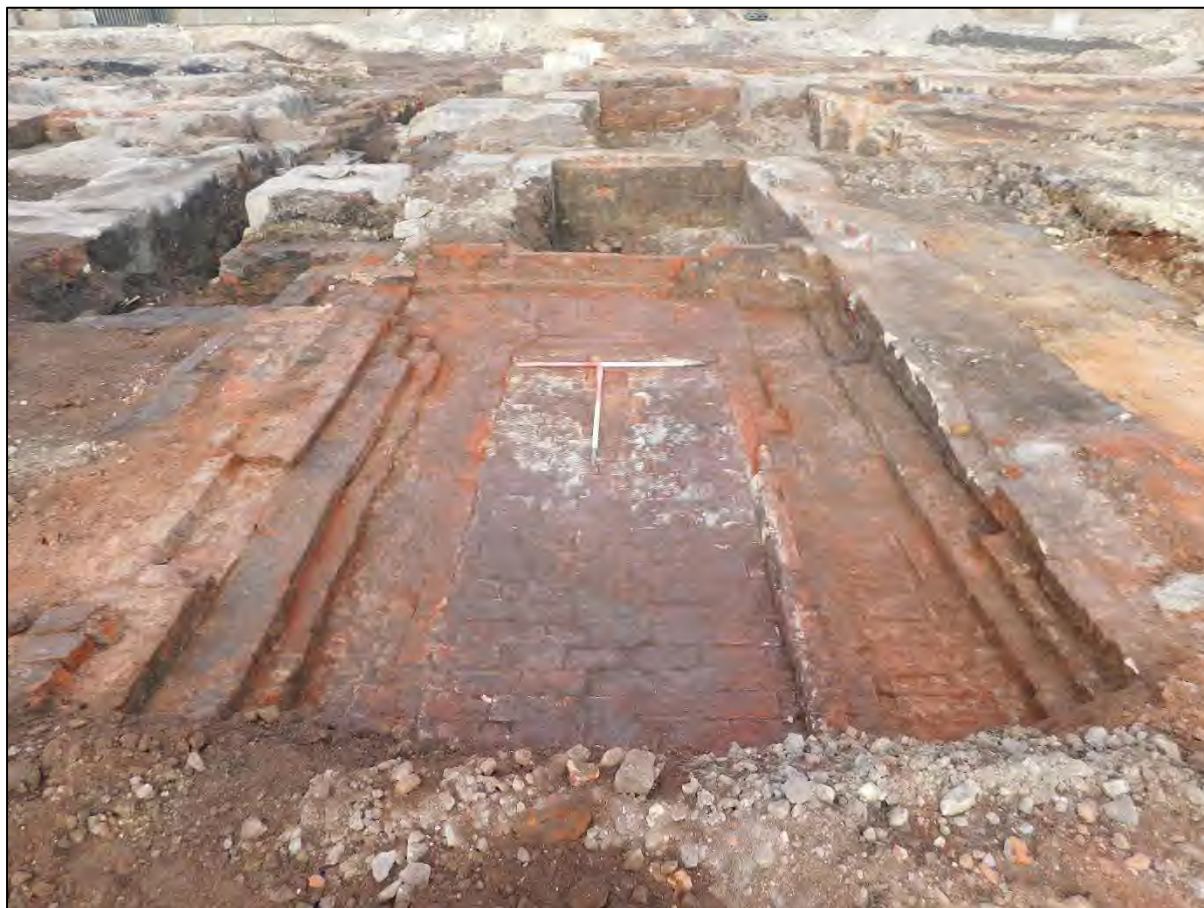
*Plate 161: Wall 431 and surface 432 forming one end of a probable boiler bed, facing north west*

An additional wall and extension to Building A was constructed during this phase, represented by an external wall **431** orientated north-east / south-west, measuring 8.60m in length and 0.85m in width (Plate 161). An internal floor surface **432** covering an area of 4.30m x 2.85m had been laid up to the walls. It was constructed of heat-affected red handmade bricks and firebrick, some of which were stamped 'Lamb & Co, Manchester'.

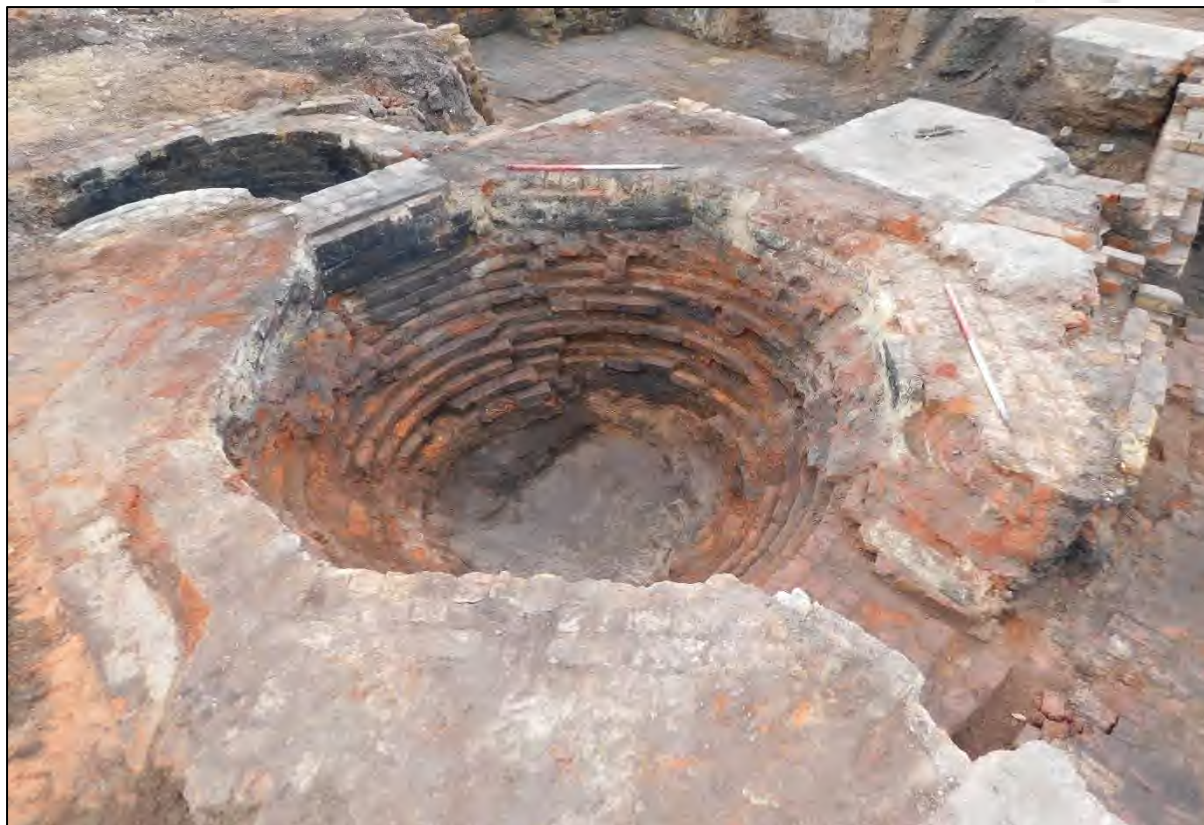
*Plate 162: Chimney 424, facing south east (2 x 1m scales)*

Chimney **424** (Plate 162) was had an octagonal shape in plan with a length of 5m and a depth of 1.6 constructed from an inner single skin of firebricks with the outer shell of red handmade brick; its bonding material was pinkish mortar. It was 5m wide with a depth of 1.05m. This structure is first depicted on the 1891 OS map but was likely established in *Phase 4* (1850 – 1871) and certainly pre-dates other structural elements depicted on the 1891 OS map.

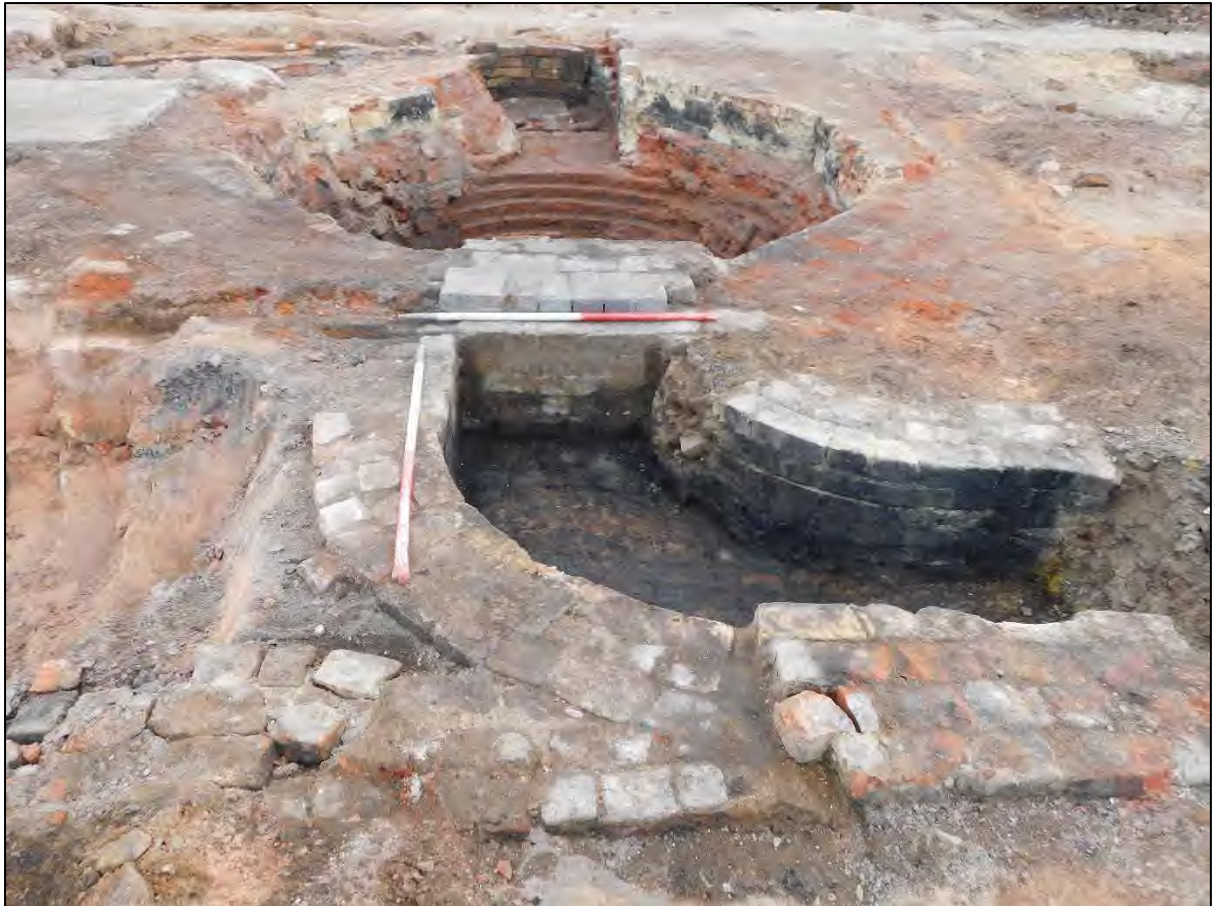
*Plate 163: Flue 422 feeding into chimney 424 blocked by later brick wall 423, facing north (2 x 1m scales)*

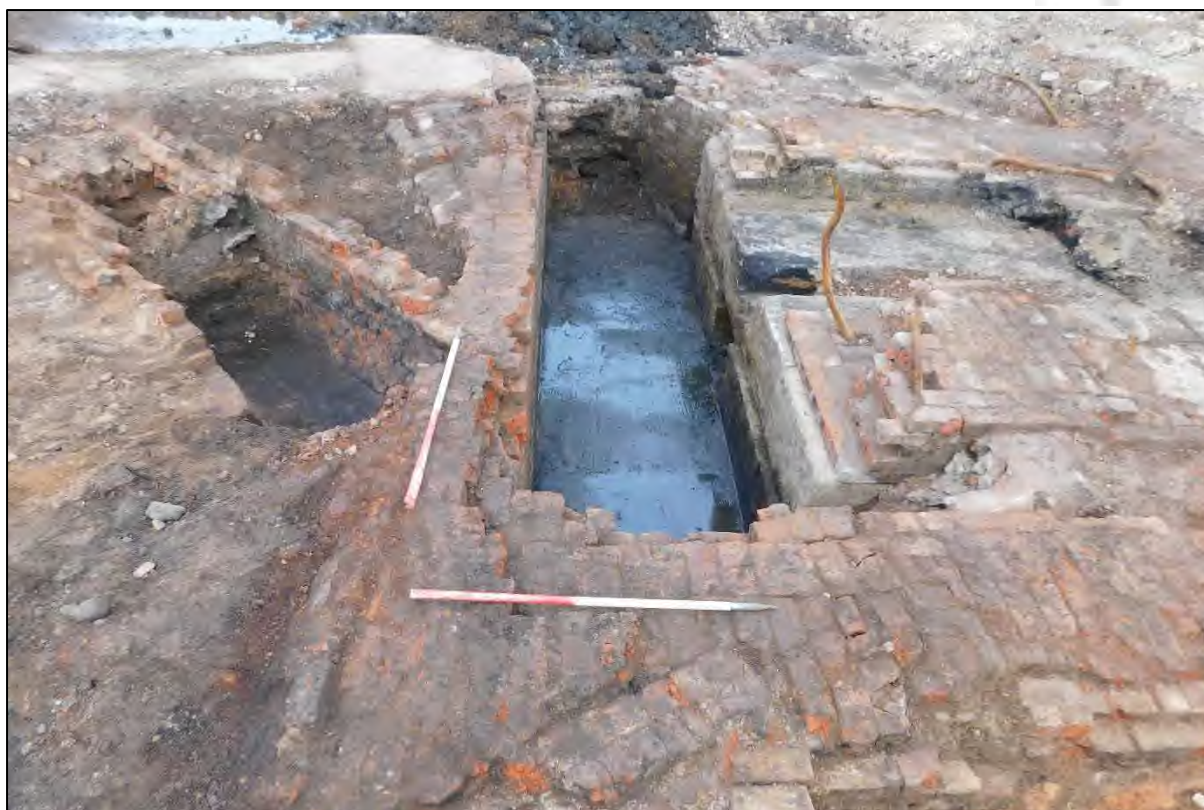
*Plate 164: Flues 421 and 422 truncated by the wheel-pit within engine house 434, looking north east (2 x 1m scales)*

Flue **422** probably functioned as the south-western continuation of flue 421 (Plates 164 and 165). The structure was aligned northeast / southwest and fed into the chimney on its south-eastern side; it was an L-shaped feature, 10m long, 1.40m wide with a depth from top to bottom of 0.50m. The flue was constructed of red handmade brick. Flue 422 contained a very dark sooty fill and the walls were heavily stained with soot. Flue 422 was truncated by the construction cut for an engine house and wheel pit 434.

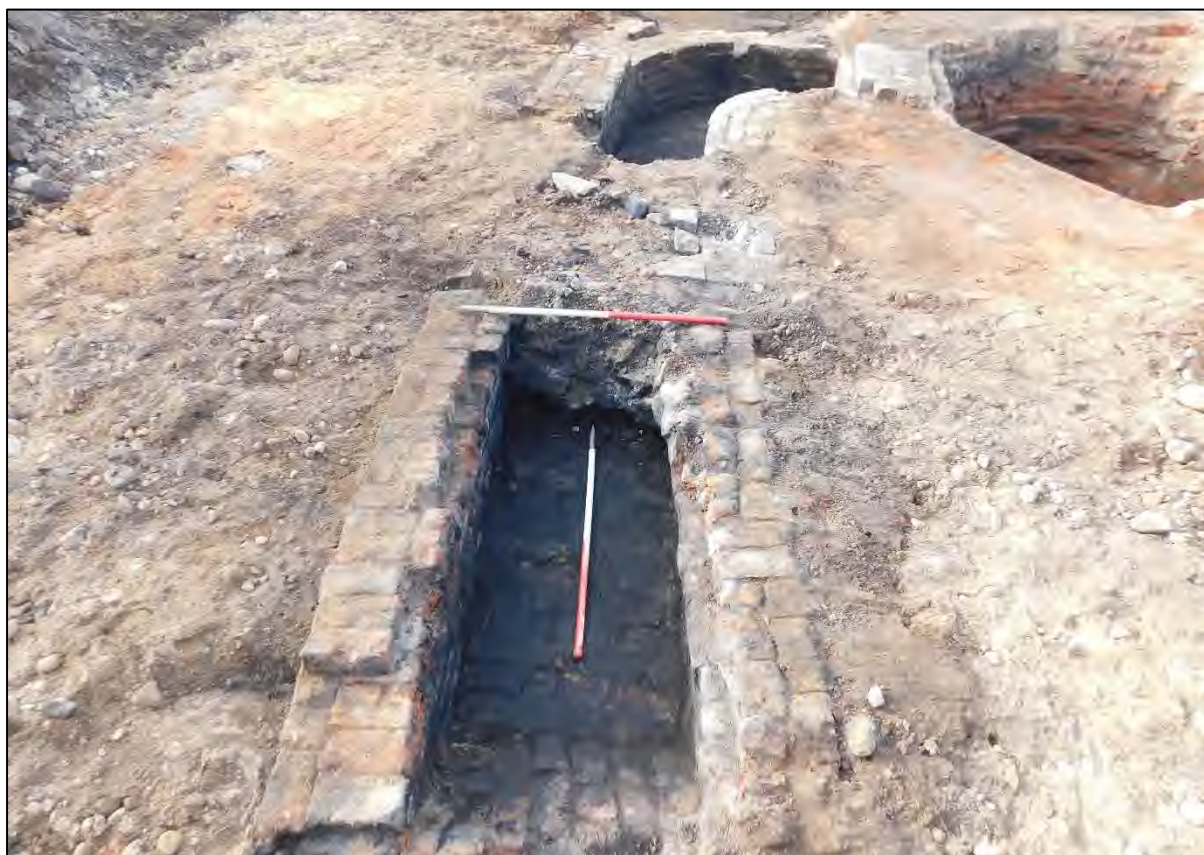
*Plate 165: Flue 422, facing west (2 x 1m scales)*

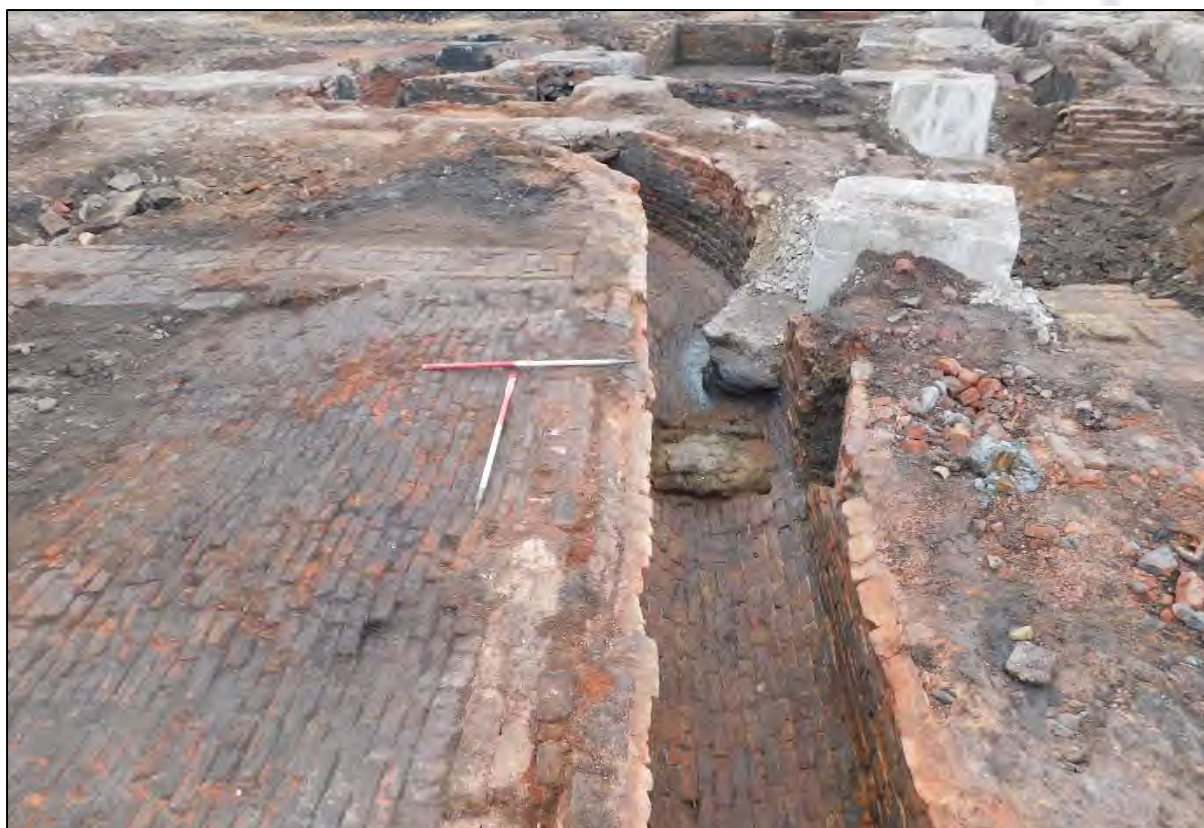
*Plate 166: Flue 425 cutting surface 405 and wall 406 with modern concrete truncation, facing south east (2 x 1m scales)*

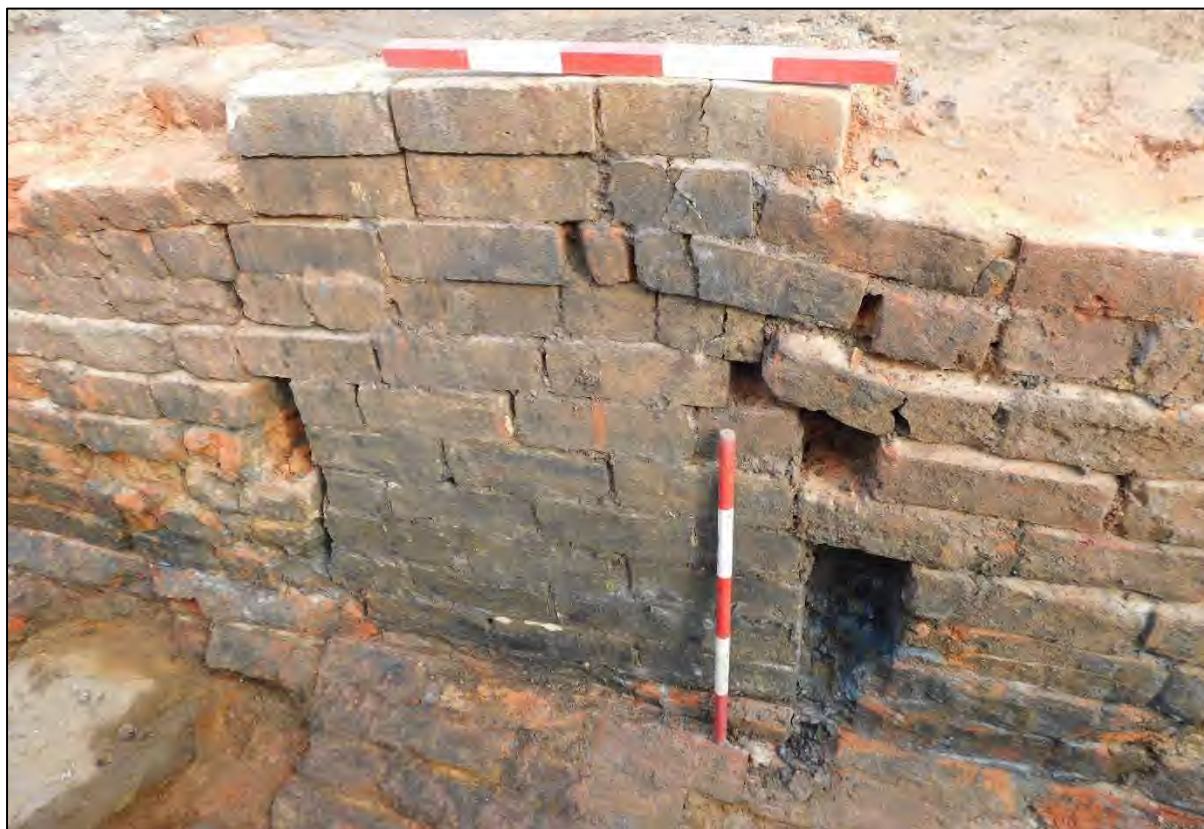
*Plate 167: Wall 406 built over by Flue 425, facing north (2 x 0.50m scales)*

Flue **425** fed into the chimney to the north and was 12.40m long, 1.27m wide with a depth of 1.04m constructed from red handmade bricks (Plate 167). Flue **425** showed signs of intense heat but no soot was present on its walls or floor. The construction of this flue utilised an existing wall 406, which has been quite clearly built over and incorporated in this structure.

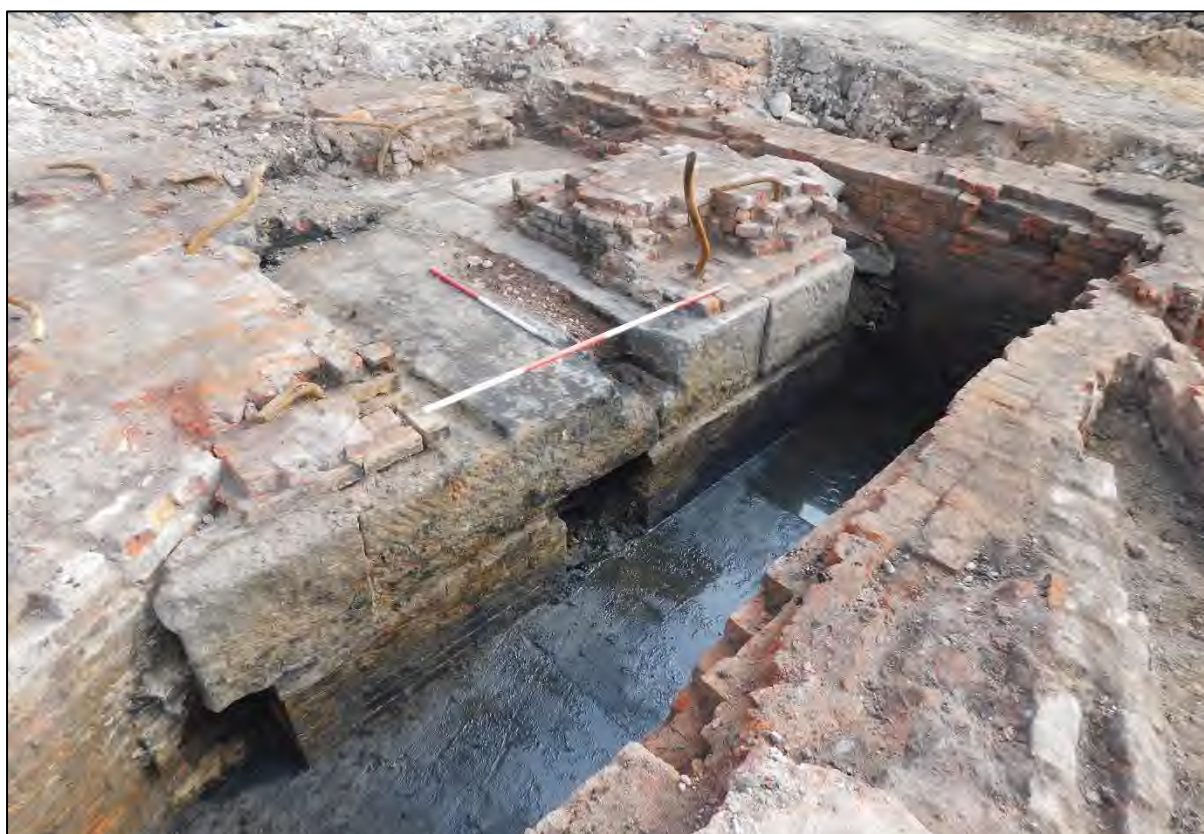
*Plate 168: Engine bed 434 looking east (1 and 2m scales)*

An engine house and wheel pit **434** (Plate 168) were constructed by 1891 and truncated earlier flue **422** also, which was also blocked off into chimney **424** by later brick wall **423** orientated north east to south west and was 0.96m long and 0.75m wide constructed of blue machine-made house brick (230mm by 110mm by 80mm).

The engine bed **434** was constructed with large rectangular cut stone bedding blocks overlain by brick bases a further level of cut stone with this overlain by brick bases with iron fittings (Plate 168). A large rectangular wheel pit was formed by wall **435** aligned northwest / southeast, measuring 6.5m long, 0.42m wide and standing to a height of 1m. It was constructed from red handmade bricks bonded with a sandy light brown mortar. This was abutted to the south by external wall **436** orientated northeast / southwest, measuring 4.45m in length, 0.75m in width. The northern extent of the engine house was truncated by a later concrete base.

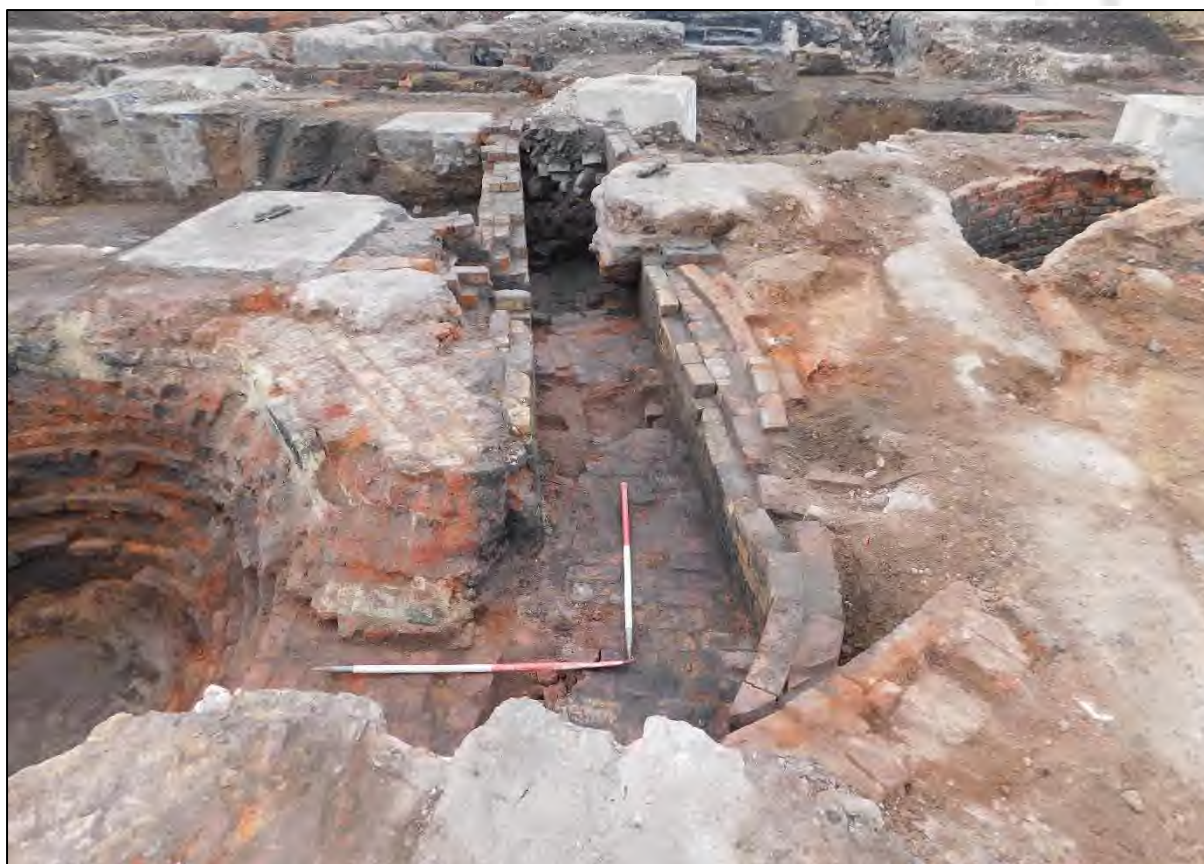
*Plate 169: Flue 426 feeding into chimney 424 and blocking Flue 425, facing west (2 x 1m scales)*

Broadly contemporary with this building was the last active flue **426**, which fed into chimney **424** to the south-west. Flue **426** (Plate 169) had an L-shaped form in plan and measured 7.8m by 9.96m in length, 1.60m in width with an inner lining of firebrick (brick dimensions: 240mm by 110mm by 90mm) and the outer wall of red brick. The construction of flue **426** signalled the redundancy of an earlier flue **425**. Flues **421**, **422** and **425** had all fallen out of use by 1891 with only **426** being active.

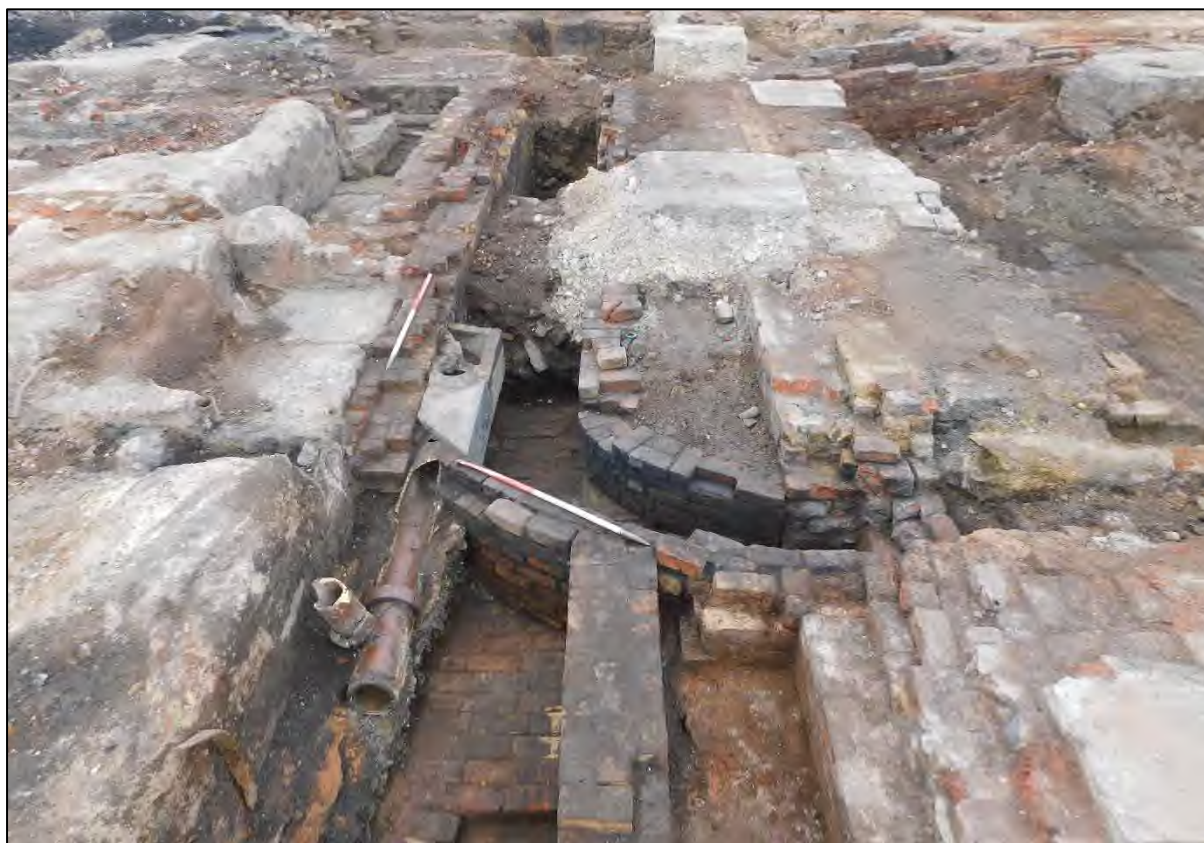
*Plate 170: Walls 429 and 430, facing north west (2 x 1m scales)*

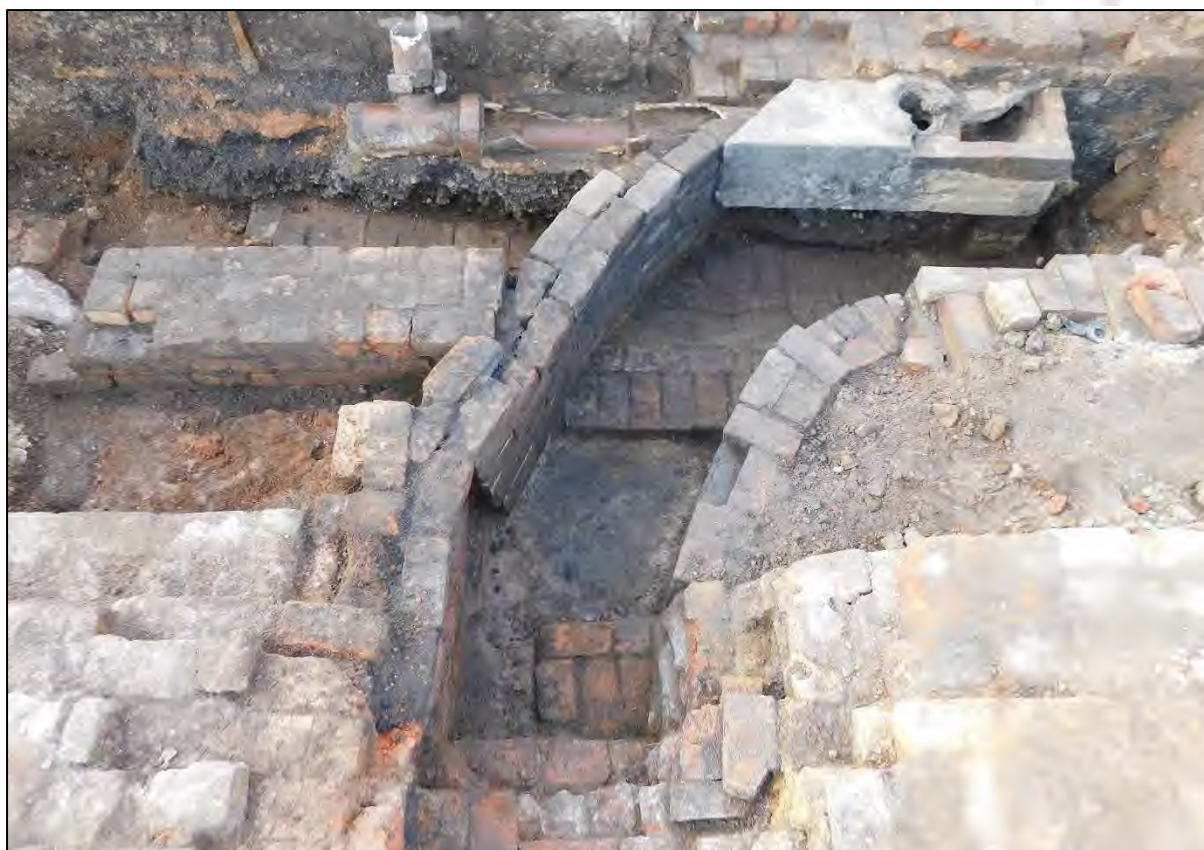
*Plate 171: Vertical detail shot of walls 429 and 430*

Flue 426 showed signs of modification over its period of use, with curvilinear walls **429** and **430** being constructed 5.40m from its south-eastern extent (Plate 171); wall **429** was 1.35m long, 0.23m wide and 0.45m high constructed from blue machine-made brick (230mm by 110mm by 80mm). Wall **430** was 1.66m long, 0.23m wide and 0.60m high, constructed from the same brick material. Both walls cut off access to the south-eastern end of the flue, where it ran up to boiler 431 and served to redirect the flue towards structure 428.

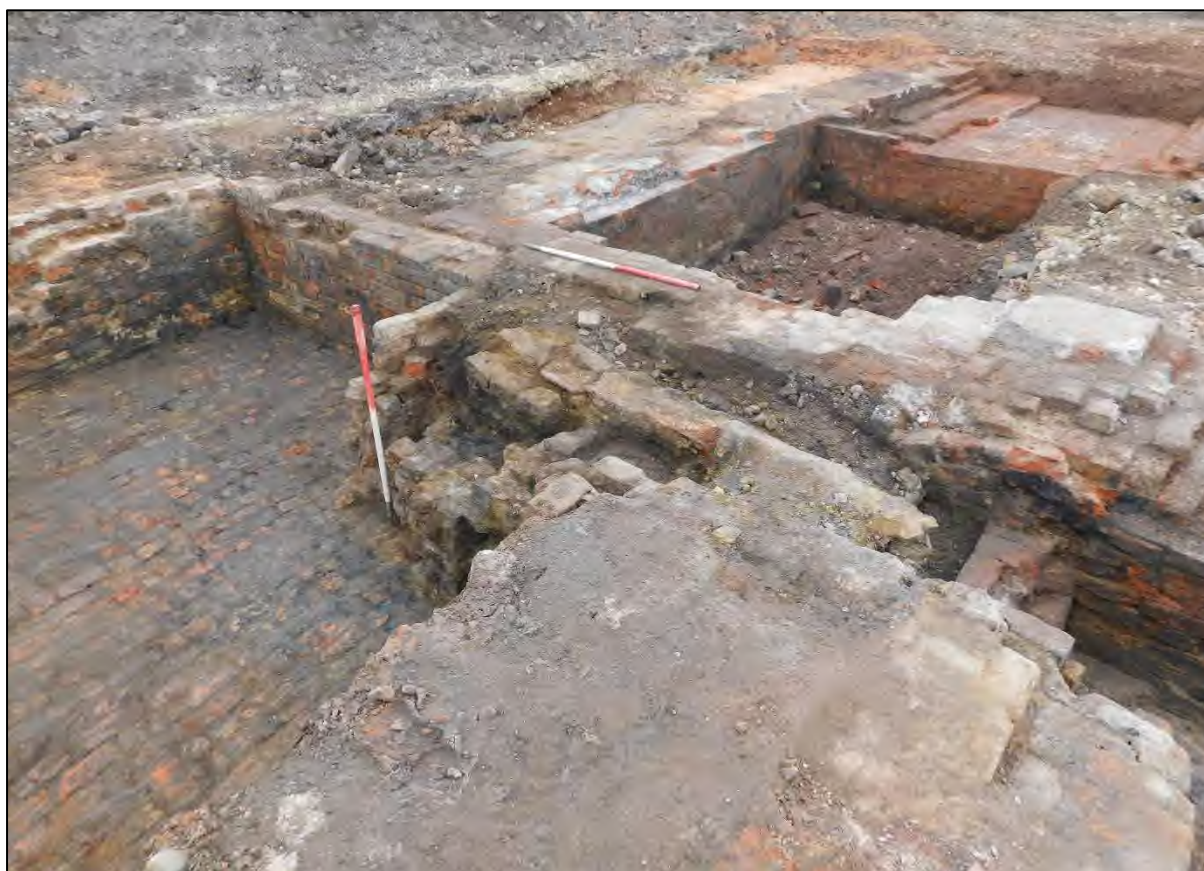
*Plate 172: Pipe feeding into 429 & 430 with walls 428 constructed over surface 404, facing south east*

Remnants of a large cast iron steam pipe were identified within structure 428 (Plate 172), surviving in the south-eastern corner of an earlier room in Building A (defined by walls 402, 403 and 437). Structure **428** measured 1.27 x 1.47m and was positioned to the north-east of flue 426.

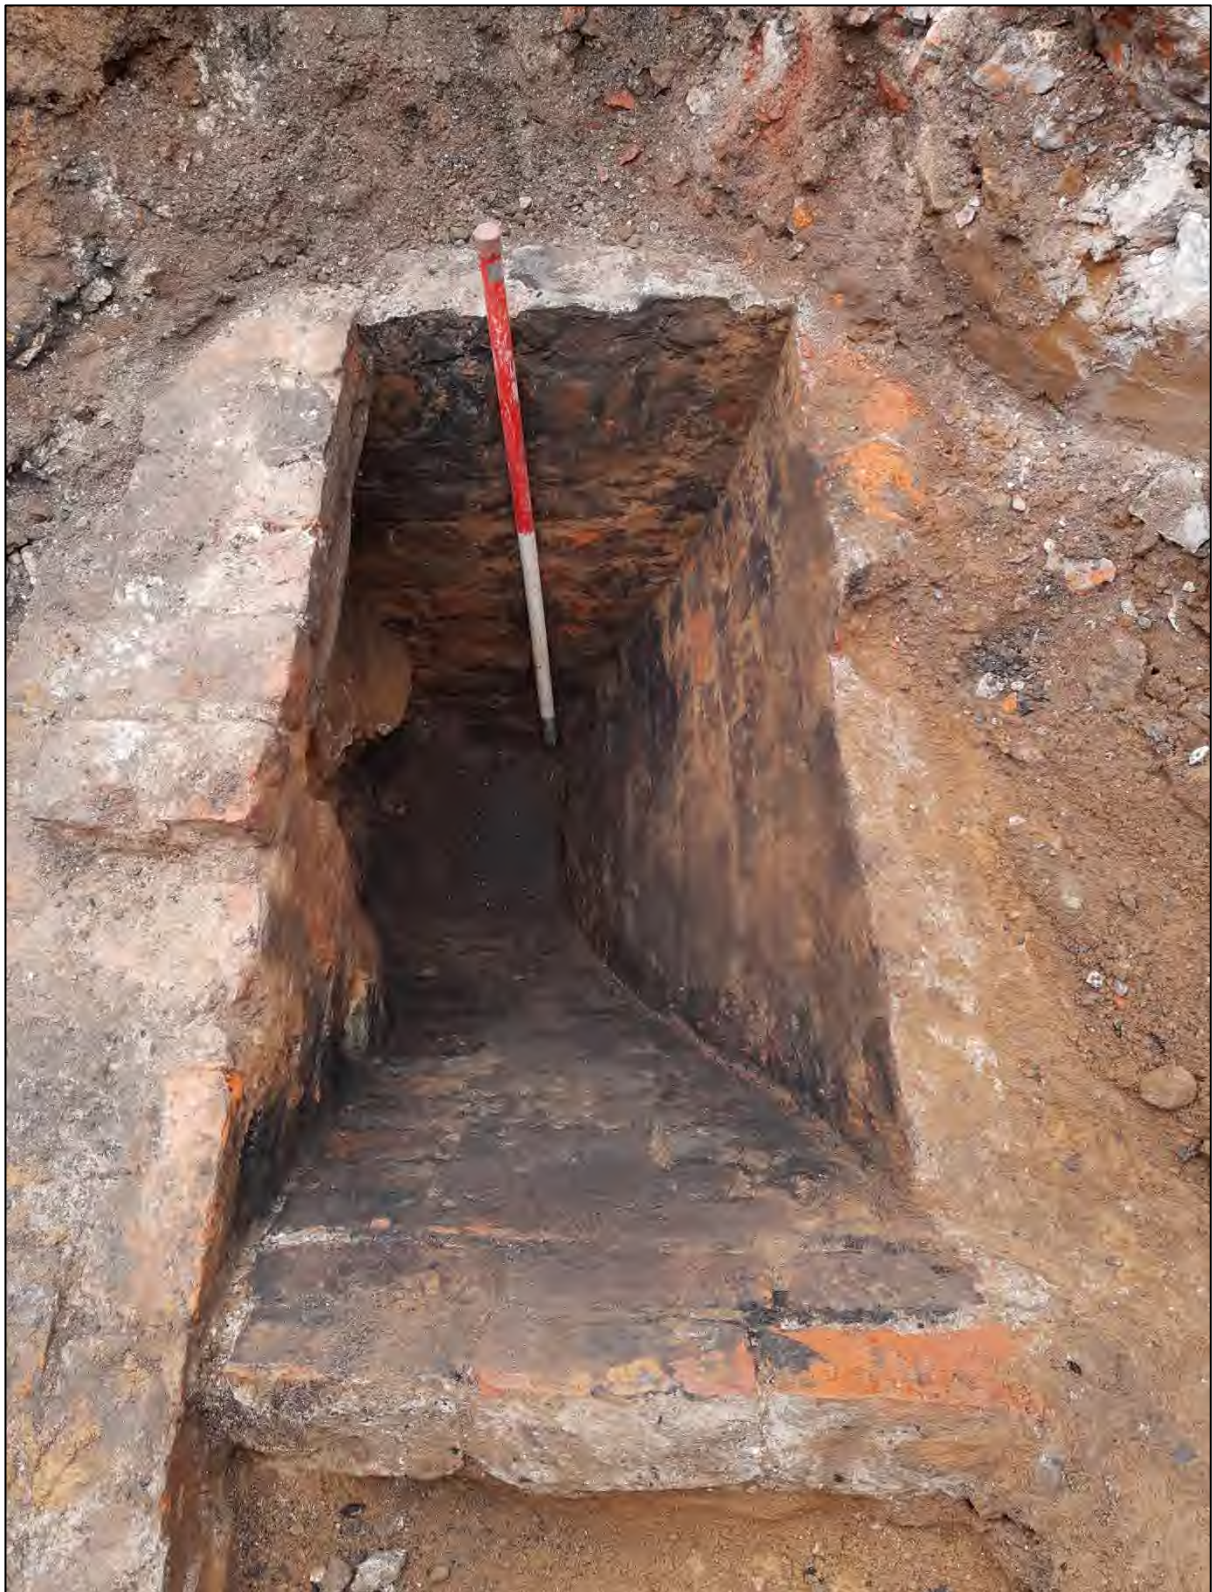
*Plate 173: Remains of the chimney-flue in Trench 7.*

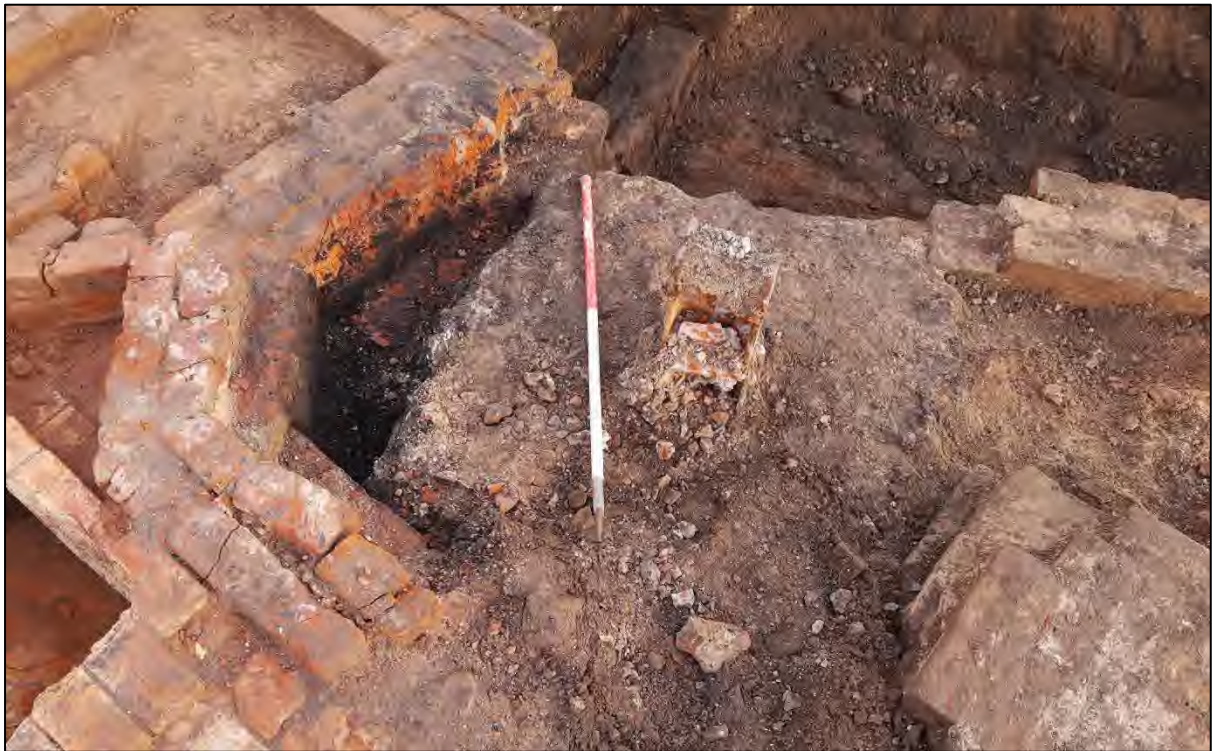
Three years later, the tannery suffered a second disaster when a fire broke out at the premises. Reported on in the *Leeds Intelligencer* on the 21<sup>st</sup> of April 1860, 'much valuable property was placed in considerable danger' but owing to swift action, the cost of the damage was estimated to be £2000, a sum likely covered by insurance.

By the time of the survey for the 1891 OS map, the Ardwick Tannery had further expanded. The courtyard building remained mostly unchanged. A new rectangular building had been built to the southwest adjacent to a new roadway, Nether Street. The 'Tan Pits' recorded on the 1851 Map were no longer visible and appeared to have been encompassed with a new building.
