## Archaeological Excavation Report

Mayfield,  
Manchester

**Report No:**  
SA/2021/56

**Project:** Mayfield, Manchester: Archaeological Excavation

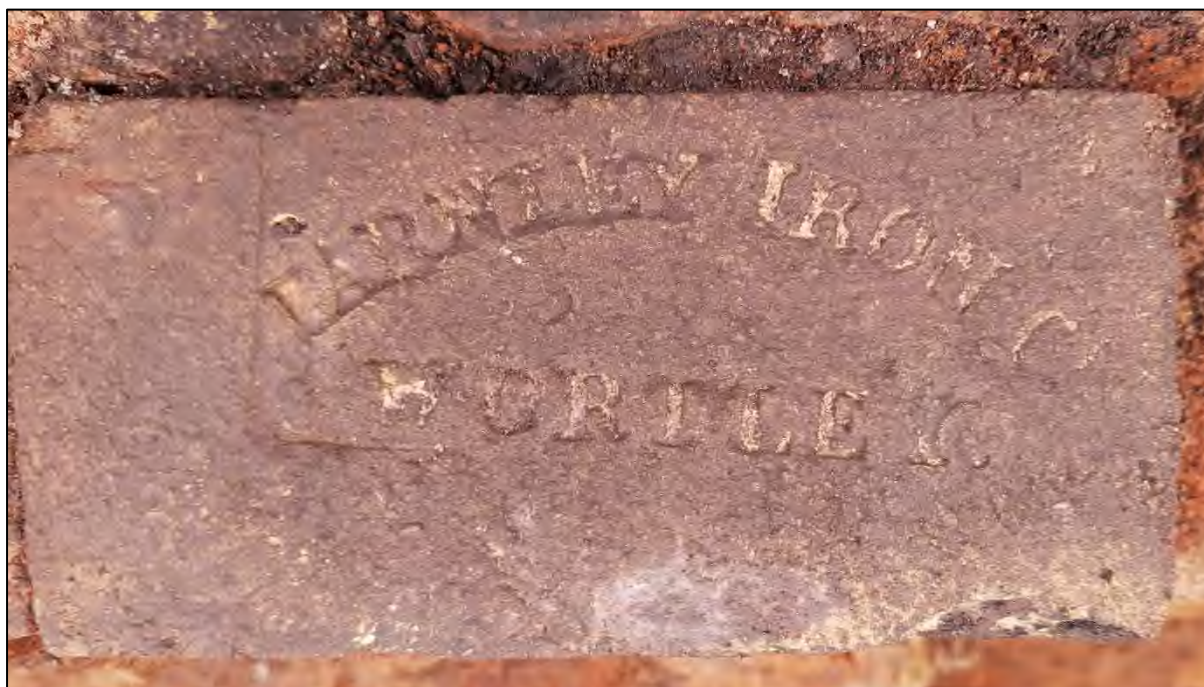
*Plate 179: Firebrick bearing the stamp Farnley Iron Co. Wortley' utilised in Boiler 111*

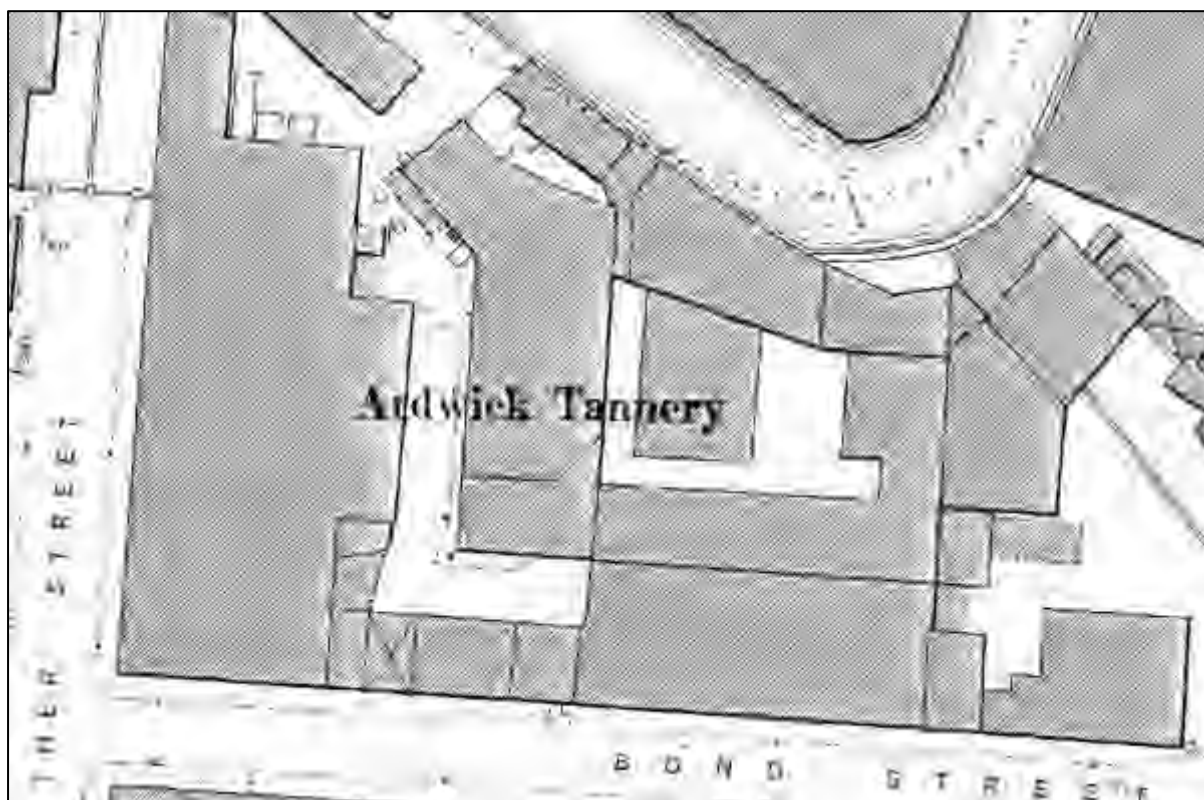
undertaken by specialists in 19<sup>th</sup> Century Britain (See Nevell & Bell, 2009, 9-10), it appeared that the full suite of tanning activities from initial cleaning to final rolling were undertaken at the Ardwick Tannery. *Whellan's Directory of Manchester and Salford*, 1853, listed some of the products made and processes undertaken at the site: 'Cunliffe Thomas & Sons, tanners, curriers, buffalo hide curers, sizing dealers, and makers of buffalo skips, laces, pickers, picking bands, &c. 15 Church St; work Tipping St, Ardwick'.

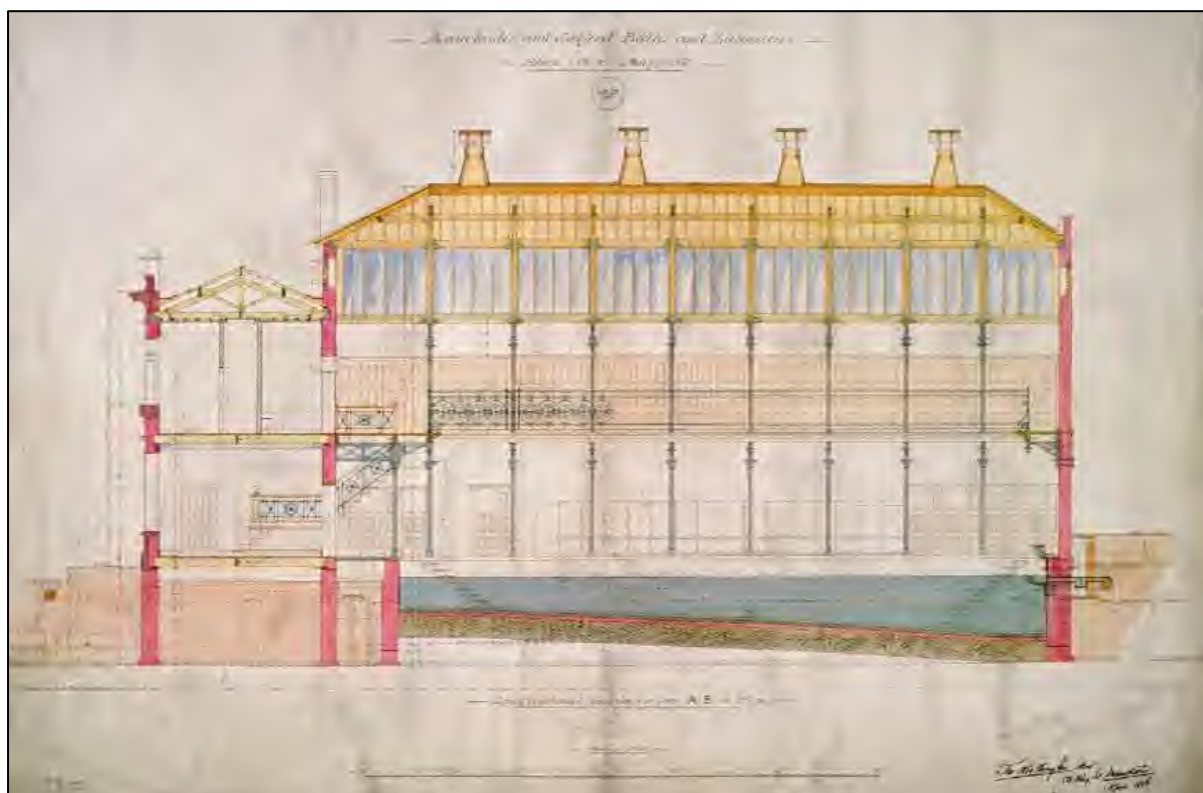
In addition to the by-products produced at the tannery, such as fat and hair, other products and agents used in the manufacturing of leather were also reused and sold on. This included used lime and the oak bark, which had been used to produce the tanning liquor. An advertisement in the *Manchester Courier and Lancashire General Advertiser*, 28<sup>th</sup> March 1857, stated 'To farmers, gardeners, and other. Spent Oak Bark on sale, 2s. per load; also Lime pit Bottoms, an excellent manure, at 2s. 6d. per load, at Thomas Cunliffe and Sons' Tannery, Tipping-street, Ardwick.

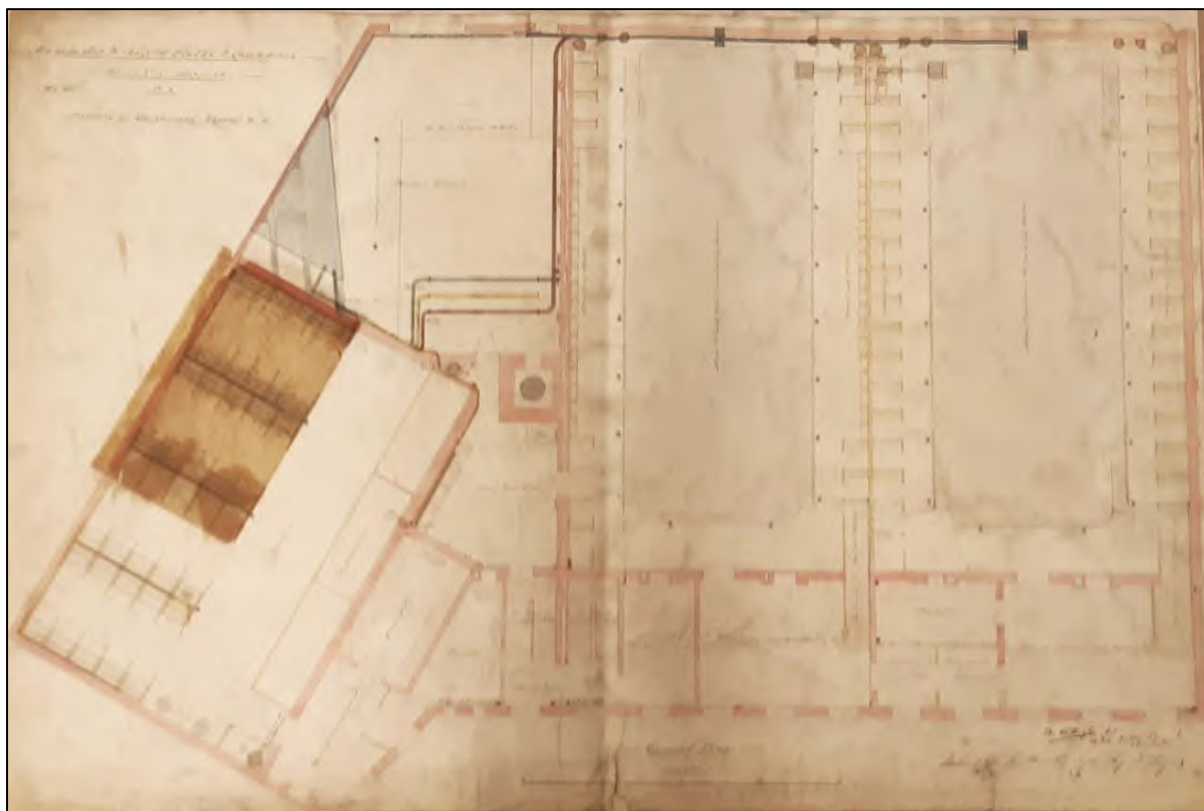
The construction of the Mayfield Baths was part of a wider social movement to increase the sanitation of particularly the working classes. This was in part the result of writers such as Kay-Shuttleworth (1832) and Engels (1845) who had raised issues related to the living conditions of the working classes in Manchester through the previous decades. Attitudes

Mayfield baths opened to the public in 1857 and remained operational until it sustained damage during bombing raids in 1941. It was originally operated by The Manchester and Salford Baths and Laundries Company and later purchased by the Manchester Corporation. The building was designed by well-known architect, Thomas Worthington (1826-1909), whose other works included the Memorial Hall (1866) and other bathhouses, such as Leaf Street (1860). A considerable amount of evidence related to the bathhouse was available including original plans, photographs, prints, articles, maps, and other items.

'This extensive establishment situate near the Mayfield Print Works, off Buxton-street, London-road, and the second erected by the Manchester and Salford Baths and Laundress Company, is now completed in all its departments and in full operation the receipts during the prevailing hot weather being we believe, something like £50 per week. The first and the second class baths occupy two large compartments of the buildings, having each a swimming bath in the lower portion. The private baths are formed around an upper gallery, supported by pillars, above which is an arched roof of ample elevation. In the first-class department, to which the admission is sixpence, there are 18 bathrooms. The baths are of white glazed earthenware; and supplied with hot and cold water, and the rooms furnished with looking glass, comb, brush, flesh-brush, soap, two towels, footboard, and bootjack, and the floor laid with oilcloth and carpet. The dimensions of each are 7 feet 7 inches by 7 feet. There are five superior baths of a larger kind, with mahogany fittings, at one shilling each. Also a family bathroom, containing two baths; and a shower bath can be had for an additional half price of the bath.

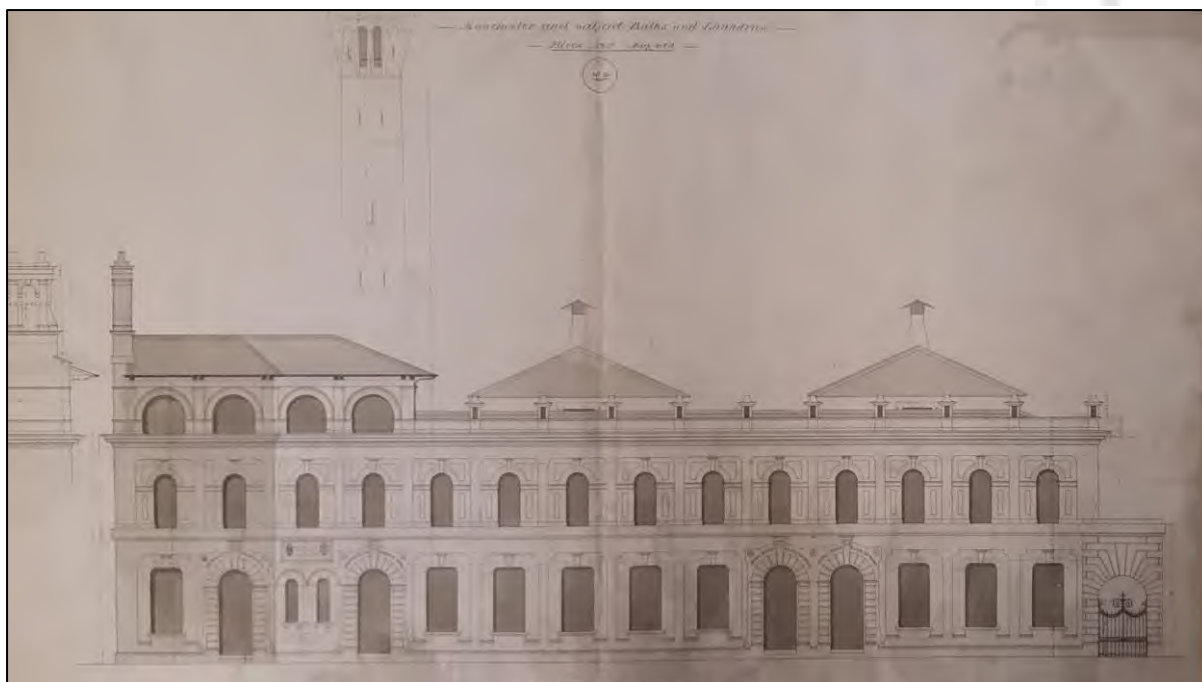
The Baths and Washhouse Act of 1846 gave local governments greater powers to establish such facilities and importantly allowed loans to be taken to fund such endeavours. In Manchester this led to a suit of new public bathing sites being constructed, although in the case of the early examples these were constructed as a result of private enterprise rather than municipal funding. In many cases the baths and washhouses were constructed by the Manchester and Salford Baths and Laundries Company, including the Mayfield Baths. The earliest premises to be erected included Miller Street, Shudehill (1846); Miles Platting (1849); Greengate, Salford (1856); Mayfield, Ardwick (1856); Leaf Street, Hulme (1860); and Penny Bath, Ardwick (1860). This trend continued into the early 20<sup>th</sup> century with the construction of further bathhouses such as at Withington, Moss Side, and Victoria.

Many of these mid-19<sup>th</sup> century premises followed similar layouts, perhaps unsurprisingly as many had been designed by the same architect: Thomas Worthington, whose works included the baths at Mayfield, Leaf Street, and Greengate. These bathhouses often included multiple swimming pools – 1<sup>st</sup> class men, 2<sup>nd</sup> class men, and women, in addition to Turkish baths, wash-baths, and facilities for the washing and drying of clothes and sheets.

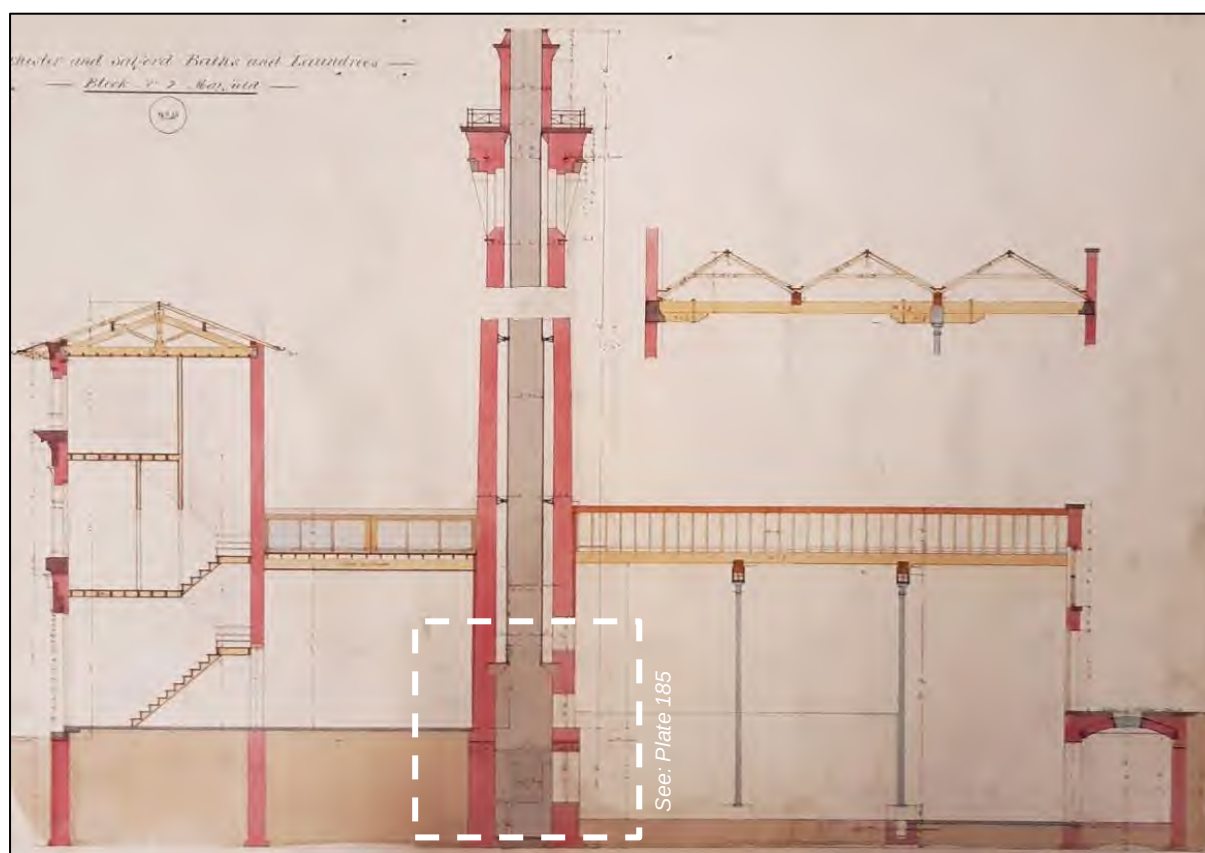
Plate 184: Cross-section through the northern part of Mayfield Baths with detail of chimney foundation

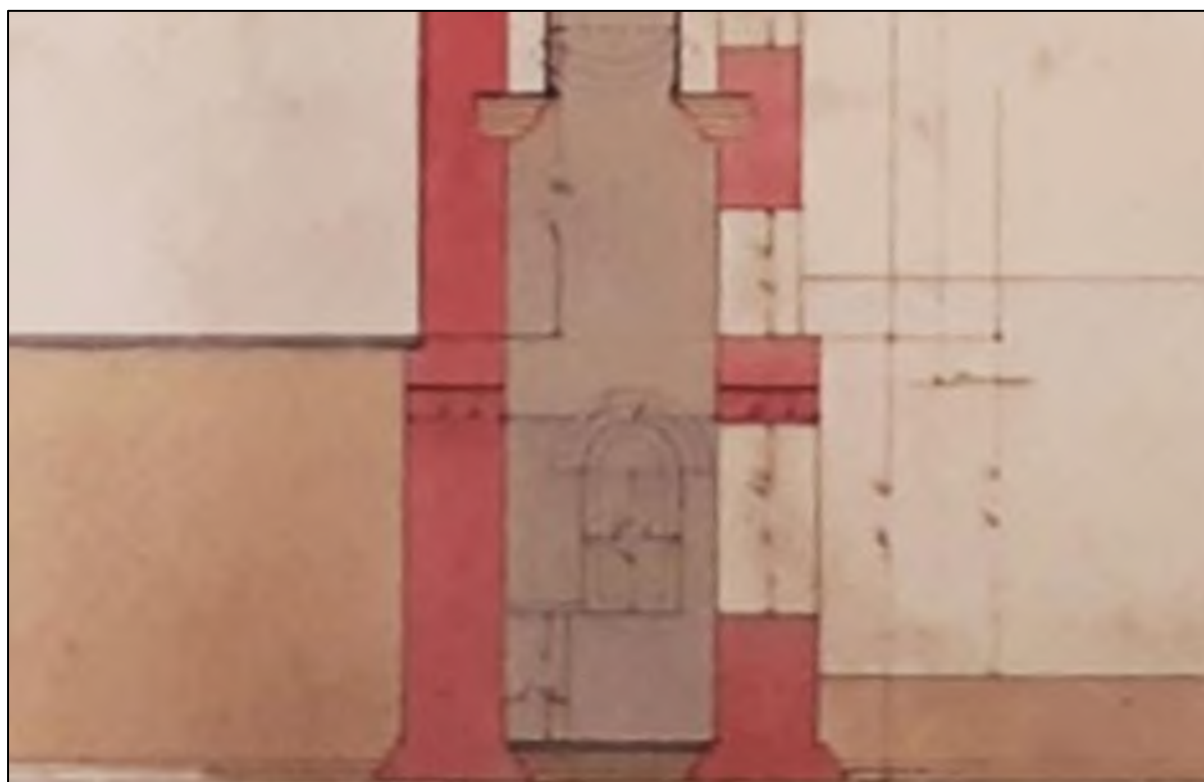
Plate 185: Detail of chimney foundation illustrating the position of the flues

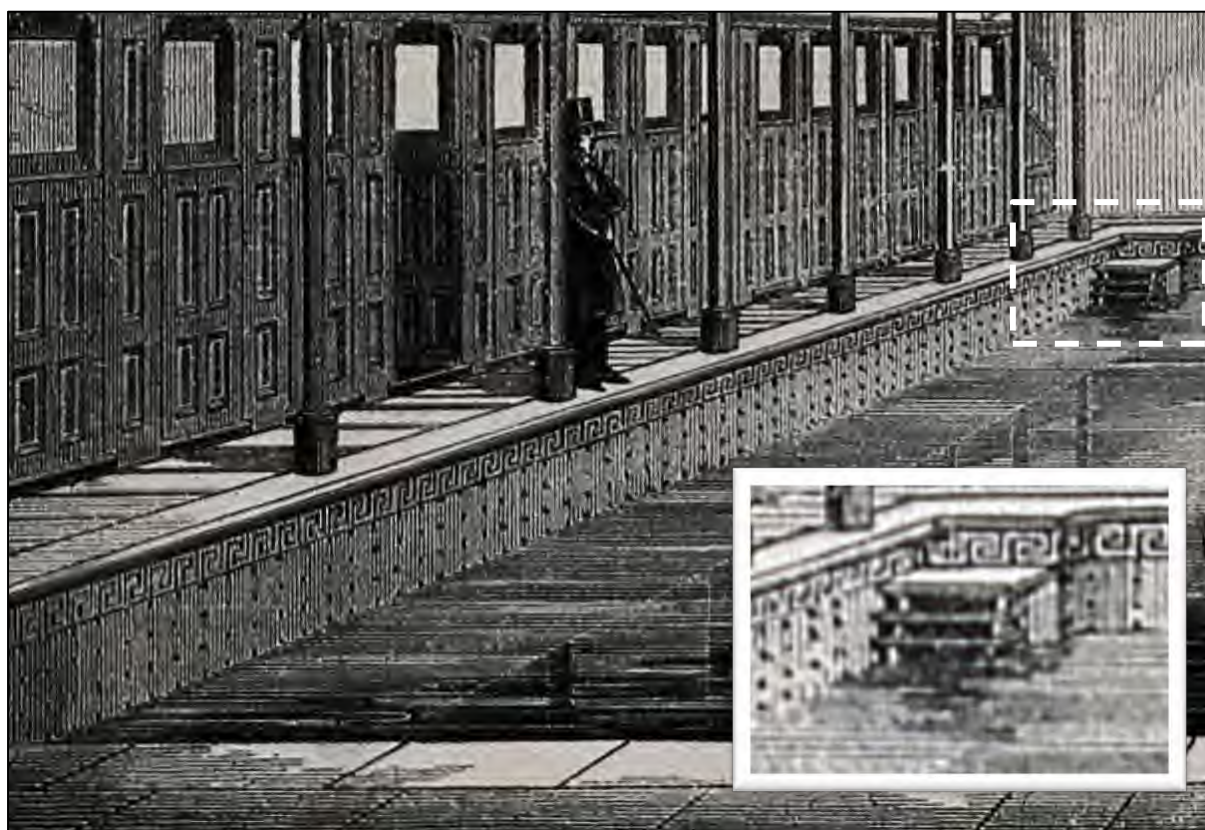
Plate 187: Extract from *The Builder* 1858 showing the original tiles and steps installed in the plunge pool of the first-class men's pool at Mayfield Baths (see inset for close-up)

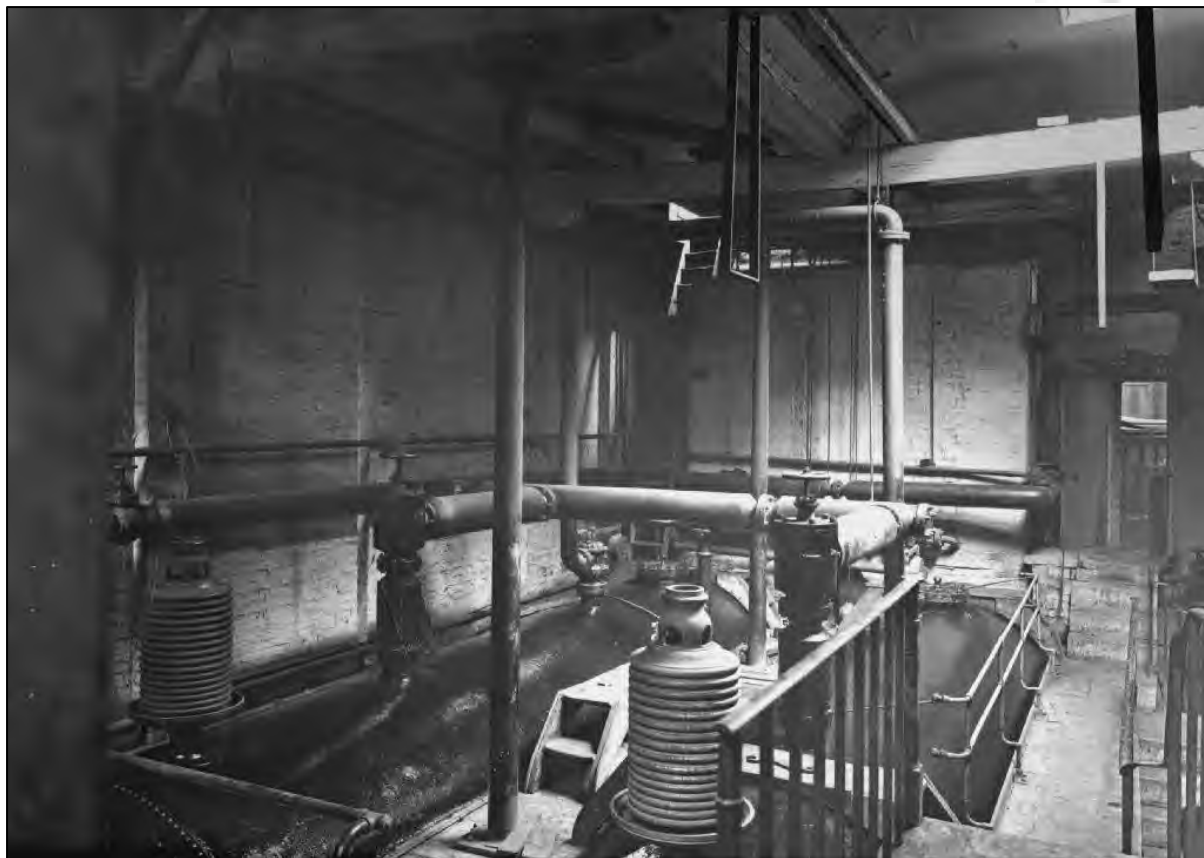
*Plate 189: Photograph showing the two steam boilers at Mayfield Baths*

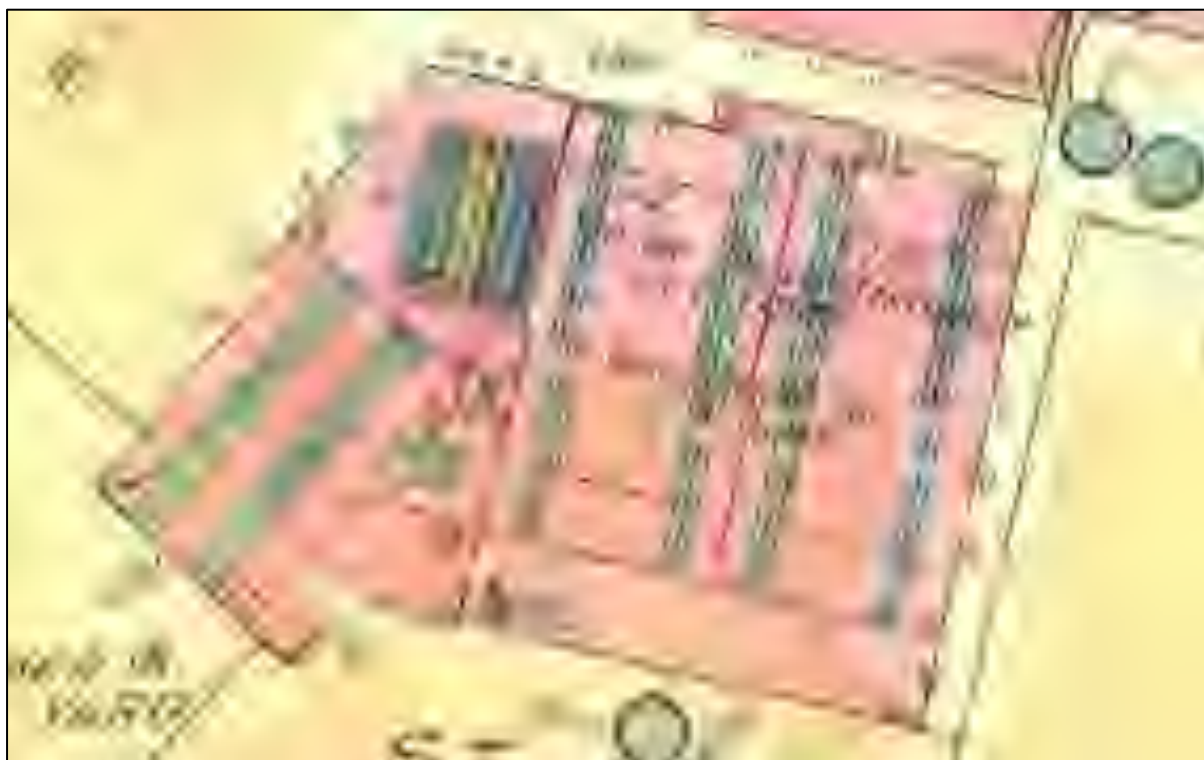
'The Mayfield Baths Company were paid £8,528. 12sd 8d. for the buildings, &c.; £8,927. 4s. 5d. had since been expended on alterations and improvements, and £2,263. 6s. 9d. on restoring the foundation, making the total cost to the Corporation, £19,376. 5s. 11d.'

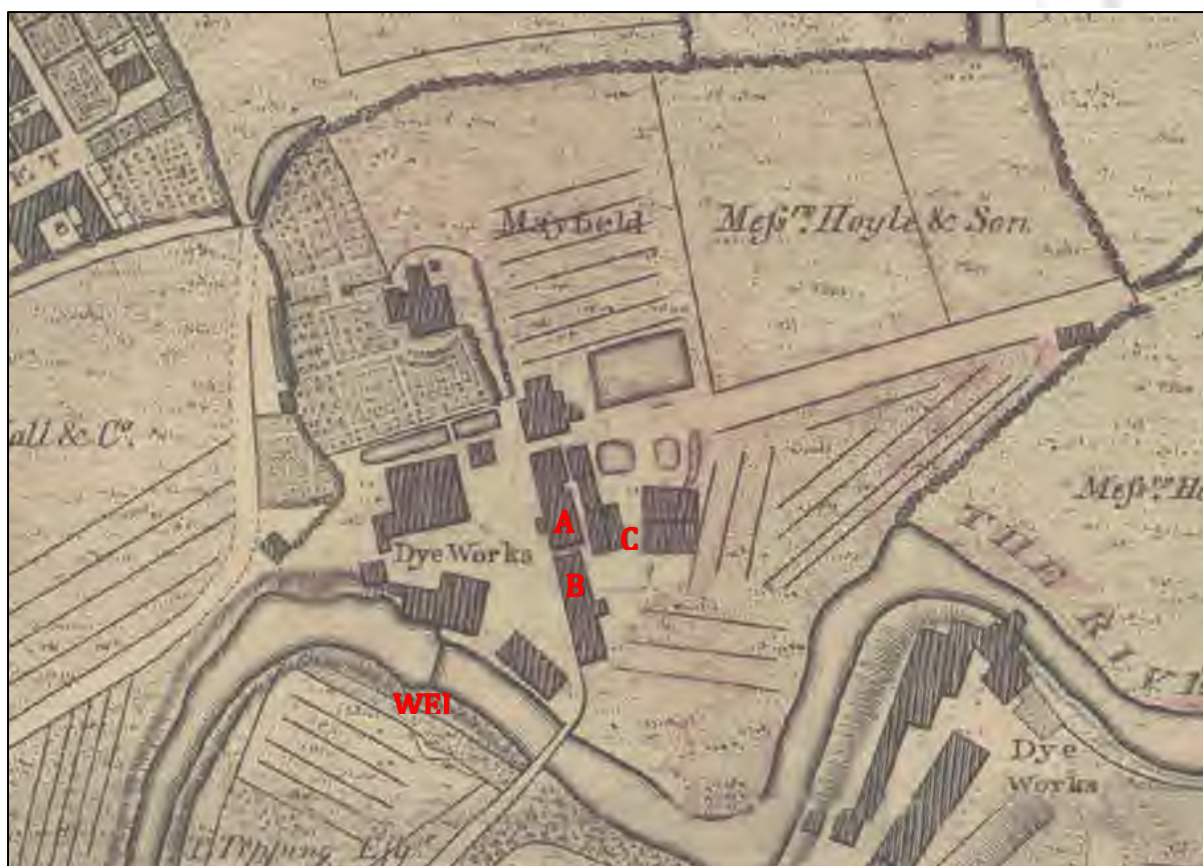
In 1843, an article appeared in the Penny Magazine titled 'A Day at a Lancashire Print-Work', which described in depth a visit to Thomas Hoyle and Sons finishing works, including the Mayfield Printworks in Manchester and another finishing works owned by Hoyle in Dukinfield (Penny Magazine, 1843, 289). Printworks are described in the article as odd places that "combine taste, chemistry and mechanism, three agencies that are often associated with manufacture however only found working together within finishing works" (Penny Magazine, 1843, 289). The article gives a detailed description of the finishing works. The Dukinfield Works was mainly used for the bleaching and dyeing whereas the Mayfield Printworks focused on dyeing and printing (*ibid*). The Dukinfield Works was located on a large area by the banks of the River Tame, approximately six miles from Manchester. The complex included the croft or bleach-house, dye house, reservoirs and water filtering ponds and subsidiary buildings. The

'I left the College at the close of the session in the summer of 1839. I had a desire at this time to take up the study of medicine, but my father did not approve of it, and it was eventually settled that I should enter his business of calico printing' (*op cit*, 14).

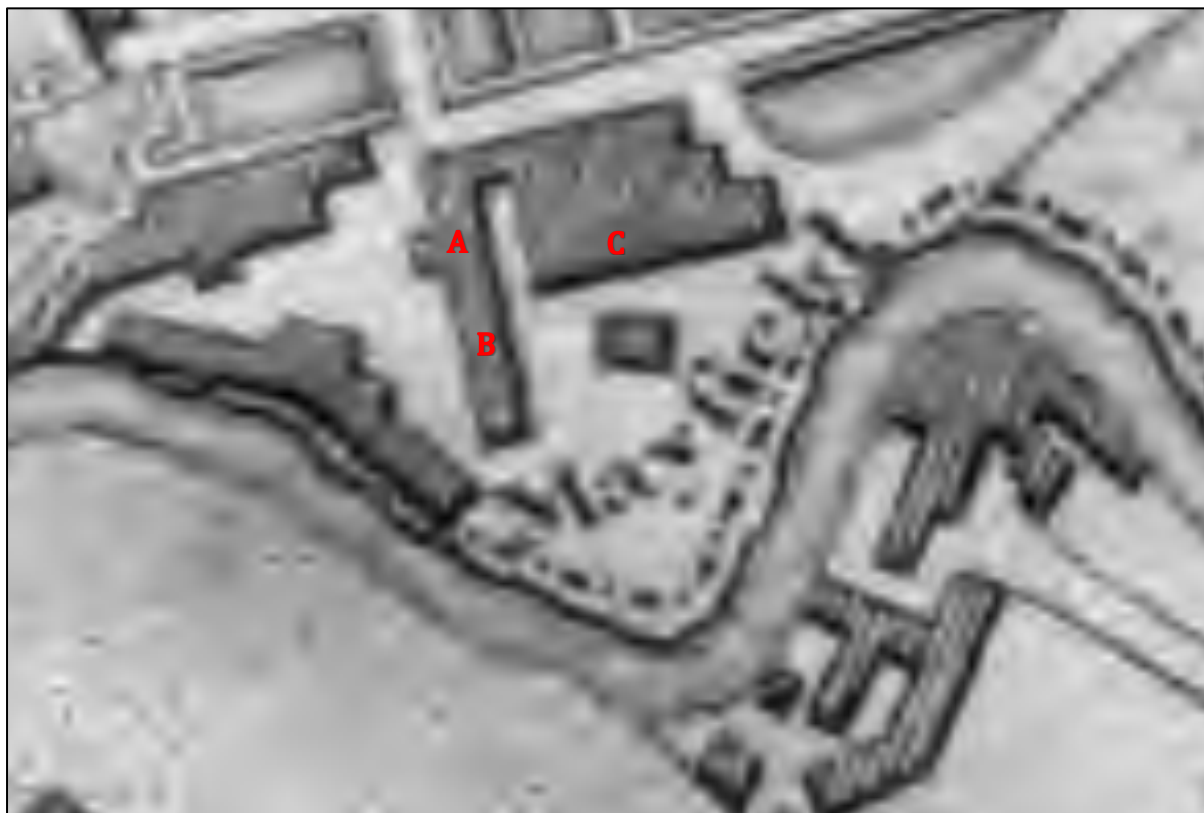
*Plate 18: Extract from Adshead's map of 1851 showing Mayfield Print Works*

Feroukh Khan, a Persian ambassador in December 1857, an ambassador from Madagascar in June 1864 and the Sultan of Zanzibar in 1875 (Manchester Evening News 9th July 1875). The Manchester Evening News reported that the Emperor and Empress of Brazil visited the Mayfield Printworks during July 1871. Many printworks during the 19th century were known for their poor working conditions, including long shifts and child workers. However, during Lord Ashley's speech, the Mayfield Printworks is mentioned as being in agreement to ending night work. In 1849, a spacious reading room and a smoking room were added for the workers, where tobacco and drinks could be bought at cost price. On 10th November 1849, an article appeared in the Northern Star and Leeds General Advertiser concerning these additional rooms:

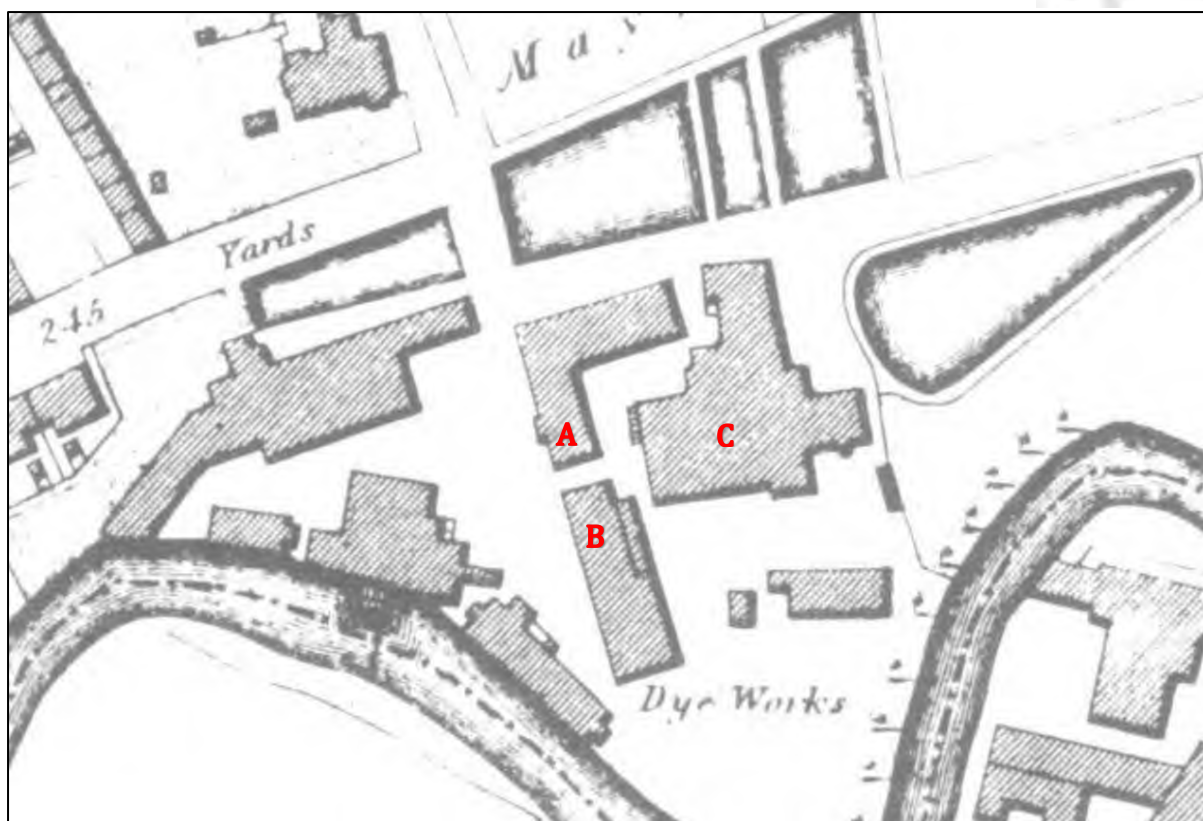
Plate 195: Extract from Bancks and Co's map of 1831 showing buildings A, B and C

The dyeworks complex altered little in the following decades and appears much the same from maps produced in the early 19<sup>th</sup> century, only undergoing significant expansion in the 1820s and '30s, as indicated by Swire's map of 1824 (Plate 194) and Banks and Co.'s 1831 map (Plate 195). The 1831 map reveals an addition to the eastern side of Building B, Room 4, with more extensive changes made in the central part of the excavation area, with two extensions added, to the main floor of Building C, consolidating the former detached buildings into one large unit. An attached building, probably housing the early boiler house was situated north-east of the excavation area.

The extent of development between 1831 and 1849 can be gleaned through a comparison of Bancks and Co's map of 1831 and the OS 1851 Town Plan (Plates 195 and 197). The overriding picture from OS 1851 Town Plan is the proliferation of boiler- and engine houses, signalling a widespread adoption of steam-powered apparatus within the works. A considerable number of new buildings were erected to the north and south of the excavation area, with almost all of the northern bank of the river occupied by workshops.

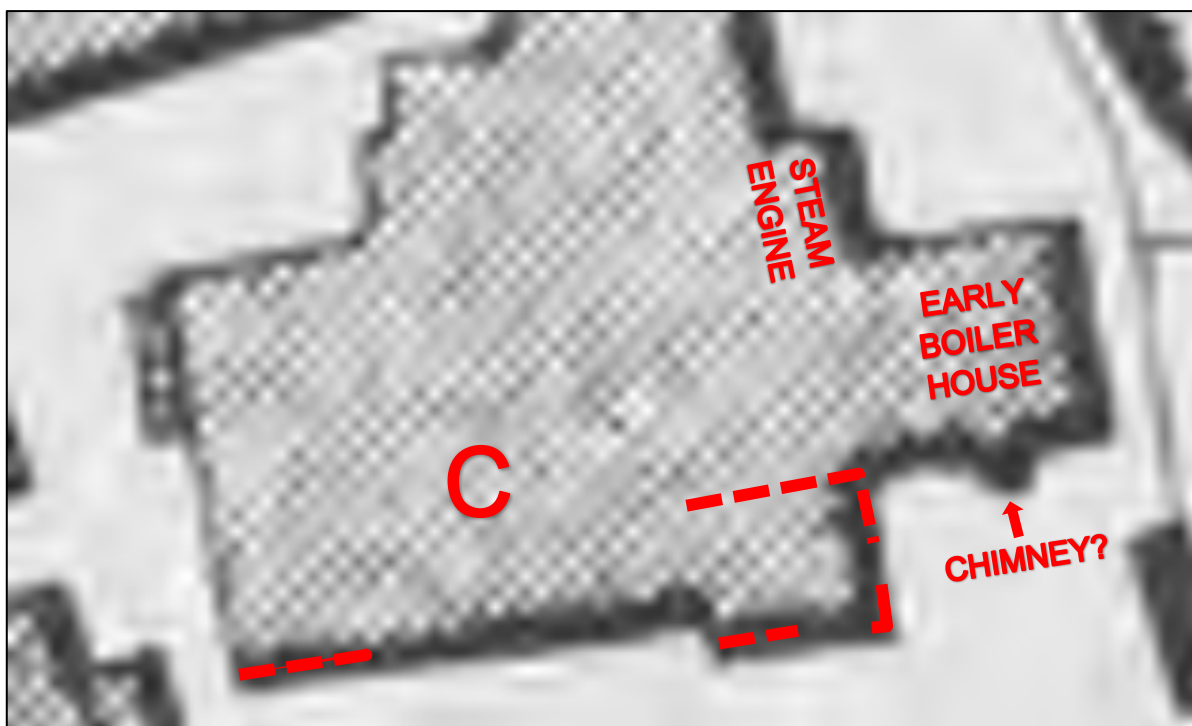
*Plate 196: Extract from Bancks and Co's 1831 map showing the Phase 2 walls revealed in Area 3, Building C, together with the location of the early engine and boiler houses*

Four simple slabs of stone (**3118**, **3098**, **3099** and **3104**) were exposed within this space; they were interpreted as vat bases. They exhibited a shallow groove within the surface, running around the edge all four sides; the groove was presumably for the insertion of wooden or stone upright sections, since removed, that would have formed the sides of the vats or baths. A single circular aperture drilled in the corner of each stone served the function of a plughole, allowing liquid to be drained off; run-off was channelled into sub-floor drains connected to a larger east / west conduit **3083** running the width of the room (Room 65 on the 1872 insurance plan). The presence of lead piping running up to slab **3118** implies they were supplied with water, probably heated by a steam boiler and pumped to the dye house by means of an engine located to the north-east (Plate 196).

The archaeological and historical evidence indicates that within the confines of Area 3, Building C was subject to the most development during this period with several additional rooms built to the south of the existing building. This included a southward extension to the pre-existing boiler house, containing a new bank of four boiler beds and an associated charging floor. A free-standing chimney serving the southern boilers may also have been erected at this time. Previously, there may have been an attached chimney on the southern side of the former house, possibly indicated on Bancks and Co's map (Plate 196). Only minor additions and alterations were detectable within Buildings A and B during this period

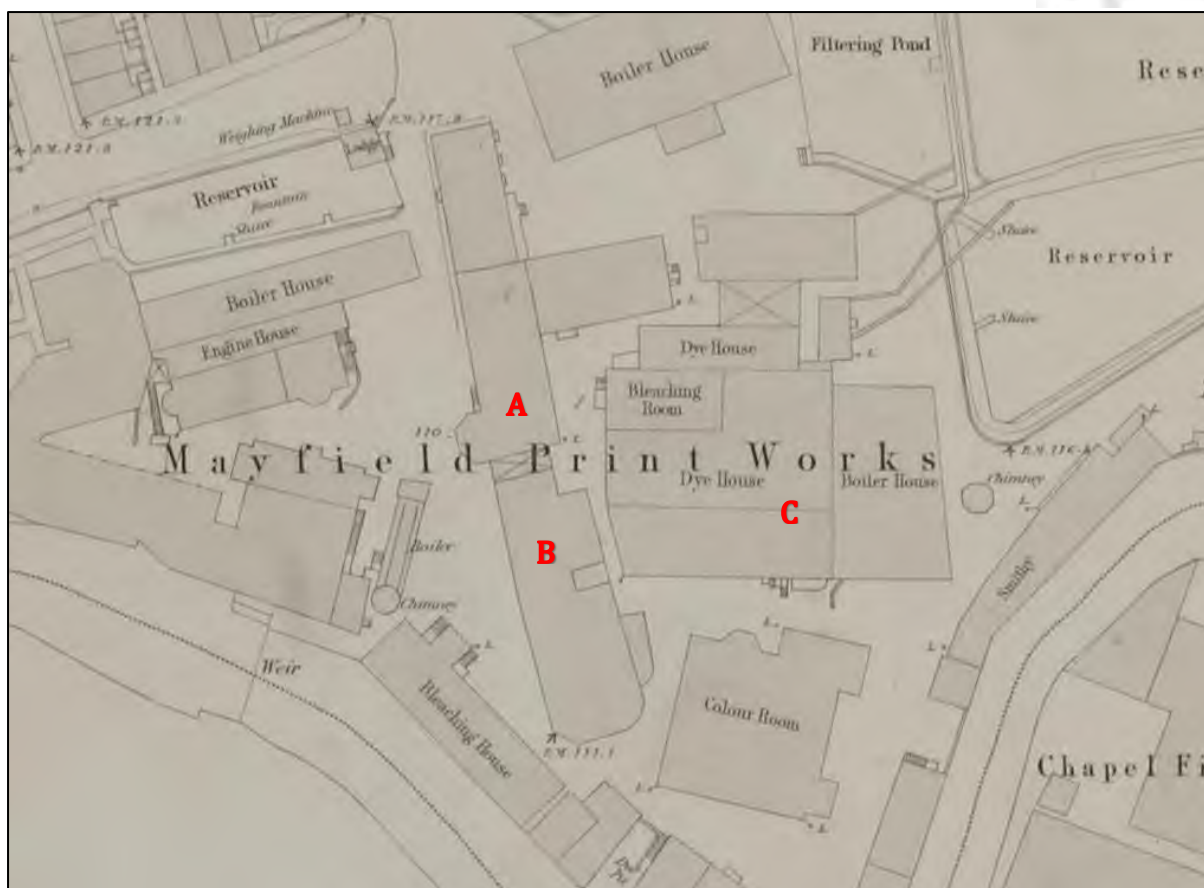
Plate 197: Extract from the OS 1851 Town Plan showing the layout of the Print Works buildings

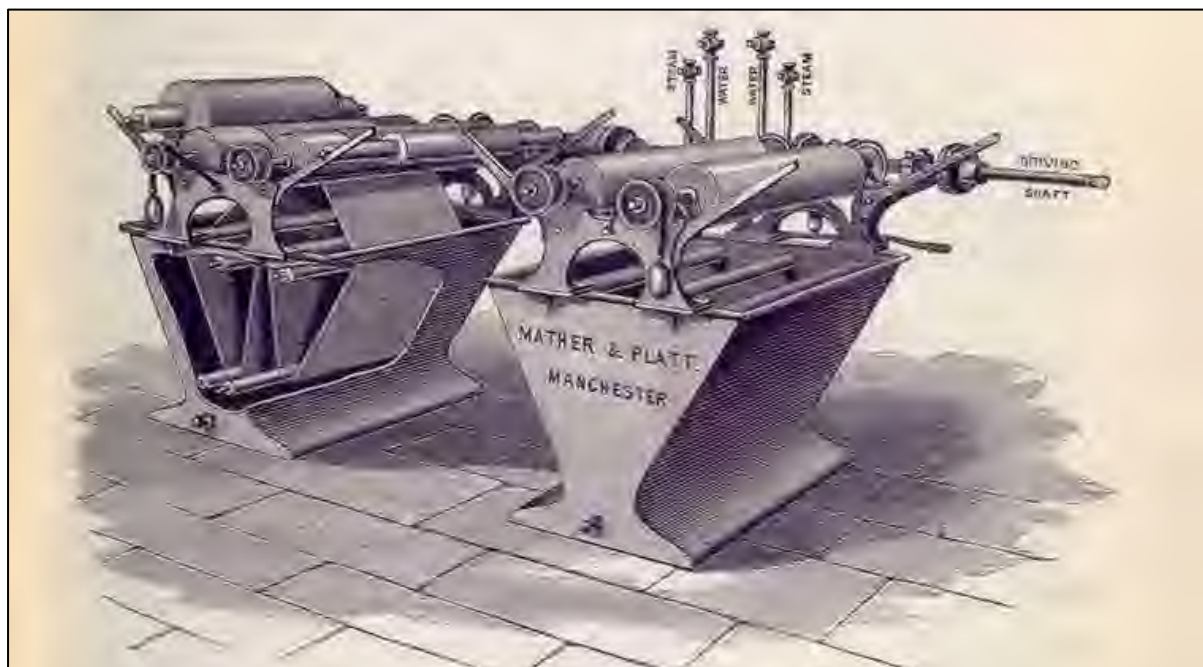
Plate 198: Dye jigger

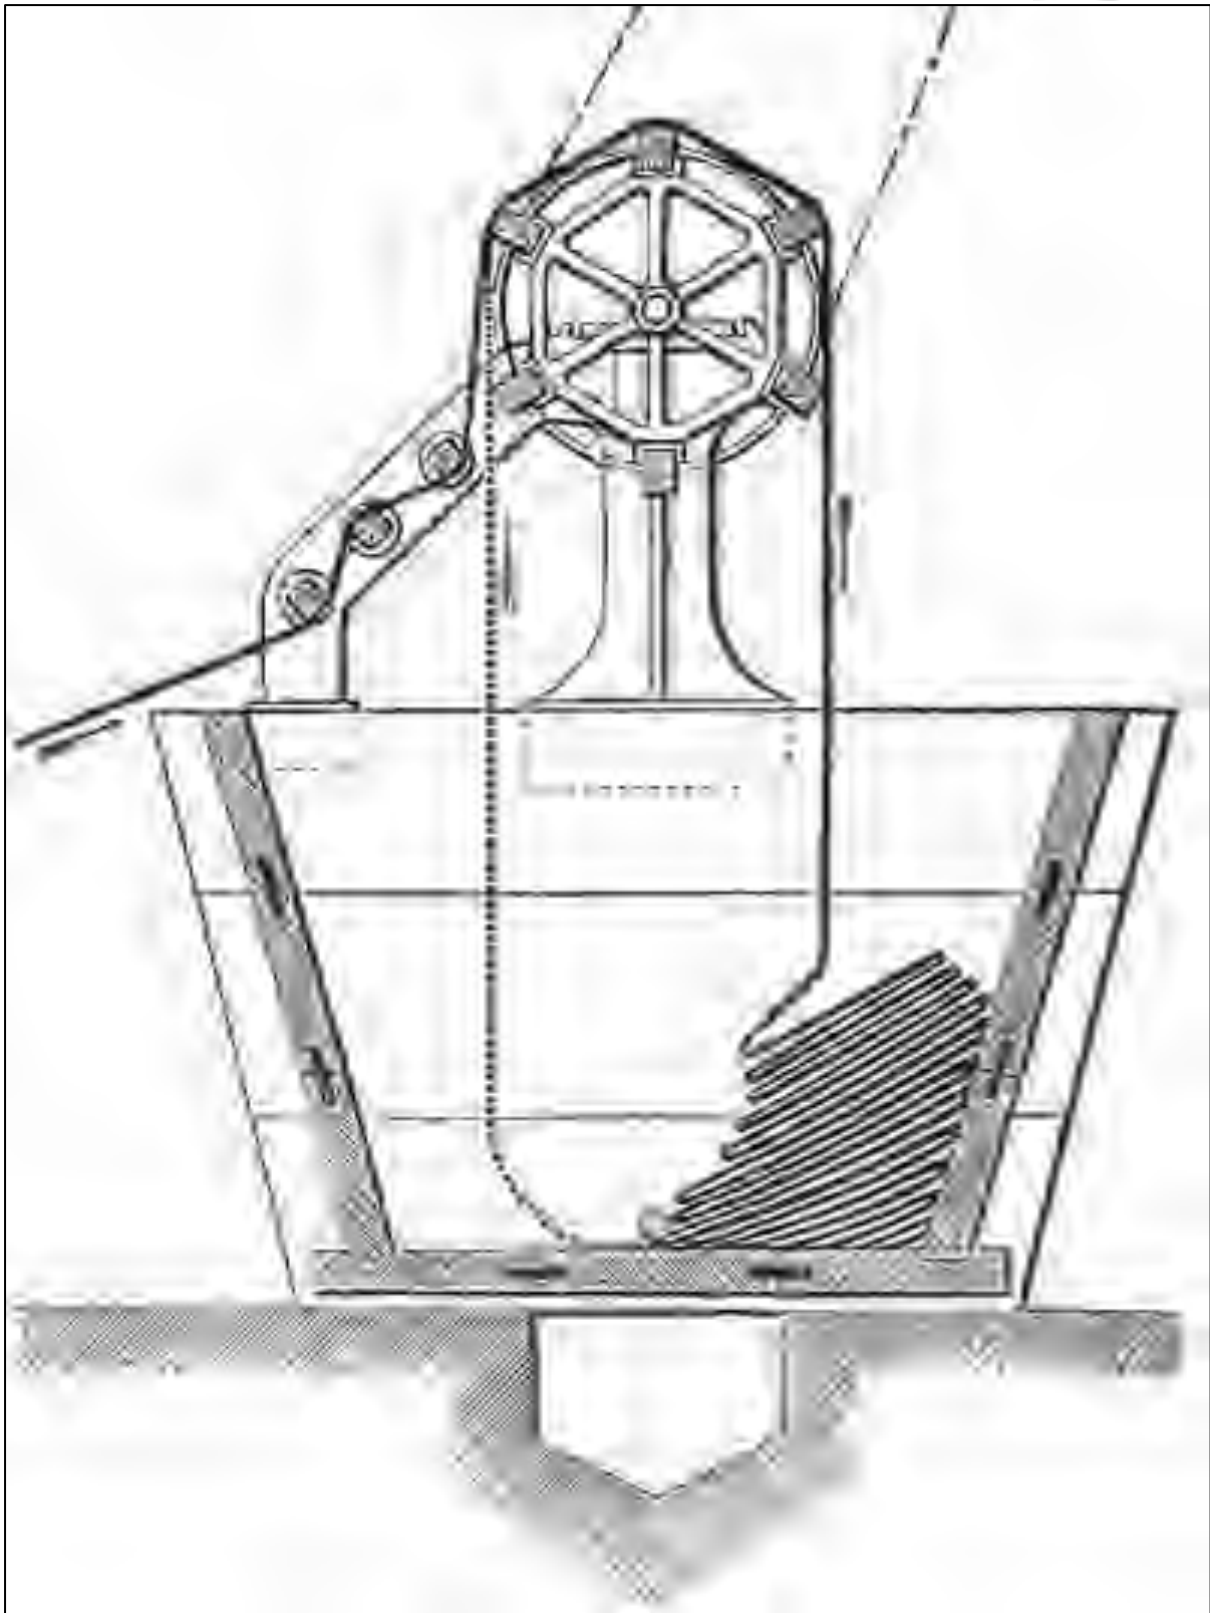
*Plate 199: Diagram of a wince dye beck or dye digger*

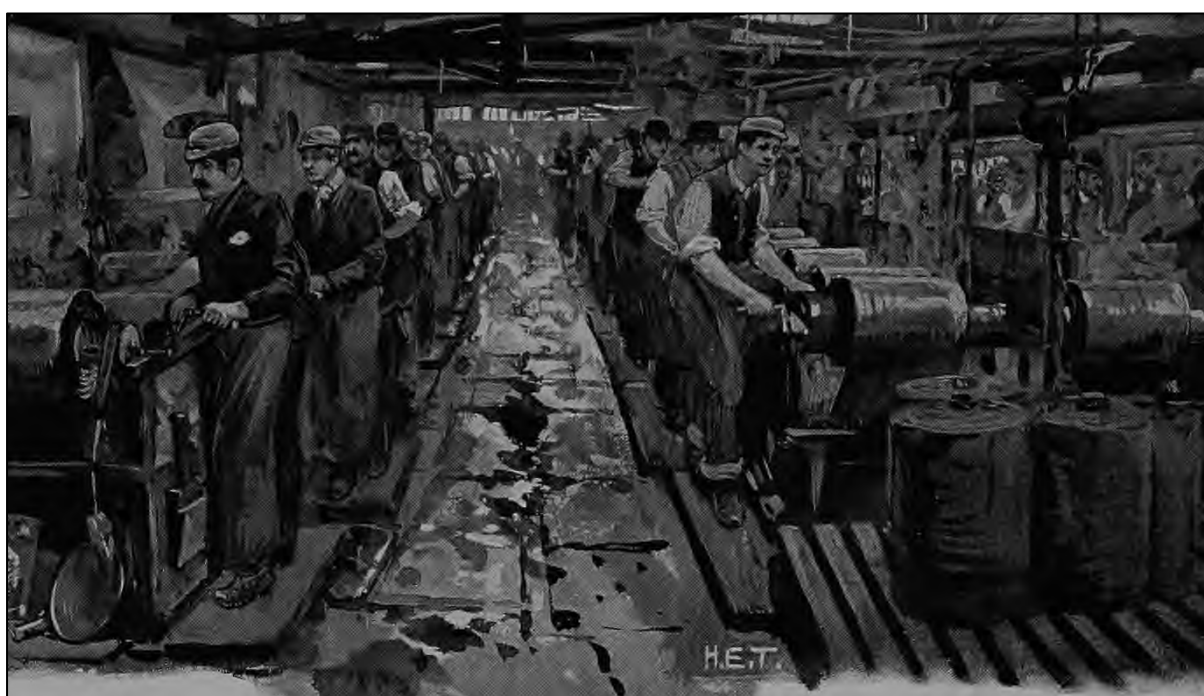
*Plate 200: Dye house in Messrs Worrall's works, Manchester*

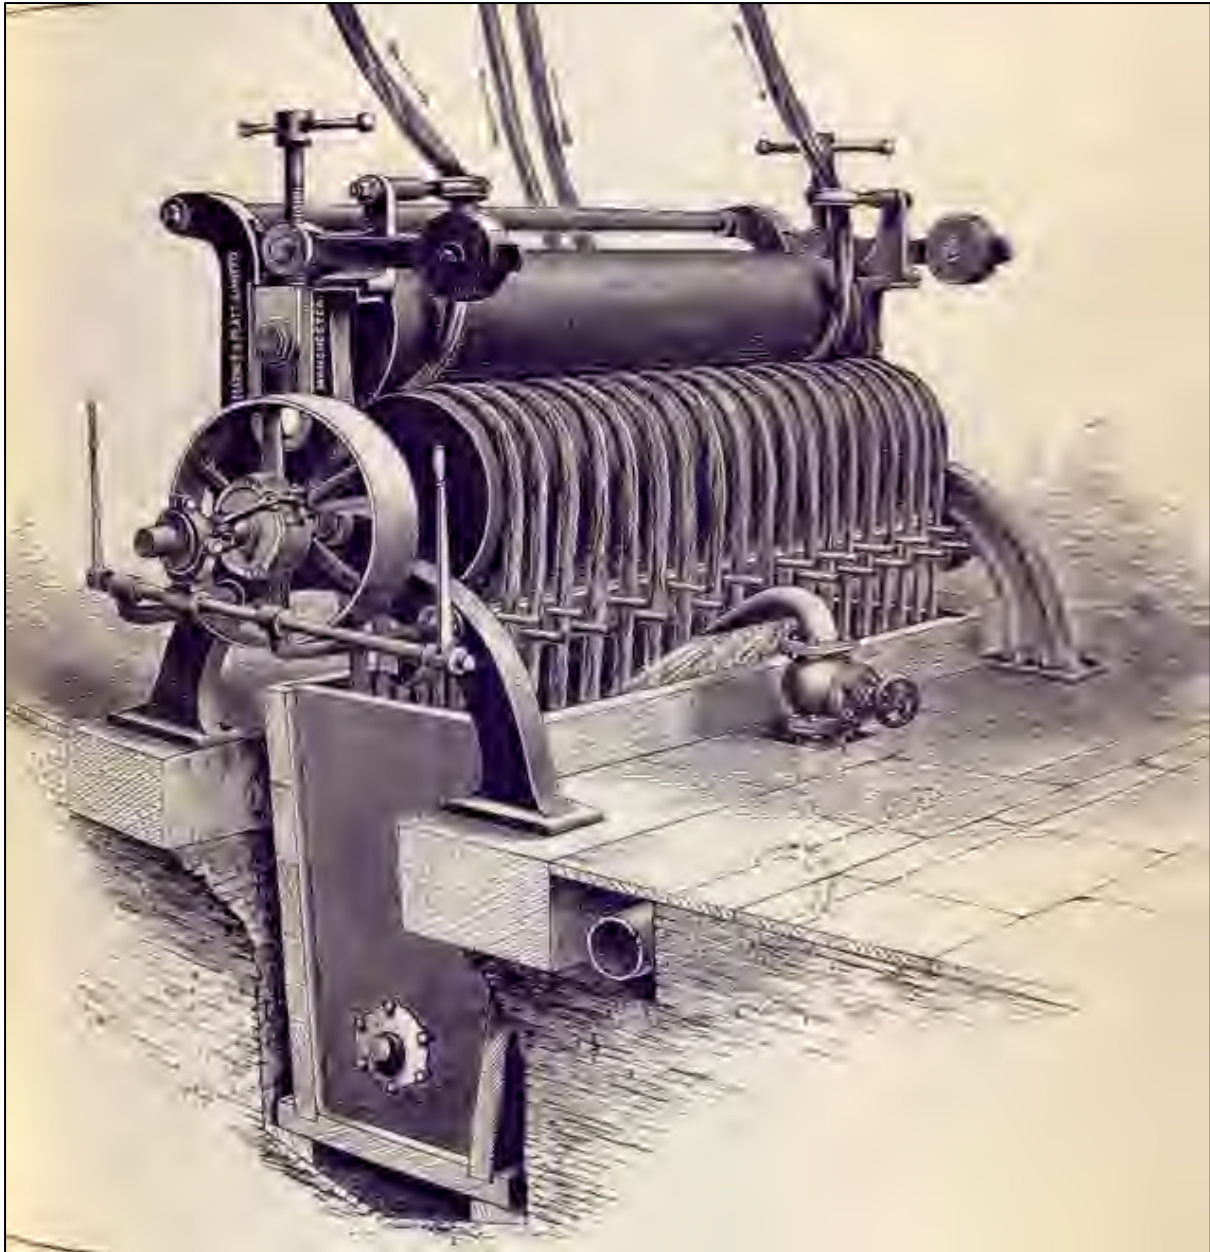
*Plate 200: Improved roller washer machine*

Soaping and washing were both important operations connected with the final cleansing of dyed and printed fabrics. At Mayfield there were at least two washhouses, a washing room and roller washing room, the latter probably housing row upon row of machines (Plate 200). Soaping served to remove some of the colouring matter and to make the white areas of the fabric bright and clear from dye (Anon 1880 170). This process was carried out using apparatus similar to a dye bath, in which the material is passed into a solution of soapy water (ibid). This was repeated multiple times, with sometimes up to six immersions. Although no such installations were revealed in the southern half of the building, it remains a possibility that the stone slabs found to the north, within the earlier parts of Building C, were utilised for this purpose. Other becks or baths may have once existed but owing to the lack of surviving floor surfaces had since been removed. The process of soaping was mechanised in the 19<sup>th</sup> century and within the Mayfield works, an entire room was dedicated for soaping machines; this room however lay beyond the limit of excavation and was located to the south-west of Building B (Room 43).
