## Archaeological Excavation Report

Mayfield,  
Manchester

**Report No:**  
SA/2021/56

**Project:** Mayfield, Manchester: Archaeological Excavation

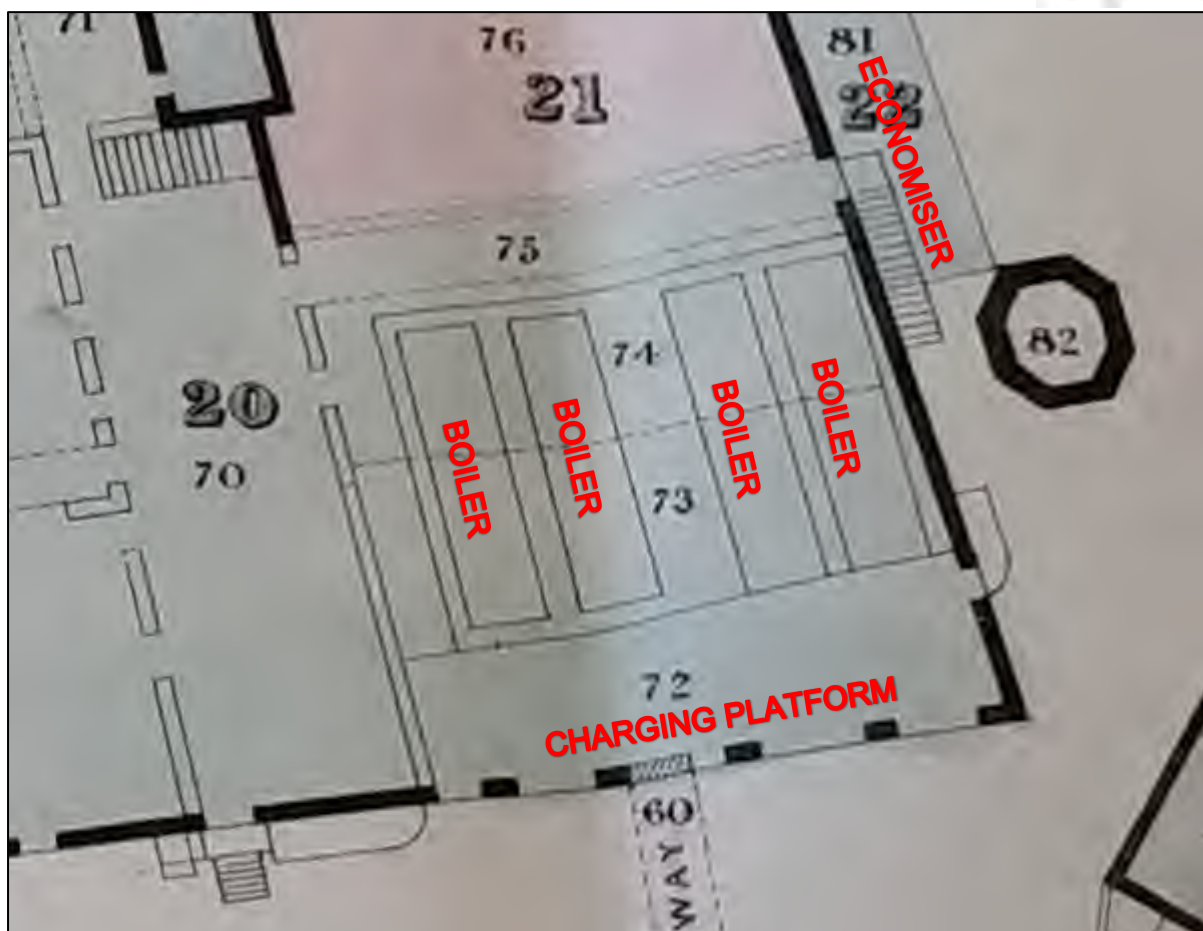
The boiler house contained a bank of four boilers, which were survived by a series of brick and firebrick boiler beds **3060 – 3063**, side flues, a maintenance or access tunnel **3069** and rear flue **3064**. The boiler beds were of a typical T-shaped form in plan, set back from the front wall to create a stoking or charging floor, situated to the south (Plate 201). The boiler beds were of a form that could have supported either Cornish, Lancashire or Galloway boilers; the latter two were adopted widely the during second of the 19<sup>th</sup> century. Lancashire- and Galloway boilers were patented by Fairbairn and Hetherinton in 1844 and William and John Galloway in 1851, respectively. The exact date the boiler house was built is not known but it was certainly in existence by 1849, making it a strong probability that Lancashire boilers were the first to be installed. Two types of boiler were listed in the winding-down sale in the 19<sup>th</sup> century, including four of Galloway boilers and three Lancashire boilers.

Plate 201: Extract from the 1872 insurance plan showing the internal layout of the boiler house

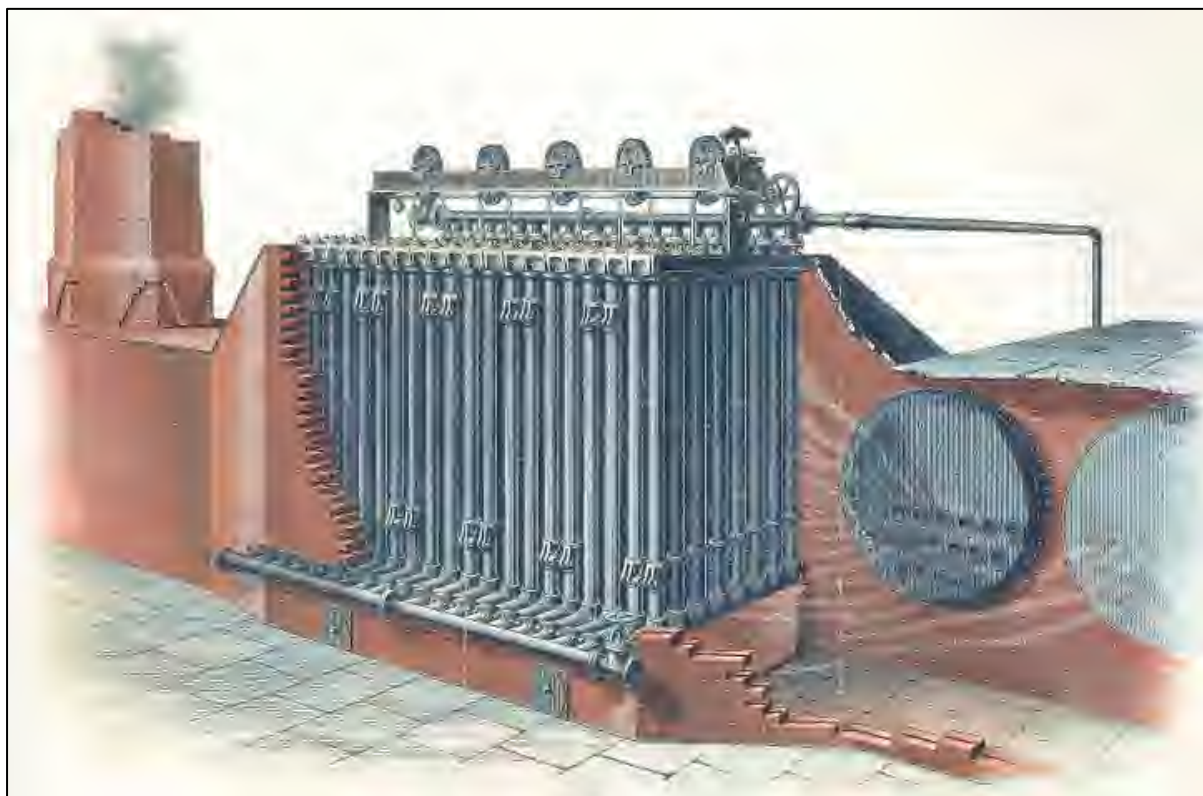
*Plate 202: Green's patent fuel economiser*

Broadly contemporary with these changes was another key development which improved the efficiency of the steam-boilers. This came in the form of an economising house, partially exposed in the north-east corner of the excavation. This excavated portion was represented by walls: **3181**, **3183** and **3186** and incorporated several brick floors **3182** and **3185**, and a brick-built flue **3184**. The flue was aligned east / west and ran in the direction of an existing octagonal chimney. A rock-cut long conduit housing a cast iron pipe ran alongside the western side of the boiler house. This building would have housed an economiser, which utilised the residual heat in the exhaust gases from the boiler furnace to pre-heat the water feed to the boiler. Internally it was made up of a series of metal pipes arranged within the flues between the chimney and boiler. The latest configuration of the economising house at Mayfield was likely 'Green's economiser with 192 pipes', which was recorded in the winding-down sale of 1897 (Plate 202). Economisers were first developed by Green in Yorkshire in the 1840s and widely adopted in the second half of the 19<sup>th</sup> century.

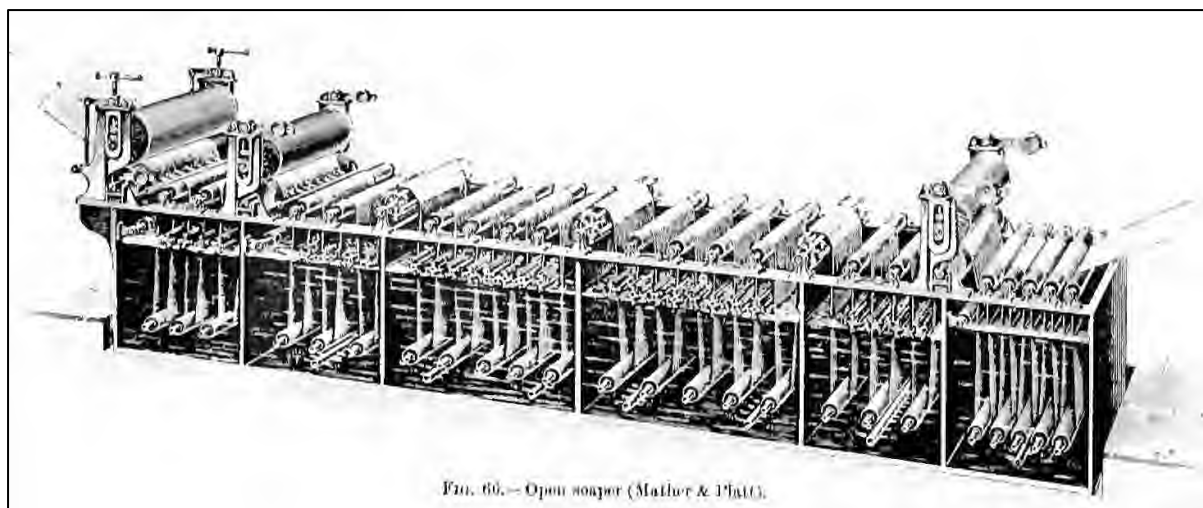
FIG. 66. — Open soaper (Mather & Platt).

*Plate 203: An open soaper similar to the models produced by Furnival and Co. and Hawthorn and Co used at Mayfield dye and print works*

and 3044 respectively. Within structure 3085 were vestiges of a white soapy substance, perhaps a remnant of soap or lime used in either the soaping or orange-raising processes. The mechanisation of soaping saw the development of the 'open soaper' (Plate 203), which consisted of a range of adjoining 'watertight boxes...fitted with rollers at the top and bottom' and filled with hot soapy solutions and 'hot or cold water' (Cole 1911 706); it also featured 'a series of "spirt pipes" to better wash out the soap' (ibid). One of the exposed structures, **3085** was abutted by an additional structure **3153**. **3153** was sited directly over a drain **3086**.

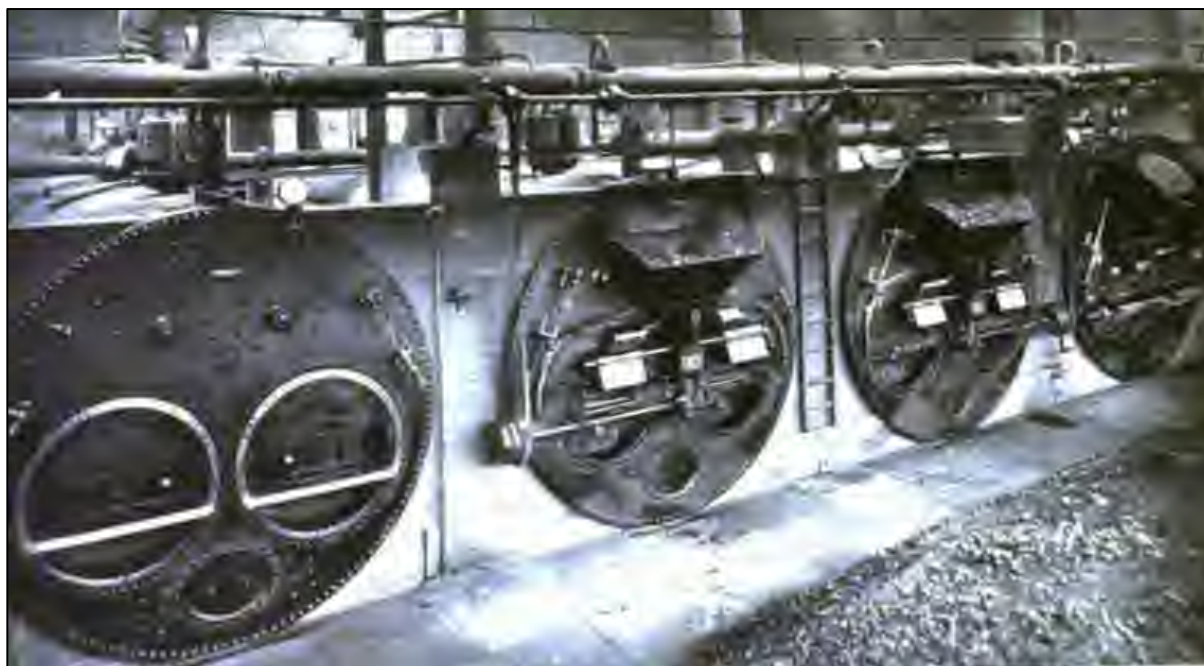
The introduction of automatic feeders to the boilers was inferred from several adaptations in the southern half of the boiler house. The floor alongside the southern wall of the boiler house was raised up. The elevated surfaces (**3066** and **3174**) presumably allowed the hoppers, positioned at the top of each boiler door, to be filled with ease from above. Around the same time, a series of walls were constructed along the front of the building perhaps signifying the construction of a coal store or related structure. Walls **3071** and **3073=3173** together formed a diagonal extension across the previously open-fronted boiler house. Reconfiguration of the access, in the form of a ramped floor **3168** leading into the boiler house may also have been added.

*Plate 204: An example of a bank of Lancashire boilers, some fitted with automatic feeders (hoppers)*

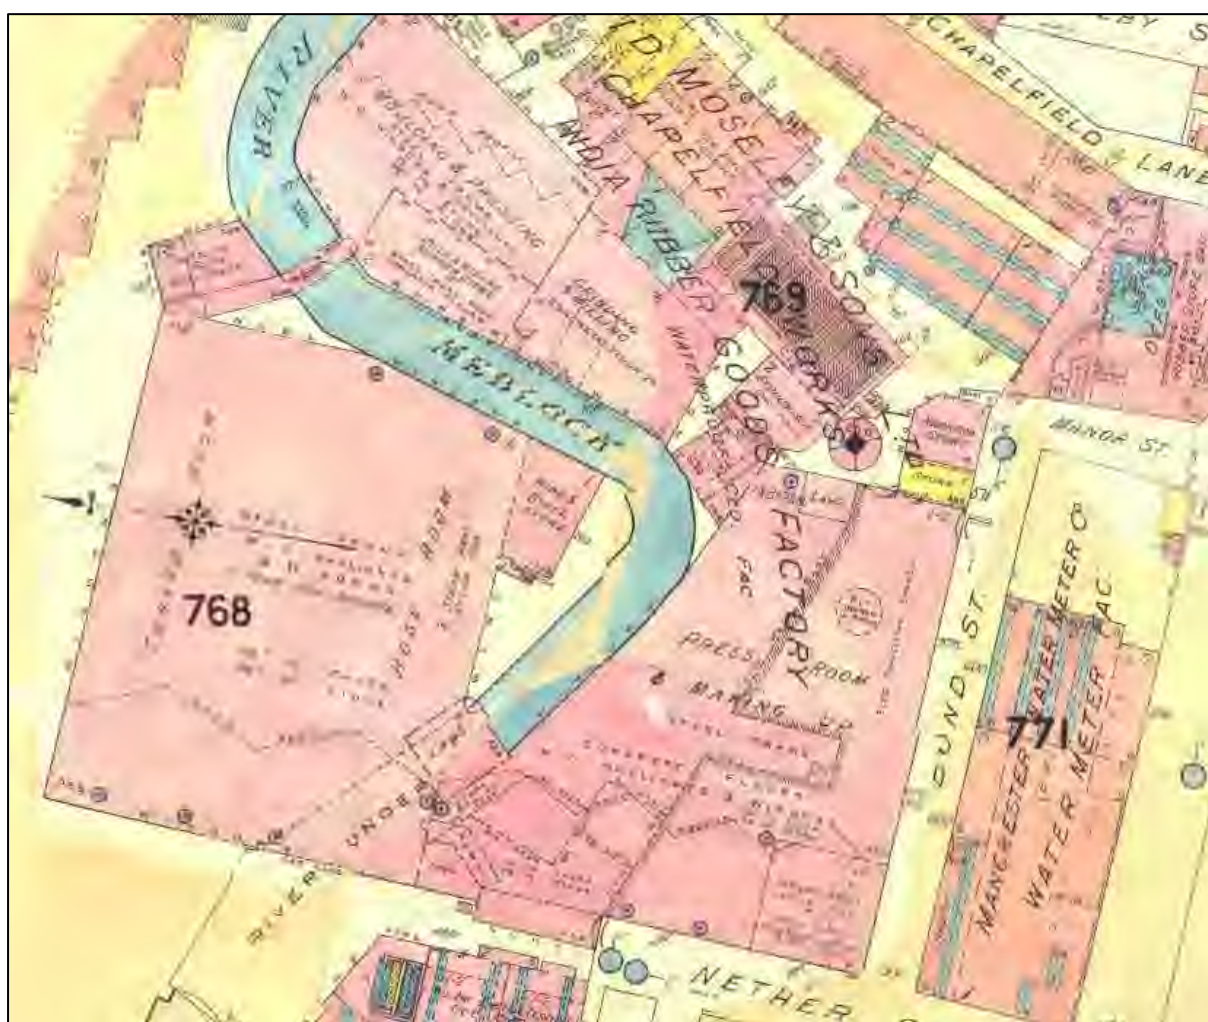
*Plate 205: Goad's map revised 1942 showing the extent of David Moseley's Chapelfield Works*

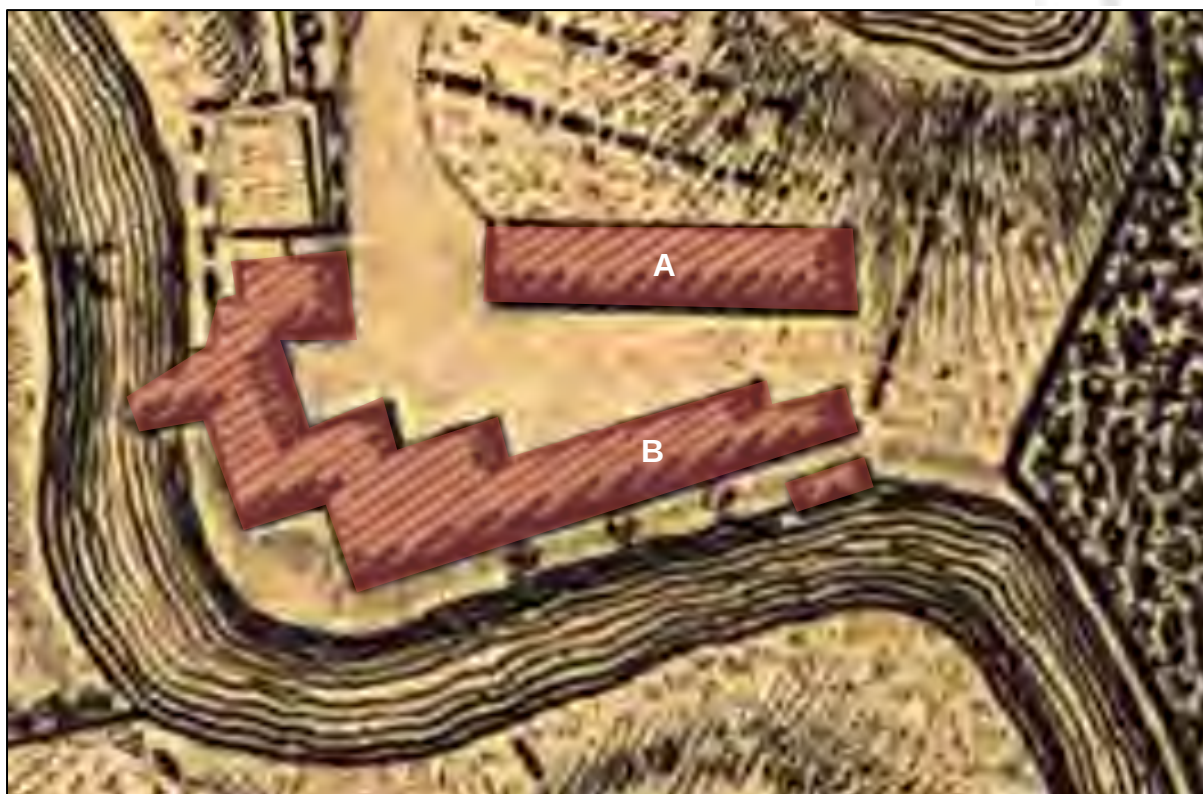
Plate 206: Extract from Laurent's map of 1793 showing the early components of the dyeworks

Elements of two buildings (designated Buildings A and B) once formed part of the 18<sup>th</sup> century dyeworks. These were revealed in the southern half of the excavation (Plate 206). The location and alignment of the outer walls correspond to the position of buildings shown on Laurent's map of 1793 and Green's map of 1794 (Figure 17). The materials used during this period were consistent with those found in the earliest buildings exposed across the river at Thomas Hoyle's dyeworks. Moreover the scale and form of the buildings as depicted on the mapping mirrors that of contemporary dyeworks in the area.

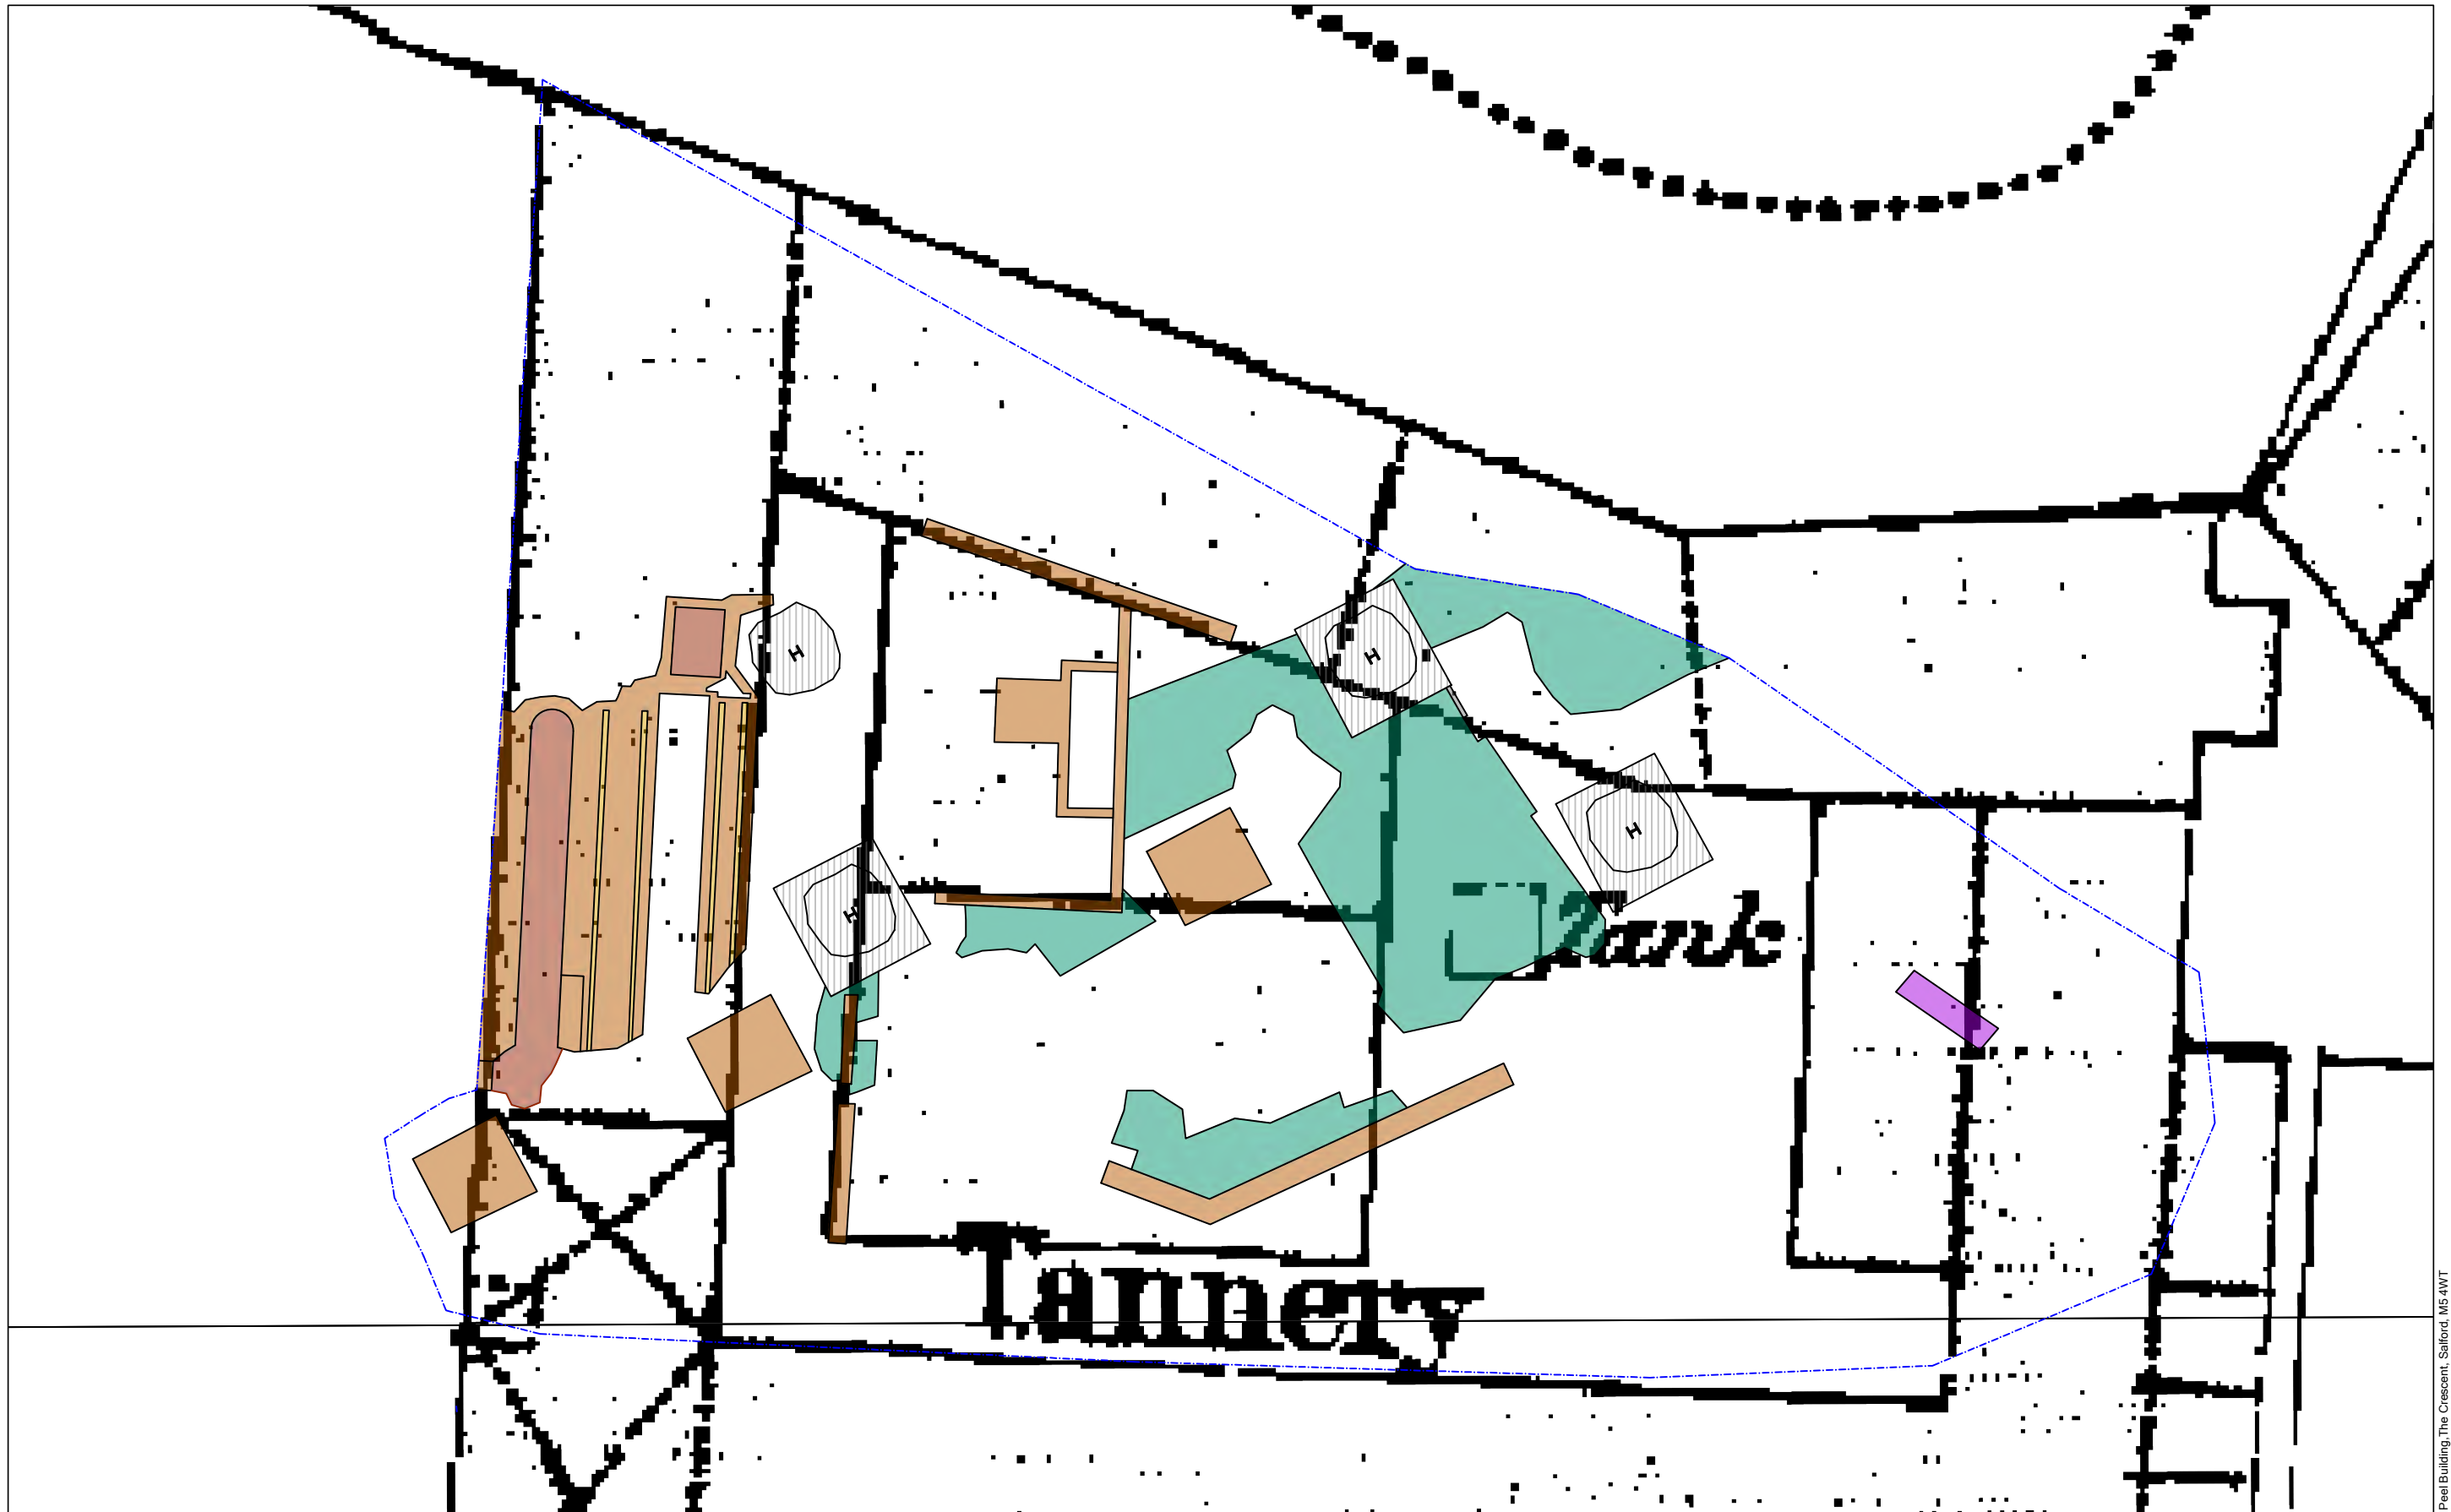
Figure 5:  
Area 1 Excavated remains superimposed onto the 1:1056 Town Plan of 1851  
Contains Ordnance Survey data © Crown copyright and database right 2021

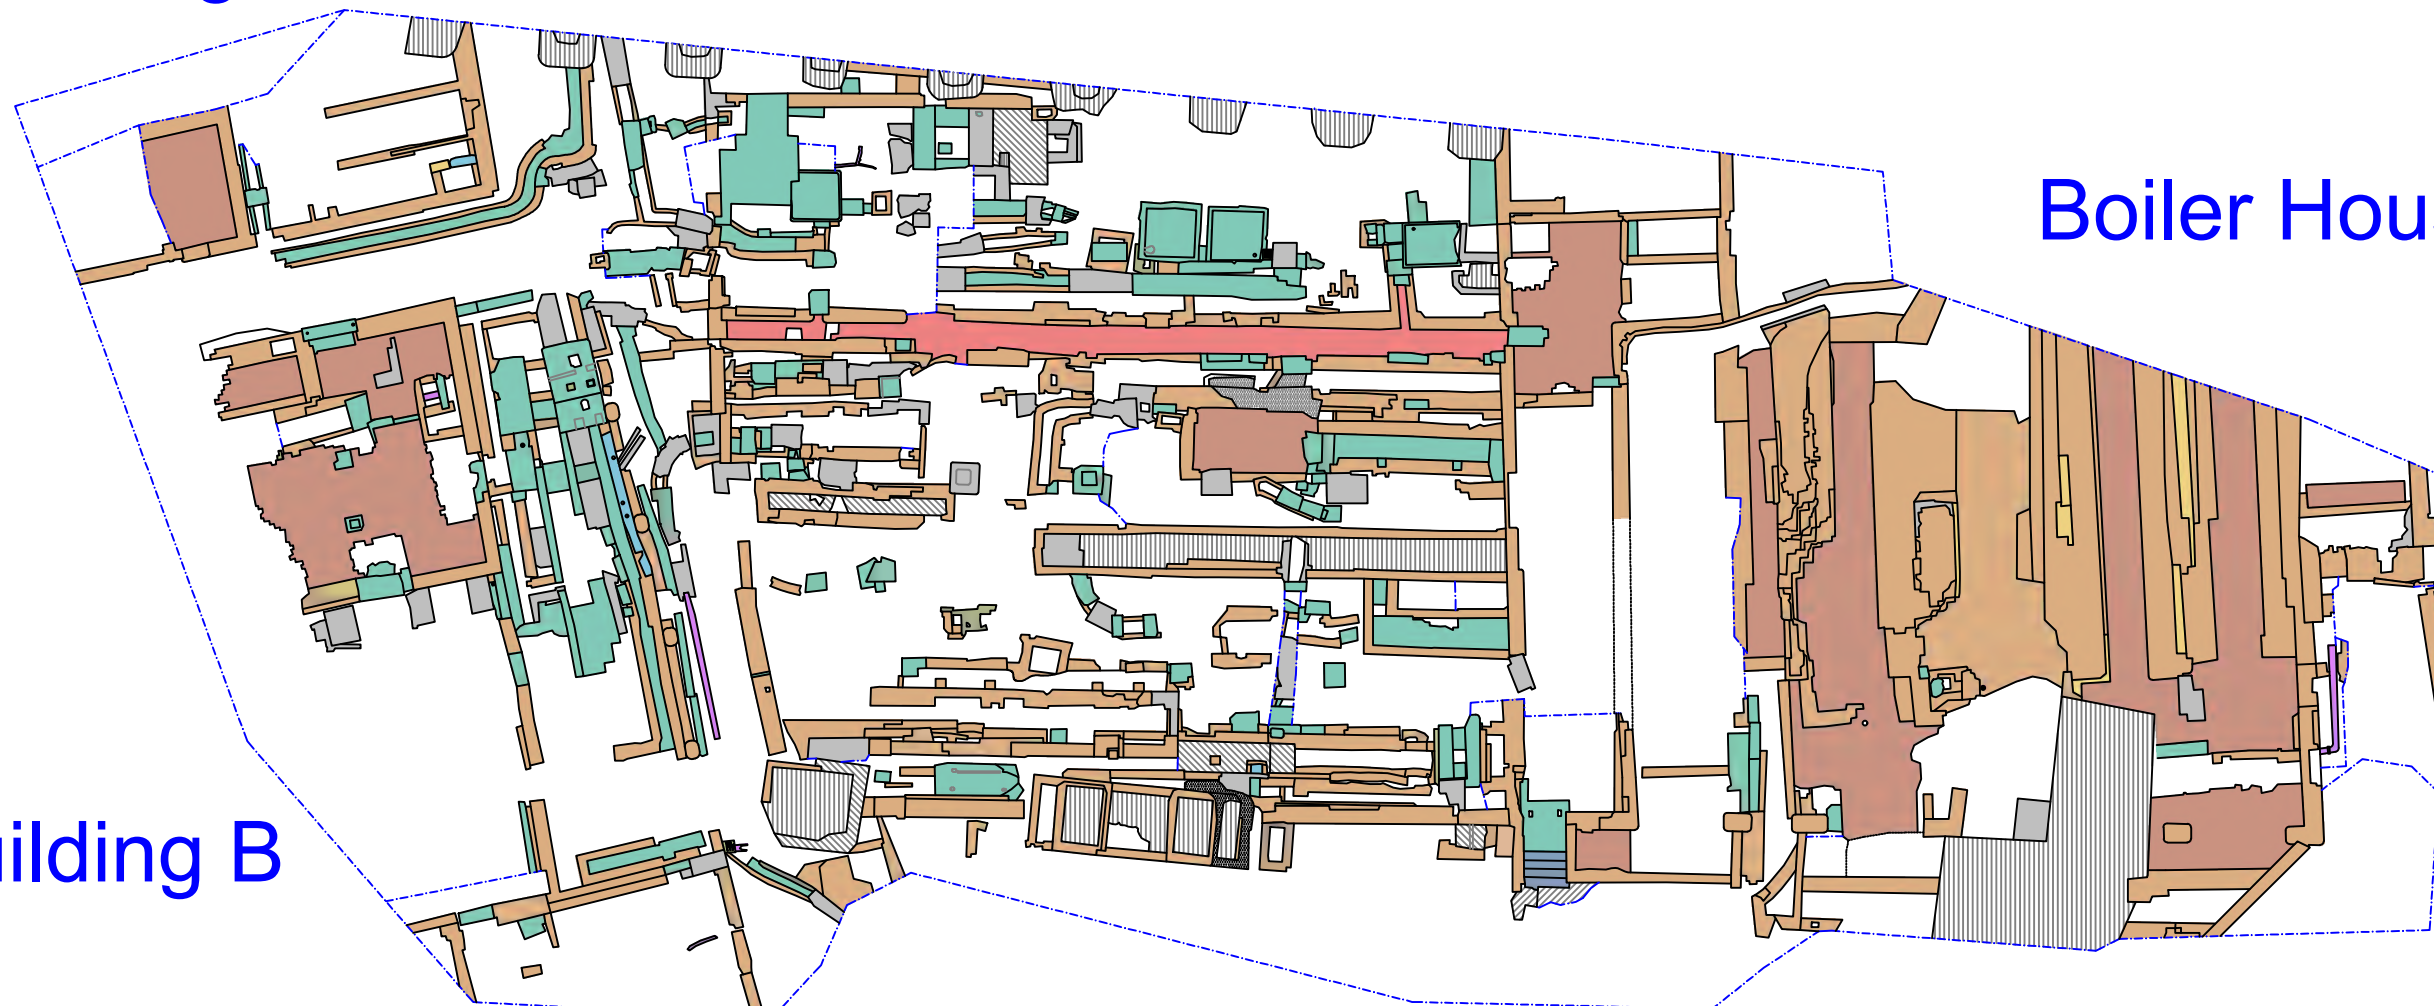
Figure 9:  
Area 3 (Mayfield Dye Works) Showing Remains

Three buildings (designated A, B and C) were subject to excavation (Figures 9, 10 and 11). A suite of structural remains including brick walls, floors, drains, dye-vat bases, machine and engine beds, boiler beds, flues, a chimney and part of the economising house were revealed across the excavated area. This represented a relatively small sample of the overall dyeworks but served to demonstrate how the works were expanded and altered over the course of a century (Plate 191).

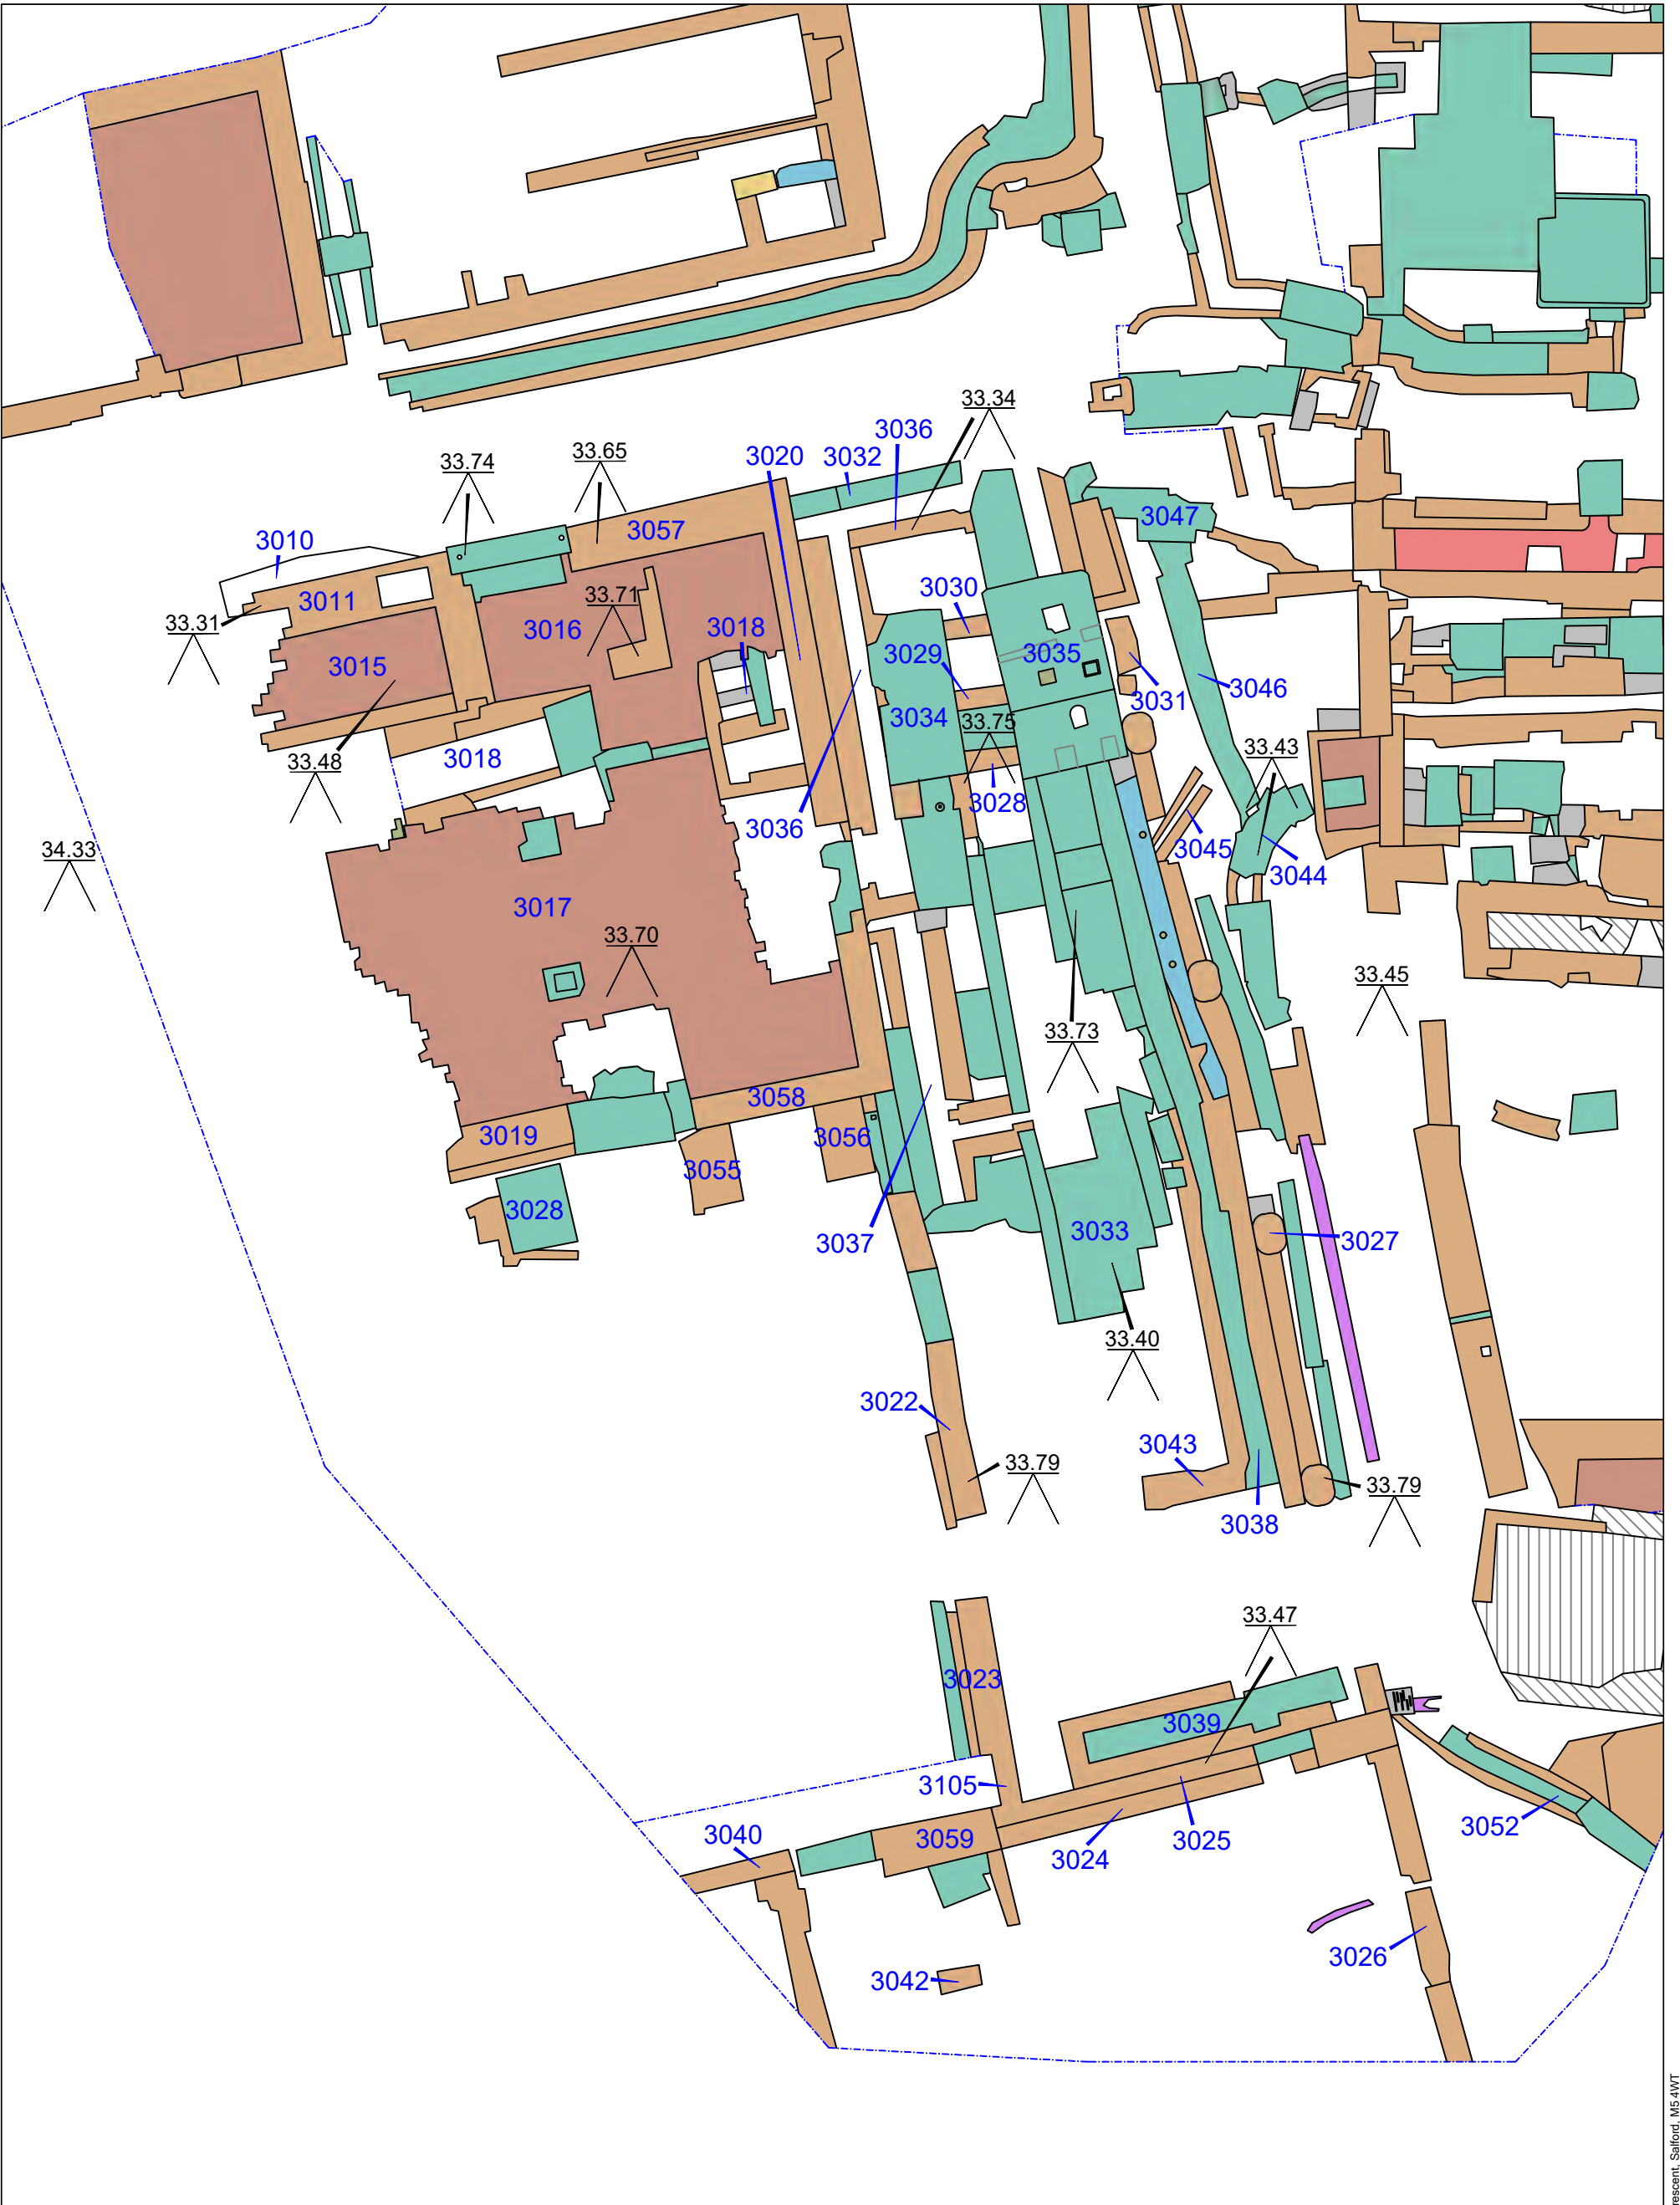
Figure 11:  
Area 3 Building B

### 5.5.3 Building B (Figure 11)

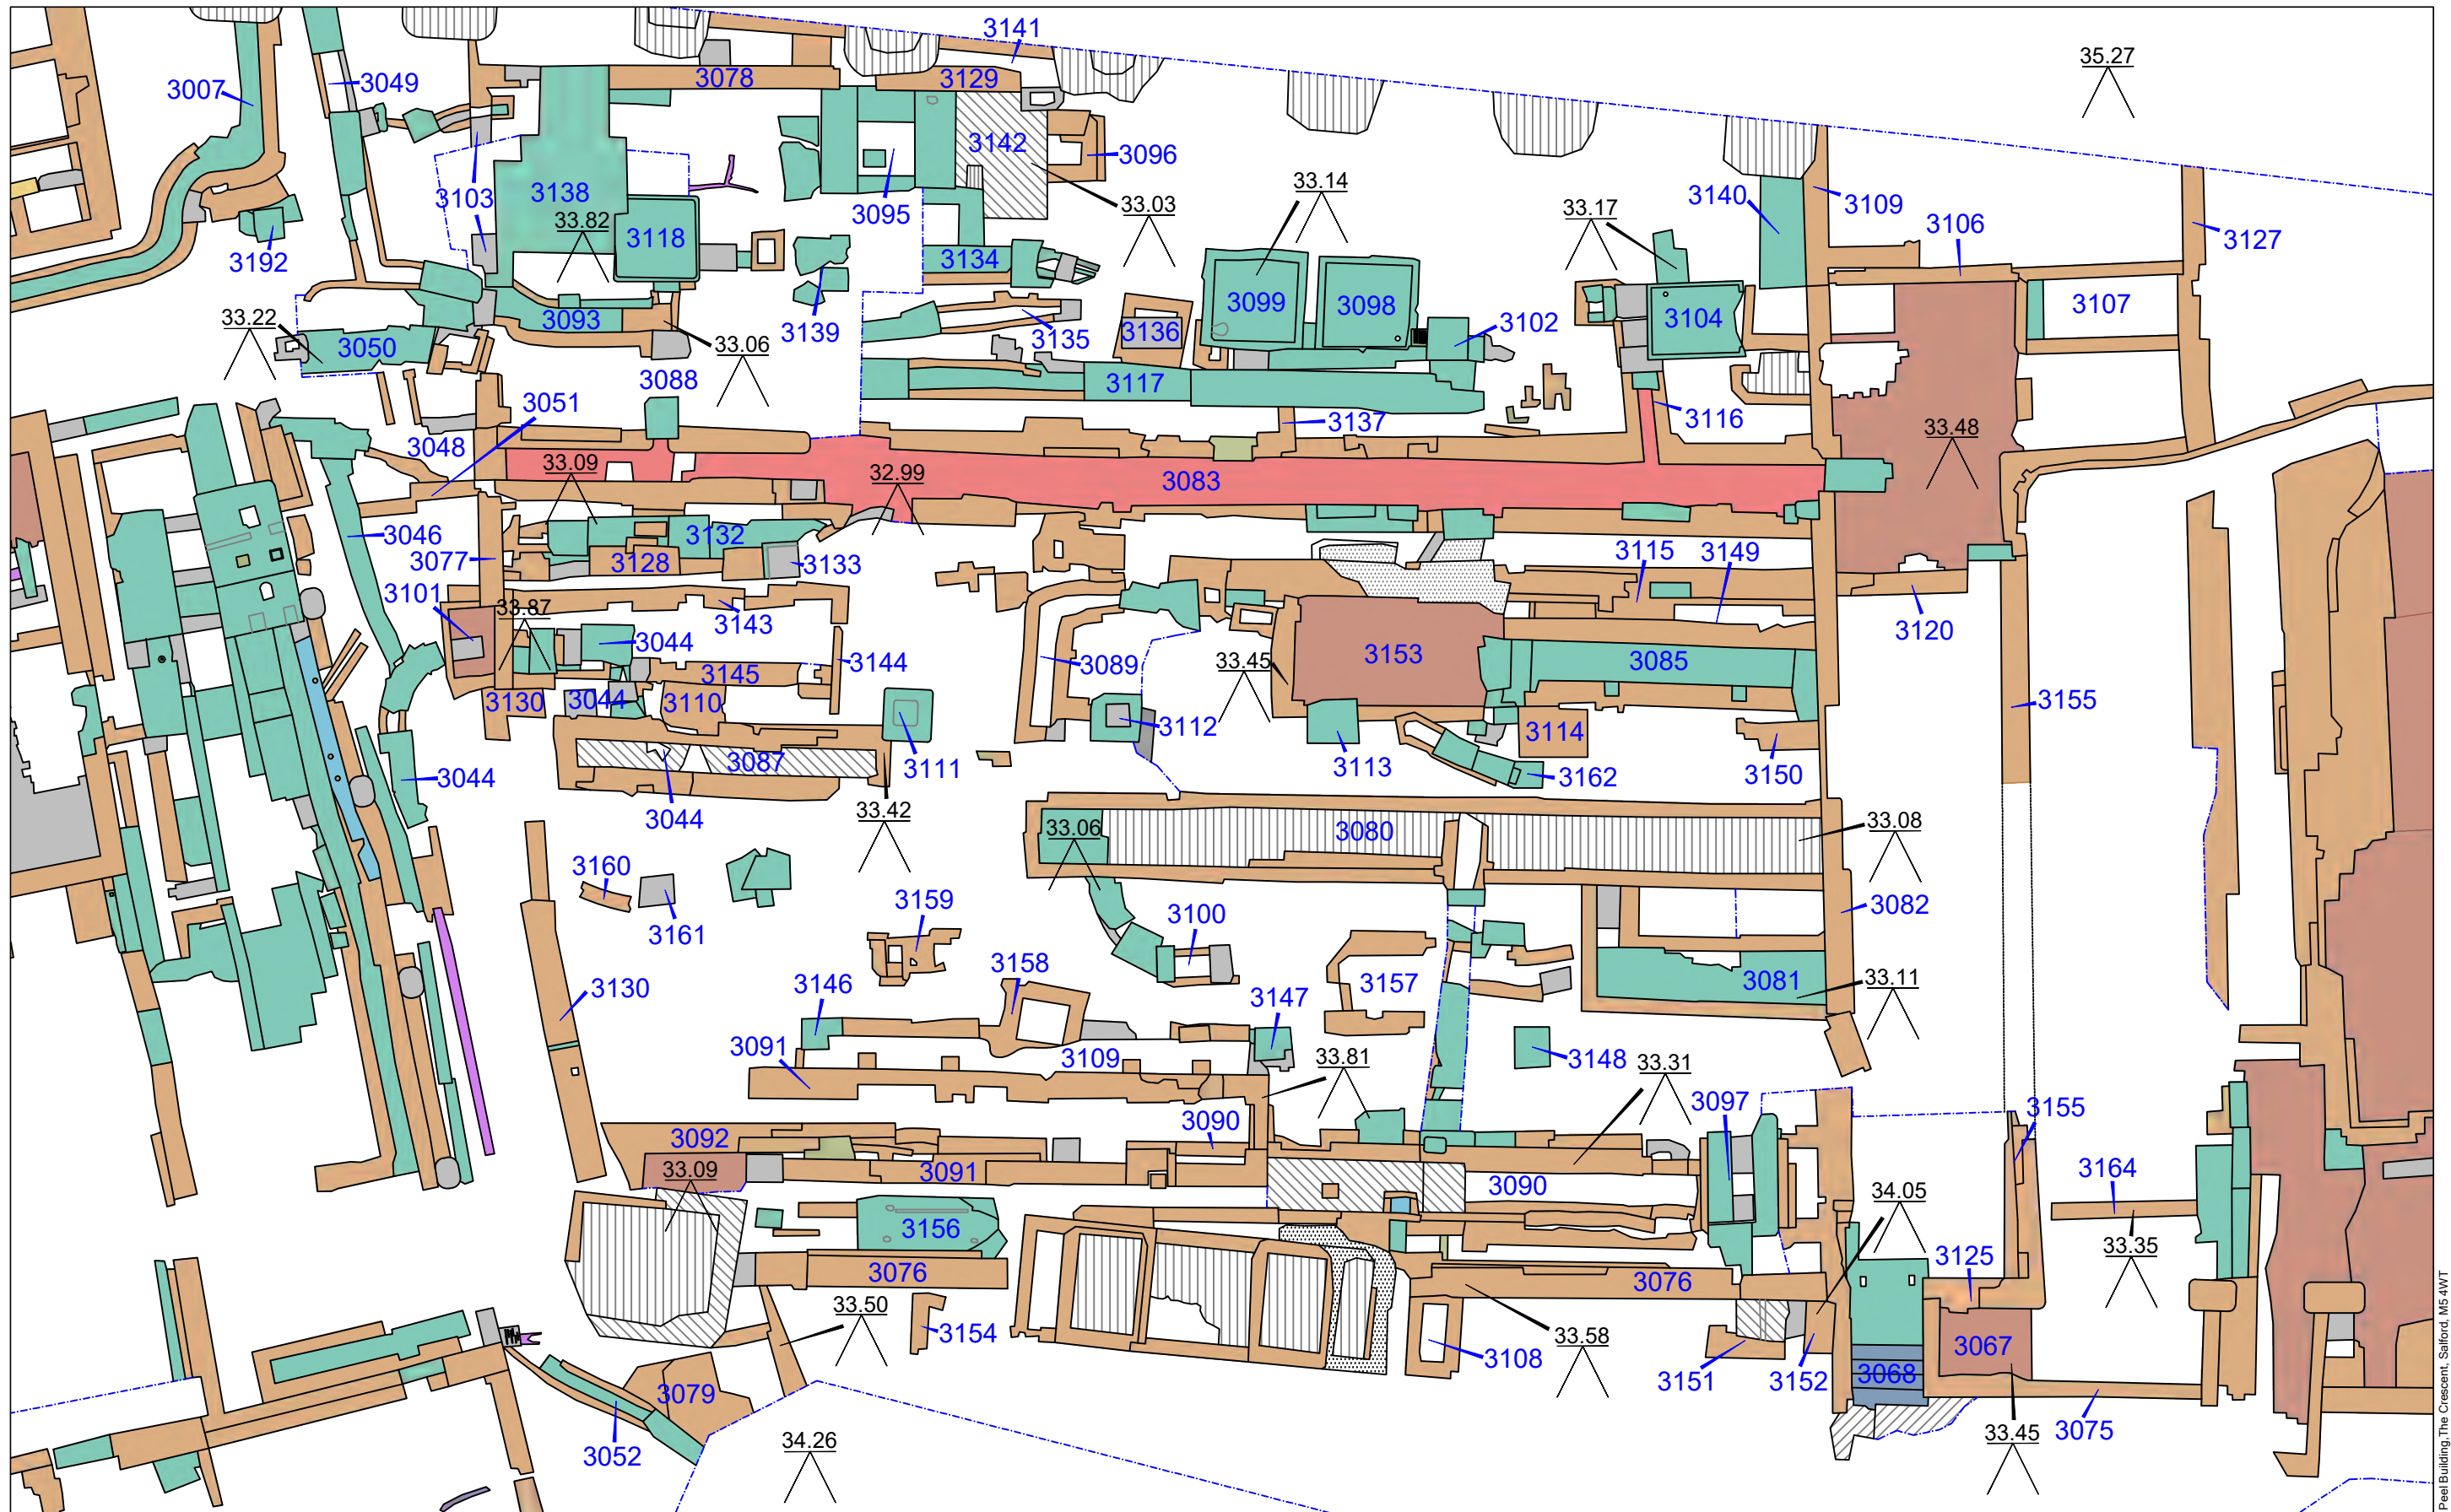
Figure 12:  
Area 3 Building C

#### 5.5.4 Building C (Figure 12)
