## Archaeological Excavation Report

Mayfield,  
Manchester

**Report No:**  
SA/2021/56

**Project:** Mayfield, Manchester: Archaeological Excavation

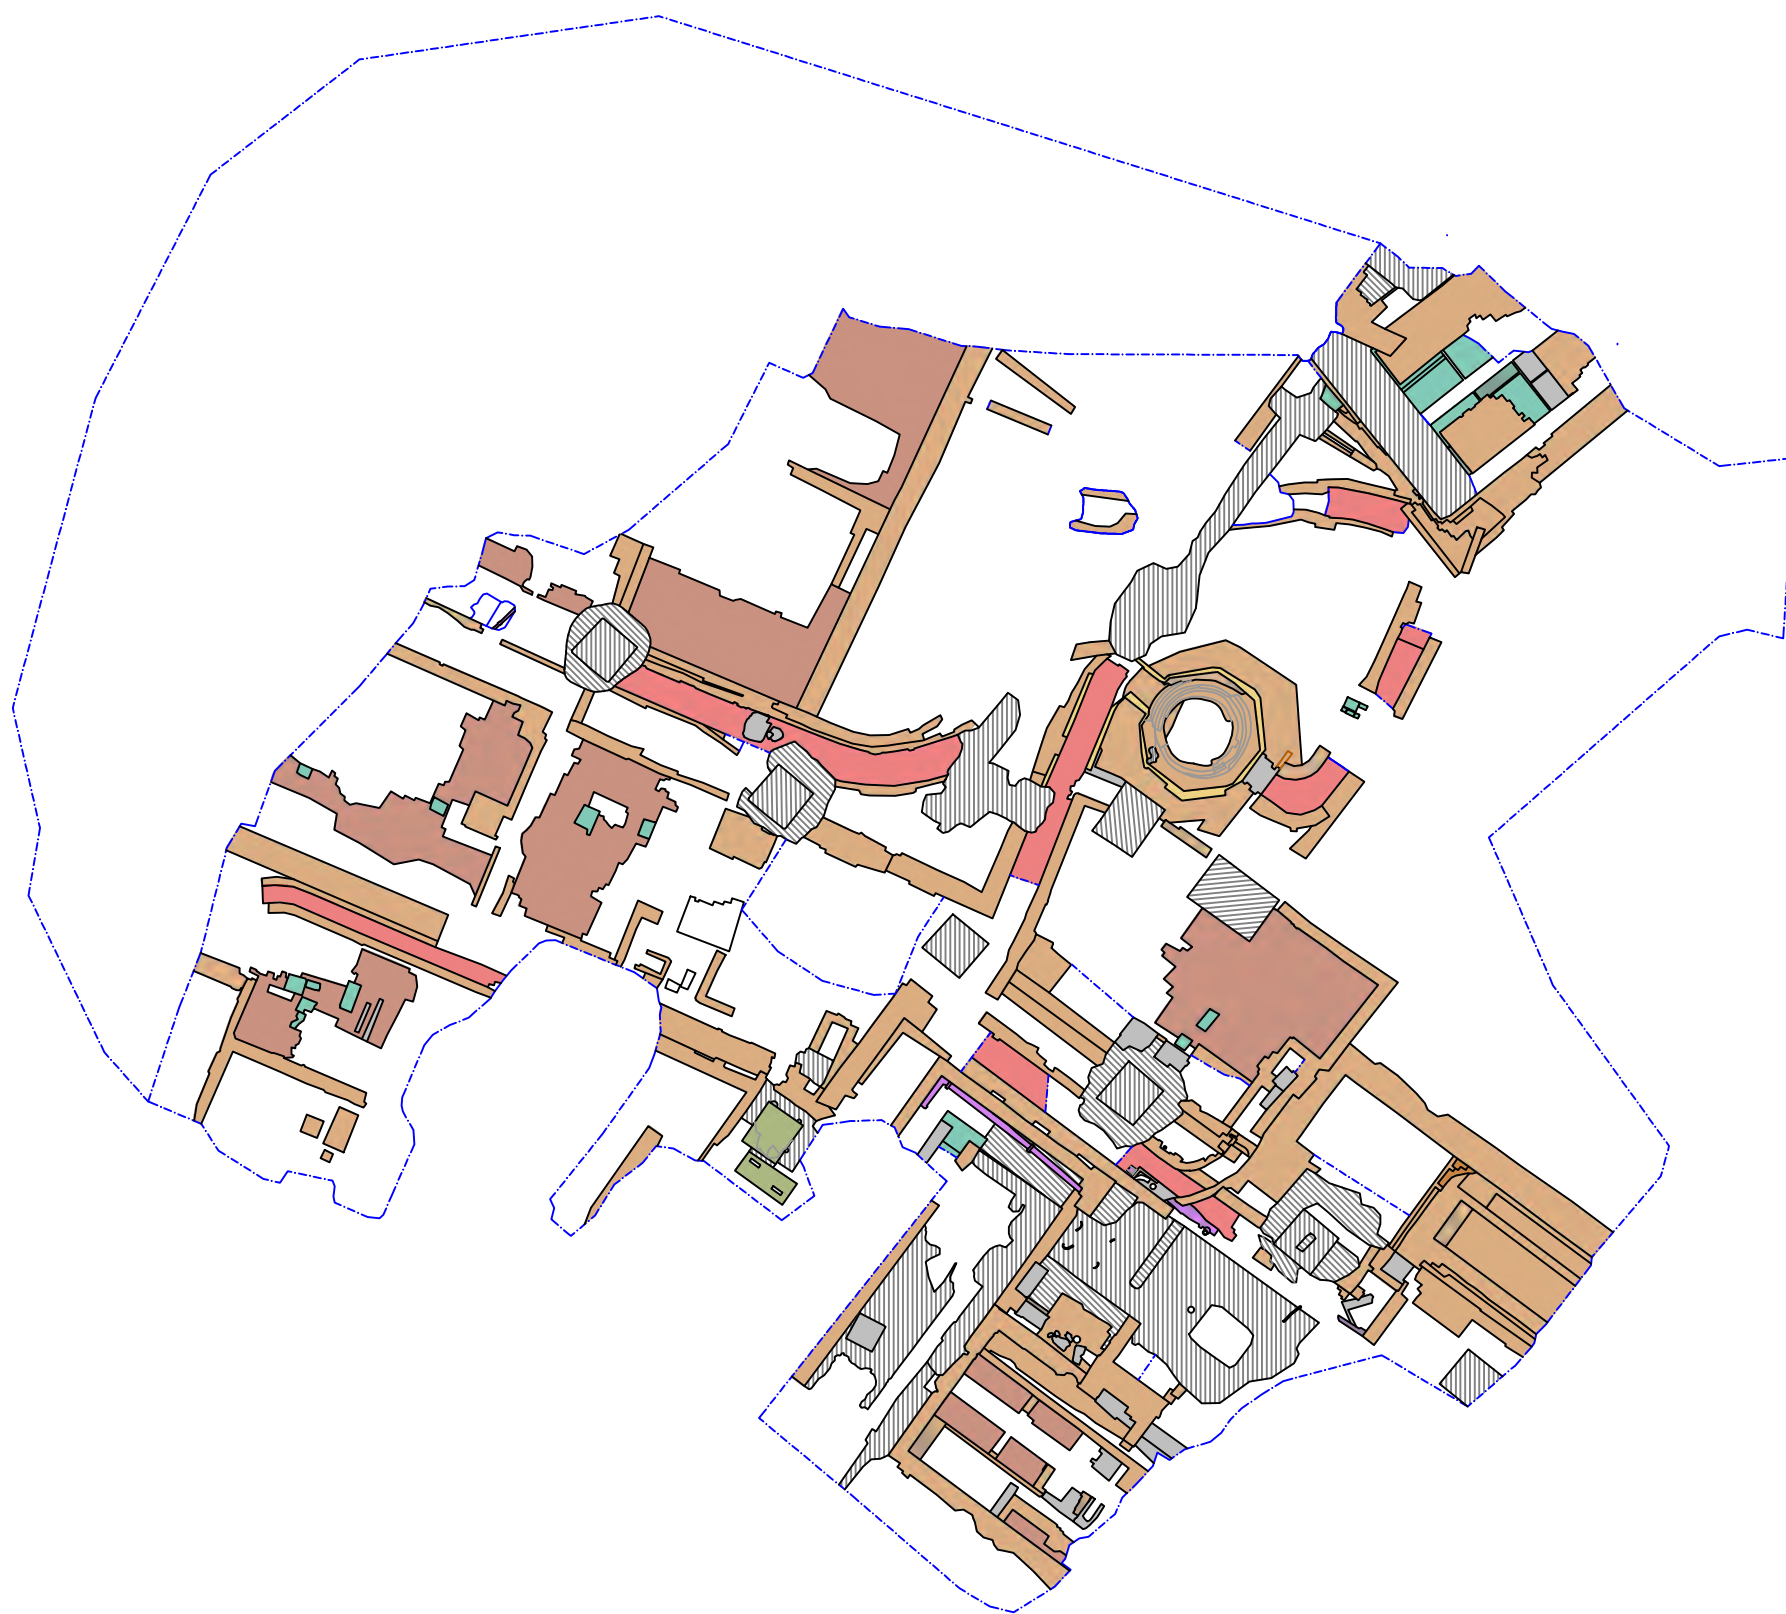
Figure 18:  
Area 4 (Chapelfield Dye Works) showing remains

#### 6.2.4 Area 4: The Ardwick and Chapelfield Dyeworks (Figures 18 – 24)

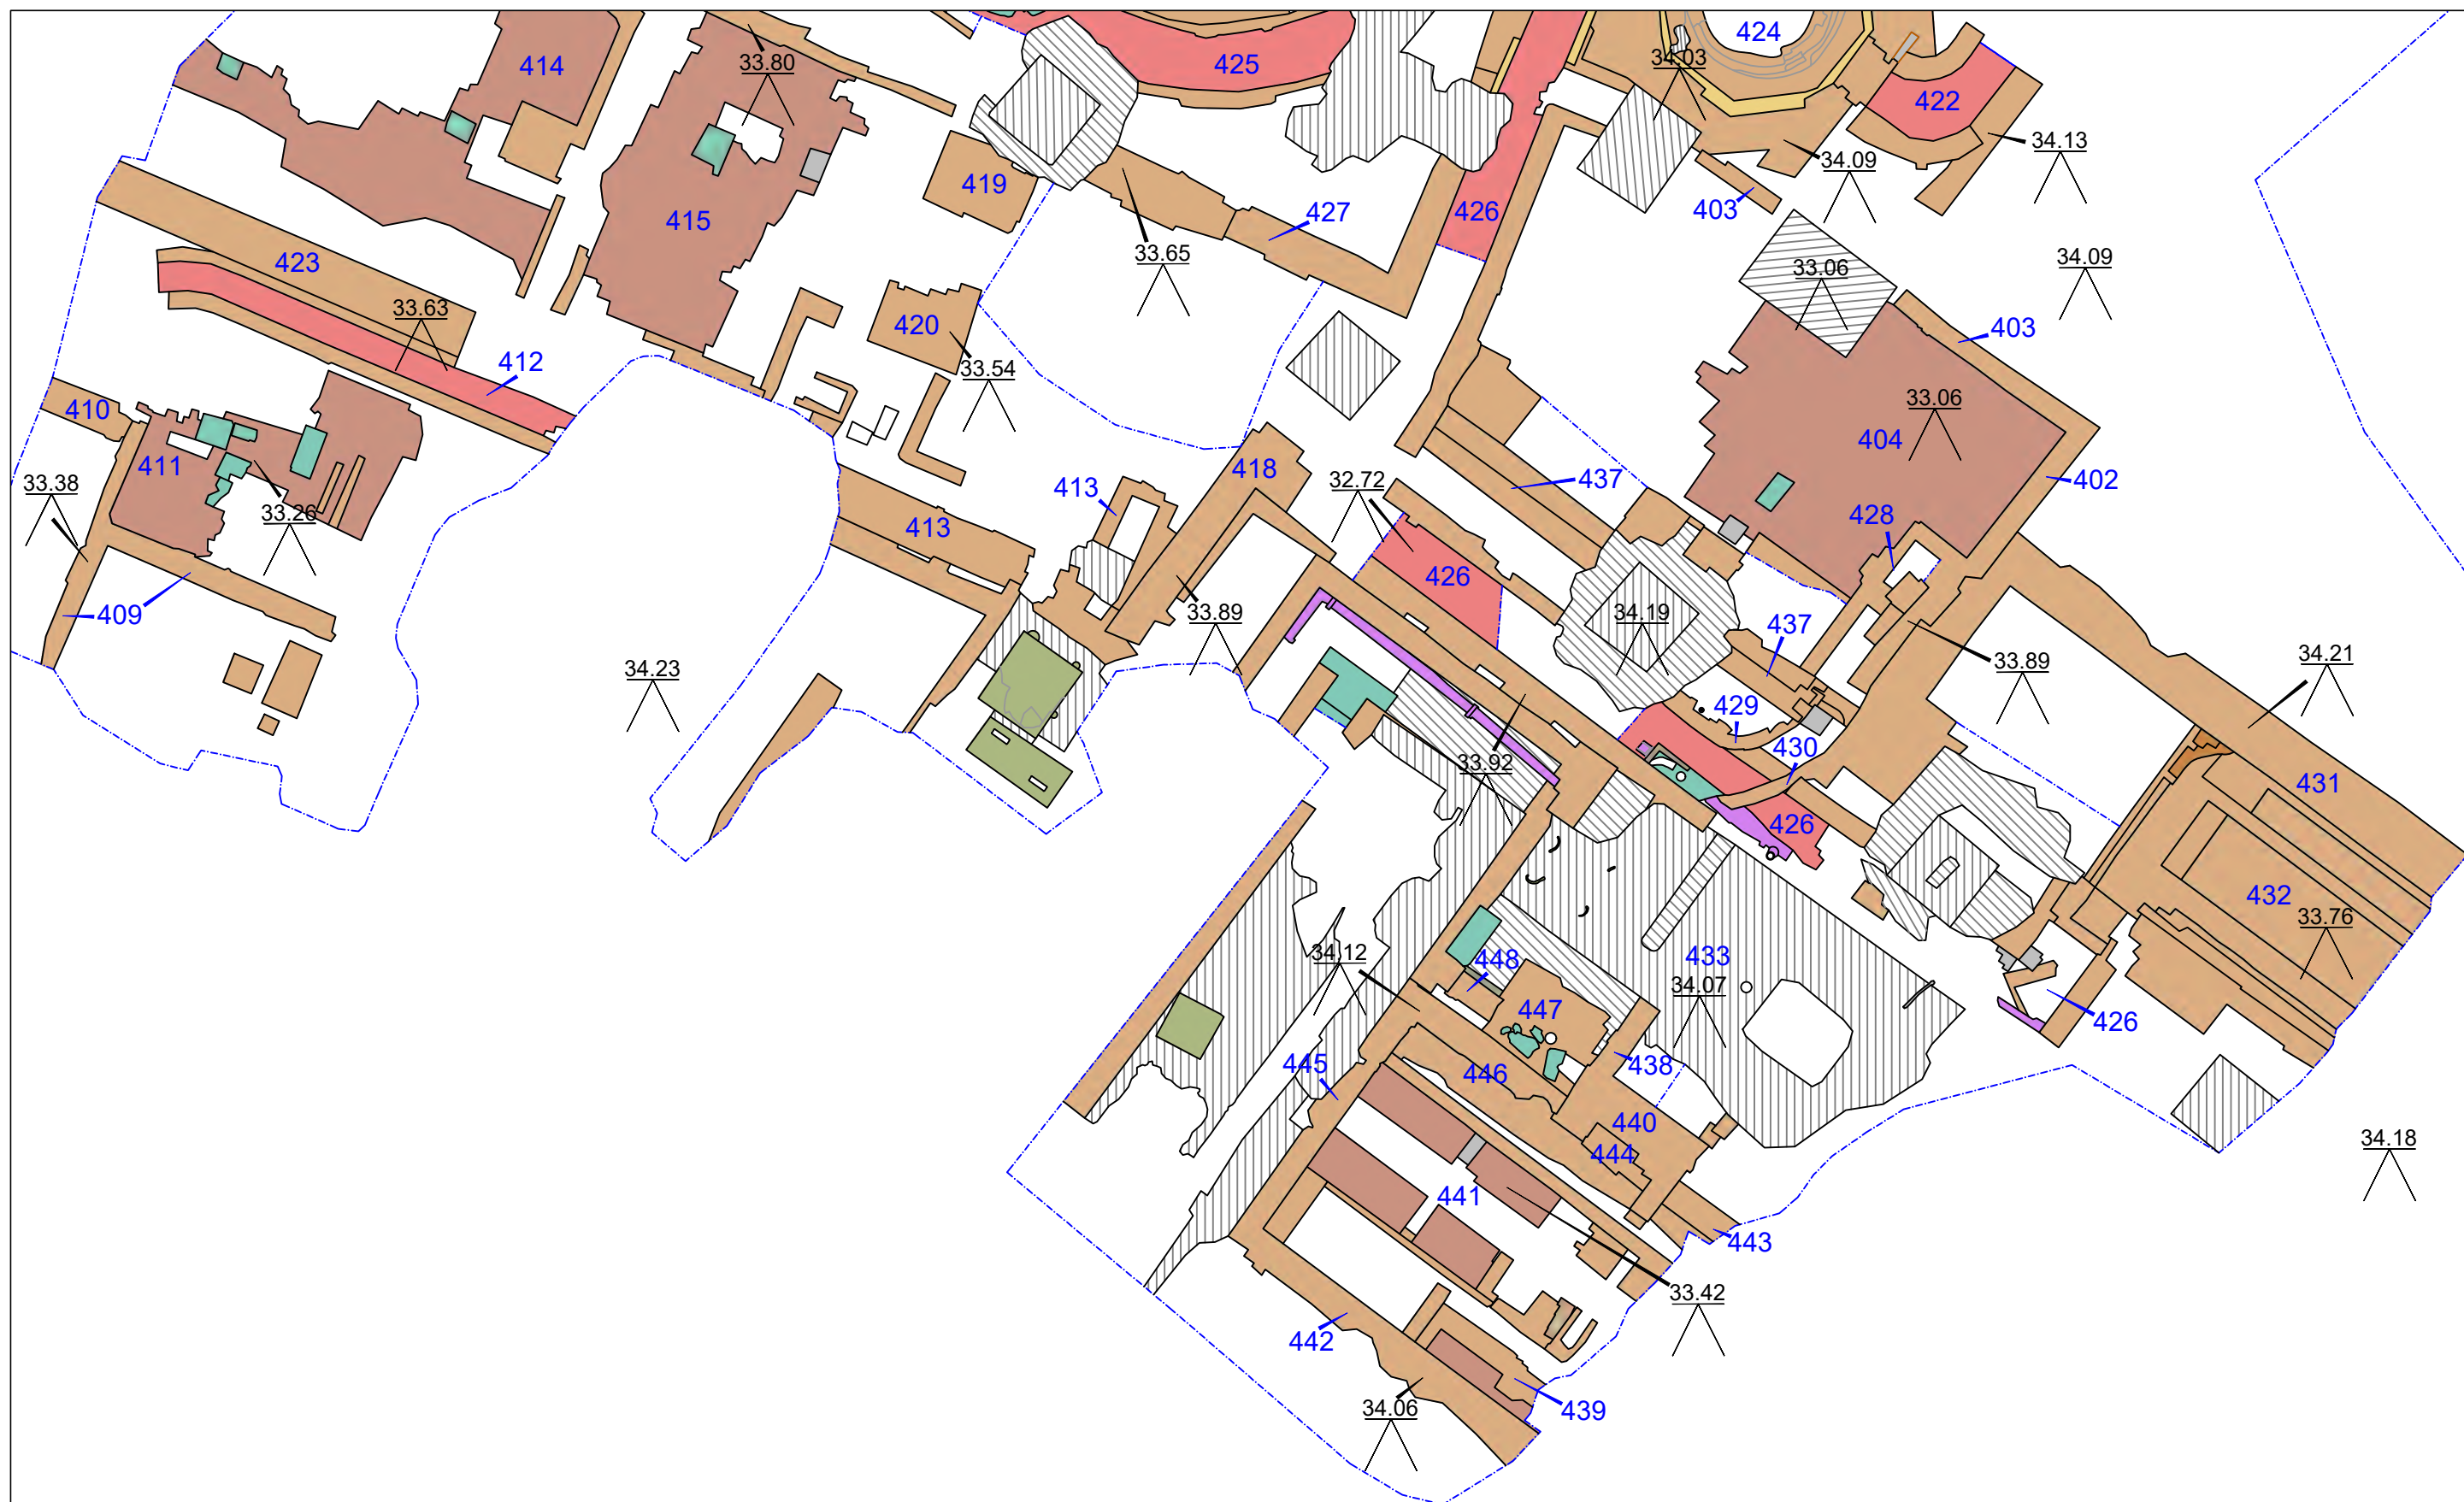
Figure 20:  
Area 4: Southern half of the excavation

Elements of two buildings (designated Buildings A and B) once formed part of the 18<sup>th</sup> century dyeworks. These were revealed in the southern half of the excavation (Plate 206). The location and alignment of the outer walls correspond to the position of buildings shown on Laurent's map of 1793 and Green's map of 1794 (Figure 17). The materials used during this period were consistent with those found in the earliest buildings exposed across the river at Thomas Hoyle's dyeworks. Moreover the scale and form of the buildings as depicted on the mapping mirrors that of contemporary dyeworks in the area.

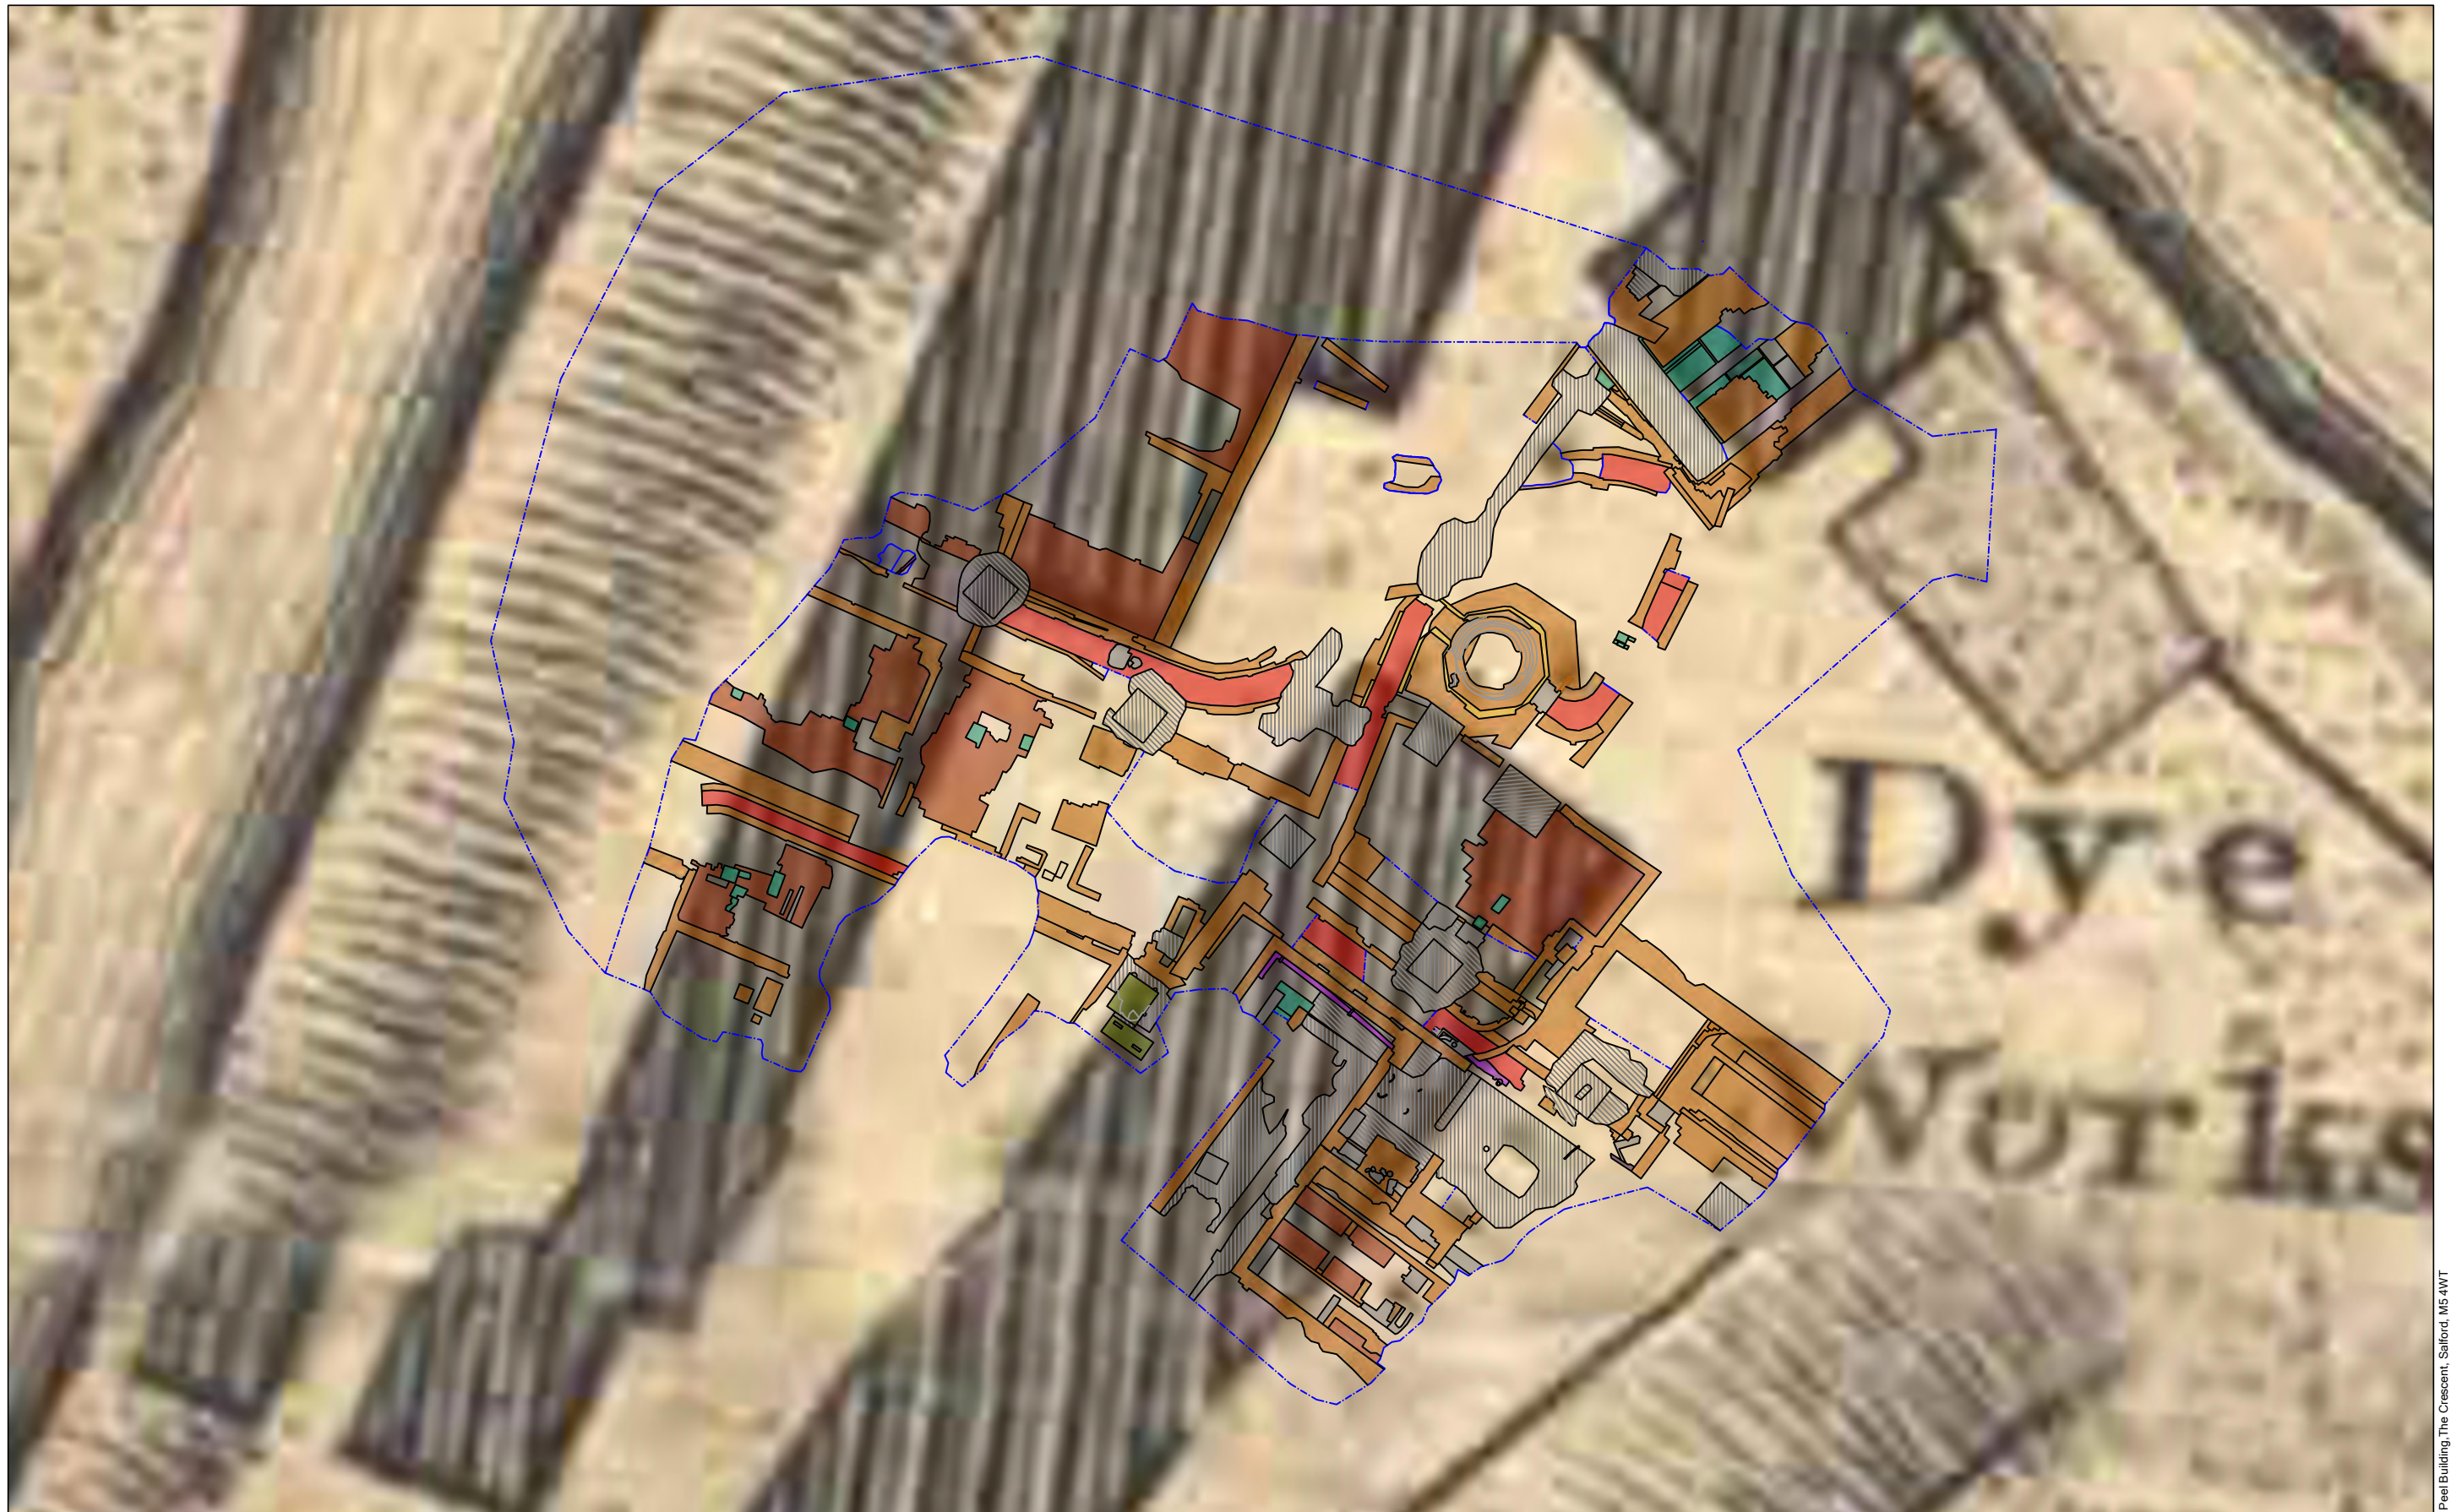
Figure 21:  
Area 4 Excavated remains superimposed onto Green's map of 1787-94

Once the site survey was overlaid onto an 18<sup>th</sup>-century map covering the site, it was clear the outline of a building on Green's map (surveyed 1787-94) closely corresponds with the outer of the walls Building B (Plate 156; Figure 21).

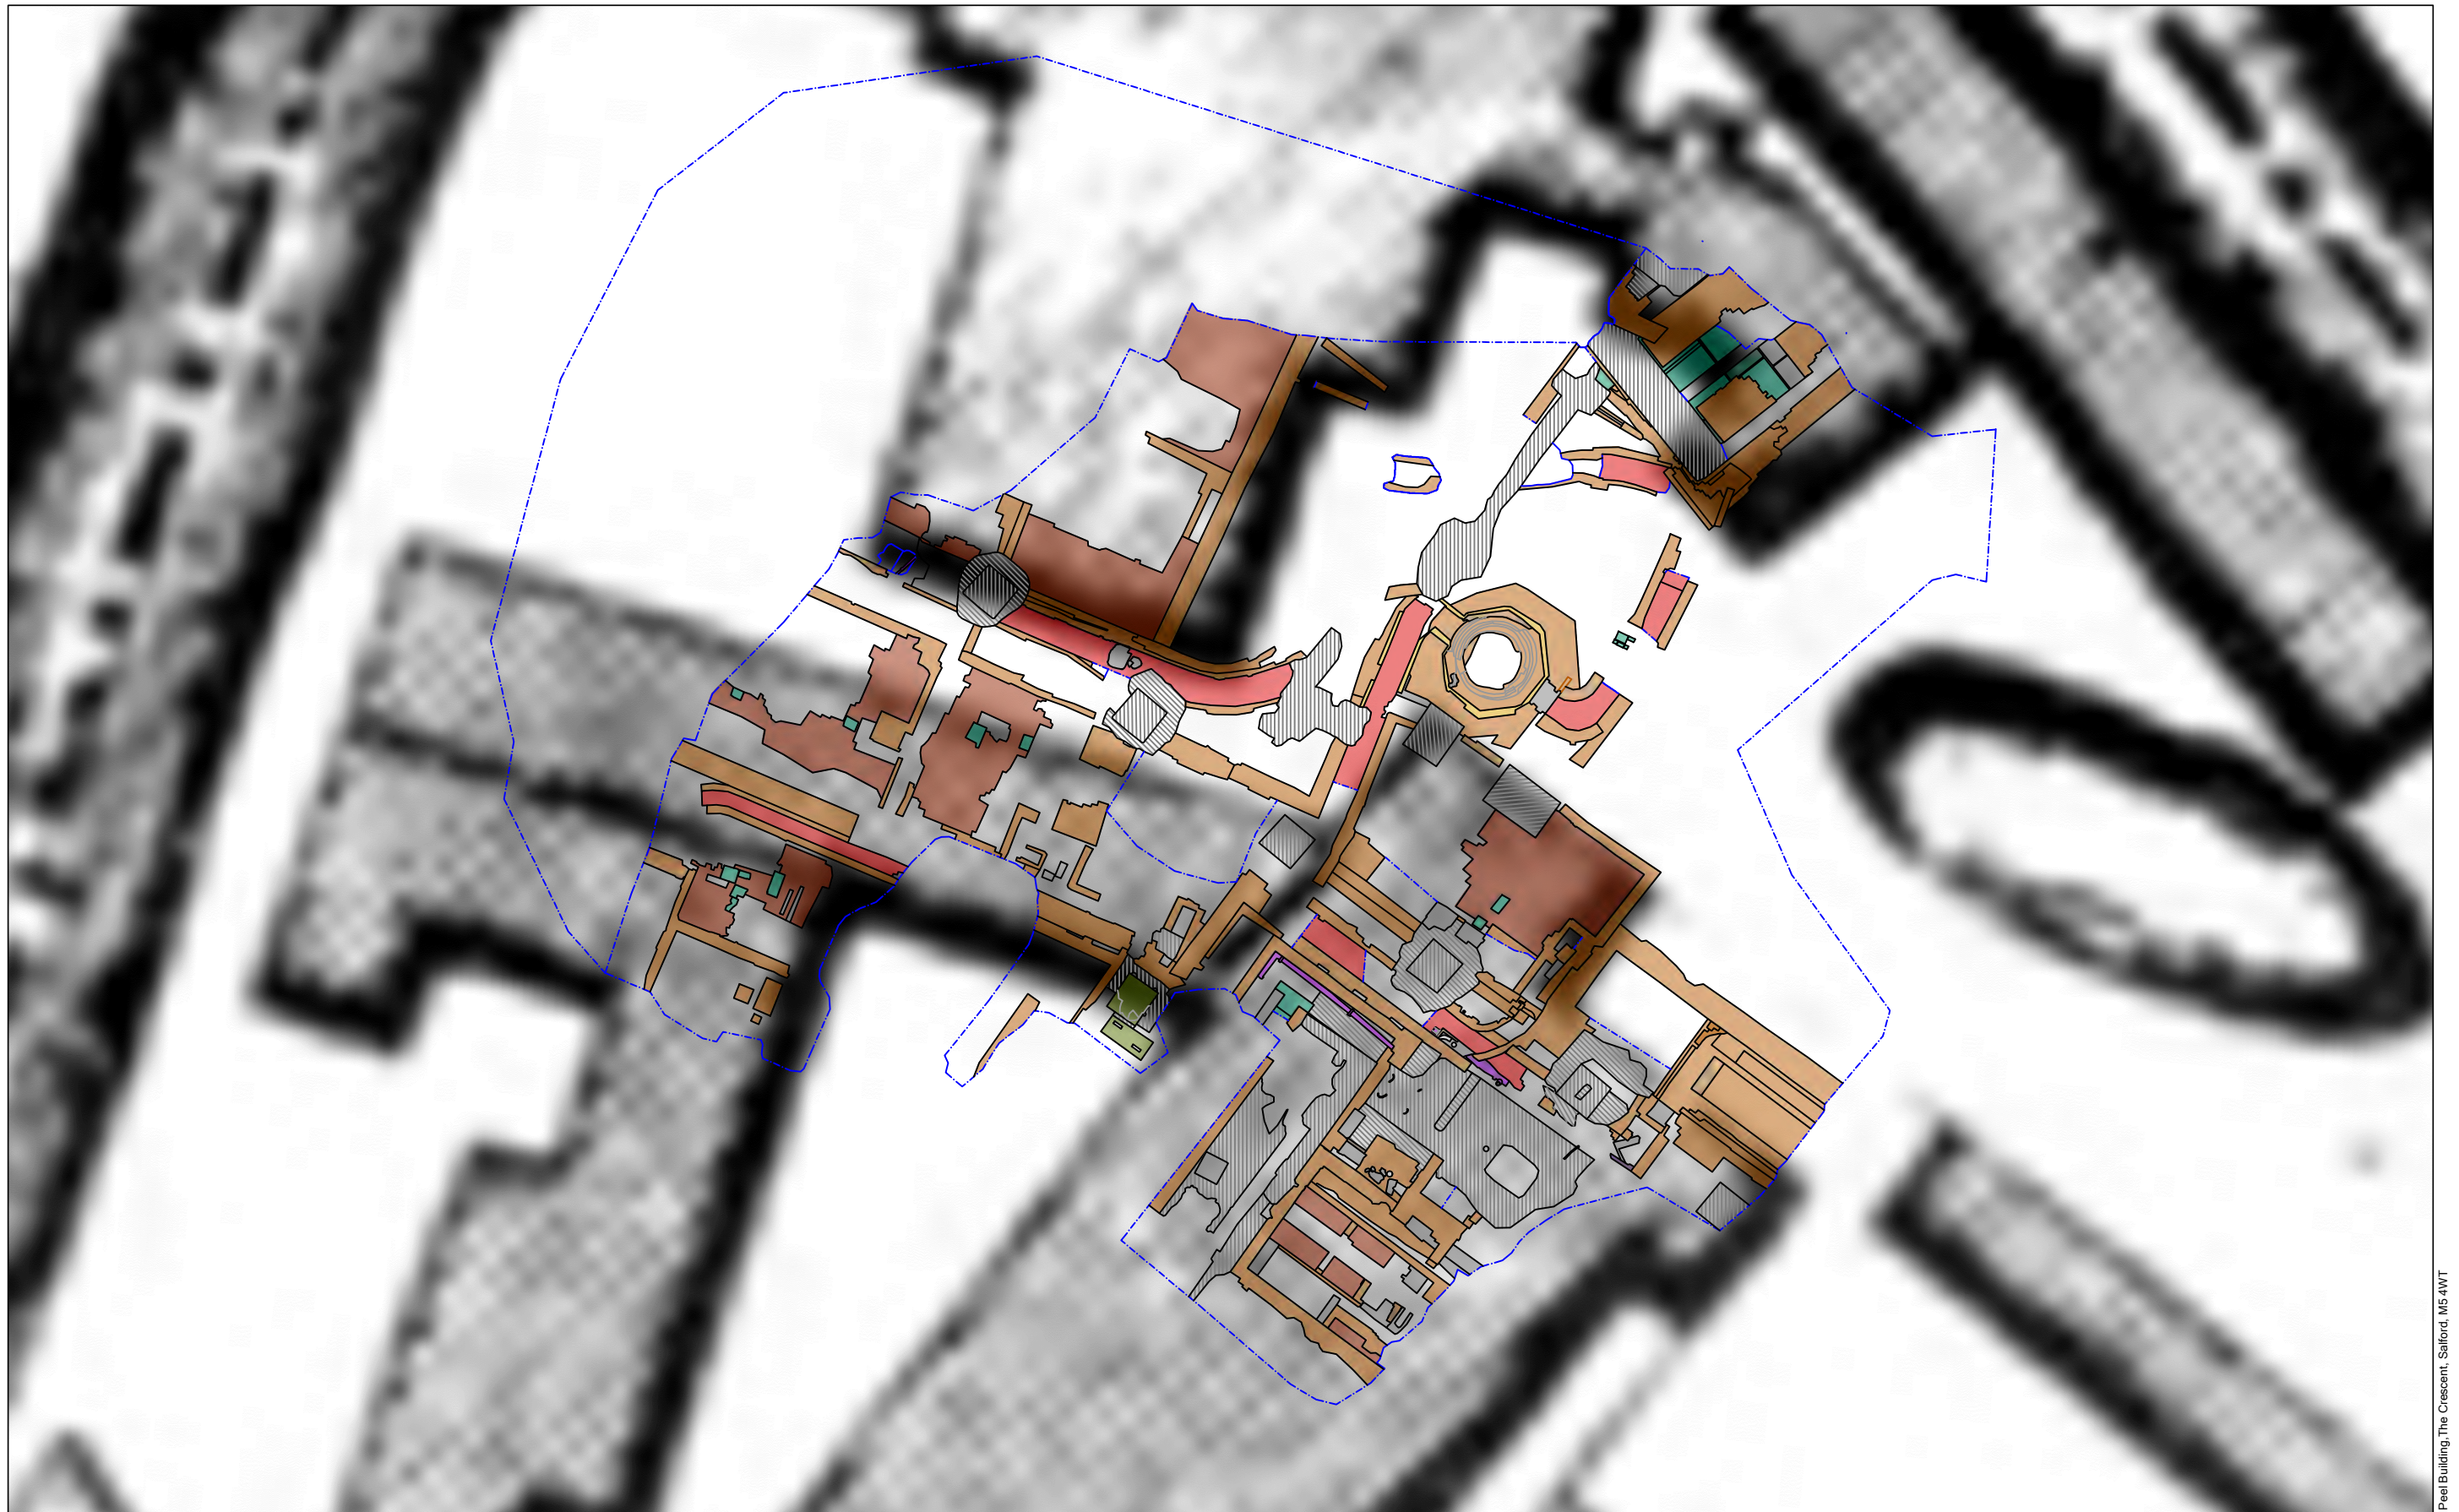
Figure 22:  
Area 4 Excavated remains superimposed onto Bancks & Co's map of 1831

Wall **413** abutted wall **418** and was orientated north-east / south-west, measuring 4.08m in length, 1.20m in width and stood to a height of 11 courses (Plate 160). It was constructed of red handmade bricks bonded with a grey sandy mortar. This is the external wall to Building A which has been extended and modified to as seen on Bancks and Co's map from 1831 (Figure 22).
