Sir Ralph Abercromby Pub,  
St Michaels  
Bat Roost Inspection Survey

Project Title             Sir Ralph Abercromby Pub

Project Reference       RHE.4746

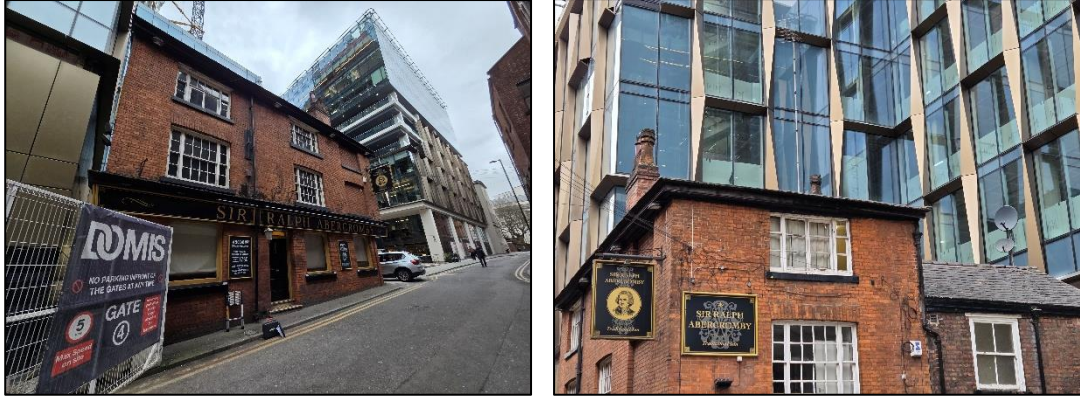
- 3.3.1 The building is of mid-1900's construction and is predominantly three-storey with later two-storey extensions (Plate 1). The main roof is pitched with slate tiles, which are lifted/missing in a considerable number of areas. The ridge tiles present are lifted in areas, and an original chimney stack has areas of missing mortar (Plate 2). Lead flashing is lifted where at the base of the chimney stack.

Plate 1. The Sir Ralph Abercromby Pub, subject to survey.

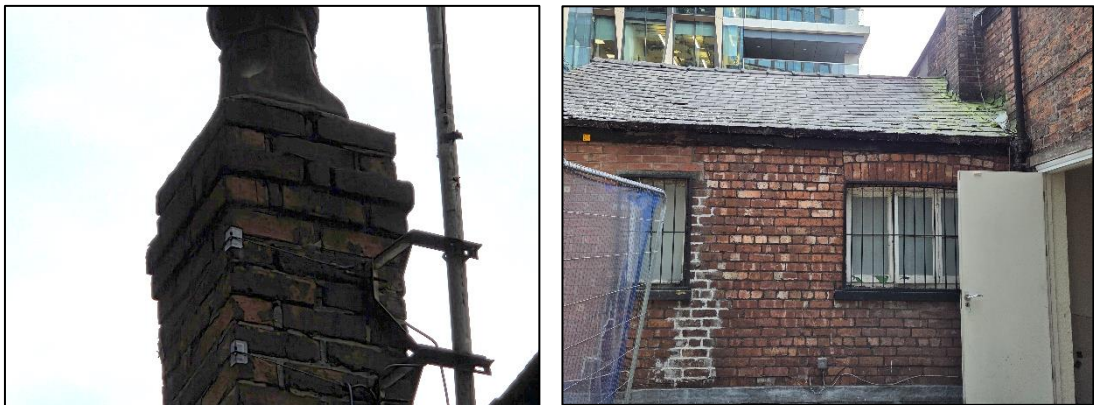
- 3.3.2 The extensions are located at the rear of the building, the first to has a bitumen flat roof and the second has a slate tile pitched roof. The latter is in a similar state to the main roof, with lifted tiles, ridge tiles, and lead flashing (Plate 2).

Plate 2. Lifted slate tiles and ridge tiles on the northern extension, and gaps in the chimney stack.

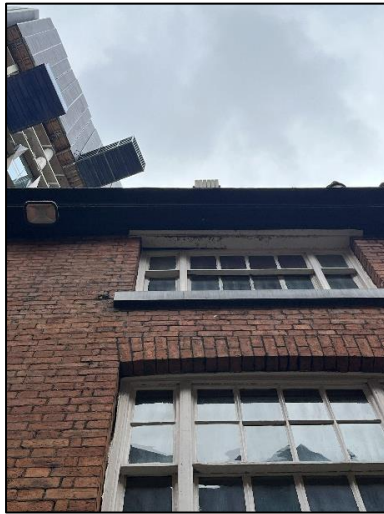
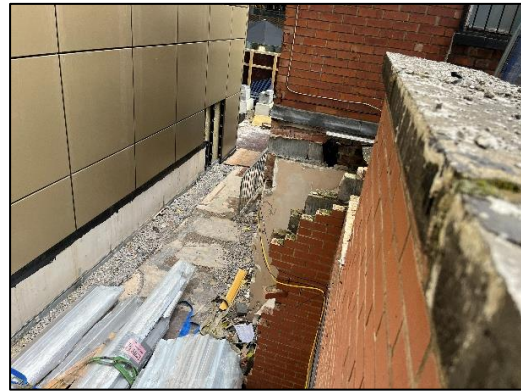
- 3.3.3 The walls are of coursed brick and there are gaps where mortar has come loose around the building, excepting the western wall of the rear extension and the northern wall of the original building which appear to have been recently repointed (Plate 2). The windows are original, and whilst some smaller gaps are present, a large gap is present above the central window in the front (south) of the building (Plate 3).

- 3.3.4 Significant gaps are present along a length of partially demolished wall to the west (Plate 3); a close inspection could not be made here due to access restrictions.

Plate 3. Large gap above the central window; partially demolished wall to the north.

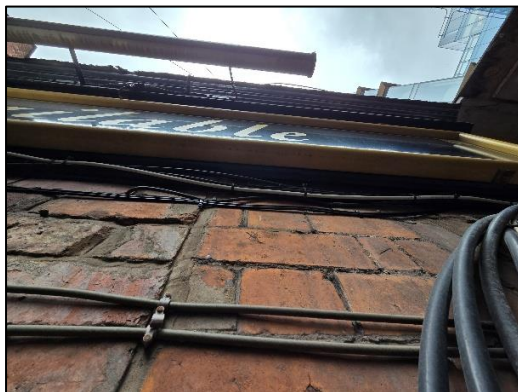
- 3.3.5 Good cavities were present under signage and a steel tie plate to the rear of the building (north) (Plate 4), endoscope inspection showed no evidence of bat activity.

Plate 4. Cavities behind signage and steel plates to the north of the building.

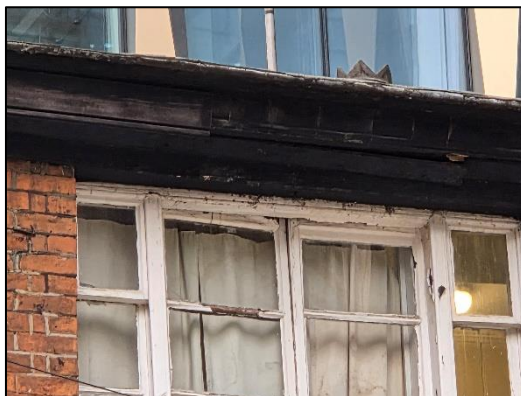
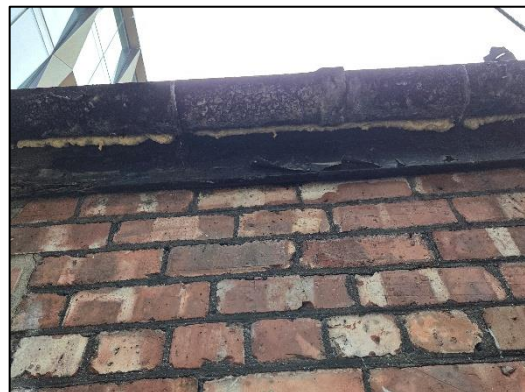
- 3.3.6 Smaller cavities are also present under the fascia boards around the building (Plate 5).

Plate 5: Gaps behind fascia boards.

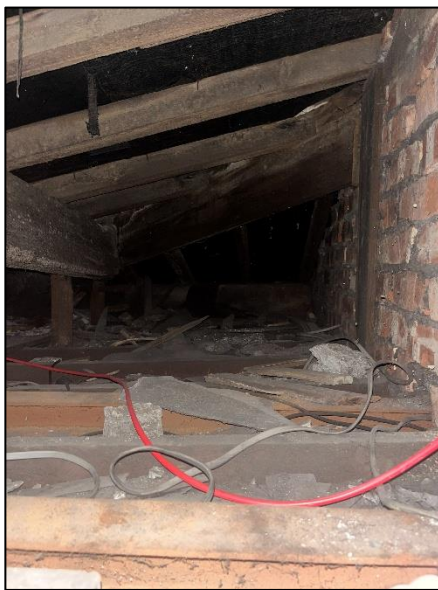
- 3.4.1 Inside, the loft areas are accessed through two hatches. The first leads to a small pitched roof and the latter leads to a large pitched roof (Plate 6), although in the latter large water containers hindered visibility.
- 3.4.2 Both loft spaces had a bitumen felt liner in place; this was torn in places but was generally in a good condition and no daylight was visible. Water ingress was noted and there was significant damp/mould in the upstairs living area.
- 3.4.3 Mouse droppings, cobwebs and disused wasps nests were noted within the loft spaces, no evidence of bat use was observed.

Plate 6. Loft spaces accessed during the survey.

- 4.2.1 Although some potential roosting features were able to be closely examined by endoscope, not all features could be exhaustively searched due to health and safety concerns. It is therefore considered that further survey is required to determine the status of roosting bats within the building. This should comprise **two emergence surveys** undertaken between May and September, with at least one survey timed between May and August. Surveys should be spaced a minimum of 3 weeks apart and supported by the use of Night Vision Aids (NVAs).
- 4.2.2 It is not considered necessary to undertake detailed breeding Black Redstart surveys, however as a precautionary measure it is recommended that **static acoustic monitoring** is undertaken for a minimum of one month, to determine the status of Black Redstart on site. Monitoring should be done during the period April – June (inclusive).
