# PHASE 2 SITE INVESTIGATION

Proposed Mayfield Park, Manchester

Mayfield Partnership Ltd

December 2020

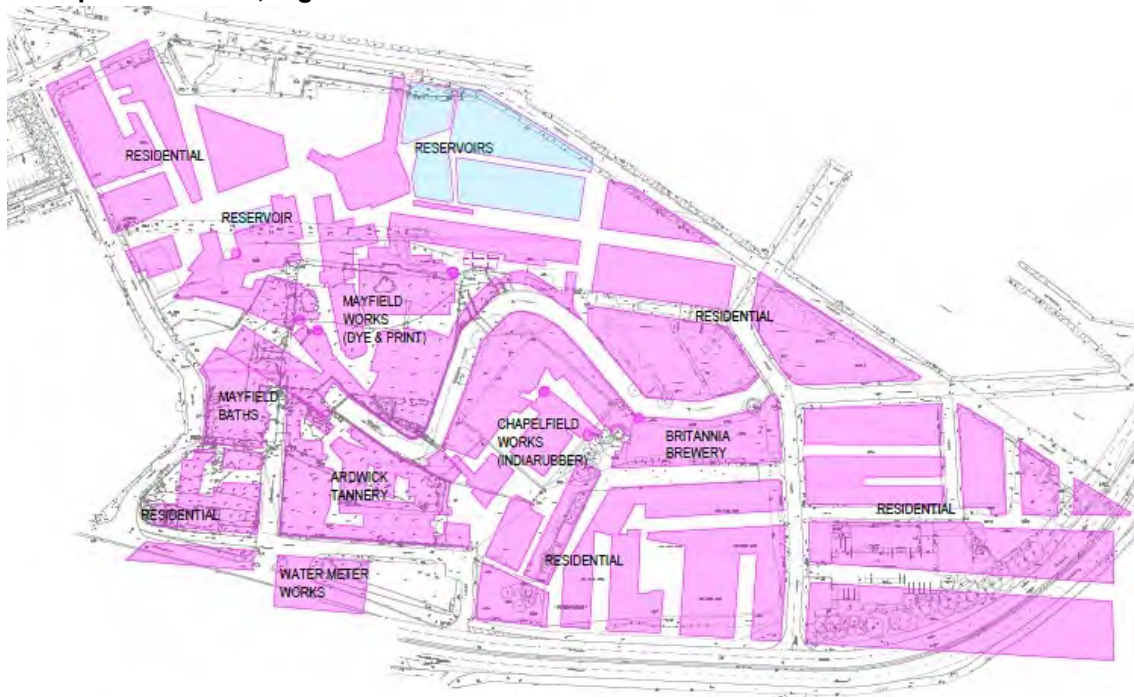
**Excerpt from ES102; Figure 1: 1891**

- 3.3.2 The earliest mapping records for the site show a number of potentially contaminative sources these have been broken down by zone below.
- 3.3.3 Zone 1 "Lawns": Earliest mapping dated 1891 indicates the zone to be occupied by the Mayfield dye and print works across the entire zone with associated filter pools, tanks and chimneys. Several reservoirs are located to the north of the zone associated with the dye and print works.

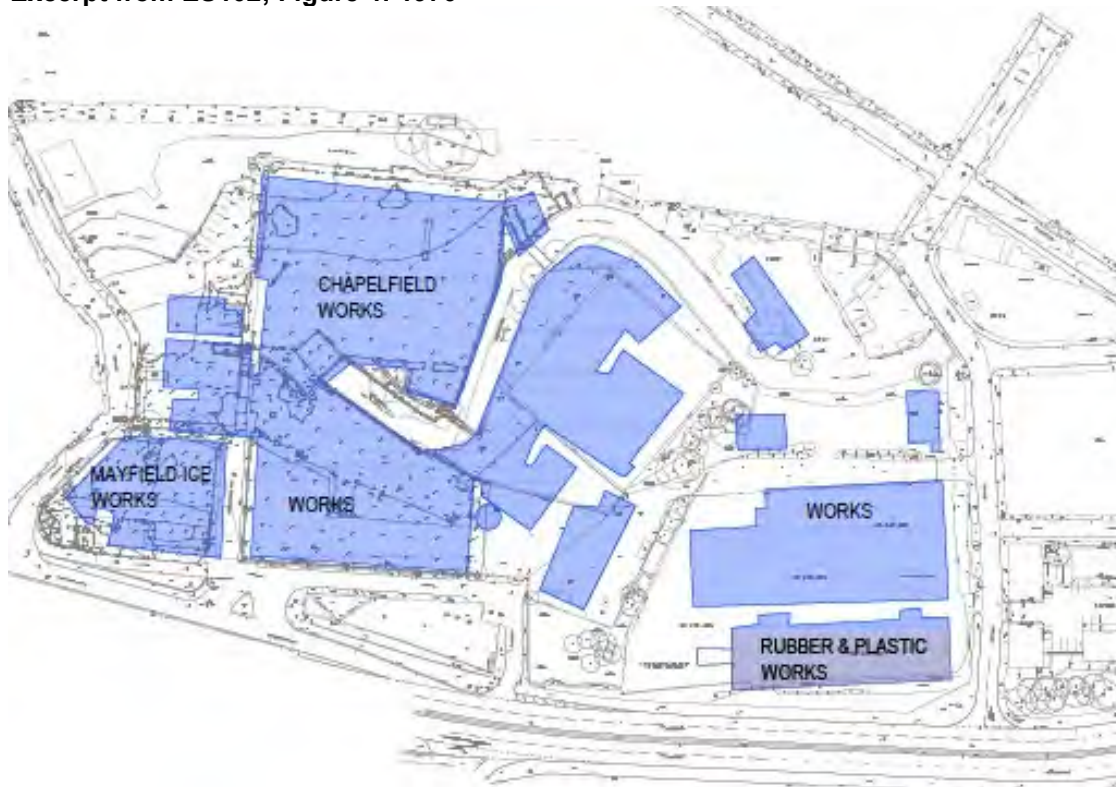
**Excerpt from ES102; Figure 4: 1970**

- 3.3.9 With reference to R<sup>2</sup>C Consulting drawing ES103, redevelopment of the site was undertaken during the 1950's to clear the bomb damage; with key feature being the expansion of Chapelfield Rubber works to the north side of the river. By the 1970's it was referred only as 'works', however the south eastern corner still produces rubber and plastic. To the northeast corner a vehicle maintenance yard is present.

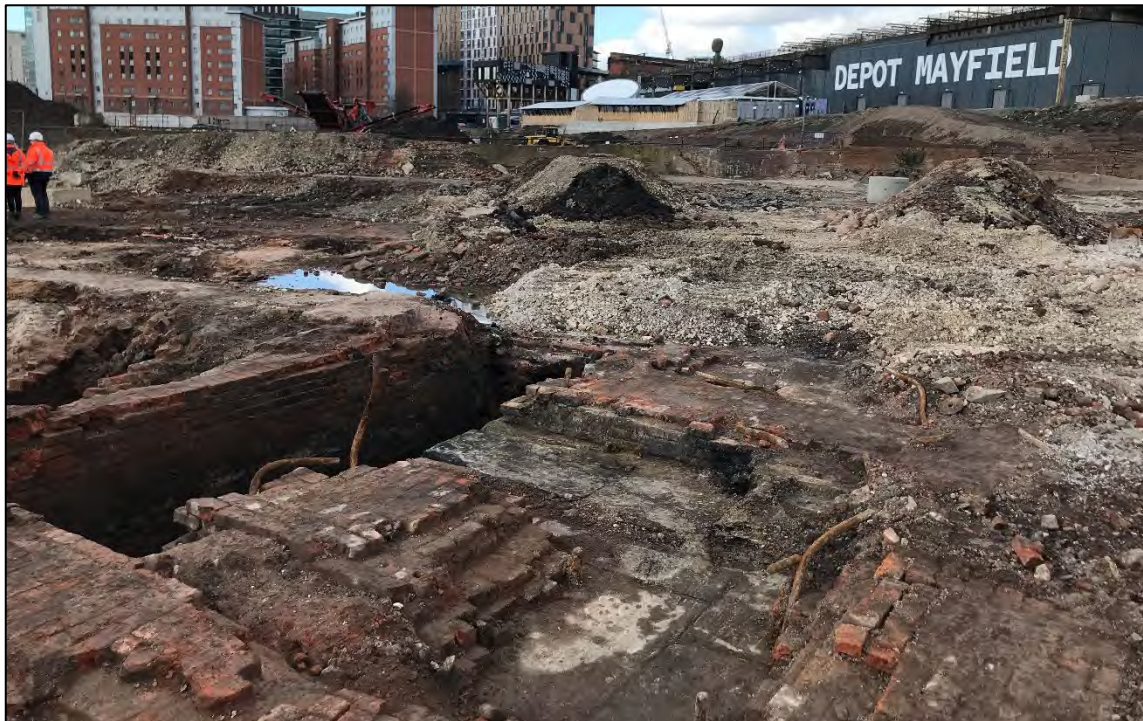
### 2021 Update: Post Demolition Dirt Factory

- 6.1.5 Shallow Made Ground deposits consisting of granular ashy material were excavated, exposing in-situ structures relating to historical operations (walls, chimney bases, drainage runs). Weathered bedrock is encountered at a depth circa 1mbgl, although it locally varies in depth and comprises of alluvium. This is likely a result of historical flooding and erosional forces from the river. Where bedrock occurs, it is very weak and poorly cemented and excavated as a gravelly sand. Further information is contained within Appendix B.

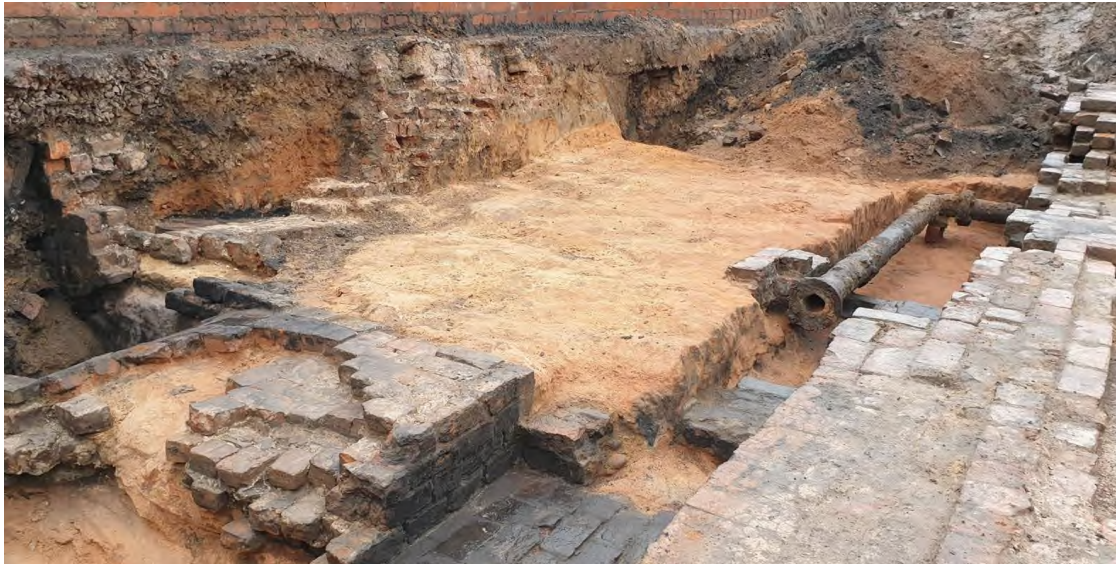
Figure 6.1: Photograph from archaeological survey works within former Mayfield Dye Works portion of the site showing relic structures dating from this phase have been constructed on top of the weathered Sandstone bedrock.

- 6.6.2 Subsequent more extensive archaeological investigation works have revealed structures relating to previous phases of development across the majority of the site (i.e., former Mayfield Dye works, Swimming Pool etc) remain largely intact beneath the site, having been demolished to ground level and constructed on top of during subsequent phases of development.

- 6.6.3 As such, and away from areas that have been covered by site investigation fieldworks, the presence of relic structures relating to previous phases of development should be anticipated the approximate spatial extent of which will broadly accord with the layouts shown on RoC drawing ES101 provided within Appendix A.

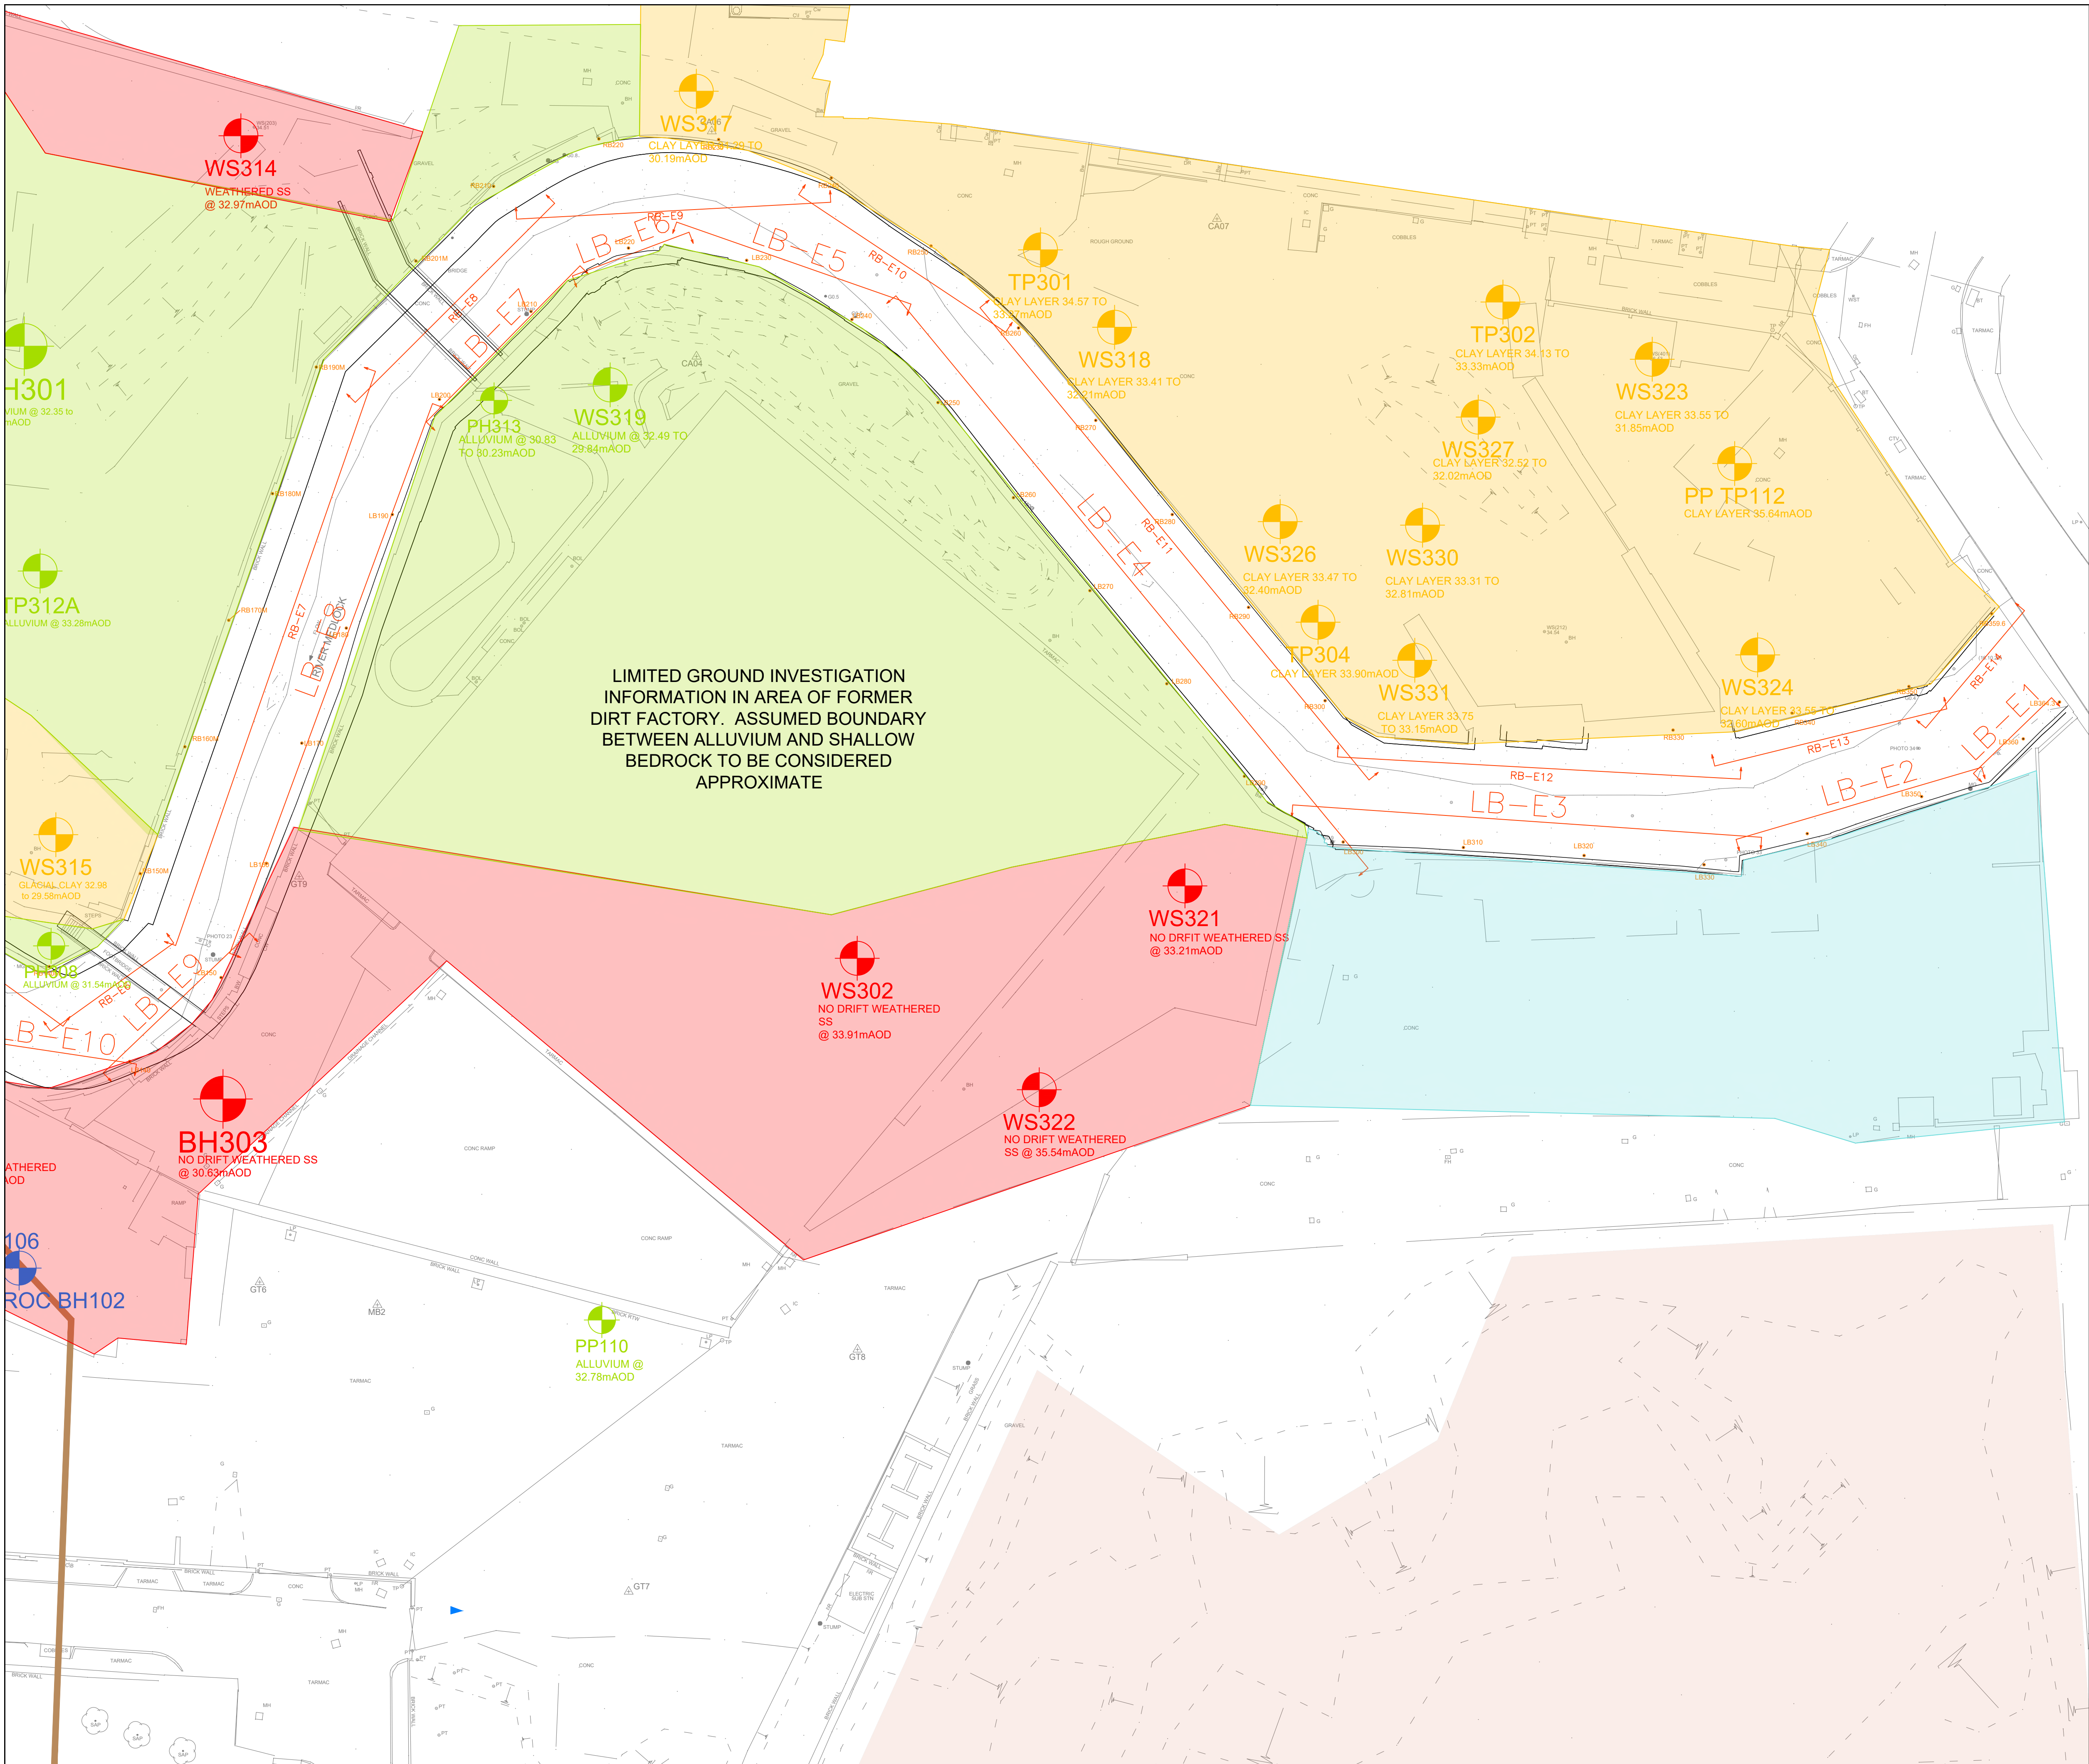
- 8) DRIFT DEPOSITS WILL BE SUBJECT TO LOCALISED VARIANCE FROM THAT INDICATED THIS PLAN. INCLUSIONS OF CLAY OR SILTY SAND MAY OCCUR IN POCKETS / ZONES IN CONTRADICTION OF PATTERNS INDICATED ON THIS PLAN.

- 9) THE PLAN HAS BEEN COLLATED TO SHOW APPROXIMATE EXTENTS OF LIKELY DRIFT GLACIOL LENSING AND MADE GROUND DEPOSITS AND SHOULD BE REVIEWED FOR INFORMATION ONLY.

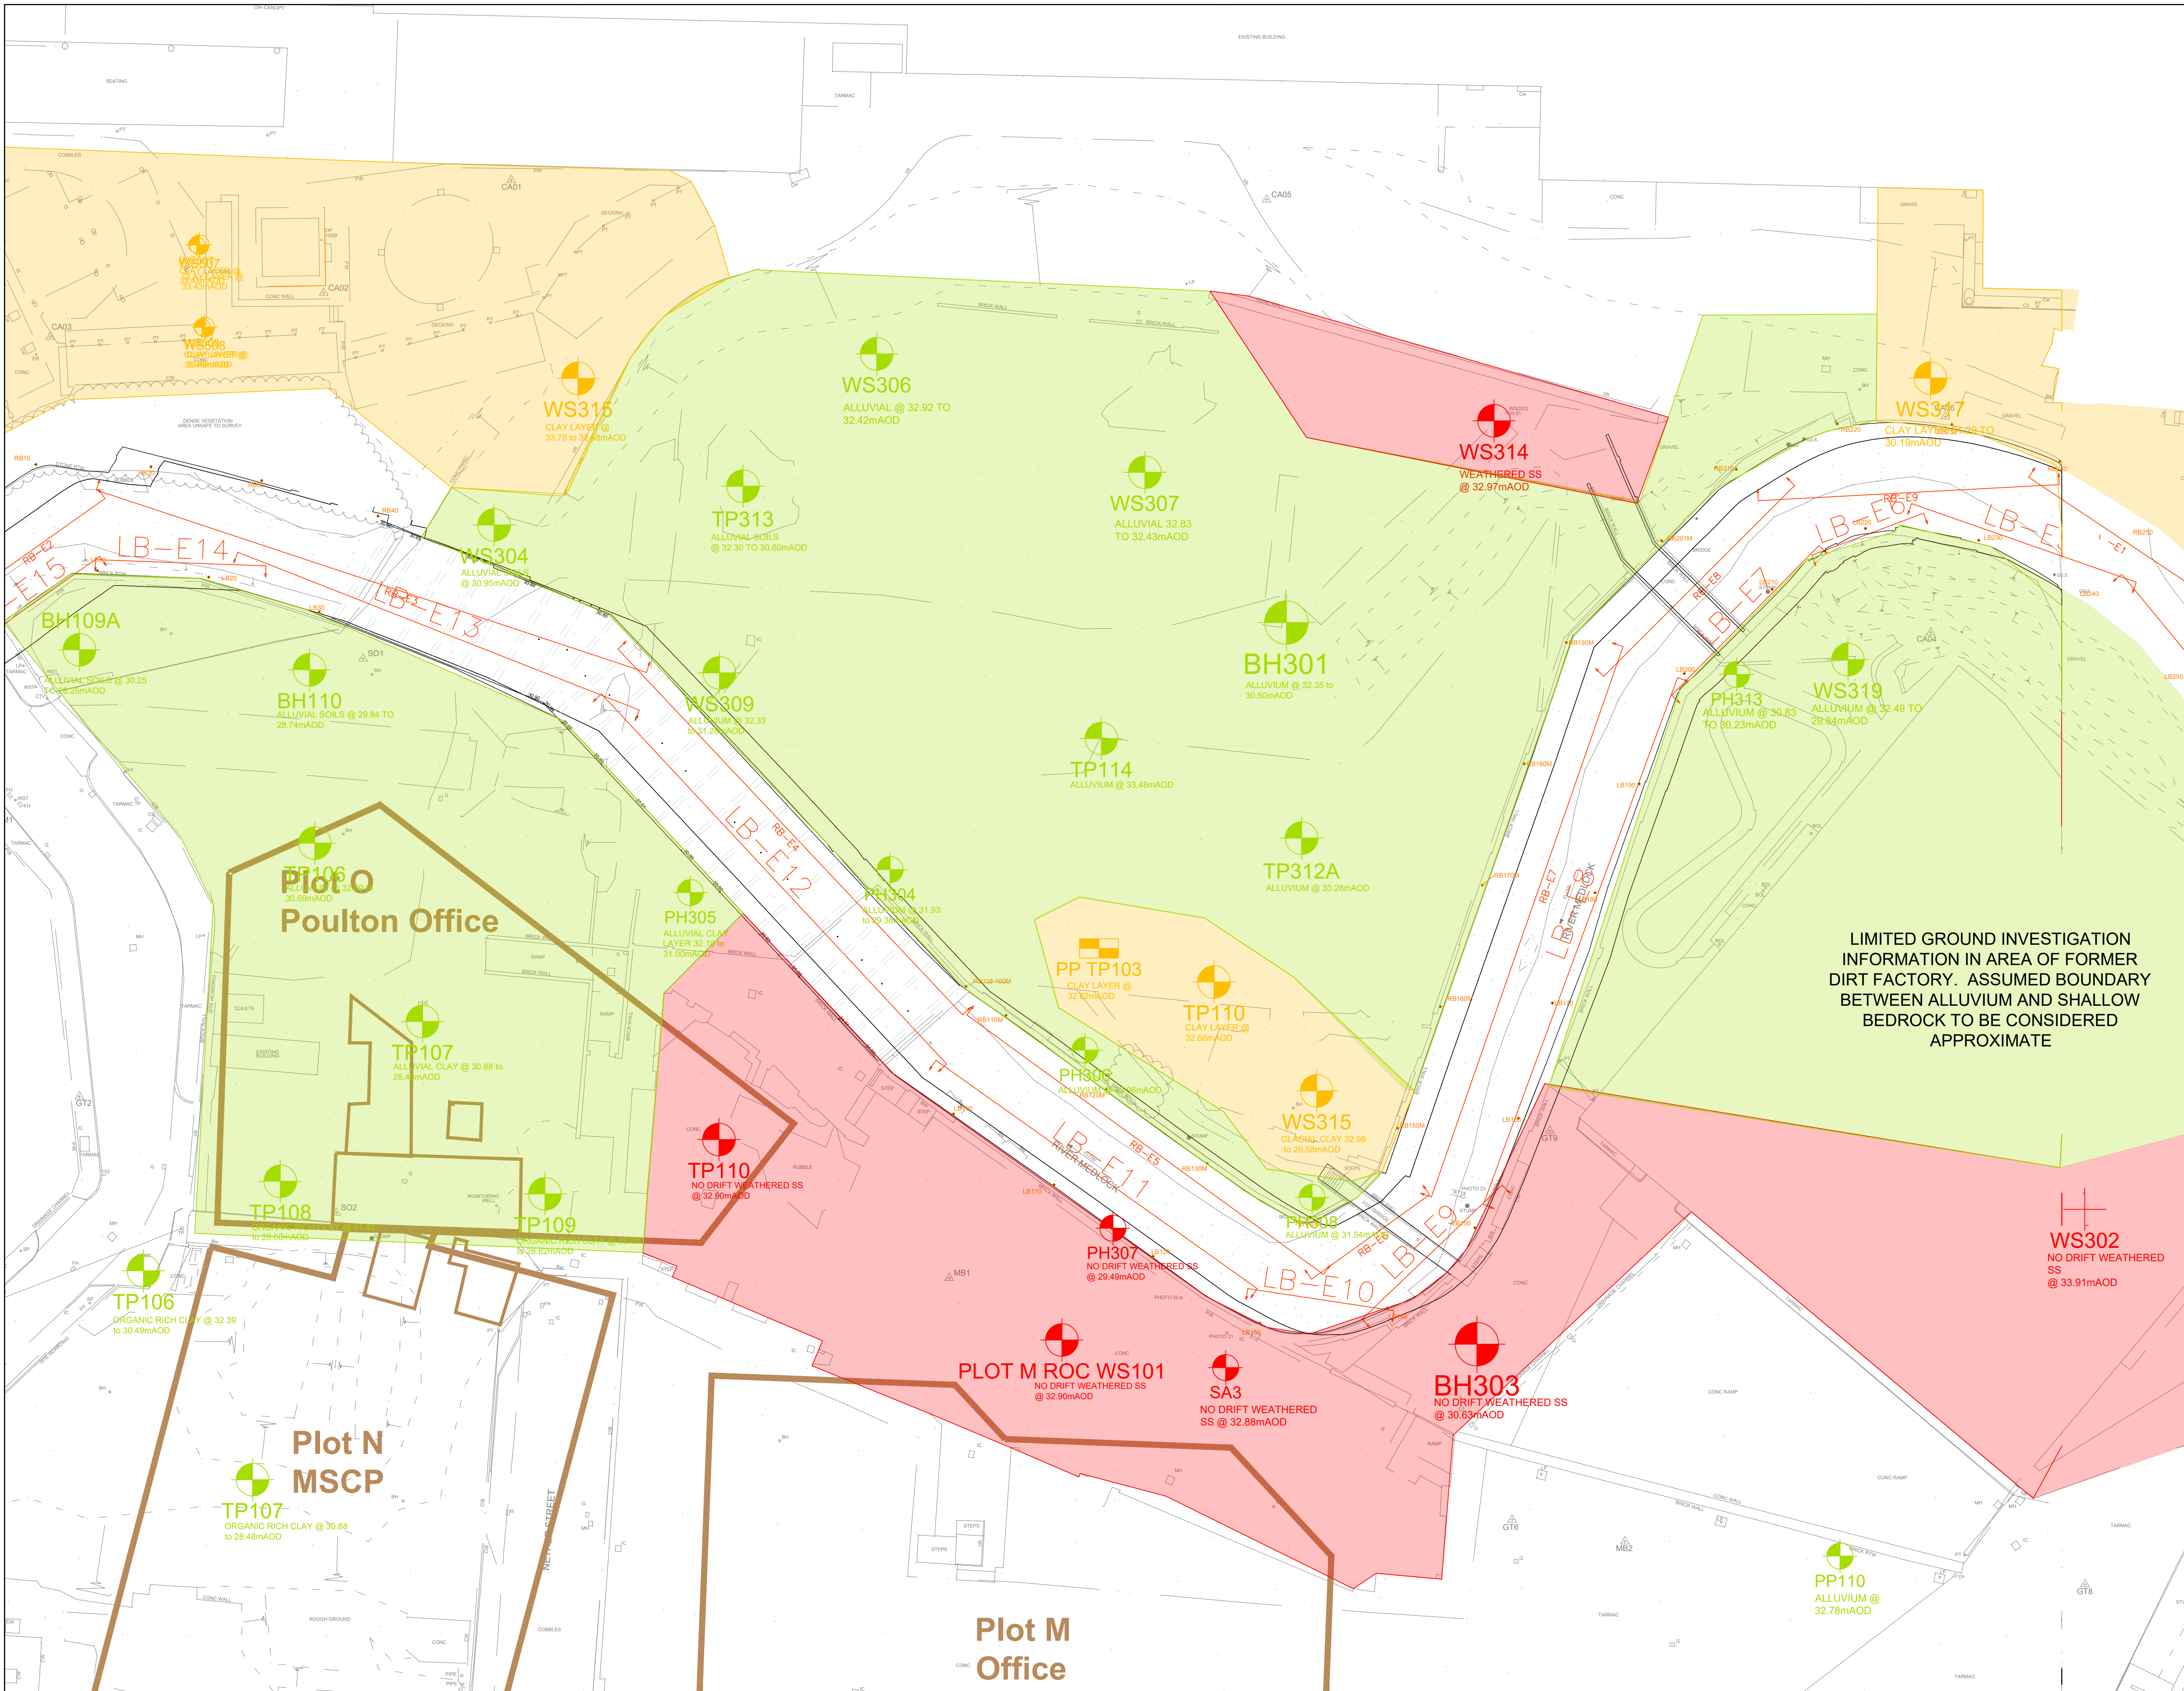
- 8) DRIFT DEPOSITS WILL BE SUBJECT TO LOCALISED VARIANCE FROM THAT INDICATED THIS PLAN, INCLUDING OF CLAY OR SILTY SAND MAY OCCUR IN POCKETS / ZONES IN CONTRADICTION OF PATTERNS INDICATED ON THIS PLAN.

- 9) THE PLAN HAS BEEN COLLATED TO SHOW APPROXIMATE EXTENTS OF LIKELY DRIFT GEOLOGY UNDERLYING MADE GROUND DEPOSITS AND SHOULD BE REVIEWED FOR INFORMATION ONLY.

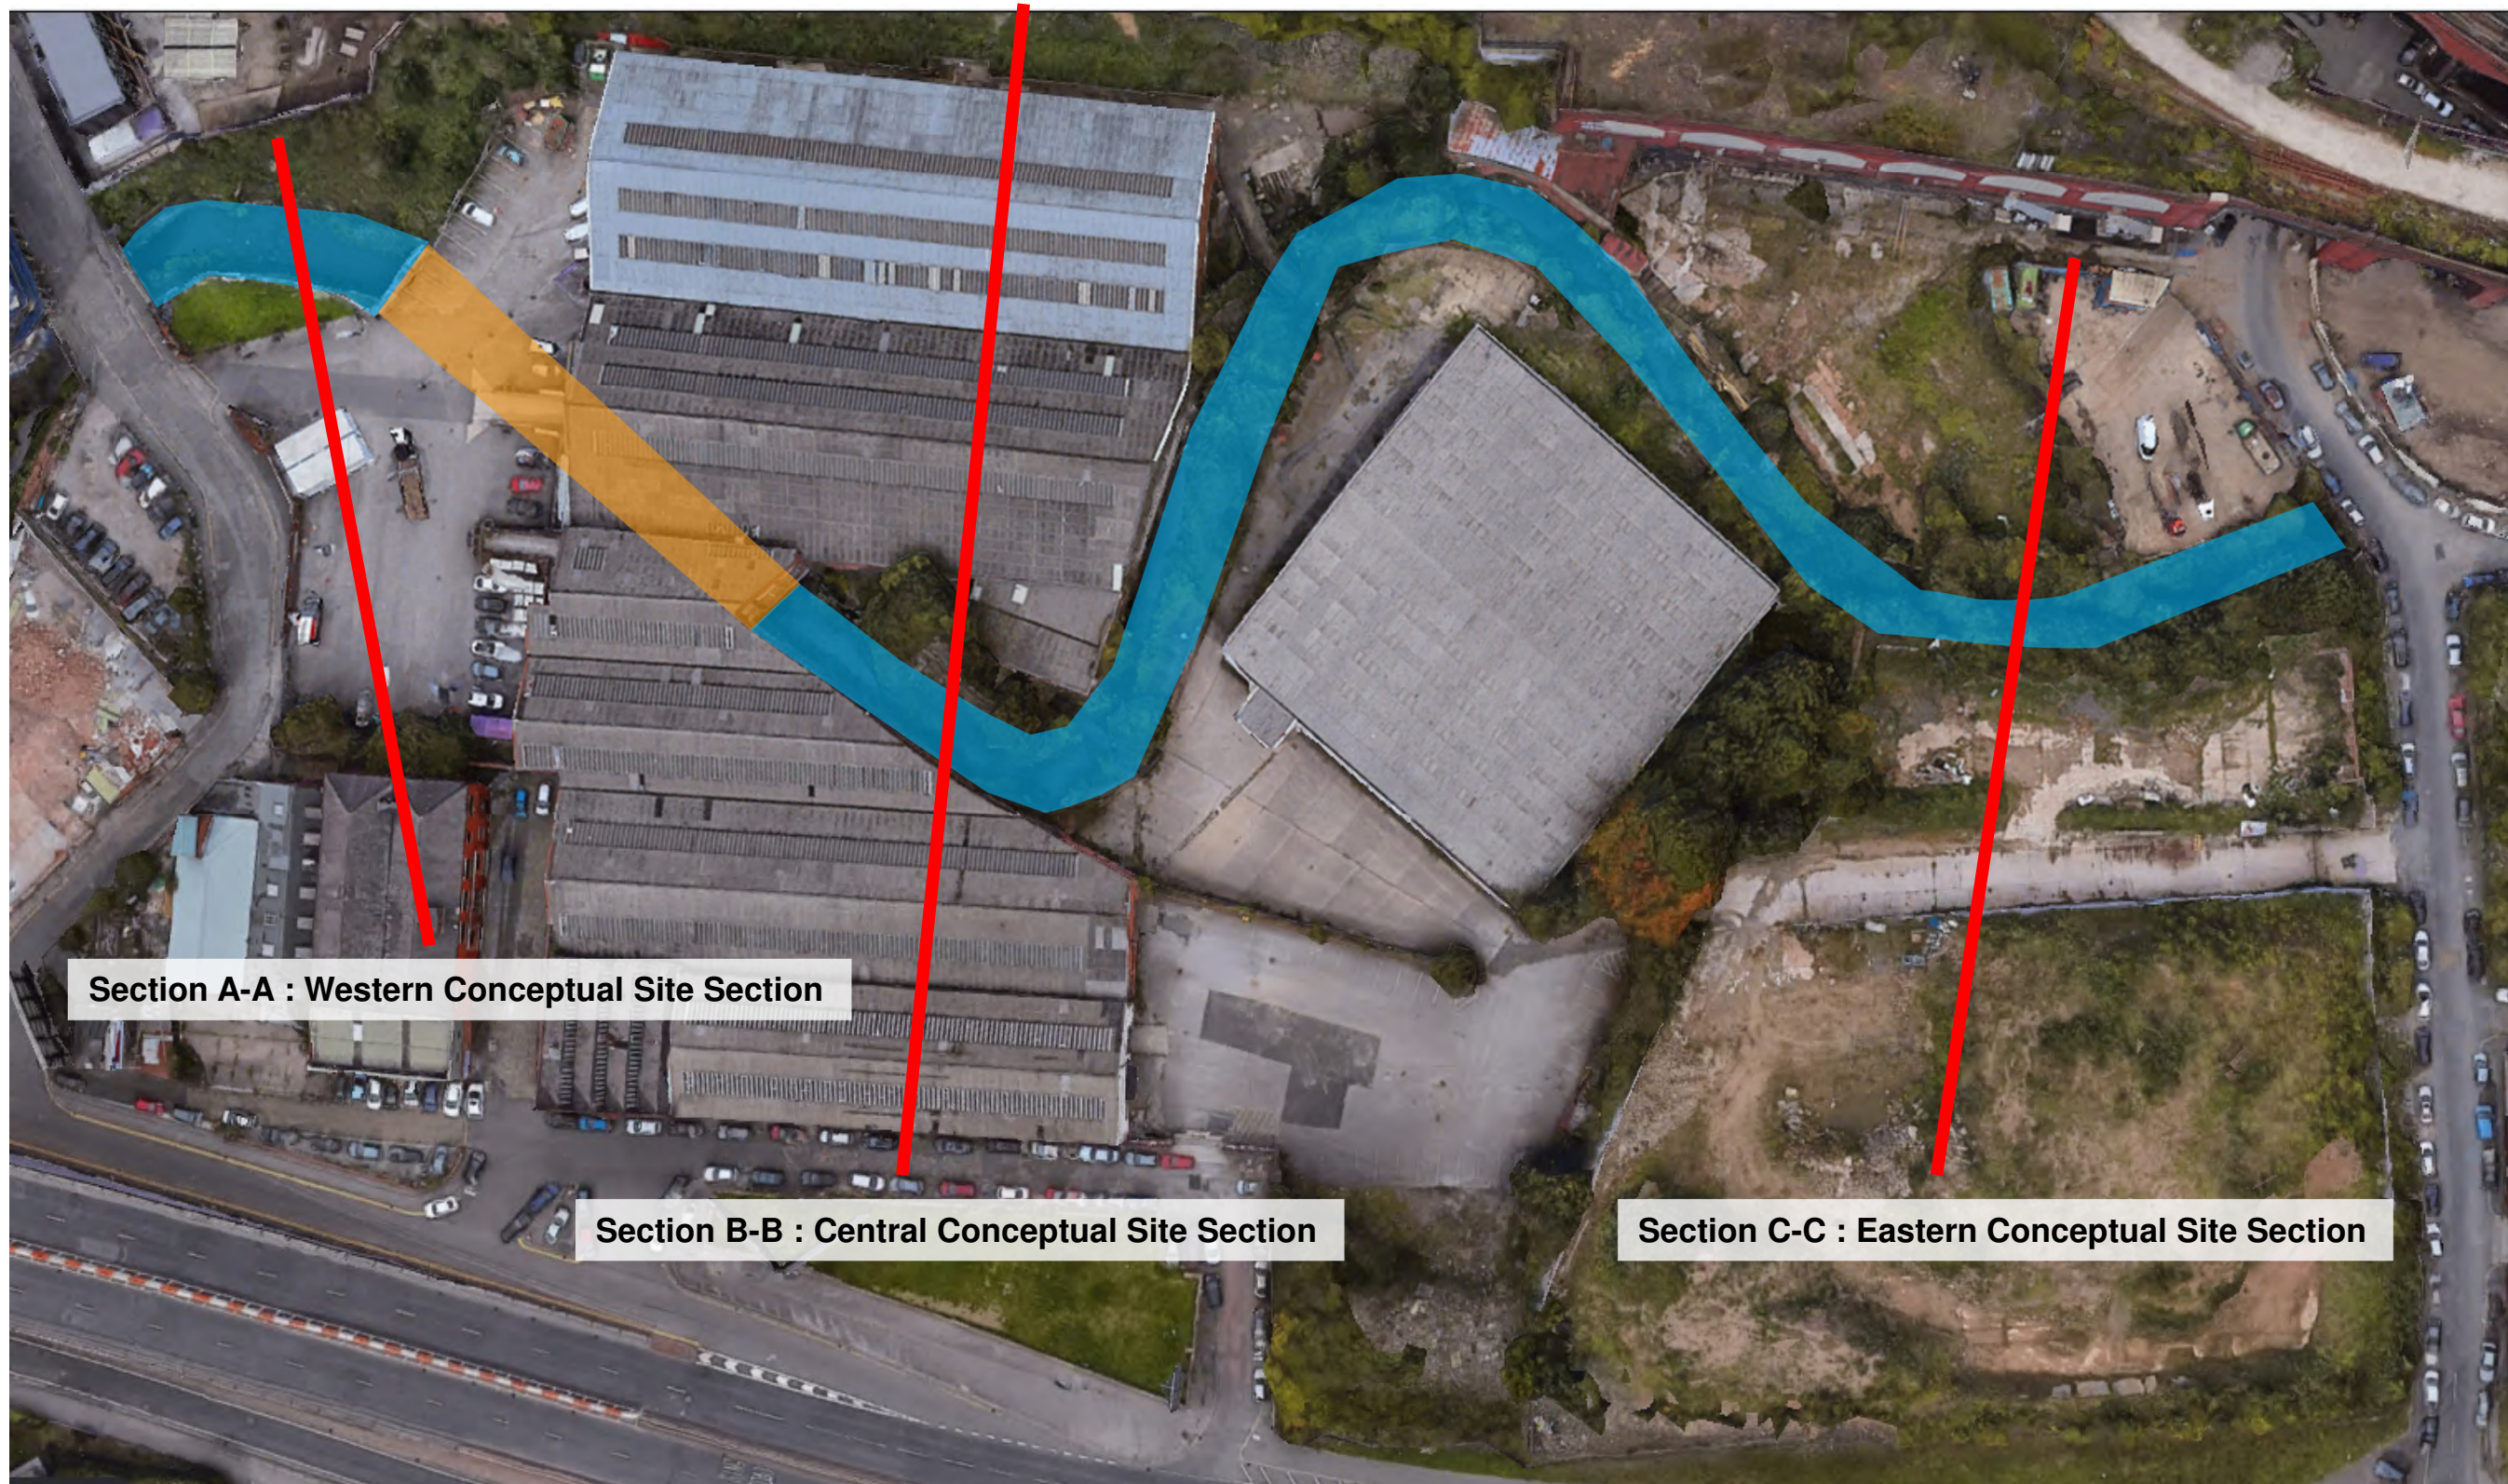
| | PROJECT TITLE | Mayfield Park | SKETCH TITLE | Conceptual Model Cross Section | |

**Section A-A : Western Conceptual Site Section**

**Section B-B : Central Conceptual Site Section**

Section C-C : Eastern Conceptual Site Section

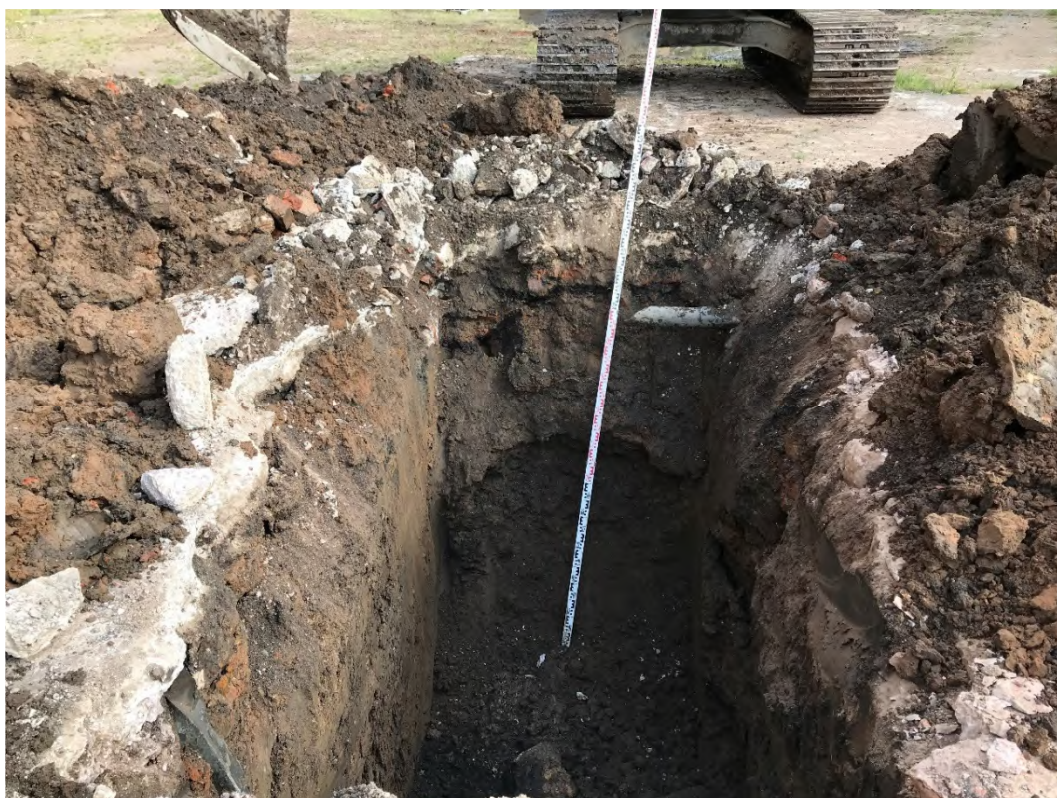
Photo No. 1: TP301

1. Location cleared for services prior to excavation. 2. Groundwater was not observed. 3. Upon completion exploratory location backfilled with arisings

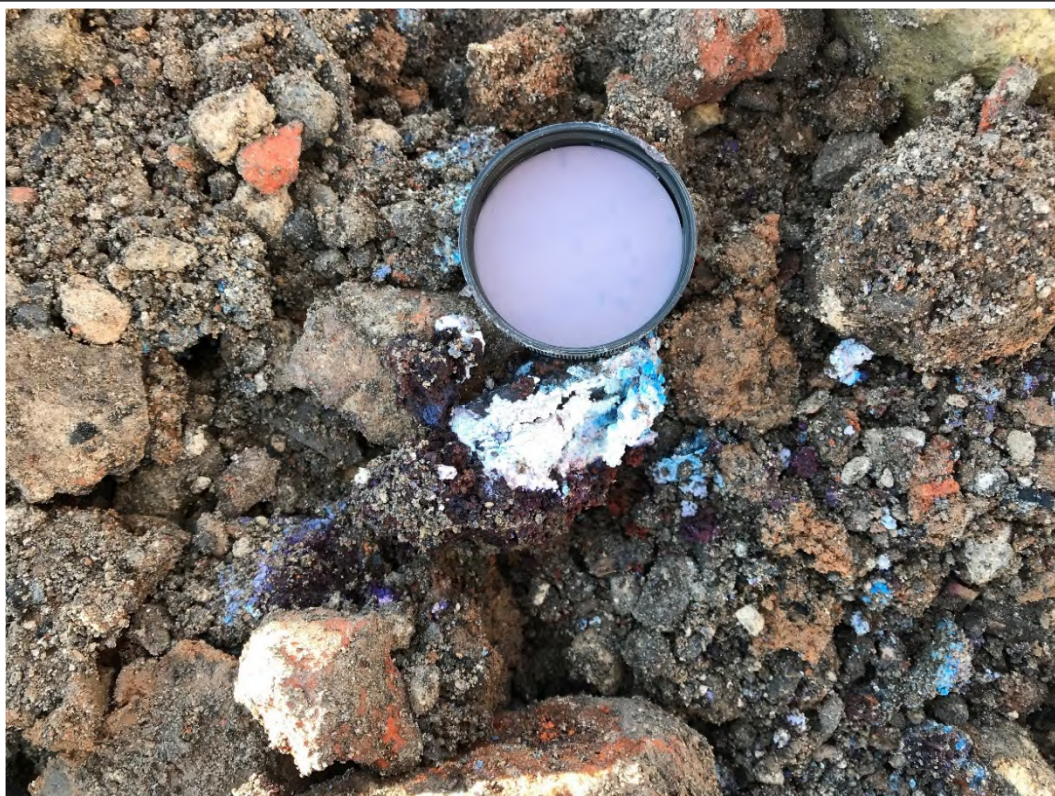
Photo No. 34: TP310 Suspected dye works contamination

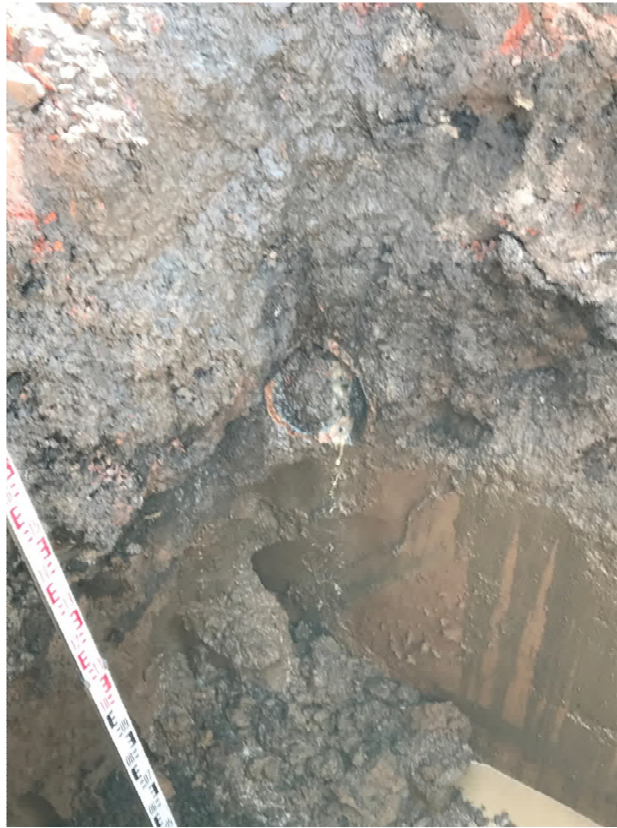
Photo No. 35: TP310 Clay pipe

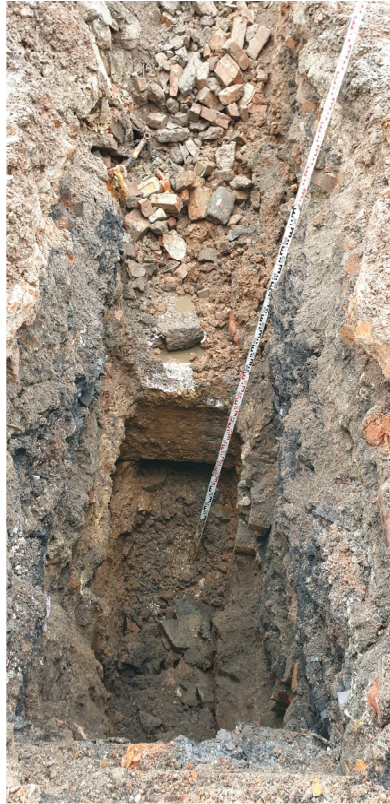
Photo No. 45: TP313 – concrete block at 2.0 -2.8m in southern pit face

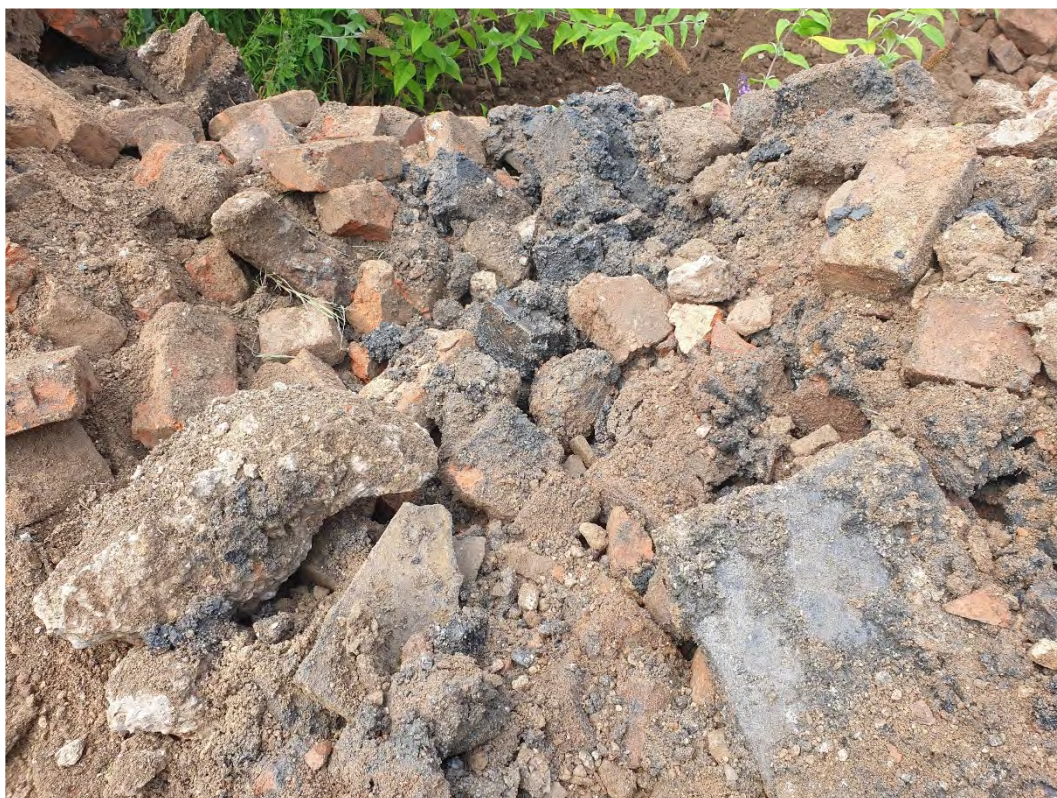
Photo No. 10: TP403 Arisings / Suspected Contamination

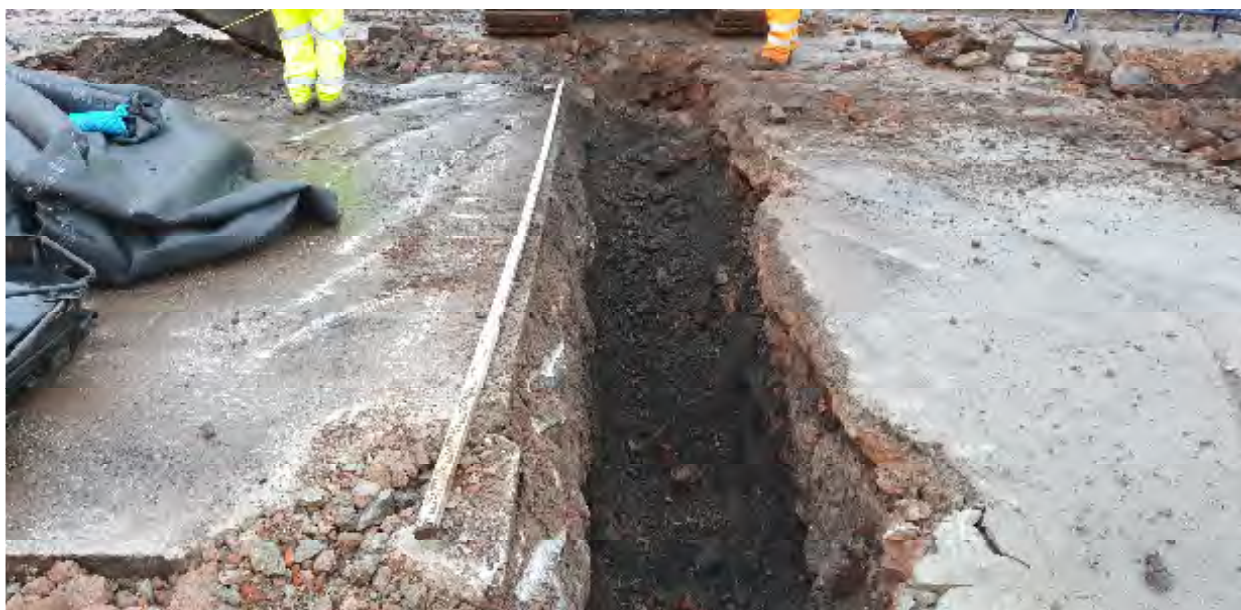
Plate No. 1: PP TP101: 5400x2300x800mm concrete pad

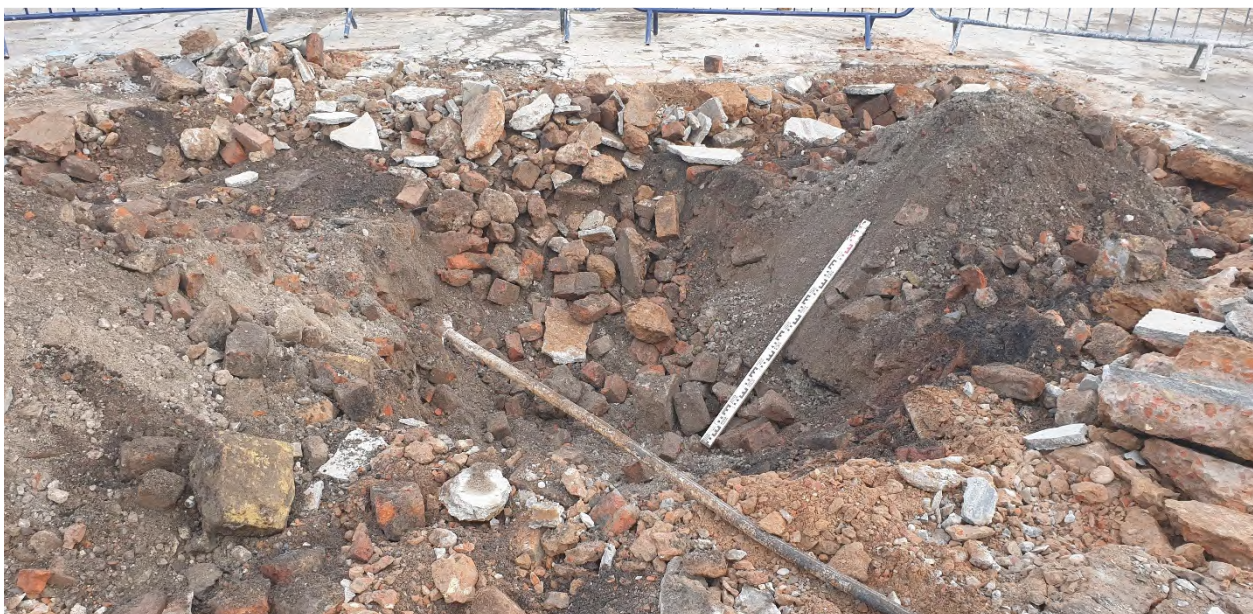
Plate No. 3: PP TP102 – 1000 x 800 x 600mm concrete base with metal H frame removed

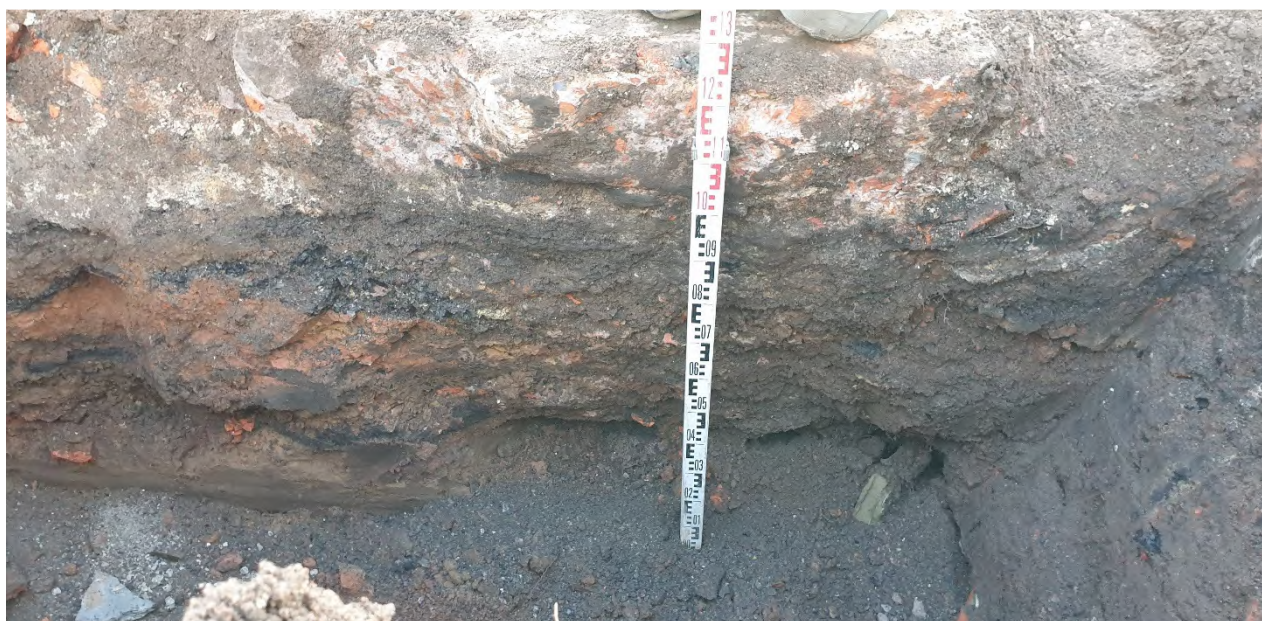
Plate No. 4: PP TP103 – 1200mm deep concrete base with H frame protruding

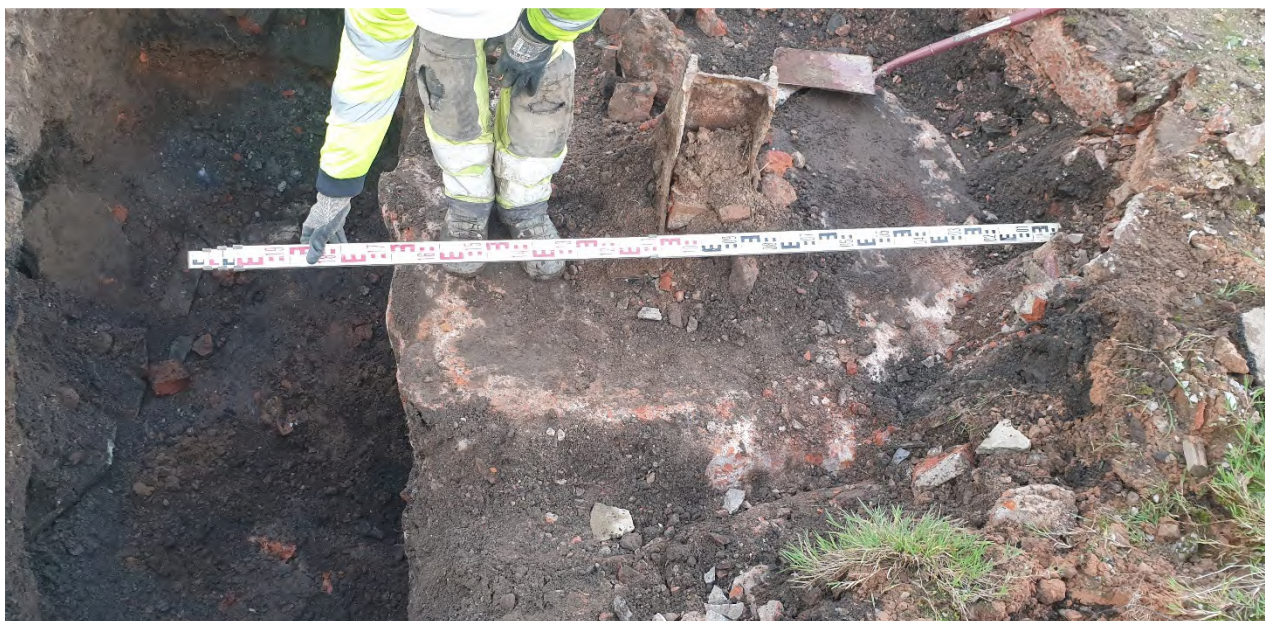
Plate No. 5: PP TP103 1200mm wide concrete pad with H frame exposed

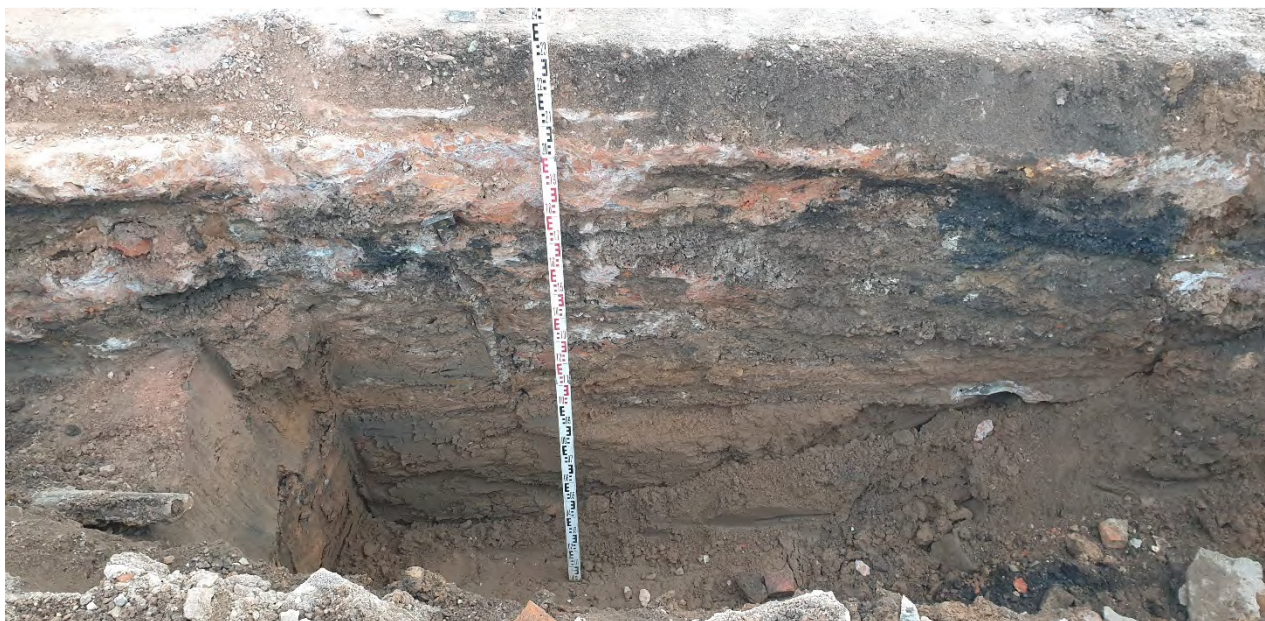
Plate No. 7: PP TP104 1800mm deep concrete stanchion base
