# PHASE 2 SITE INVESTIGATION

Proposed Mayfield Park, Manchester

Mayfield Partnership Ltd

December 2020

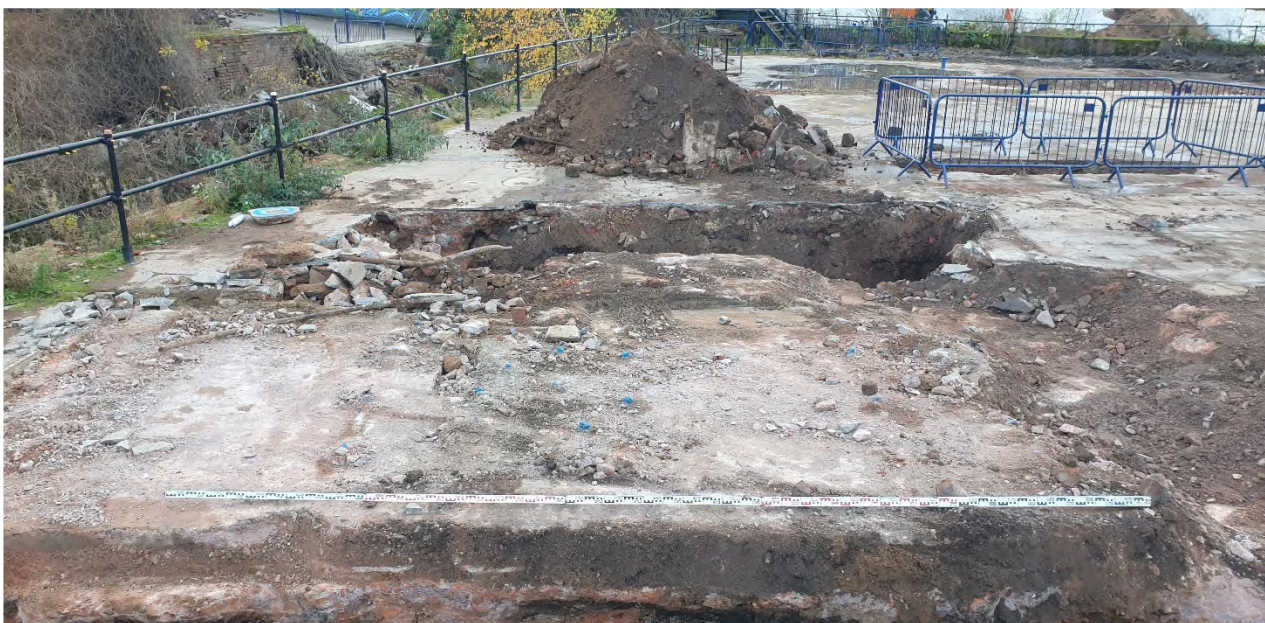
Plate No. 8: PP TP104 – 5500x2300x1800mm concrete base

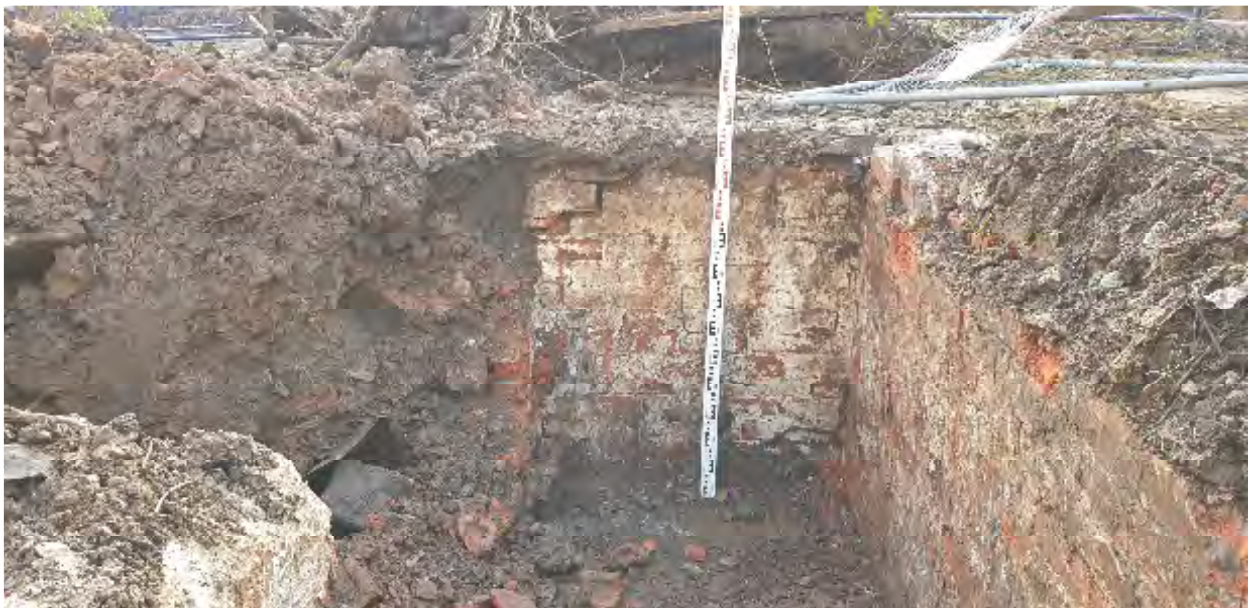
Plate No. 10: PP TP105 – 1200mm wide machine pit; wall 230mm thick, base 300mm thick

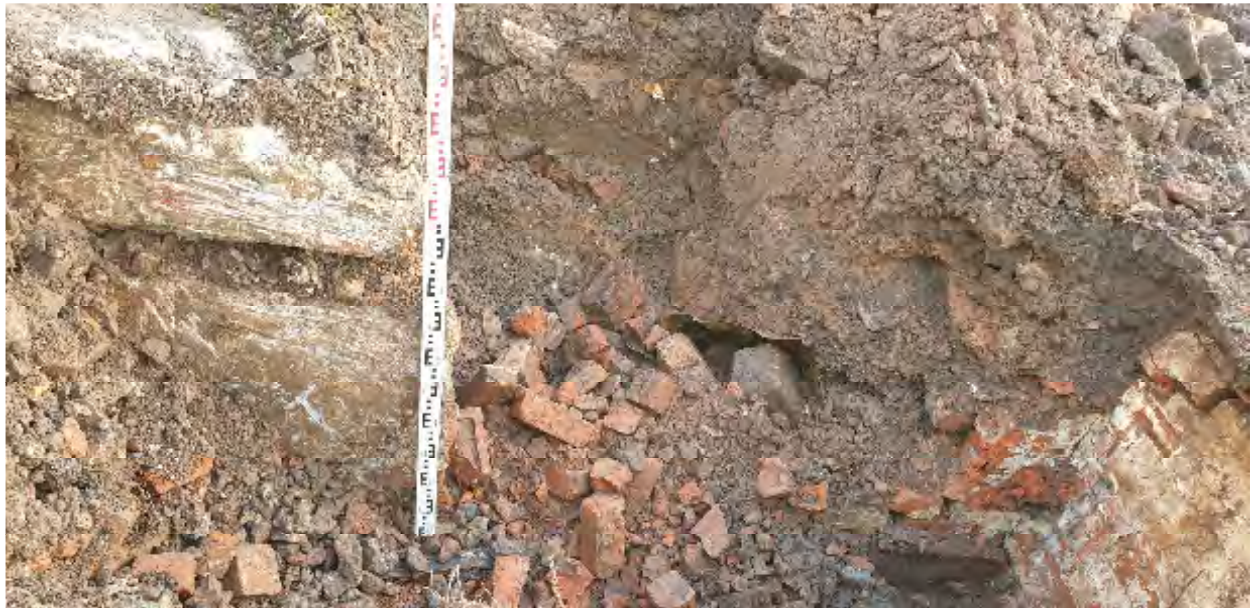
Plate No. 11: PP TP105 – Concrete 250mm thick overlying 150mm gap and 800mm concrete exposed

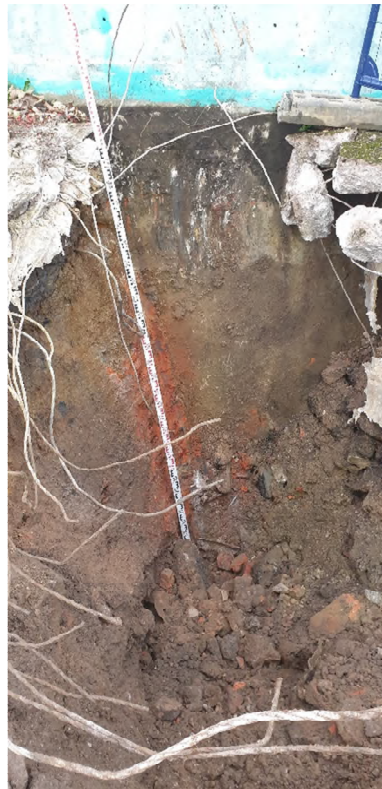
Plate No.14: PP TP109 – foundation of retaining wall not found due to depth and pit instability

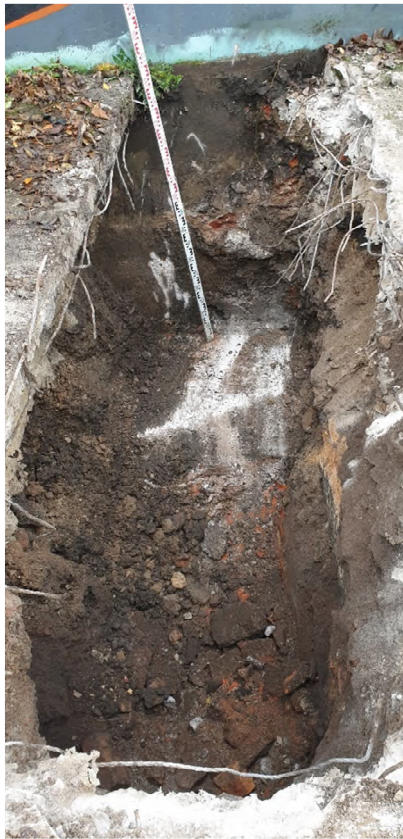
Plate No. 15: PP TPI09A – concrete footing at 1.6mbgl, extending out 1.0m and 1.0m deep

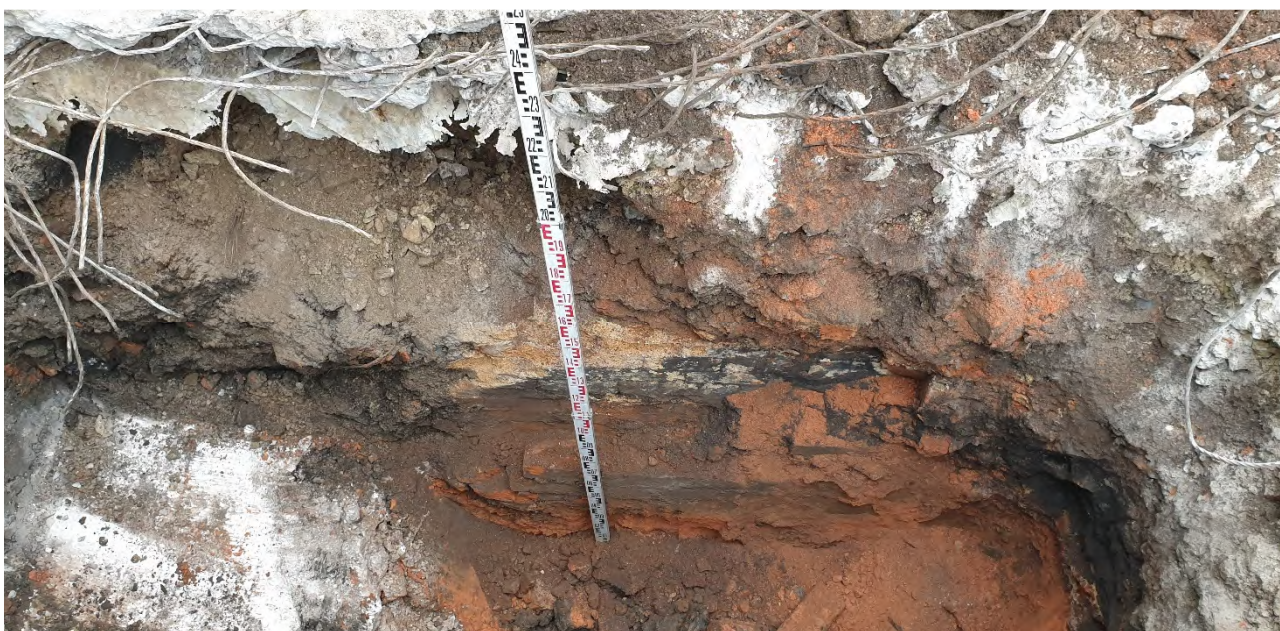
Plate No. 17: PP TPI09A footing founded on sandstone

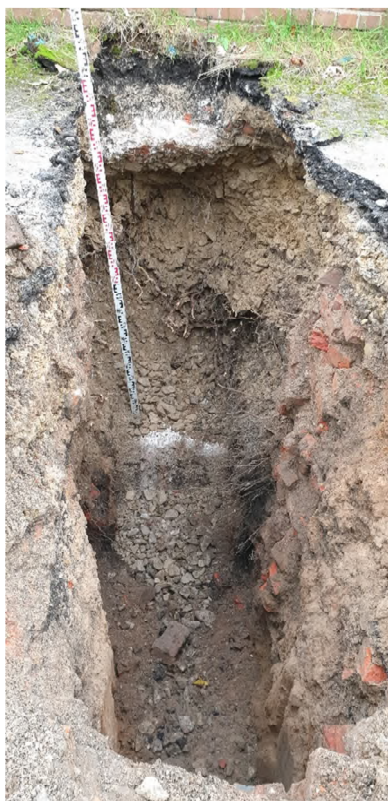
Plate No.18: PP TPI110 – concrete footing 1.7mbgl

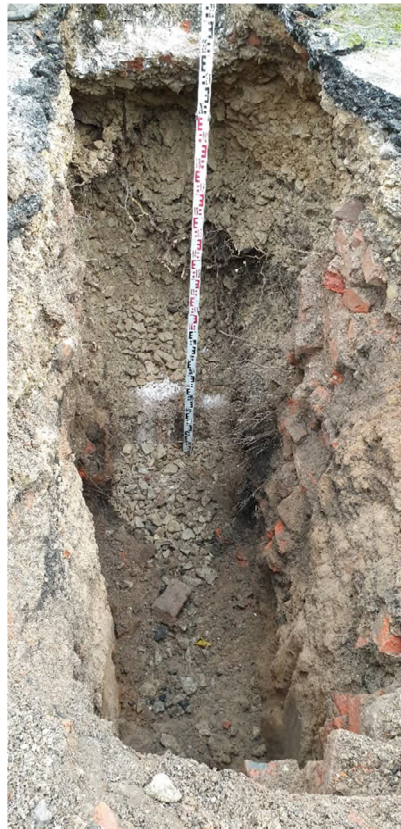
Plate No. 19: PP TPI10 concrete footing extending 1.0m and 0.5m deep, founded on sandstone

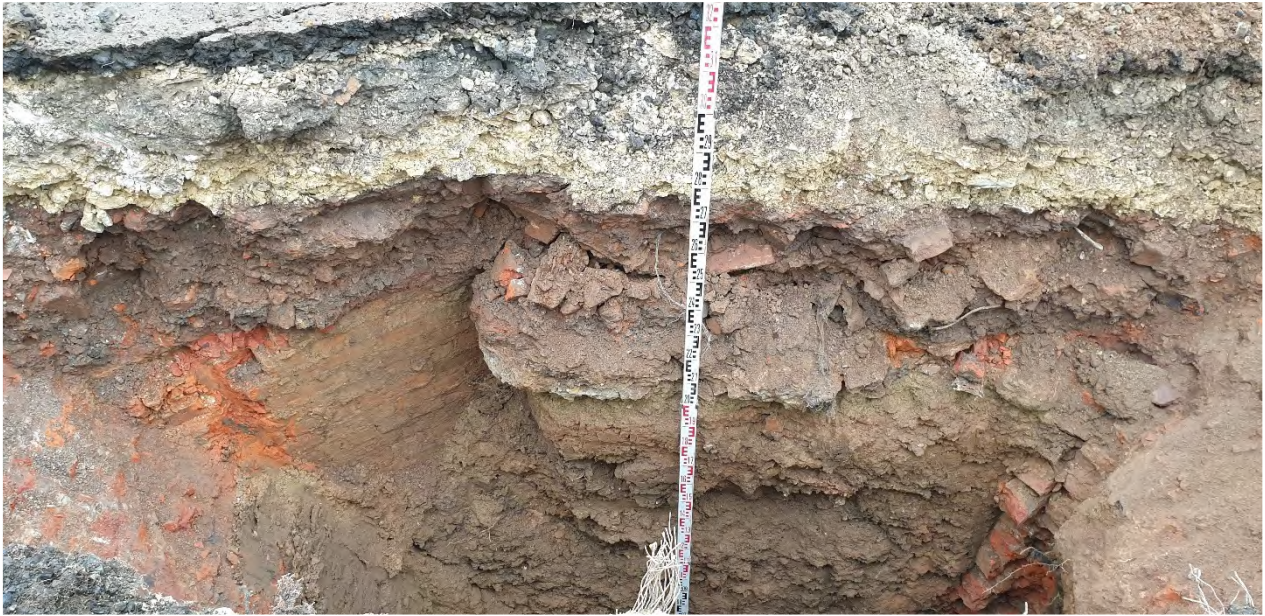
Plate No. 21: PP TPI11 masonry walls in southern pit face

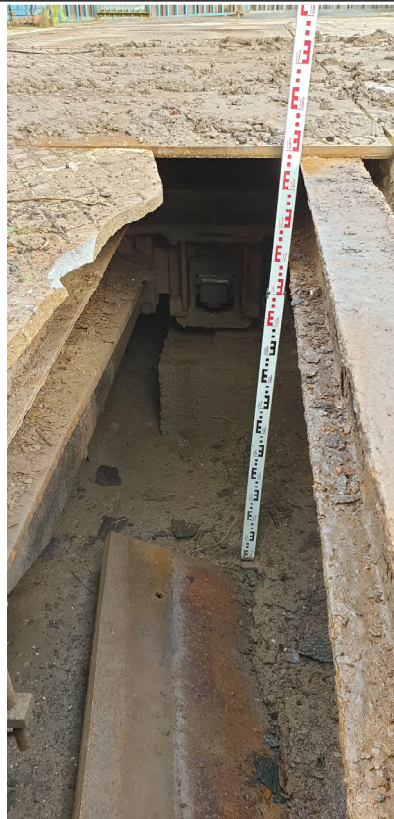
Plate No.22: PP TPI12 – Weighbridge - internal

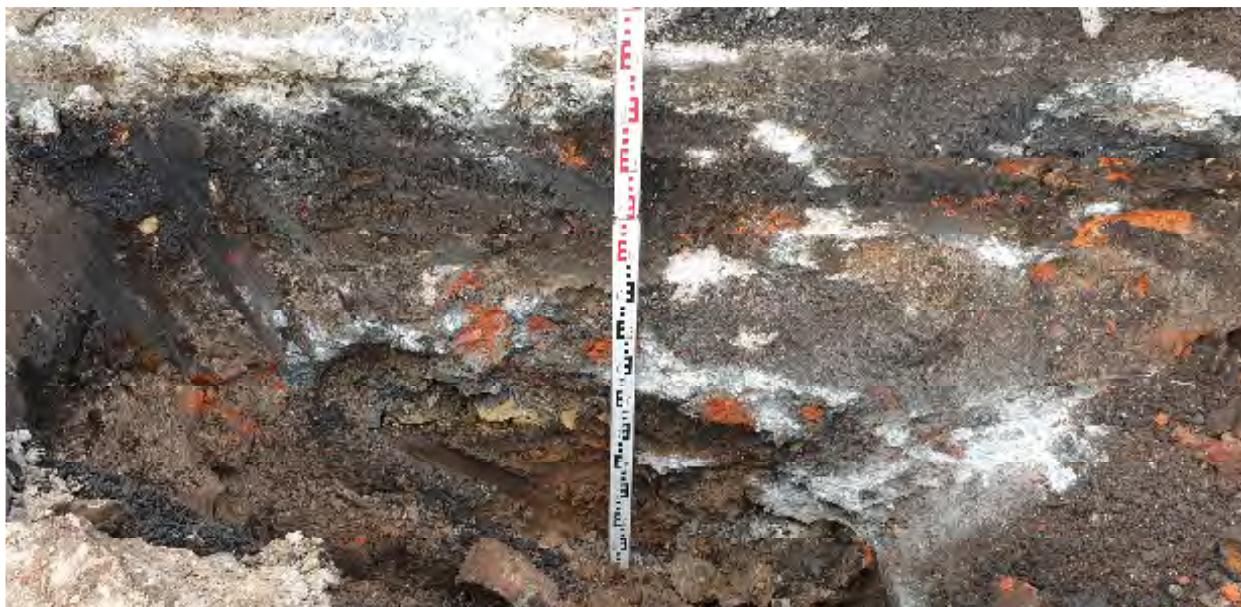
Plate No. 23: PP TPI 12 – external side of weighbridge- wall 550mm thick, concrete 1.6m

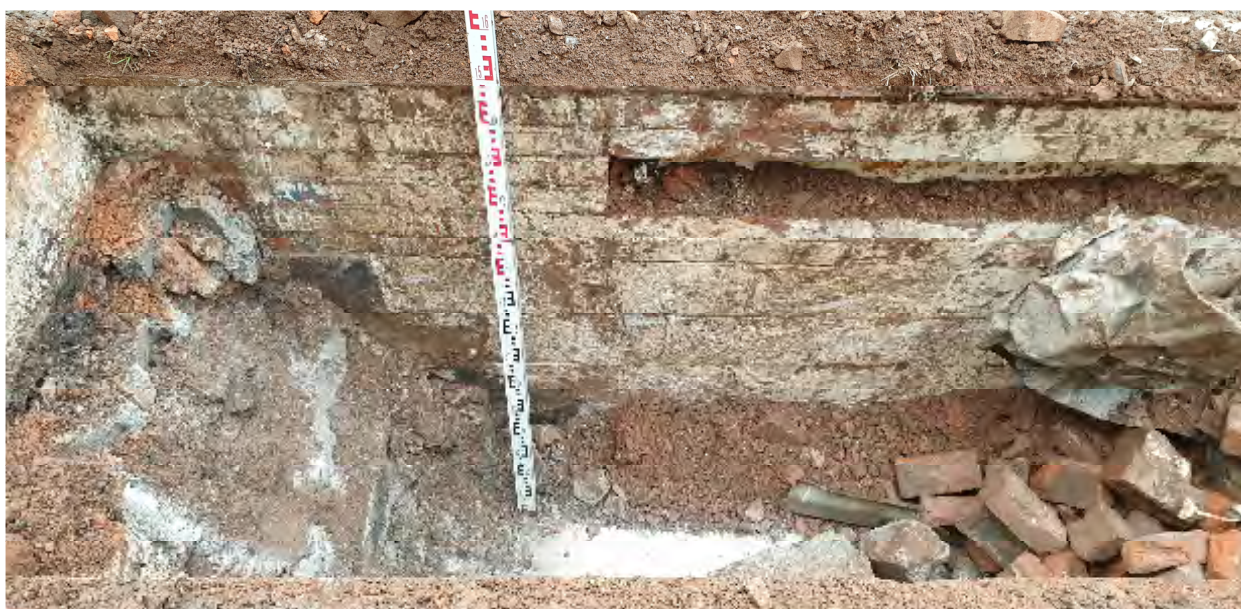
Plate No.24: PP TPI 13 – Machine pit excavated- 1.5mbgl. Concrete extending 450mm into pit from east

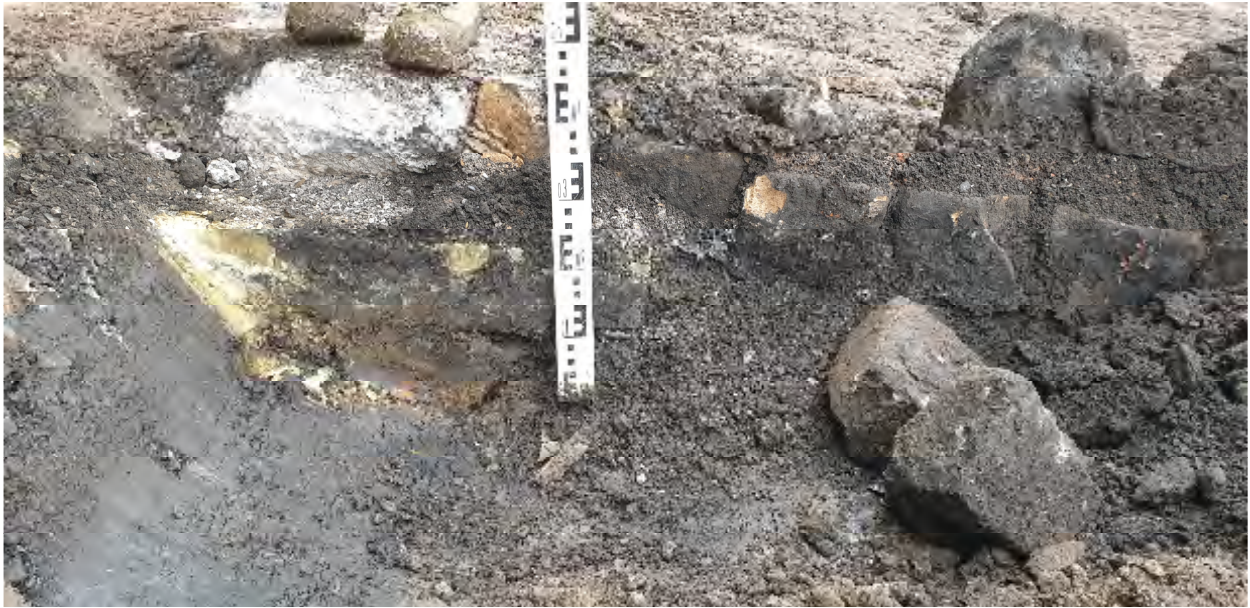
Plate No. 25: PP TPI 14 – Cobble Setts in MUGA

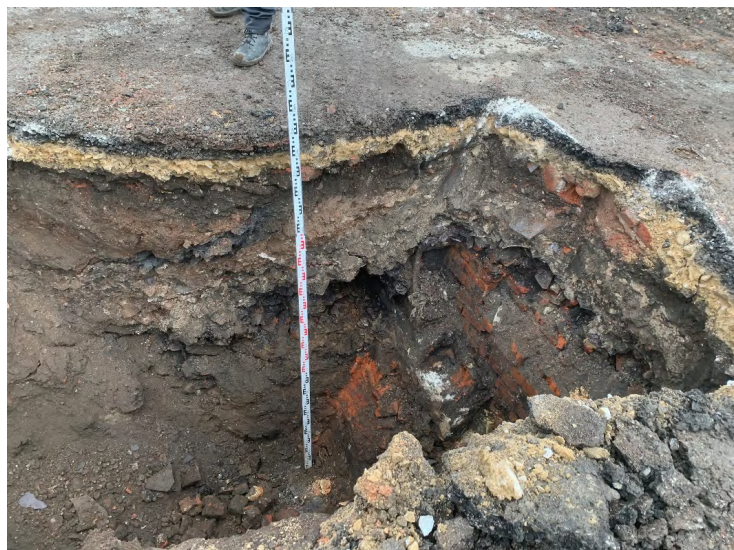
Trial Pit ref: PH302A

Hog's-back beam on padstone

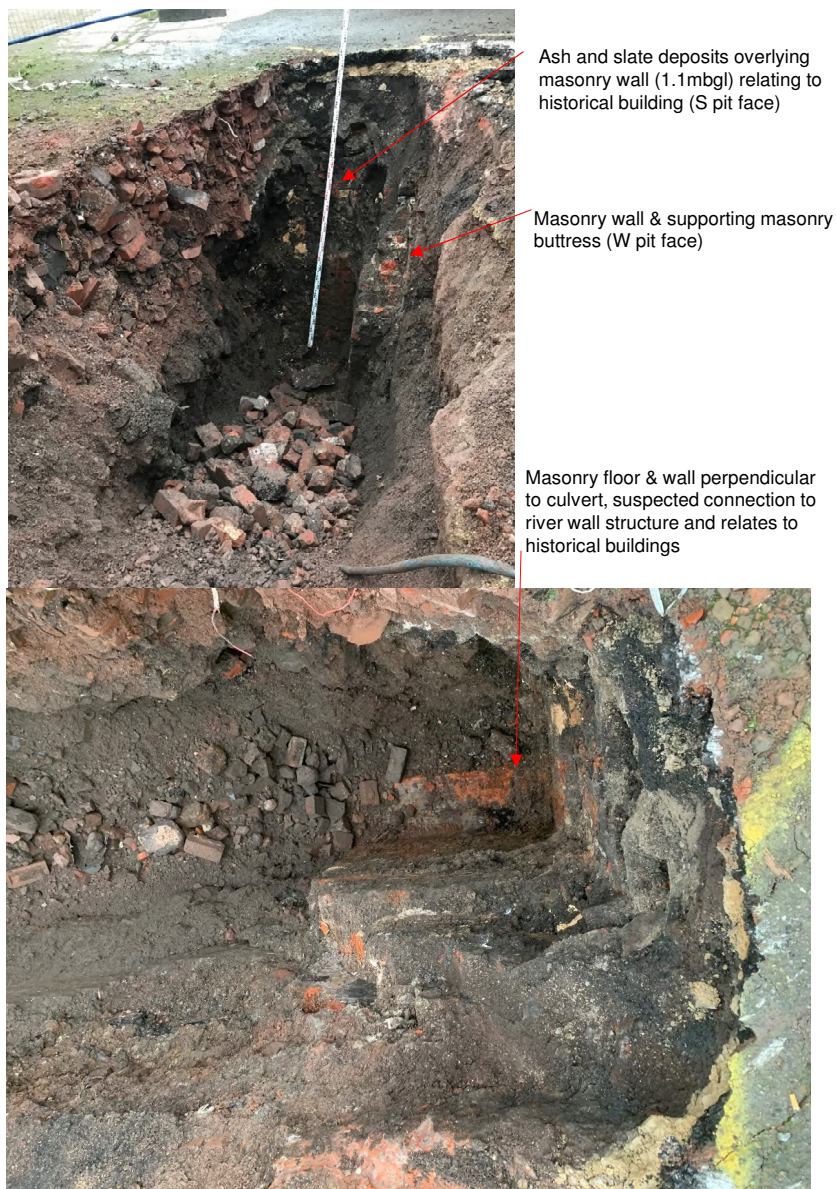
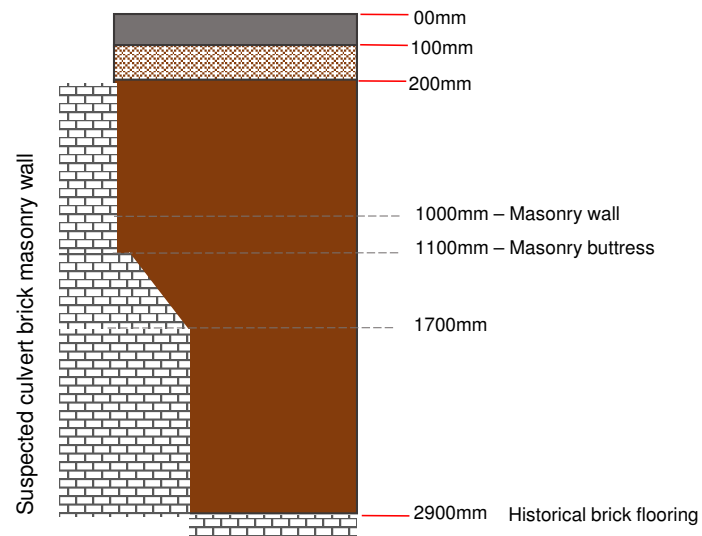
Trial Pit ref: PH302B

- MADE GROUND - ASPHALT
- MADE GROUND - LIMESTONE Sub base
- MADE GROUND - Sandy fine to coarse sub angular to angular GRAVEL of brick with frequent whole bricks

- Wall found running perpendicular, perhaps as support to river wall or remains of pre-existing building/basement

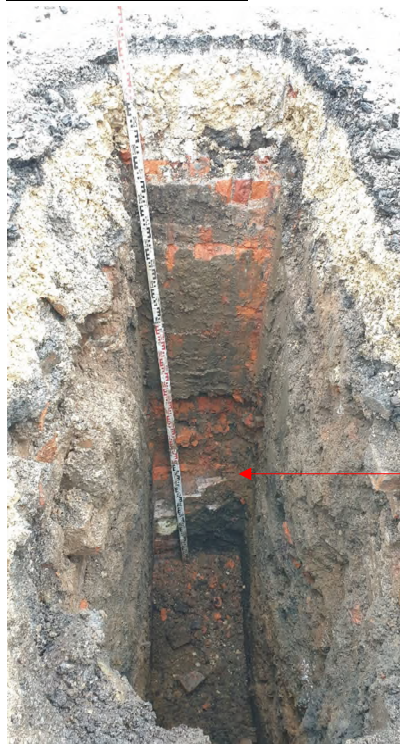
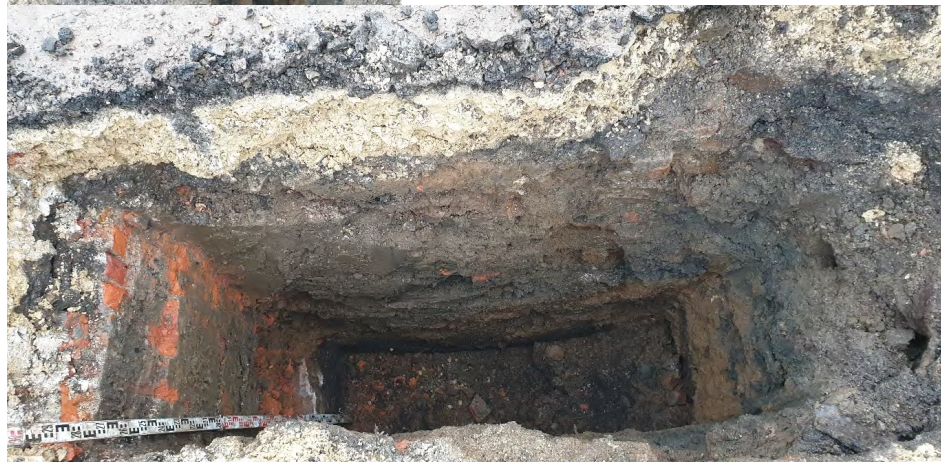
Trial Pit ref: PH303

Suspected Stone footing

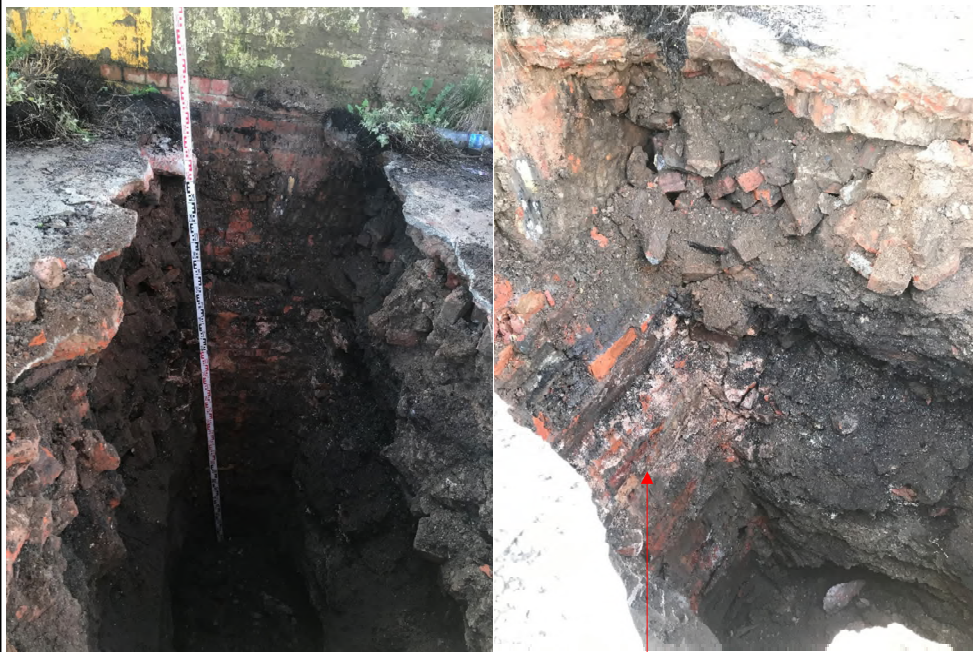
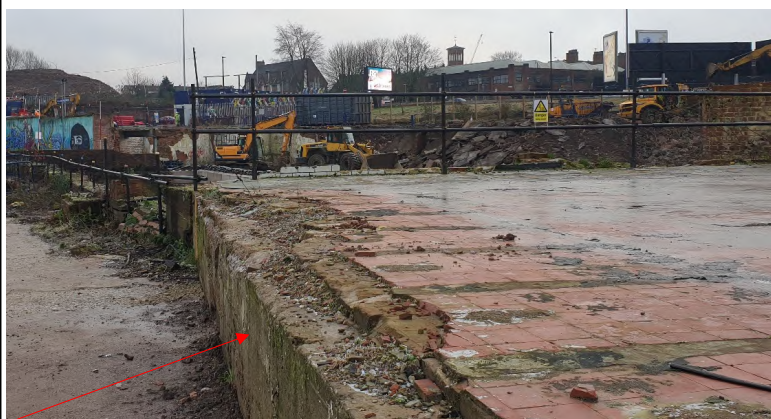
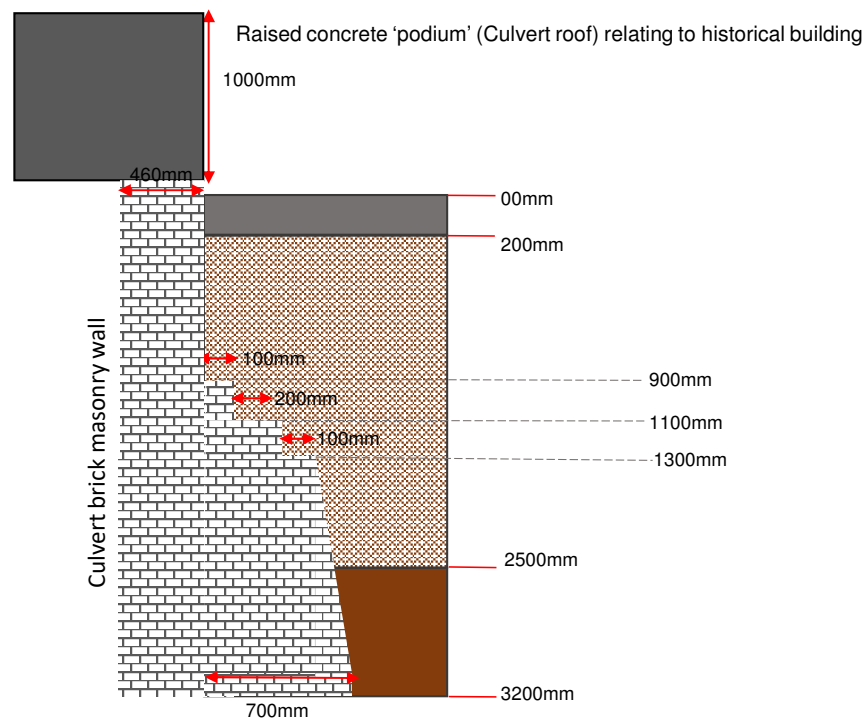
Trial Pit ref: PH304

Stepped brick masonry

Raised Concrete 'podium', Culvert entrance. Formed part of historical building

- PH304 log shows dense gravel at 5.0mbgl, with overlying soils very loose alluvium, suggesting the founding level of the wall to be on the dense gravel. Adjacent borehole also correlates with a dense strata at 5.0mbgl

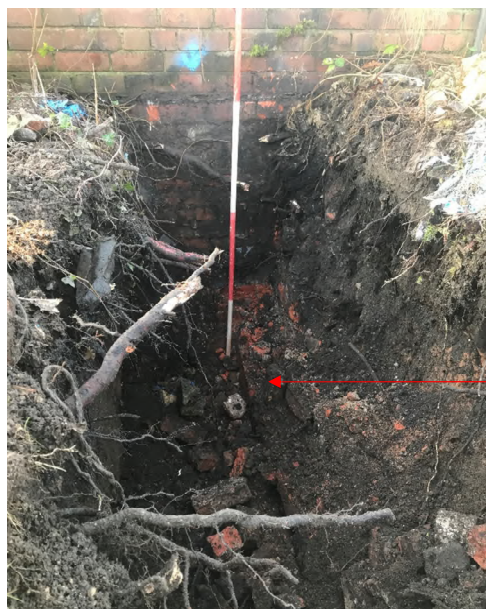
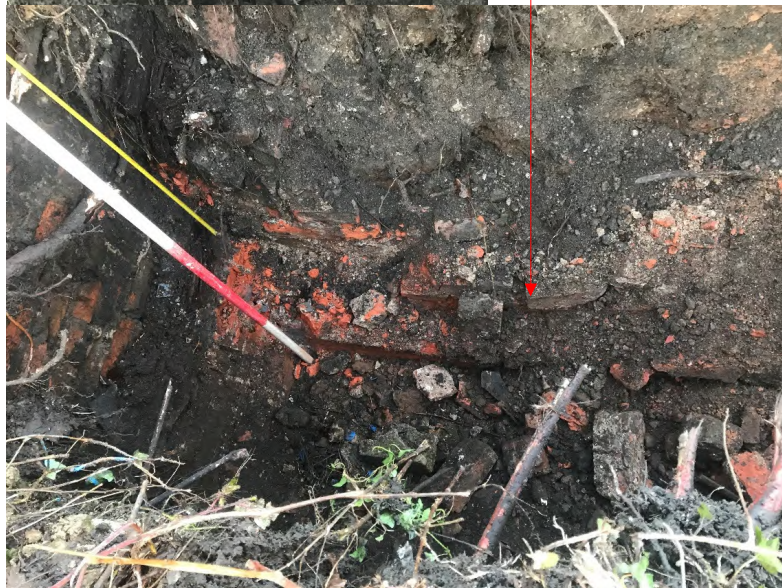
Trial Pit ref: PH306

Brick wall at 1.6mbgl;  
connect to and running  
perpendicular to river  
wall

- PH306 Log indicates Made Ground to 3.3mbgl, underlying alluvium is loose to medium dense with extent not proven
- Pit abandoned due to suspected asbestos at 1.8m depth
- Brick wall starting at 1.6m depth running perpendicular to river wall

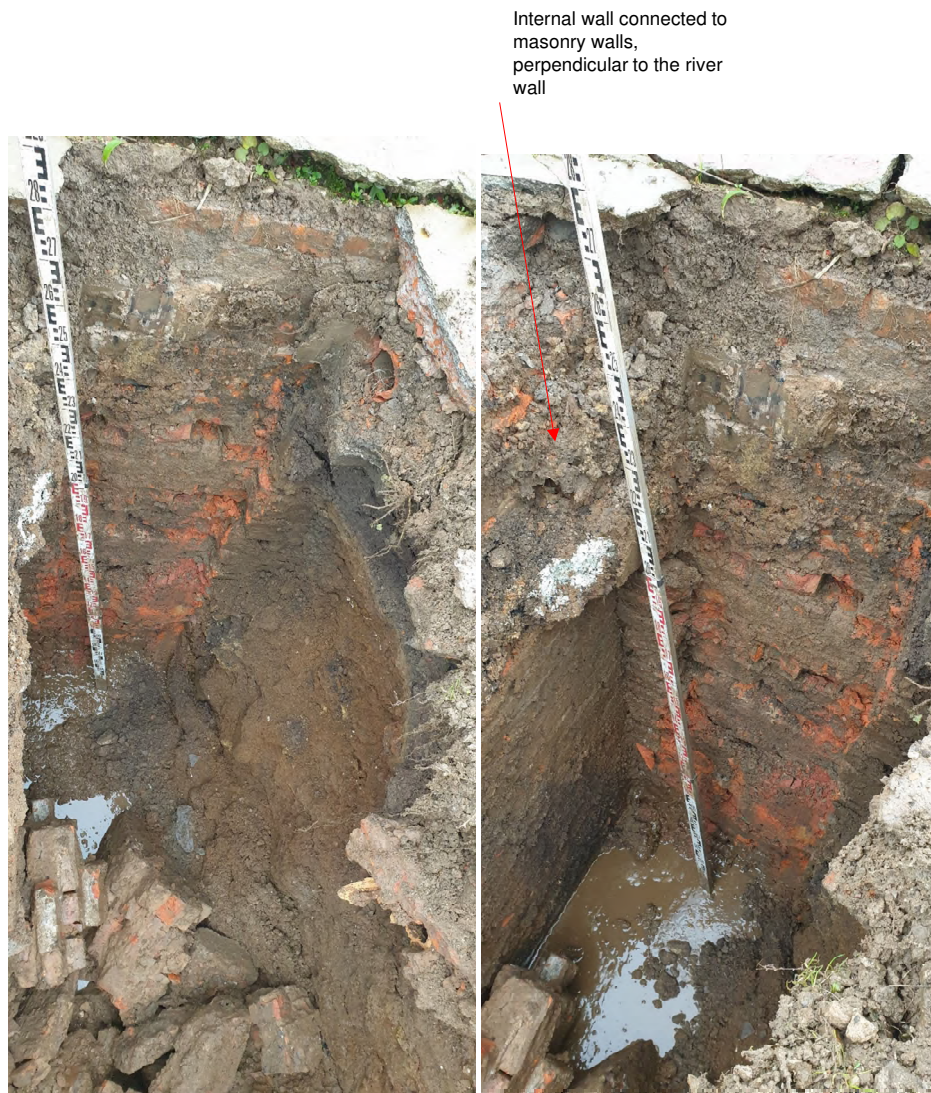
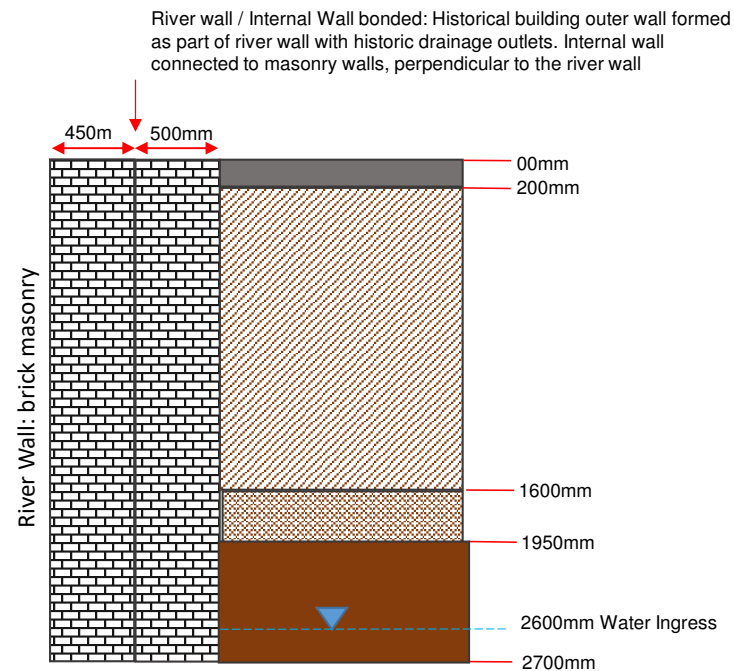
Trial Pit ref: PH307

- **PH307 borehole log indicates very dense gravels at 3.8mbgl- suspected founding strata**
- Water strike recorded at 2.6m depth, unable to progress pit
- Wall found perpendicular to river wall, connected to internal brickwork / river wall

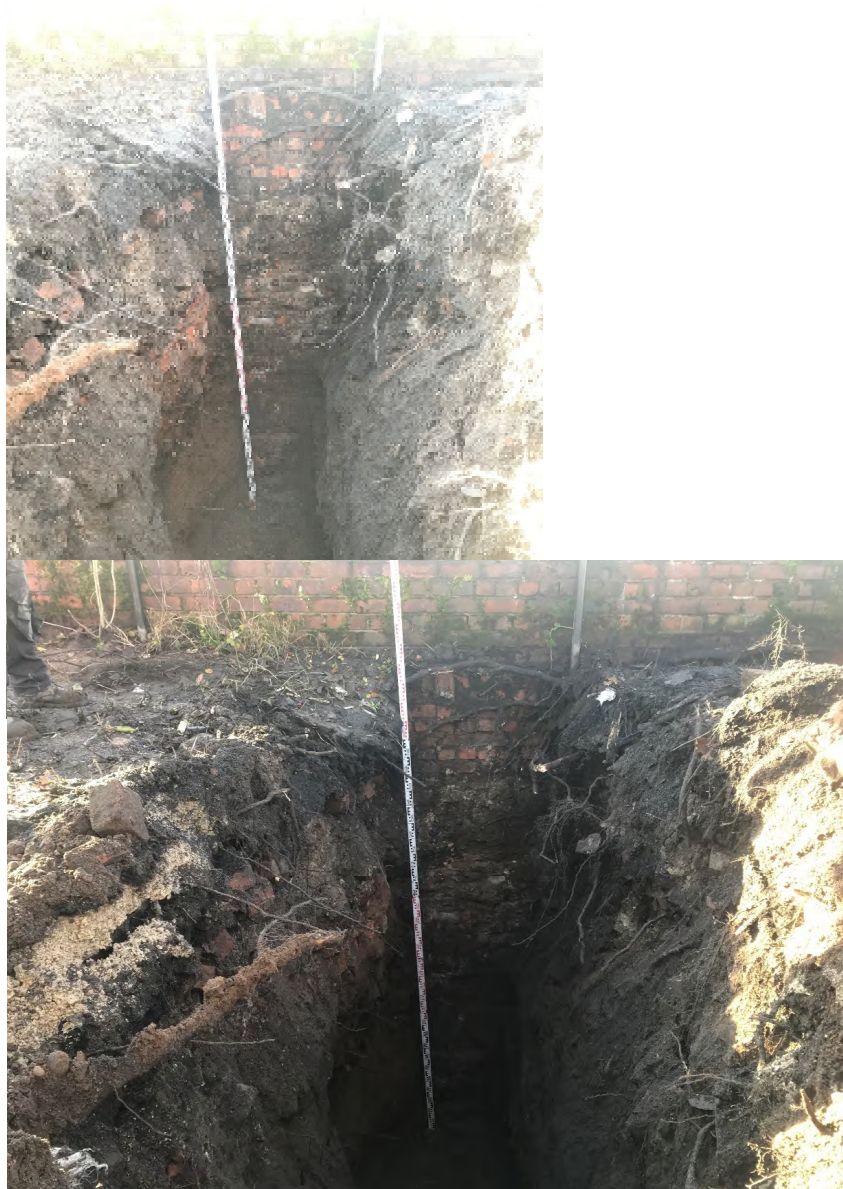
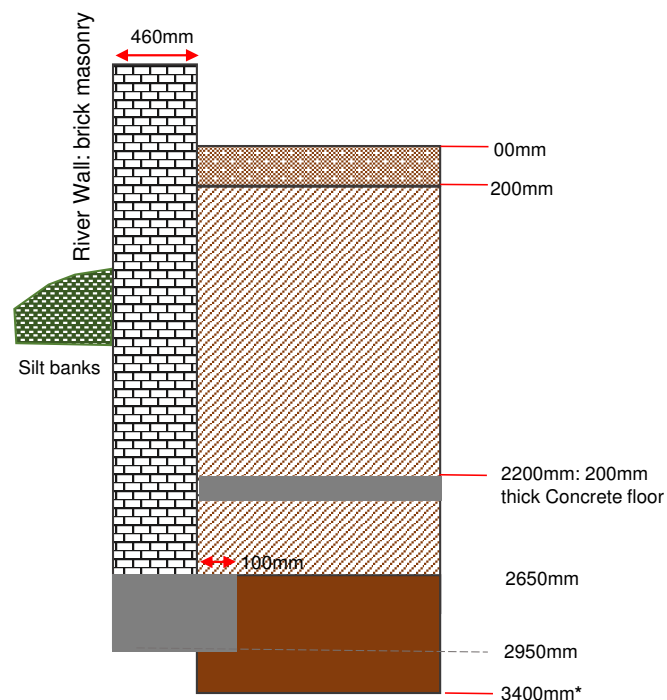
Trial Pit ref: PH308

- \*PH308 log indicates natural soils to be very loose from 3.0mbgl, adjacent WS215 indicates very dense gravel at 4.7mbgl, with bedrock underlying at 5.0mbgl
- 200mm thick concrete slab found at 2.2m depth. Potentially linked to river wall/historical structure
- Water seepage at approx. 3.3m depth

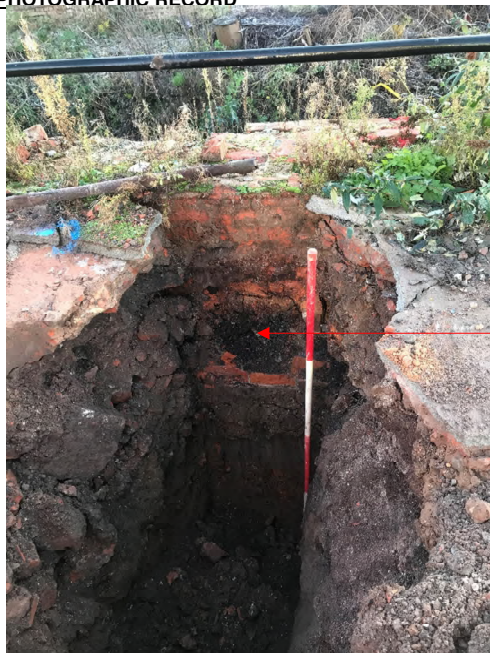
# Trial Pit ref: PH310

200mm step out of brick masonry

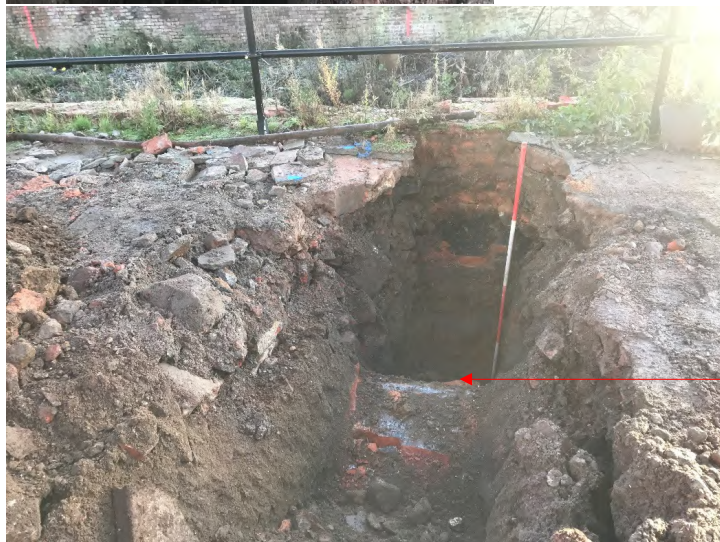
Historical masonry wall running parallel to river wall

- PH310 Log indicates underlying alluvium is loose, with dense gravel at 3.7mbgl
- Parallel running historical masonry wall does not appear connected to river wall structure

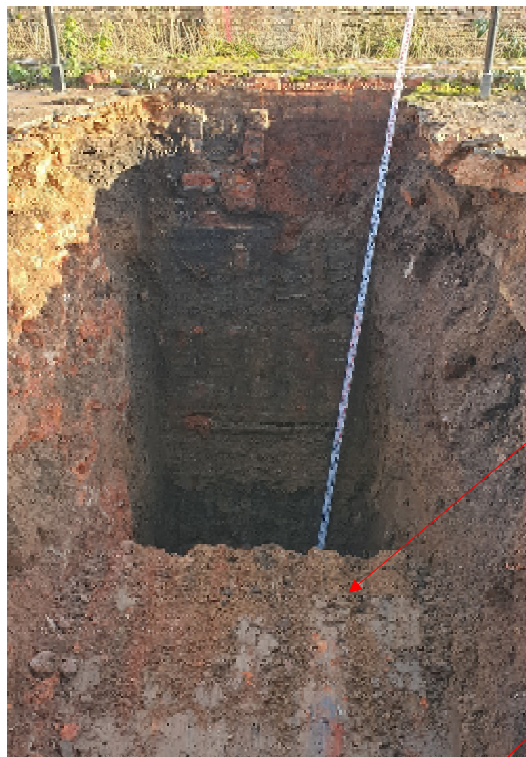
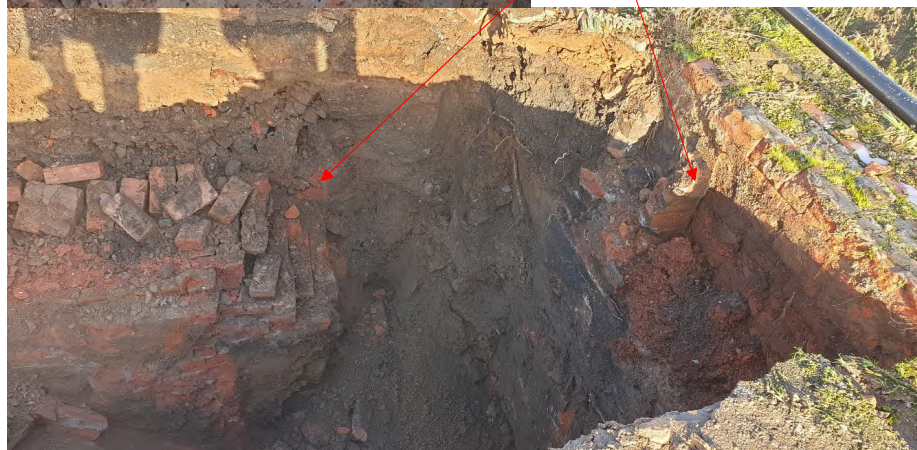
Trial Pit ref: PH312

Relic floor of historical building

1200mm gap between river wall and historic brickwork showing no connectivity

Dual brick masonry wall

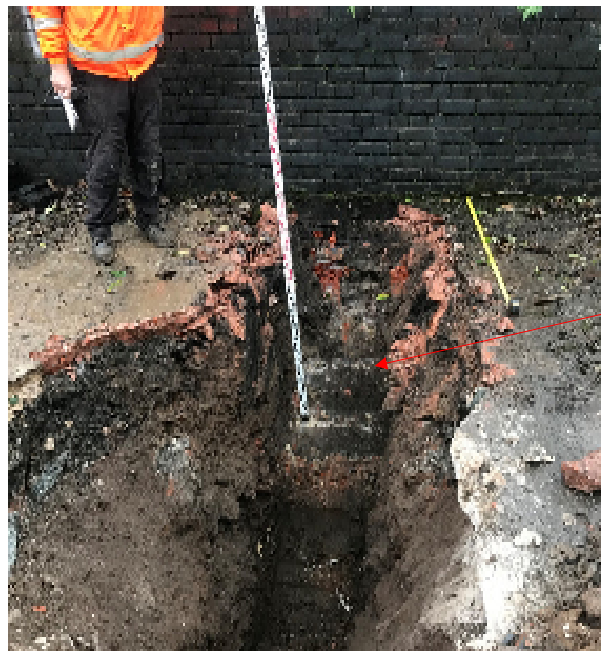
Trial Pit ref: PH315

Concrete footing stepping out

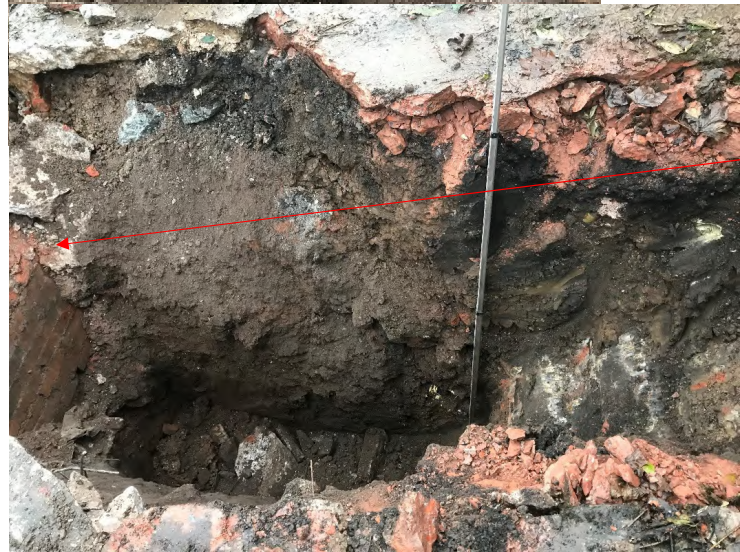
Parallel brick structure

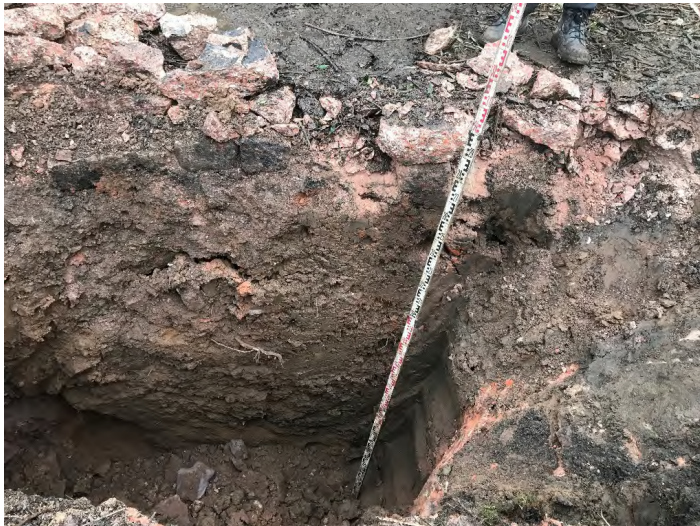
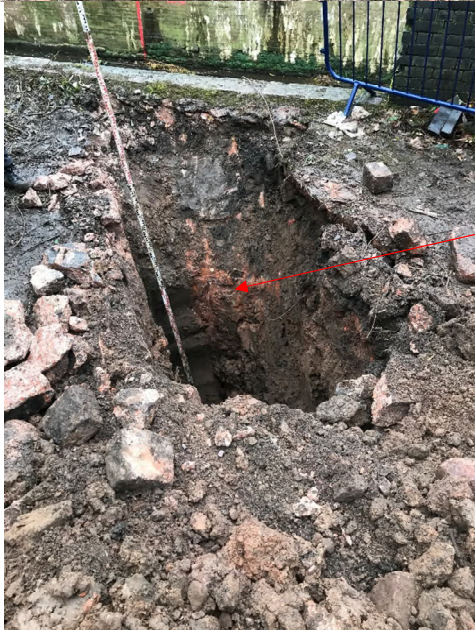
Trial Pit ref: PH316

Brick  
masonry  
buttress

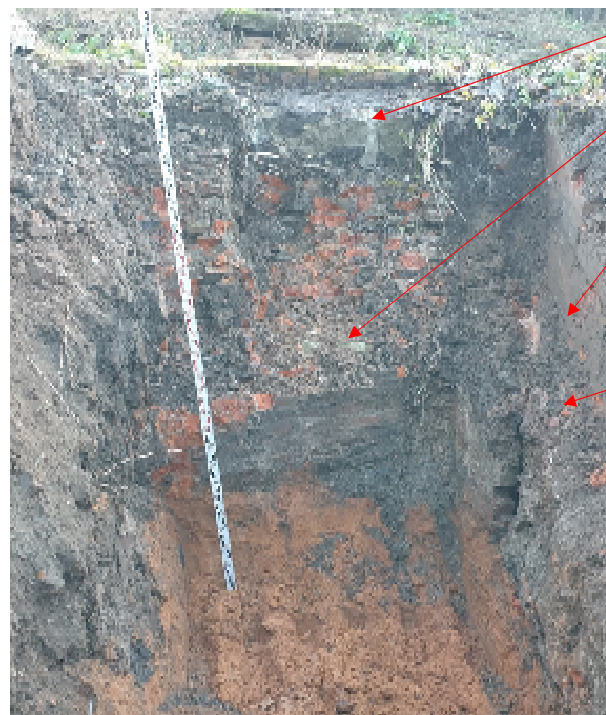
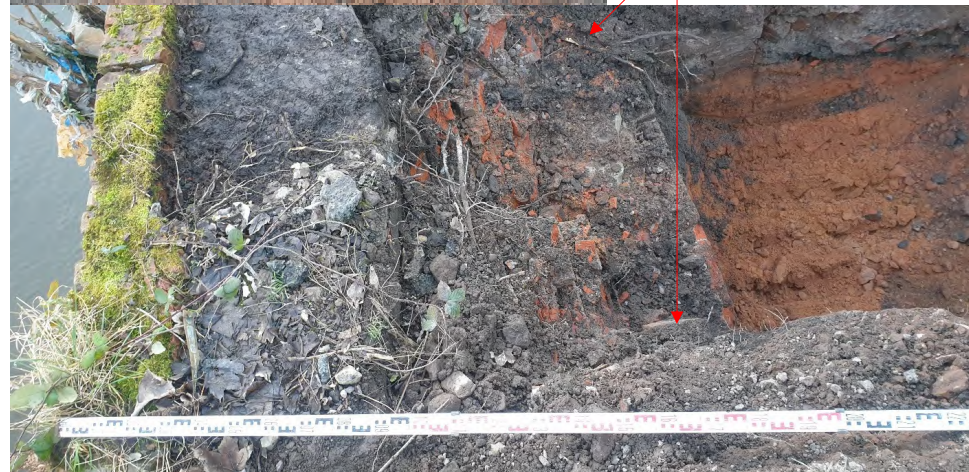
Trial Pit ref: PH319

Coping Stone

Secondary Coping Stone / footing

Concrete floor(1.6mbgl) associated with historical development (removed during excavation)

Lower brick masonry appears angled to correlate with bend in river wall

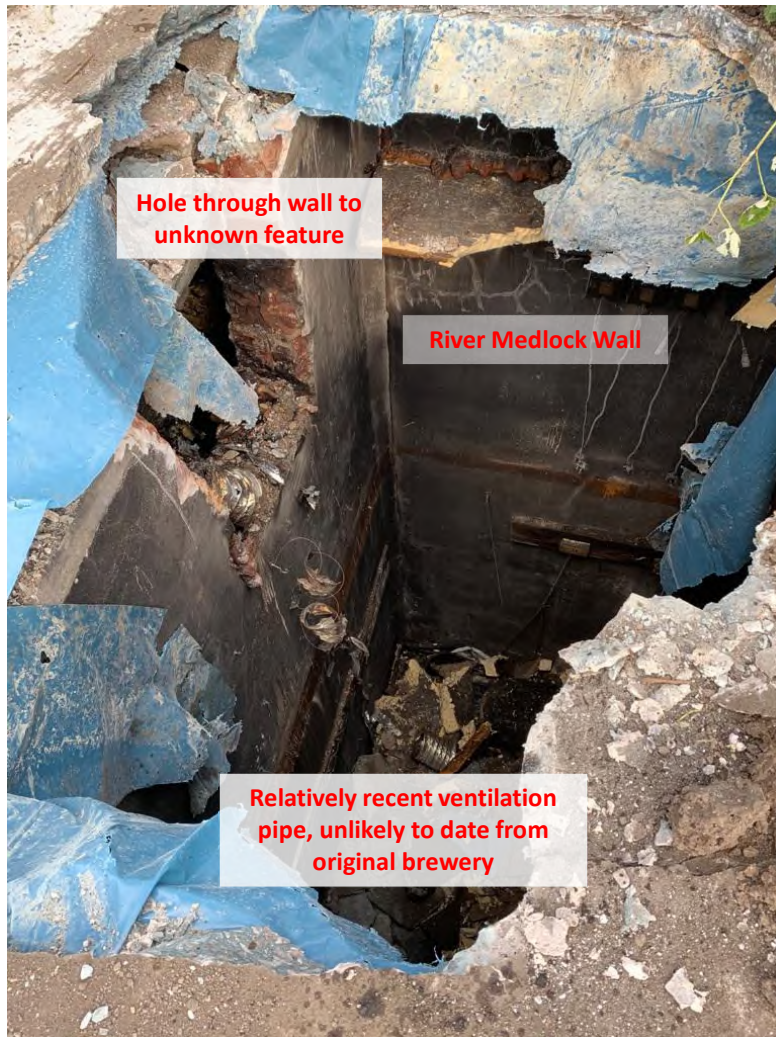
**Photo into basement looking north**

### Brewery Basement Feature Initial Observations

- 7) Similarly the large river wall noted to the north is likely to date from the brewery era, with the basement likely to extent much of the full depth of the wall.

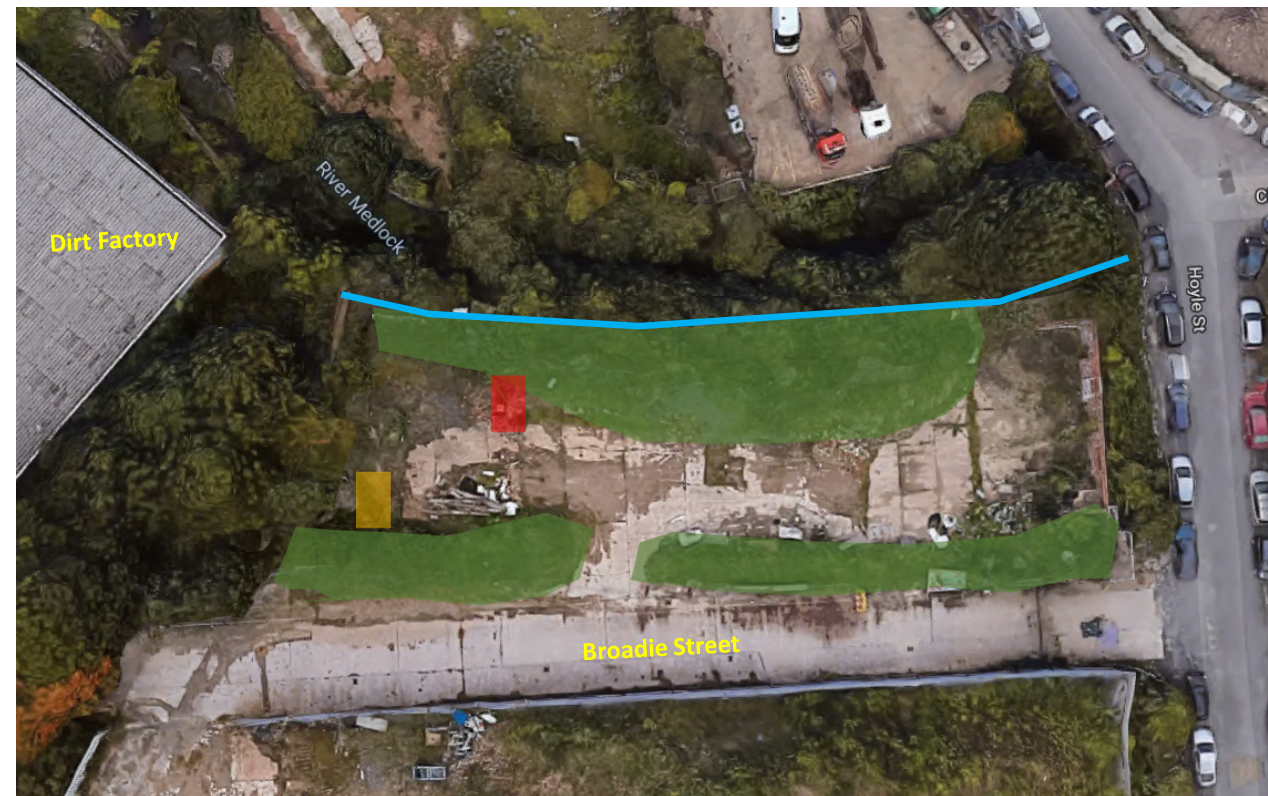
- 4) Trial hole "TP306" encountered the basement beneath an existing concrete slab. The slab (circa 100mm thick) appears to have been cast onto pre-stressed concrete roof joists (or similar) which were damaged and fell into the basement by the excavator bucket during trial pitting.

- 5) The basement extended southward from the TP306 and also appeared to abut the River Medlock. Based on materials noted within the basement it is likely the structure was in use during the most recent site operations (recent building material, insulation pipe, polythene sheeting are all noted within the basement which all post date 1930s).

Previous sink hole (may also relate to basement feature?)

TP306 Location (Approx.)

- 7) Once cleared the area could be delineated by a combination of ground penetrating radar and dynamic probe holes / very small diameter concrete coring.

- 8) The northern wall of the basement appears to be bounded by the Medlock. As such due care and consideration will be needed to ensure the outer wall does not fall into the Medlock
