# PHASE 2 SITE INVESTIGATION

Proposed Mayfield Park, Manchester

Mayfield Partnership Ltd

December 2020

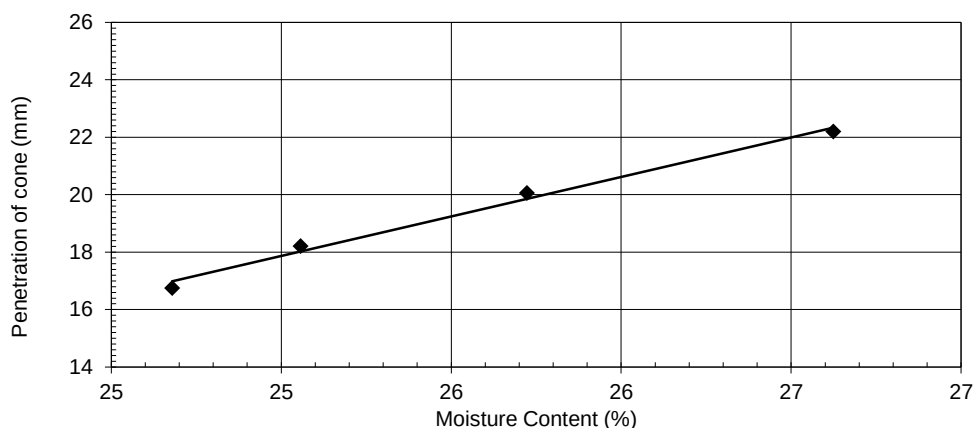
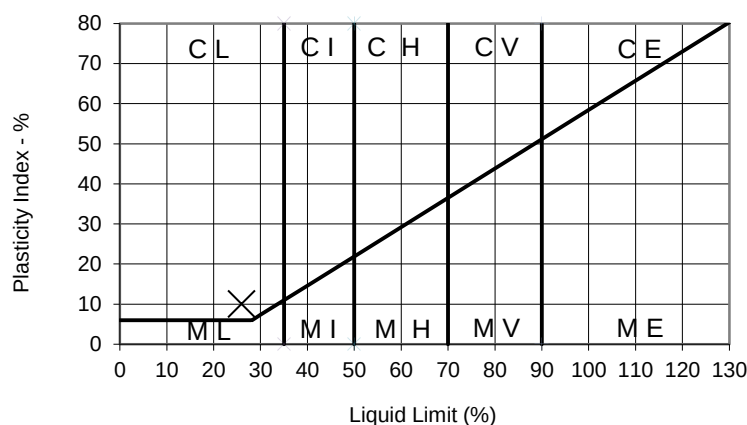
**CROSS SECTION**

Water Content : (BS EN ISO 17892-1:2014) 21.1 %  
 Estimated percentage passing 425µm sieve : 100 %  
 Liquid Limit - Fall Cone 4 point Method (cone angle 30°) with increasing water content : 26 %  
 Plastic Limit : 16 %  
 Plasticity Index : 10 %  
 Equivalent Water Content of material passing 425µm sieve : 21.1 %  
 Liquidity Index : 0.51

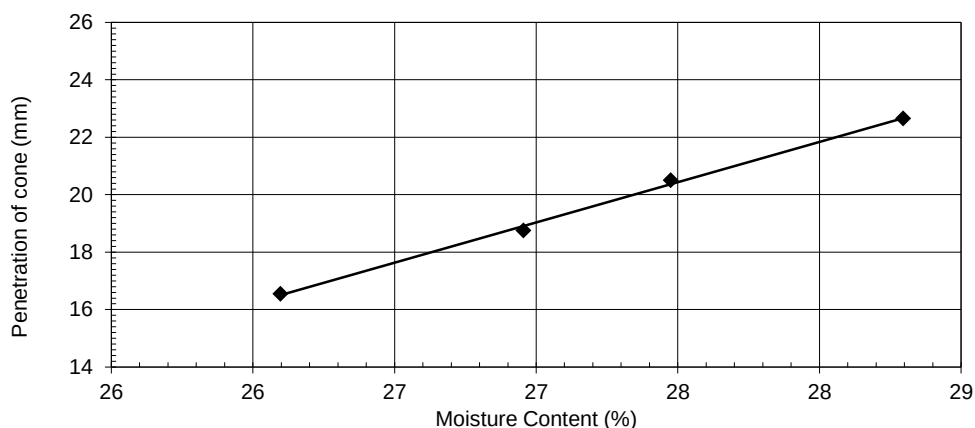
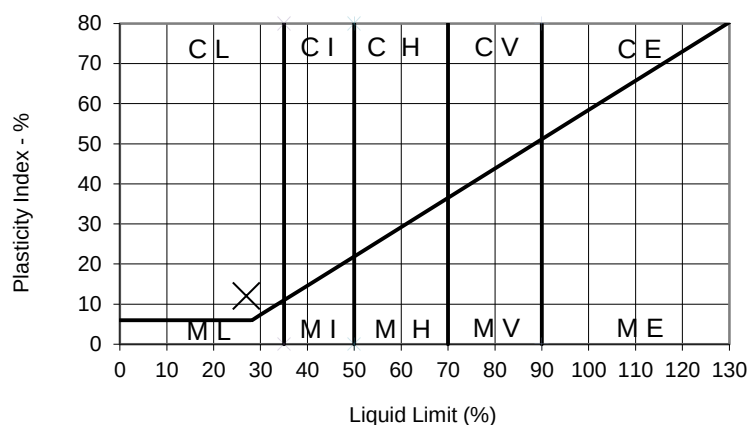
Water Content : (BS EN ISO 17892-1:2014) 20.0 %  
 Estimated percentage passing 425µm sieve : 100 %  
 Liquid Limit - Fall Cone 4 point Method (cone angle 30°) with increasing water content : 27 %  
 Plastic Limit : 15 %  
 Plasticity Index : 12 %

Equivalent Water Content of material passing 425µm sieve : 20.0 %  
 Liquidity Index : 0.42

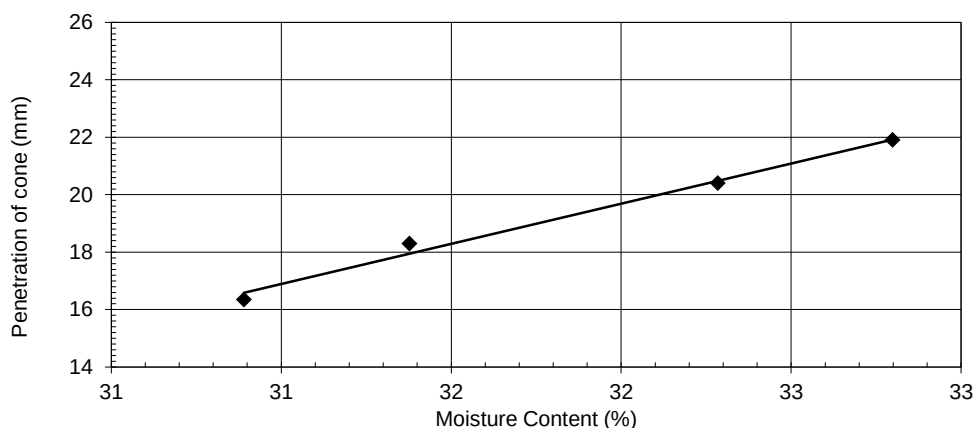
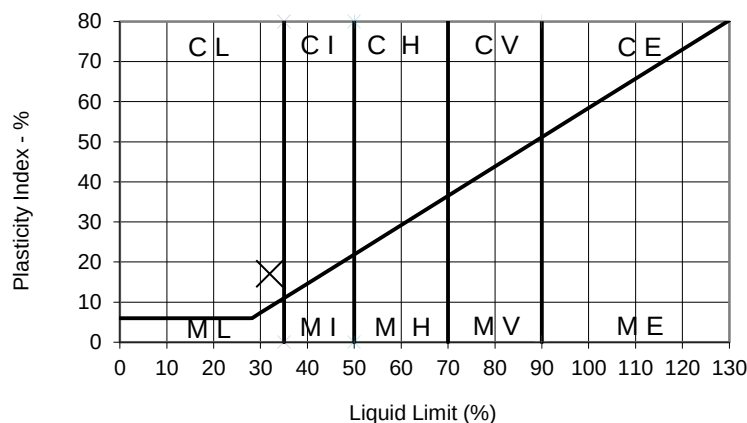
Water Content : (BS EN ISO 17892-1:2014) 21.9 %  
 Estimated percentage passing 425µm sieve : 98 %  
 Liquid Limit - Fall Cone 4 point Method (cone angle 30°) with increasing water content : 32 %  
 Plastic Limit : 15 %  
 Plasticity Index : 17 %

Equivalent Water Content of material passing 425µm sieve : 22.4 %  
 Liquidity Index : 0.44

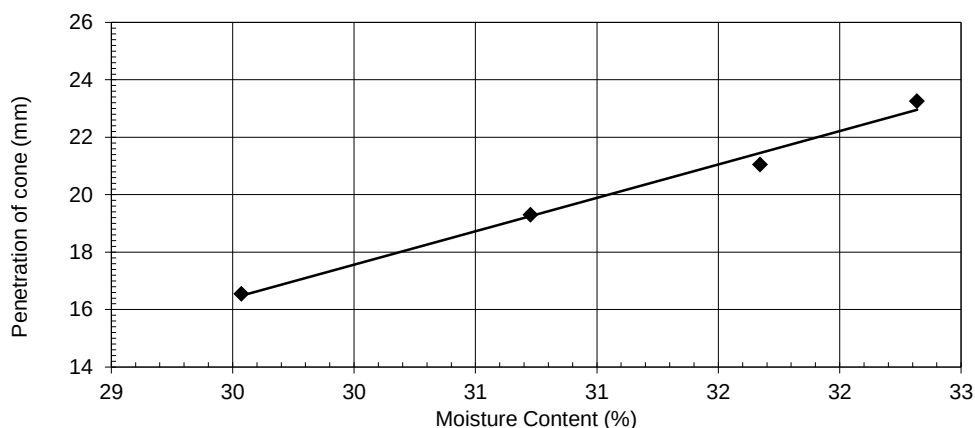
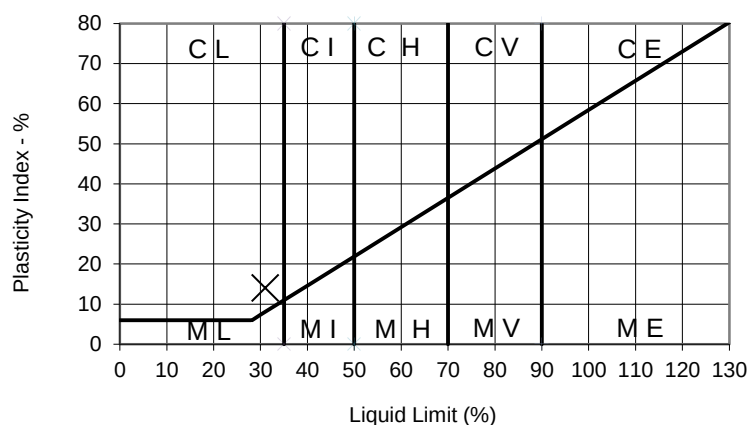
Water Content : (BS EN ISO 17892-1:2014) 20.9 %  
Estimated percentage passing 425µm sieve : 98 %  
Liquid Limit - Fall Cone 4 point Method (cone angle 30°) with increasing water content : 31 %  
Plastic Limit : 17 %  
Plasticity Index : 14 %

Equivalent Water Content of material passing 425µm sieve : 21.4 %  
Liquidity Index : 0.31

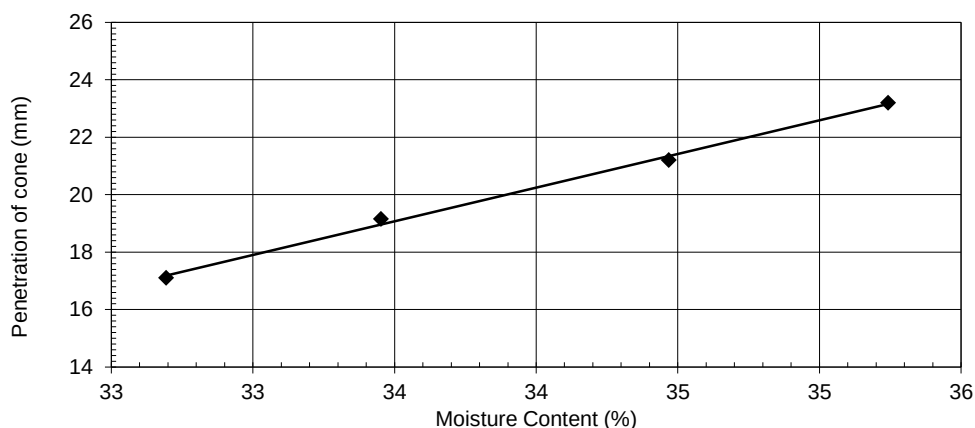
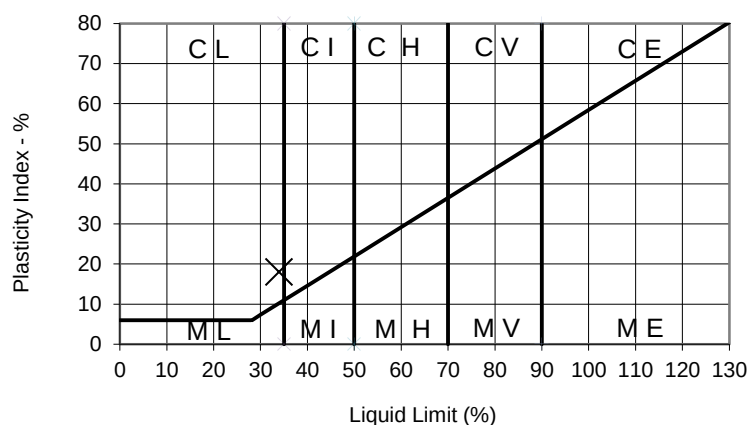
Water Content : (BS EN ISO 17892-1:2014) 19.7 %  
Estimated percentage passing 425µm sieve : 96 %  
Liquid Limit - Fall Cone 4 point Method (cone angle 30°) with increasing water content : 34 %  
Plastic Limit : 16 %  
Plasticity Index : 18 %

Equivalent Water Content of material passing 425µm sieve : 20.4 %  
Liquidity Index : 0.24

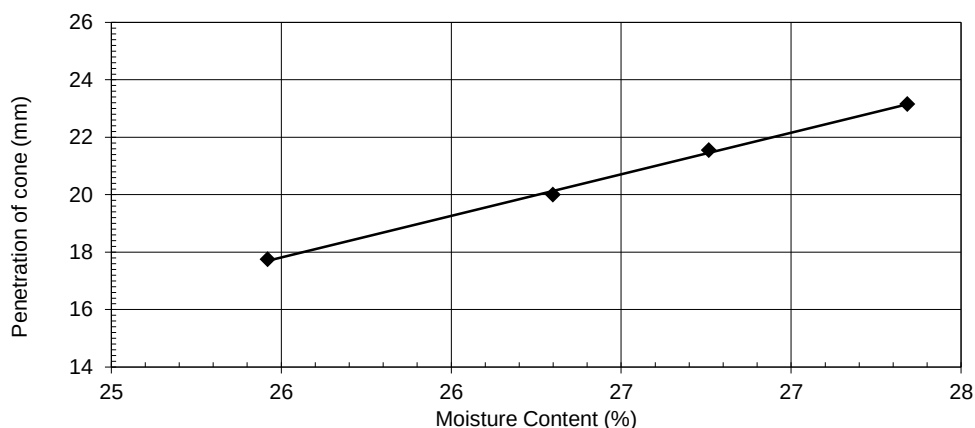
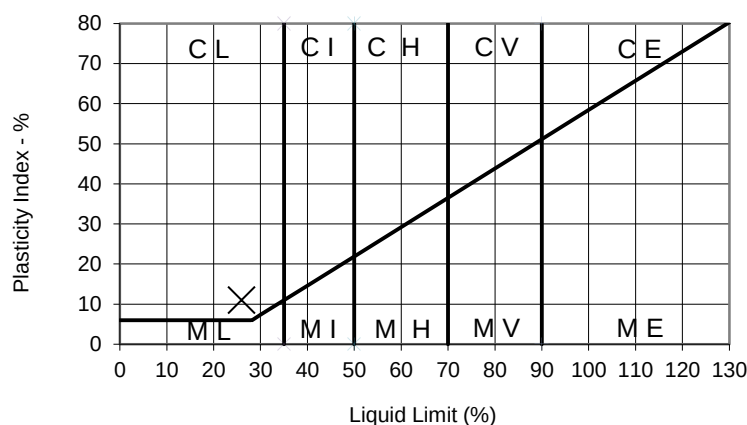
Water Content : (BS EN ISO 17892-1:2014) 14.0 %  
Estimated percentage passing 425µm sieve : 98 %  
Liquid Limit - Fall Cone 4 point Method (cone angle 30°) with increasing water content : 26 %  
Plastic Limit : 15 %  
Plasticity Index : 11 %

Equivalent Water Content of material passing 425µm sieve : 14.3 %  
Liquidity Index : -0.06

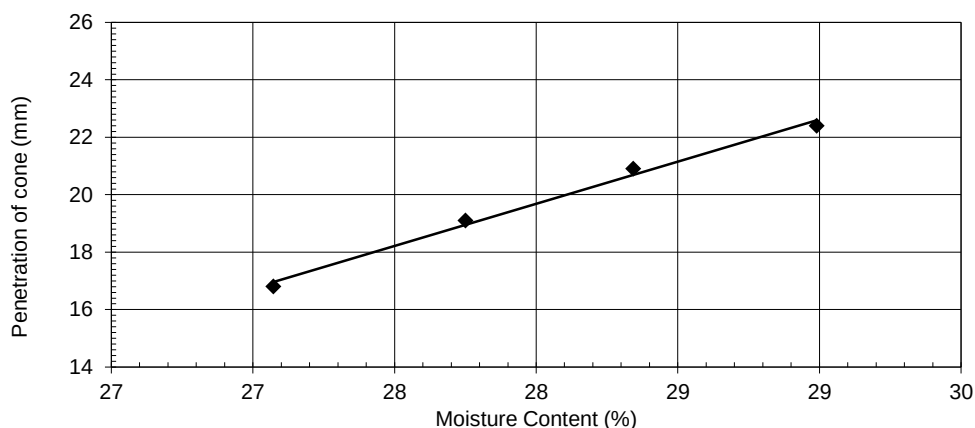
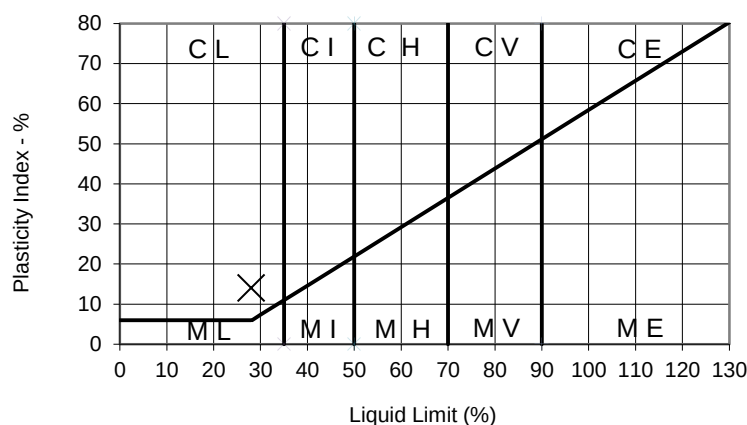
Equivalent Water Content of material passing 425µm sieve : 18.1 %

Liquidity Index : 0.29

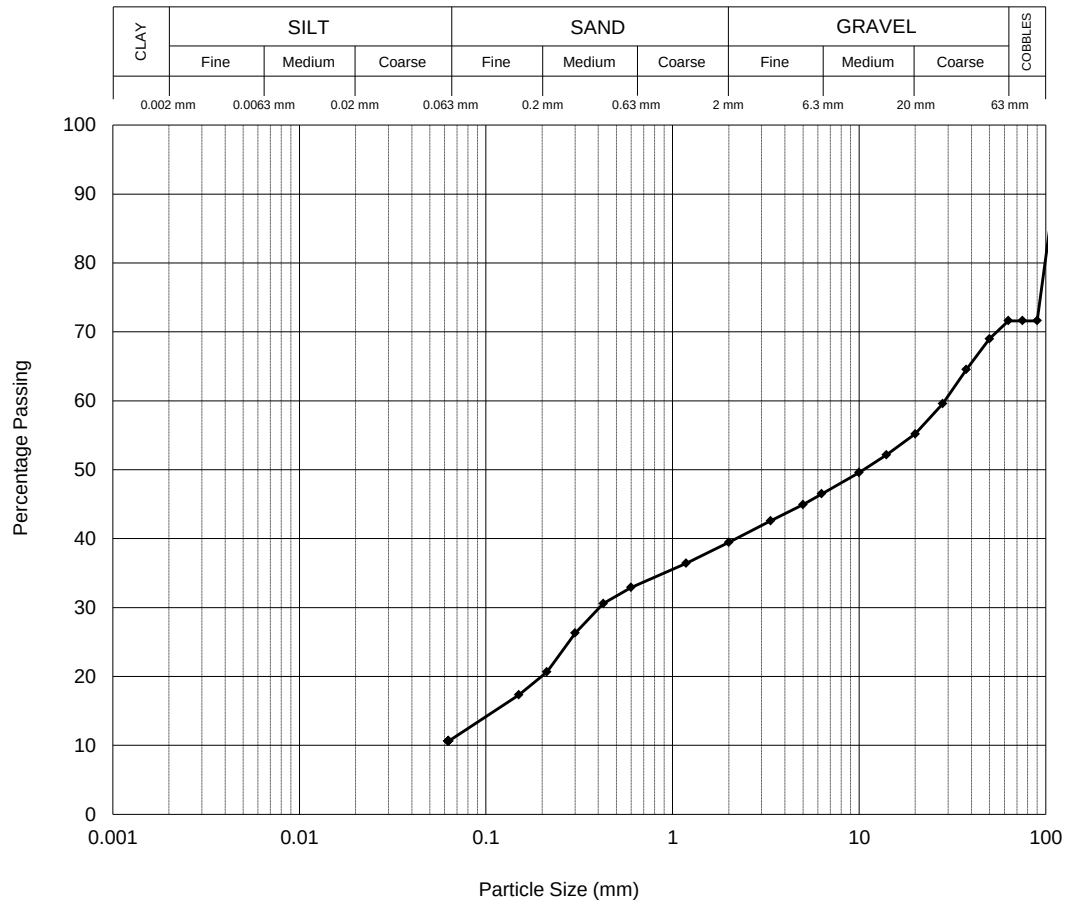
| Sieve | |
|---|---|
| 150 µm | 17 |
| 63 µm | 11 |

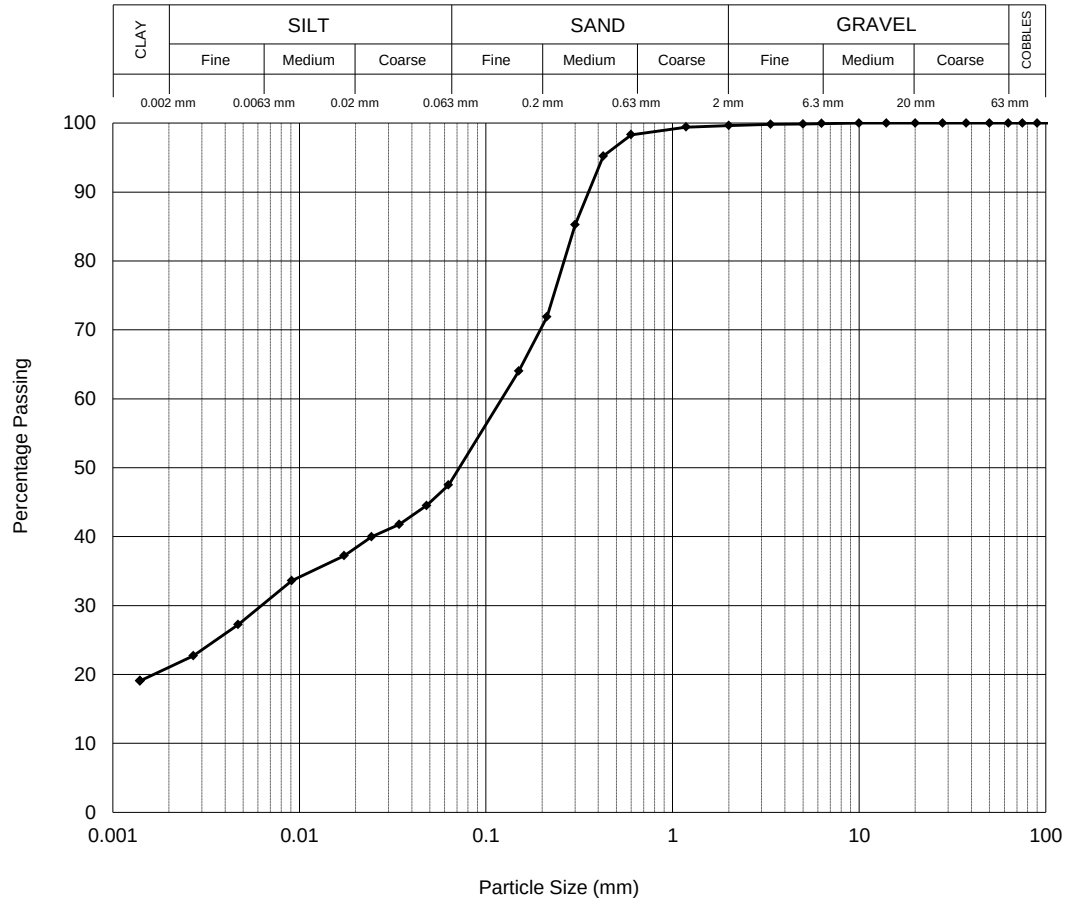
**PARTICLE SIZE DISTRIBUTION**

Location TP309  
Depth (m) 1.50  
Sample Type B

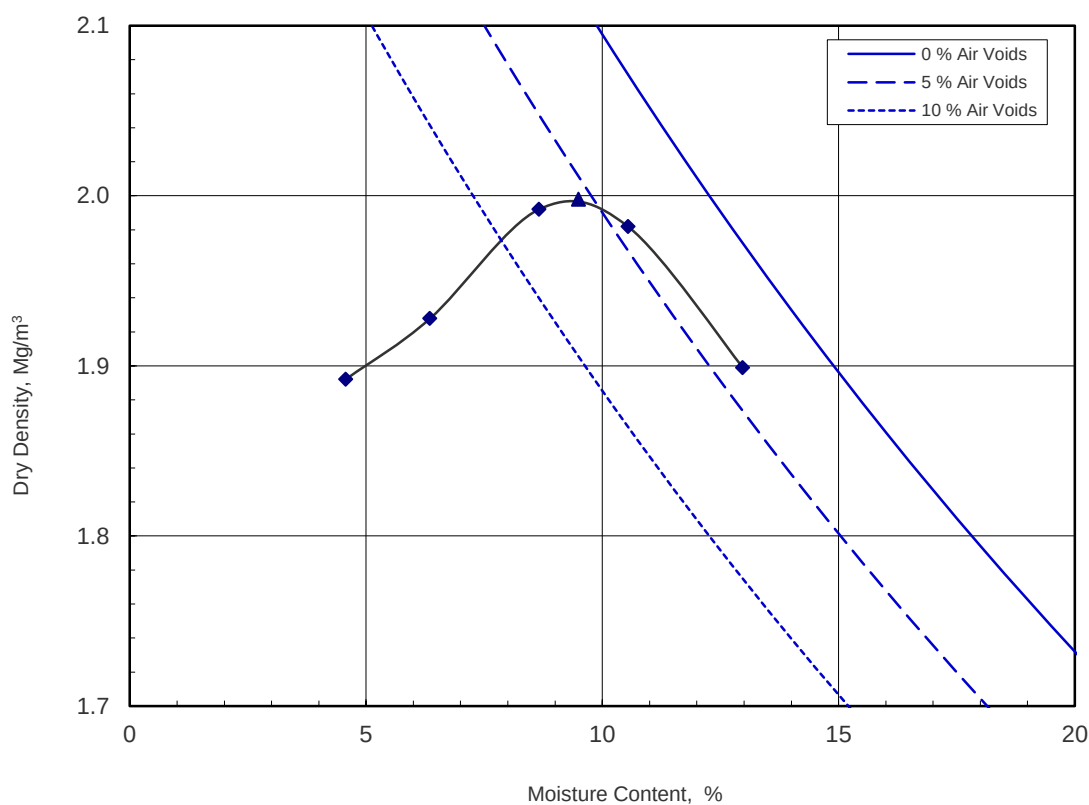
**MOISTURE CONTENT / DRY DENSITY RELATIONSHIP**

Optimum Moisture Content

9.5

| Determination | 1 | 2 | 3 | 4 | 5 |
|---|---|---|---|---|---|
| Moisture Content % | 4.6 | 6.4 | 8.7 | 10.5 | 13.0 |

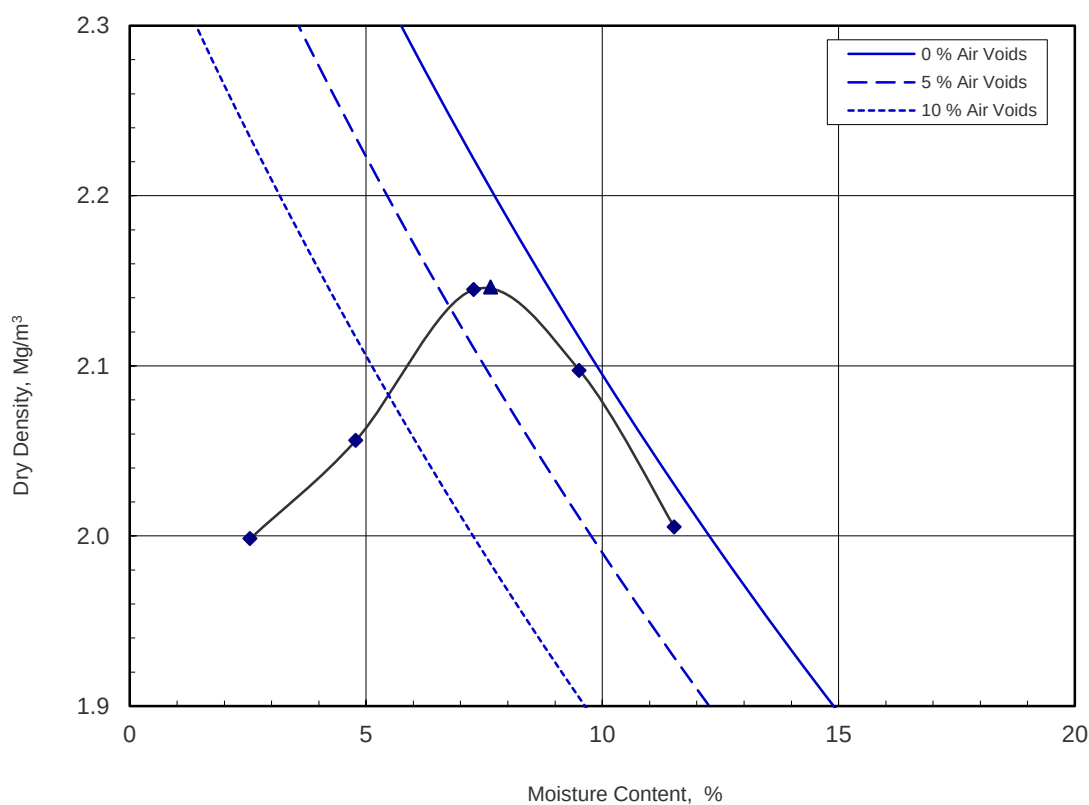
**MOISTURE CONTENT / DRY DENSITY RELATIONSHIP**

Optimum Moisture Content

7.6

| Determination | 1 | 2 | 3 | 4 | 5 |
|---|---|---|---|---|---|
| Moisture Content % | 2.5 | 4.8 | 7.3 | 9.5 | 11.5 |

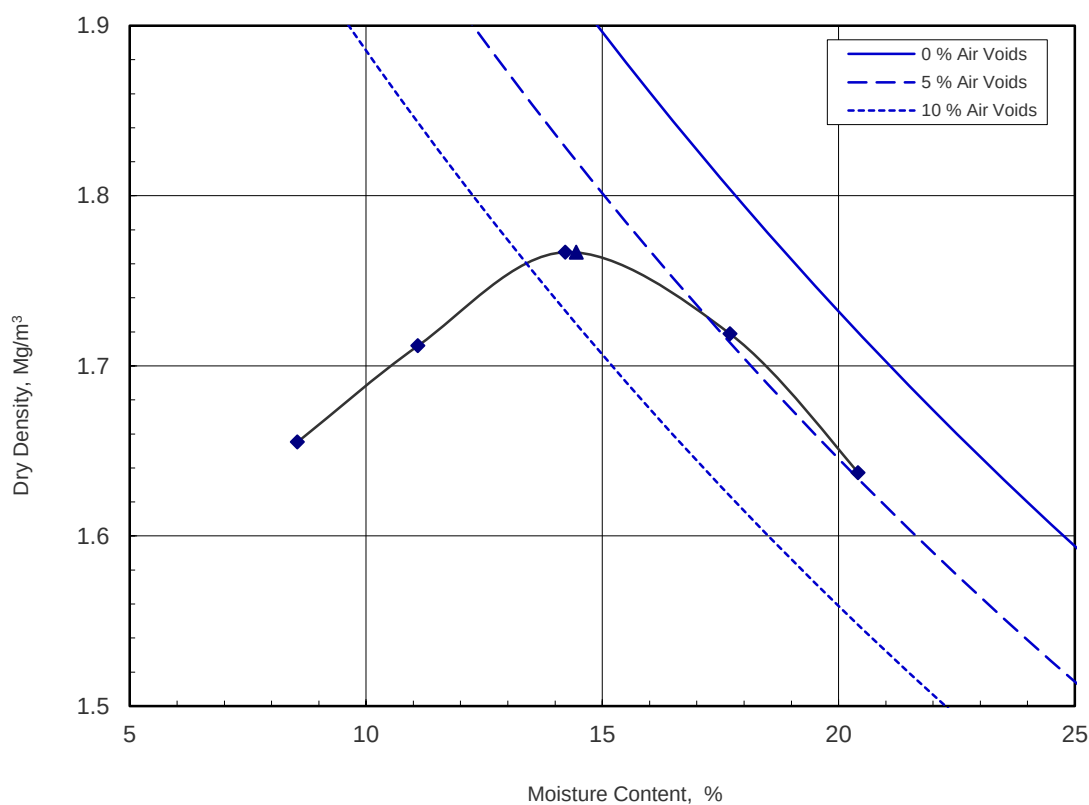
**MOISTURE CONTENT / DRY DENSITY RELATIONSHIP**

Optimum Moisture Content

14.5

| Determination | 1 | 2 | 3 | 4 | 5 |
|---|---|---|---|---|---|
| Moisture Content | 8.5 | 11.1 | 14.2 | 17.7 | 20.4 |

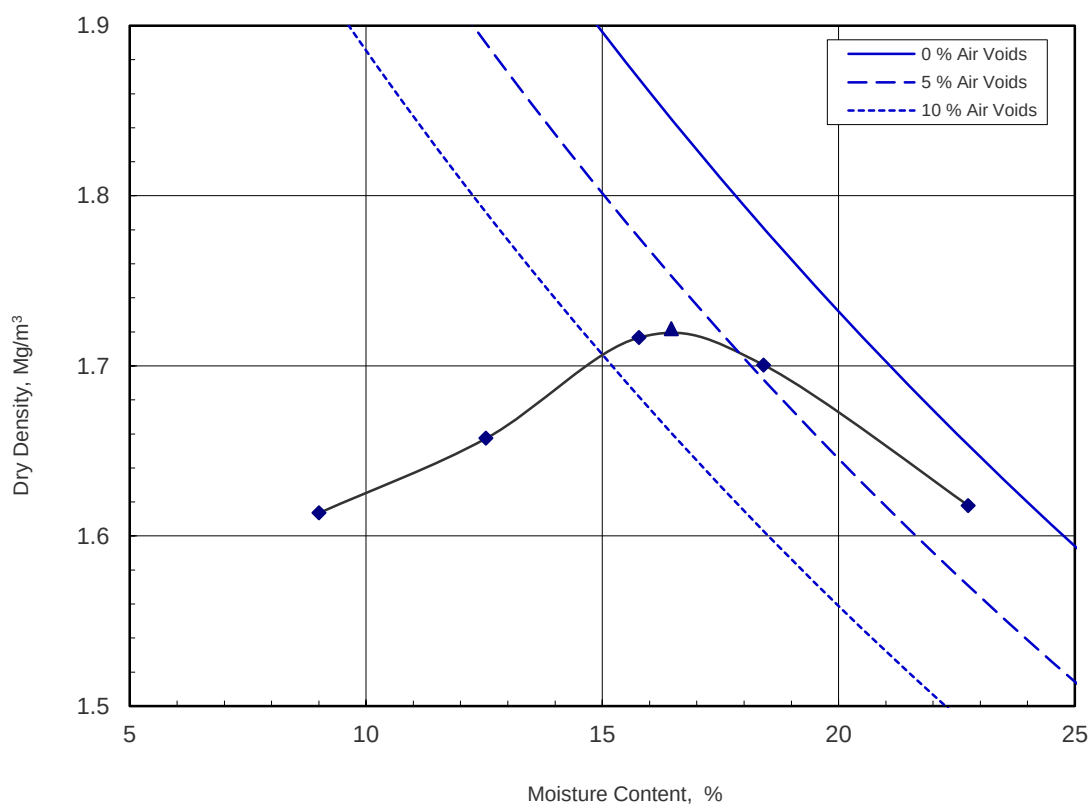
**MOISTURE CONTENT / DRY DENSITY RELATIONSHIP**

Optimum Moisture Content

16.5

Oven dried  
 2.5kg Rammer for soils with some coarse  
 gravel-size particles

| Determination | 1 | 2 | 3 | 4 | 5 |
|---|---|---|---|---|---|
| Moisture Content | 9.0 | 12.5 | 15.8 | 18.4 | 22.7 |

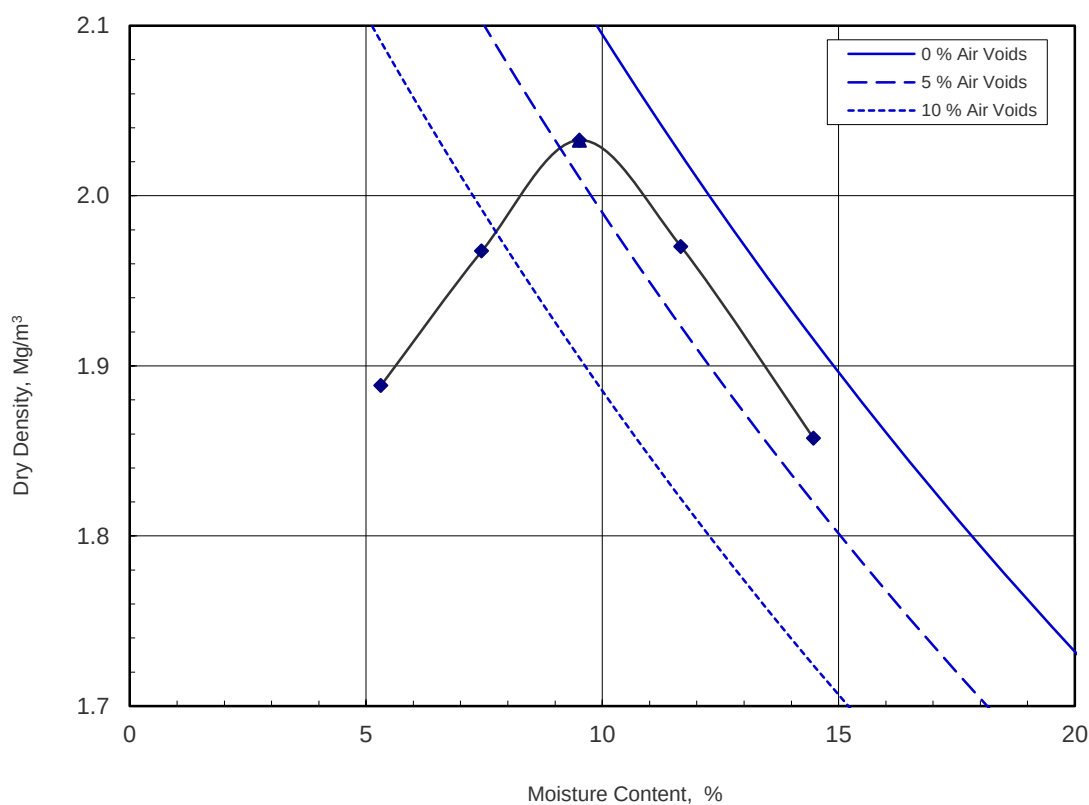
Optimum Moisture Content

9.5

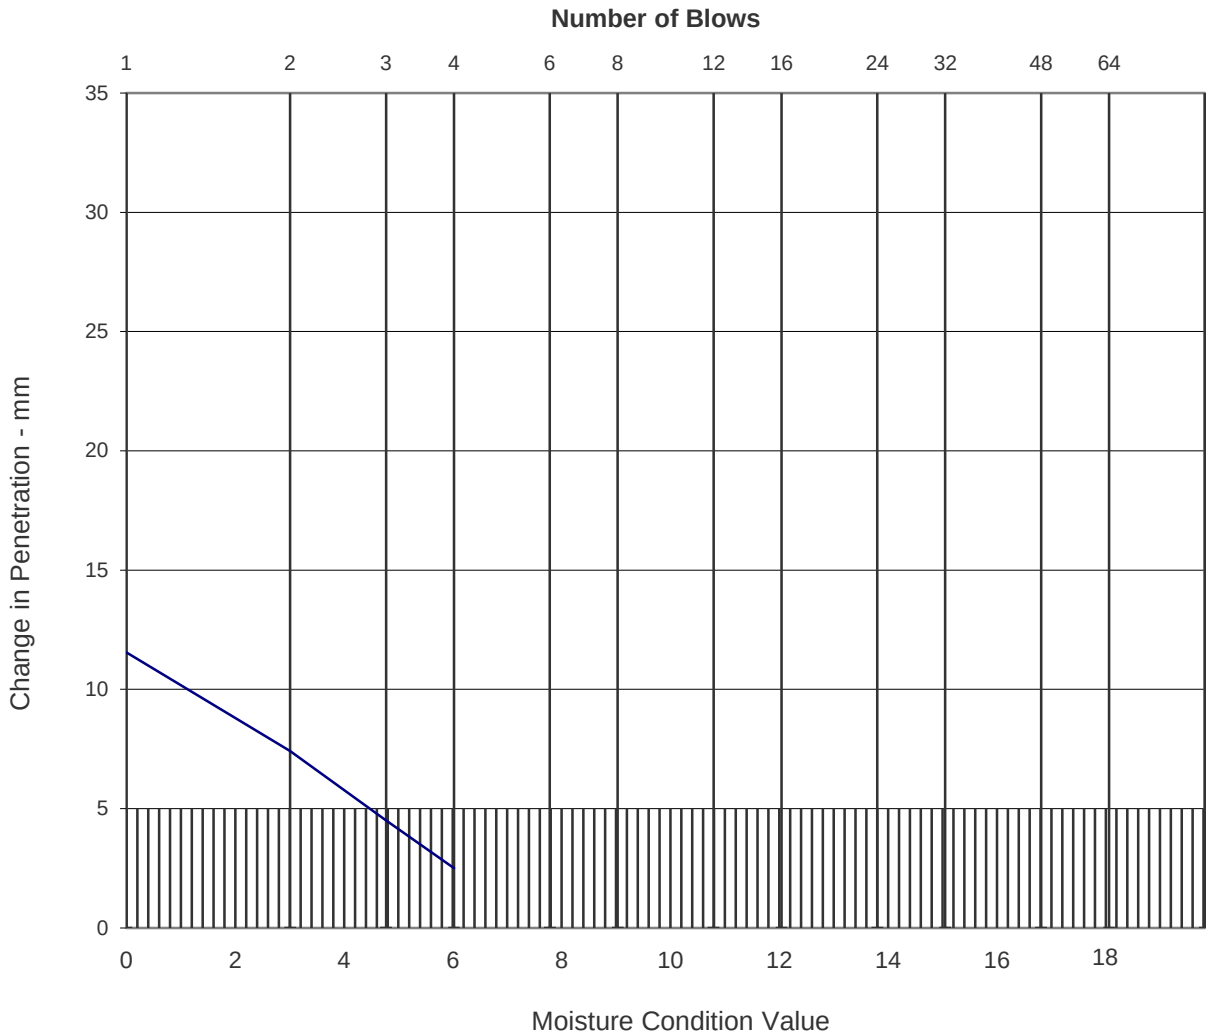
Location BH301  
 Sample Ref B4  
 Depth (m) 1.20  
 Sample Type B

BS1377:Part 4:1990 Clause 5.4  
**MOISTURE CONDITION VALUE**

Description:  
 Orangish brown slightly clayey sandy fine to coarse GRAVEL.

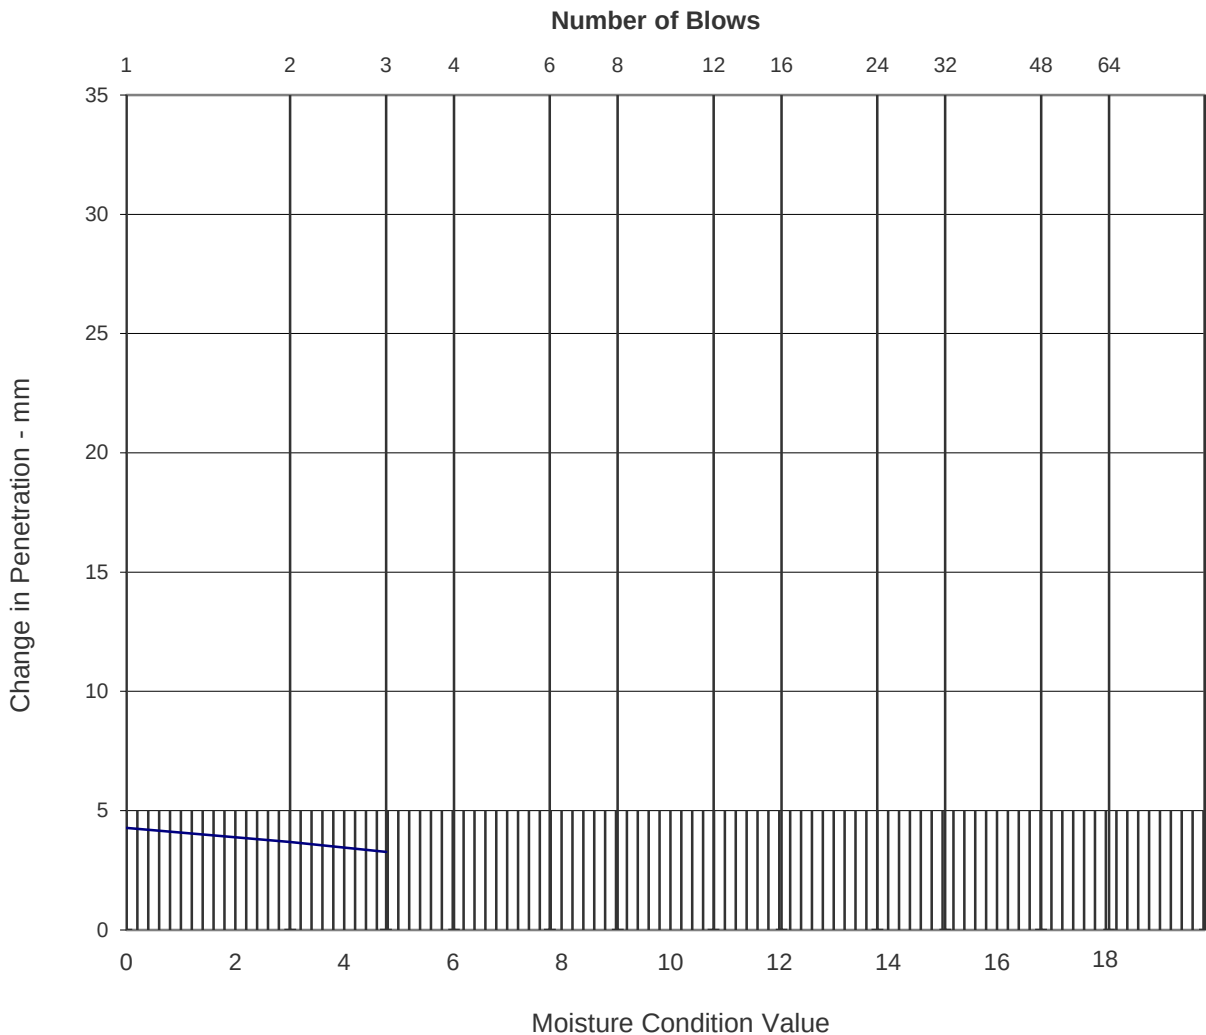
Location BH302  
 Sample Ref B4  
 Depth (m) 1.20  
 Sample Type B

BS1377:Part 4:1990 Clause 5.4  
**MOISTURE CONDITION VALUE**

Description:  
 Dark grey clayey very sandy fine to coarse GRAVEL.

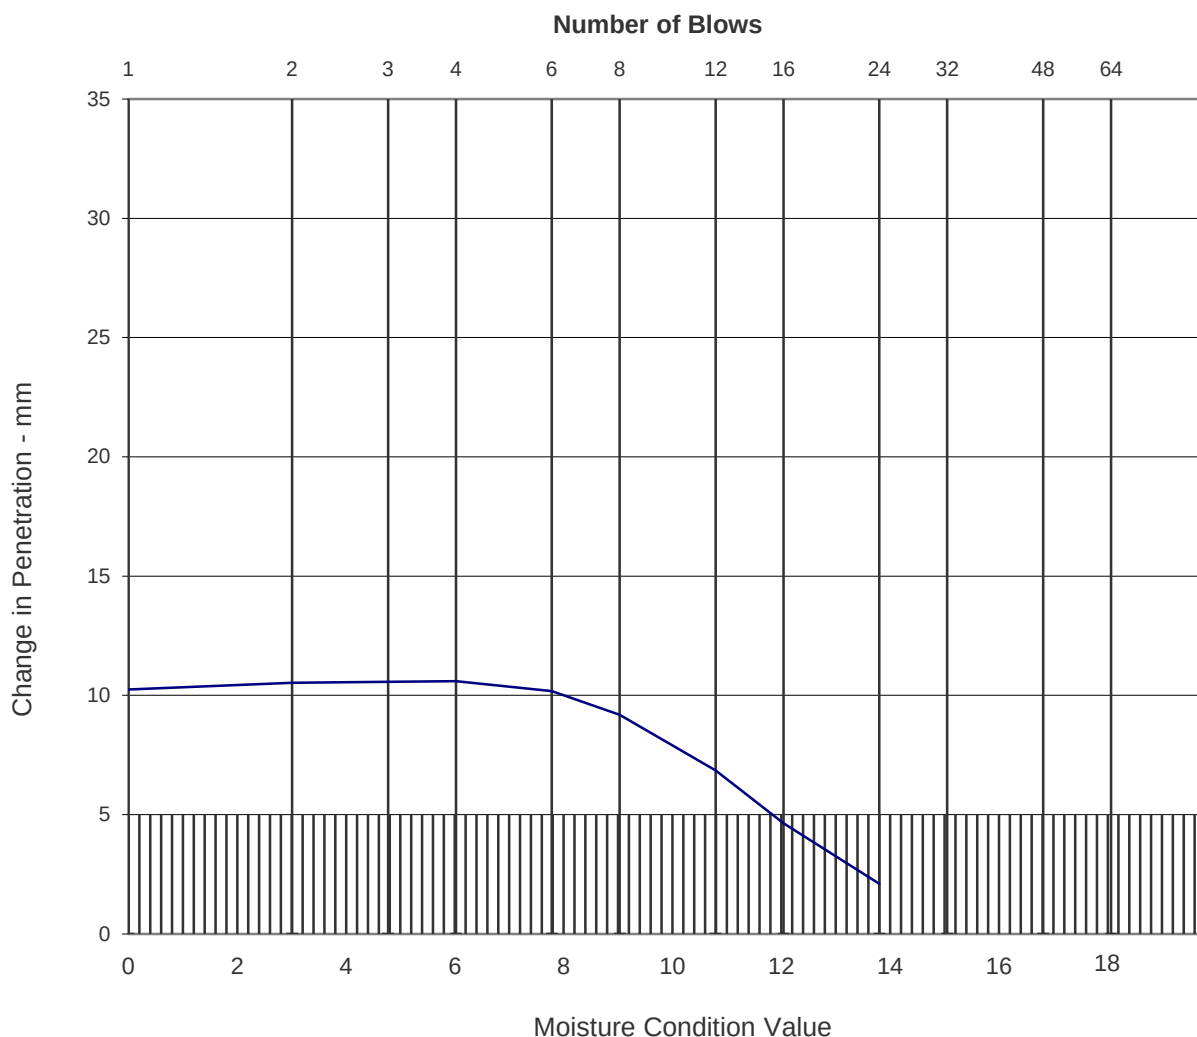
Location BH303  
 Sample Ref B2  
 Depth (m) 0.60  
 Sample Type B

BS1377:Part 4:1990 Clause 5.4  
**MOISTURE CONDITION VALUE**

Description:  
 Light brown clayey sandy fine to coarse GRAVEL.

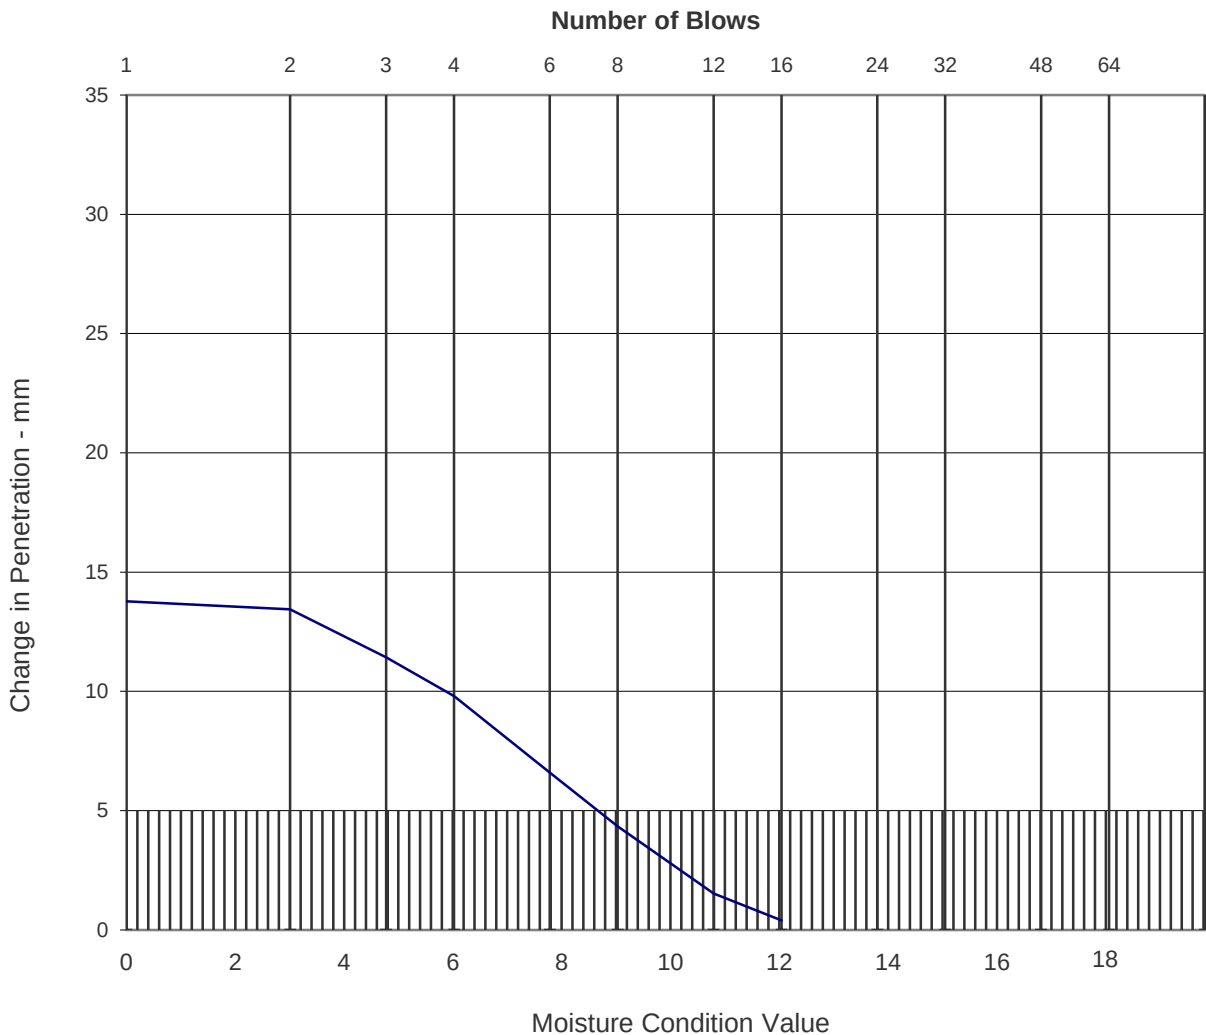
Location BH401  
 Sample Ref B3  
 Depth (m) 1.50  
 Sample Type B

BS1377:Part 4:1990 Clause 5.4  
**MOISTURE CONDITION VALUE**

Description:  
 Dark brown clayey sandy fine to coarse GRAVEL.

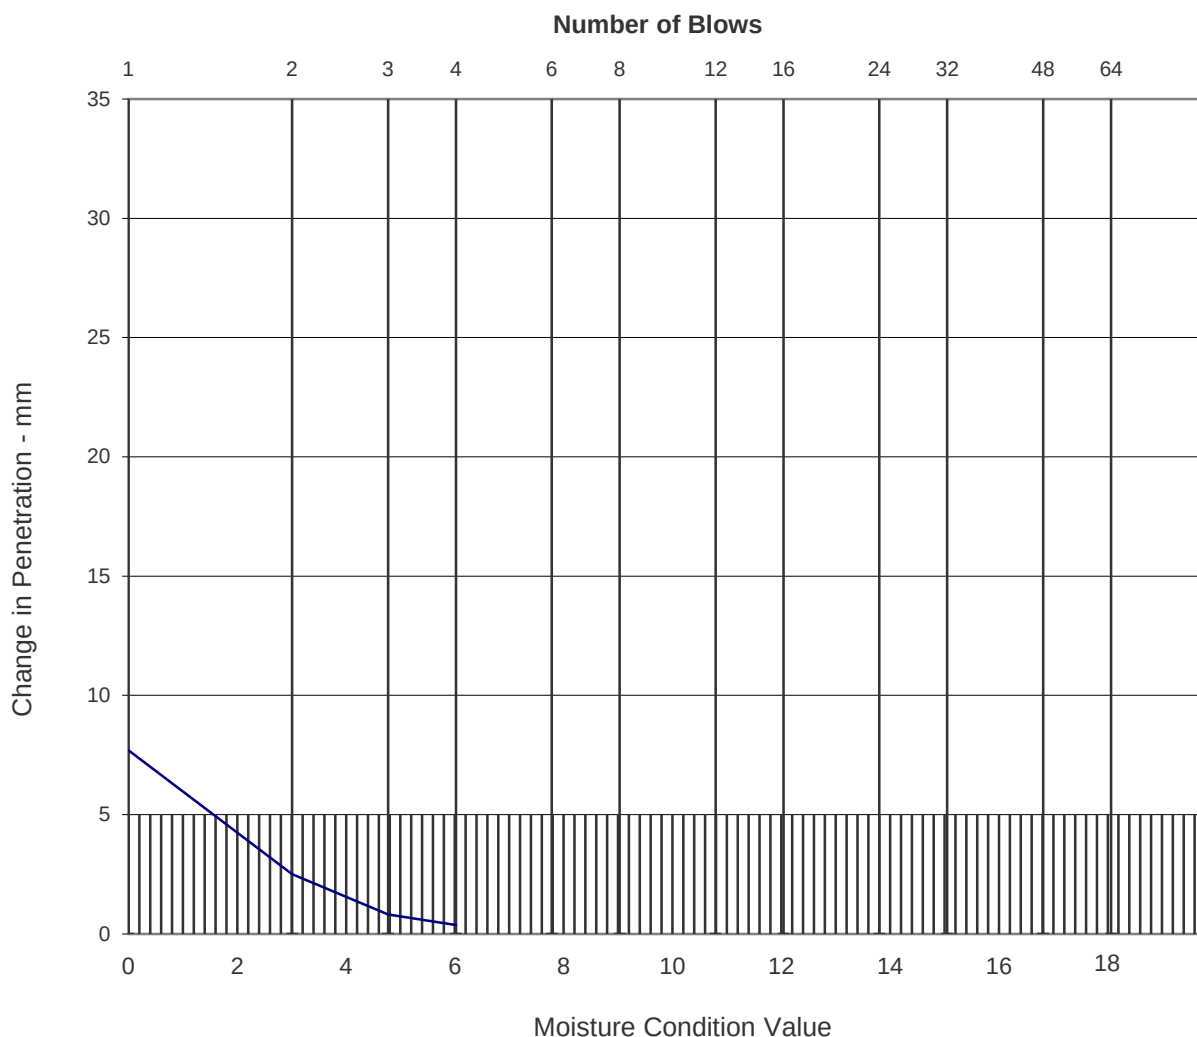
Location BH402  
 Sample Ref B4  
 Depth (m) 1.20  
 Sample Type B

BS1377:Part 4:1990 Clause 5.4  
**MOISTURE CONDITION VALUE**

Description:  
 Reddish brown slightly clayey sandy fine to coarse GRAVEL.

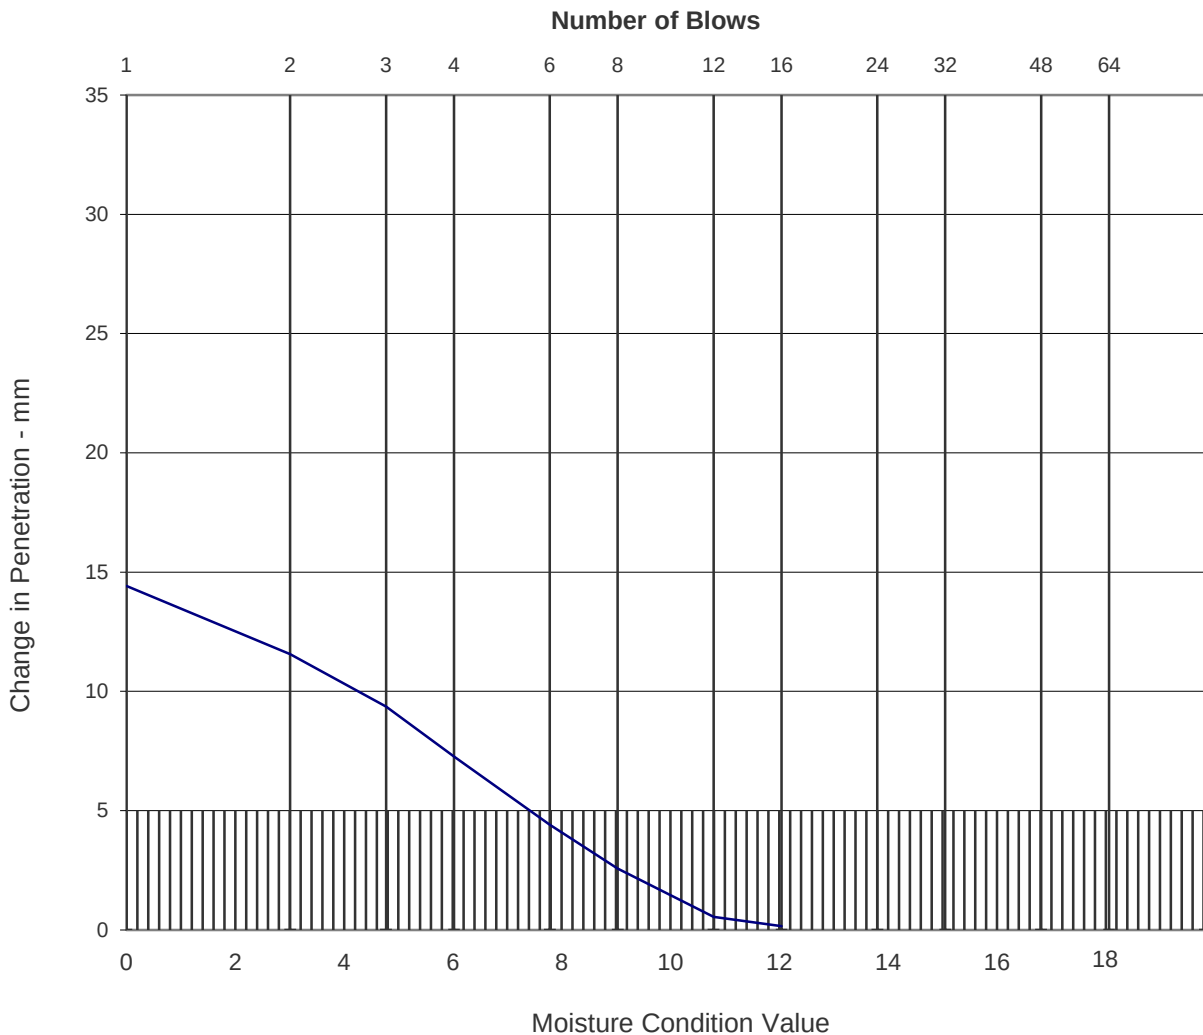
Location BH403  
 Sample Ref B4  
 Depth (m) 1.20  
 Sample Type B

BS1377:Part 4:1990 Clause 5.4  
**MOISTURE CONDITION VALUE**

Description:  
 Reddish brown very sandy CLAY with some fine to coarse gravel.

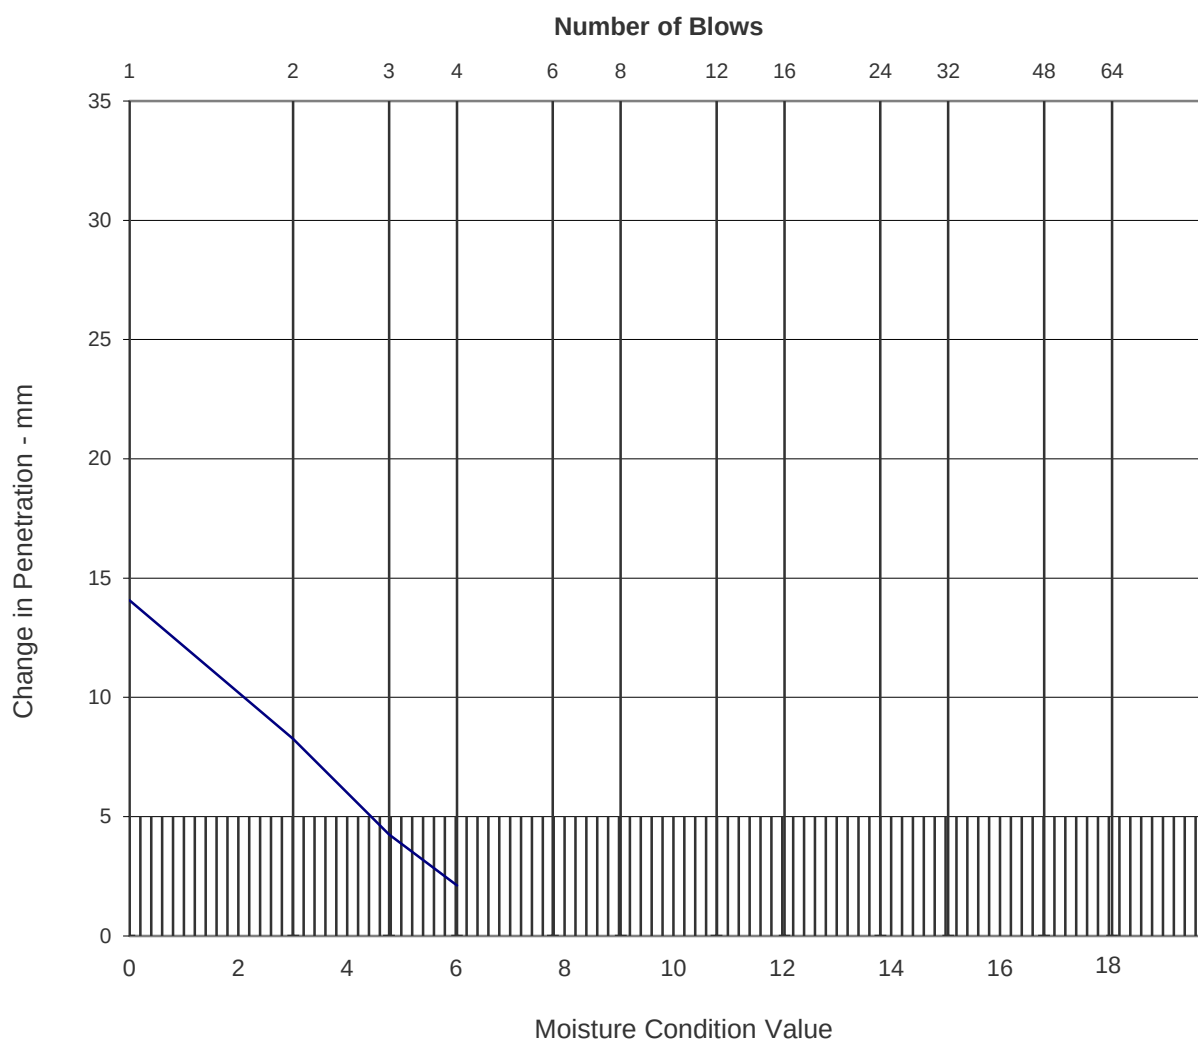
Location TP309  
Depth (m) 1.50  
Sample Type B

**MOISTURE CONDITION VALUE**

Description:  
Brown sandy CLAY.
