# PHASE 2 SITE INVESTIGATION

Proposed Mayfield Park, Manchester

Mayfield Partnership Ltd

December 2020

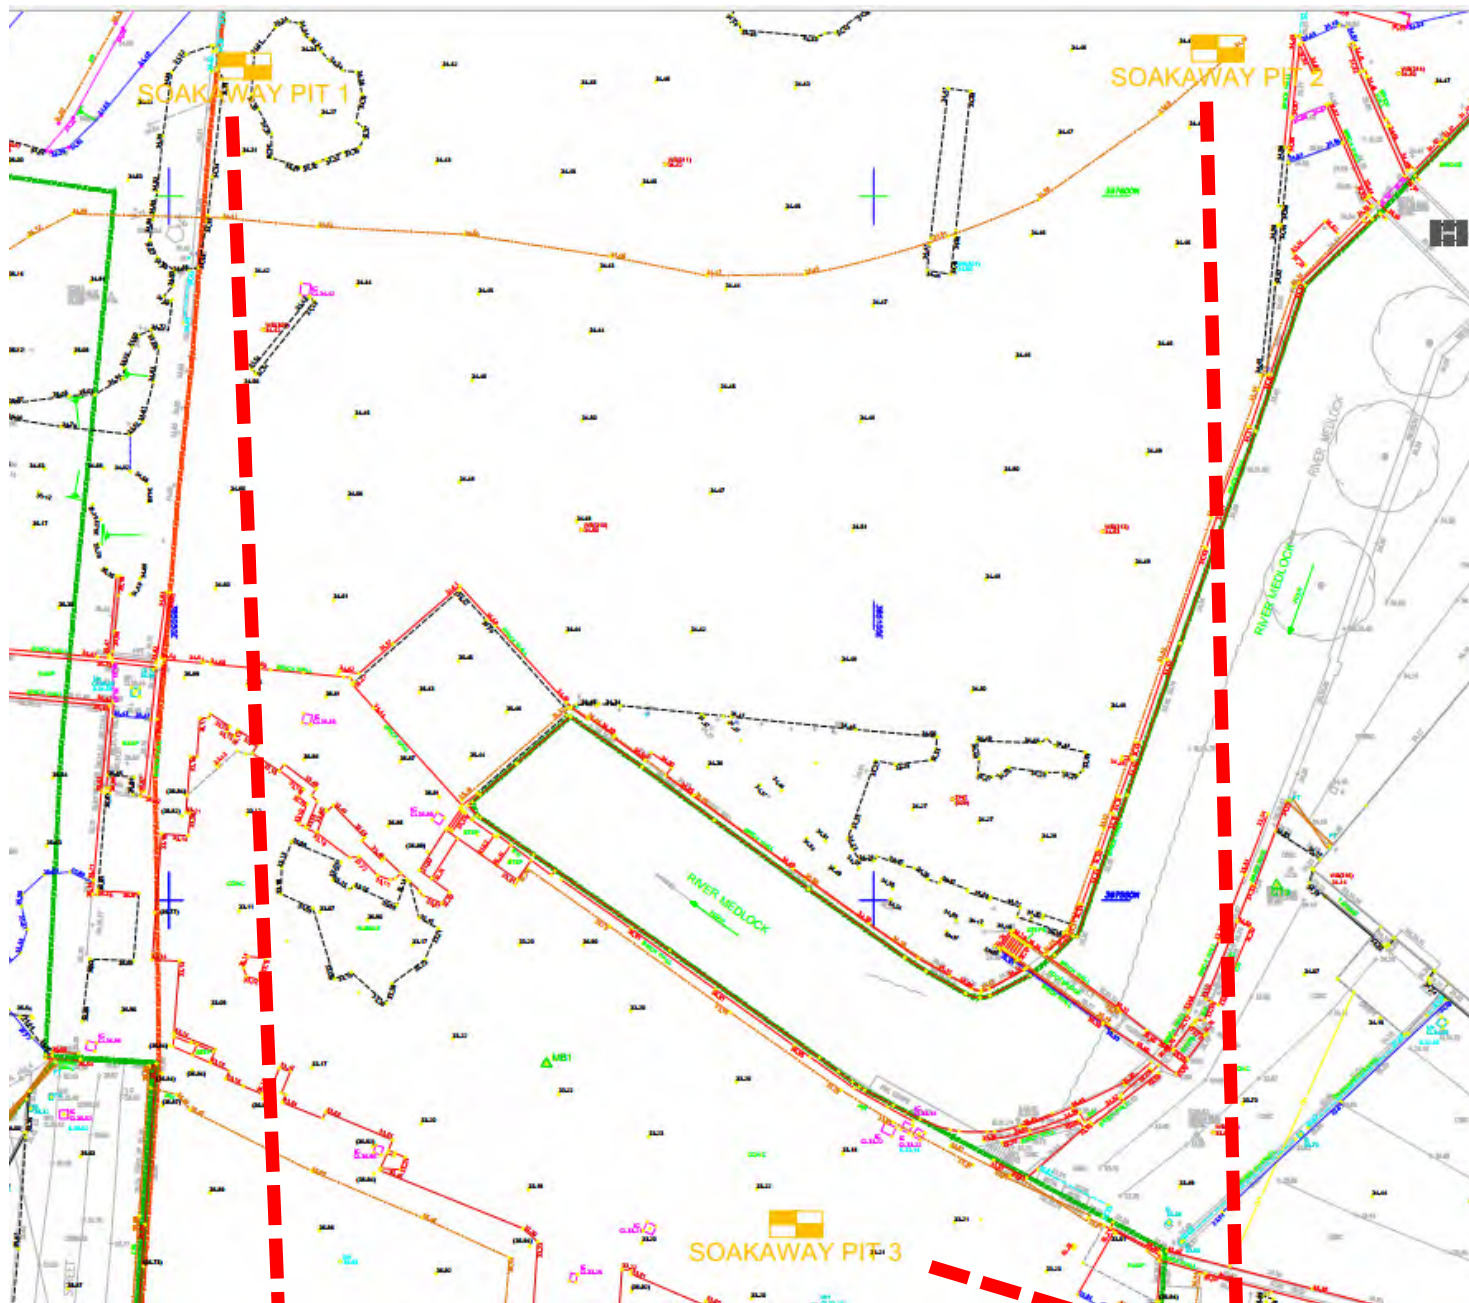
| | PROJECT TITLE | Mayfield Park, Manchester | SKETCH TITLE | Proposed Soakway Test Locations | |

- 1) Soakaway pits to be completed in accordance with BRE 365 guidance document.
- 2) Soil samples for leachate testing to be completed from two locations in each pit and tested for a range of determinands including Heavy Metals, PAH and TPHCWG.
- 3) Soakaway pit to be formed to anticipated invert level of proposed rain gardens. Any below ground structures encountered to be grubbed up and broken out and backfilled as appropriate.

Enc: Drawing 4153 SOAK101 Soakaway test location plan  
Soakaway test pit results & photographs

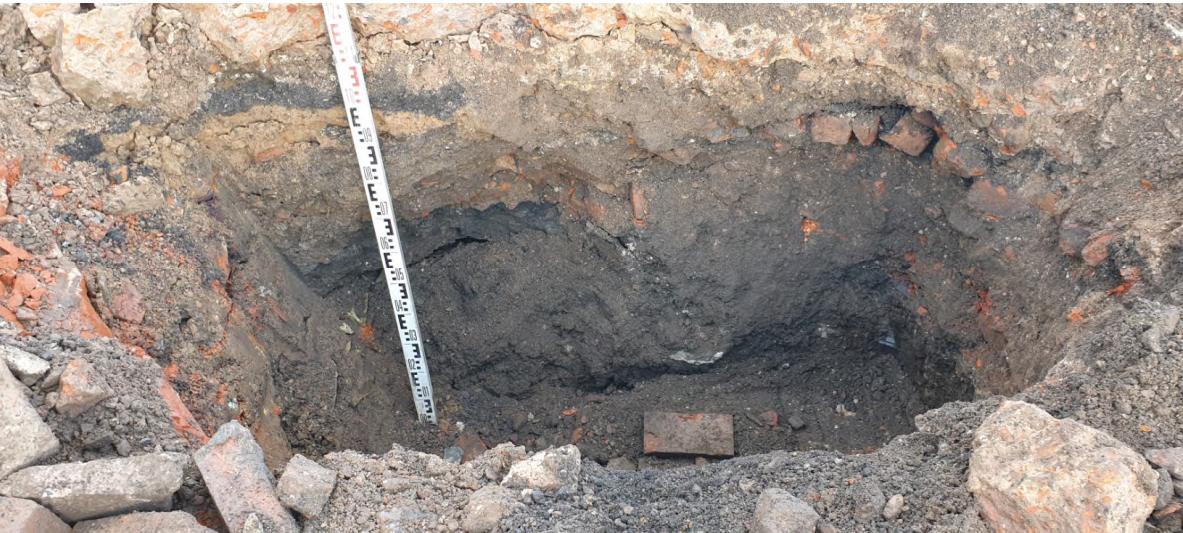
Soil sample obtained for leachate analysis in pit at depth of 1.25m

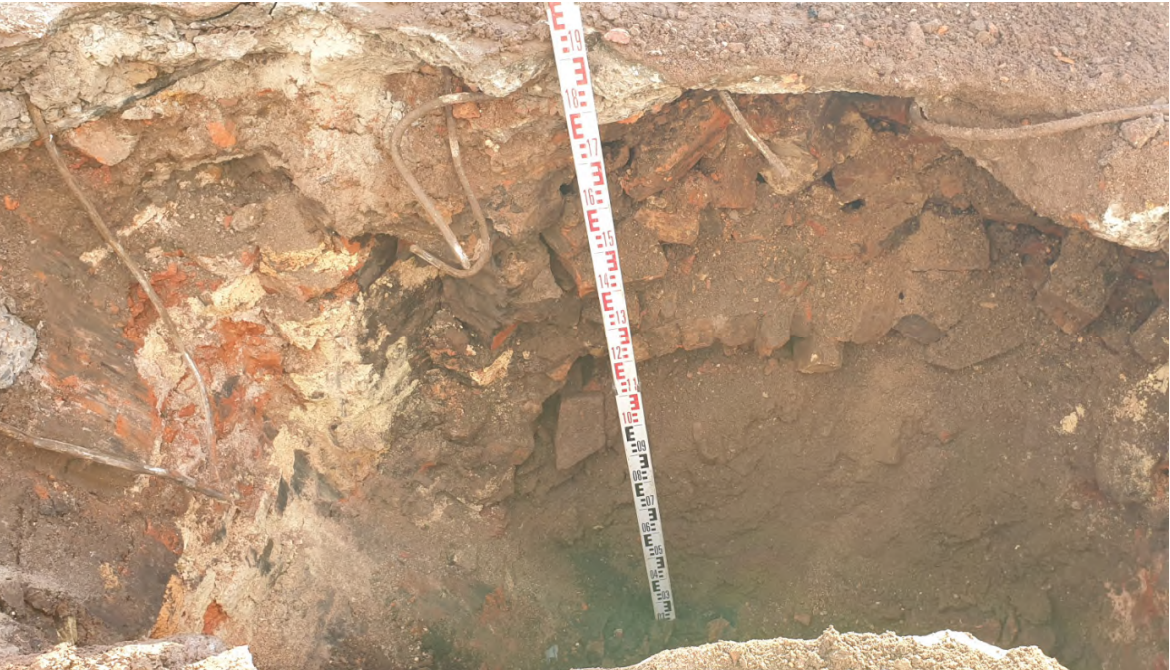
Soil sample obtained for leachate analysis in pit at depth of 1.95m

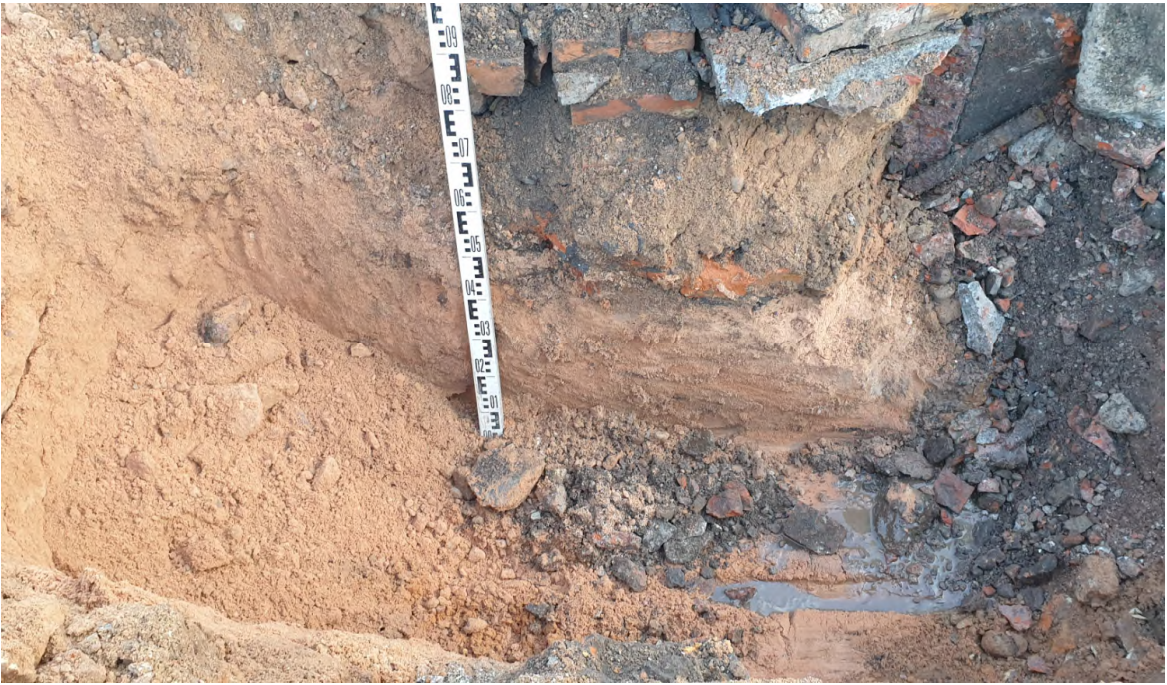
Soil sample obtained for leachate analysis in pit at depth of 1.00m

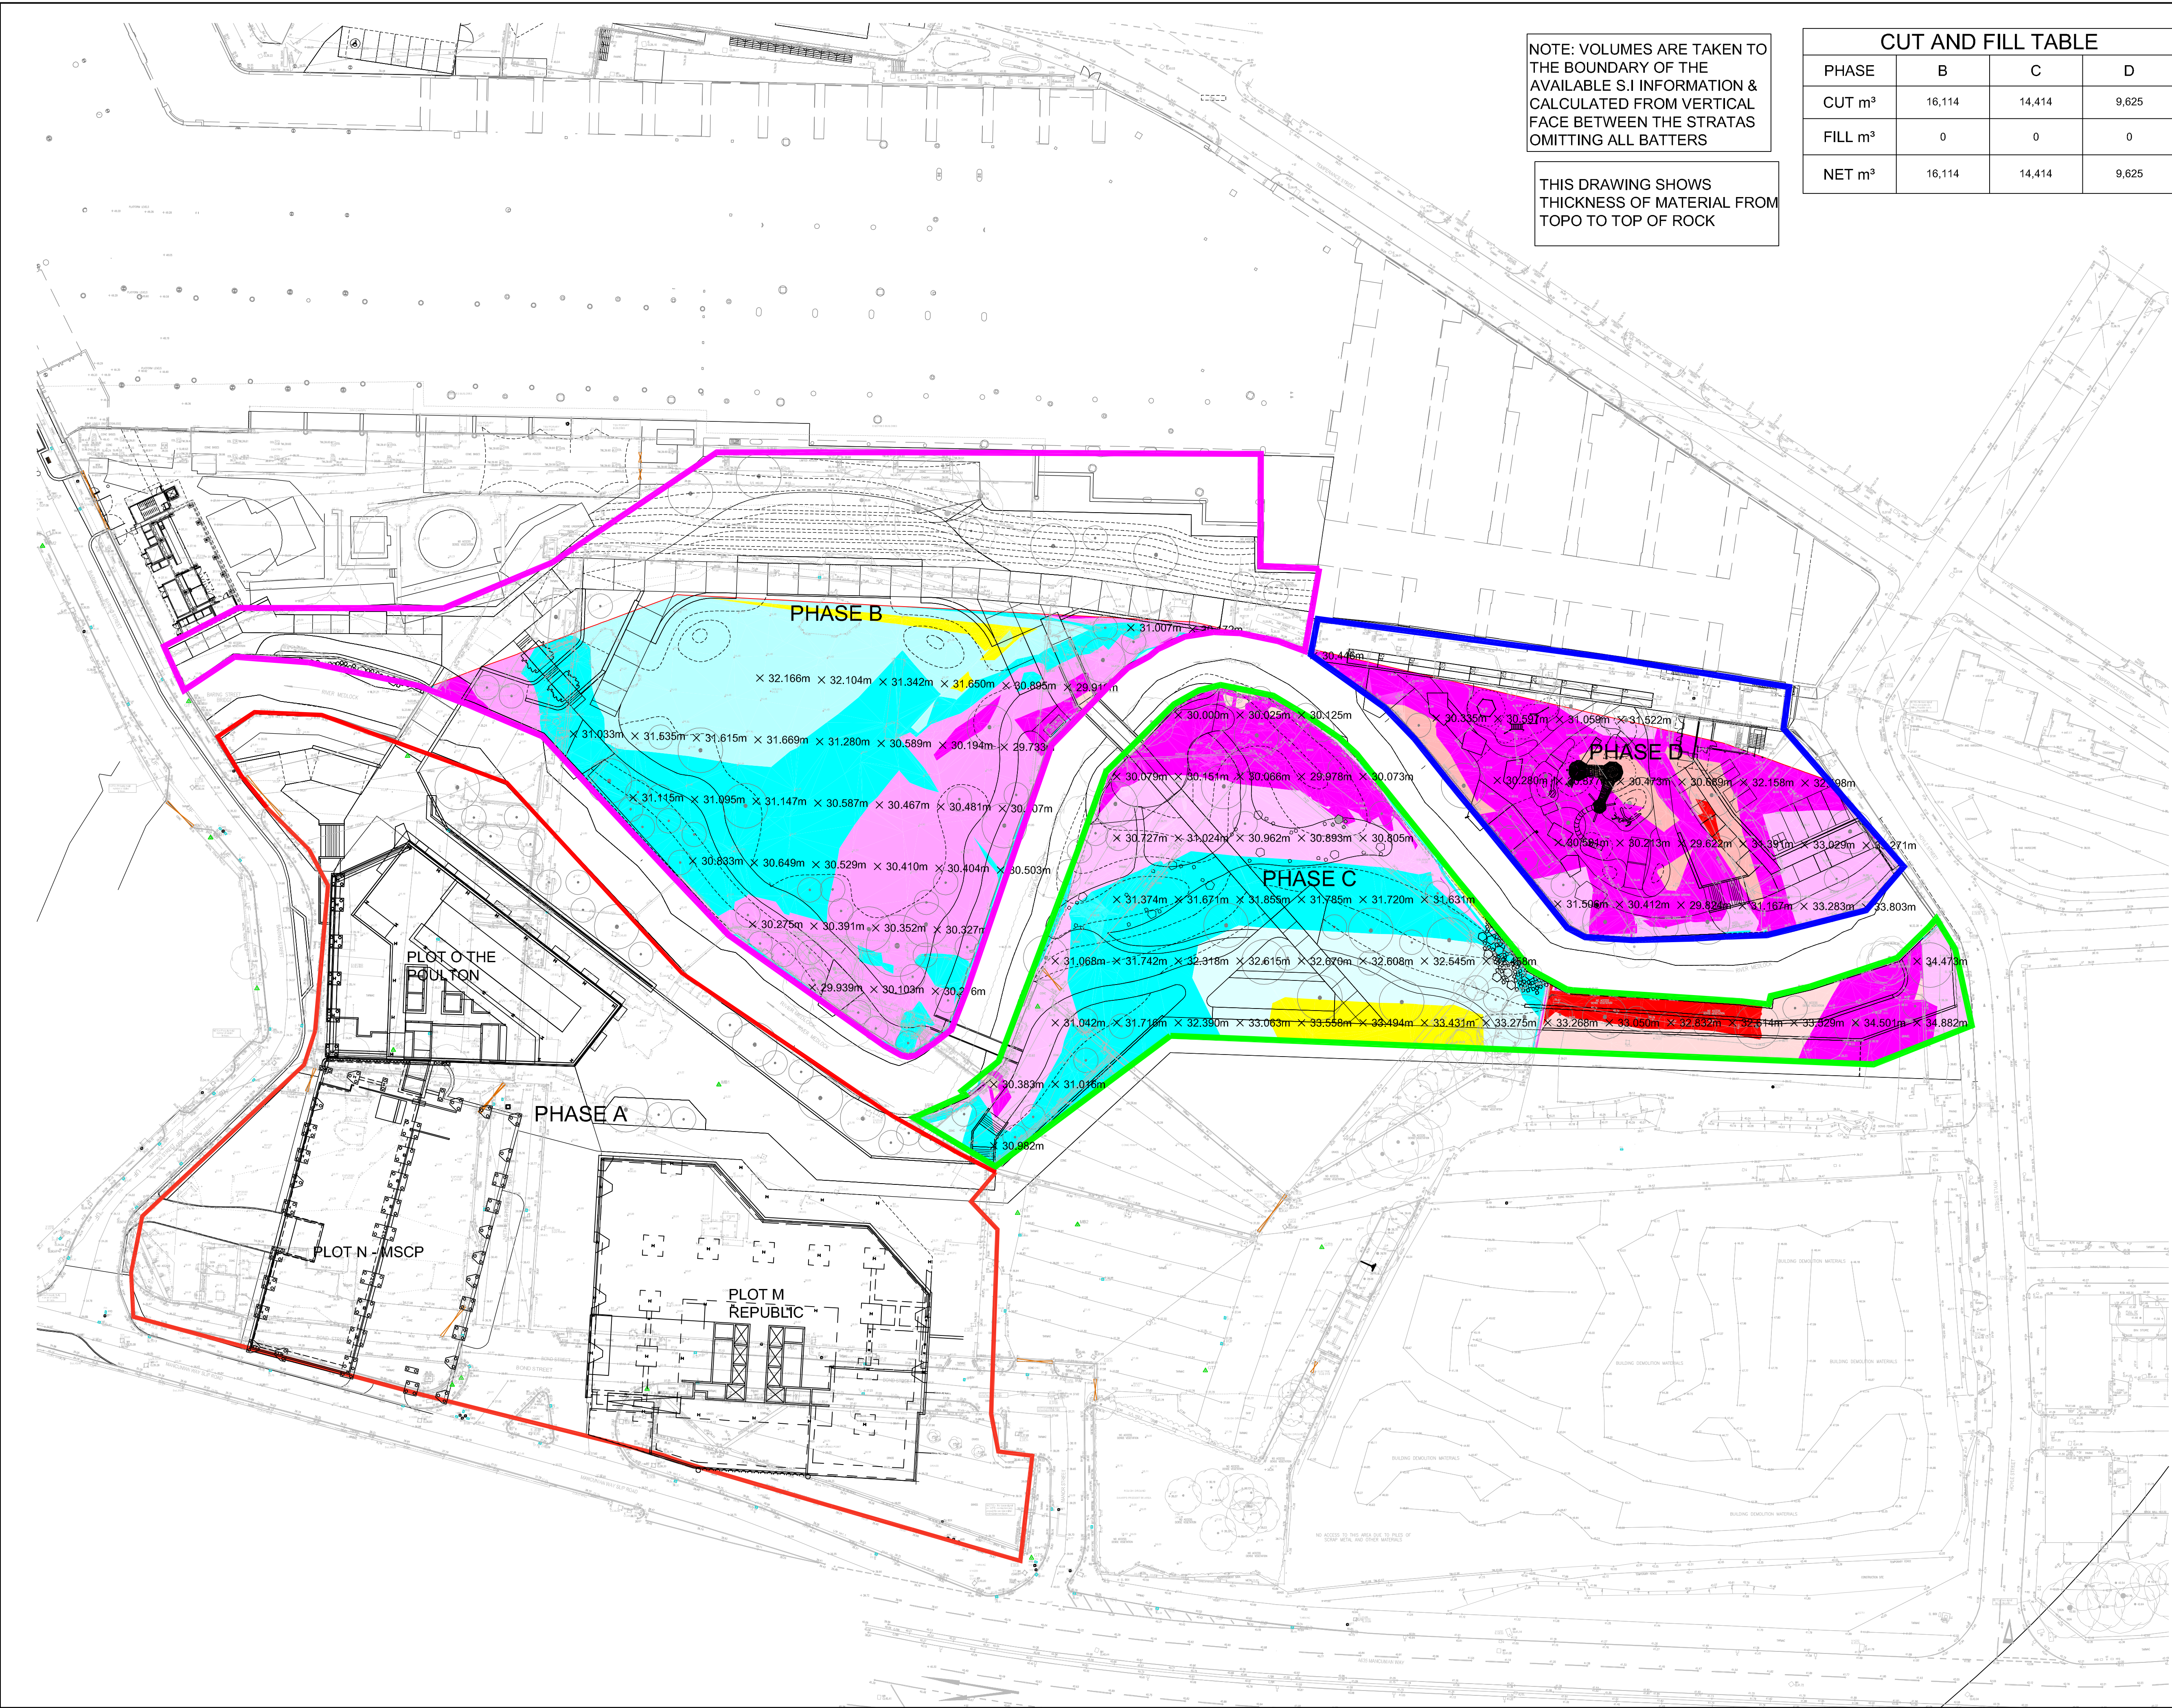
NOTE: VOLUMES ARE TAKEN TO THE BOUNDARY OF THE AVAILABLE S.I INFORMATION & CALCULATED FROM VERTICAL FACE BETWEEN THE STRATAS OMITTING ALL BATTERS

THIS DRAWING SHOWS THICKNESS OF MATERIAL FROM TOPO TO TOP OF ROCK

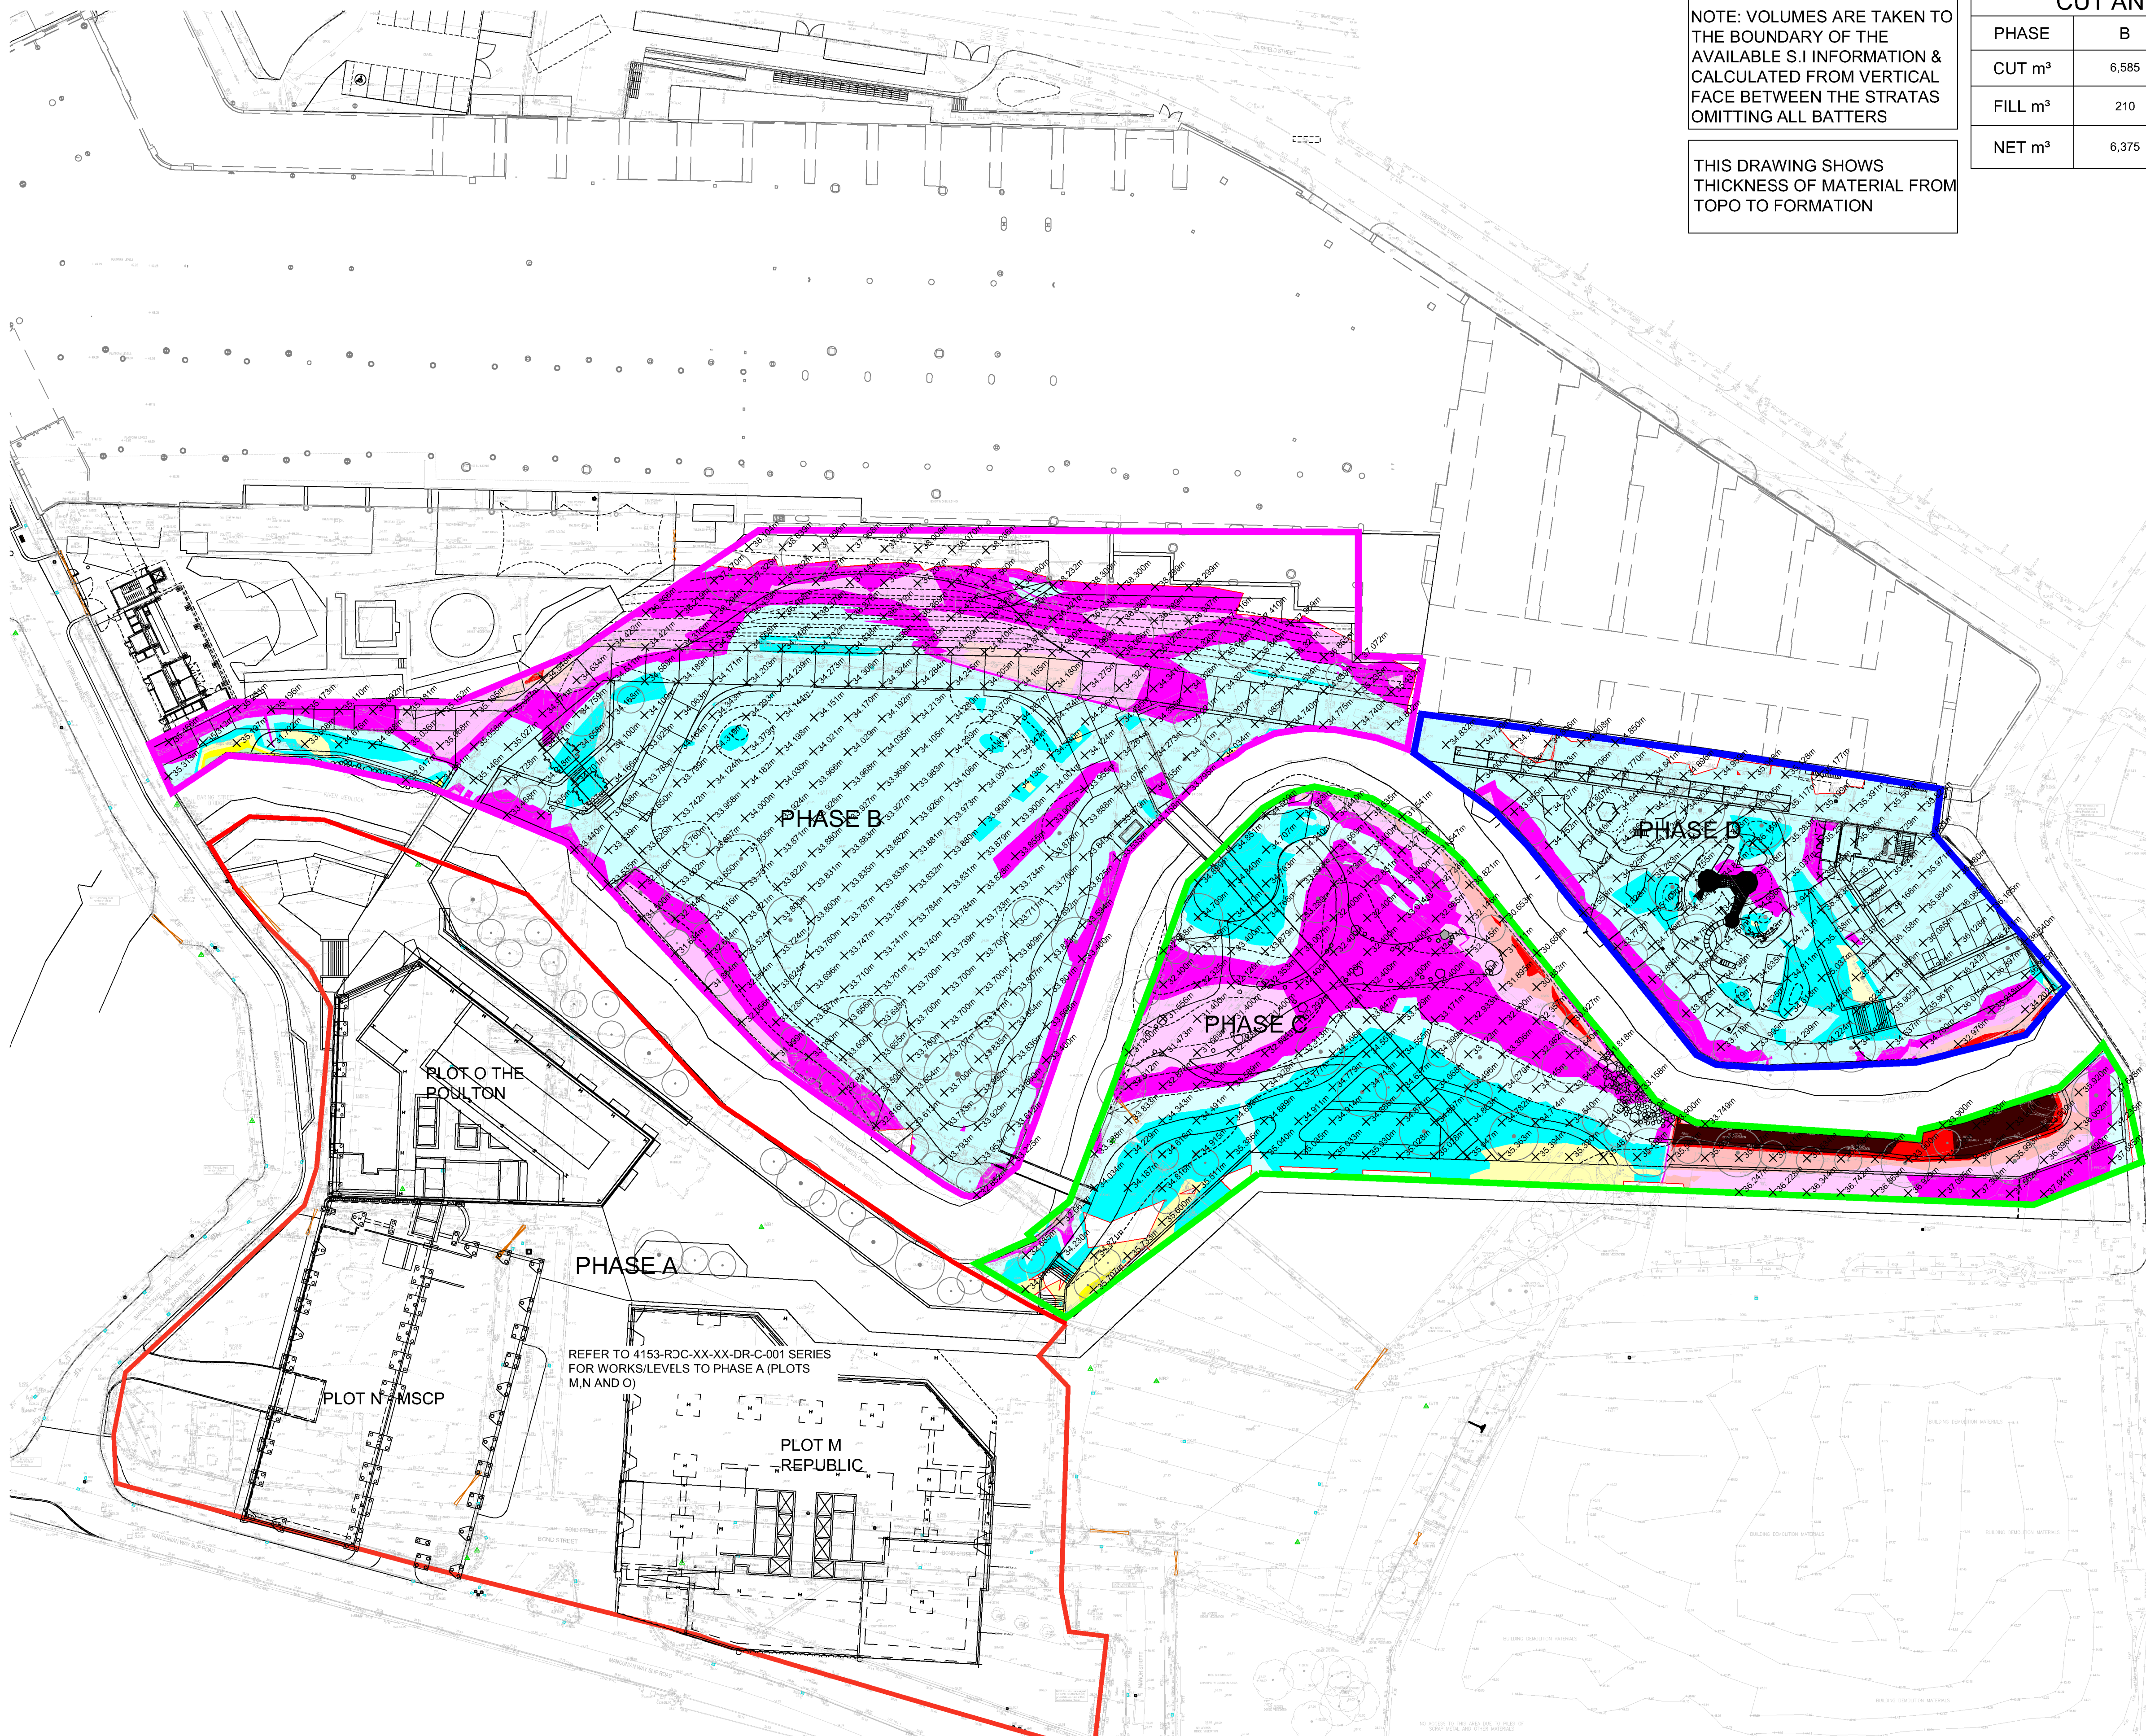
NOTE: VOLUMES ARE TAKEN TO THE BOUNDARY OF THE AVAILABLE S.I INFORMATION & CALCULATED FROM VERTICAL FACE BETWEEN THE STRATAS OMITTING ALL BATTERS

THIS DRAWING SHOWS THICKNESS OF MATERIAL FROM TOPO TO FORMATION

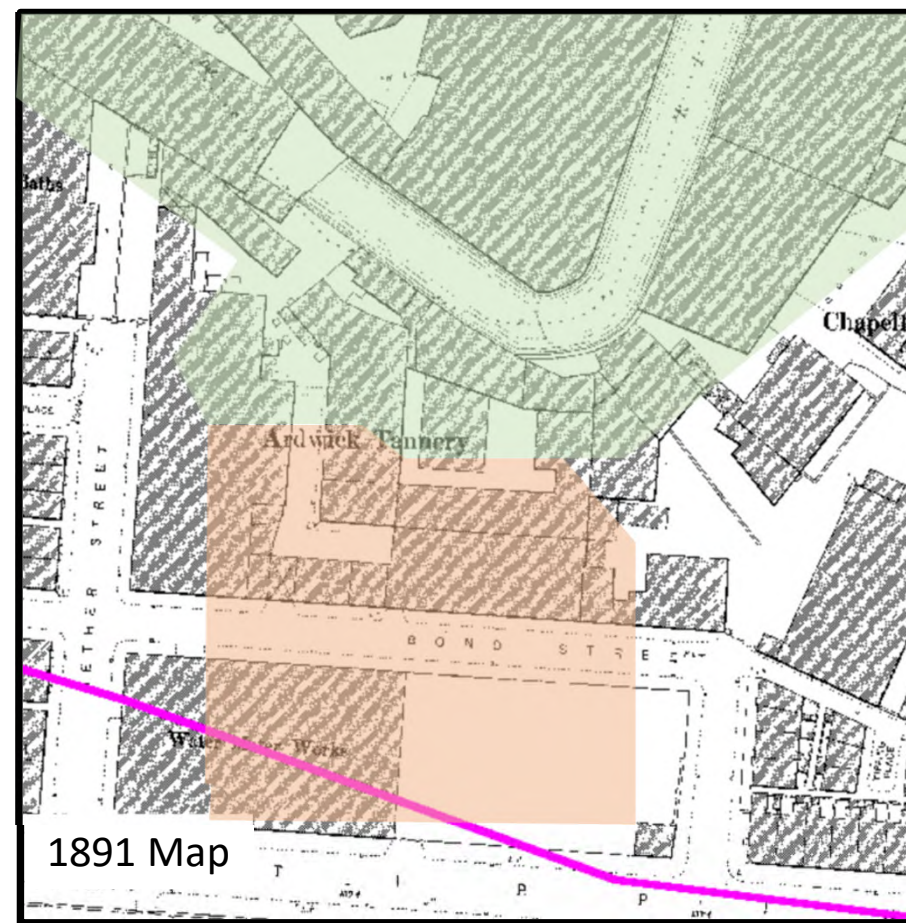
1891 Map

Approx. location of  
proposed Plot M  
Office relative to  
Tannery Site

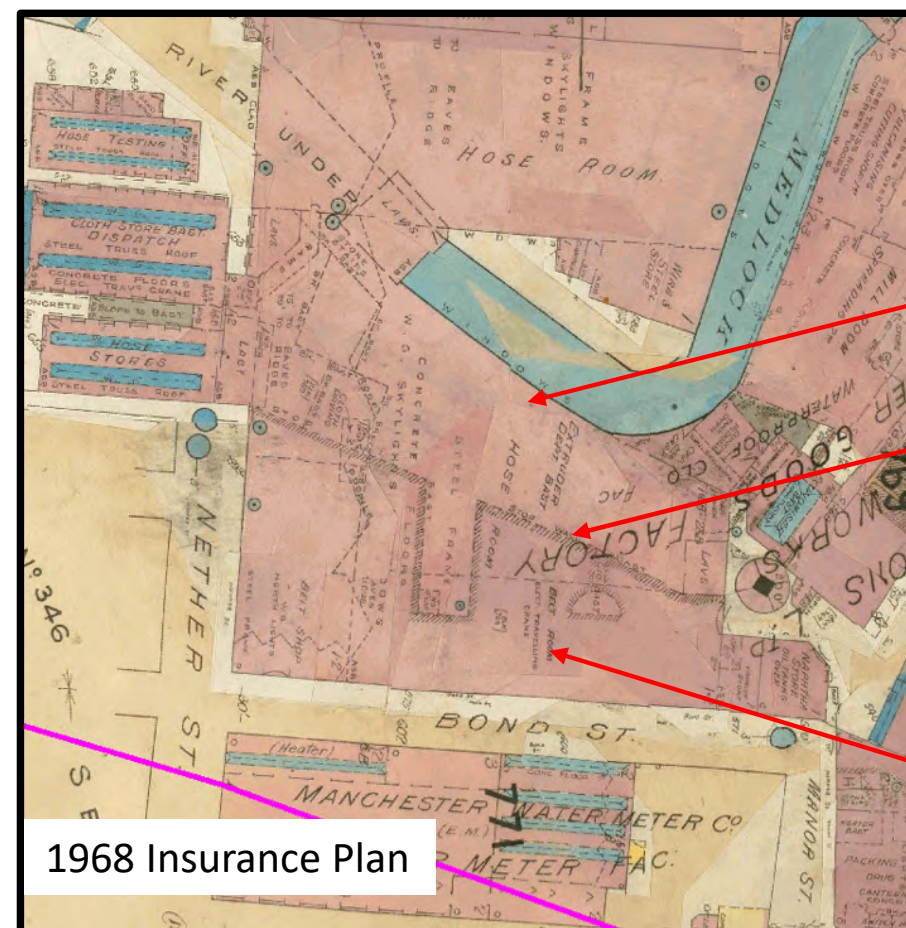
1968 Insurance Plan

Lower former sub  
basement level

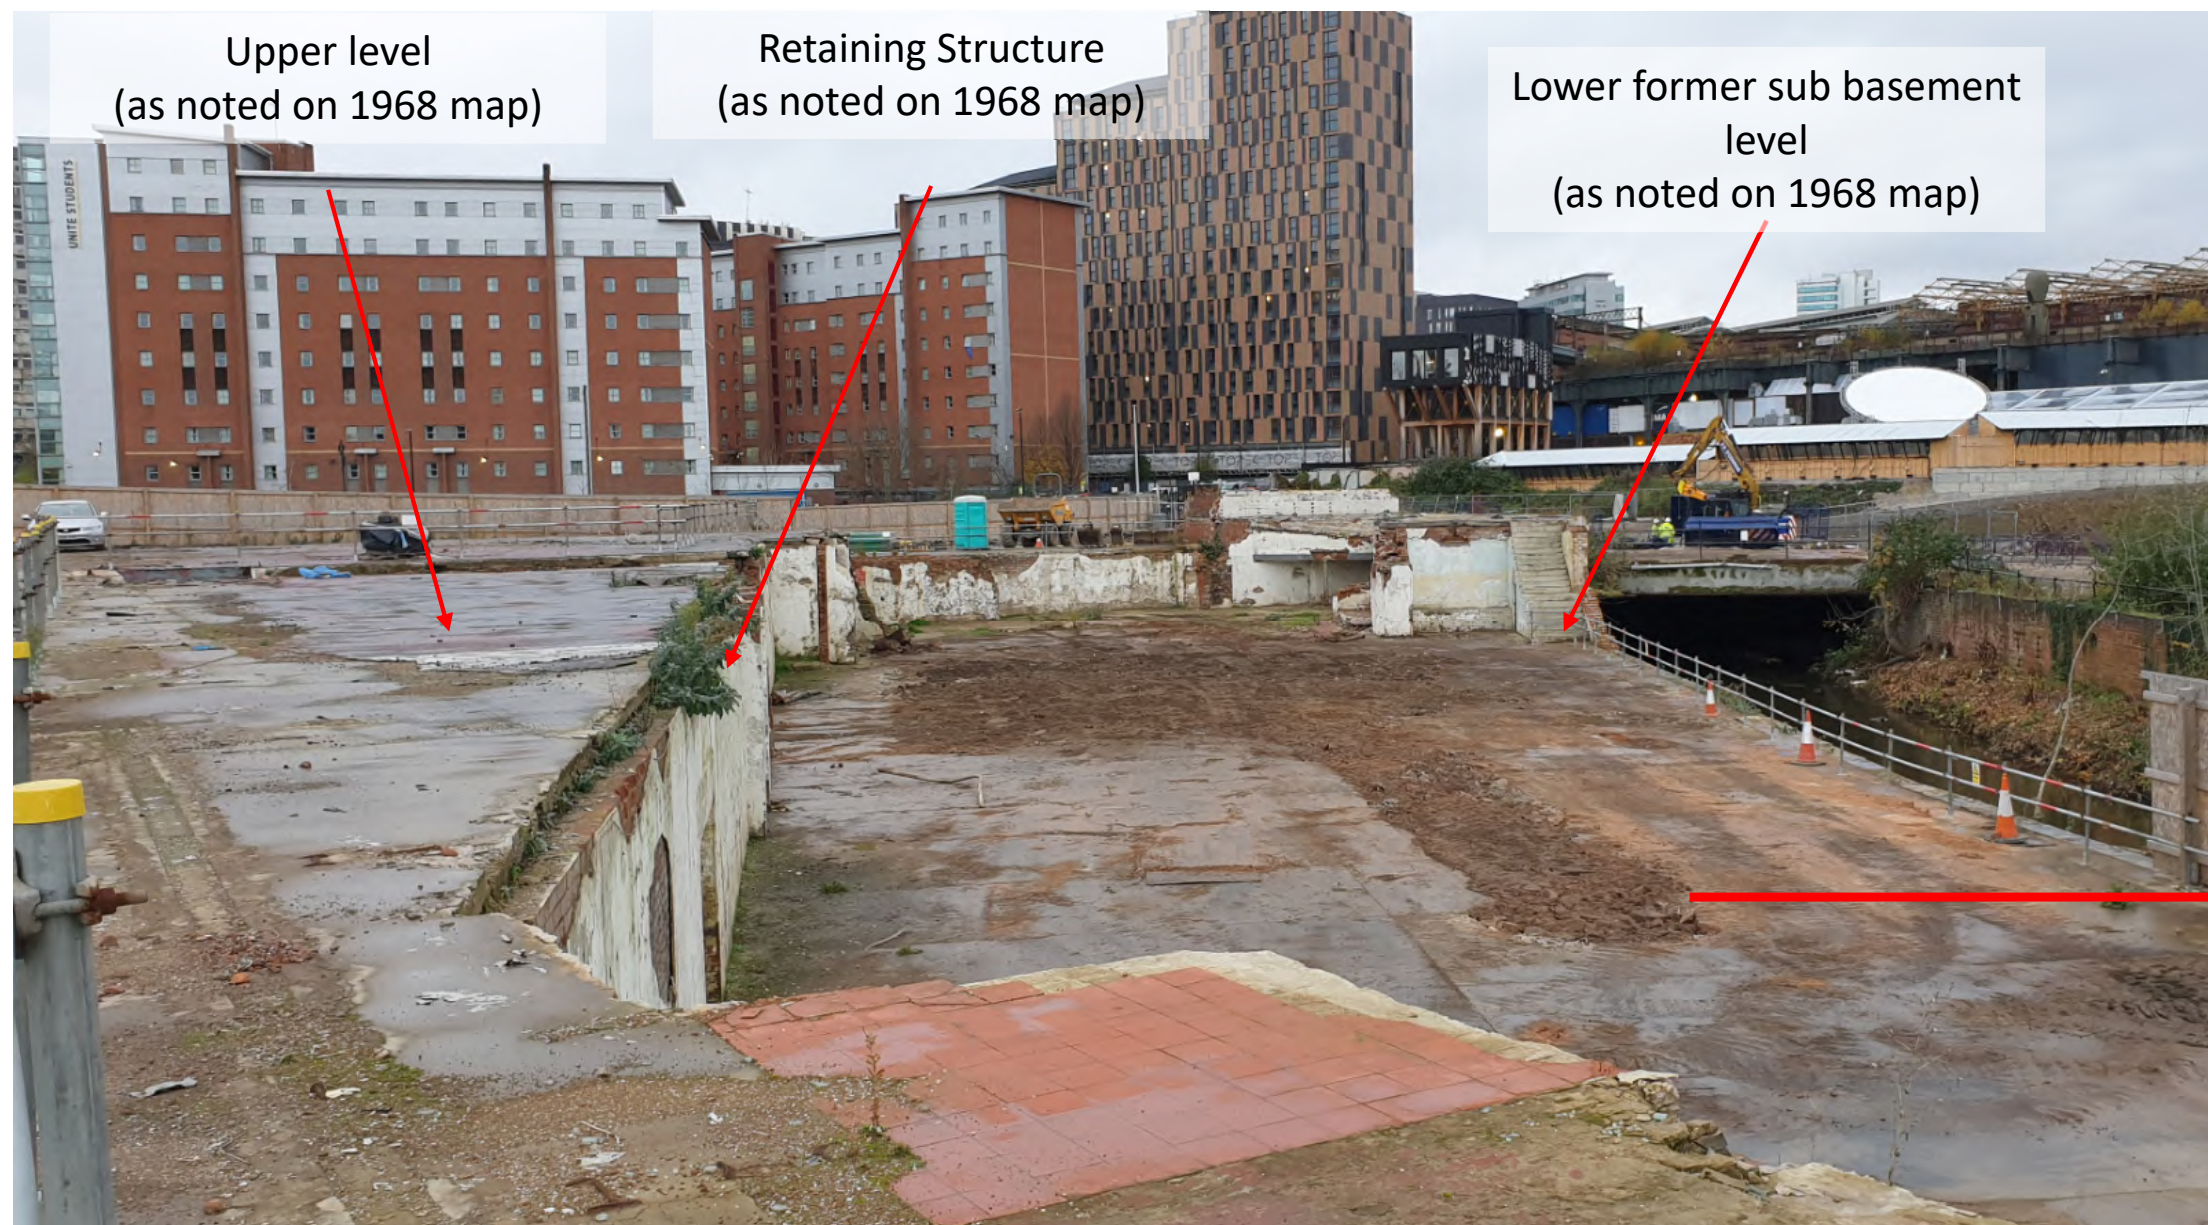
Upper level  
(as noted on 1968 map)

Looking west across the former Tannery site in October 2020 showing extent of upper and lower levels & recently completed archeological trenches

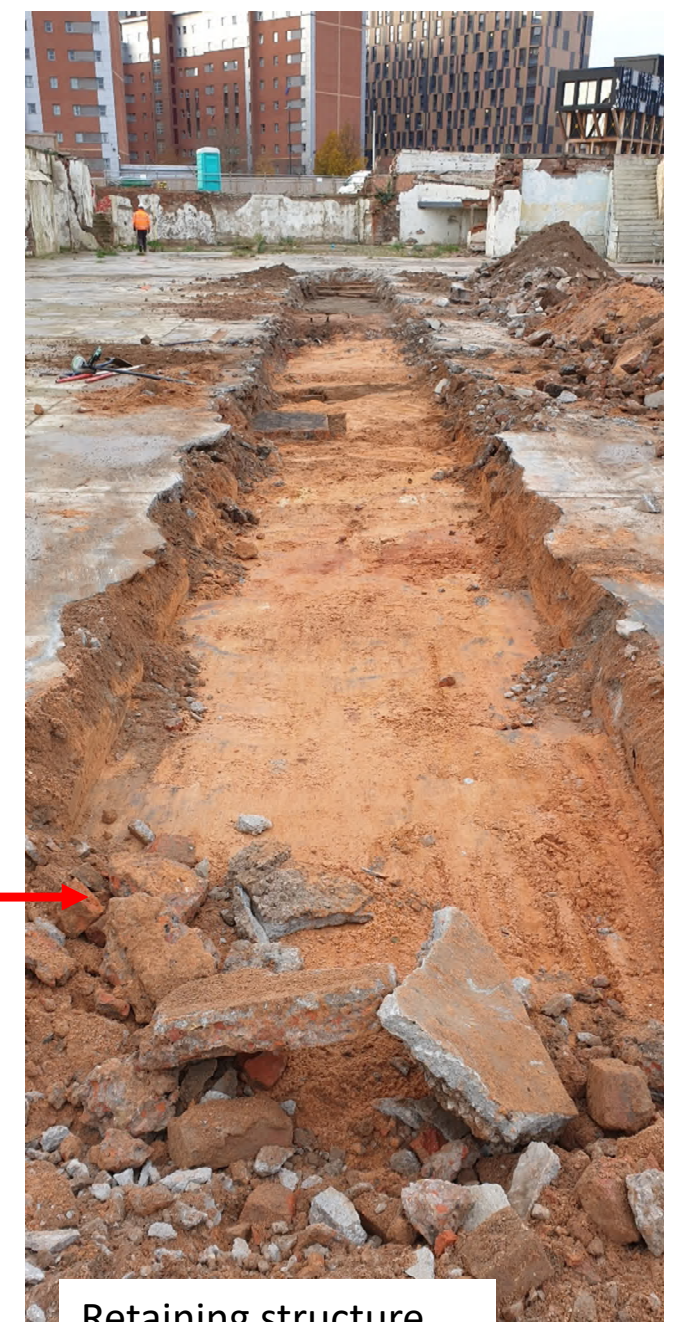
Retaining structure  
Slit trench formed through lower  
level showing sandstone beneath  
existing floor slab

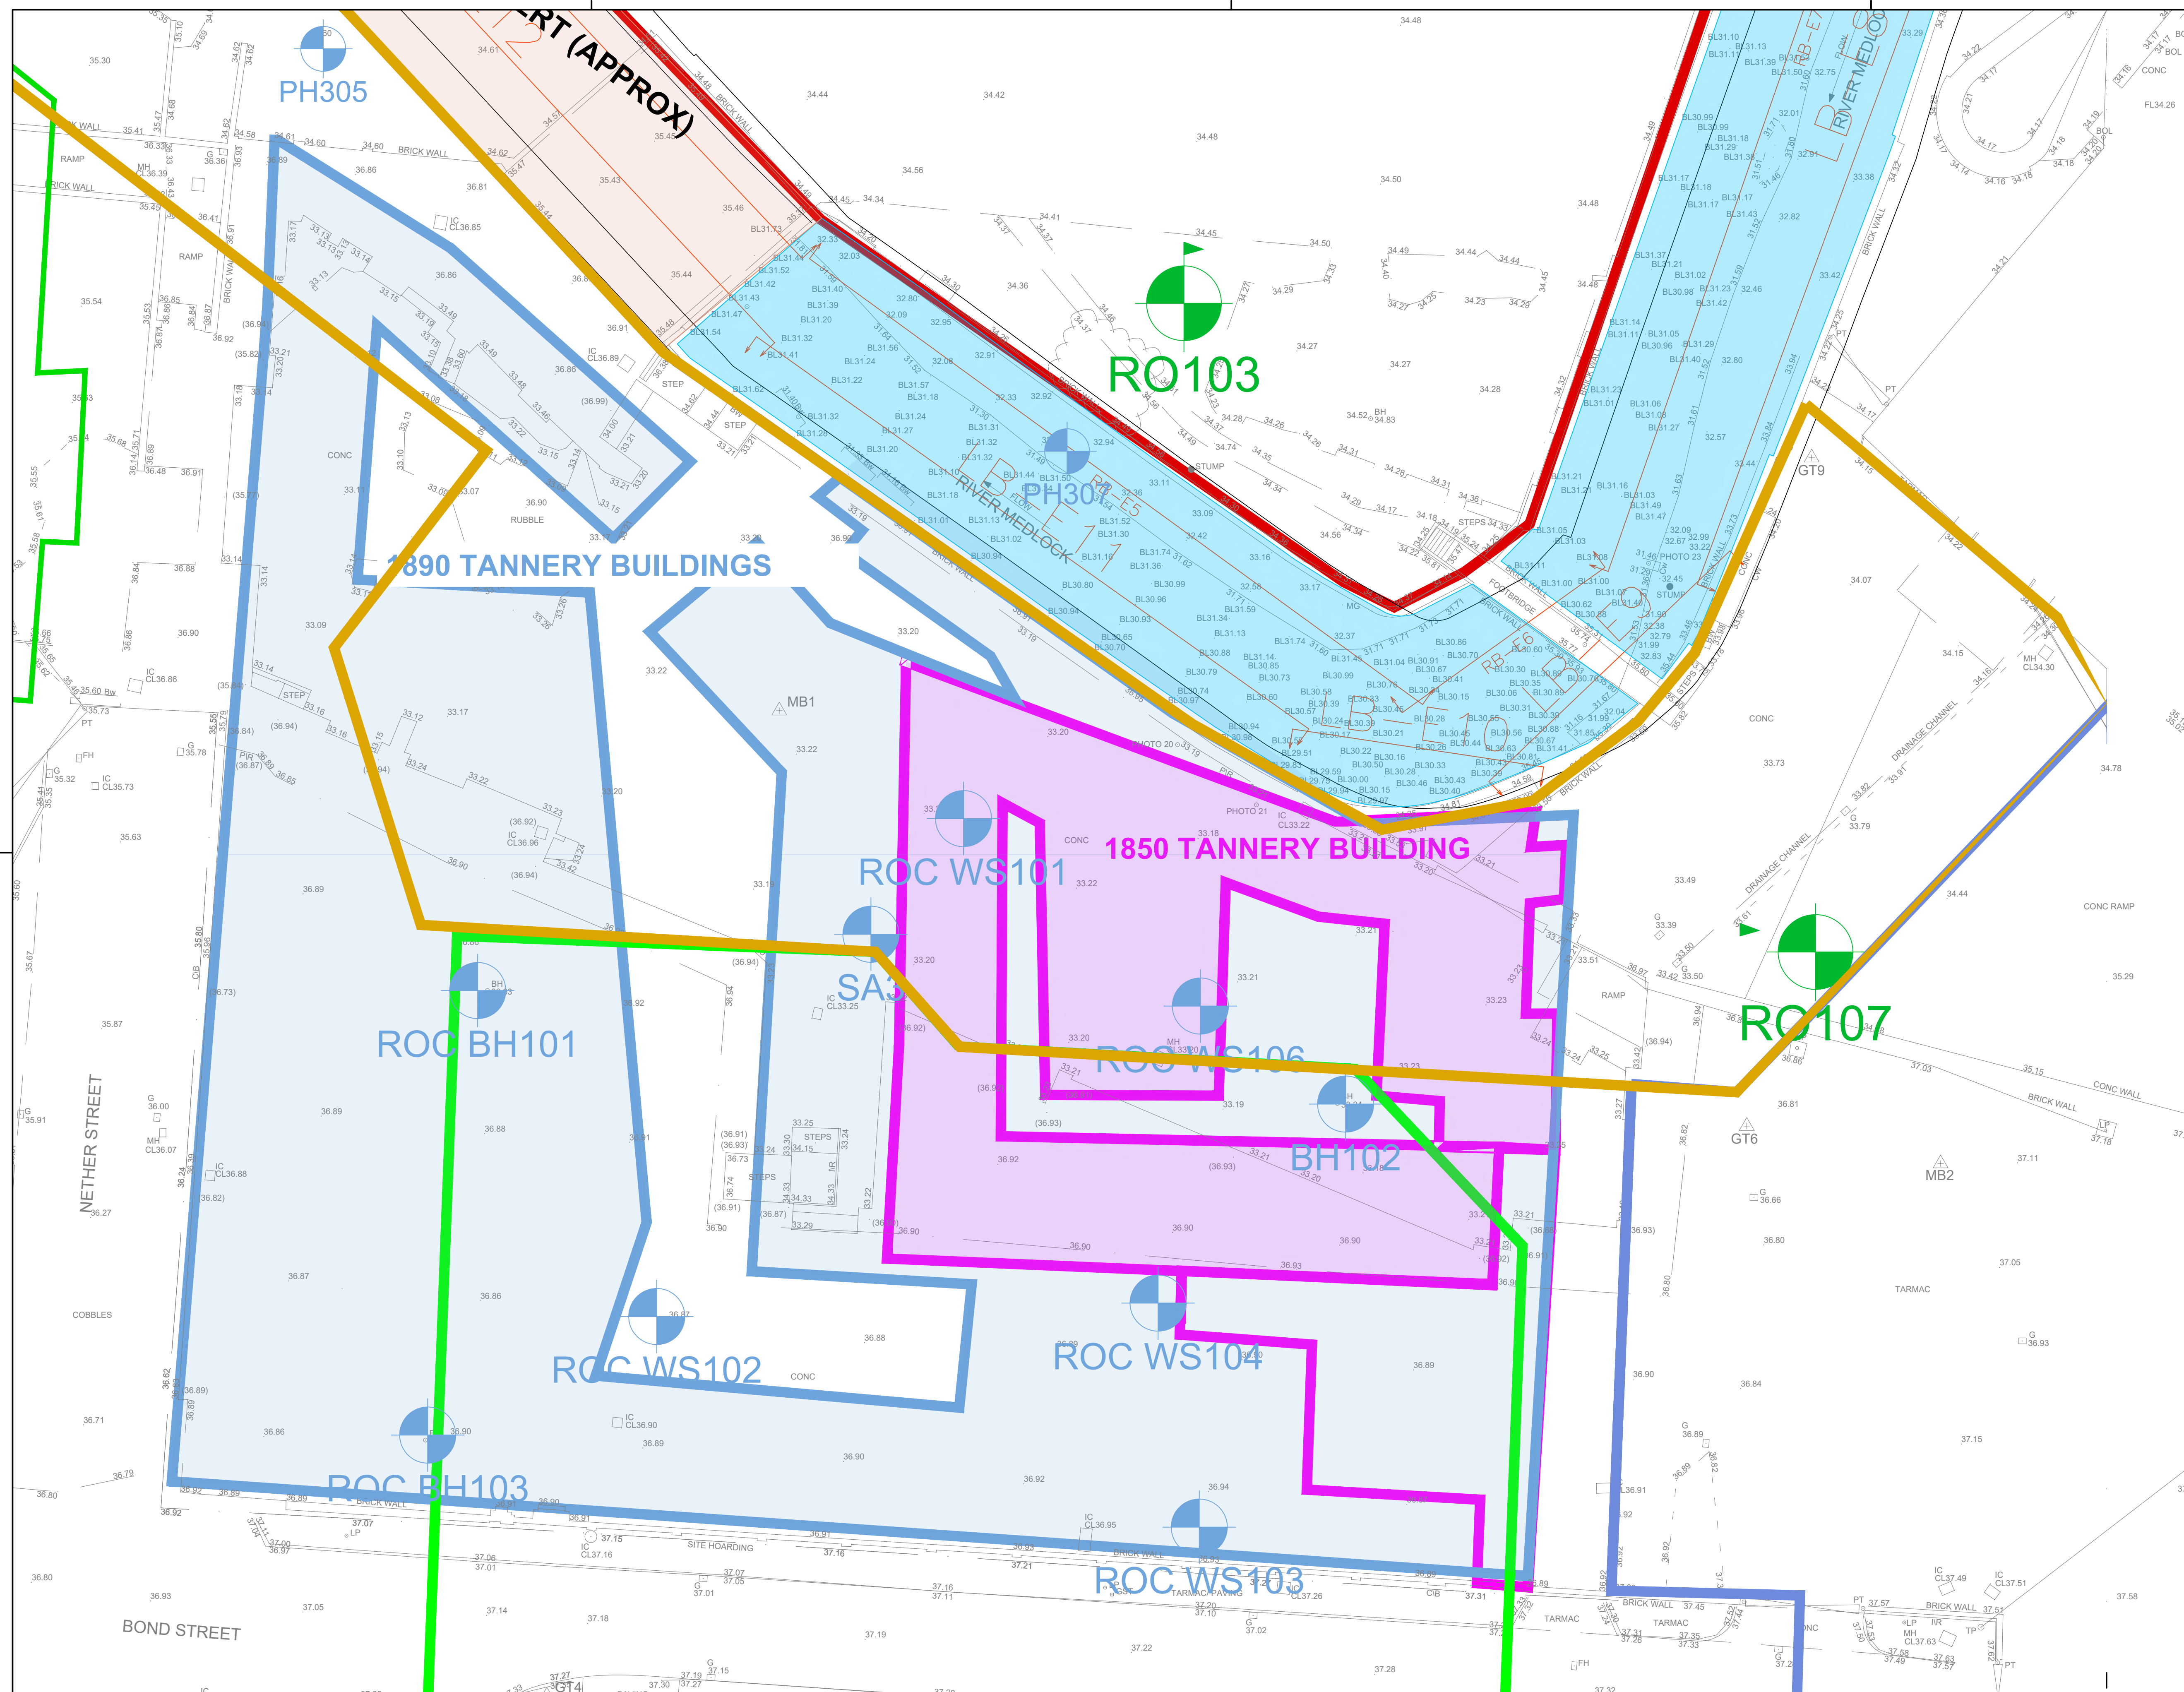
| | PROJECT TITLE | Mayfield Park, Manchester | SKETCH TITLE | October 2020 Site Photographs | |

Retaining Structure  
(as noted on 1968 map)

Lower former sub basement  
level  
(as noted on 1968 map)

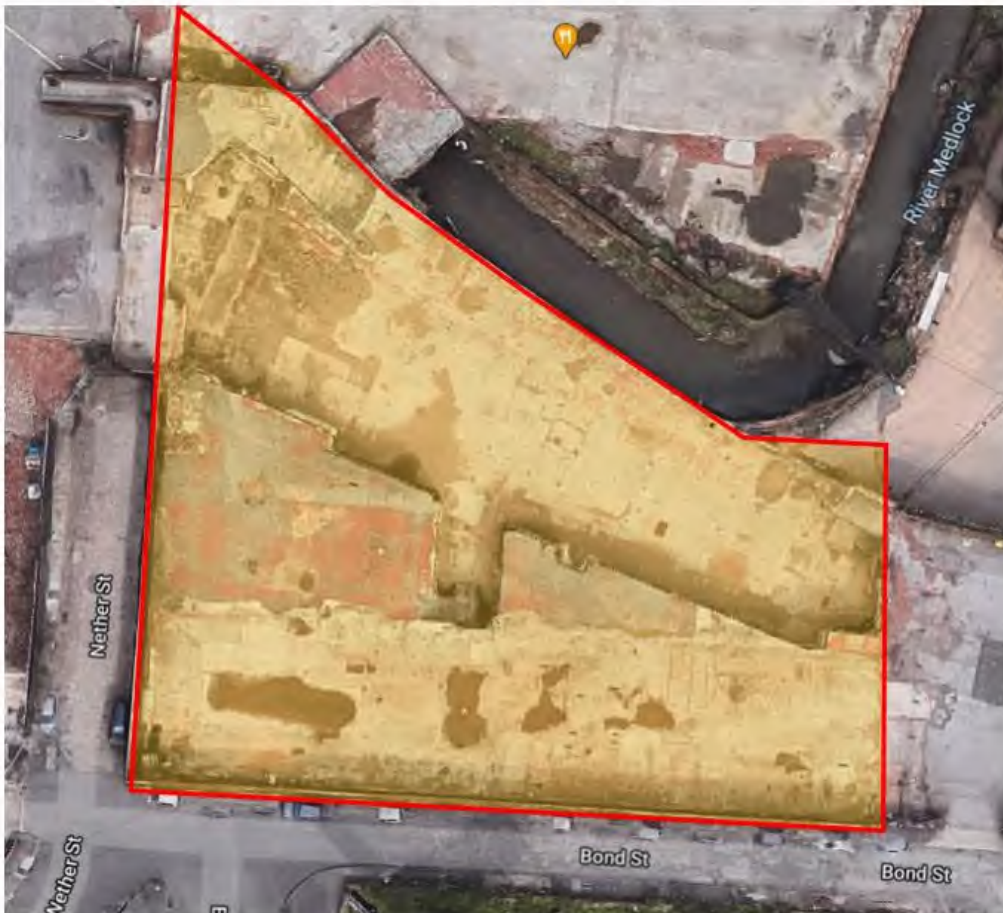
**Fig 1.0 : Portion of site containing former Tannery operation.**

The following note has been prepared for all contractors to review and adhere with when completing any excavations or works that may break ground in the area of the former Ardwick Tannery (see Fig 1.0 below for location).
