# PHASE 3A REMEDIATION STRATEGY

Mayfield Park  
Mayfield, Manchester

Mayfield Partnership Ltd

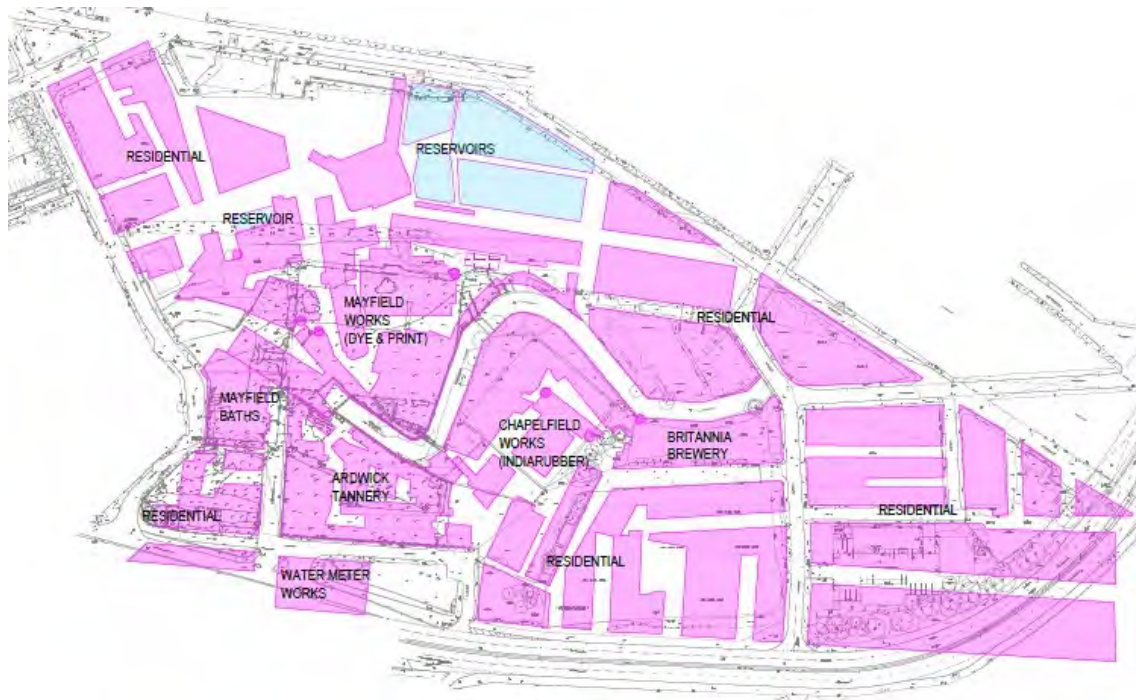
### Excerpt from ES102; Figure 1: 1891

- 2.3.2 The earliest mapping records for the site show a number of potentially contaminative sources these have been broken down by zone below.
- 2.3.3 **Zone 1 “Lawns”:** Earliest mapping dated 1891 indicates the zone to be occupied by the Mayfield dye and print works across the entire zone with associated filter pools, tanks and chimneys. Several reservoirs are located to the north of the zone associated with the dye and print works.

- 2.3.1 With reference to BuroHappold’s report and obtained historical records, RoC Consulting drawing ES101 (Appendix A) illustrates the key historical ‘phases’ of the site; an excerpt is included overleaf with commentary on key historical features within each zone. It is noted a key change occurred post WW2, following the widespread damage caused from aerial bombing (ES103; Appendix A).

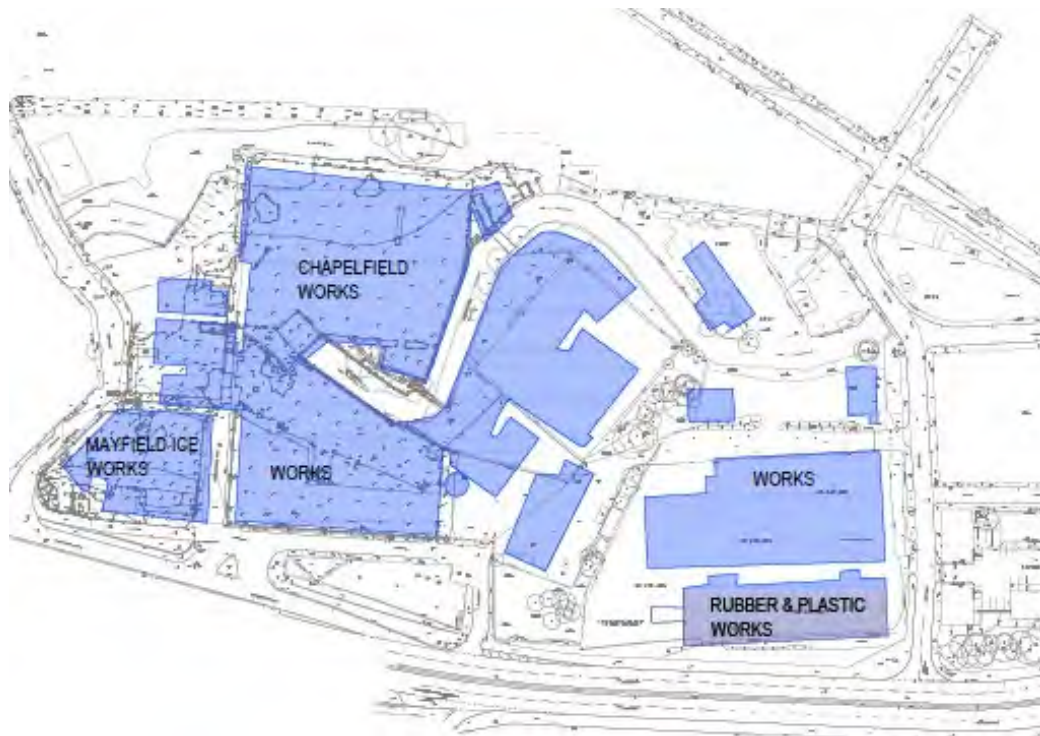
**Excerpt from ES102; Figure 4: 1970**

2.3.9 With reference to RoC Consulting drawing ES103, redevelopment of the site was undertaken during the 1950's to clear the bomb damage; with key feature being the expansion of Chapelfield Rubber works to the north side of the river. By the 1970's it was referred only as 'works', however the south eastern corner still produces rubber and plastic. To the northeast corner a vehicle maintenance yard is present.

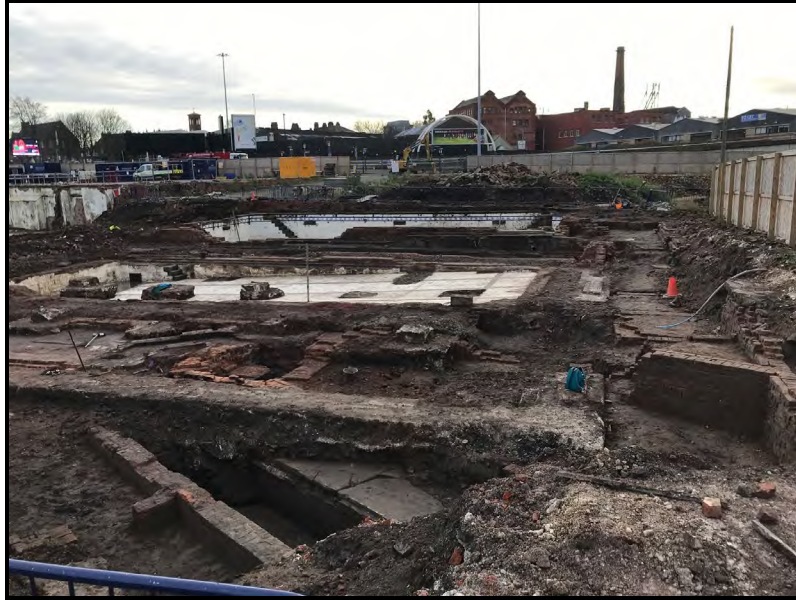
**Plate 2.0: Mayfield Baths site following excavation**

- 2.6.6 The former Mayfield Baths' site was subsequently fully exposed and excavated by Salford Archaeology as part of the pre-commencement planning condition discharge relating to archaeological surveys. These works have revealed the majority of the swimming baths structure and ancillary walls / drainage are still largely intact. A visual inspection of the area was completed by engineers from RoC Consulting to assess what (if any) areas of potential contamination had been revealed, although no visual or olfactory evidence of significantly impacted soils was noted during this inspection.

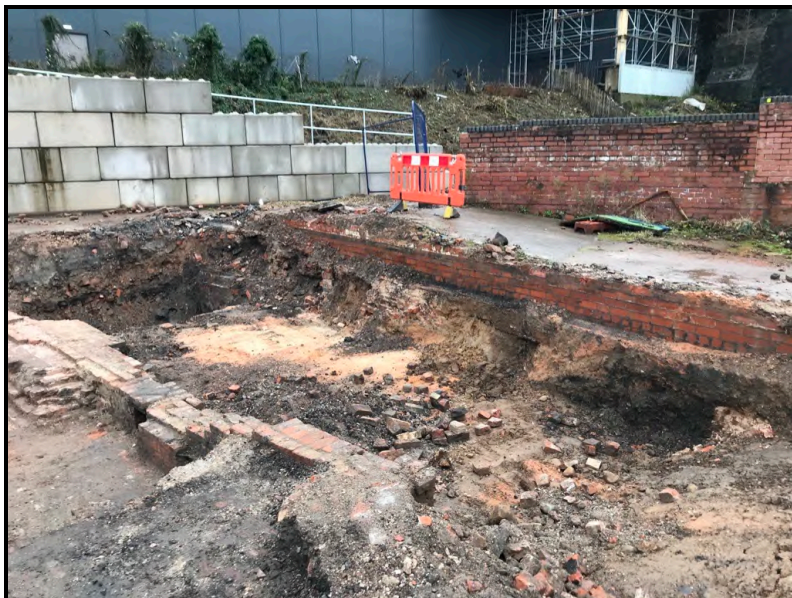
**Plate 2.1: Chapelfield Dye Works Excavation**

2.6.7 An extensive area within Zone 1 “Lawns” has been excavated as part of a pre-commencement planning condition discharge relating to archaeological surveys. These excavations have revealed numerous below ground structures relating to numerous phases of development at this area of the site.

2.6.8 It is believed that structures relating to the initial phase of development have been uncovered, and therefore it is likely these structures are founded within natural soils or the sandstone bedrock.

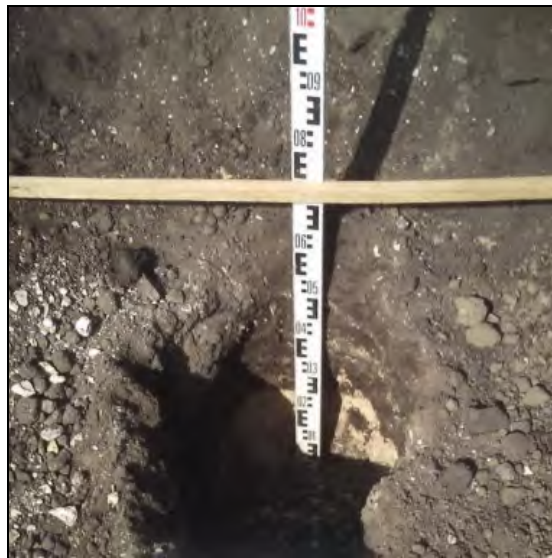
**Fig 3.0 Example of soil capping depth validation photograph**

3.2.8 Both photographic validation pit records, locations and associated soil chemical testing certificates should be collated for inclusion within an appropriate section of the Phase 3b Site Validation report to support pre-operational planning condition discharge.

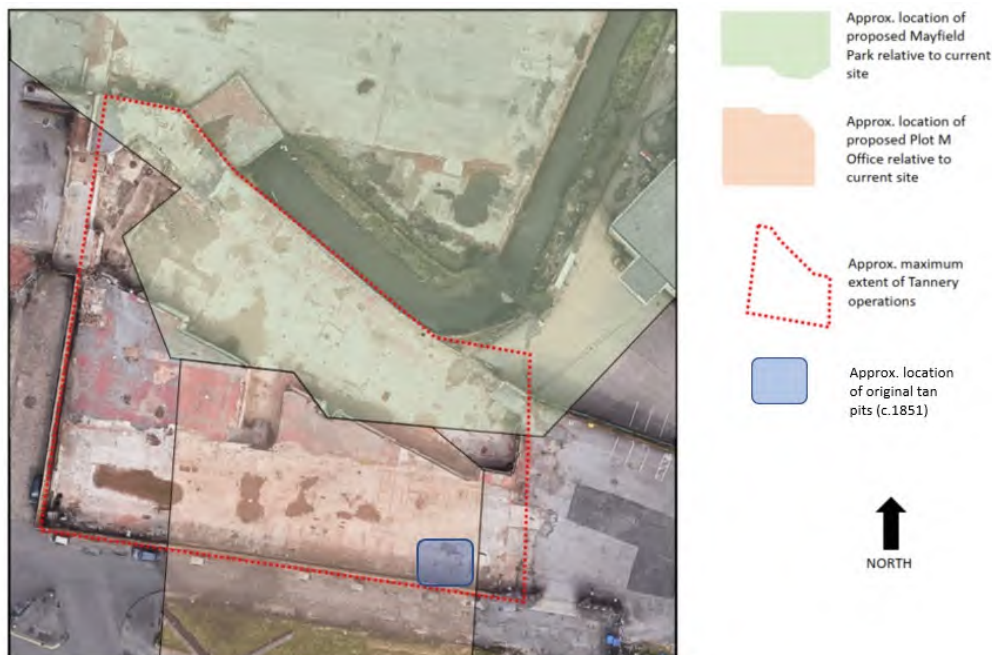
- 3.6.2 The potential for residual tannery wastes has been identified across a small portion of the proposed Park / Plot M office development to the central and southern extent. A technical note relating to the control and mitigation of tannery wastes that may be uncovered in this area has been prepared and included within the RoC Consulting Phase 2 SI report. A copy of this note (TN1.1) has also been included in the current report (see Appendix D) and should be reviewed by all contractors working in the area indicated below.

**Fig 3.1: Approx. former Tannery Extent (red dashed line)**  
**General Remedial Comments**

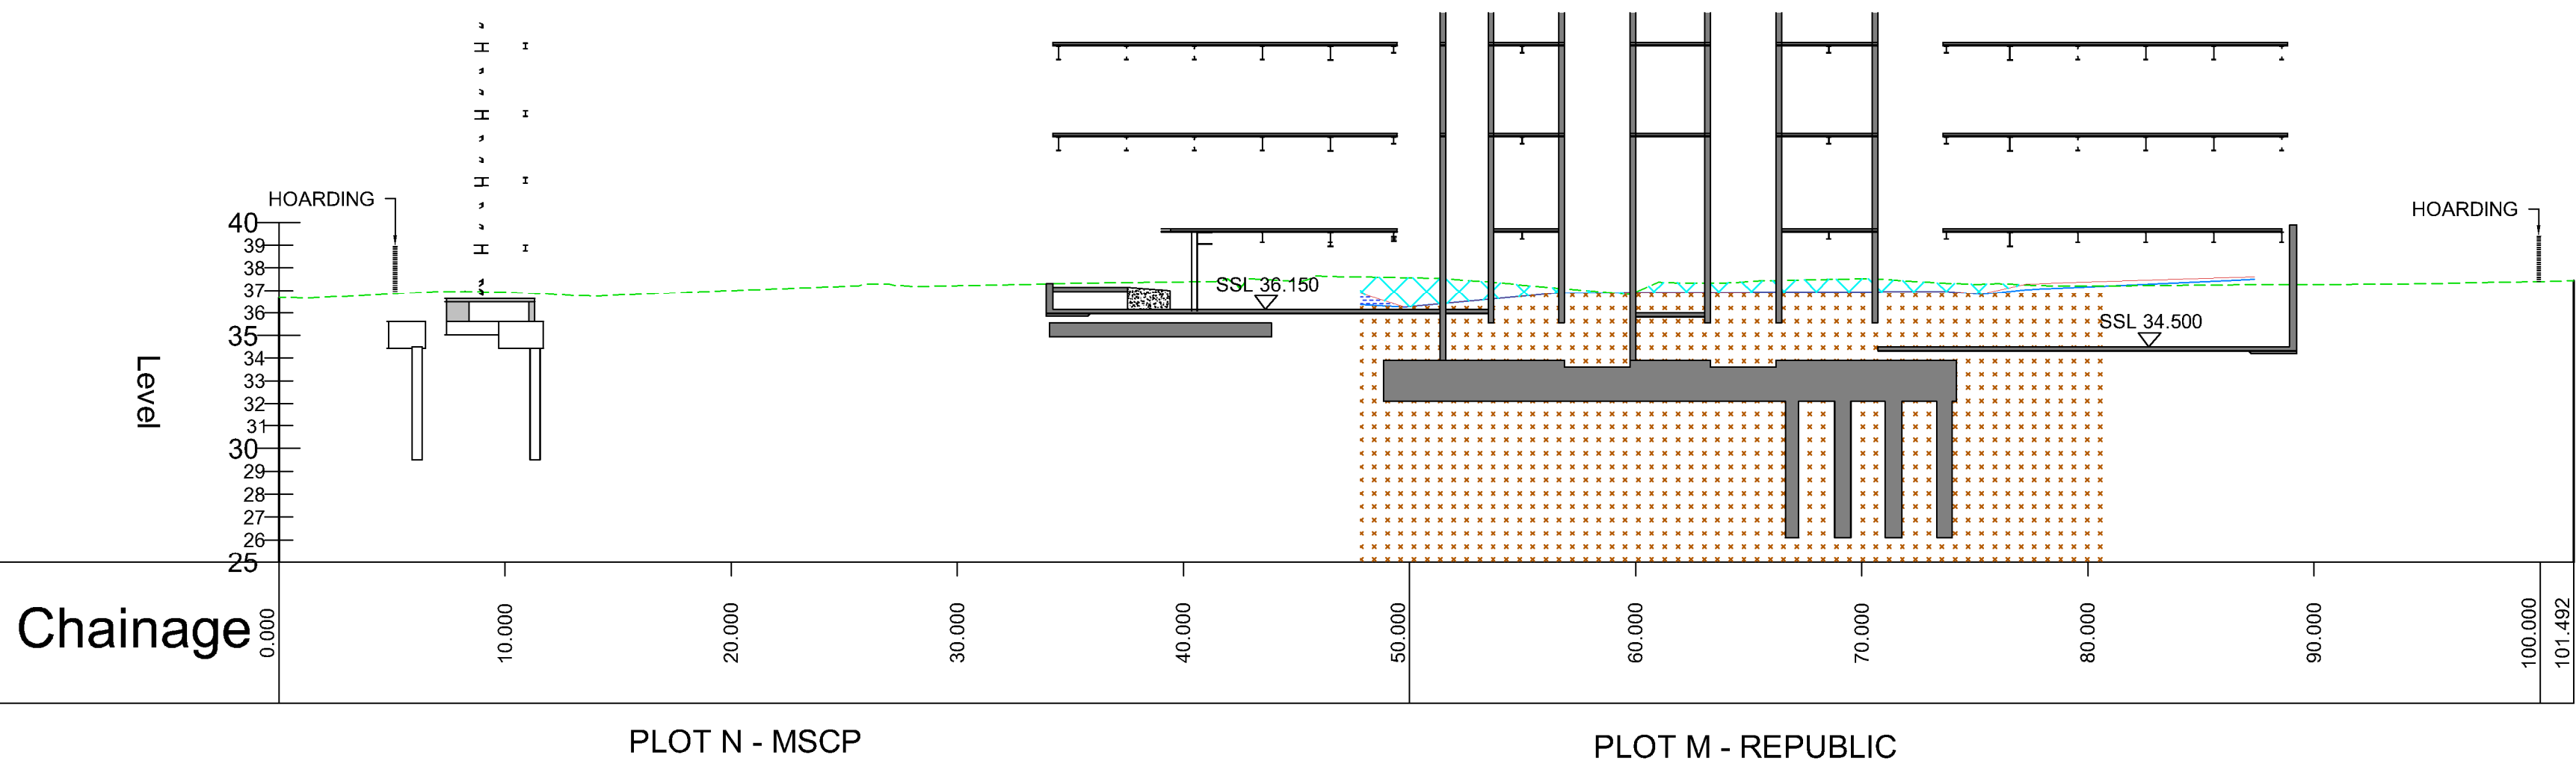
1-1 - LONGSECTION  
SCALE: H 1:250,V 1:250. DATUM: 25.000

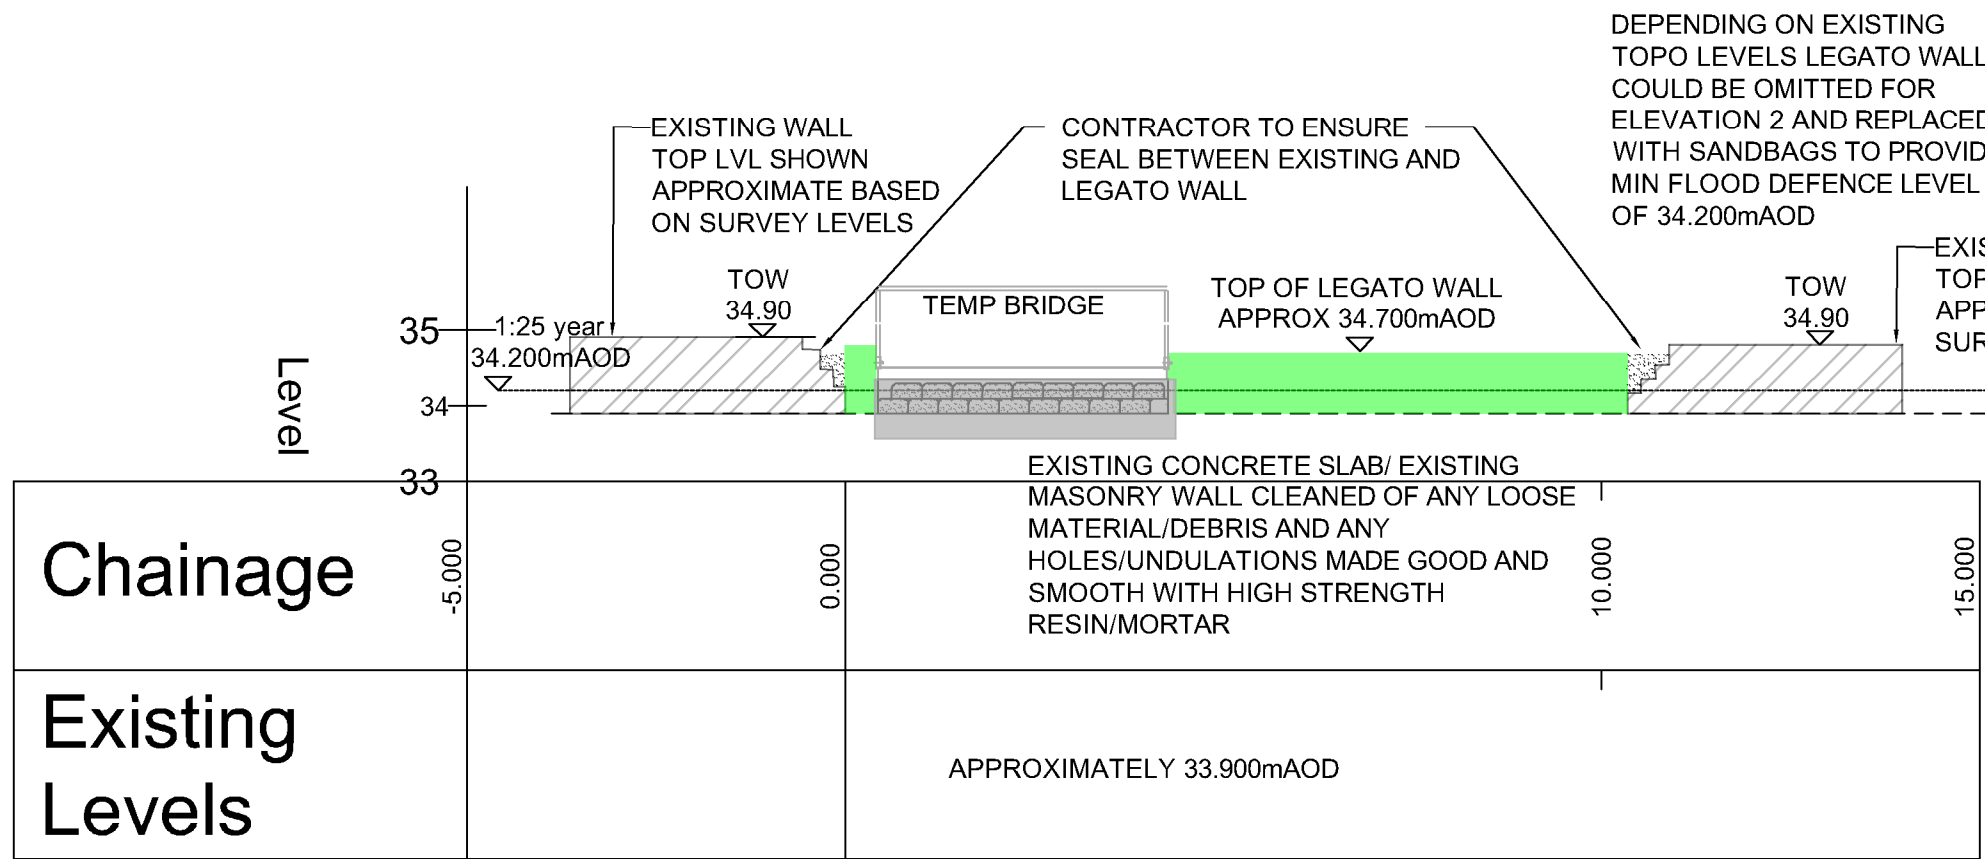
ELEVATION SIMILAR TO ELEVATION 1 EXCEPT EXISTING LEVELS INDICATE THAT TOP OF LEGATO WALL WILL BE ABOVE 1in25 YR FLOOD LEVEL OF 34.200mAD AND NO ADDITIONAL BUILD UP (SANDBAGS) WILL BE REQUIRED SUBJECT TO TOPO SURVEY LEVELS

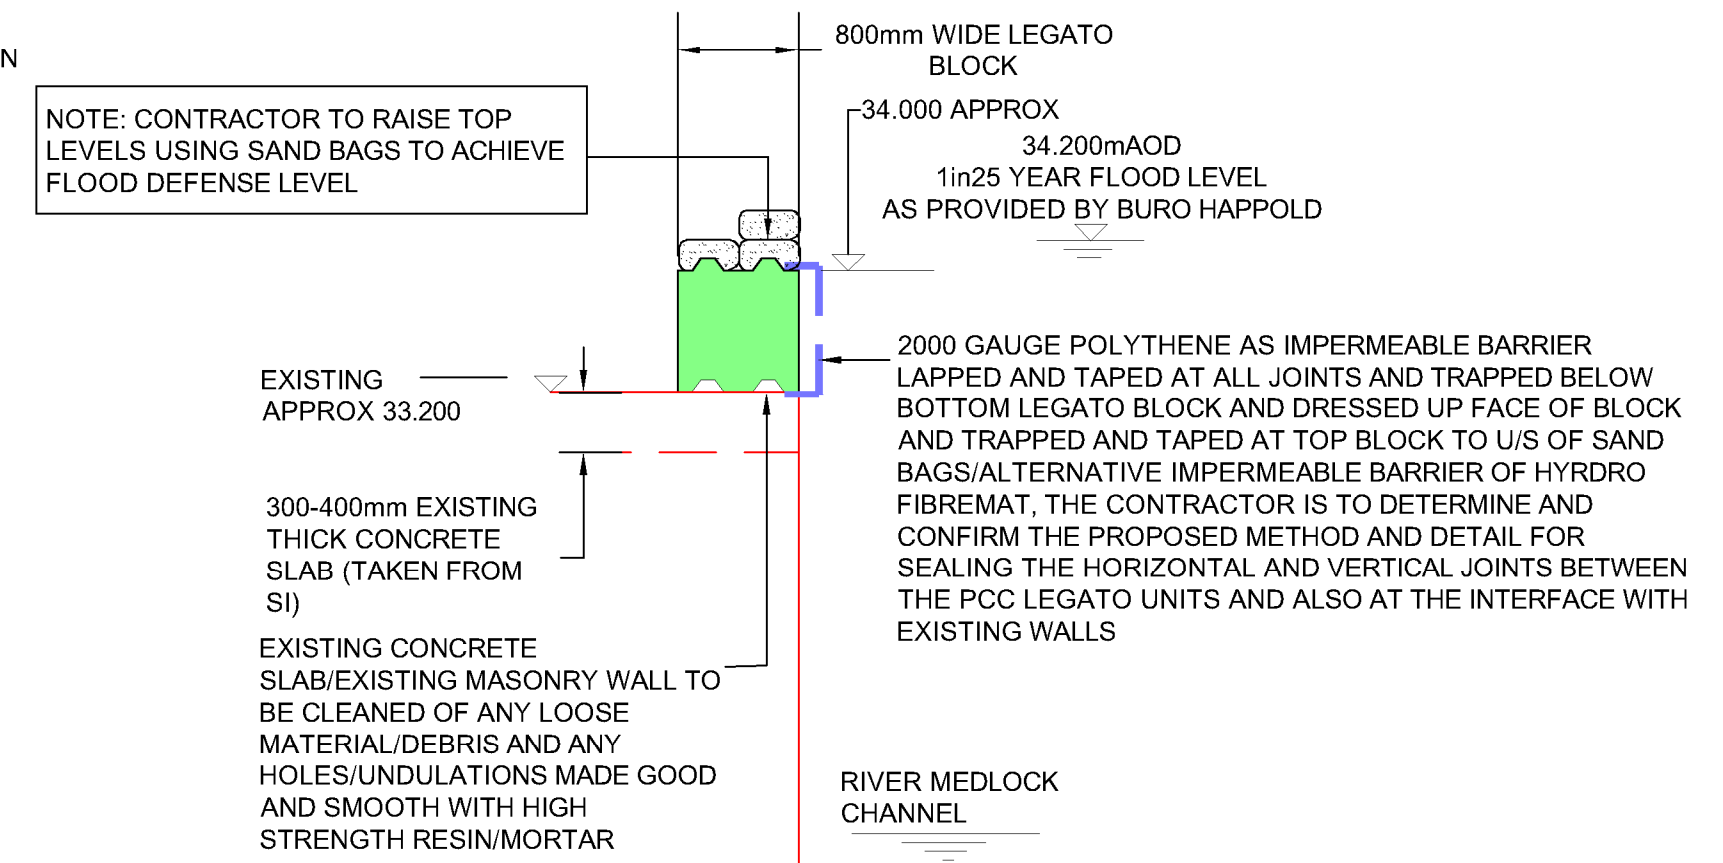
SECTION THROUGH WALL AT  
APPROX CHAINAGE 20 ON  
ELEVATION 1  
SCALE 1:50

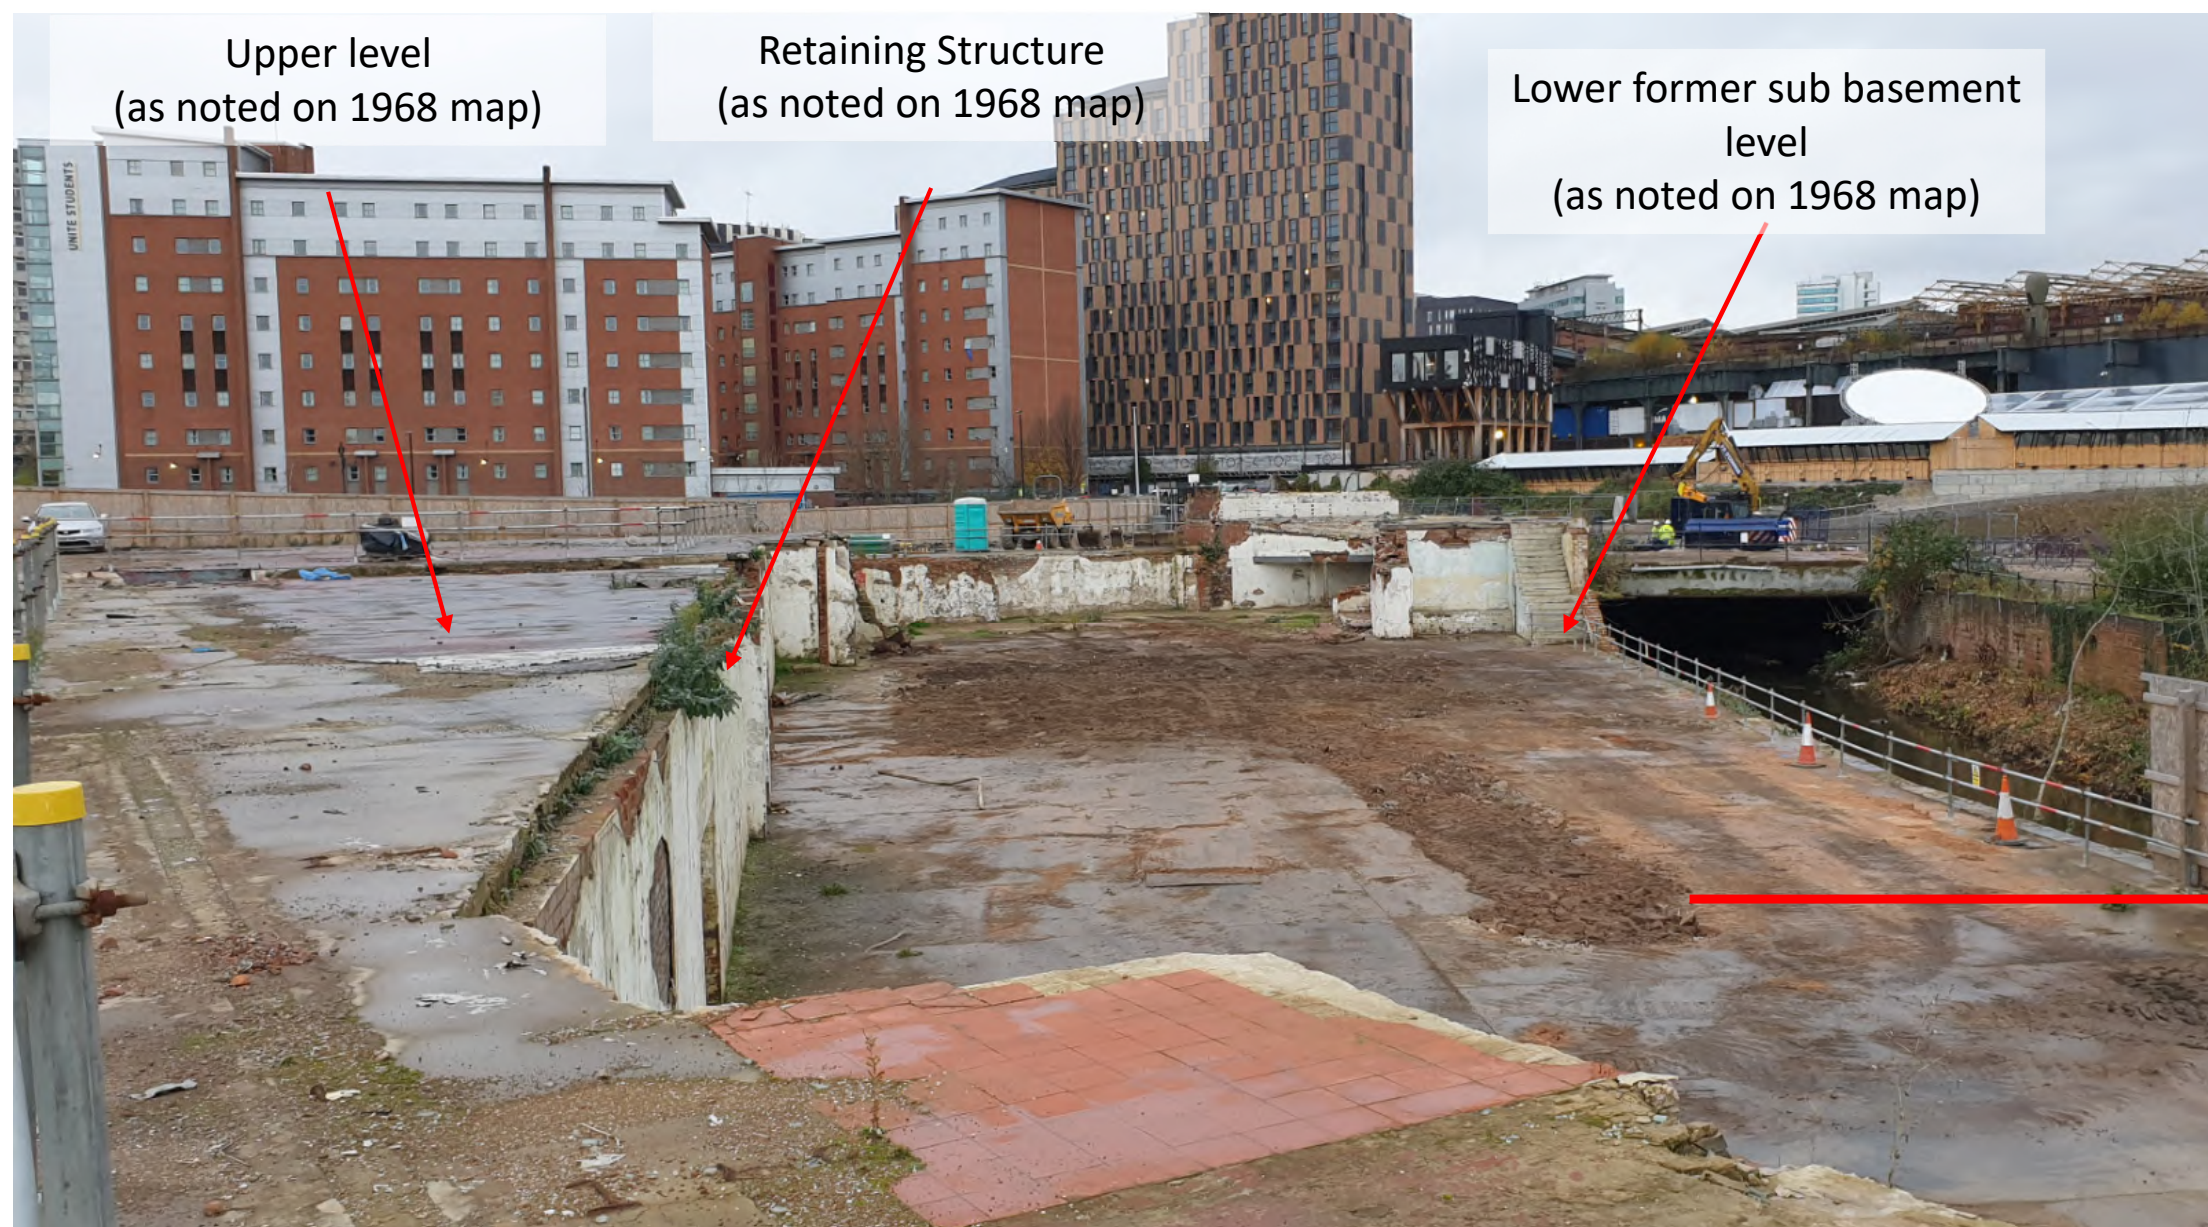
Upper level  
(as noted on 1968 map)

Retaining Structure  
(as noted on 1968 map)

Looking west across the former Tannery site in October 2020 showing extent of upper and lower levels & recently completed archeological trenches

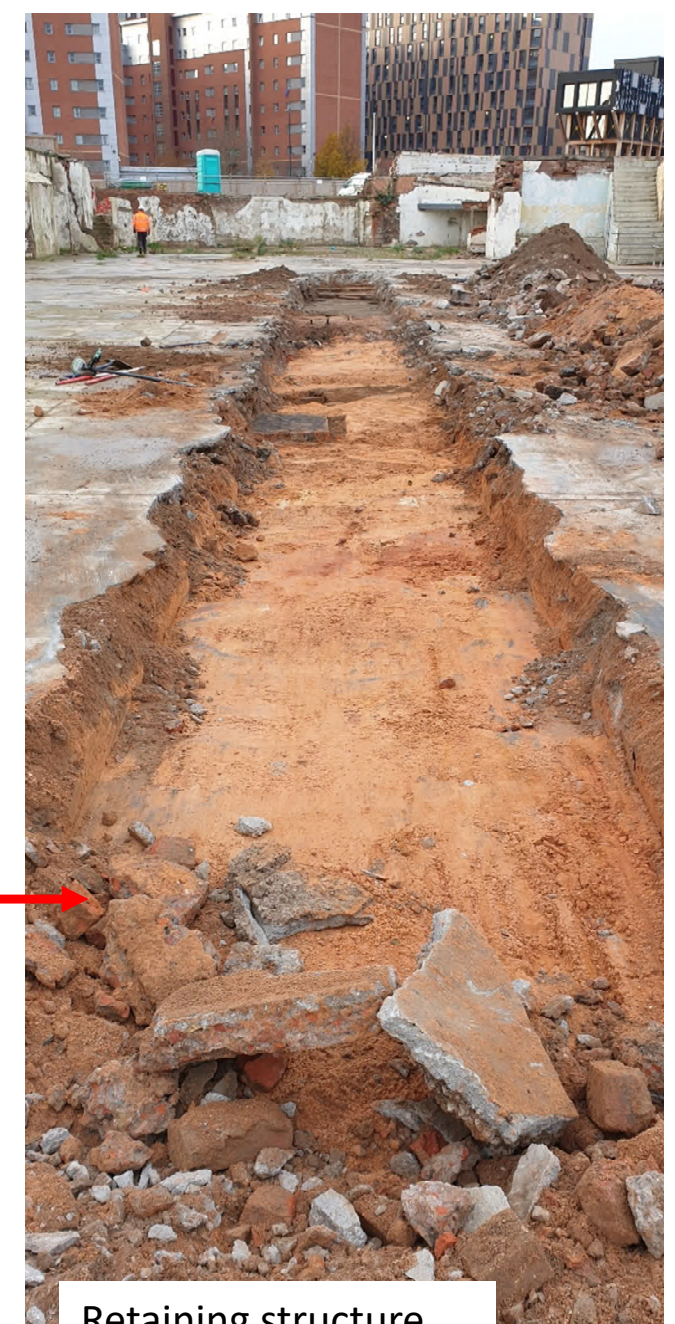
Retaining structure  
Slit trench formed through lower  
level showing sandstone beneath  
existing floor slab
