# PHASE 2 SITE INVESTIGATION

Plots O + N, Mayfield

Mayfield Partnership Ltd

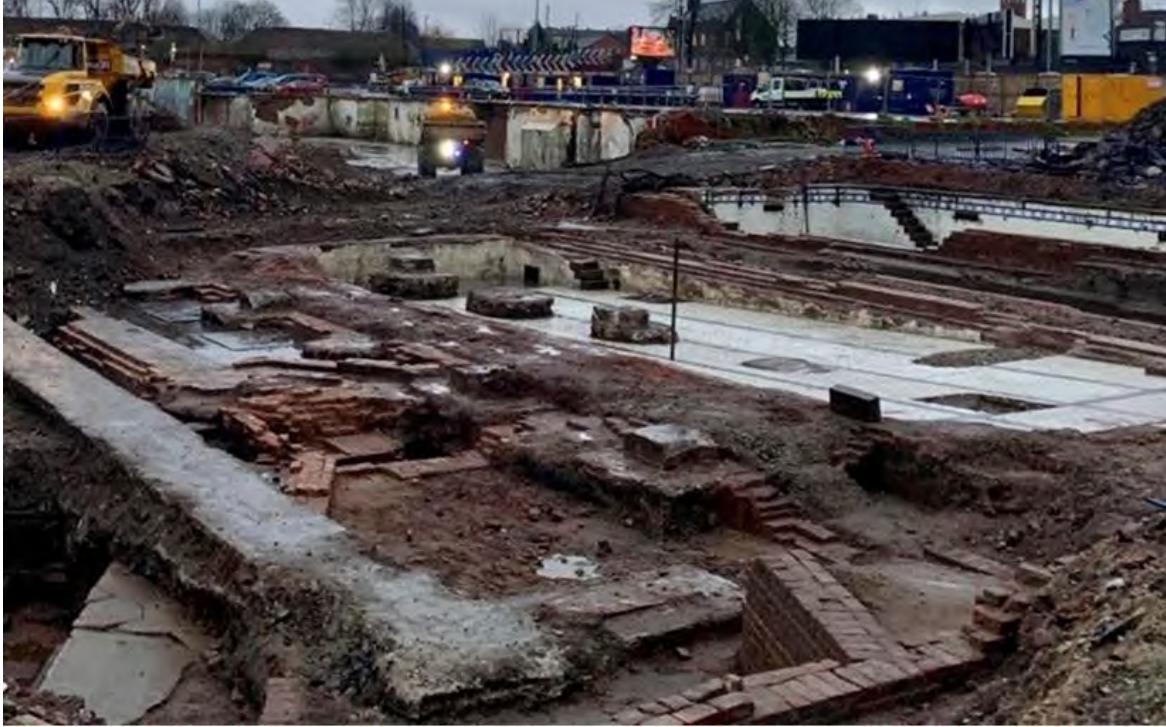
Fig 6.1 : Looking south east from Baring Street across excavated Mayfield Baths site.

- 6.1.6 Figure 6.1 and 6.2 provided overleaf were taken in December 2020 following the complete exaction of the baths by Salford Archaeology.

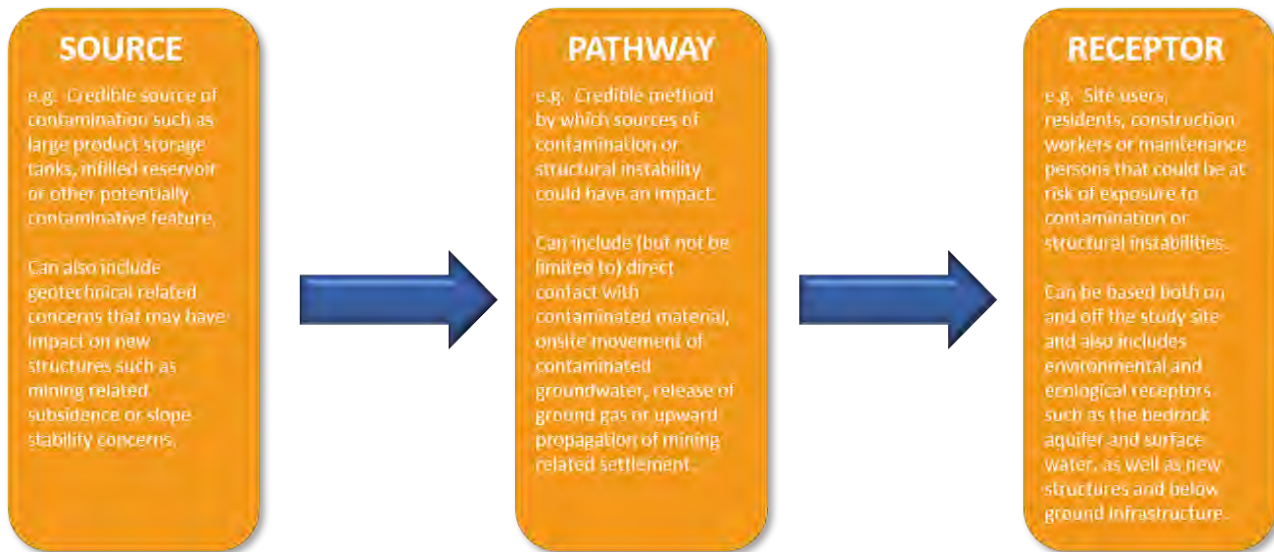
**Figure 8.0 Source Pathway Receptor Diagram**

- 8.0.1 The information obtained during the desk-based study has been reviewed to establish the Preliminary Conceptual Model for the site. This model is based around the Source / Pathway / Receptor methodology as outlined in Figure 8.0.

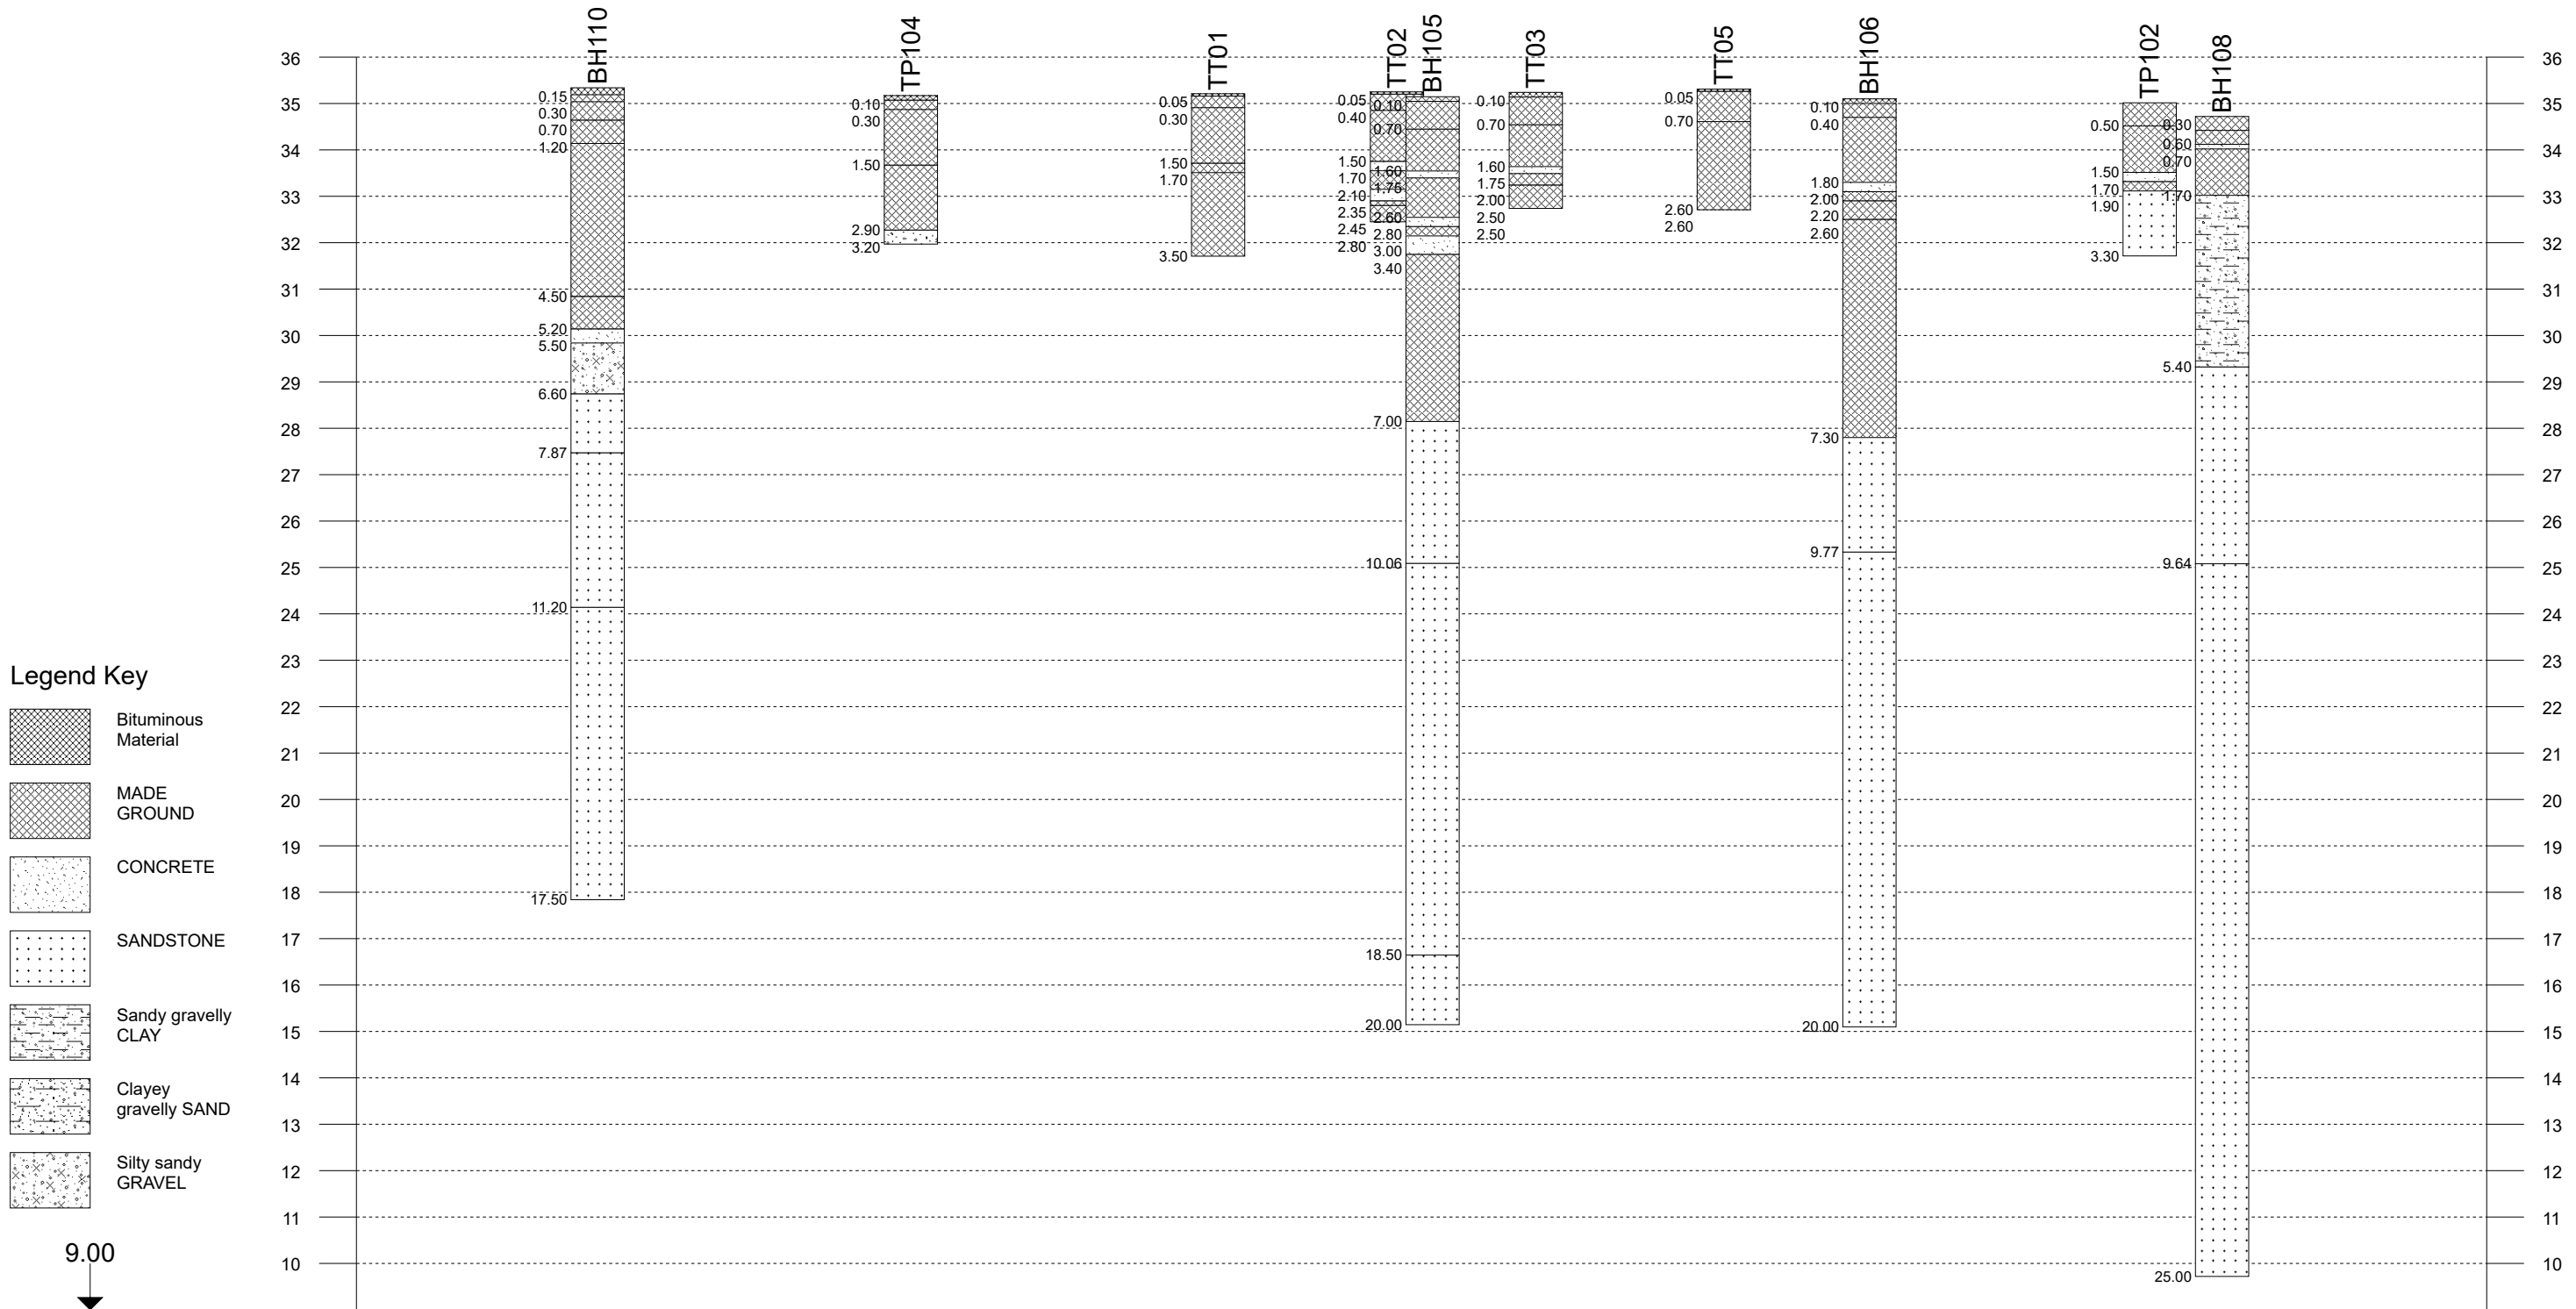
Title: N-S Geological Cross Section  
Vertical Scale: 1:143  
Horizontal Scale: 1:502  
Engineer: L. Daley

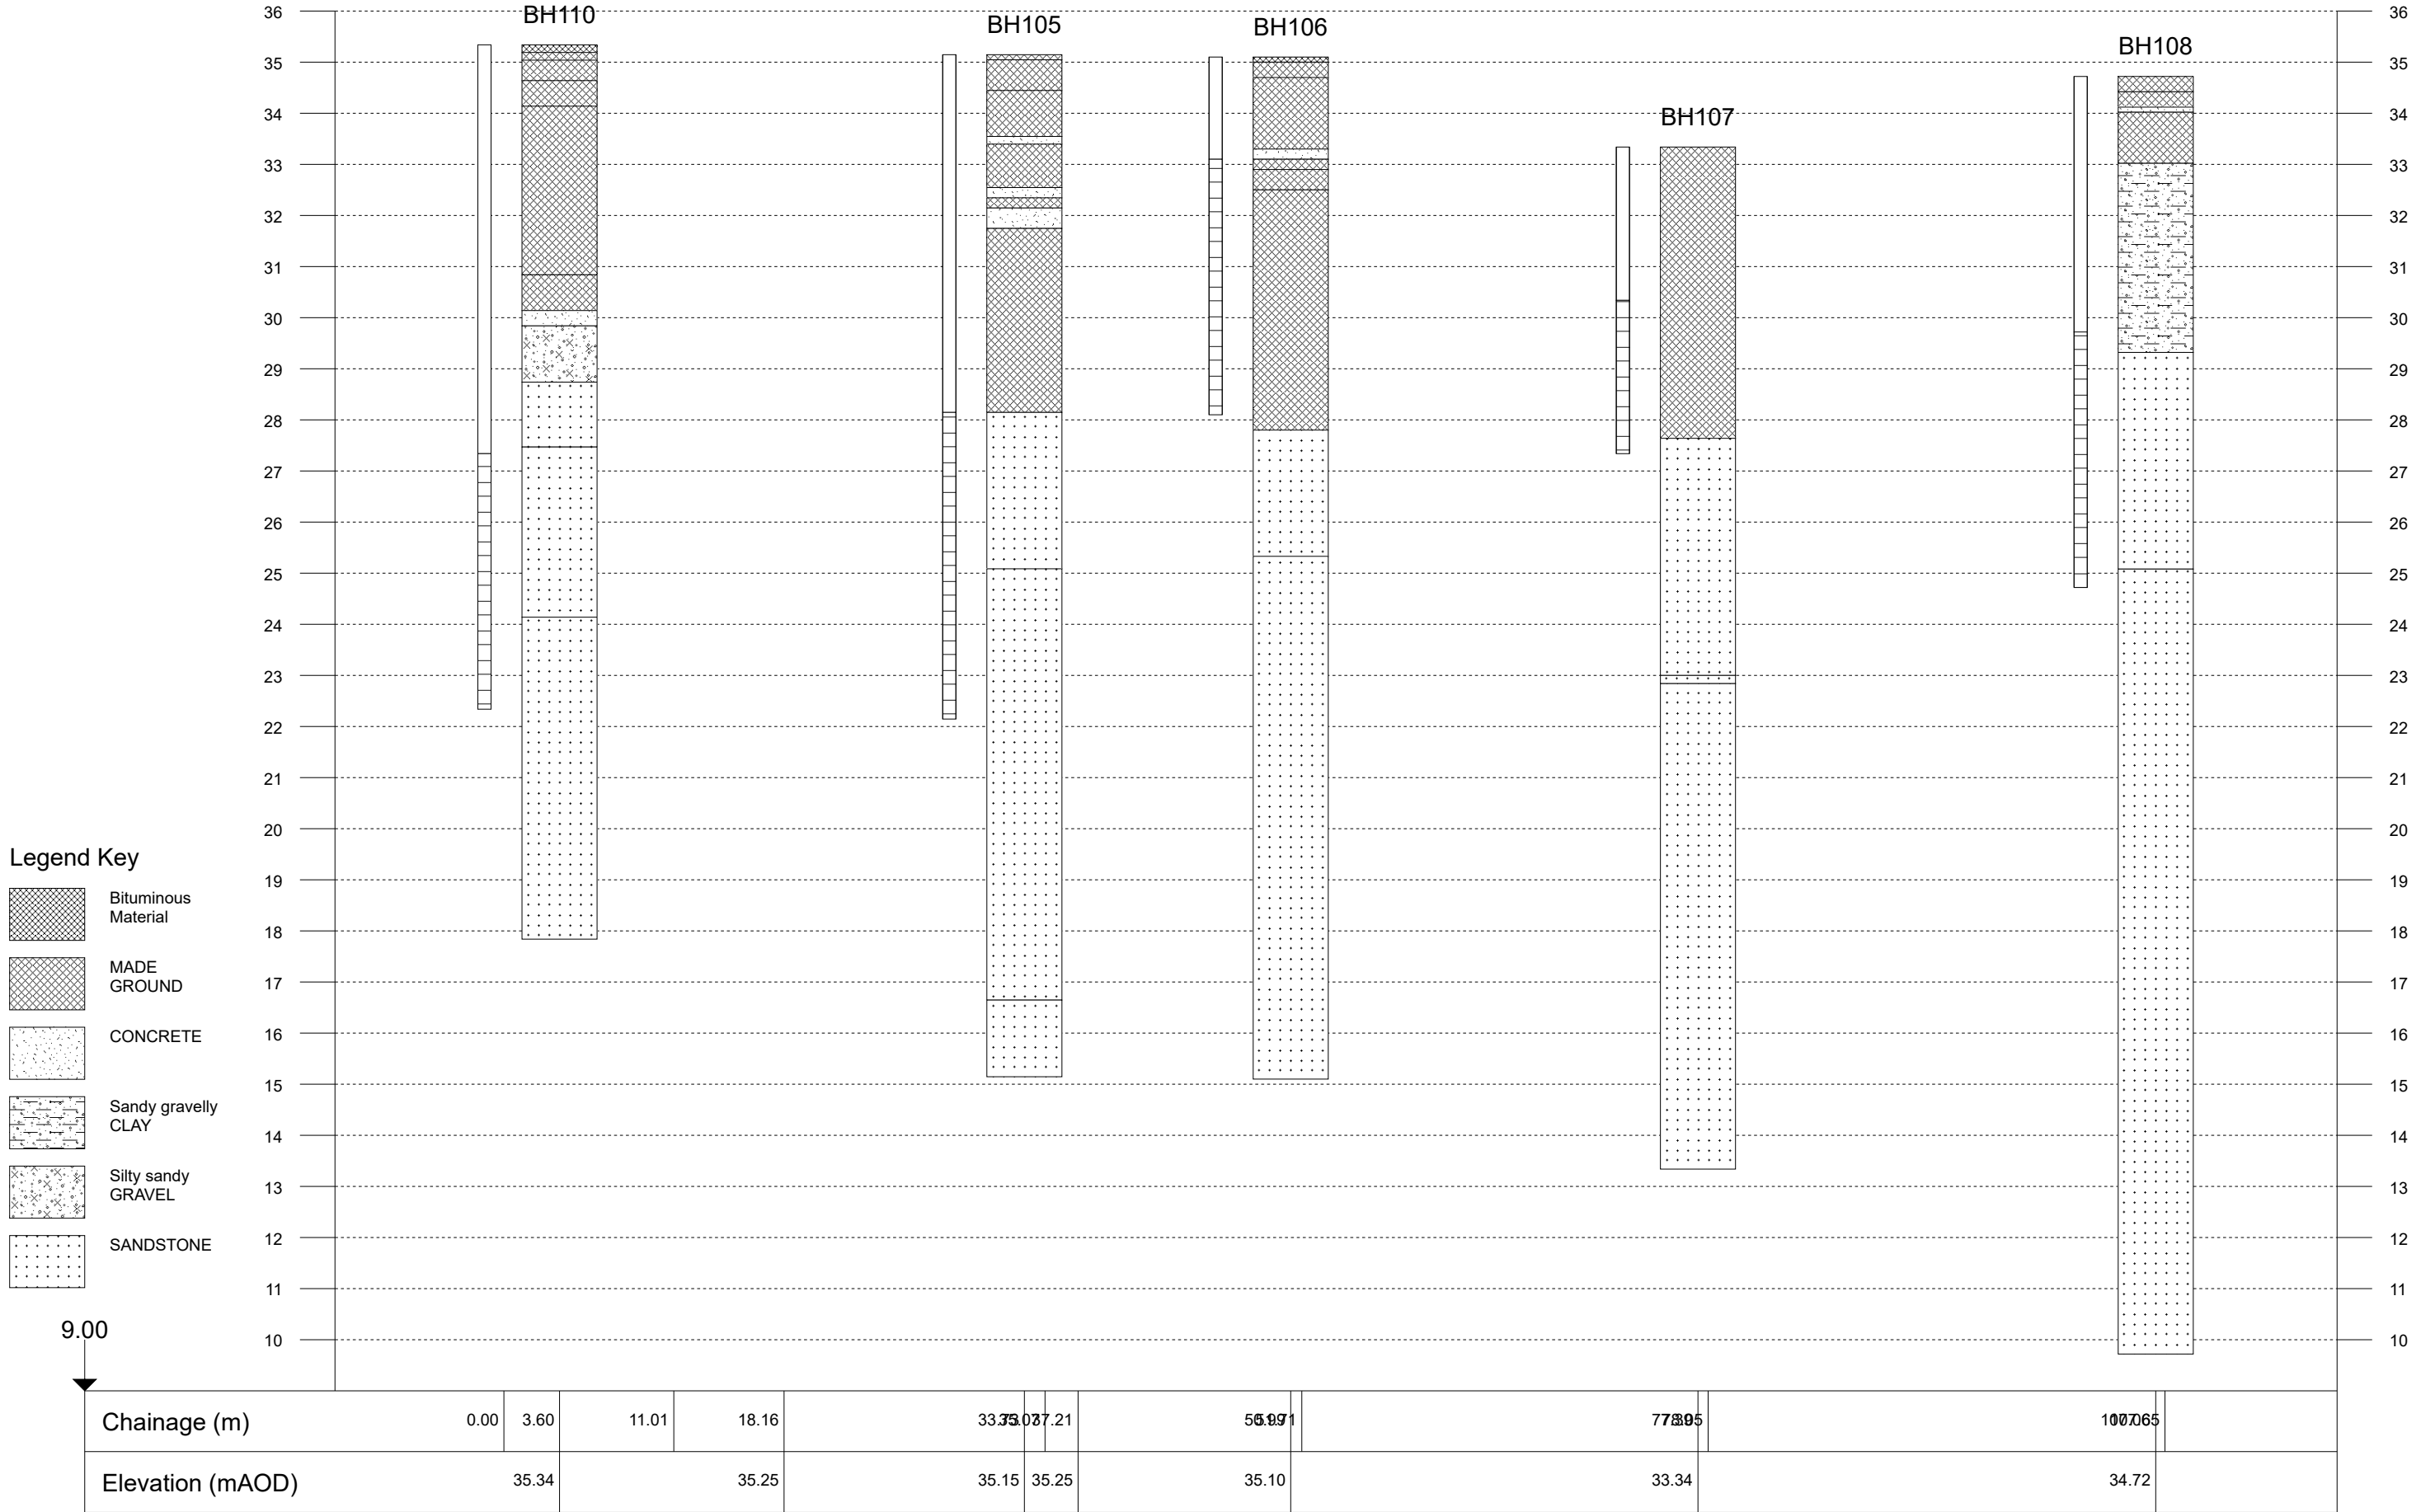
Title: Monitoring Well Cross Section  
Vertical Scale: 1:122  
Horizontal Scale: 1:404  
Engineer: L. Daley

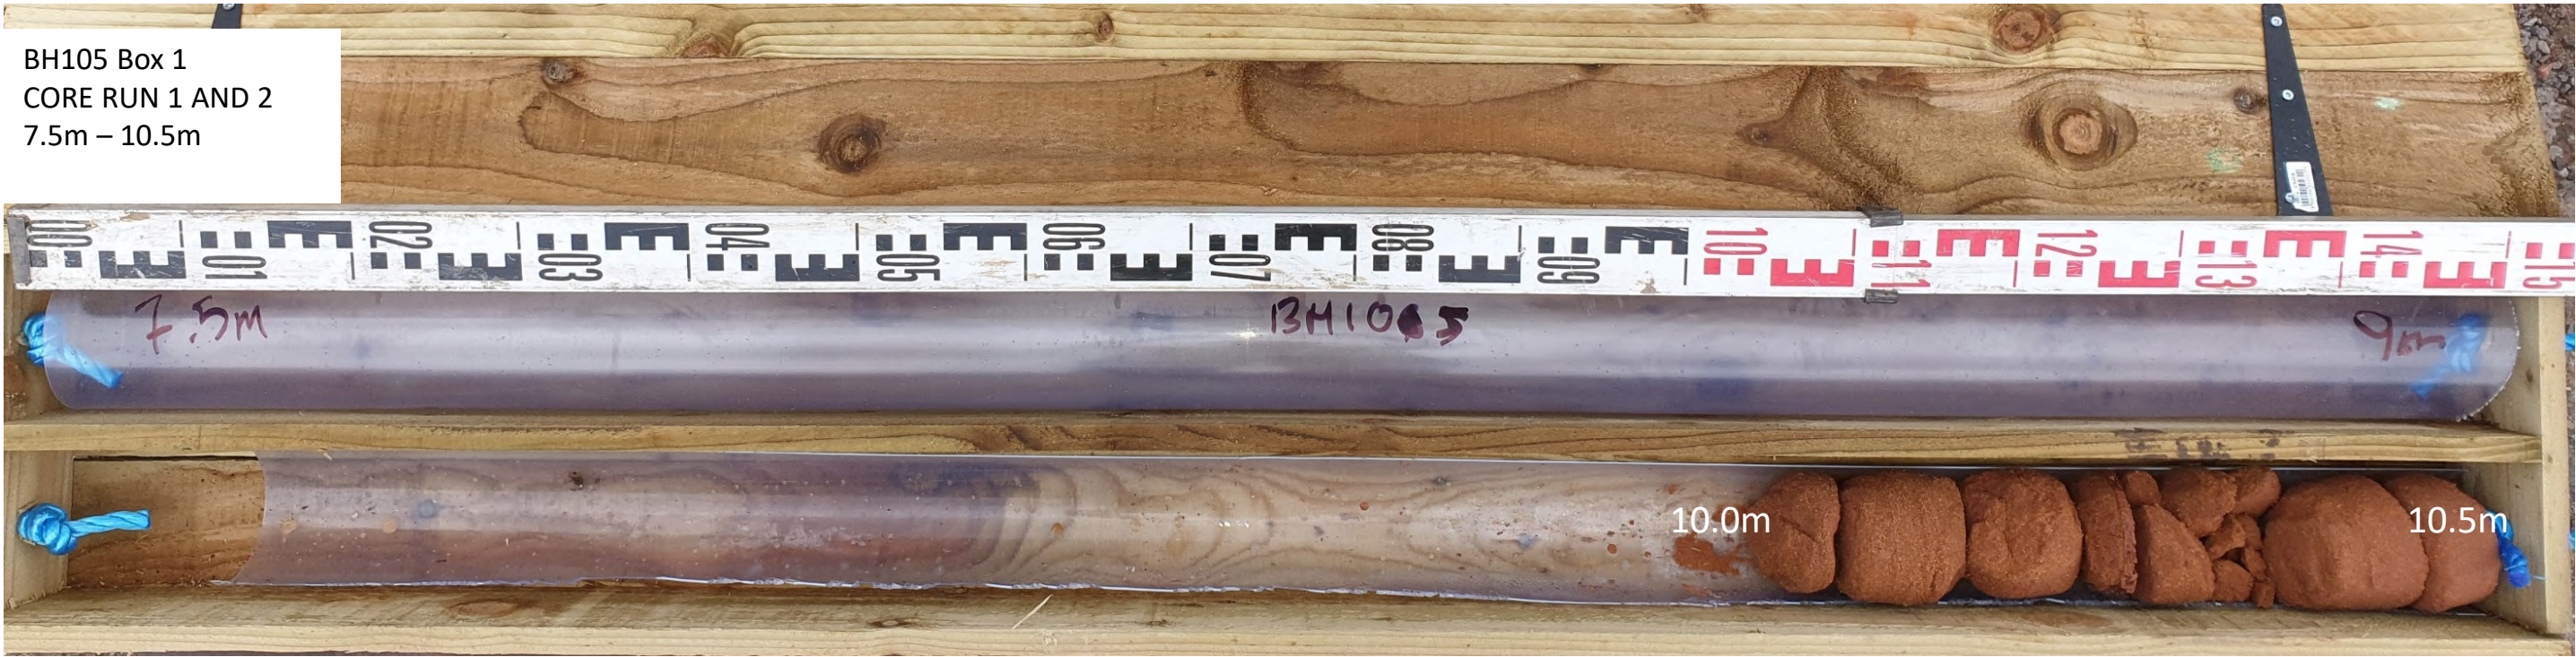
BH105 Box 1  
CORE RUN 1 AND 2  
7.5m – 10.5m

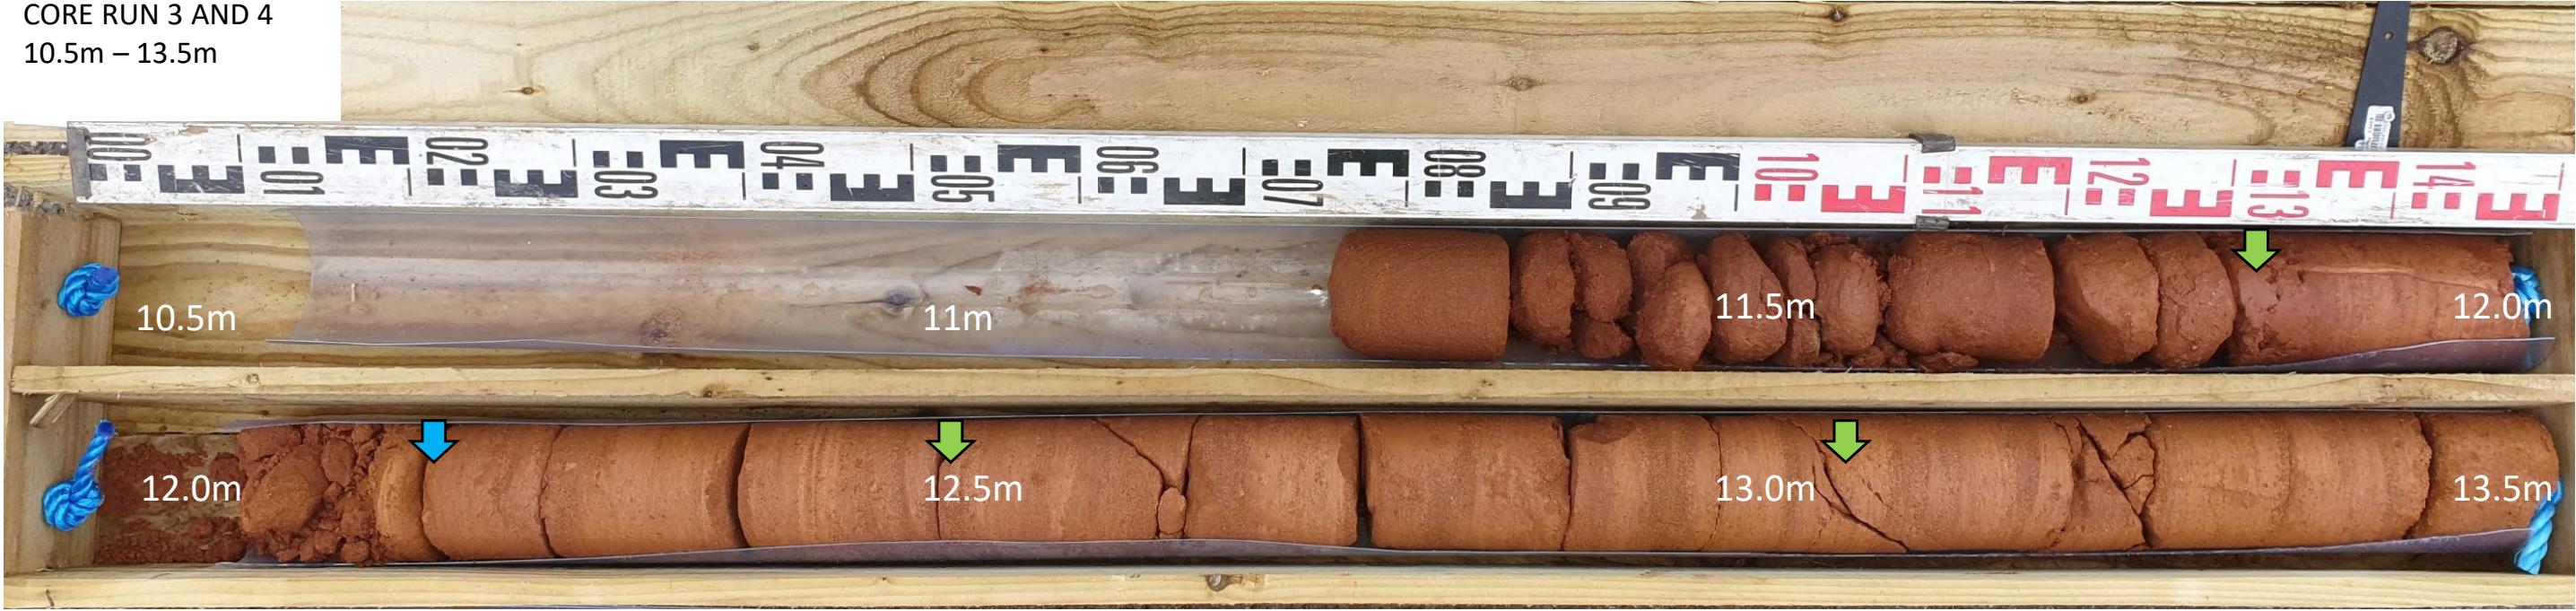
BH105 Box 2  
CORE RUN 3 AND 4  
10.5m – 13.5m

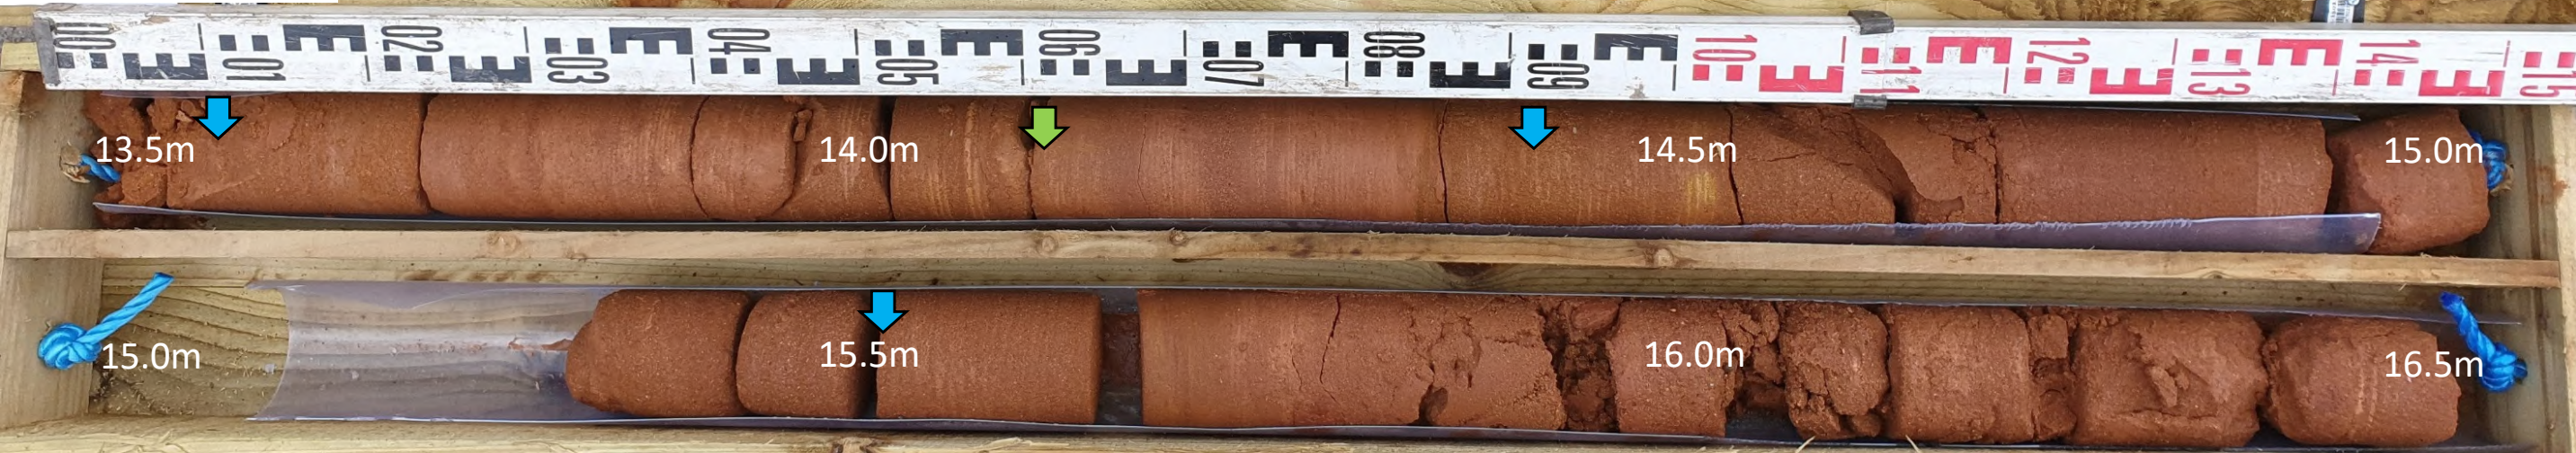
BH105 Box 3  
CORE RUN 5 AND 6  
13.5m – 16.5m

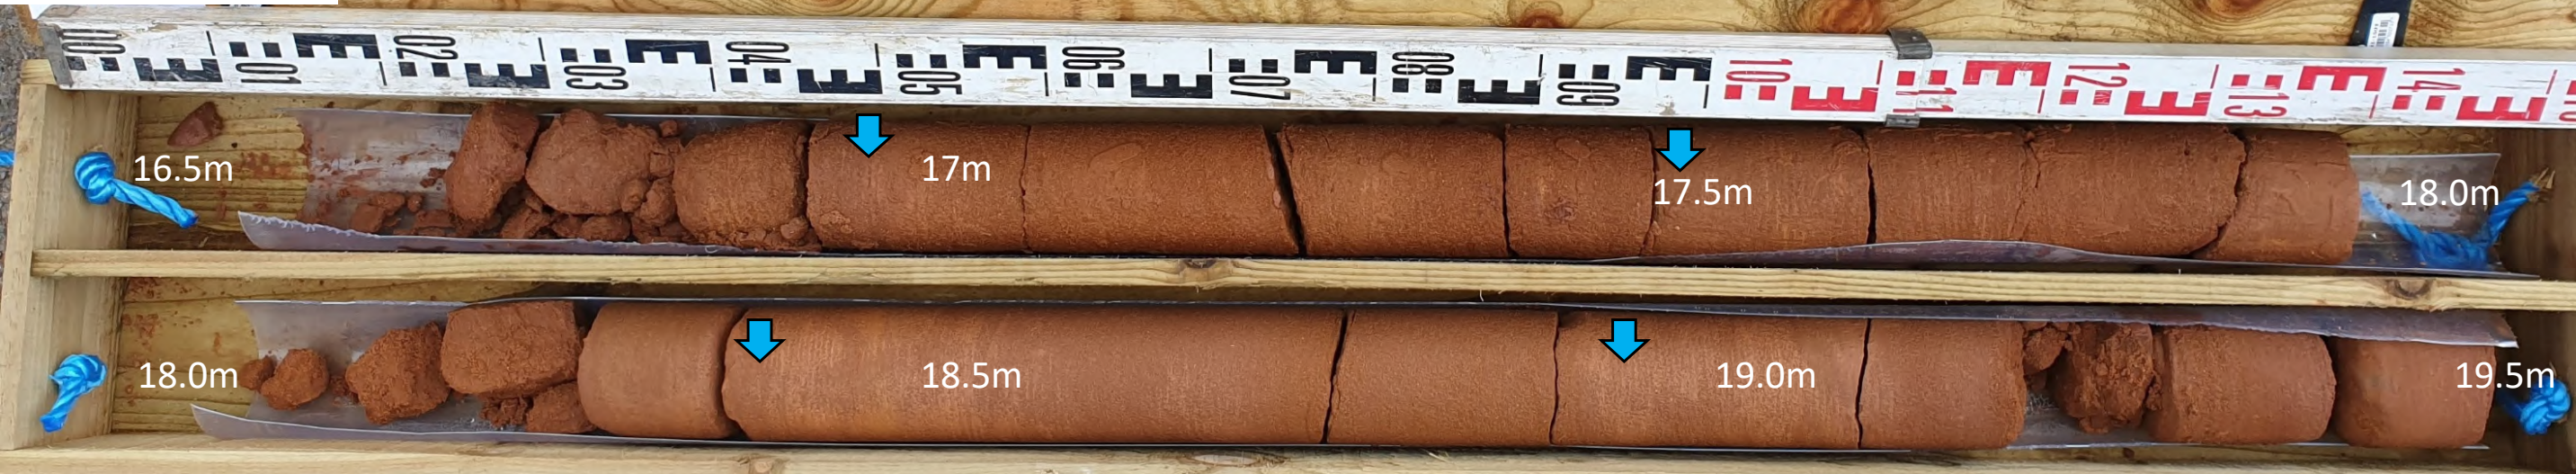
BH105 Box 4  
CORE RUN 7 AND 8  
16.5m – 19.5m

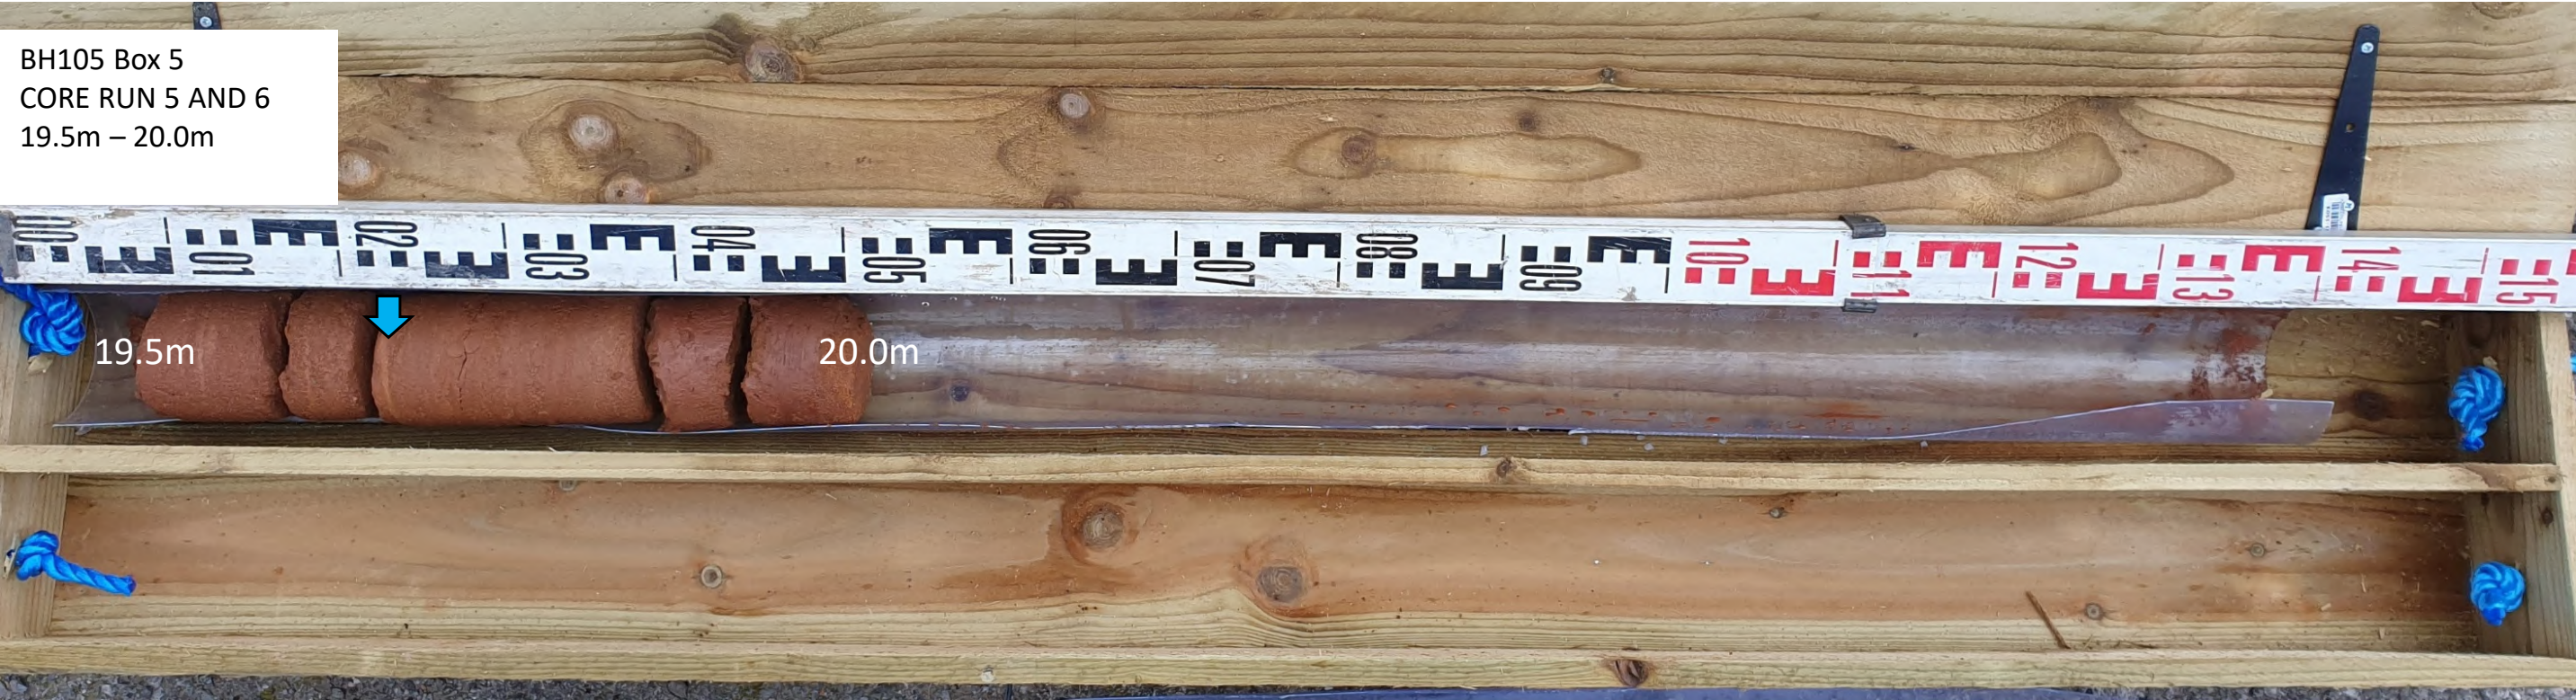
BH105 Box 5  
CORE RUN 5 AND 6  
19.5m – 20.0m

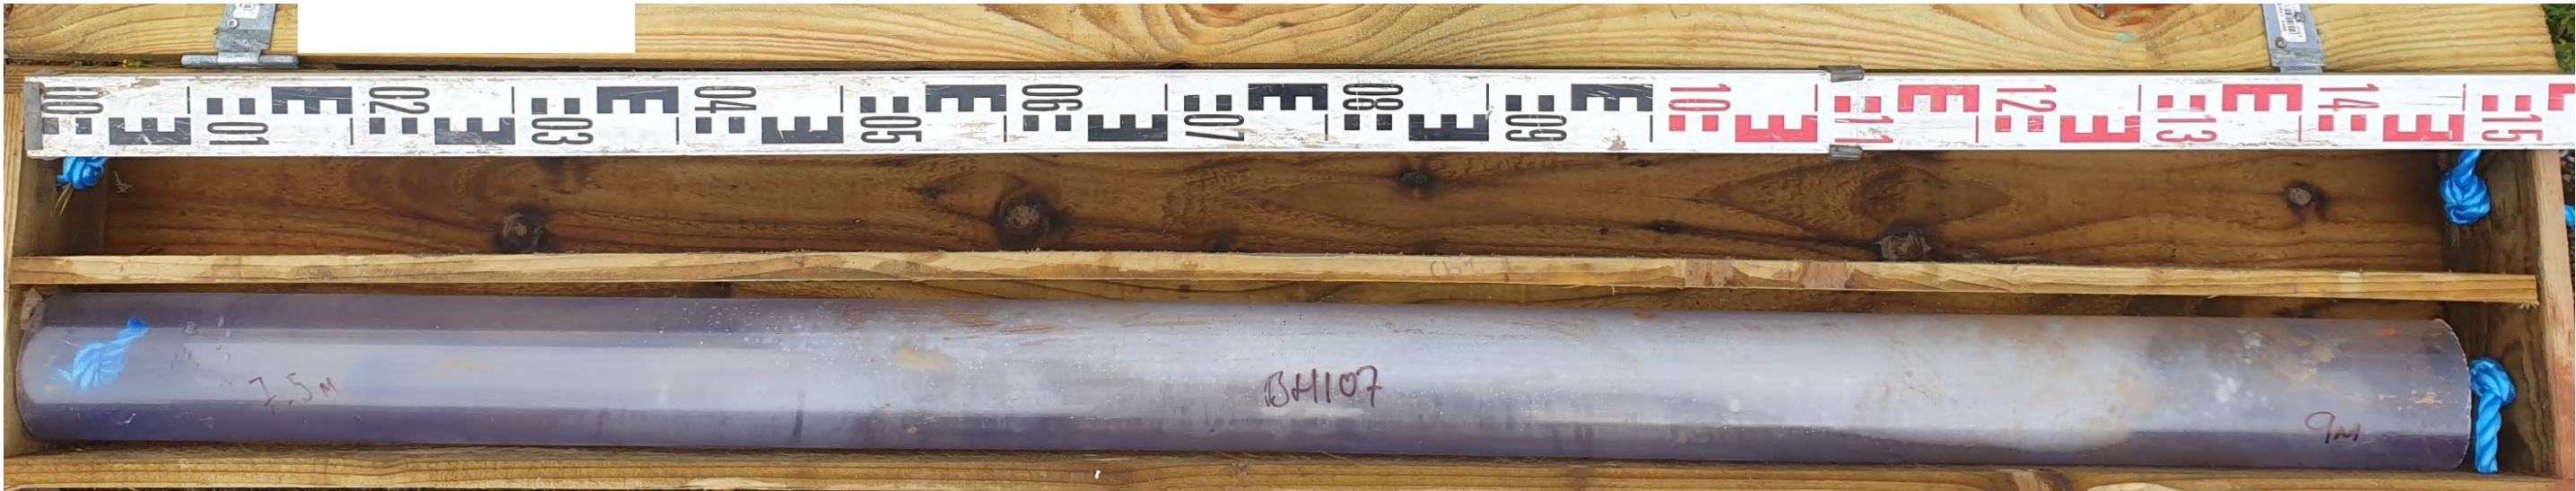
BH107 Box 1  
CORE RUN 1 7.5m –  
9.0M

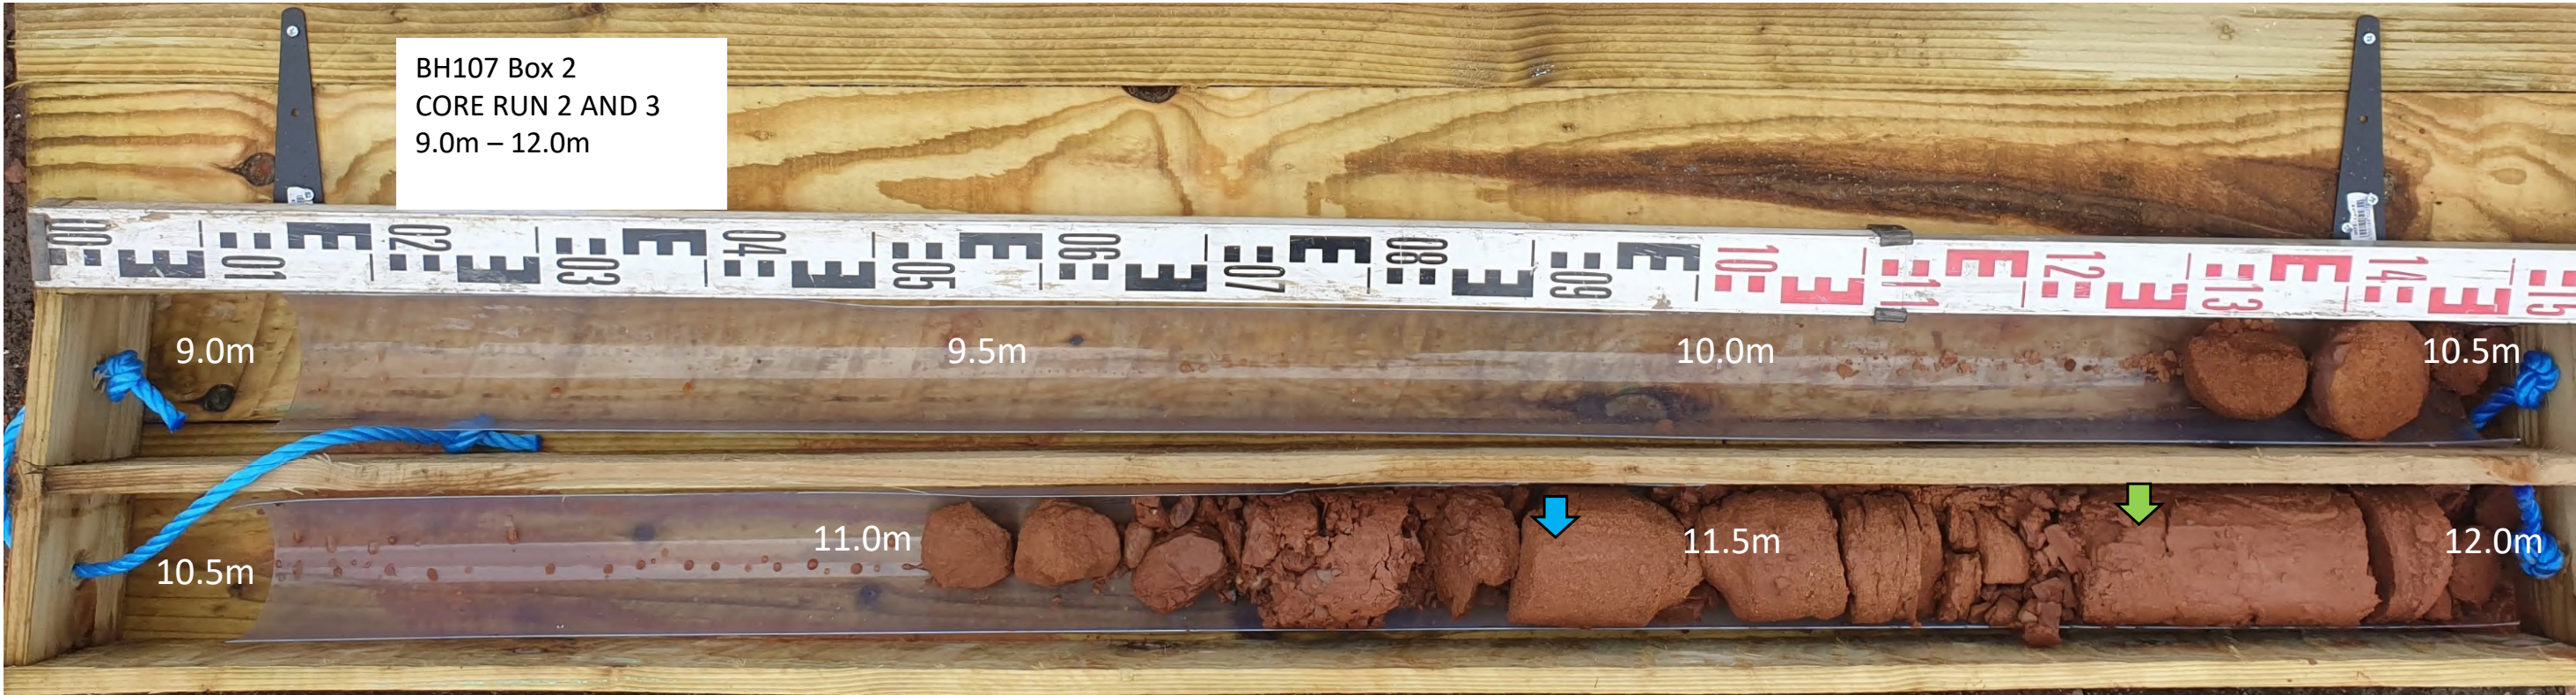
BH107 Box 2  
CORE RUN 2 AND 3  
9.0m – 12.0m

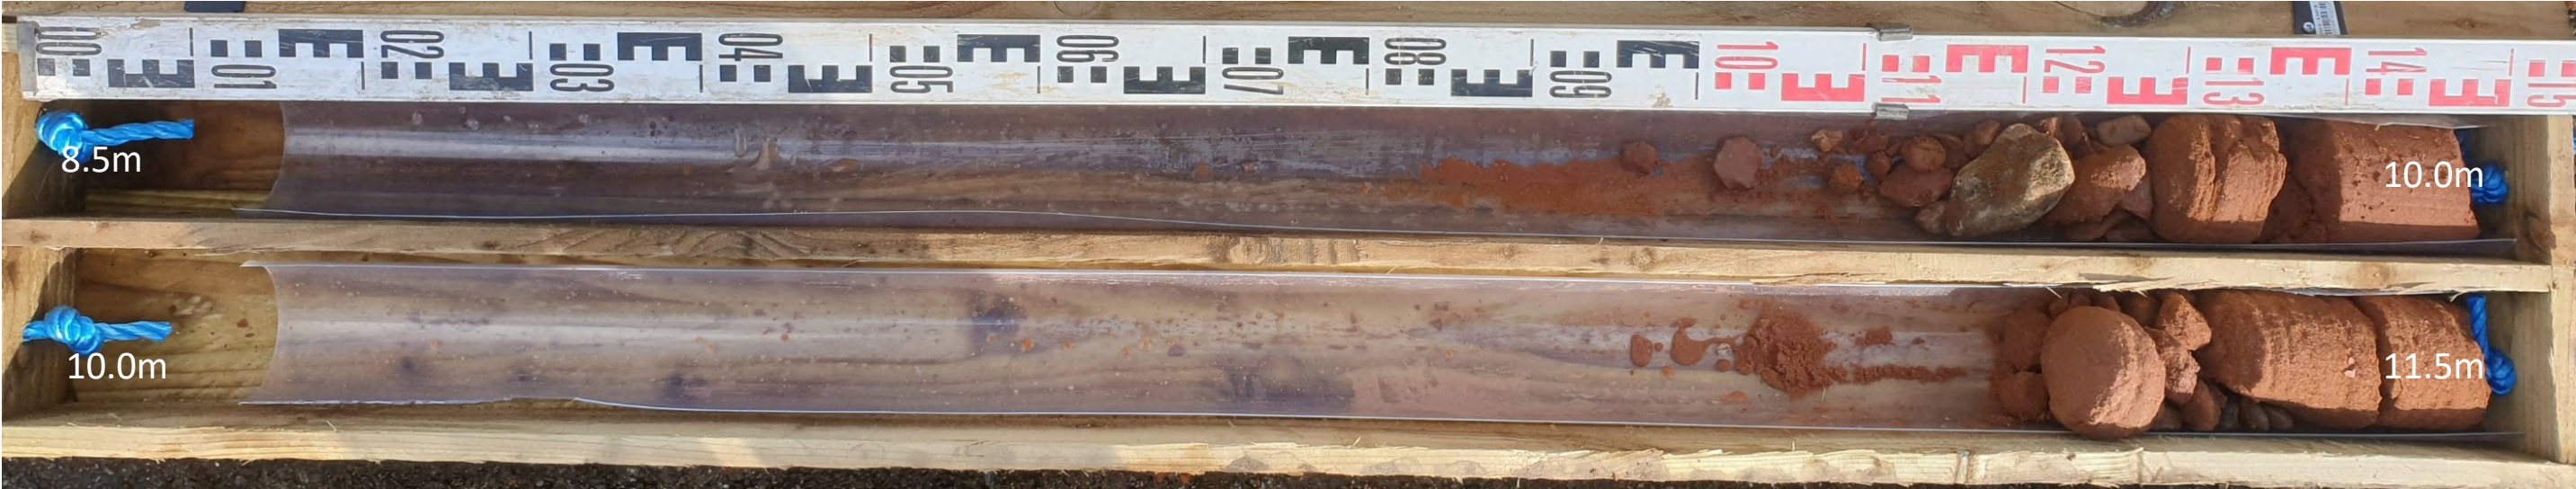
BH108 Box 1  
CORE RUN 1 AND 2  
8.5m – 11.5m

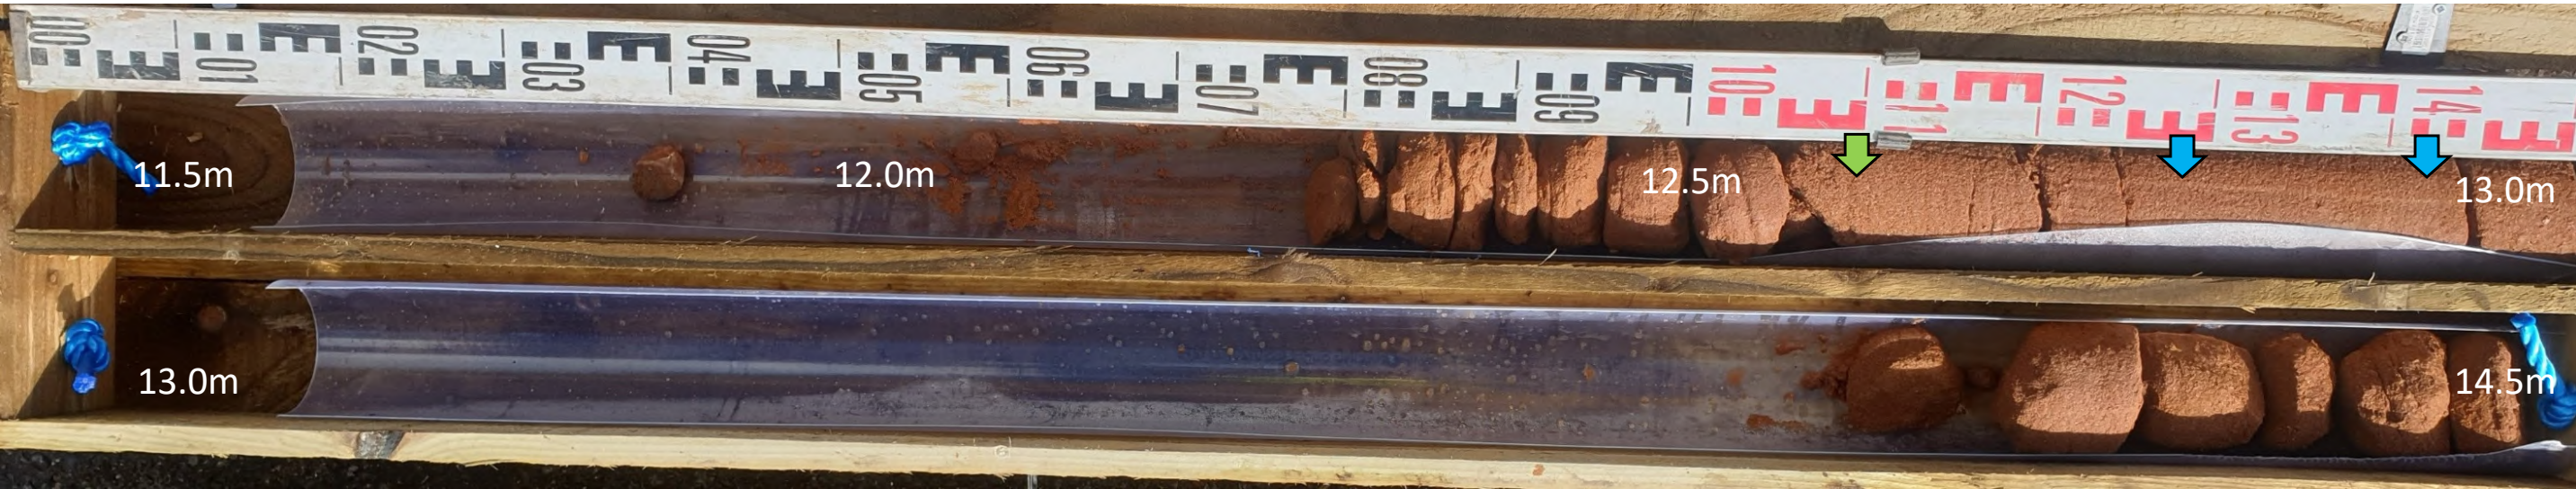
BH108 Box 2  
CORE RUN 3 AND 4  
11.5m – 14.5m
