# PHASE 2 SITE INVESTIGATION

Plots O + N, Mayfield

Mayfield Partnership Ltd

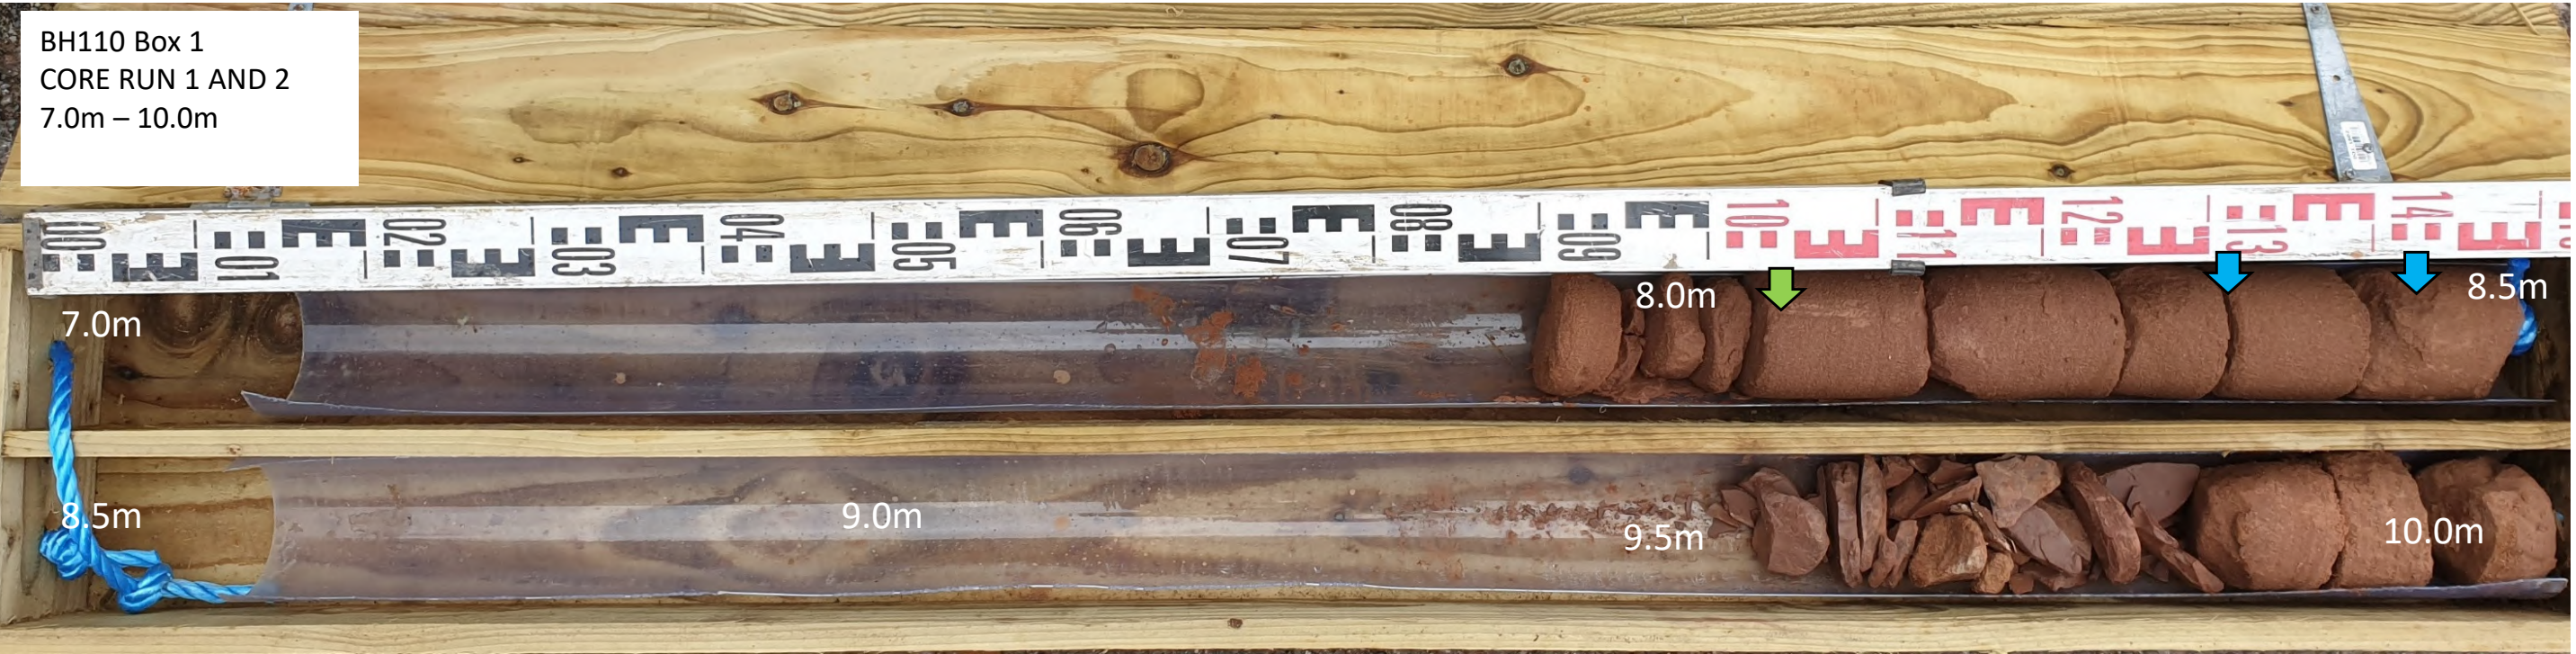
BH110 Box 1  
CORE RUN 1 AND 2  
7.0m – 10.0m

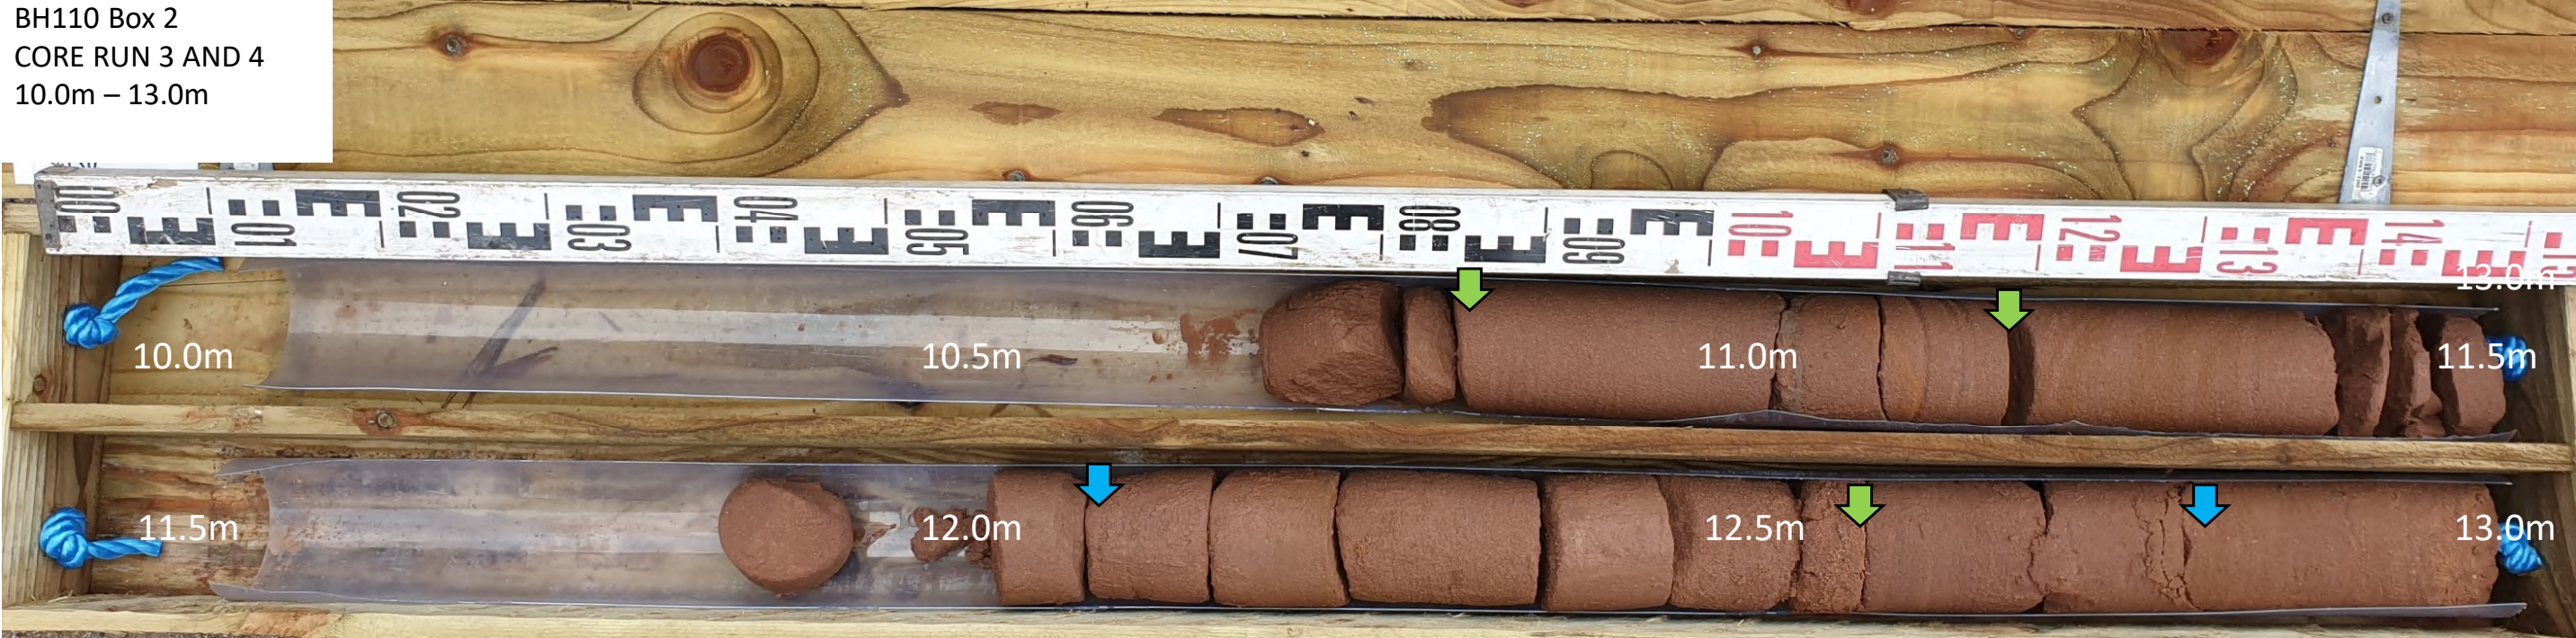
BH110 Box 2  
CORE RUN 3 AND 4  
10.0m – 13.0m

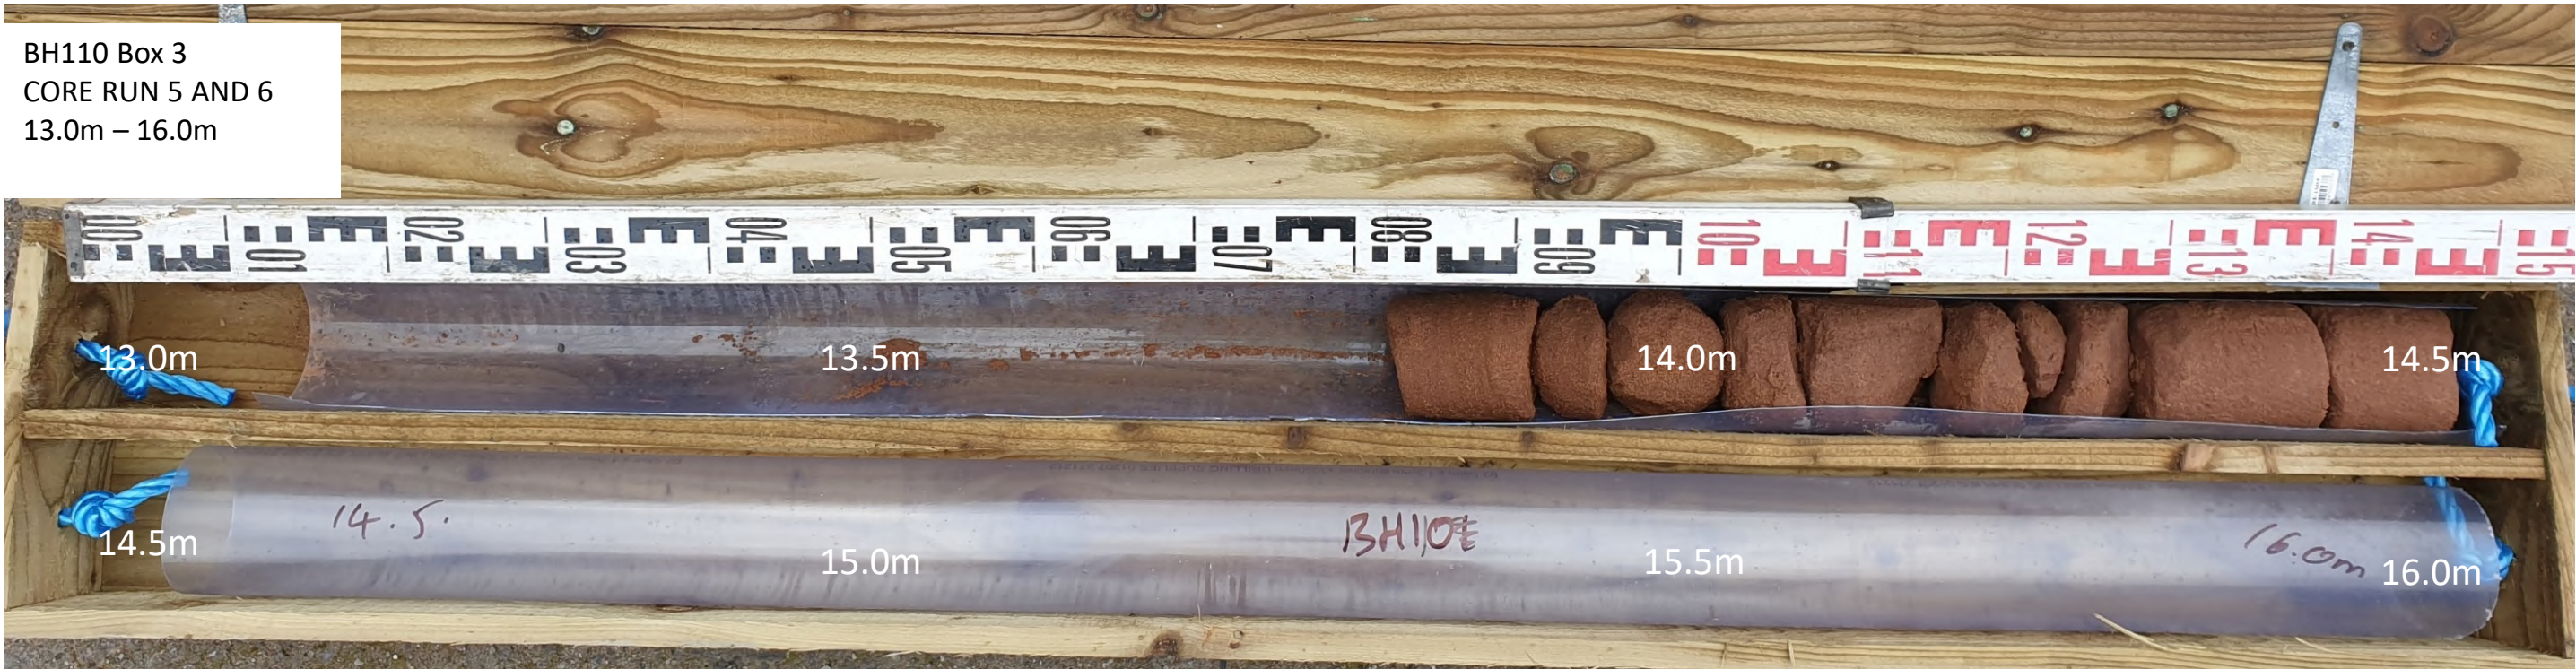
BH110 Box 3  
CORE RUN 5 AND 6  
13.0m – 16.0m

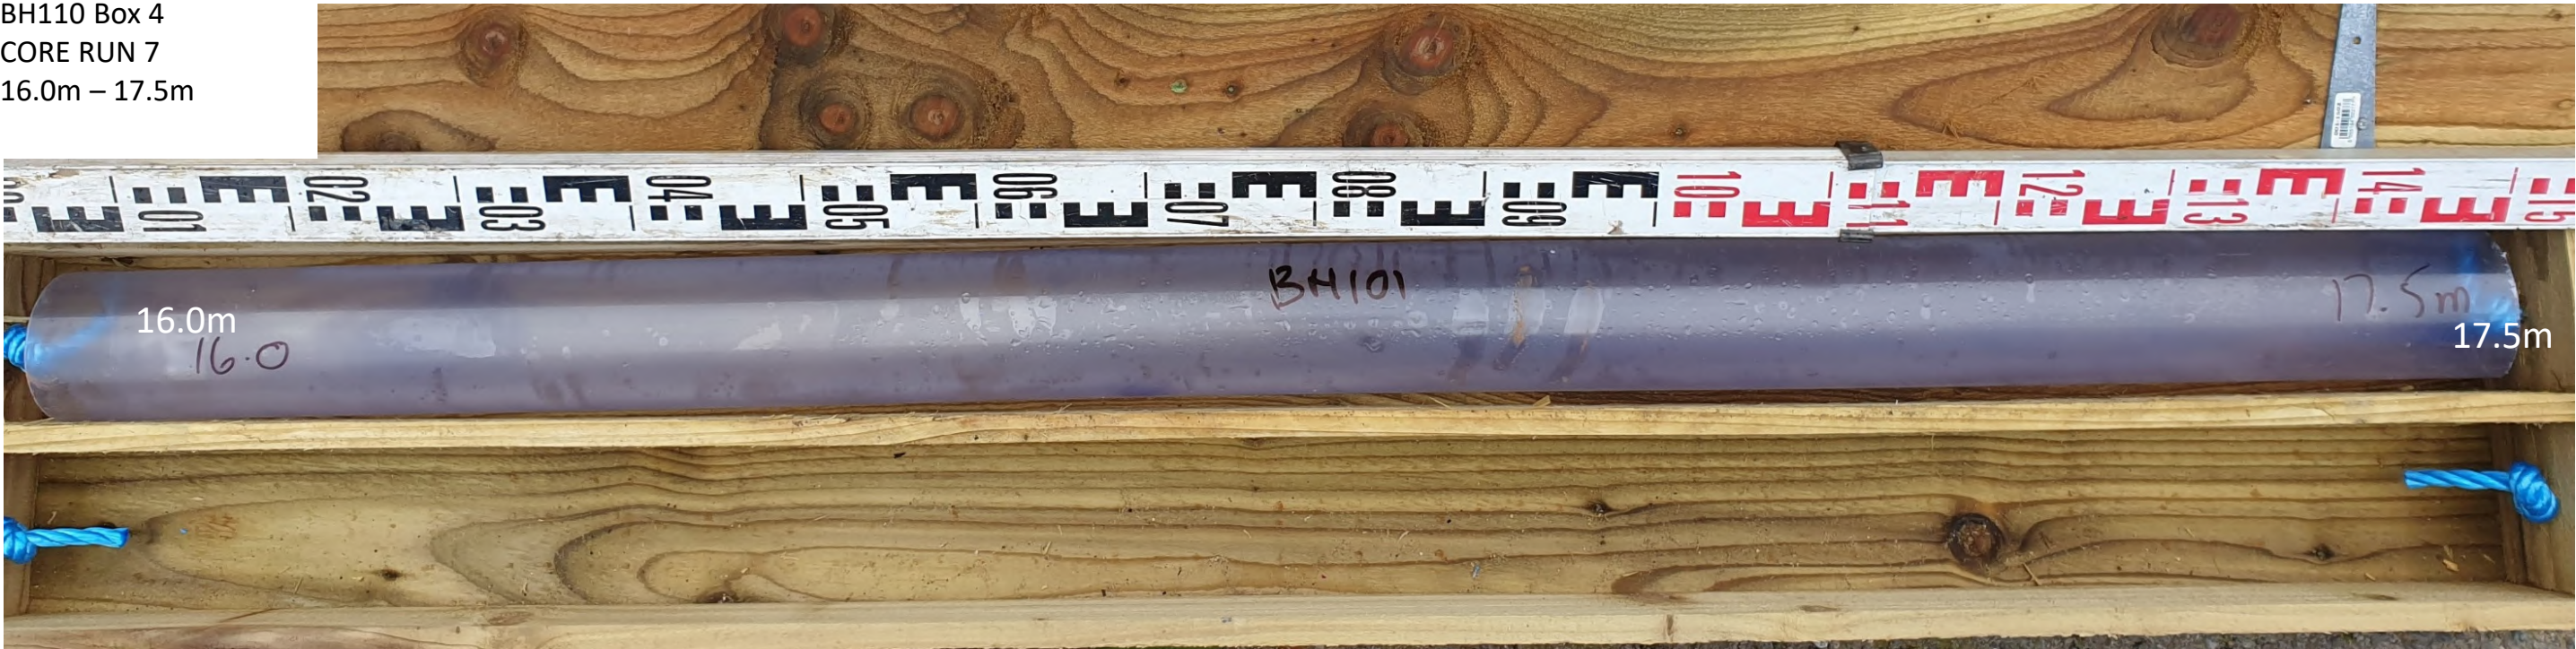
BH110 Box 4  
CORE RUN 7  
16.0m – 17.5m

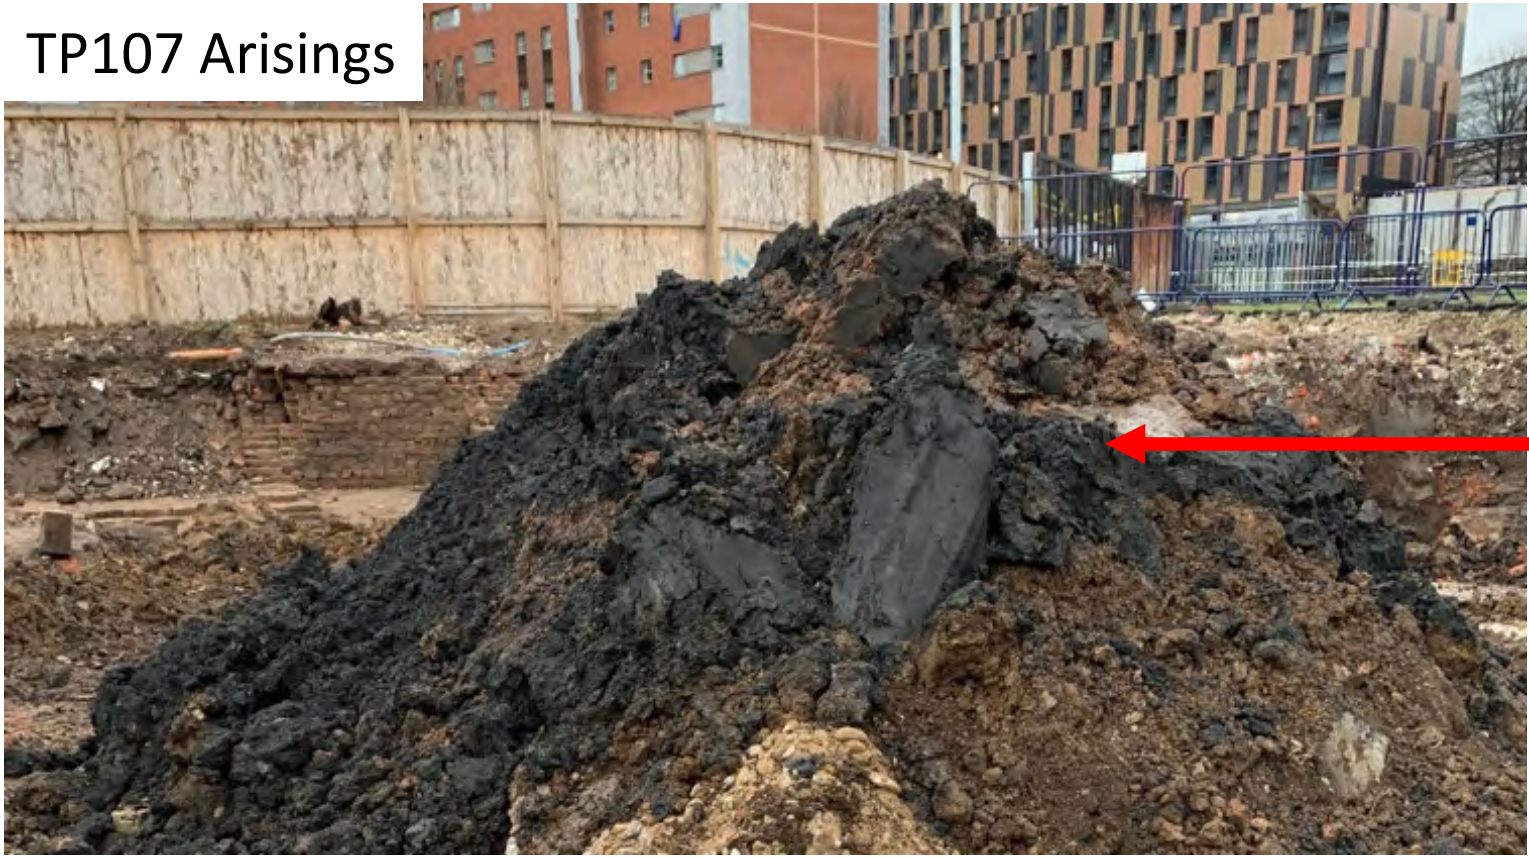
TP107 Arisings

Organic rich clay

- 6.1.8 Made ground was reported at all exploratory locations comprising a mixture of demolition type fill material and the Victorian construction build up of the swimming pools (a detailed description of which is provided on TP107 log and accompanying photographs within Appendix B). The depth of made ground varied around the baths to depths between 30.0 and 32.9mAOD with some brick walls and structures found to extend to significant depths beneath the site (possible relating to old drainage infrastructure) e.g. brick wall noted in TP108 that extended to a depth circa 28.8mAOD.

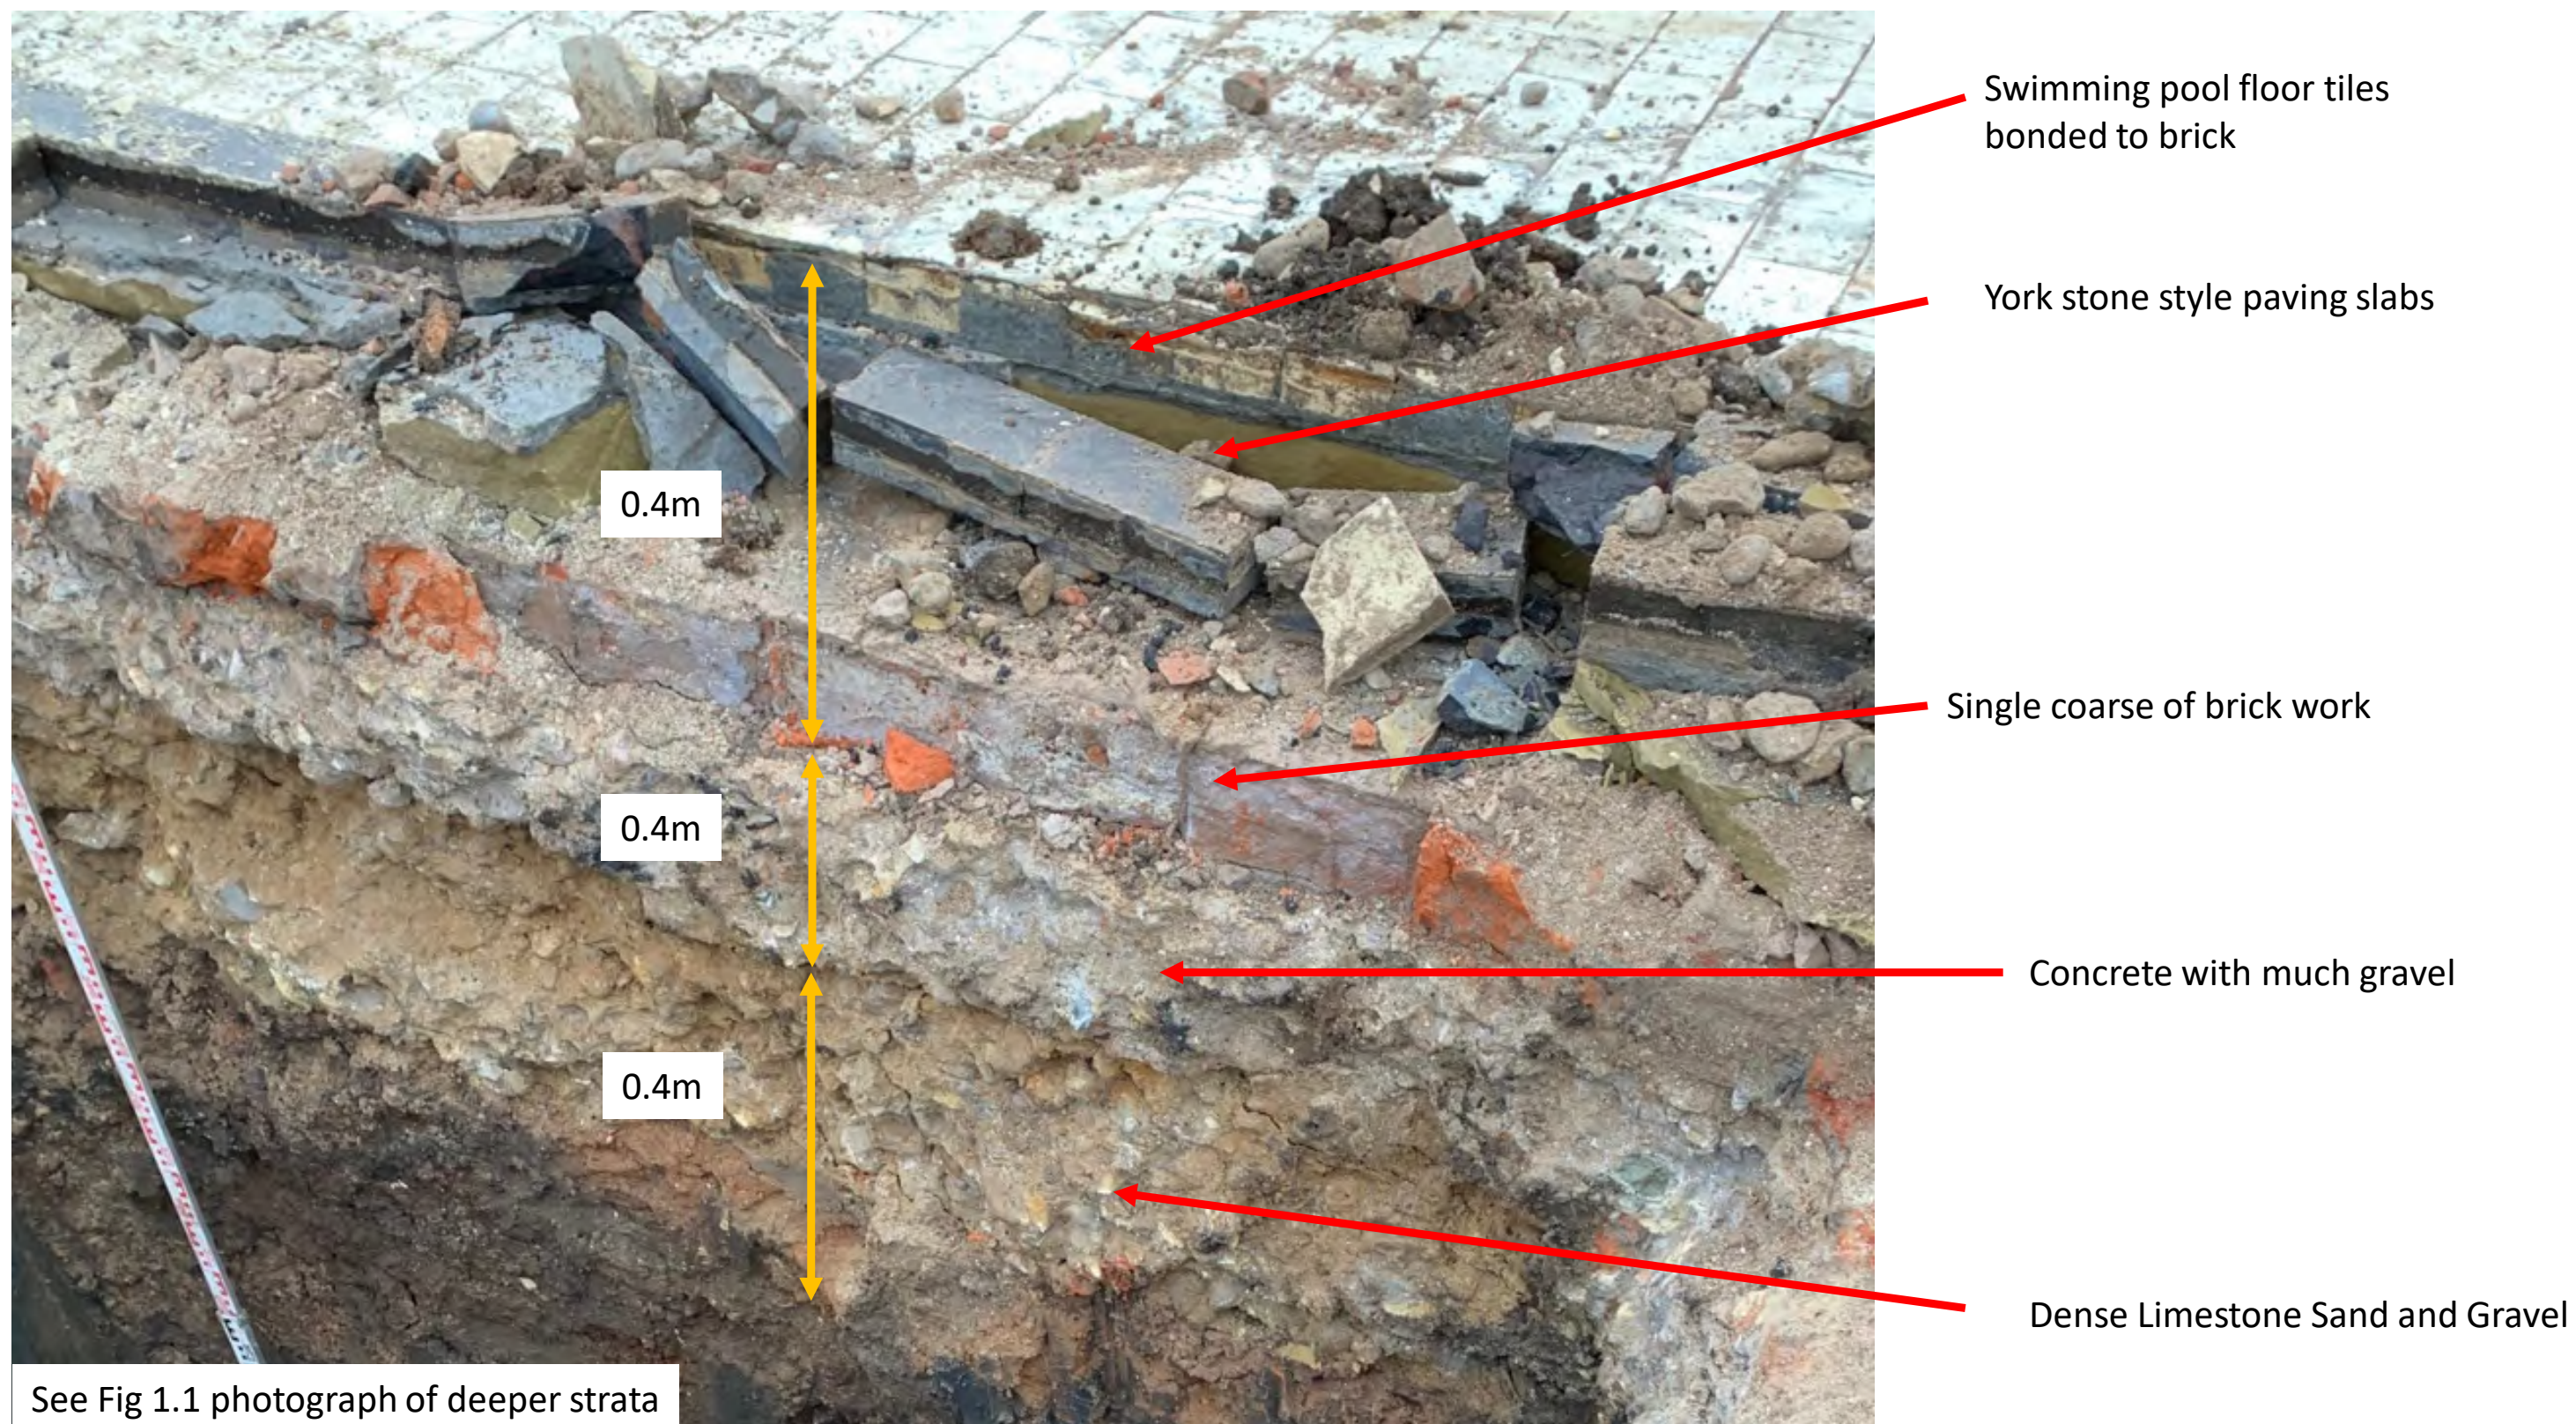
| | PROJECT TITLE | Poulton Additional Trial Holes | SKETCH TITLE | Section through ladies swimming pool | |
