| | Calcs for<br><b>Northern Boundary Wall Survey</b> | | | | Start page no./Revision<br><b>00002/ 1 / C02</b> | |

| Report | Proj Ref | Orig | Zone | Level | Type | Role | Doc No | Rev |
|---|---|---|---|---|---|---|---|---|
| <b>Northern Boundary Wall Survey</b> | <b>RUS</b> | <b>SGi</b> | <b>XX</b> | <b>XX</b> | <b>RP</b> | <b>S</b> | <b>00002</b> | <b>C02</b> |

SGi have been commissioned by Rowlinson Construction Ltd (RCL) to carry out a visual survey of the boundary wall along the northern edge of the site. The extent of the survey is shown on the appended drawings.

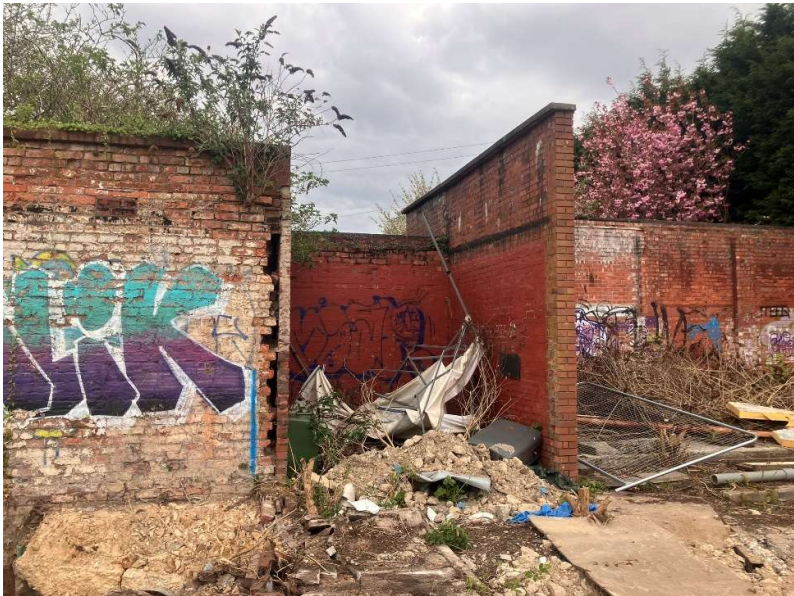
This is the freestanding wall, the end of which can be seen in the photograph below (right of centre).

It is around 4.2m in height and only 215mm thick, with nothing buttressing the free end seen in the photograph.

We would not be able to demonstrate that this length of wall has sufficient strength to resist wind loads and recommend that it is locally dismantled, back to where wall W04 connects to it.

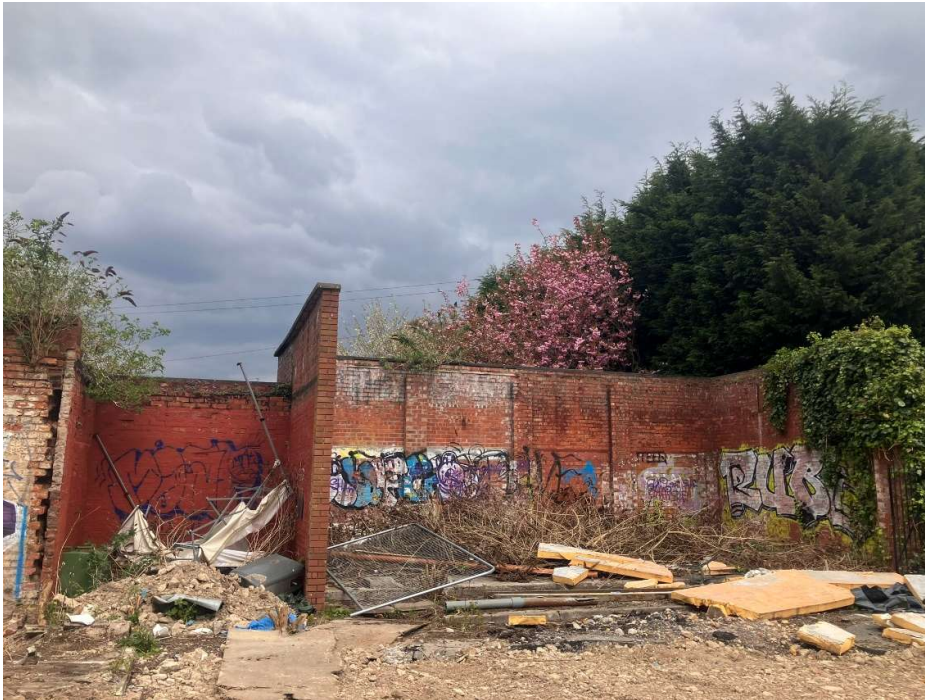
The form of construction differs in this area. It can be seen that there are three brickwork piers which project by 110mm from the main face. The brickwork is stretcher bonded and it appears that there is another leaf of brickwork visible behind this wall at the top, both of which suggest this is a cavity wall. We believe that this may have previously formed part of a substation in this area which has had it's roof removed. This wall is around 4.2m high.

We advise that, if possible, this wall is also reduced in height to the 3m height discussed earlier.

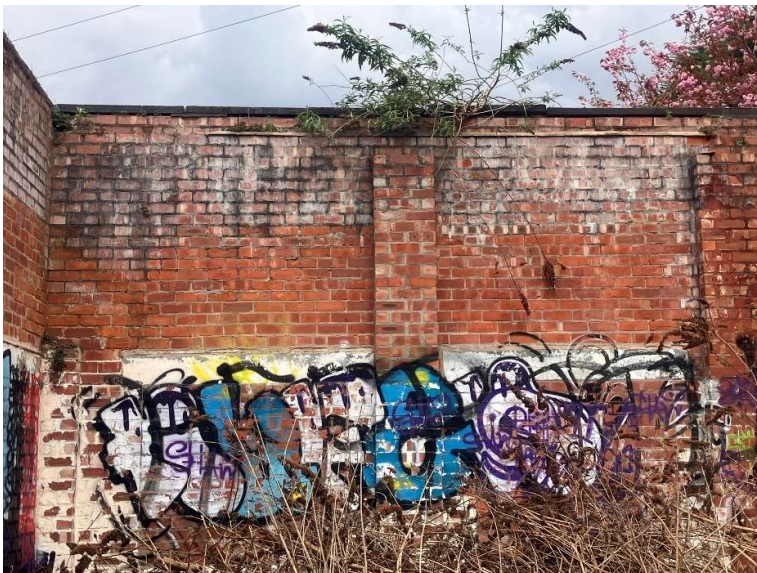
In each of the 4 panels in this wall it can be seen that there is a band of concrete 3 courses high around half-way up the wall (e.g. at the top of the graffiti in the image below)

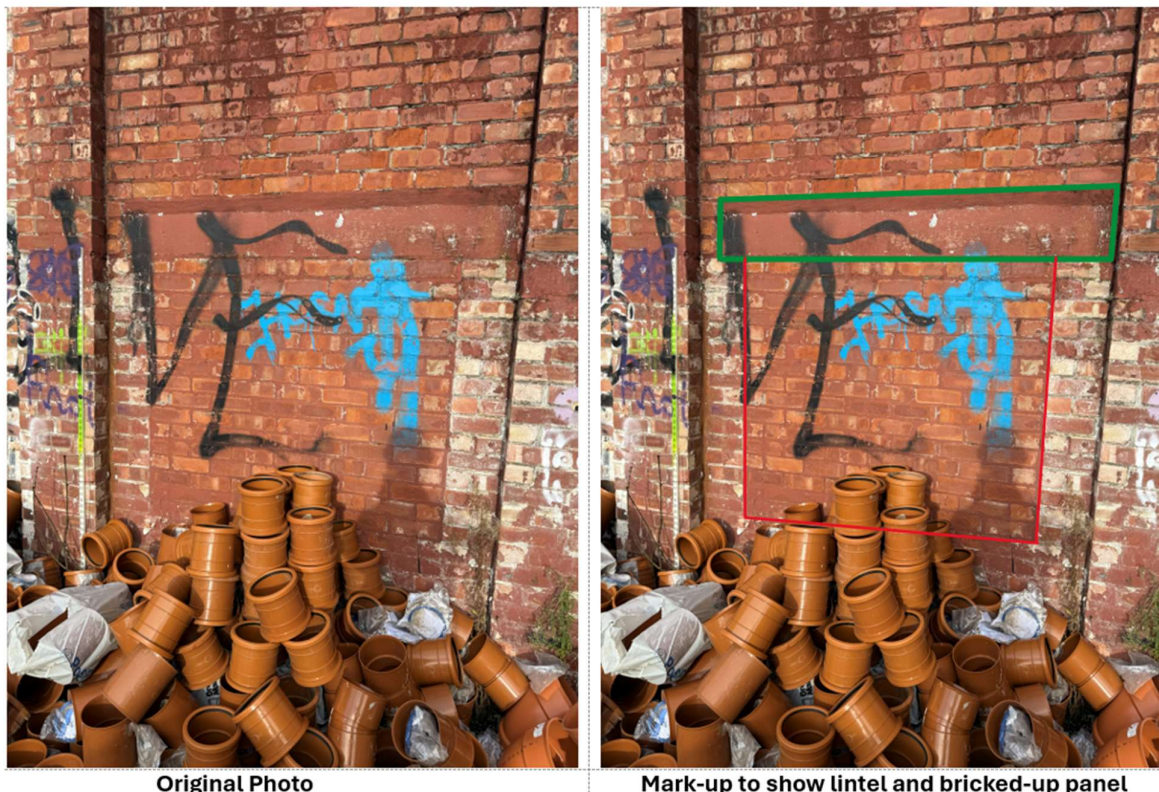
Inspections from closer range make it clear that these are lintels over bricked-up openings as indicated below.

There are numerous such bricked up openings in walls W06, W07 and W08 but it seems to us unlikely that these were previously window openings. We suspect instead that these are actually explosion relief panels from the previous use of this area as a substation. By this we mean that these panels were deliberately built to be weaker than the surrounding structure so that, should an explosion occur in the substation, the panels would be blown out allowing the explosive forces to dissipate rather than blowing the whole building apart.

We also anticipate that the substation probably had a heavy concrete roof, the load of which applied compression into the main wall structures below and contributed to their stability. The removal of this roof has (i) removed restraint from the top of the wall and (ii) removed this compression force, both of which weaken the wall.

- a) Stitch repair the explosion relief panels into the surrounding structure and then build a new 215mm thick brickwork wall in front, fully tied back to the original wall. Construct an extension to the existing foundation to support this.
- b) As above but use a grouted cavity wall (i.e. reinforcement and concrete within a masonry cavity) rather than solid brickwork.
- c) Stitch repair the explosion relief panels into the surrounding structure. Increase the size of the existing piers, new foundations will be required to support these.

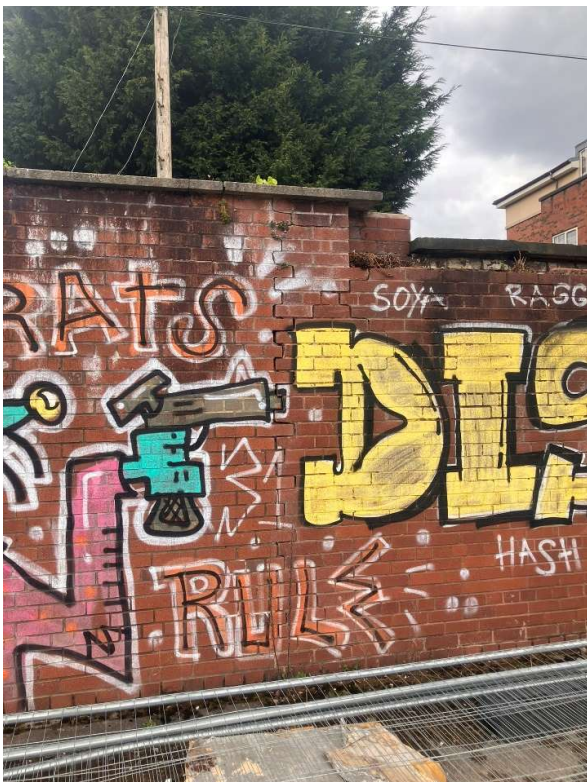
There is significant cracking at the junction of walls W11 and W12, just to the left of the graffiti letter D below. This crack increases in width towards the top of the wall.

The W11 brickwork colour to the left of the crack appears slightly different to the W12 colour to the right of the crack.

We believe that wall W11 has probably been built at a later date than wall W12 and that, whilst it has been bonded into wall W12 at it's right hand end it appears as though the wall generally has settled due to inadequate foundations which has caused anti-clockwise rotation about it's right hand end and the opening up of the crack towards the top.

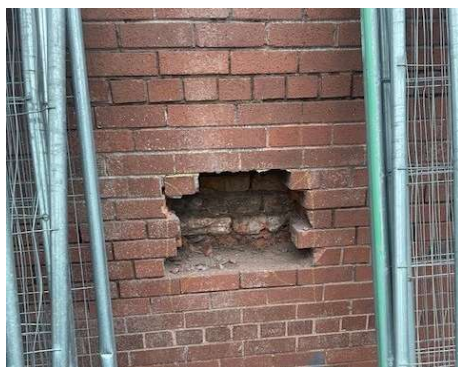
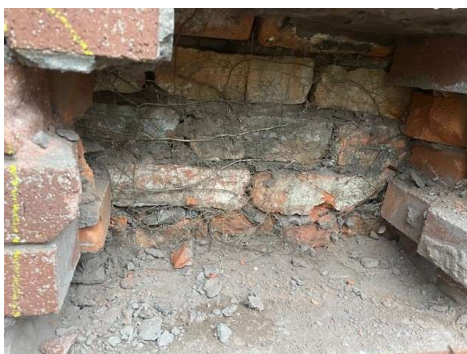
**Exploratory Hole**

At the exploratory hole locations the new and old leaves can be seen to be tight against each other i.e. just a 10mm joint between them.

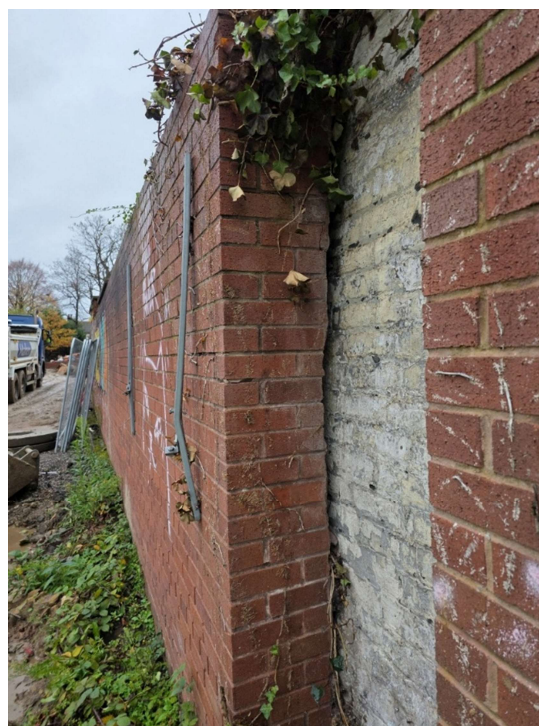
**Photo P19A**

However, at photo P19A the new leaf stopped and started either side of a tree (which had been growing tight against the old leaf) and the photo shows a brick return here which is approximately 300mm wide. We believe this closes off a cavity behind a 225mm brick wall. This brick return is close to the old leaf at the bottom but further apart at the top suggesting that the new leaf has moved away from the old leaf after construction.

We believe that the increasing gap at photo P19A has been caused by this. This does not appear to have yet occurred at the two exploratory hole locations but, as the same shallow foundation is present all along these walls, it could occur in the future.

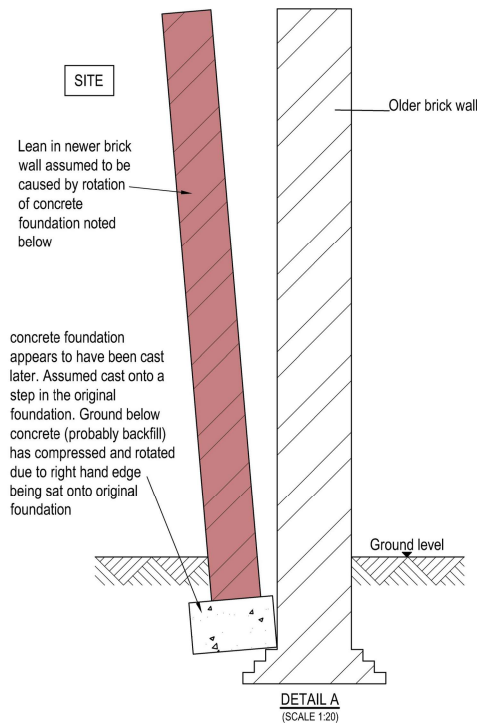
The trialpits in this area show that the new leaf has been built off a shallow concrete foundation which appears to have been built at the time the new leaf was constructed. This shallow foundation is perched on the edge of the original spread foundation but has not been taken down to the same depth as the original foundation, which means it is probably sat partly onto backfill following construction of the original foundation. If settlement of the fill below this newer foundation occurs this results in the foundation rotating which causes the wall to lean and the two leaves to move apart as shown in Detail A below.

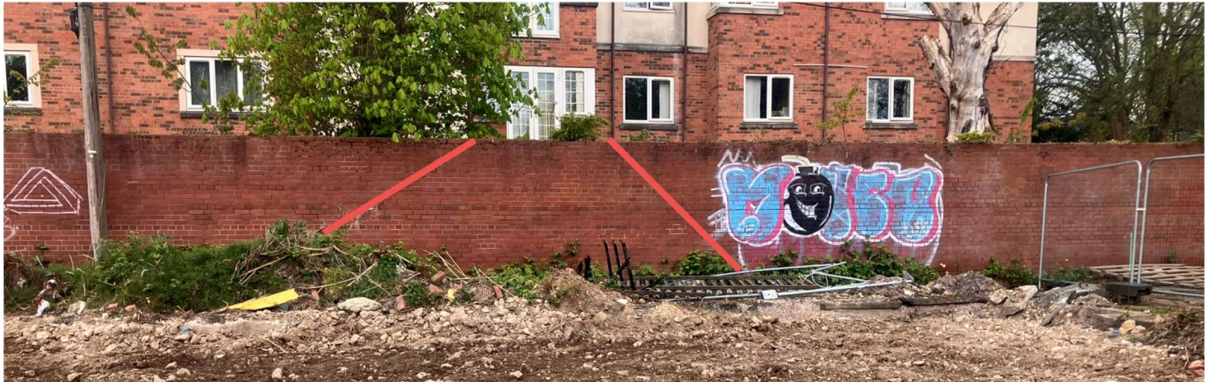
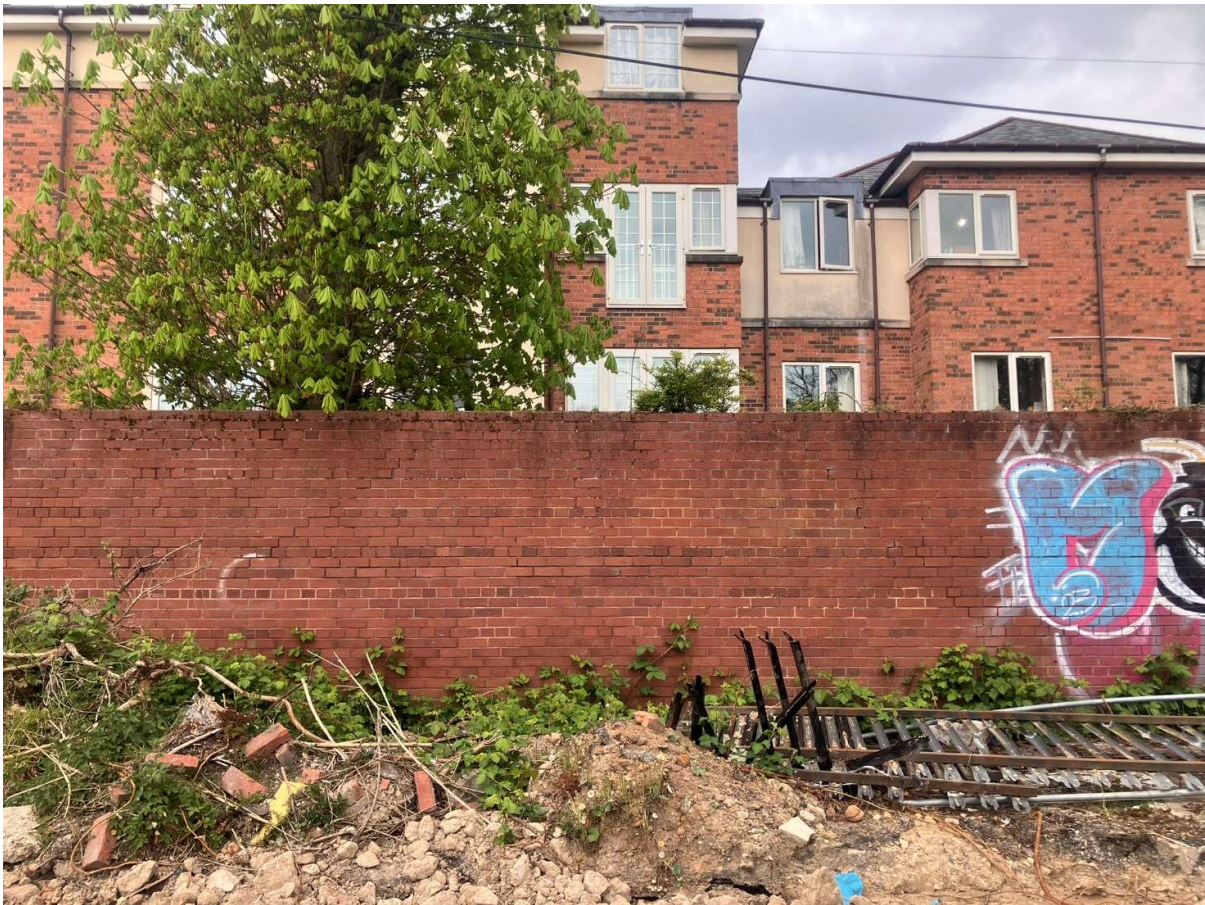
In Wall W13 there are also a pair of diagonal cracks as shown in the images below (highlighted red in the first image).

These are symptomatic of differential settlement and show the foundation of the wall between the cracks has settled further than those either side. This is probably due to variations in the compaction of backfill discussed earlier.

In many cases the presence of a tree, such as that shown in the photograph, can be the cause of differential settlement but, in this case, we suspect the differential settlement is occurring just in the shallow new foundation rather than the deeper old foundation. Inspections of the opposite side of the wall did not note cracking in these locations which reinforces the view that it is just the new foundation which has settled.

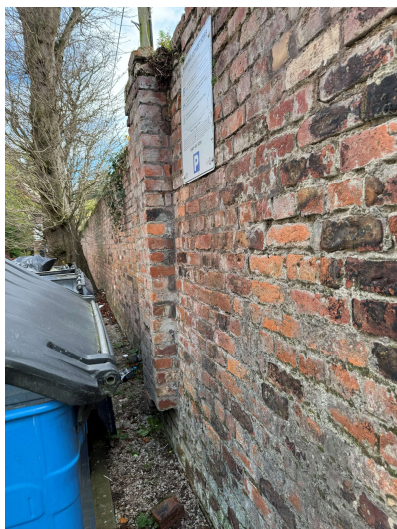
**Pier 3**

However the pier that we have labelled pier 3 appears to have been built at a later date. The photo below shows that the width varies from approx 110mm at the base to approx 140mm at the top suggesting that the wall was leaning 30mm here and that, in an attempt to strengthen it, a pier was built with the left hand edge vertical and the right hand edge following the lean of the wall. Several courses of brickwork are missing at the base, suggesting movement continued which cracked and loosened this low level brickwork and that it has since been removed.

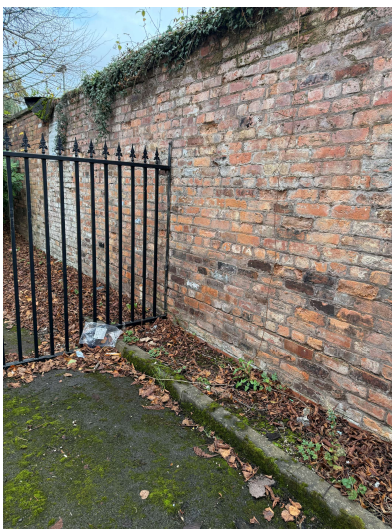
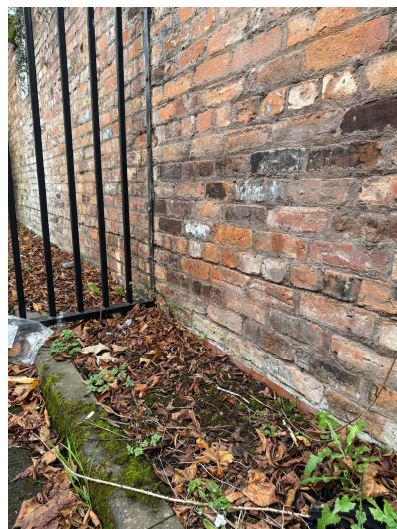
**Wall W13**

Further evidence of movement is present on the opposite side of wall W13. There is a recessed bed joint around 4 courses up from ground level suggesting that cracking may have occurred in this location, which could have loosened the mortar in this joint.

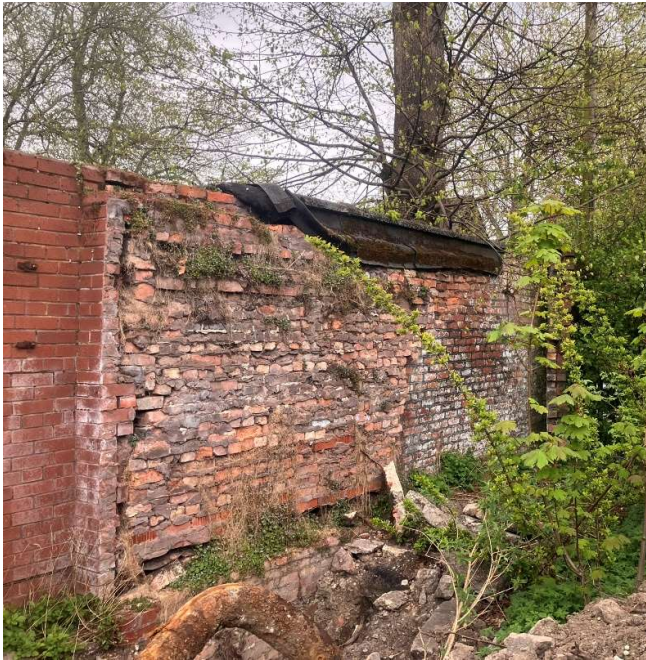
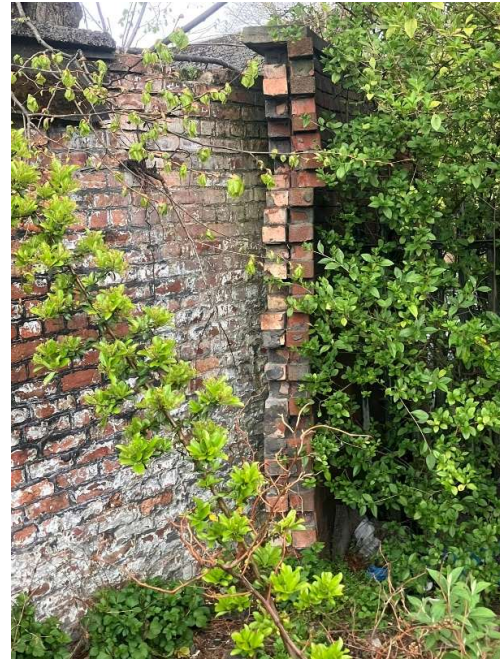
This length of wall is beyond the extent of the new wall discussed in W12 and W13. The photo below shows W13 on the left and then wall W14 beyond this which is clearly in poor condition with loose bricks and inadequate pointing present. It appears as though there may previously have been another wall in front of this that has been removed for some reason.

Also, at it's right hand end there is a broken end to a wall and the photo on the right shows that this is the remnants of a curved wall which has been broken out at some time.

Following the agreed remedial proposals for Walls 12 & 13, we advise an additional 215mm wall onto a new foundation is built here and tied to the existing. Refer to SK03 in Appendix C for the detailed remedial proposal.

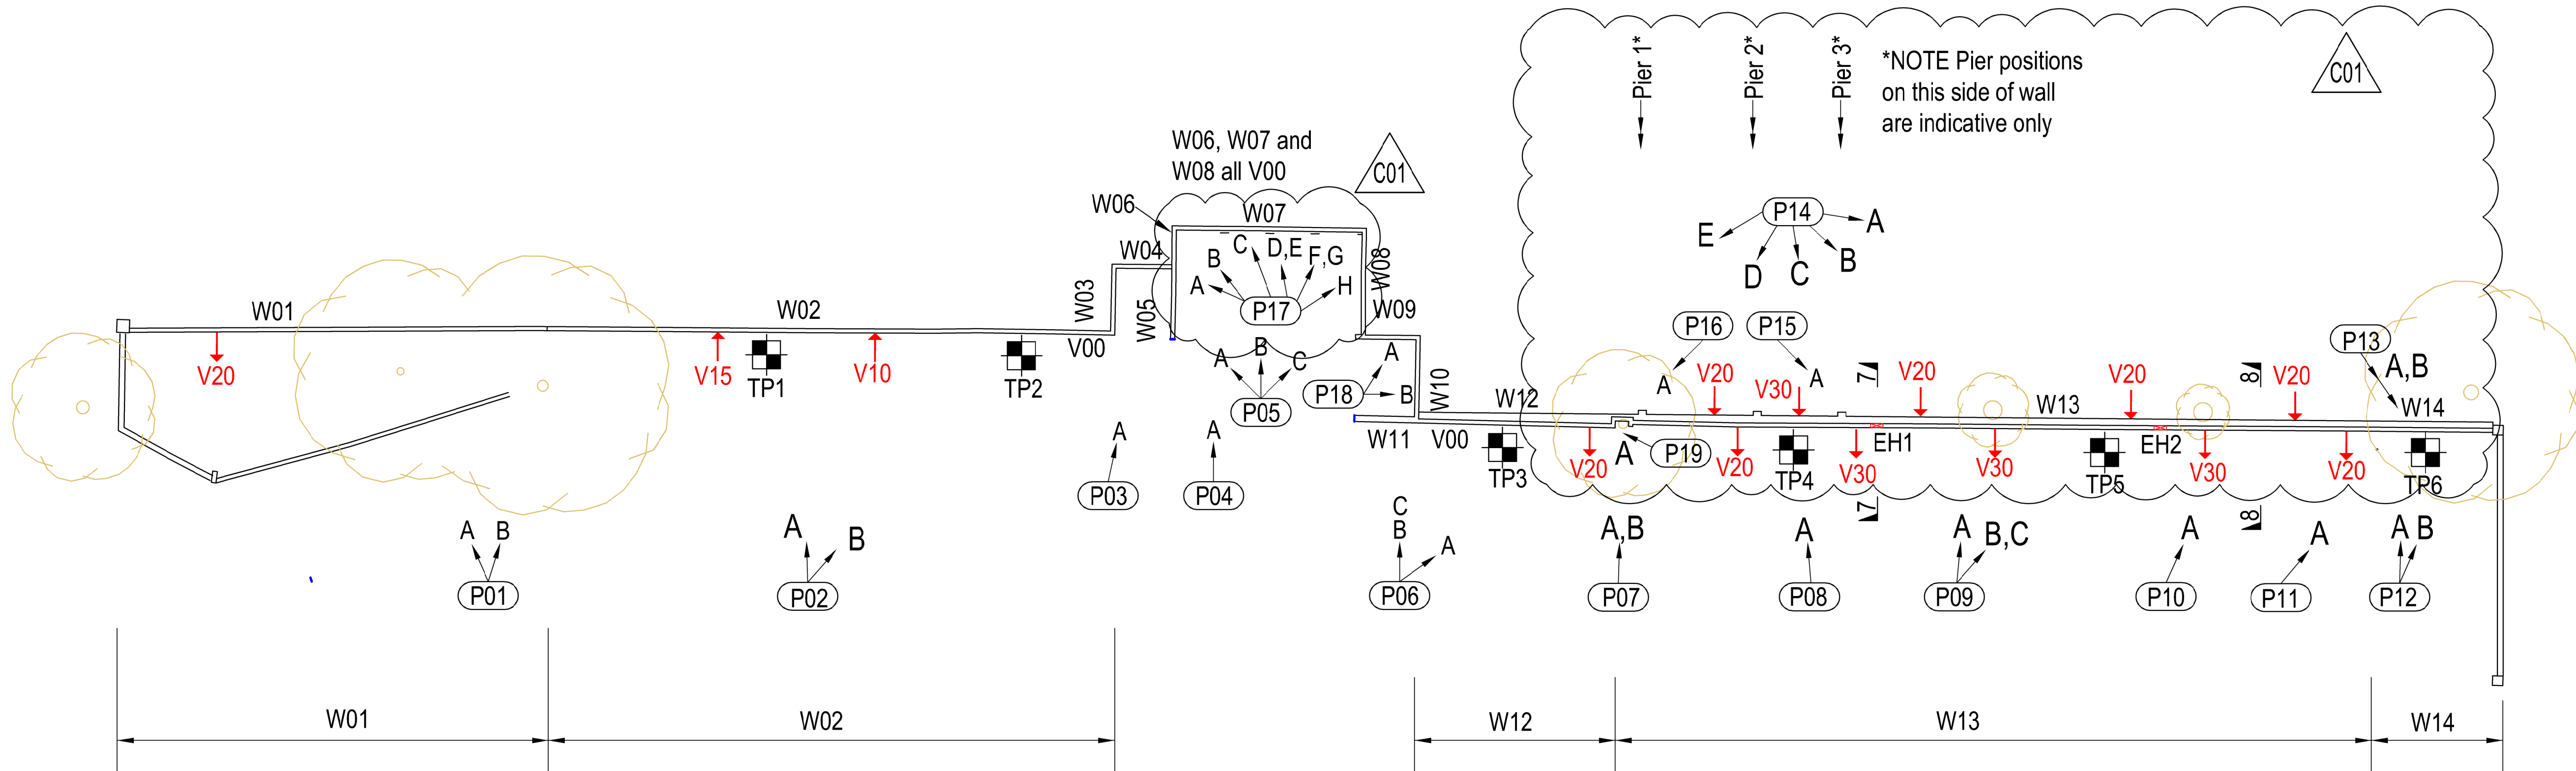
PLAN ON BOUNDARY WALL (1:200)

| RUS-SGI-XX-XX-DR-S-1200 | Plan on wall showing wall references, trialpit and exploratory hole locations, photo locations, verticality checks, elevation on Wall W07 etc |

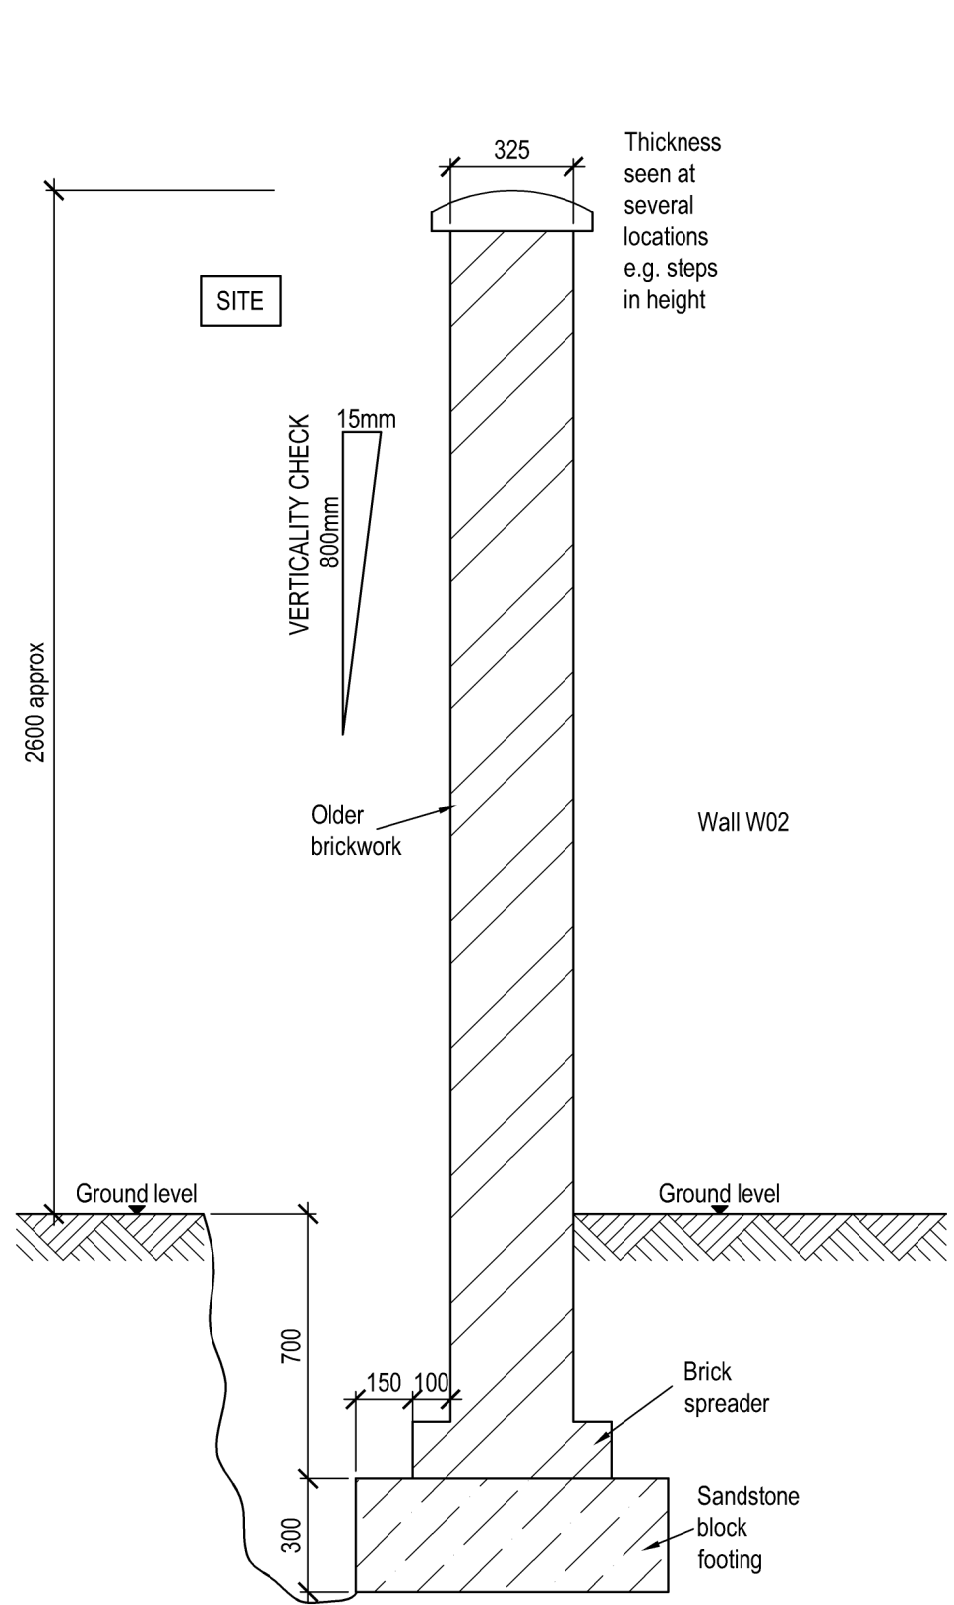
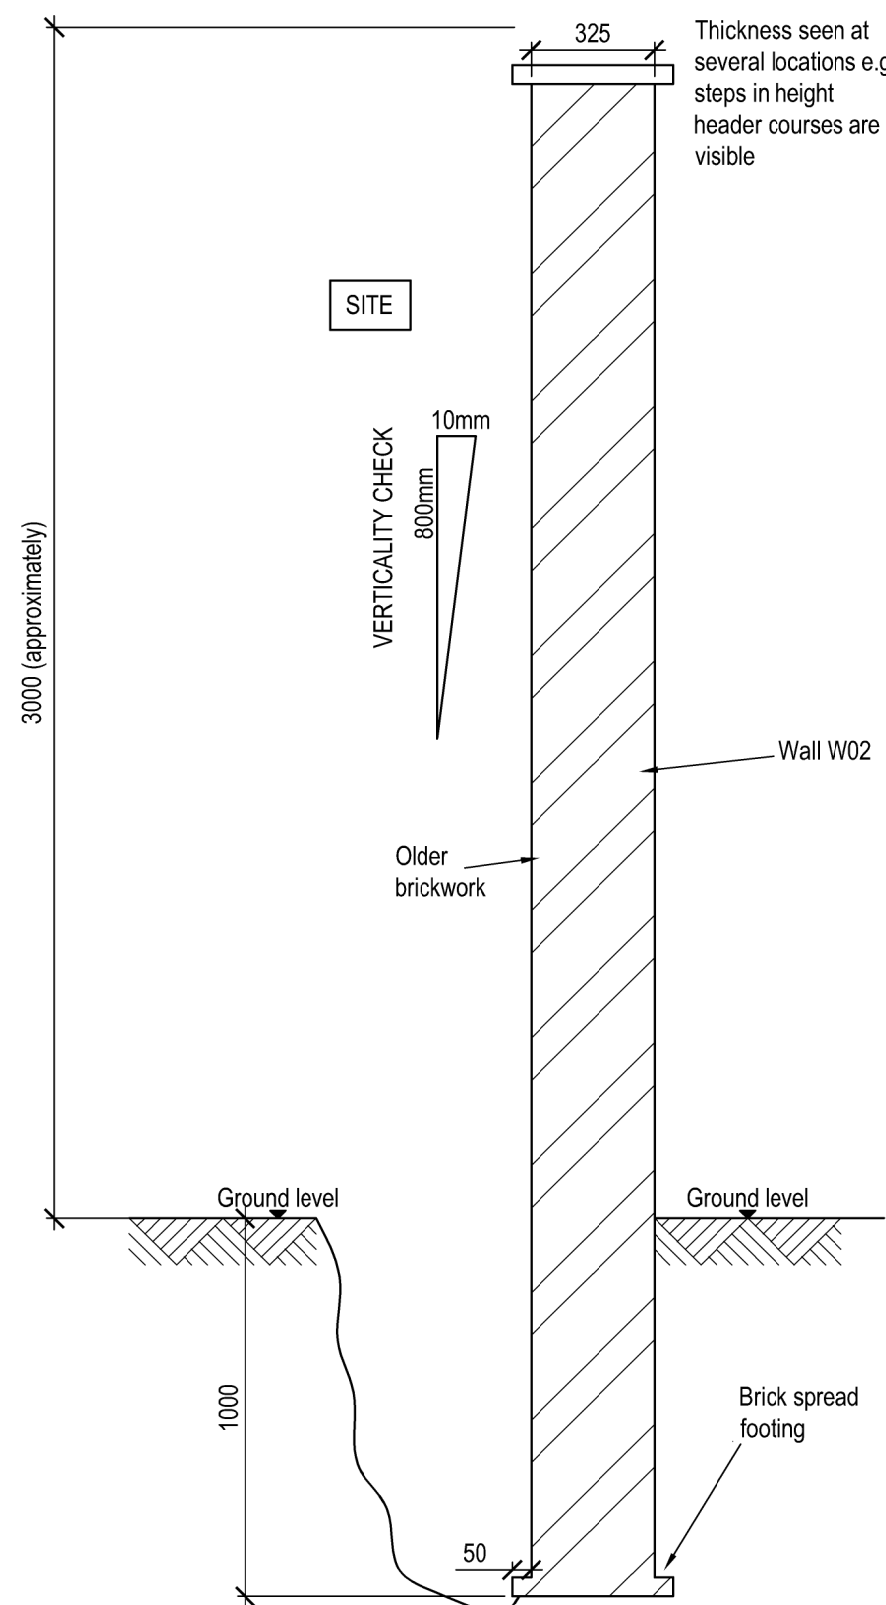
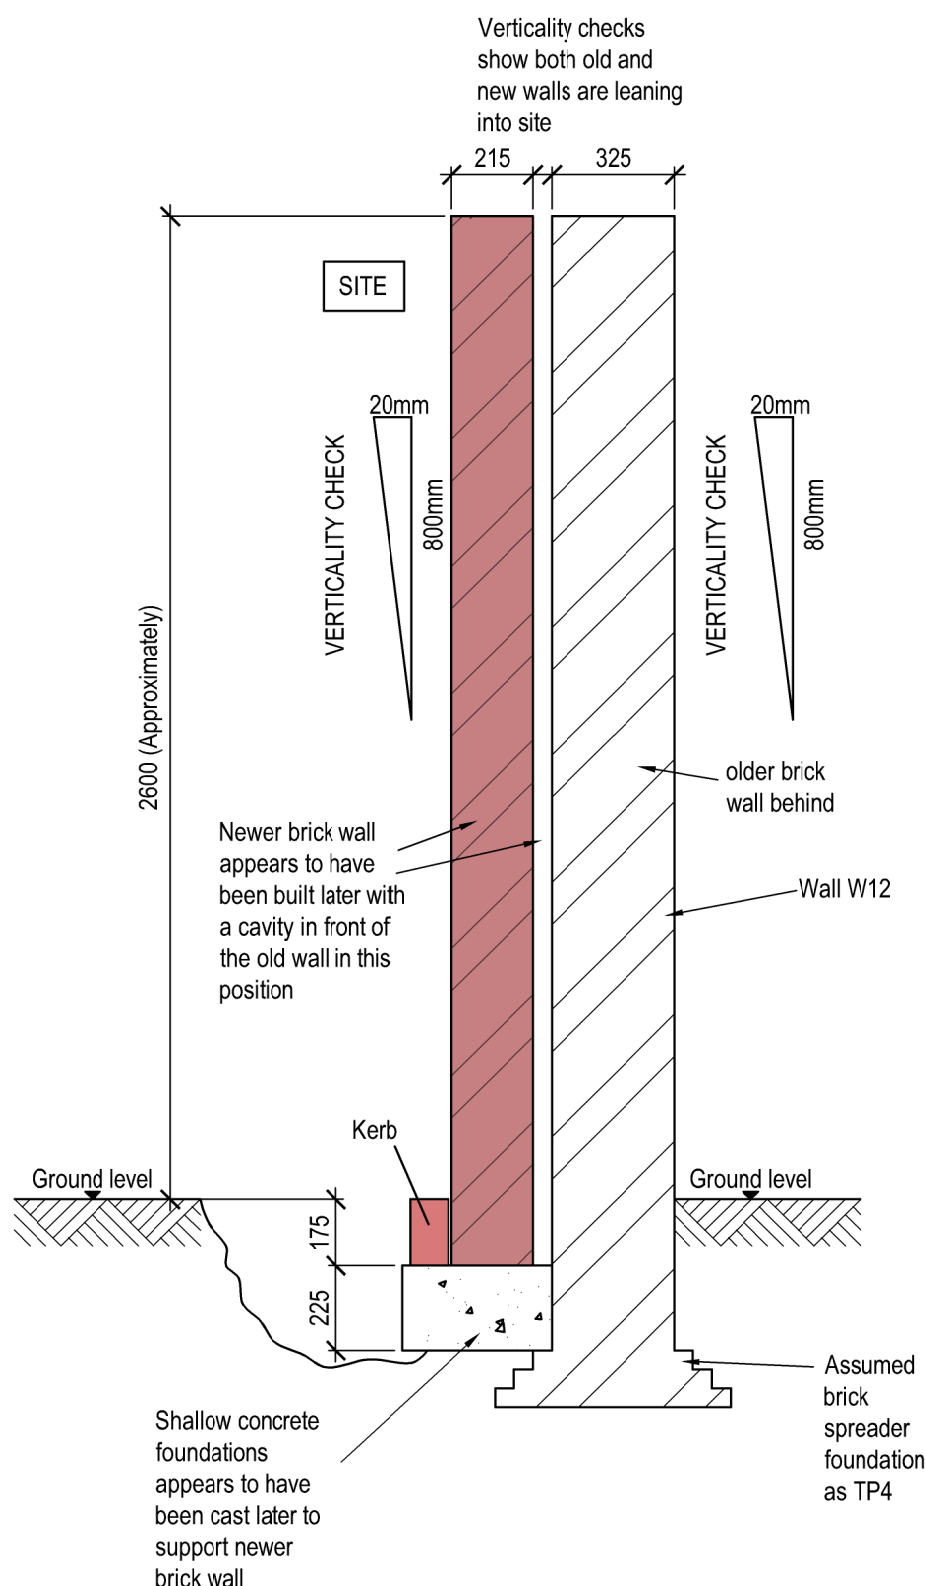
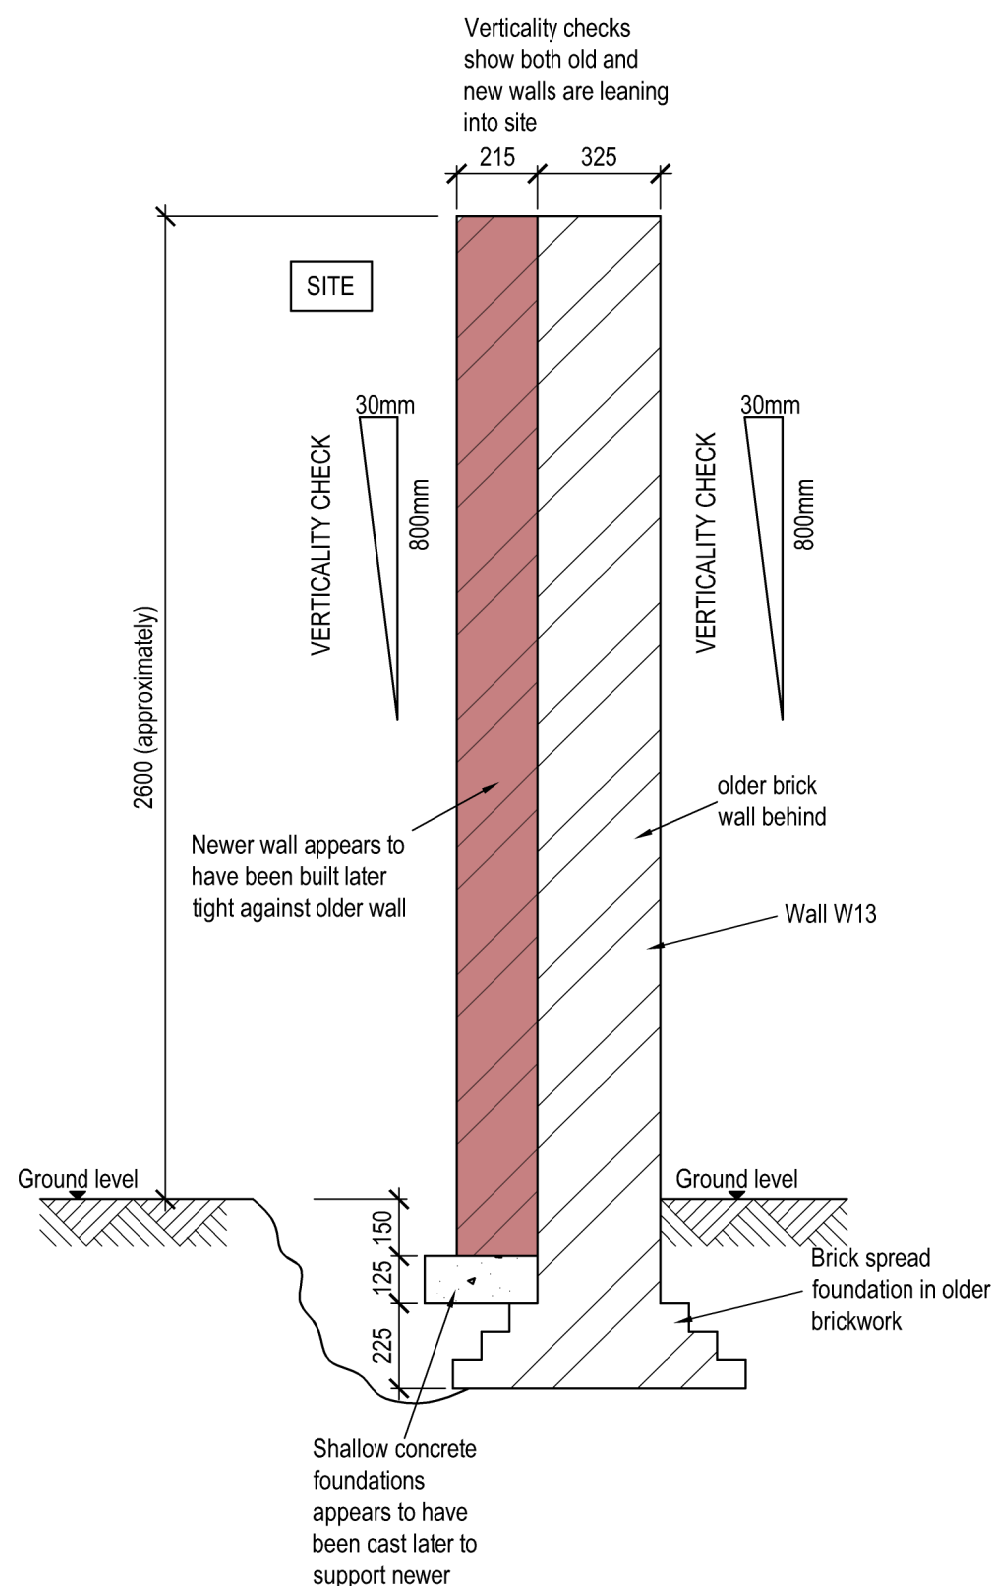
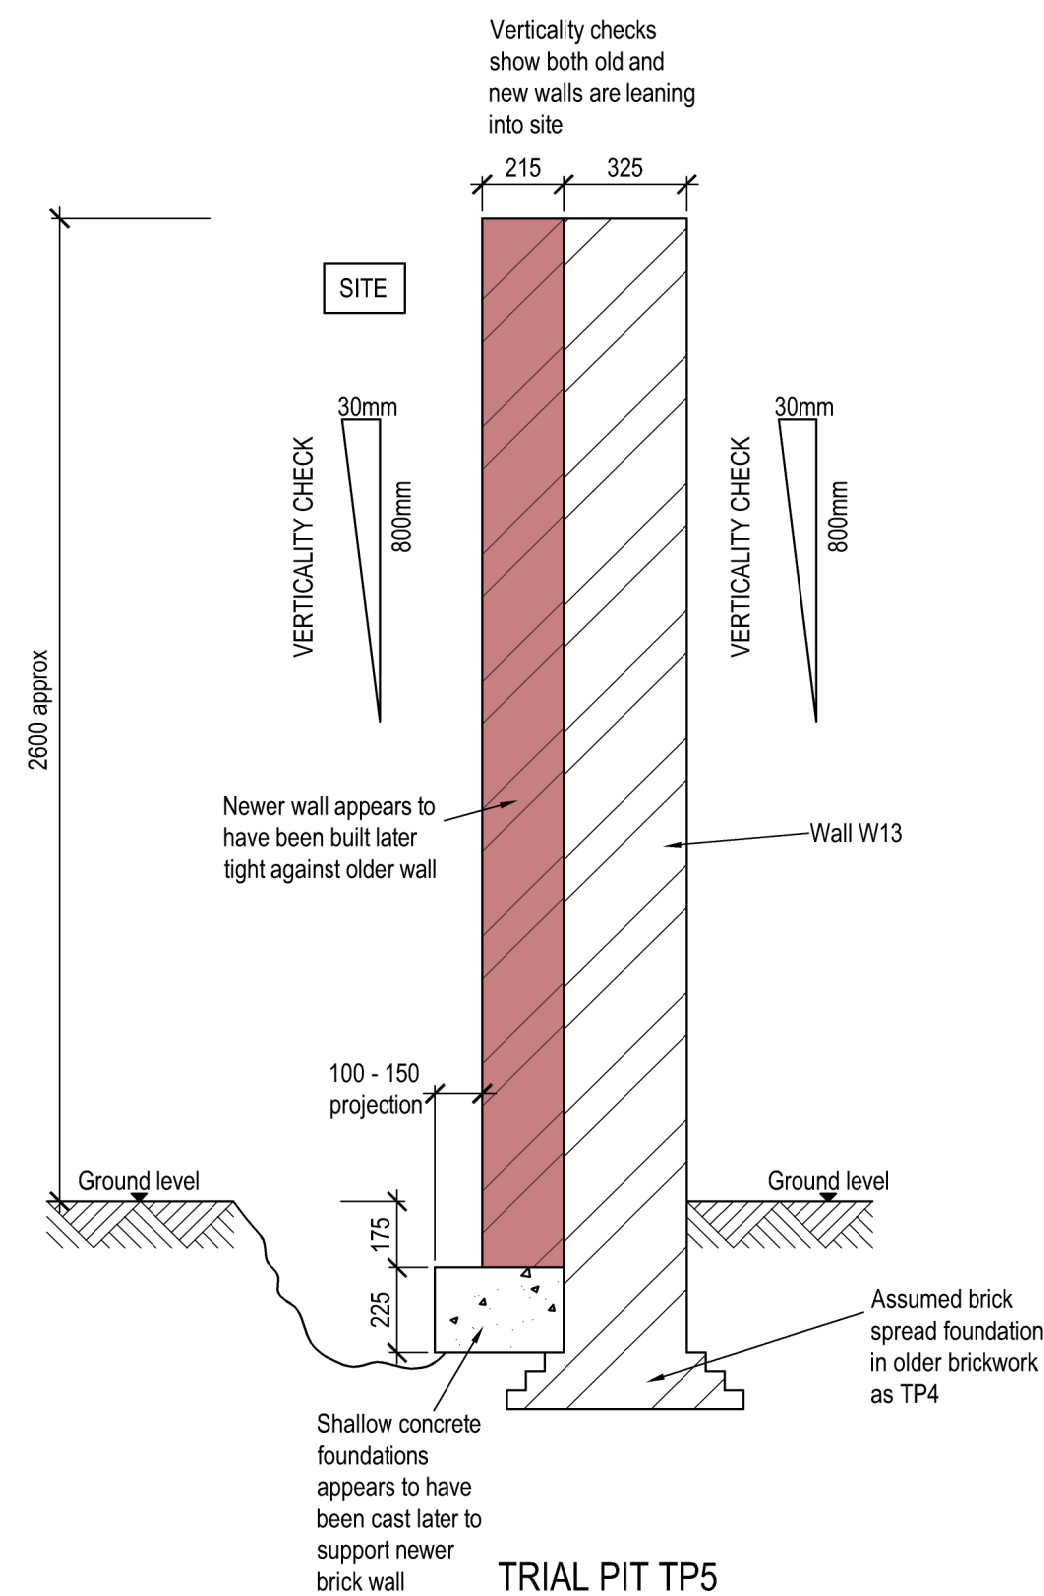
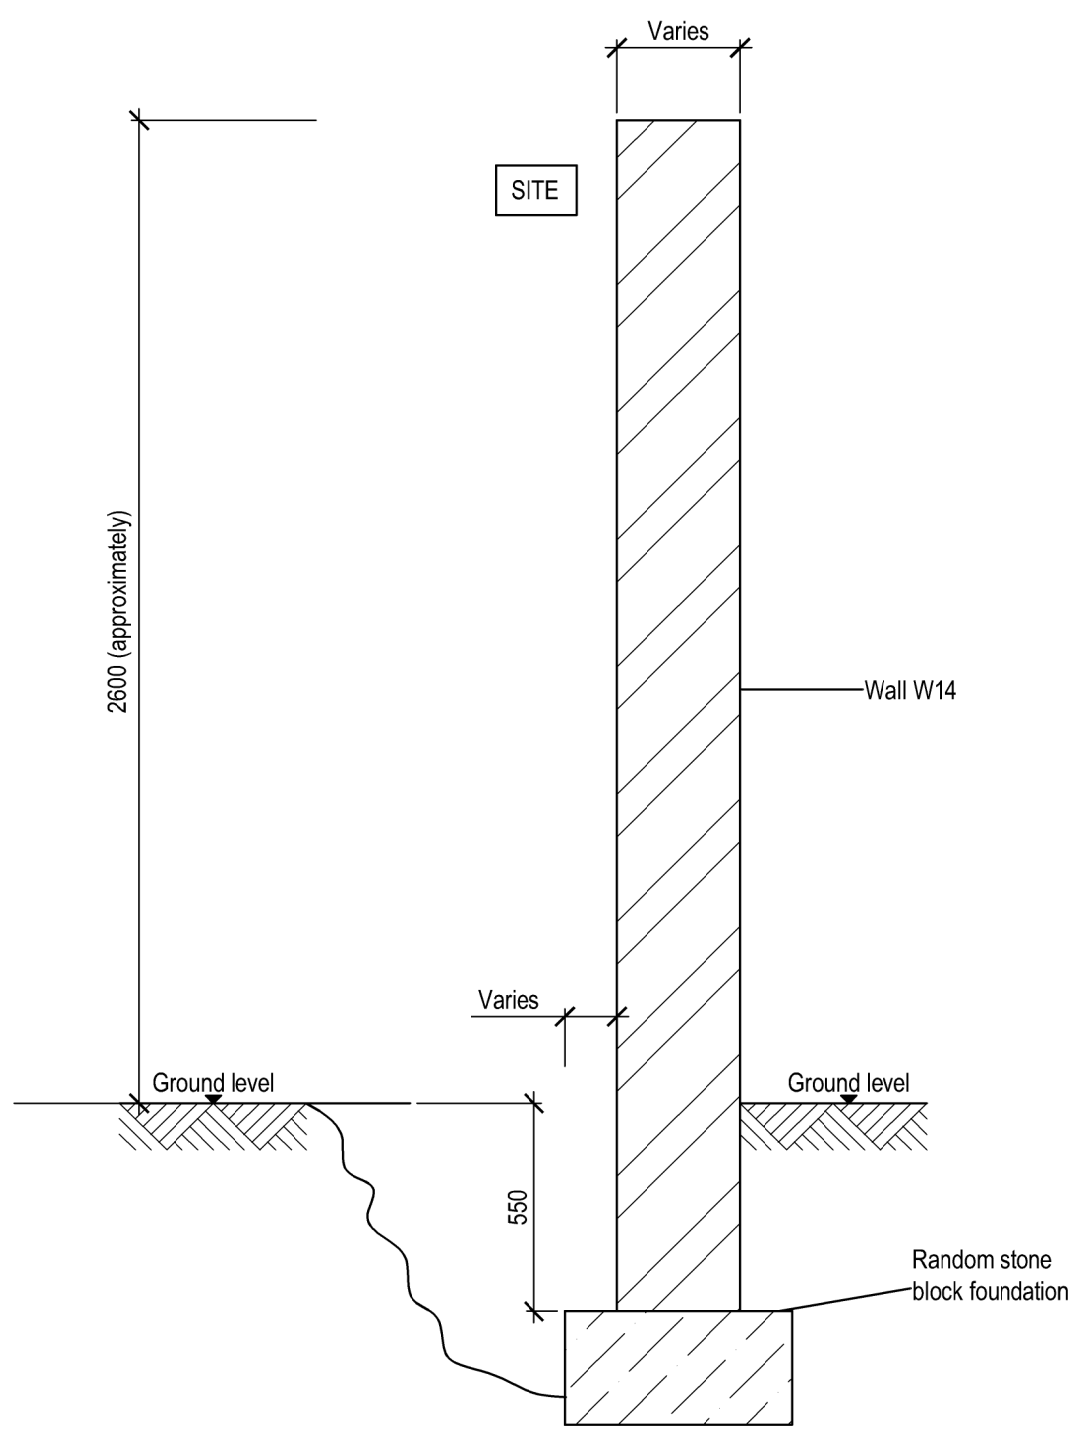
| RUS-SGI-XX-XX-DR-S-1201 | Sections through the wall showing construction and thickness, trial pit details and verticality checks |

These were dug by RCL, generally to the level of the bottom of the foundations to identify the sizes and depths of the foundations and the strata into which they sit.

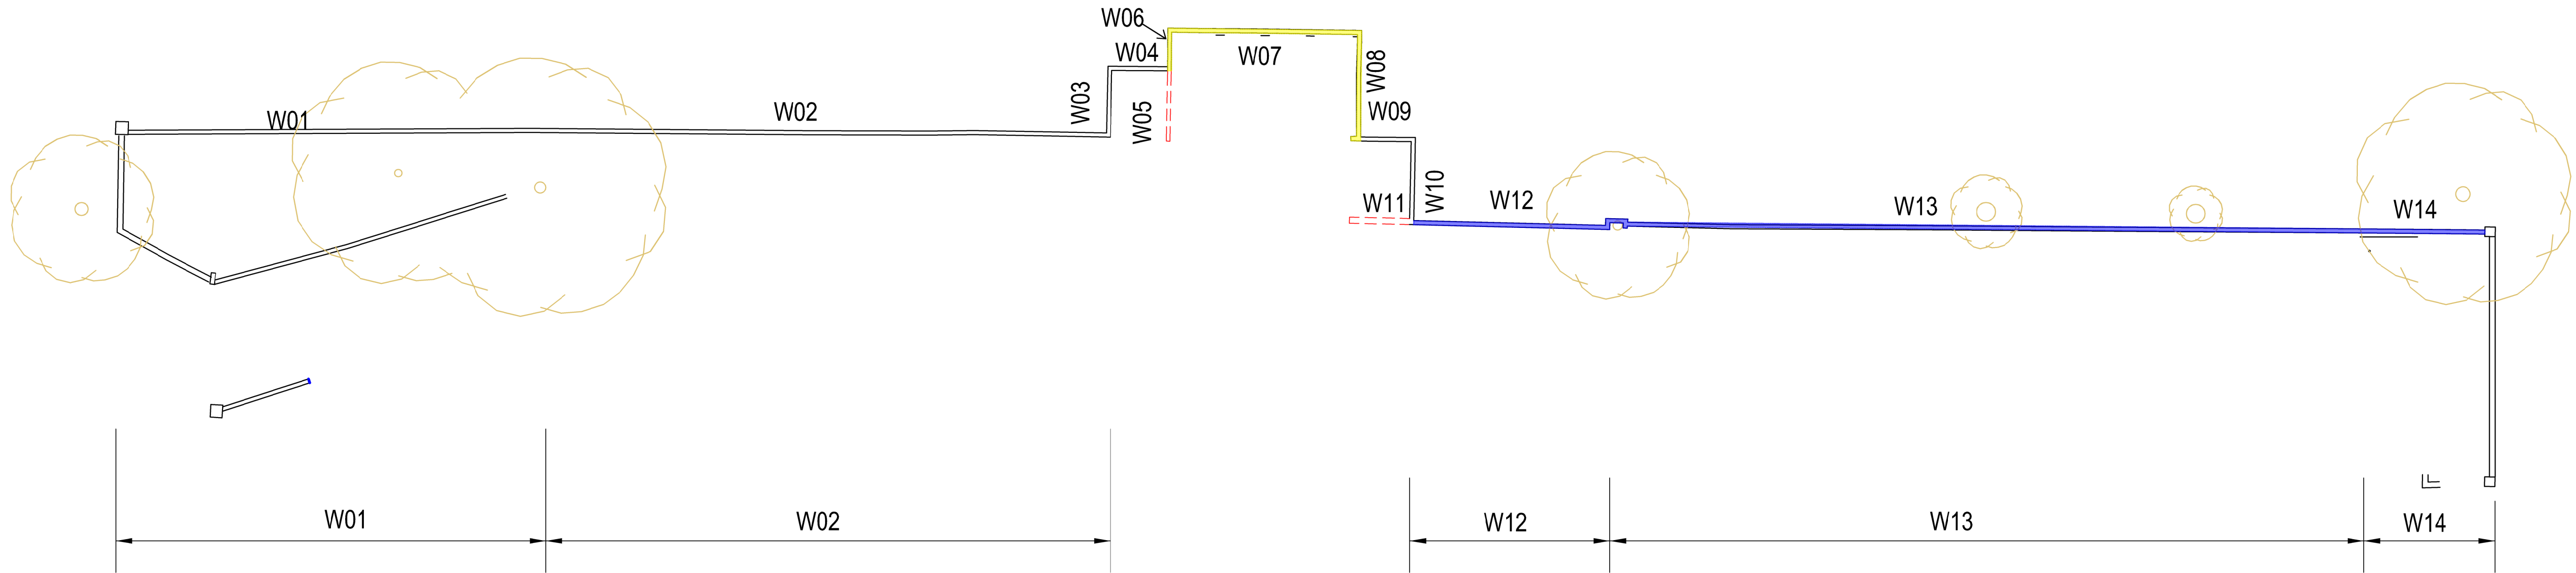
PLAN ON WALLS W01 TO W14

| RUS-SGI-XX-XX-DR-S-1202 | Plan on wall highlighting walls which are recommended to be removed, reduced in height, strengthened or rebuilt |

- Wall to be removed.
- Wall height to be reduced from 4.2m to 3.0m. Strengthening also required.
- Wall to be rebuilt / strengthened
