# PHASE 3A REMEDIATION STRATEGY

Mayfield Park  
Mayfield, Manchester

Mayfield Partnership Ltd

| DESCRIPTION | DATE | AUTHORS | | APPROVED BY |
|---|---|---|---|---|
| Phase 3a Remediation Strategy Report | 18-12-20 | Elizabeth Stewart<br> | Alex Smiles<br> | Alex Smiles<br> |

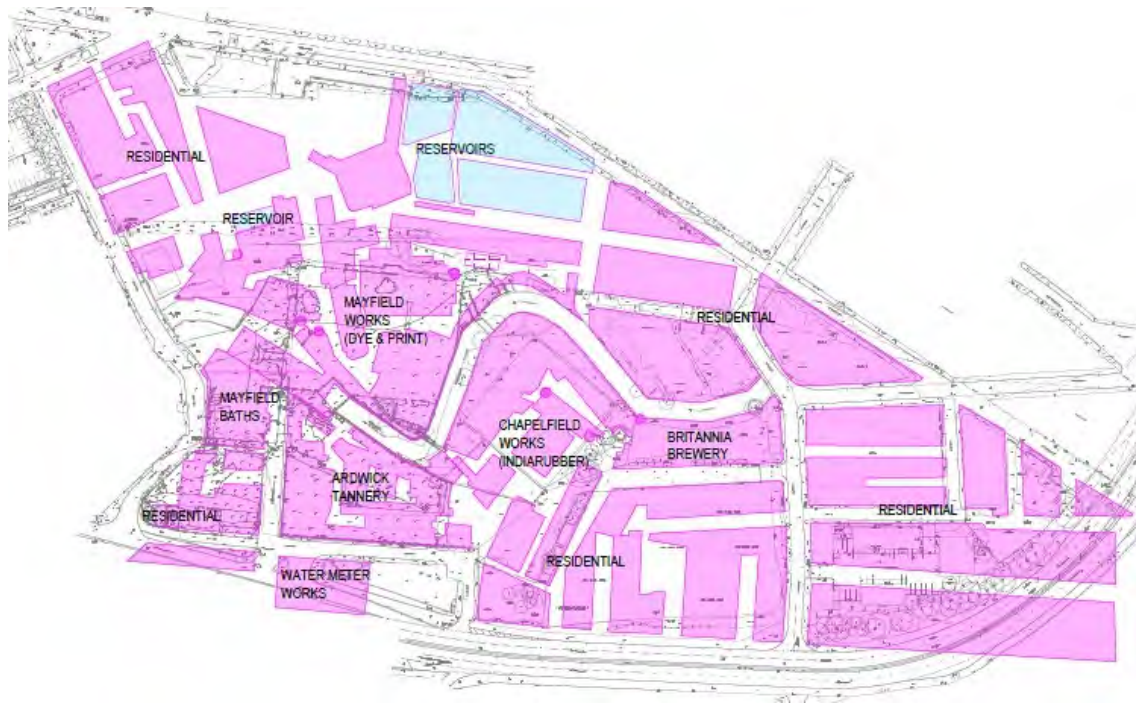
### Excerpt from ES102; Figure 1: 1891

- 2.3.2 The earliest mapping records for the site show a number of potentially contaminative sources these have been broken down by zone below.
- 2.3.3 **Zone 1 “Lawns”:** Earliest mapping dated 1891 indicates the zone to be occupied by the Mayfield dye and print works across the entire zone with associated filter pools, tanks and chimneys. Several reservoirs are located to the north of the zone associated with the dye and print works.

- 2.3.8 **Zone 5 “Hoyle Street West”:** Earliest mapping dated 1891 indicates the area to be occupied by residential housing. This remains the case until 1948 where records depict the residential housing to have been cleared and a residential public house present in the southern area of the zone, along with several other buildings the use of which are unknown. In the present-day car parking area of the zone a larger building is depicted believed to be associated with the Chapelfield India Rubber Works. Mapping dated 1970 shows the Delaney’s Yard area of Hoyle street West to be occupied by a rubber and plastic works and a works with several other smaller buildings in the general vicinity.

- 2.3.1 With reference to BuroHappold’s report and obtained historical records, RoC Consulting drawing ES101 (Appendix A) illustrates the key historical ‘phases’ of the site; an excerpt is included overleaf with commentary on key historical features within each zone. It is noted a key change occurred post WW2, following the widespread damage caused from aerial bombing (ES103; Appendix A).

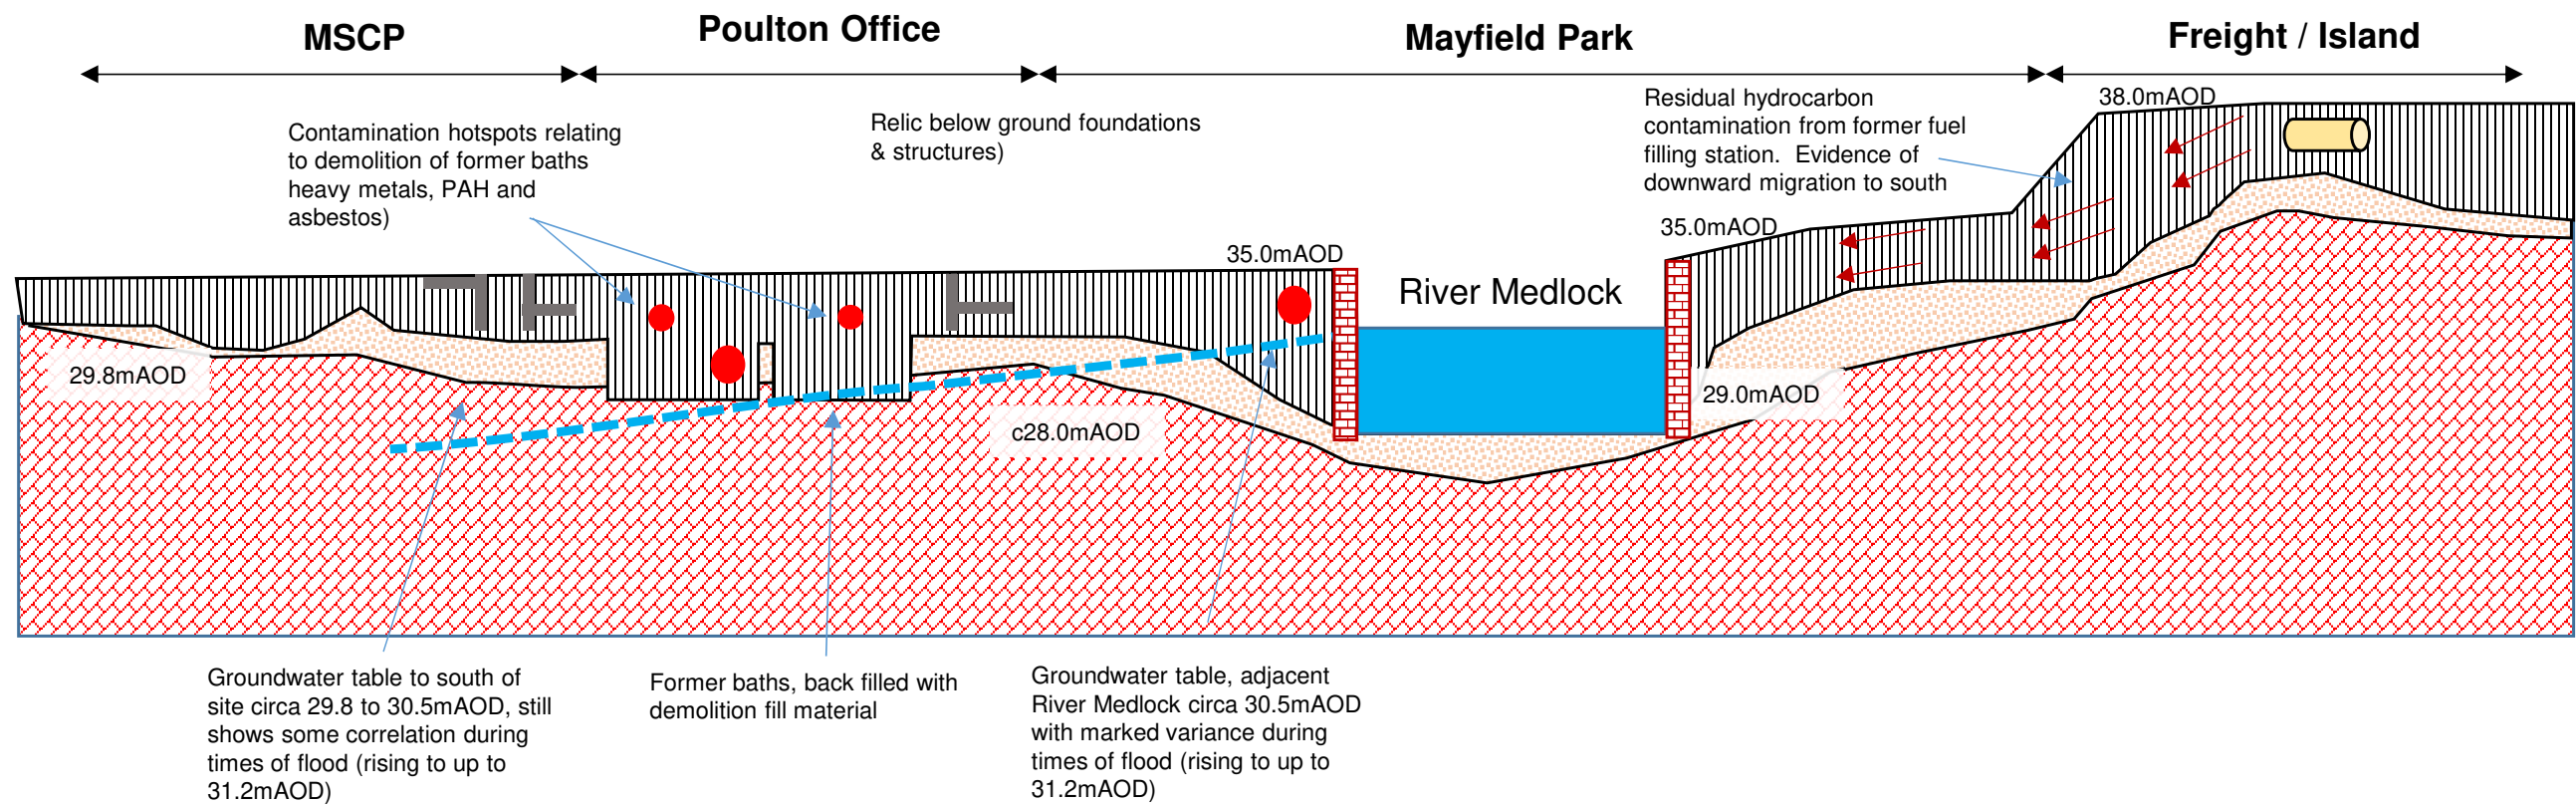
Section A-A : Western Conceptual Site Section

Section B-B : Central Conceptual Site Section

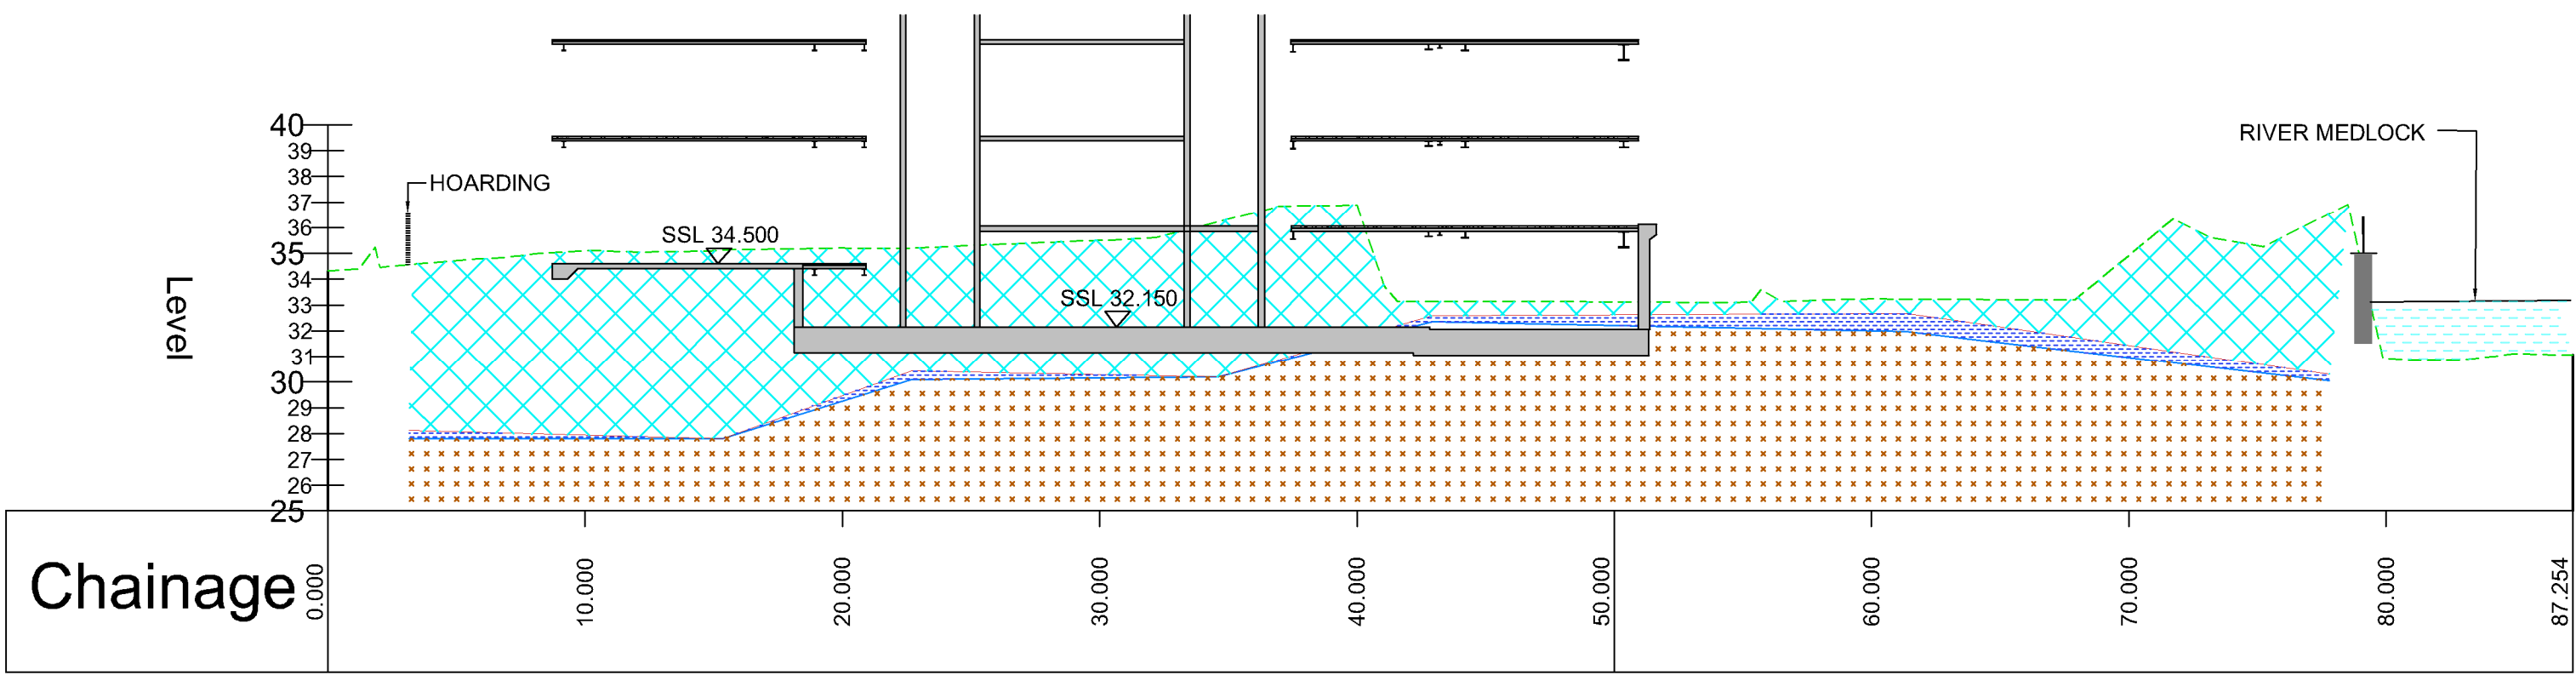
4-4 - LONGSECTION  
SCALE: H 1:250,V 1:250. DATUM: 25.000

**MADE GROUND** - COMPRISING A PREDOMINATELY GRANULAR FILL MATRIX OF BRICK, CONCRETE, ROOF SLATE ETC WITH OTHER DELETERIOUS INCLUSIONS SUCH AS DECAYED TIMBER, ASH AND ASBESTOS FRAGMENTS.

**ALLUVIUM** - COMPRISING A MIXTURE OF FINE TO COARSE SAND AND GRAVEL WITH FREQUENT FINER SILT INCLUSIONS AND OCCASIONAL CLAYS. VARIABILITY IN STRATA IS AT RANDOM ACROSS THE SITE BASED ON HISTORIC FLOOD PLAIN OPERATION

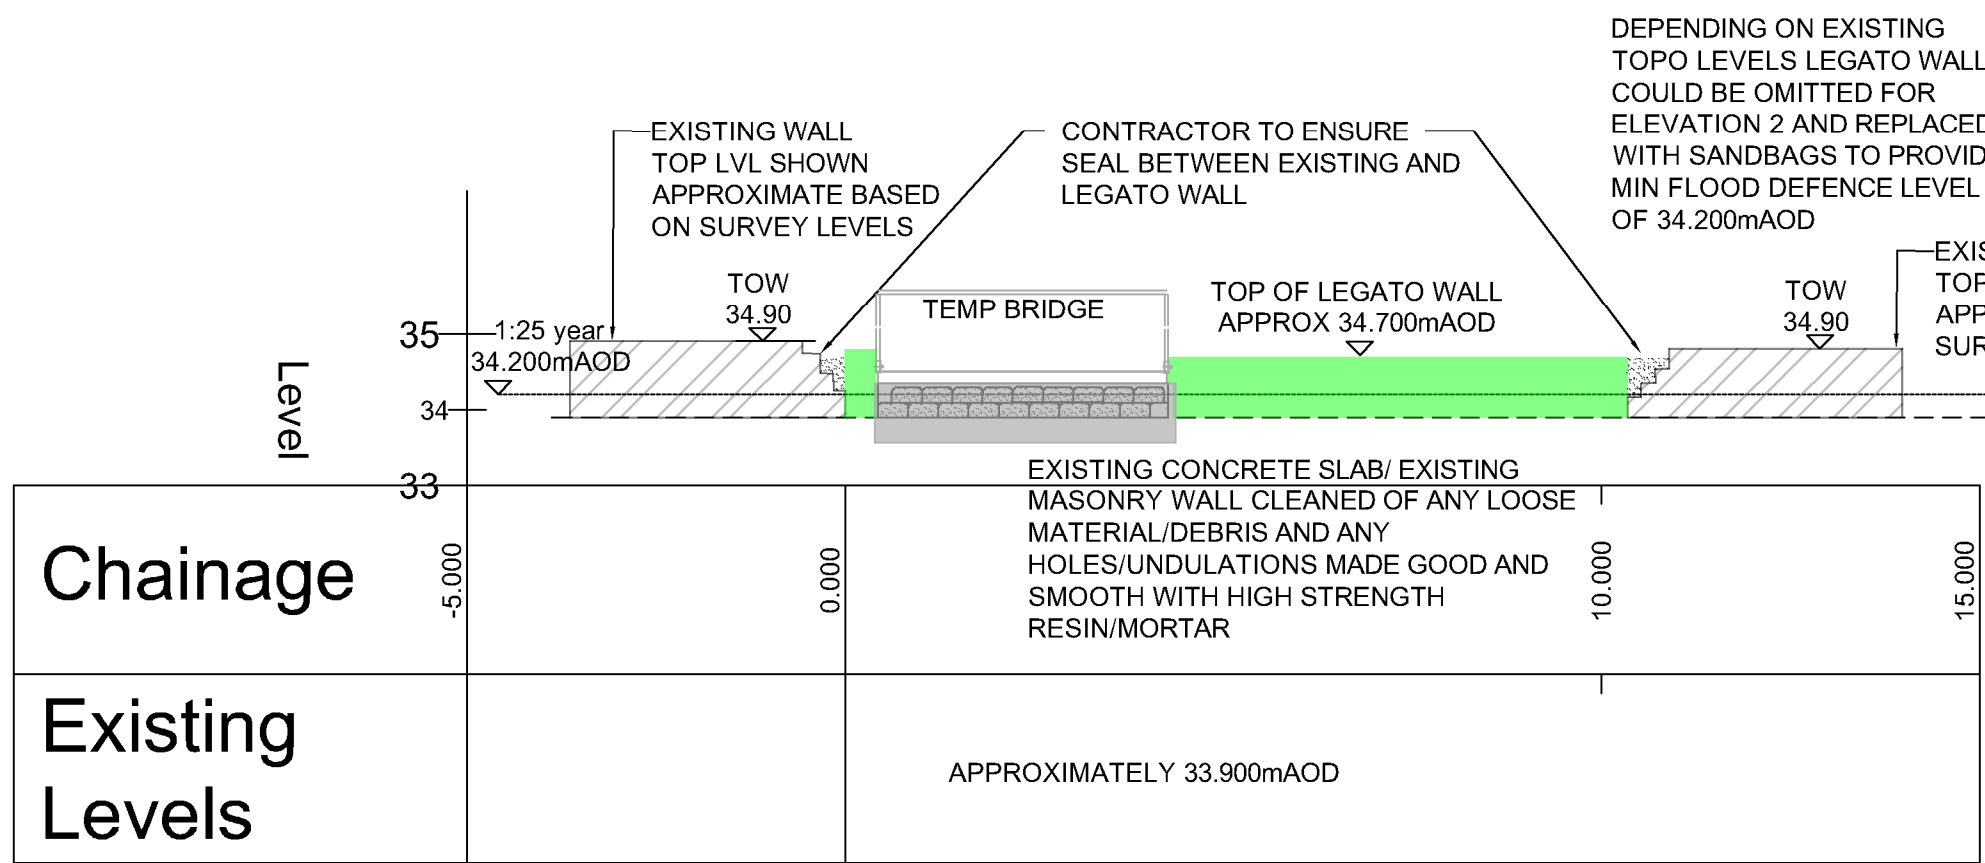
LEGATO WALL - ELEVATION 2  
SCALE: H 1:100, V 1:100. DATUM: 33.000  
(VIEWED FROM RIVER)

ELEVATION SIMILAR TO ELEVATION 1 EXCEPT EXISTING LEVELS INDICATE THAT TOP OF LEGATO WALL WILL BE ABOVE 1in25 YR FLOOD LEVEL OF 34.200m AOD AND NO ADDITIONAL BUILD UP (SANDBAGS) WILL BE REQUIRED SUBJECT TO TOPO SURVEY LEVELS

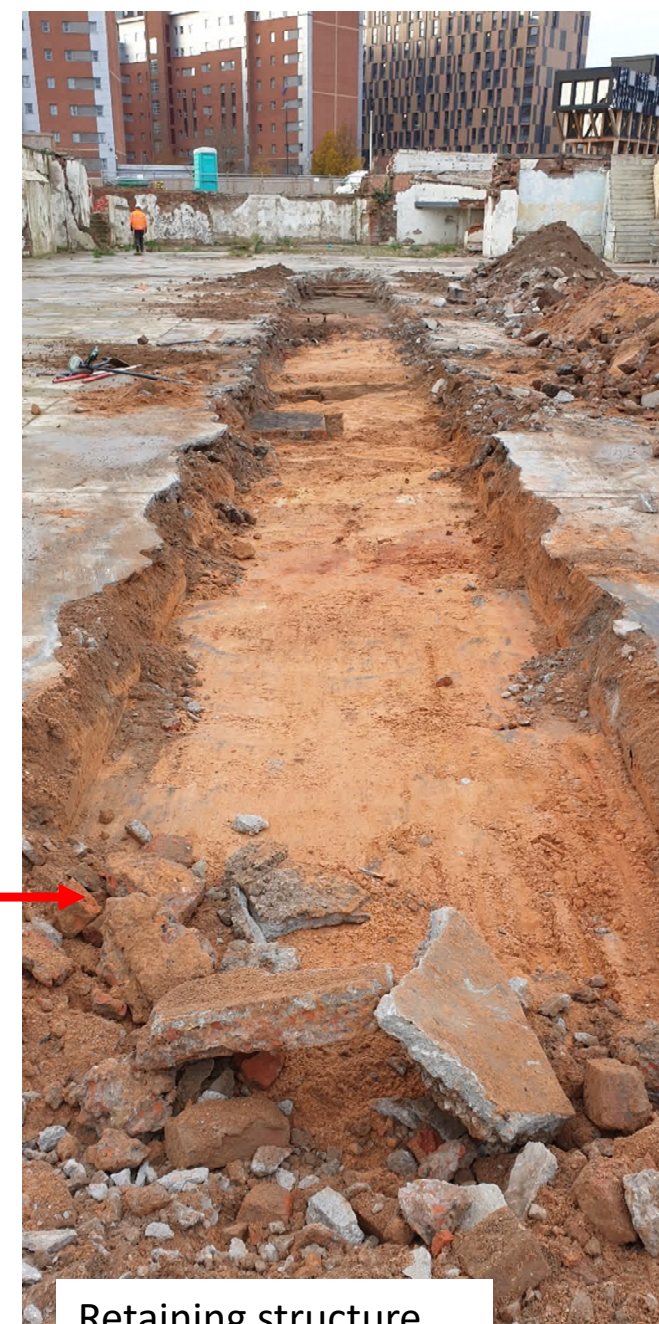
Retaining structure  
Slit trench formed through lower level showing sandstone beneath existing floor slab

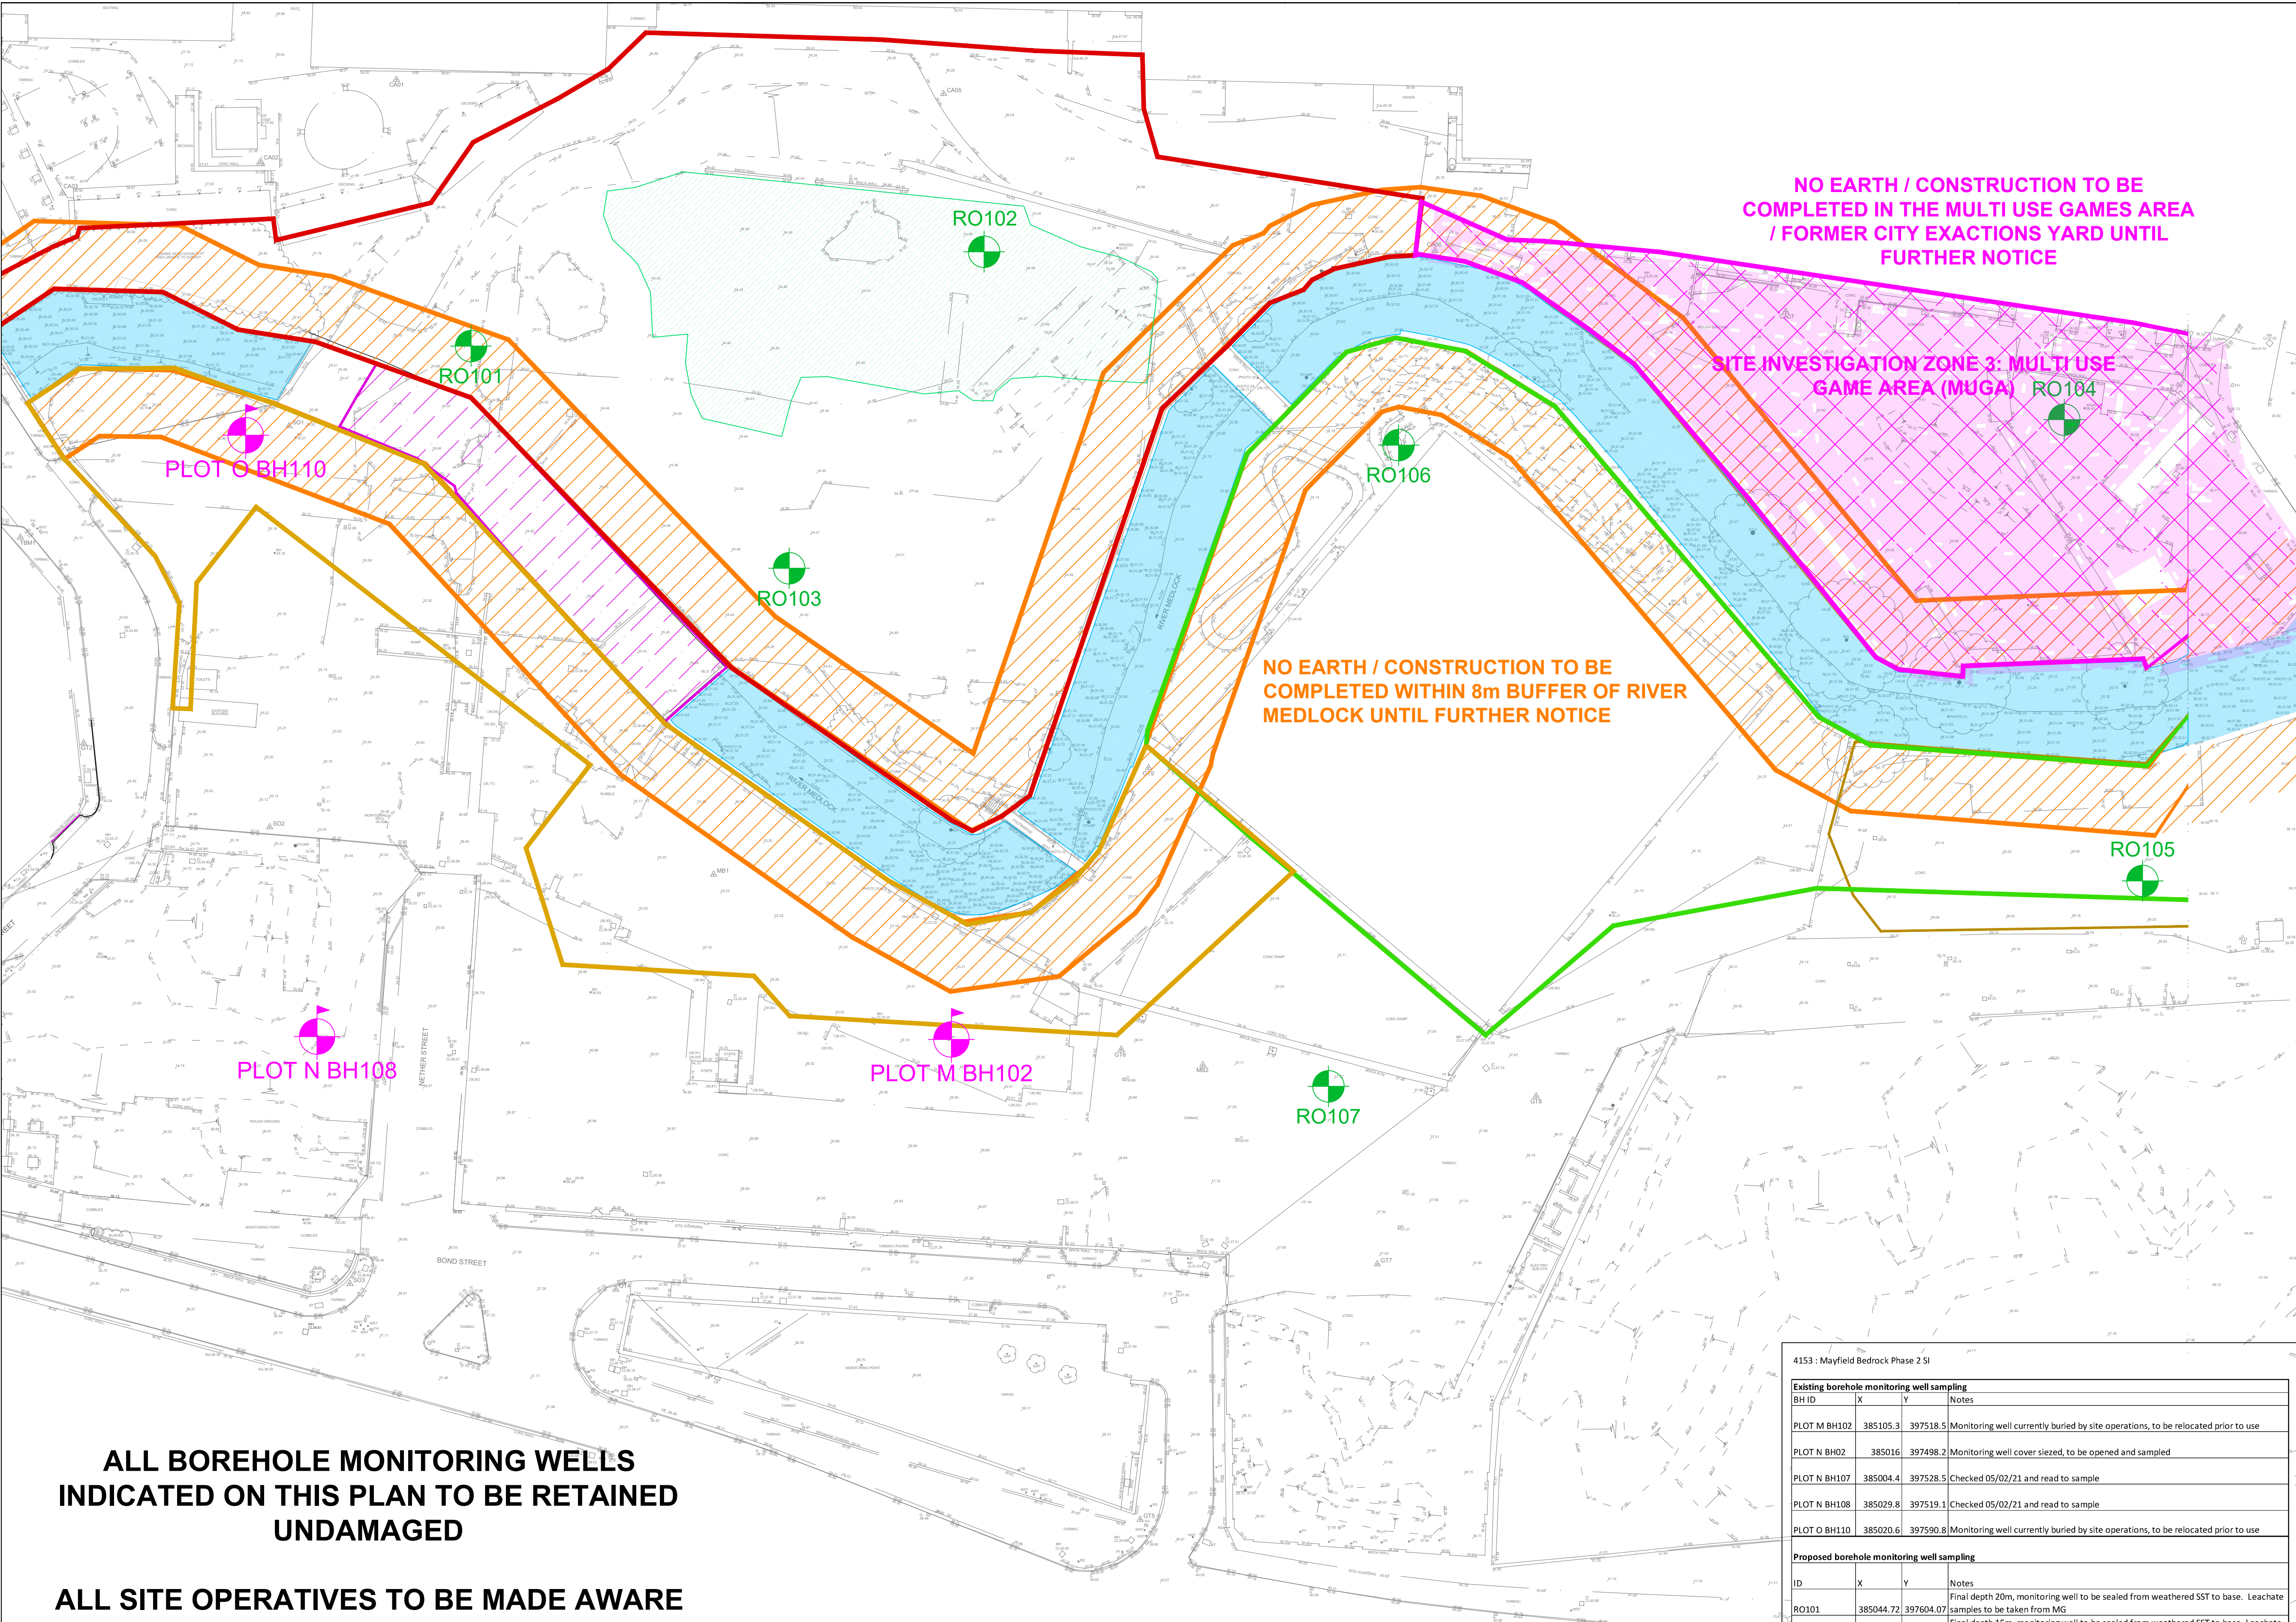
ALL BOREHOLE MONITORING WELLS  
INDICATED ON THIS PLAN TO BE RETAINED  
UNDAMAGED

ALL SITE OPERATIVES TO BE MADE AWARE  
OF MONITORING WELL LOCATIONS AND  
ADJUST WORKING PRACTICE ACCORDINGLY
