Higher Openshaw Community Primary School,  
Openshaw, Manchester

Ecological Appraisal and  
Preliminary Roost Assessment  
2026

Project Title [Higher Openshaw Community Primary School, Manchester](#)

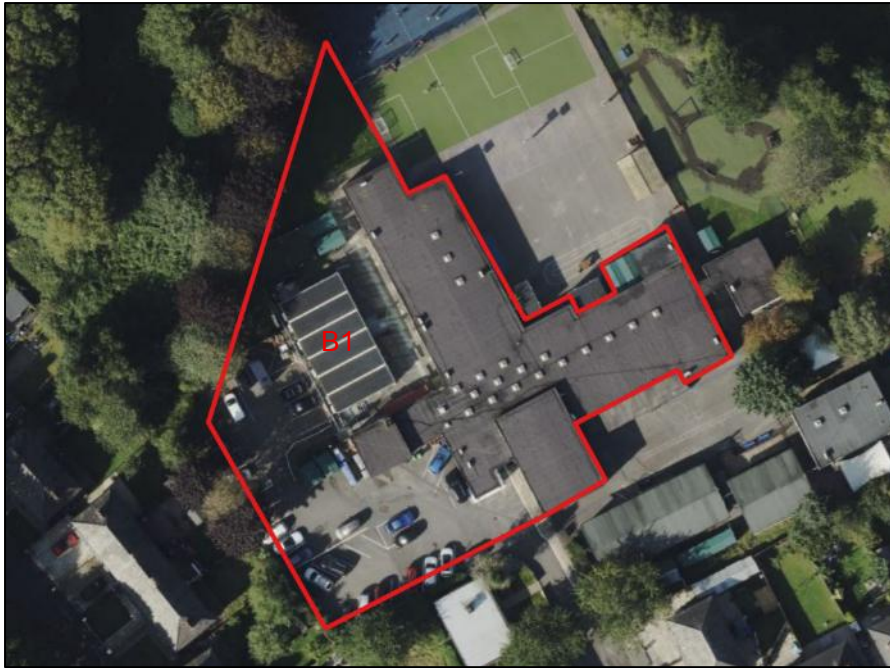
Figure 2 showing Building 1 location

Building 1 (Figure 1) is a temporary SEN classroom located to the west of the main school building. Car parking for the school is present to the south of Building 1 and is sealed tarmac.

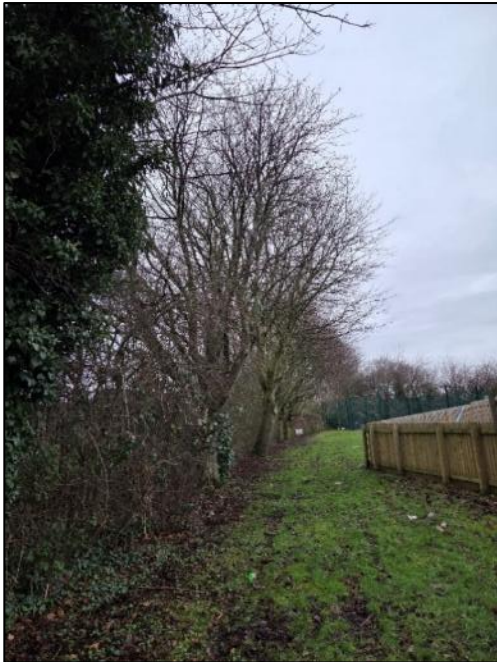
A line of mature Sycamore *Acer pseudoplatanus* trees is present along the northwestern site boundary.

Photograph 1 showing the modified grassland and line of trees.

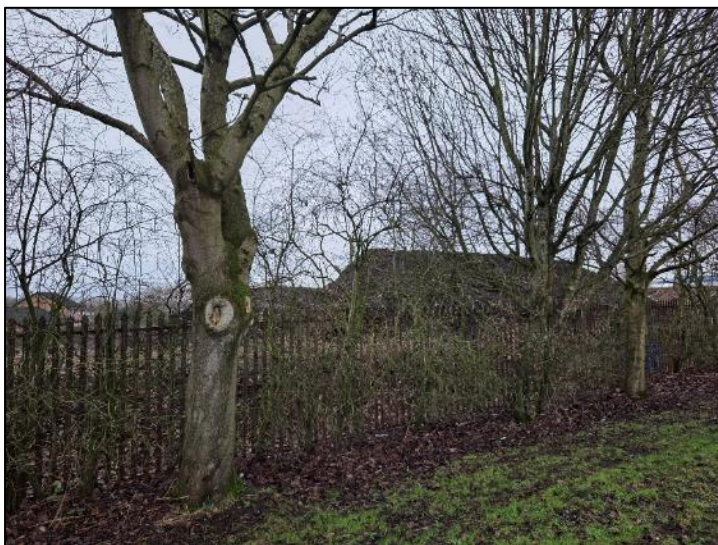
The land beyond the line of trees has been cleared (Photograph 2). Aerial imagery shows it was previously covered by woodland.

Photograph 2 – land beyond western site boundary (previously woodland).

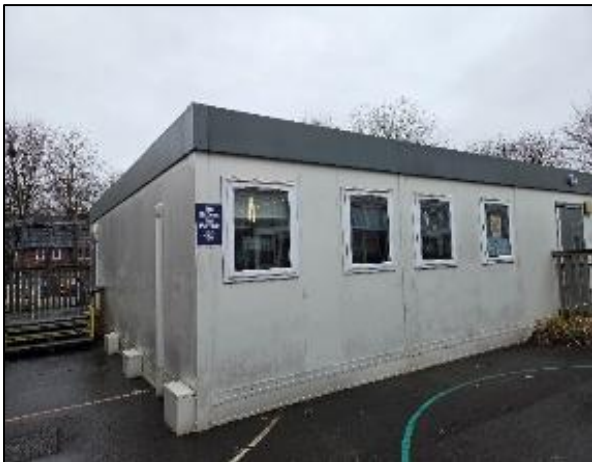
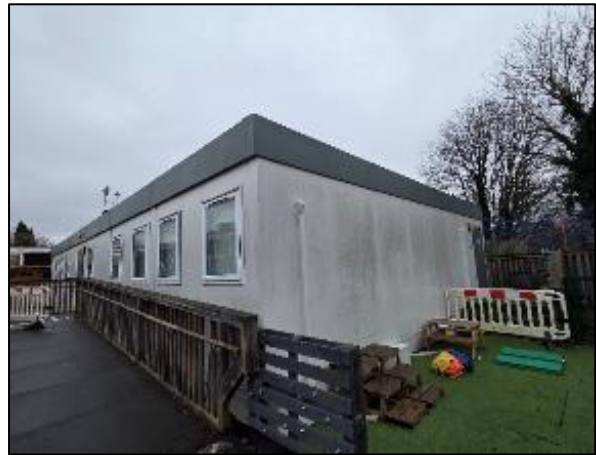
Building 1 is a small single-storey prefabricated structure with a flat roof. A small gap is present on the north-east elevation between the building and the fascia board, but this does not allow access internally. The gap was shallow and exposed to the elements suggesting unsuitability for a day roost. Windows were well sealed. No roof void is present. All interior spaces are well illuminated and in use as a classroom during the day. The plasterboard ceilings and walls within the interior are in good condition and offer no entry points from the exterior. No potential roosting

features were identified, and Building 1 was assessed as offering **negligible** potential to support roosting bats.

Photograph 3 and 4 showing the exterior of Building 1.

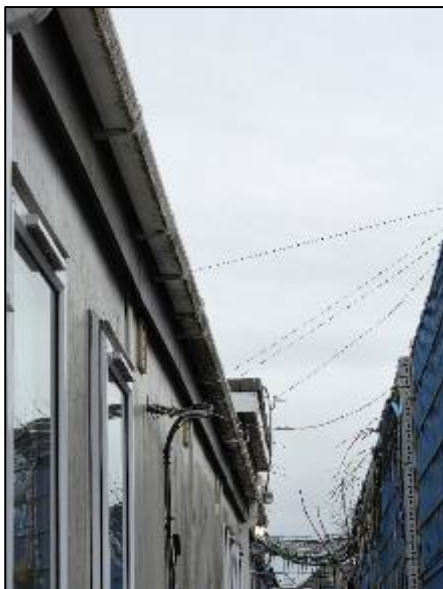
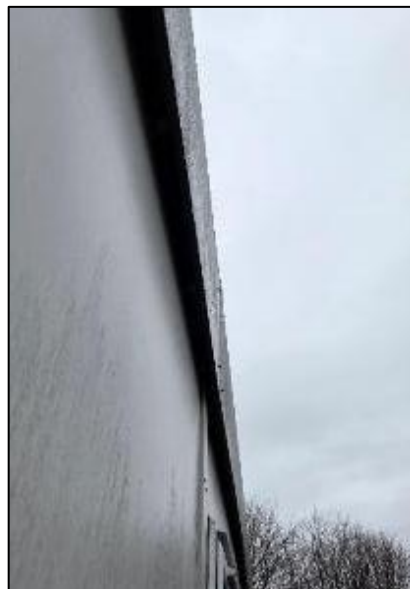
Photograph 5 and 6 showing the fascia.

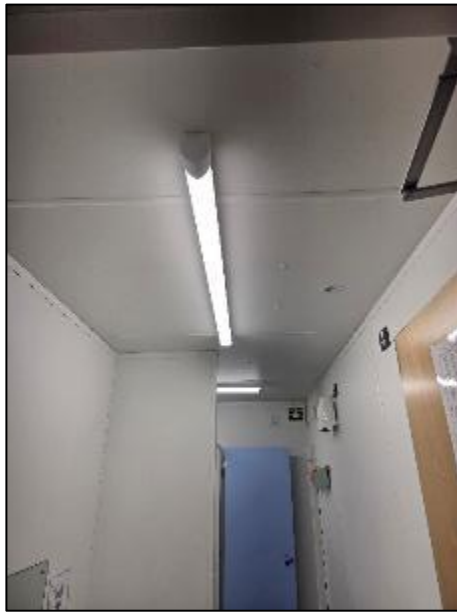
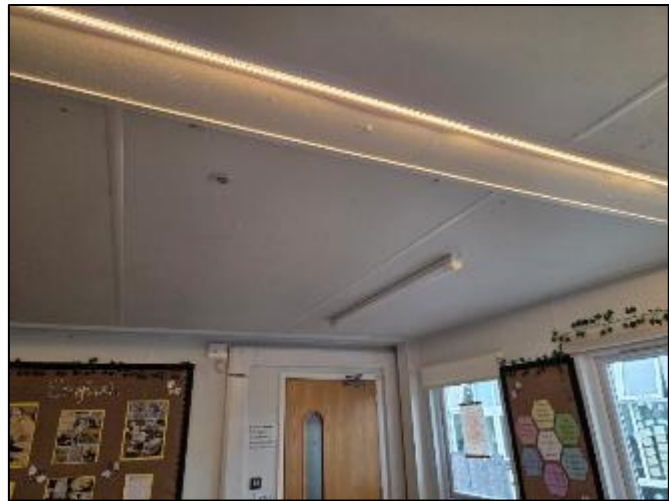
Photograph 7 and 8 showing the interior of Building 1.

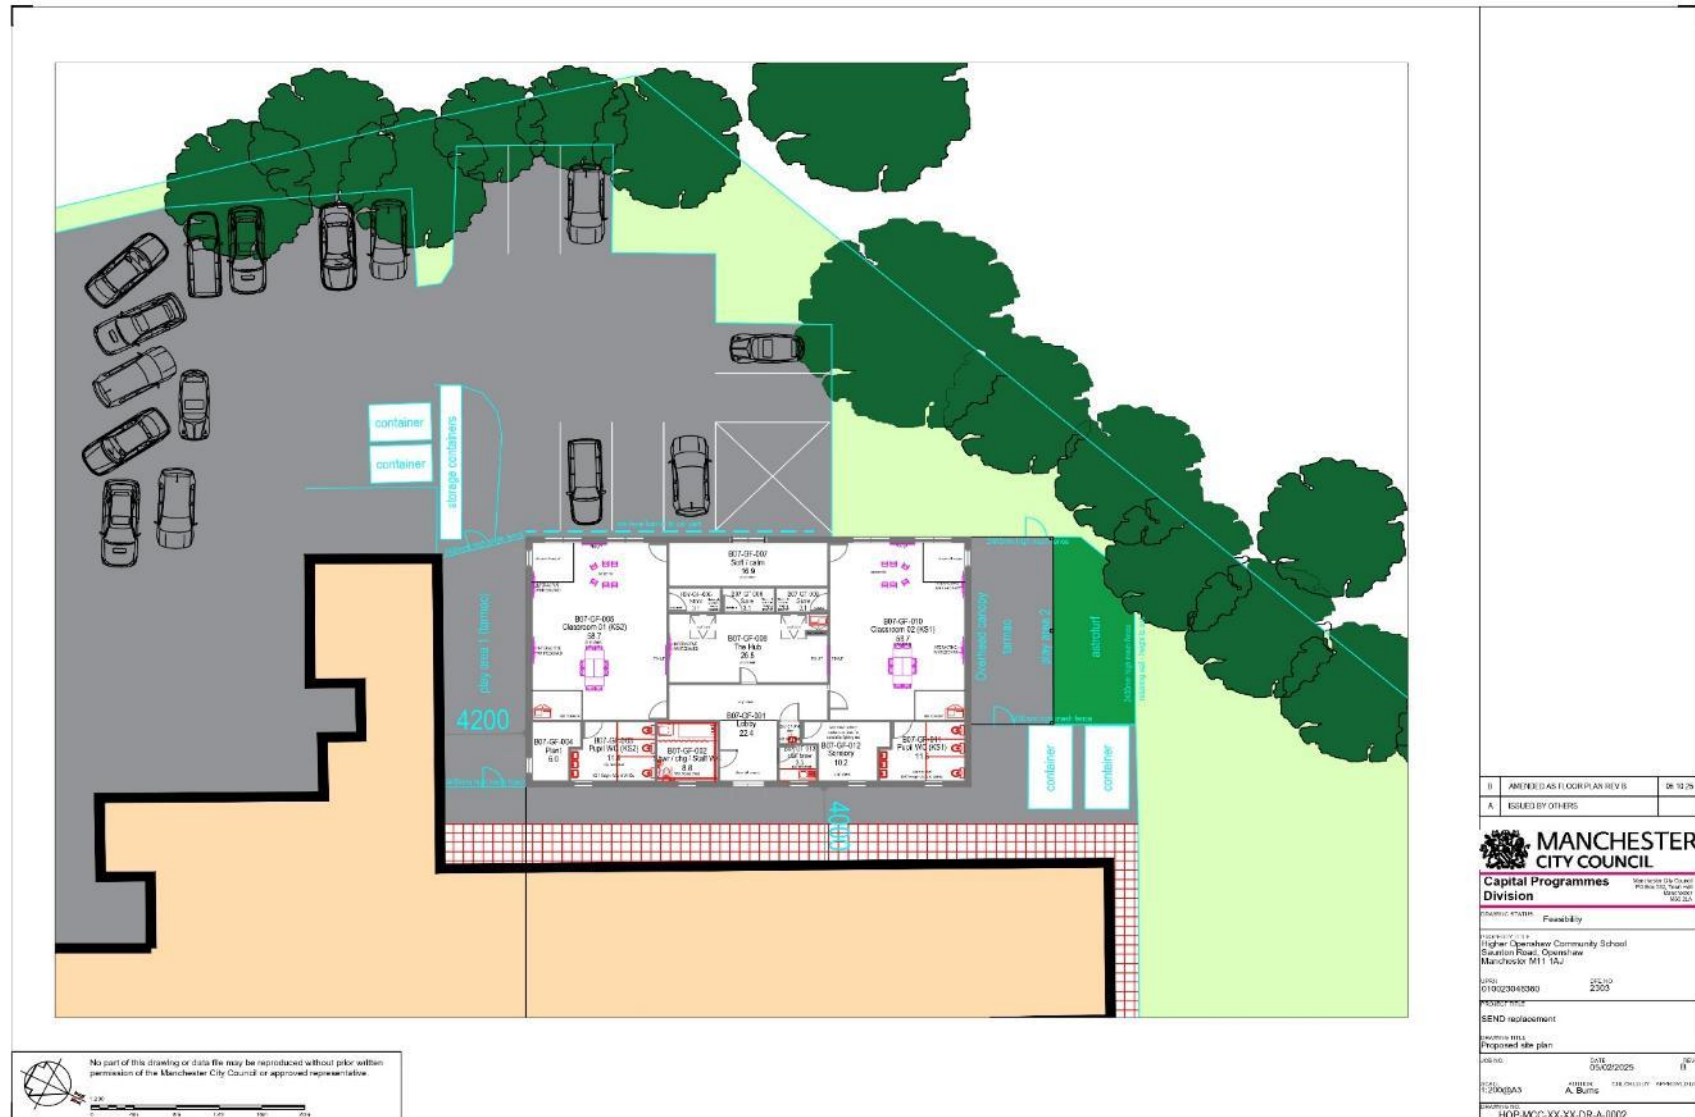
Ground Floor Plan - Option 2

Total site area:  
Gross external area: 273.4  
Gross internal area: 253.3  
Total room area: 171.5  
Net internal area: 246.6  
Building footprint area: 273.4
