Phase II Geoenvironmental Site Assessment  
Domett Street, Manchester

## **PHASE II GEOENVIRONMENTAL SITE ASSESSMENT**

Land off Domett Street  
Manchester  
M9 8DG

**Report Ref: 16-716-R1-2**  
**Date Issued: August 2024**

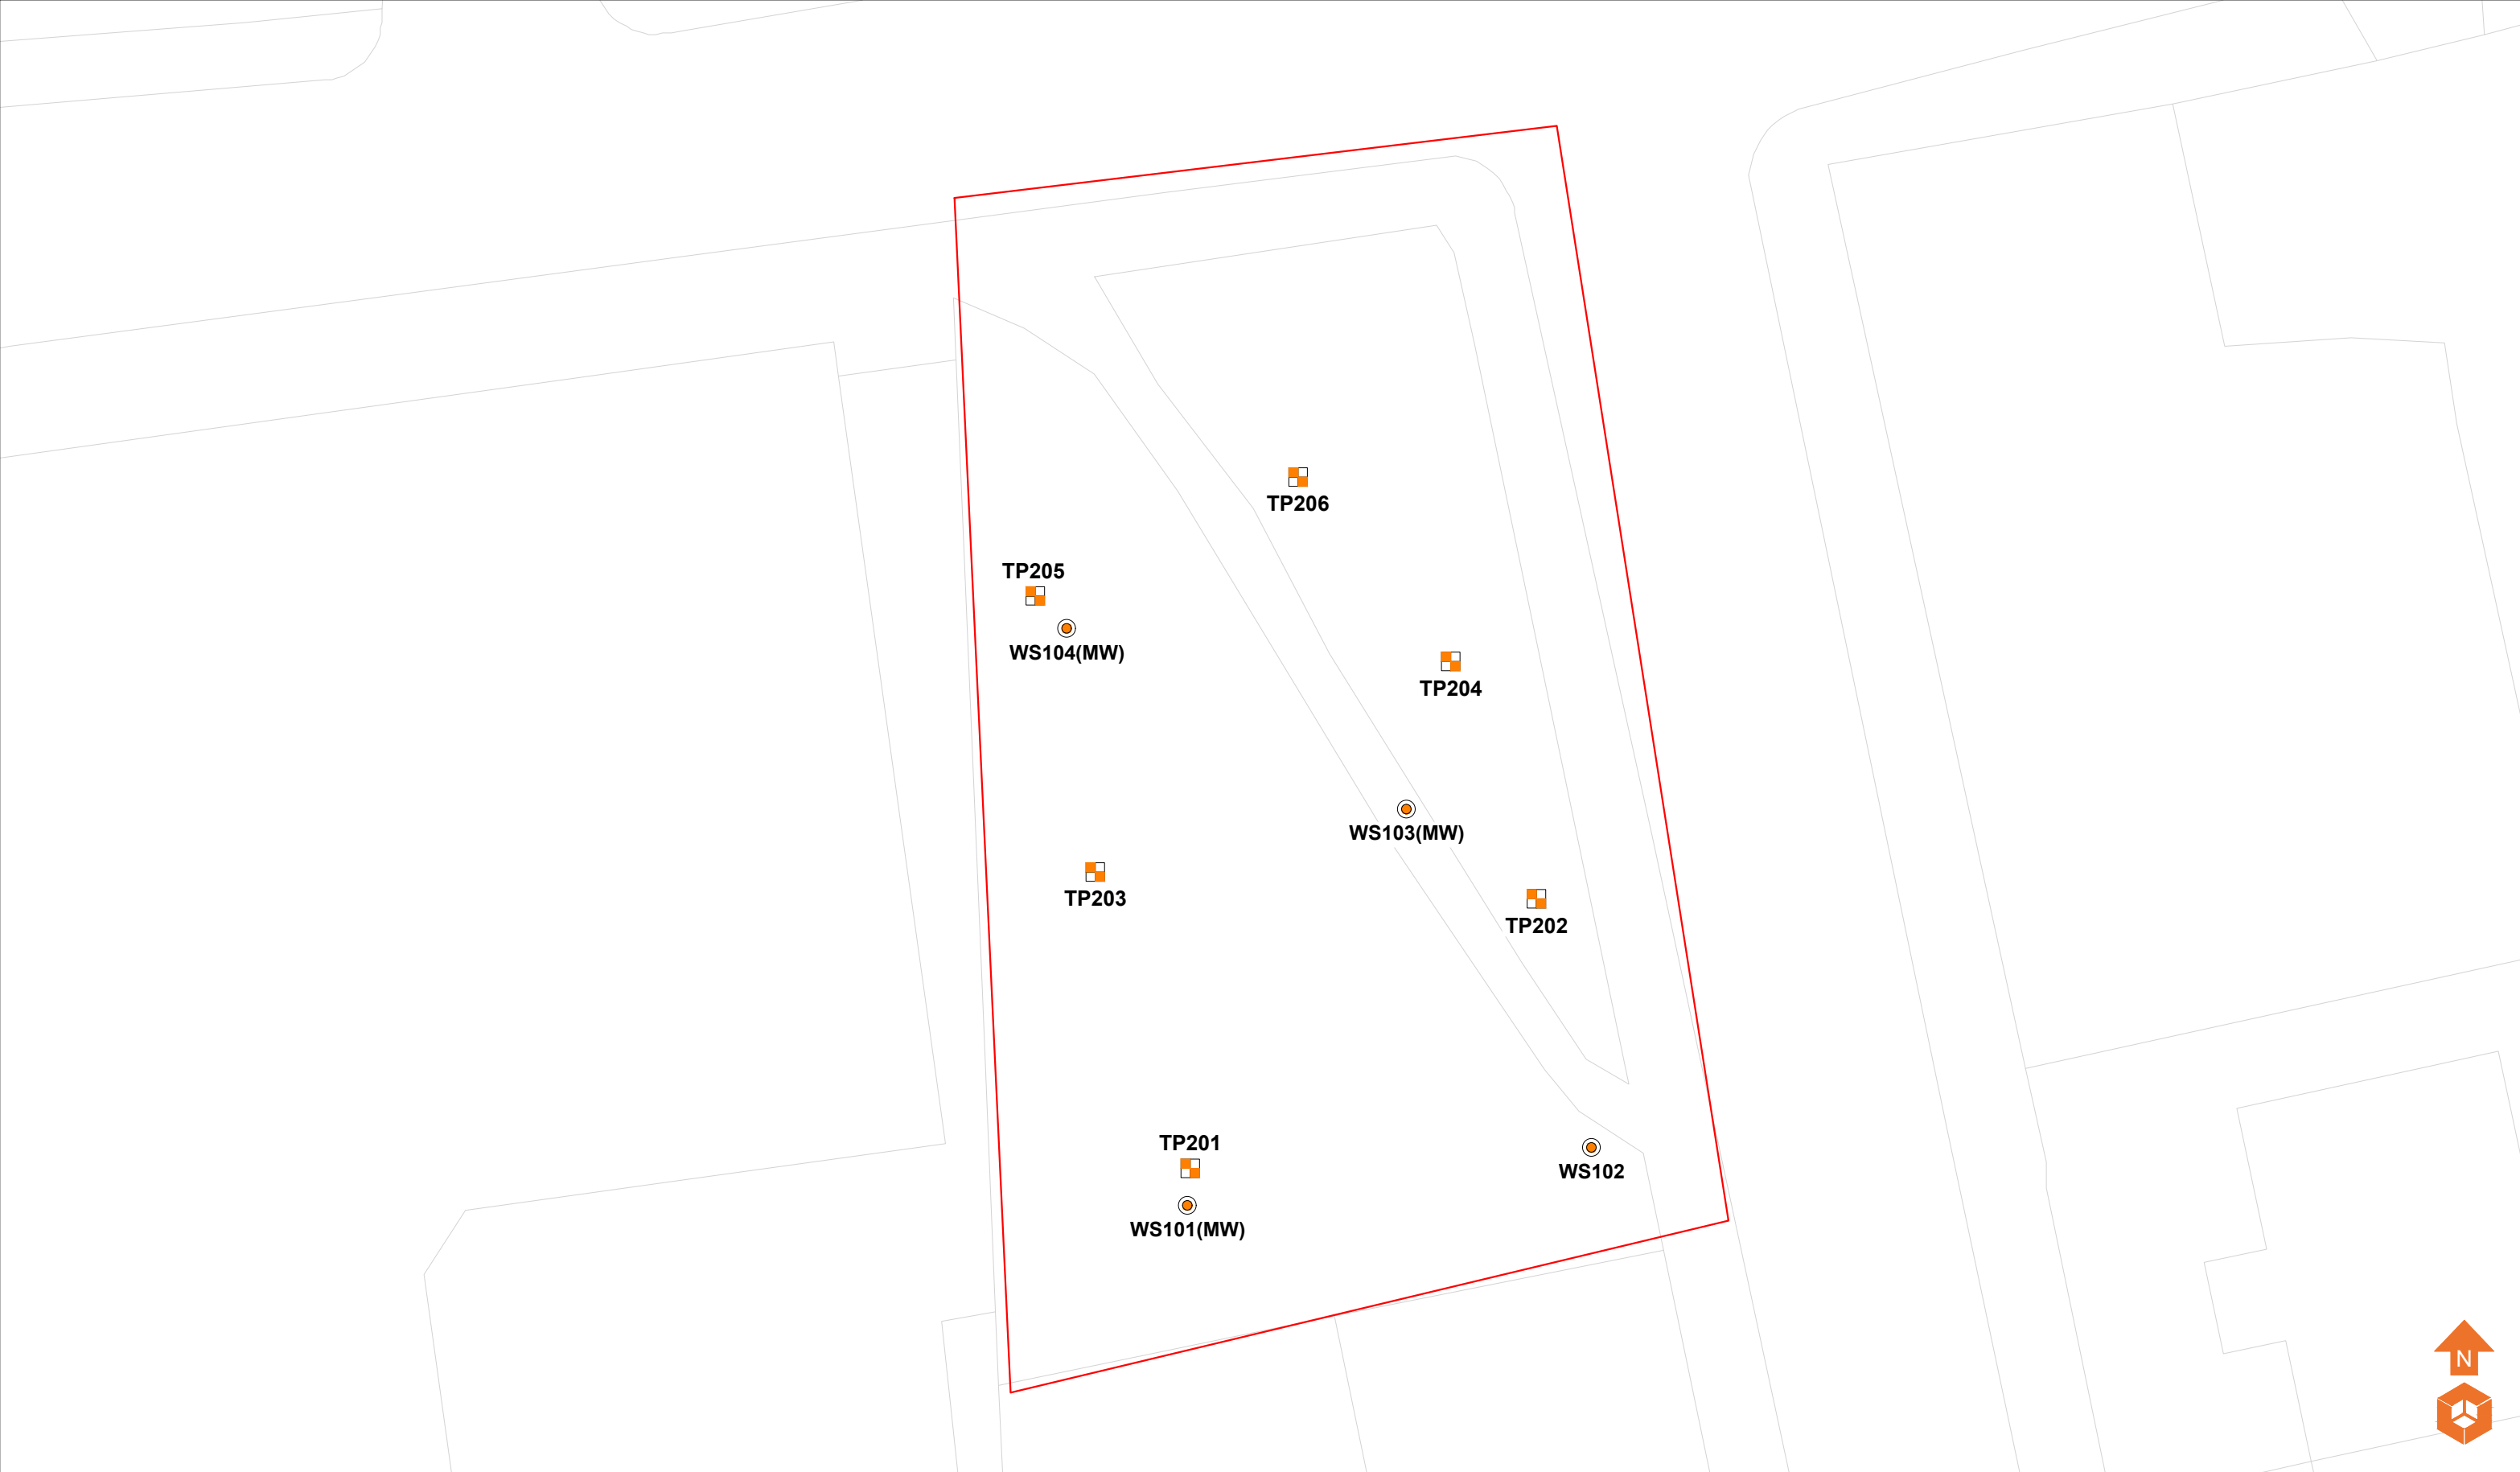
Location Symbols

WS101

The sampling locations are illustrated in Drawing 16-716-005 (Appendix III). The ground conditions encountered are indicated on the logs, which are provided in Appendix V.

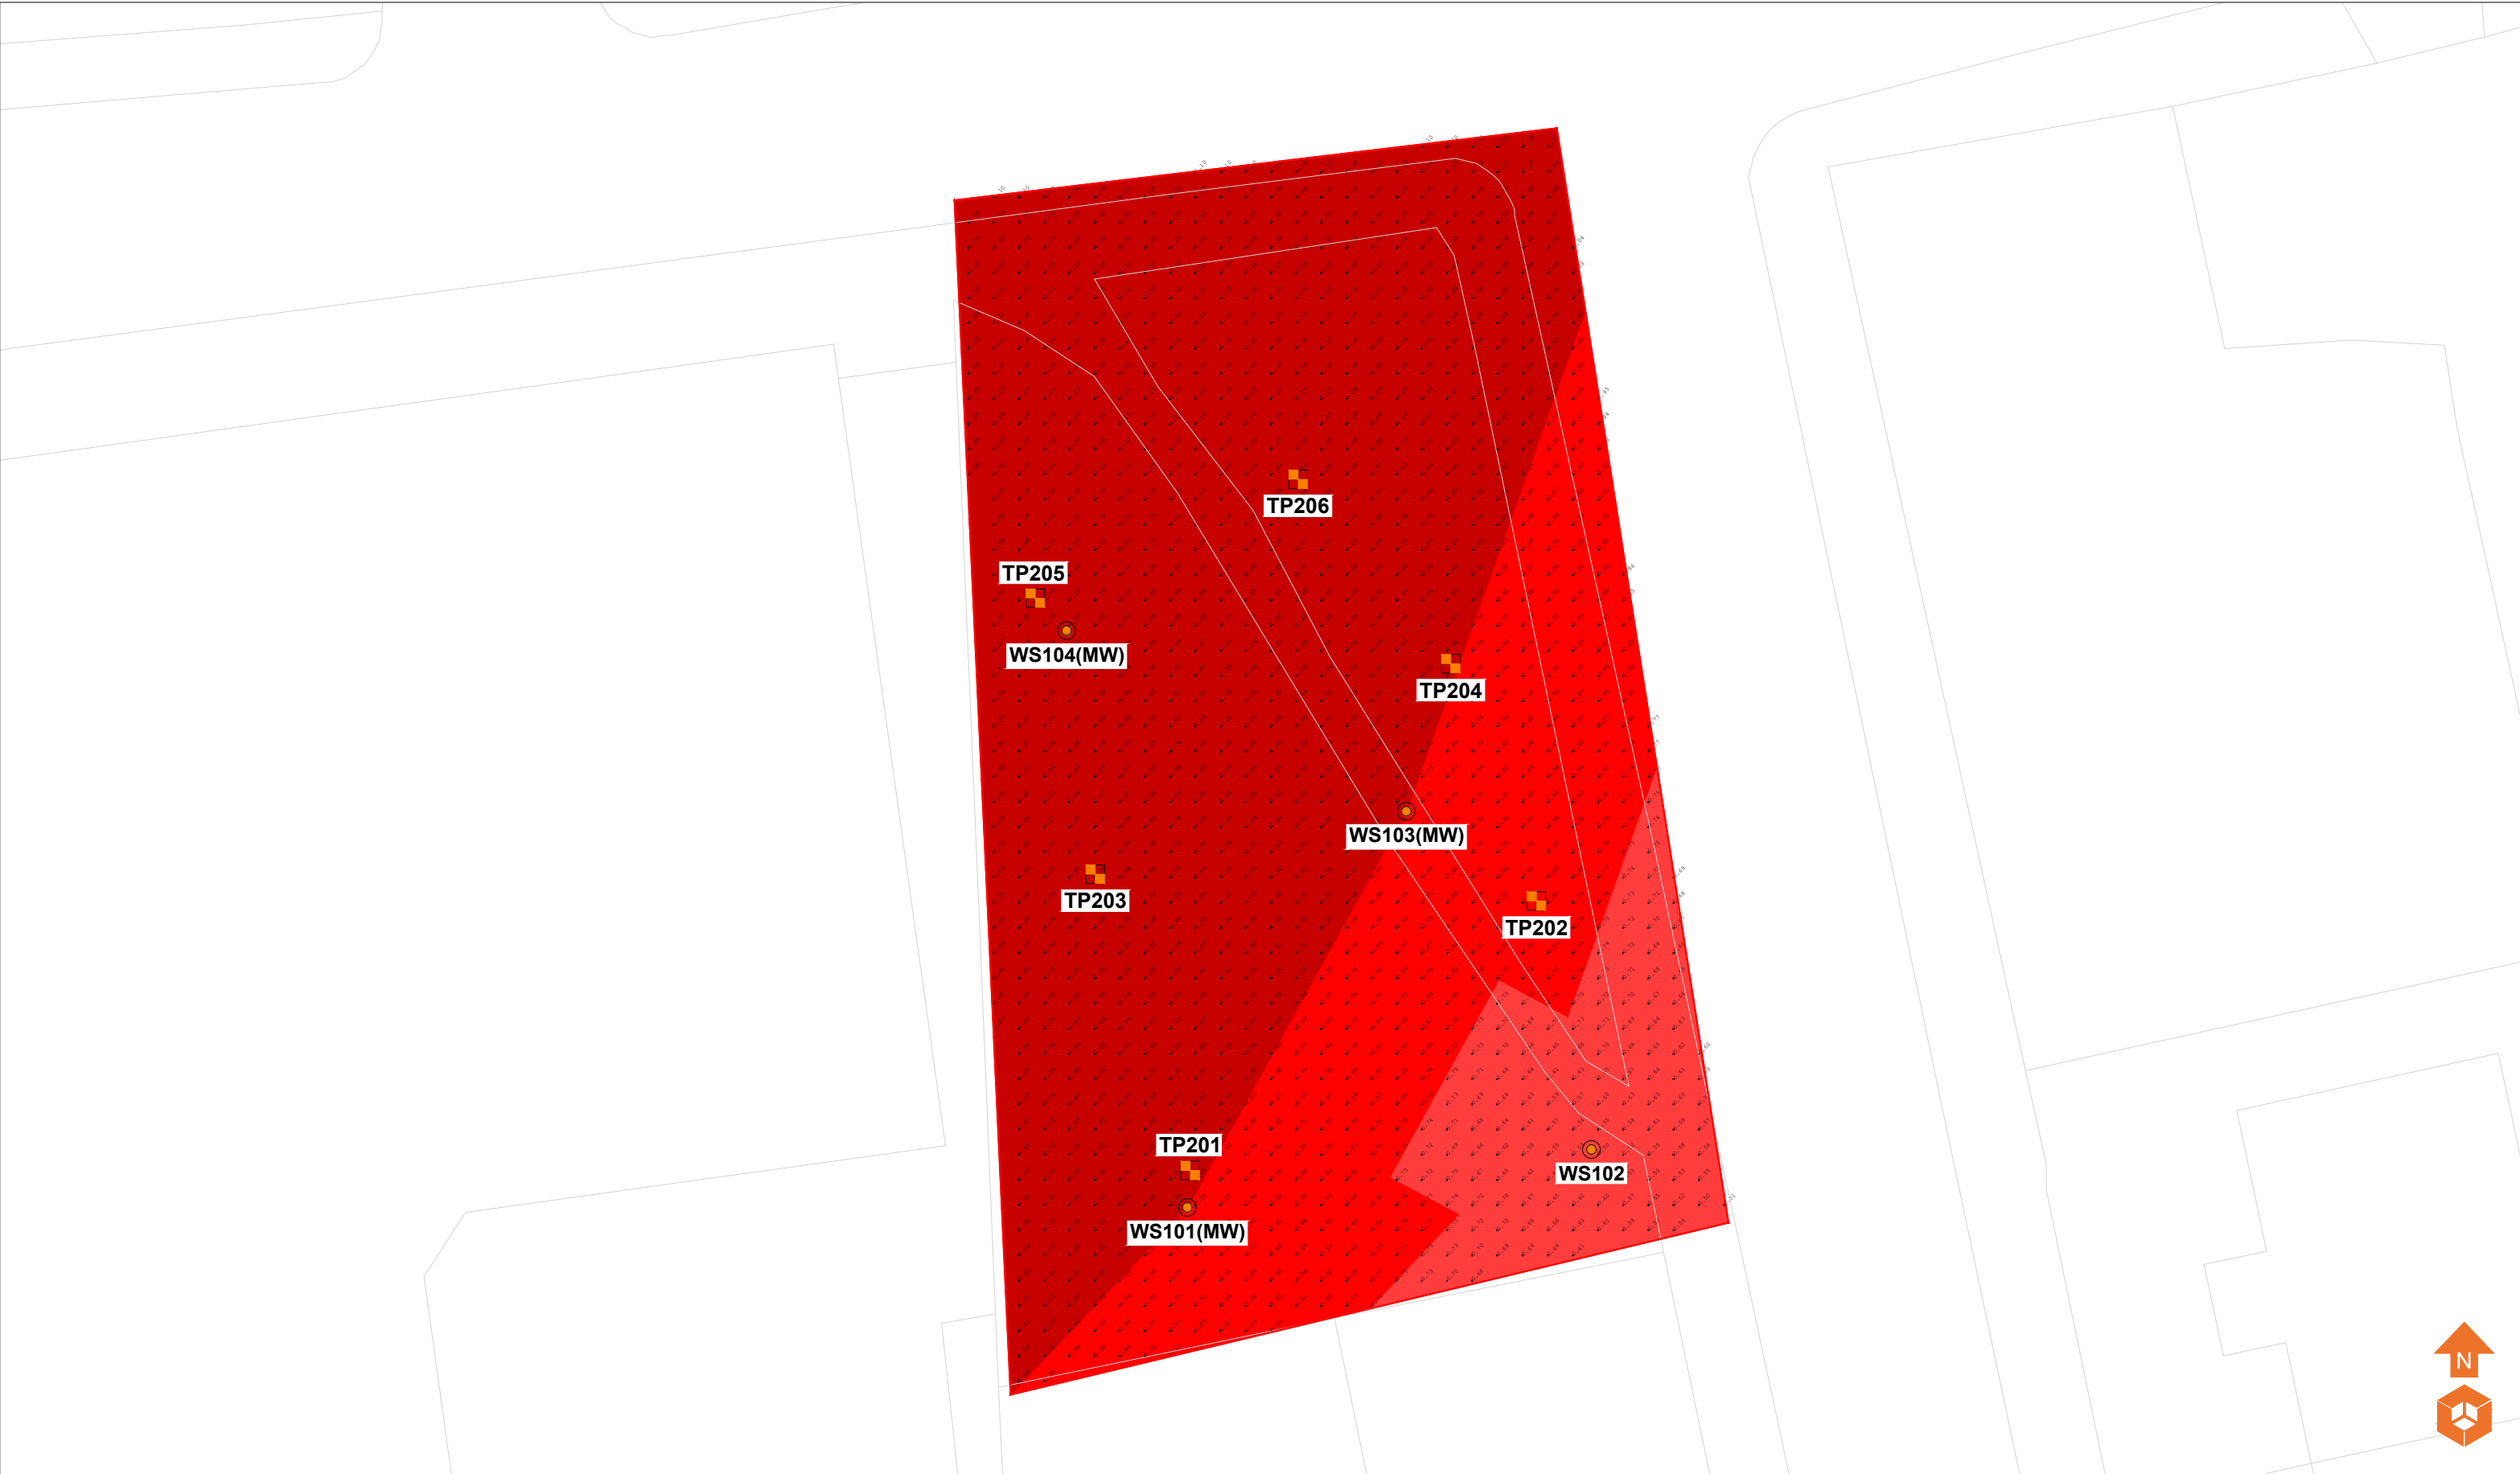
Approximate Window Sample Probehole Location

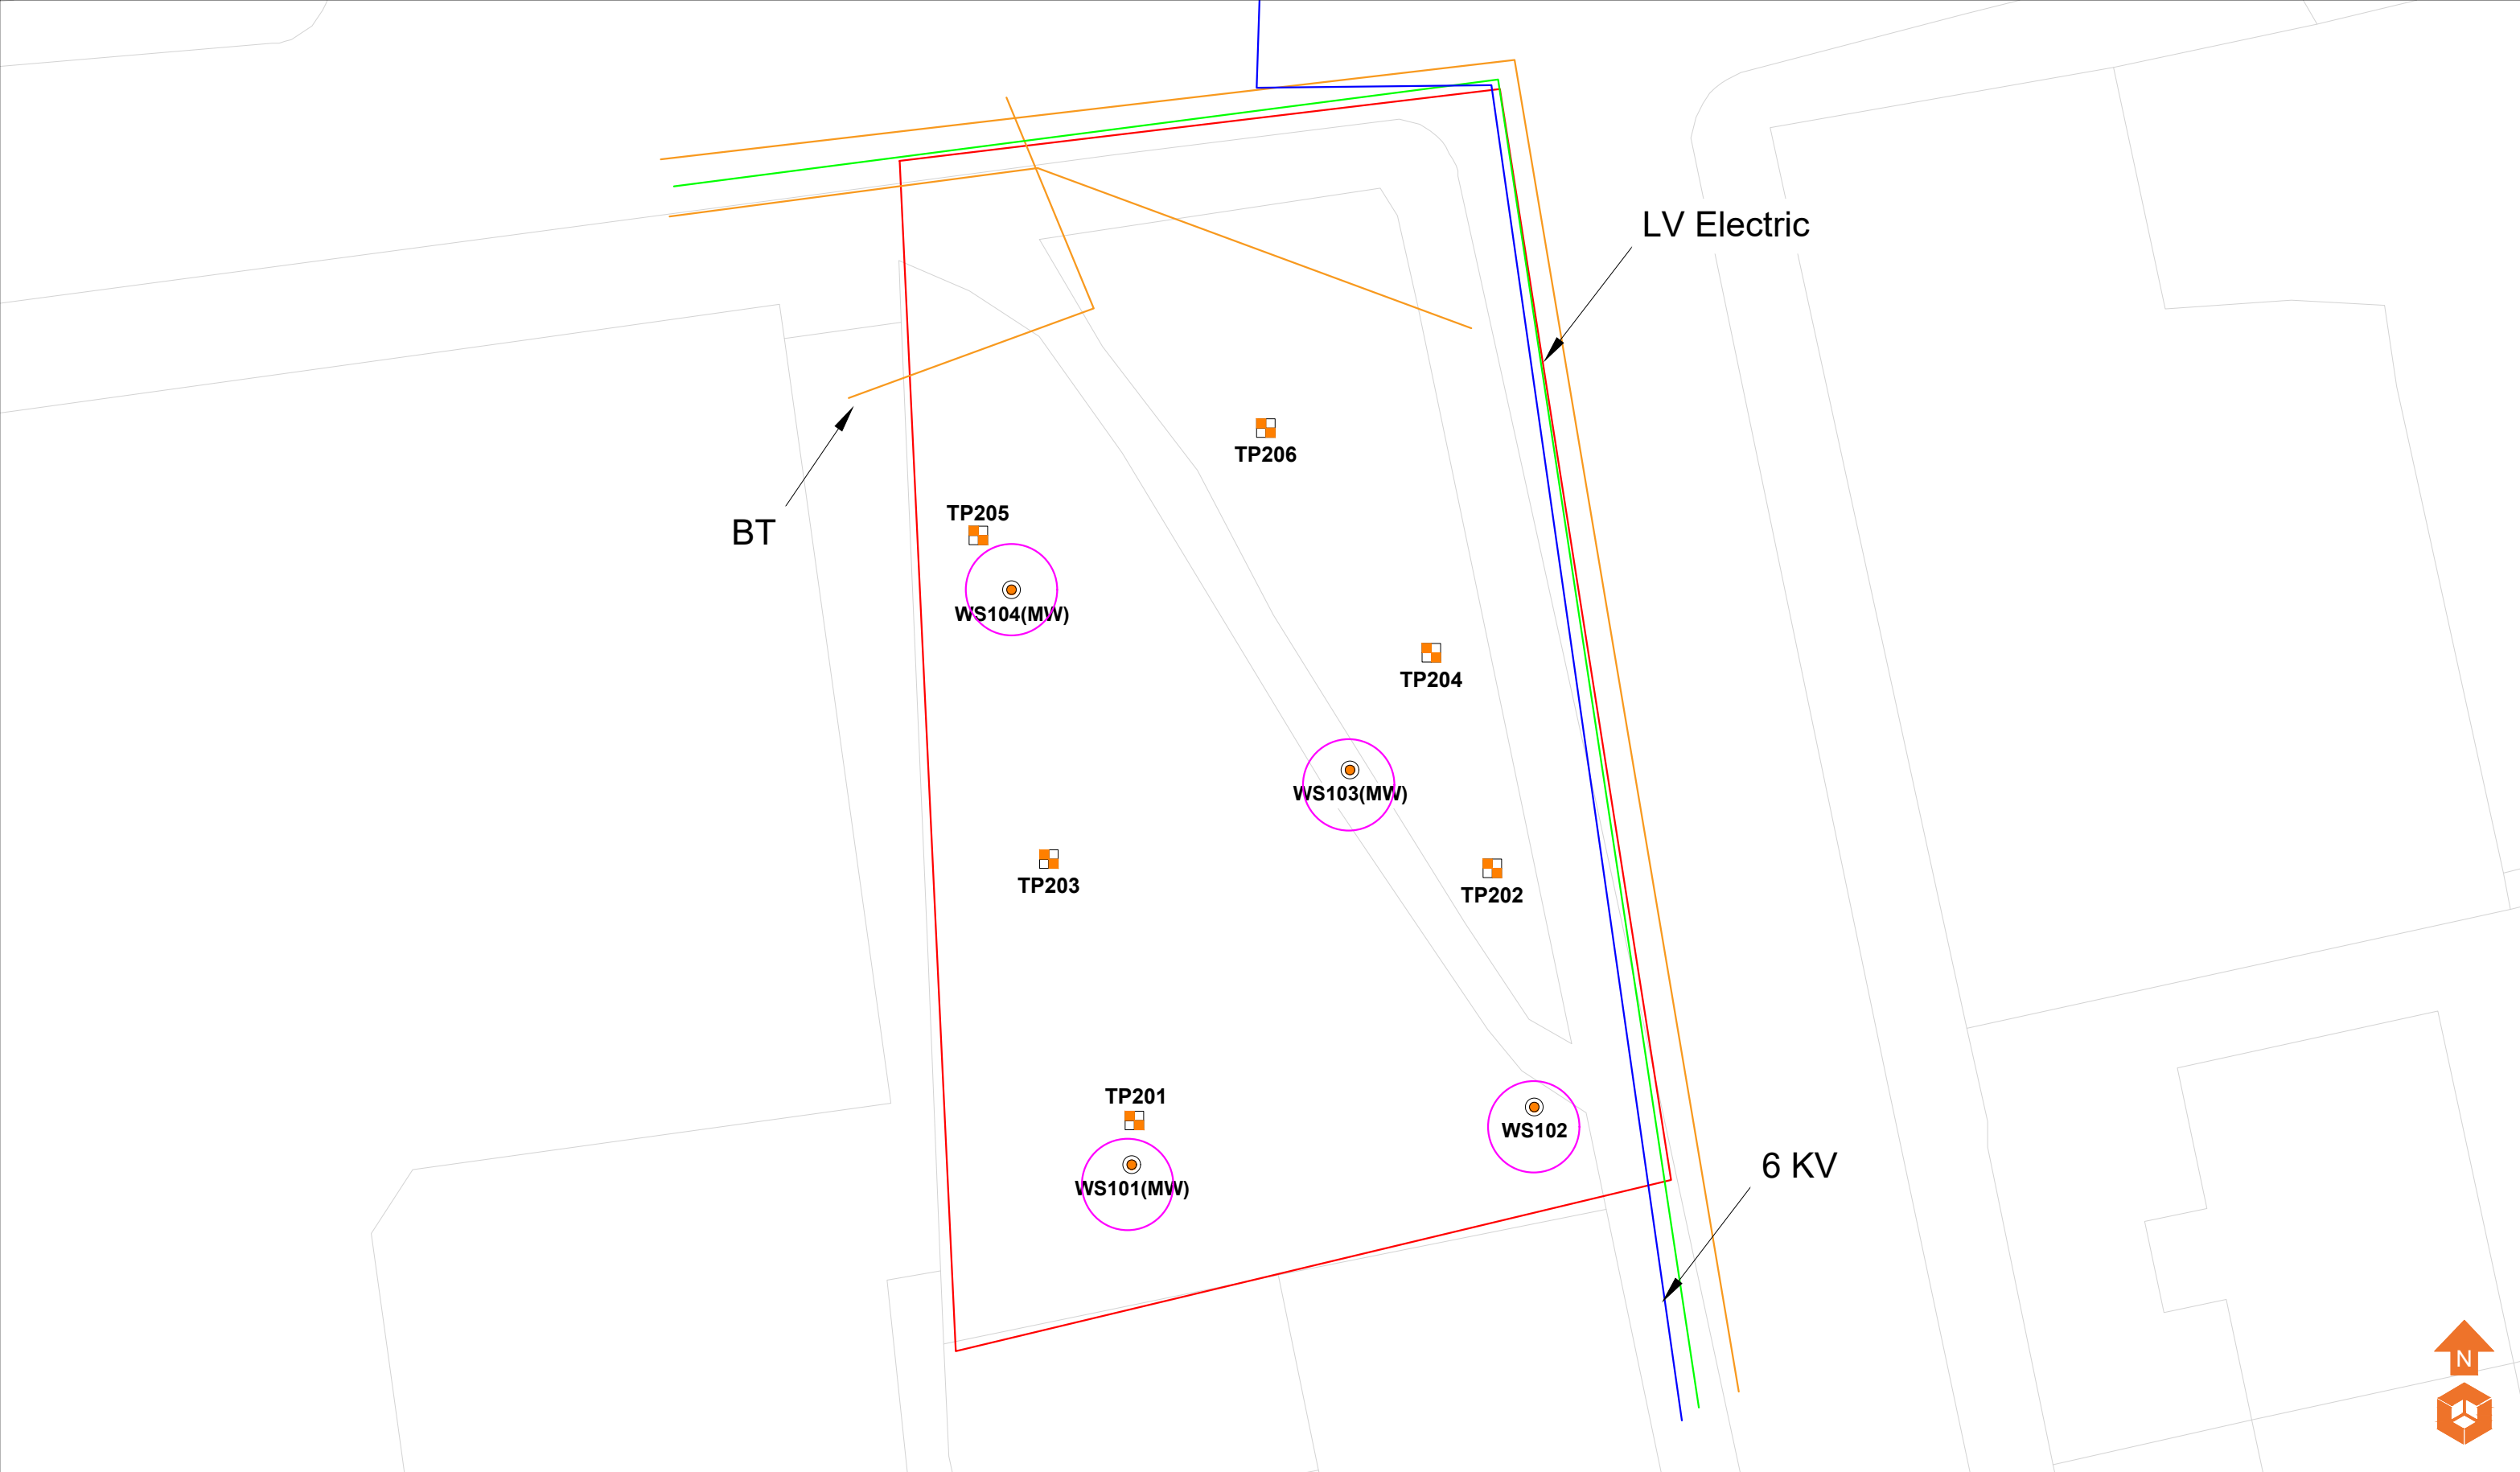
- Approximate Window Sample Probehole Location
- Approximate Window Sample Probehole Location with Install

- 6 KV
- LV Electric
- BT
- Loose Sands

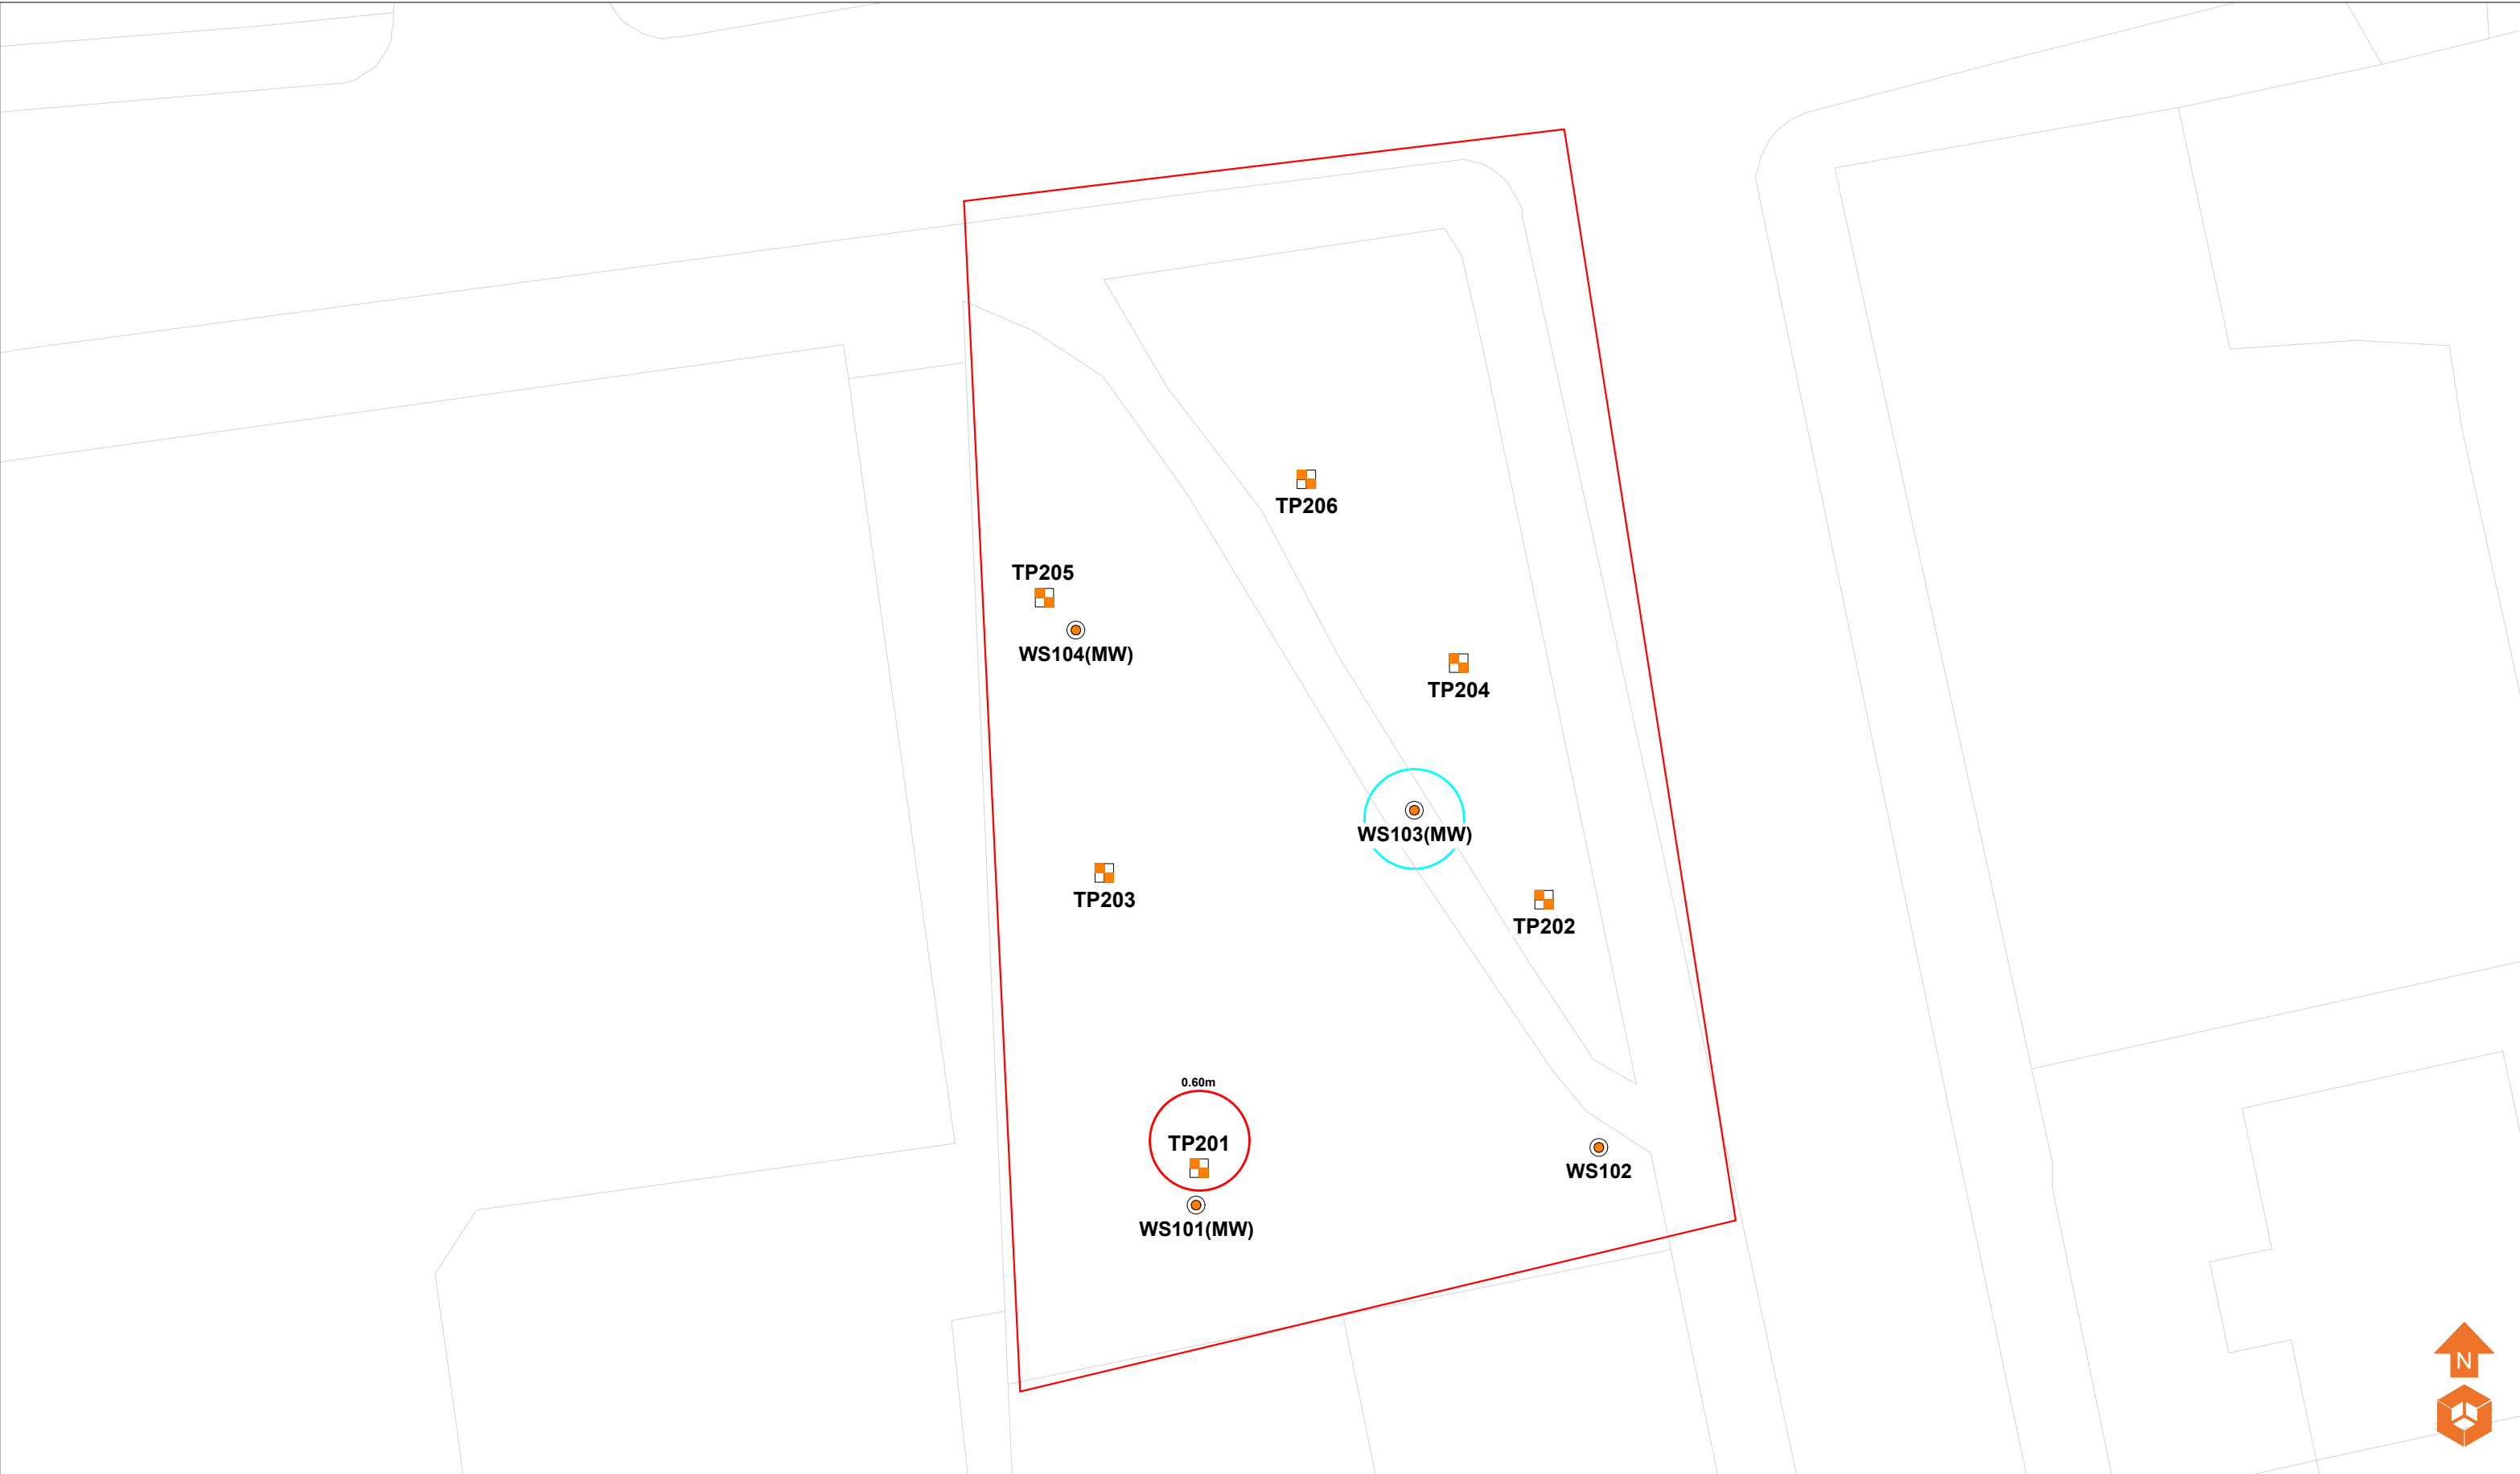
Location Symbols

Approximate Window Sample Probehole Location

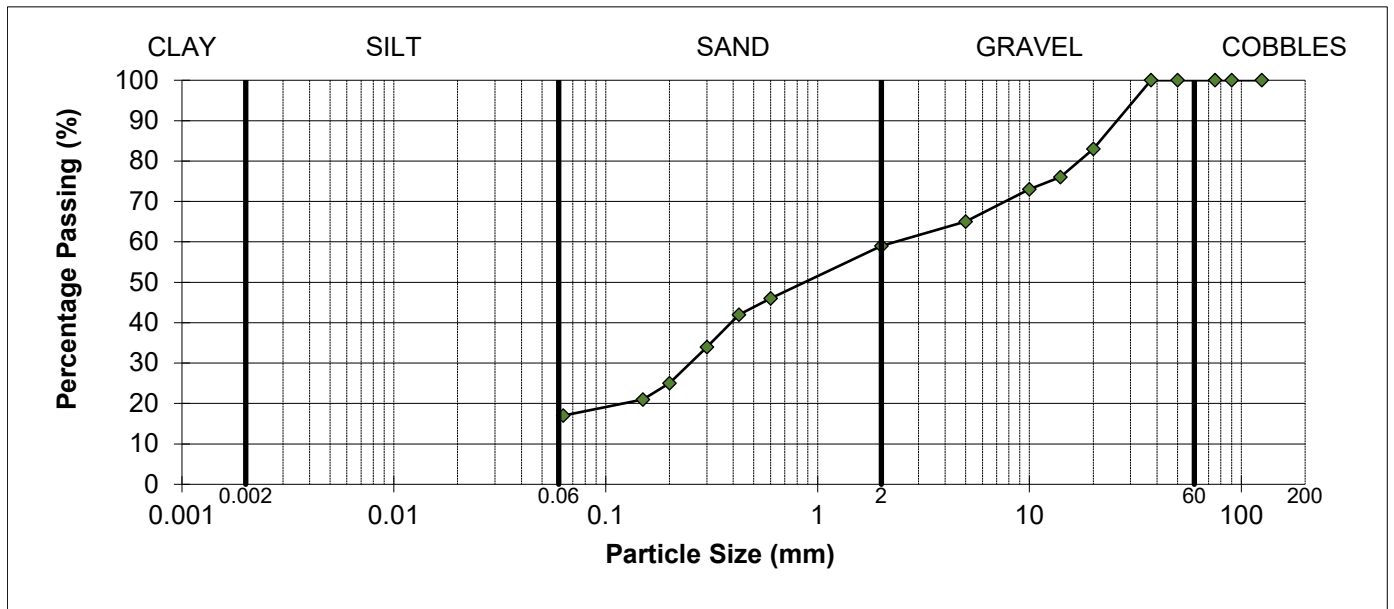
As received water content = 9.3%

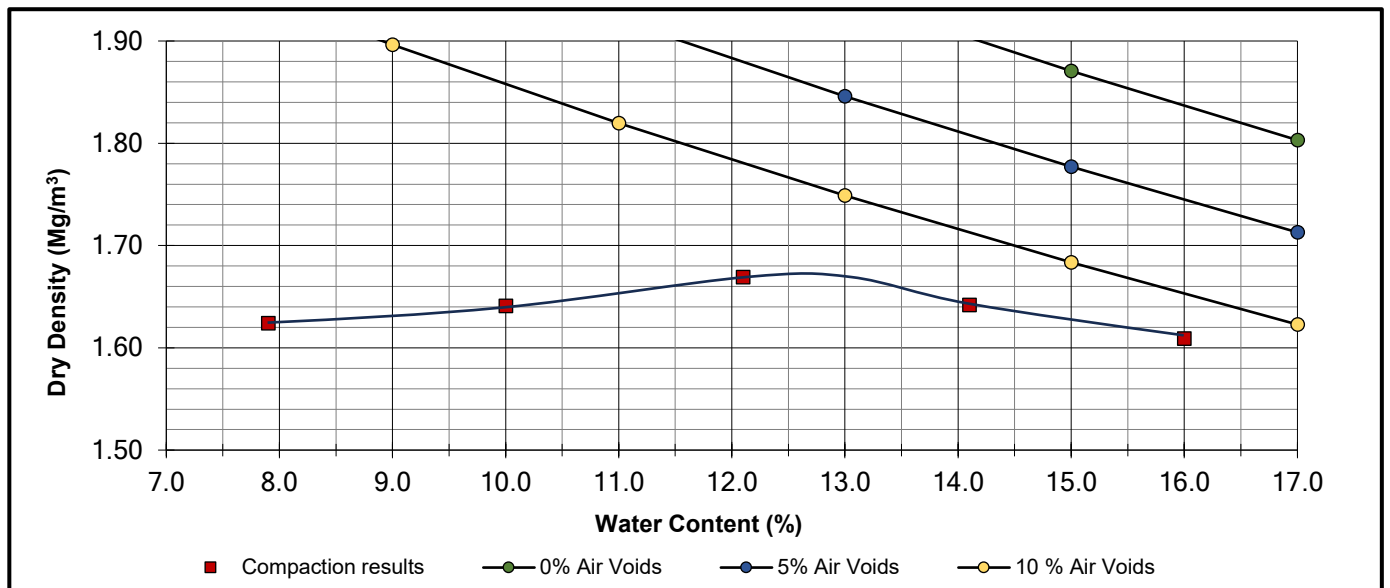
| OPTIMUM WATER CONTENT | 13 | (%) |
| MAXIMUM DRY DENSITY | 1.67 | (Mg/m <sup>3</sup> ) |

The proctor compaction tests have indicated that the material in WS103 has a lower initial moisture content than the optimum moisture content.
