## Plymouth Grove - UXO Desk Study & Risk Assessment

**Document Title** UXO Desk Study & Risk Assessment  
**Document Ref.** P13001-23-R1  
**Revision** A  
**Project Location** Plymouth Grove  
**Client** RECOM Solutions  
**Date** 31<sup>st</sup> May 2023

## UXO DESK STUDY & RISK ASSESSMENT

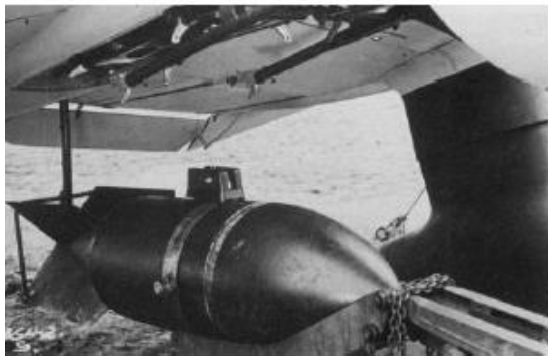
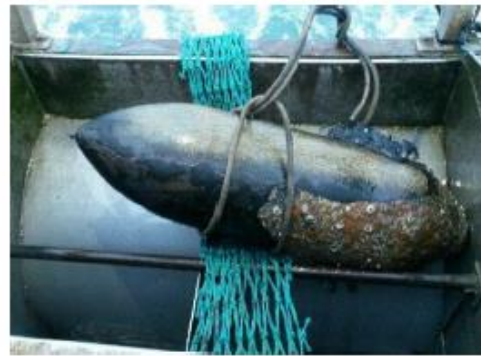
**Category** Bomb  
**Type** Sprengbombe-Cylindrisch (SC) 250kg

**Description** Thick nose welded to steel body. Nose may be attached to Kopfring (triangular section steel ring) or spike. Sheet metal tail attached to body with rivets/screws. Suspension eye bolt in the nose/body. Originally painted green-grey with a yellow stripe on the tail. TNT; amatol; TNT and aluminium powder, naphthalene, ammonium nitrate and wax/ wood meal filling.

**Function** Designed to maximise shock waves through air, water and earth and general demolition. Used against railway installations, large buildings, ammunition depots and below-ground installations (to 8m). Spike bombs/ 'Stabo' (SC 50 with spikes attached to nose) used against rail lines and country roads.

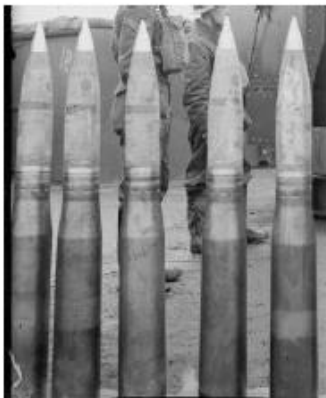
**Category** Projectile  
**Type** 4.5" Shell (Mark II – Anti-Aircraft)

**Description** Square-based, tapered-nosed shell filled with TNT or Amatol. Steel casing, rotating band of either copper or gilding metal located 3.5" in front of the base end with single groove.

**Function** Used as field artillery and adapted for use in anti-aircraft defence from fixed batteries. Rate of fire of 8 rounds per minute, maximum ceiling of 44,000ft and horizontal range of 22,800 yards.
