# A53 INTRUSIVE INVESTIGATION

Core samples & Endoscope survey

Project: Intrusive Investigation of Masonry Arch (A53)

Report Reference: REP01/2507E029

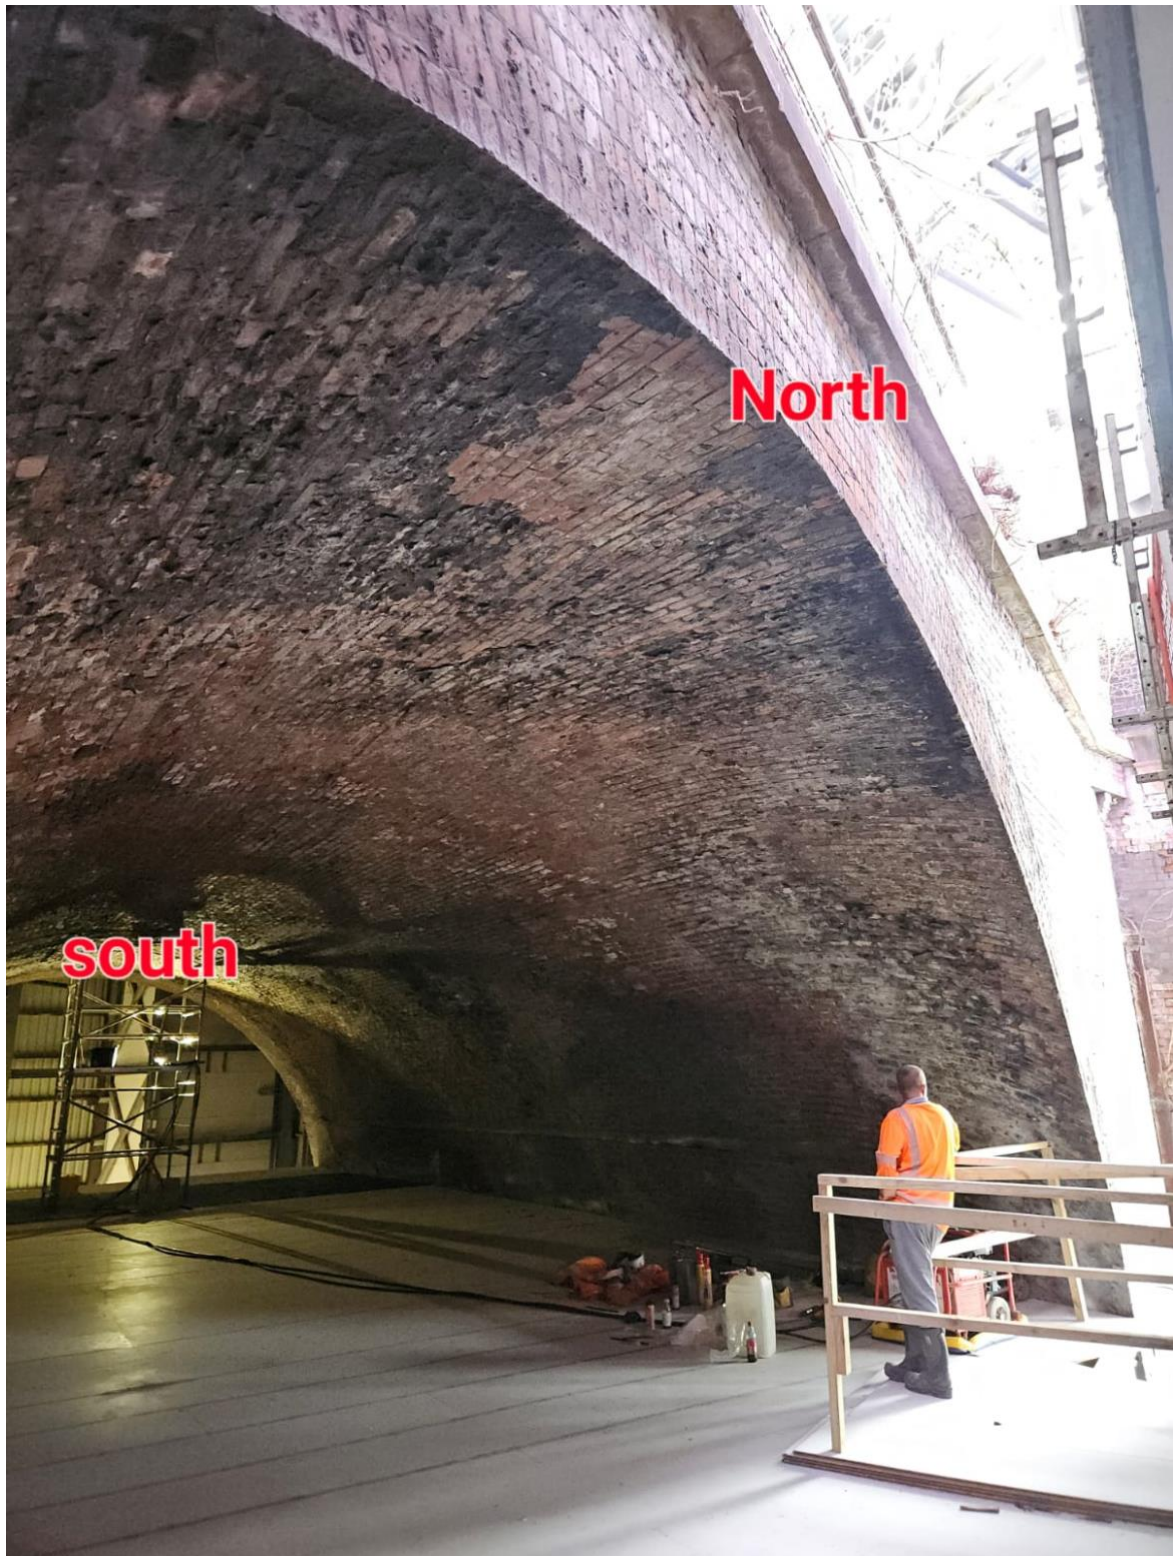
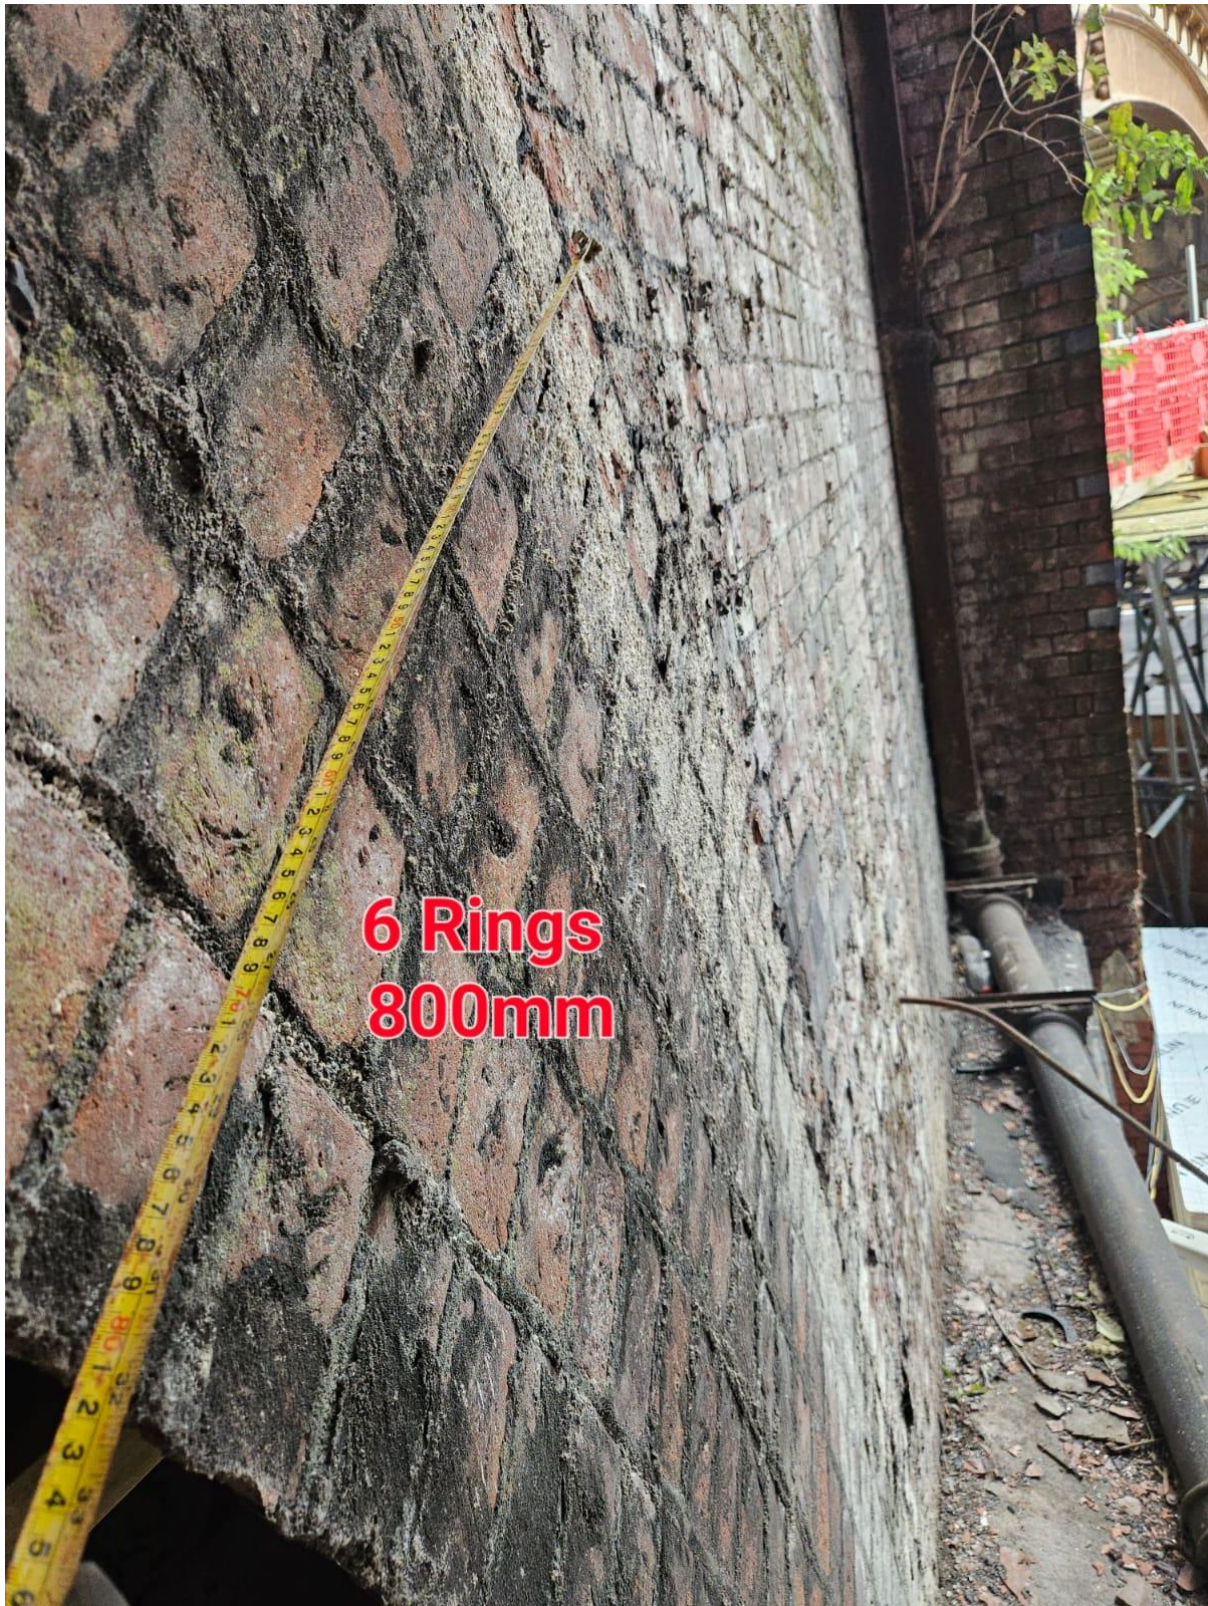
Results & Observations:

A survey has been requested by Assured CMS (for Metrolink) to investigate for potential voids behind arch barrel, CoreFIX carried out both core samples and an endoscope survey into six locations, 3 at the south end of the arch and 3 at the north end of the arch.

As shown only 1 location (Mid Crown - Right hand side facing south end of the tunnel) showed presence of voids behind the arch, the rest of the cores provided full brickwork

retrieval as shown above. The depth of brickwork cored ranged between 850-950mm. While no voids were present in the rest of the cores, to gain further knowledge of the extent of the voids a localised survey around the area where a void was present would give more insight into its extents if deemed necessary.

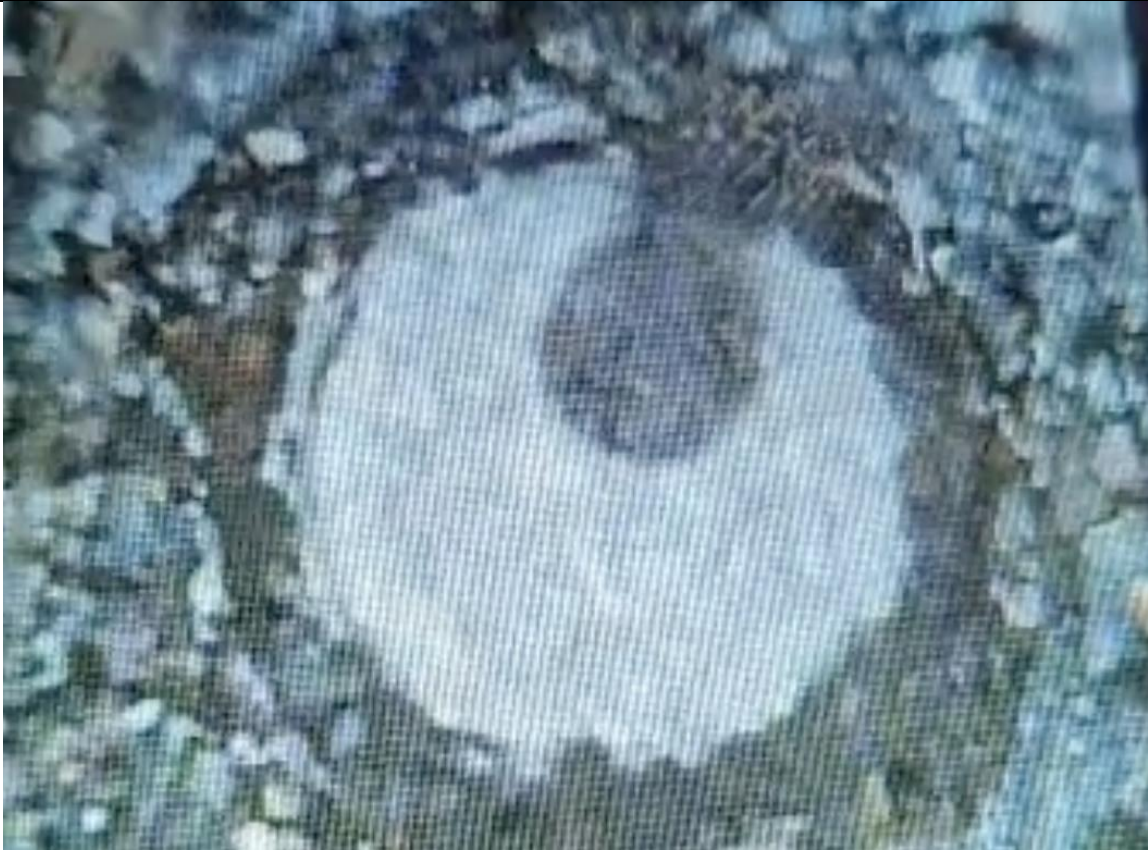
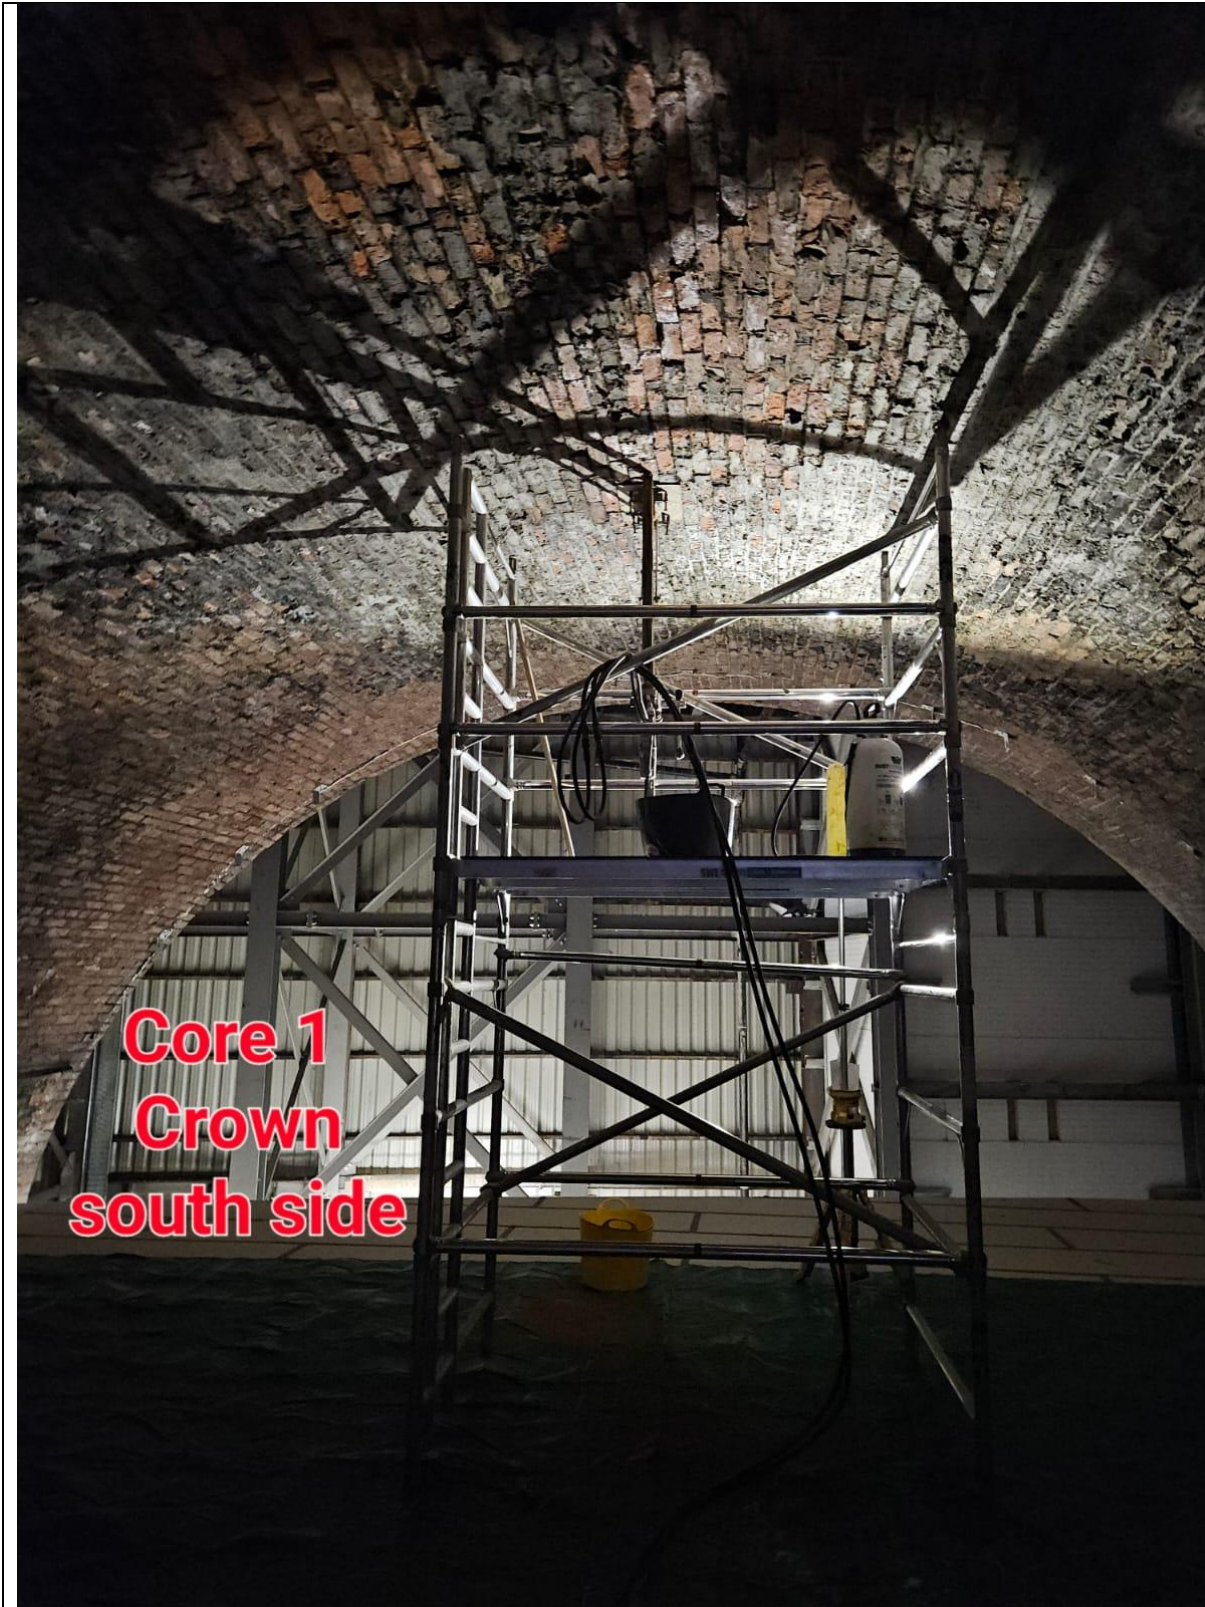
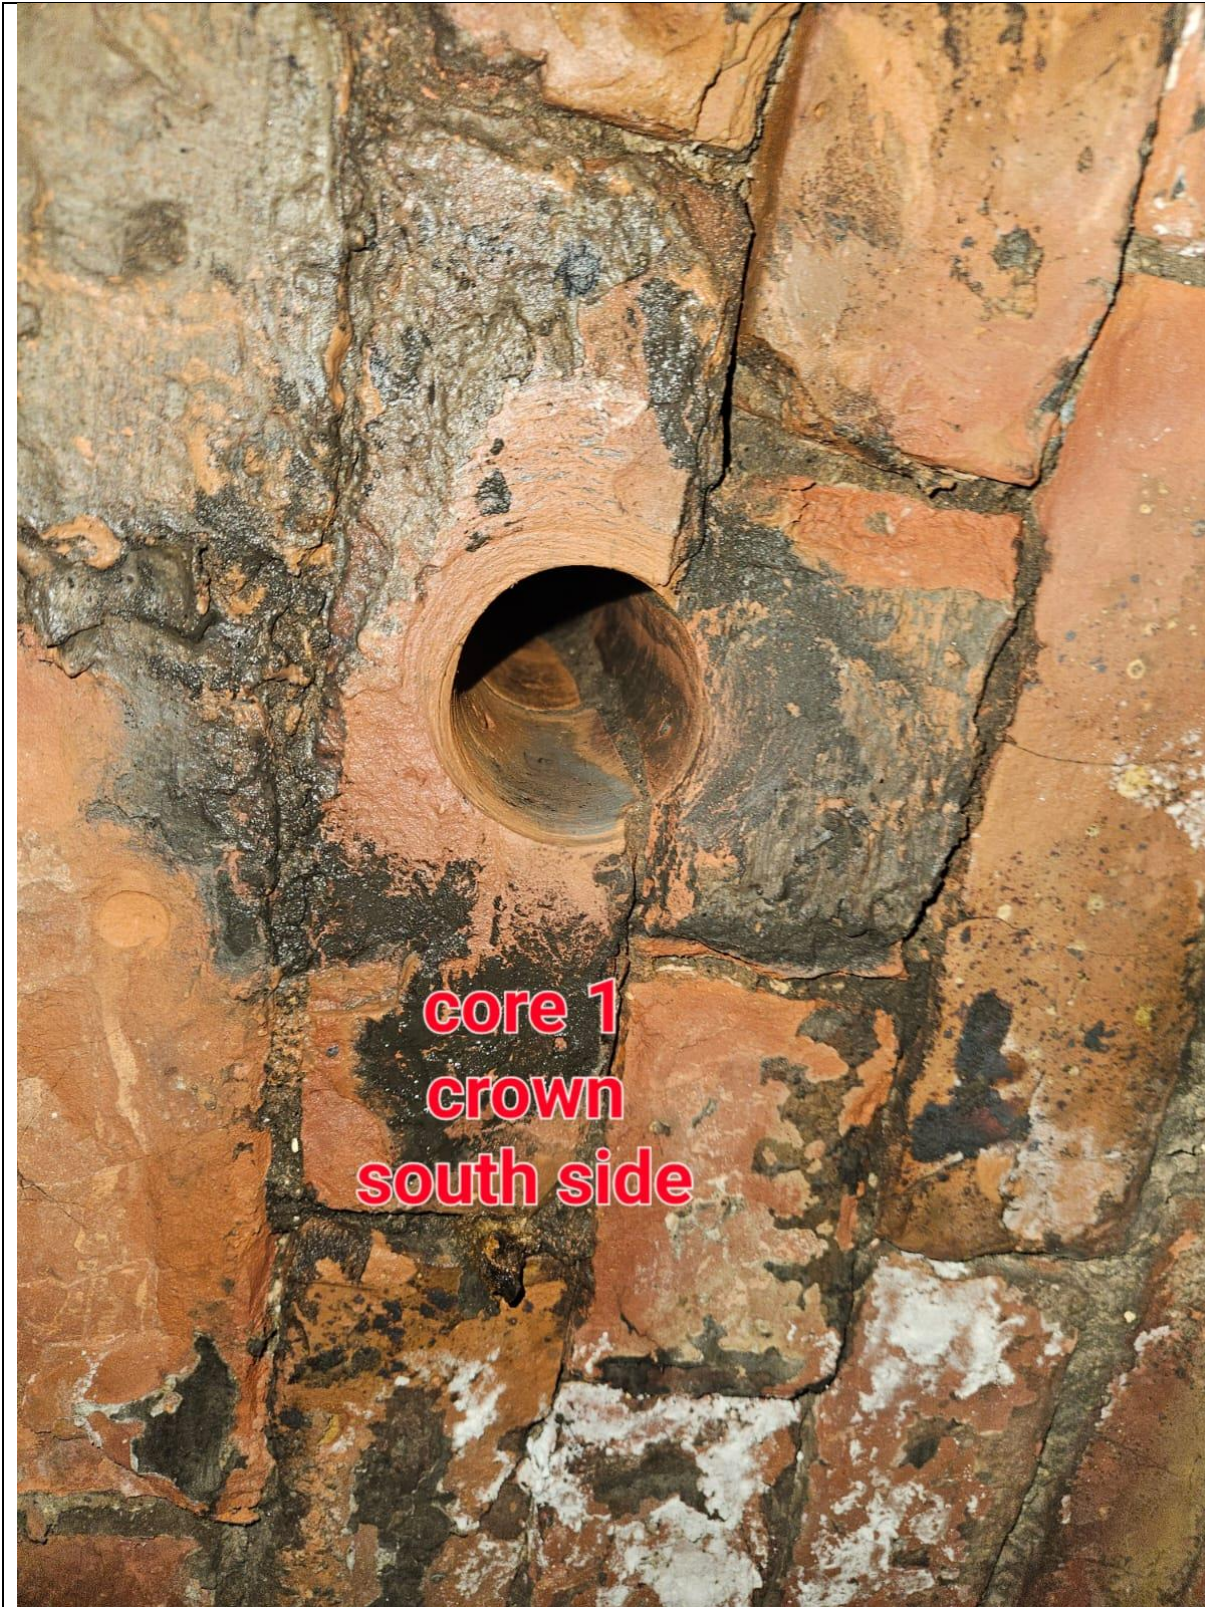
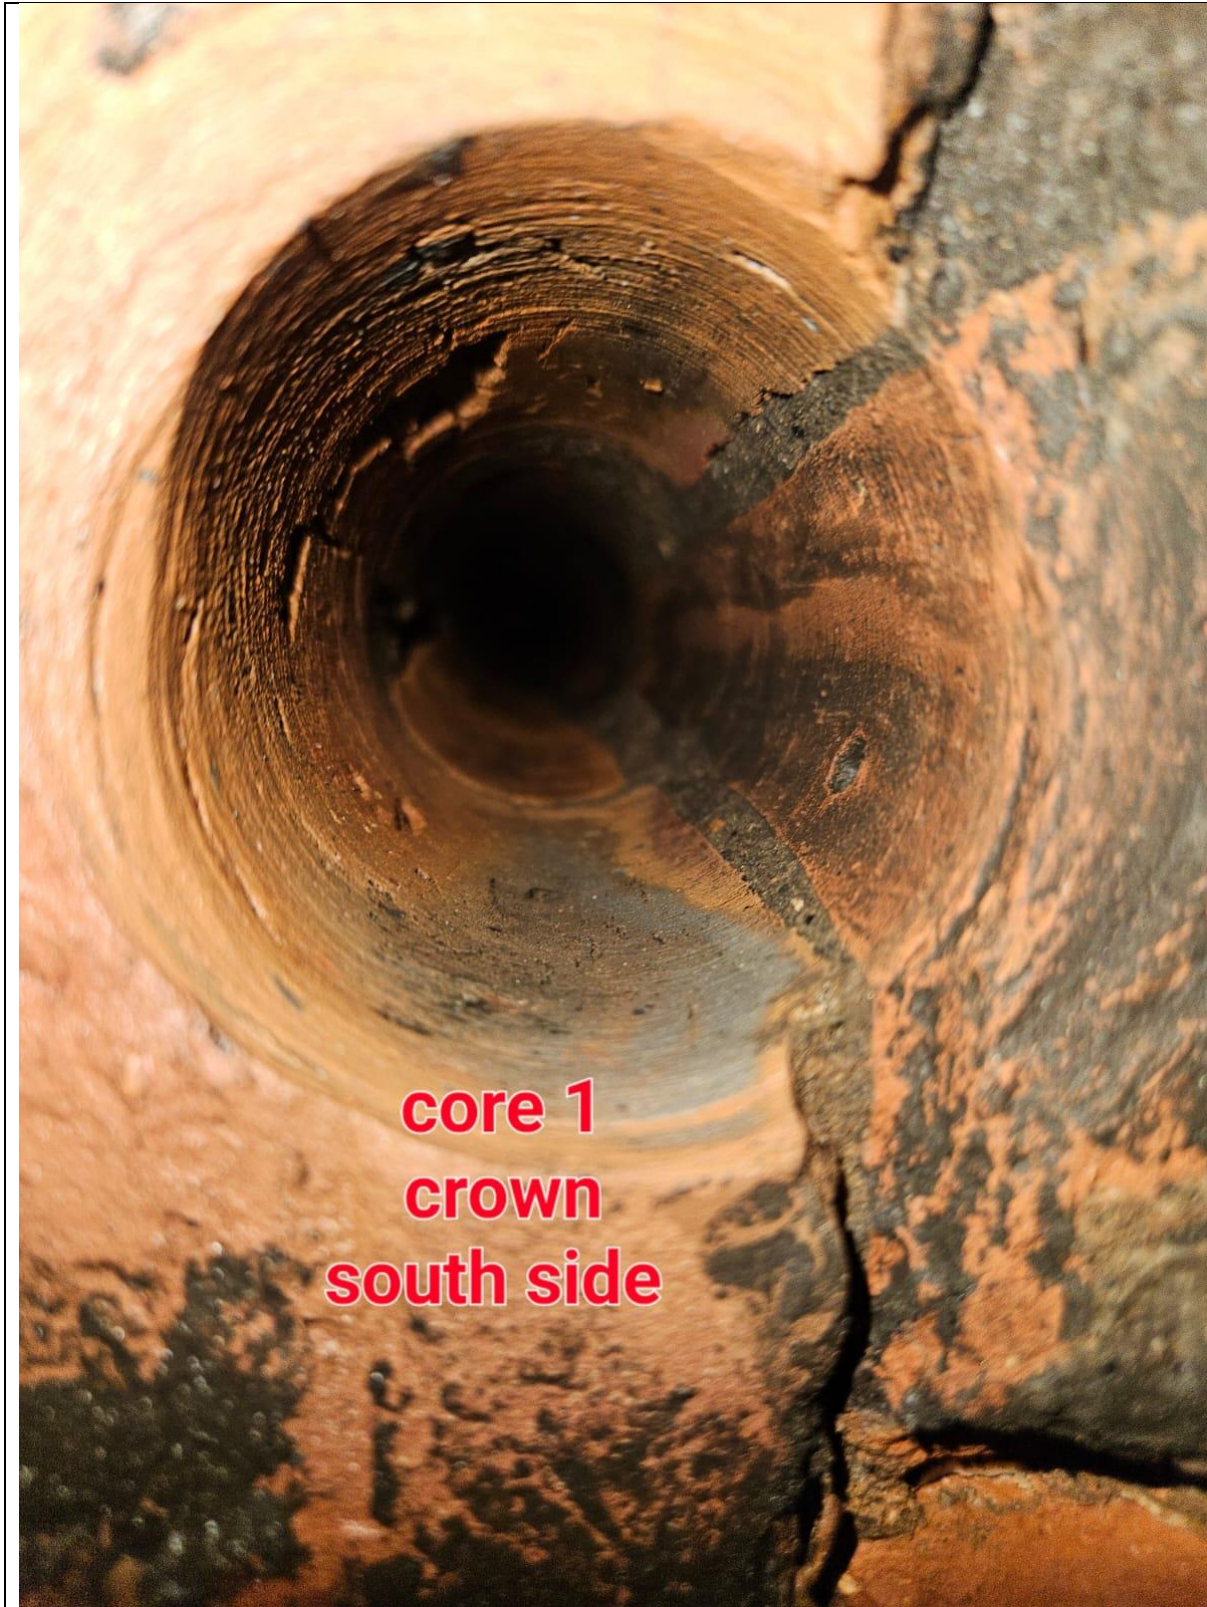
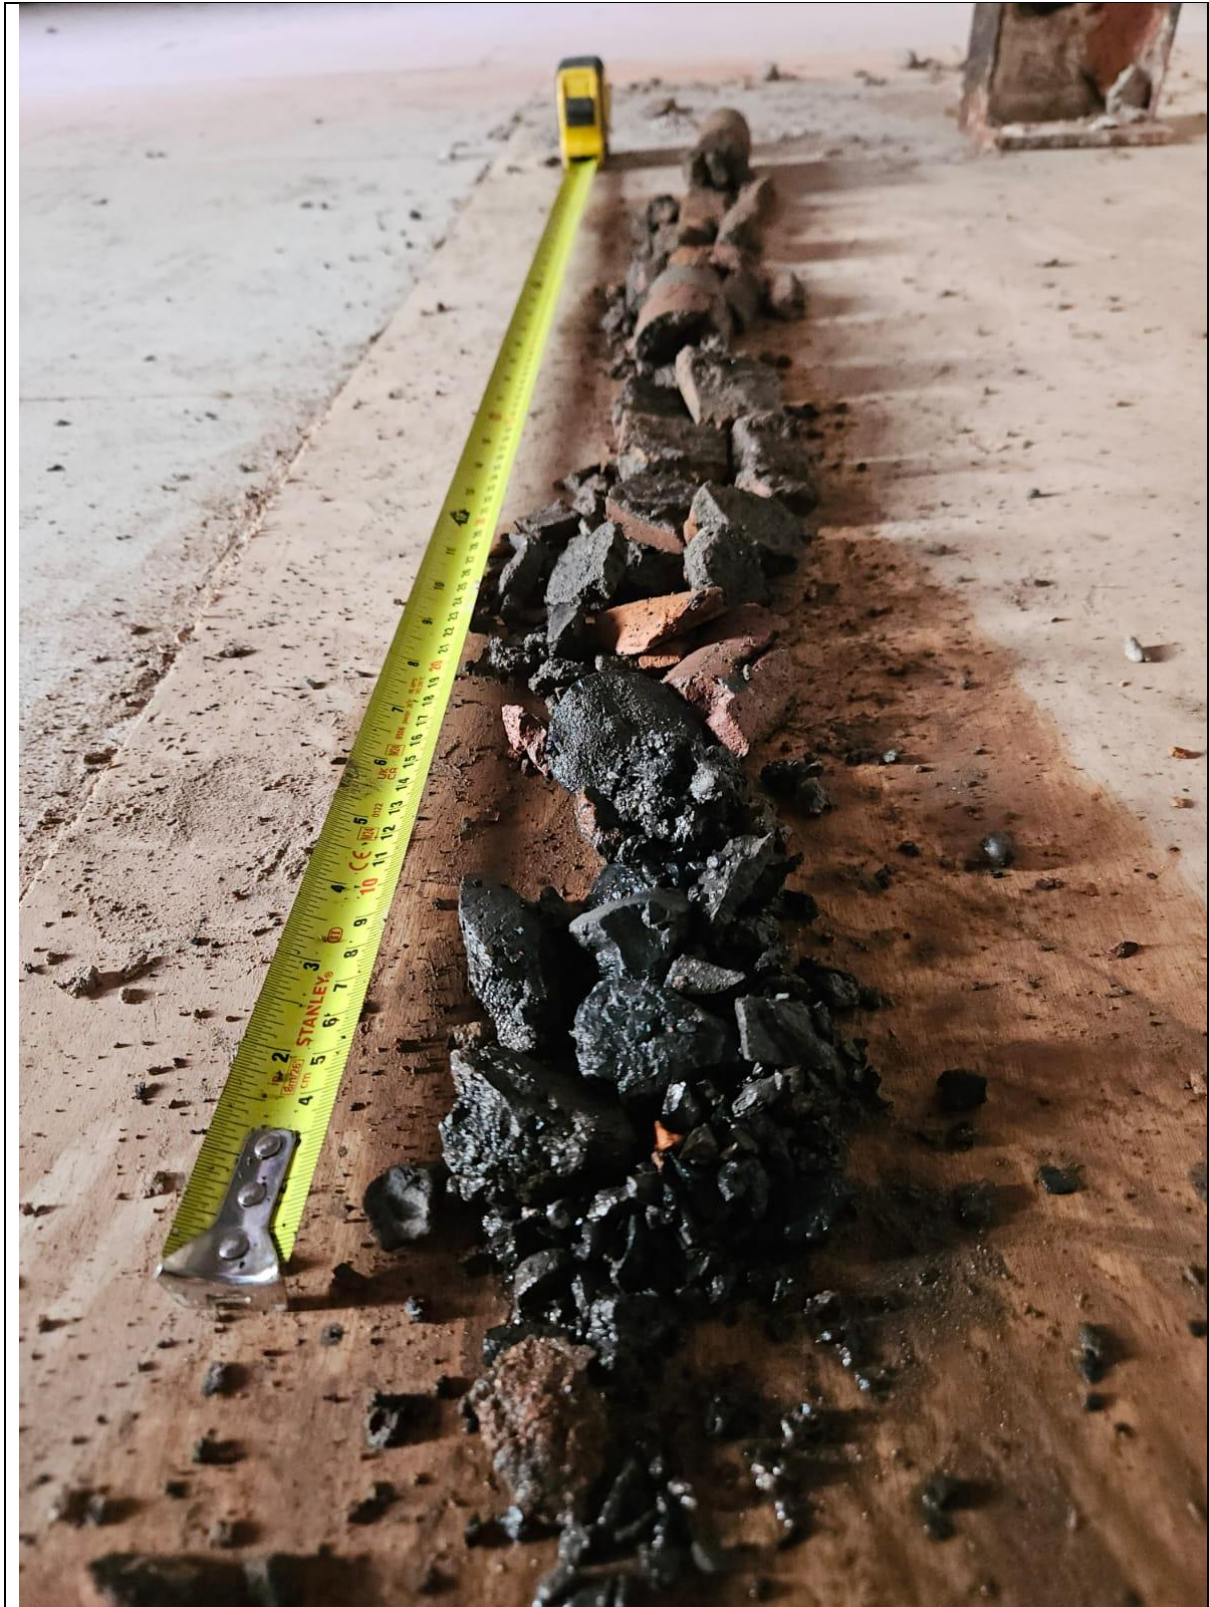
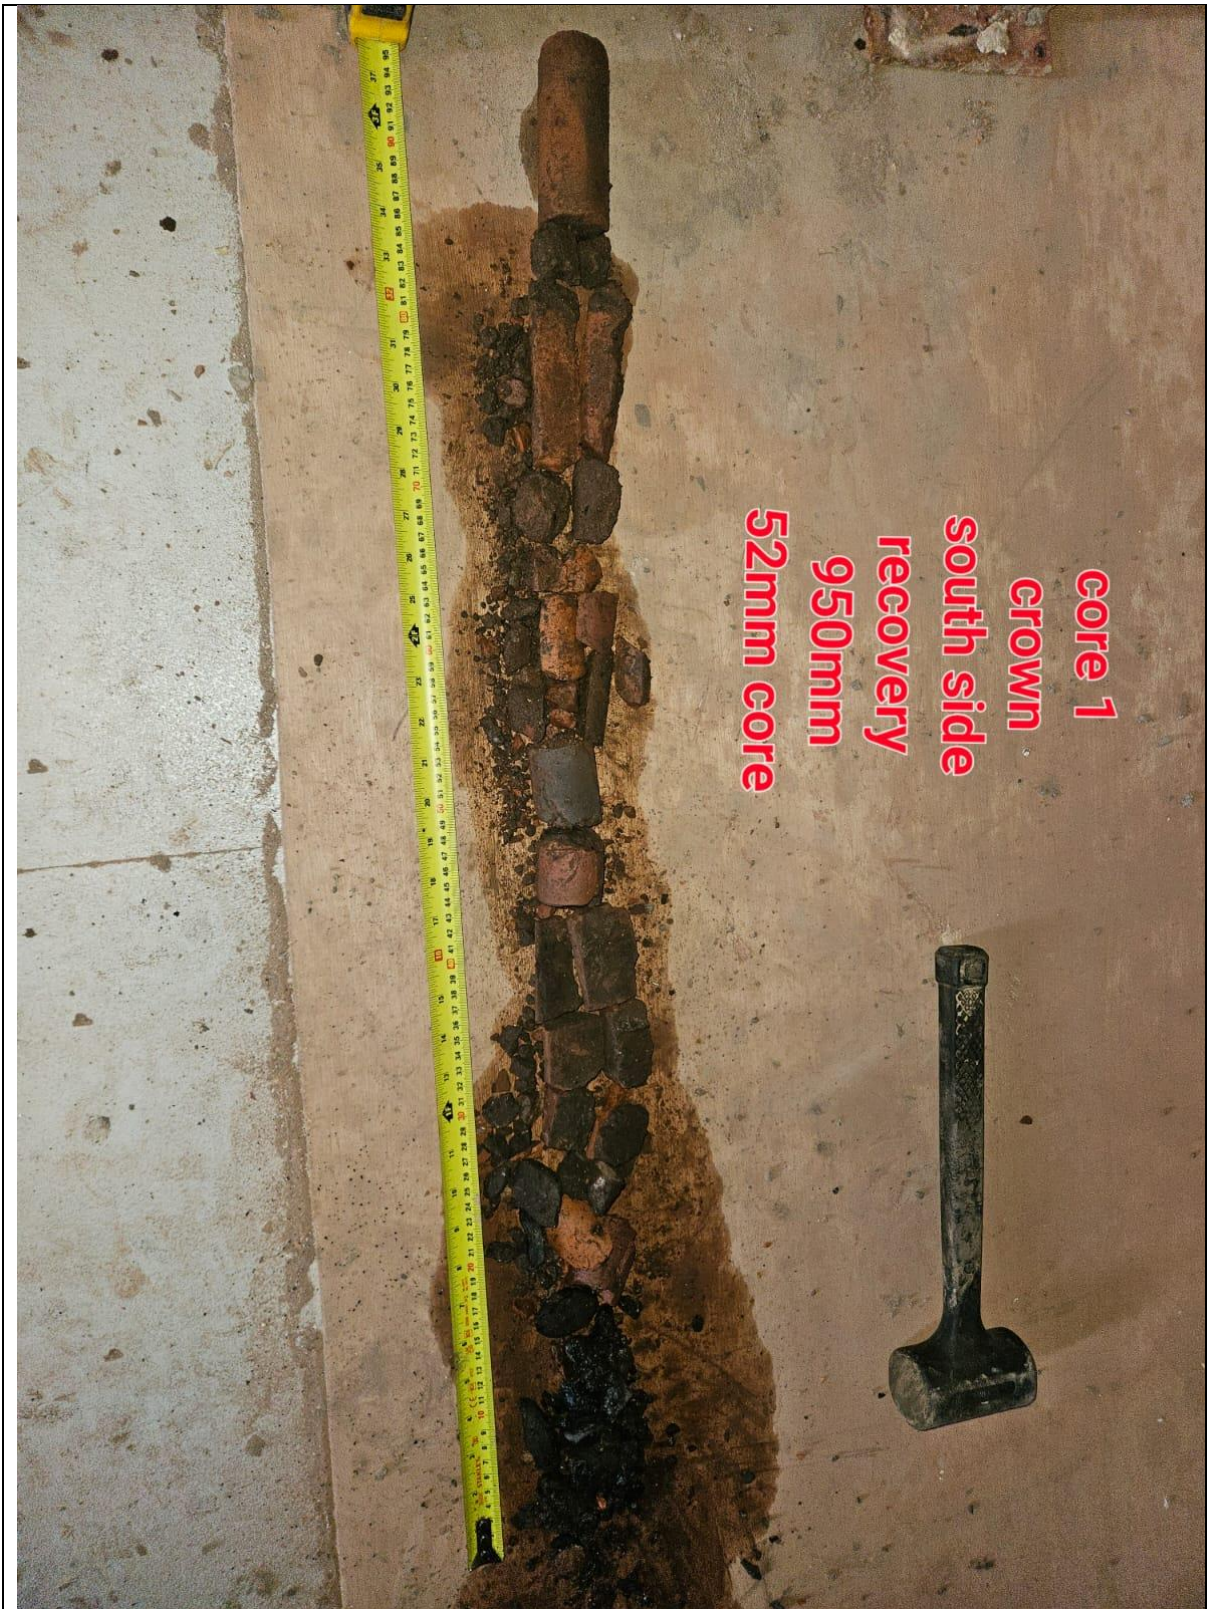
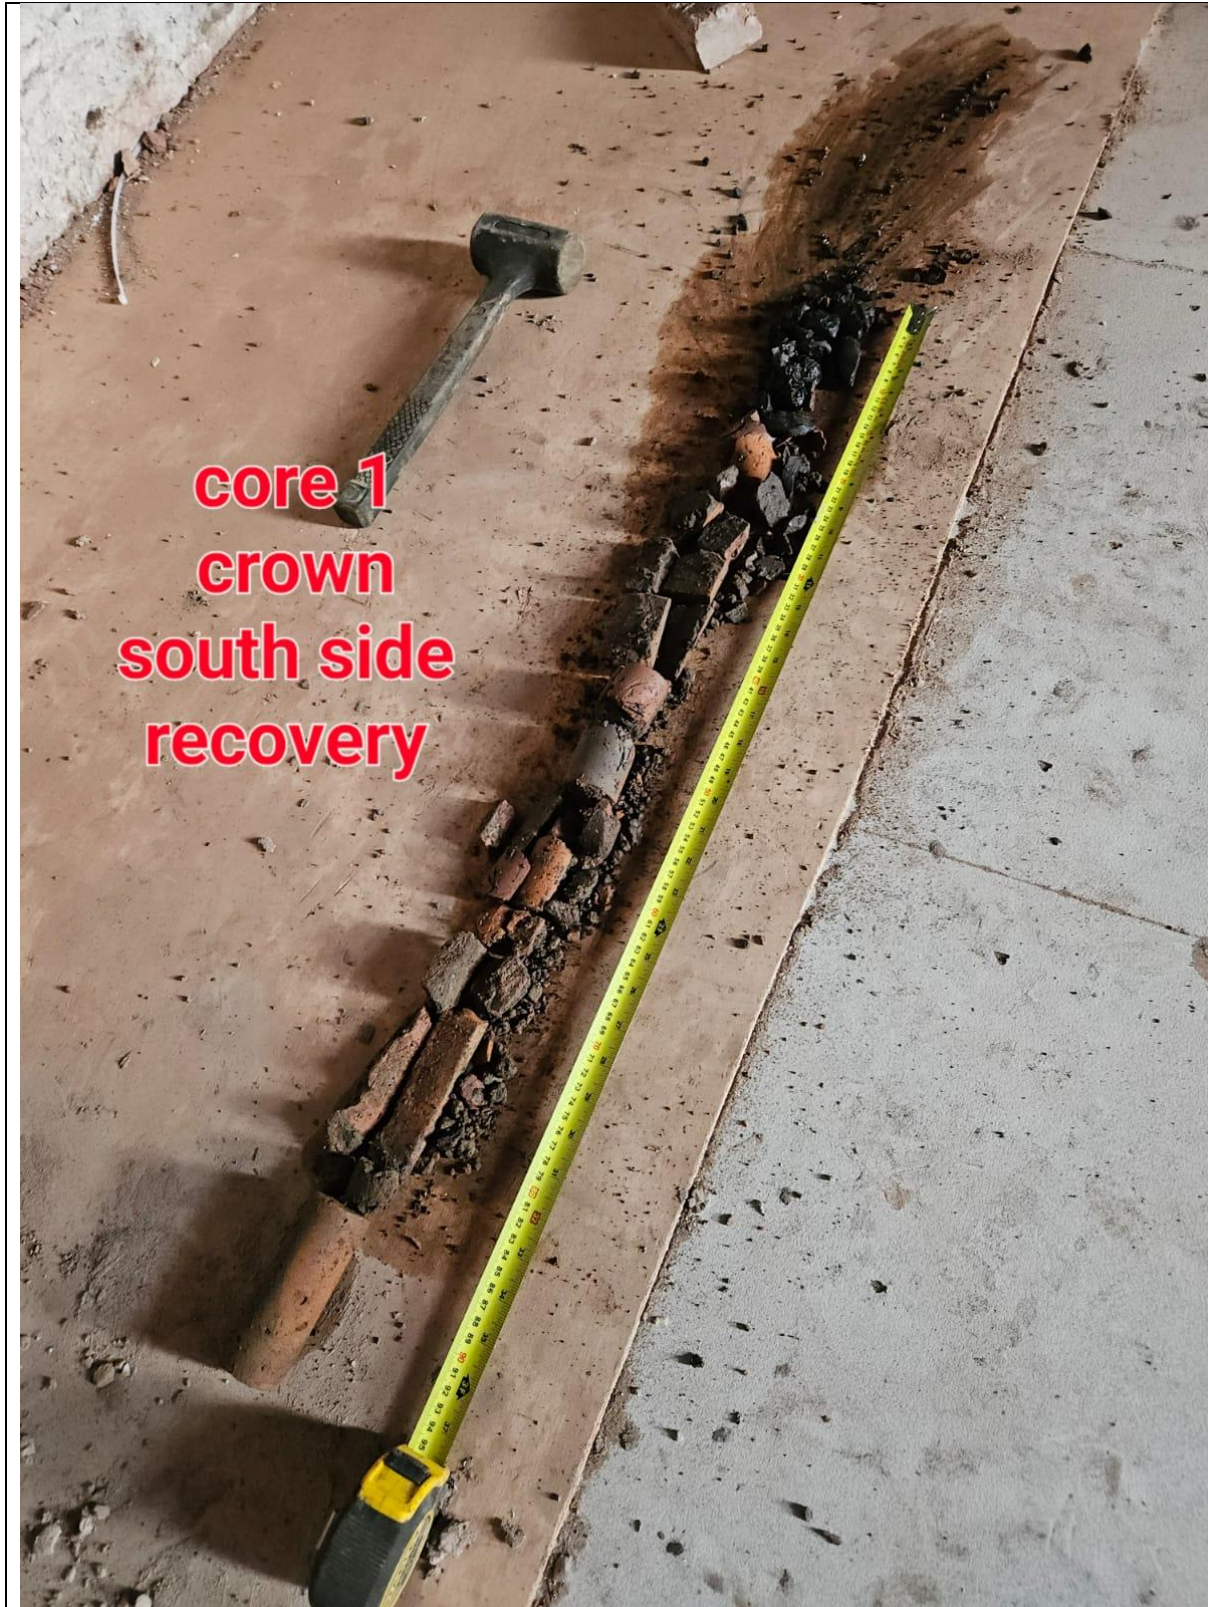
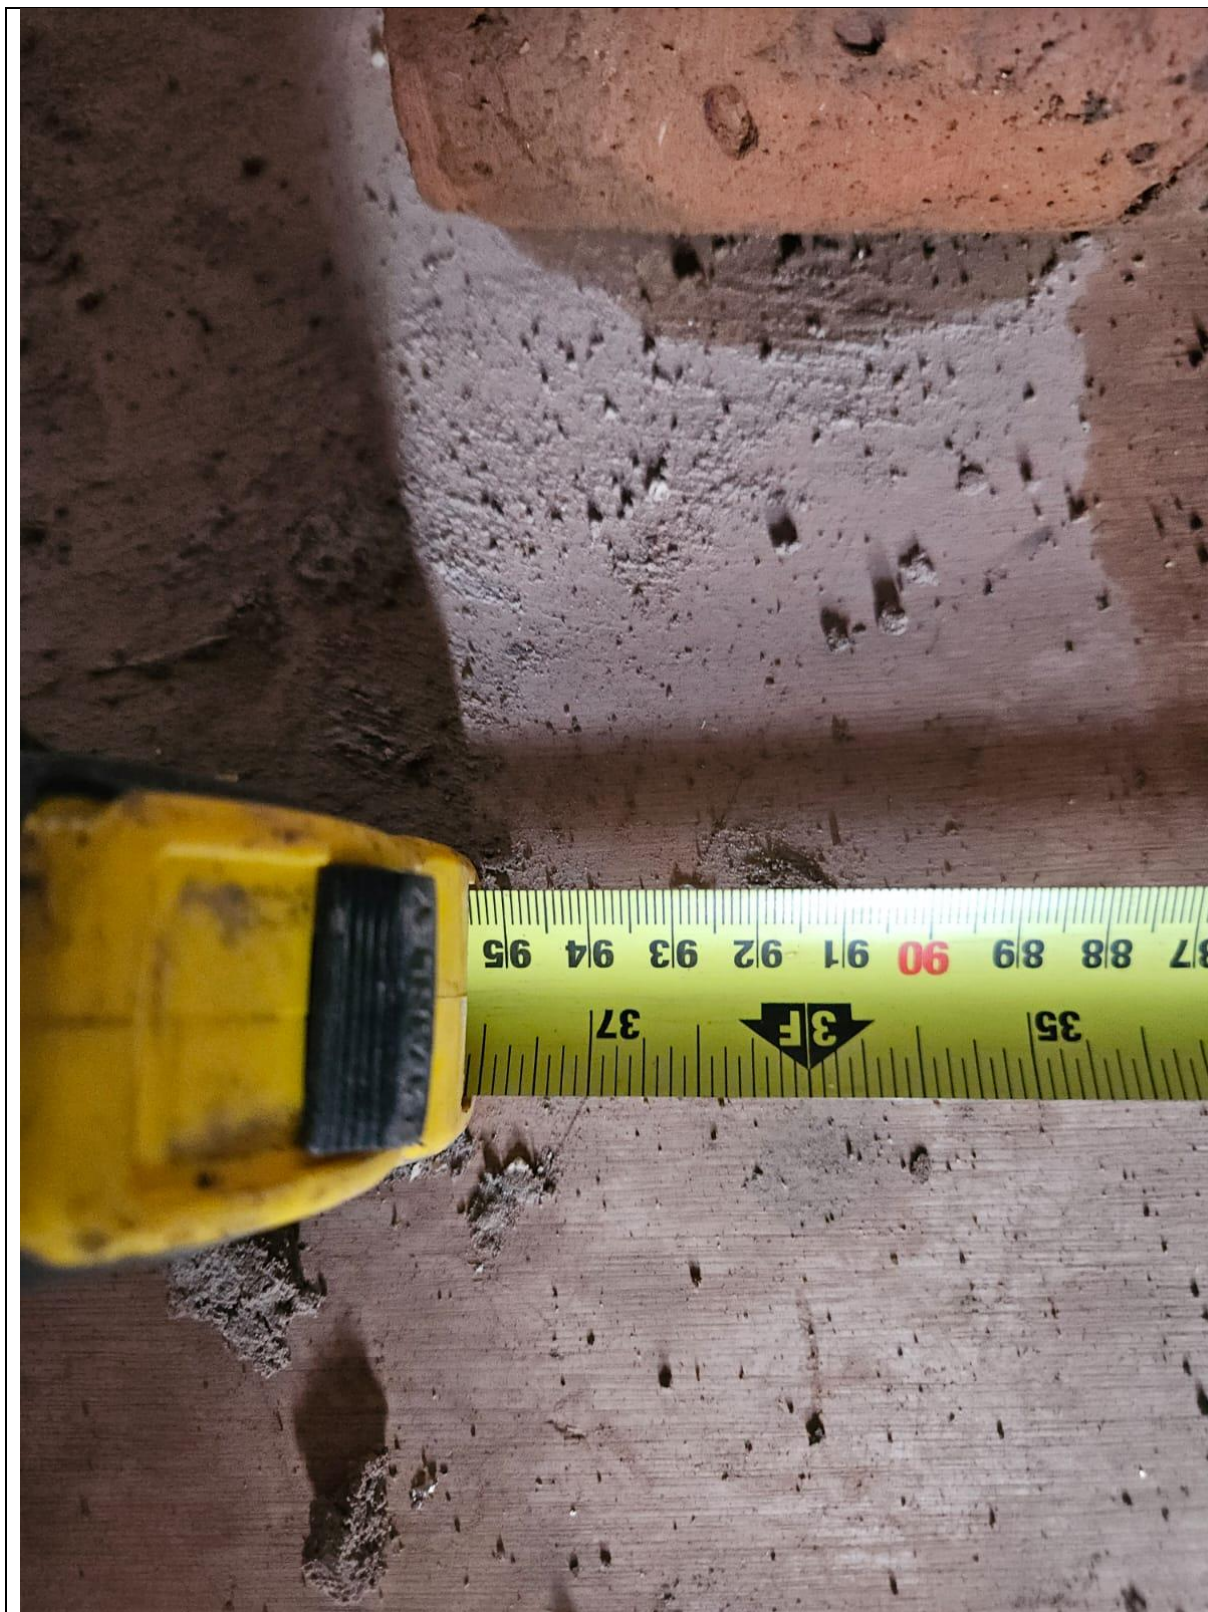
Core 1:

| Location: | Crown, South End |
| Material Description | 950mm Depth – Brickwork |
| Endoscope Results – No voids found: | |

**core 1**  
**crown**  
**south side**  
**recovery**  
**950mm**  
**52mm core**
