# A53 INTRUSIVE INVESTIGATION

Core samples & Endoscope survey

Project: Intrusive Investigation of Masonry Arch (A53)

Report Reference: REP01/2507E029

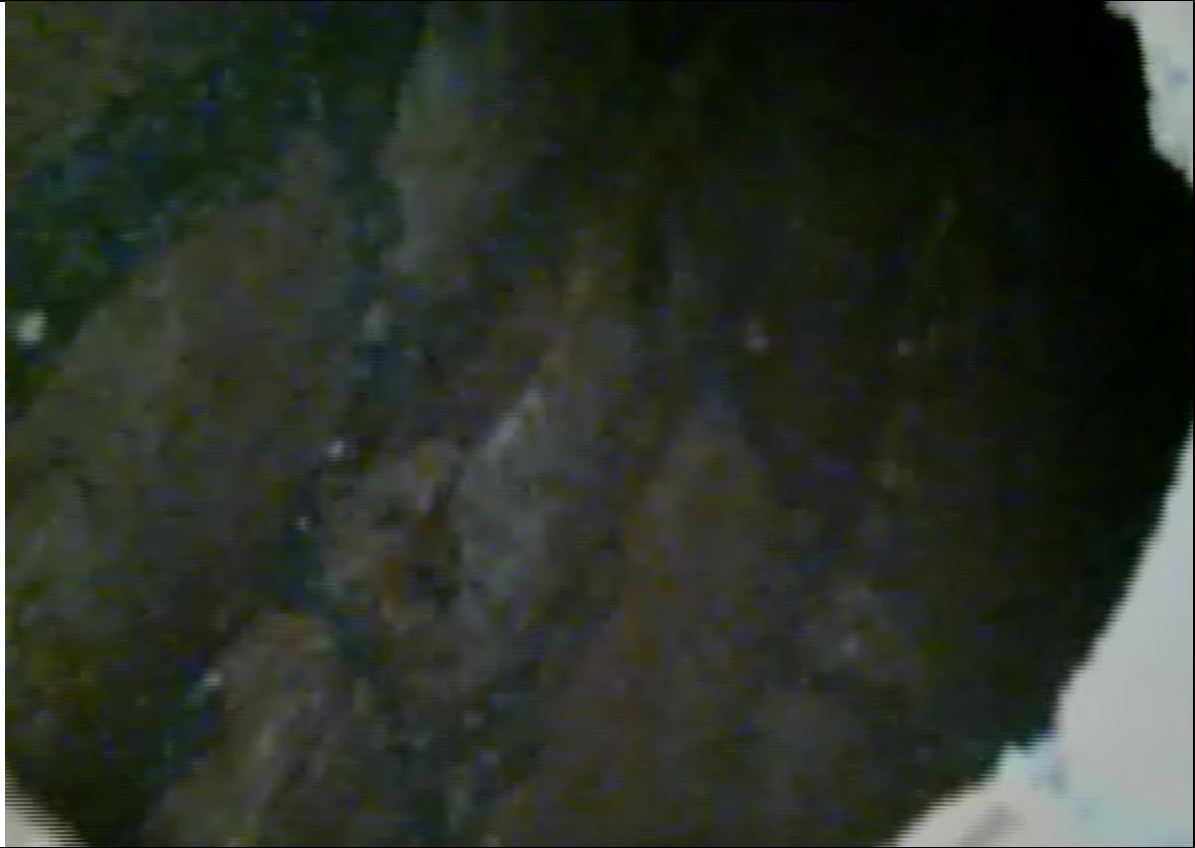
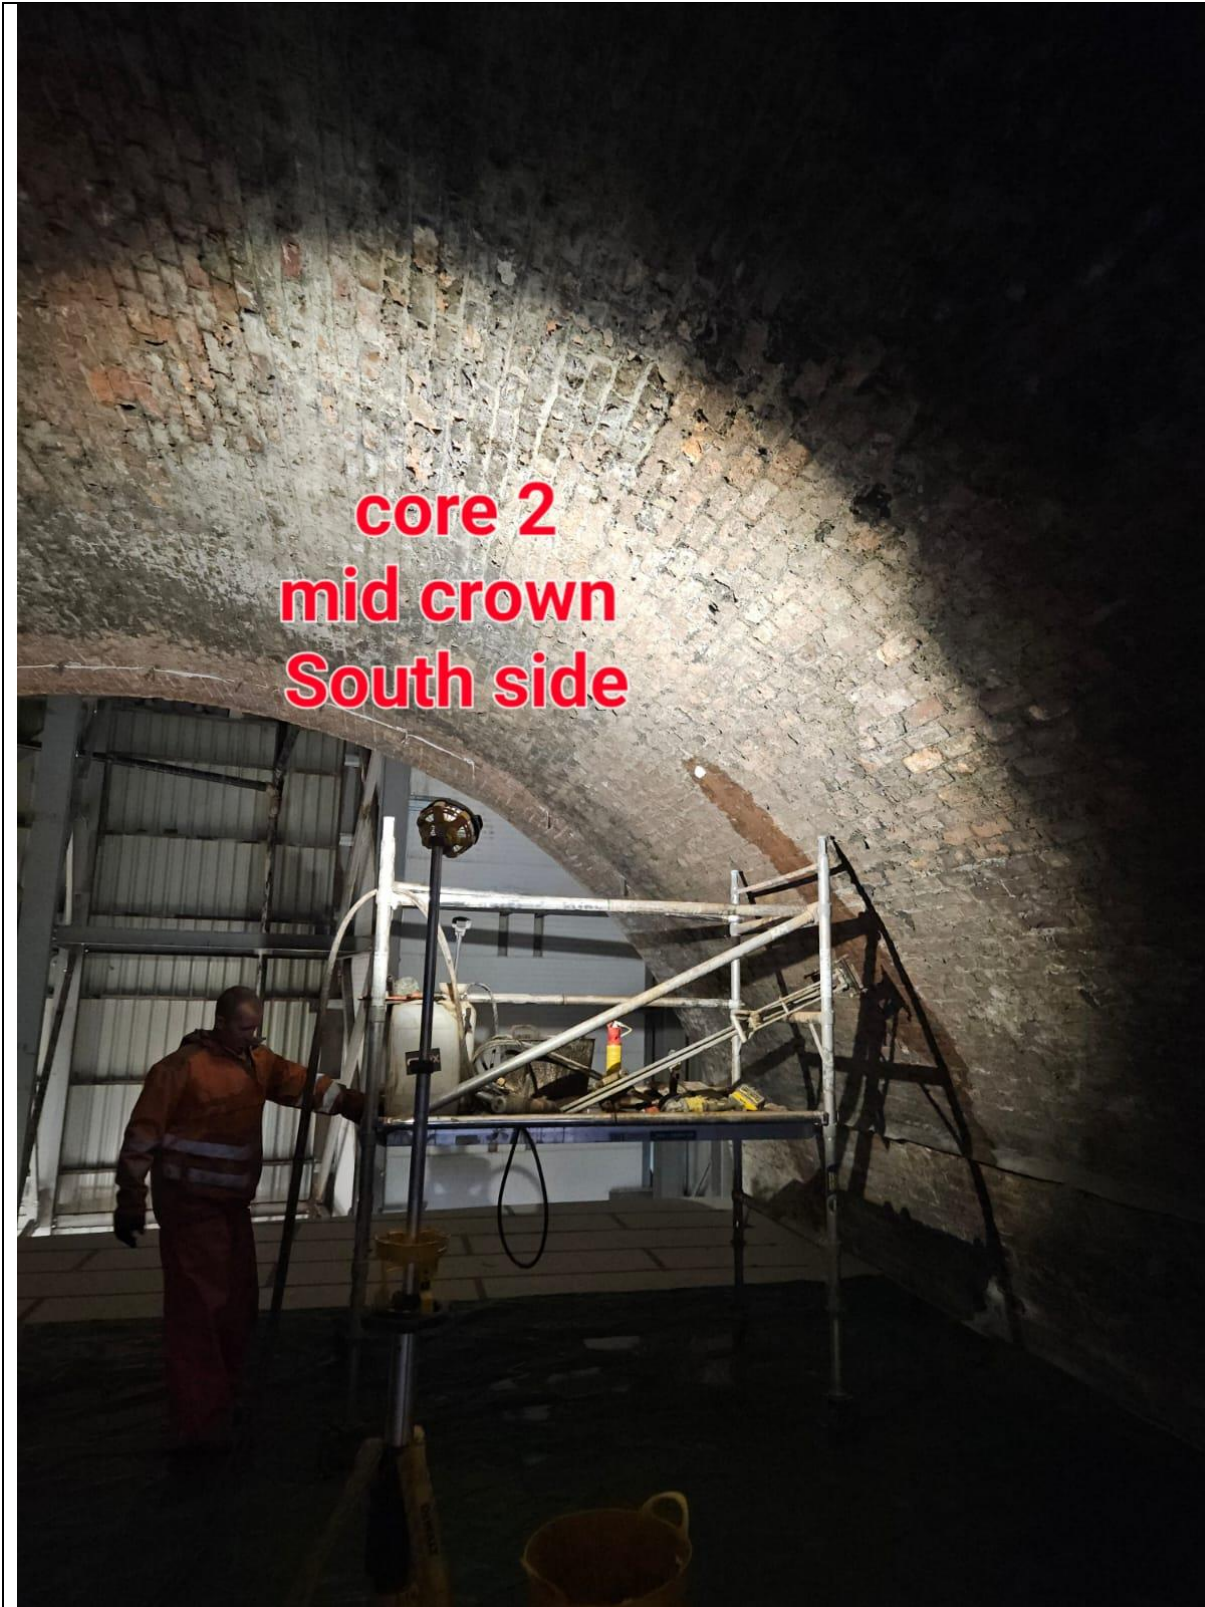
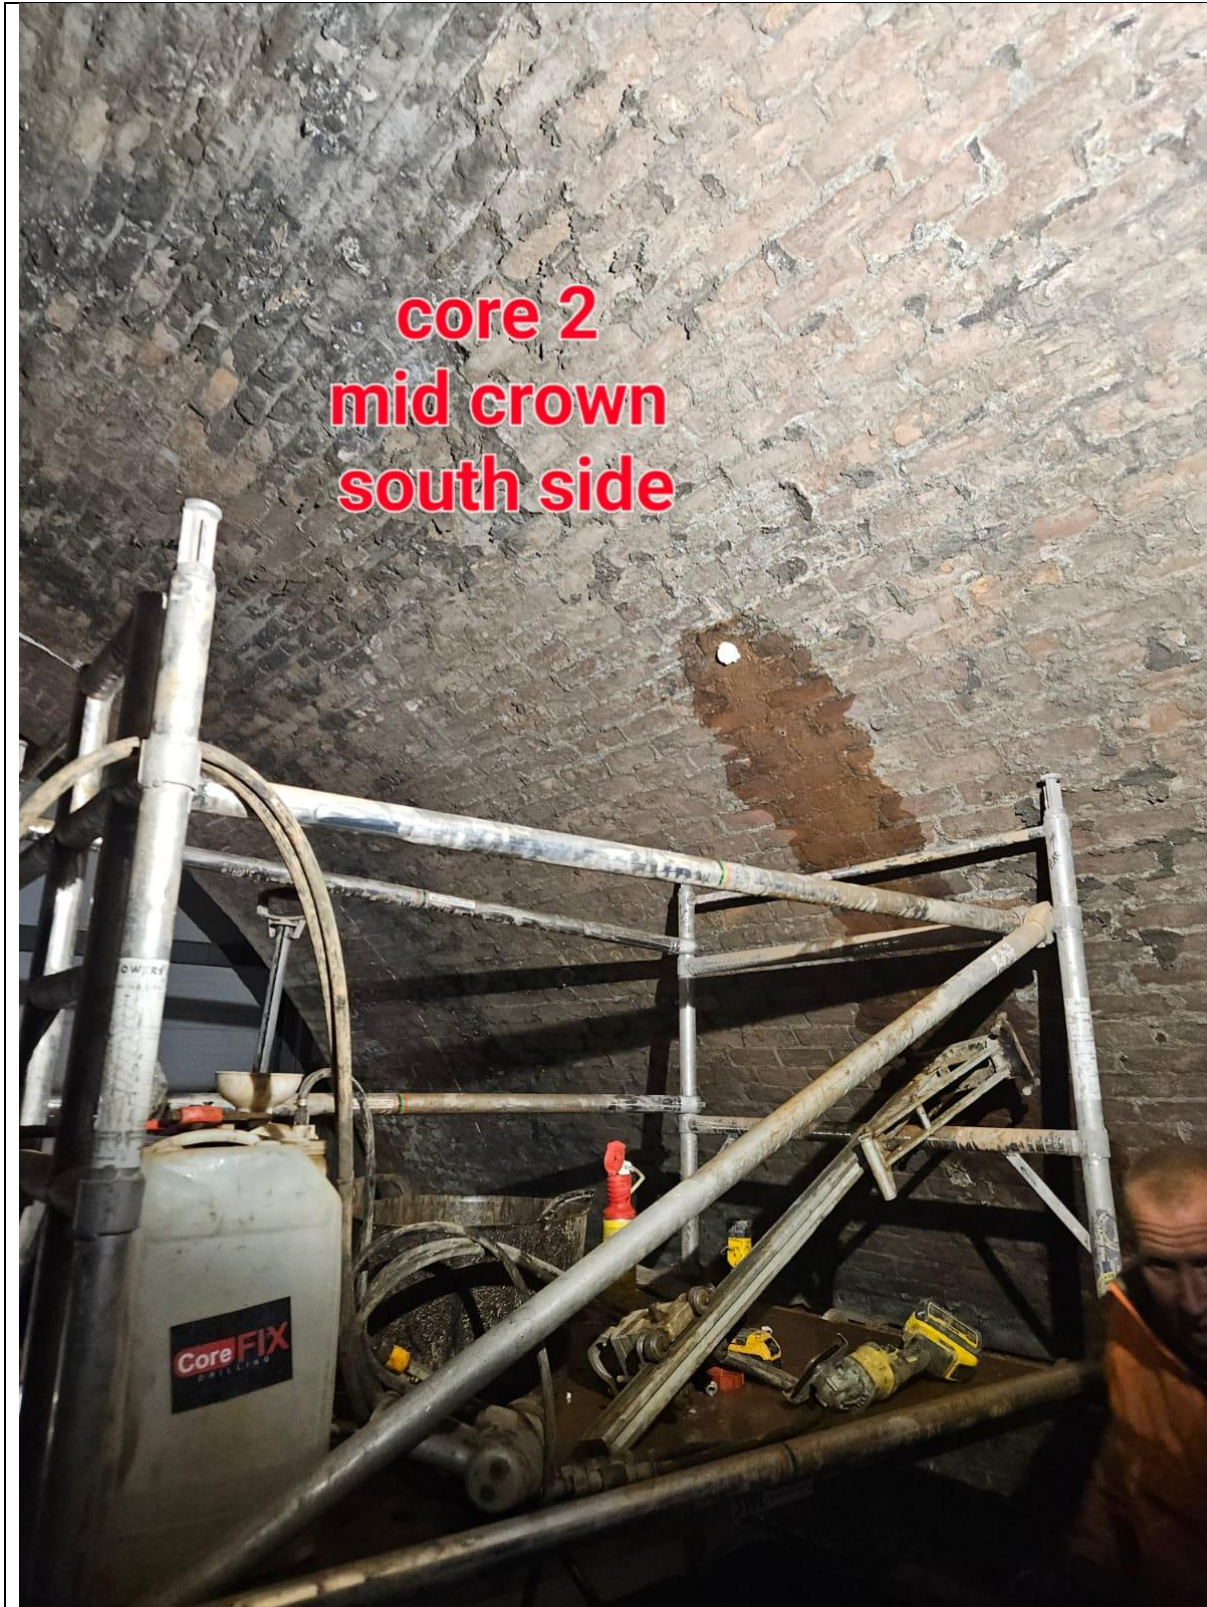
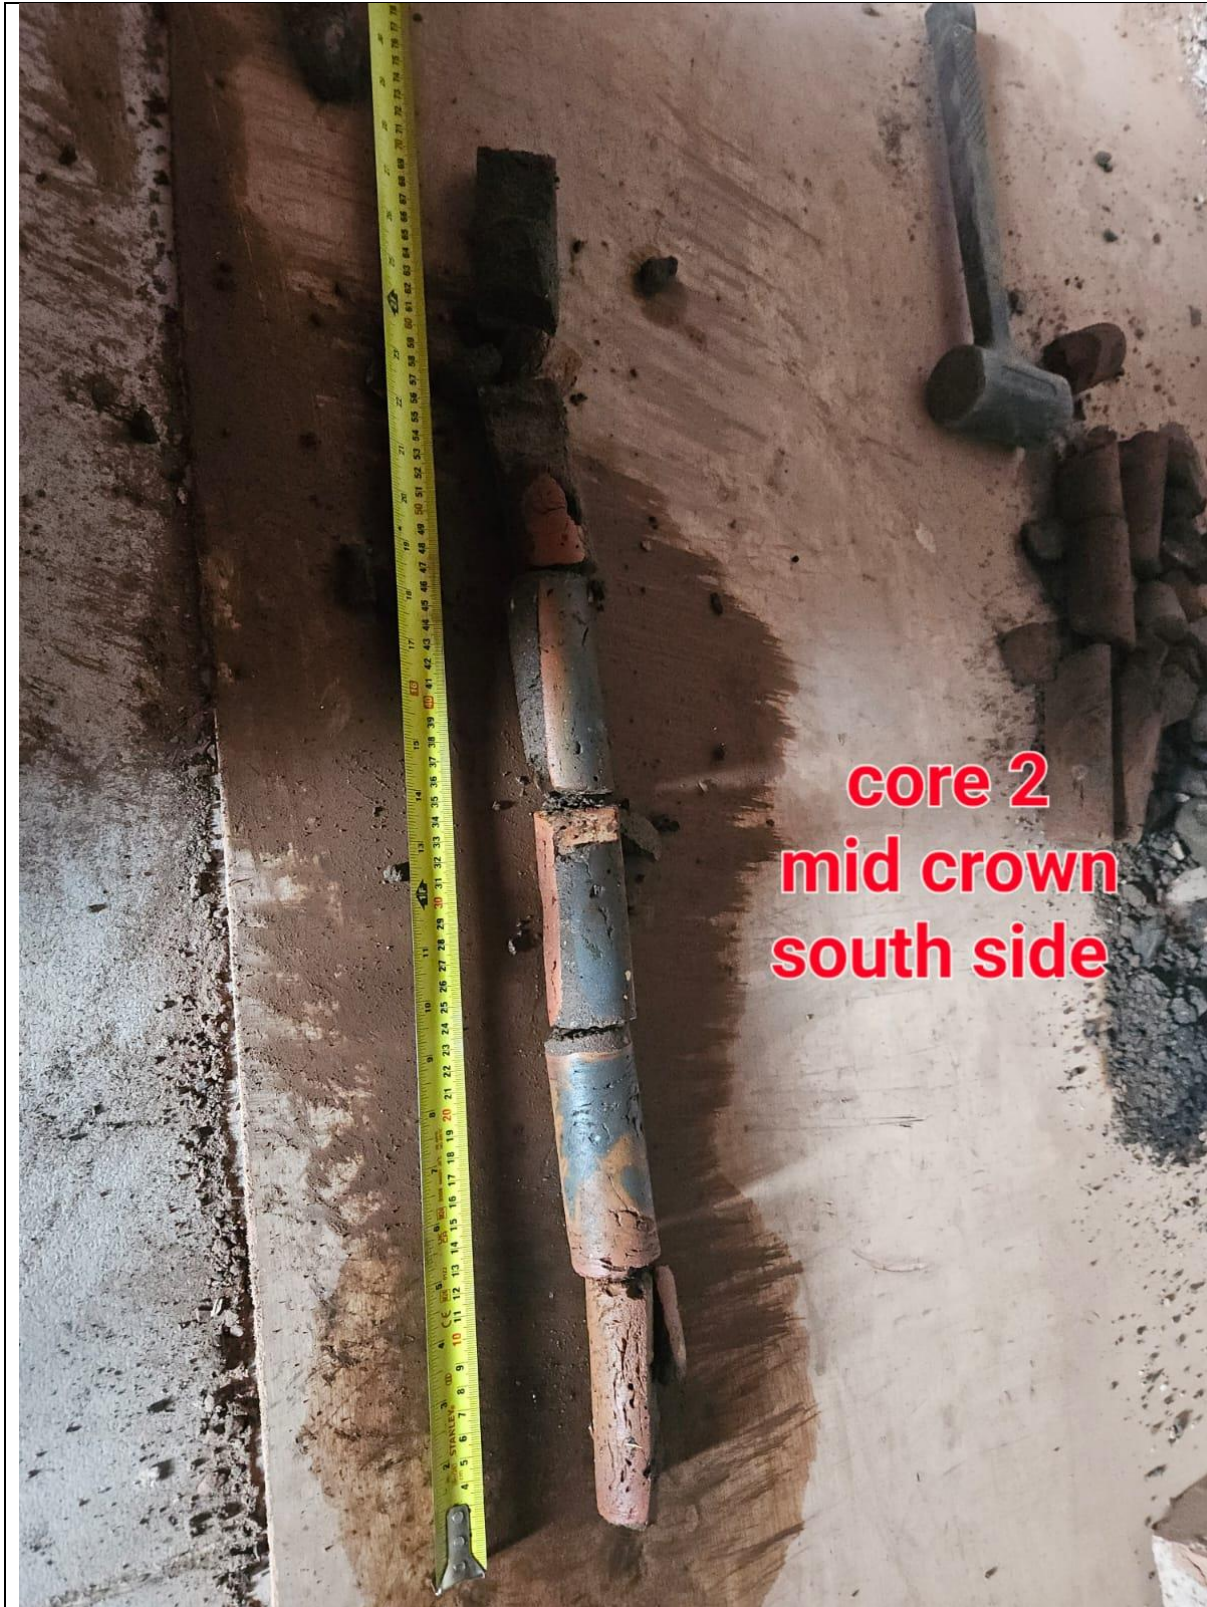
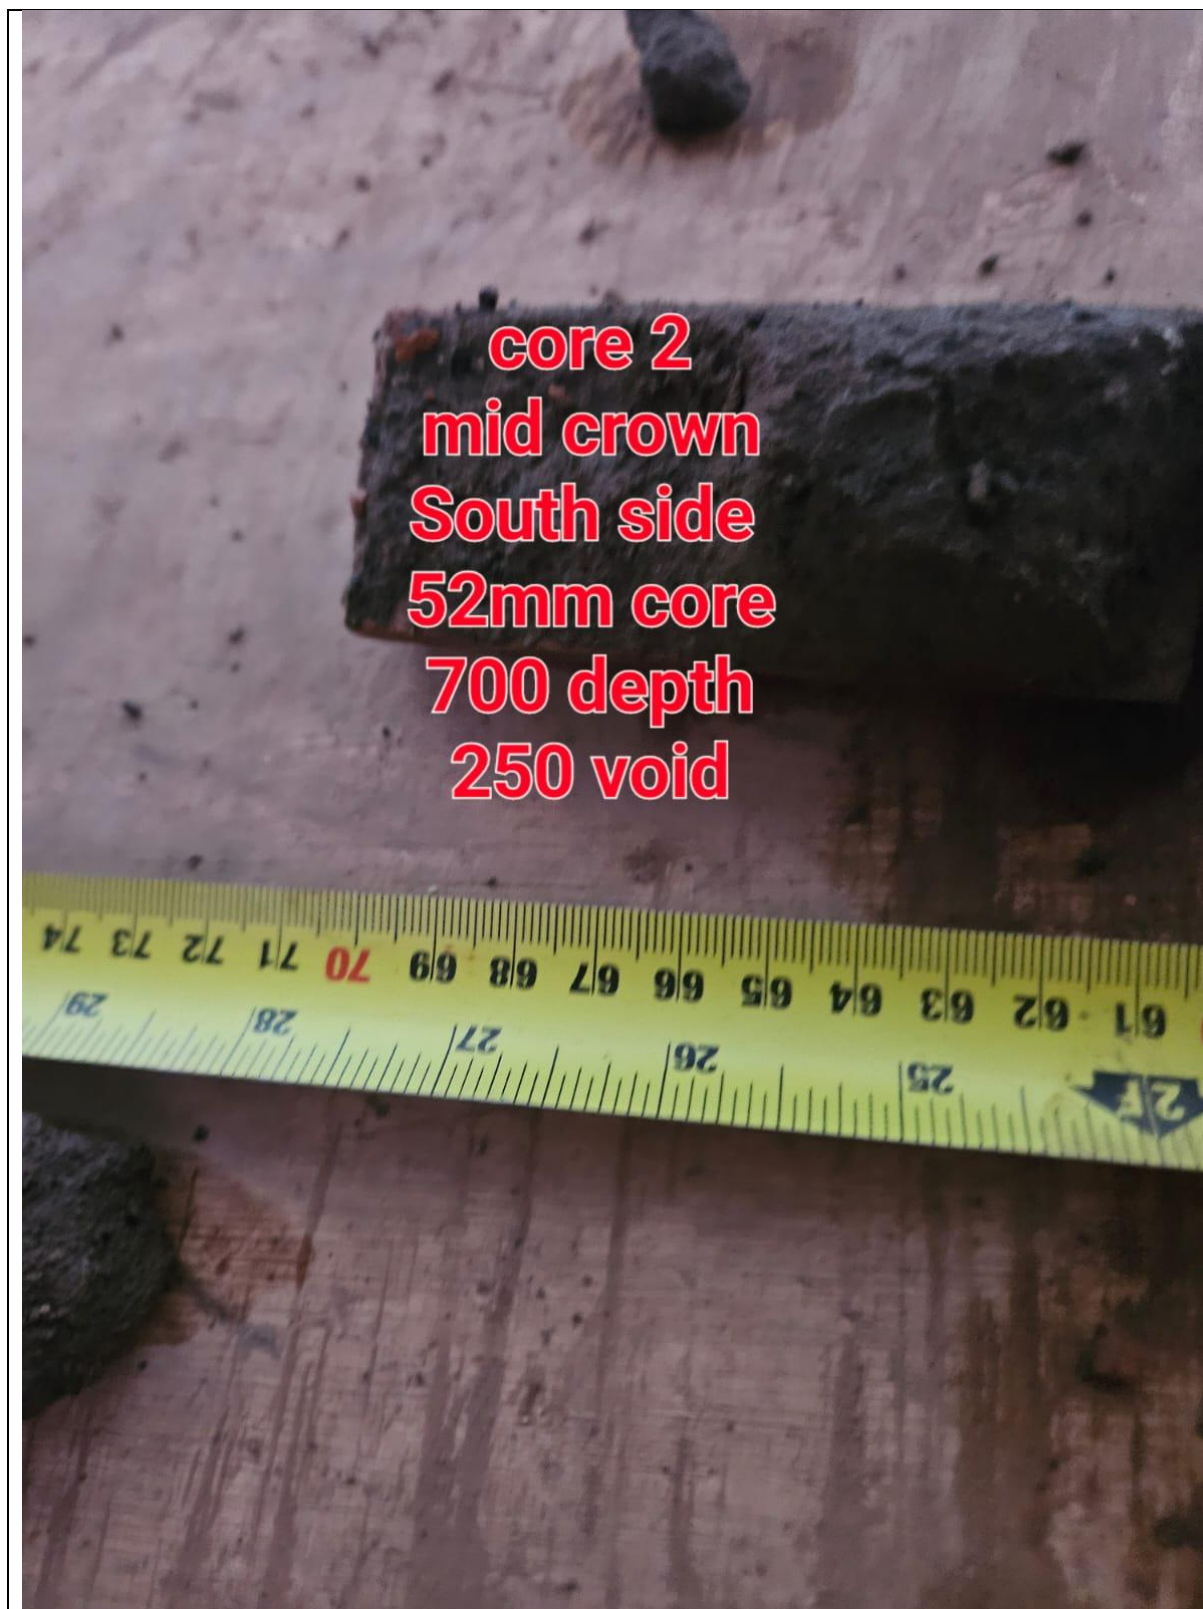
### Core 2:

| Location | Mid Crown – South End |
| Material Description | 700mm Brickwork, 250mm Void |
| Endoscope Results – Void Discovered | |

As shown only 1 location (Mid Crown - Right hand side facing south end of the tunnel) showed presence of voids behind the arch, the rest of the cores provided full brickwork

retrieval as shown above. The depth of brickwork cored ranged between 850-950mm. While no voids were present in the rest of the cores, to gain further knowledge of the extent of the voids a localised survey around the area where a void was present would give more insight into its extents if deemed necessary.

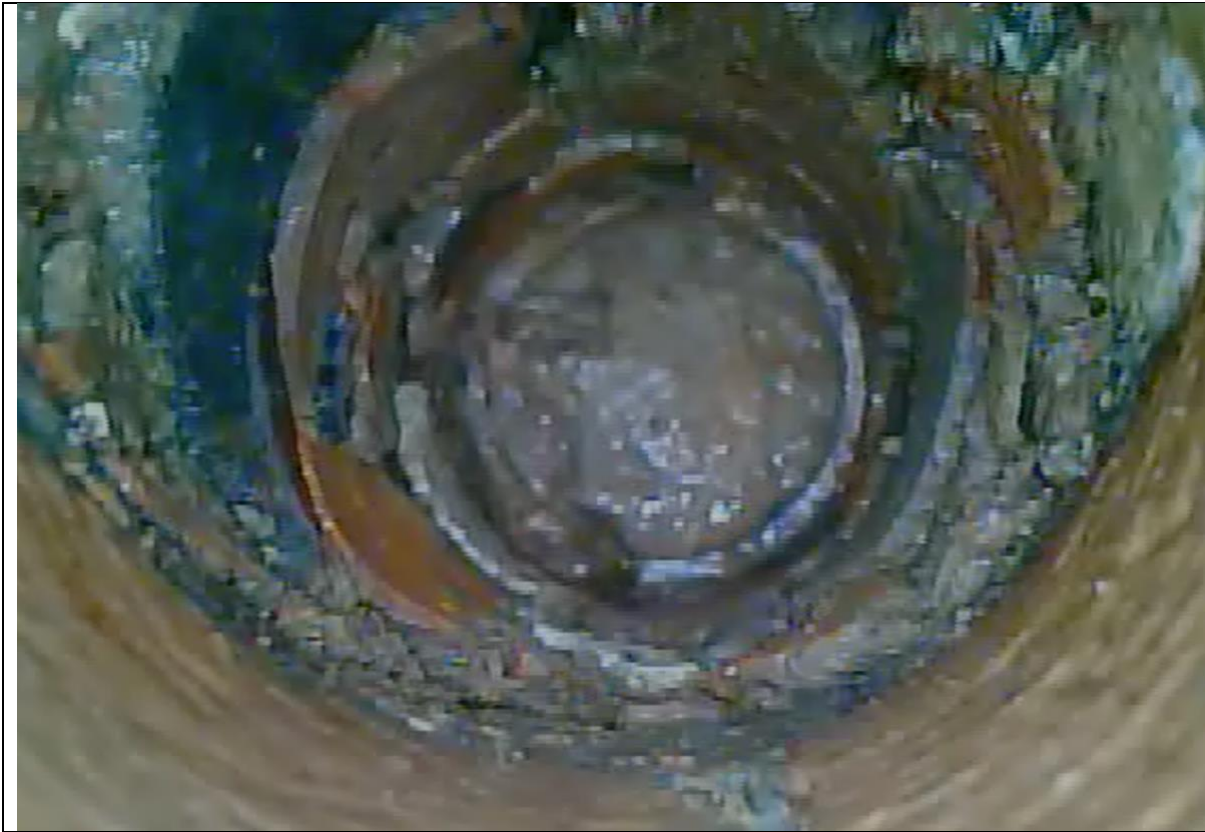
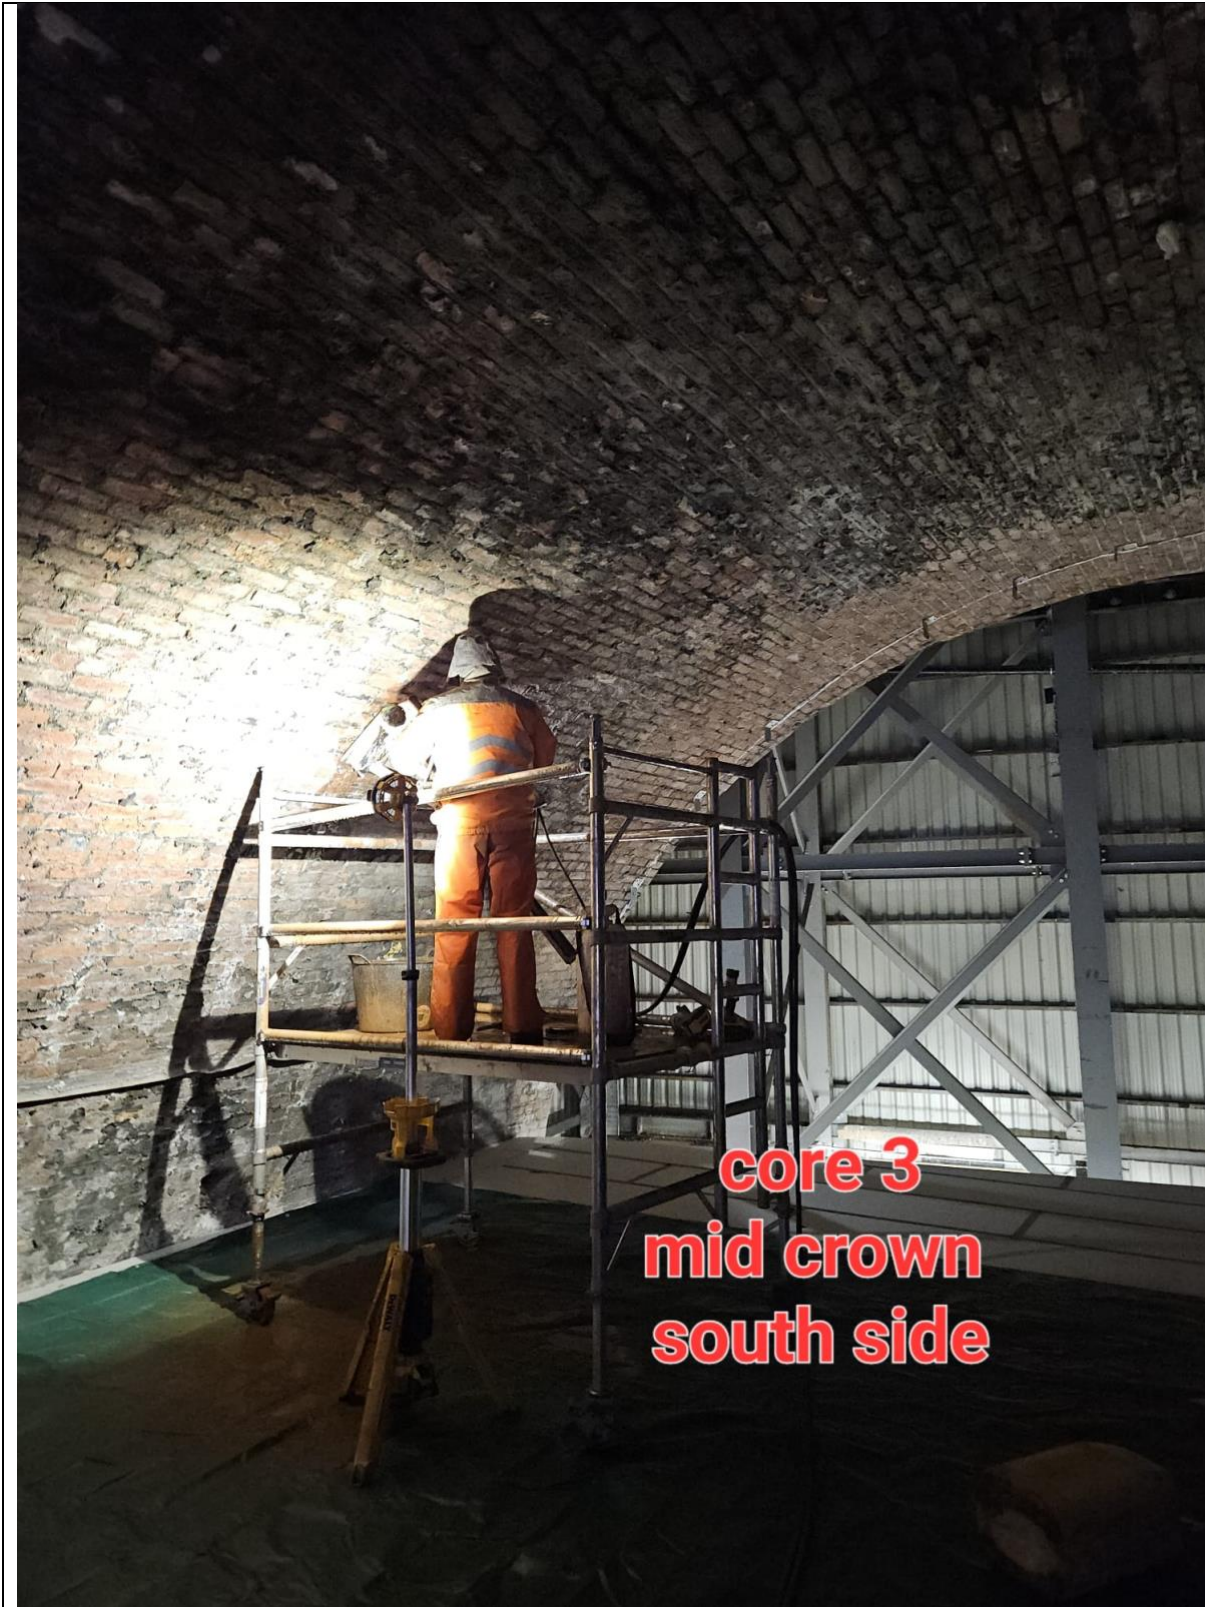
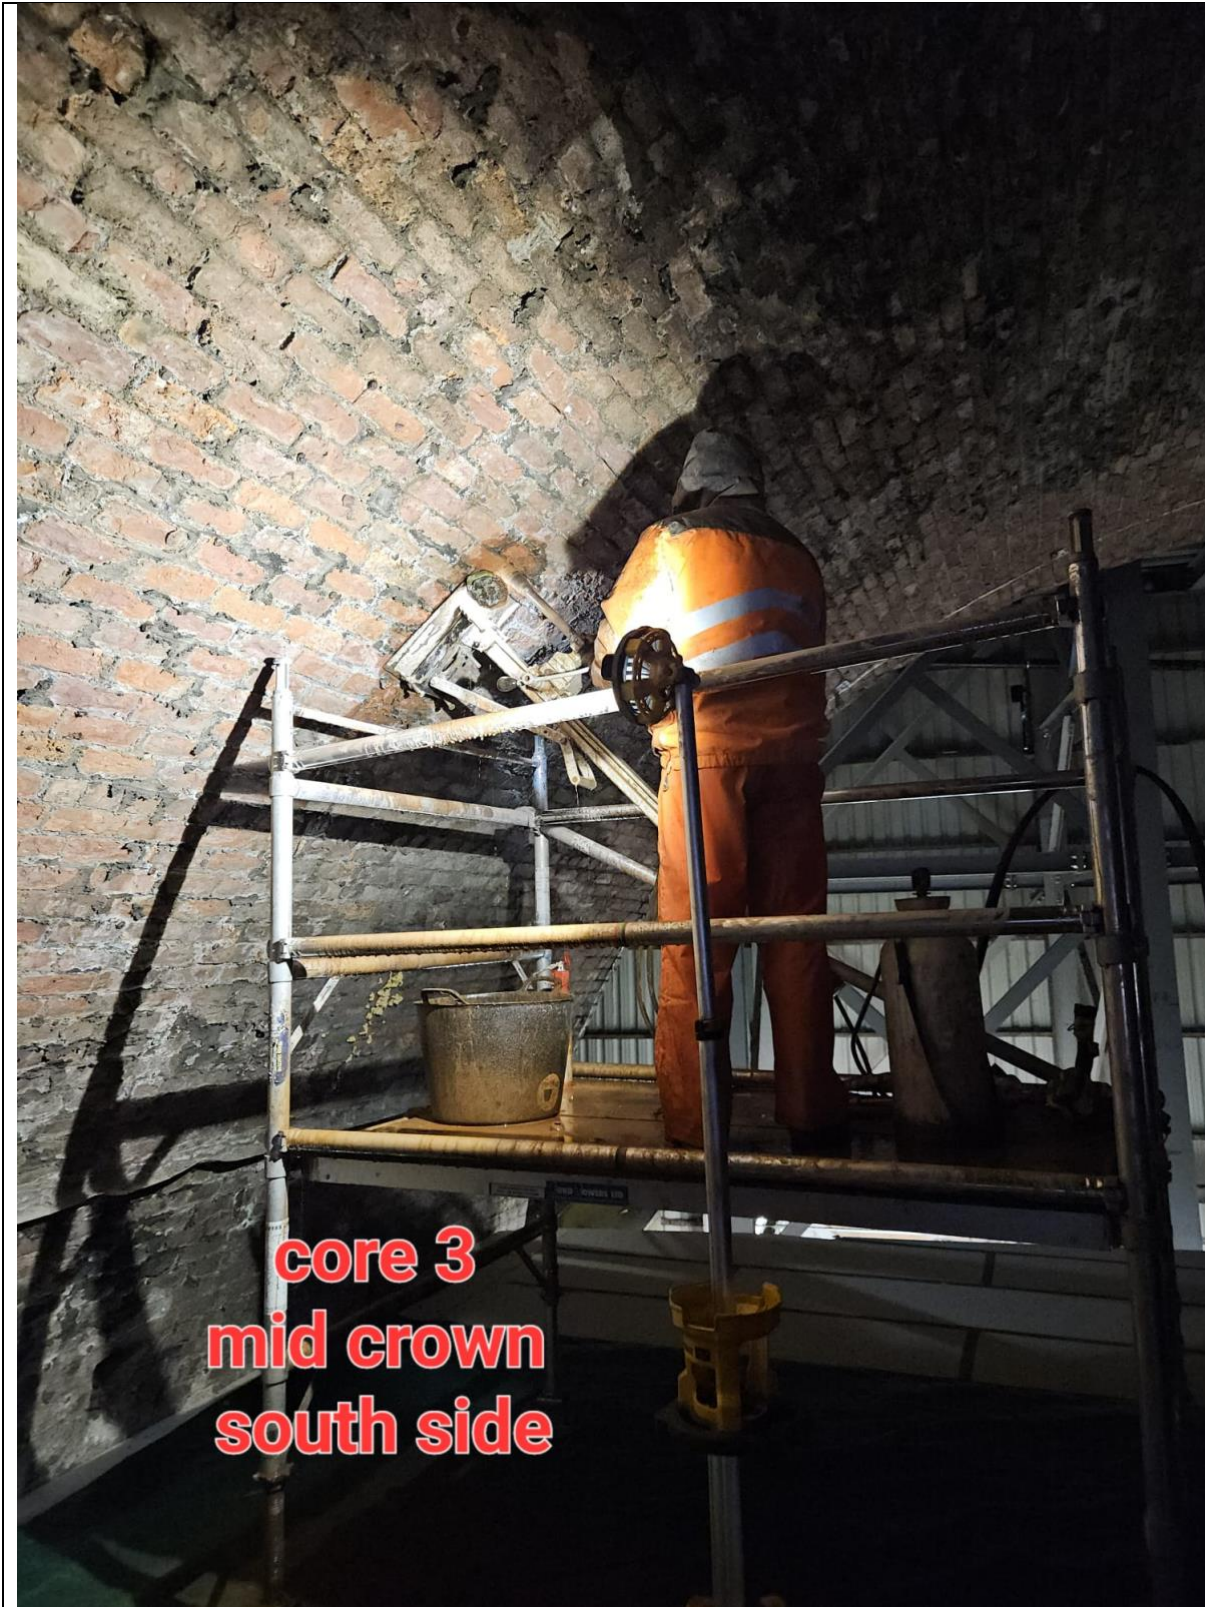
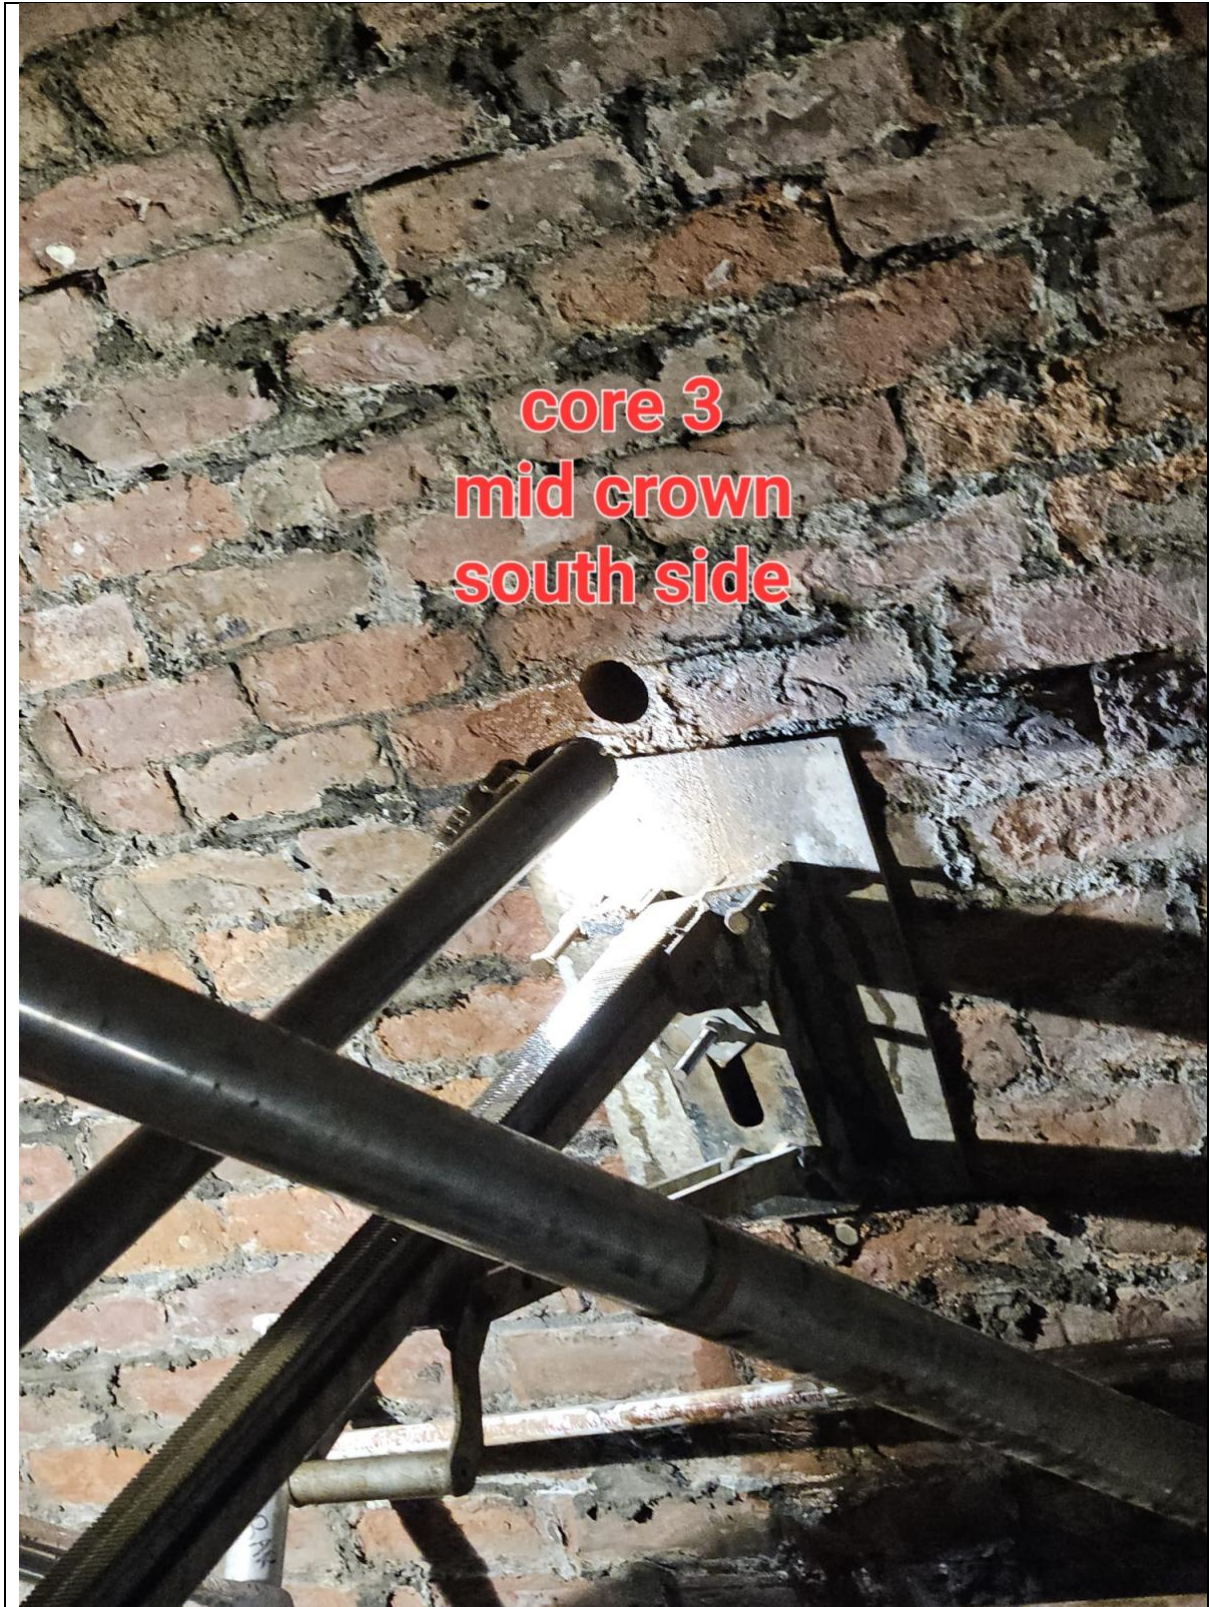
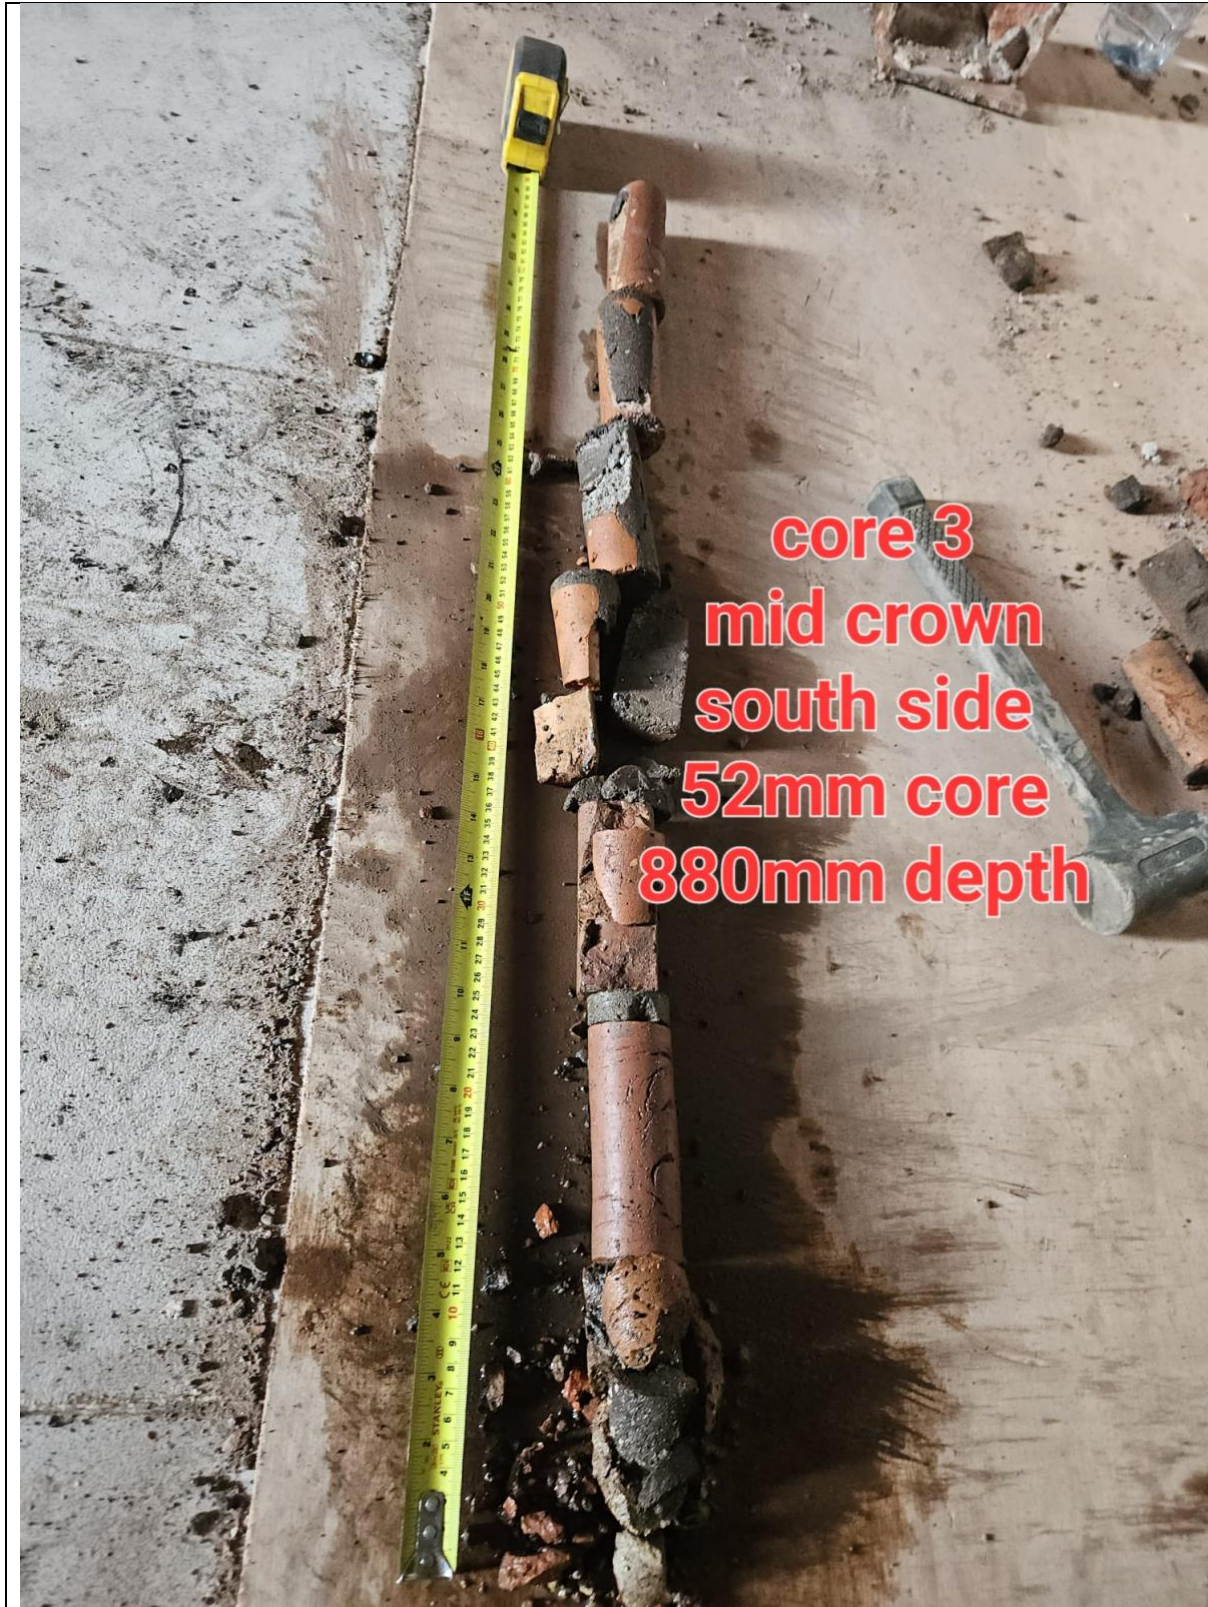
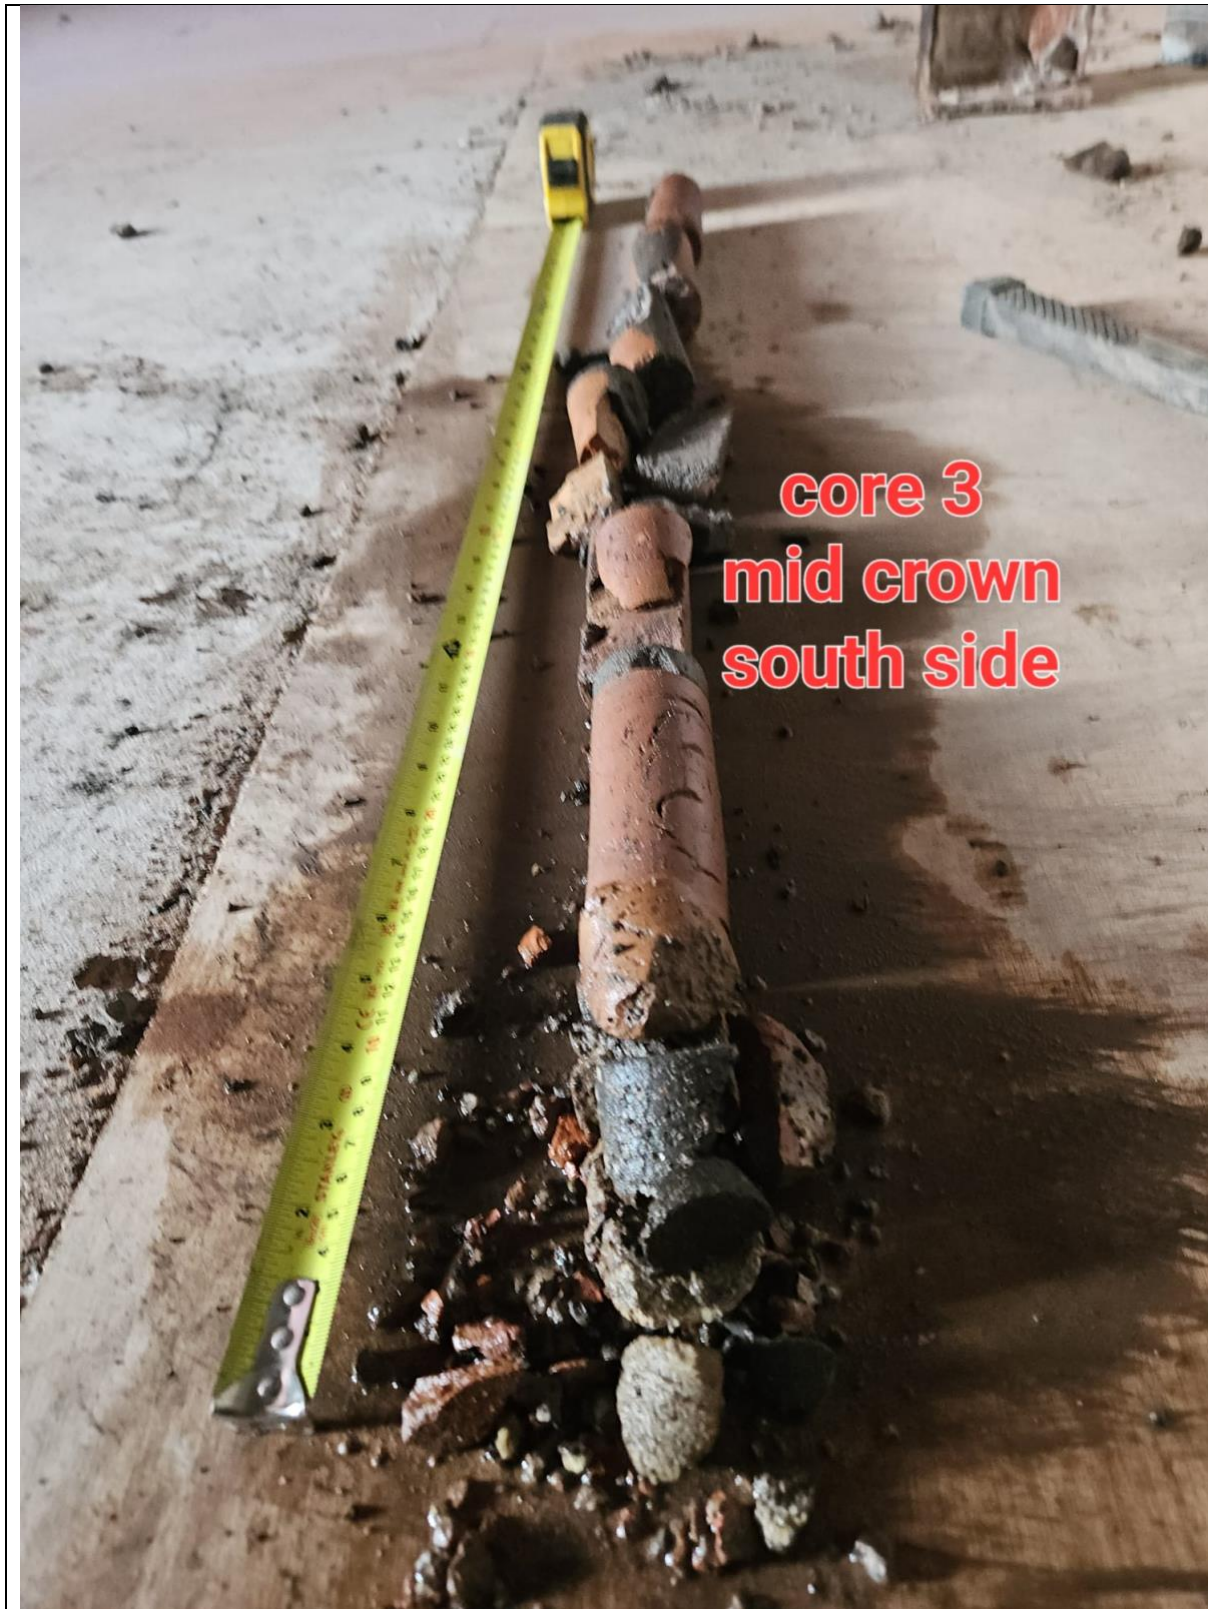
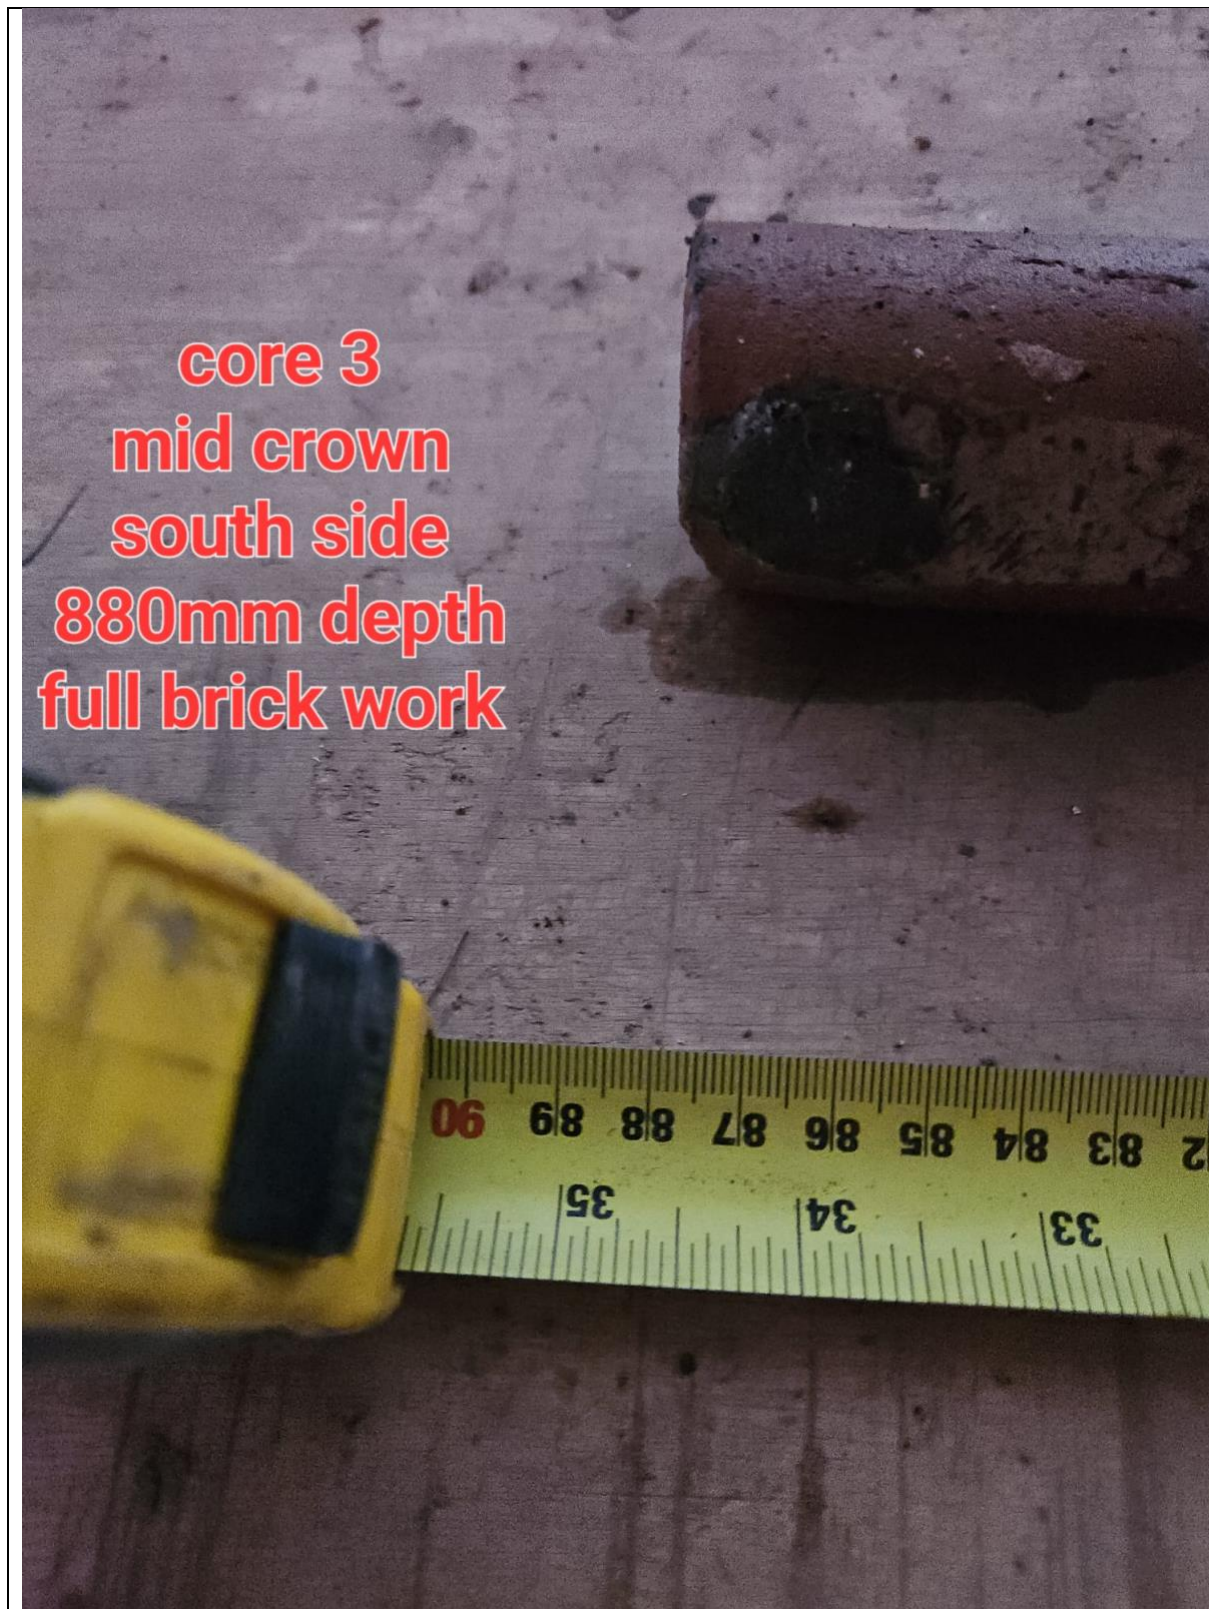
### Core 3

| Location | Mid Crown – South End |
| Material | 880mm Brickwork |
| Endoscope Results – No Voids Discovered | |

**core 3  
mid crown  
south side**
