# A53 INTRUSIVE INVESTIGATION

Core samples & Endoscope survey

Project: Intrusive Investigation of Masonry Arch (A53)

Report Reference: REP01/2507E029

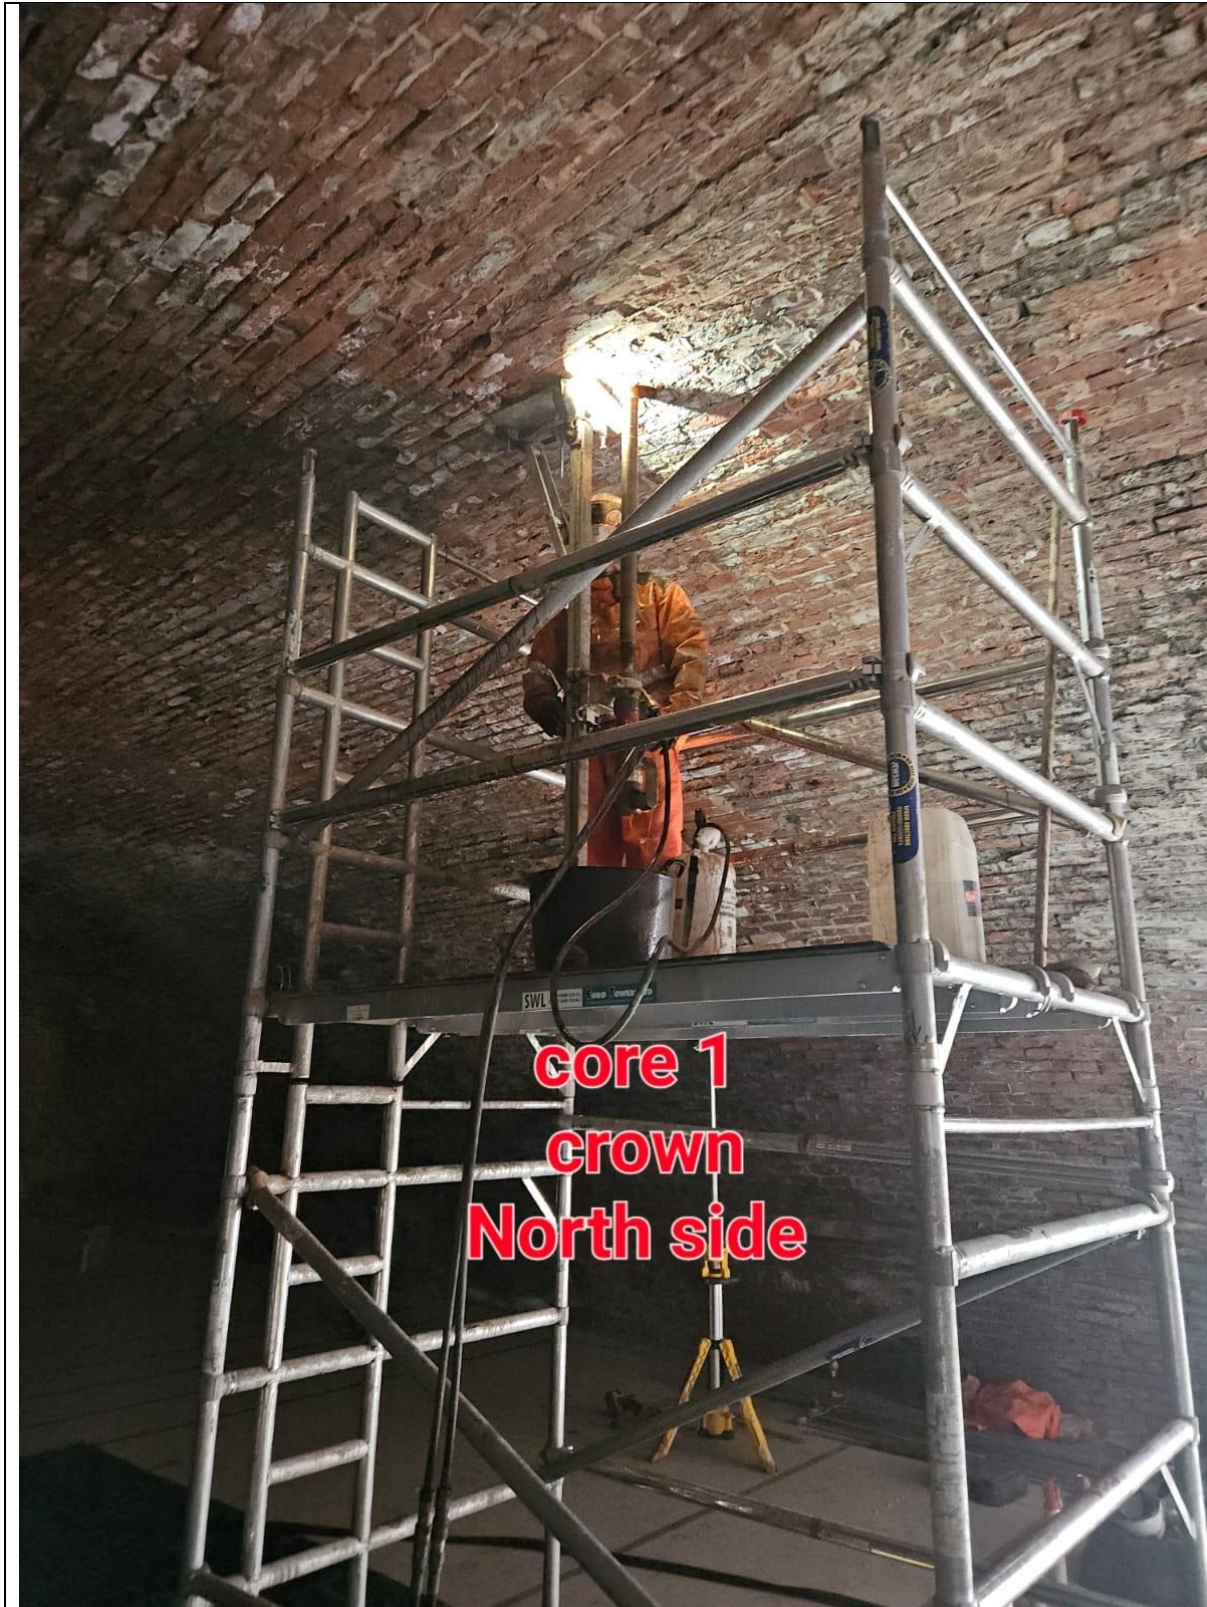
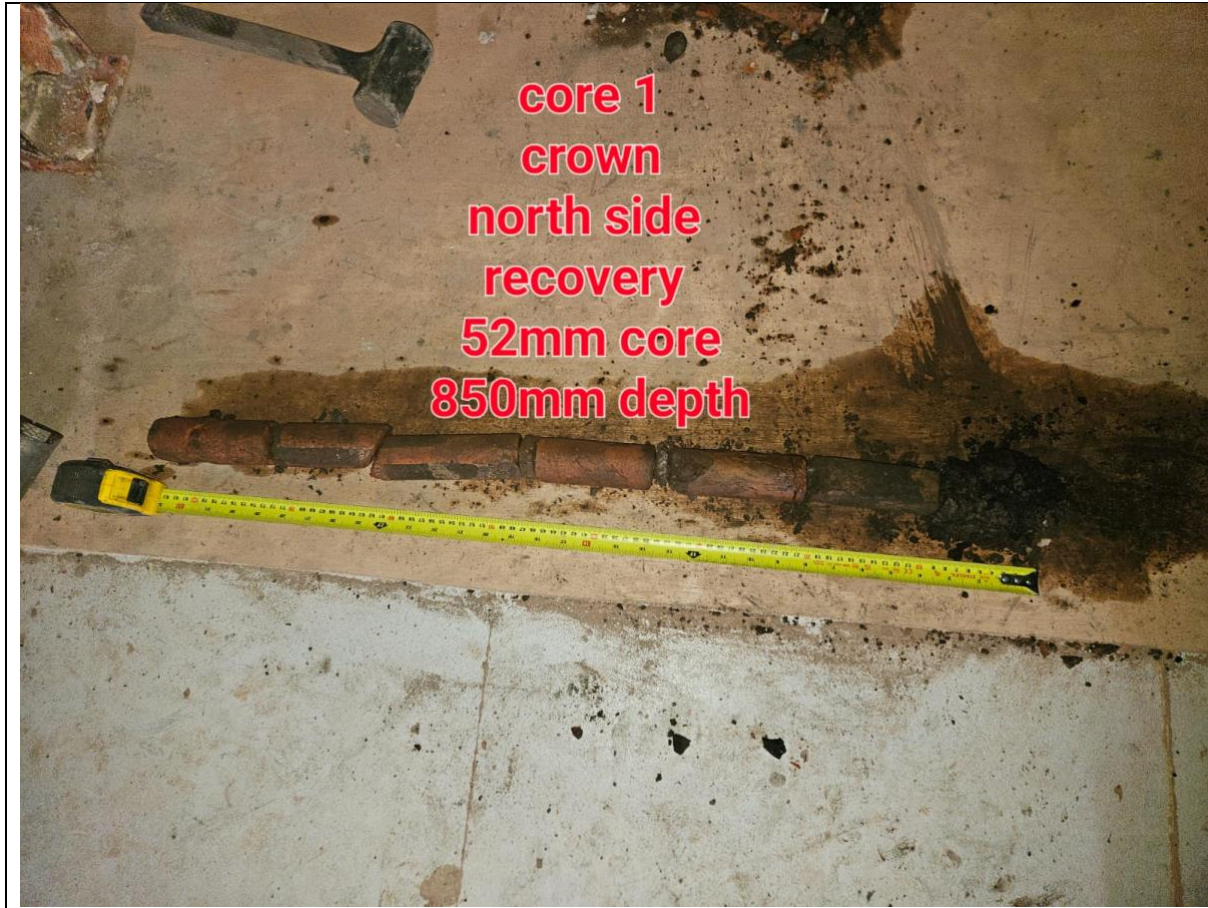
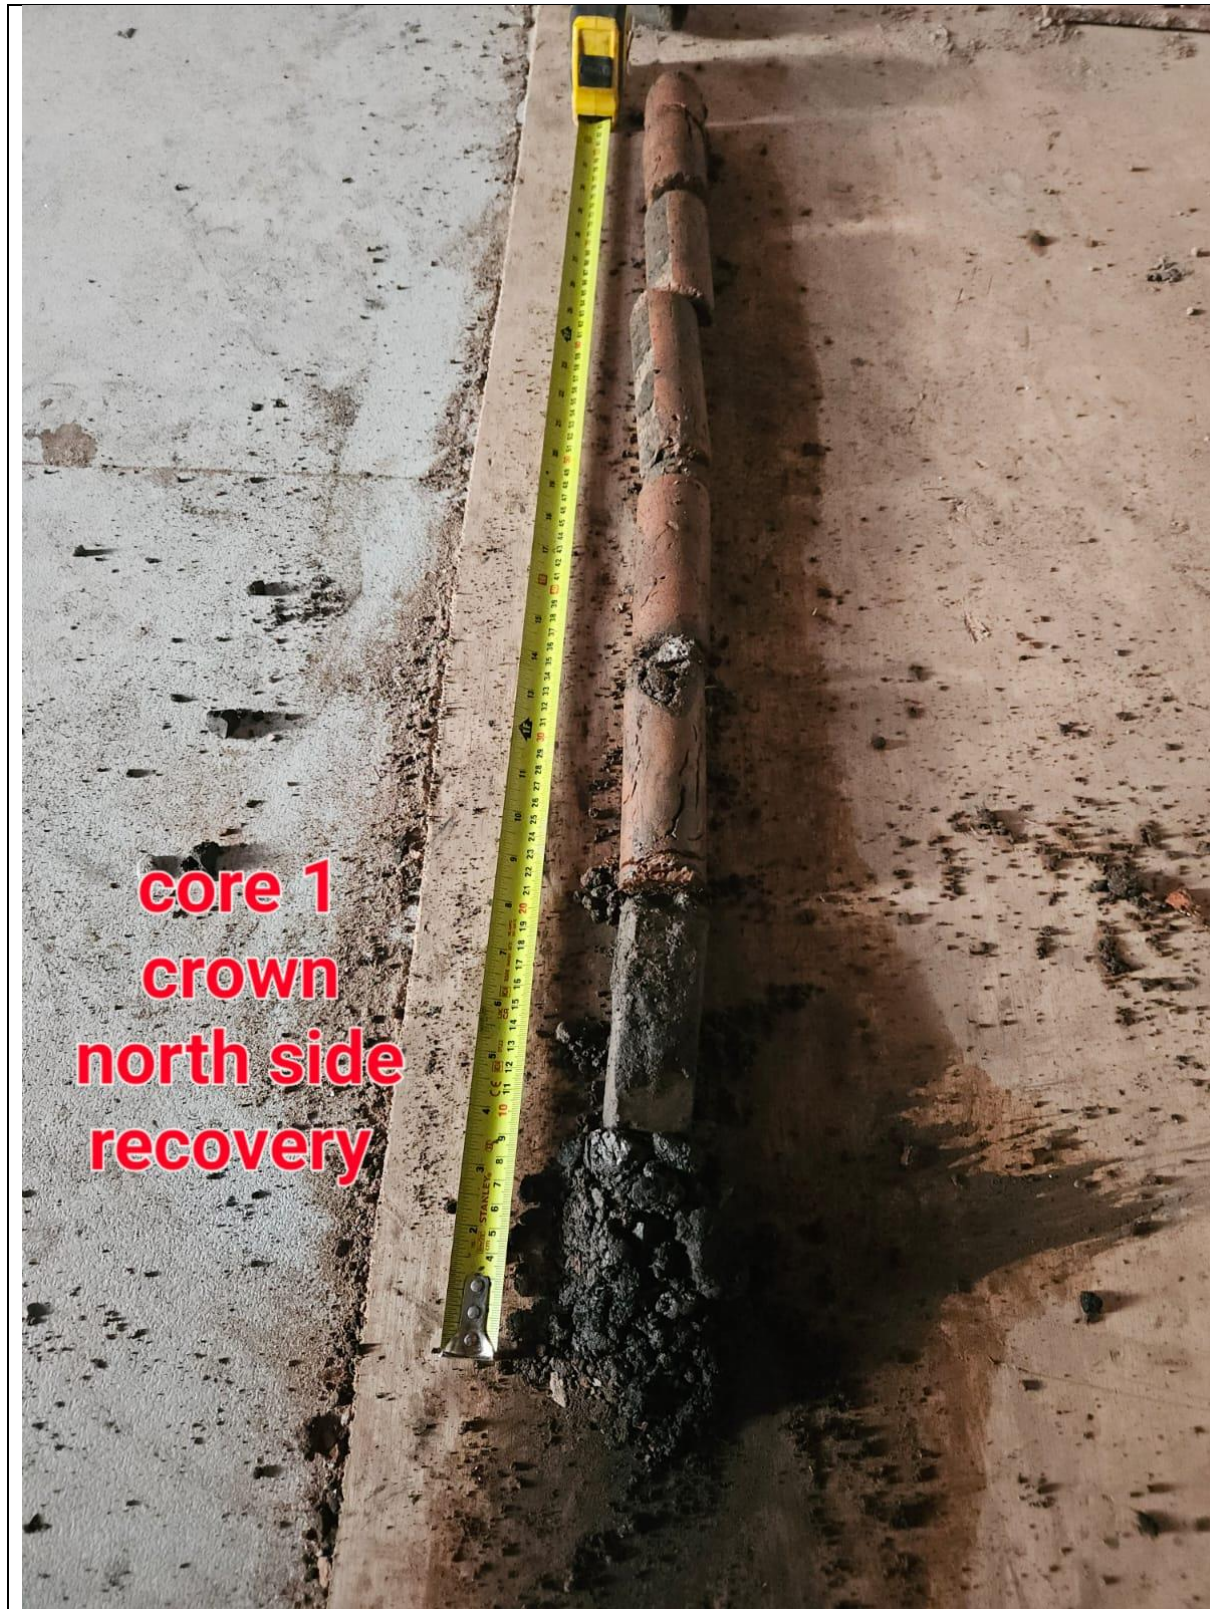
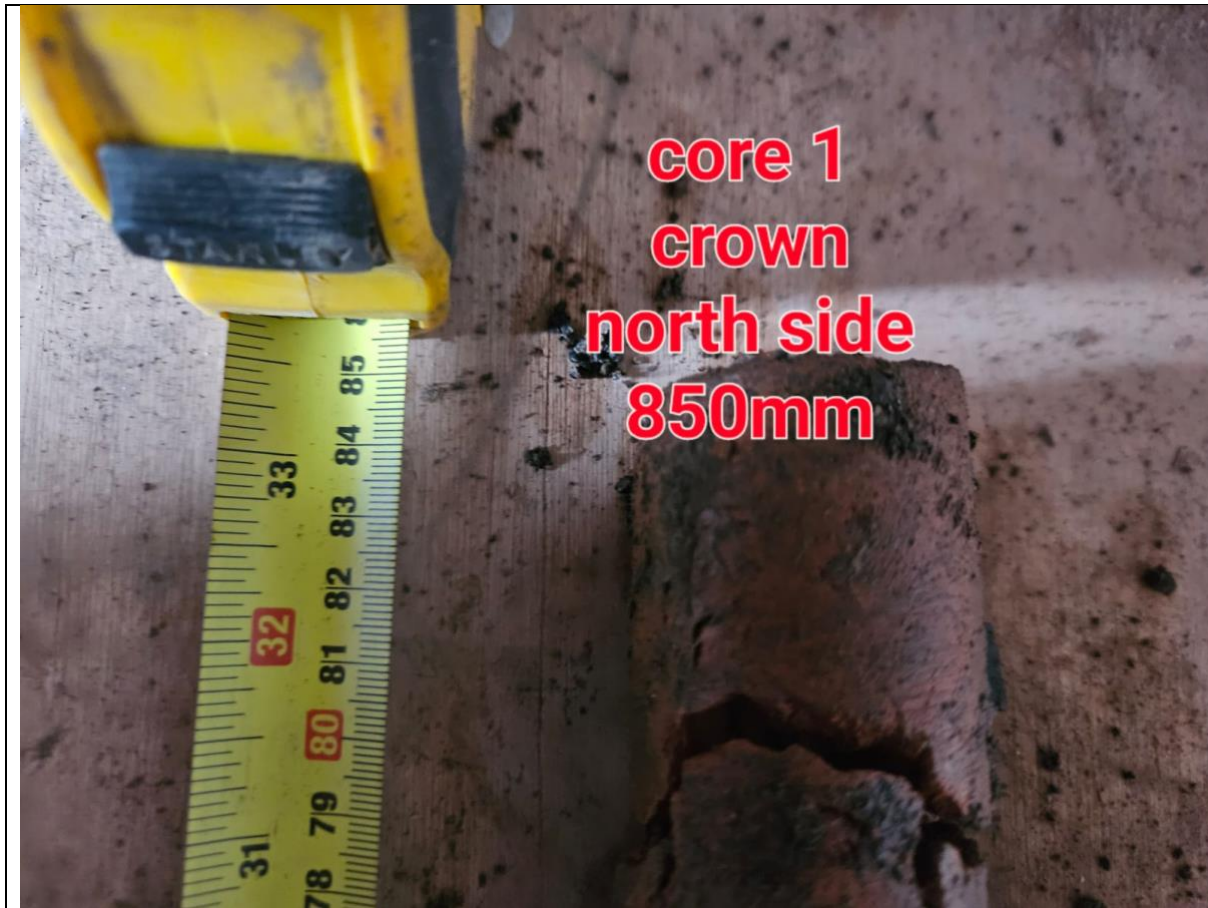
Core 4:

| Location | Crown – North side |
| Material | 850mm Brickwork |
| Endoscope Results – No Voids | |

**core 1  
crown  
North side**

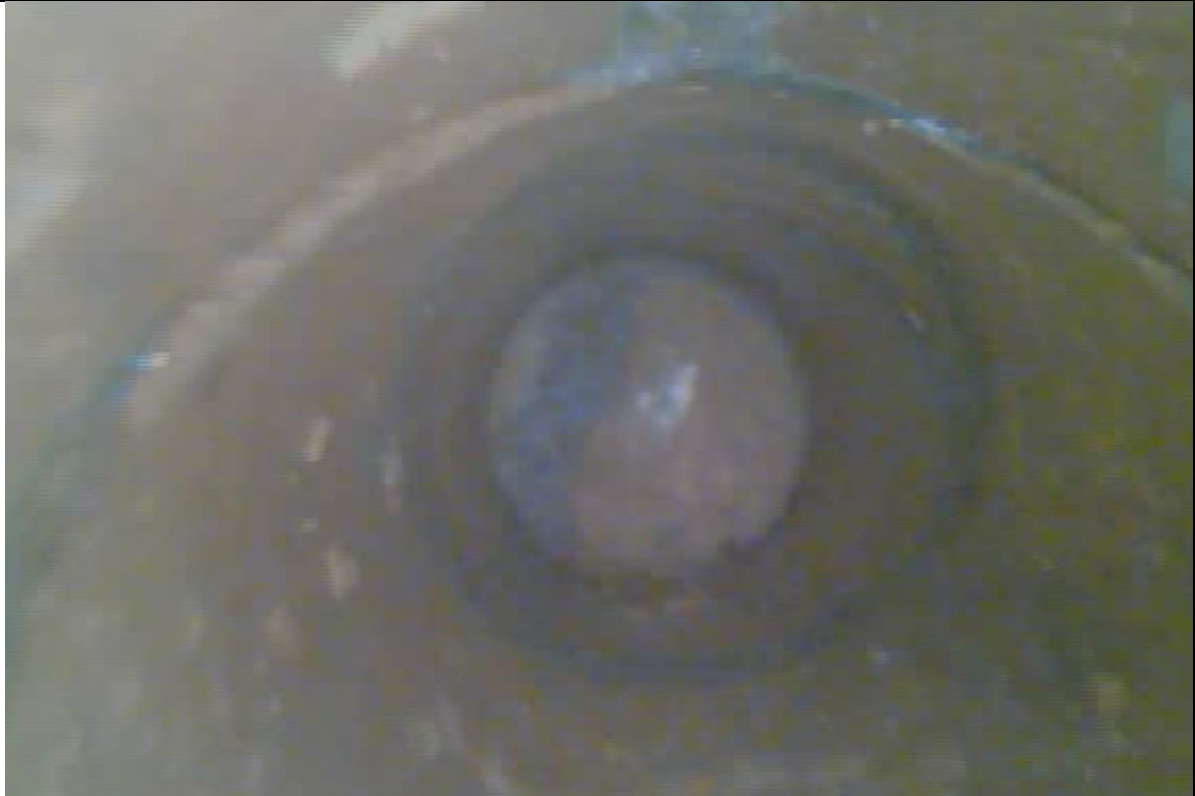
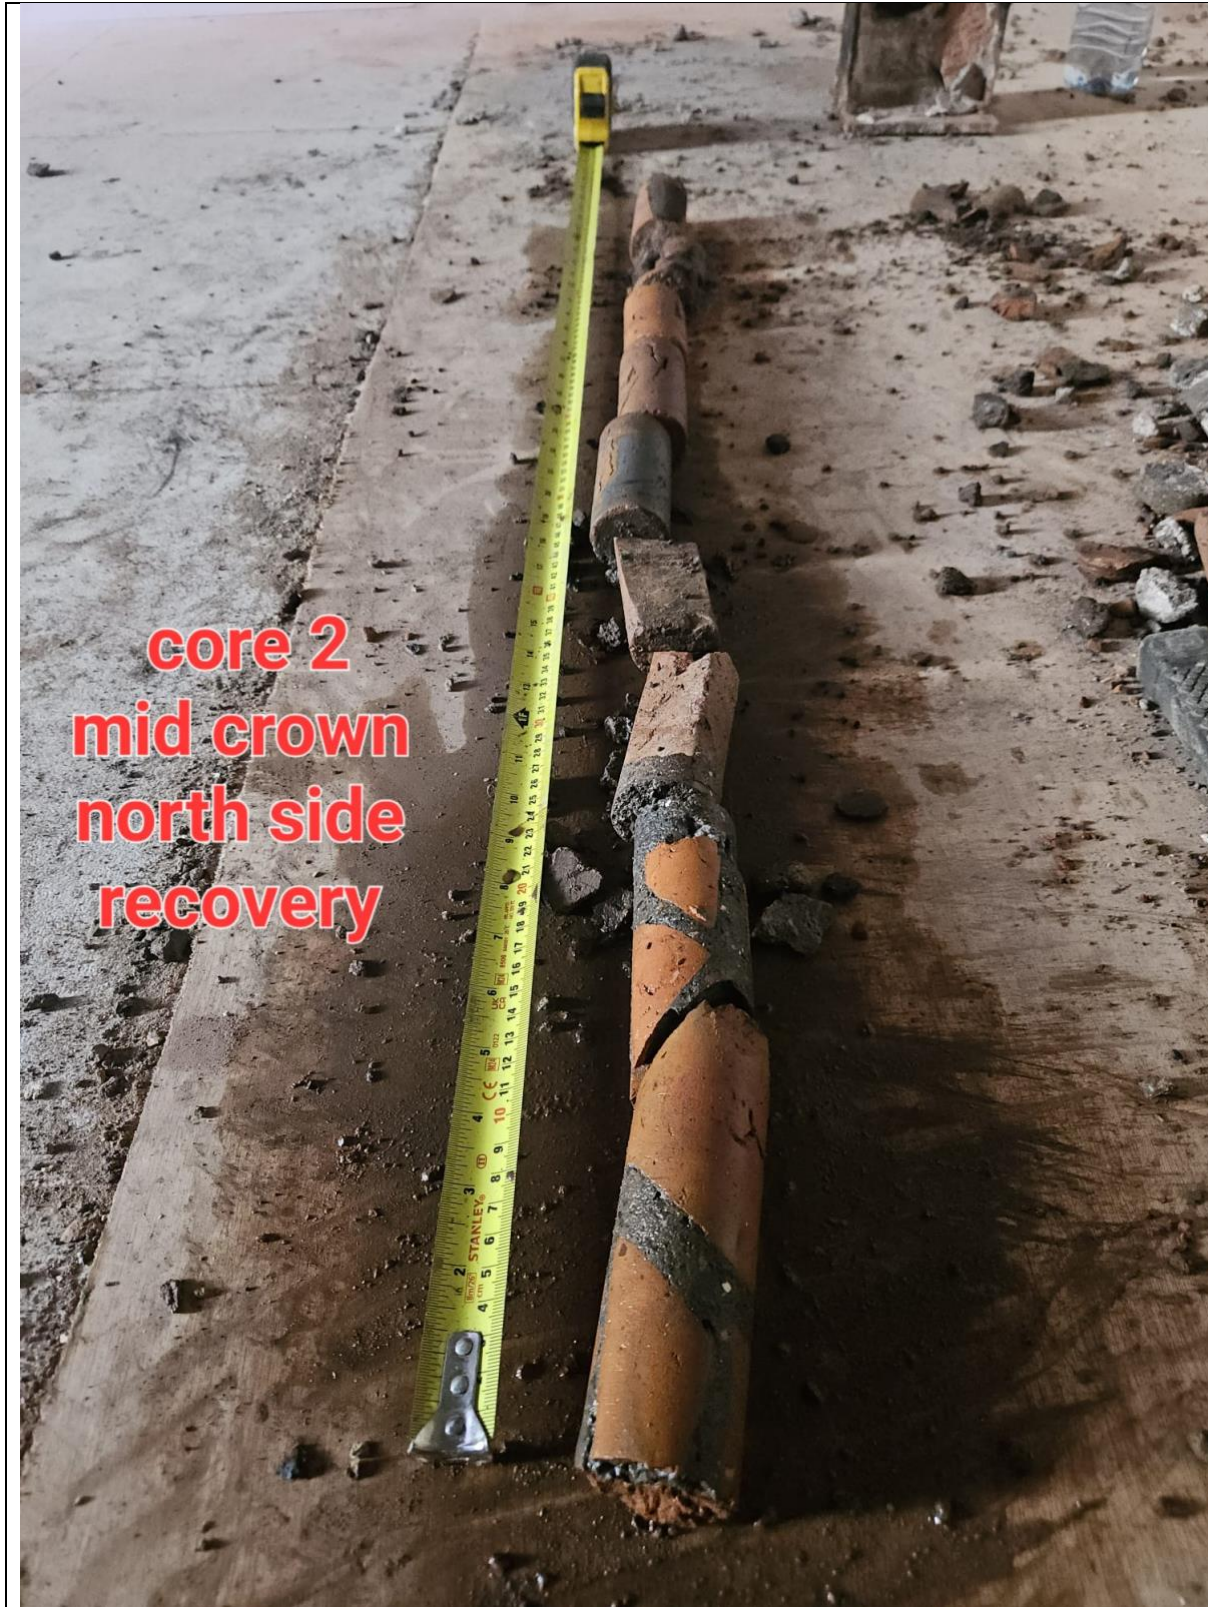
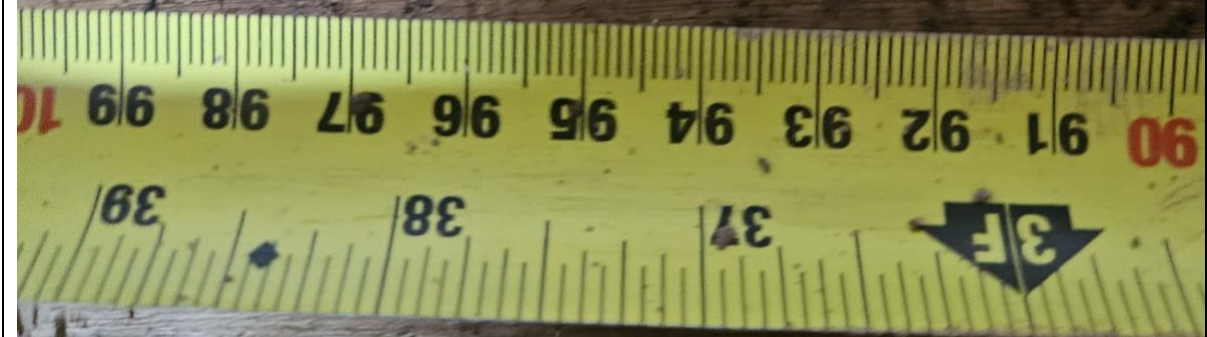
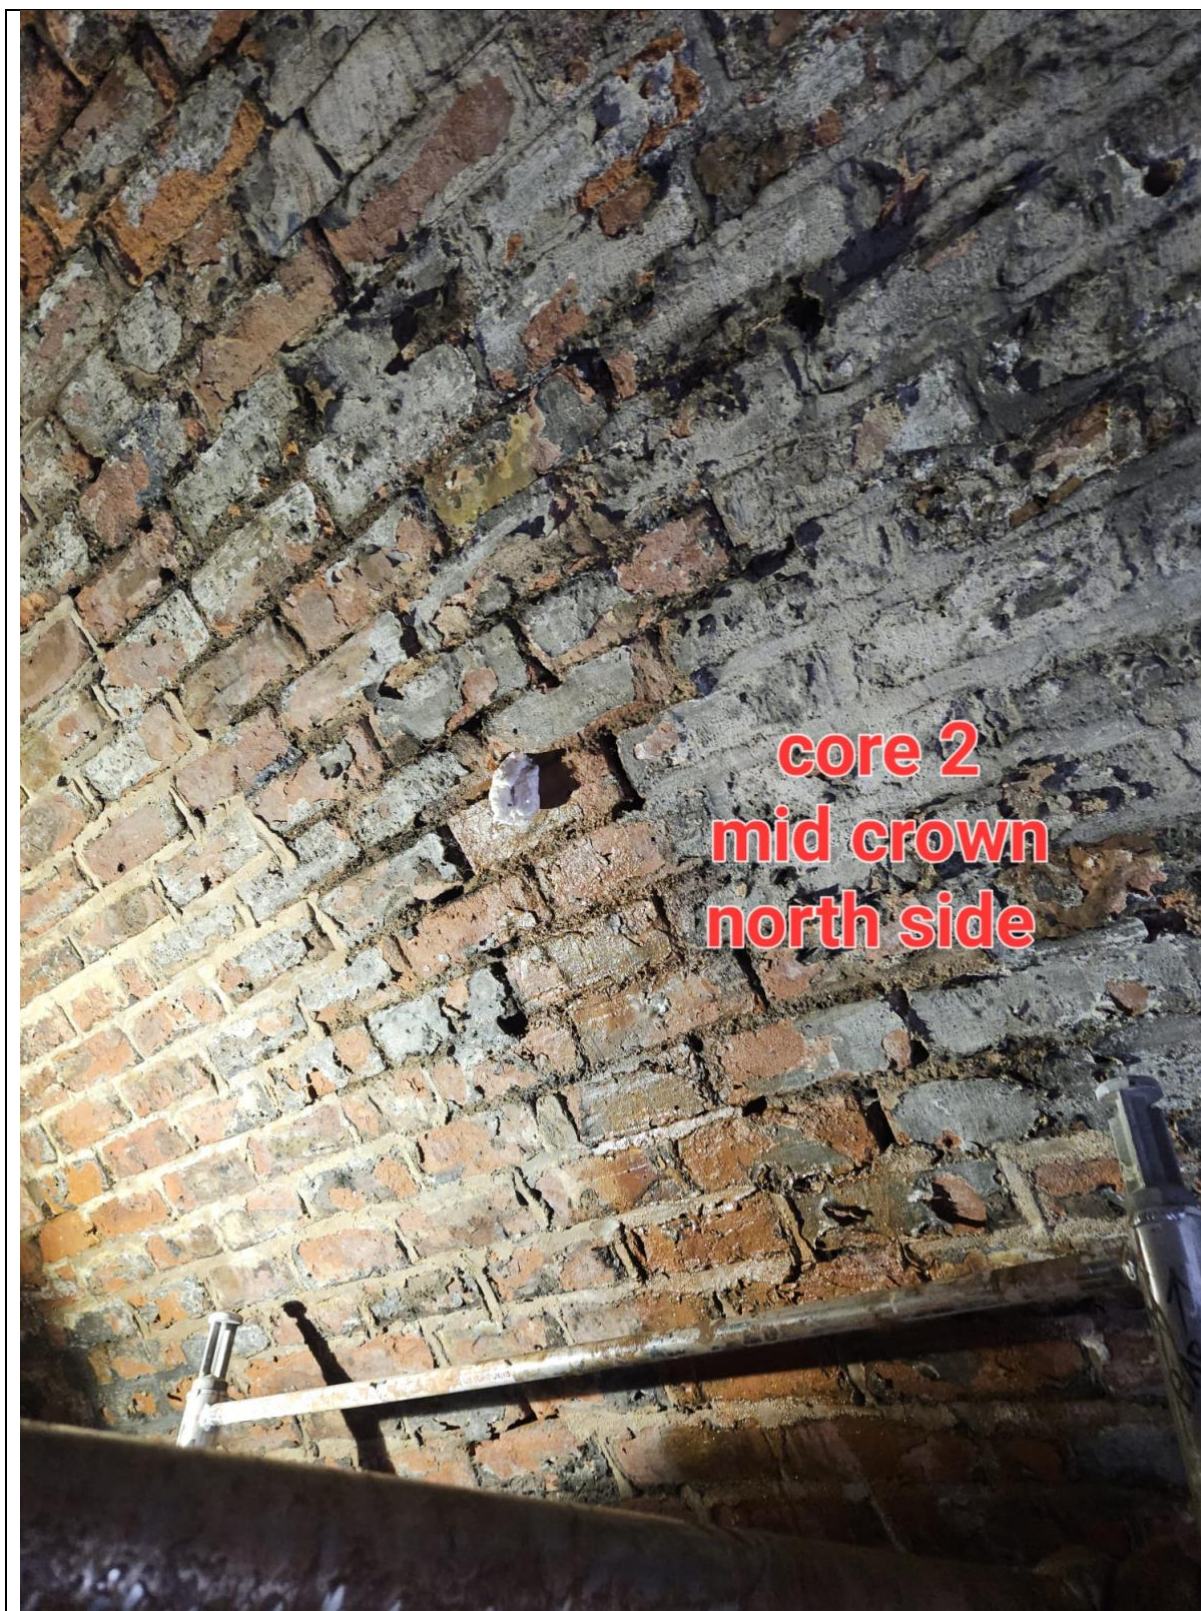
**Core 5:**

| Location | Mid Crown – North End |
| Material | 960mm - Brickwork |
| Endoscope Results – No Voids | |

core 2  
mid crown  
north side  
960mm depth  
full brick

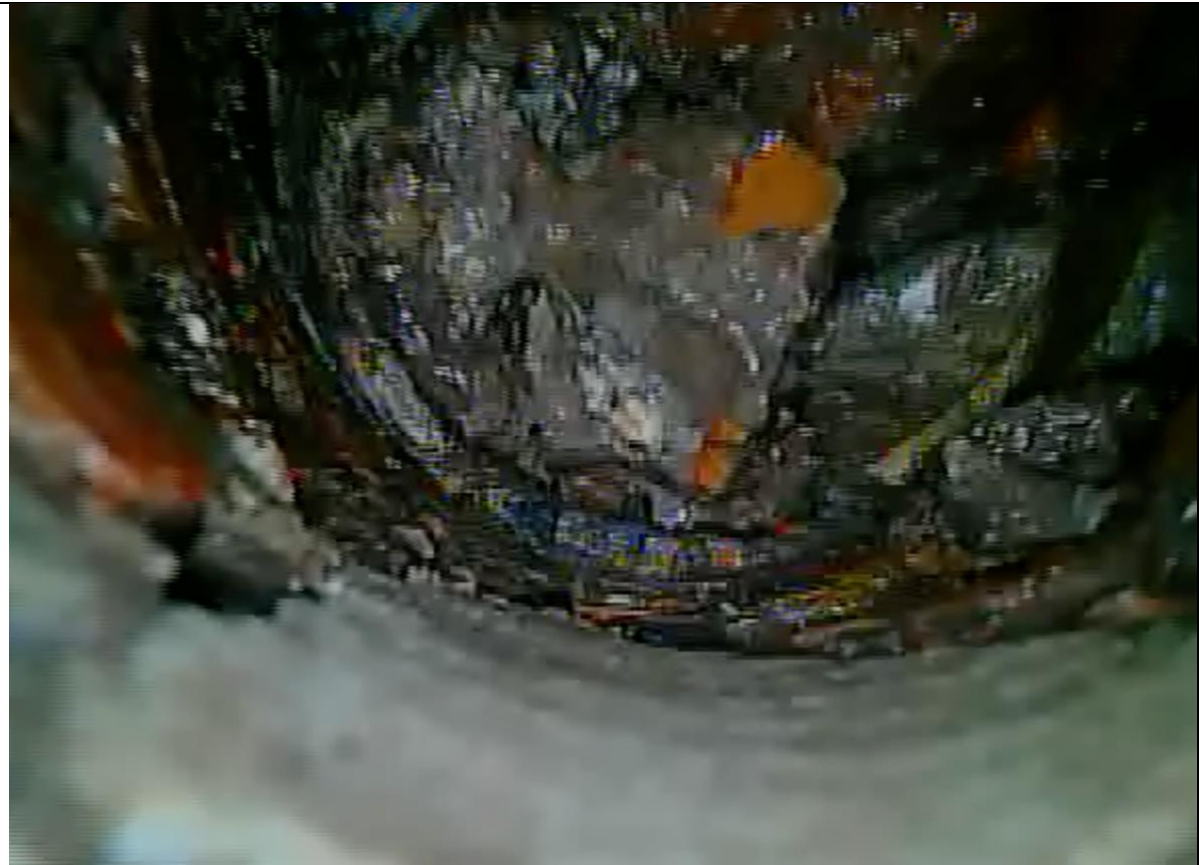
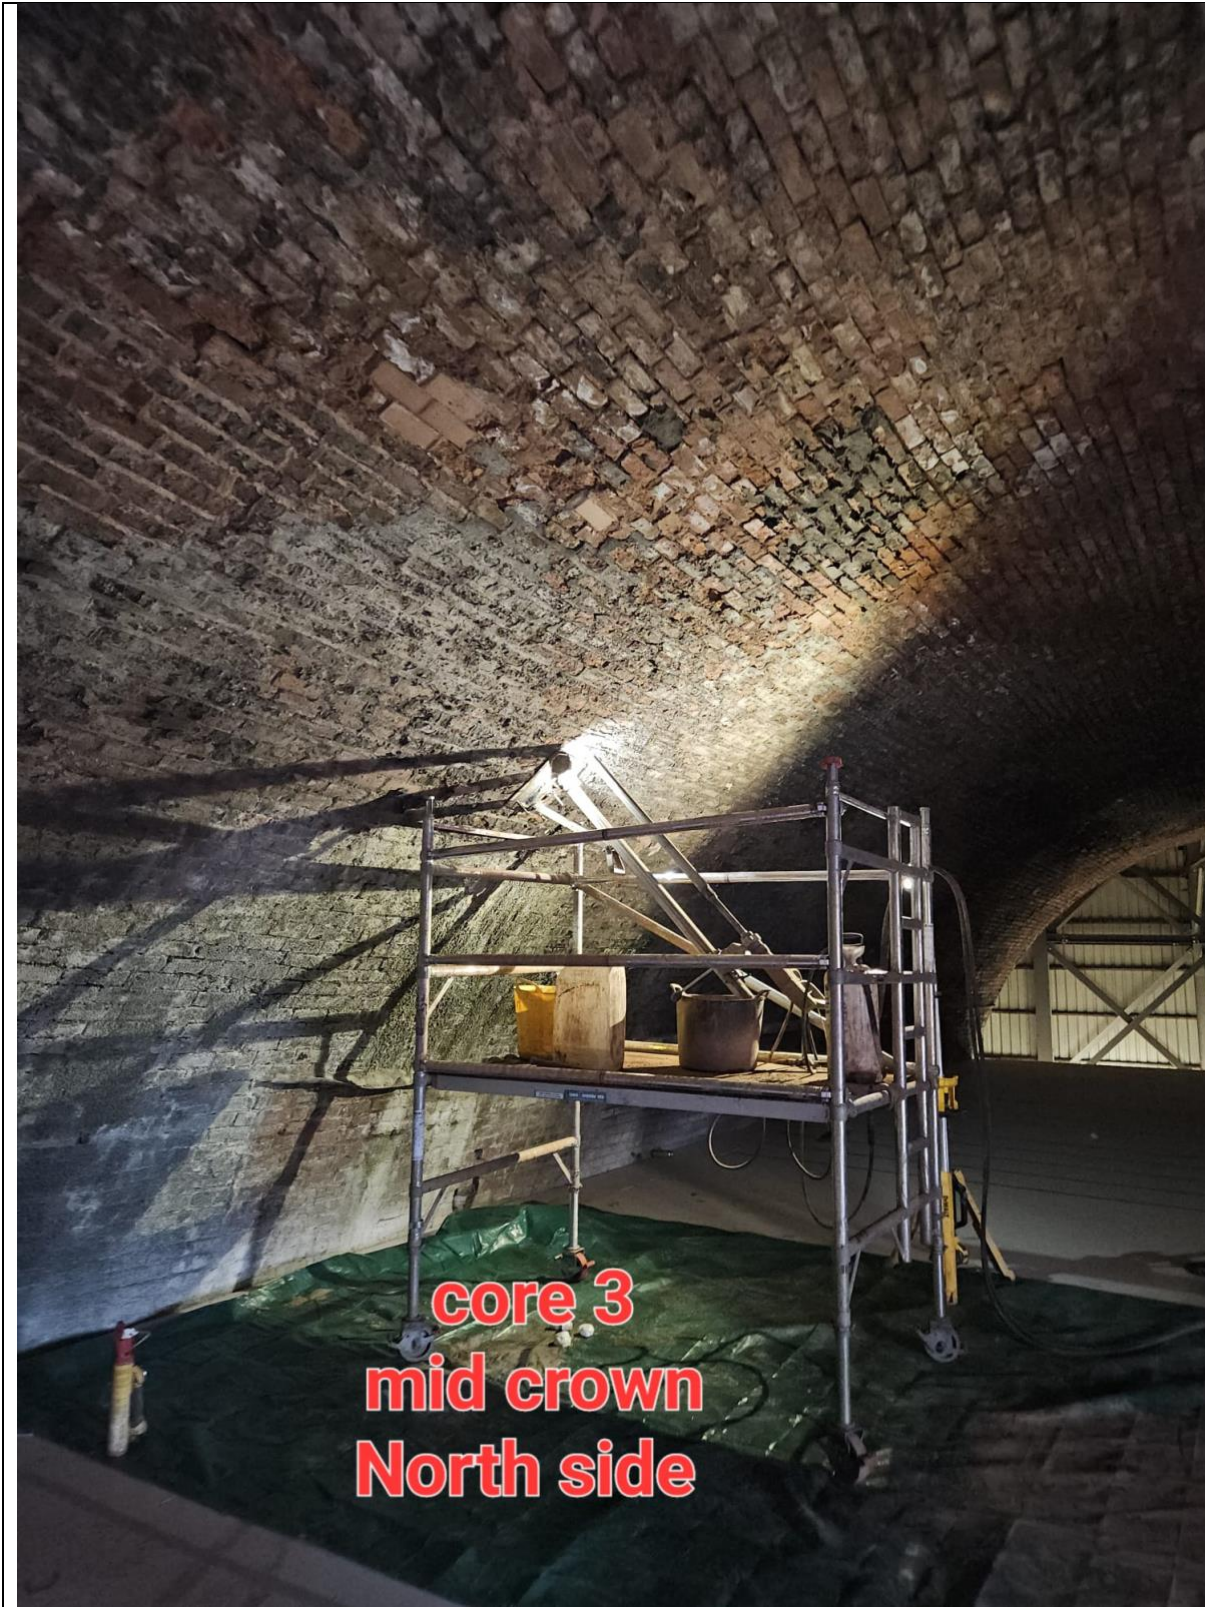
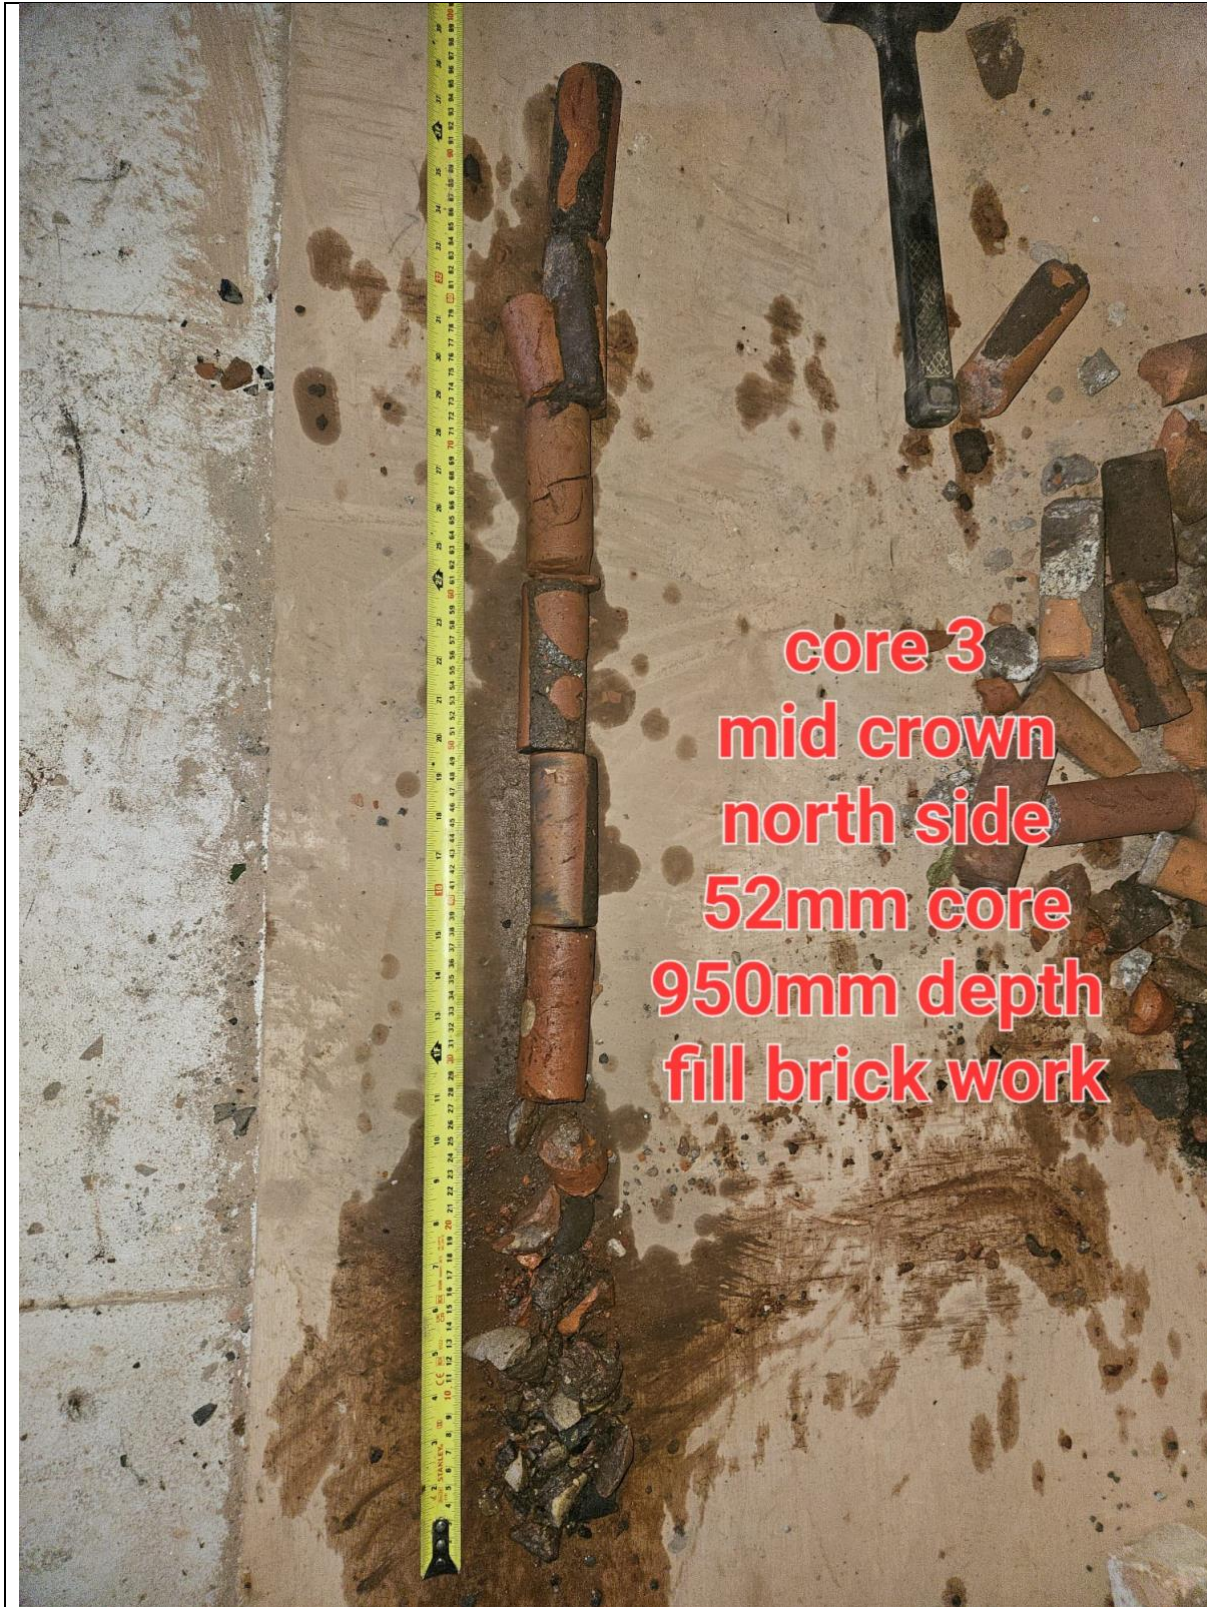
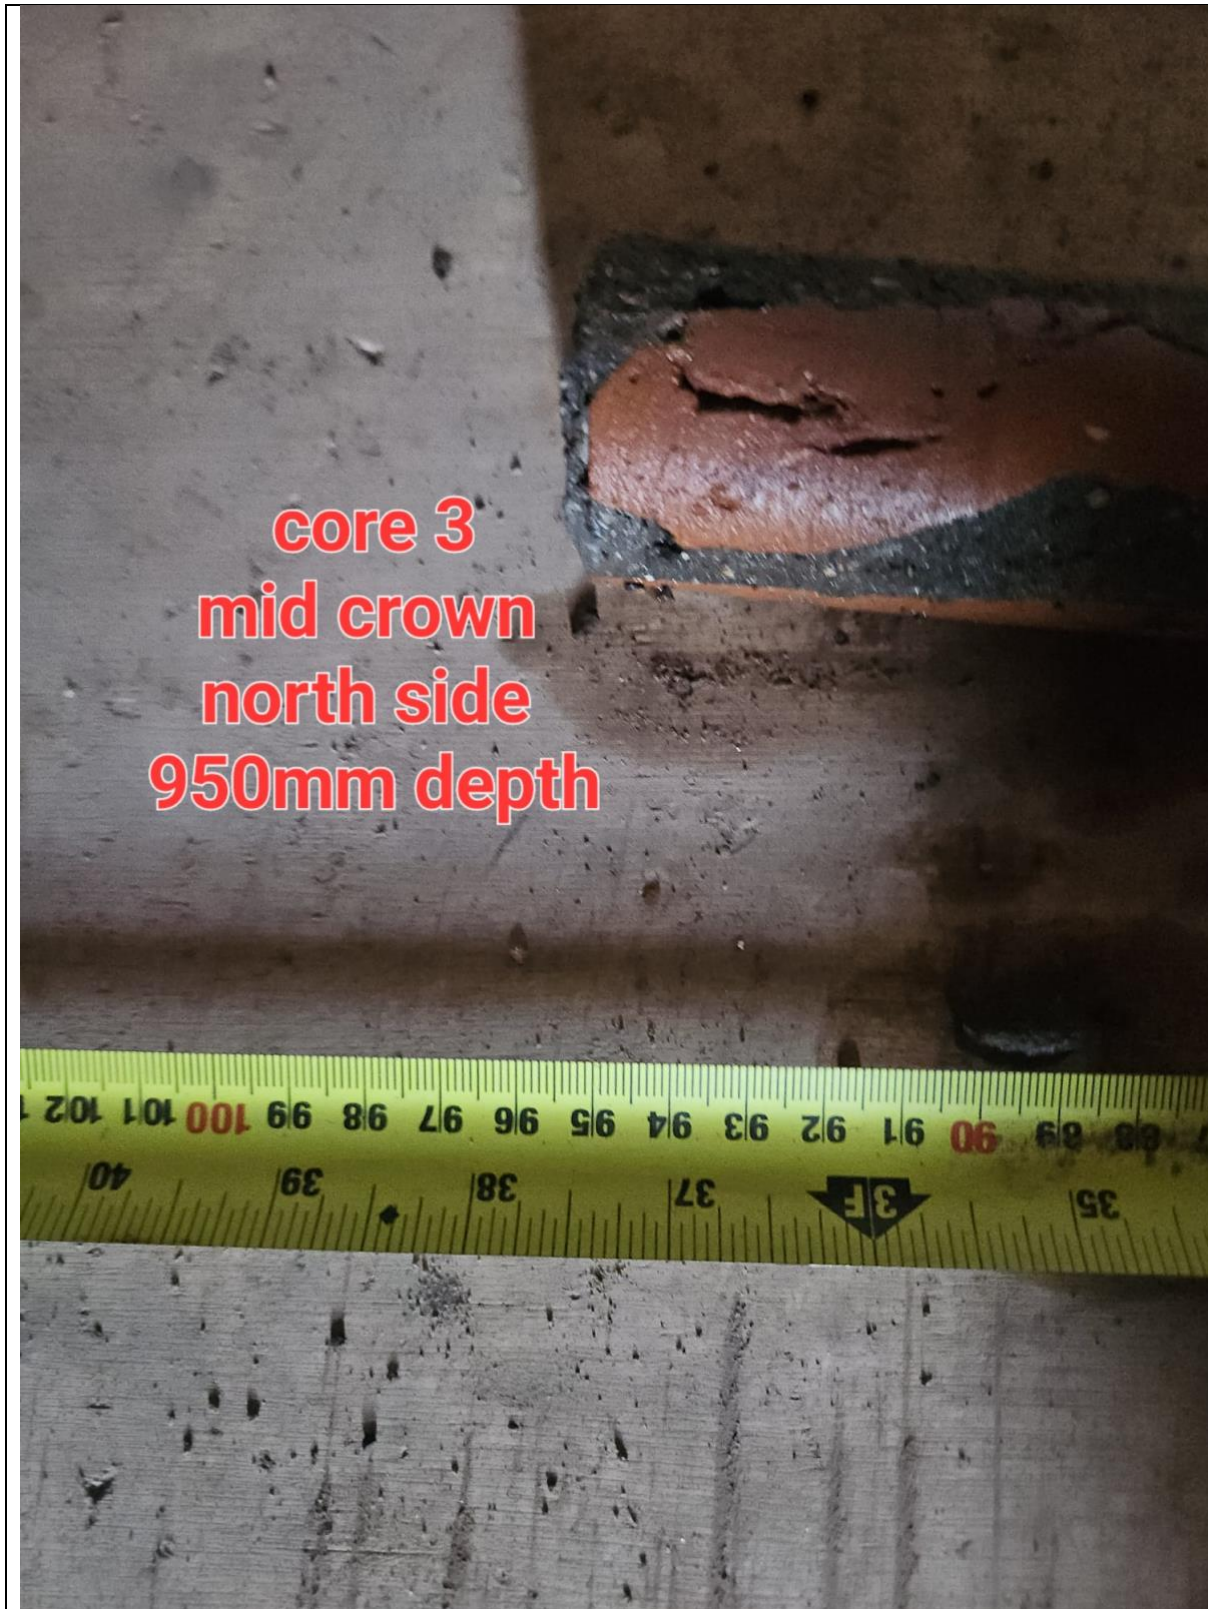
**Core 6:**

| Location: | Mid Crown – North Side |
| Material: | 950mm – Brickwork |
| Endoscope Results – No Voids | |

**core 3**  
**mid crown**  
**north side**  
**recovery**
