# Ecology Report

**All Saints West  
3rd February 2026**

TG Report No. 13126\_R09a\_BP

**MMU, All Saints  
13th February 2023**

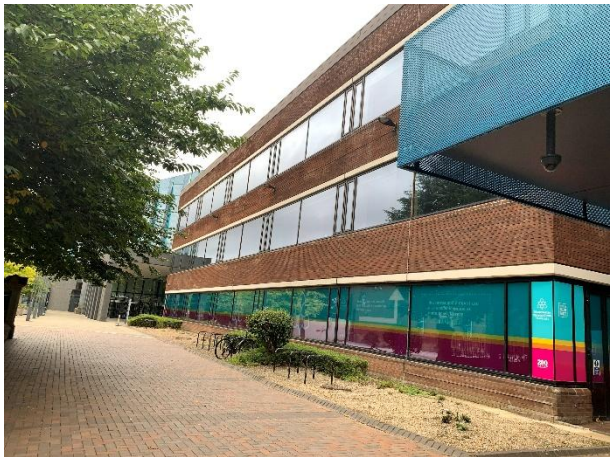
| Habitat Type (UKhab) | Description and Species | Photograph |
|---|---|---|
| <b>Developed Land; Sealed Surface</b> | Single hardstanding, sealed surface building located within the Site (B1). Hardstanding area also includes areas around the building for access. | |

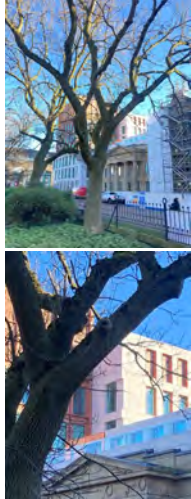
| <b>T4 (offsite)</b> | Ash | Mature, approximately 10 meters tall. some cut branches forming features however all are relatively superficial.<br>2x knot holes on southern aspect, 2m high. | | LOW |

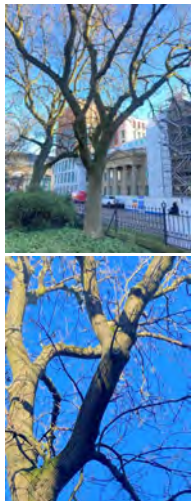
| <b>T5 (offsite)</b> | Ash | Mature, approximately 10 meters tall. Some cut branches forming features however all are relatively superficial. | | LOW |

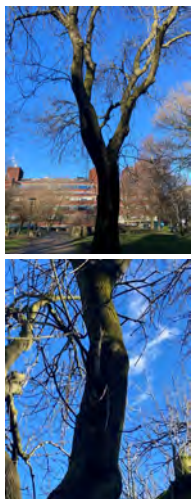
| <b>T6 (offsite)</b> | Ash | Mature, approximately 10 meters tall. Some cut branches forming features however all are relatively superficial. | | LOW |

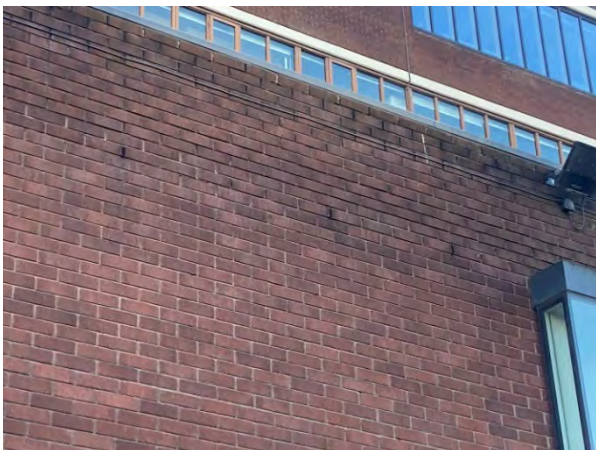
**Photograph 3 : Weep holes present on the exterior of MMU library building (B01)**

- 1.2. Features noted to have suitability for bats are illustrated in plan 13126/P02 at **Appendix 2**. Features include:
  - Weep holes present throughout the building's exterior forming gaps in the brick work;

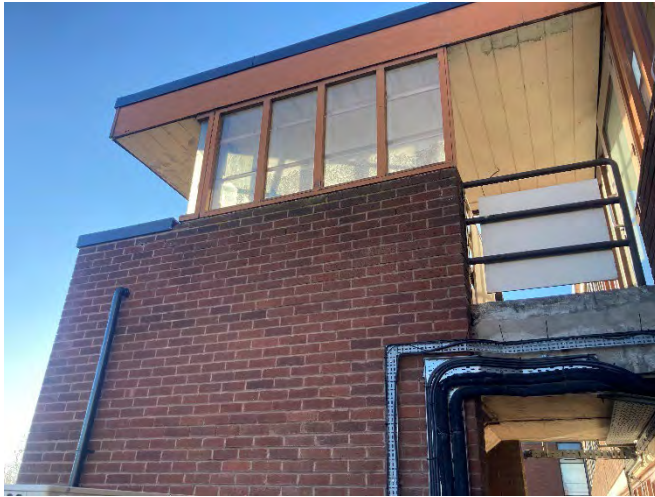
**Photograph 4: Exterior of fire escape present on levels 4 and 5**

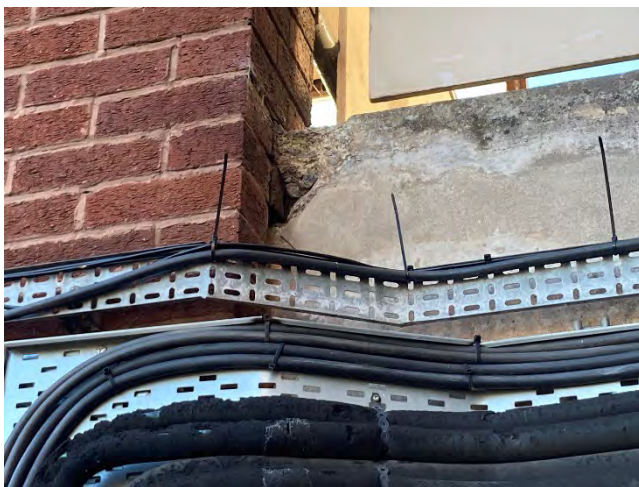
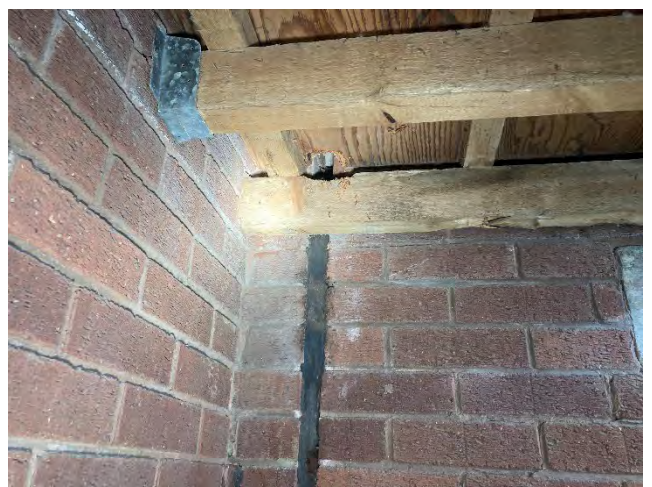
**Photograph 5 and 6: Gaps in mortar present on levels 4 and 5 fire escape**

- Gaps in the mortar on the wester aspect;
  - On the 6th floor a metal barge board present, forming a crevice between the wall and the board itself which may be used by low numbers of bats on an occasional basis;

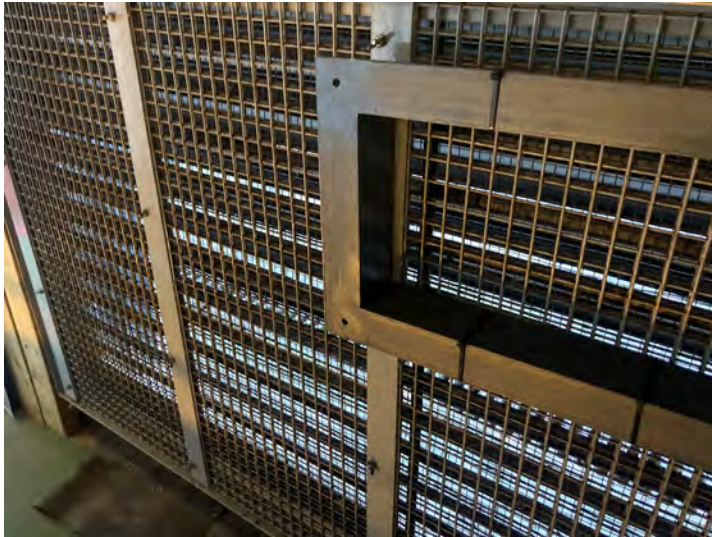
**Photograph 8: Mesh over vent into basement**

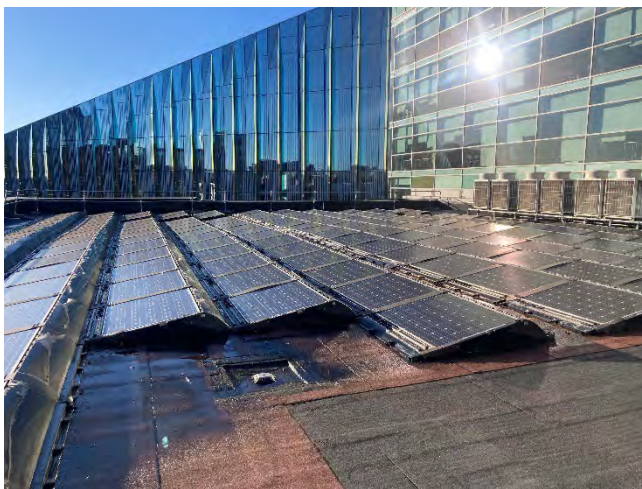
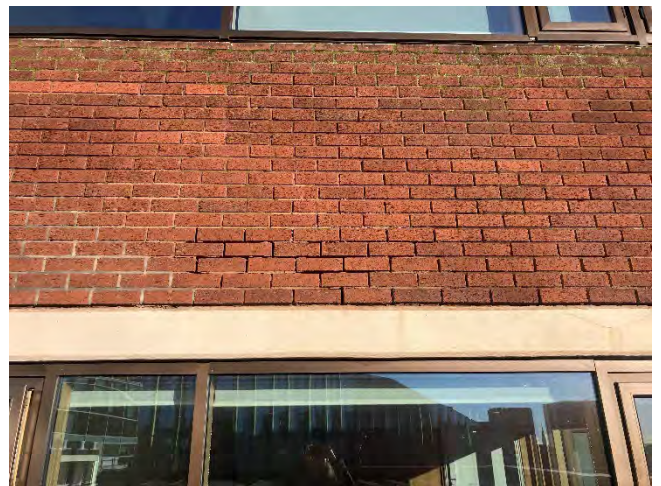
**Photograph 18 and 19: Level 3 flat roof with solar panels and gaps in mortar present in brickwork**

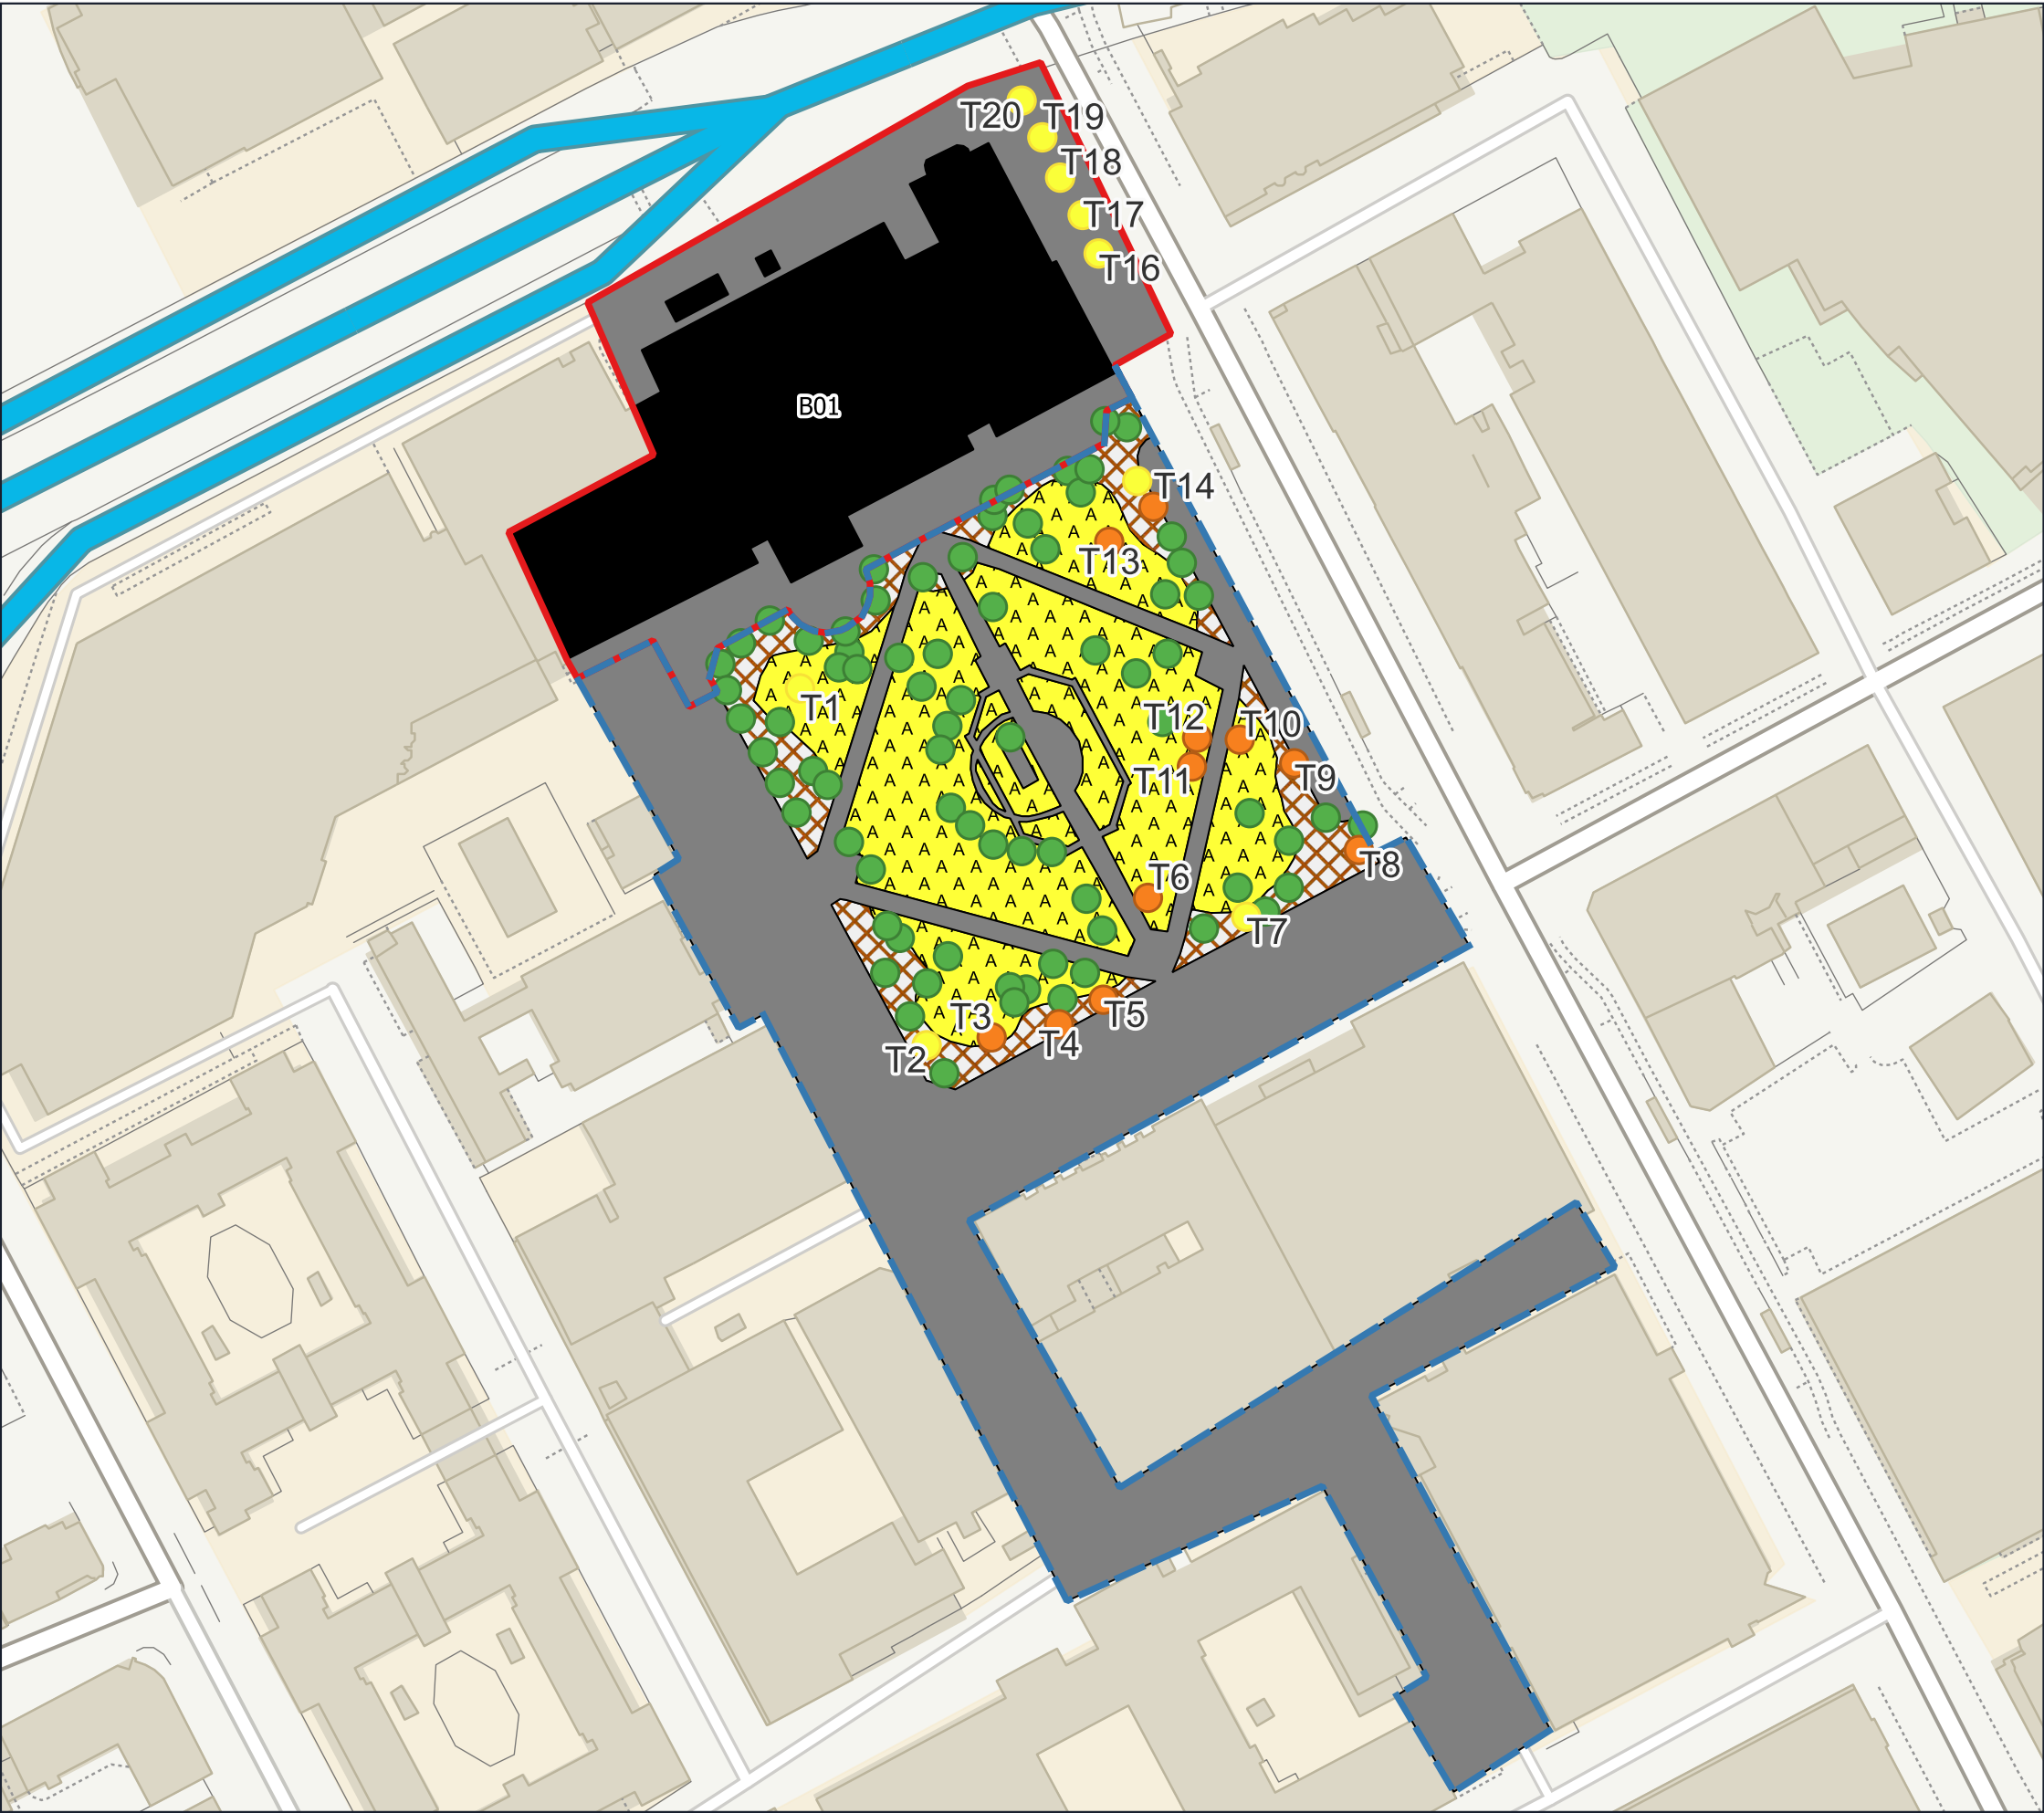
### **Plan 1: Habitat Features Plan (13126/P01c)**

- Redline Boundary
- All Saints Park
- Buildings
- Introduced shrub
- Amenity Grassland
- Hardstanding
- Scattered Tree Negligible Potential
- Scattered Tree Low Potential
- Scattered Tree Scattered Tree

- 3.10. The habitats present on-site are summarised below in **Table 2.1**, along with a description of the composition of the main plant species present. The location of habitats is shown on the Baseline Habitat Features Plan (**Plan 1**).
- 3.11. The results of the habitat surveys were used to inform the completion of condition assessments for all habitats, which were completed with reference to The Statutory Biodiversity Metric User Guide<sup>5</sup>.
- 3.12. A summary of the BNG assessment of the baseline habitats is detailed below in **Table 2.2**. This includes their BNG unit value as calculated through the BNG metric (ref: **13126\_BNG\_a\_All\_Saints\_West\_Refurbishment\_03022026**).

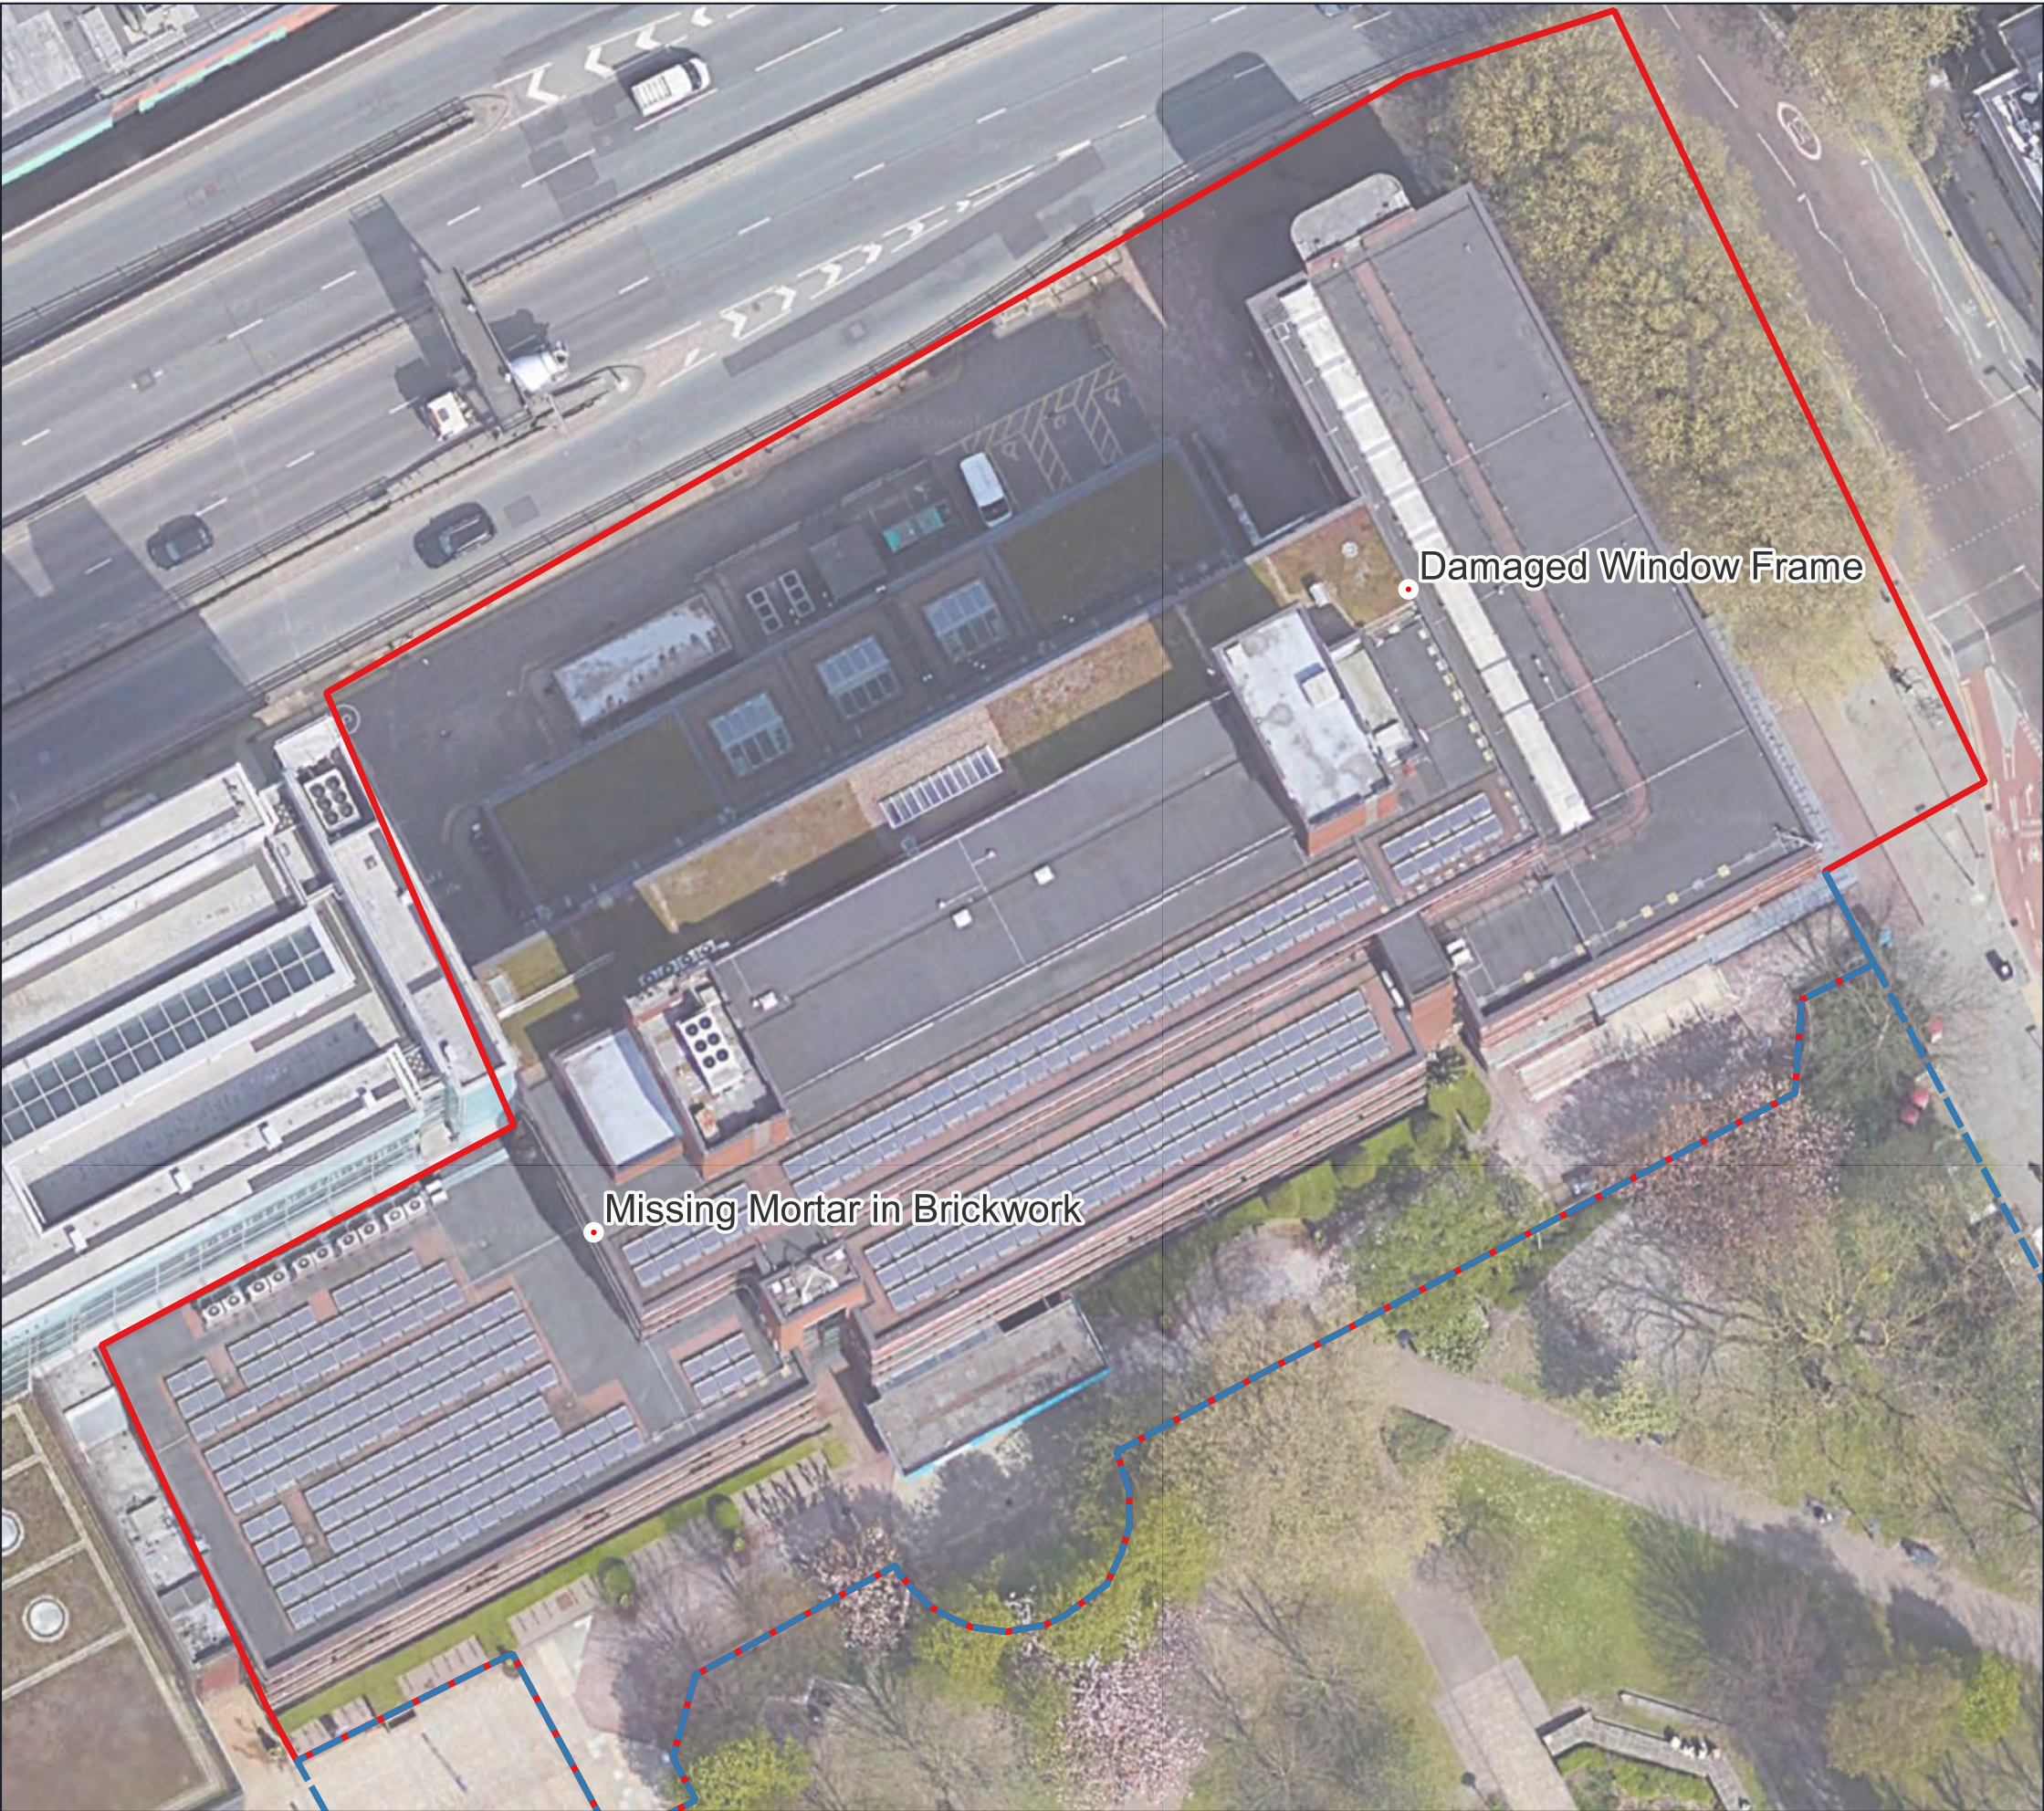
## Plan 2: Bat Roosting Features Plan (13126/P02)

- 3.6. No evidence was found to show that void-dwelling species were present or have been present in B01 and during the preliminary roost assessment, there was no direct evidence of bats recorded externally or internally, however, features that would be suitable for crevice-dwelling bats were noted. These features are illustrated in plan **15234/P02** and include the following:

- 1.7. It is recommended that pre-construction checks of the low bat roost potential features are required to ensure the protection of bats. It is not recommended that nocturnal surveys are undertaken given the structure of this building (i.e. no roof void), the high temperate of the spaces with crevices and the urbanised location. Additionally, due to the features being positioned on the 6th floor and above, nocturnal surveys would be unsuitable due to low visibility.

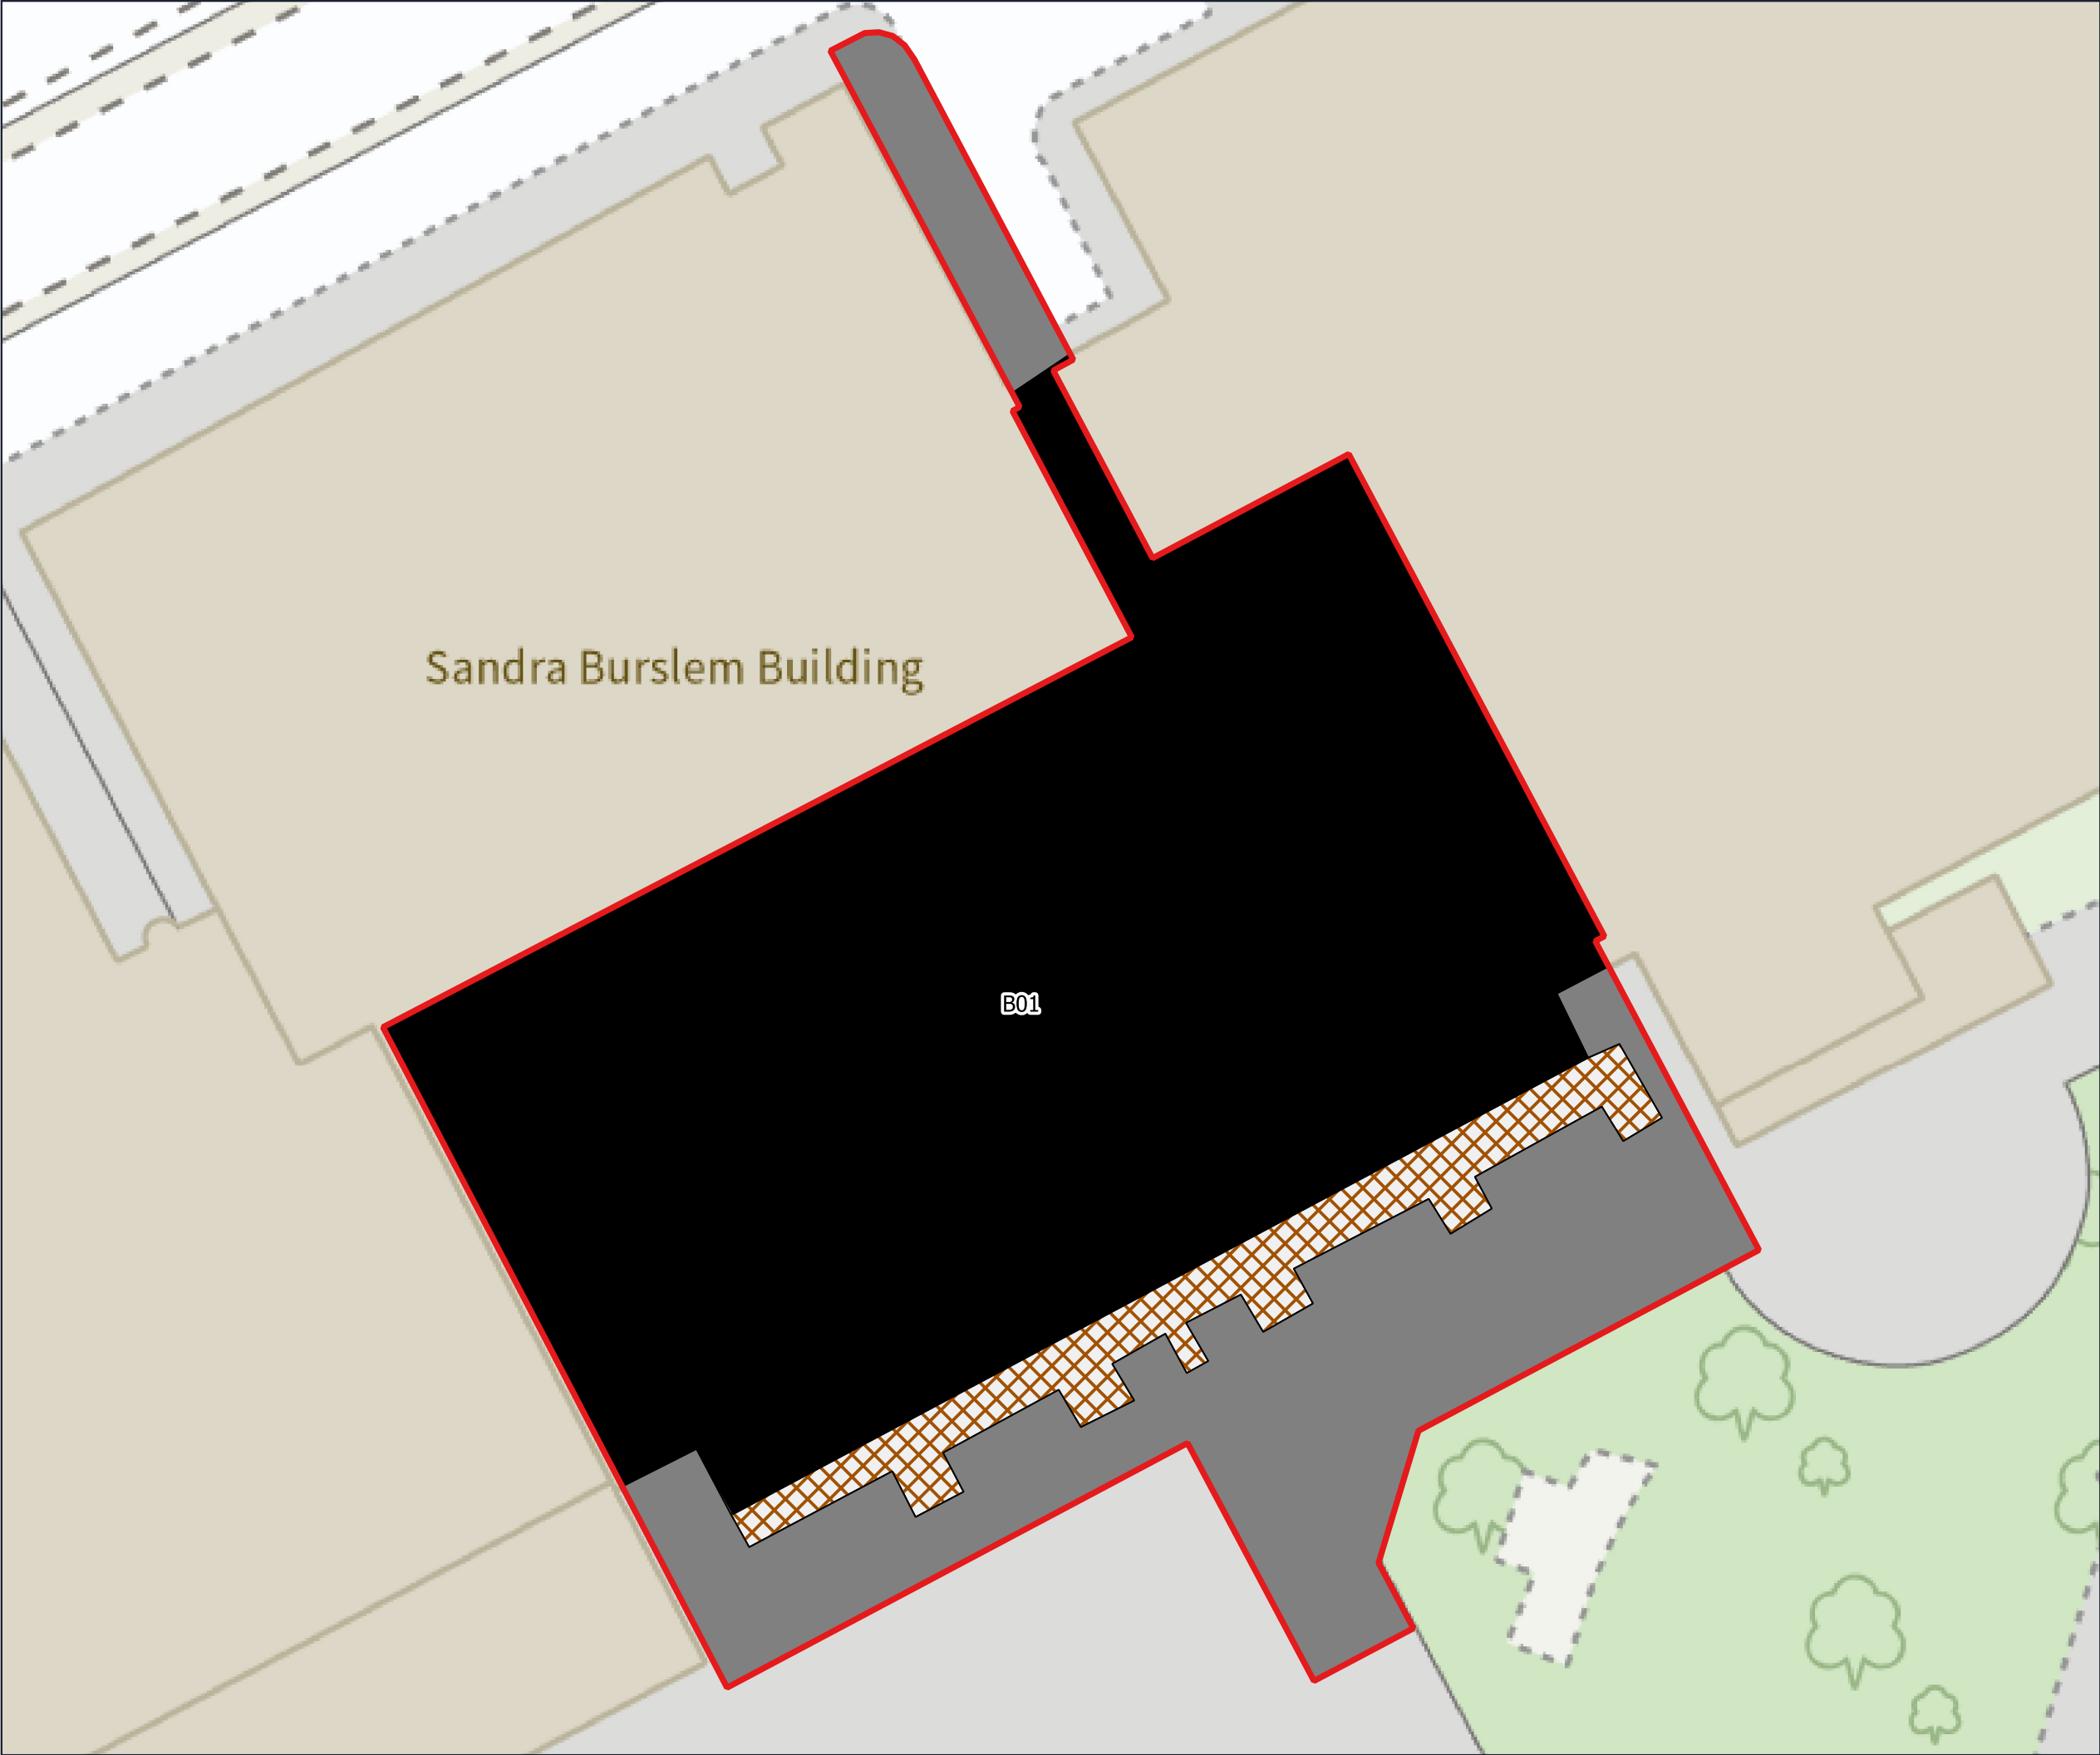
**Plan 2: Post-development Plan**

- Building
- Introduced shrub
- Hardstanding

- 3.15. No habitats are to be retained. An area of planting is proposed including small tree planting (5 trees), see The details of post-development habitats which will be present are shown on the post-development habitats plan (**Plan 2**). Condition assessment reasoning is provided in the BNG metric (ref: **13126\_BNG\_a\_All\_Saints\_West\_Refurbishment\_03022026**).
