## **GARDEN VALIDATION - BELLE VIEW PLOTS 113-124**

An E3P engineer attended the above site to validate the thickness of the cover system that had been placed within the rear garden of plots 113-124 at Belle View.

## Site: Belle View Stadium

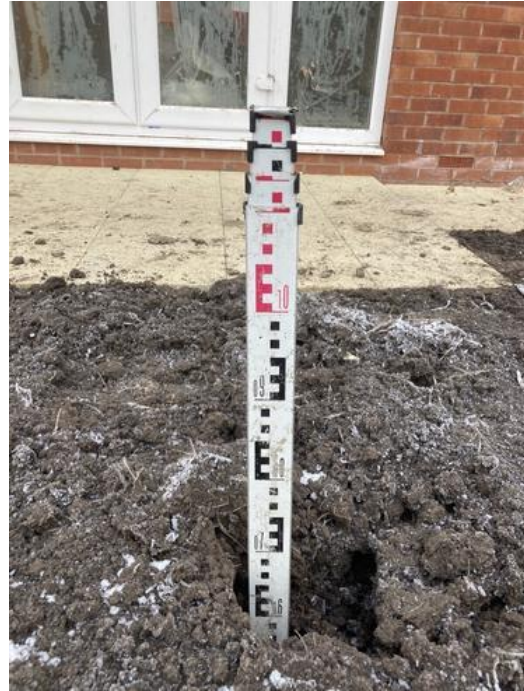
Photo 1

Depth of Cover System Materials (record the depth and support with Photo down the hole)

0.6

Depth of Topsoil (mm)

150

Depth of Subsoil (mm)

450

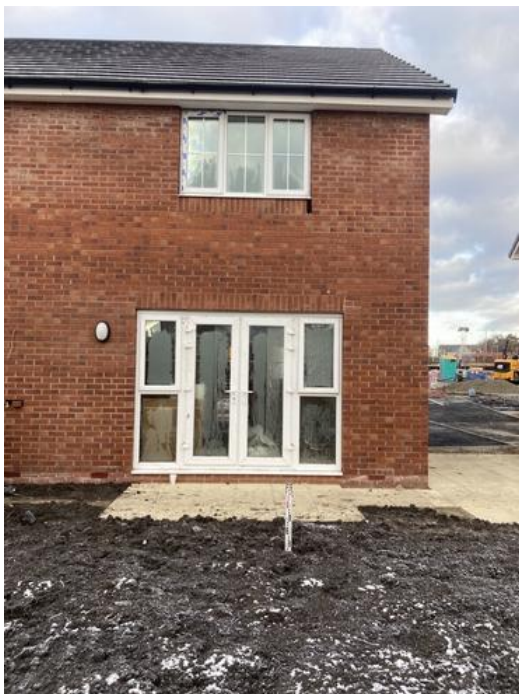
Photo 10

Depth of Cover System in Relation to Plot (Ensure the whole plot can be seen in the photo)

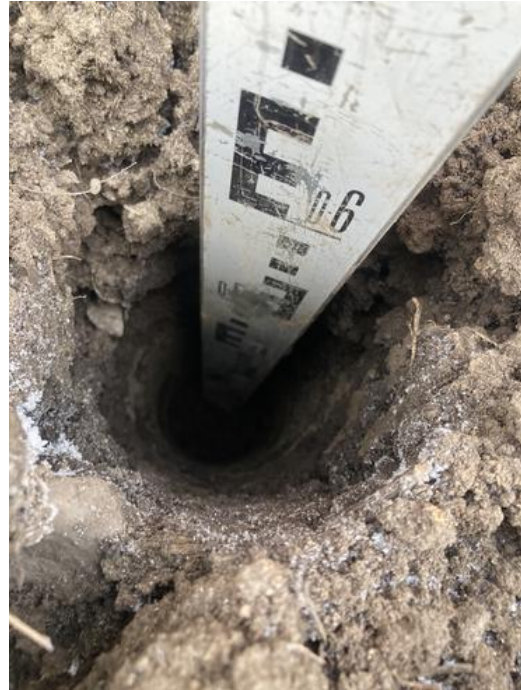
Photo 13

Depth of Cover System Materials (record the depth and support with Photo down the hole) 0.6

Depth of Topsoil (mm) 150

Depth of Subsoil (mm) 450

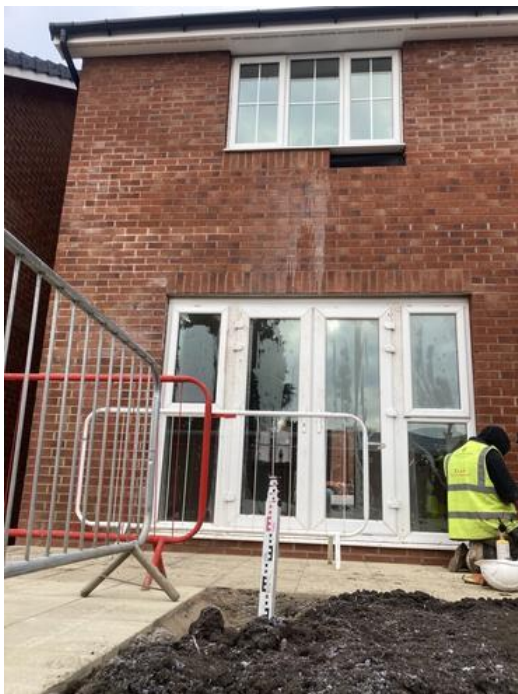
Photo 22

Depth of Cover System in Relation to Plot (Ensure the whole plot can be seen in the photo) ☒

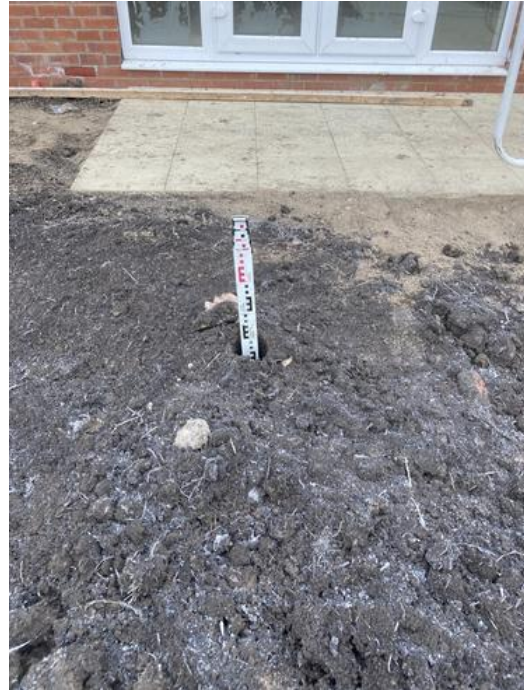
Photo 25

Depth of Cover System Materials (record the depth and support with Photo down the hole)

0.6

Depth of Topsoil (mm)

150

Depth of Subsoil (mm)

450

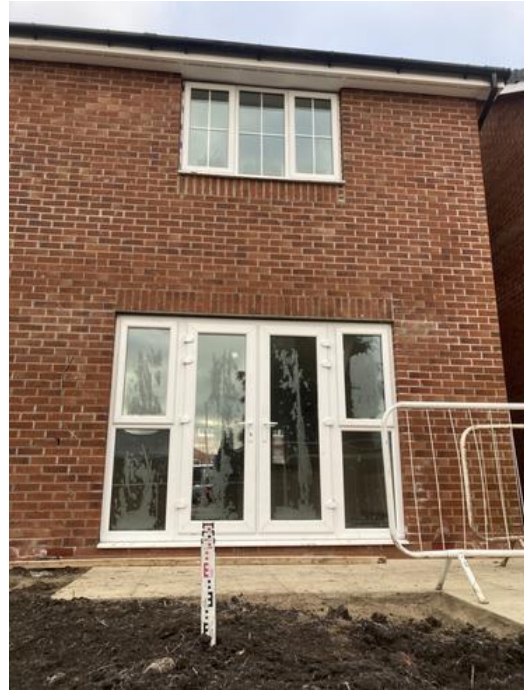
Photo 33

Depth of Cover System in Relation to Plot (Ensure the whole plot can be seen in the photo)

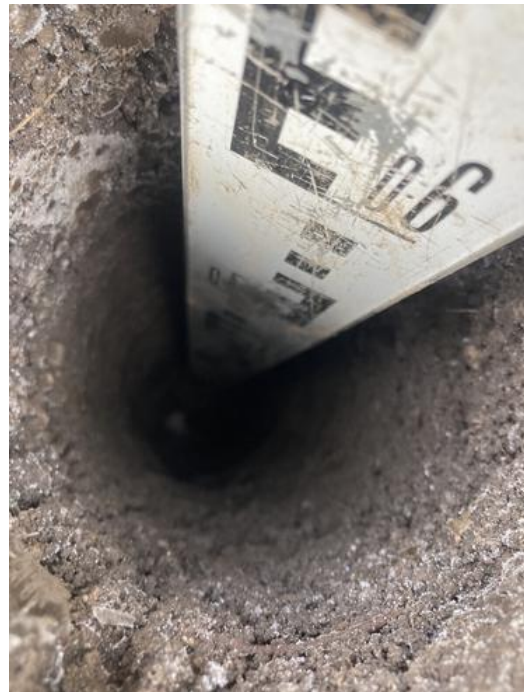
Photo 35

Depth of Cover System Materials (record the depth and support with Photo down the hole) 0.6

Depth of Topsoil (mm) 150

Depth of Subsoil (mm) 450

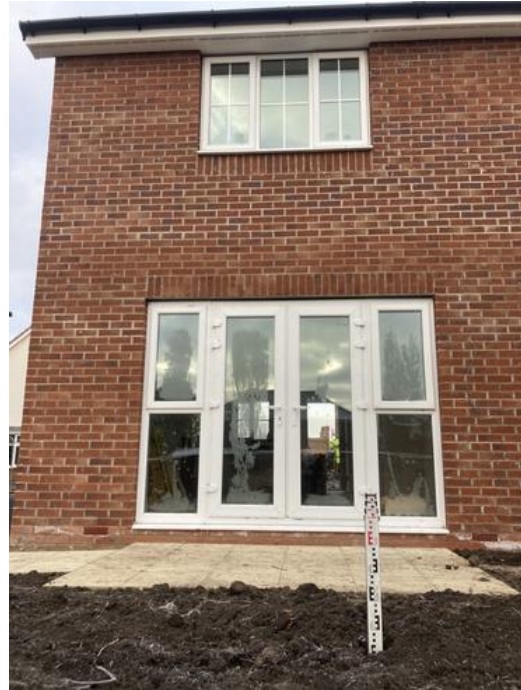
Photo 41

Depth of Cover System in Relation to Plot (Ensure the whole plot can be seen in the photo) ☒

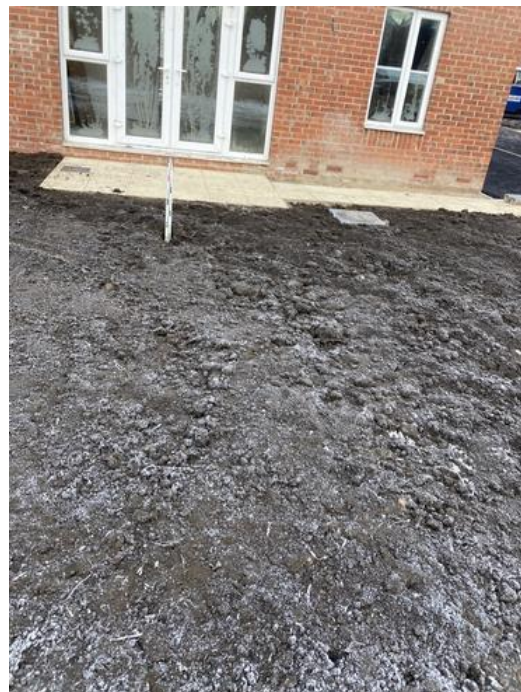
Photo 43

Depth of Cover System Materials (record the depth and support with Photo down the hole) 0.6

Depth of Topsoil (mm) 150

Depth of Subsoil (mm) 450

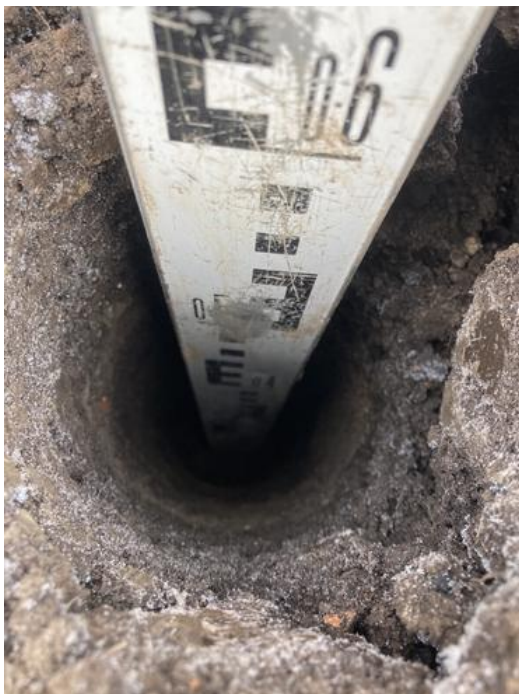
Photo 54

**Depth of Cover System Materials (record the depth and support with Photo down the hole)**

0.6

**Depth of Topsoil (mm)**

150

**Depth of Subsoil (mm)**

450

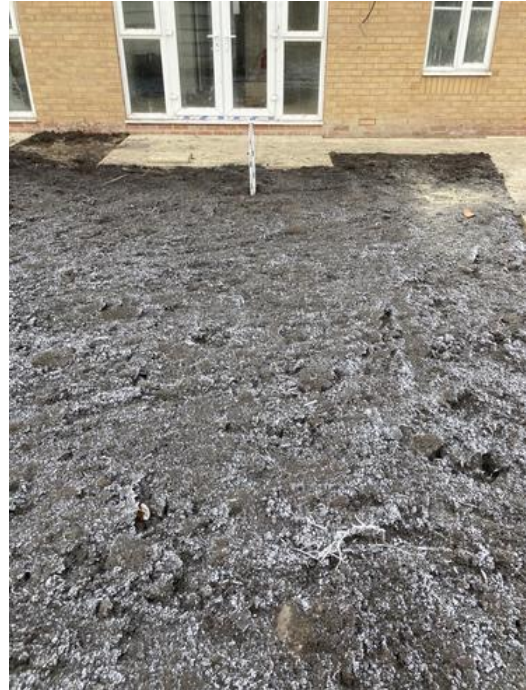
Photo 65

**Depth of Cover System Materials (record the depth and support with Photo down the hole)**

0.6

**Depth of Topsoil (mm)**

150

**Depth of Subsoil (mm)**

450

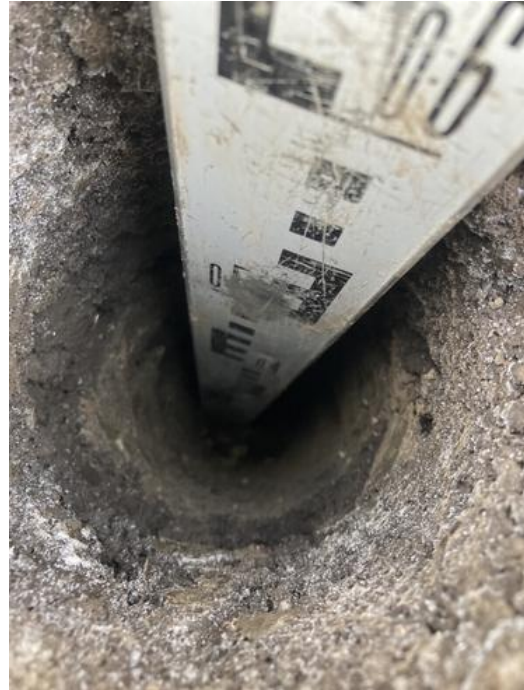
Photo 81

**Depth of Cover System Materials (record the depth and support with Photo down the hole)**

0.6

**Depth of Topsoil (mm)**

150

**Depth of Subsoil (mm)**

450

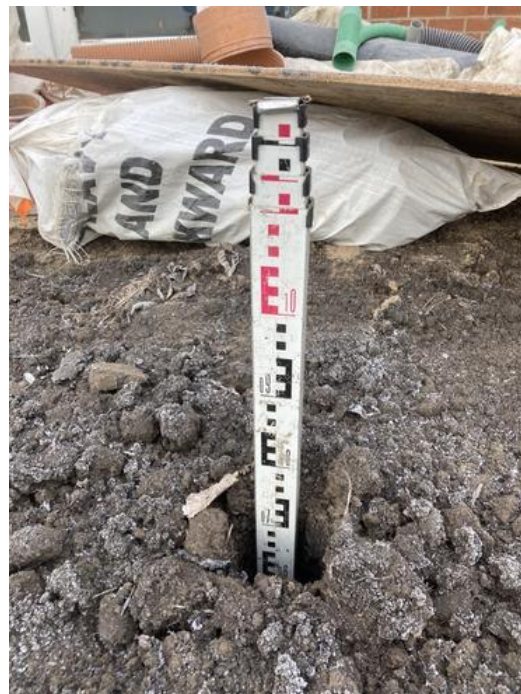
Photo 87

Depth of Cover System Materials (record the depth and support with Photo down the hole)

0.6

Depth of Topsoil (mm)

150

Depth of Subsoil (mm)

450

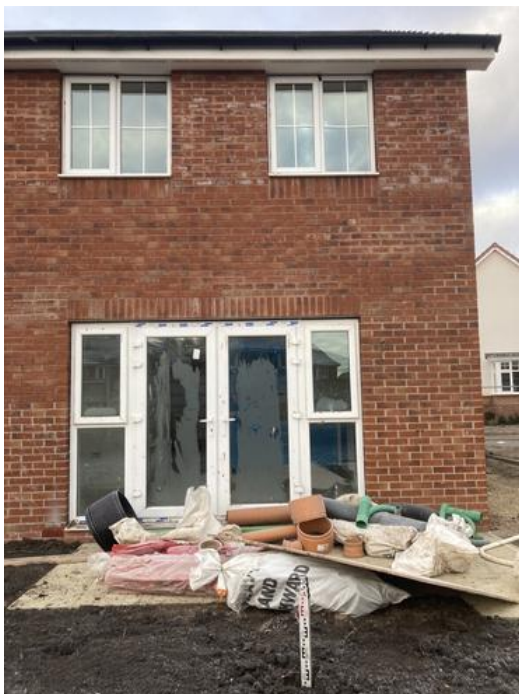
Photo 98

Depth of Cover System in Relation to Plot (Ensure the whole plot can be seen in the photo)

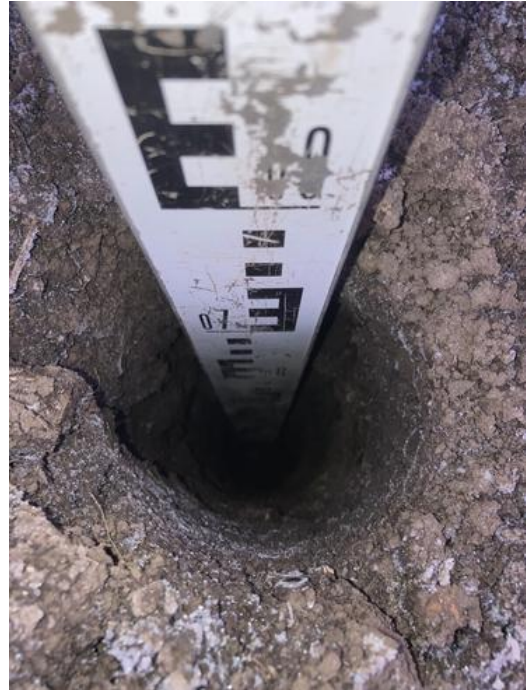
Photo 121

**Depth of Cover System Materials (record the depth and support with Photo down the hole)** 0.6

**Depth of Topsoil (mm)** 150

**Depth of Subsoil (mm)** 450
