4047-04 / JH

## **COVER SYSTEM VALIDATION REPORT - PARKMOUNT ROAD, MANCHESTER – PLOTS 5-13 (BLOCKS 1B & 2)**

### **This Validation Report concerns the cover system validation of plots 5-13 only.**

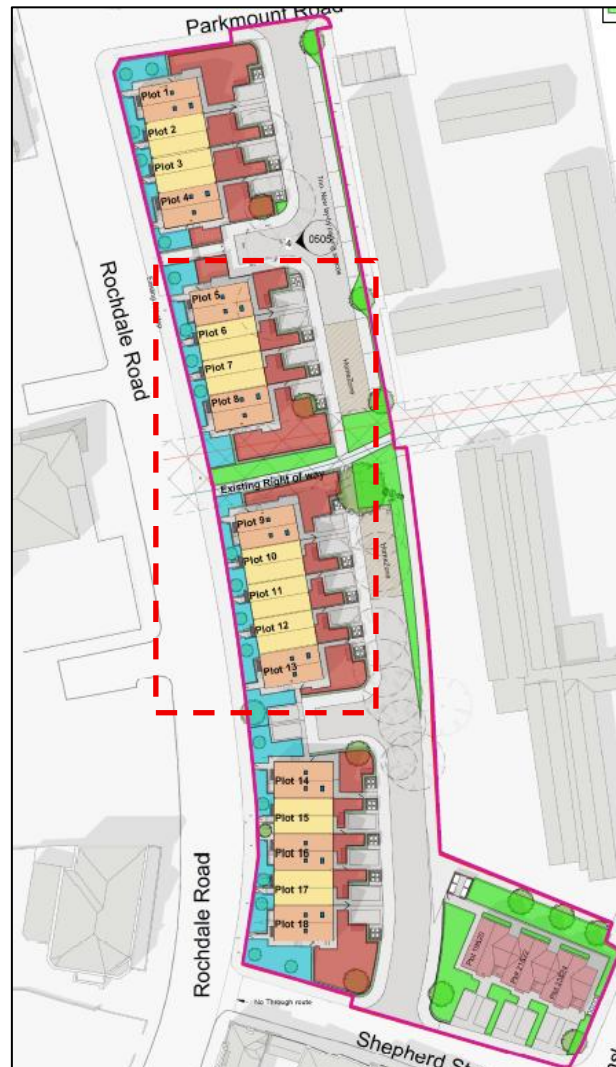
The following Landscaping Plan details the private rear gardens (red), private front gardens (blue) and POS soft landscaping (Public Open Space / POSresi – green) on site. This cover system validation report will refer to the landscaping designations detailed in the below extract.

Figure 1: Extract of the landscape plan of the site (SI-02 Landscaping Plan, Mar 2024). Red = private rear gardens.  
Blue = private front gardens. Green = soft landscaping / public open space.

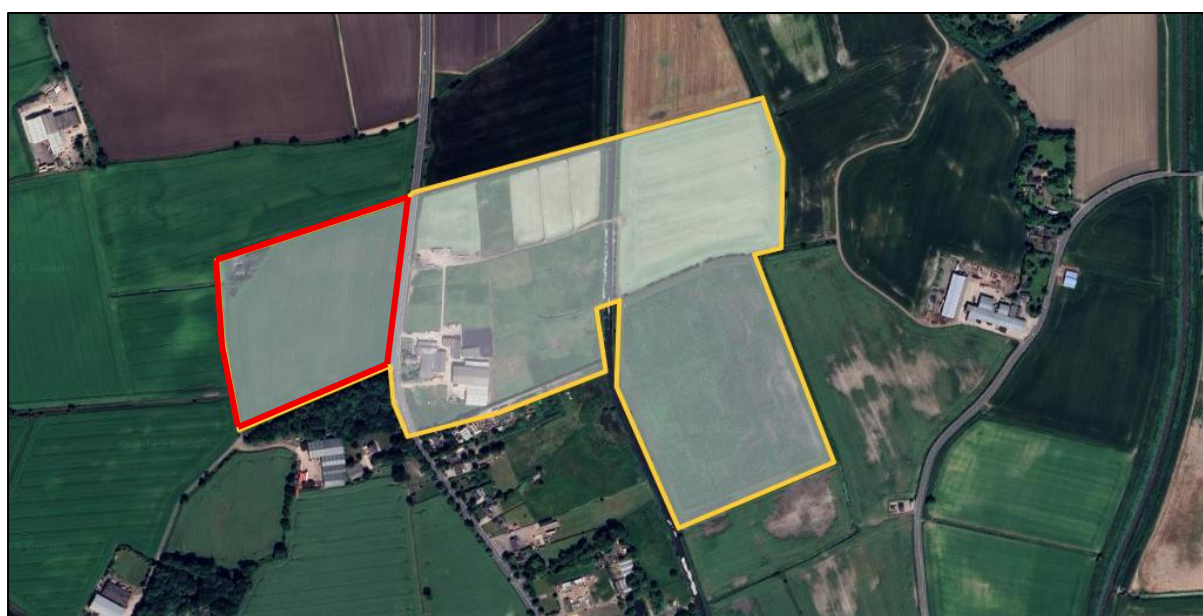
The topsoil for the clean cover system was imported from R Draper Ltd, a topsoil supplier, the topsoil was sourced from Fearn's Farm Equestrian & Country, Liverpool Rd, Rufford, Ormskirk L40 1SQ. The material is Grade 1 topsoil excavated from greenfield land. Chemical testing of the imported topsoil was provided by the supplier and assessed by IGE Consulting. A google maps extract of the site and 5 No. historical maps have been included below to illustrate the greenfield nature of the site. The topsoil was taken from the western field of the site, indicated by the red boundary below. No material was taken from in and around the farm buildings and topsoil only was exported from site.

Figure 2: Google Maps extract showing Fearn's Farm Equestrian & Country (approximate site boundary shown in yellow), Area of topsoil strip shown with red boundary.

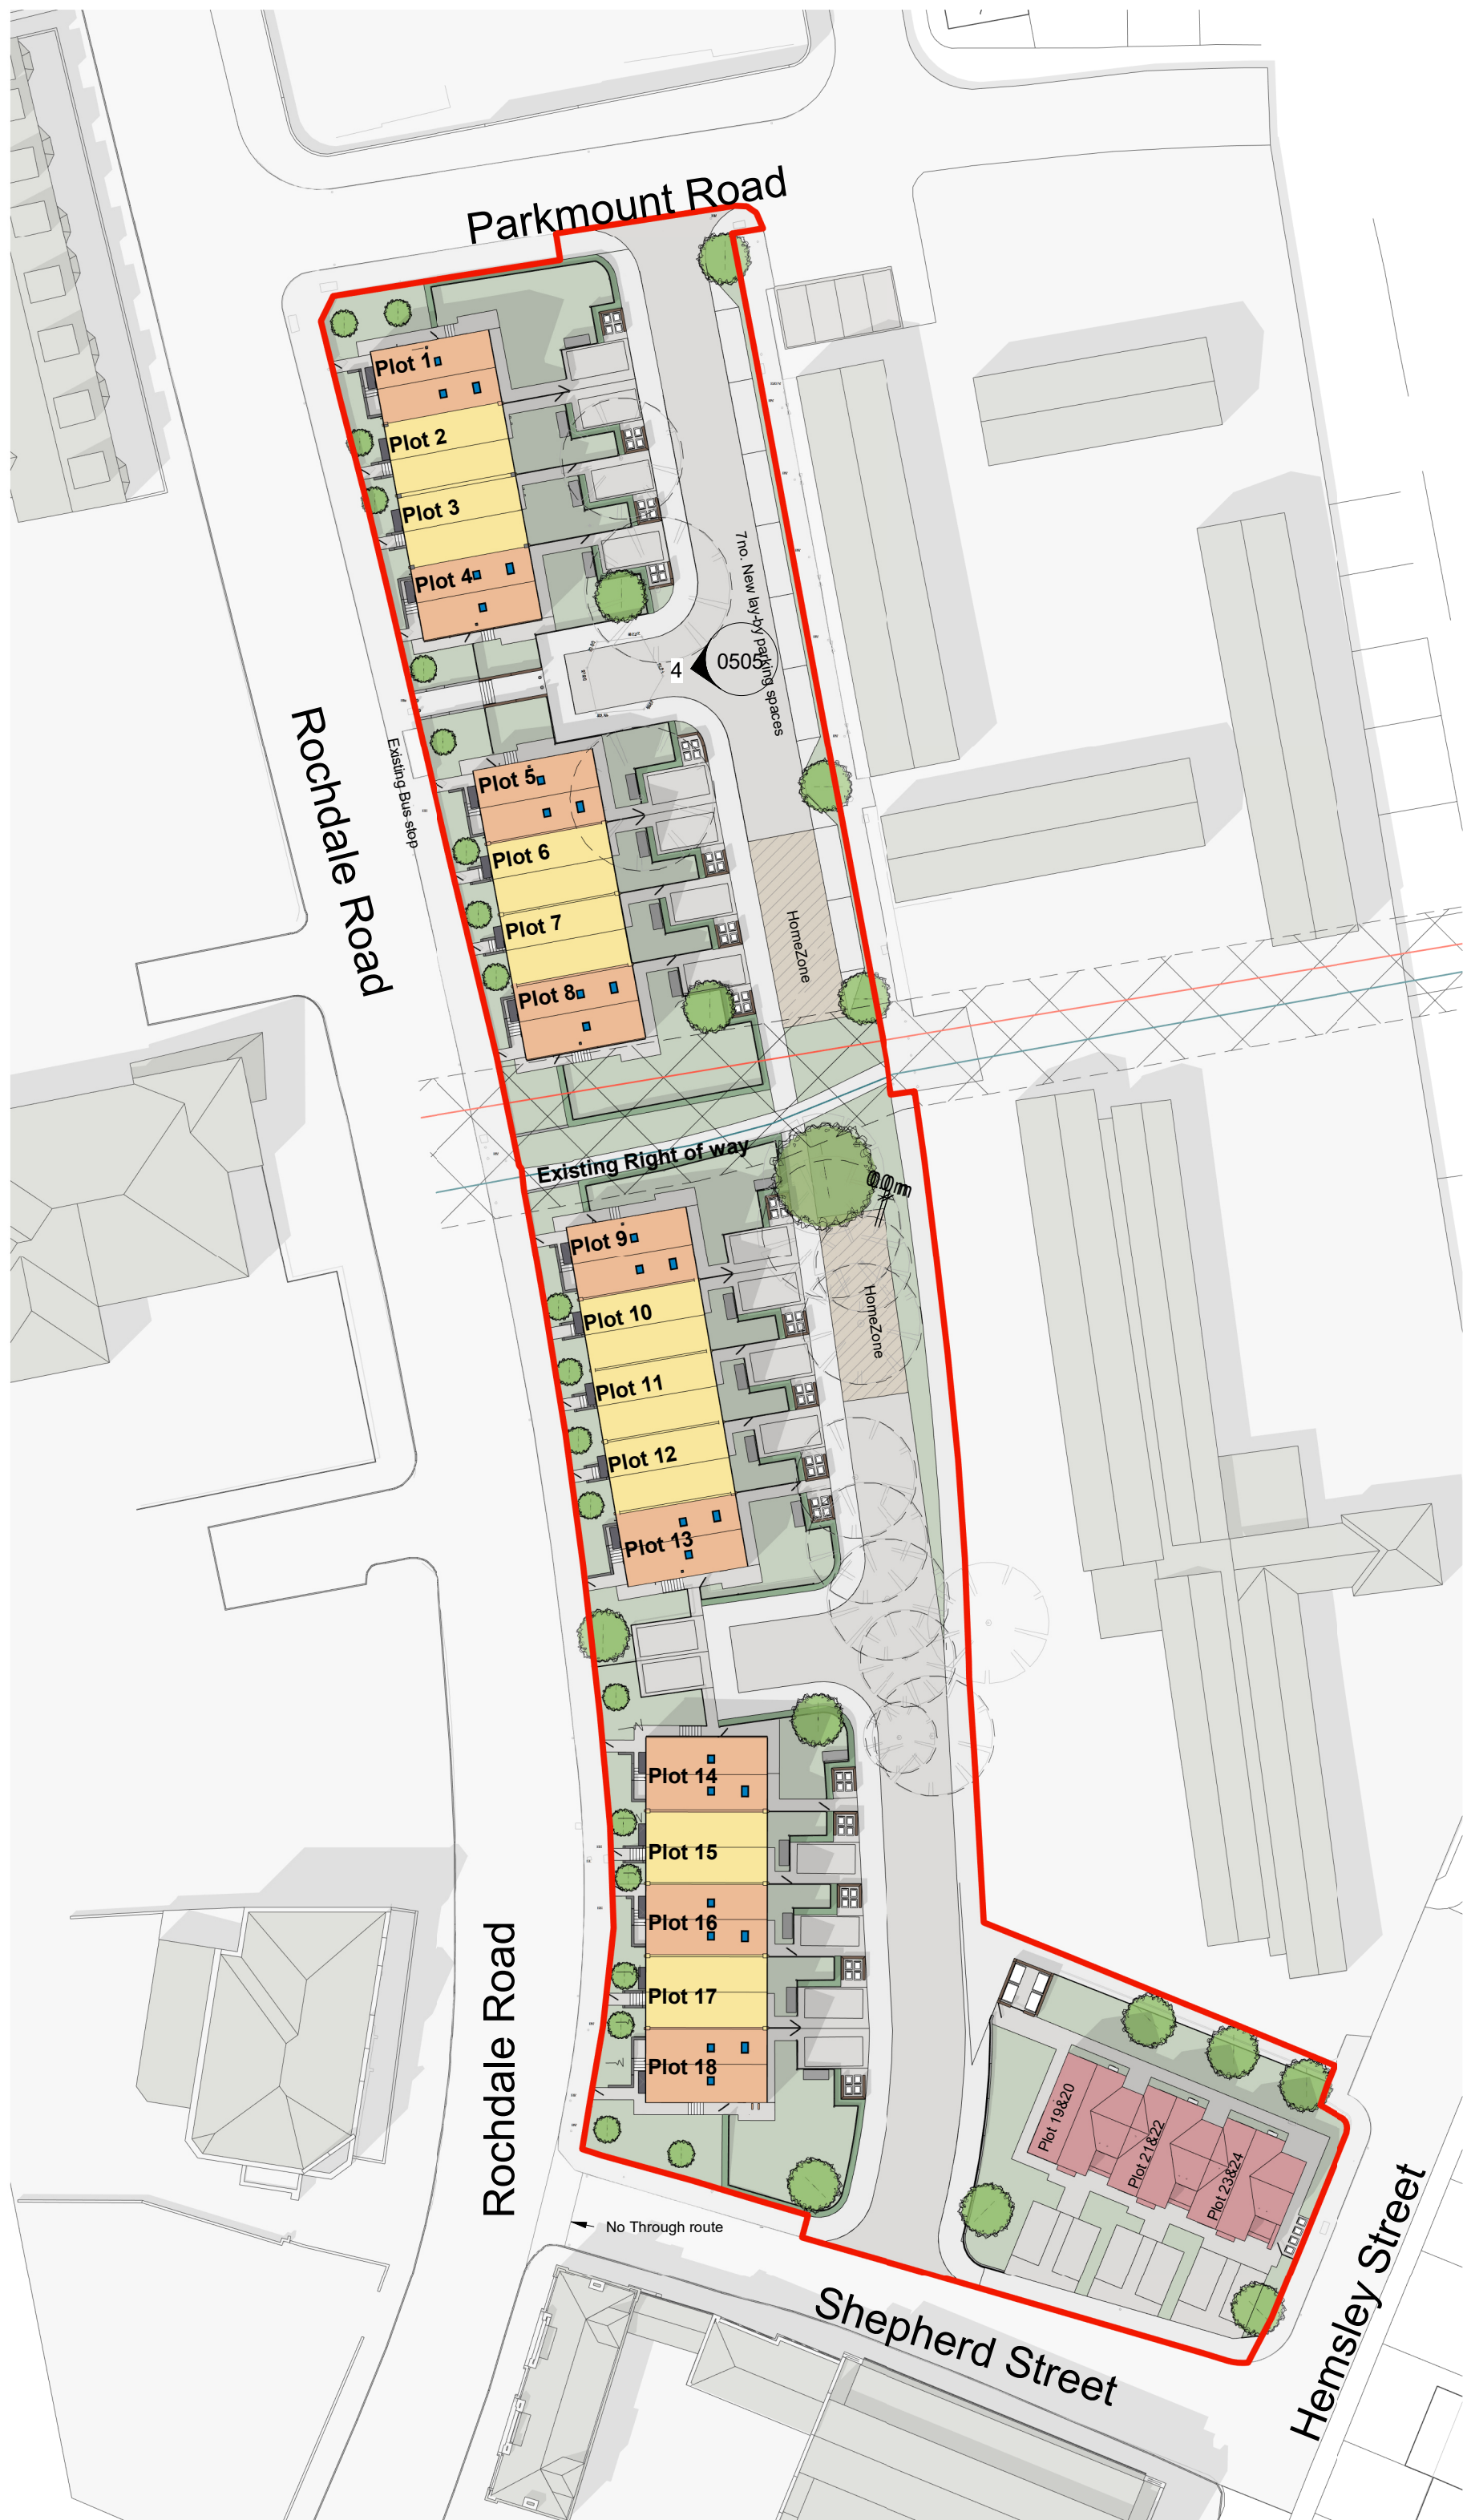
Site Layout - Proposed  
Scale @ 1 : 500

Eight small holes were dug in total across plots 5-13; four holes in the private front gardens and four in private rear gardens. Photographs were taken of the cover system thickness in these areas, which was found to be equal or greater than the required thickness with the yellow hi-viz geotextile marker present. The photographs and confirmation of cover depth for the private gardens of plots 5-13 are contained in the Verification Logs in Appendix 4. Although confirmed as present during the visit and noticeable to the validator, the hi-viz membrane is not immediately clear on the attached verification logs for the rear gardens of Plots 9-13 due to the greater depth of cover system in this area (c.700-800mm) reducing the light at depth and the wet weather at the time of validation causing a smearing effect across the membrane. A development site layout plan, showing the locations of the gardens and soft landscaping areas, is contained in Appendix 1.

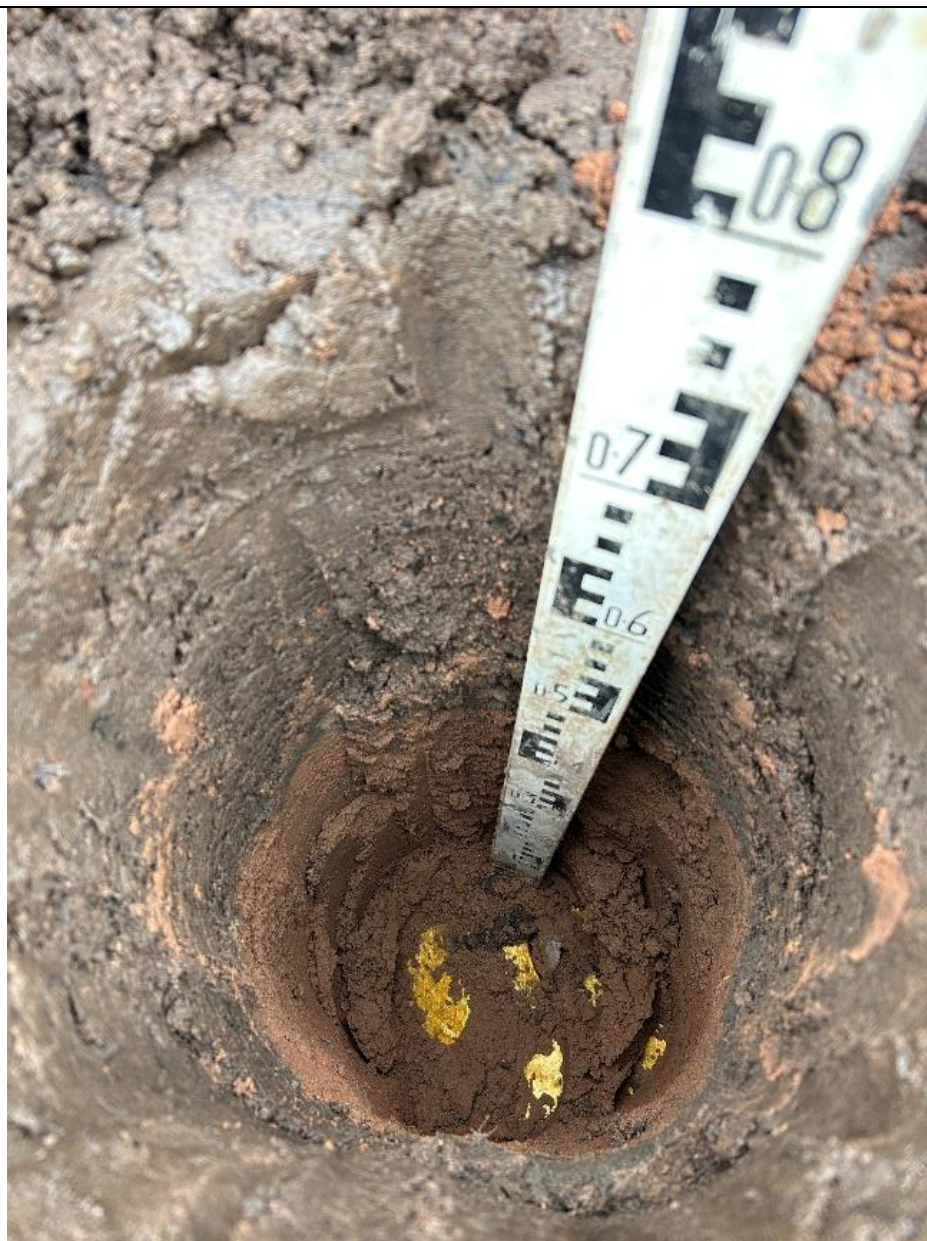
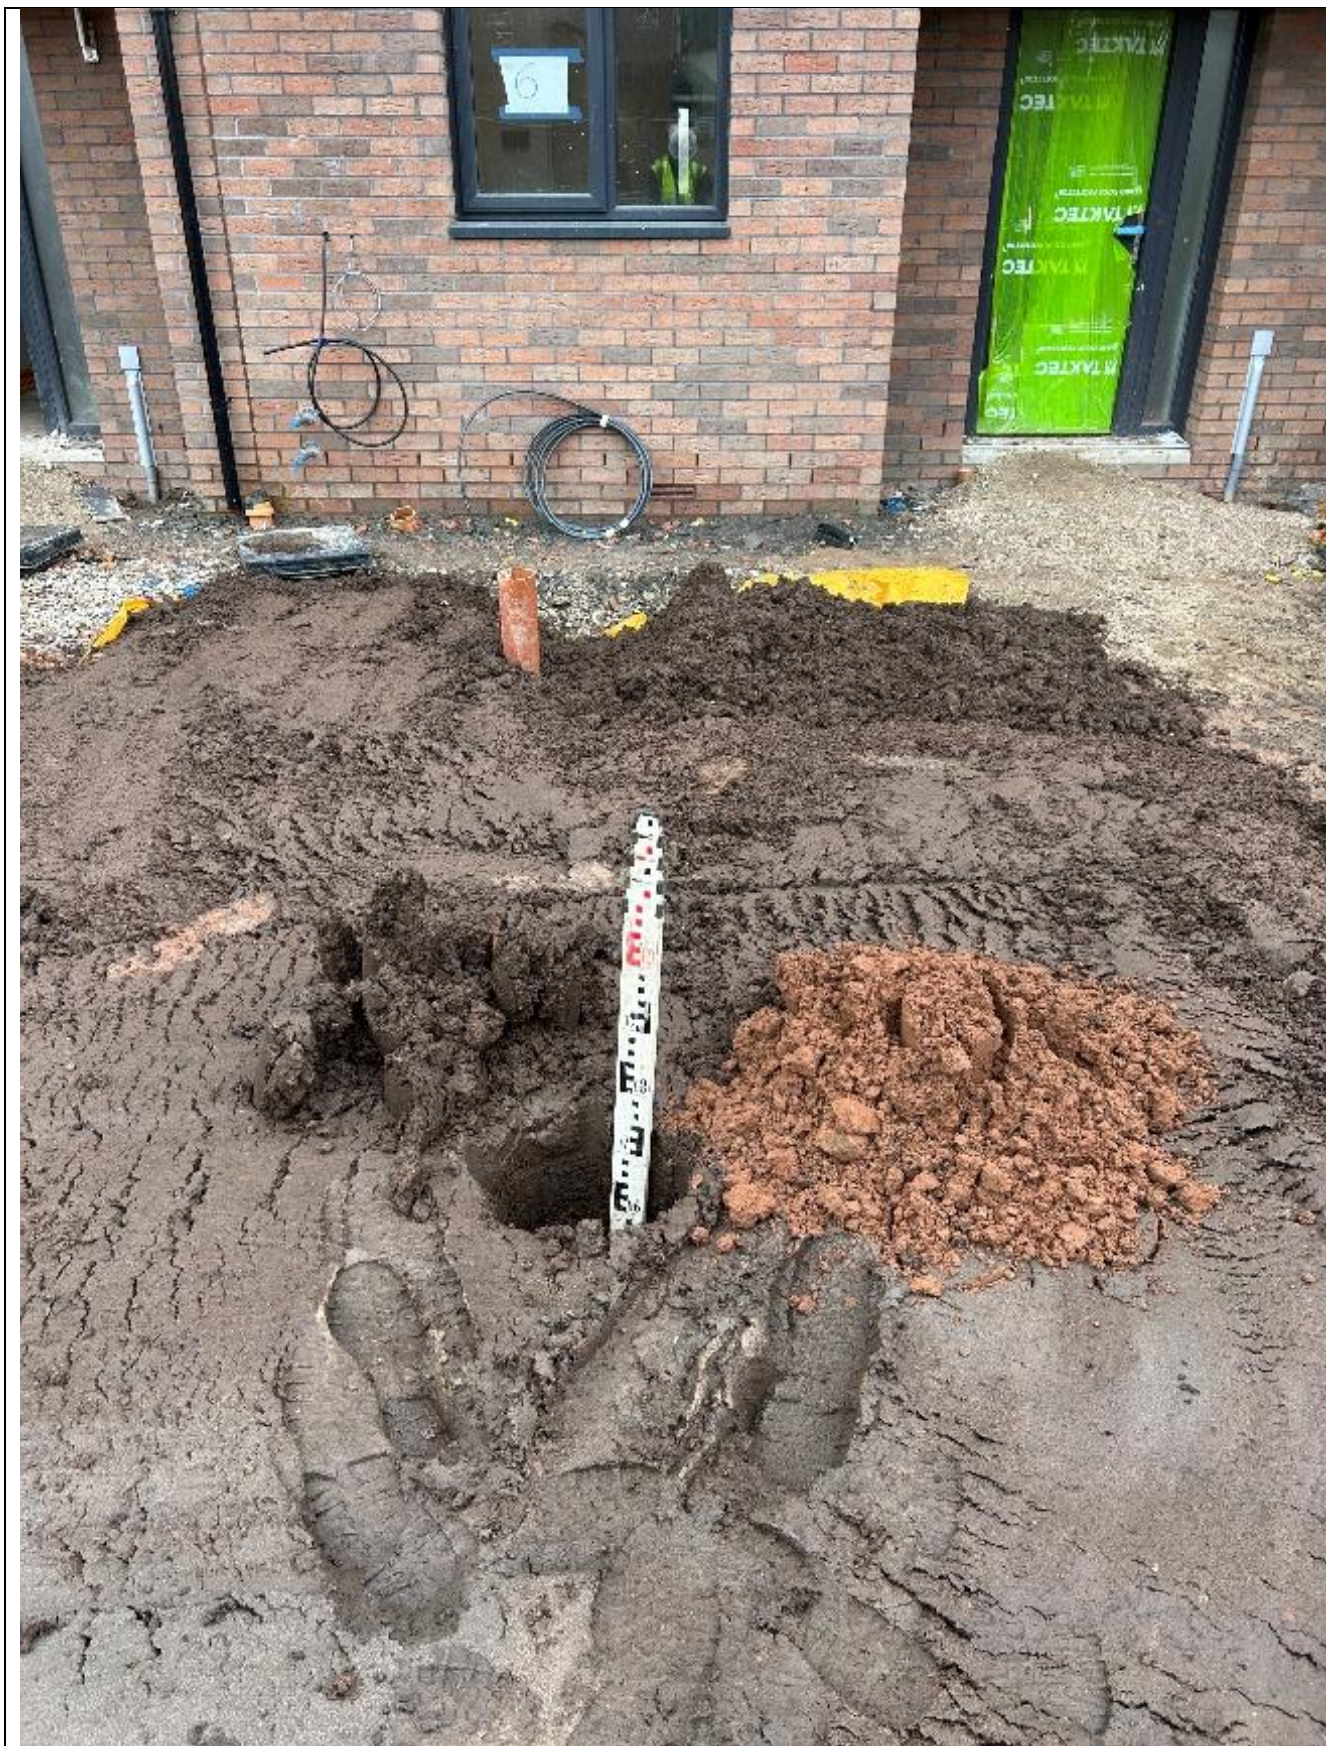
Photographs show 300mm of topsoil; underlain by 500mm subsoil; underlain by hi-vis membrane and plot context.

**This plot has PASSED / FAILED\* verification**

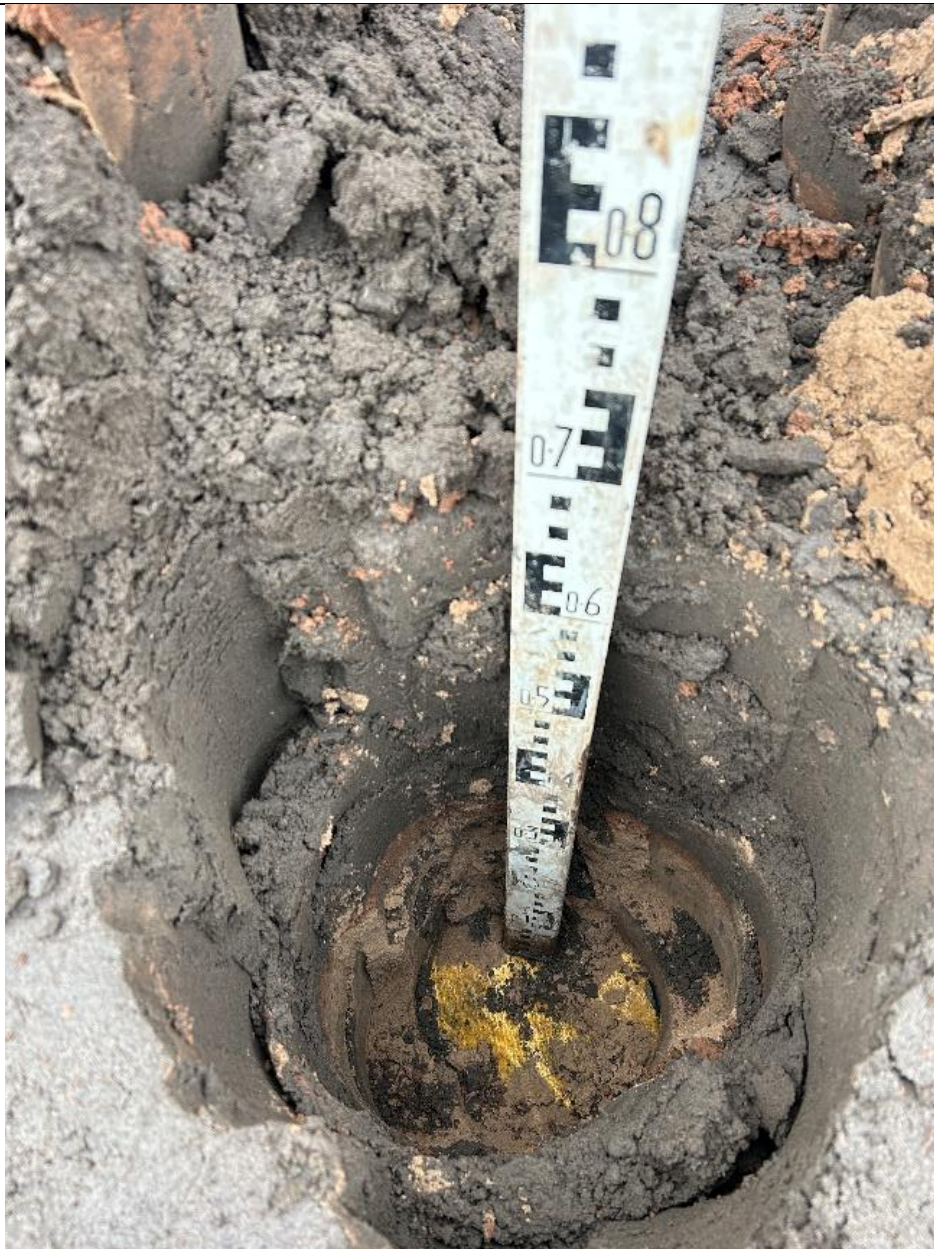
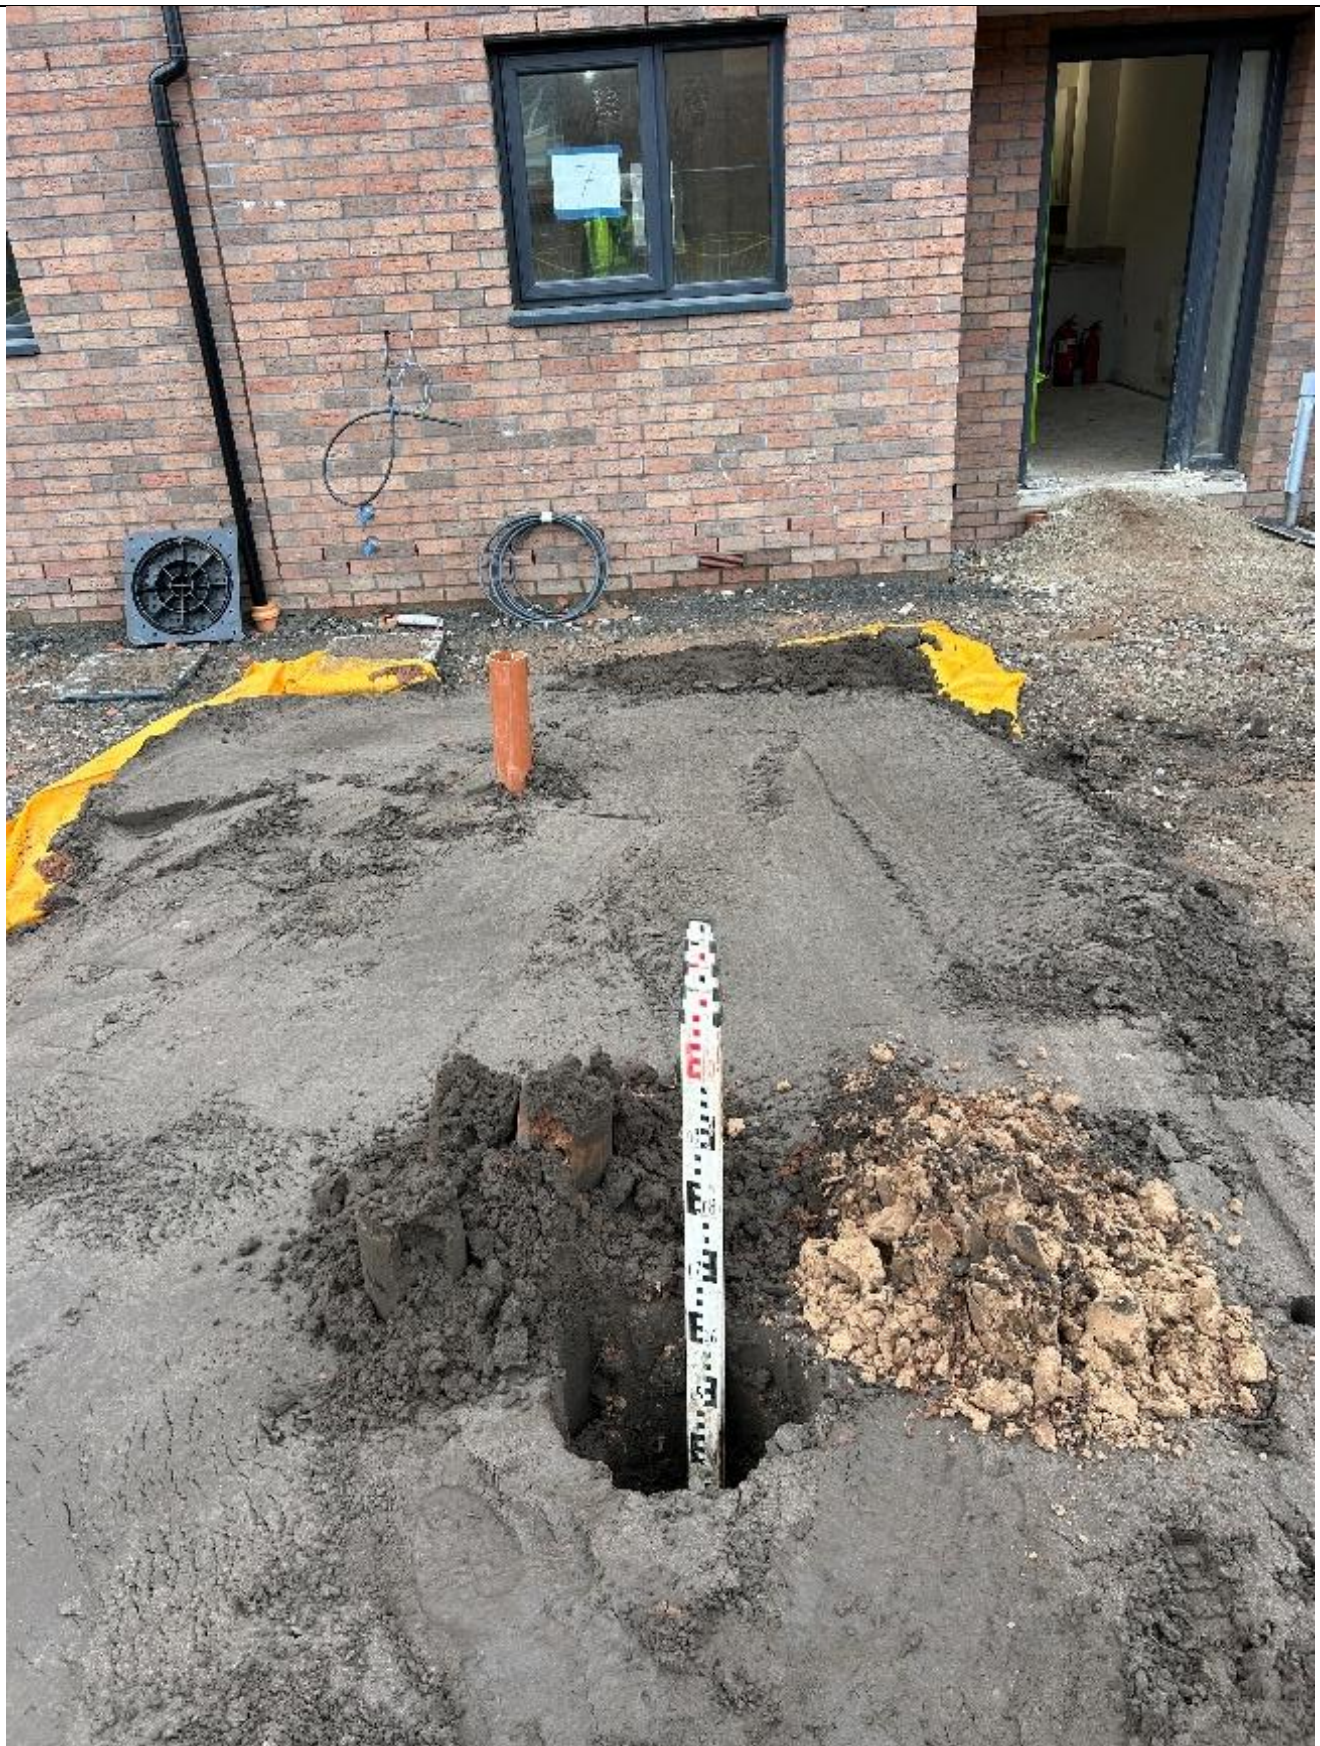
Photographs show 300mm of topsoil; underlain by 400mm subsoil; underlain by hi-vis membrane and plot context.

**This plot has PASSED / FAILED\* verification**

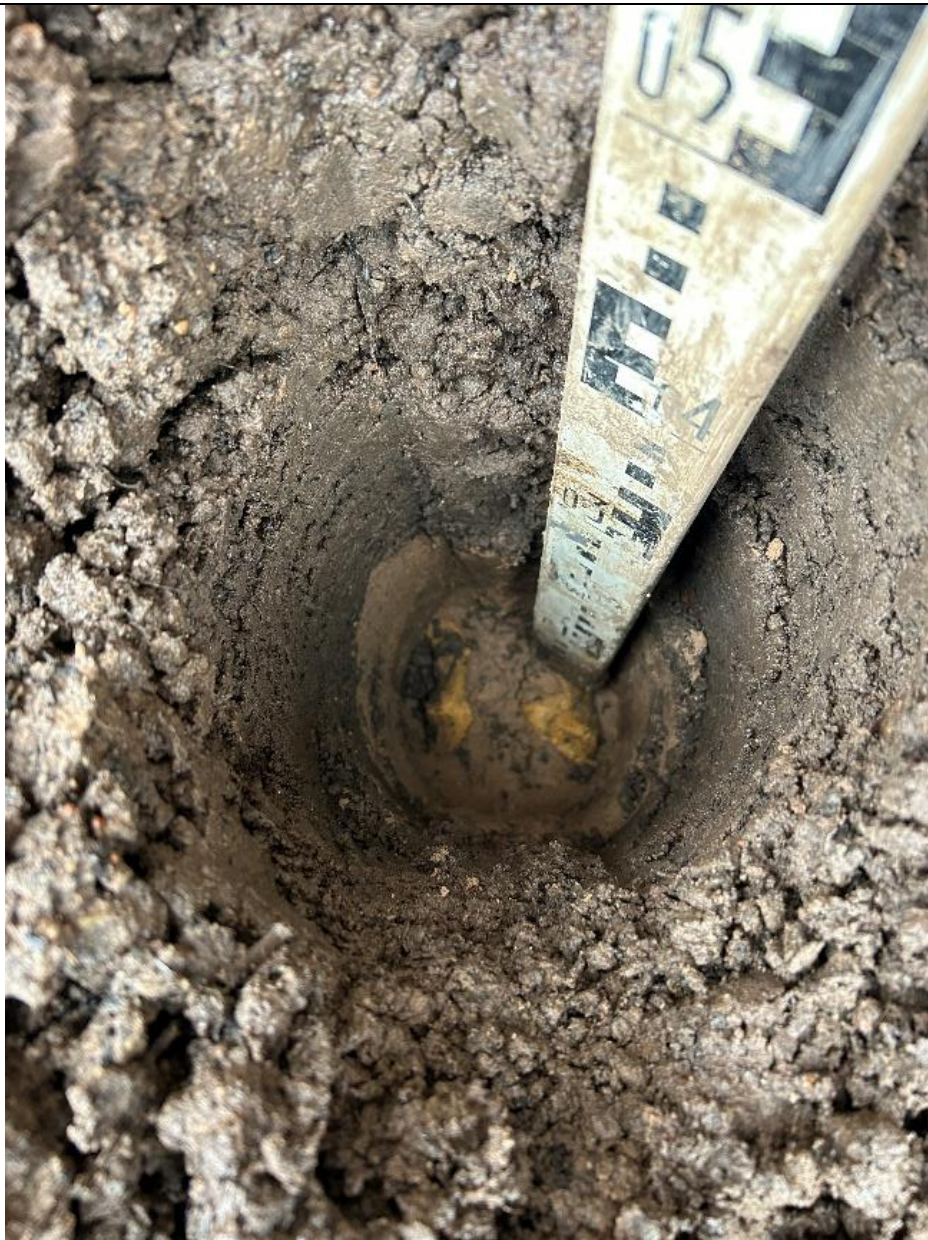
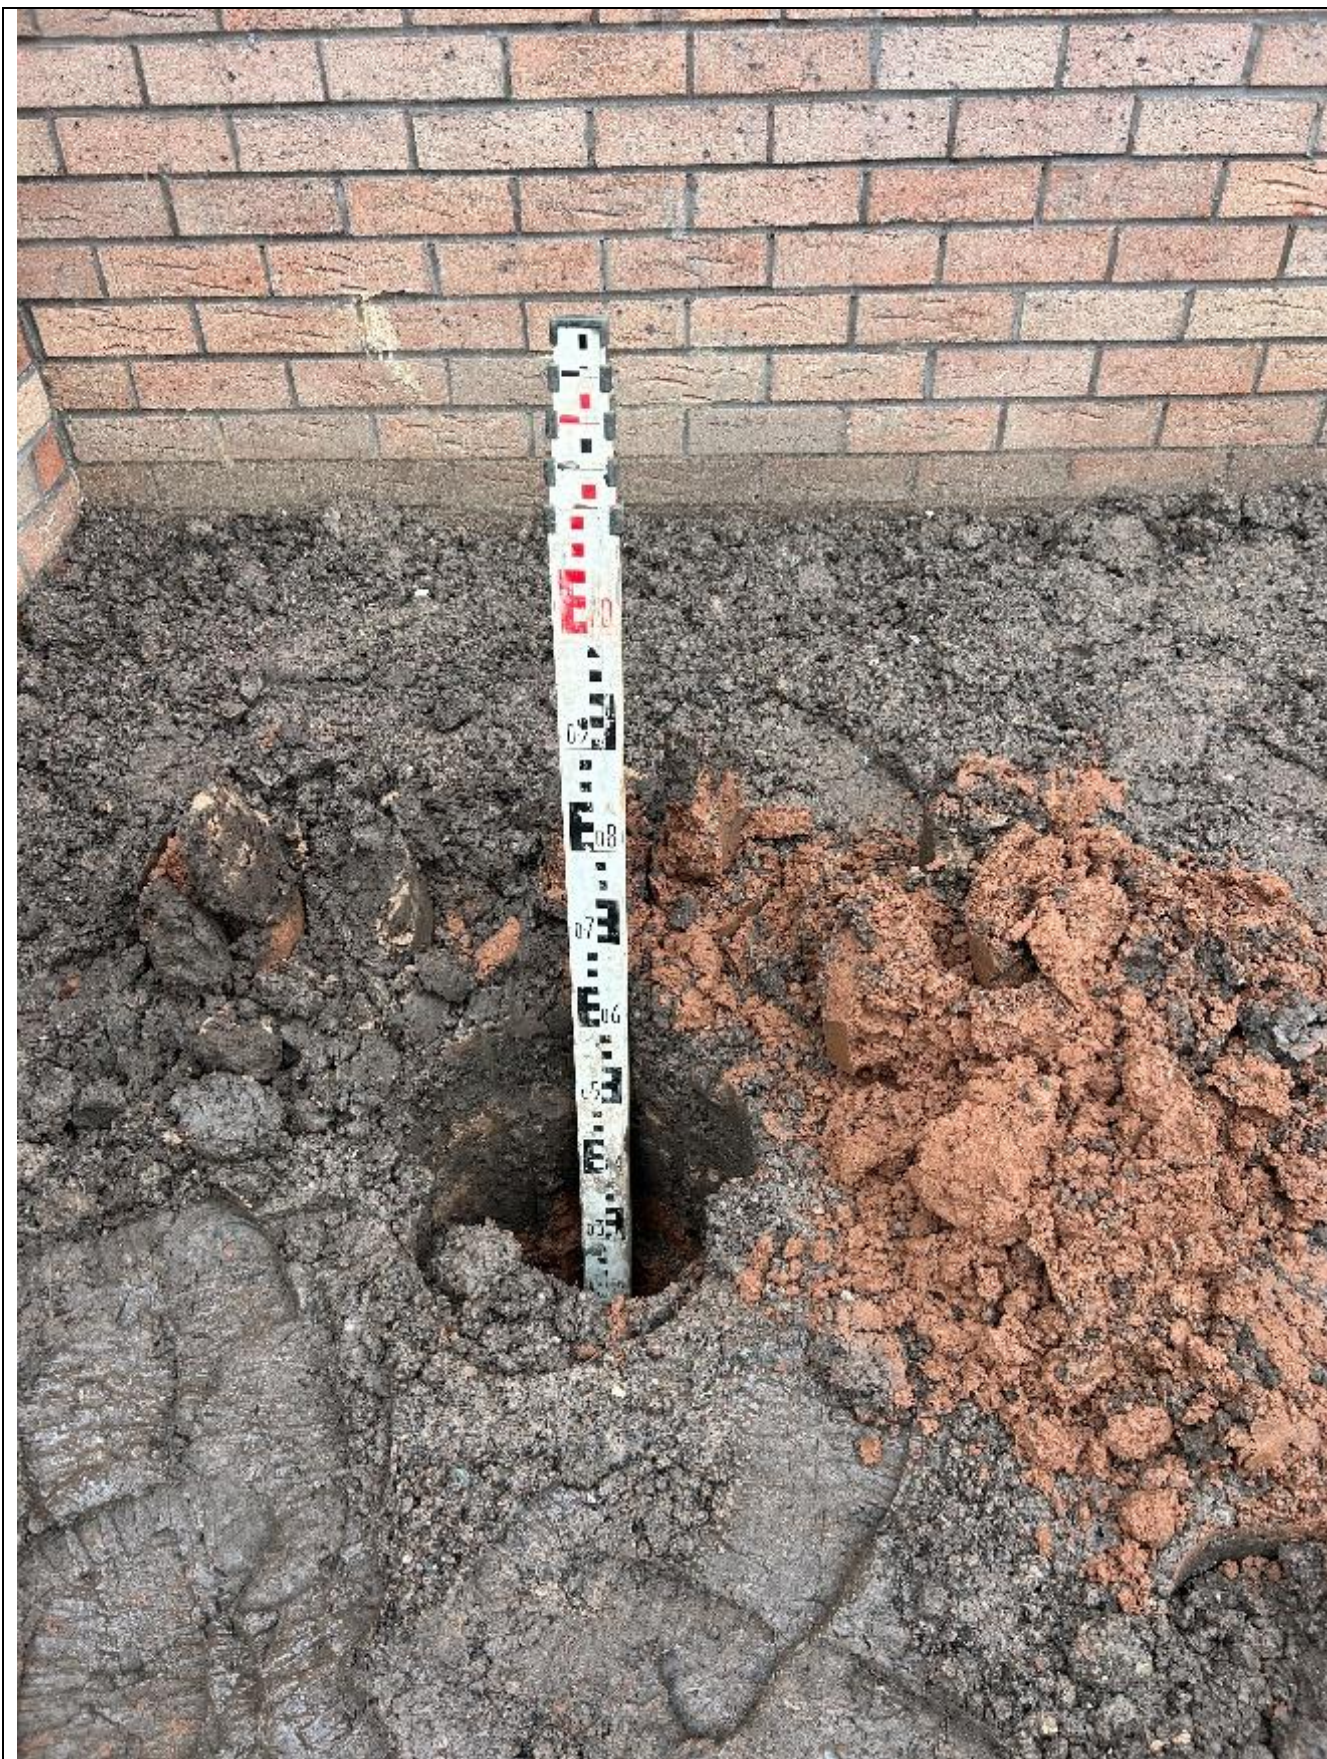
Photographs show 300mm of topsoil; underlain by 300mm subsoil; underlain by hi-vis membrane and plot context.

**This plot has PASSED / FAILED\* verification**

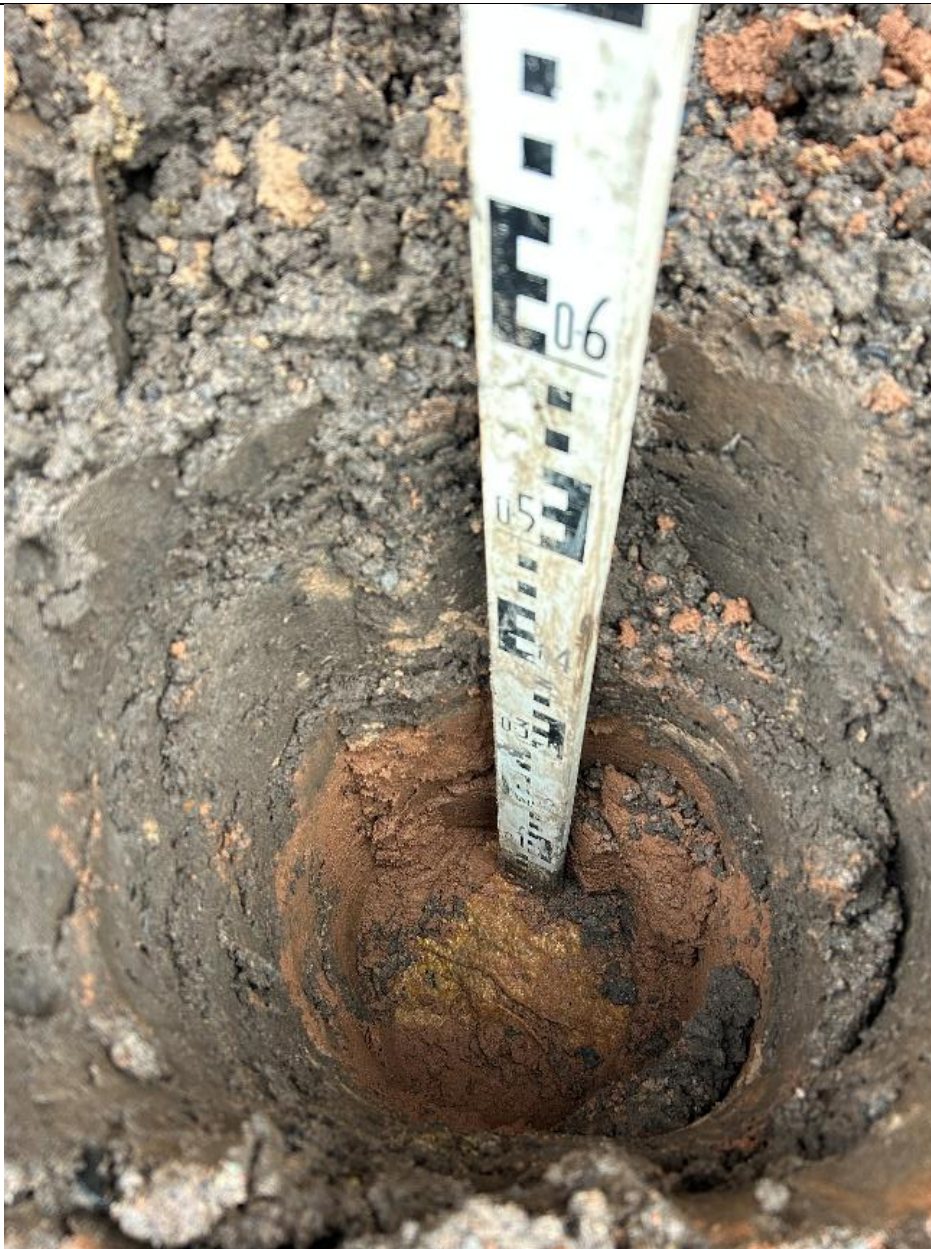
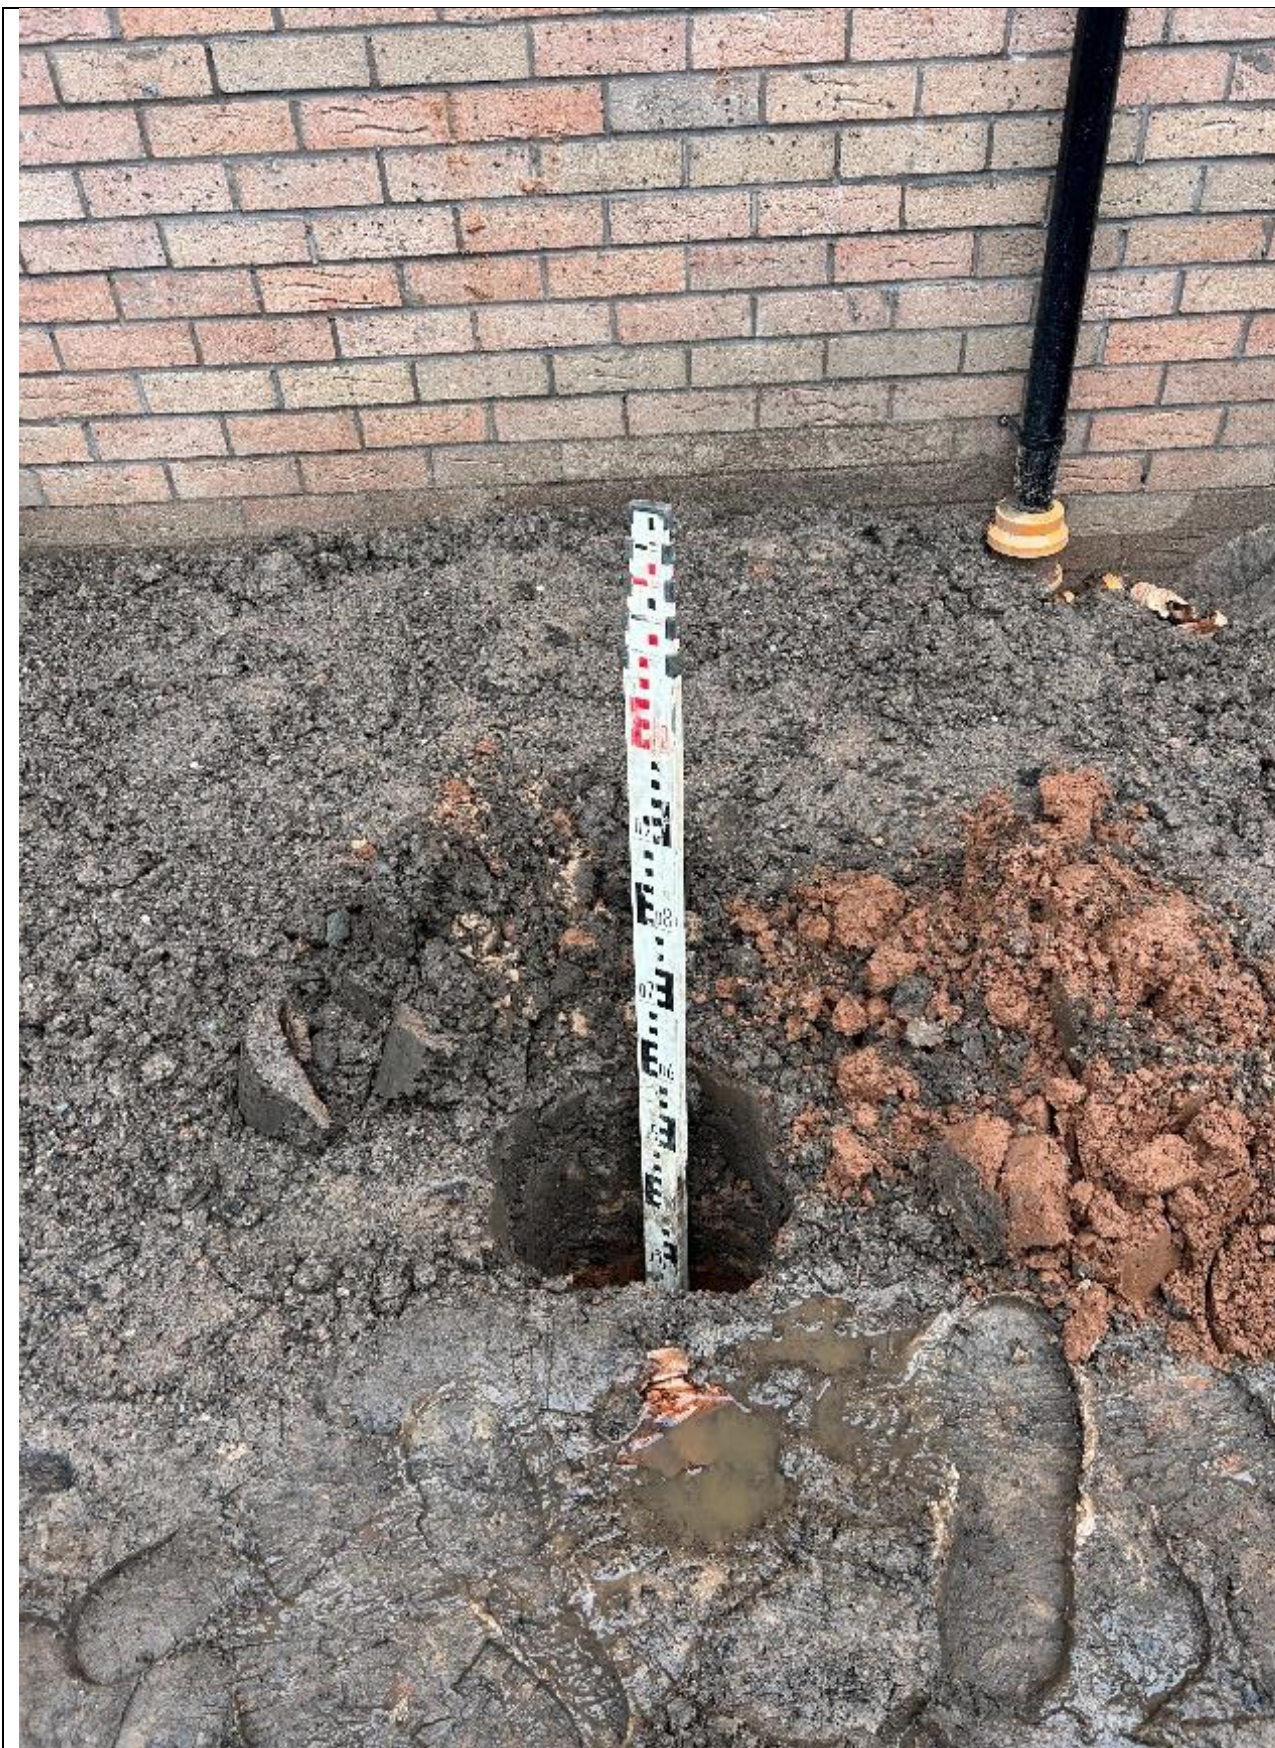
Photographs show 300mm of topsoil; underlain by 300mm subsoil; underlain by hi-vis membrane and plot context.

**This plot has PASSED / ~~FAILED~~\* verification**

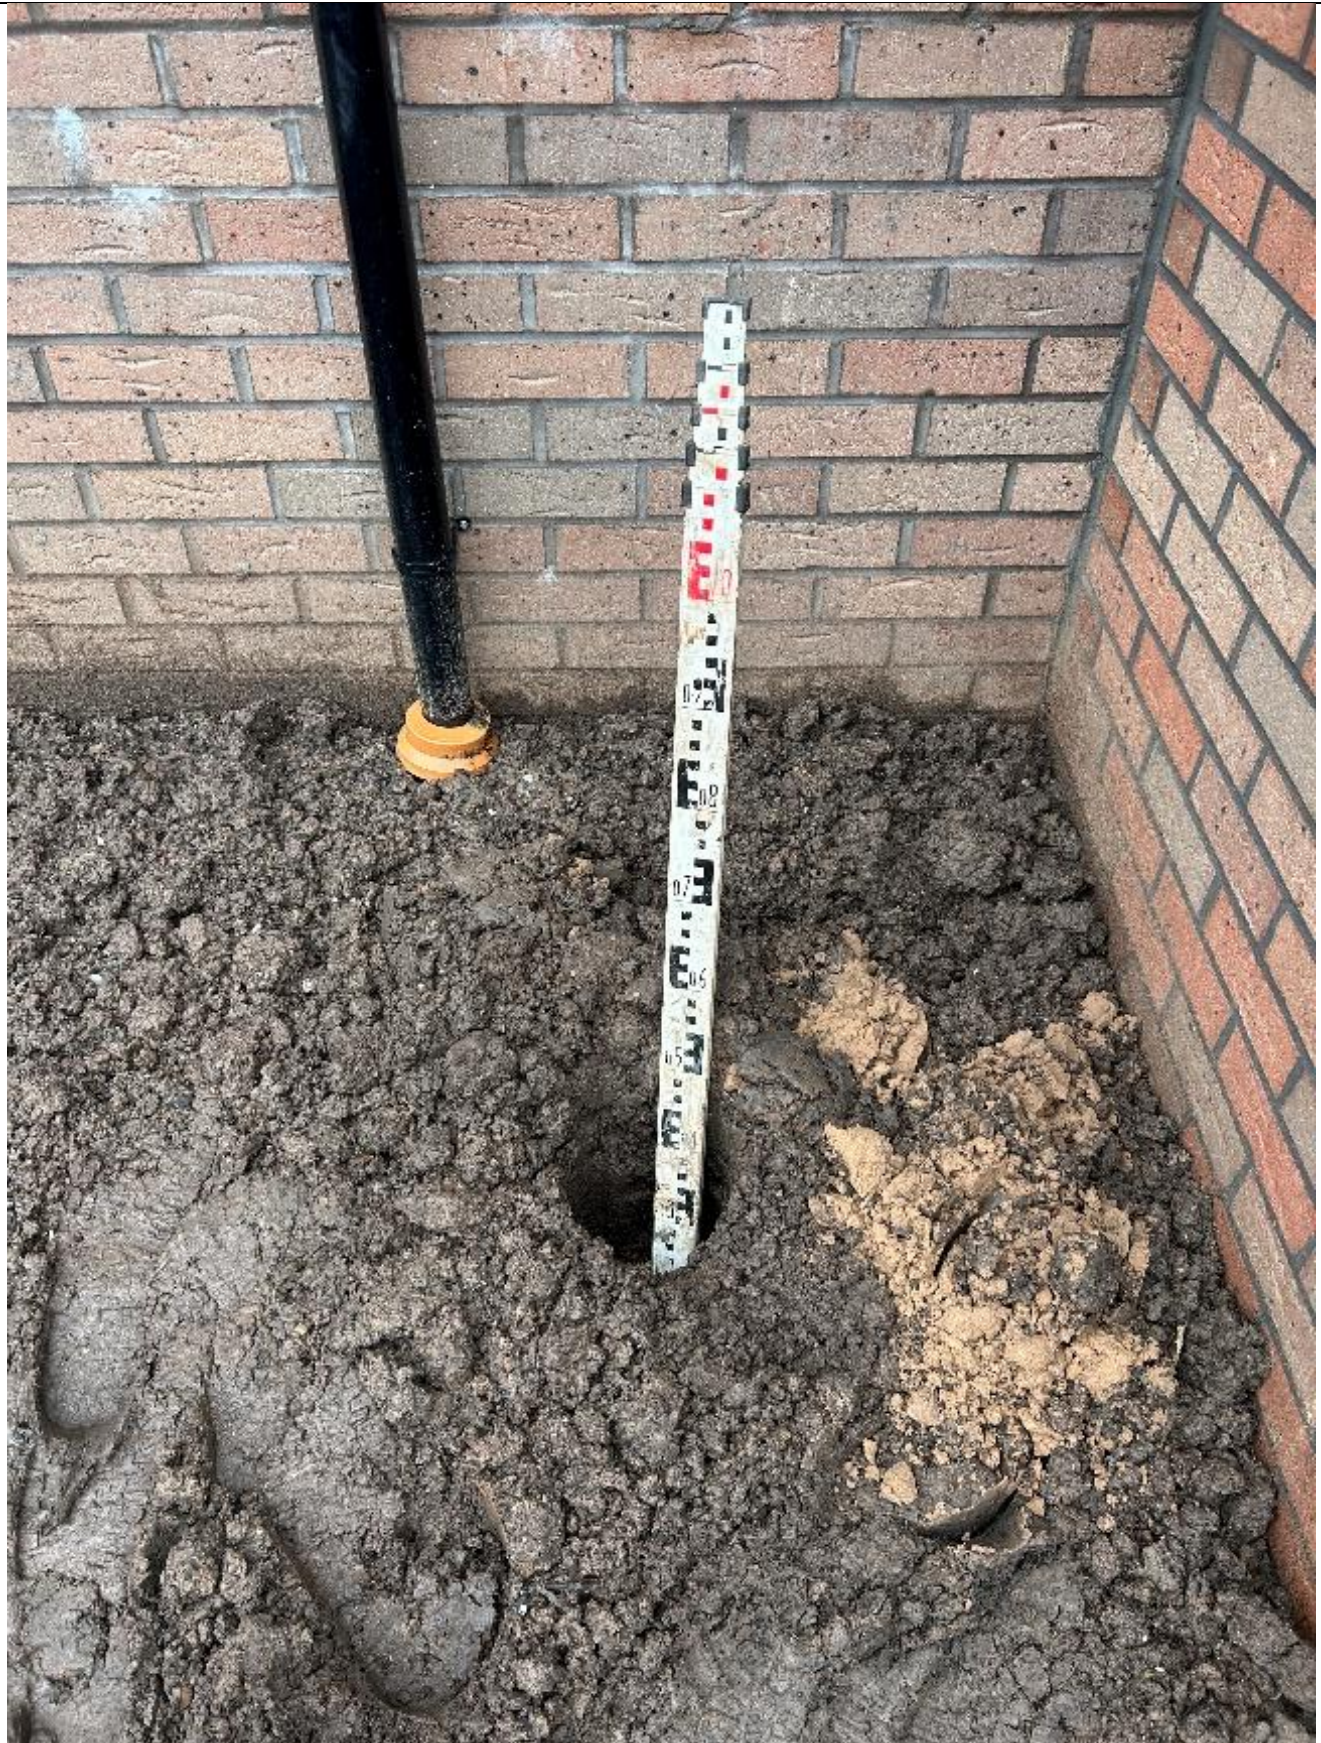
Photographs show 300mm of topsoil; underlain by 300mm subsoil; underlain by hi-vis membrane and plot context.

**This plot has PASSED / ~~FAILED~~\* verification**
