4047-04 / JH

## **COVER SYSTEM VALIDATION REPORT - PARKMOUNT ROAD, MANCHESTER – PLOTS 5-13 (BLOCKS 1B & 2)**

### **This Validation Report concerns the cover system validation of plots 5-13 only.**

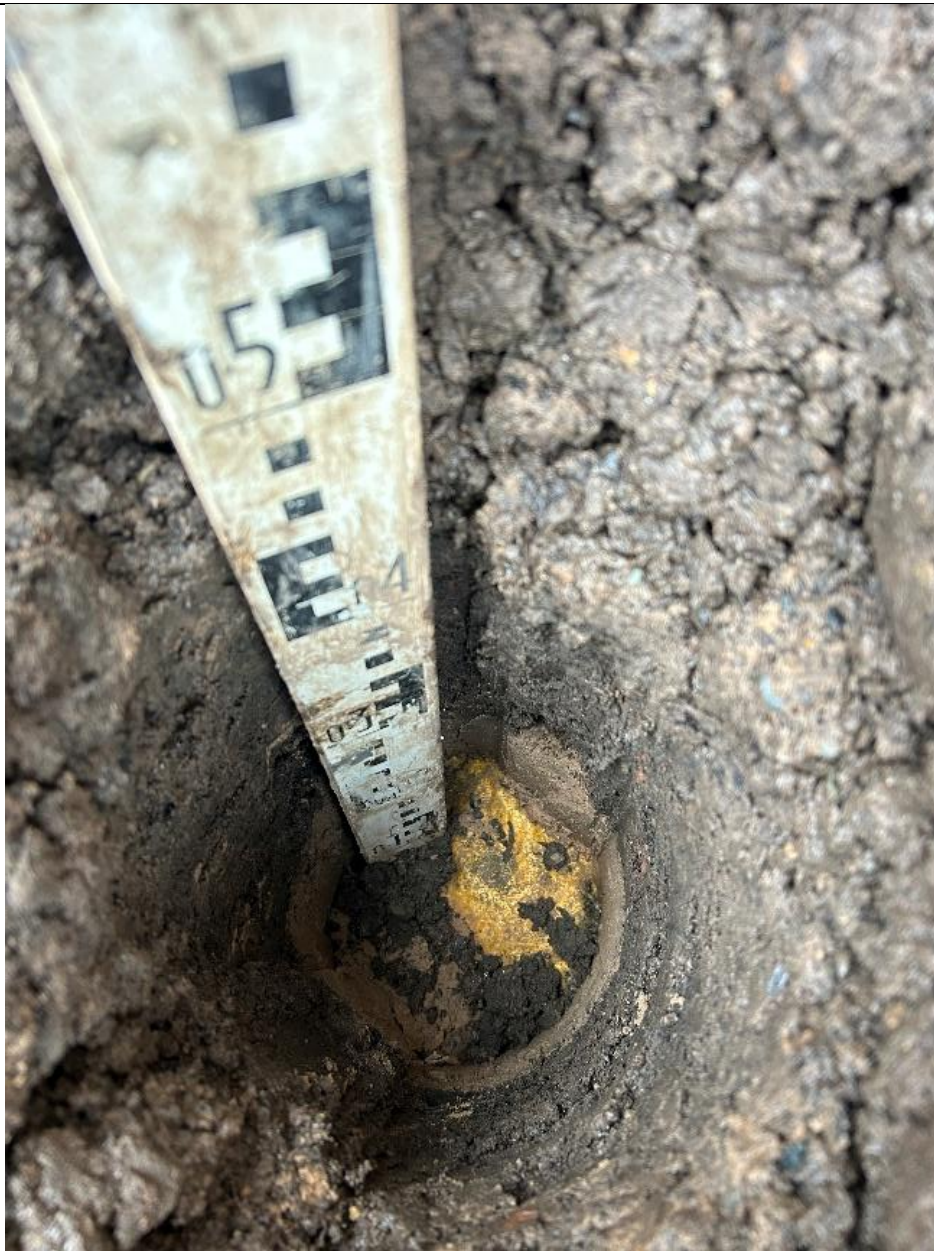
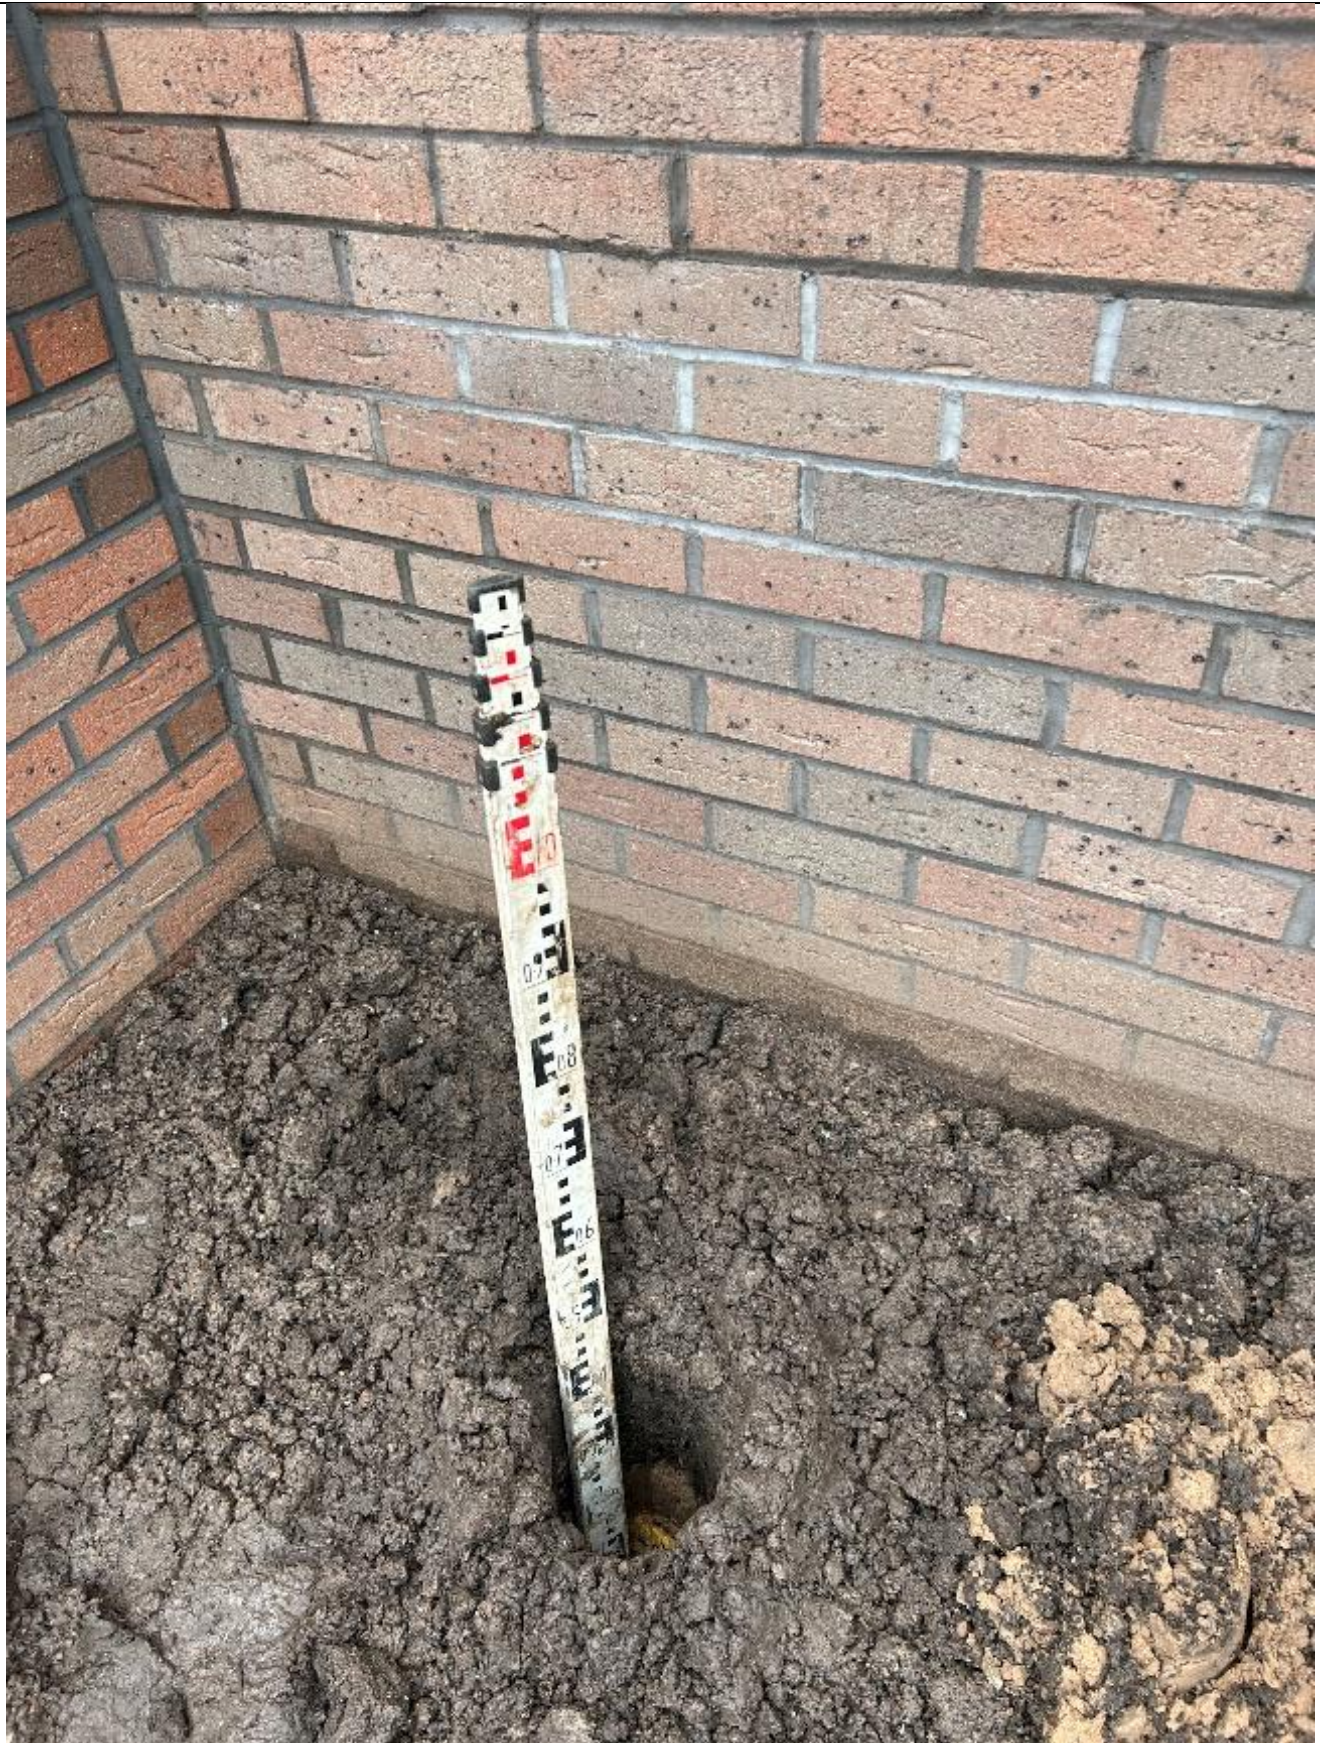
Photographs show 300mm of topsoil; underlain by 300mm subsoil; underlain by hi-vis membrane and plot context.

**This plot has PASSED / ~~FAILED~~\* verification**

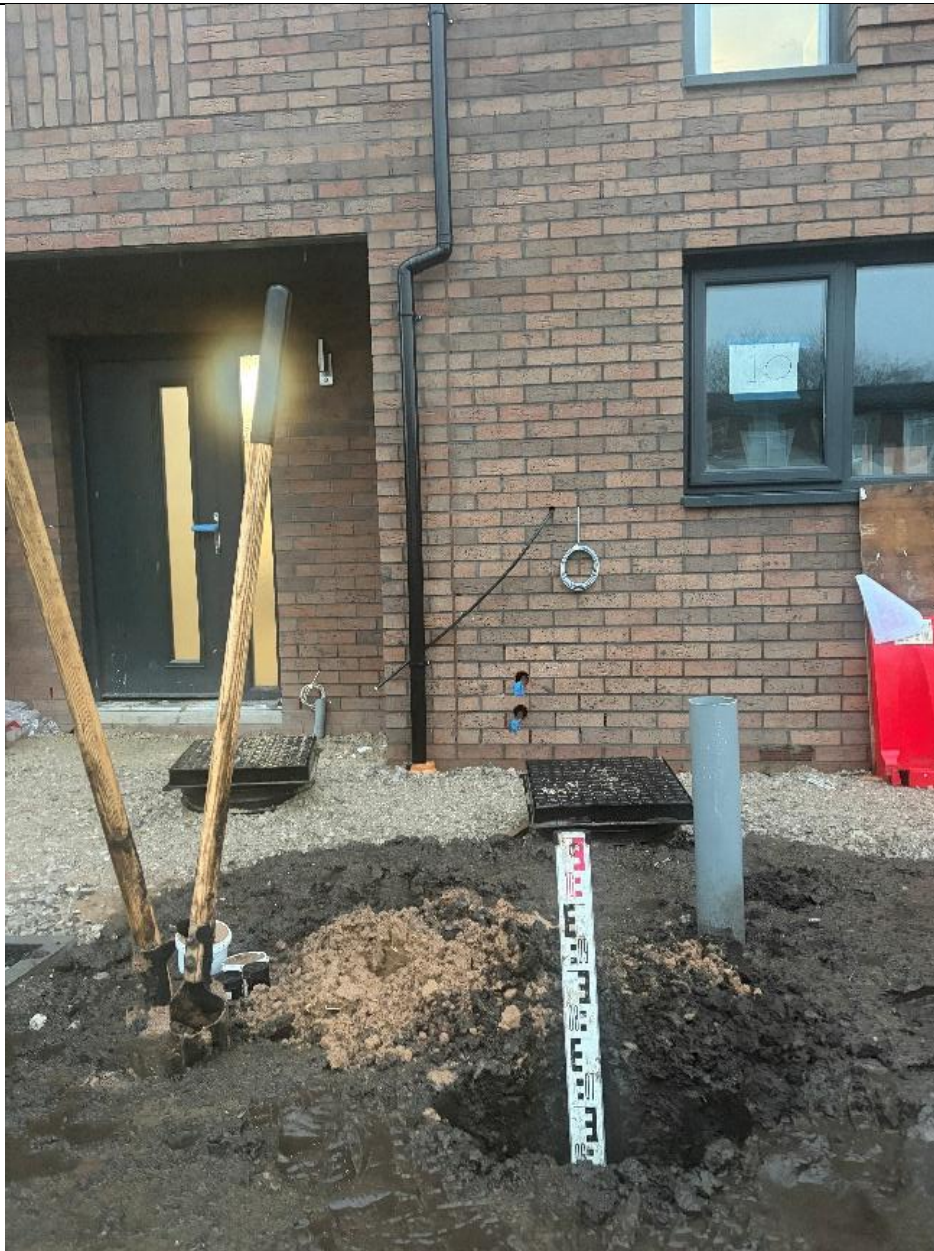
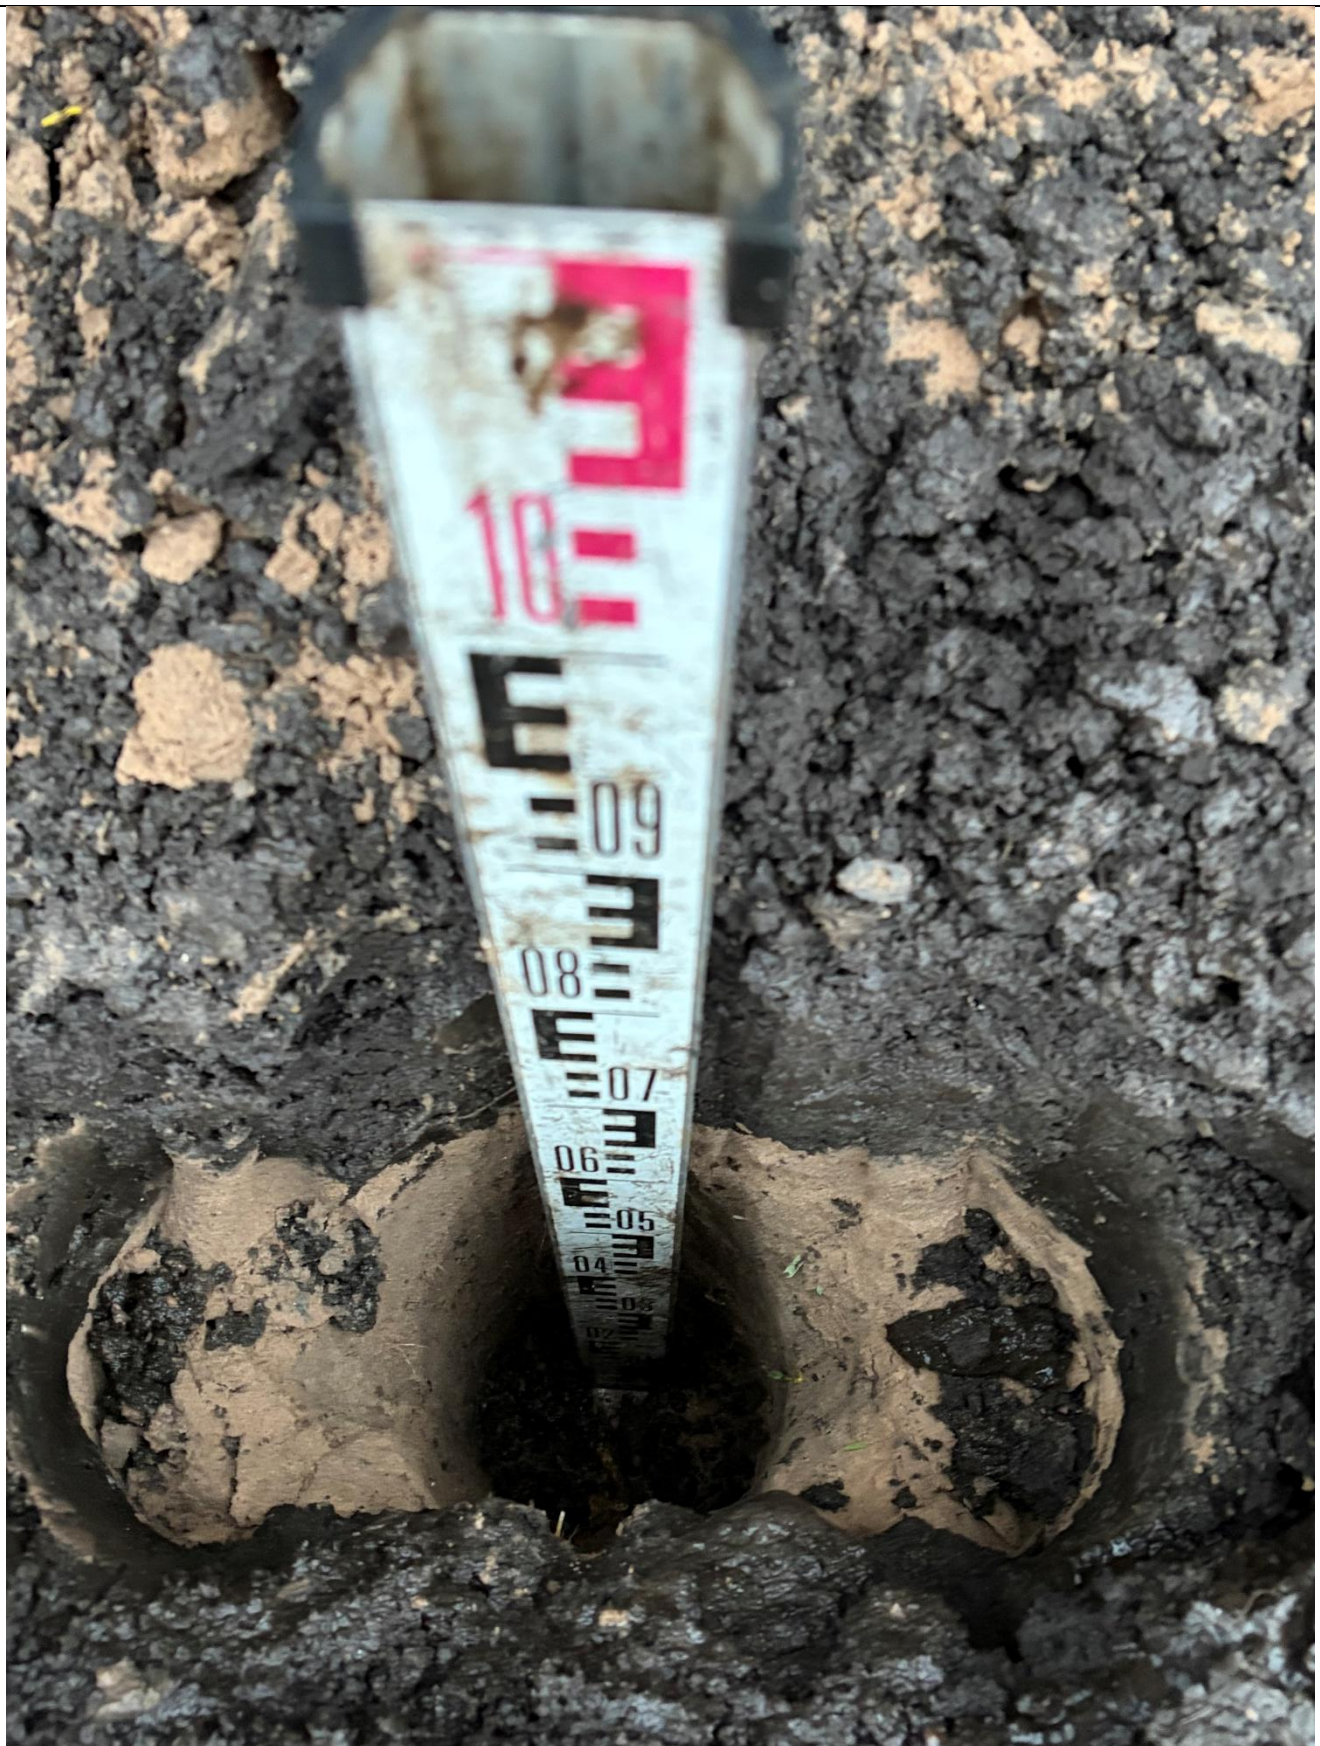
Photographs show 200mm of topsoil; underlain by 600mm subsoil; underlain by hi-vis membrane and plot context. Hi-viz membrane not clear on the above photo due to the greater depth of cover system (c. 800mm) and the recent weather causing a smearing effect at the base. The membrane is present and visible above.

**This plot has PASSED / FAILED\* verification**

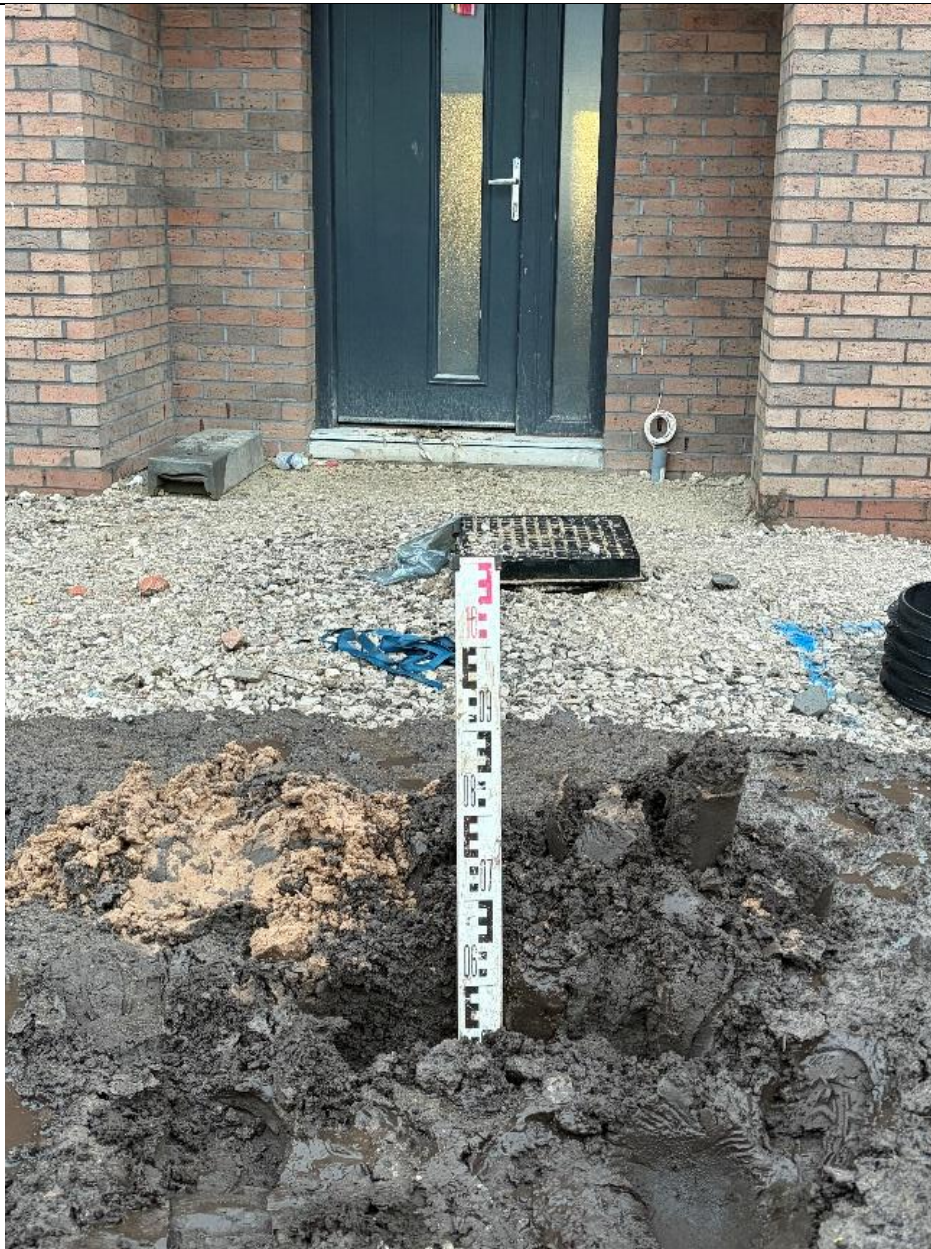
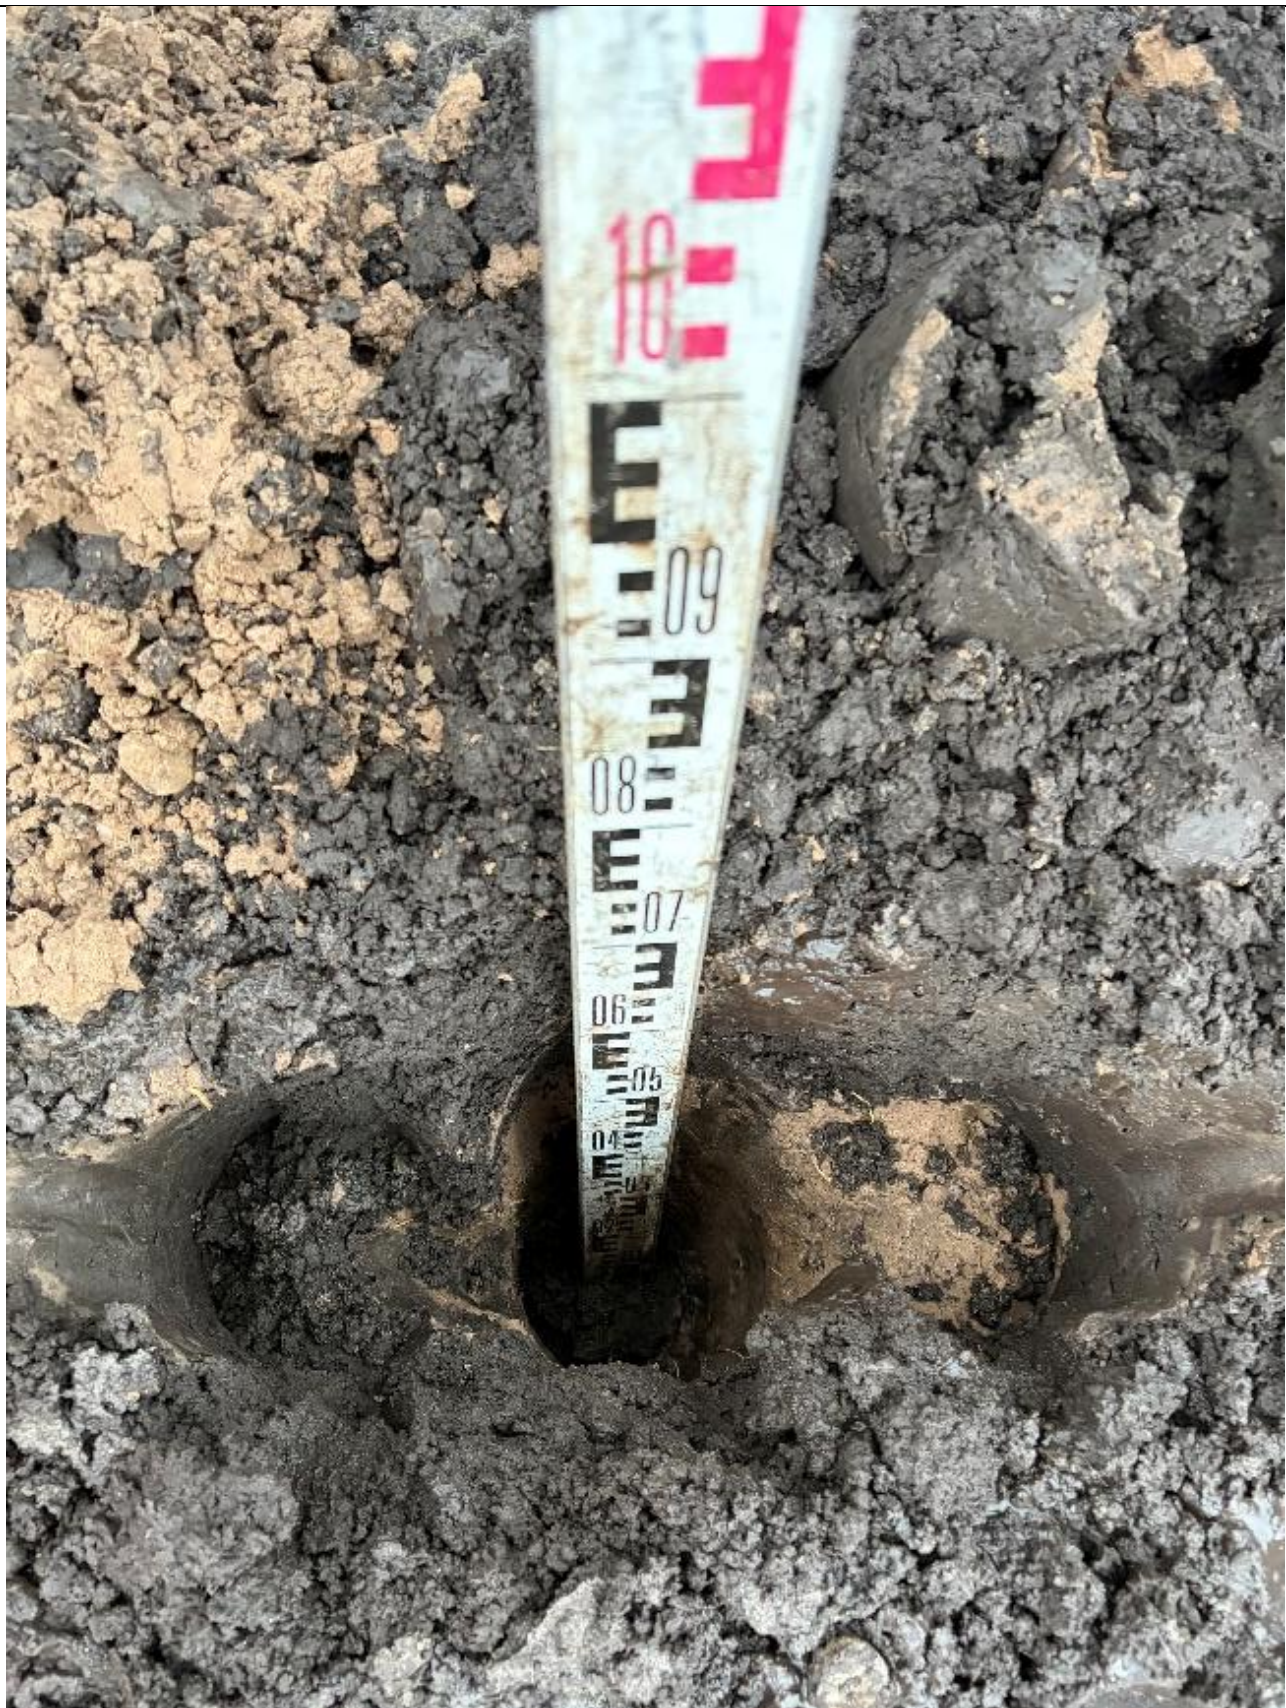
Photographs show 250mm of topsoil; underlain by 450mm subsoil; underlain by hi-vis membrane and plot context. Hi-viz membrane not clear on the above photo due to the greater depth of cover system (c. 700mm) and the recent weather causing a smearing effect at the base. The membrane is present and visible above.

**This plot has PASSED / FAILED\* verification**
