## CORNBROOK RESIDENTIAL, MANCHESTER

### **DRAINAGE STRATEGY**

Project No: 2306-18

CBR-REN -XX-XX-RP-C-00002

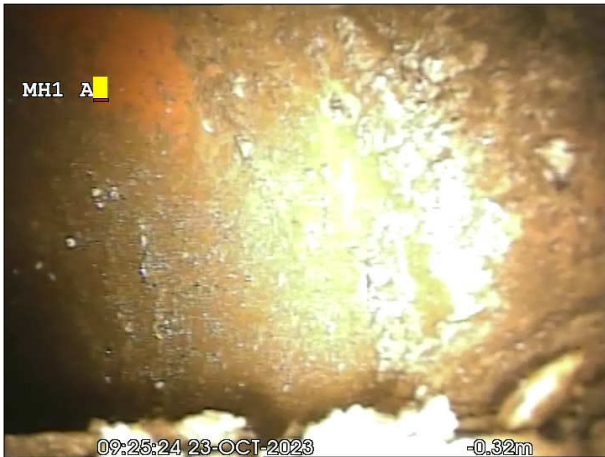
Photo: 10\_4a, 00:00:00  
0.1m, Debris, 20 % cross-sectional area loss

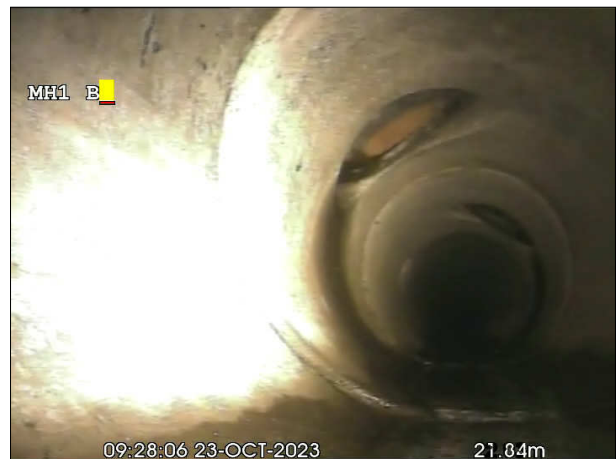
Photo: 19\_7a, 00:00:00  
22.4m, Junction at 11 o'clock, dia 150 mm

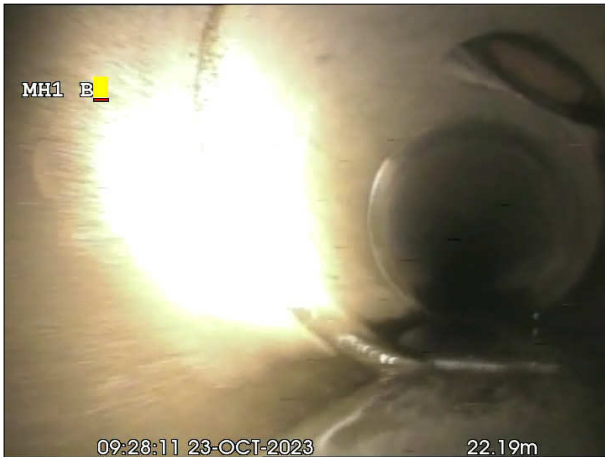
Photo: 20\_8a, 00:00:00  
23m, Junction at 01 o'clock, dia 150 mm

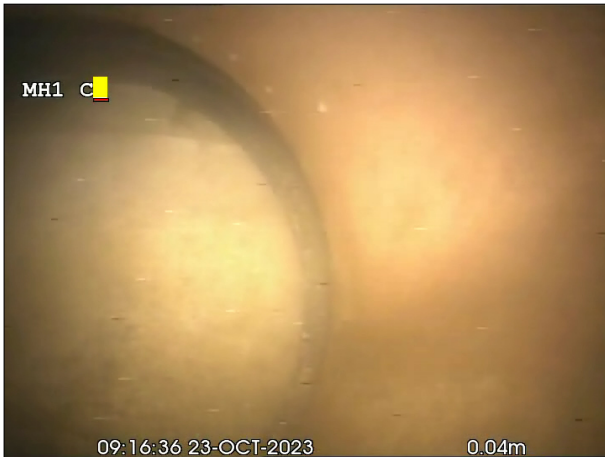
Photo: 26\_4a, 00:00:00  
0.3m, Finish Survey, Remark: Line capped.

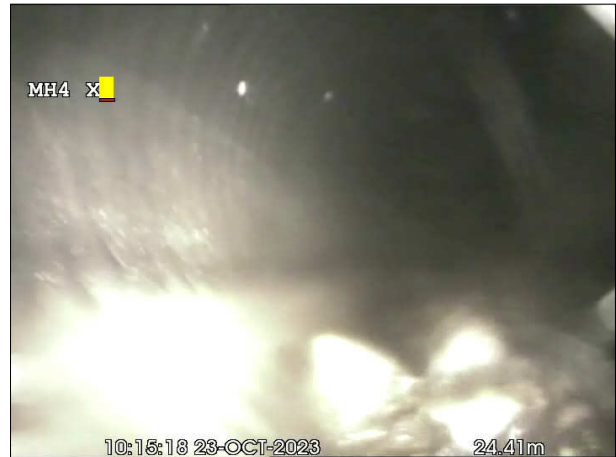
Photo: 74\_6a, 00:00:00  
24.4m, Debris silt, 10 % cross-sectional area loss, Start

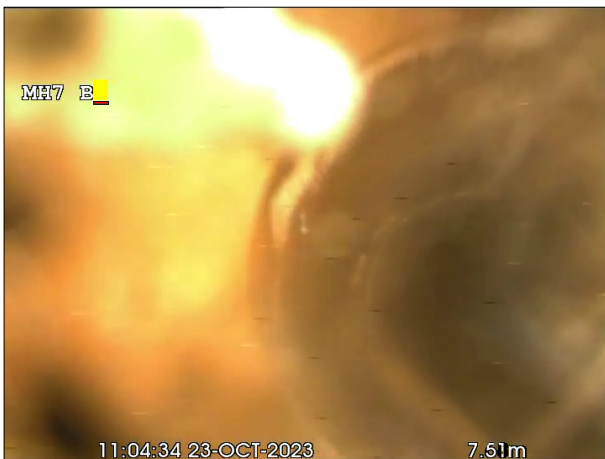
Photo: 97\_6a, 00:00:00  
 7.6m, Dimension of sewer changes, new dimension dia 100 mm

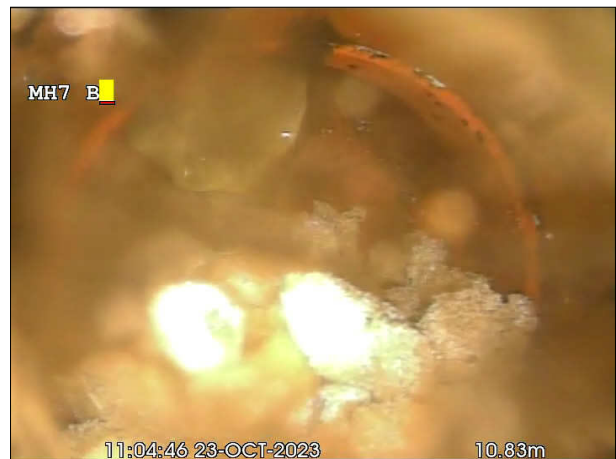
Photo: 98\_7a, 00:00:00  
 10.9m, Debris, 30 % cross-sectional area loss

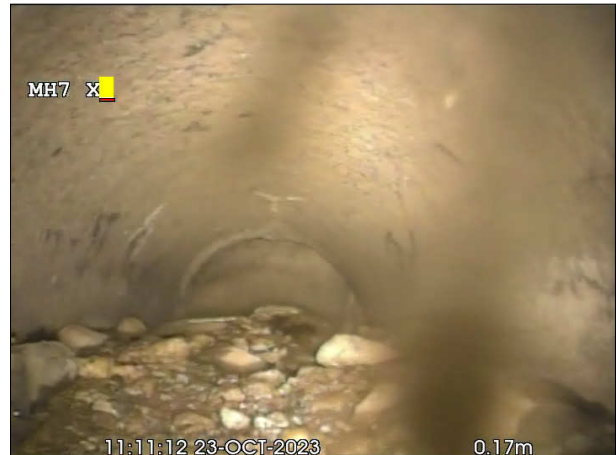
Photo: 104\_5a, 00:00:00  
0.3m, Debris silt, 10 % cross-sectional area loss, Start

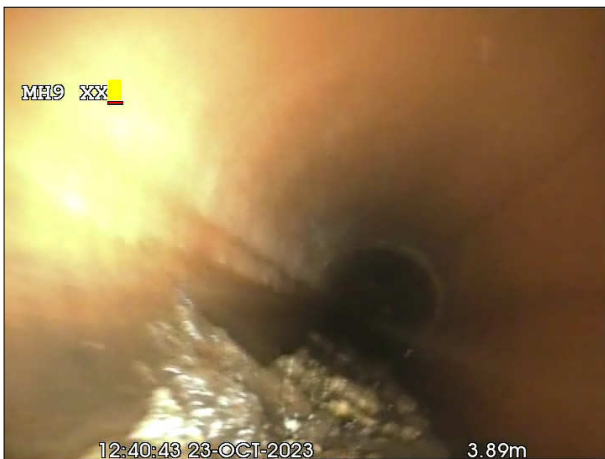
Photo: 138\_8a, 00:00:00  
3.9m, Debris silt, 5 % cross-sectional area loss, Start

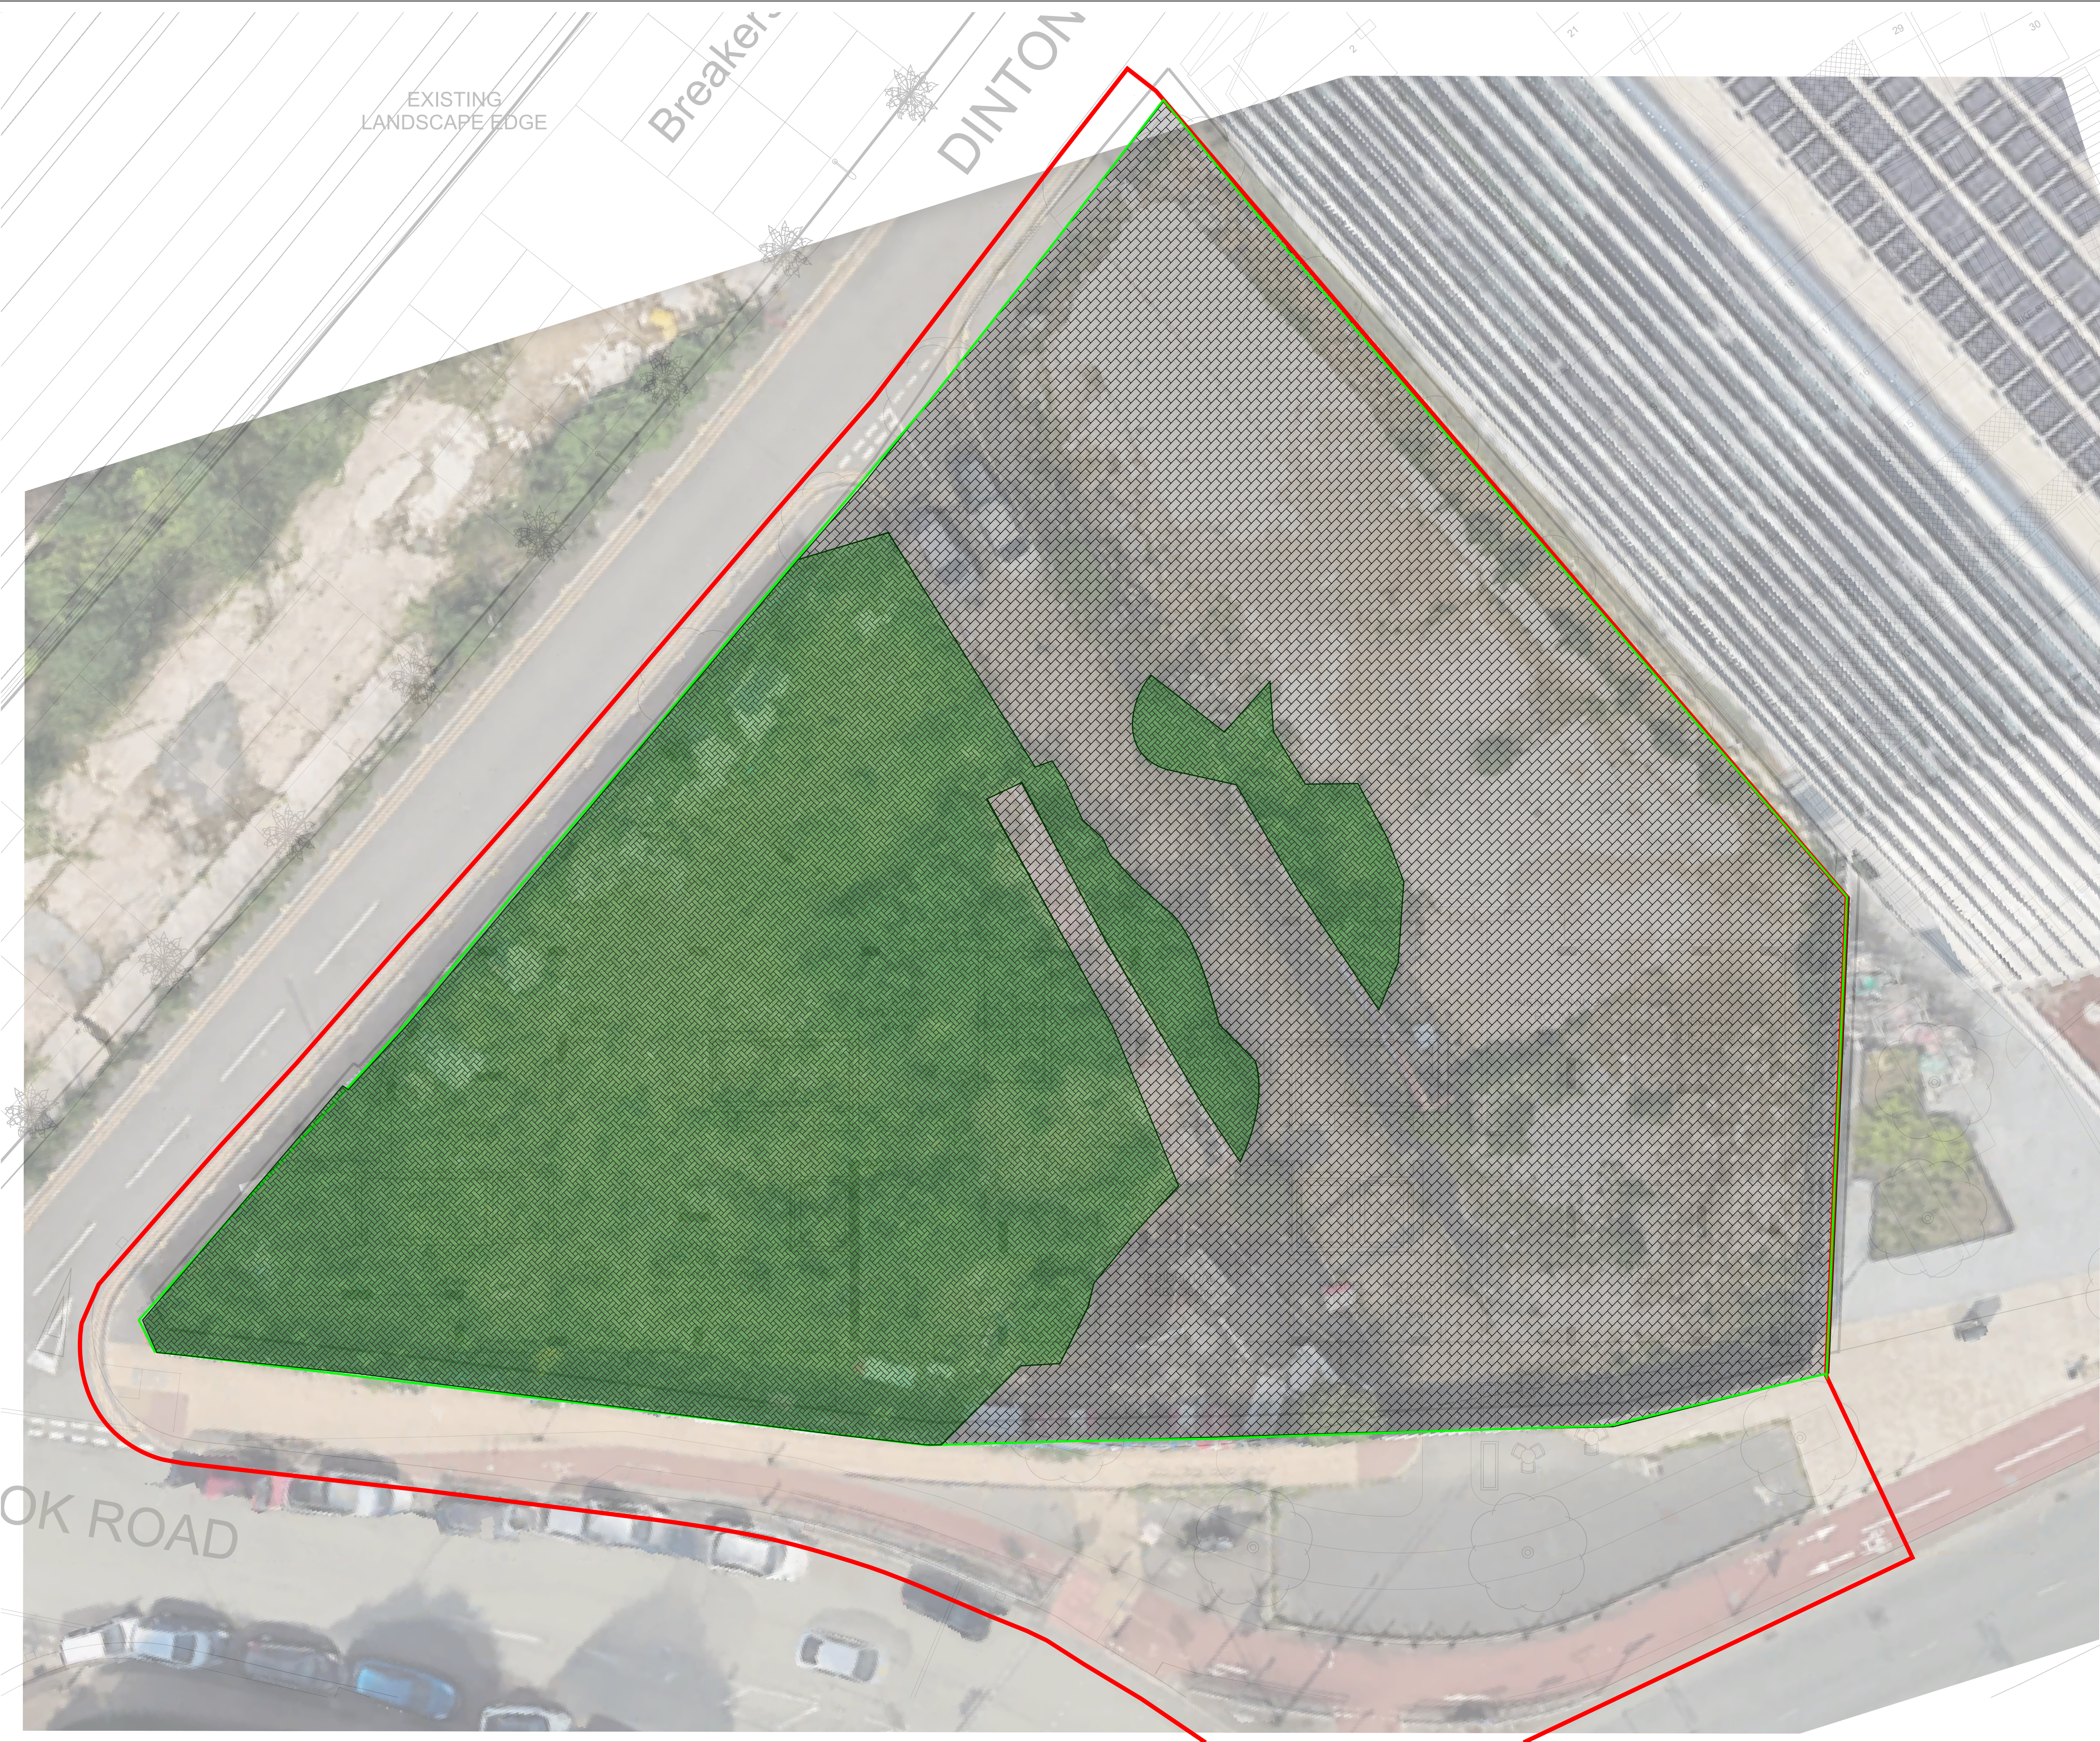
**APPENDIX E**  
**EXISTING DRAINED AREAS PLAN**

1. THIS DRAWING IS INTENDED TO INDICATE THE EXISTING DRAINED AREAS FROM THE CORNBROOK SITE. IT IS BASED UPON A REVIEW OF THE TOPOGRAPHICAL SURVEY AND AERIAL IMAGES OF THE SITE.

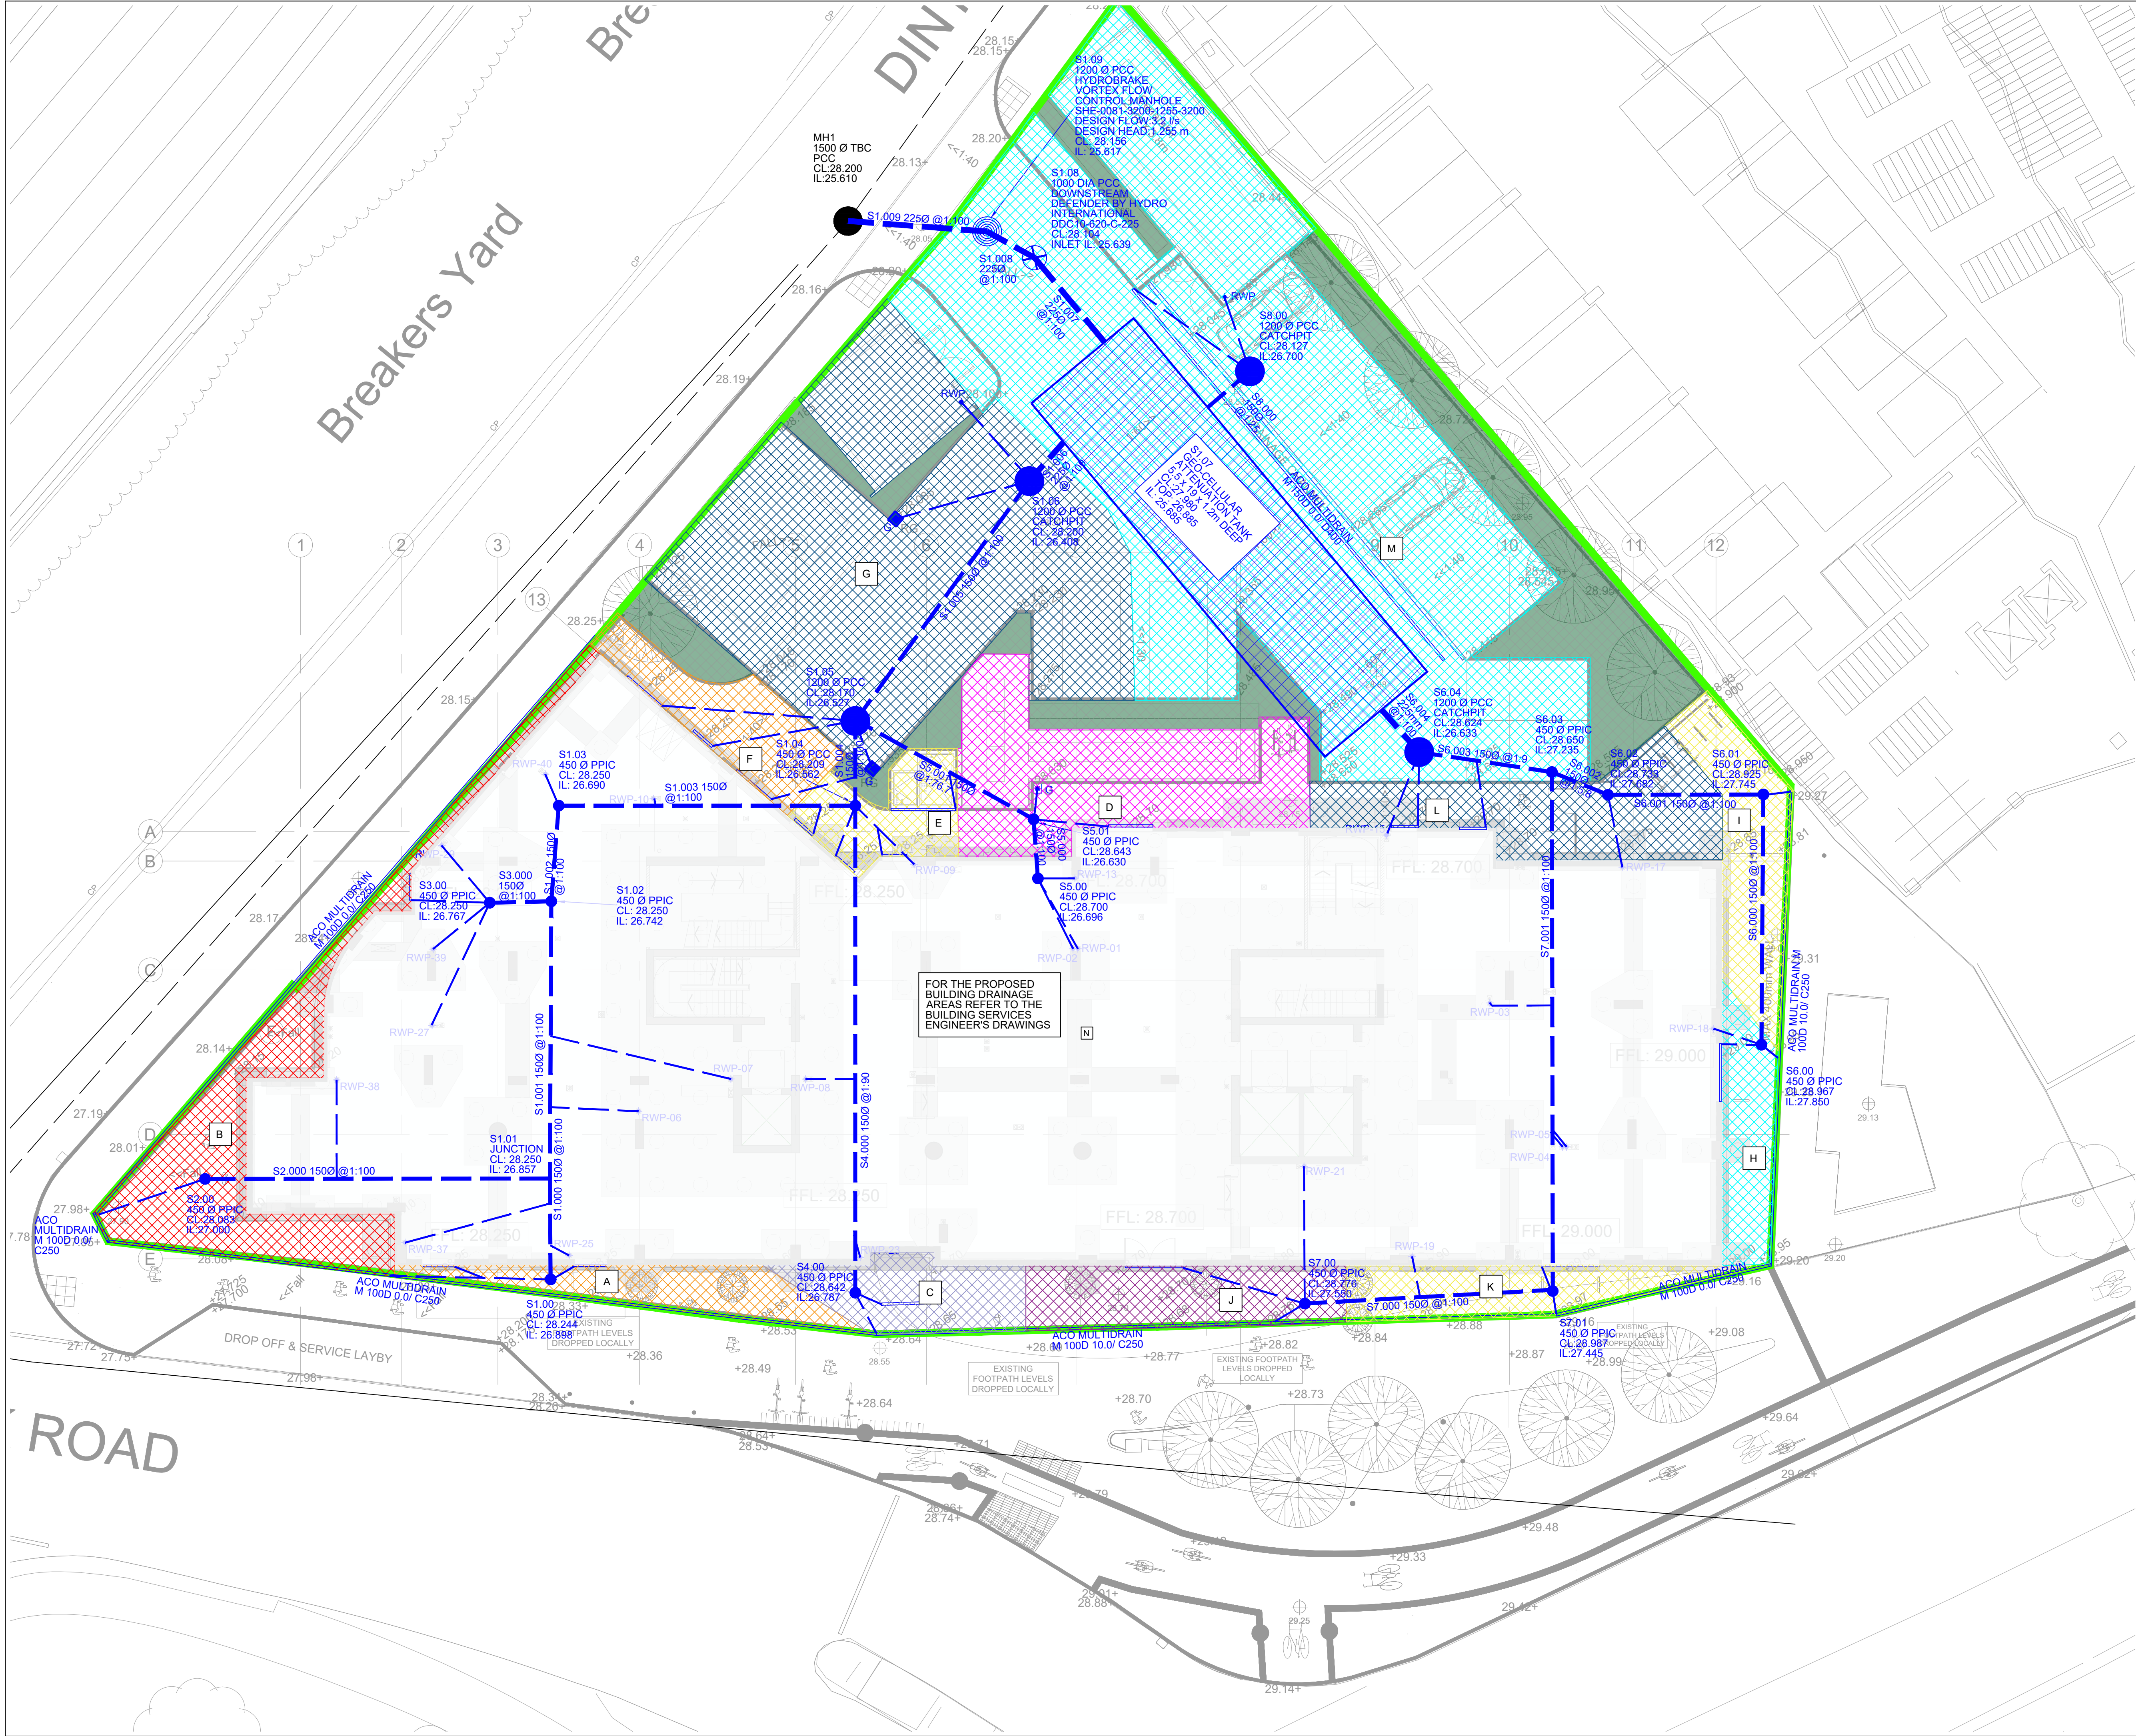
**APPENDIX H**  
**PROPOSED DRAINED AREAS PLAN**

**NOTES:**  
1. THIS DRAWING SHOULD BE READ IN CONJUNCTION WITH:  
- EXISTING IMPERMEABLE AREA PLAN  
- PROPOSED BELOW GROUND DRAINAGE DRAWING  
- MICRODRAINAGE MODEL AND CALCULATION OUTPUTS

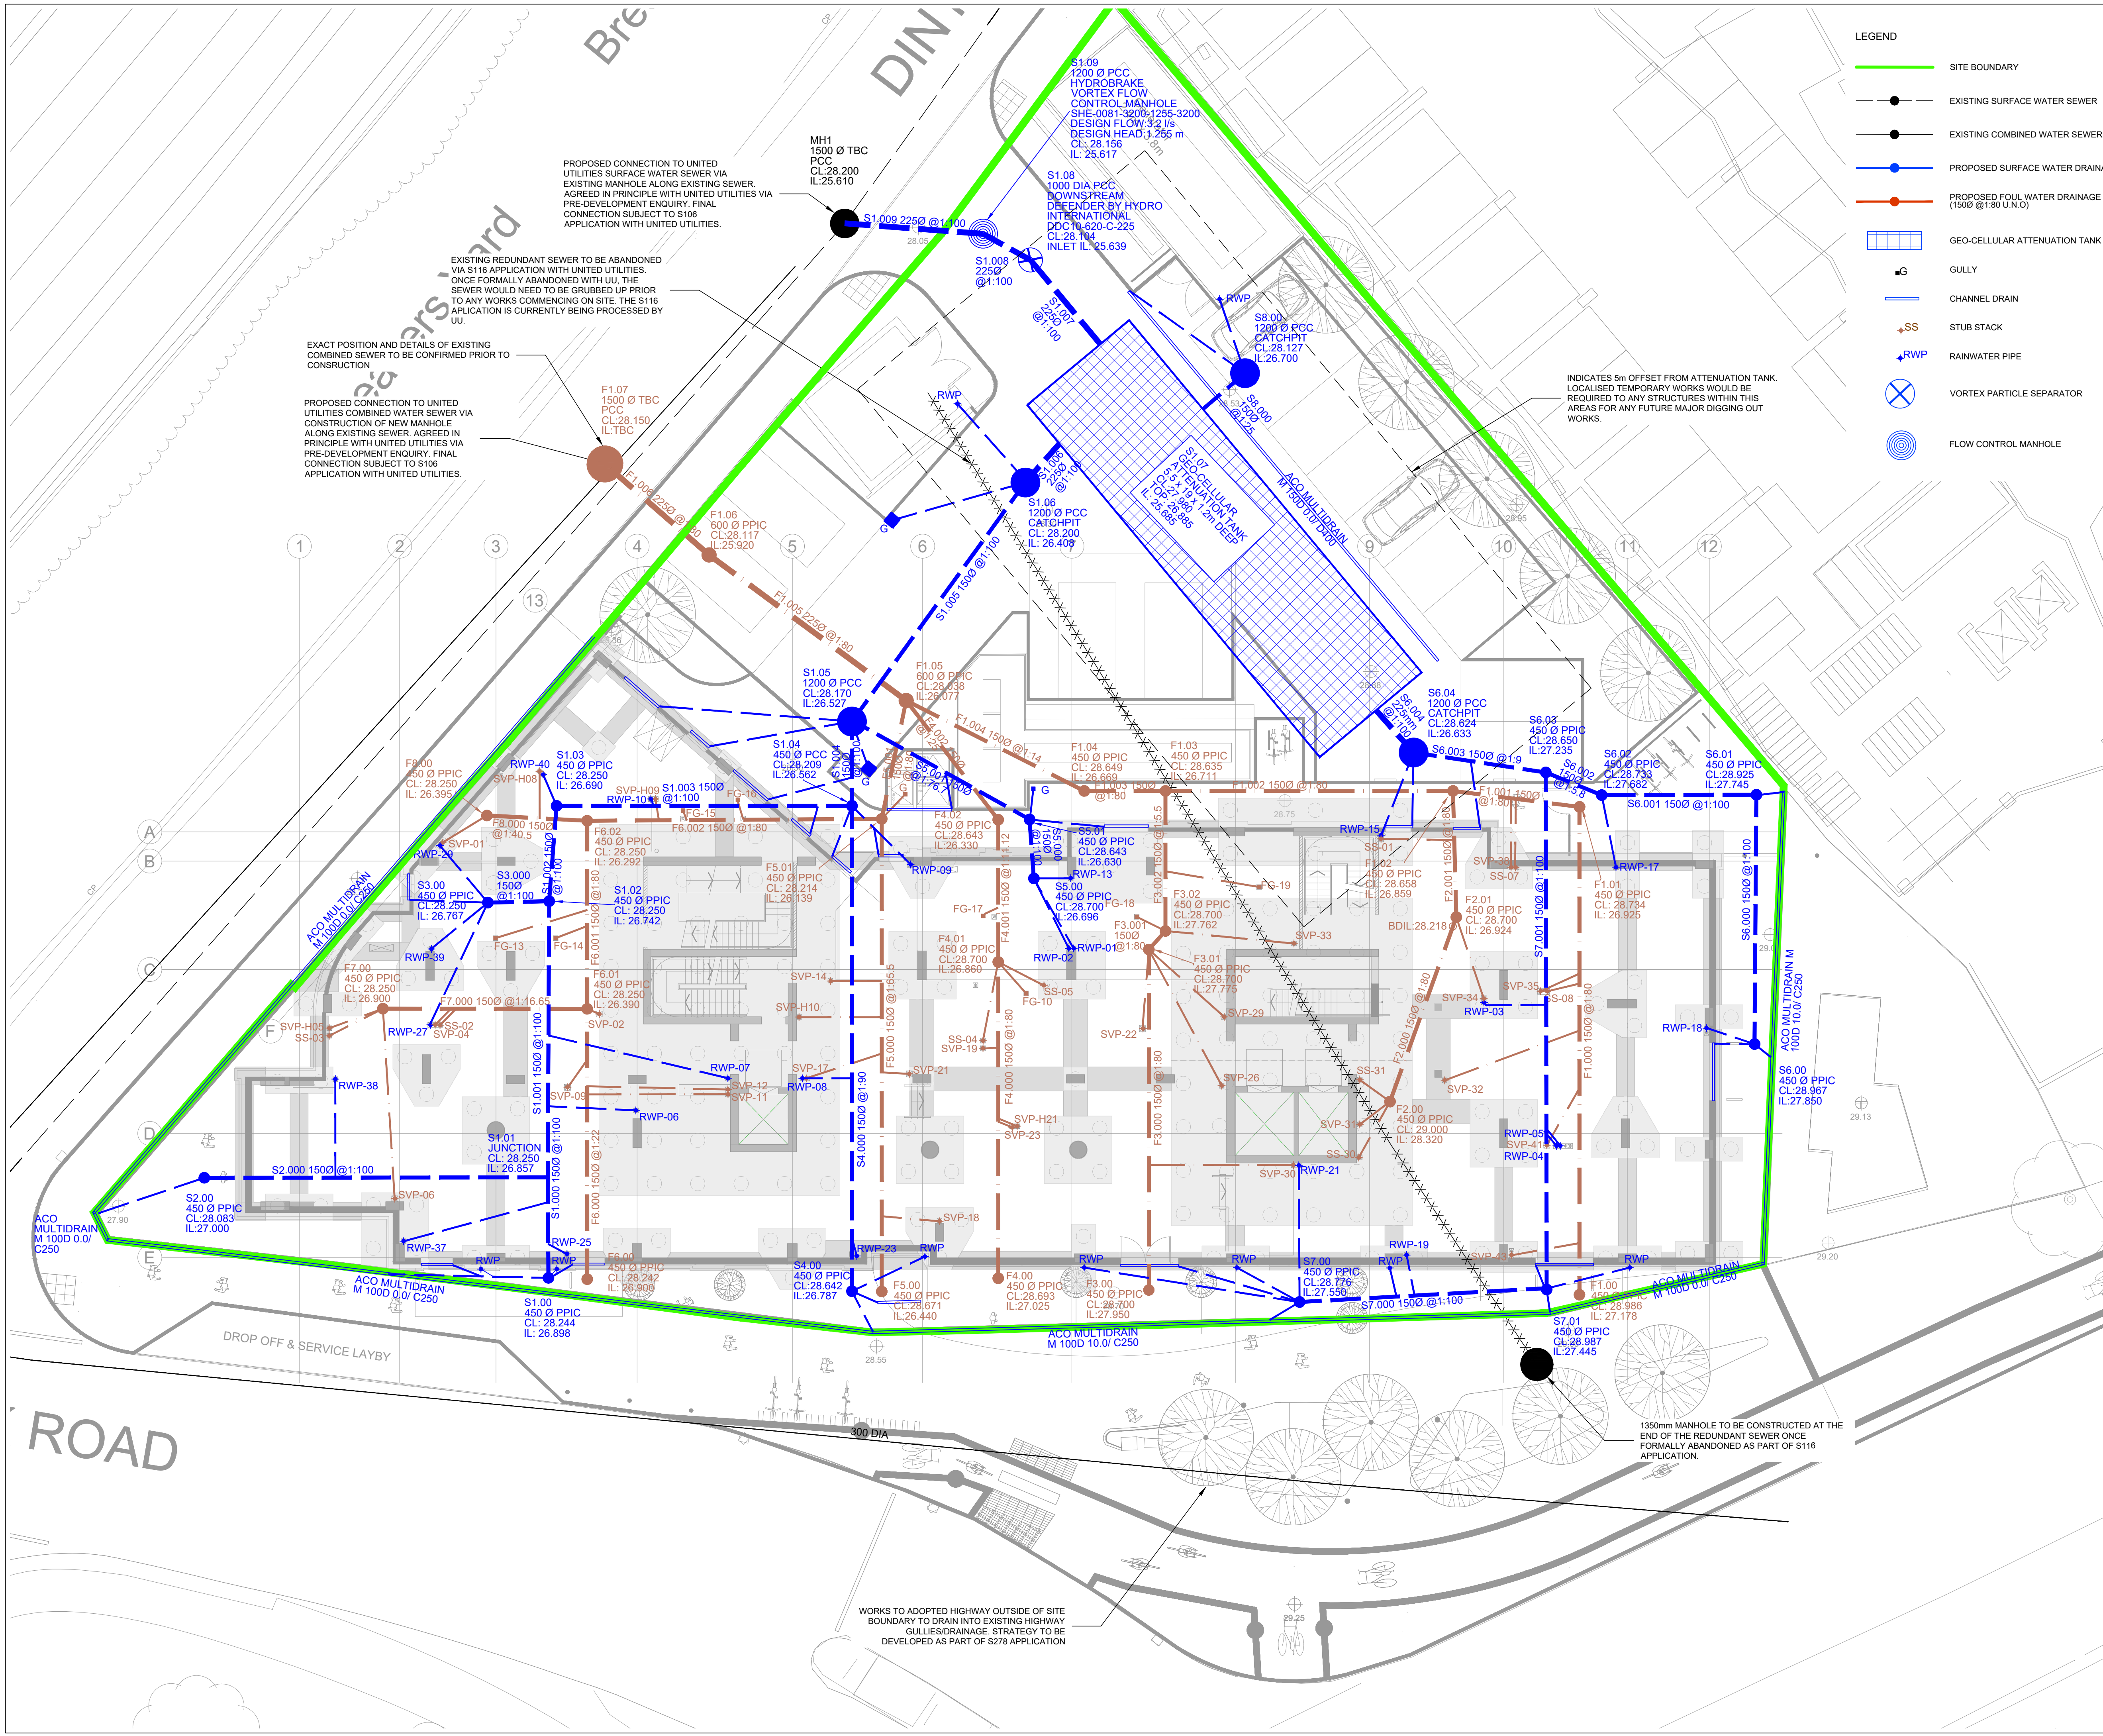
### **BELOW GROUND DRAINAGE PLAN**

- LEGEND
- SITE BOUNDARY
  - EXISTING SURFACE WATER SEWER
  - EXISTING COMBINED WATER SEWER
  - PROPOSED SURFACE WATER DRAINAGE
  - PROPOSED FOUL WATER DRAINAGE (1500 @ 1.80 U.N.O)
  - GEO-CELLULAR ATTENUATION TANK
  - GULLY
  - CHANNEL DRAIN
  - STUB STACK
  - RAINWATER PIPE
  - VORTEX PARTICLE SEPARATOR
  - FLOW CONTROL MANHOLE

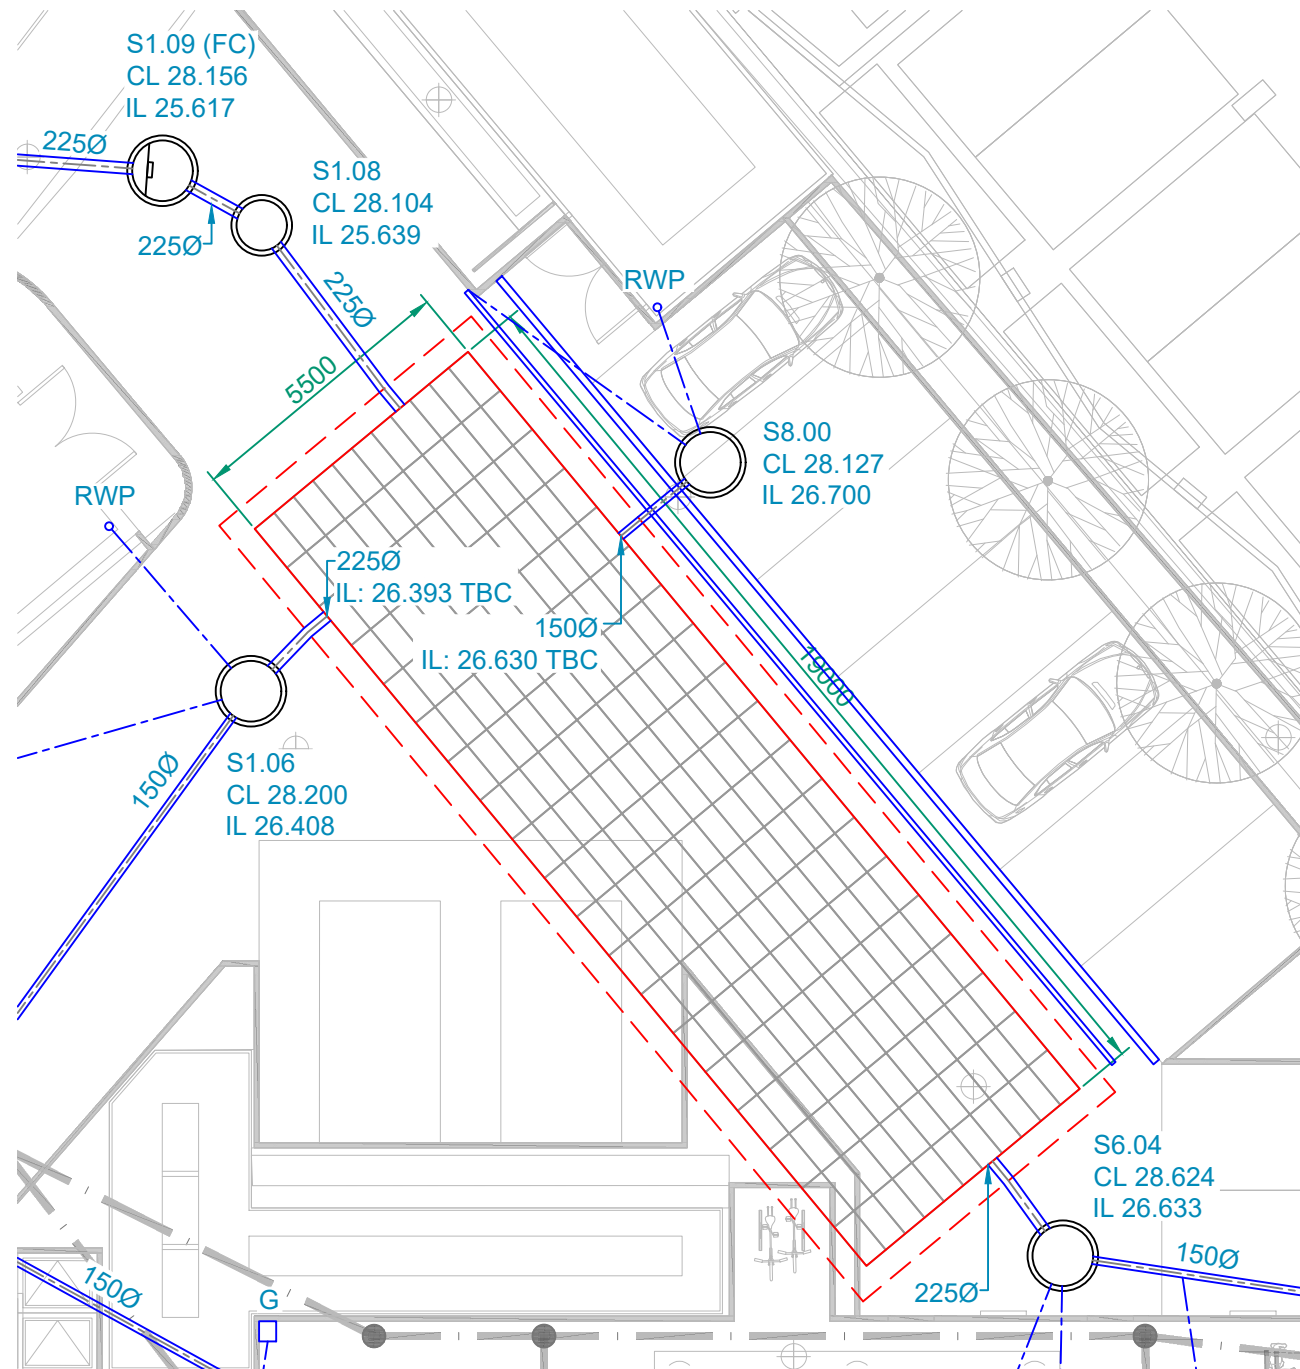
Proposed Plan  
 (Scale 1:150)

\*Extents of excavation to be an additional 500mm around the perimeter of the tank\*

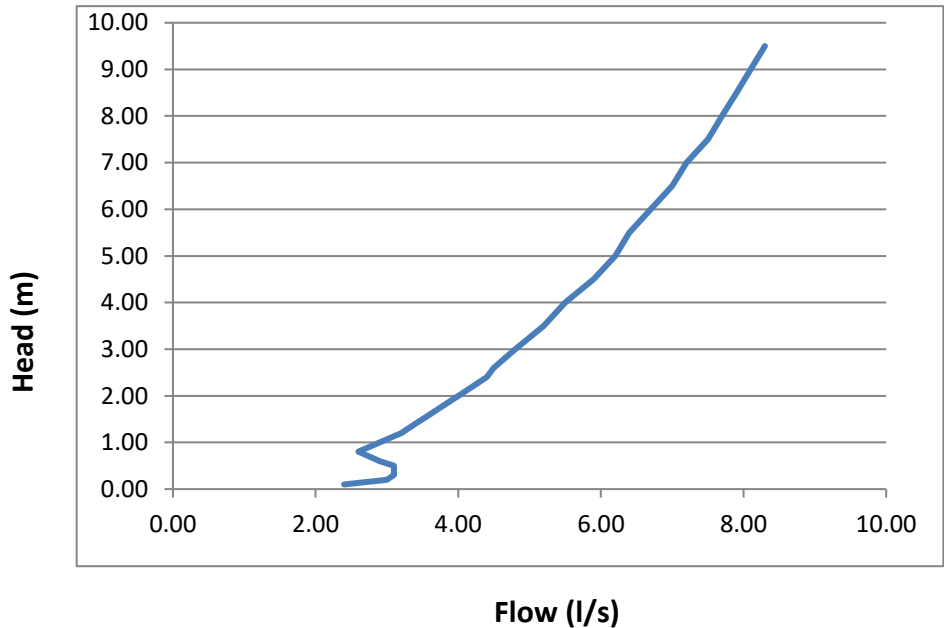
Head / Flow characteristic

| Flow (l/s) | Head (m) |
| 2.40 | 0.10 |

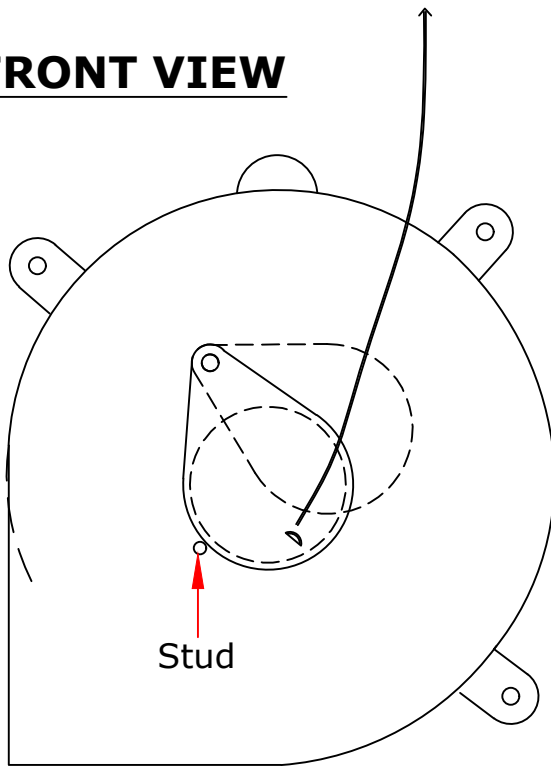
## FRONT VIEW

Stainless Steel  
Straps

Sleeve Dia (O.D) - 100 mm
