**The Park Public House,  
153 Moorcroft Road,  
Wythenshawe,  
Manchester.**

*On behalf of Watson Homes Ltd.*

**Preliminary Ecological Appraisal and Bat  
Scoping Report**

| Report Number | <u>ThePark/001-2025</u> |

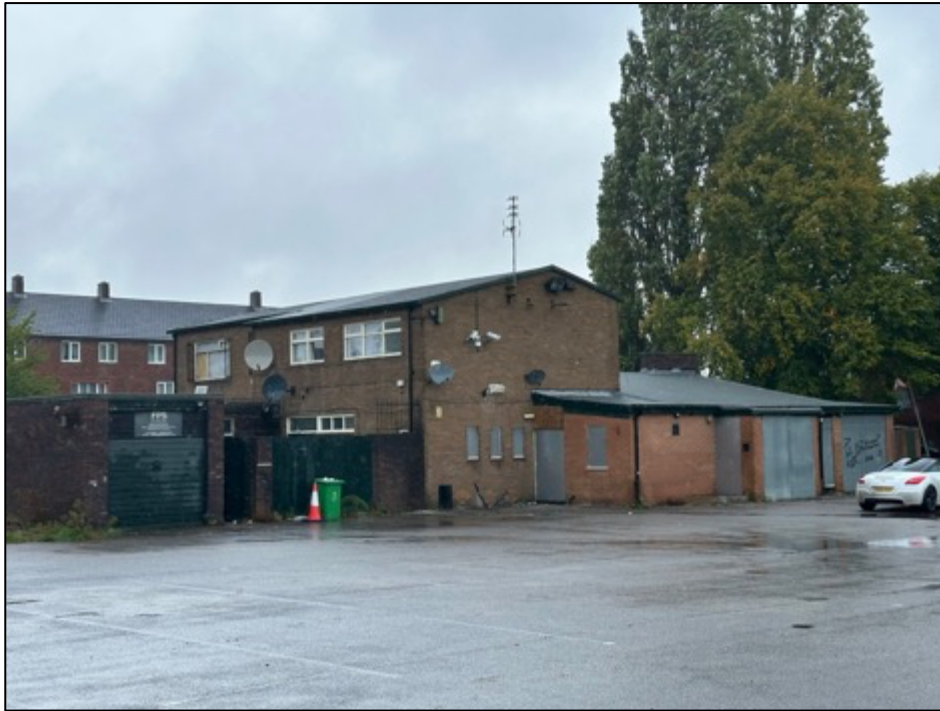
**Photograph 1;** An external view from the southern side of the building, clearly showing the composition. The building features several single storey extension sections, all sections feature a felt external roof.

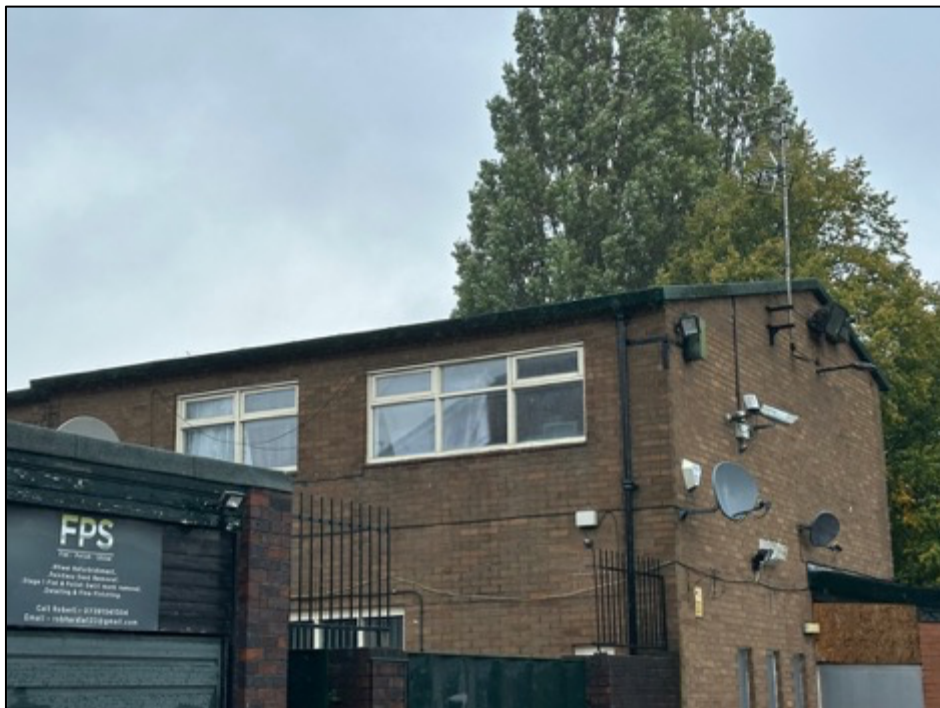
**Photograph 2;** View of the main section of the building, showing the two-storey base of the former pub. The external brick walls are well-structured and in good condition.

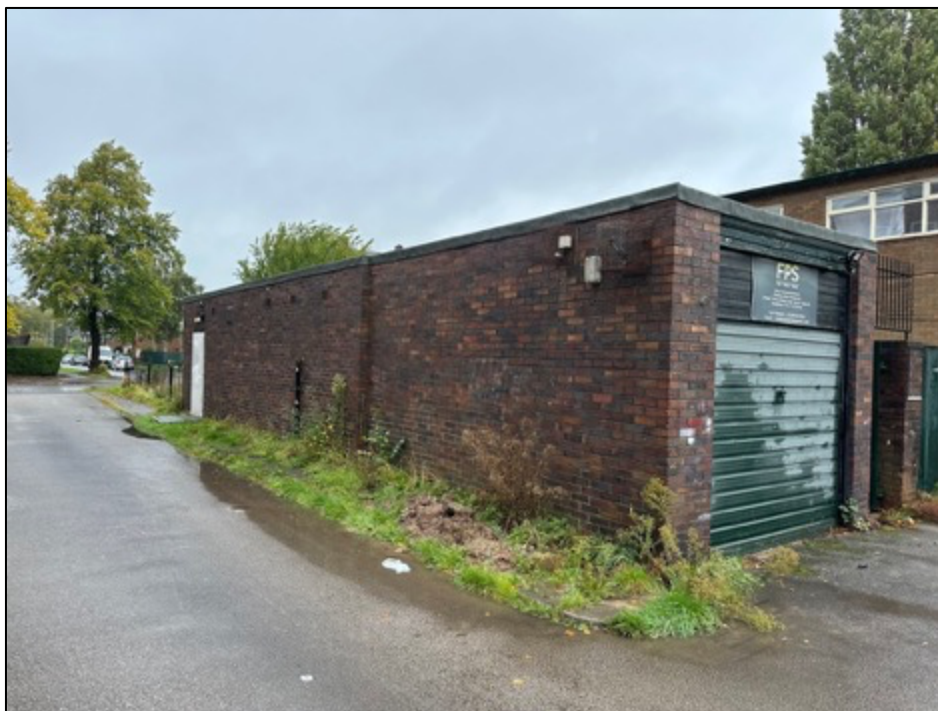
**Photograph 3;** A view of the attached flat roof section with corrugated roller door. A slight linear buffer of modified grassland, featuring common thistle and stinging nettle.

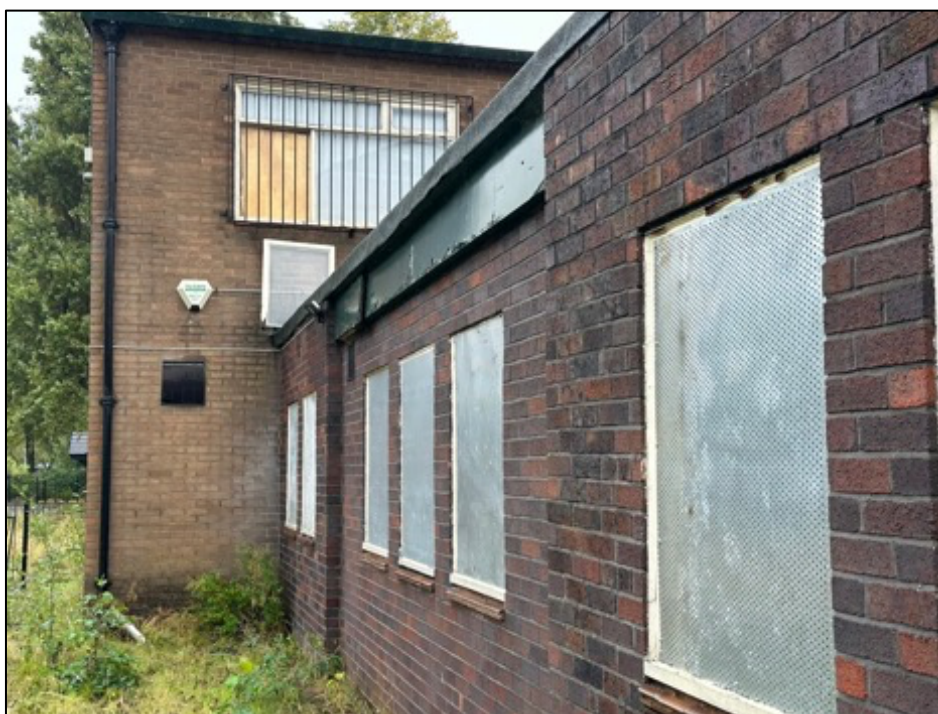
**Photograph 4;** A view of the front of the subject building, beneath one of the single storey, flat roof sections. External fascia boarding shows some sign of rotting and cosmetic damage. External windows are boarded.

A large single-storey section also features a pitched felt roof, while other sections have flat felt roofs. Wooden fascia boarding was noted as damaged in several locations, particularly on the front elevation and at junctions between the single- and two-storey sections. The front elevation also includes

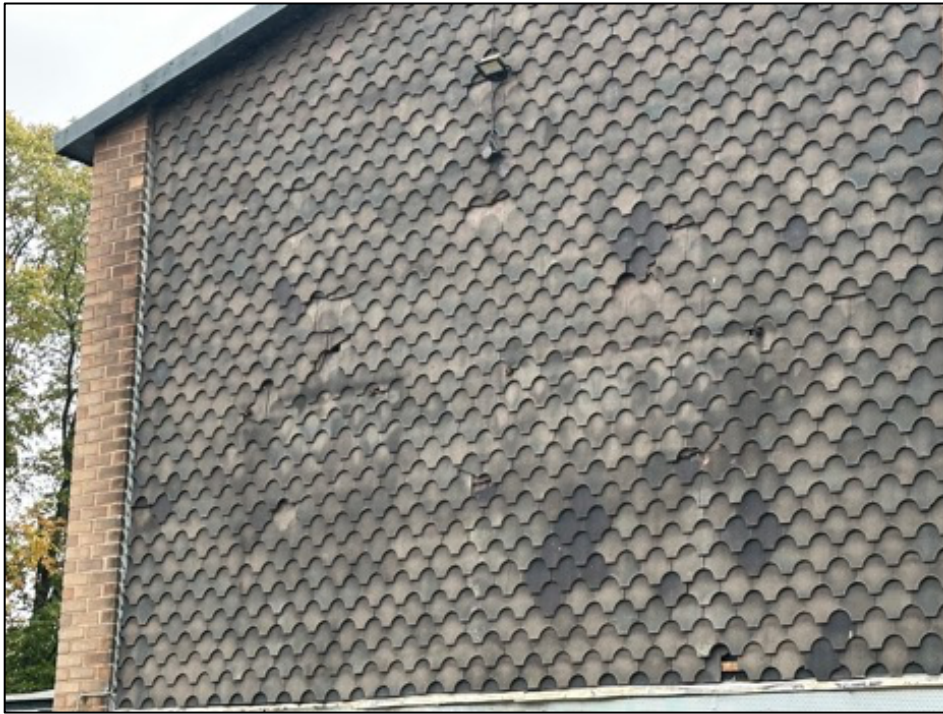
**Photograph 5;** Clay cladding tiles feature on the front face, with some instances of damage noted.

decorative tiled cladding, which shows multiple areas of damage. These damaged areas in both the fascia and cladding may provide potential roosting opportunities for bats. The PRF's identified across the building are small and unsuitable for larger roosts due to the size and positioning, mostly being slight damage to external cladding or boarding. The specific PRF's identified may be more suitable for a transient roost, given they are shallow openings and upon the exterior of the building mostly.

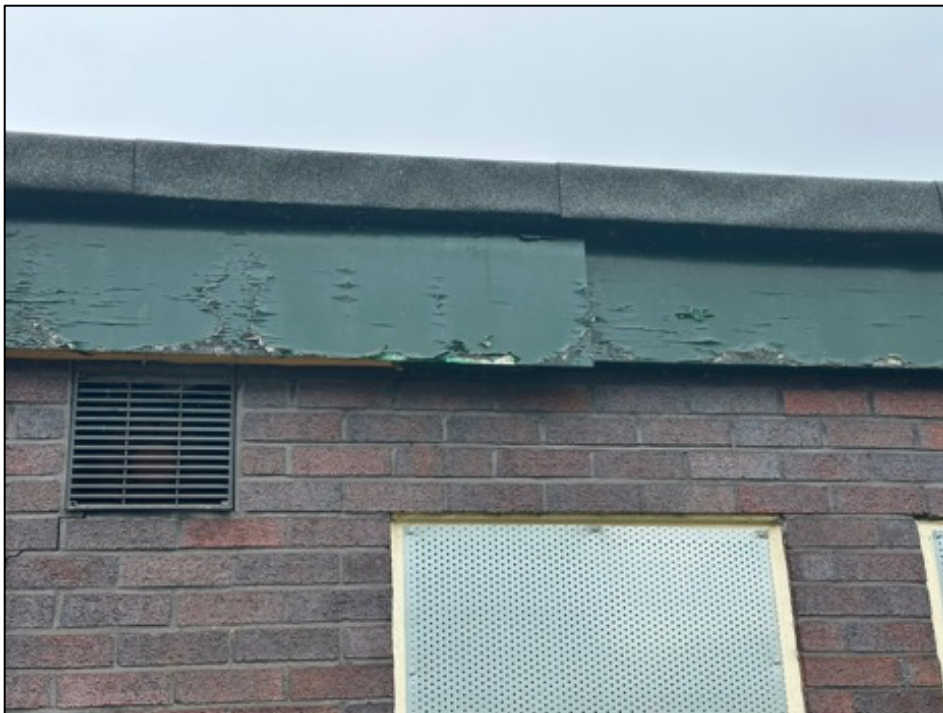
**Photograph 6;** A view of some wooden fascia boarding, which is detached from the external walls and damaged. This paneling is set away from the wall, and when investigated does not lead to internal cavity space or roof space.

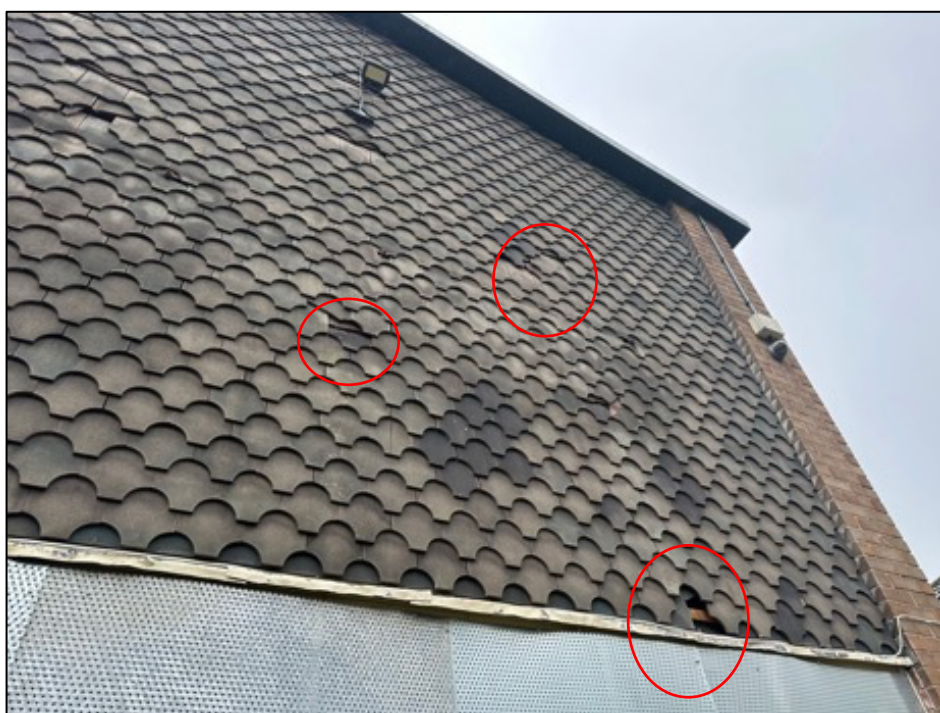
**Photograph 7;** A front view of the clay tile cladding exterior. Again, damage was noted and lead directly to the external wall, with crawlspace between the tiles and the wall. This cladding sits atop the external wall and does not lead to the internal composition.

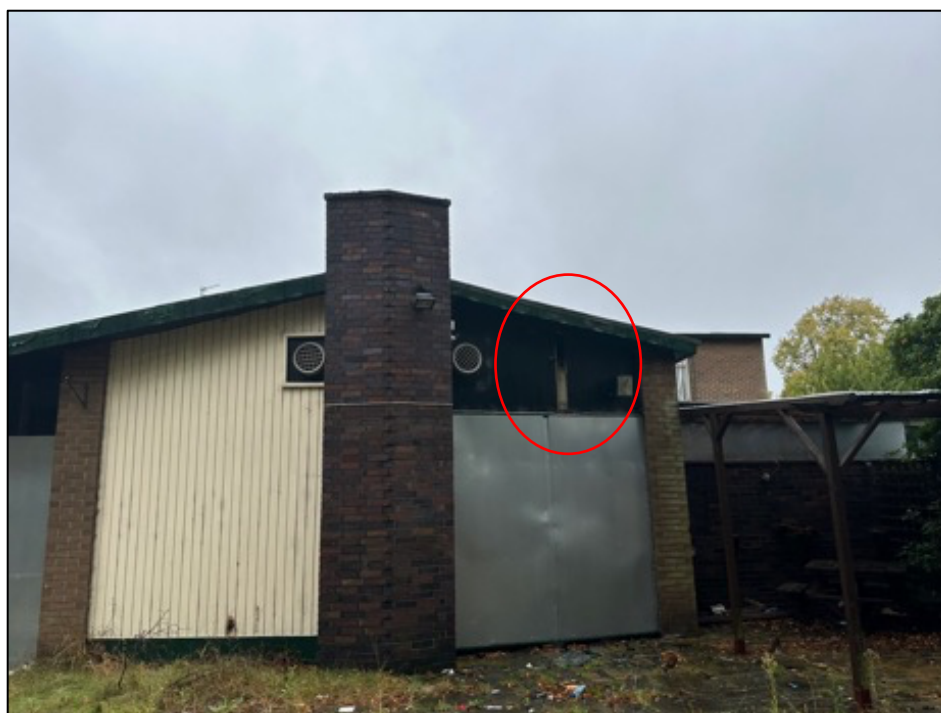
**Photograph 8;** A view of the northeastern face of the building, where the former outdoor seating area was located. The single storey section features damage to external wooden wall panels (circled).

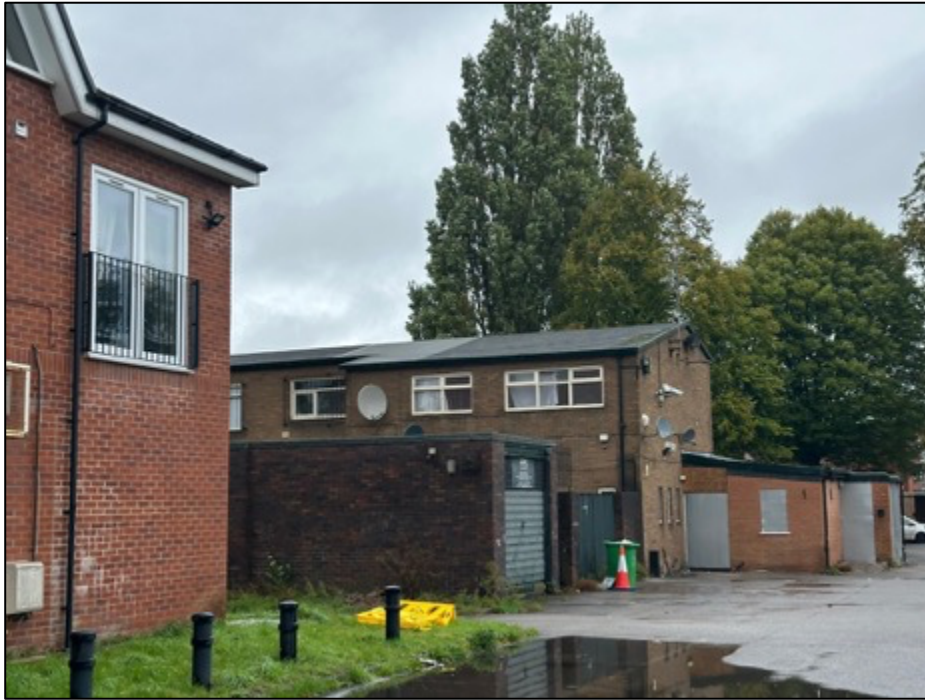
**Photograph 9;** A distant view of the external felt roof. The roof is in good condition considering the age and composition.

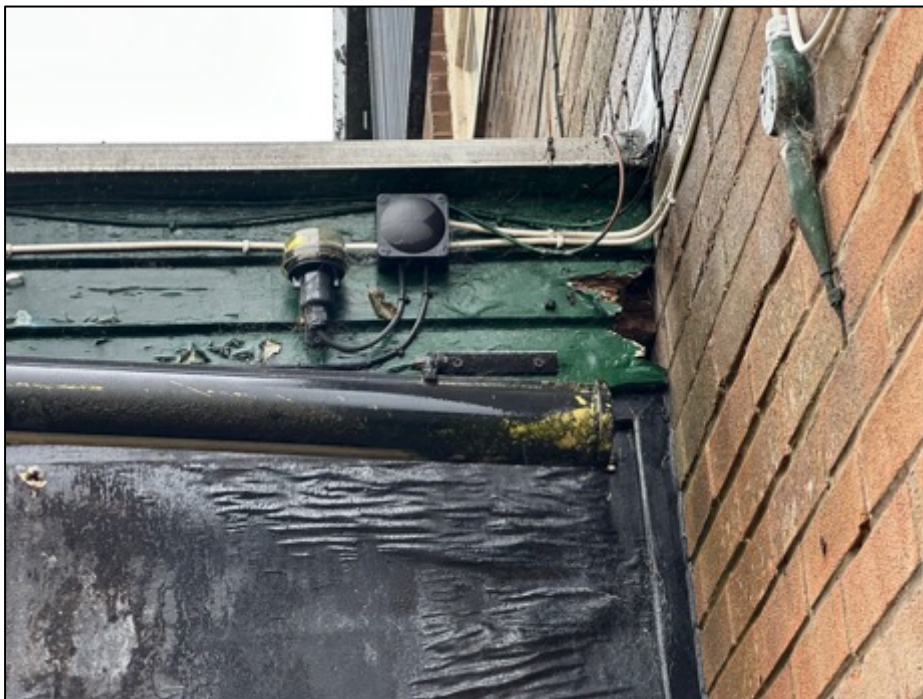
**Photograph 10;** A view of further fascia boarding which shows signs of damage, notably at an intersection of the single storey section with the larger building.

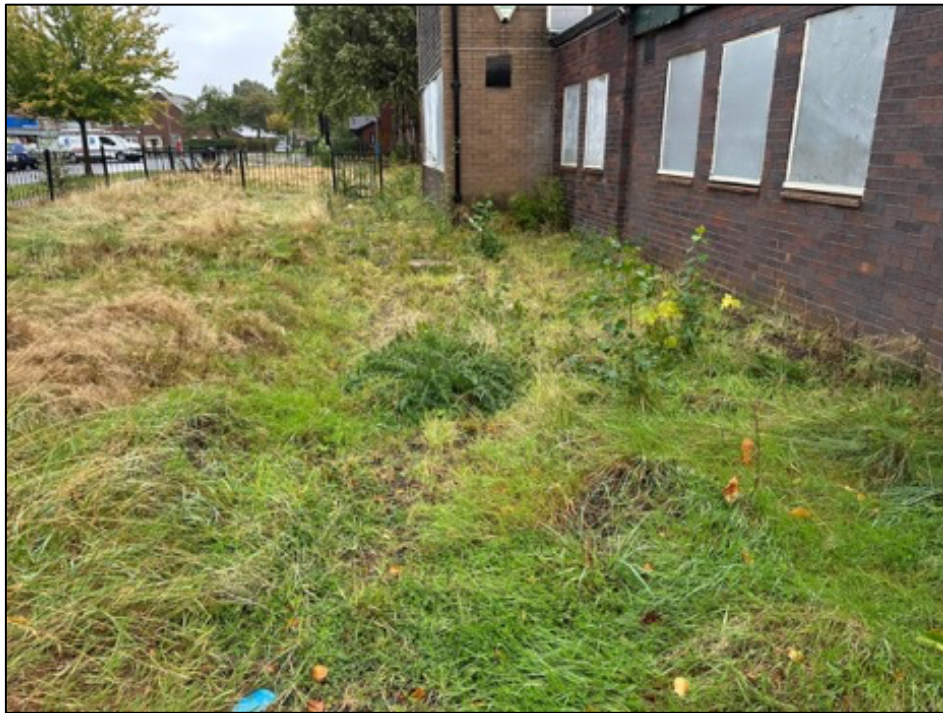
**Photograph 11;** A view of a large patch of unmanaged, other neutral grassland situated to the front of the building.

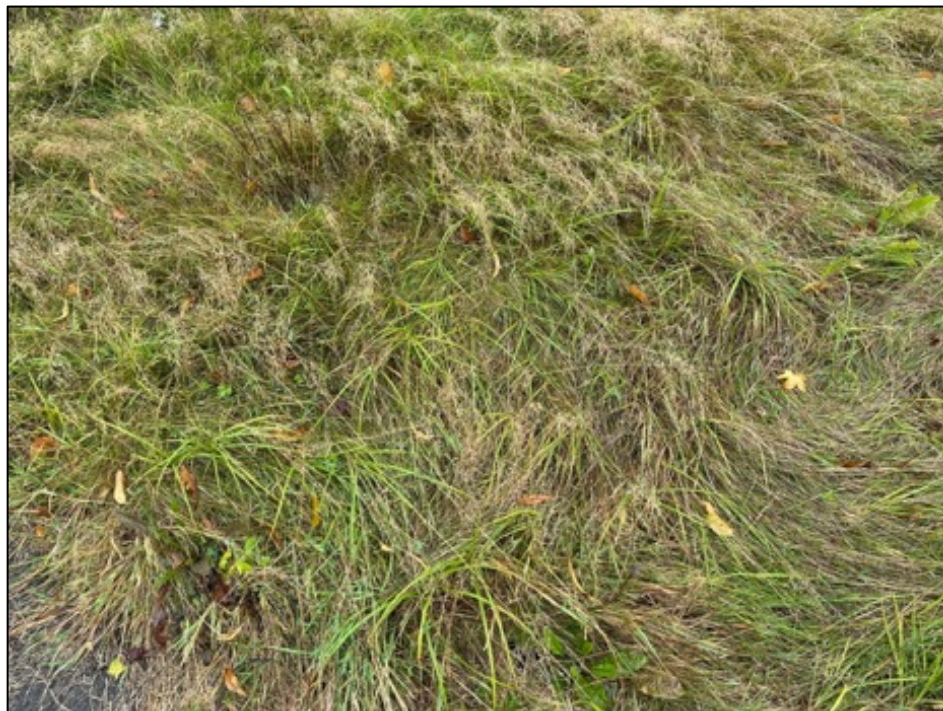
**Photograph 12;** A closer view of the grassland section. Quadrat sampling was undertaken to find ryegrass and common bent dominance, with broad-leaved dock and creeping thistle prominent, common thistle and Robert geranium were noted toward periphery areas, as well as horseweed between hard standing slabs.

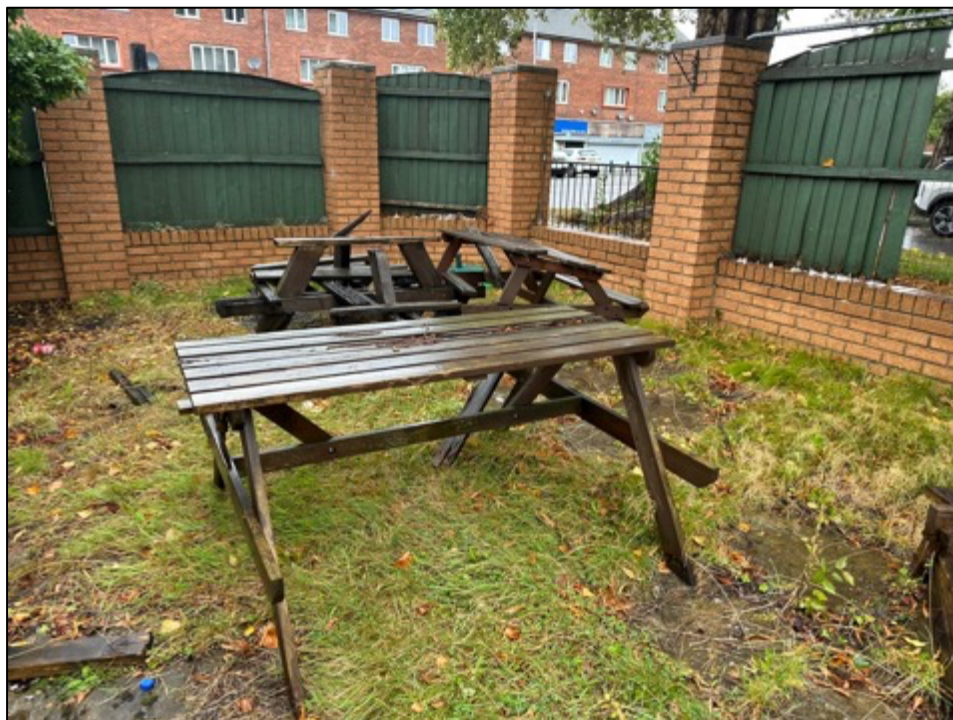
**Photograph 13;** A view of the grassland and accompanying benches within the previous outdoor seating area of site. Common bent and ryegrass dominance was noted.

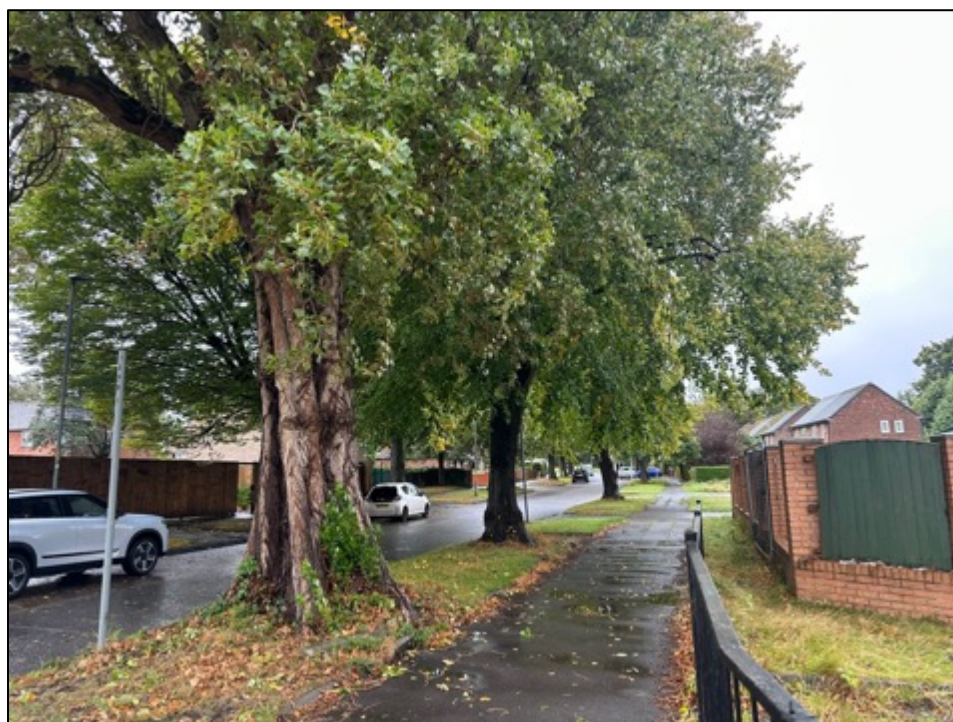
**Photograph 14:** A row of prominent, mature trees has been identified along the northeastern boundary, with their canopy extending over the hard standing area of the site. It is essential that the black poplar, as well as the lime trees located further along, are retained. This tree line continues along Stedmoor Road, leading toward Wythenshawe Park (Local Nature Reserve).

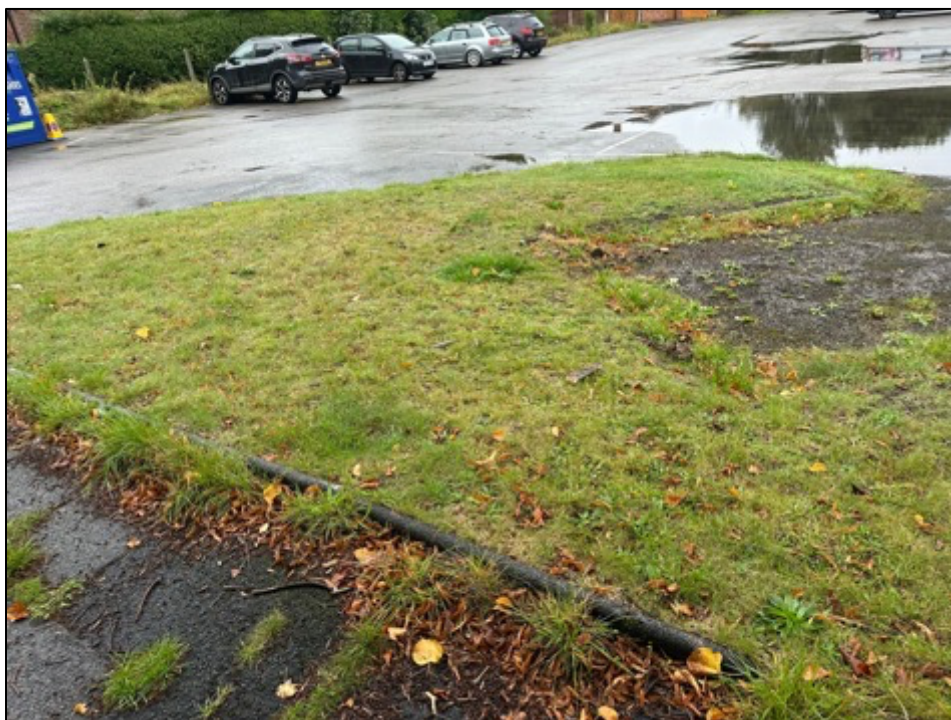
**Photograph 15:** A section of managed modified grassland accompanying the rear car parking area.

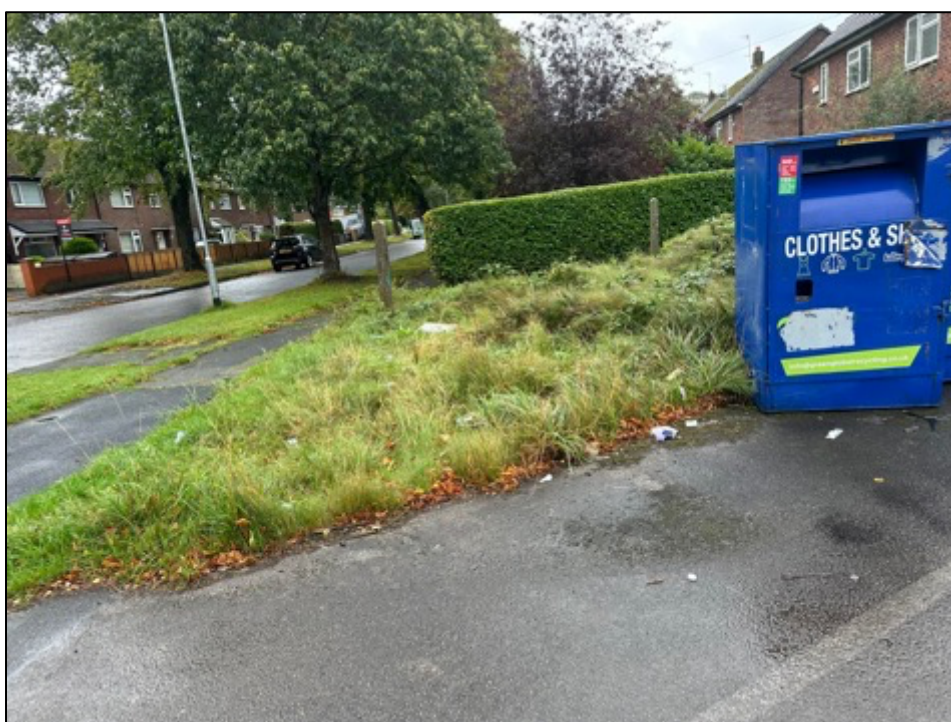
**Photograph 16:** A small bund, featuring mixed grass and forbs species at the rear of the car park. Bramble, Yorkshire fog and curled dock are prominent within the bund.

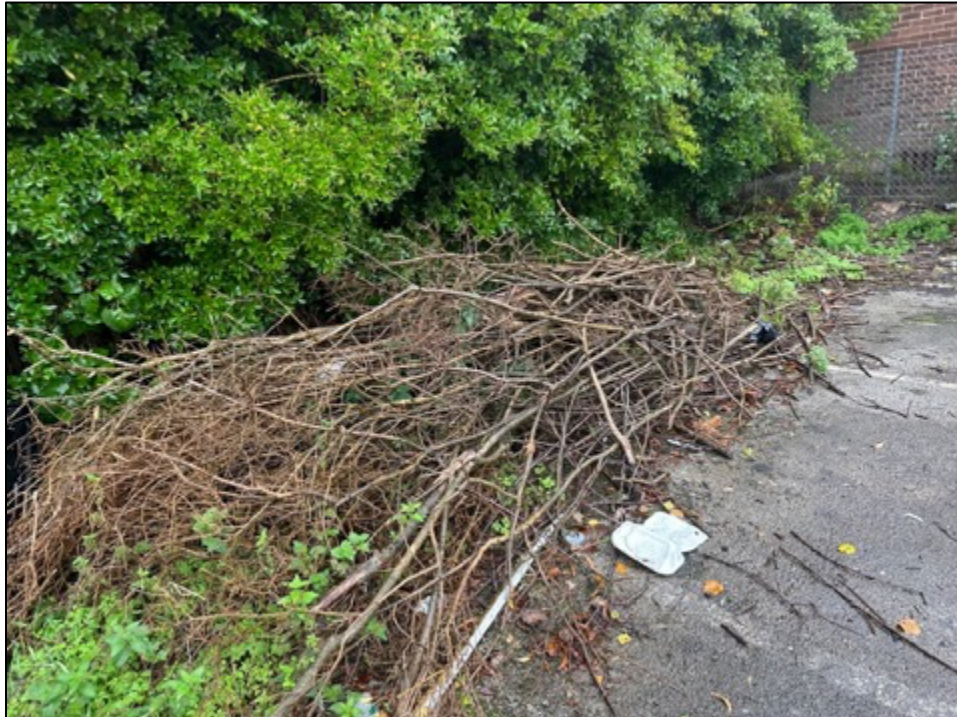
**Photograph 17:** A view of the southwestern boundary of site, comprising a dense hedgerow with some succession growth atop disturbed land, as well as a small pile of felled tree limbs. Oak and privet are the dominant species across this hedgerow boundary.

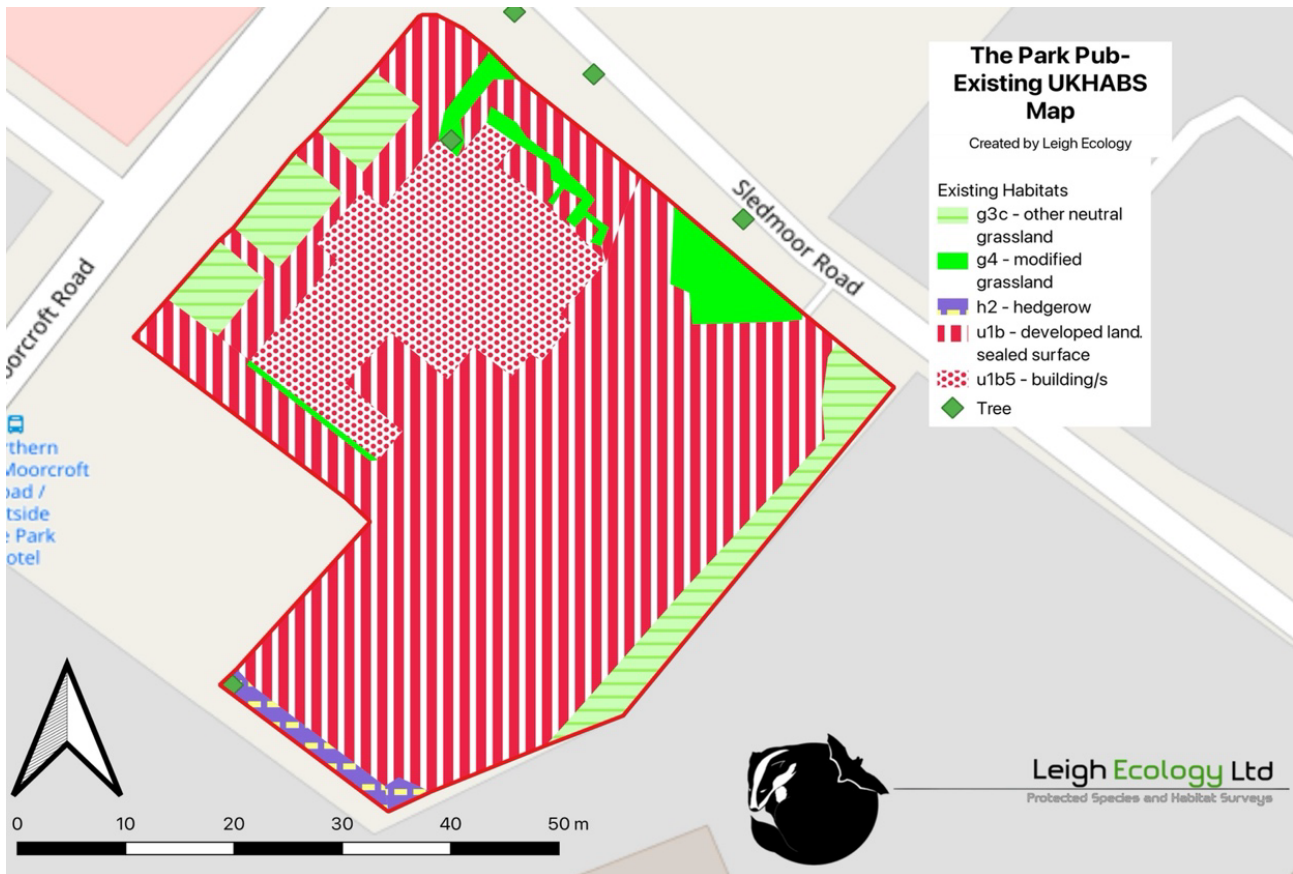
## Appendix 1 – UKHABS Map

The results of the Phase 1 Habitat Survey are presented in Appendix 1, with accompanying photographs included within the text. Habitat types are described, and species are referred to using their English names. The survey covered the full extent of the land shown in Figure 2.1.

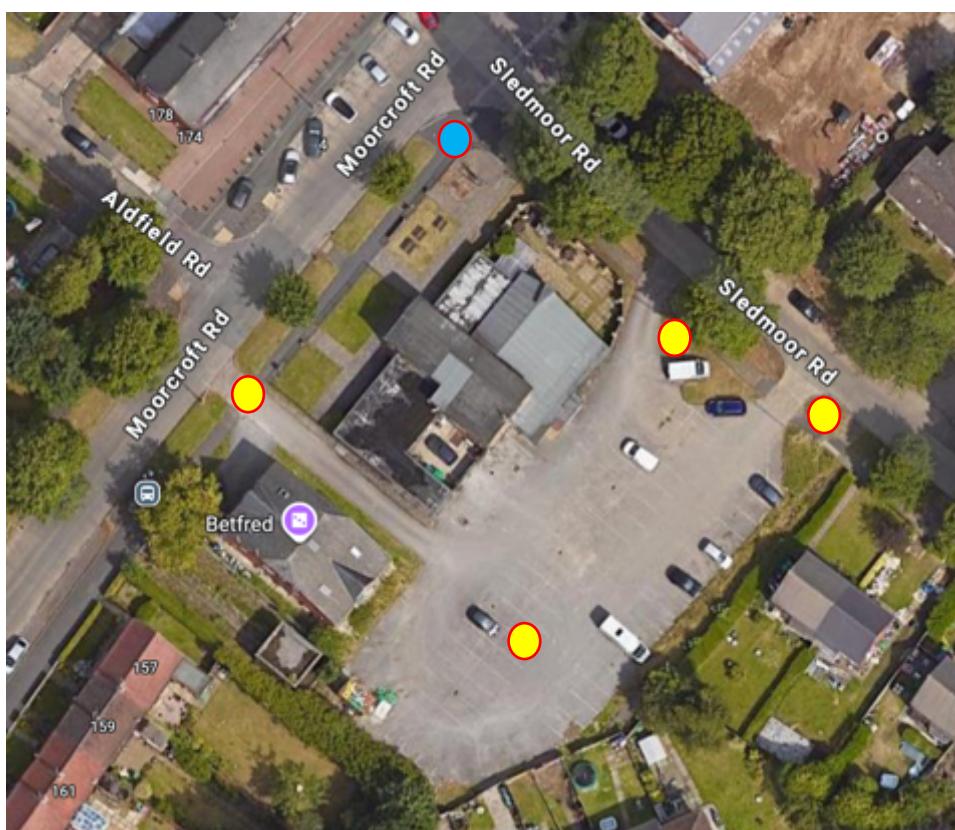
Figure 1: Surveyor positions

The survey was led by Roy Leigh ACIEEM, a Natural England licensed bat ecologist (licence number: 2015-15883–CLS). To ensure full coverage of all potential access points, **four surveyors and one thermal imaging camera were positioned at strategic points around the site, with clear views of all elevations and roof lines of the main building and adjacent treeline.** This setup allowed for simultaneous monitoring of all potential roost features. Surveyor locations are shown in the accompanying plan (*see Figure 1 – Surveyor Location Plan below*).
