## Phase 2 Site Investigation

Plots NT02, NT03 & NT04  
Dantzic Street

Far East Consortium International Ltd

| TITLE | NAME | SIGNATURE | DATE |
|---|---|---|---|
| Report Reference | 4328-ROC-ZZ-XX-RP-ES-P2-101 | | |

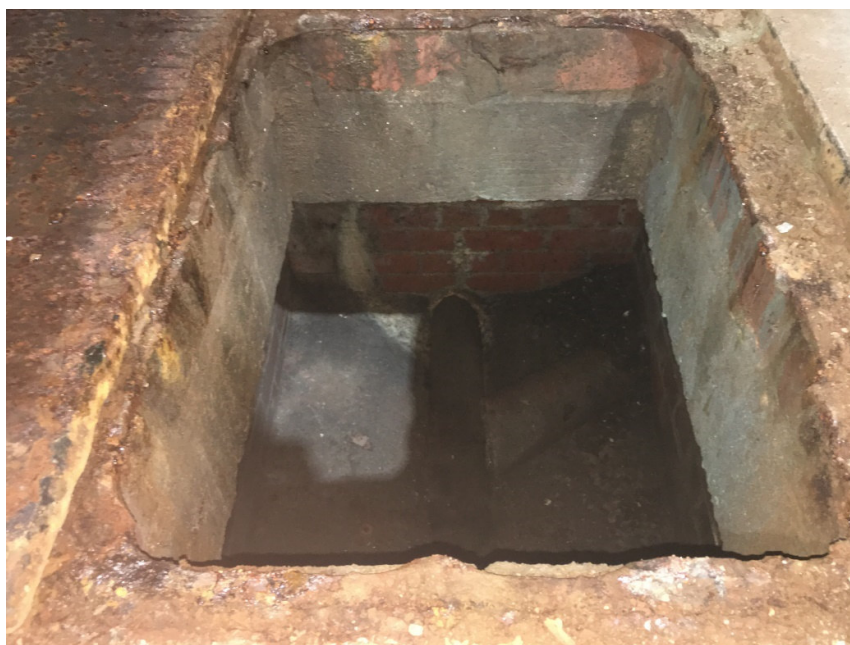
**Figure 5.0 – Southern warehouse manhole chamber**

- 5.2.2 A photoionisation detector (PID) has been used to assess potential volatile organic contamination in soils in this location across multiple stages of investigation and monitoring. While positive detections have been made, these are inconsistent, and are considered to be of lesser relevance for assessment than laboratory testing and subsequent vapour sampling.
- 5.2.3 In addition, as part of these works, a manhole in the centre of the southern warehouse was lifted to determine if this presented a potential source of contamination. A photograph of the chamber is presented below. The chamber has no contents or labelling, and its structure suggests it is a former drain. There was no visual or olfactory evidence of contamination.
