Preliminary Roost Assessment Report

University of Manchester, Rutherford Building

Reference: 81-271-R1-1

Date: June 2023

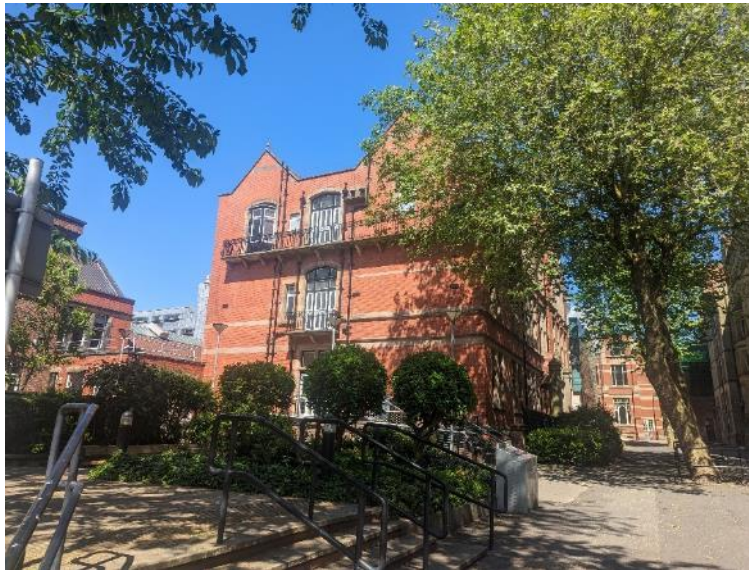
PLATE 1      SHOWING THE RUTHERFORD BUILDING

The Rutherford Building is a three-storey Grade II Listed building with a raised basement. The walls comprised red brickwork with areas of stone.

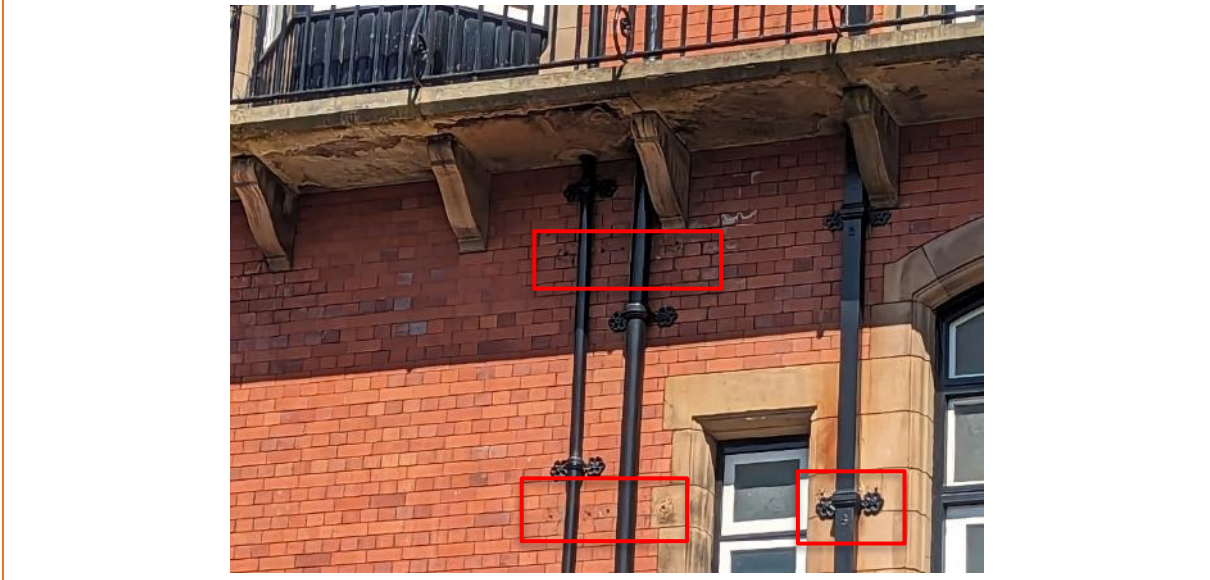
PLATE 2      SHOWING SMALL HOLES IN THE BRICKWORK AND STONE

The majority of the brickwork and stone on the accessible walls were well-sealed and pointed at the time of the survey. Small holes were present within the walls surrounding the downpipes on all accessible aspects of the building, caused by the removal of downpipe brackets. These holes could provide access to the cavity walls that could conceal further bat potential features. This could provide opportunities for a small number of crevice-dwelling bat species on a more regular basis.

The Rutherford Building was assessed as having Moderate bat roosting potential. As such, if the potential roost features identified within the report are affected or disturbed then two Nocturnal Bat Surveys will be required on the building between May and September (inclusive), with one of these surveys completed between May and August (inclusive). The surveys are to follow the guidance set out in Collins (2016), surveyors are to be positioned at areas of greatest roosting potential and should be completed by suitably qualified ecologists. If bats are identified roosting within the building, further surveys will be required to characterise the roost with one further survey required. A European Protected Species Licence (EPSL) would also be required with up-to-date surveys from the survey season prior to the application submission.

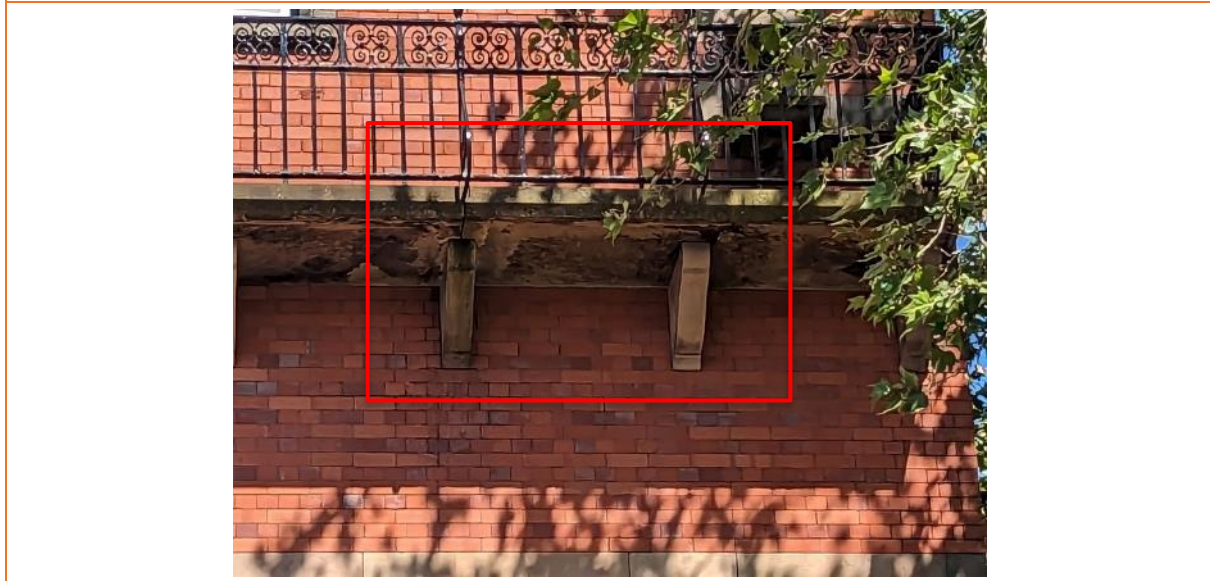
PLATE 3      SHOWING STONE BALCONIES

Stone balconies with wrought iron railings were present on the western aspect of the building. Gaps between the stone were present, which could provide roosting opportunities for a small number of crevice-dwelling species on an occasional basis.

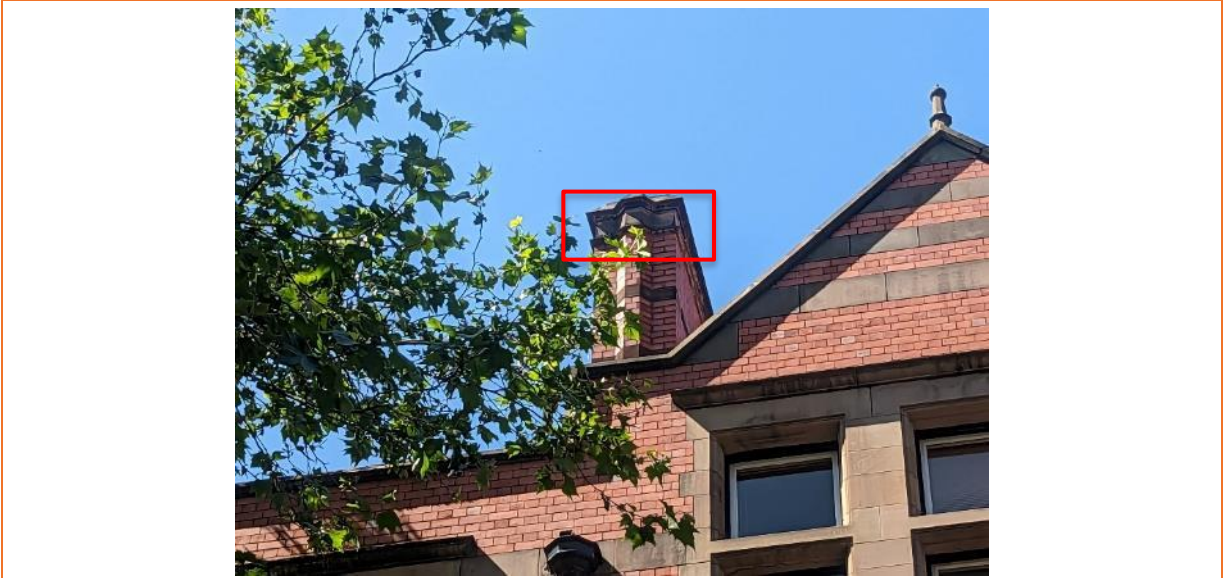
PLATE 5      SHOWING THE SOUTHERN CHIMNEY STACK

Three chimney stacks were present on the roof of the building which comprised red brickwork walls with stone caps. The southern chimney stack featured missing mortar between the brickwork and the stone. This created crevices that crevice-dwelling species may utilise on an occasional basis.

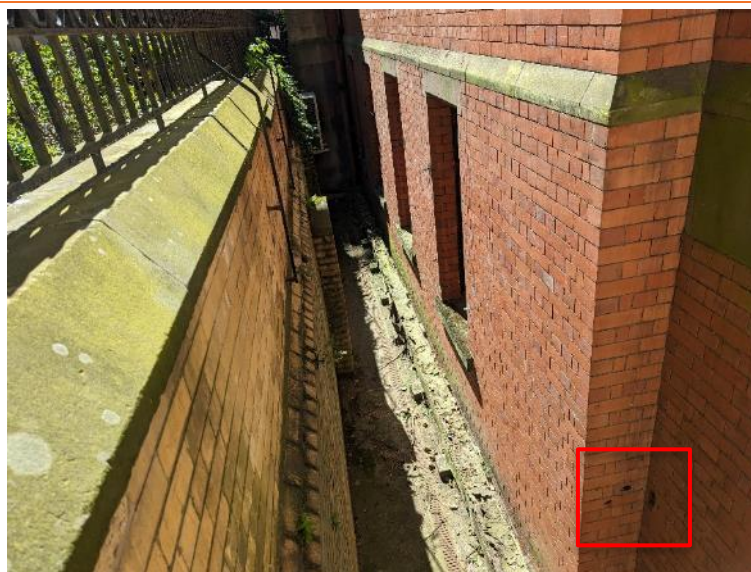
PLATE 7      SHOWING RAISED BASEMENT

A raised basement is present on the southern and northern aspects of the building. Several areas of damage were present on the north-west corner within the brickwork that could provide access to the cavity wall and basement. The cavity wall could contain further bat roosting features that could provide roosting potential for crevice-dwelling bats on a more regular basis. Potential access to the basement is provided by the holes in the damaged brickwork and a mesh metal door. However, the basement will feature disturbance due to its use by the Manchester Museum. As such, the basement is not expected to provide hibernation potential for bats. Furthermore, the height level of the features further reduces the suitability due to the emergence and re-entry patterns of bats including the need for a clear flying space and flight path.
