**VALIDATION REPORT  
FOR LAND AT  
PLANT HILL ROAD  
BLACKLEY  
PLOTS 1 TO 12**

**Ref: GSI 2209 DD PIV Report**

| Quality Assurance | |
|---|---|
| Project Name | Plant Hill Road, Blackley |
| Report Type | Phase IV Validation Report |

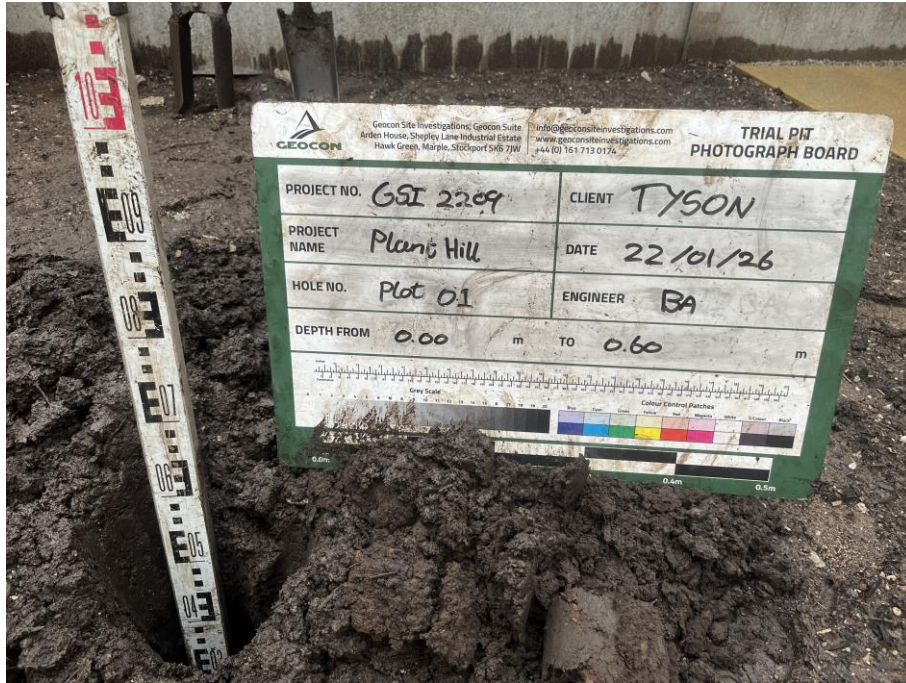
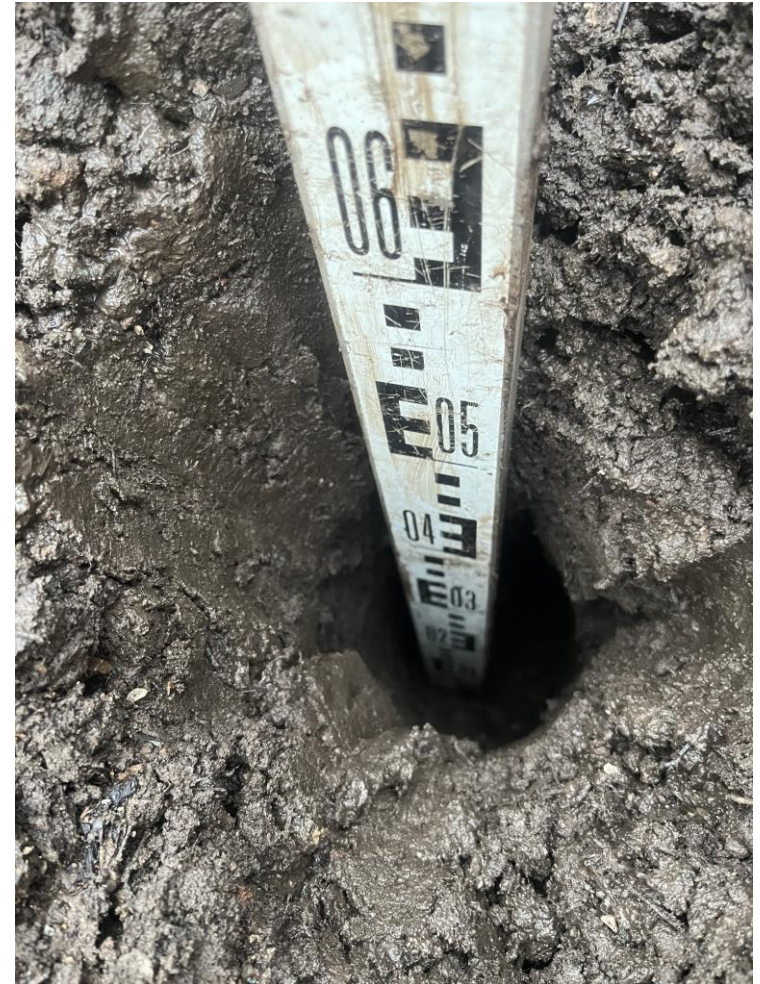
| <b>TITLE</b><br>Plot 01 Photograph & Sketch | <b>DATE</b><br>January 2026 | <b>DRAWN BY</b><br>BA |

3.3.4 All hand excavated trial pit photographs are presented in Appendix D. All locations, with the exception of Plot 10, encountered a topsoil cover of at least 600mm, generally comprising dark brown slightly clayey slightly gravelly fine to coarse sand with gravel of sandstone.

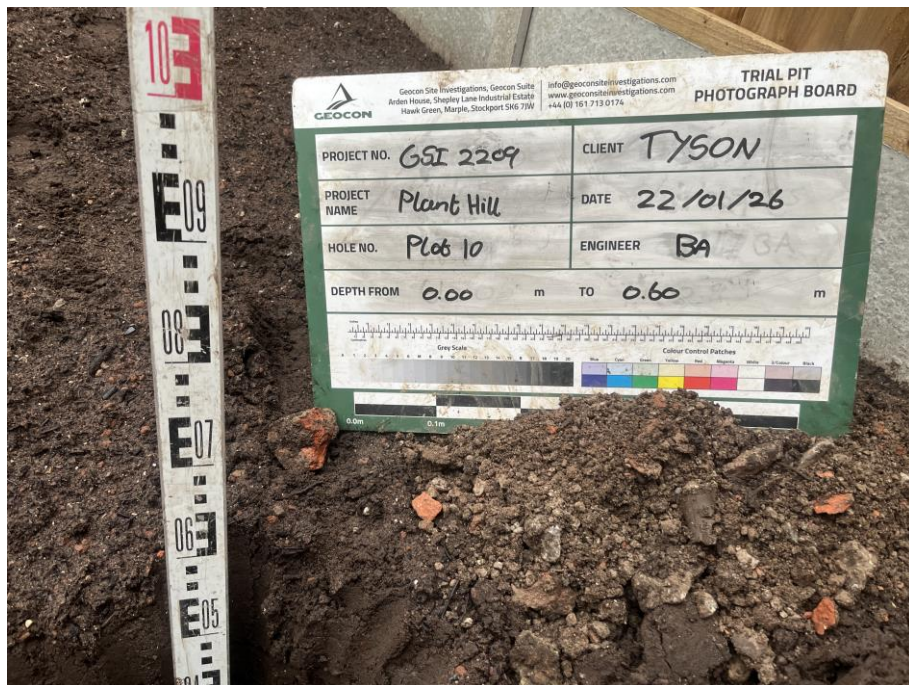
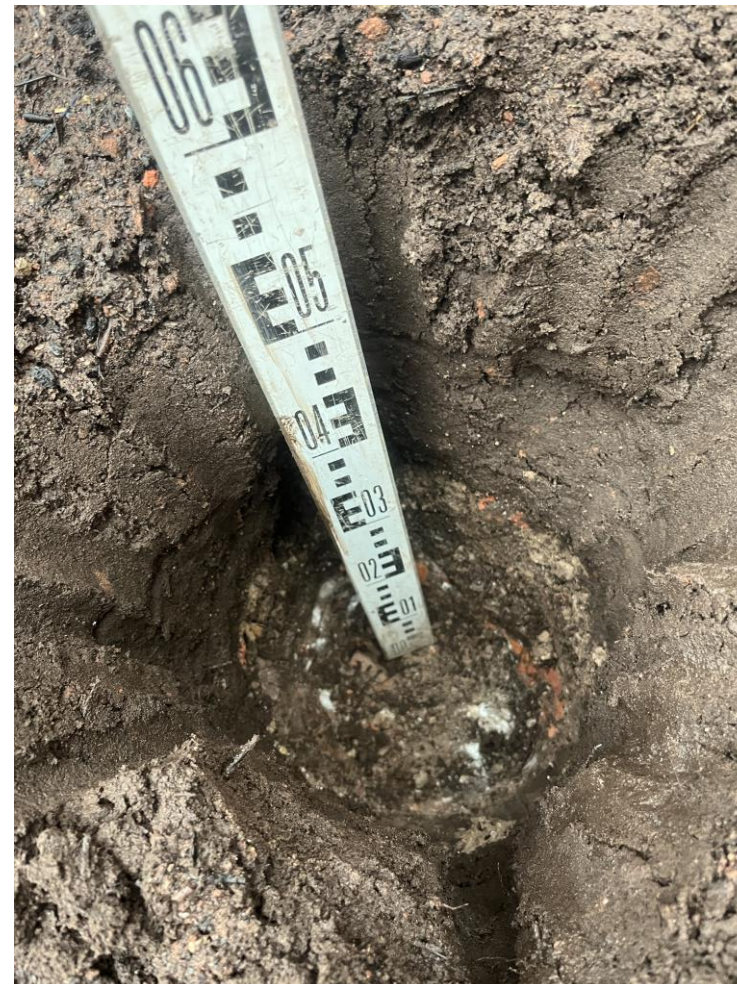
| <b>TITLE</b><br>Plot 10 Photograph & Sketch | <b>DATE</b><br>January 2026 | <b>DRAWN BY</b><br>BA |

- 3.3.5 Made Ground was encountered in the hand pit for Plot 10, beneath an insufficient depth of topsoil cover. This was subsequently rectified and the plot was validated on the second site visit with the correct thickness of topsoil cover.

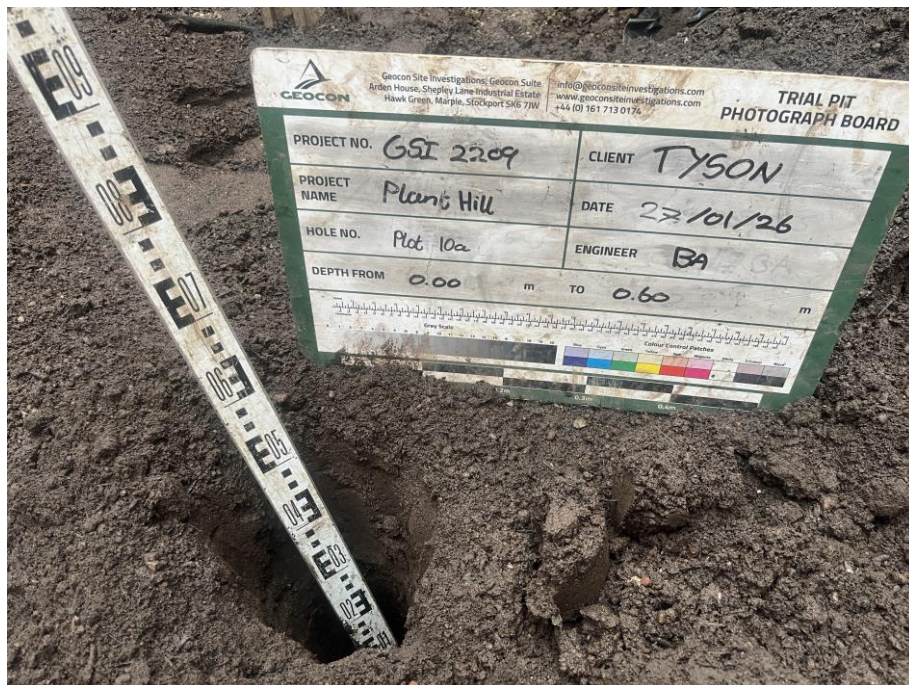
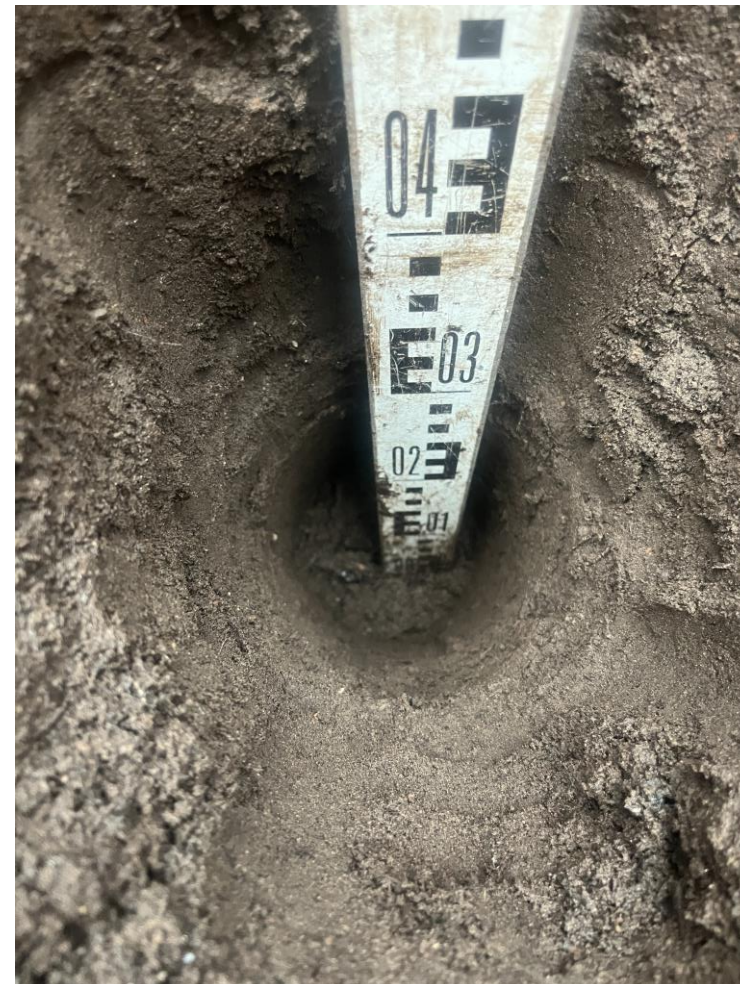
| <b>TITLE</b><br>Plot 10a Photograph & Sketch | <b>DATE</b><br>January 2026 | <b>DRAWN BY</b><br>BA |

3.2.2 A total of thirteen hand excavated trial pits were advanced to a minimum depth of 0.60mbgl, at a frequency of one in each rear garden. Two pits (Plot 10 and Plot 10a) were excavated in the rear garden of plot 10 as an insufficient depth of topsoil cover was encountered during the first visit.
