# MANCHESTER CITY ETIHAD STADIUM

## NORTH STAND

### Completion Report

Consolidation of Potential Abandoned Coal Mine Workings by Drilling and Grouting

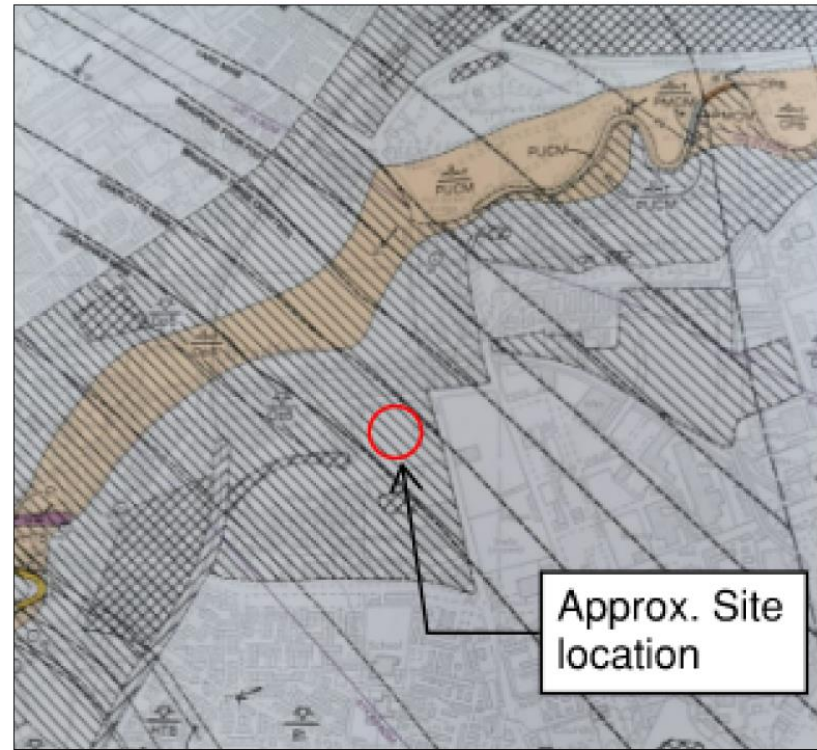
Figure 3

The expected proximate geology around the site is shown on **Figures 3 and 4** in **Appendix A**. These show the Charlotte Upper Leaf and Charlotte Lower Leaf coal seams to sub-crop beneath the site. While the Bradford series of coal seams (the most popular coal sequence) are probably too deep to have any influence on ground stability and the Openshaw seam (which overlies the Charlotte seams) probably sub-crops to the south-west, ie down dip, of the stabilisation area – See **Figure 5**.

Extract of 1:50,000 BGS map (Sheet 85)

Extract of 1:10,000 BGS map (SJ89NE)

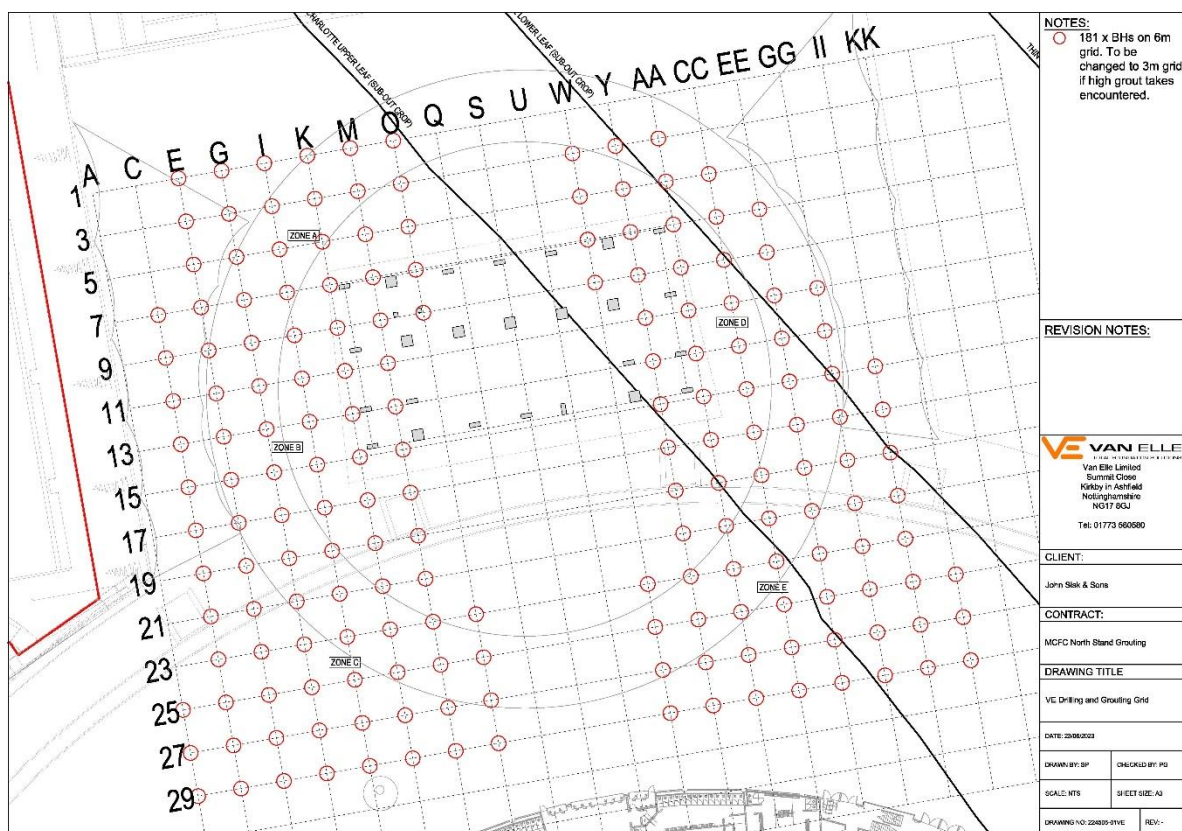
Figure 1: 6m Borehole Grid

The production stabilisation boreholes were set out on a regular 6m x 6m grid with rows designated A to N, inclusive and 1 to 16 inclusive, giving each grout injection position a unique reference. In practice, irregularities in the stabilisation area boundaries and obstructions to drilling positions meant that some of the grid boreholes were either angled off vertical or omitted – see **Appendix D**. An additional row of primary production holes, designated 'Row X' was added at the northern boundary, adjacent to Row A.

The Drilling Grid (shown in Figure 1) shows the areas to be treated from suspected workings within the Charlotte Upper and Lower Seams.

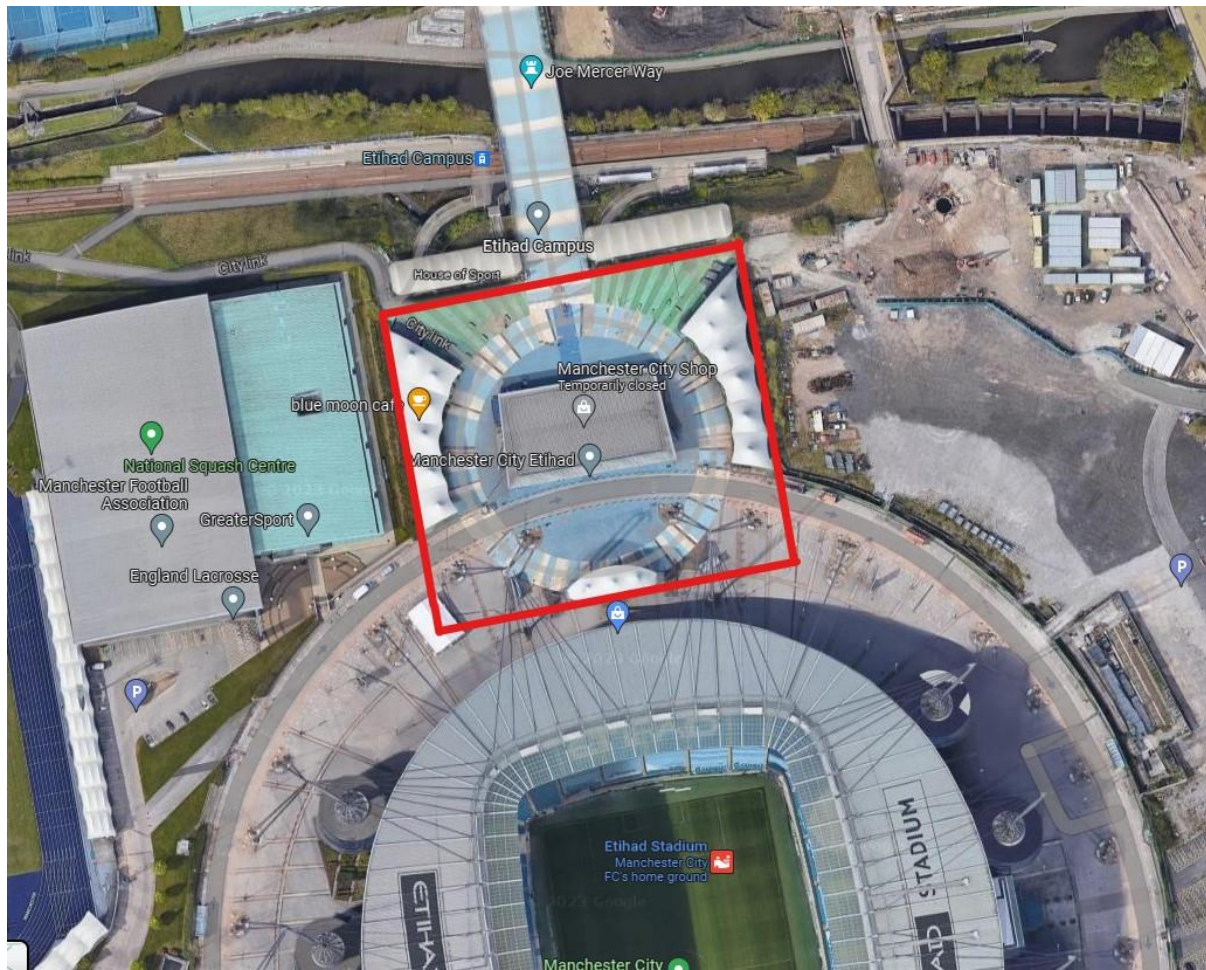
Figure 2: Site plan

The site is located off the A6020, Alan Turing Road to the east northeast of Manchester City centre the treatment area is some 10,500m<sup>2</sup> and is located to the north of the stadium where the existing club shop sits, shown in Figure 2.

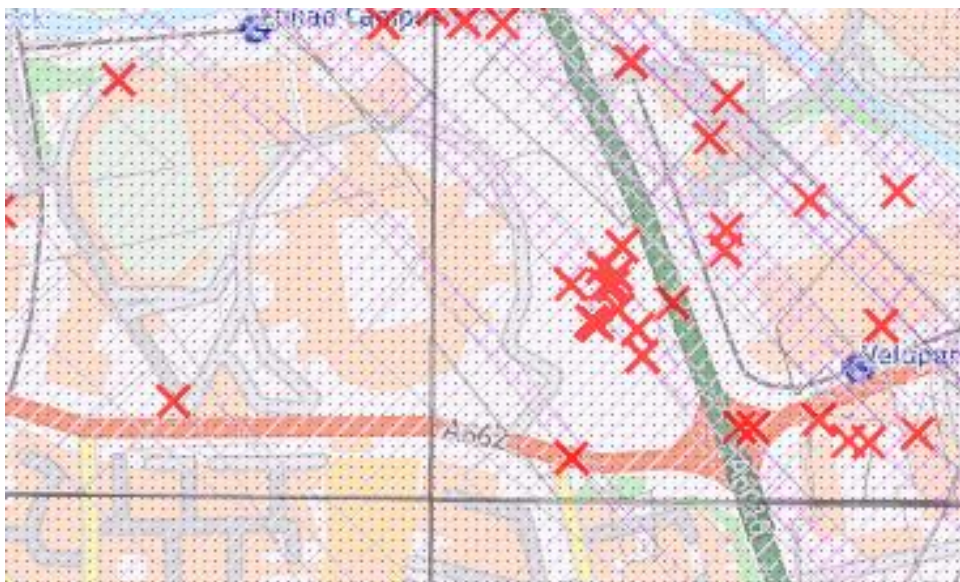
Plate 4 – showing former coal mining area.

A further check of the Coal Authority Interactive viewer also revealed that the site is within a former coal mining area. It was therefore recommended that these “seams” be investigated and if found to be showing evidence of workings to be consolidating by drilling and grouting.
