## Phase 2: Site Investigation

**99 Plymouth Grove, Manchester**

NE-26-004/SI

## PHASE 2 SITE INVESTIGATION REPORT

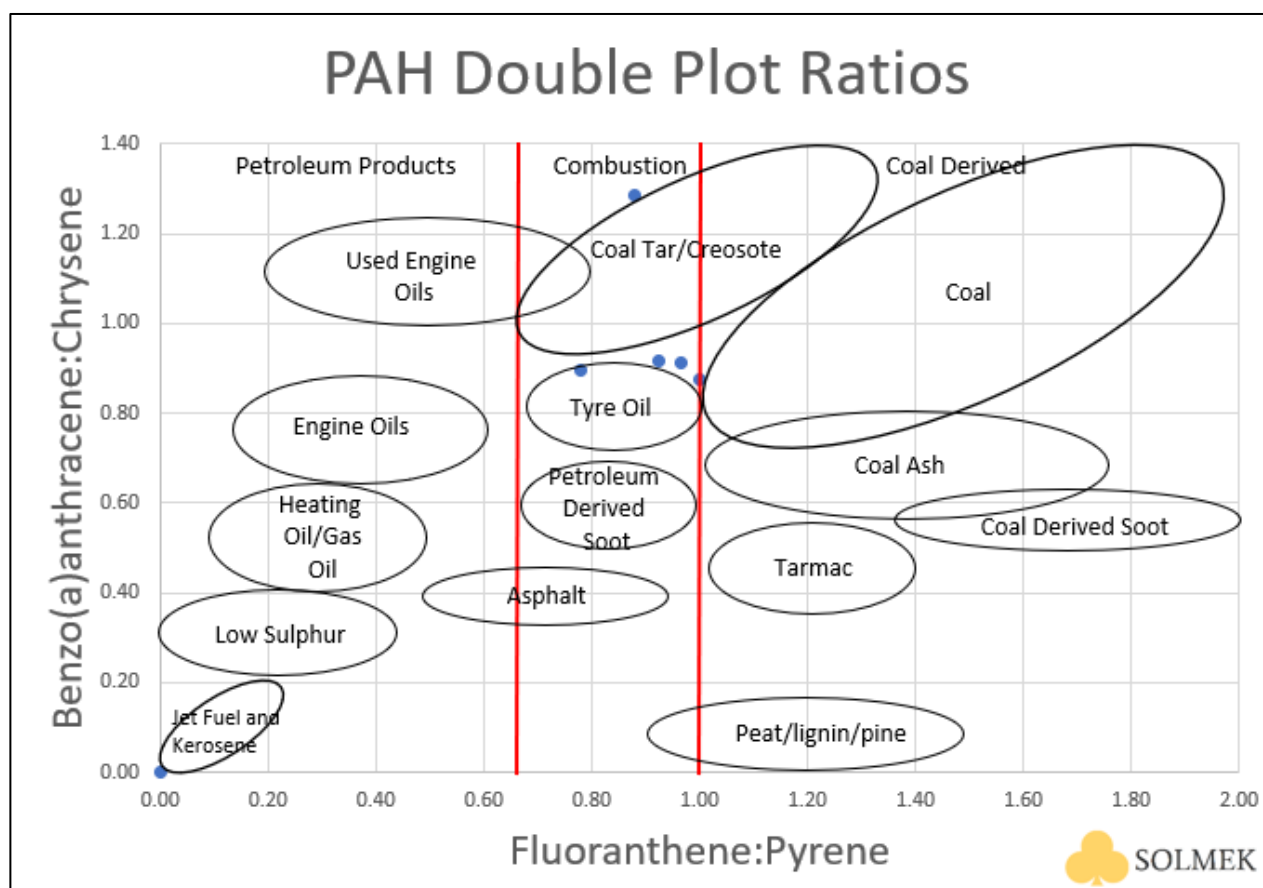
**FIGURE A: DOUBLE PLOT RATIO CHART**

Double Ratio Plot Analysis of the samples which recorded elevated PAHs (Figure A, below) indicates that the PAH is generally of tyre oil or coal tar/creosote origin.

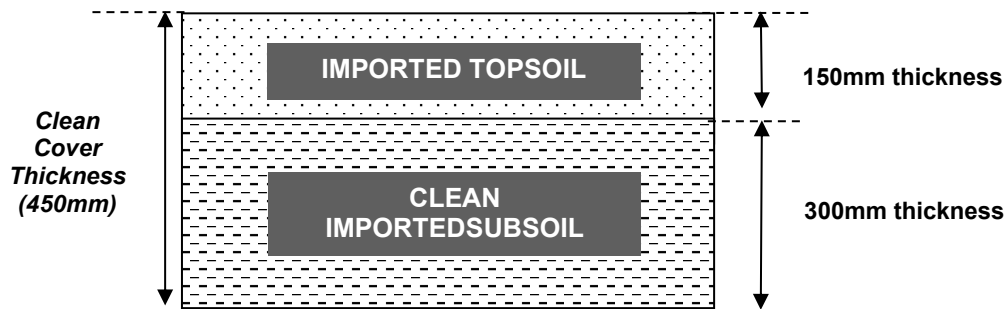
The cover system should include imported topsoil, to a depth of 150mm over either natural ground or clean imported subsoil at least 300mm in thickness. Appropriate certification would be required to ensure that the onsite or imported materials are clean and free from deleterious materials in accordance with the Local Authority Guidelines *Verification Requirements for Cover Systems, Technical Guidance for developers, Landowners and Consultants* (Yorkshire and Lincolnshire Pollution Advisory Group Version 4.1 – June 2021). Details of the clean cover system must be presented in a Phase 3 Remediation Statement.

The diagram below gives an overview of the minimum thicknesses of clean cover system that should be placed by the site operatives in soft landscaped areas.

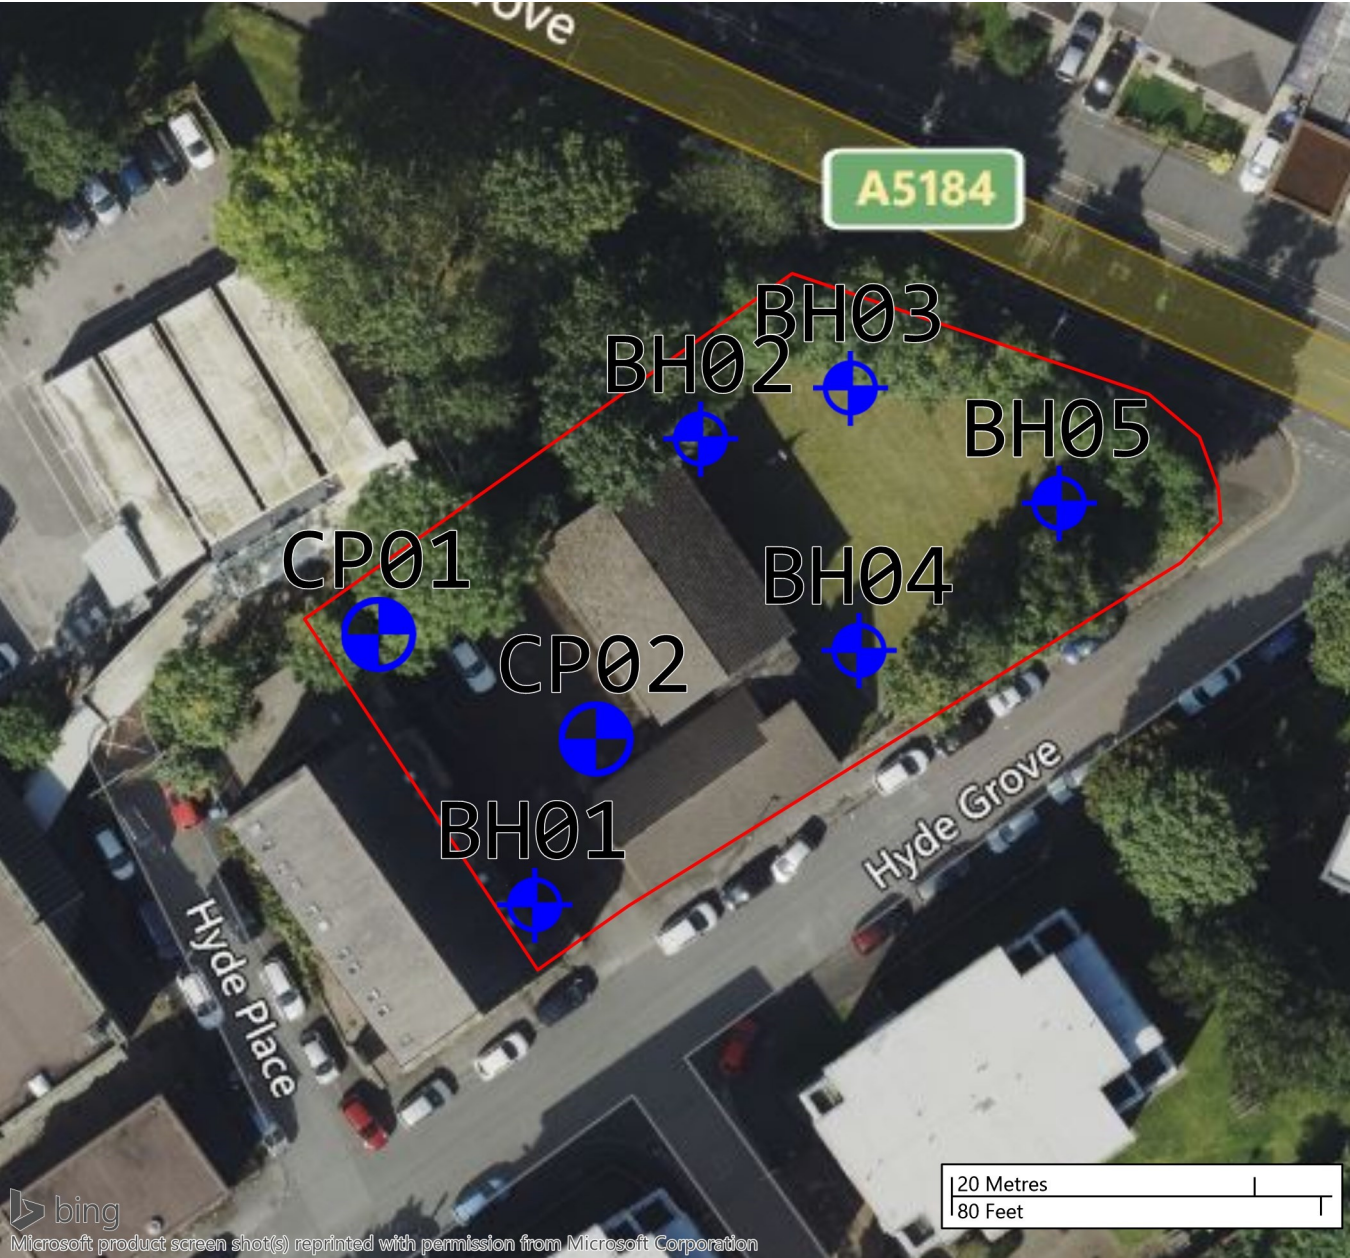
A plan showing the location of the boreholes can be found in Appendix A (Figure 2).

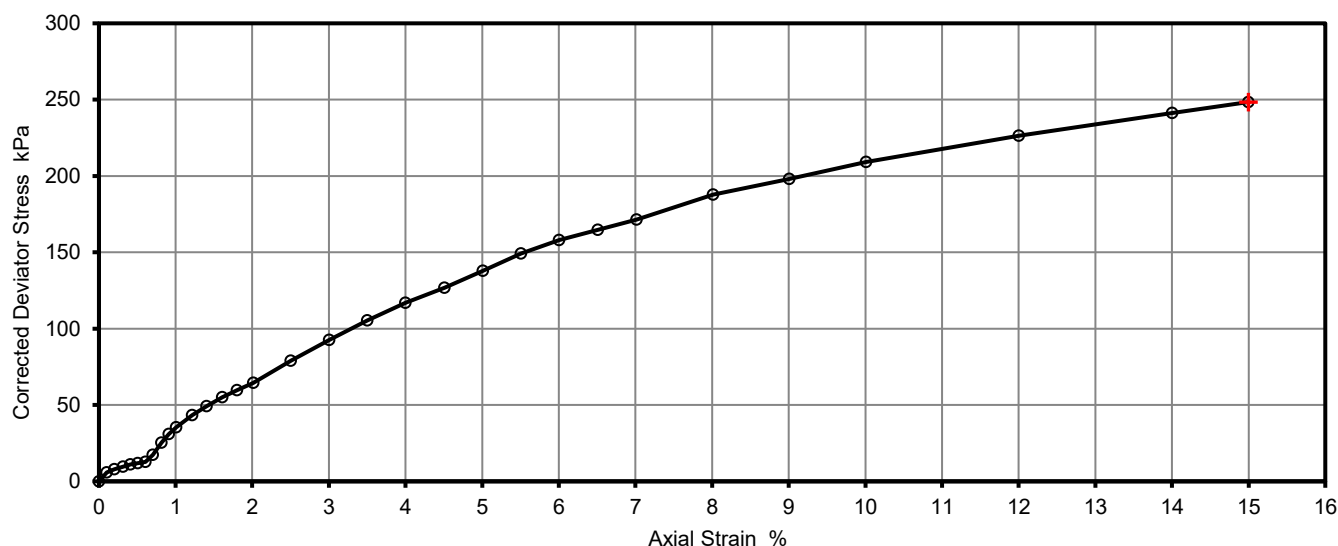
**Deviator Stress v Axial Strain**

Deviator stress corrected for area change and membrane effects

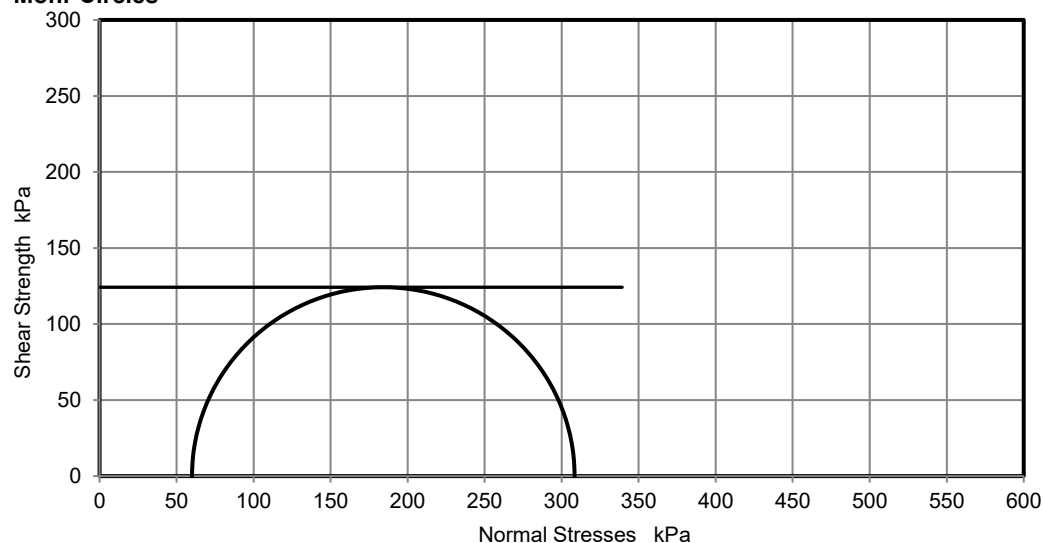
**Mohr Circles**

Mohr circles and their interpretation is not covered by BS1377. This is provided for information only.

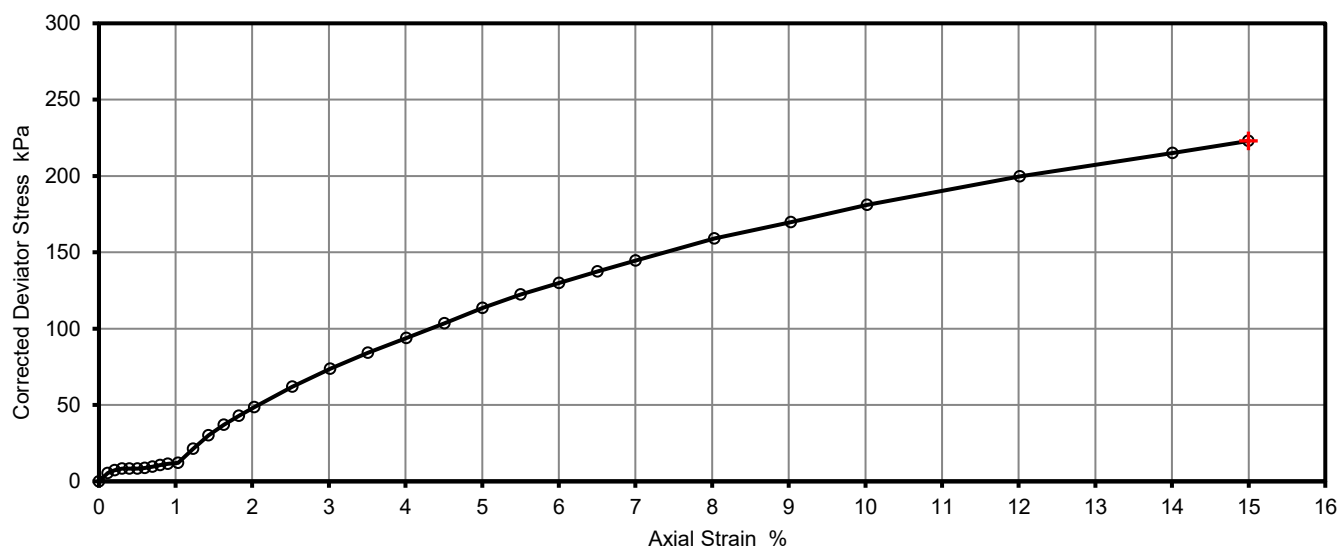
**Deviator Stress v Axial Strain**

Deviator stress corrected for area change and membrane effects

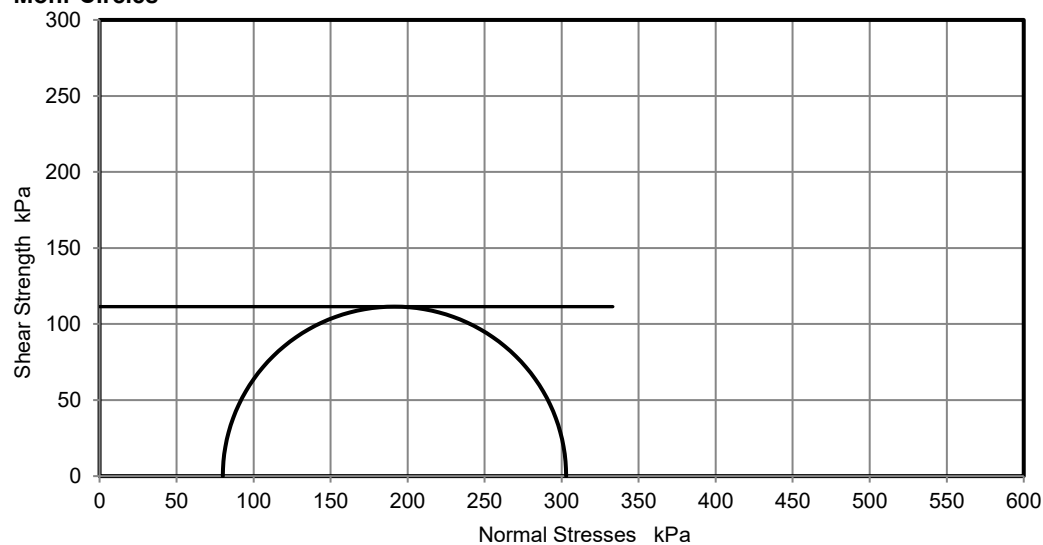
**Mohr Circles**

Mohr circles and their interpretation is not covered by BS1377. This is provided for information only.

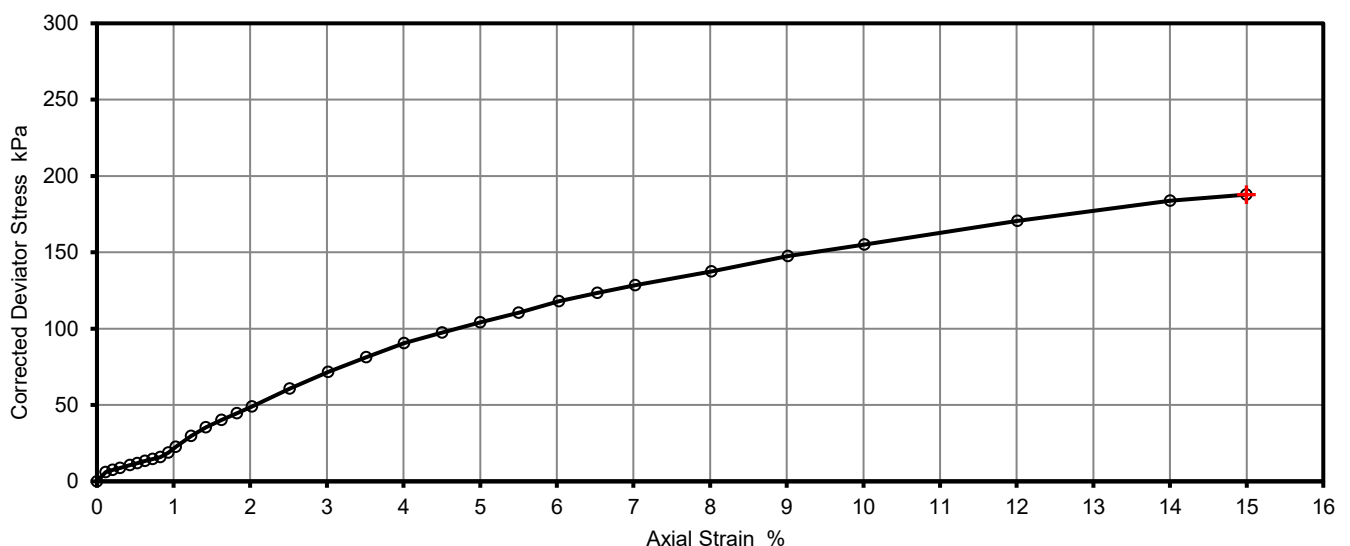
**Deviator Stress v Axial Strain**

Deviator stress corrected for area change and membrane effects

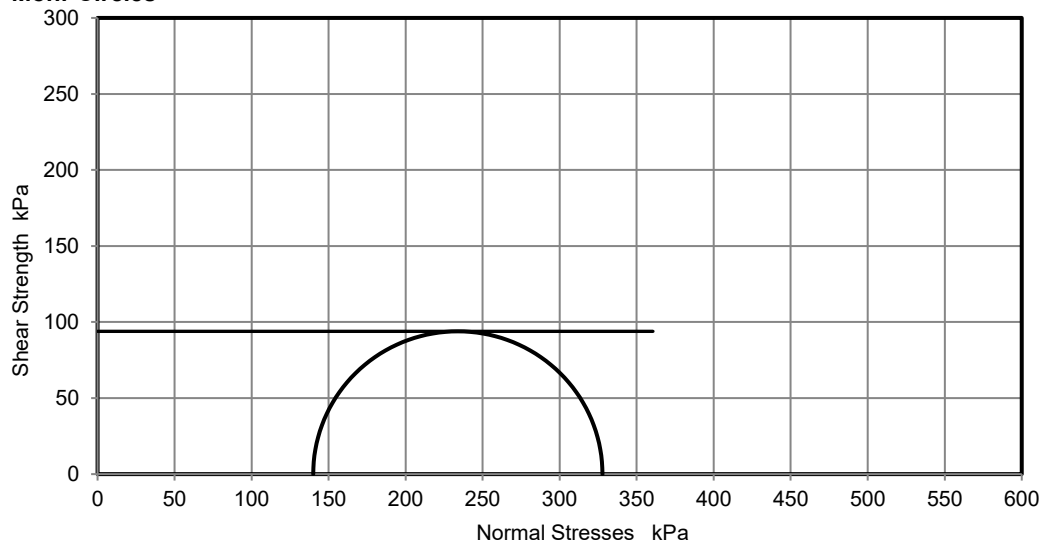
**Mohr Circles**

Mohr circles and their interpretation is not covered by BS1377. This is provided for information only.

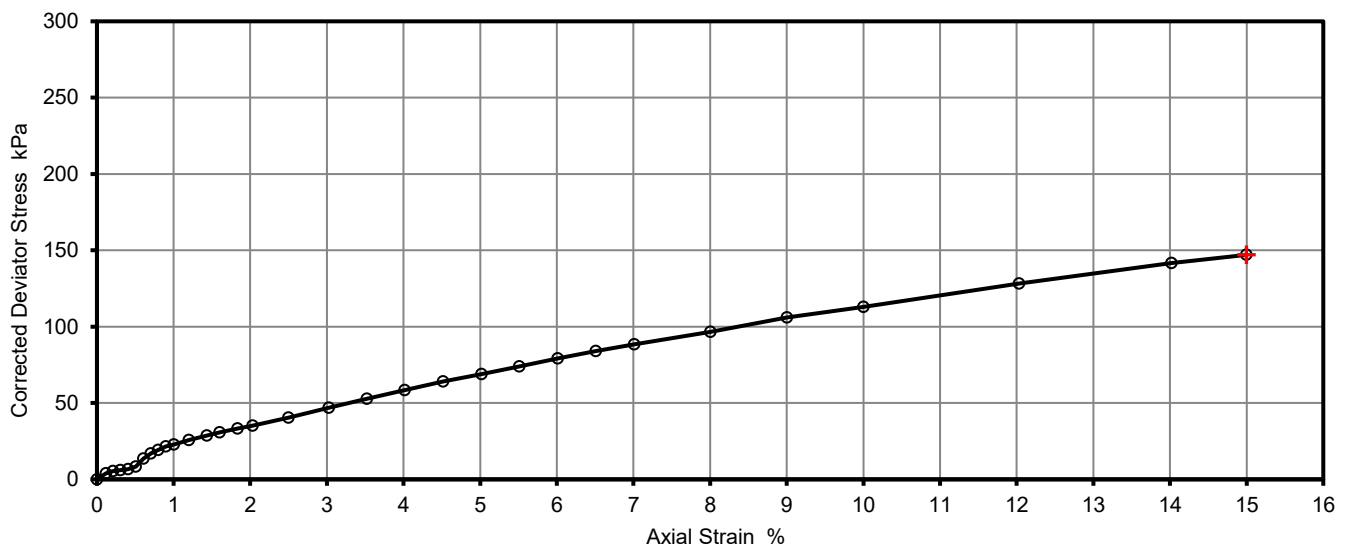
**Deviator Stress v Axial Strain**

Deviator stress corrected for area change and membrane effects

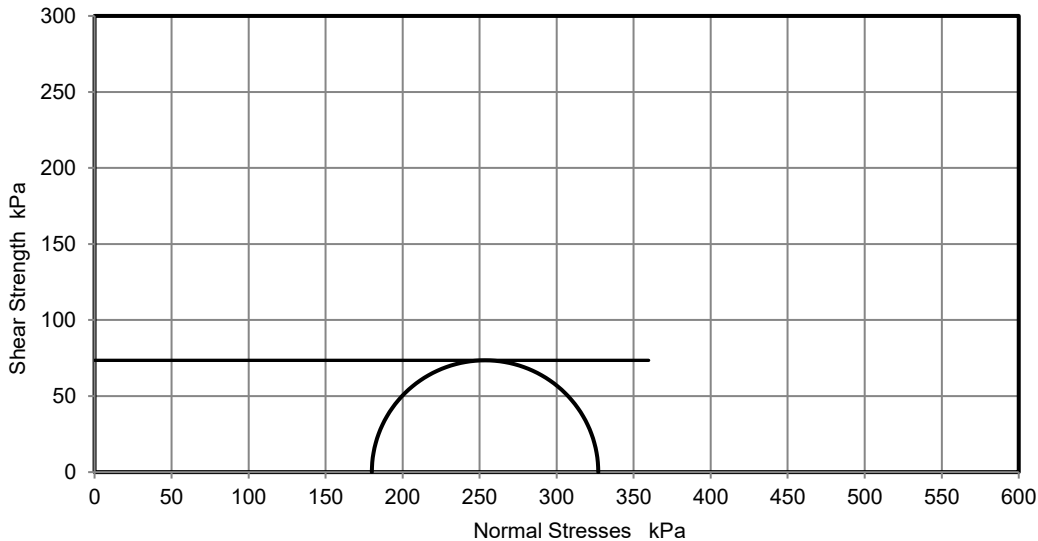
**Mohr Circles**

Mohr circles and their interpretation is not covered by BS1377. This is provided for information only.

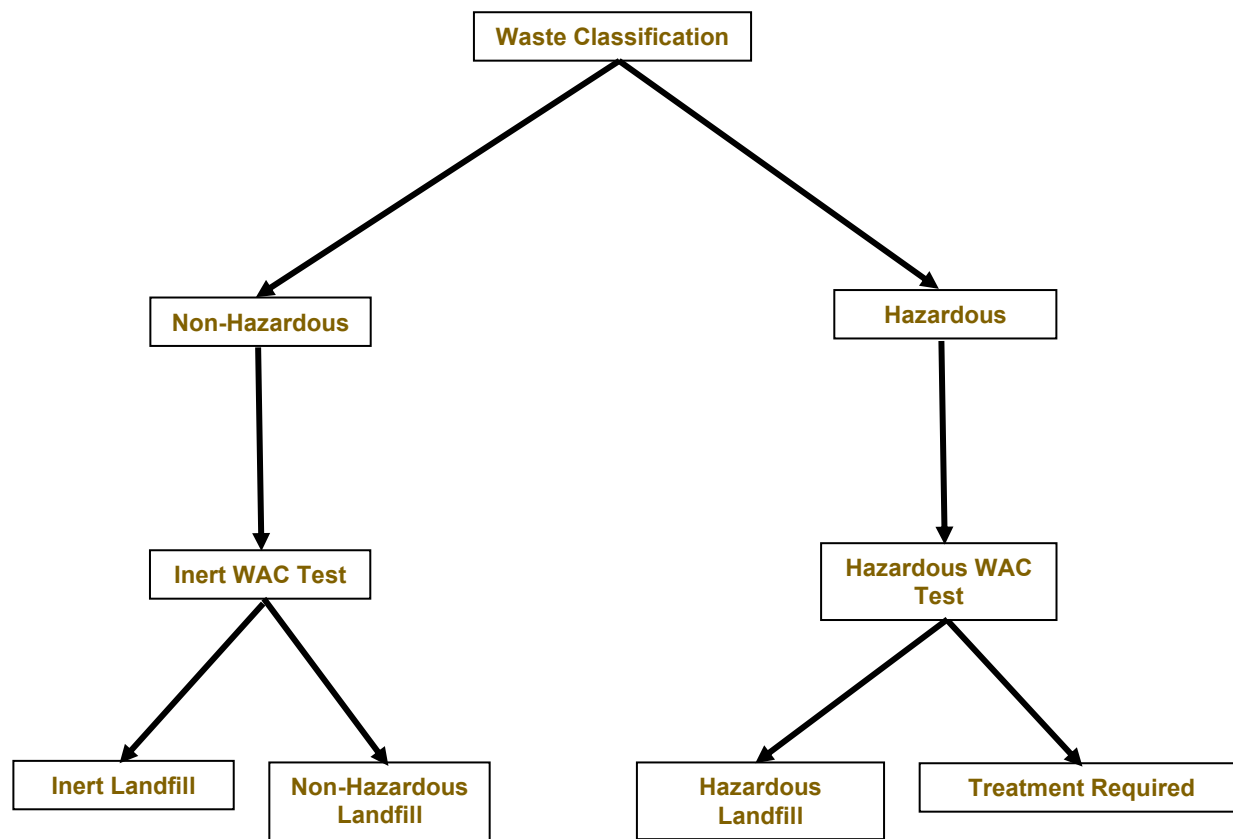
The below flow chart provides further information on the waste classification process.

During the site strip and construction activities, material may be required to be removed from site. Any such material would require classification, in line with Environment Agency Technical Guidance *Waste Classification: Guidance on the classification and assessment of waste* (2015). This would classify the material as either Non-Hazardous or Hazardous Waste.

Once the material has been classified, determining the suitable landfill for disposal is governed by landfill directive Waste Acceptance Criteria (WAC) testing, with landfills categorized as Inert Waste, Stable Non-Reactive Hazardous Waste and Hazardous Waste.
